**REPORT NUMBER: SPNCAP-MGA-2011-038**

**NEW CAR ASSESSMENT PROGRAM (NCAP)  
Side Impact Pole Test**

**HONDA MFG. OF INDIANA, LLC  
2011 Honda Civic 4-Dr Sedan  
NHTSA No.: MB5309**

**MGA RESEARCH CORPORATION  
5000 Warren Road  
Burlington, WI 53105**

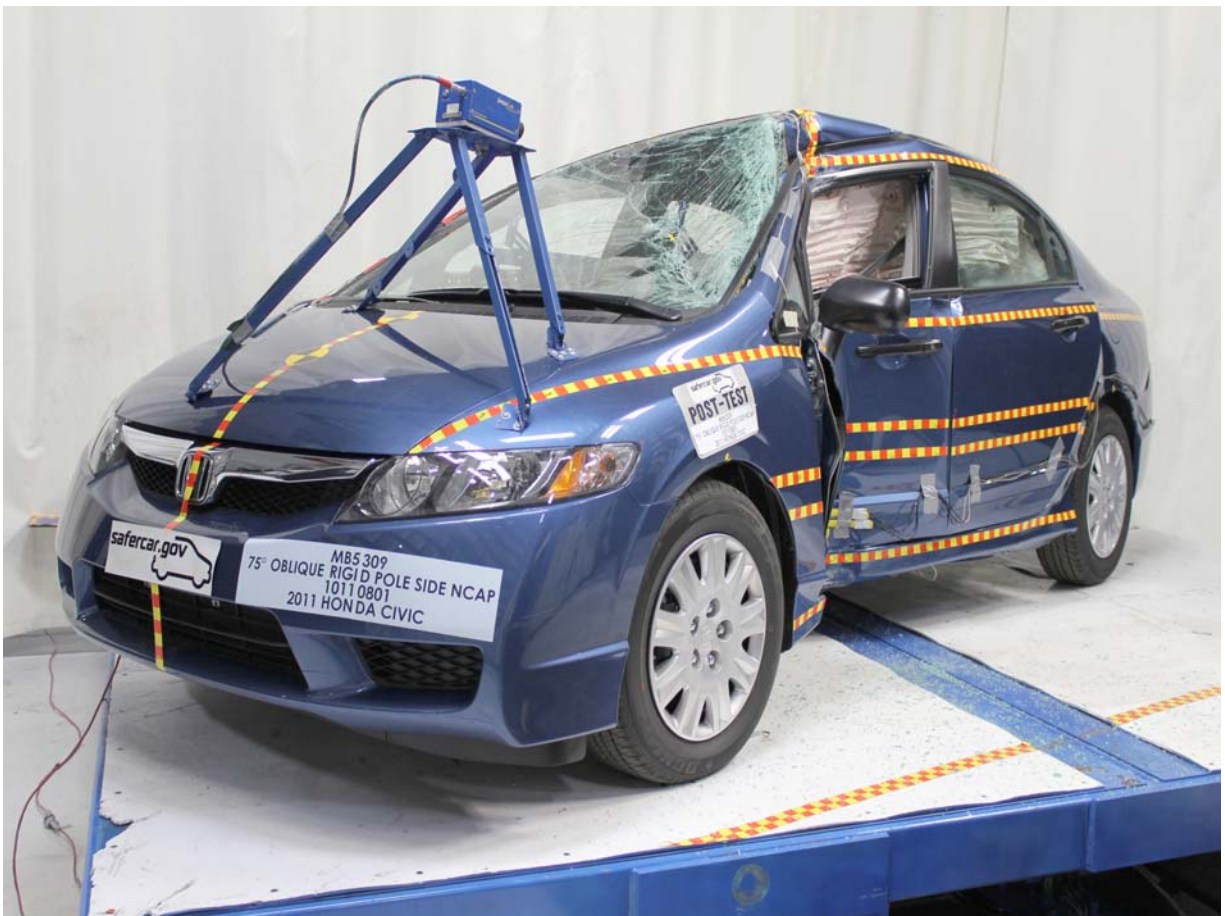
Post-Test Left Front  $\frac{3}{4}$  View of Test Vehicle

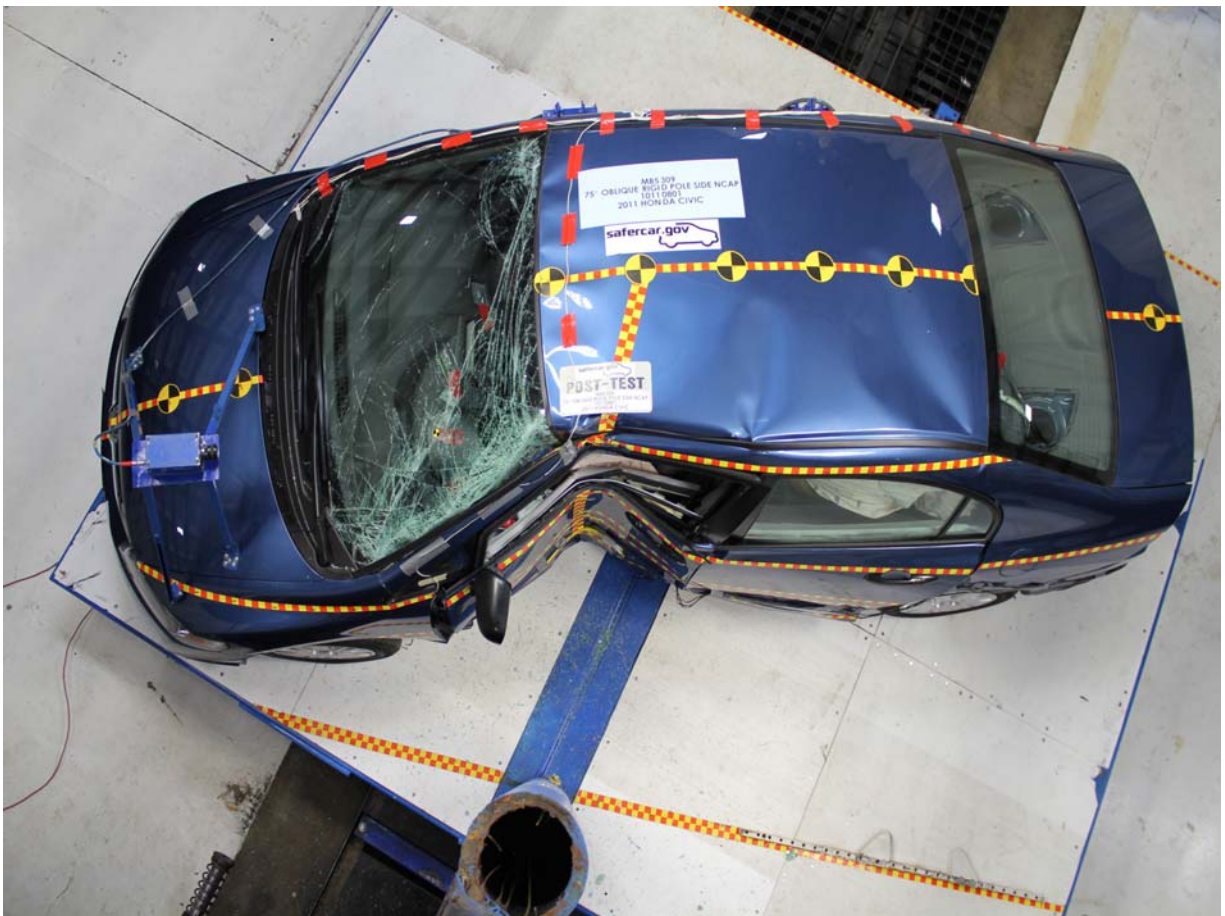
Post-Test Overhead View of Test Vehicle and Pole

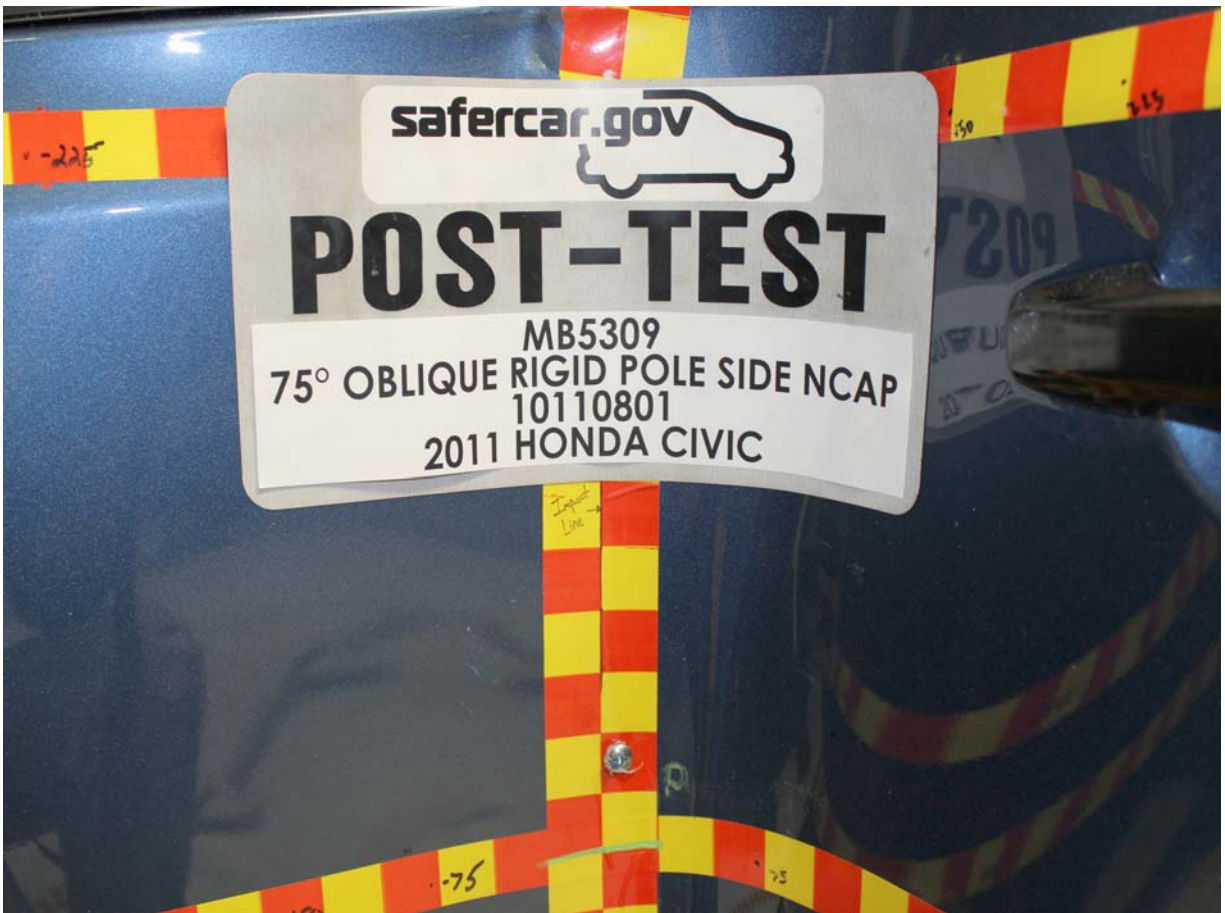
Post-Test Close-Up View of Impact Point Target Showing Impact Location

| Measurement Parameter | Units | Value |
|---|---|---|
| Actual Impact Point (Aft of Front Axle) | mm | 1086 |
| Impact Point Difference (- forward / + rearward) | mm | 7 |

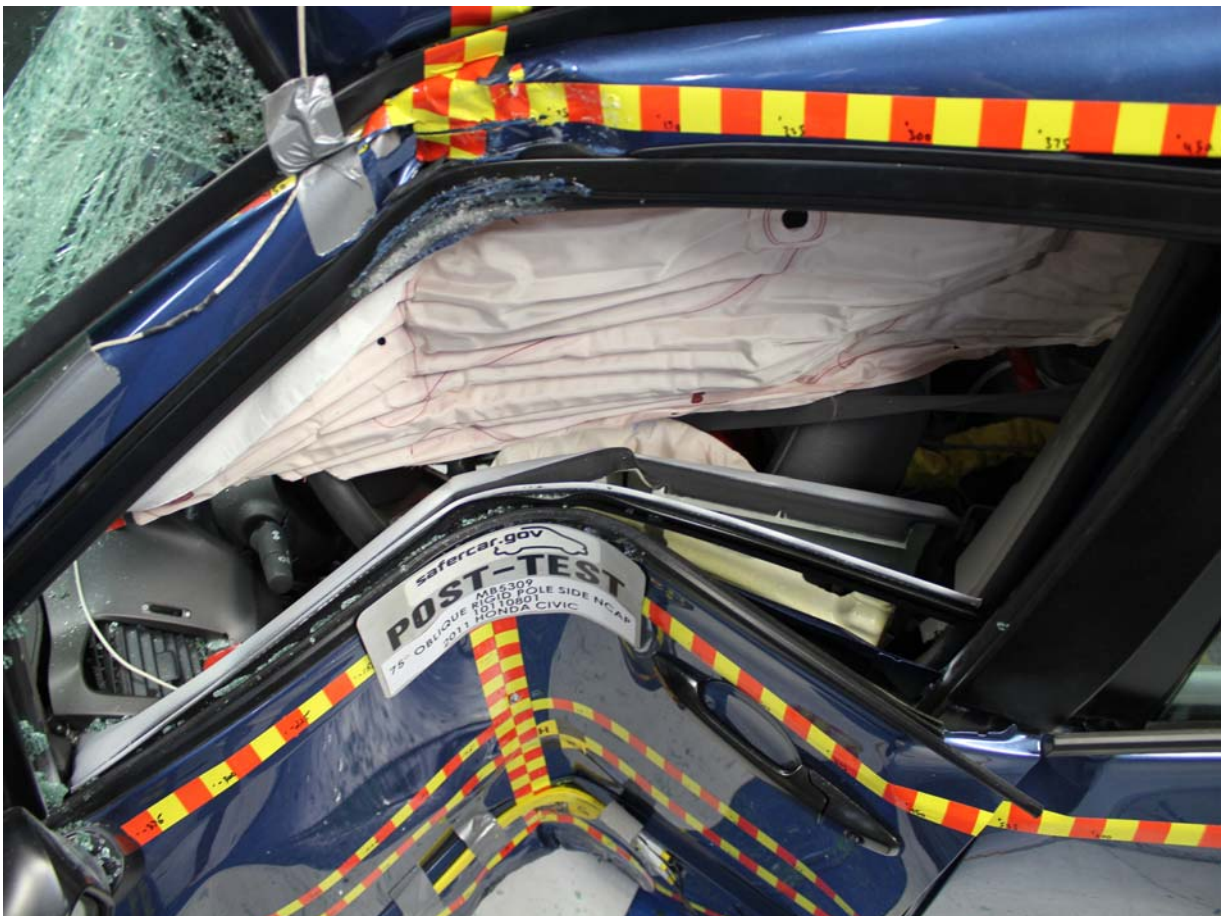
Post-Test Dummy and Door Clearance View

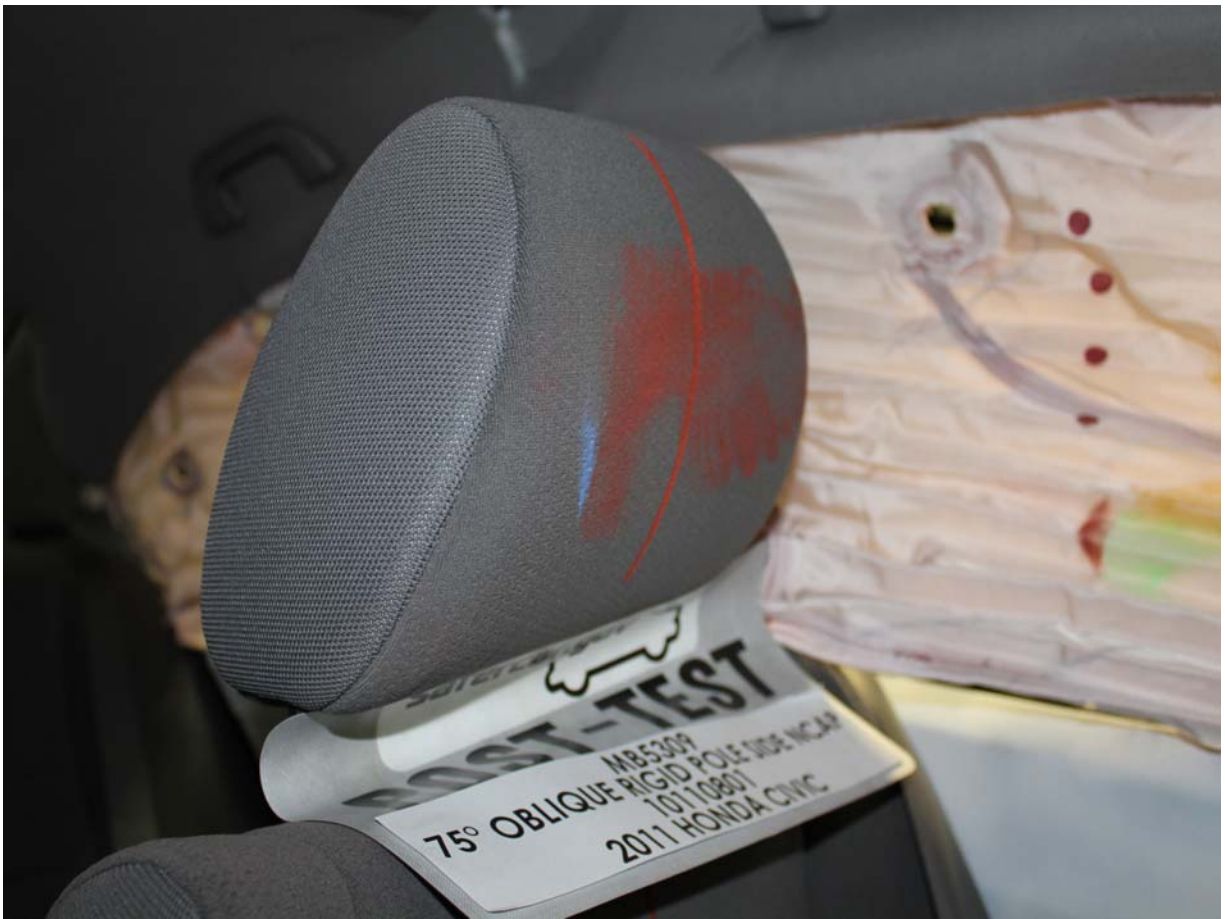
Post-Test Dummy Close-Up Head Contact with Vehicle Interior View

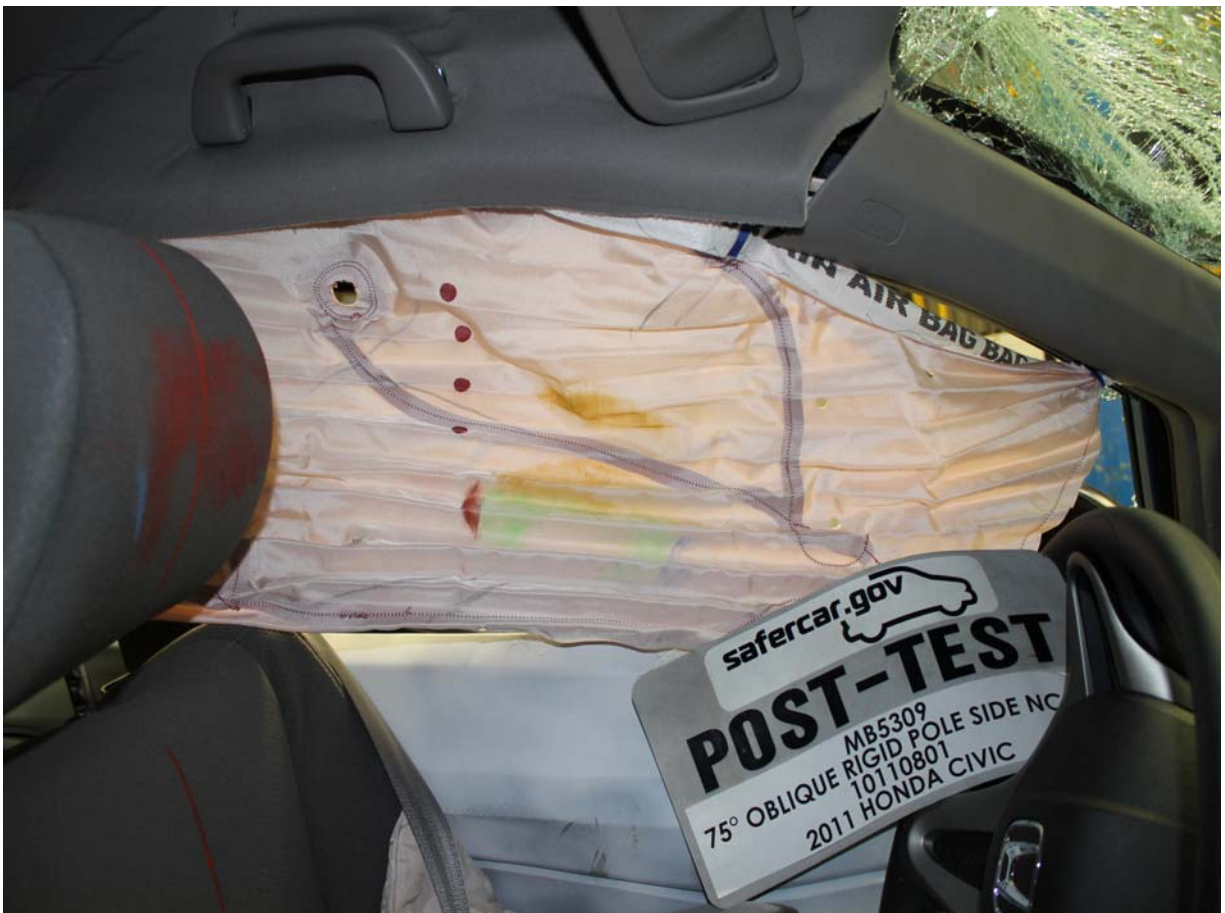
Post-Test Dummy Close-Up Head Contact with Side Airbag View

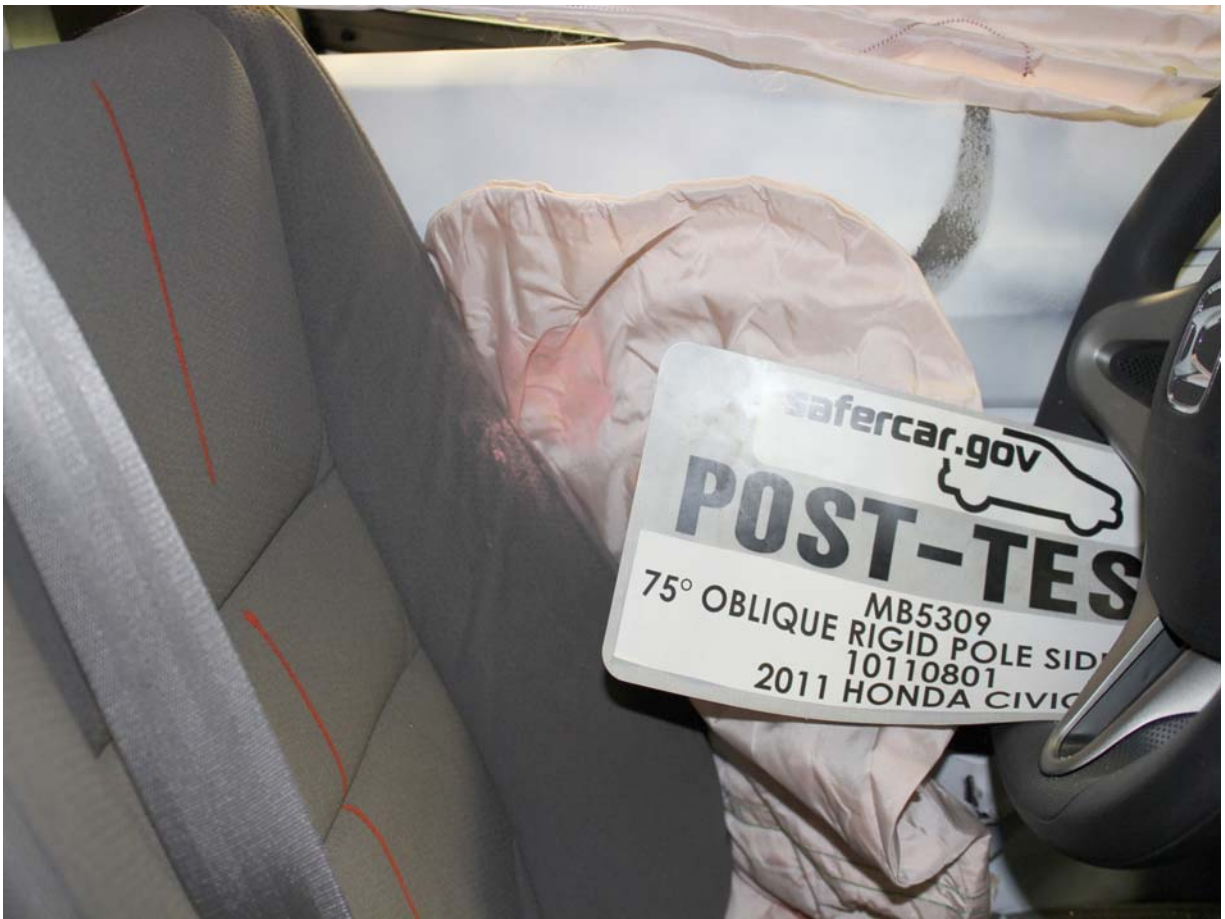
Post-Test Dummy Close-Up Torso Contact with Vehicle Interior View

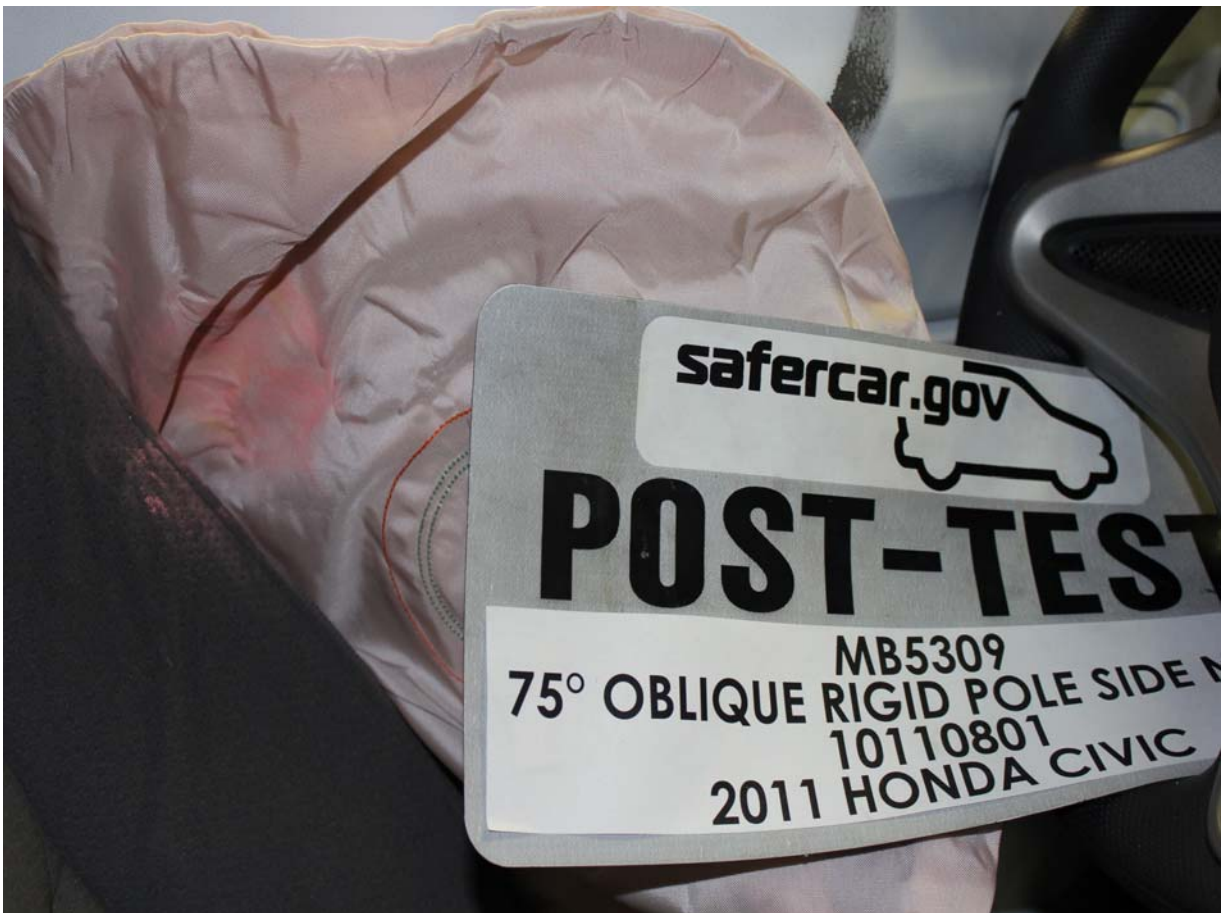
Post-Test Dummy Close-Up Torso Contact with Side Airbag View

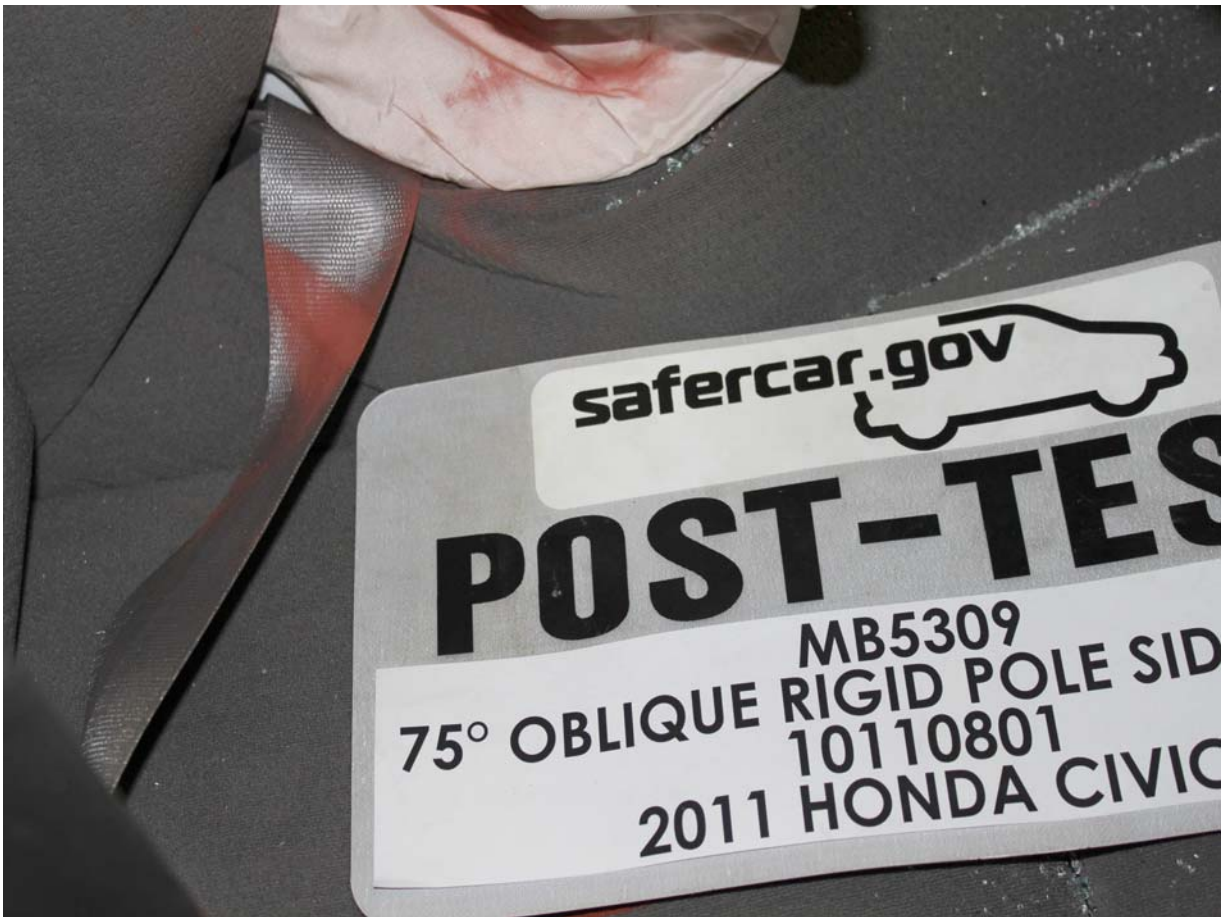
Post-Test Dummy Close-Up Pelvis Contact with Vehicle Interior View
