**REPORT NUMBER: NCAP-MGA-2011-040**

**NEW CAR ASSESSMENT PROGRAM (NCAP)  
Frontal Barrier Impact Test**

**HONDA MFG. OF INDIANA, LLC  
2011 Honda Civic 4-Dr Sedan  
NHTSA No.: MB5311**

**FINAL REPORT**

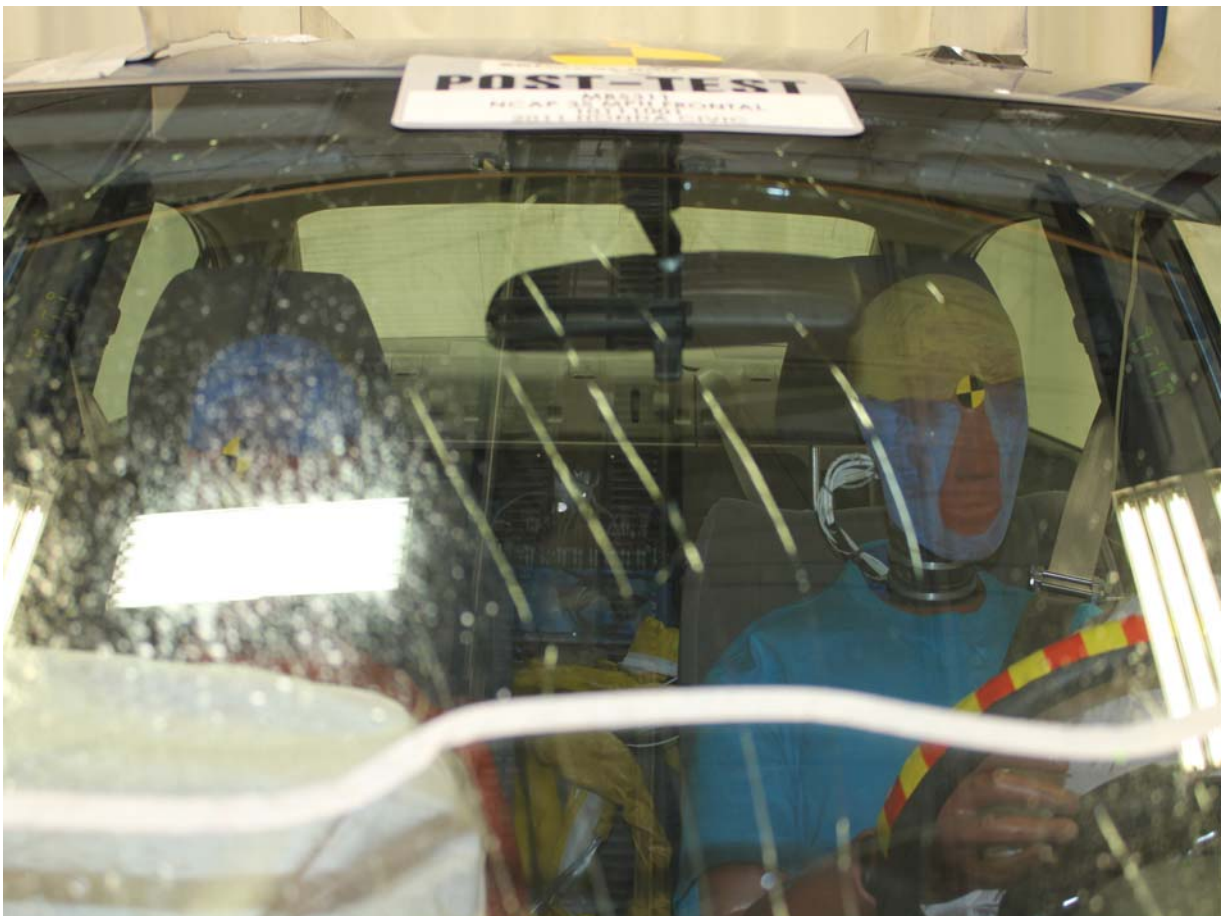
Post-Test Windshield View

There was 100 percent windshield retention and no intrusion into the protected zone of the windshield during the event. There was no Stoddard Solvent leakage after the event or during any phase of the static rollover.

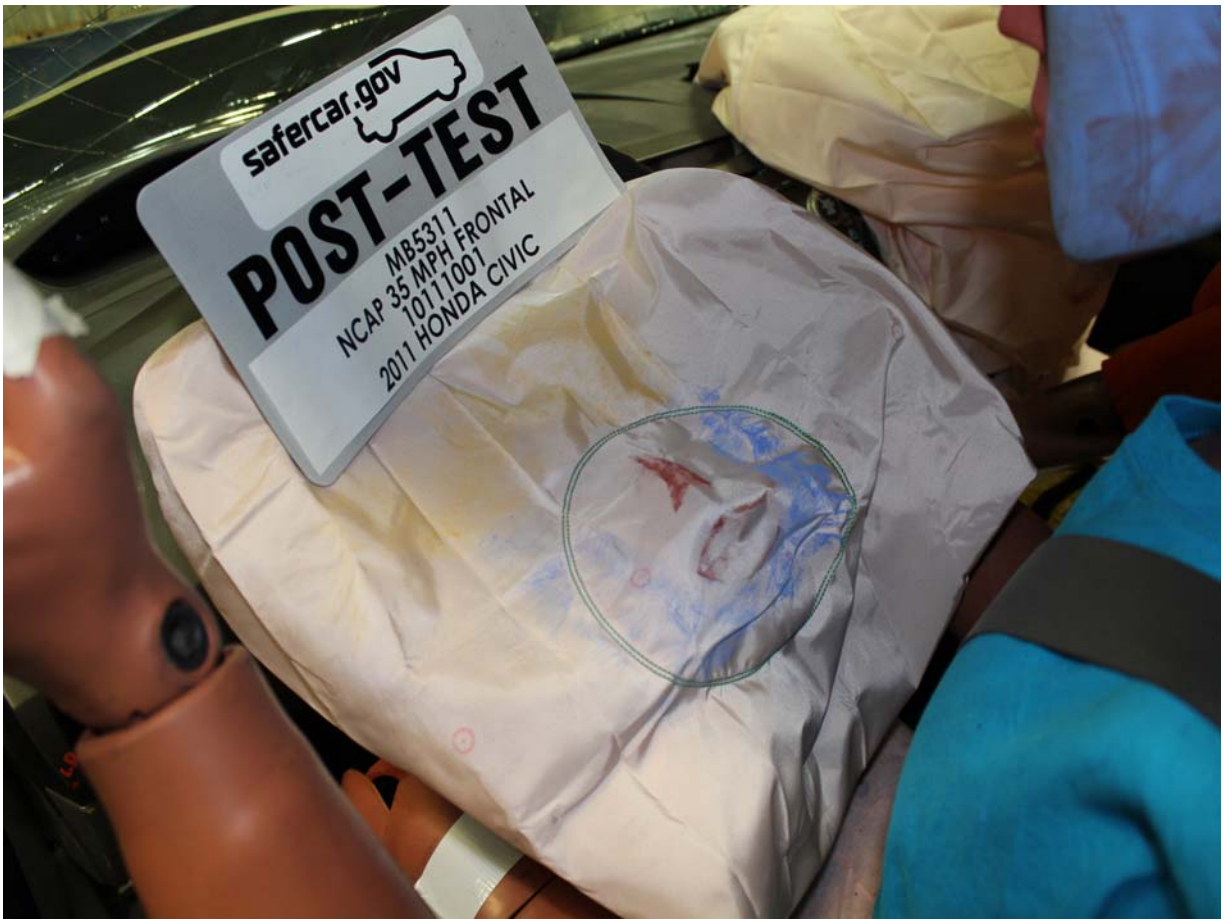
Post-Test Driver Dummy Contact with Airbag

The driver's head and chest contacted the airbag. The driver's head also contacted the headrest. The driver's knees contacted the knee bolster. The passenger's head and chest contacted the airbag. The passenger's head also contacted the headrest. The passenger's knees contacted the glovebox.

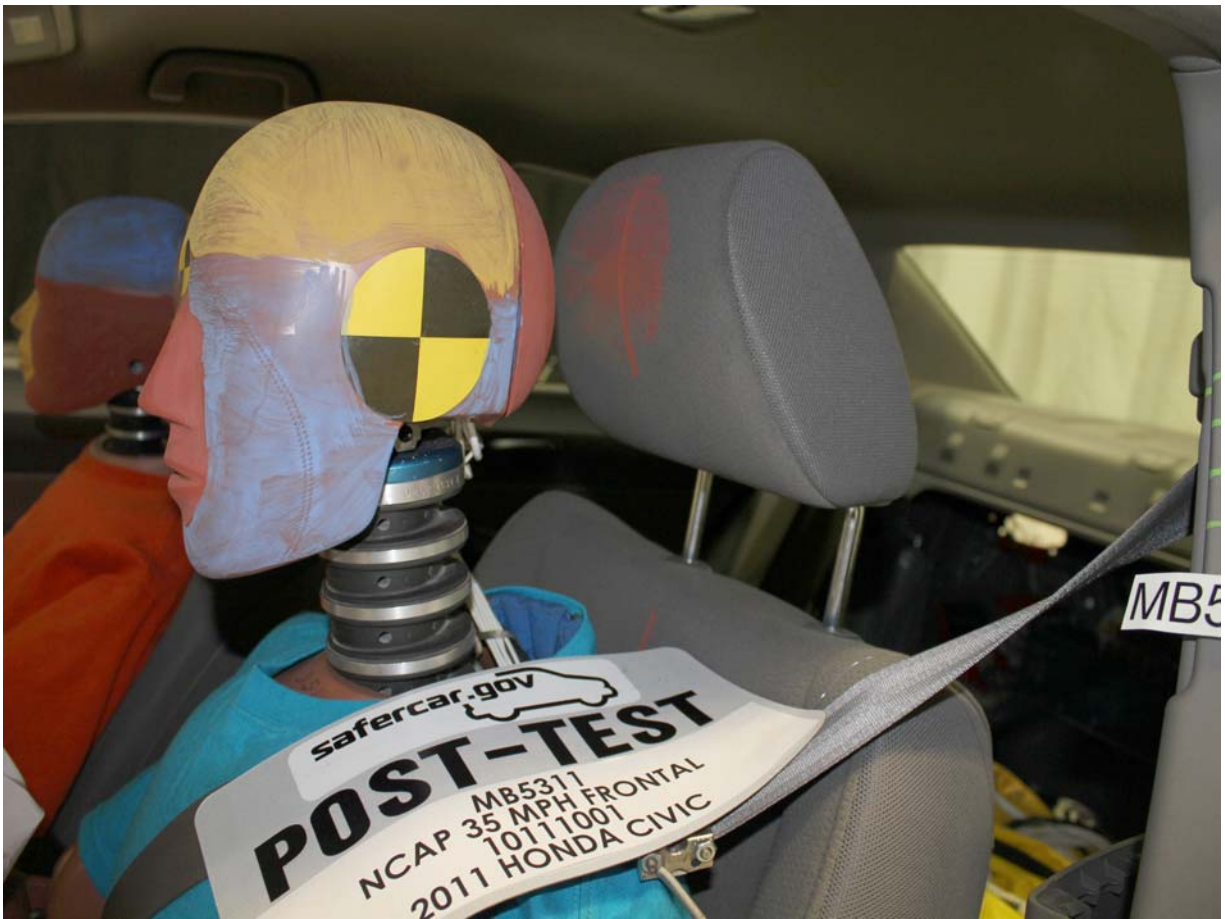
Post-Test Driver Dummy Contact with Headrest

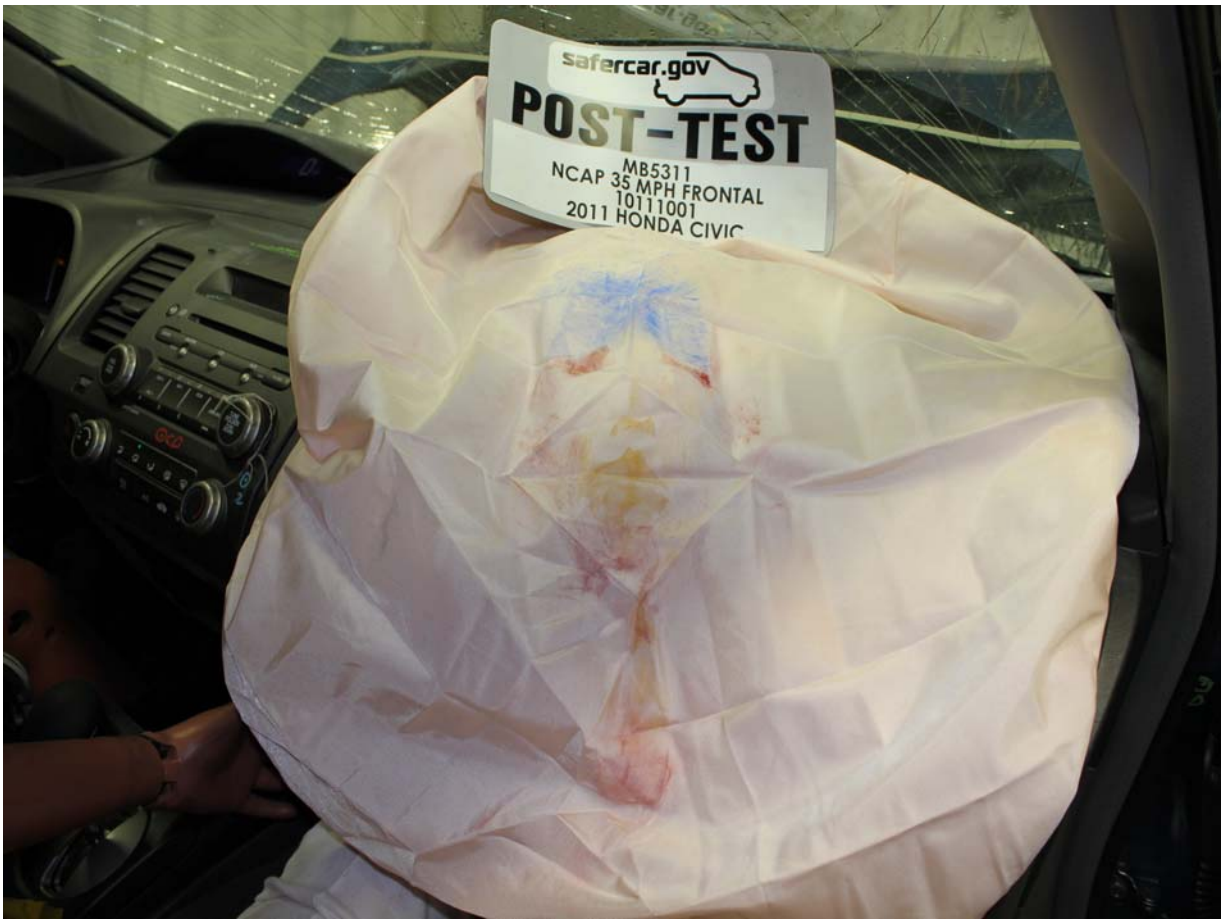
Post-Test Passenger Dummy Contact with Airbag

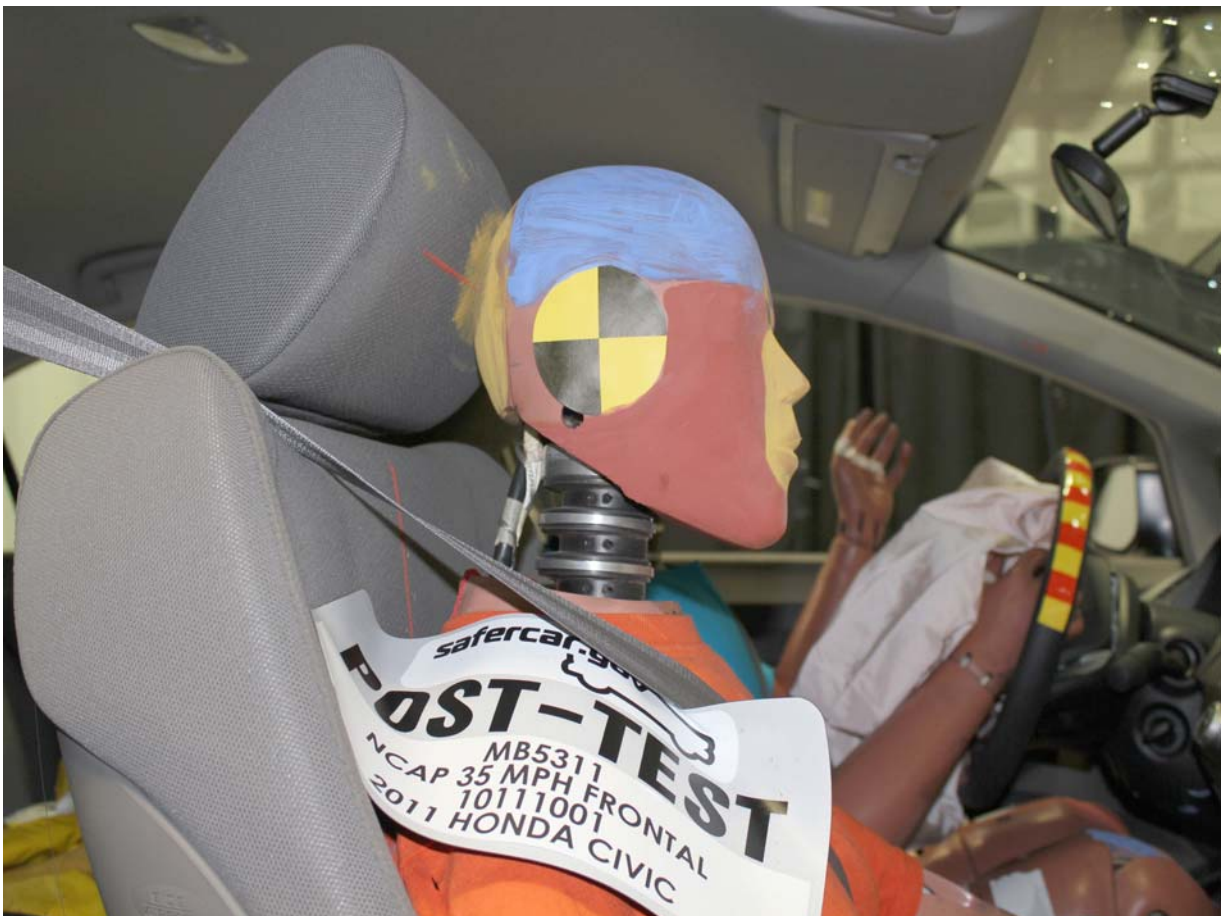
Post-Test Passenger Dummy Contact with Headrest

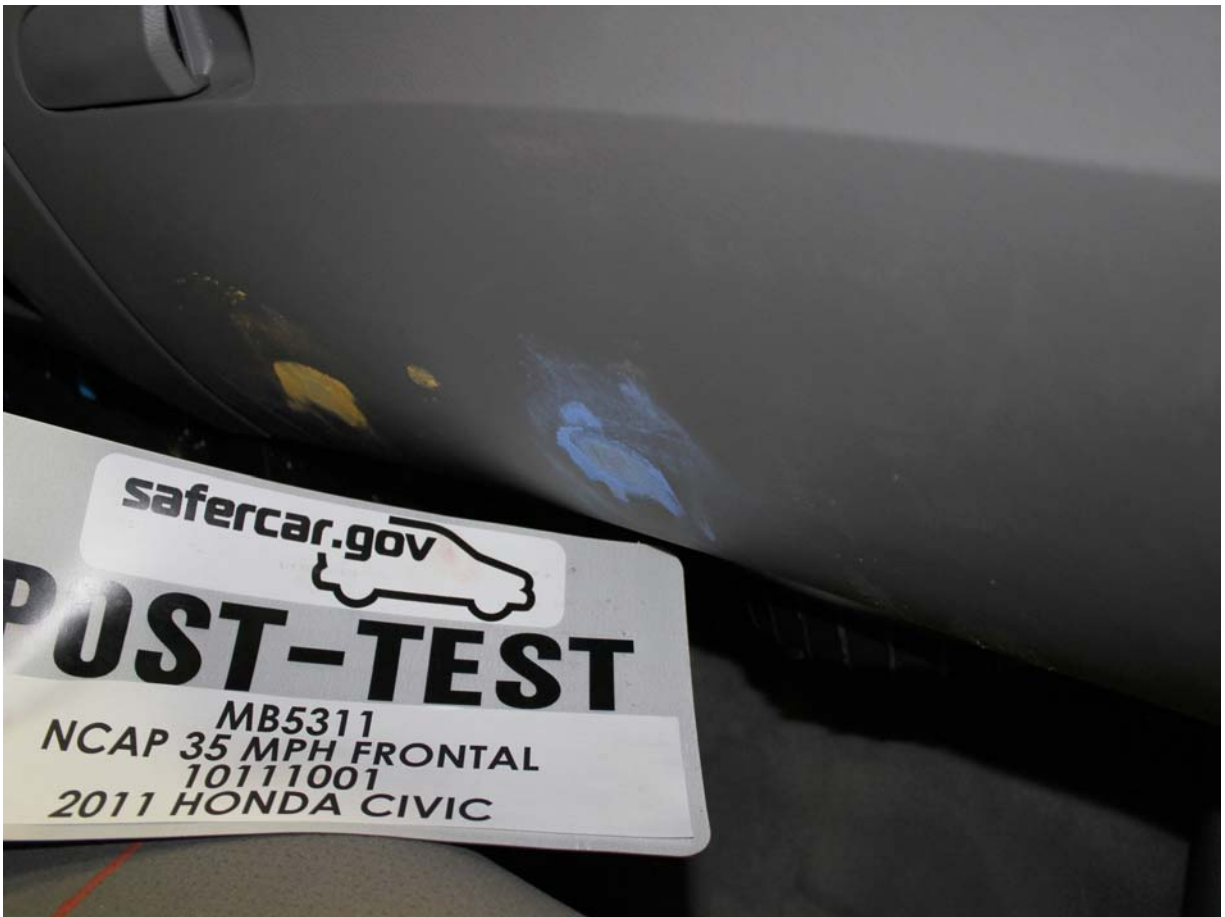
Post-Test Passenger Dummy Contact with Glovebox
