**REPORT NUMBER: NCAP-MGA-2011-041**

**NEW CAR ASSESSMENT PROGRAM (NCAP)  
Frontal Barrier Impact Test**

**HONDA OF AMERICA MFG., INC.  
2011 Honda CR-V LX 5-Dr SUV  
NHTSA No.: MB5308**

**FINAL REPORT**

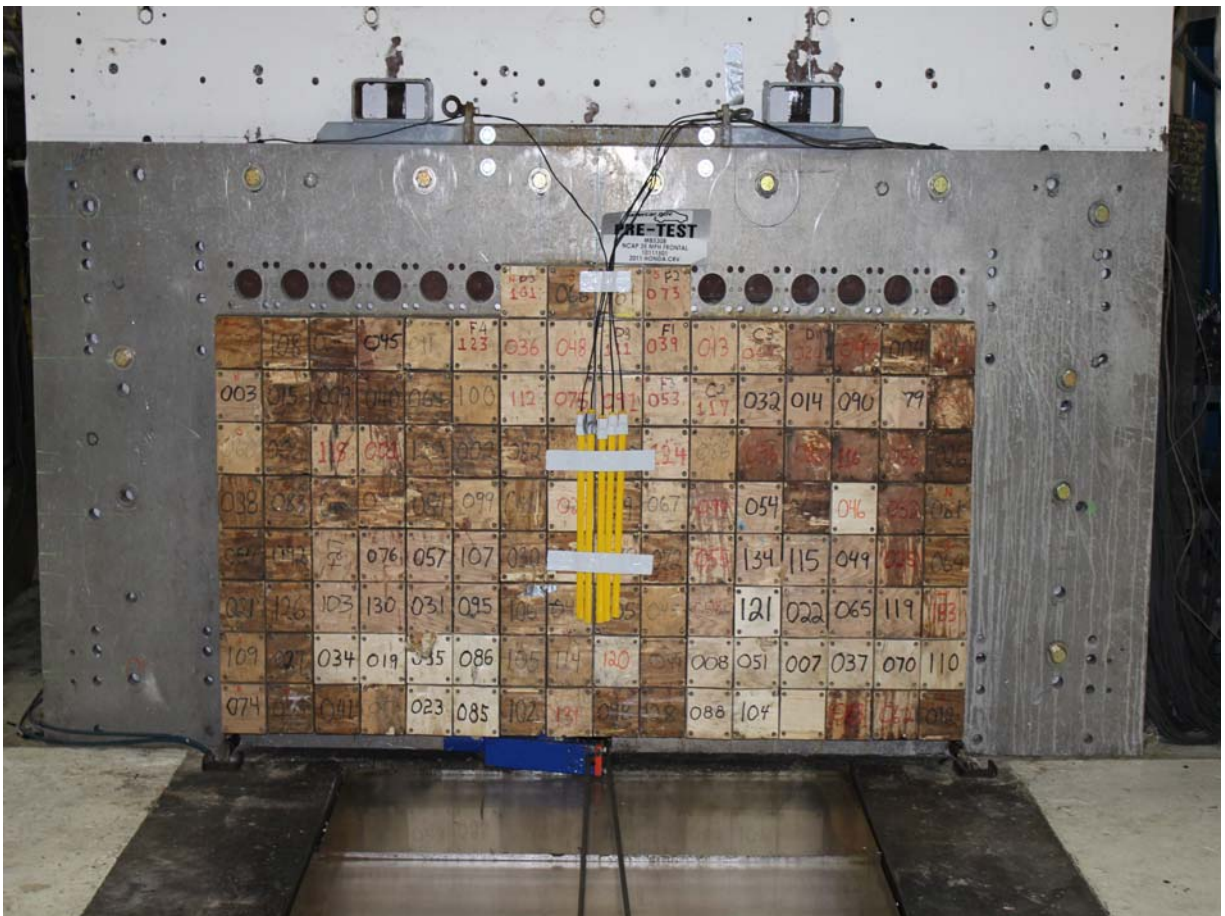
Load Cell Wall

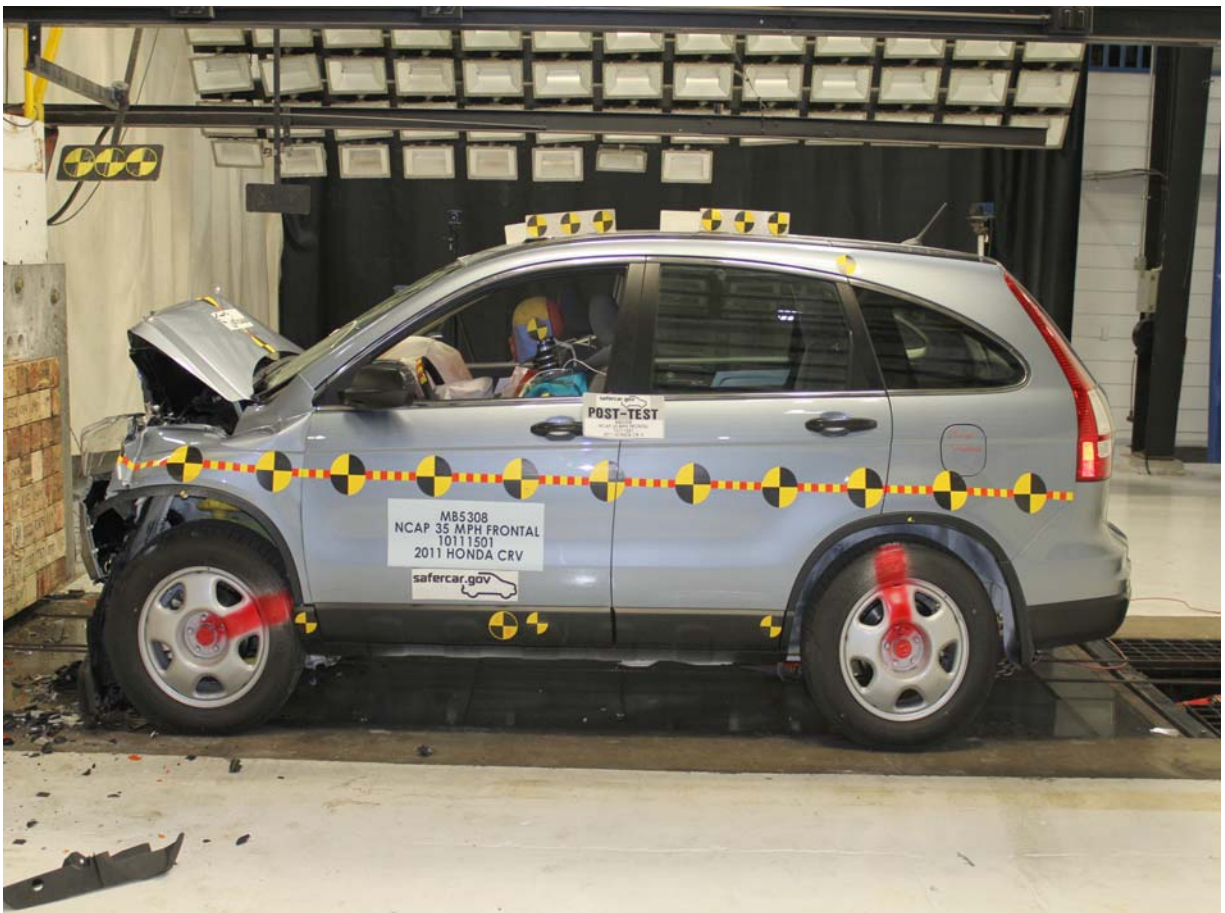
Post-Test Left Side View

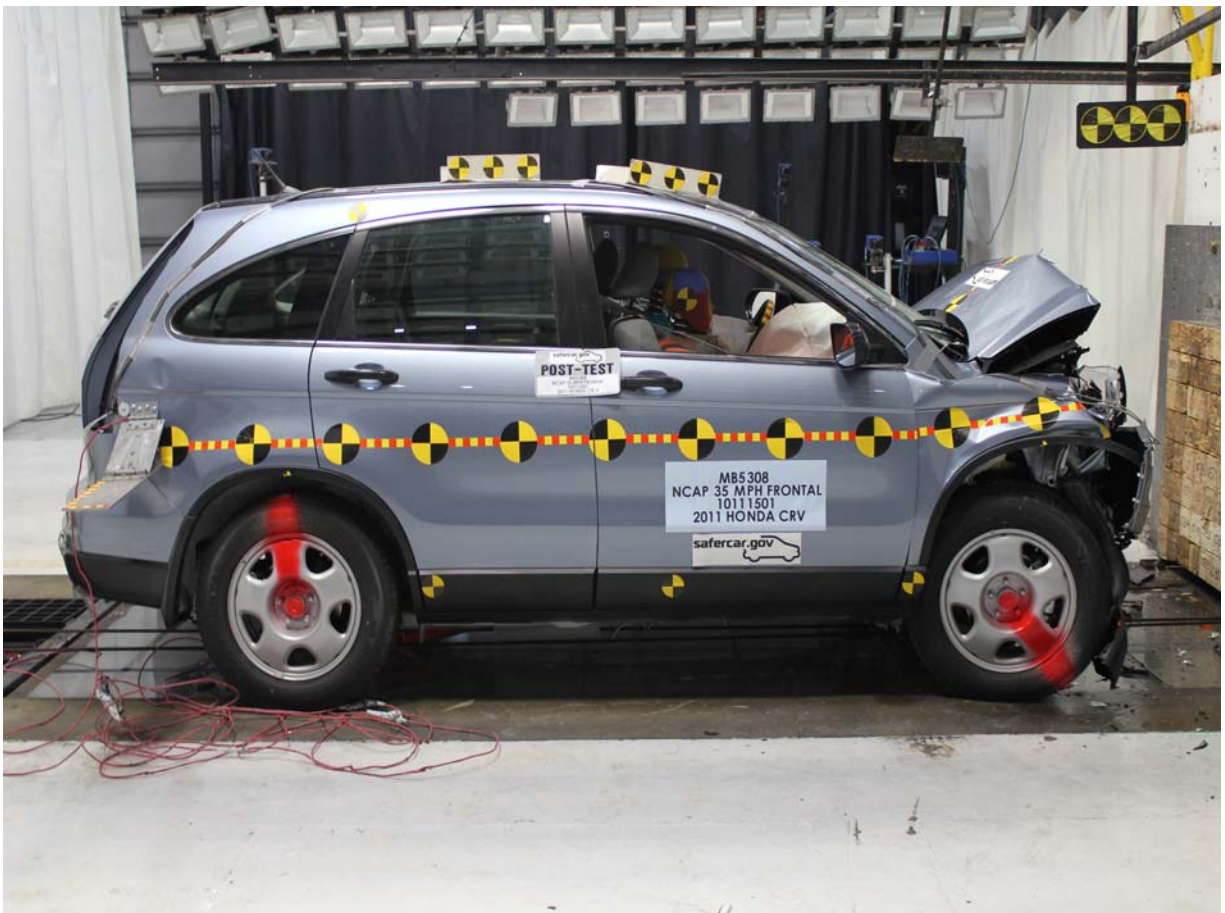
Post-Test Right Side View

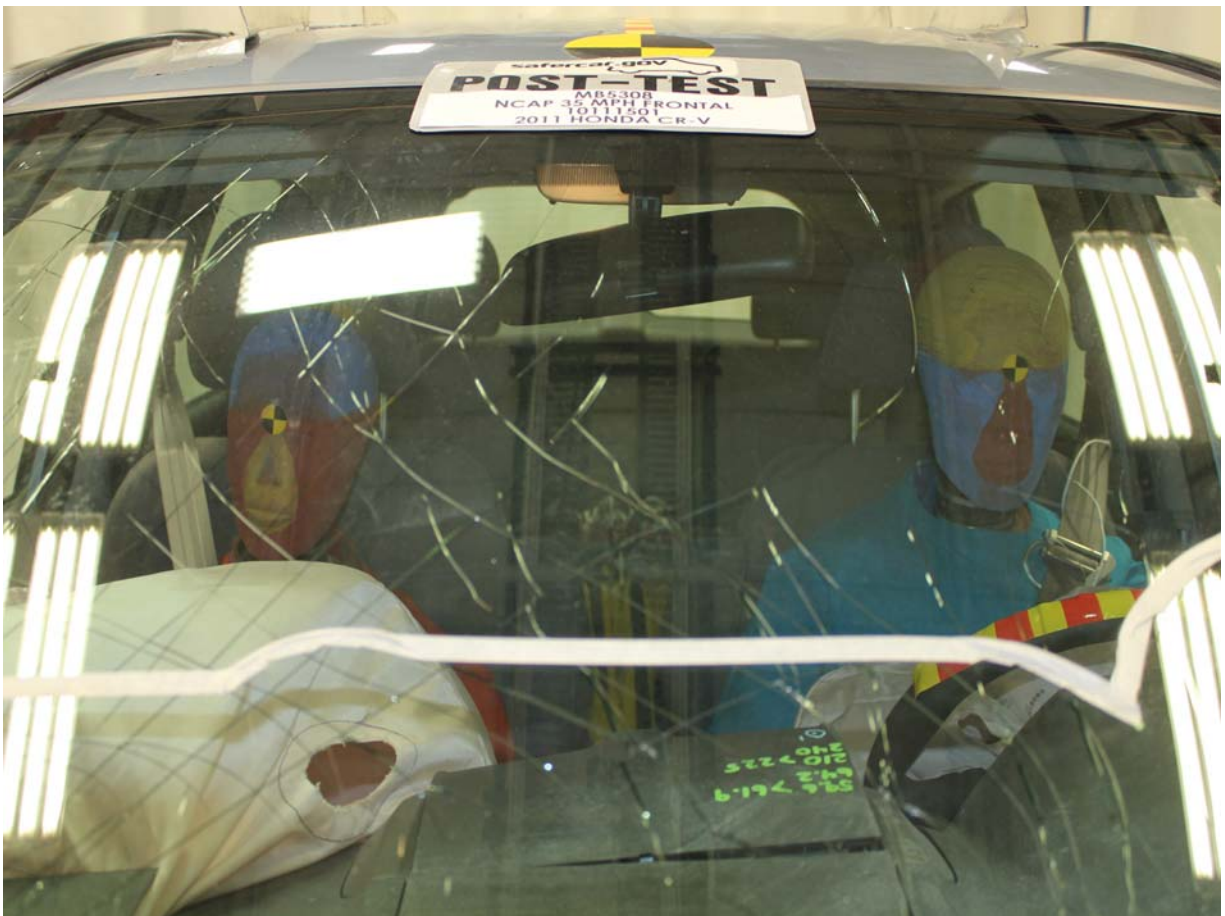
Post-Test Windshield View

There was 100 percent windshield retention and no intrusion into the protected zone of the windshield during the event. There was no Stoddard Solvent leakage after the event or during any phase of the static rollover.

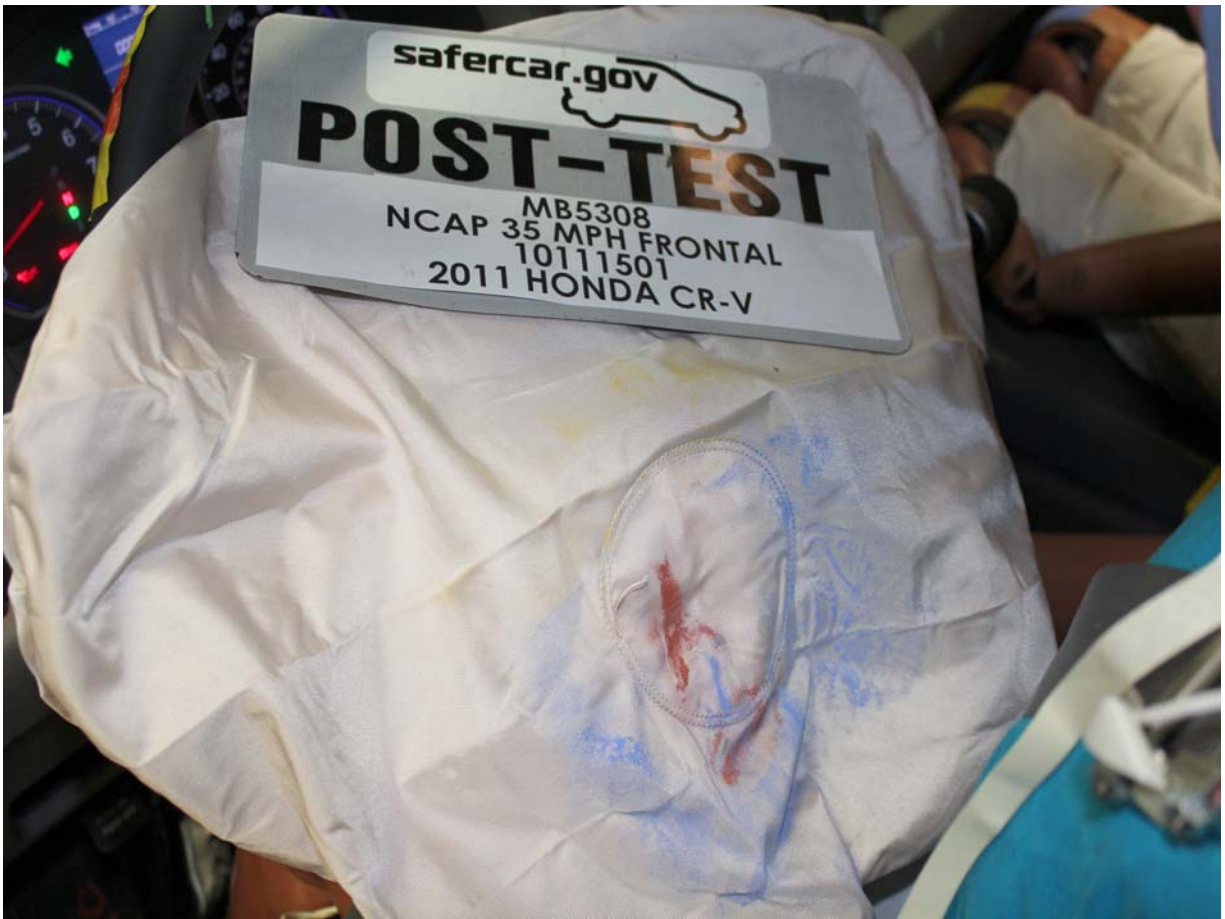
Post-Test Driver Dummy Contact with Airbag

The driver's head and chest contacted the airbag. The driver's head also contacted the headrest. The driver's knees contacted the knee bolster. The passenger's head and chest contacted the airbag. The passenger's head also contacted the headrest. The passenger's knees contacted the glovebox.

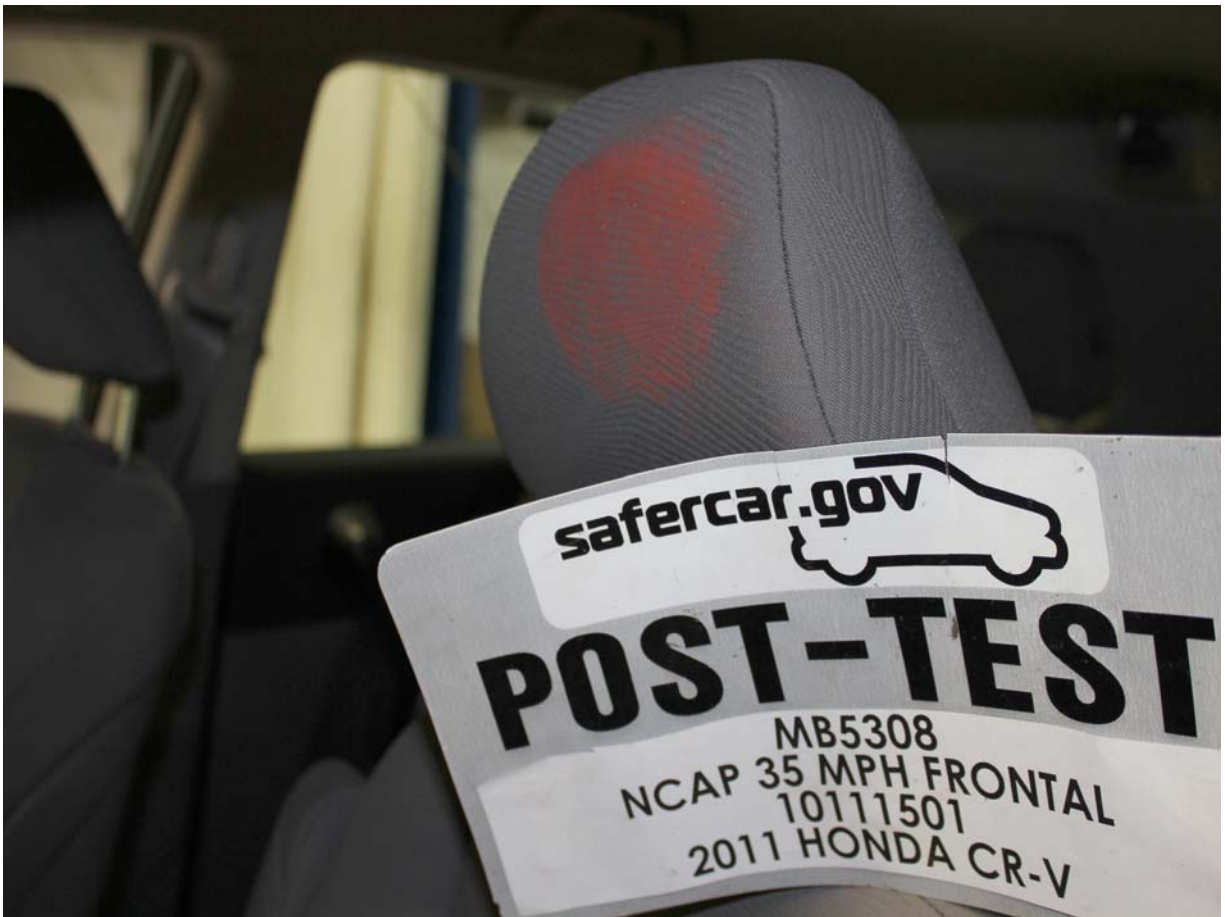
Post-Test Driver Dummy Contact with Headrest

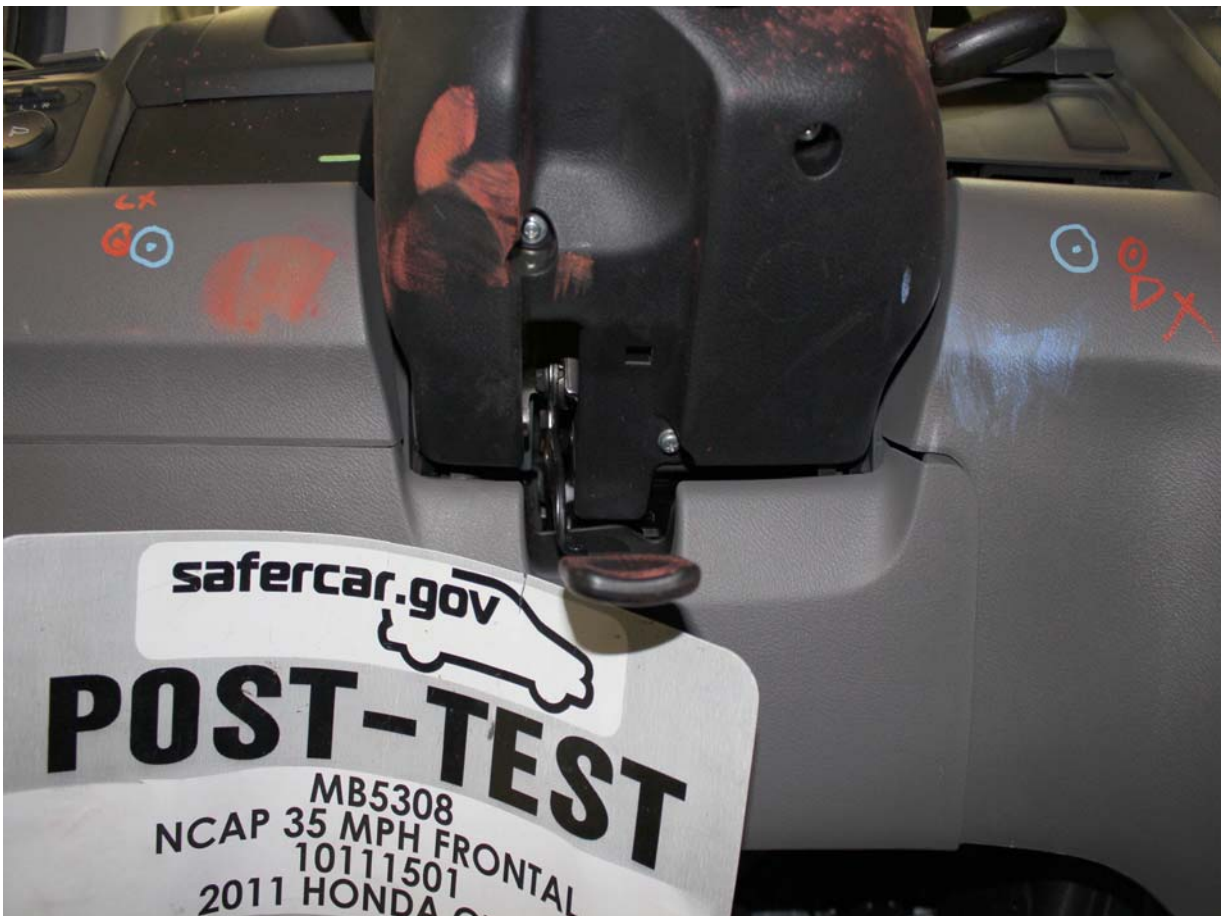
Post-Test Driver Dummy Contact with Knee Bolster

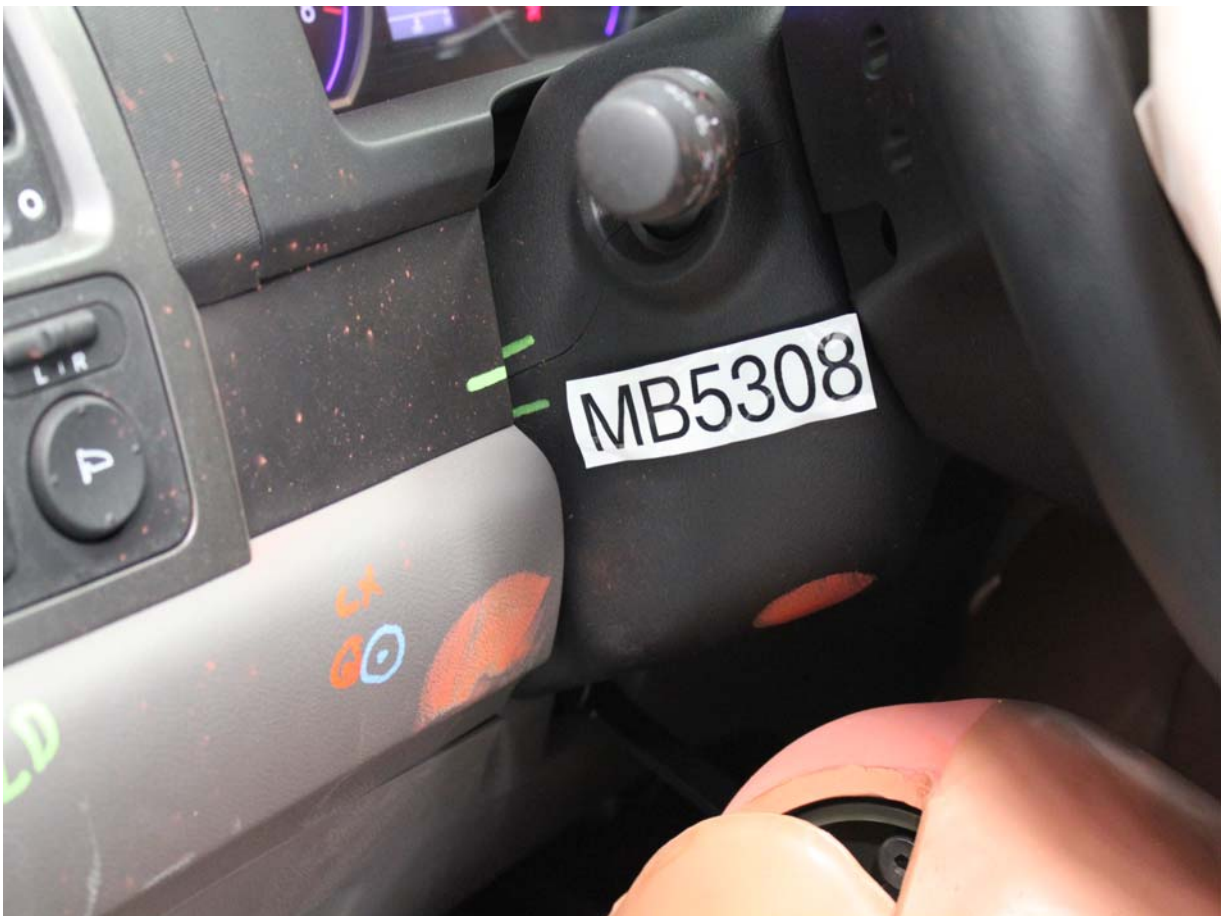
Post-Test View of Steering Column Shear Capsule

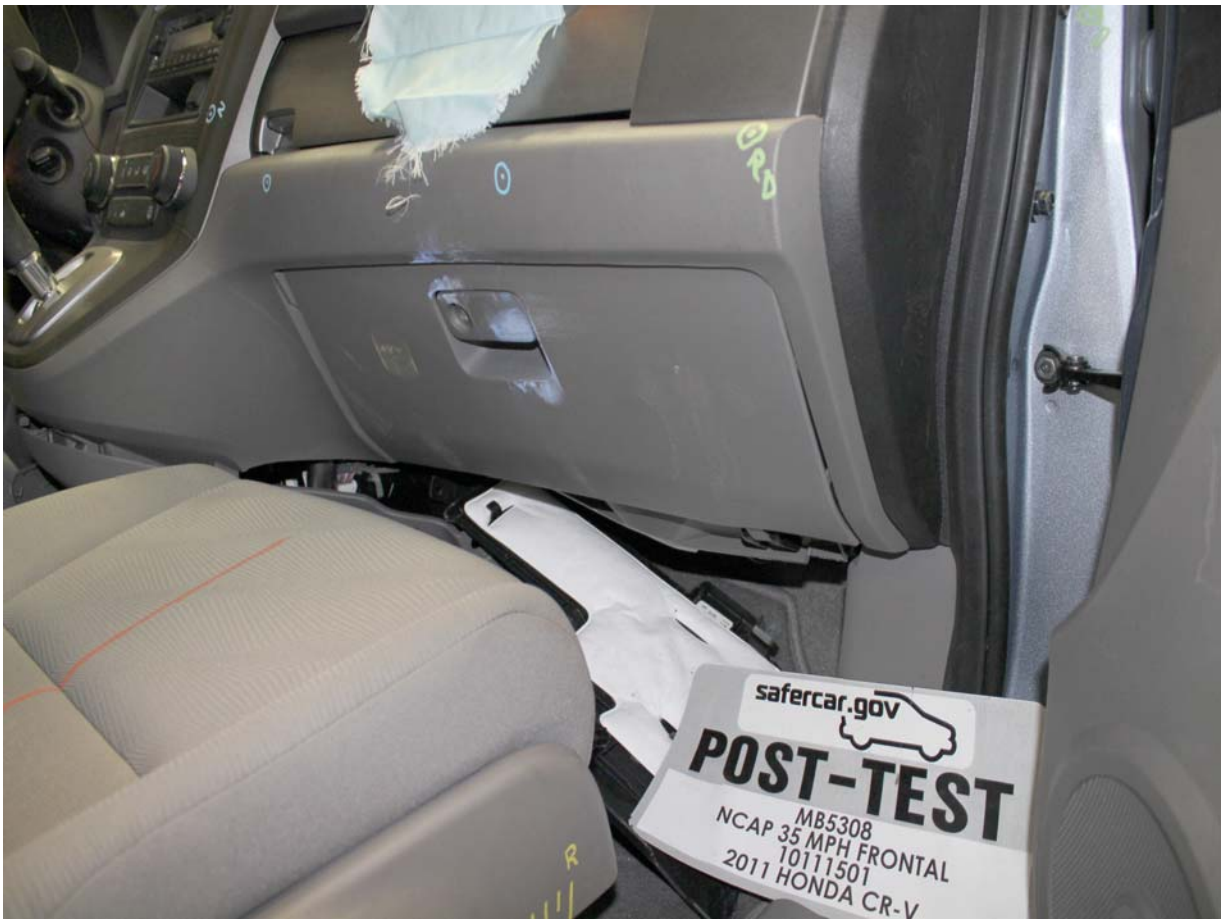
Post-Test Passenger Dummy Contact with Glovebox

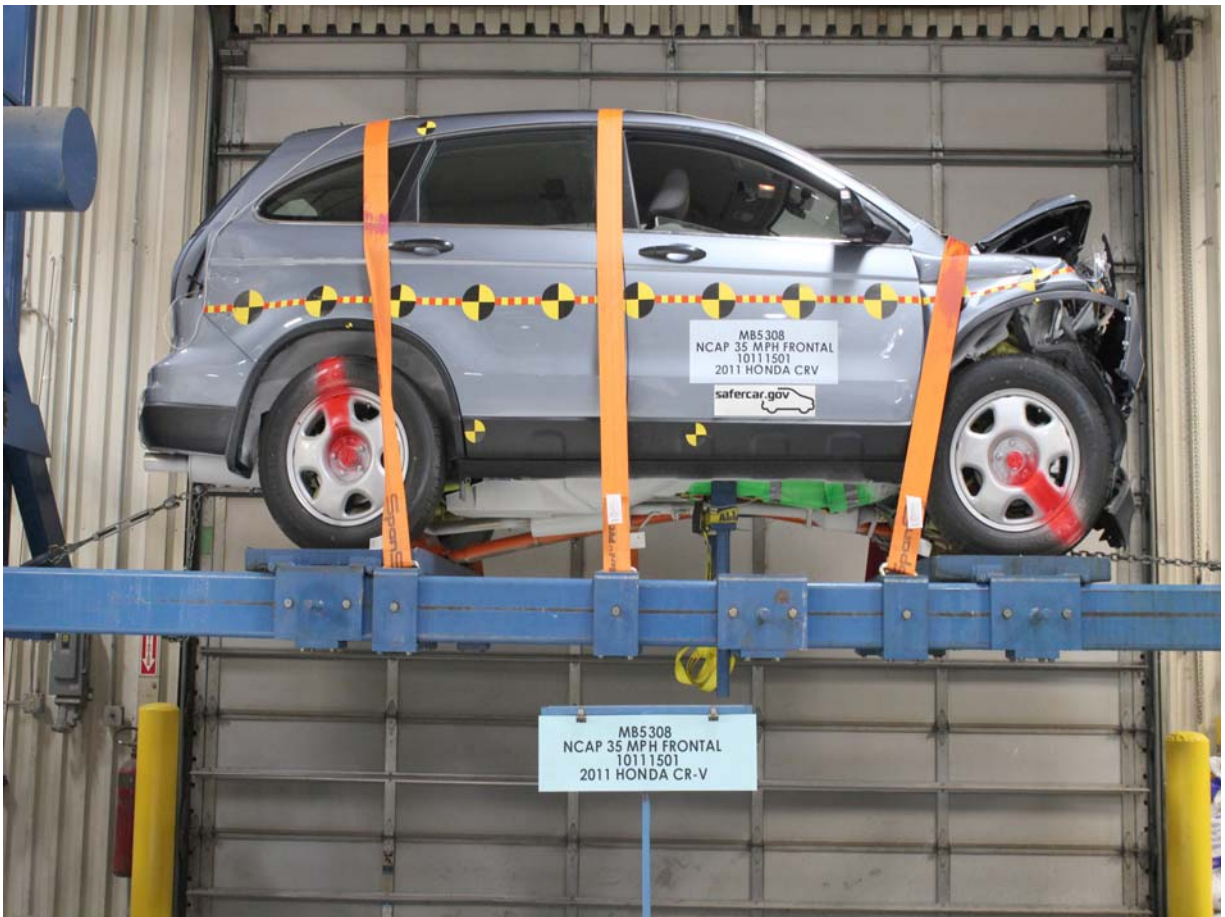
Vehicle at 0 Degrees on Static Rollover Device

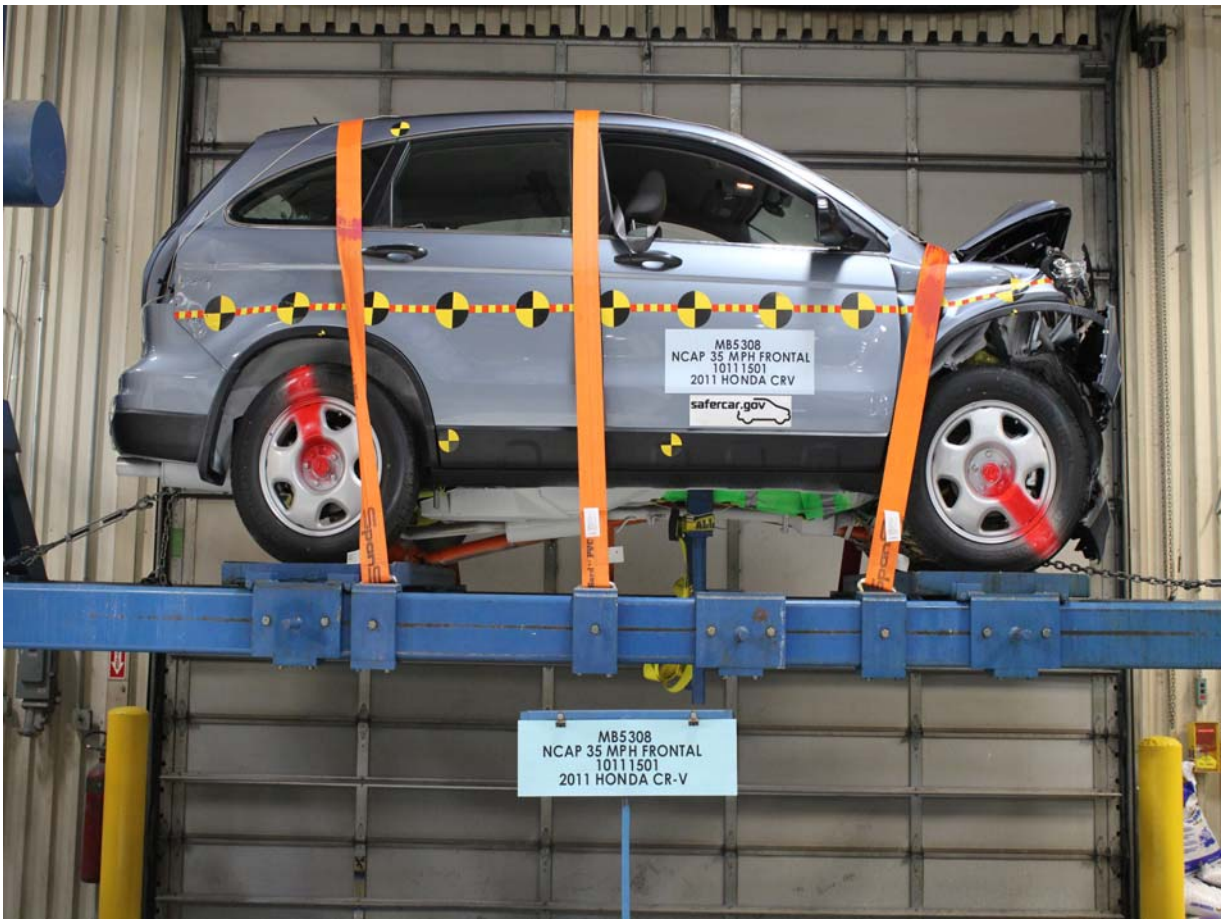
Vehicle at 360 Degrees on Static Rollover Device
