**REPORT NUMBER: SINCAP-MGA-2011-042**

**NEW CAR ASSESSMENT PROGRAM (NCAP)  
Moving Deformable Barrier Side Impact Test**

**HONDA MOTOR COMPANY, LTD.  
2011 Honda CR-V LX 5-Dr SUV  
NHTSA No.: MB5307**

**MGA RESEARCH CORPORATION  
5000 Warren Road  
Burlington, WI 53105**

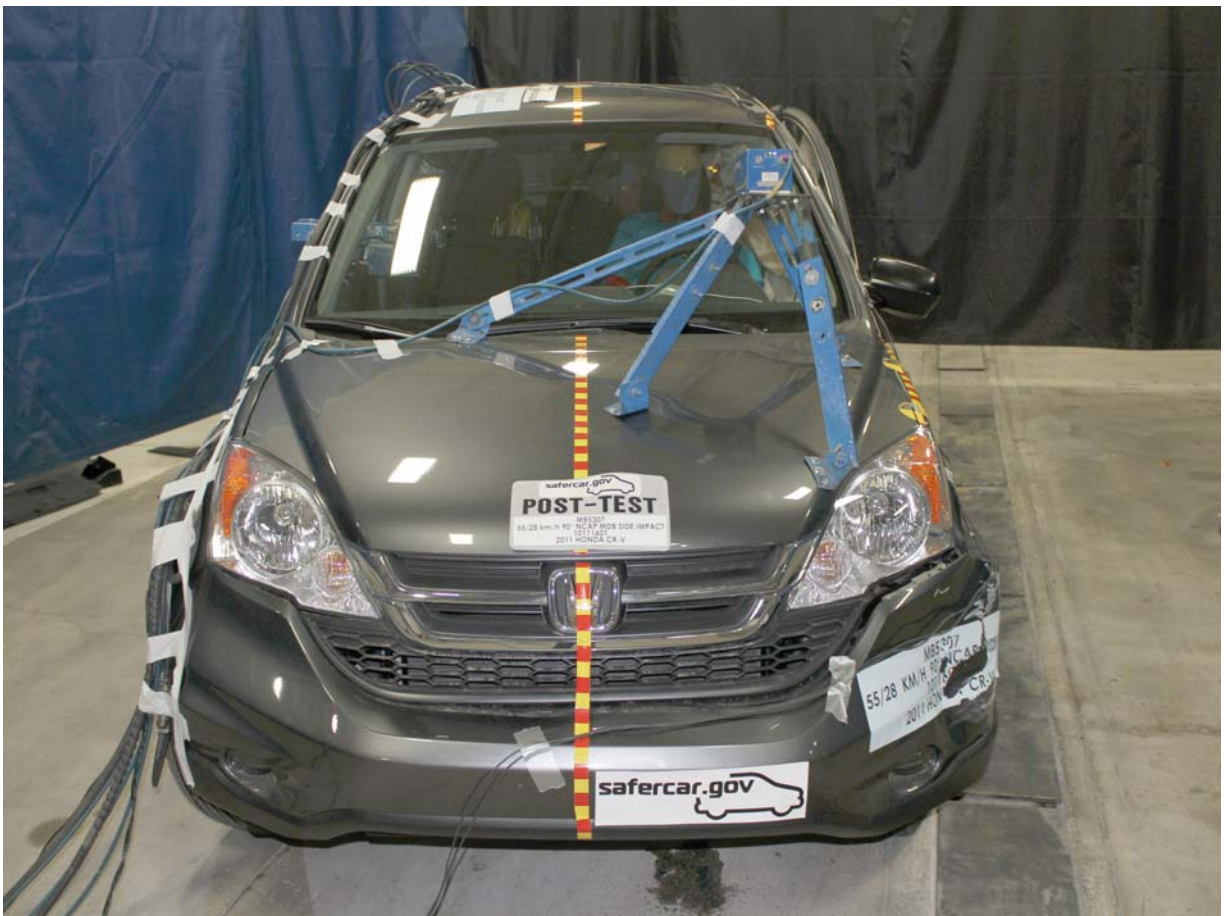
Post-Test Frontal View of Test Vehicle

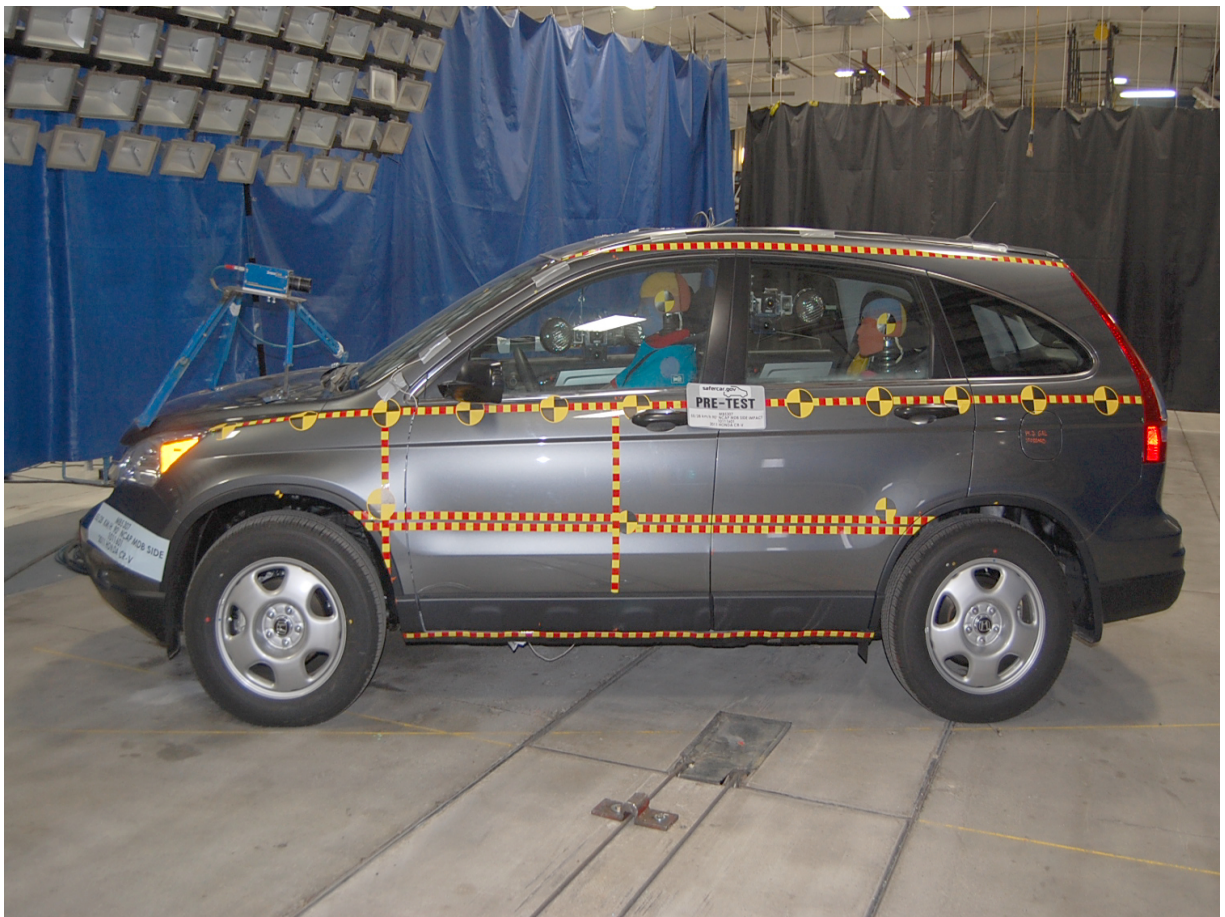
Pre-Test Left Side View of Test Vehicle

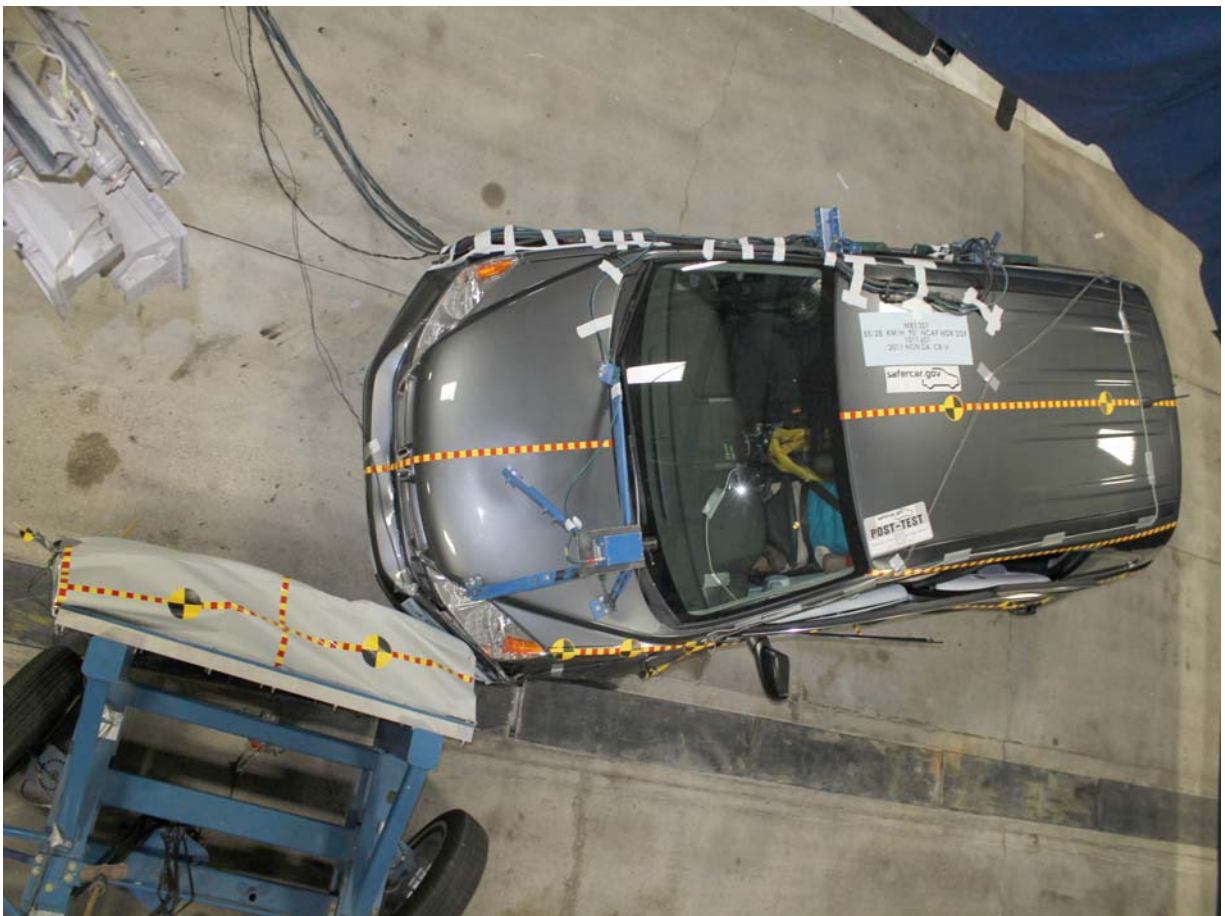
Post-Test Overhead View of Test Vehicle and MDB

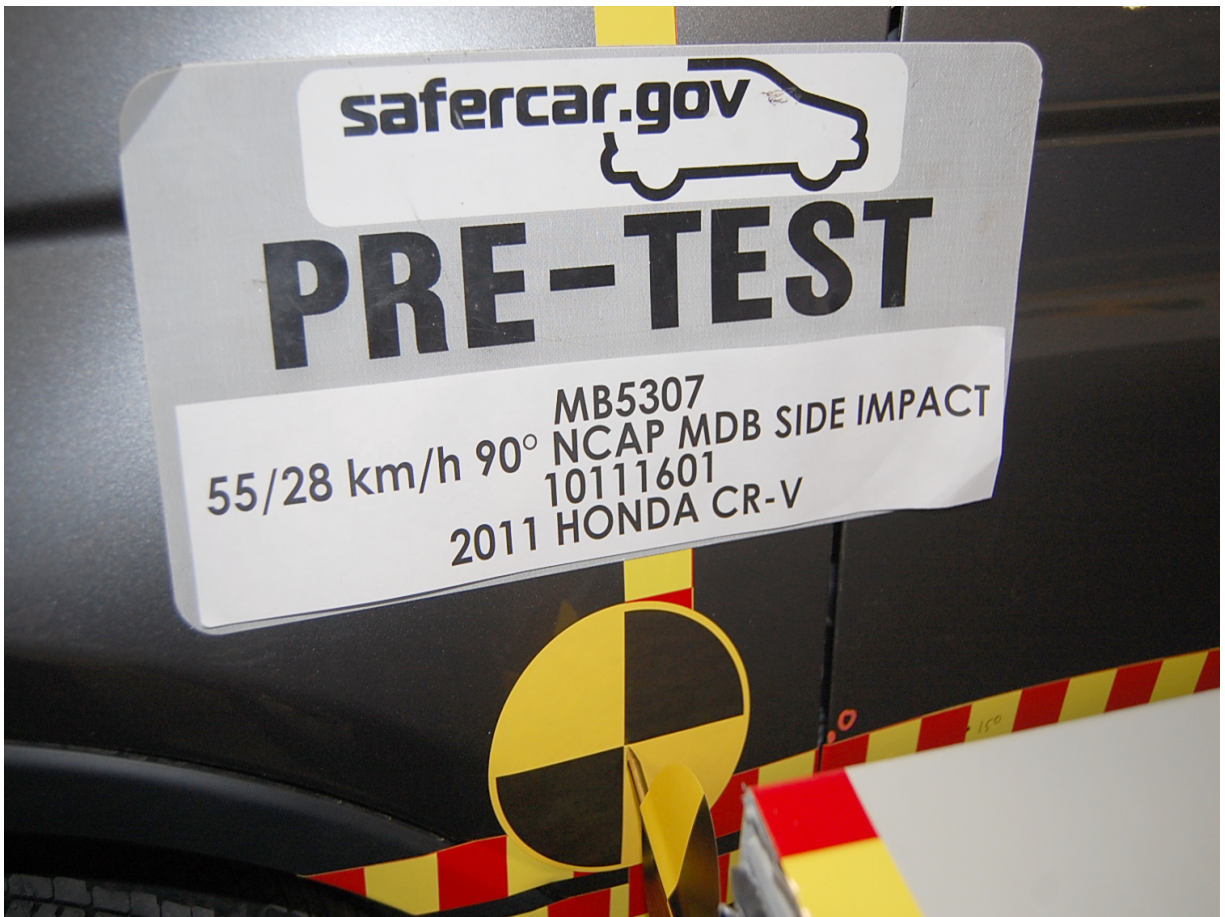
Pre-Test Close-Up View of Impact Point Target

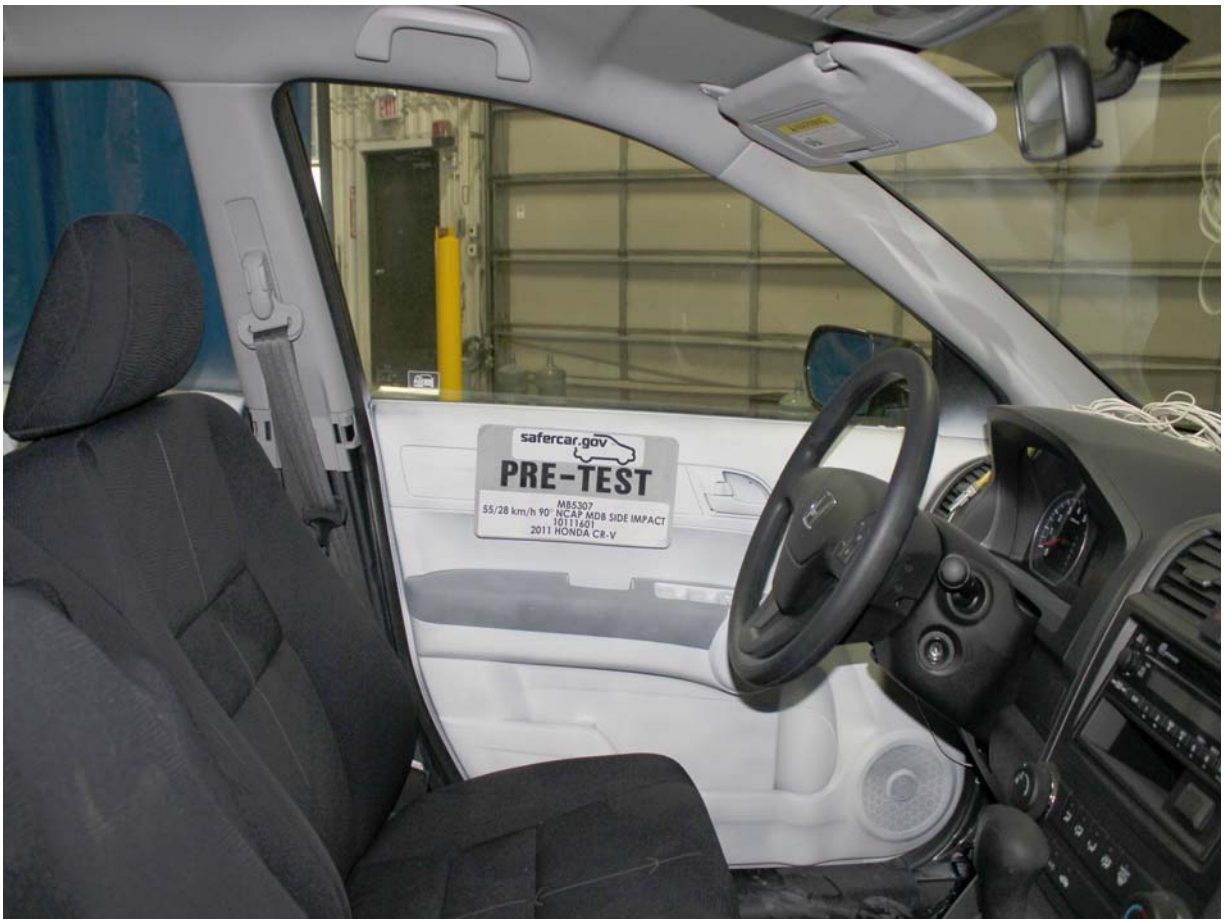
Pre-Test Driver Inner Door Panel View

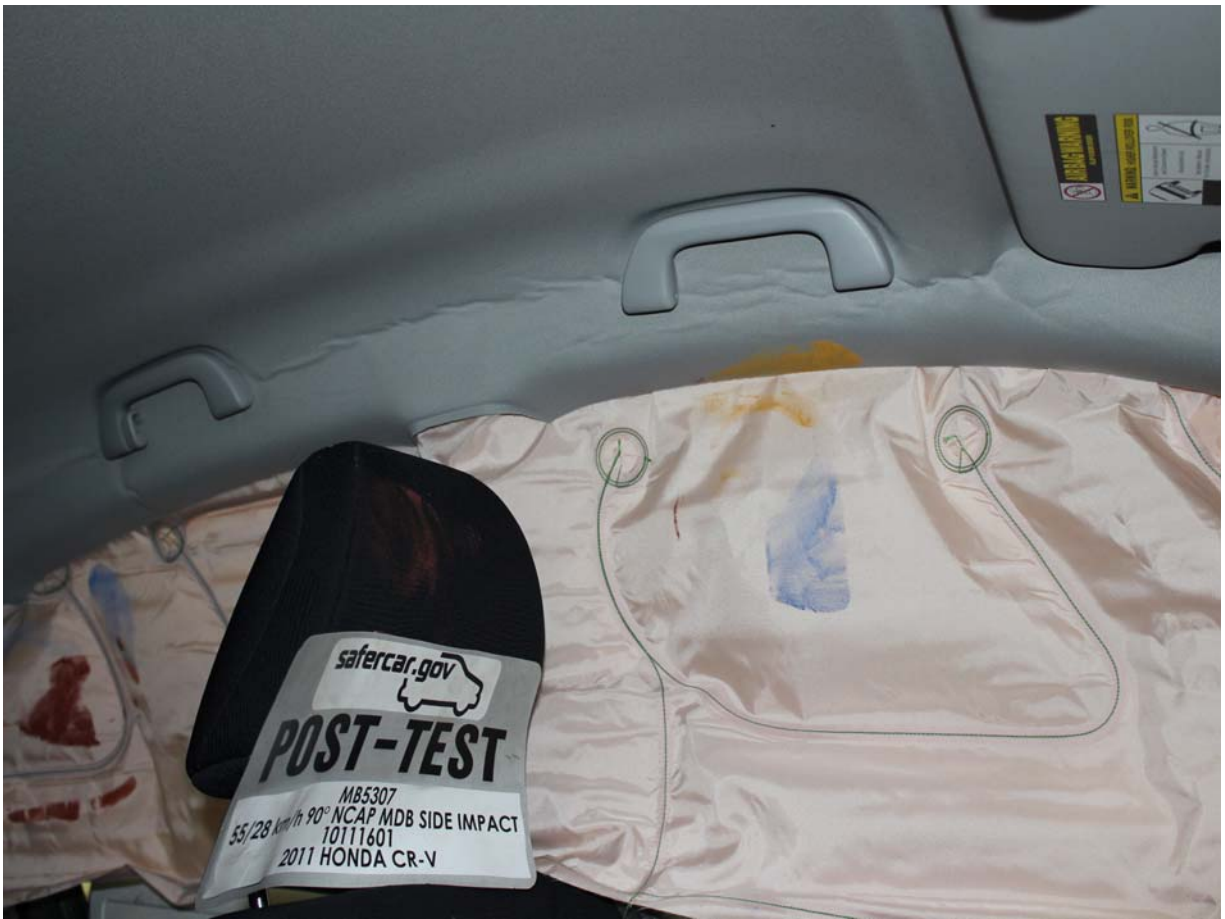
Post-Test Driver Dummy Close-up Head Contact with Vehicle View

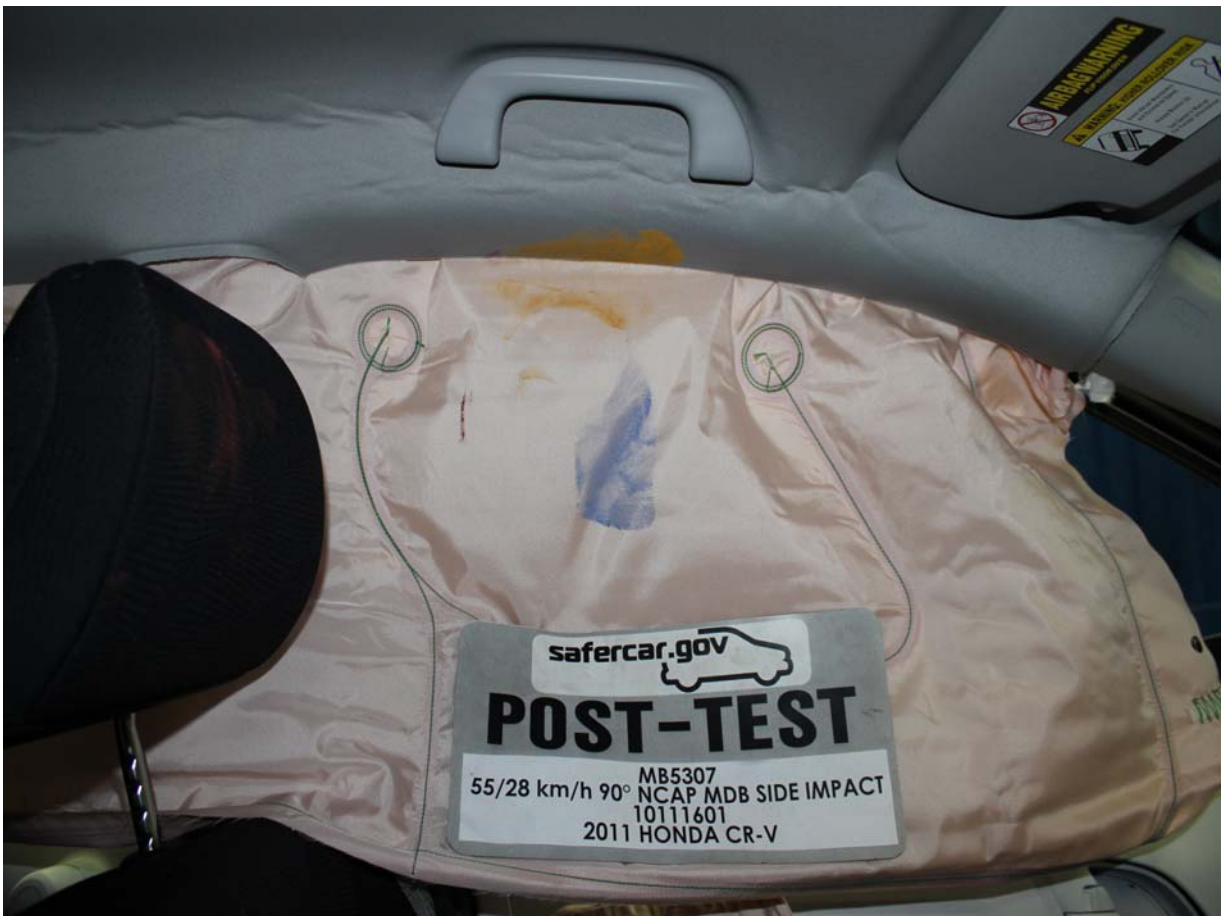
Post-Test Driver Dummy Close-up Head Contact with Side Airbag View

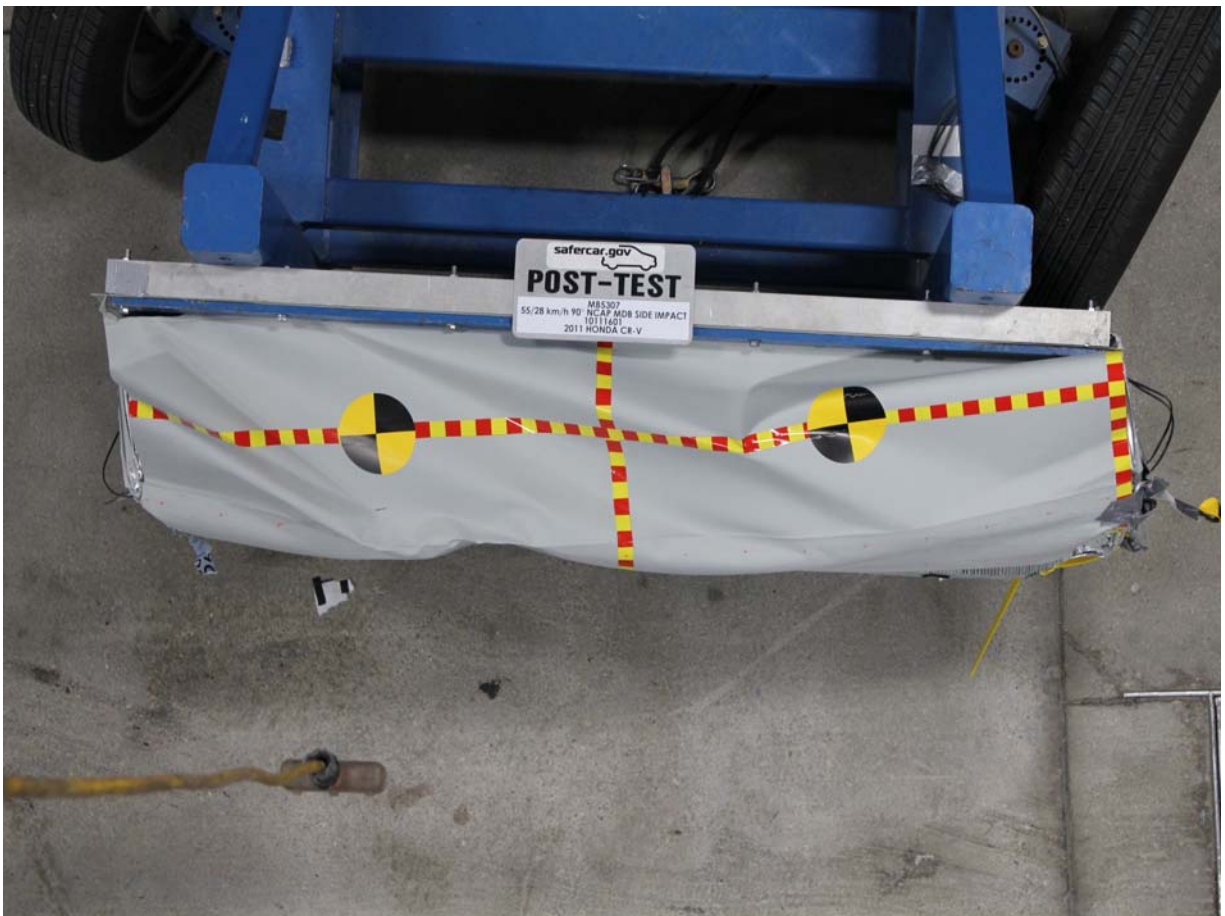
Post-Test Top View of MDB Impactor Face

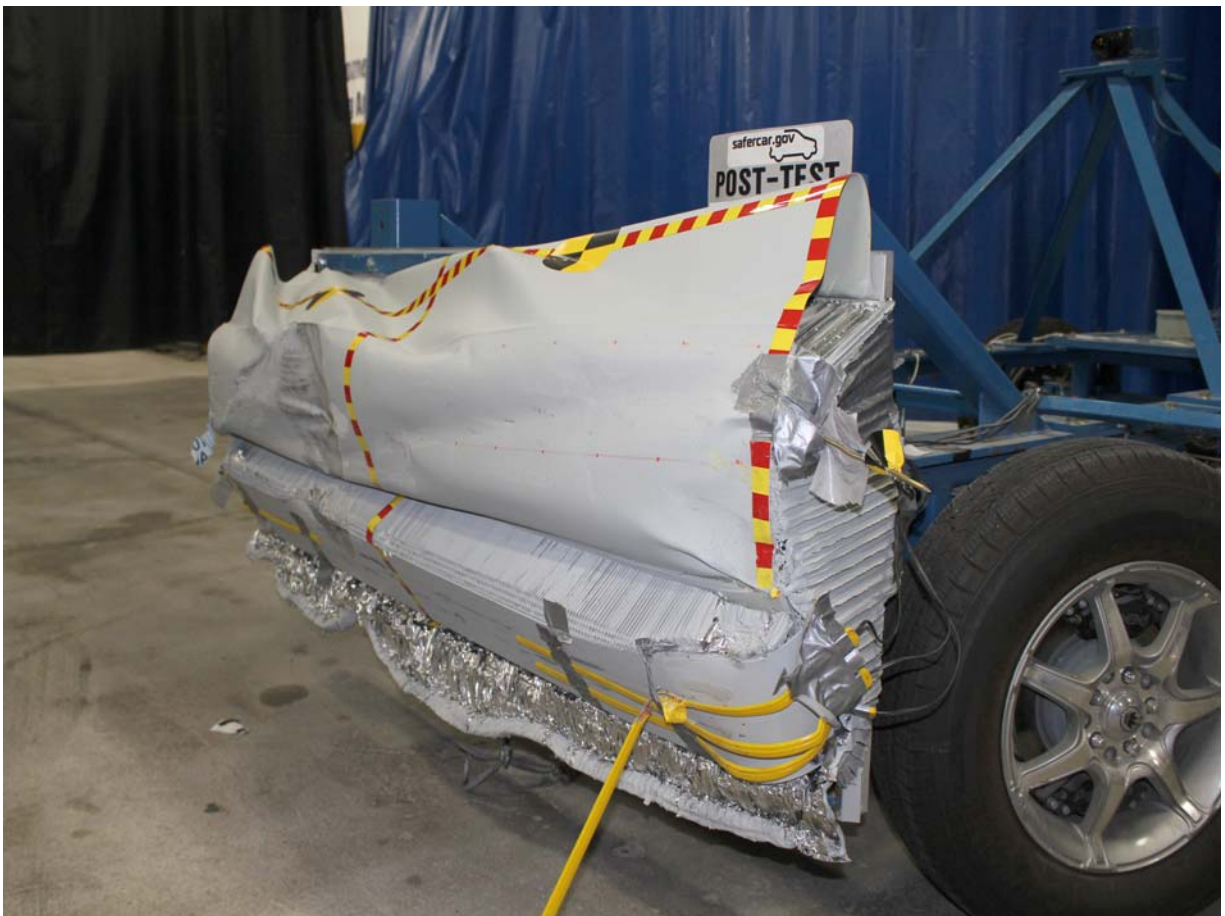
Post-Test Left Side View of MDB Impactor Face

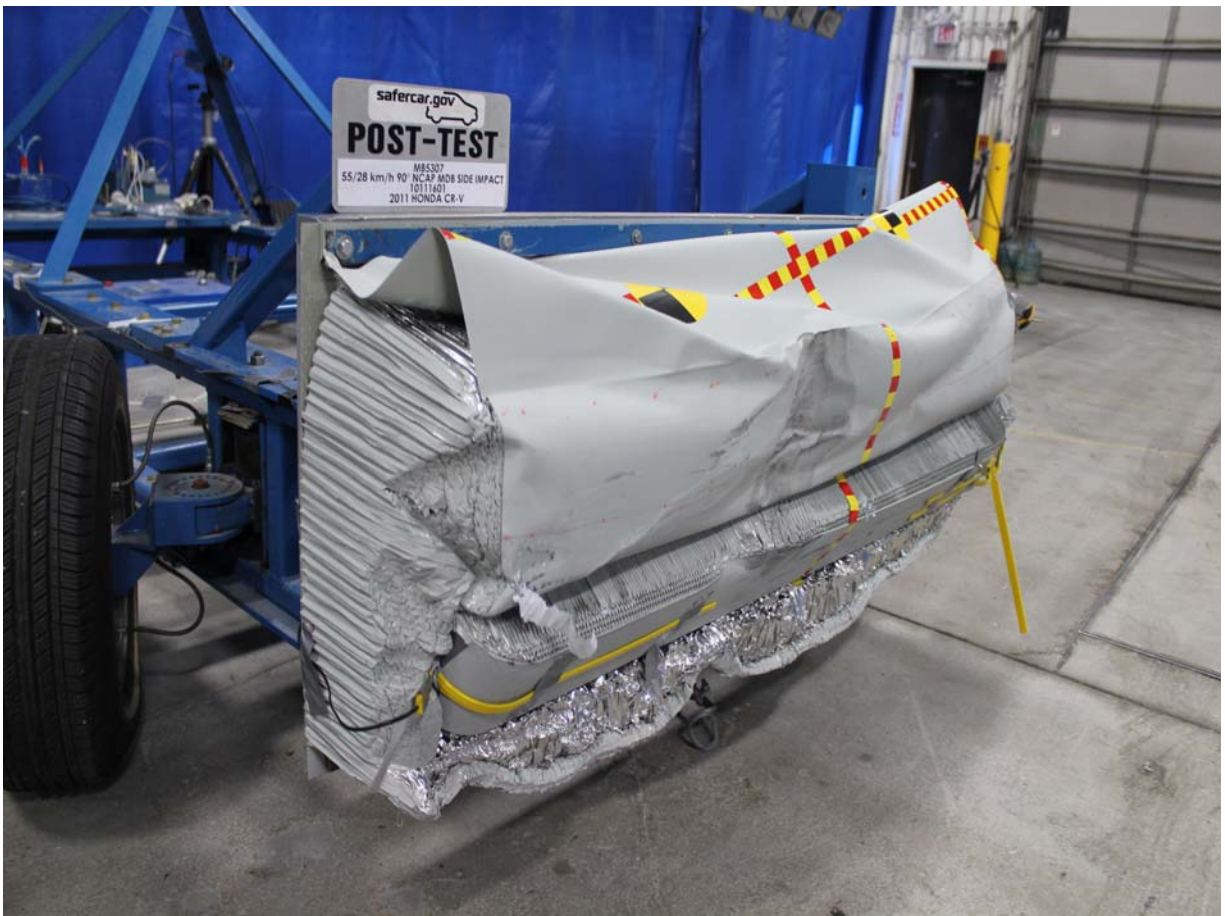
Post-Test Right Side View of MDB Impactor Face

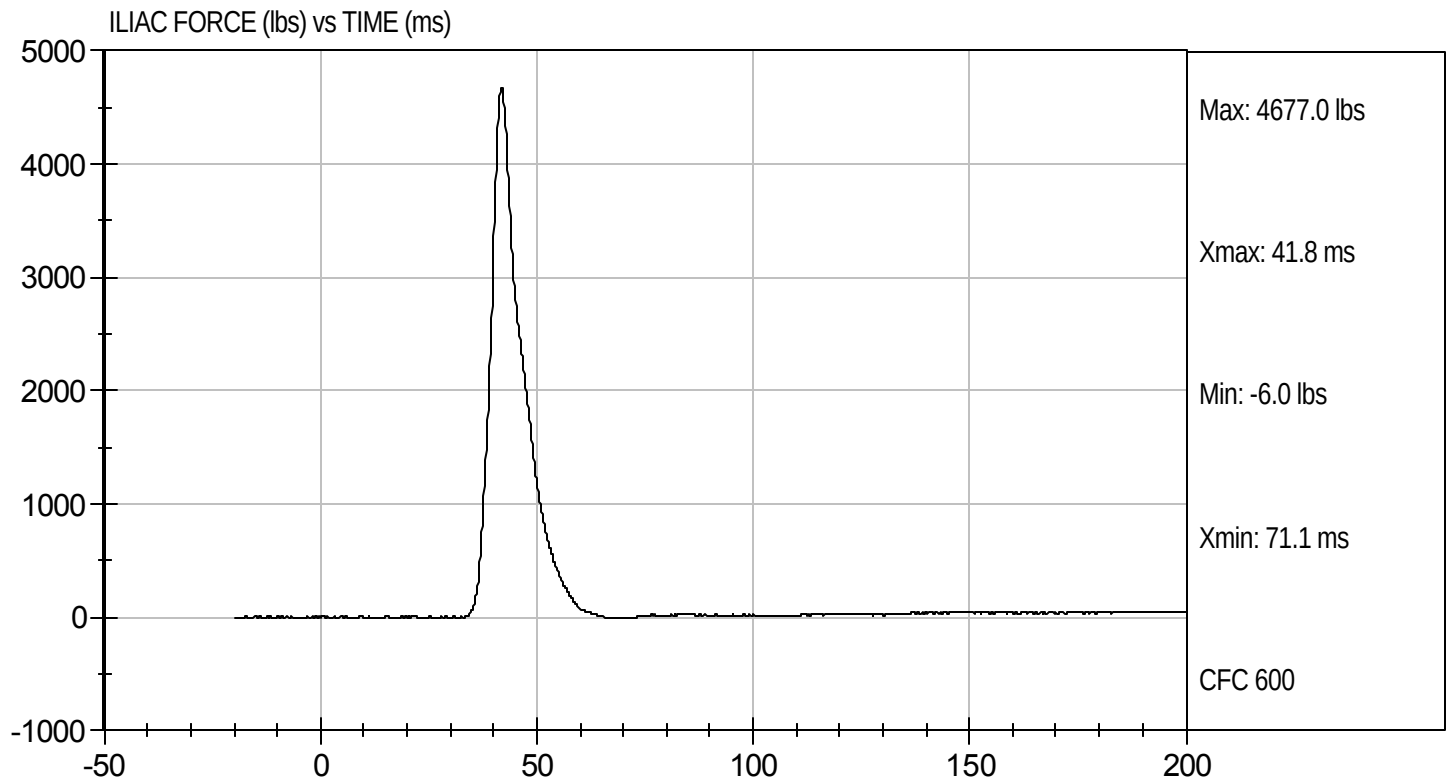
Test Desc: Iliac Impact  
Component ID: D104008

Test Date: 11/16/10  
Velocity: 14.37 ft/s, 4.38 m/s
