**REPORT NUMBER: SPNCAP-CAL-11-028**

**NEW CAR ASSESSMENT PROGRAM (NCAP)  
SIDE IMPACT POLE TEST**

**Ford Motor Company  
2011 Ford Edge  
Utility Vehicle**

**FINAL REPORT**

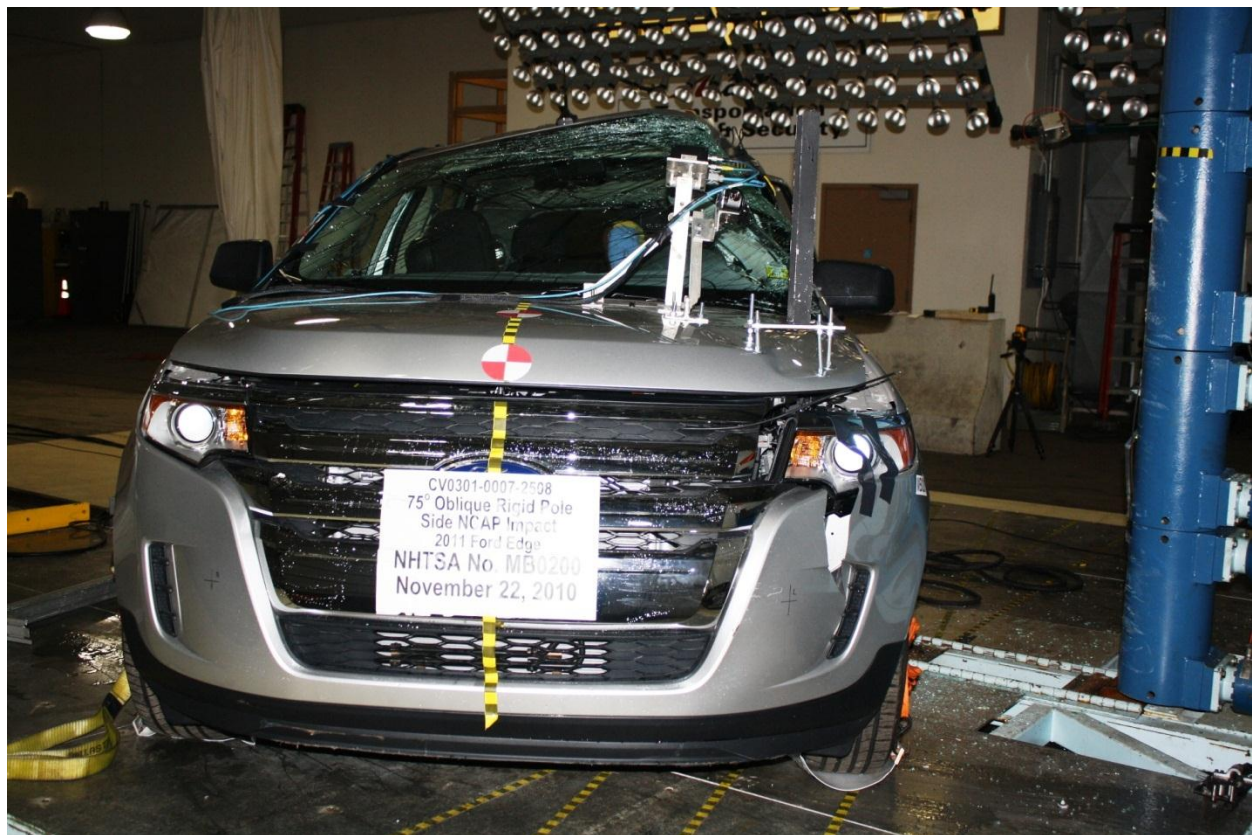
**Figure A-4: Post-Test Frontal View of Test Vehicle**

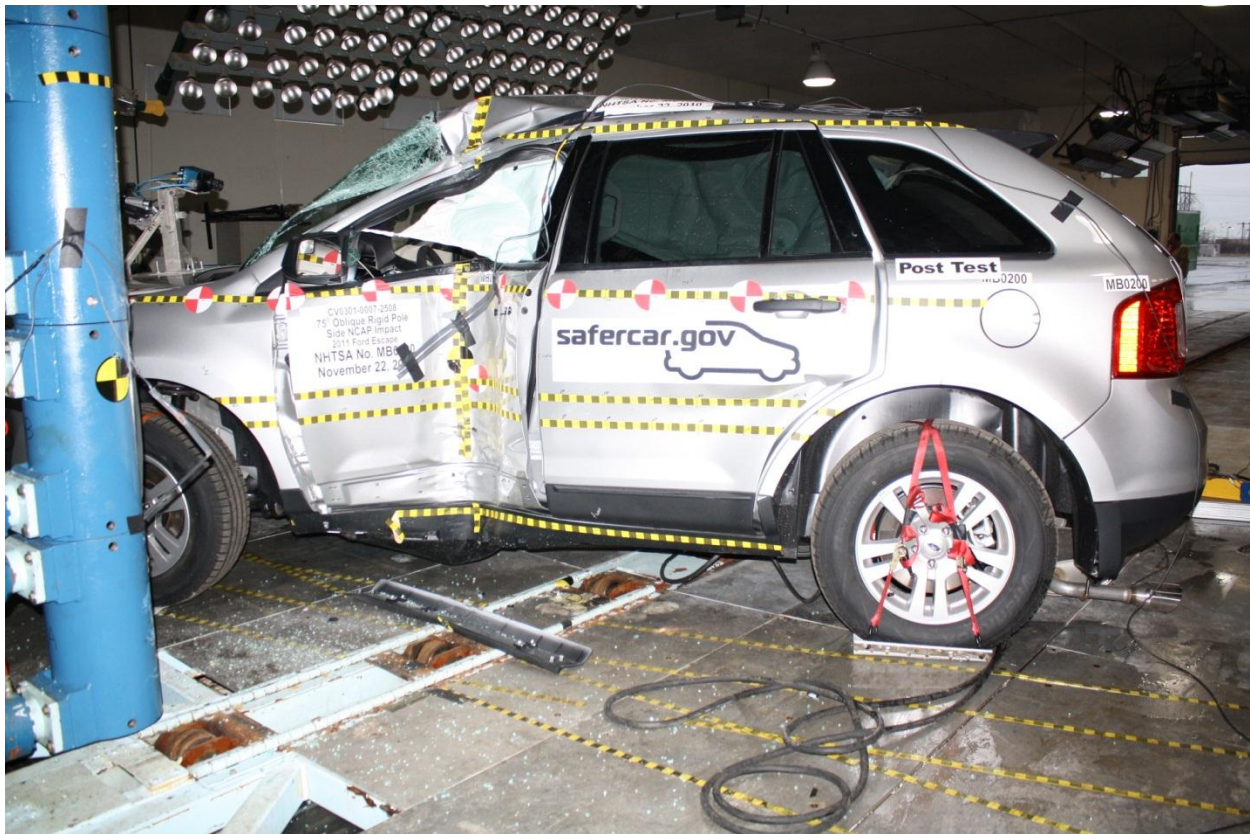
**Figure A-8: Post-Test Left Side View of Test Vehicle**

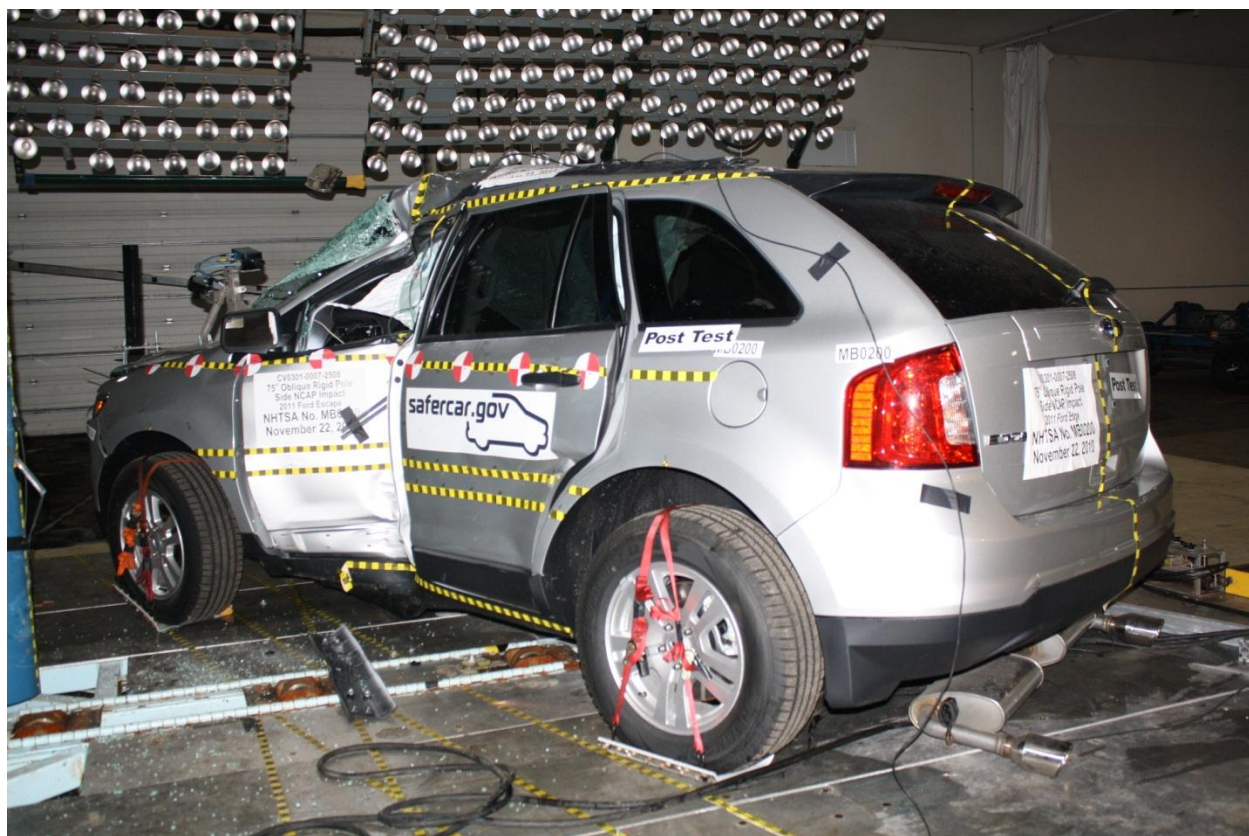
**Figure A-10: Post-Test Left Rear  $\frac{3}{4}$  View of Test Vehicle**

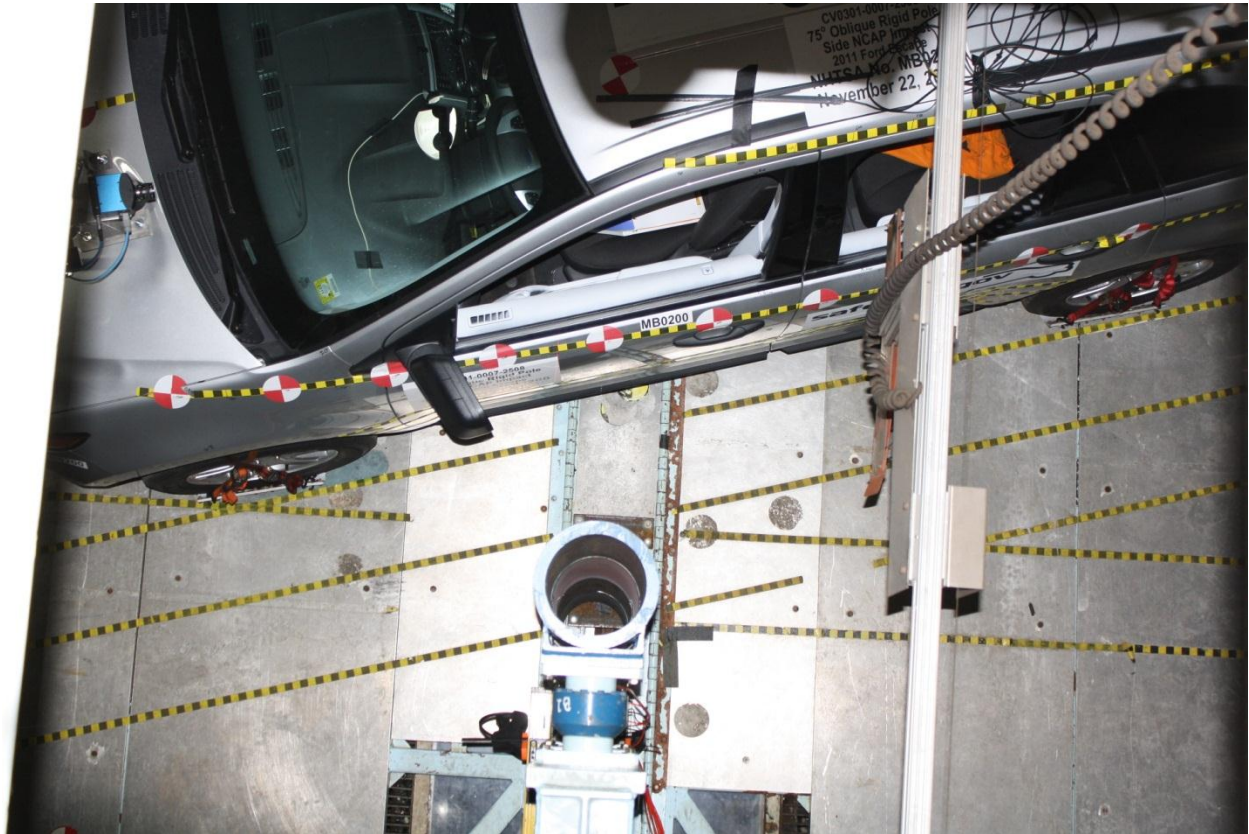
**Figure A-15: Pre-Test Overhead View of Test Vehicle and Pole**

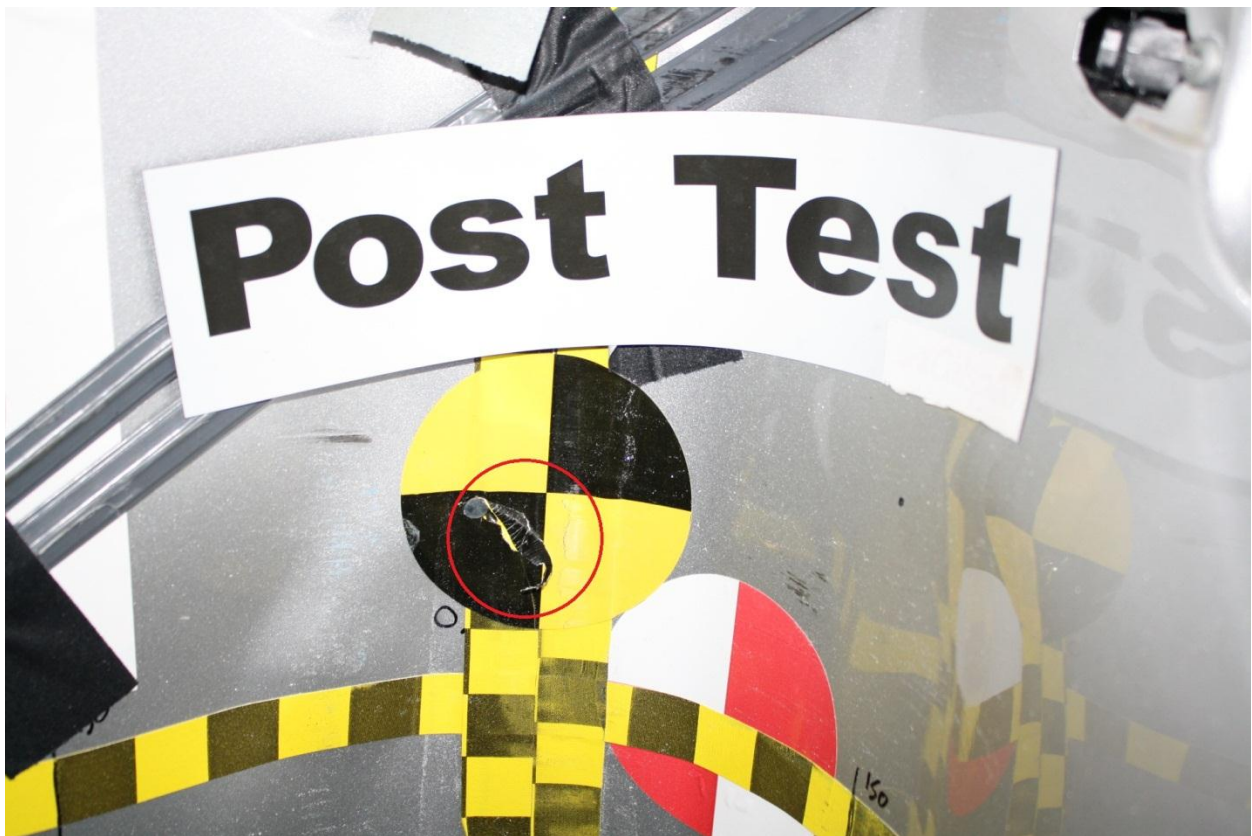
**Figure A-20: Post-Test Close-Up View of Impact Point Target Showing Impact Location**

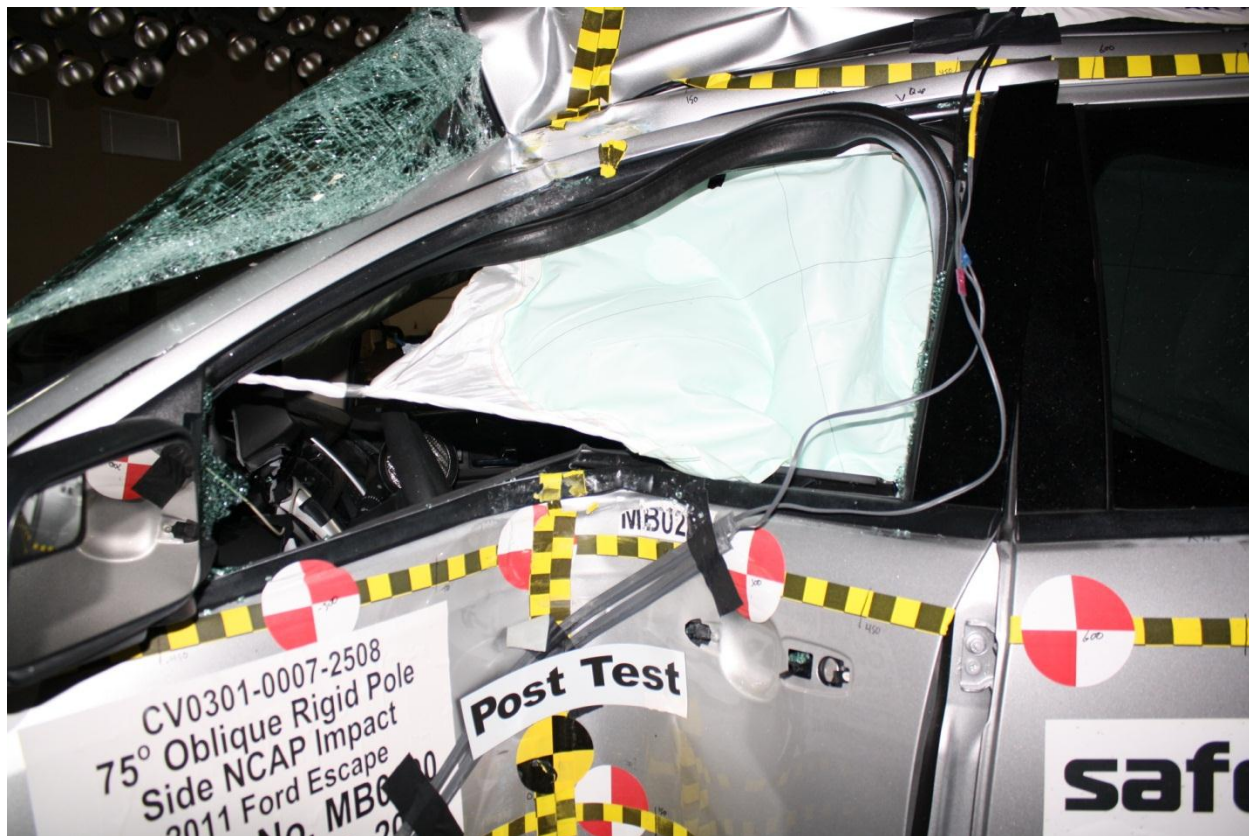
**Figure A-25: Post-Test Left Side View of Dummy Shoulder and Door Top View**

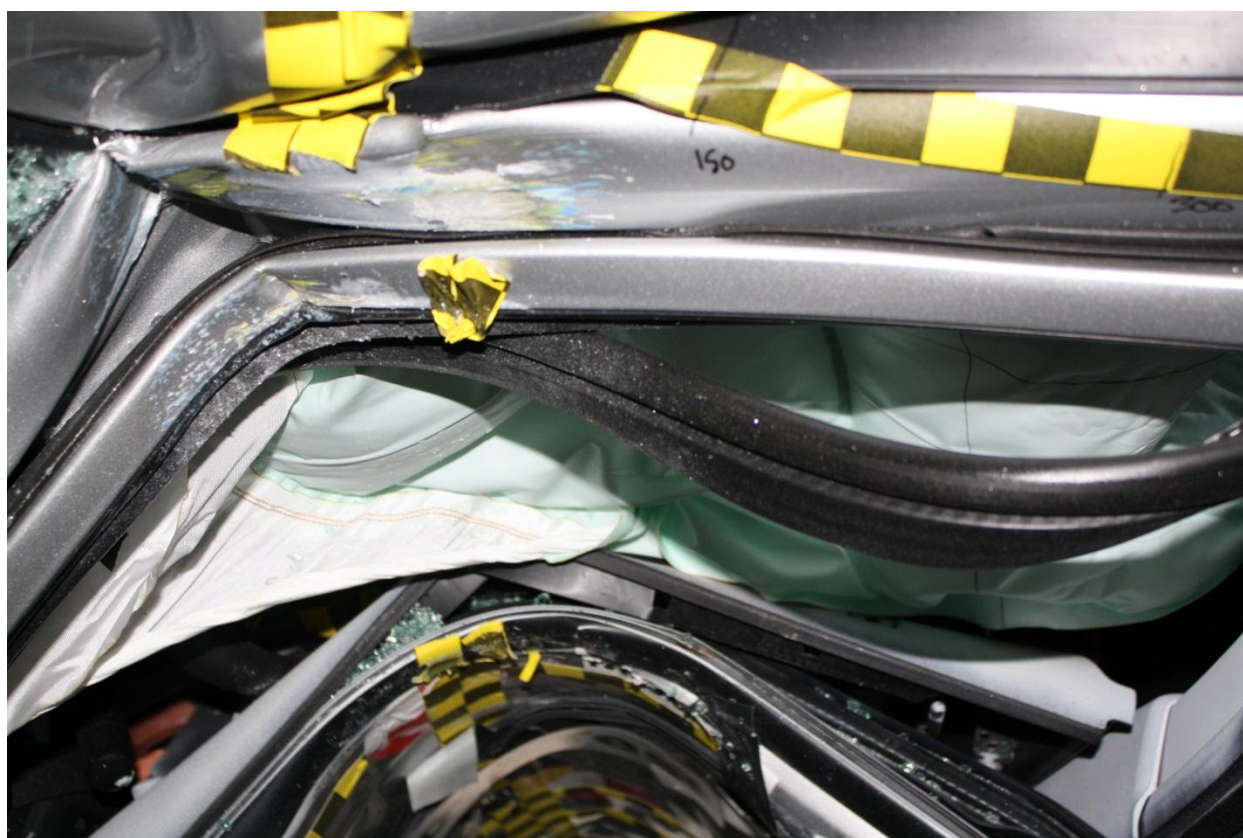
**Figure A-40: Post-Test Dummy and Door Clearance View**

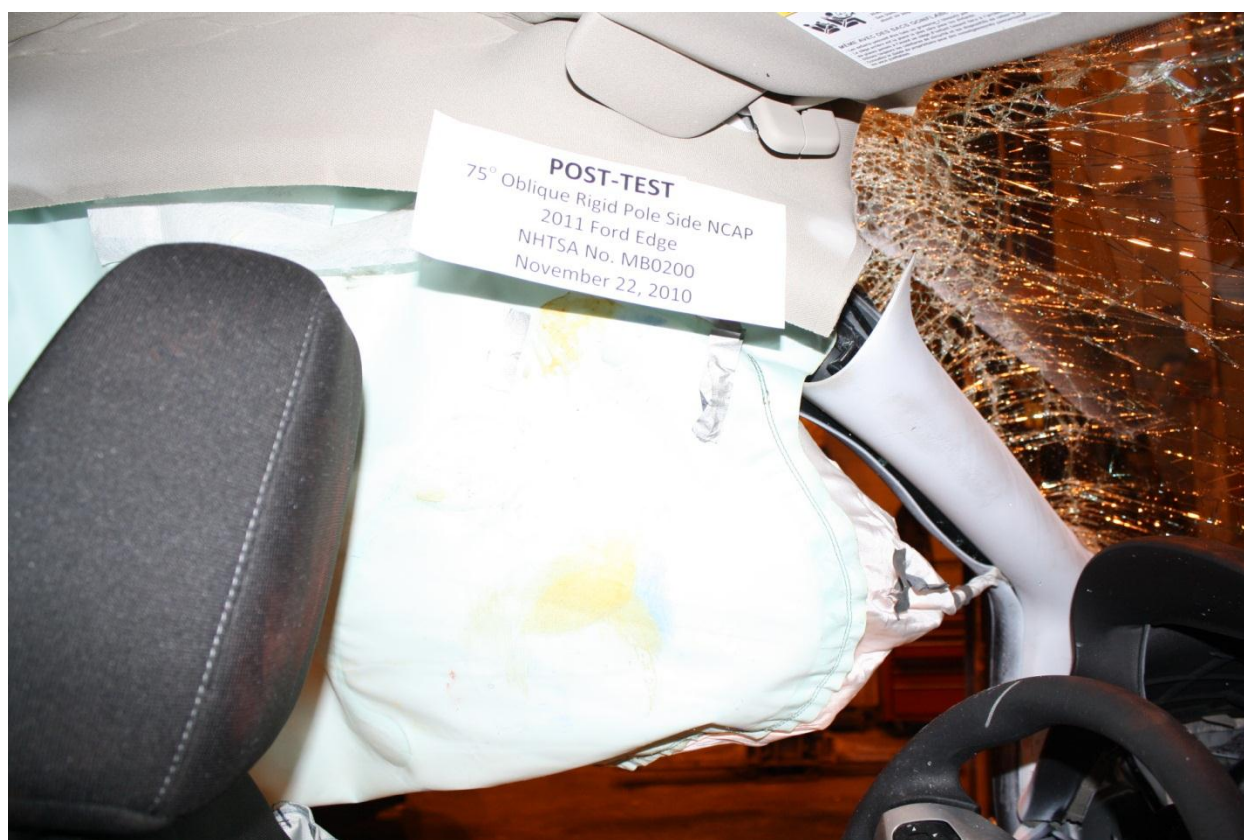
**Figure A-46: Post-Test Dummy Close-Up Head Contact with Side Airbag View**
