REPORT NUMBER: NCAP-MGA-2011-044

**NEW CAR ASSESSMENT PROGRAM (NCAP)
Frontal Barrier Impact Test**

**GENERAL MOTORS LLC
2011 Chevrolet Cruze LS 4-Dr Sedan
NHTSA No.: MB0102**

**MGA RESEARCH CORPORATION
5000 Warren Road
Burlington, WI 53105**

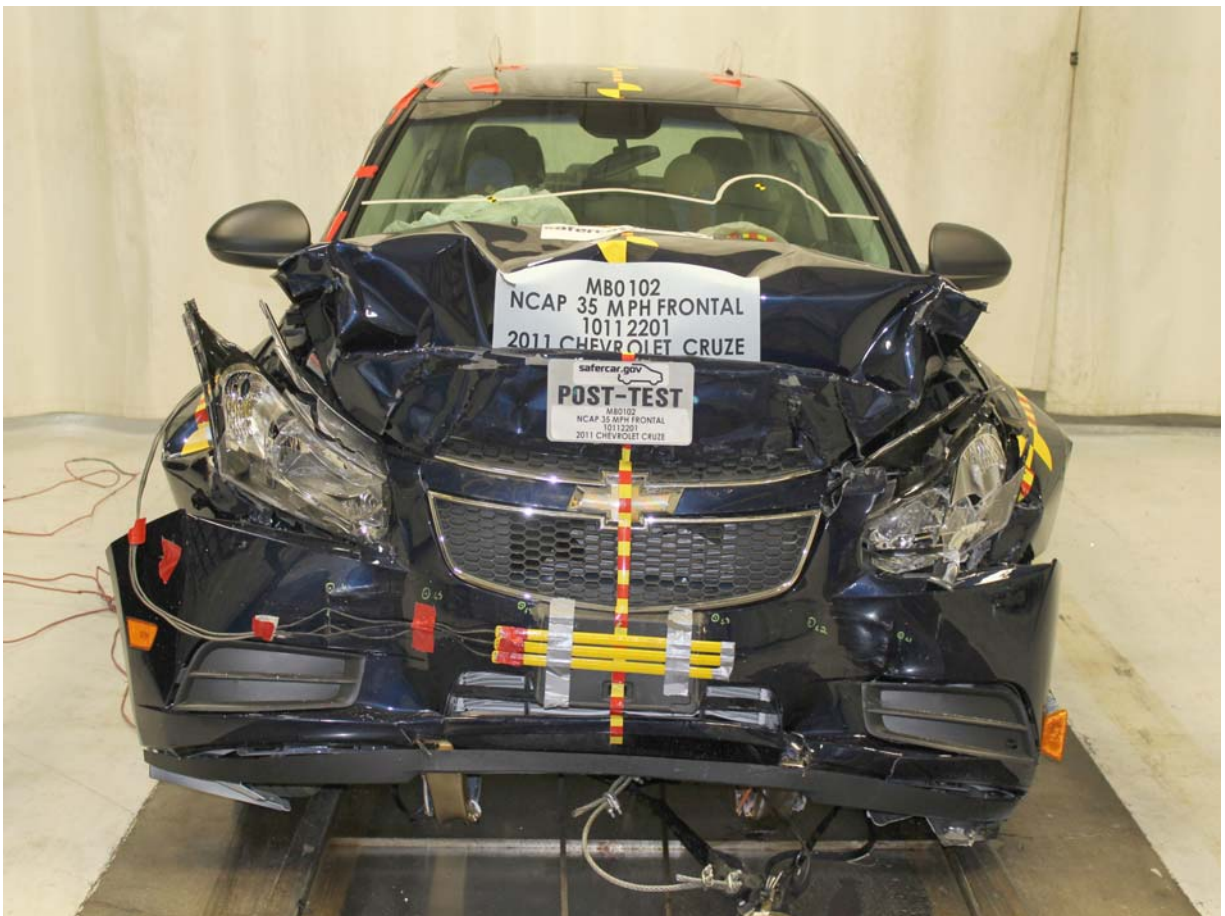
Post-Test Front View

The maximum static crush of the vehicle was 517 mm and both the driver and passenger side doors remained closed during the impact event and were operable after the impact.

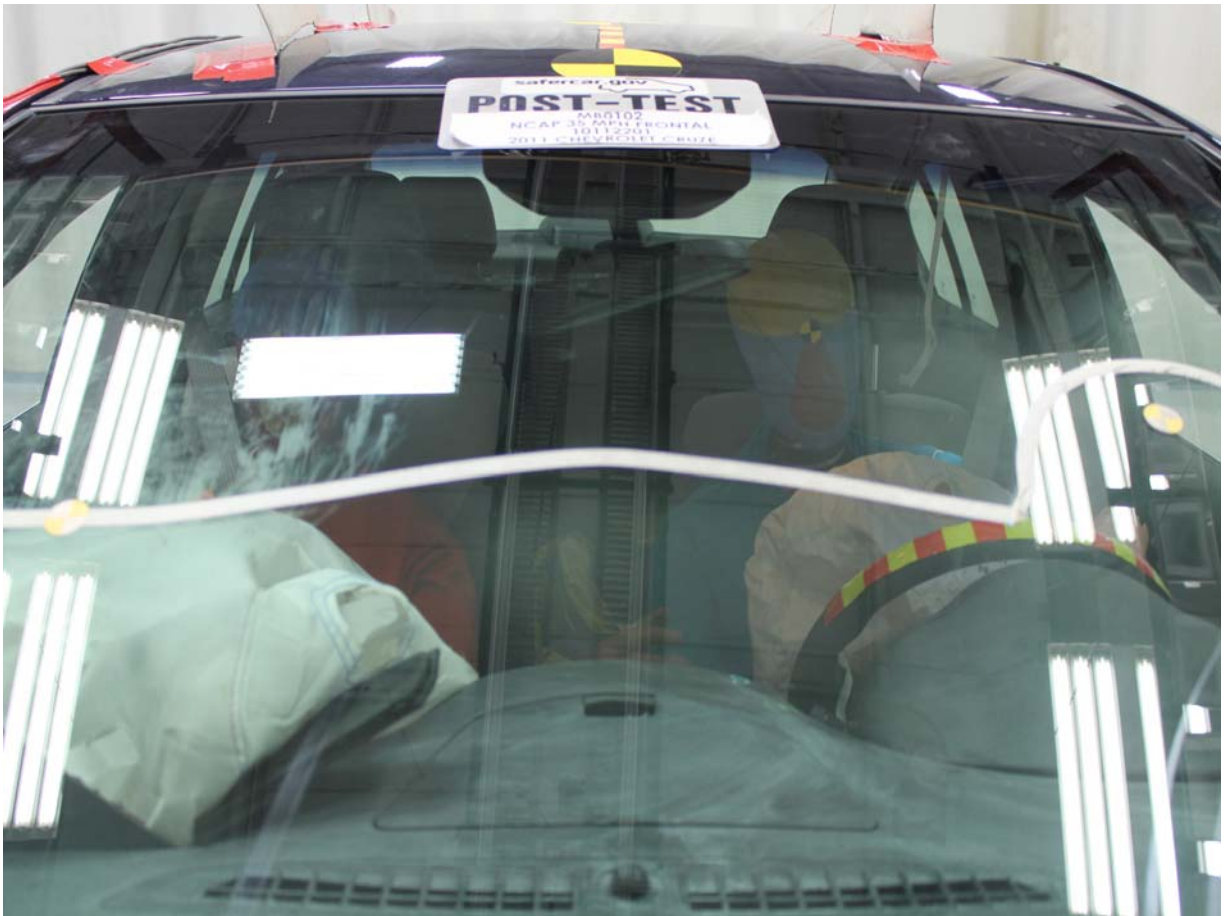
Post-Test Windshield View

There was 100 percent windshield retention and no intrusion into the protected zone of the windshield during the event. There was no Stoddard Solvent leakage after the event or during any phase of the static rollover.

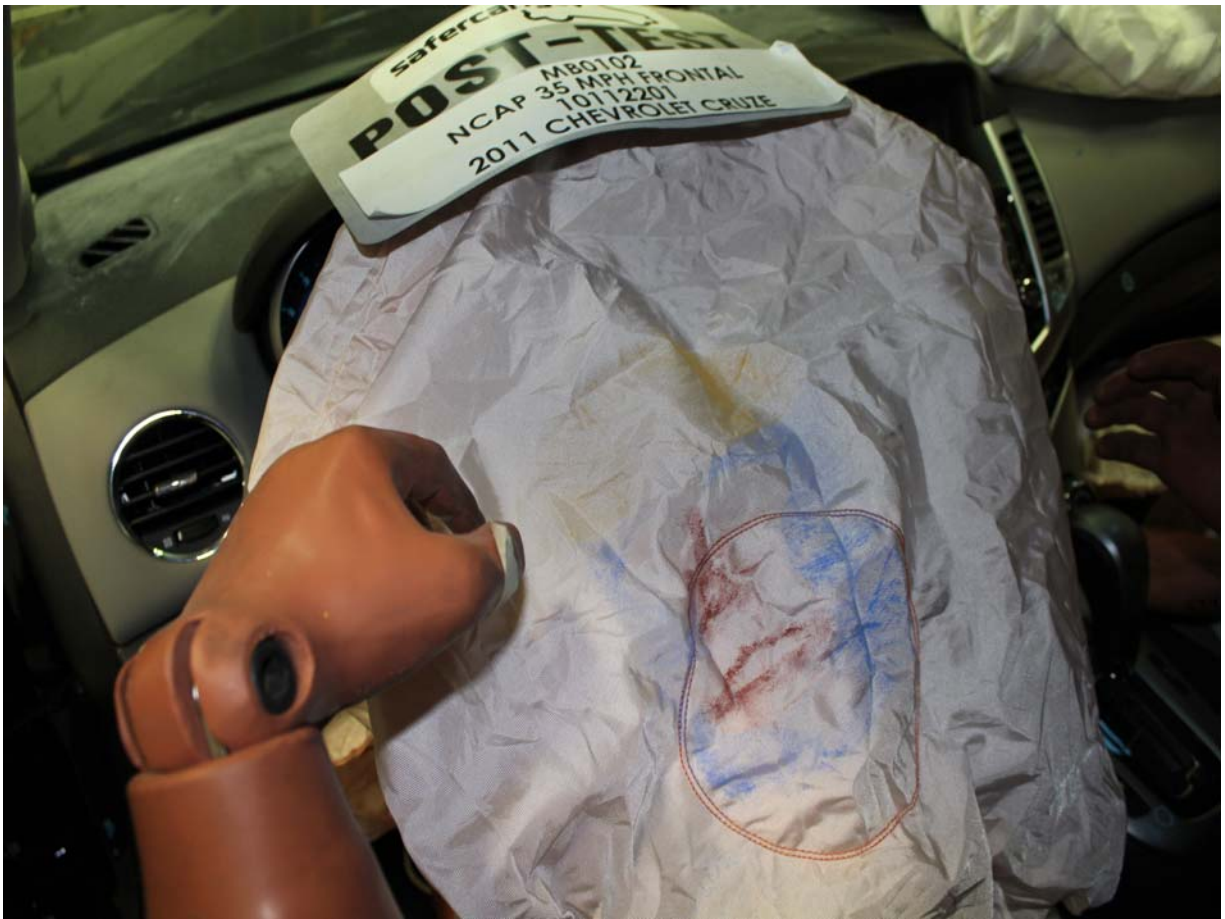
Post-Test Driver Dummy Contact with Airbag

The driver's head and chest contacted the airbag. The driver's head also contacted the headrest. The driver's knees contacted the knee airbag. The passenger's head and chest contacted the airbag. The passenger's head also contacted the headrest. The passenger's knees contacted the knee airbag.

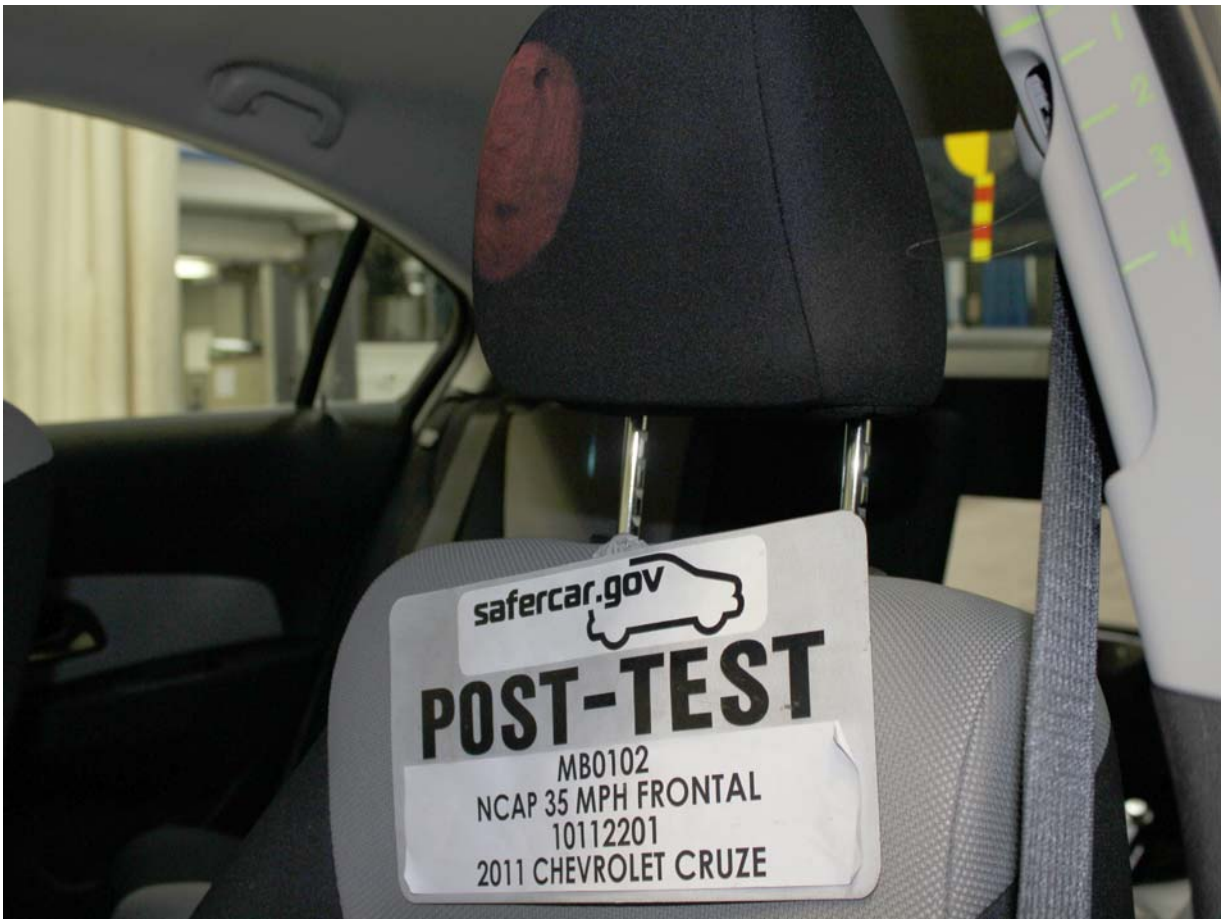
Post-Test Driver Dummy Contact with Headrest

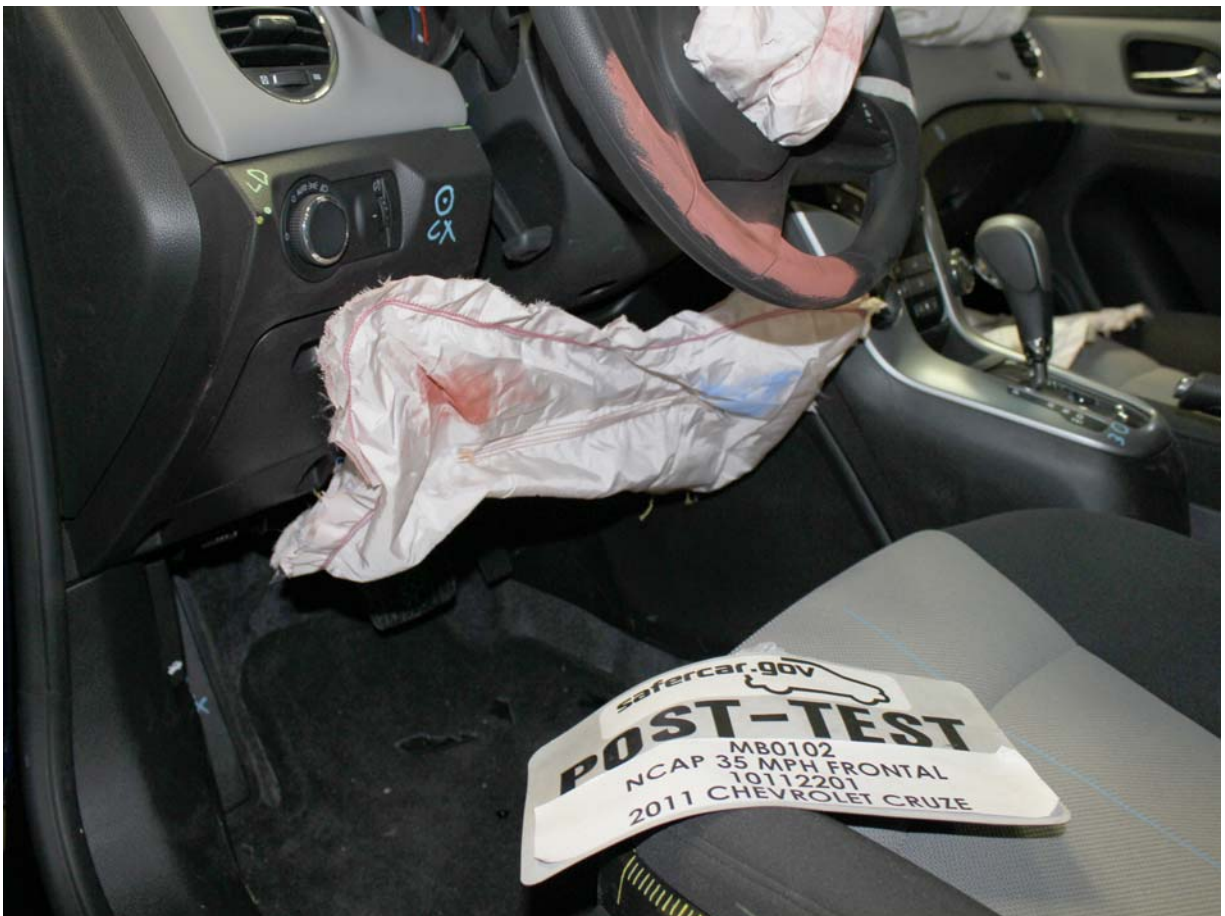
Post-Test Driver Dummy Contact with Knee Airbag

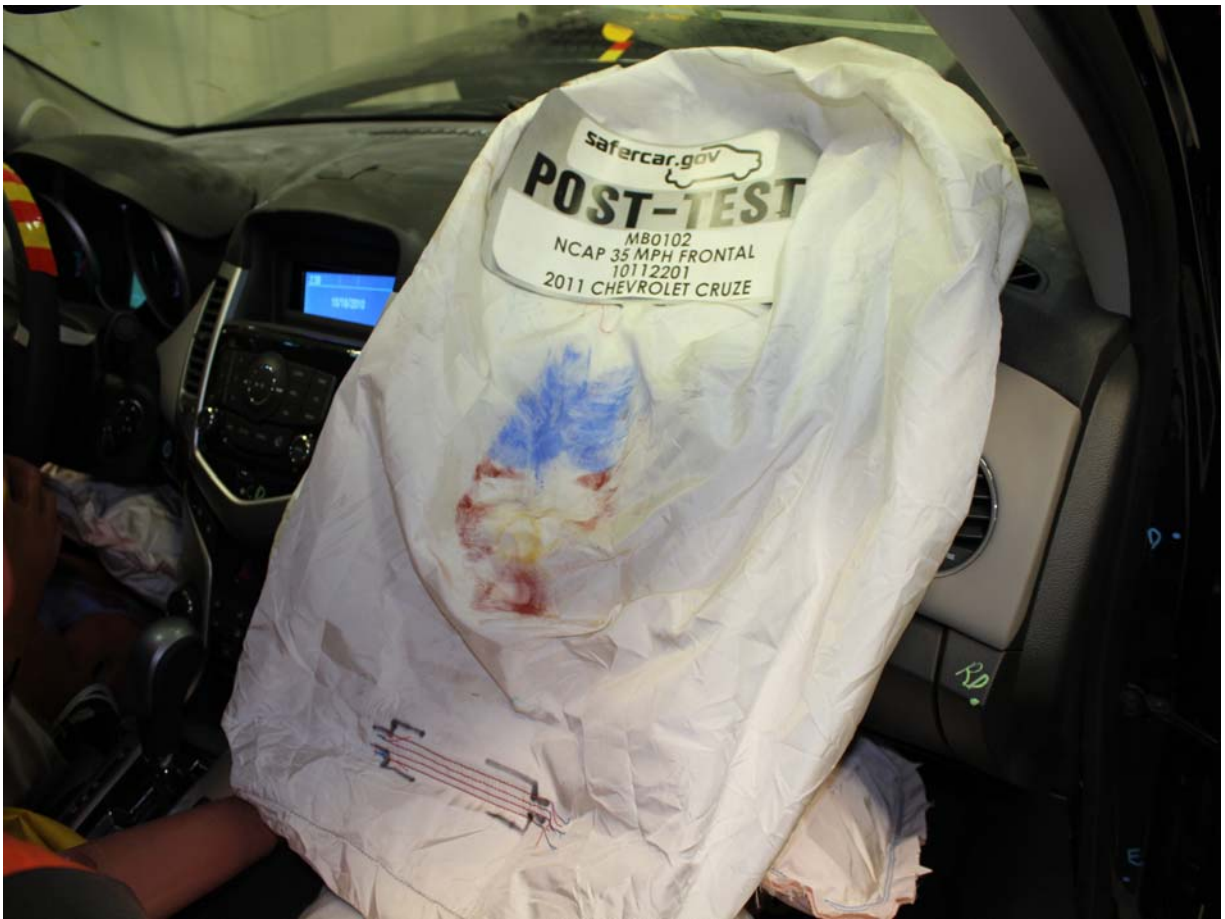
Post-Test Passenger Dummy Contact with Airbag

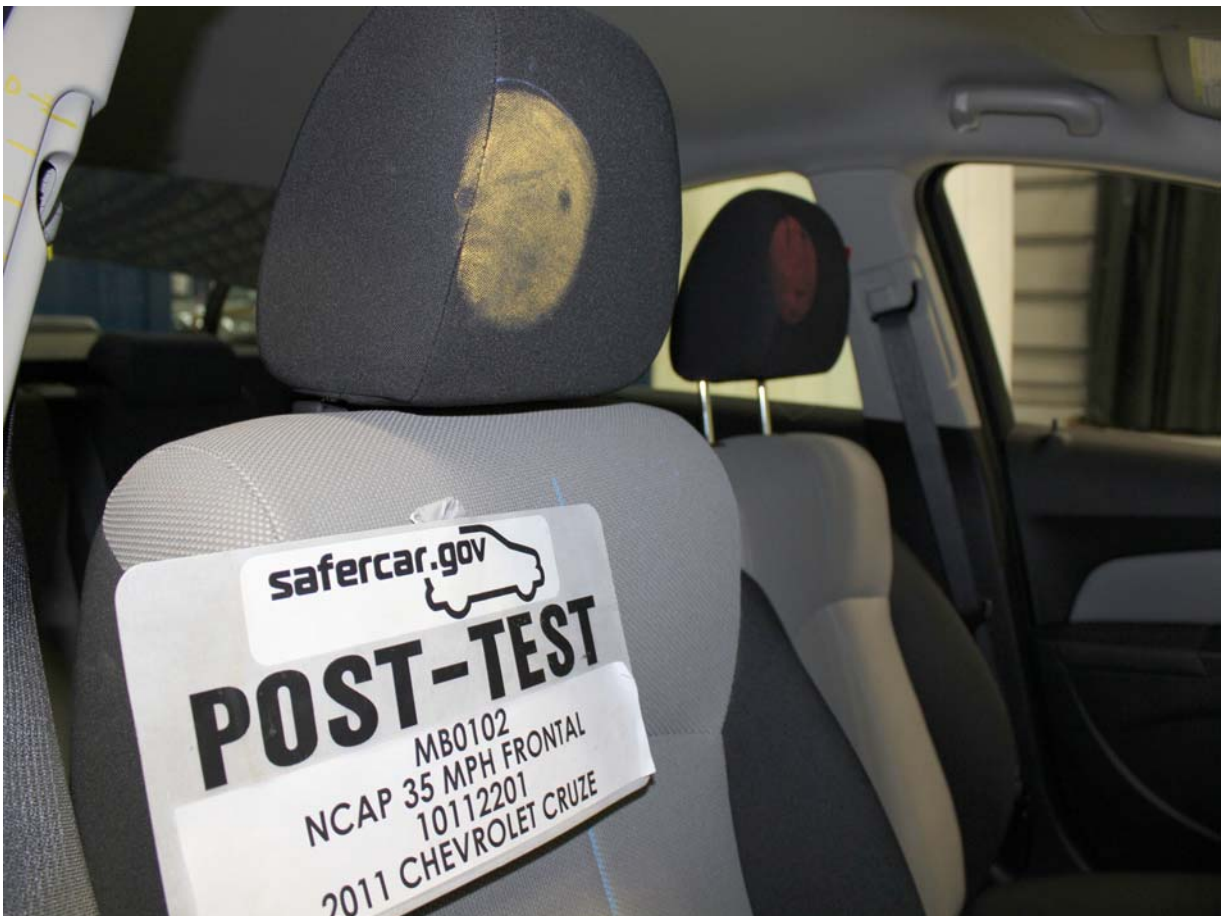
Post-Test Passenger Dummy Contact with Headrest

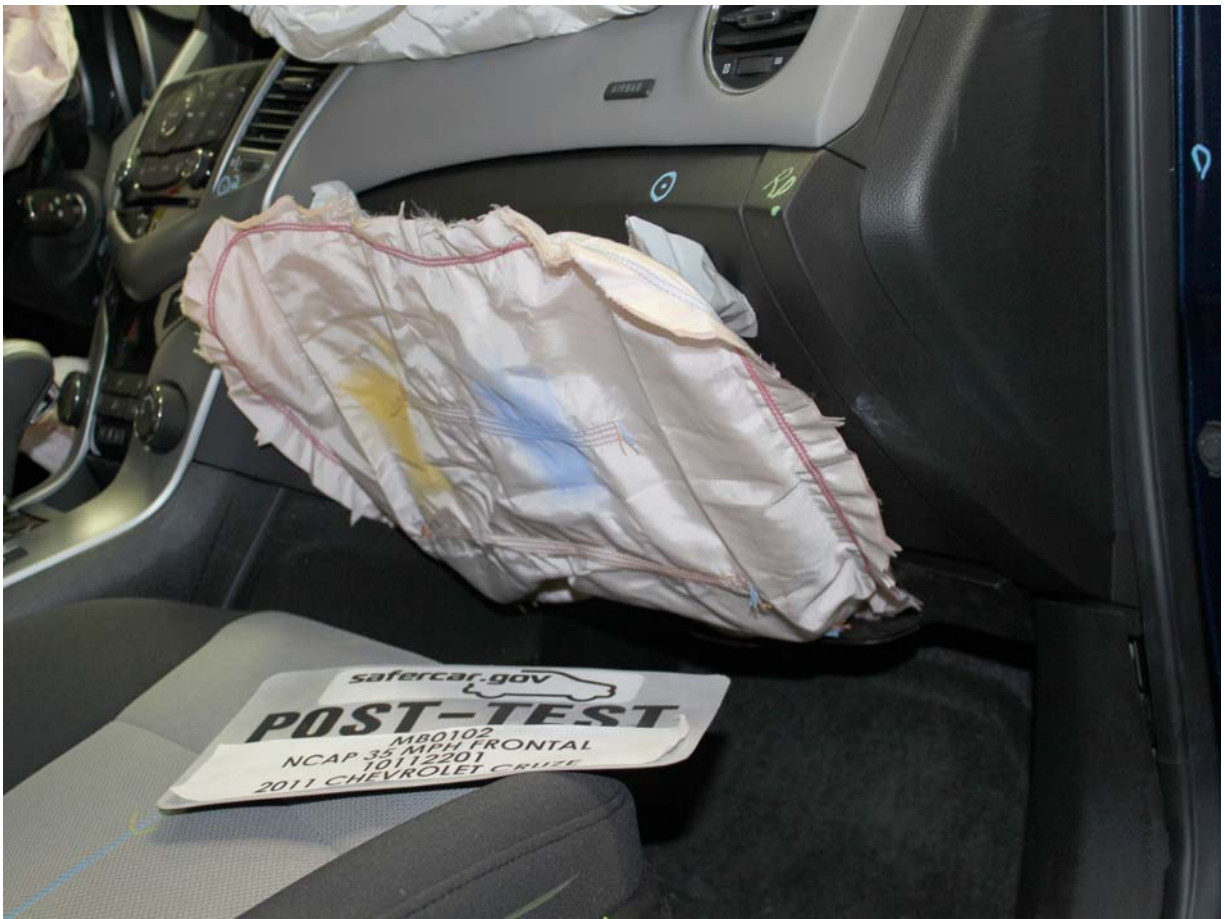
Post-Test Passenger Dummy Contact with Knee Airbag

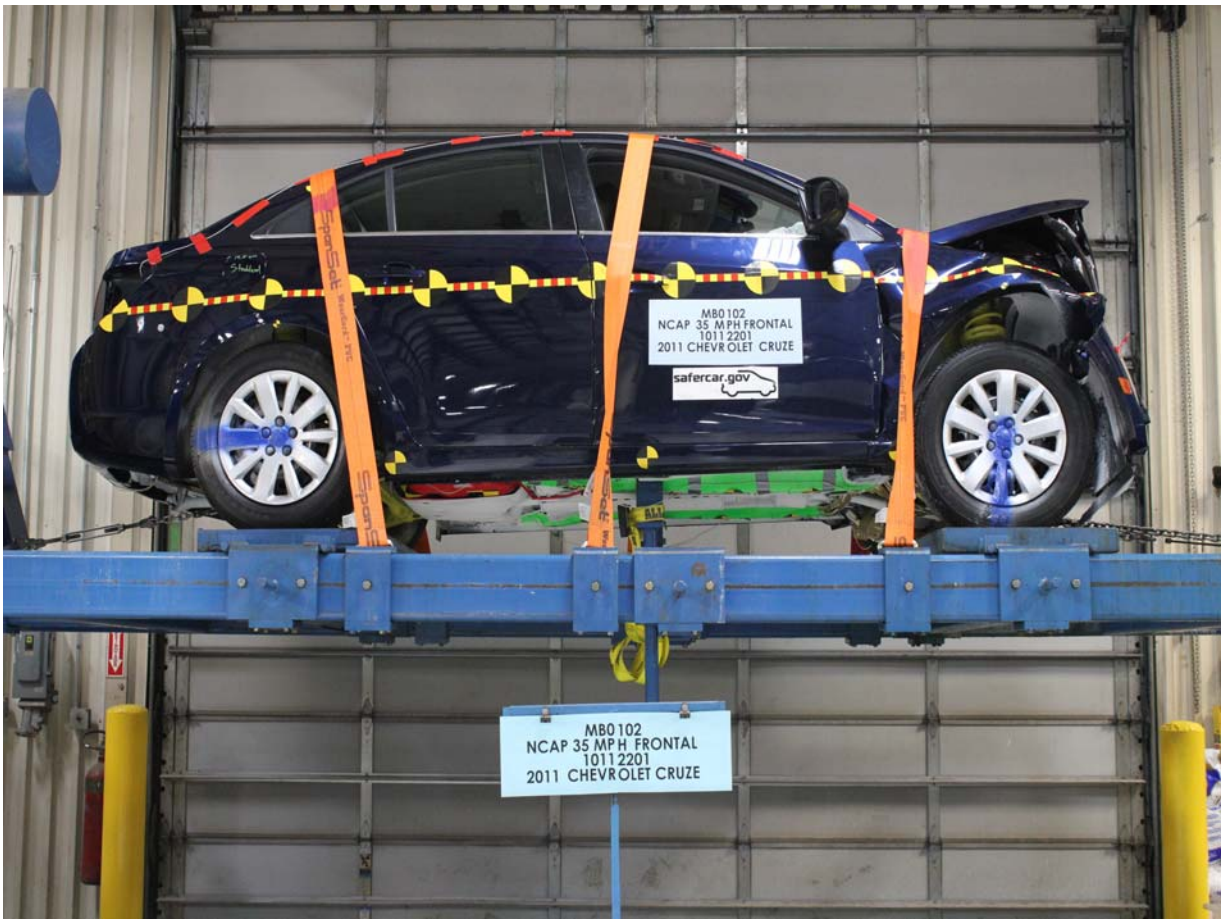
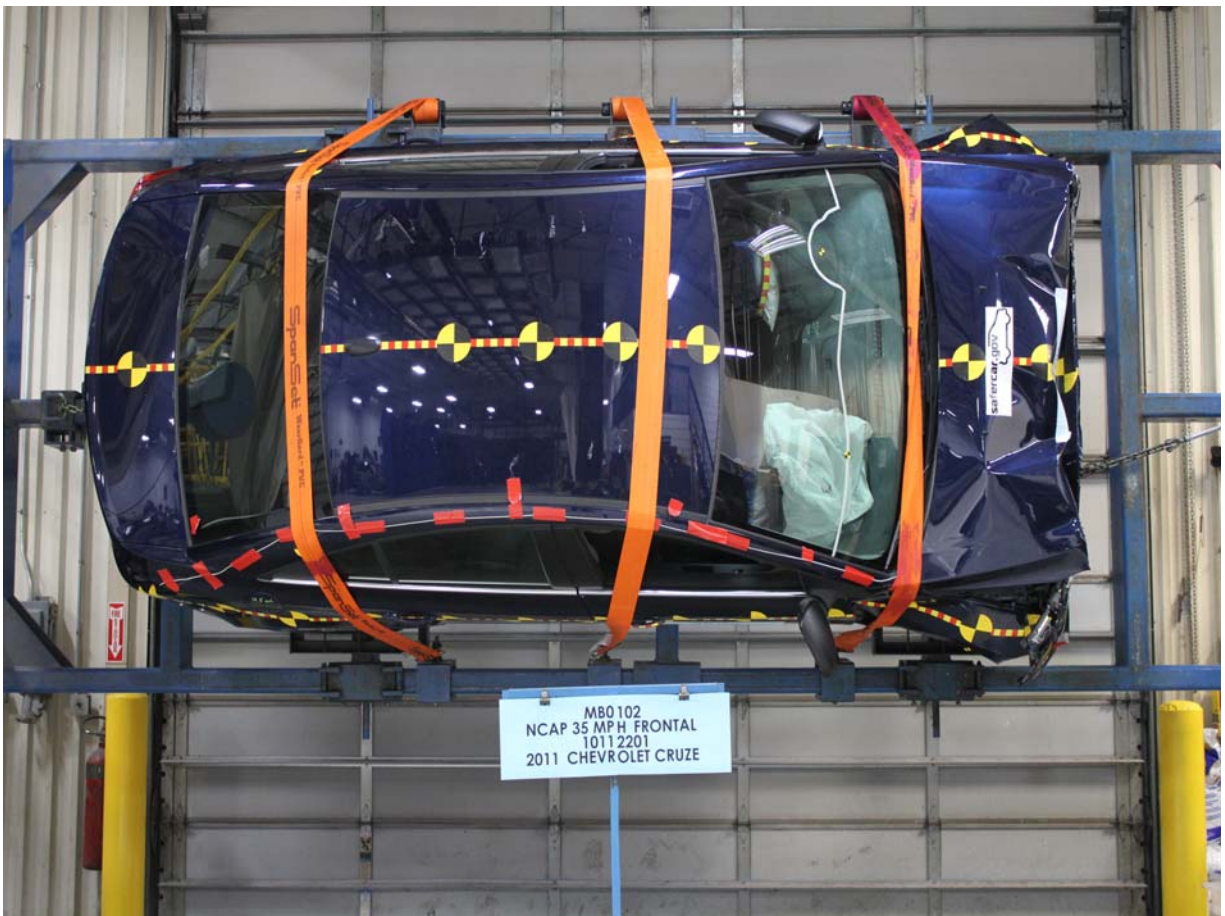
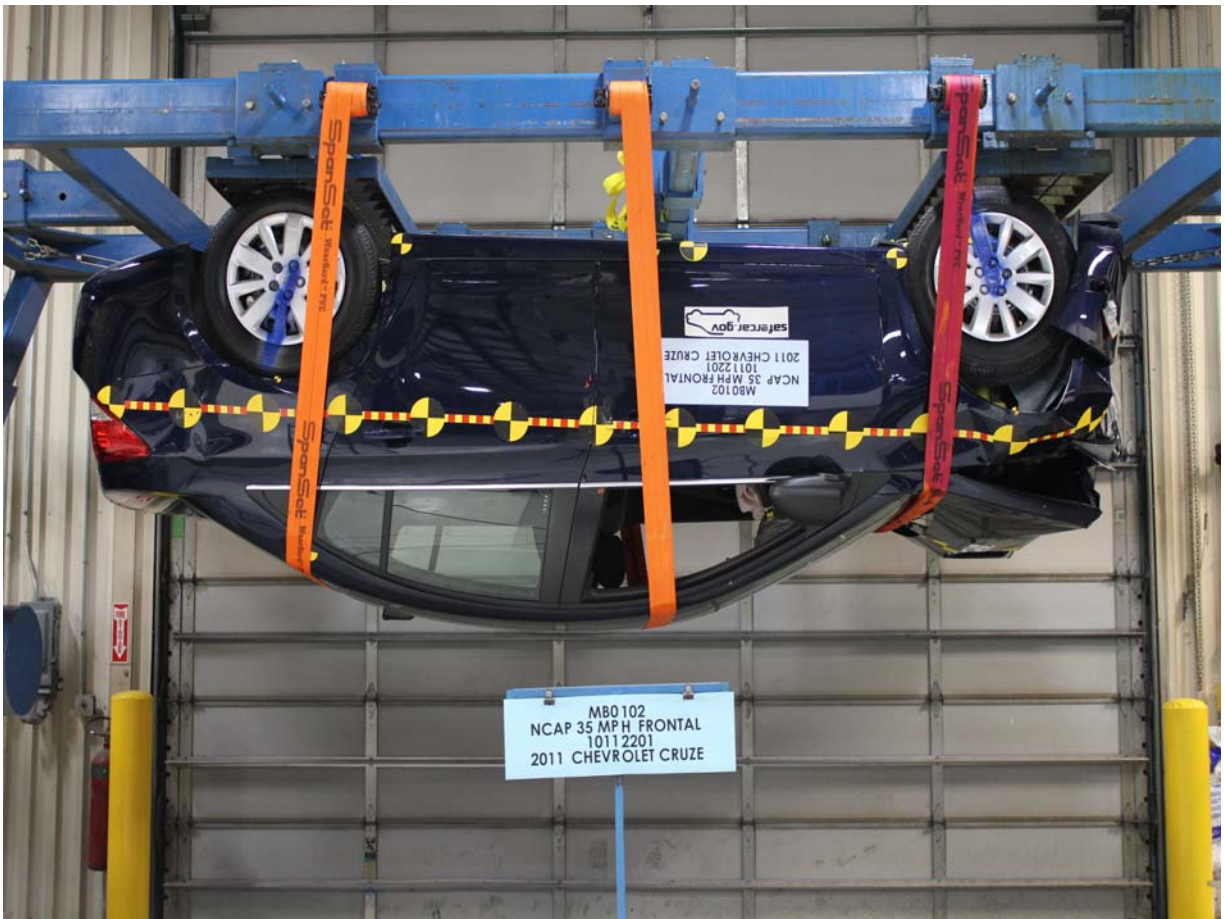
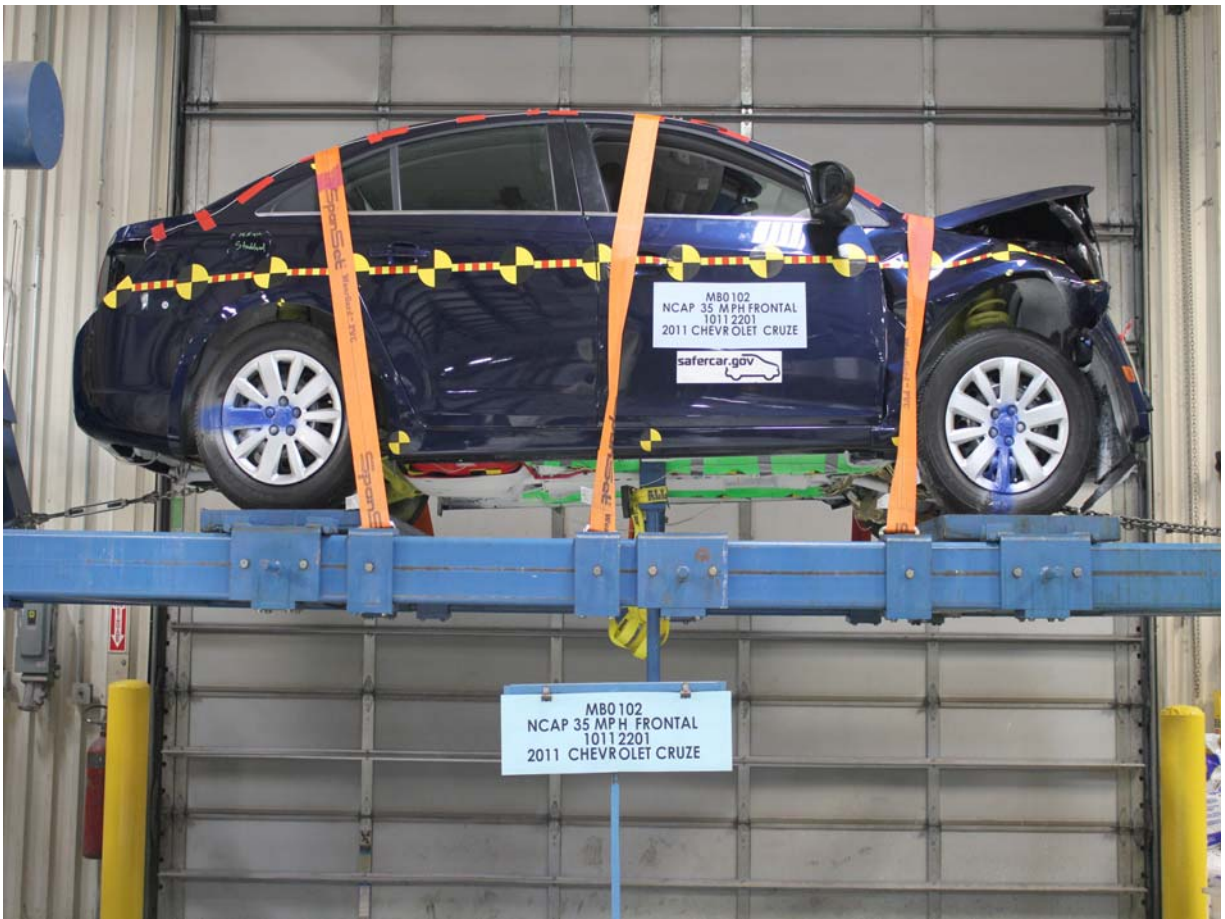
Vehicle at 0 Degrees on Static Rollover Device

Vehicle at 90 Degrees on Static Rollover Device

Vehicle at 180 Degrees on Static Rollover Device

Vehicle at 360 Degrees on Static Rollover Device

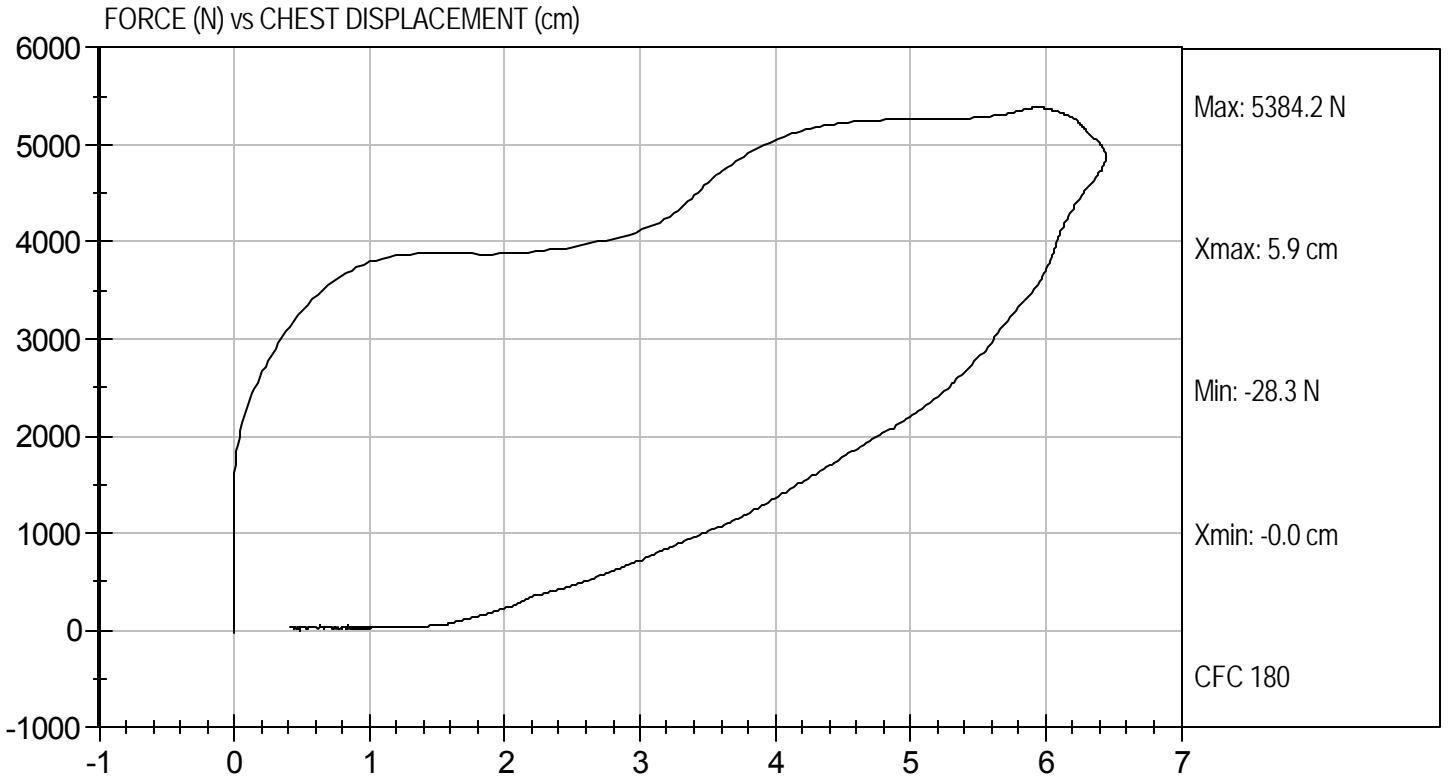
Test Desc: Thorax Impact
Component ID: D103974

Tested Parameter	Units	Specification	Result	Pass/Fail
Laboratory Temperature	deg C	20.6 to 22.2	21.8	Pass
Laboratory Relative Humidity	%	10 to 70	33	Pass
Probe Velocity	m/s	6.58 to 6.82	6.60	Pass
Peak Probe Force	N	5159 to 5893	5,384	Pass
Peak Sternum Displacement	cm	6.35 to 7.26	6.45	Pass
Internal Hysteresis	%	69 to 85	71	Pass
Overall Test Results				Pass

Test Date: 11/16/10
Velocity: 21.64 ft/s, 6.60 m/s

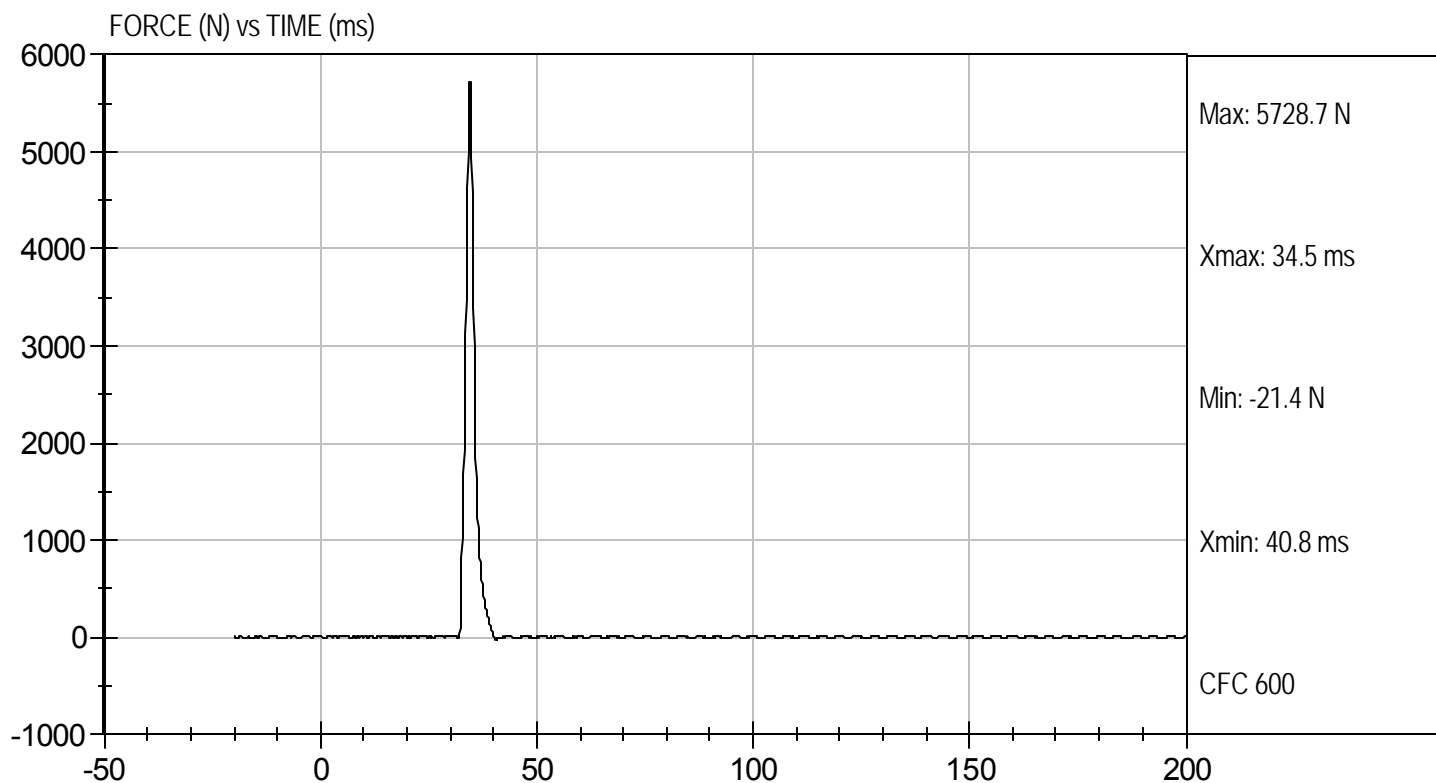
Test Desc: Right Knee
Component ID: D103975

Tested Parameter	Units	Specification	Result	Pass/Fail
Laboratory Temperature	deg C	18.9 to 25.5	22.1	Pass
Laboratory Relative Humidity	%	10 to 70	32	Pass
Probe Velocity	m/s	2.07 to 2.13	2.12	Pass
Peak Probe Force	Newtons	4715 to 5782	5,729	Pass
Overall Test Results				Pass

Test Date: 11/16/10
Velocity: 6.944 ft/s, 2.12 m/s

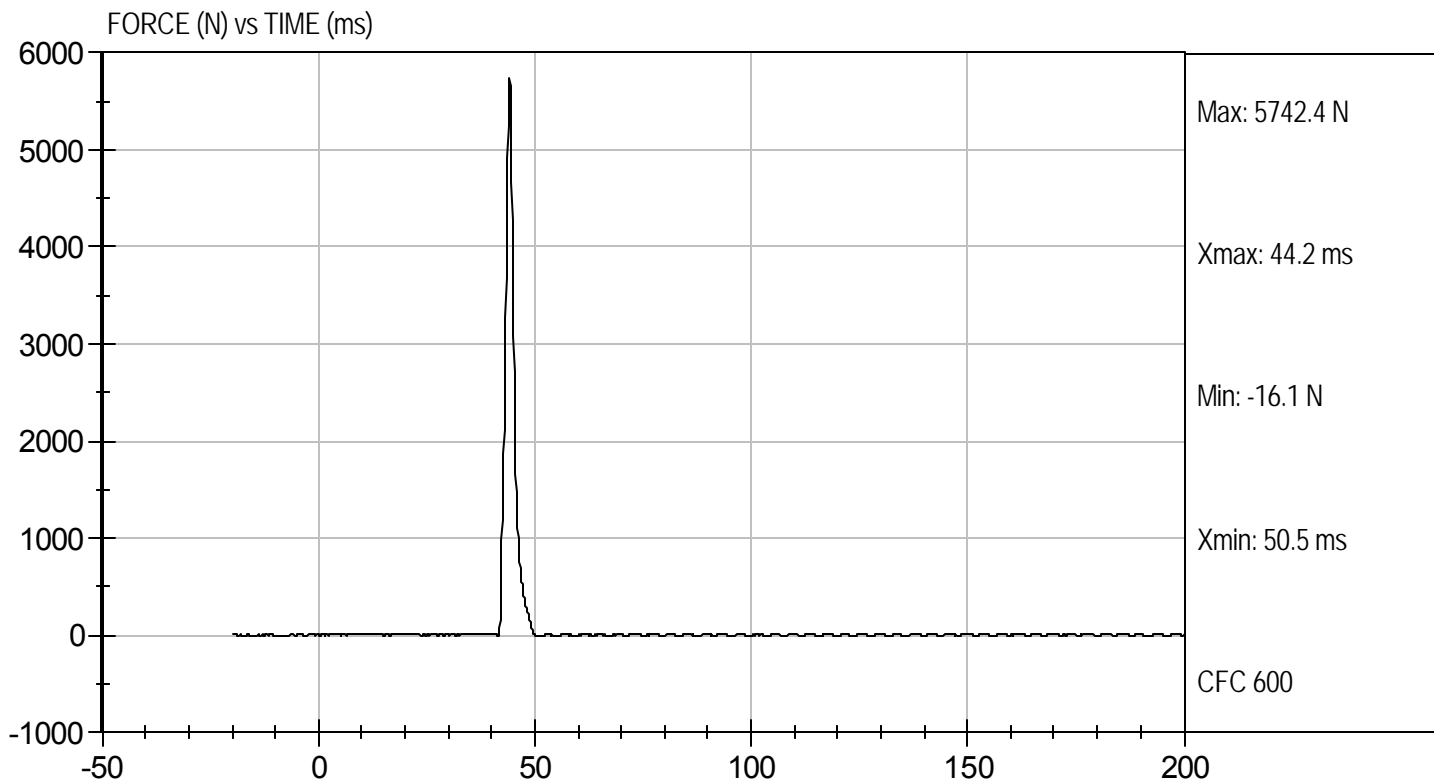
Test Desc: Left Knee
Component ID: D103976

Tested Parameter	Units	Specification	Result	Pass/Fail
Laboratory Temperature	deg C	18.9 to 25.5	22.1	Pass
Laboratory Relative Humidity	%	10 to 70	32	Pass
Probe Velocity	m/s	2.07 to 2.13	2.11	Pass
Peak Probe Force	Newtons	4715 to 5782	5,742	Pass
Overall Test Results				Pass

Test Date: 11/16/10
Velocity: 6.91 ft/s, 2.11 m/s

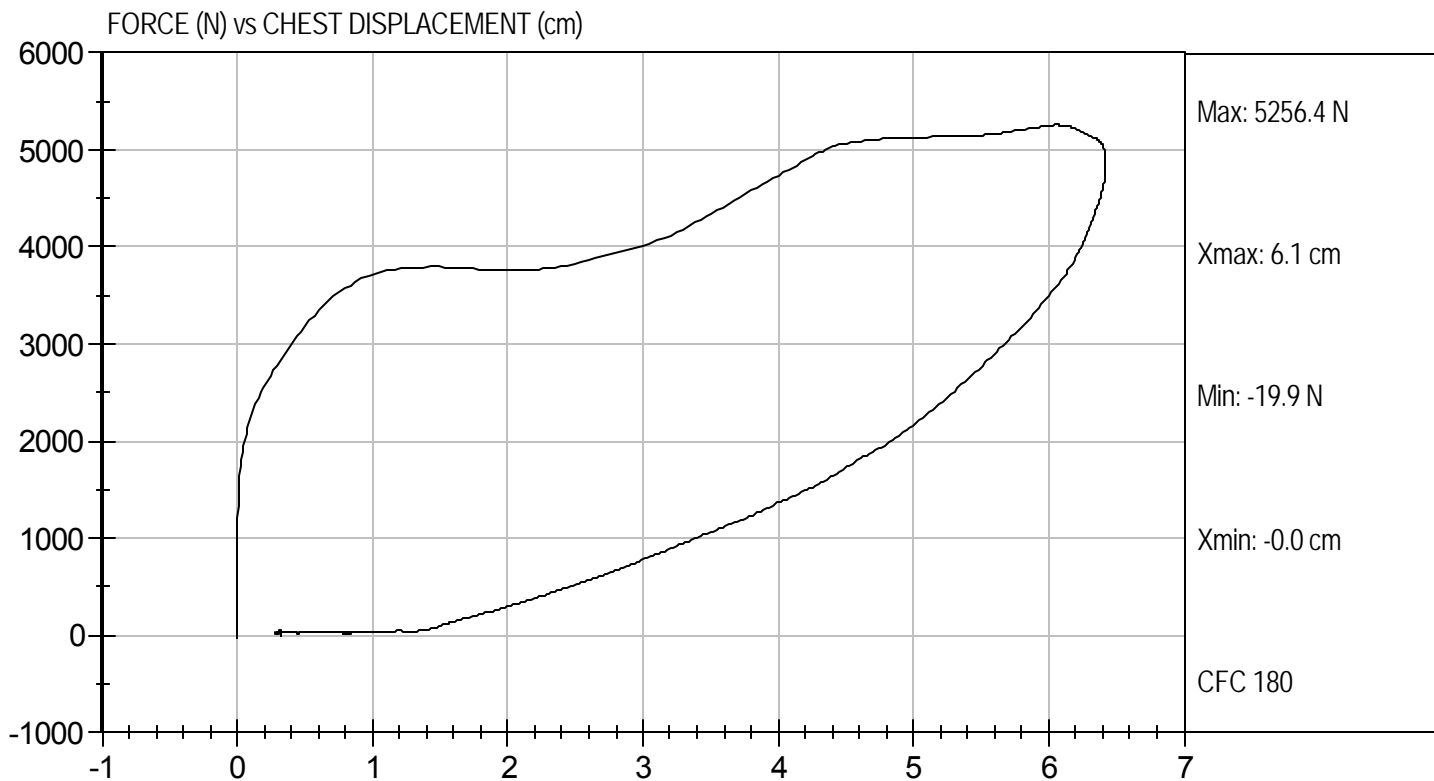
Test Desc: Thorax Impact
Component ID: D104104

Tested Parameter	Units	Specification	Result	Pass/Fail
Laboratory Temperature	deg C	20.6 to 22.2	21.6	Pass
Laboratory Relative Humidity	%	10 to 70	55	Pass
Probe Velocity	m/s	6.58 to 6.82	6.68	Pass
Peak Probe Force	N	5159 to 5893	5,256	Pass
Peak Sternum Displacement	cm	6.35 to 7.26	6.42	Pass
Internal Hysteresis	%	69 to 85	71	Pass
Overall Test Results				Pass

Test Date: 11/22/10
Velocity: 21.92 ft/s, 6.68 m/s

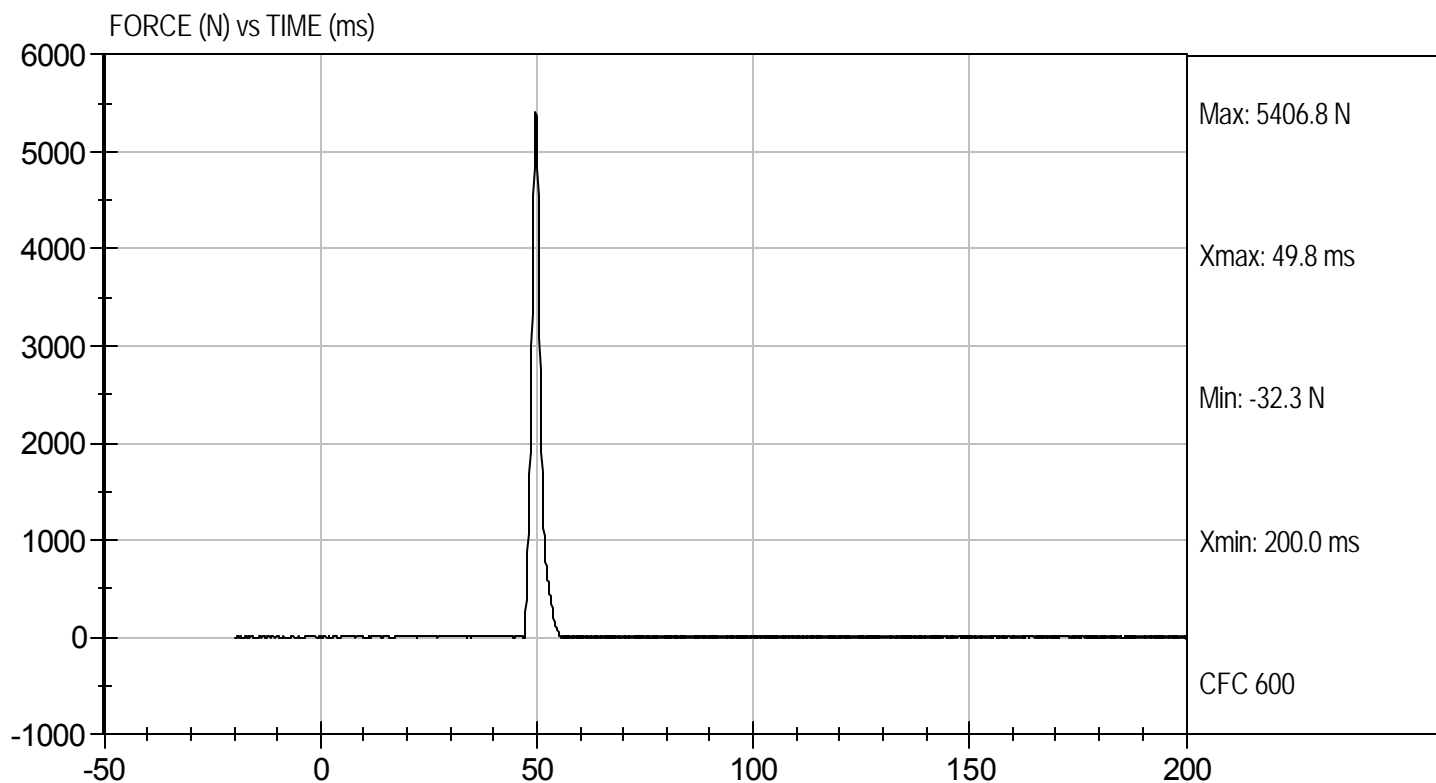
Test Desc: Right Knee
Component ID: D104105

Tested Parameter	Units	Specification	Result	Pass/Fail
Laboratory Temperature	deg C	18.9 to 25.5	21.4	Pass
Laboratory Relative Humidity	%	10 to 70	56	Pass
Probe Velocity	m/s	2.07 to 2.13	2.11	Pass
Peak Probe Force	Newtons	4715 to 5782	5,407	Pass
Overall Test Results				Pass

Test Date: 11/22/10
Velocity: 6.92 ft/s, 2.11 m/s

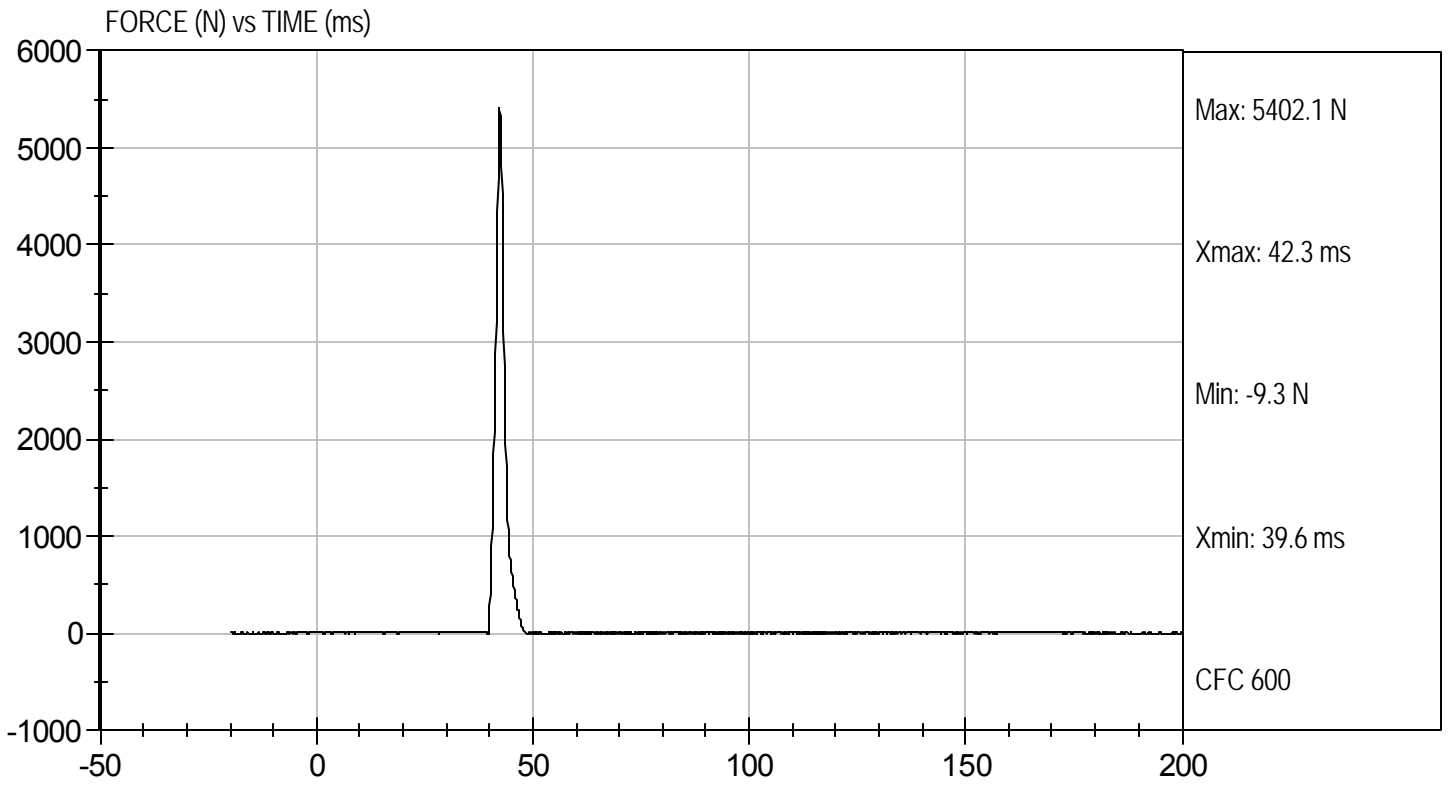
Test Desc: Left Knee
Component ID: D104106

Tested Parameter	Units	Specification	Result	Pass/Fail
Laboratory Temperature	deg C	18.9 to 25.5	21.4	Pass
Laboratory Relative Humidity	%	10 to 70	56	Pass
Probe Velocity	m/s	2.07 to 2.13	2.11	Pass
Peak Probe Force	Newtons	4715 to 5782	5,402	Pass
Overall Test Results				Pass

Test Date: 11/22/10
Velocity: 6.92 ft/s, 2.11 m/s
