**REPORT NUMBER: SPNCAP-KAR-11-043**

**NEW CAR ASSESSMENT PROGRAM (NCAP)  
SIDE IMPACT POLE TEST**

**TOYOTA MOTOR MANUFACTURING, KENTUCKY, INC.  
2011 TOYOTA VENZA 5-DOOR MPV**

**FINAL REPORT**

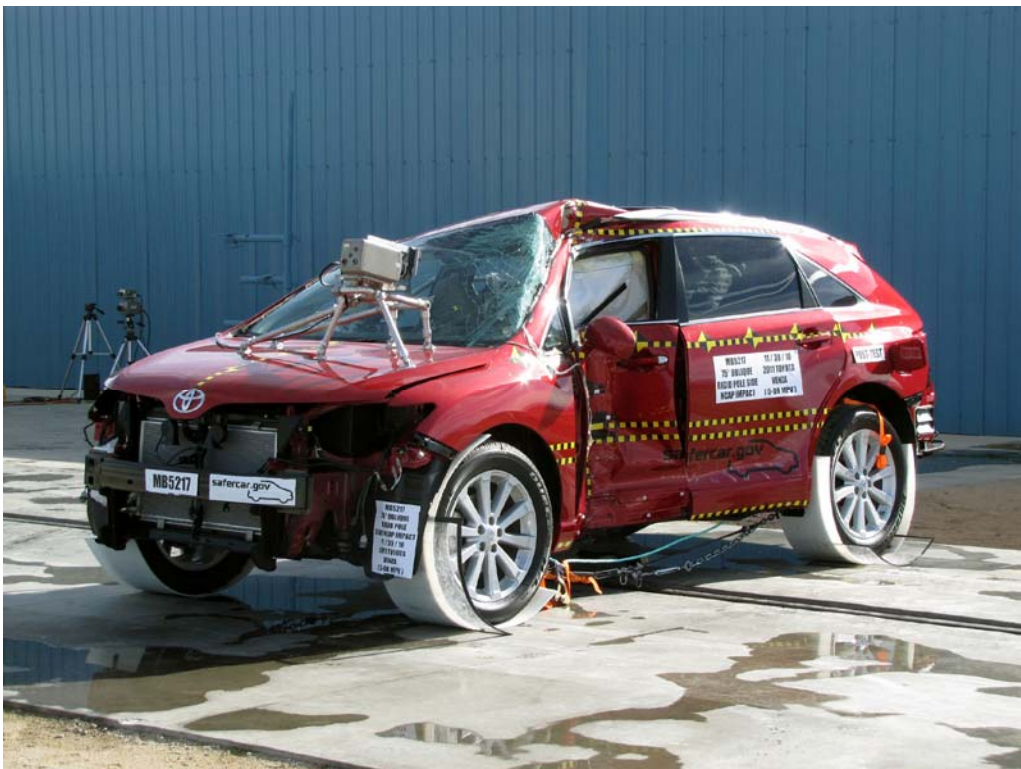
FIGURE 6. Post-Test Left Front Three-Quarter View of Test Vehicle

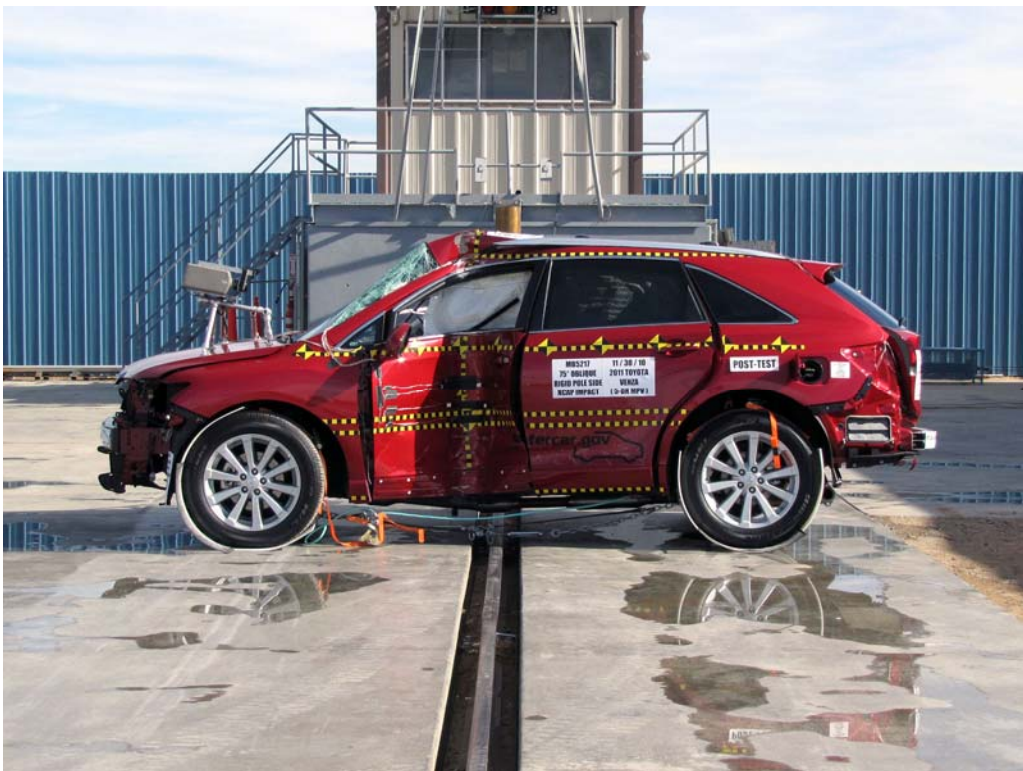
FIGURE 8. Post-Test Left Side View of Test Vehicle

Both of the struck side doors of the test vehicle remained closed and latched and were jammed shut after the impact. There was no separation at the hinges or the latches. The non-struck side doors remained closed and latched. There were no driver injury values that exceeded their limits. There was no FMVSS 301 Stoddard solvent spillage as a result of the impact.

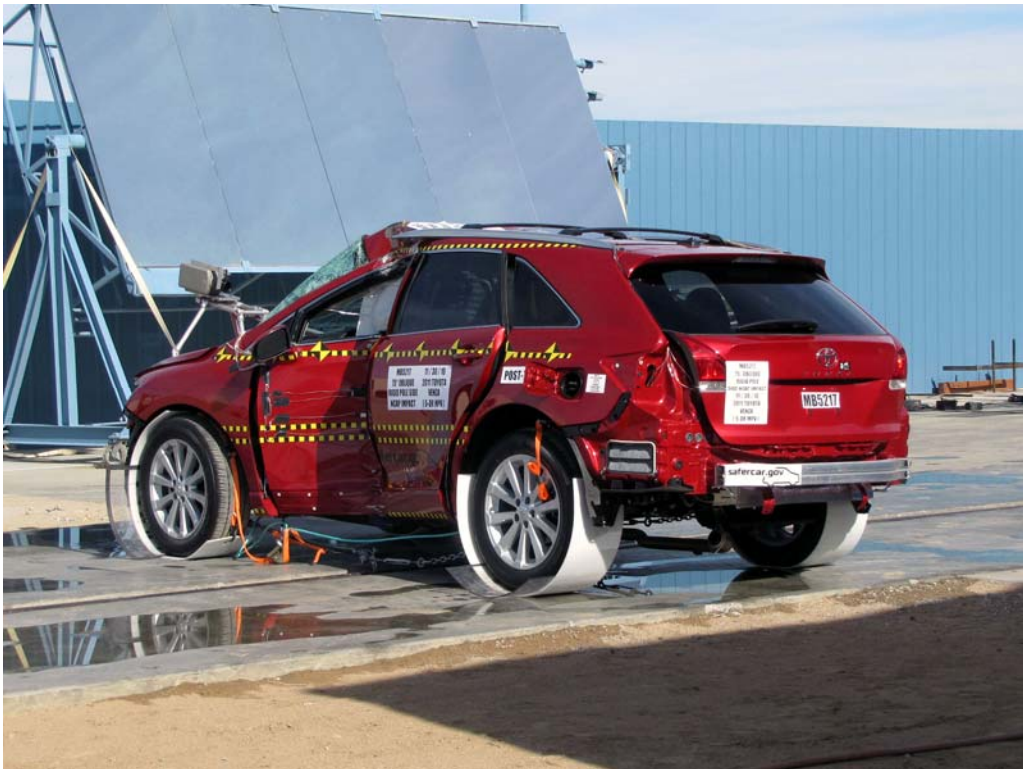
FIGURE 10. Post-Test Left Rear Three-Quarter View of Test Vehicle

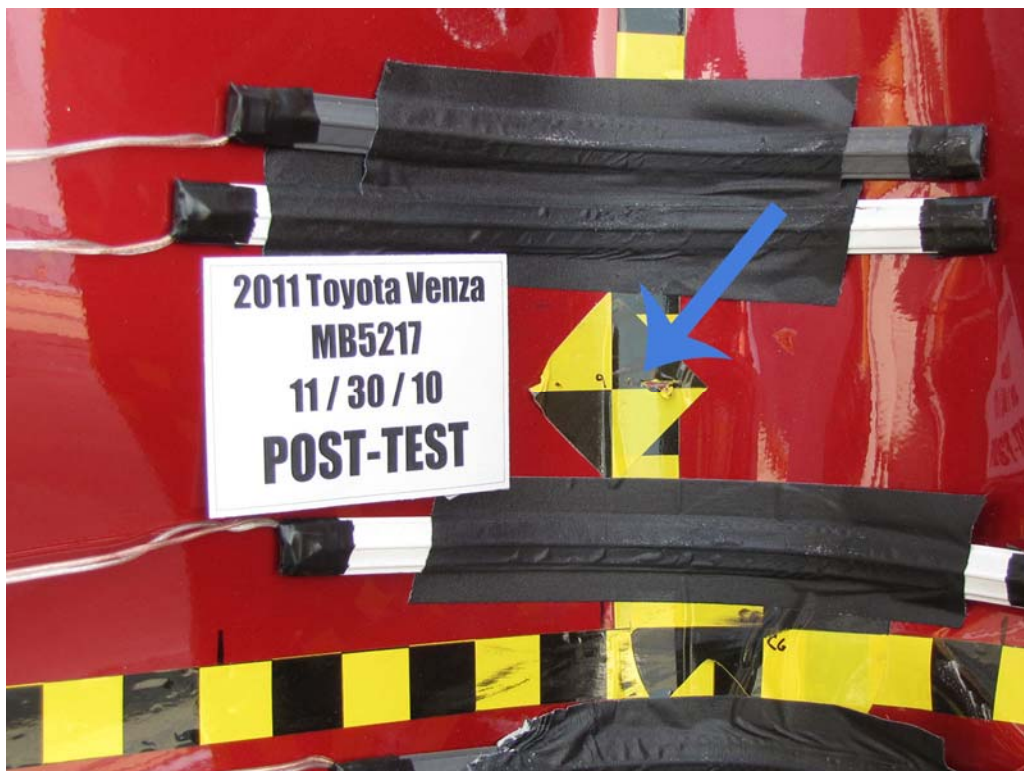
FIGURE 20. Post-Test Close-Up View of Impact Point Target Showing Impact Location

| Measurement Description | Units | Value |
|---|---|---|
| Impact Point Difference (- forward/+ rearward) | mm | 13 |

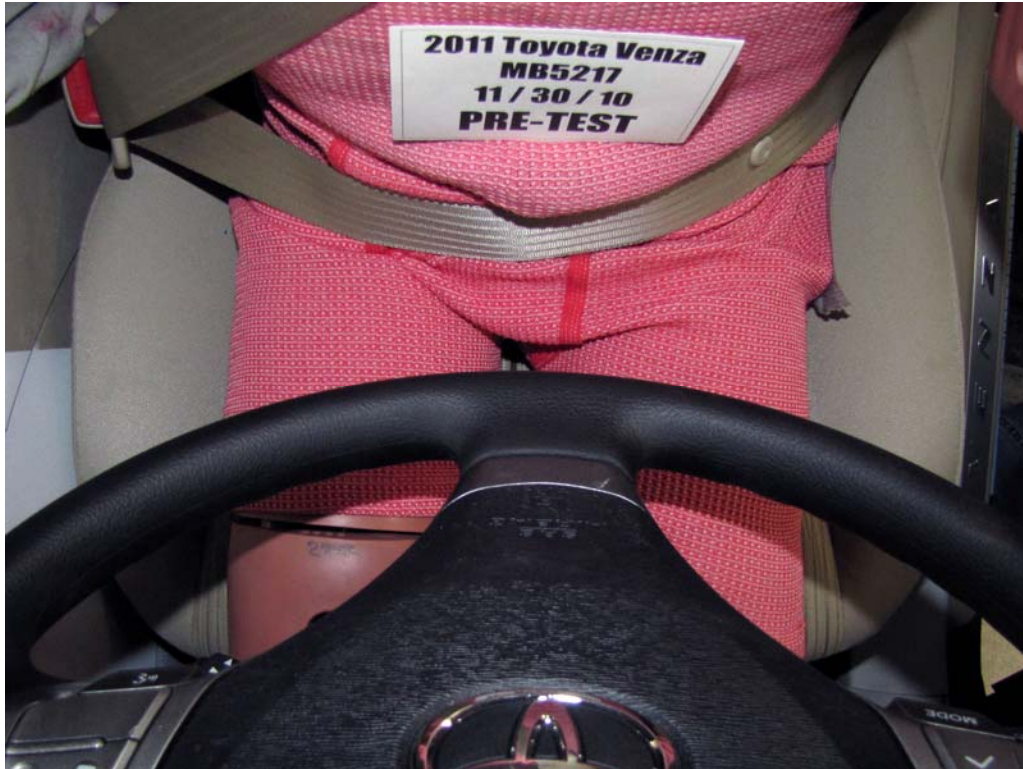
FIGURE 29. Pre-Test Overhead View of Dummy Thighs on Seat Pan

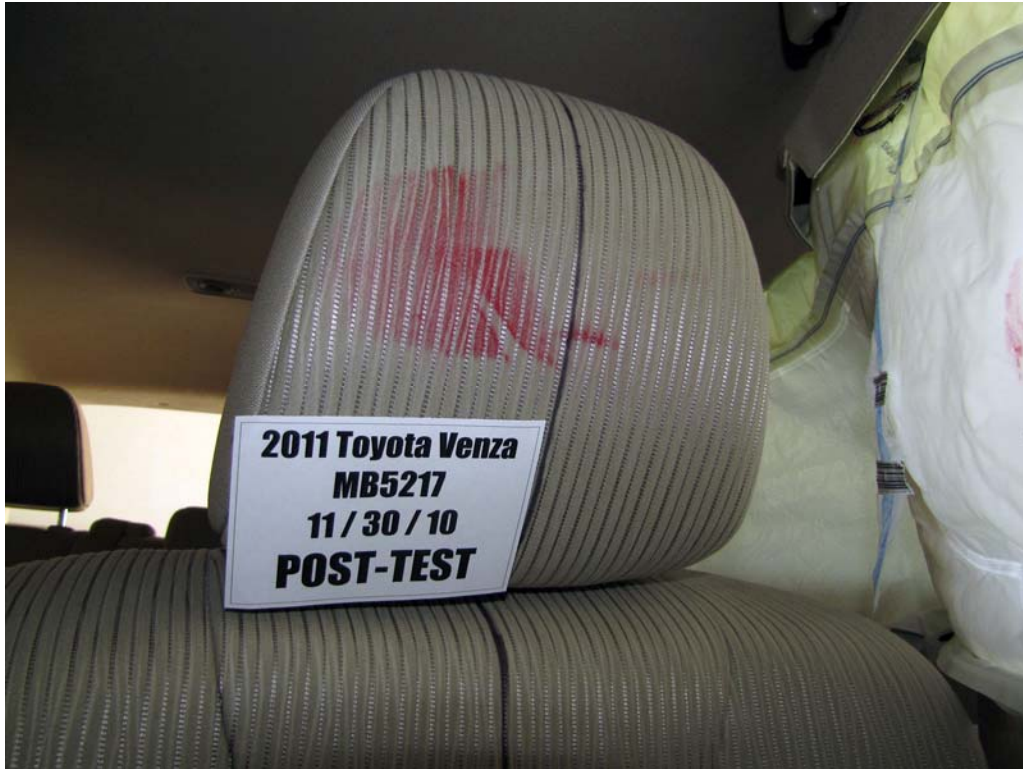
FIGURE 45. Post-Test Dummy Close-Up Head Contact with Vehicle Interior View

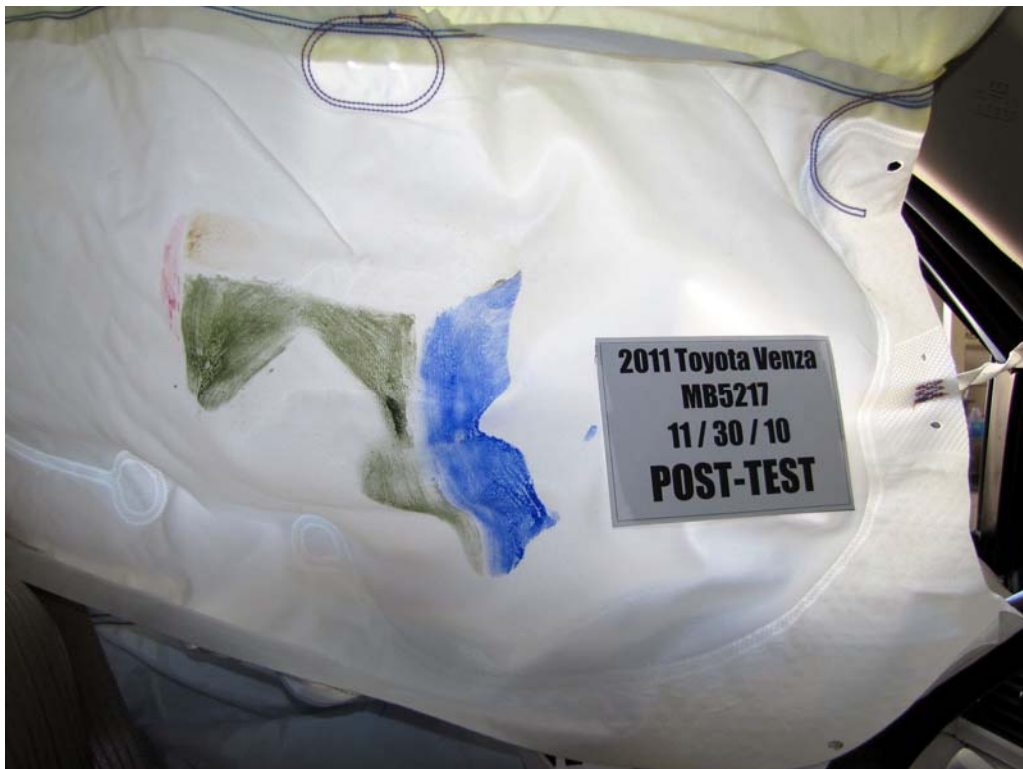
FIGURE 46. Post-Test Dummy Close-Up Head Contact with Side Airbag View

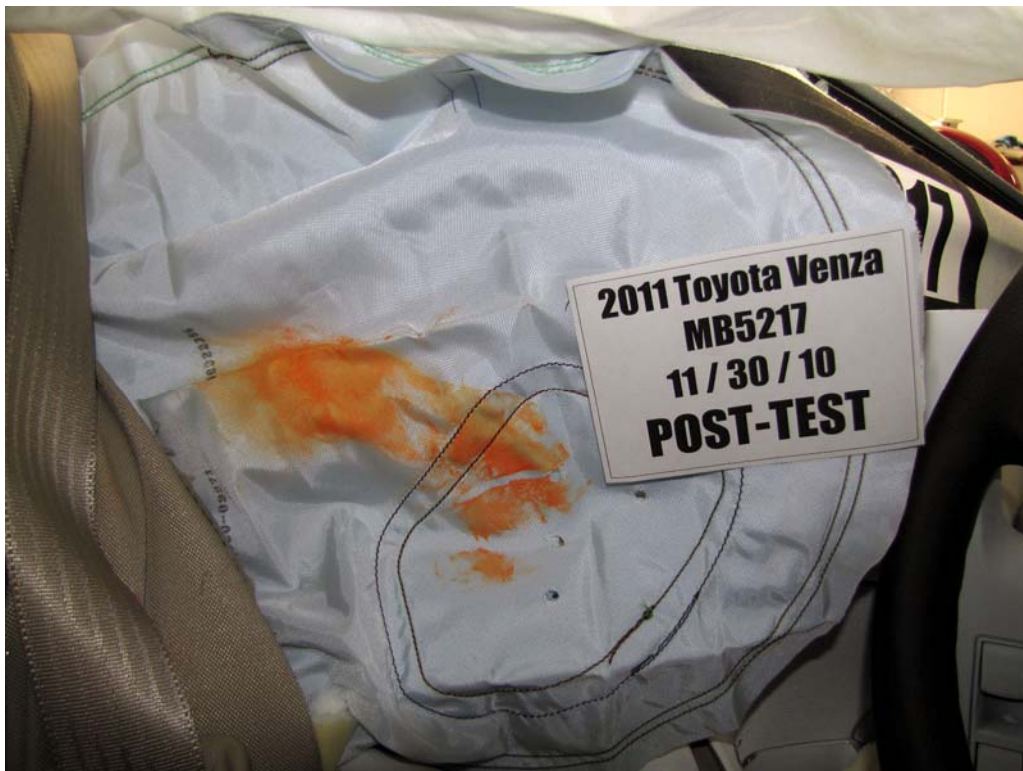
FIGURE 48. Post-Test Dummy Close-Up Torso Contact with Side Airbag View

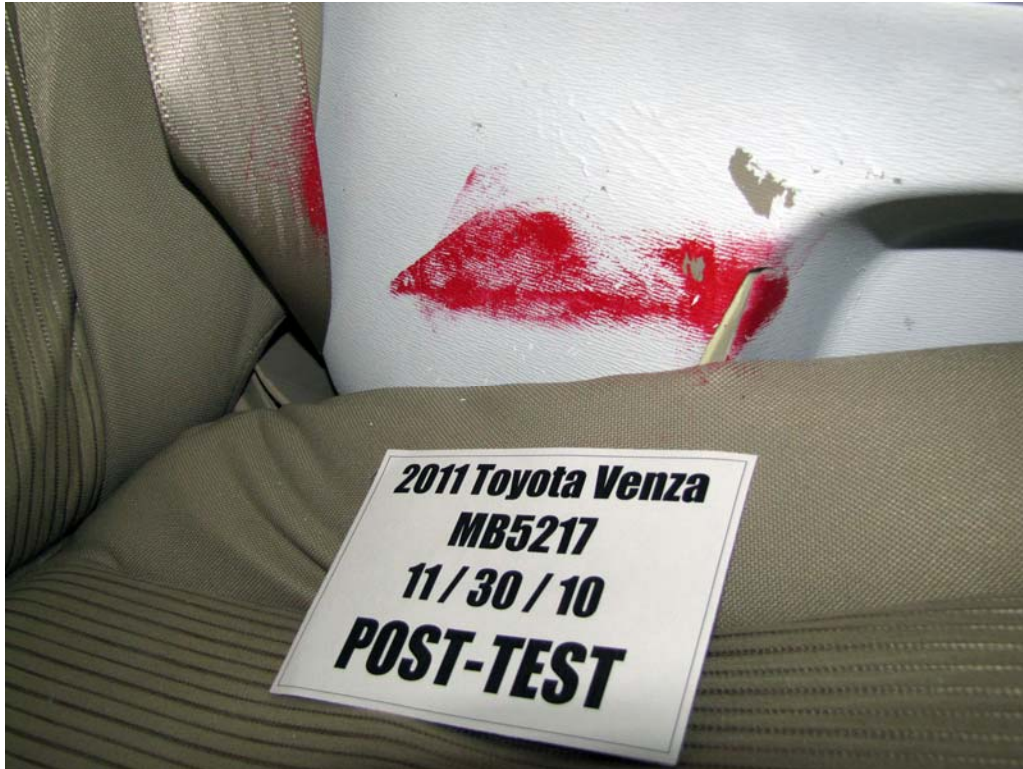
FIGURE 49. Post-Test Dummy Close-Up Pelvis Contact with Vehicle Interior View

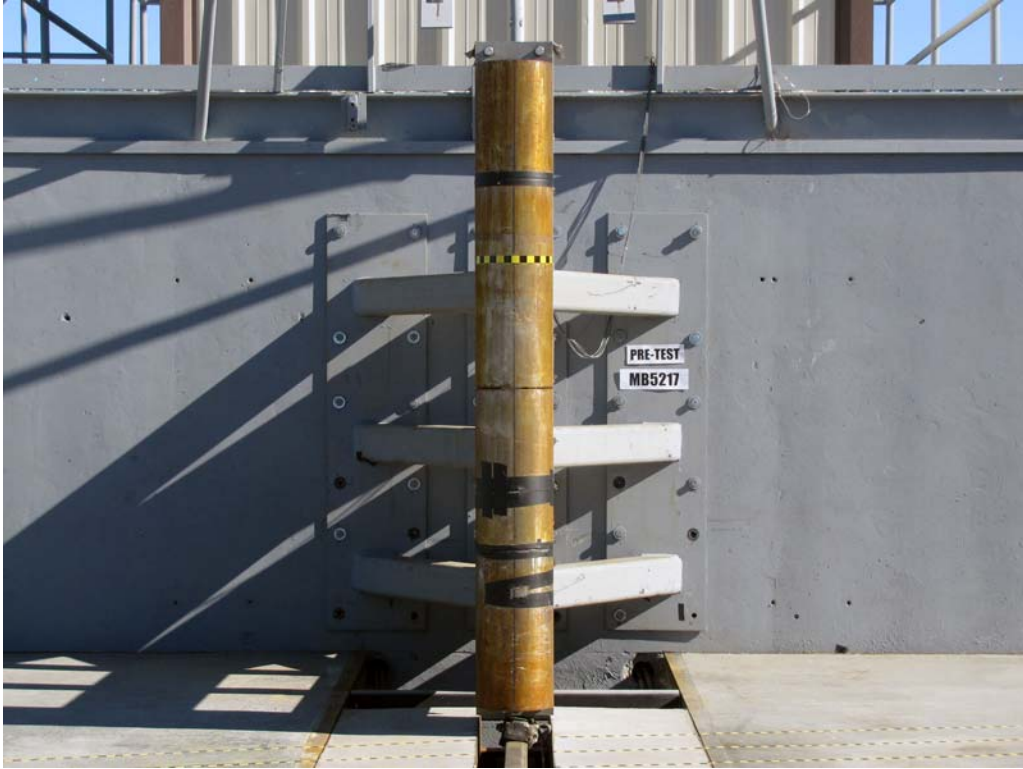
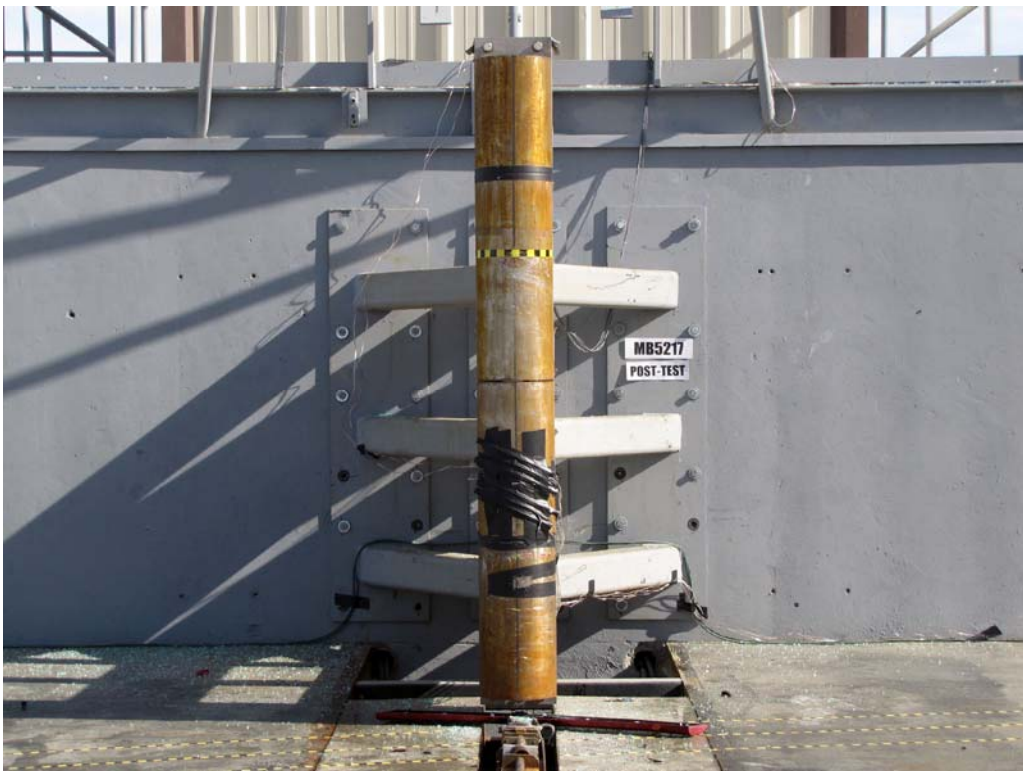
FIGURE 55. Pre-Test Pole Barrier Front View

FIGURE 56. Post-Test Pole Barrier Front View

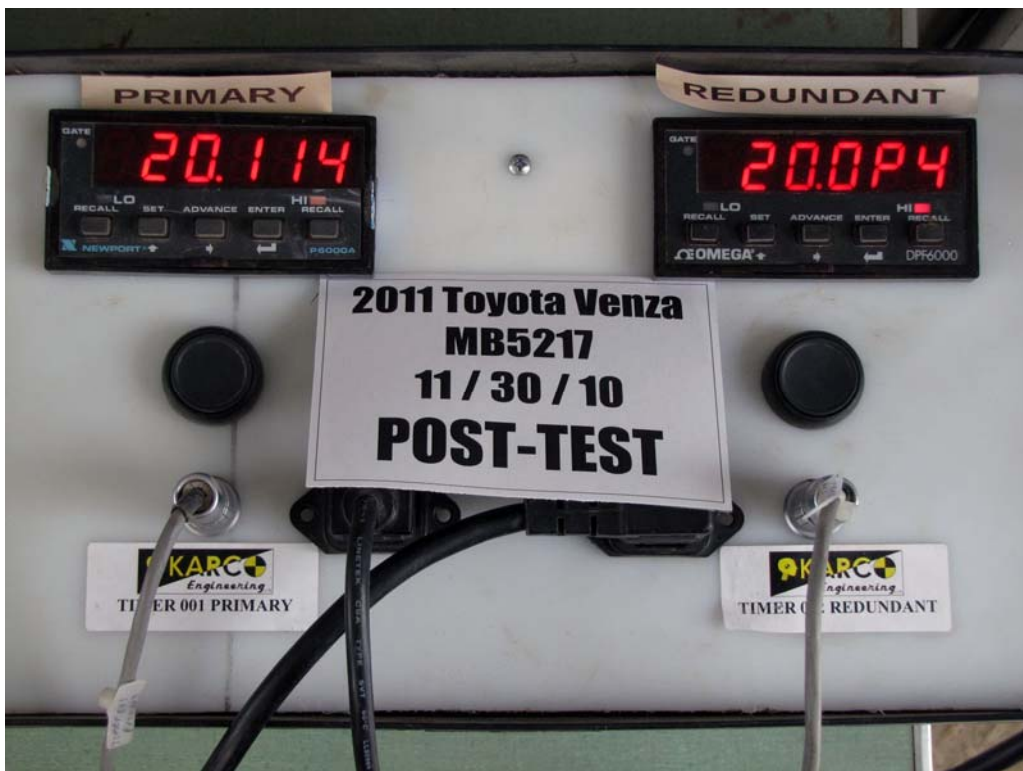
FIGURE 60. Post-Test Primary and Redundant Speed Trap Read-Out

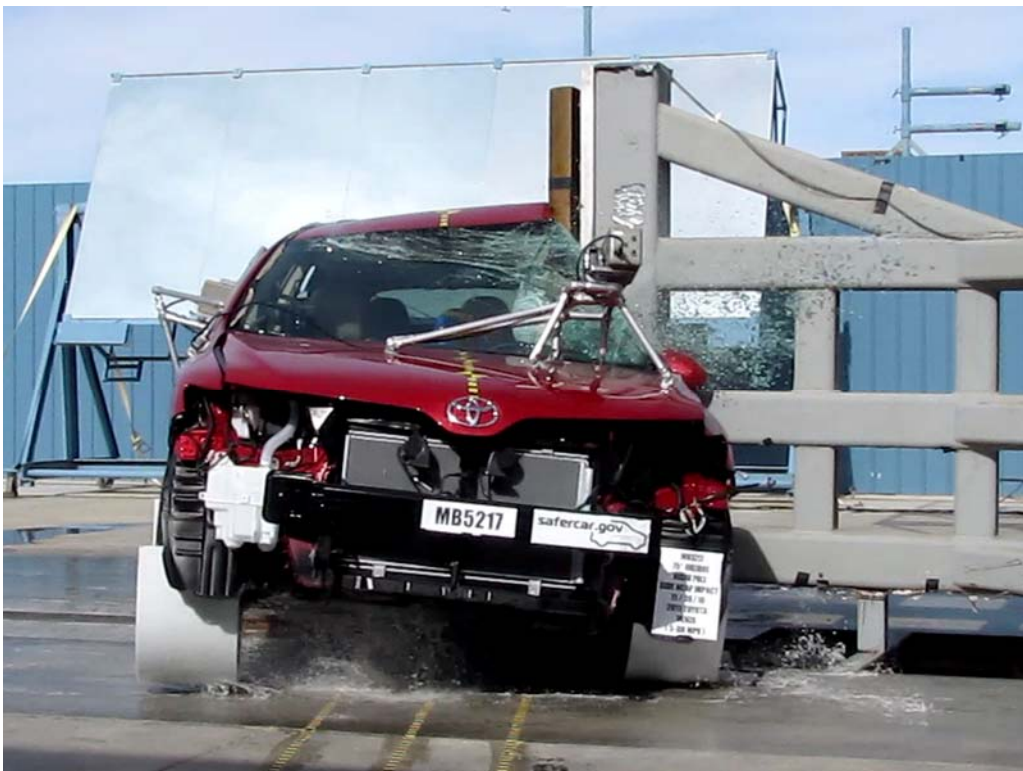
FIGURE 66. Impact Event
