REPORT NUMBER: NCAP-CAL-11-029

**NEW CAR ASSESSMENT PROGRAM (NCAP)
FRONTAL BARRIER IMPACT TEST**

**Ford Motor Company
2011 Ford Edge
Utility Vehicle**

FINAL REPORT

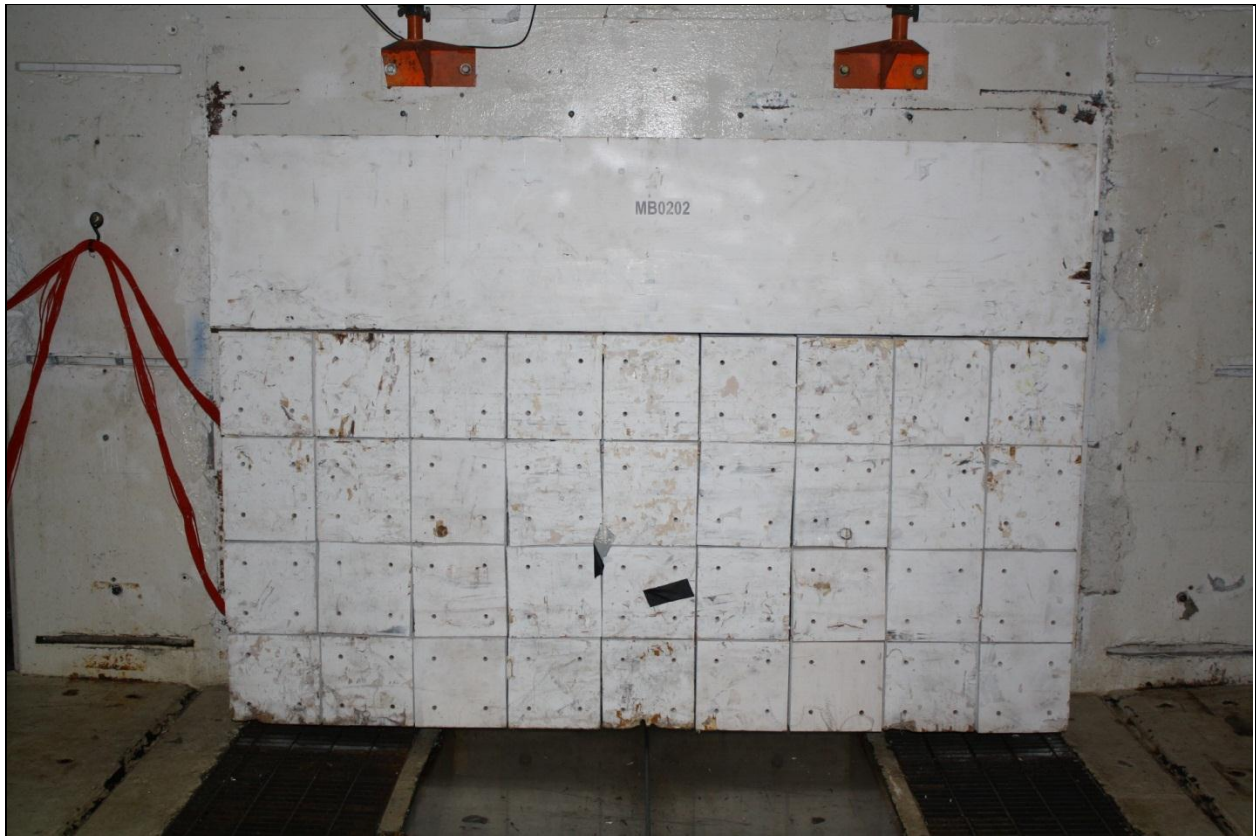
Figure A-1: Load Cell Location

A load cell barrier consisting of 36 load cells was impacted by a 2011 Ford Edge Utility Vehicle at a velocity of 56.92 kph. The test was performed at Calspan on 11/30/2010. Pre- and post-test photographs of the vehicle and dummies can be found in Appendix A.

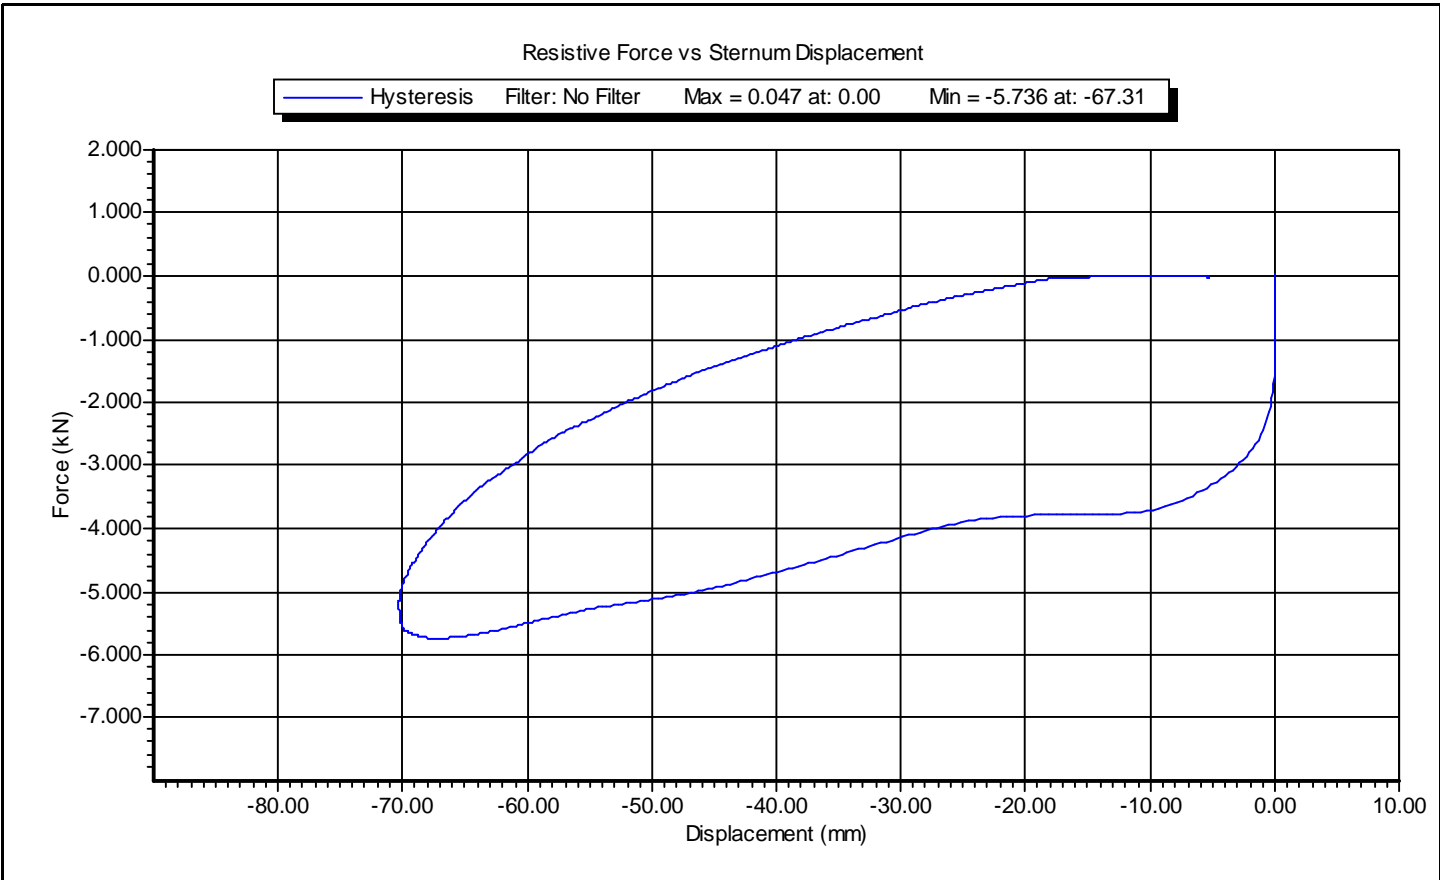
Test Parameters	Test Specifications	Test Results
Temperature	20.6 -- 22.2	21.7 deg C P
Humidity	10.0 -- 70.0	54.0 %RH P
Velocity	6.59 -- 6.83	6.71 m/s P
Resistive Force	-5.894 -- -5.160	-5.736 kN P
Sternum Displacement	-72.6 -- -63.5	-70.3 mm P
Hysteresis	69 -- 85	72 % P

Test Name:	Thorax Impact	Revision:	10/1/2001
Sub Test Name:		Spec Type:	NHTSA
ATD Type:	Hybrid III 50'th		
ATD Serial Number:	061		
Test ID:	Thorax	Test Date:	11/23/2010
Test Number:	1	Test Time:	9:55:55 AM

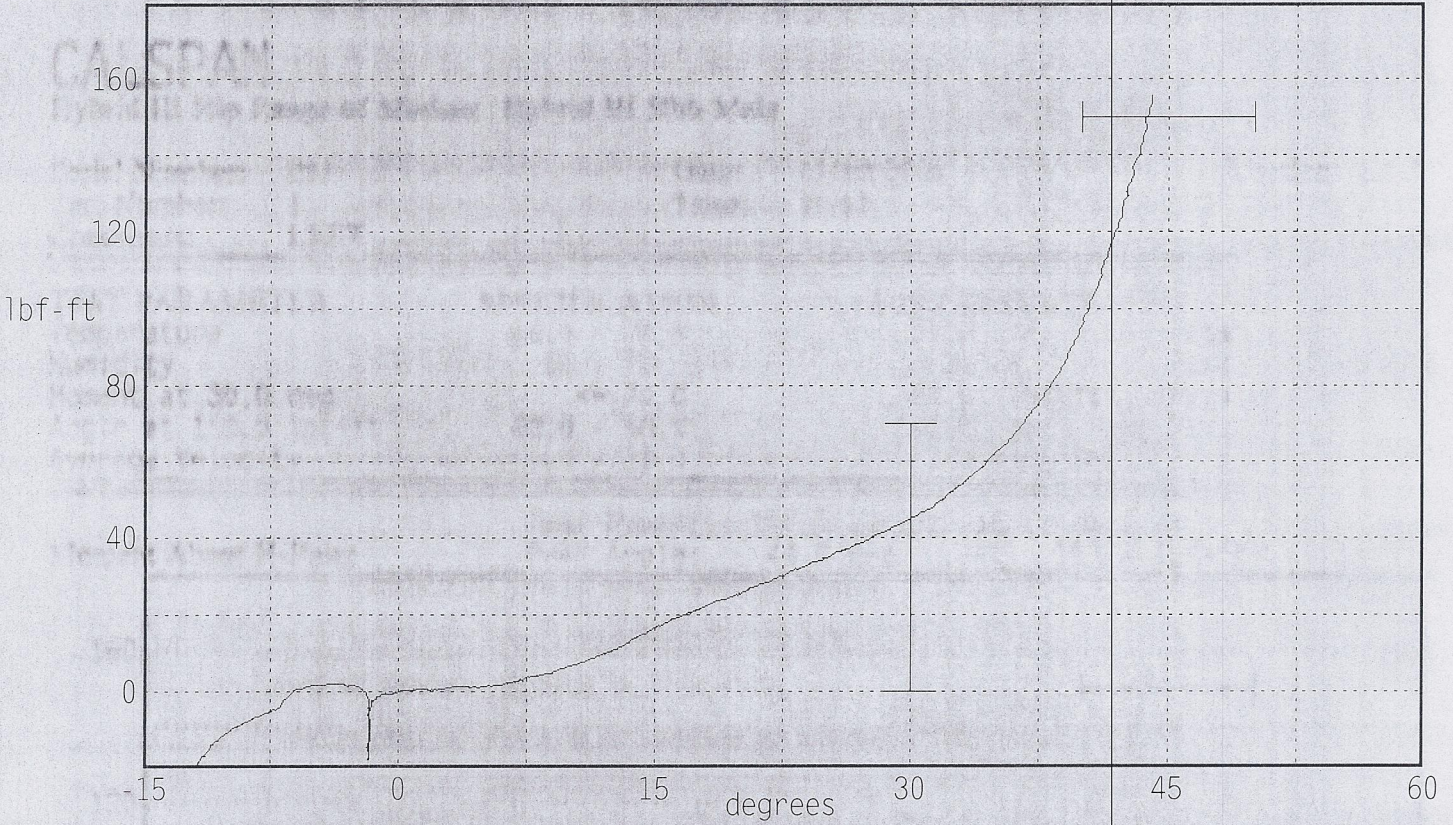
Hybrid III Hip Range of Motion: Hybrid III 50th Male

TEST PARAMETER	SPECIFICATION	TEST RESULTS	
Temperature	66.0 - 78.0	71.0 °F	Pass
Humidity	10 - 70	25 %	Pass
Moment at 30.0 deg	<= 70.0	44.9 lbf-ft	Pass
Angle at 150.0 lbf-ft	40.0 - 50.0	43.8 deg	Pass
Average Velocity	5.0 - 10.0	7.3 deg/sec	Pass

Moment About H-Point
Peak Moment: 155.5 lbf-ft at 44.0 deg
Peak Angle: 44.0 deg at 153.4 lbf-ft

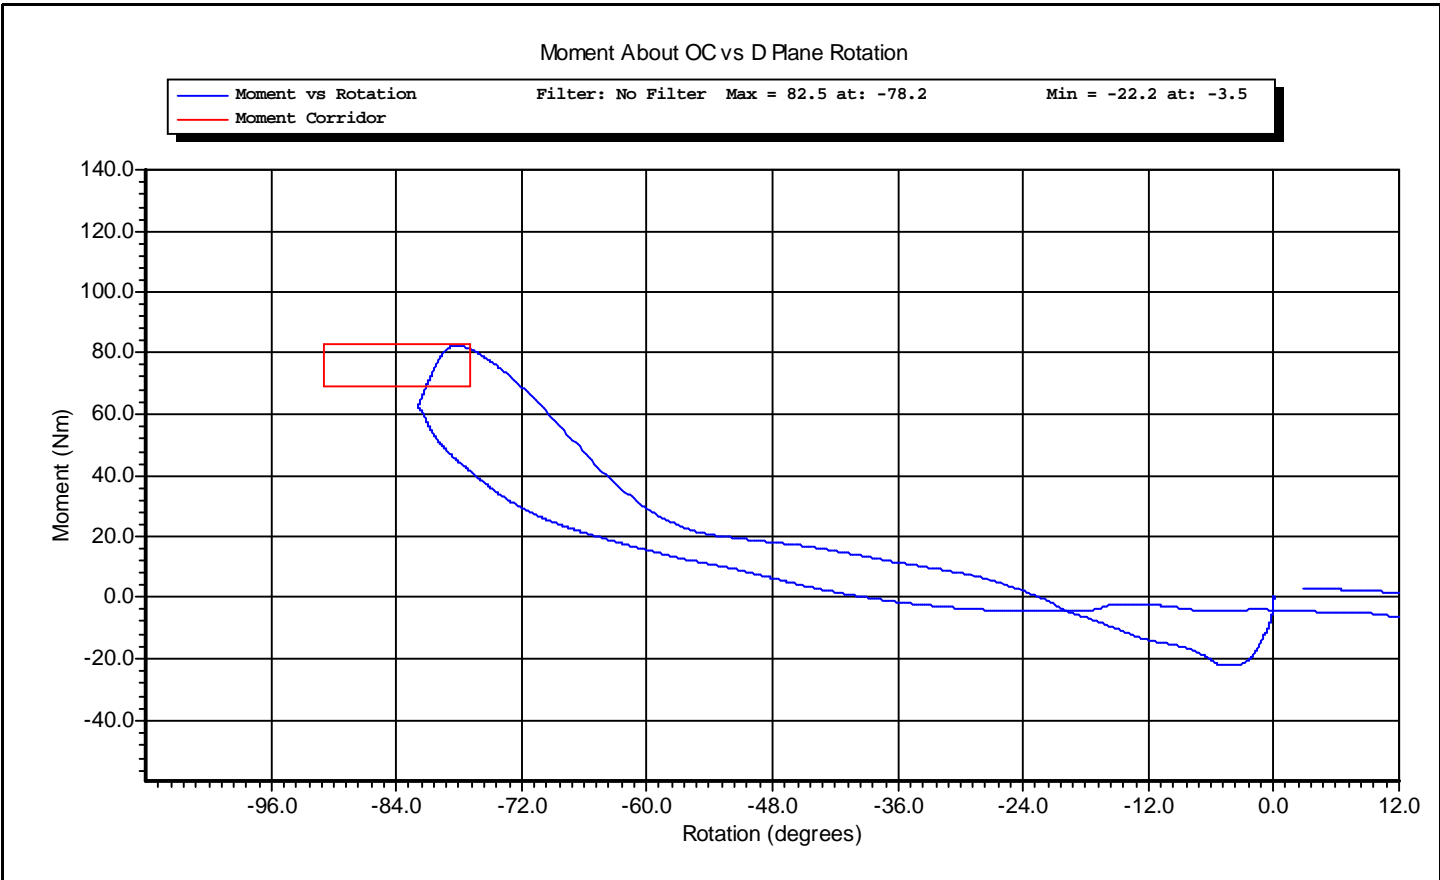
Test Parameters	Test Specifications	Test Results
Temperature	20.6 -- 22.2	22.2 deg C P
Humidity	10 -- 70	25 %RH P
Velocity	6.89 -- 7.13	7.09 m/s P
Pendulum Impulse at 10 ms	2.10 -- 2.50	2.16 m/s P
Pendulum Impulse at 20 ms	4.00 -- 5.00	4.31 m/s P
Pendulum Impulse at 30 ms	5.80 -- 7.00	6.24 m/s P
D Plane Rotation	-91.0 -- -77.0	-81.9 degrees P
Moment During Rotation Interval	69.0 -- 83.0	82.5 Nm P
Moment Decay to 10.0 Nm	80.0 -- 100.0	89.2 ms P

Test Name:	Neck Flexion	Revision:	7/15/2002
Sub Test Name:		Spec Type:	NHTSA
ATD Type:	Hybrid III 5'th		
ATD Serial Number:	143		
Test ID:	Neck Flexion	Test Date:	1/11/2011
Test Number:	3	Test Time:	11:04:18 AM

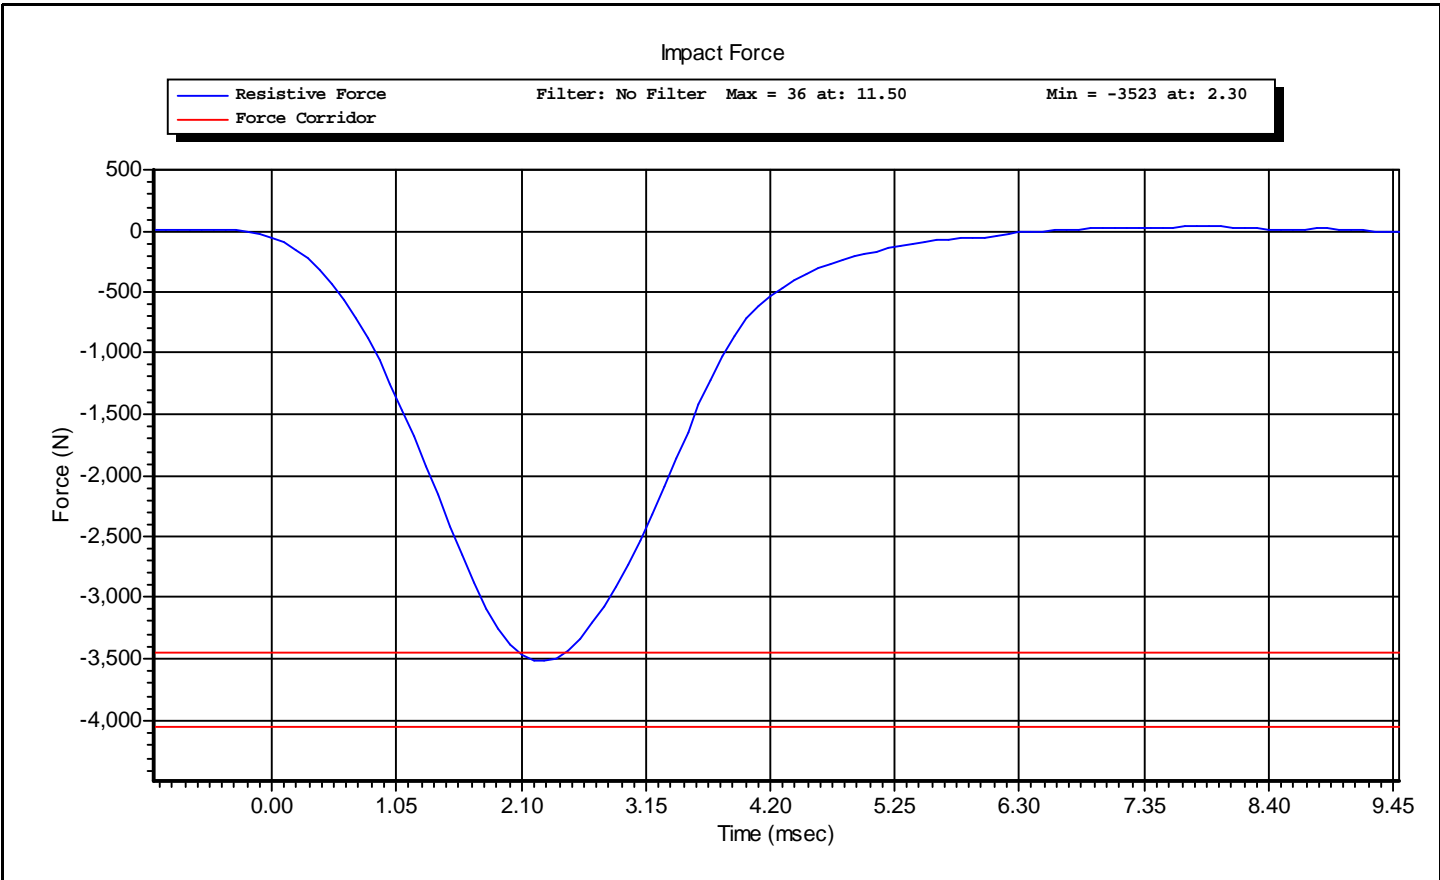
Test Name:	Knee Impact	Revision:	7/15/2002
Sub Test Name:		Spec Type:	NHTSA
ATD Type:	Hybrid III 5'th		
ATD Serial Number:	143		
Test ID:	Right Knee	Test Date:	1/12/2011
Test Number:	1	Test Time:	10:50:18 AM
