**REPORT NUMBER: SINCAP-MGA-2011-047**

**NEW CAR ASSESSMENT PROGRAM (NCAP)  
Moving Deformable Barrier Side Impact Test**

**HONDA MFG. OF ALABAMA, LLC  
2011 Honda Odyssey LX Minivan  
NHTSA No.: MB5313**

**FINAL REPORT**

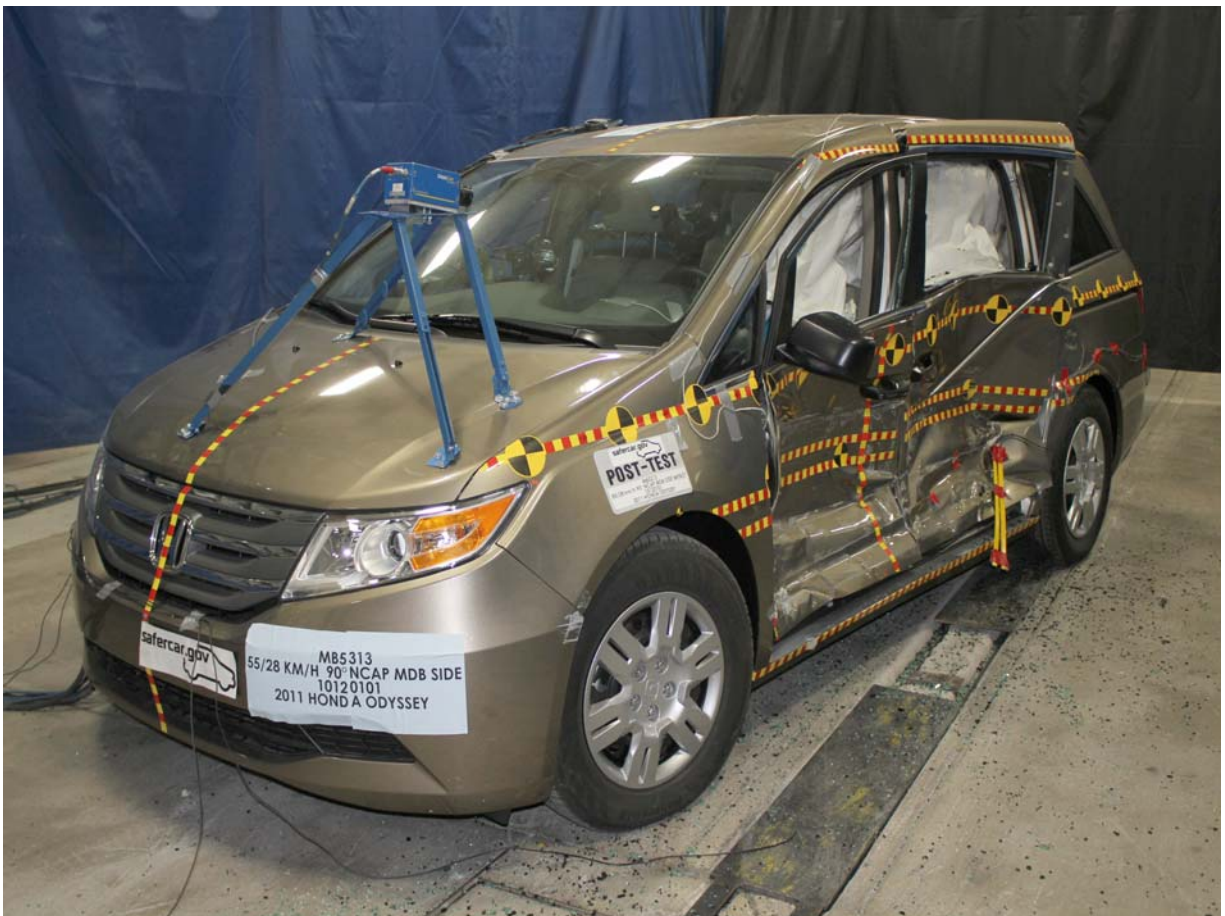
Critical Areas of Performance	Observations and Conclusions
Pillar Performance	No Separation
Sill Separation	None
Windshield Damage	None
Window Damage	Left Front and Left Rear Windows Broke
Other Notable Effects	None

Post-Test Left Three-Quarter Front View of Test Vehicle

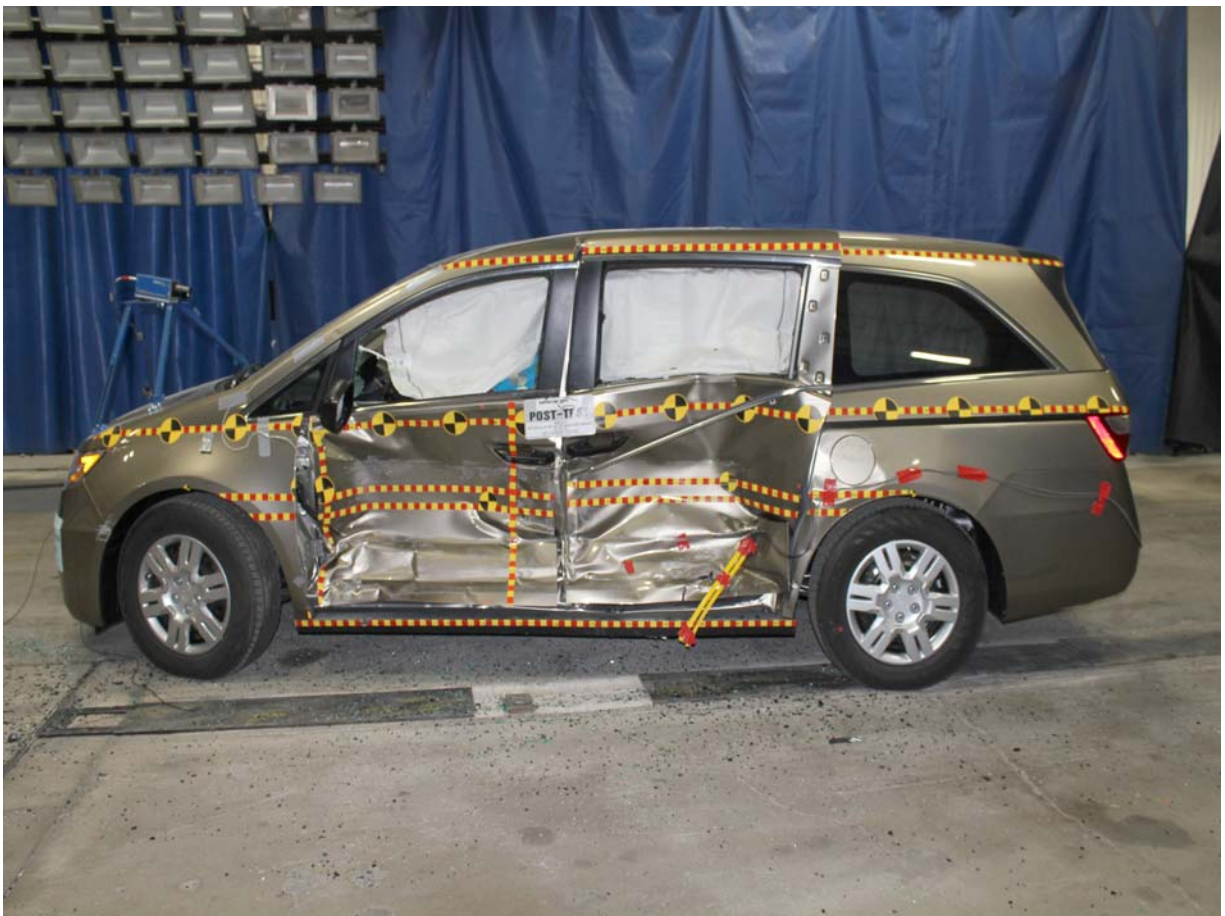
Description	Front	Rear
Left Side Doors	Remained closed and jammed shut	Remained closed and jammed shut
Right Side Doors	Remained closed and operational	Remained closed and operational
Hatch and Other Doors	Remained closed and operational	Remained closed and operational
Seat Movement	0	0
Seat Back Failure	None	None

Post-Test Left Side View of Test Vehicle

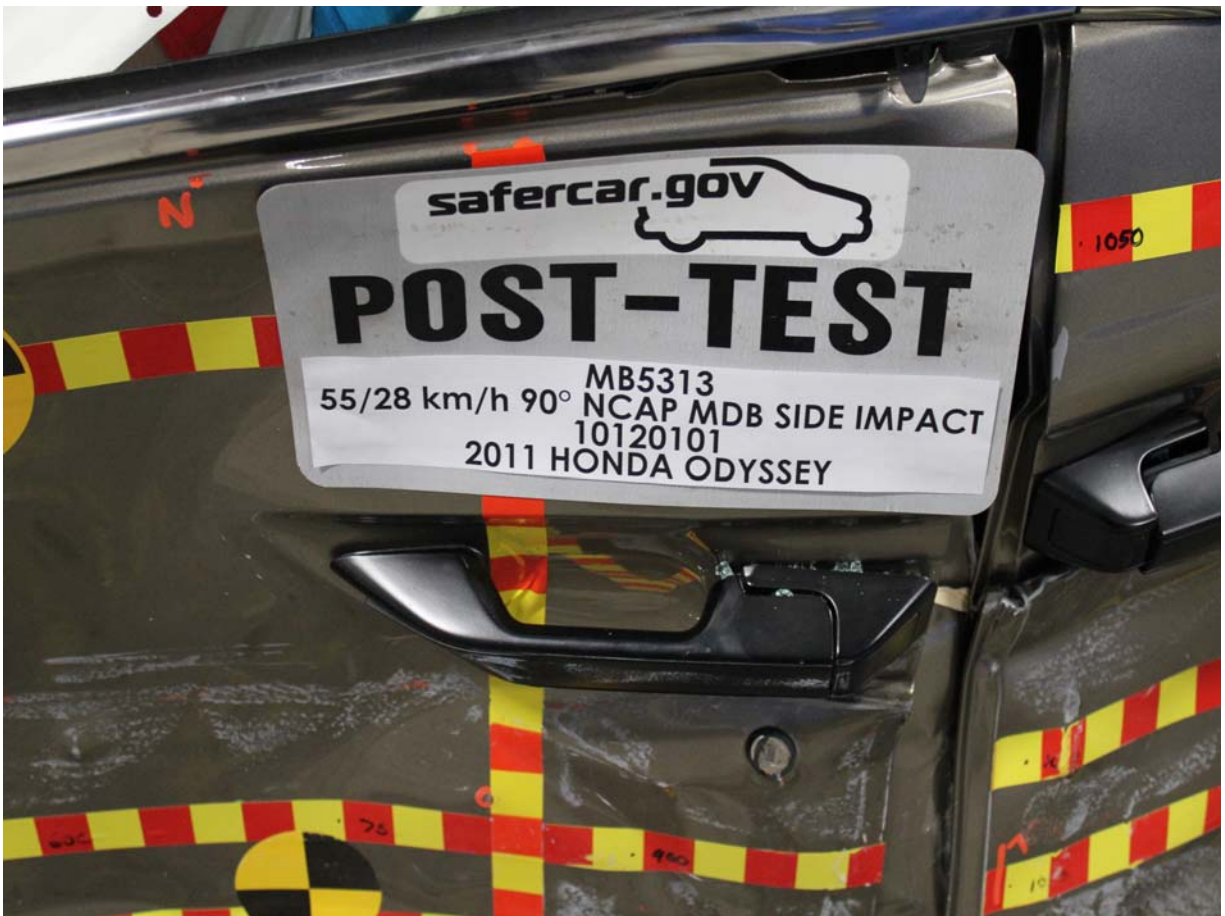
Post-Test Left Front Door Latch Close-Up

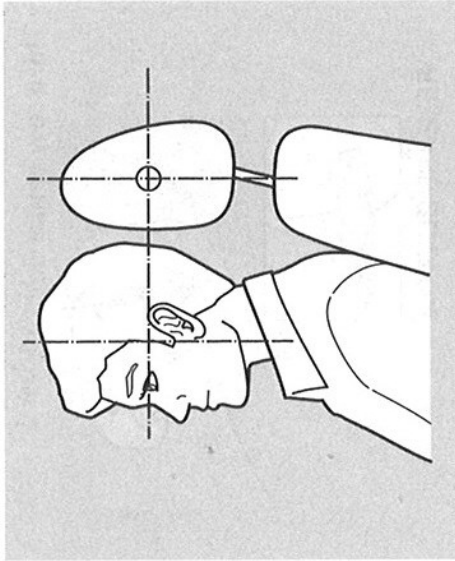
Your vehicle is equipped with head restraints in all seating positions to help protect you and your passengers from the likelihood of whiplash and other injuries.

They are most effective when you adjust them so the center of the back of the occupant's head rests against the center of the restraint.

To remove a head restraint for cleaning or repair, pull it up as far as it will go. Push the release button, then pull the restraint out of the seat-back.

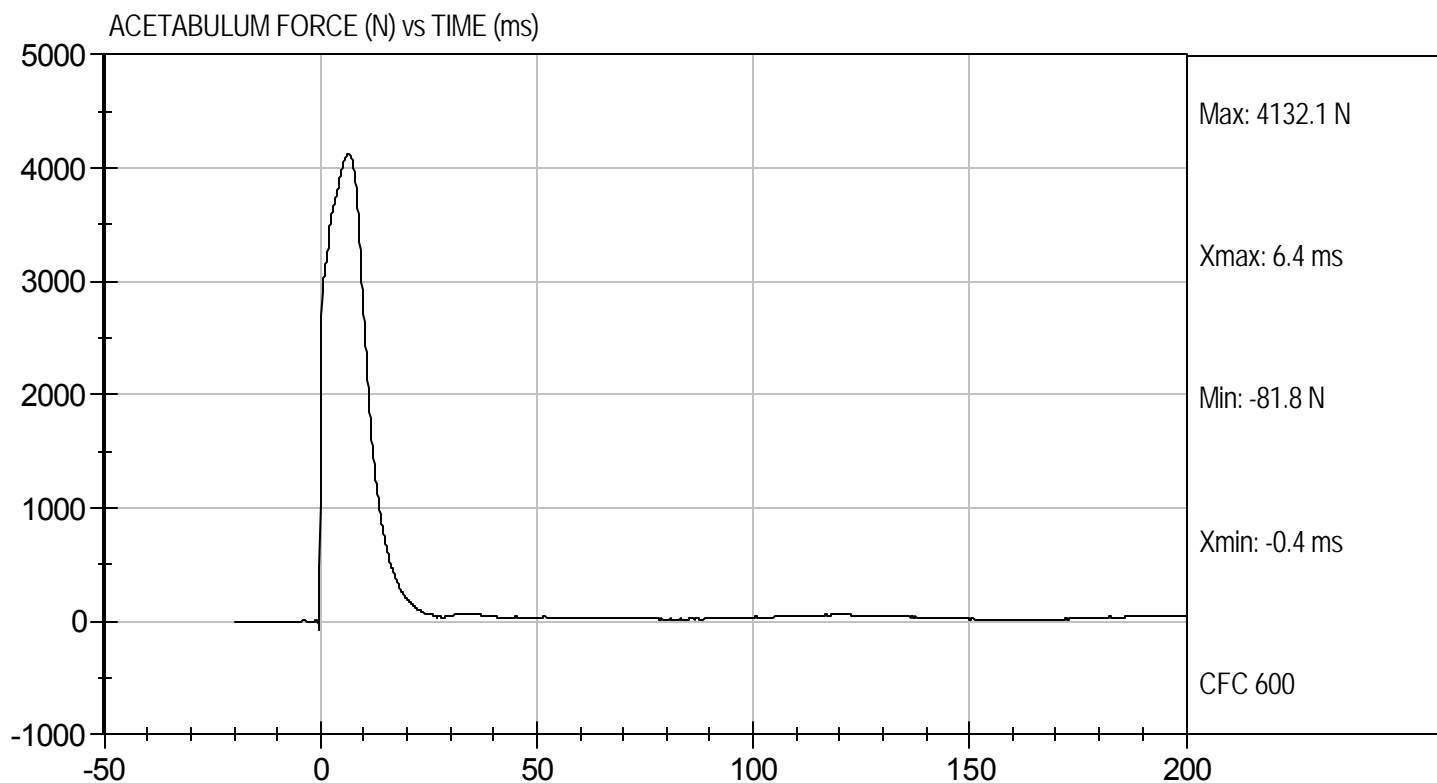
Test Desc: Pelvis Impact  
Component ID: D104137

Test Date: 11/23/10  
Velocity: 21.90 ft/s, 6.68 m/s

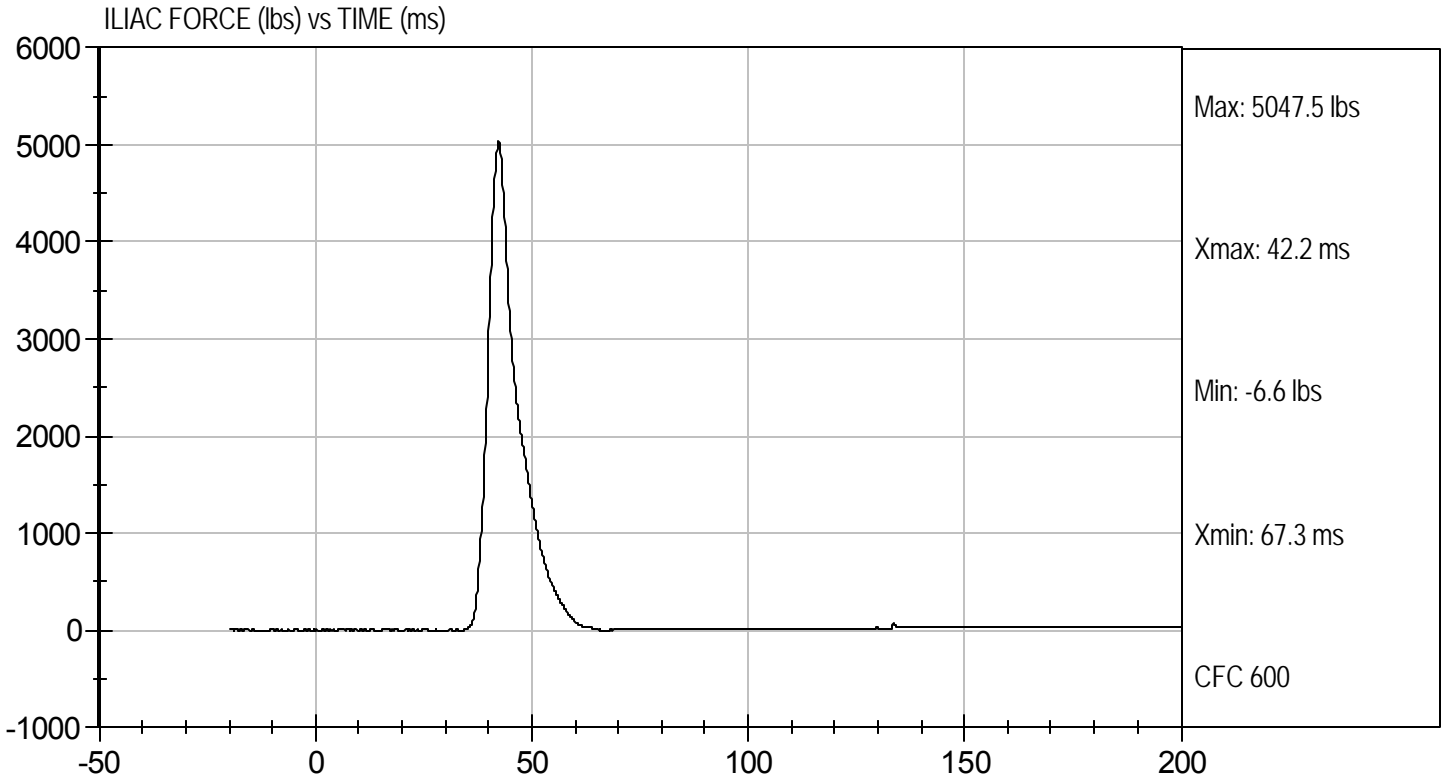
Test Desc: Iliac Impact  
Component ID: D104138

Test Date: 11/23/10  
Velocity: 14.37 ft/s, 4.38 m/s

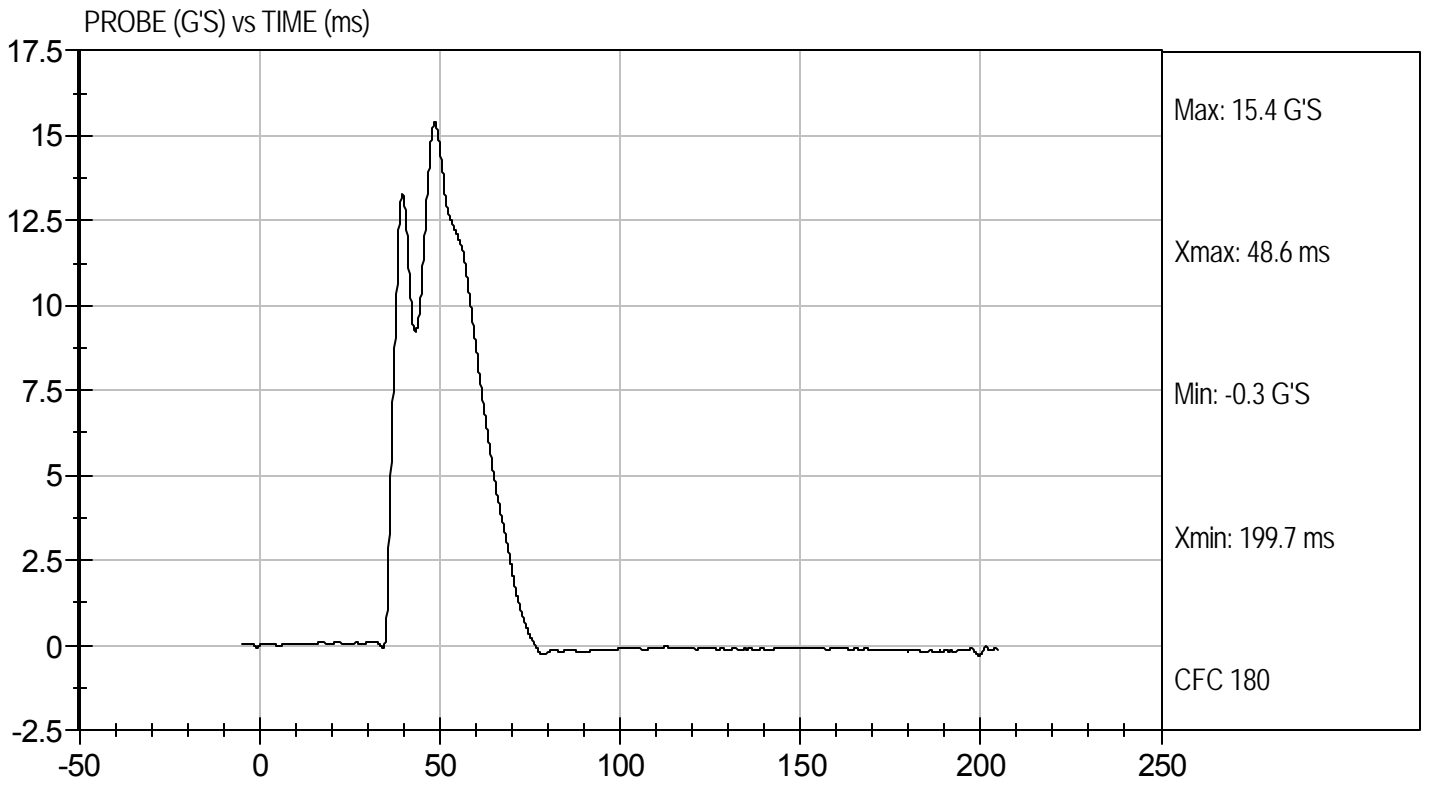
Test Desc: Shoulder Impact  
Component ID: D104203

Test Date: 12/2/10  
Velocity: 14.36 ft/s, 4.38 m/s

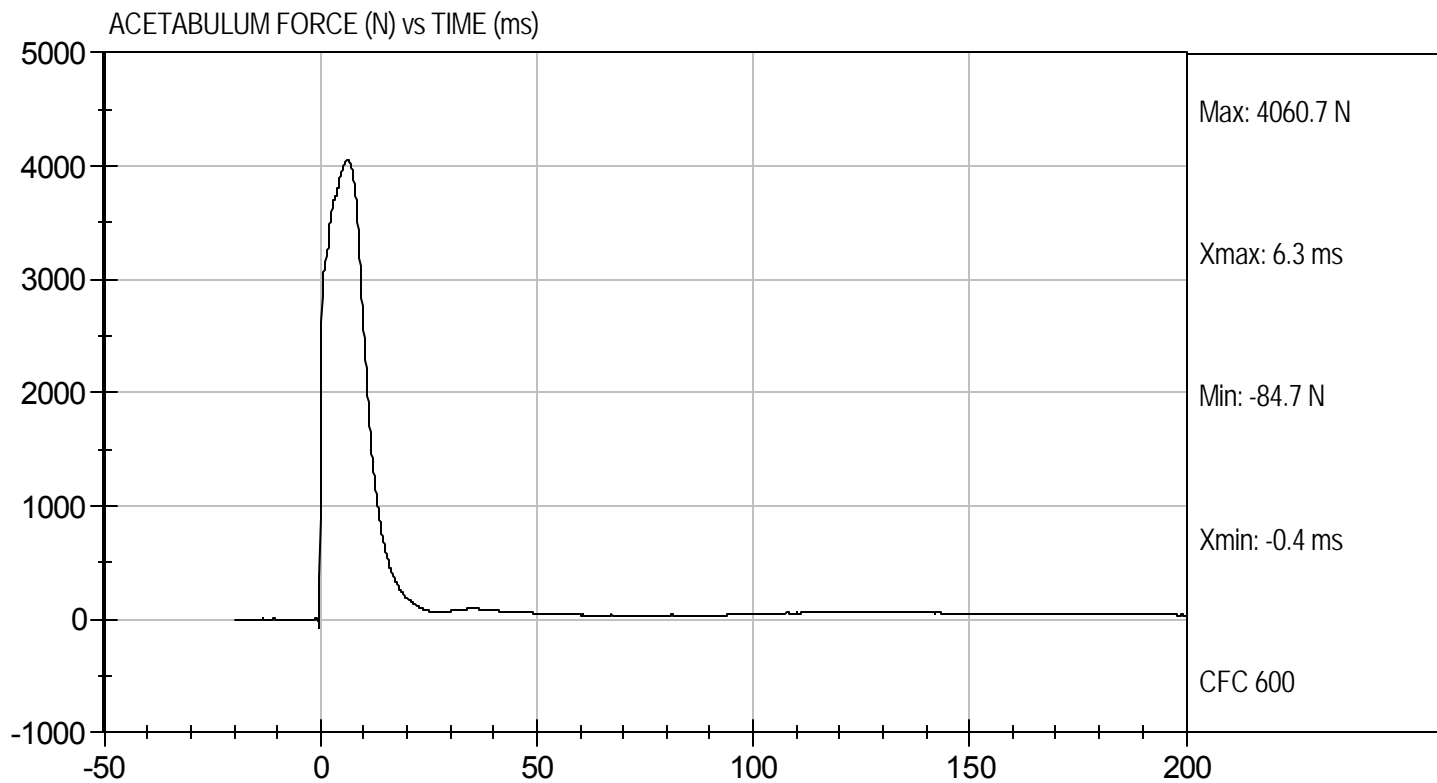
Test Desc: Pelvis Impact  
Component ID: D104207

Test Date: 12/2/10  
Velocity: 22.2 ft/s, 6.77 m/s

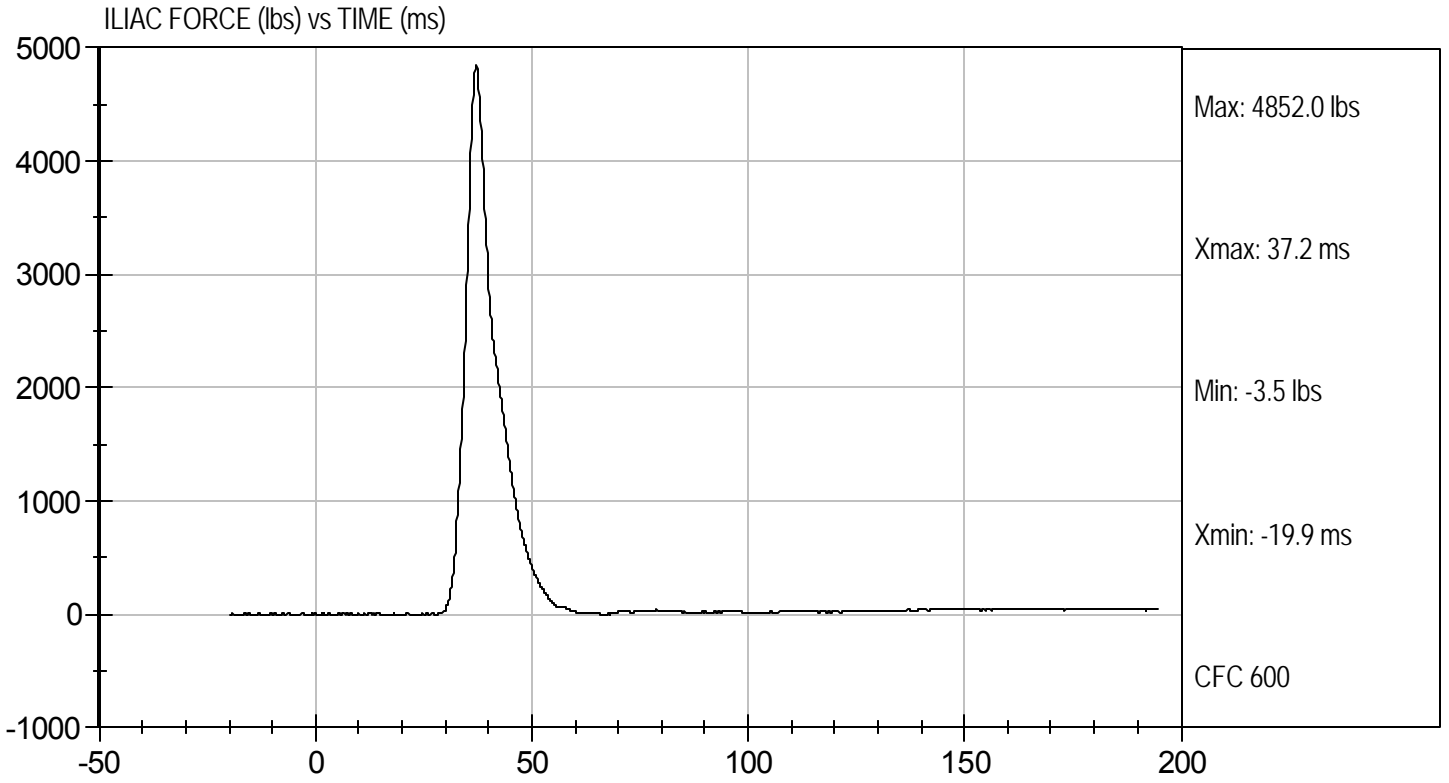
Test Desc: Iliac Impact  
Component ID: D104208

Test Date: 12/2/10  
Velocity: 14.00 ft/s, 4.27 m/s
