**REPORT NUMBER: SNCAP-KAR-11-044**

**NEW CAR ASSESSMENT PROGRAM (NCAP)  
MOVING DEFORMABLE BARRIER SIDE IMPACT TEST**

**TOYOTA MOTOR MANUFACTURING, KENTUCKY, INC.  
2011 TOYOTA VENZA 5-DOOR MPV**

**NHTSA No: MB5128**

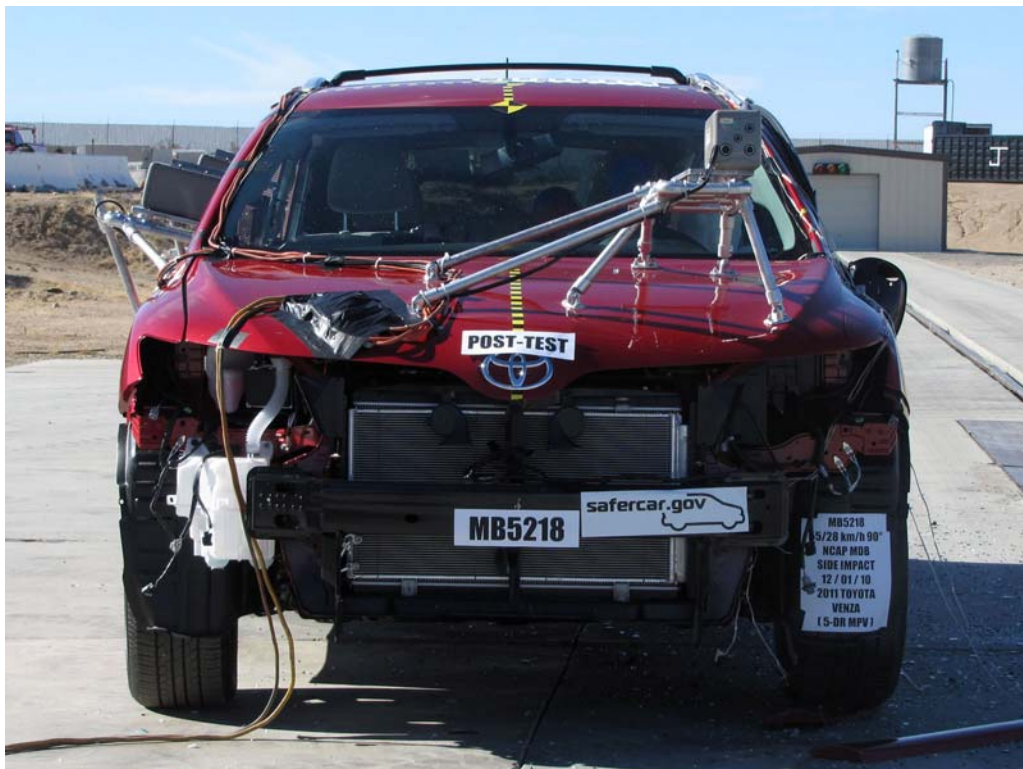
FIGURE 4. Post-Test Frontal View of Test Vehicle

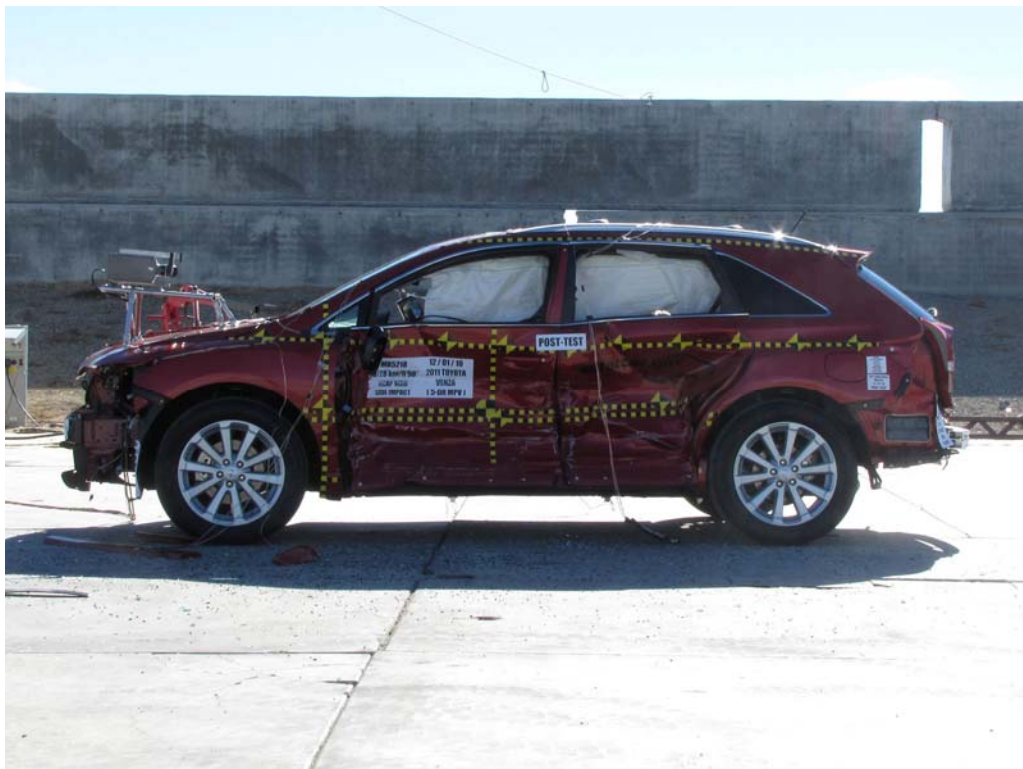
FIGURE 8. Post-Test Left Side View of Test Vehicle

Both the front and rear doors on the struck side of the vehicle remained closed and latched. There was no separation at the hinges or latches. Both doors on the non-struck side remained closed and latched. There were no ATD values that exceeded limits.

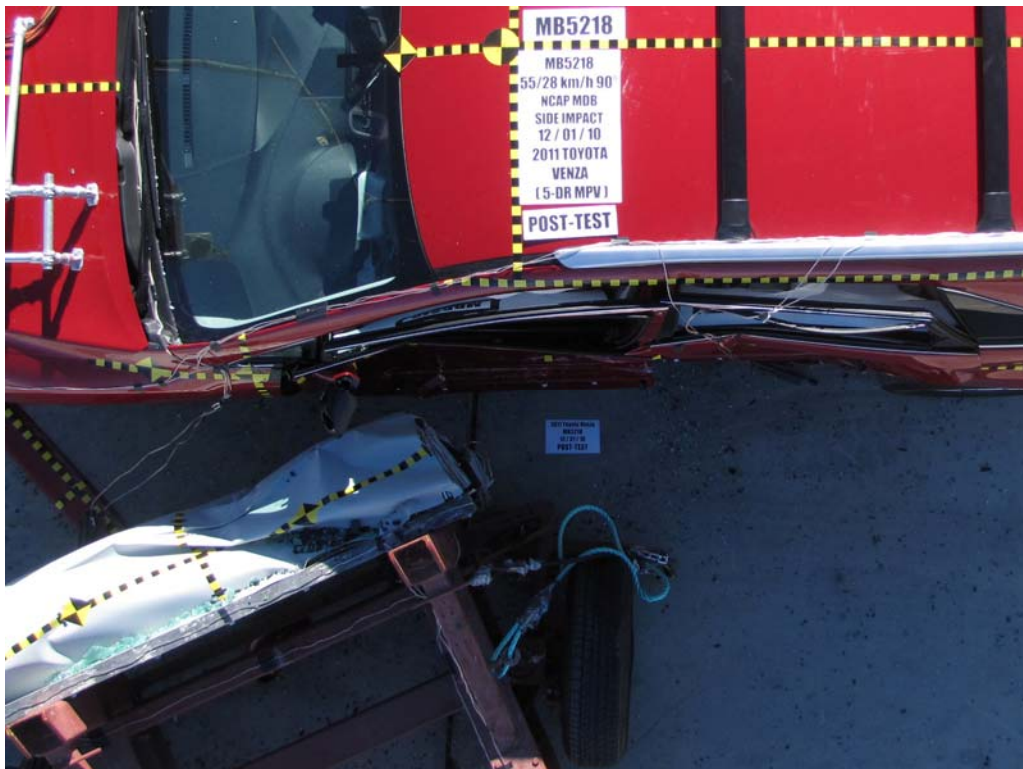
FIGURE 16. Post-Test Overhead View of Test Vehicle and MDB

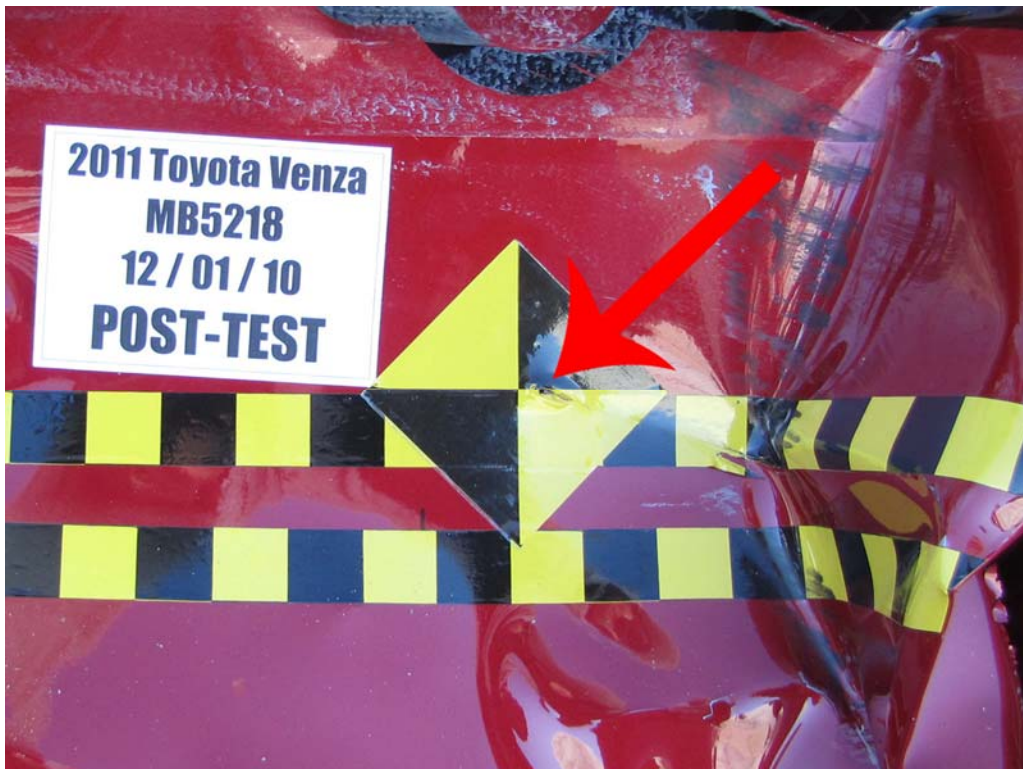
FIGURE 20. Post-Test Close-Up View of Impact Point Target  
Showing Impact Point Location

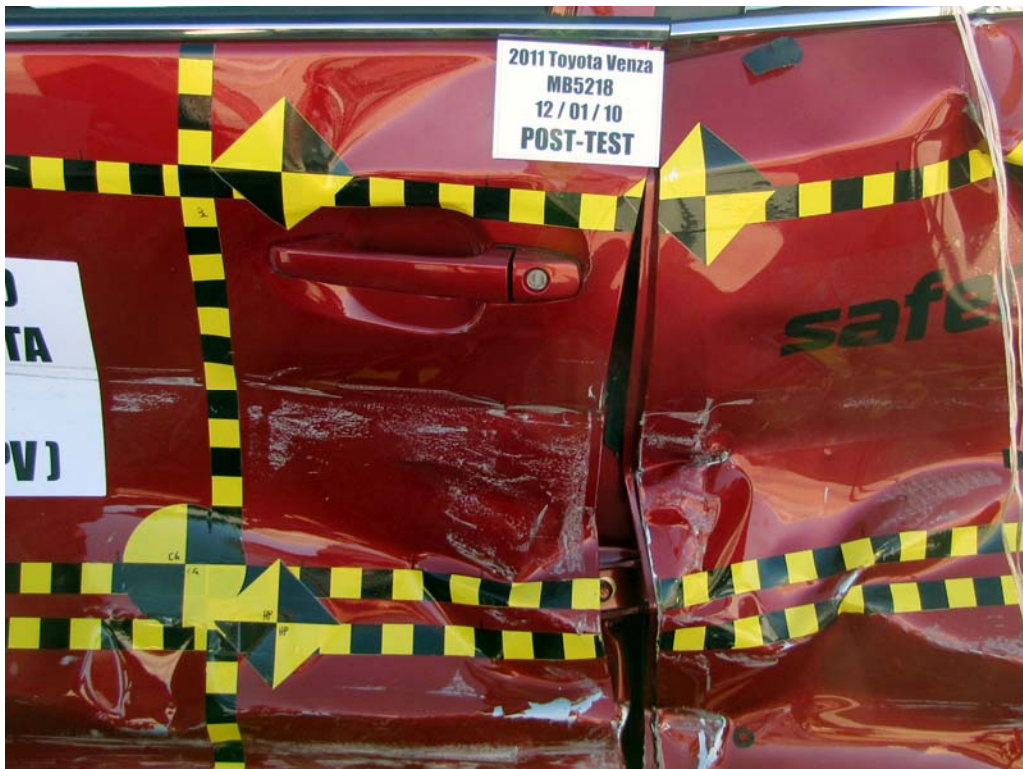
FIGURE 22. Post-Test Left Front Door Latch Close-Up

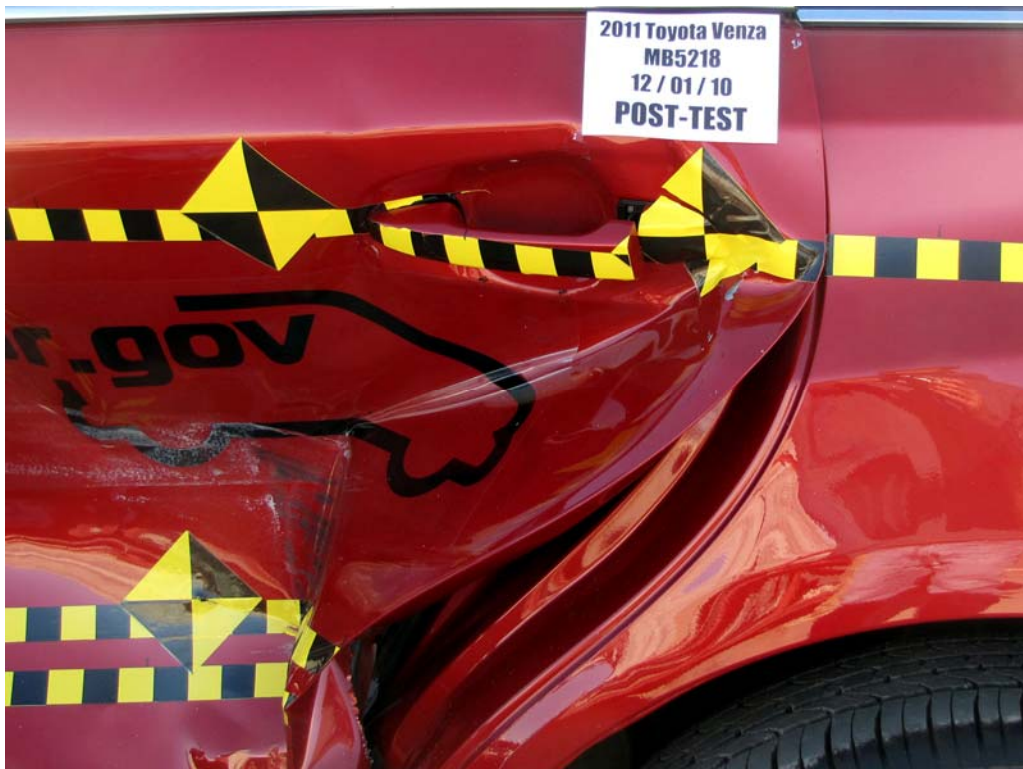
FIGURE 24. Post-Test Left Rear Door Latch Close-Up

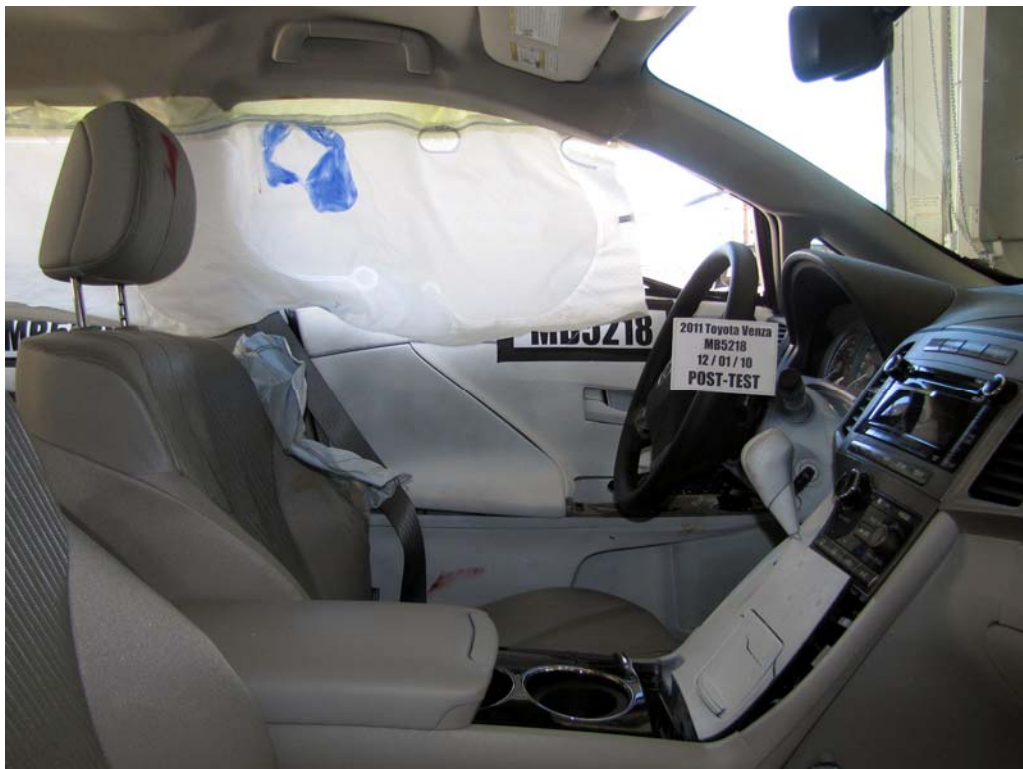
FIGURE 46. Post-Test Driver Dummy Inner Door Panel View  
Showing Driver Dummy Contact Locations

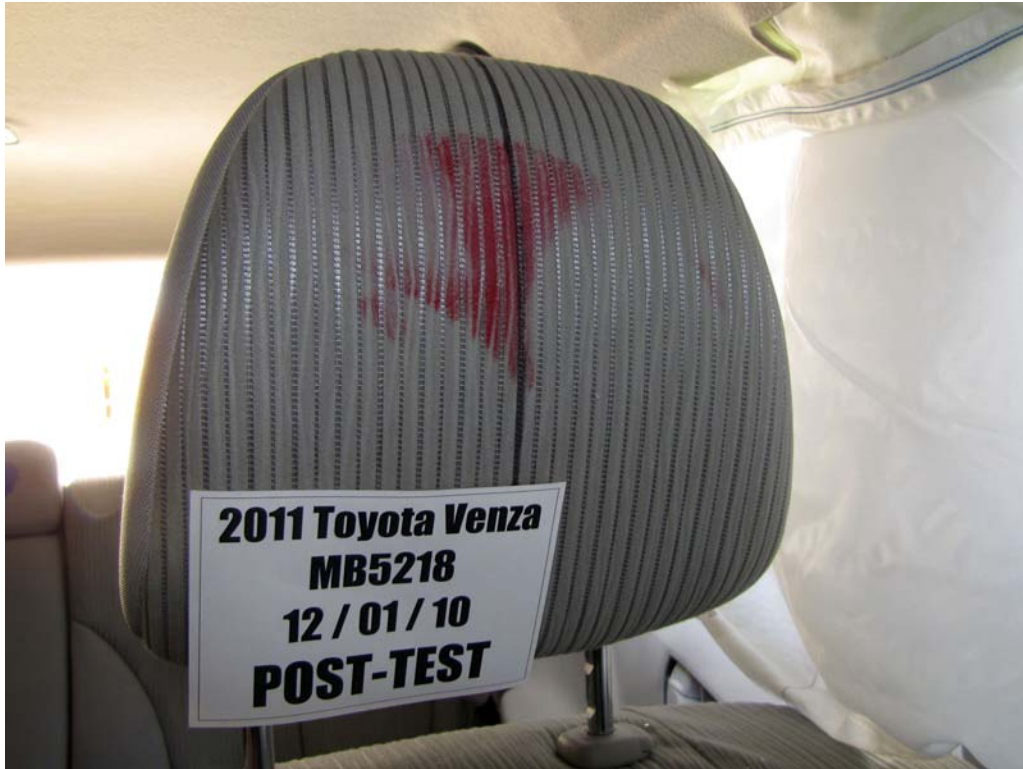
FIGURE 47. Post-Test Driver Dummy Close-Up Head Contact with Vehicle Interior View

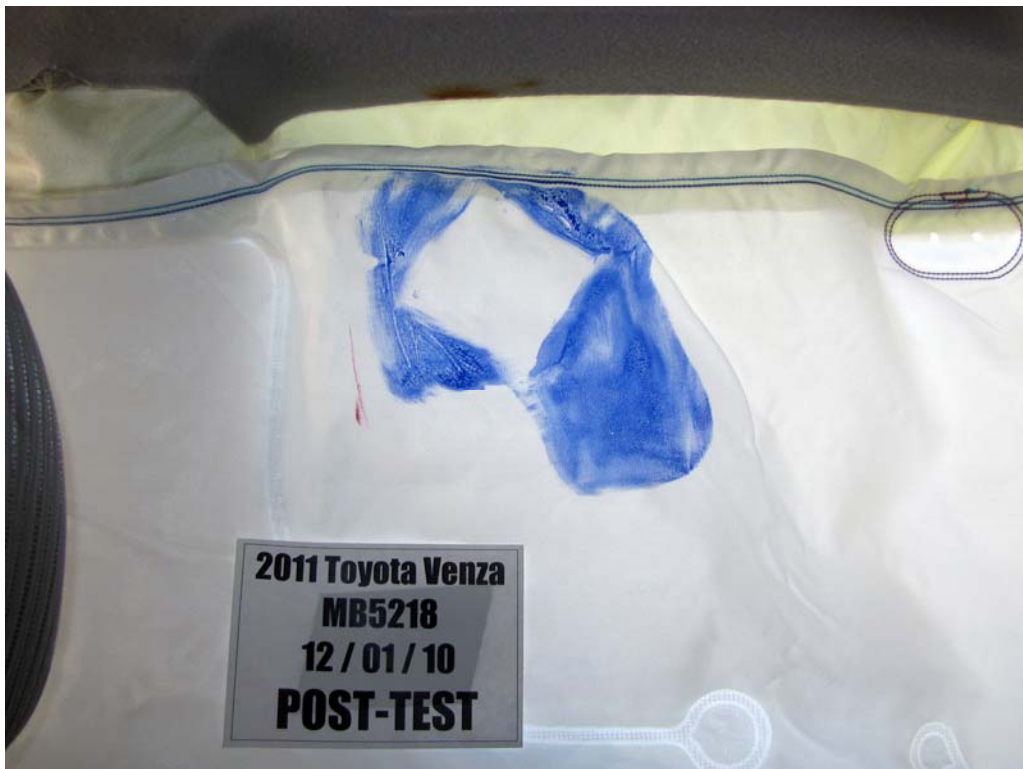
FIGURE 48. Post-Test Driver Dummy Close-Up Head Contact with Side Airbag View

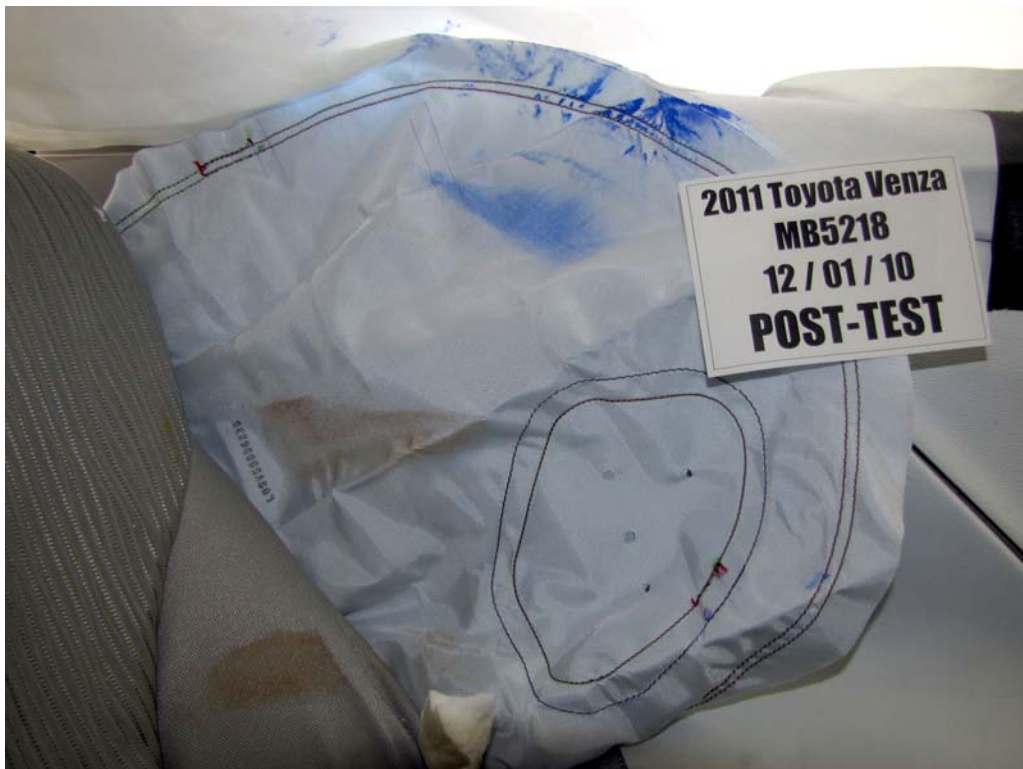
FIGURE 50. Post-Test Driver Dummy Close-Up Torso Contact with Side Airbag View

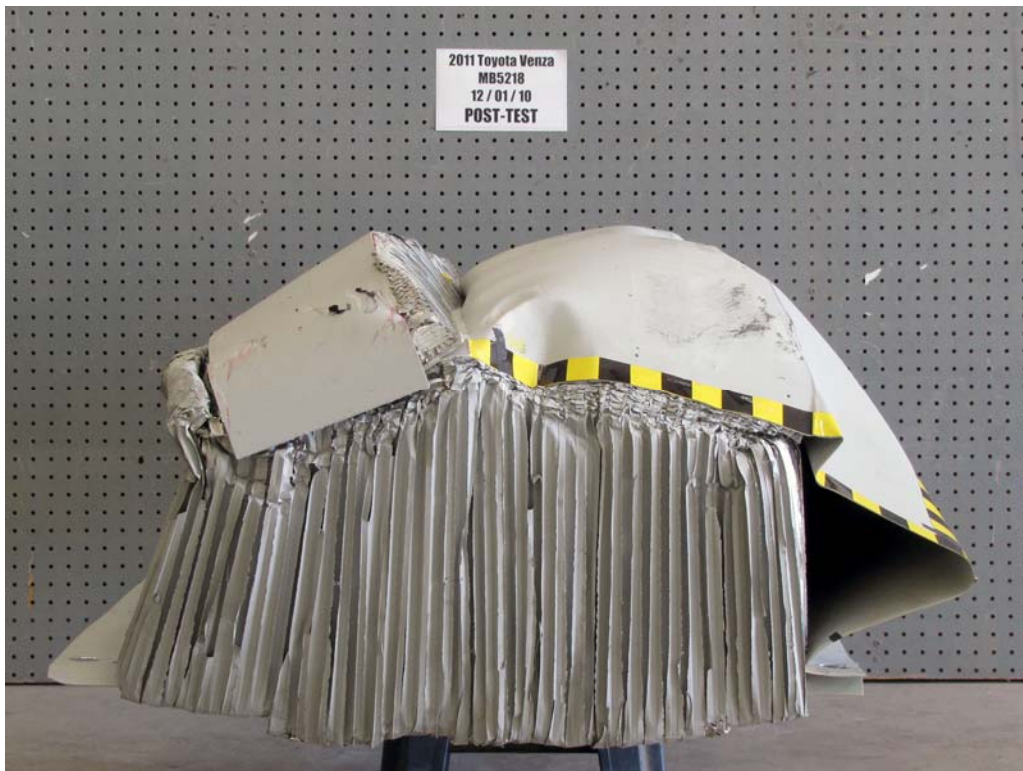
FIGURE 86. Post-Test Left Side View of MDB Impactor Face

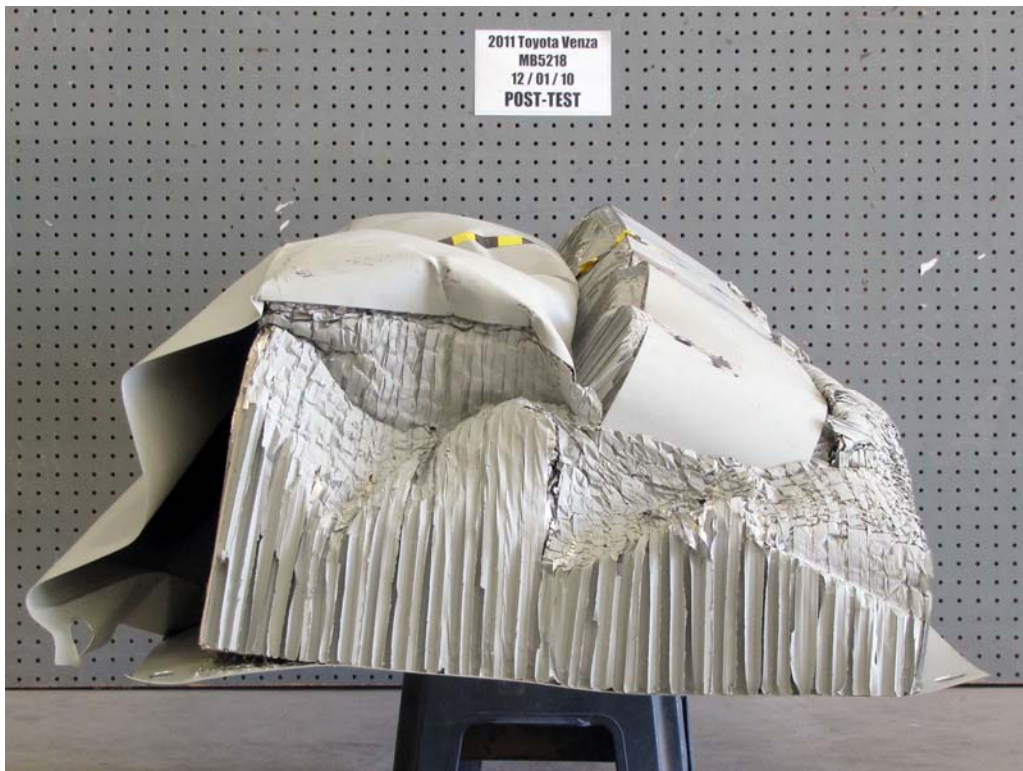
FIGURE 88. Post-Test Right Side View of MDB Impactor Face
