**REPORT NUMBER: NCAP-MGA-2011-049**

**NEW CAR ASSESSMENT PROGRAM (NCAP)  
Frontal Barrier Impact Test**

**HONDA MFG. OF ALABAMA, LLC  
2011 Honda Odyssey LX Minivan  
NHTSA No.: MB5314**

**FINAL REPORT**

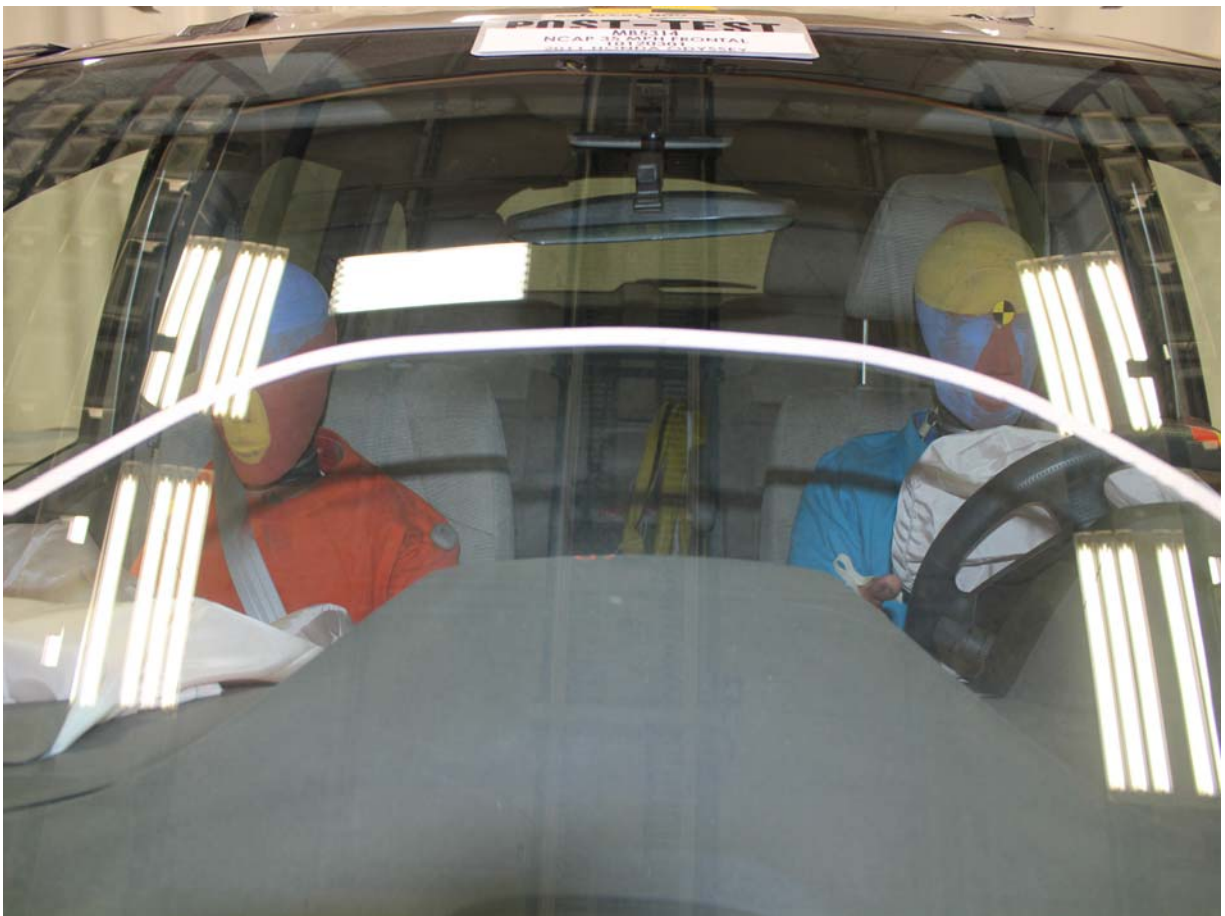
Post-Test Windshield View

There was 100 percent windshield retention and no intrusion into the protected zone of the windshield during the event. There was no Stoddard Solvent leakage after the event or during any phase of the static rollover.

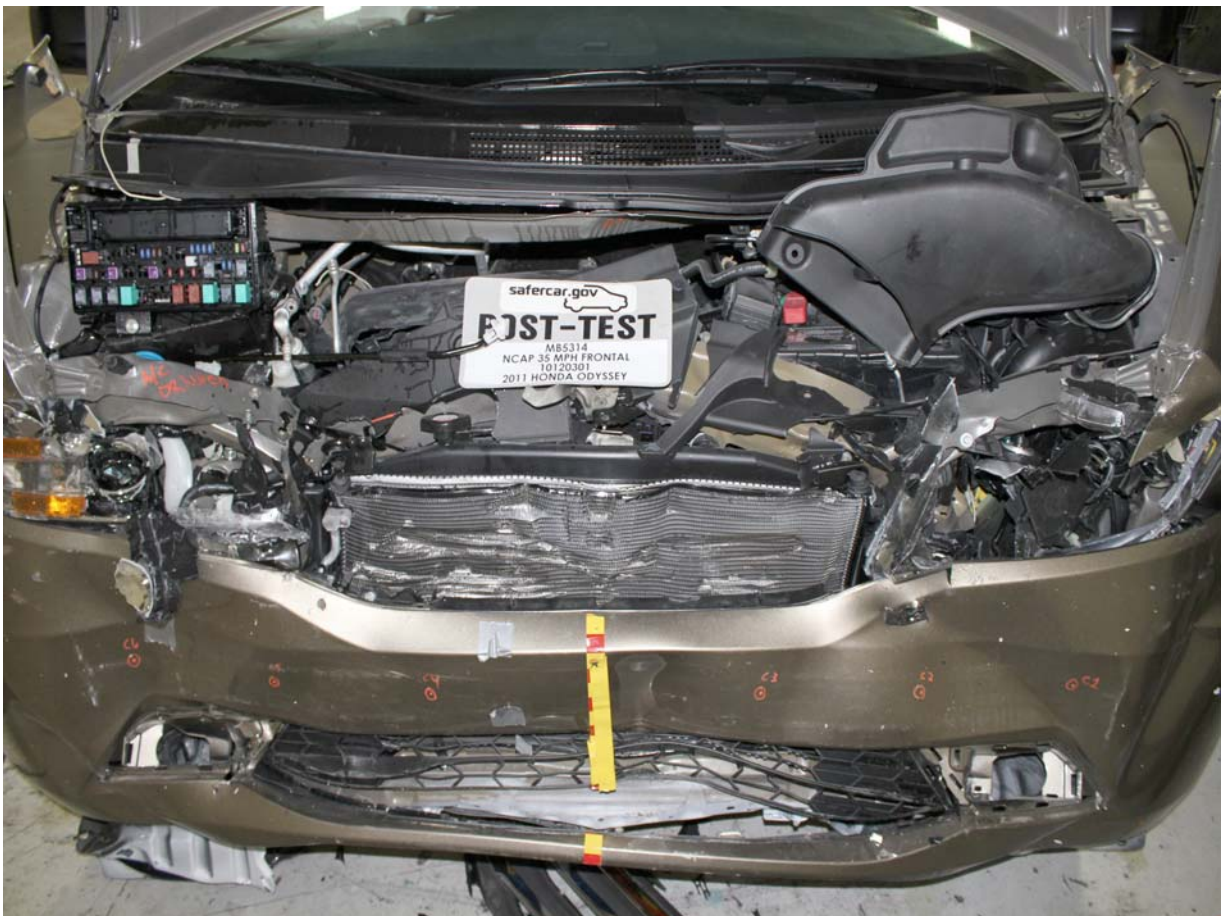
Post-Test Engine Compartment View

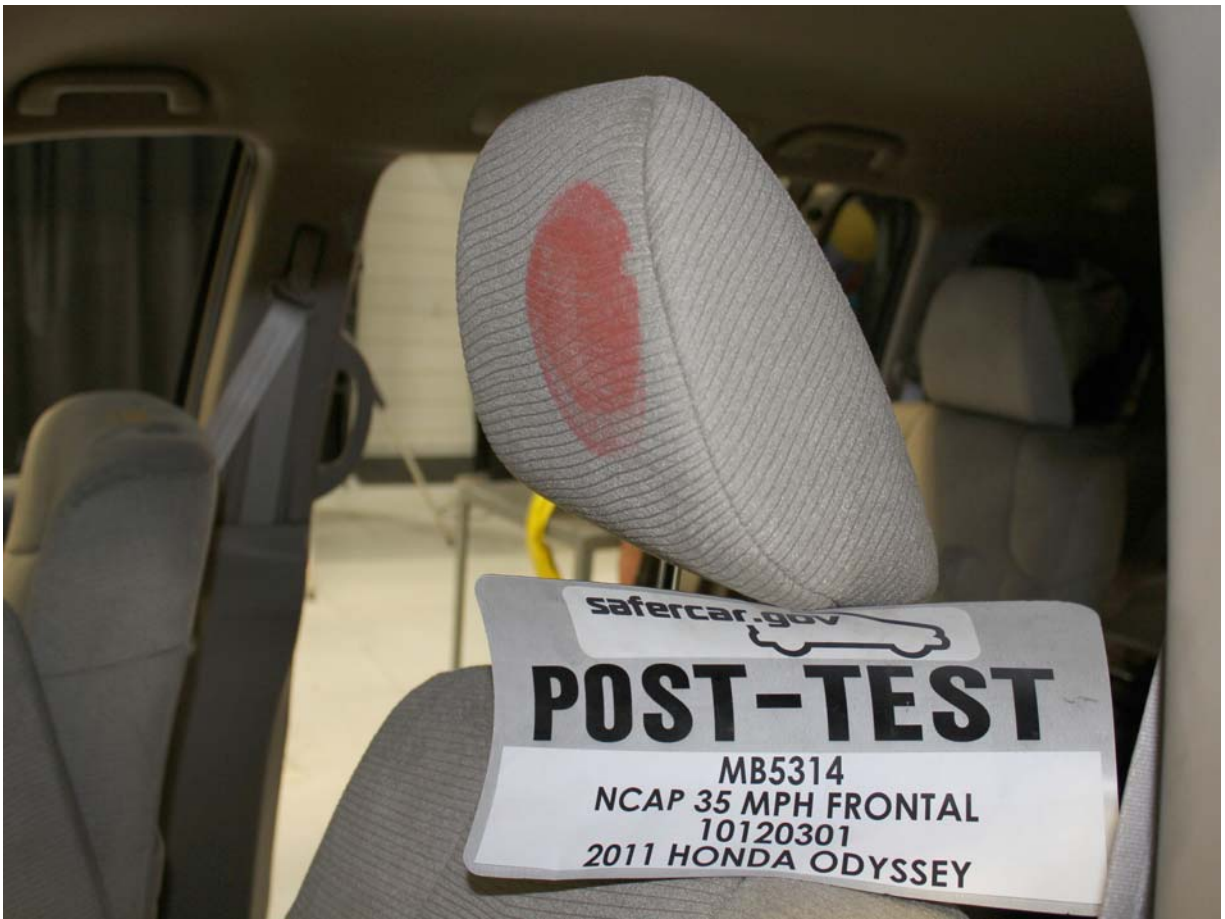
Post-Test Driver Dummy Contact with Headrest

The driver's head and chest contacted the airbag. The driver's head also contacted the headrest. The driver's knees contacted the knee bolster. The passenger's head and chest contacted the airbag. The passenger's head also contacted the seatback. The passenger's knees contacted the glovebox.

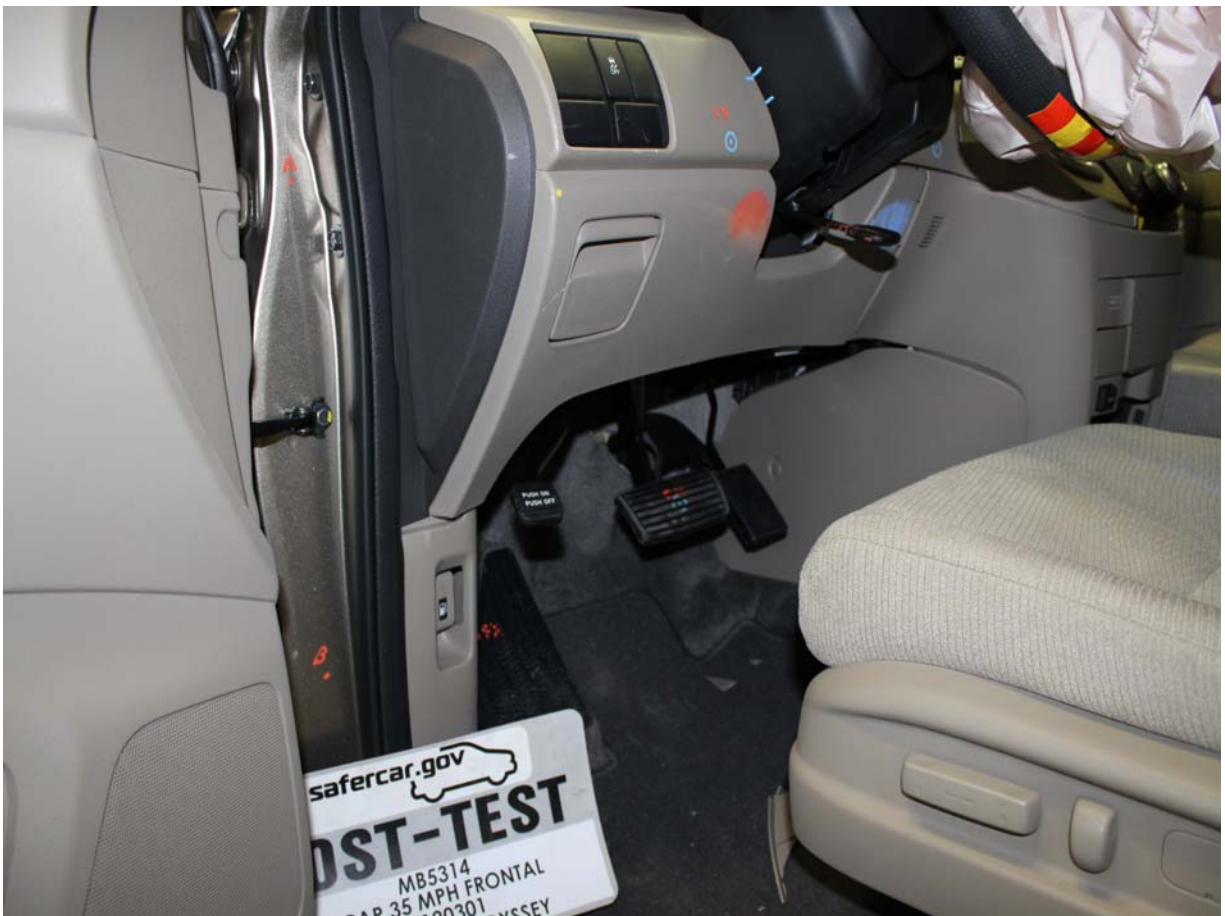
Post-Test Driver Dummy Contact with Knee Bolster

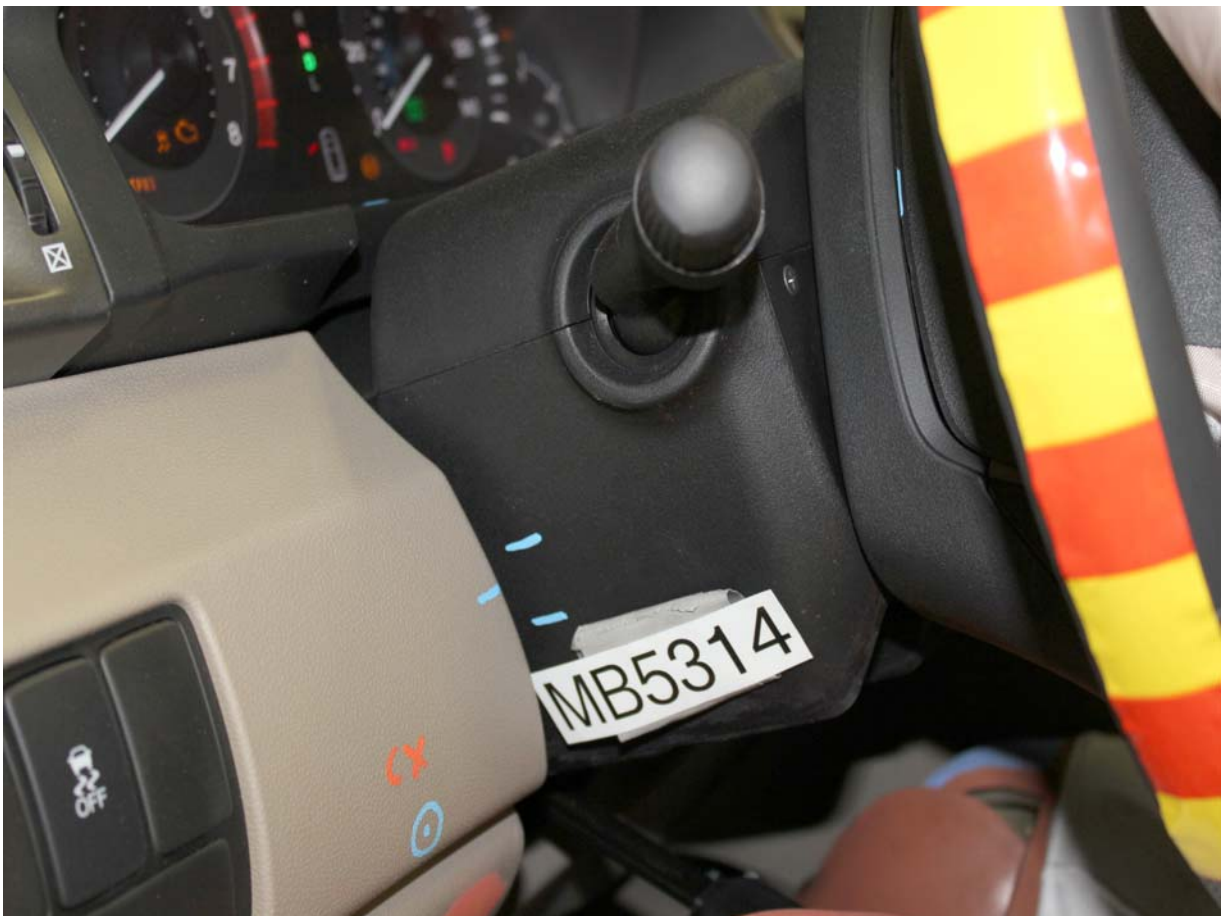
Post-Test View of Steering Column Shear Capsule

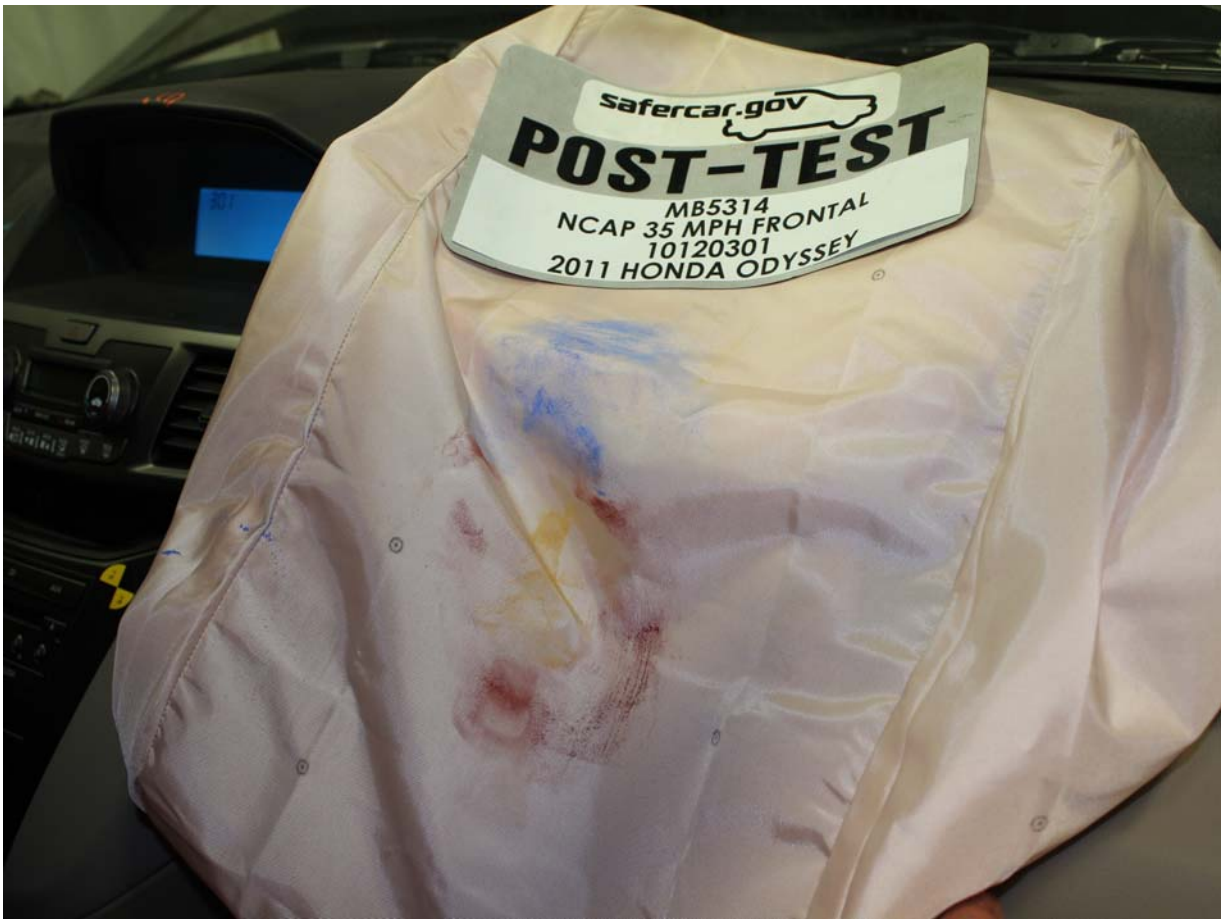
Post-Test Passenger Dummy Contact with Airbag

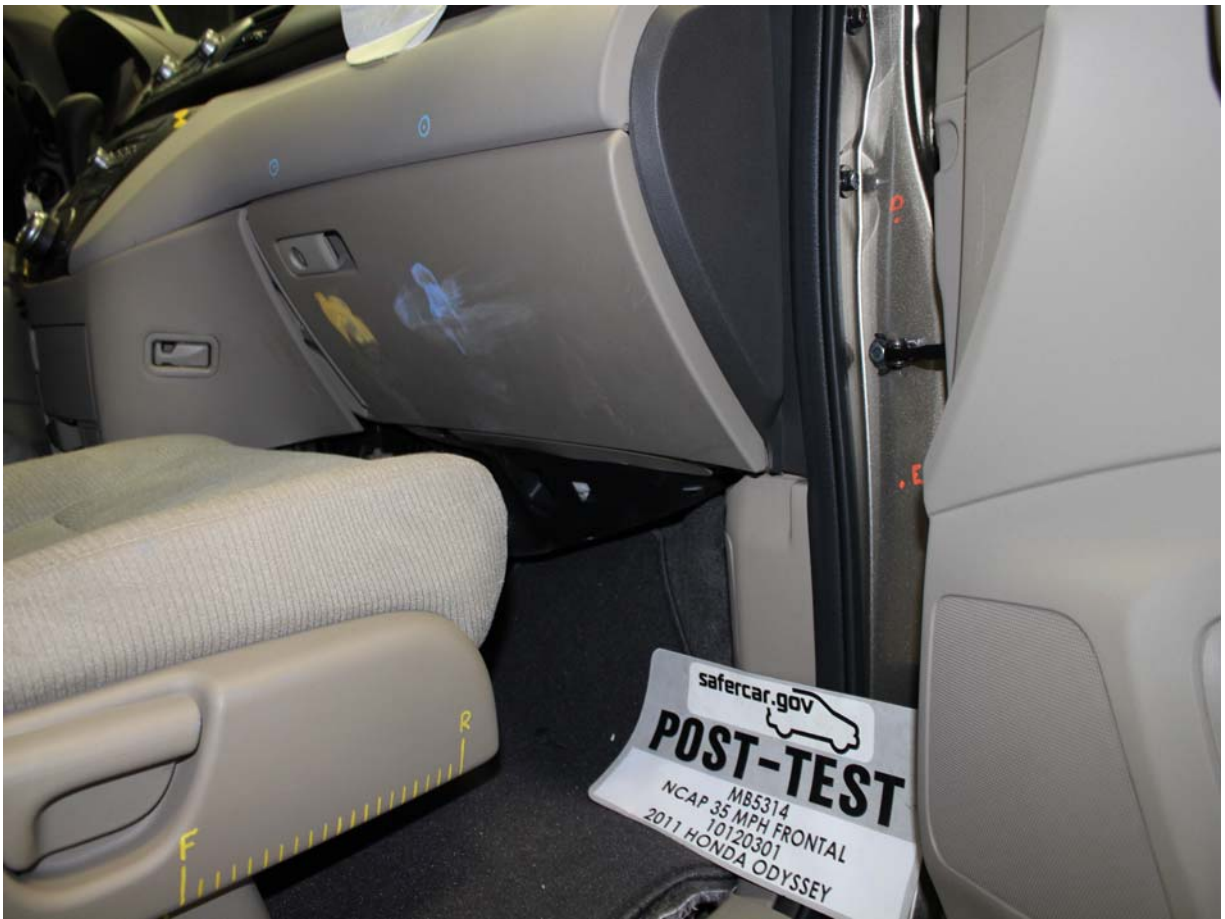
Post-Test Passenger Dummy Contact with Glovebox

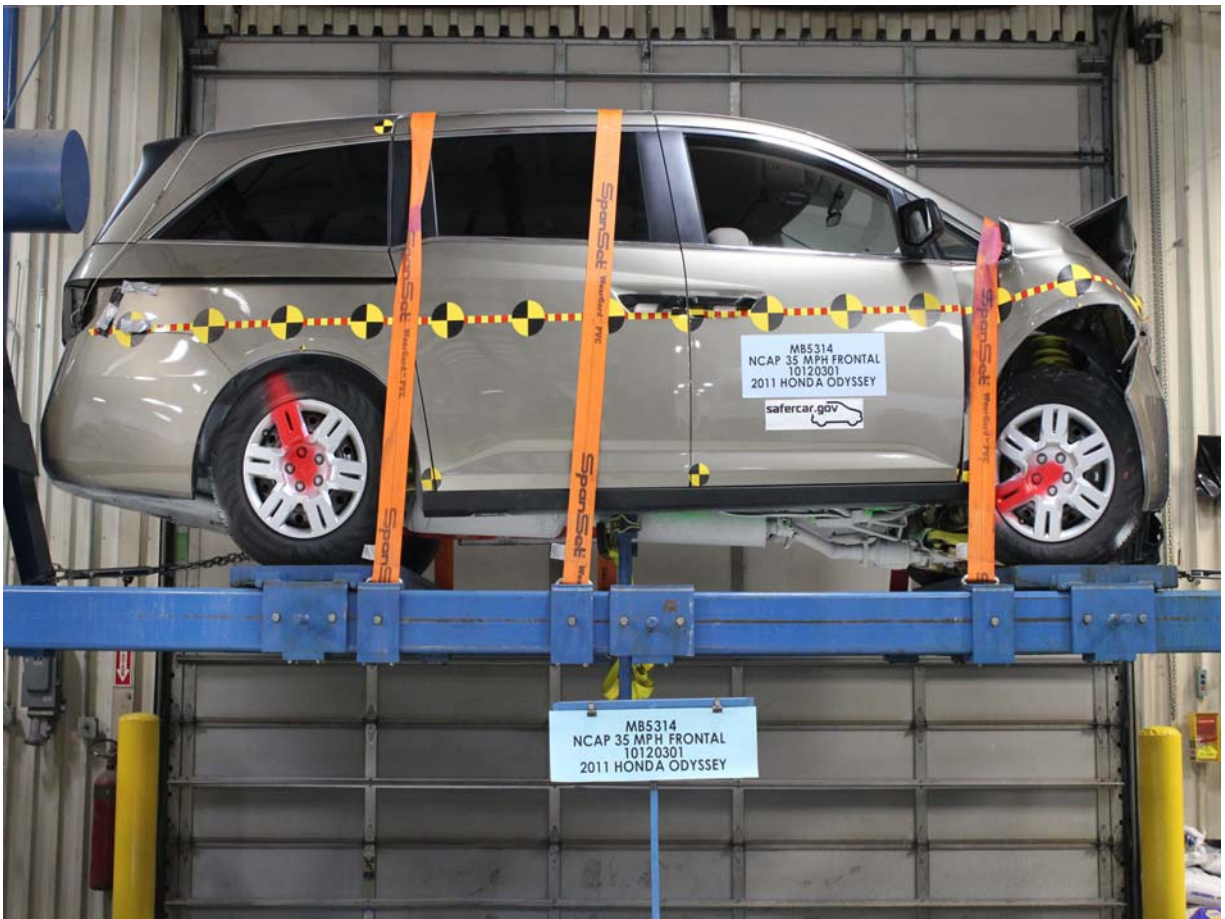
Vehicle at 0 Degrees on Static Rollover Device

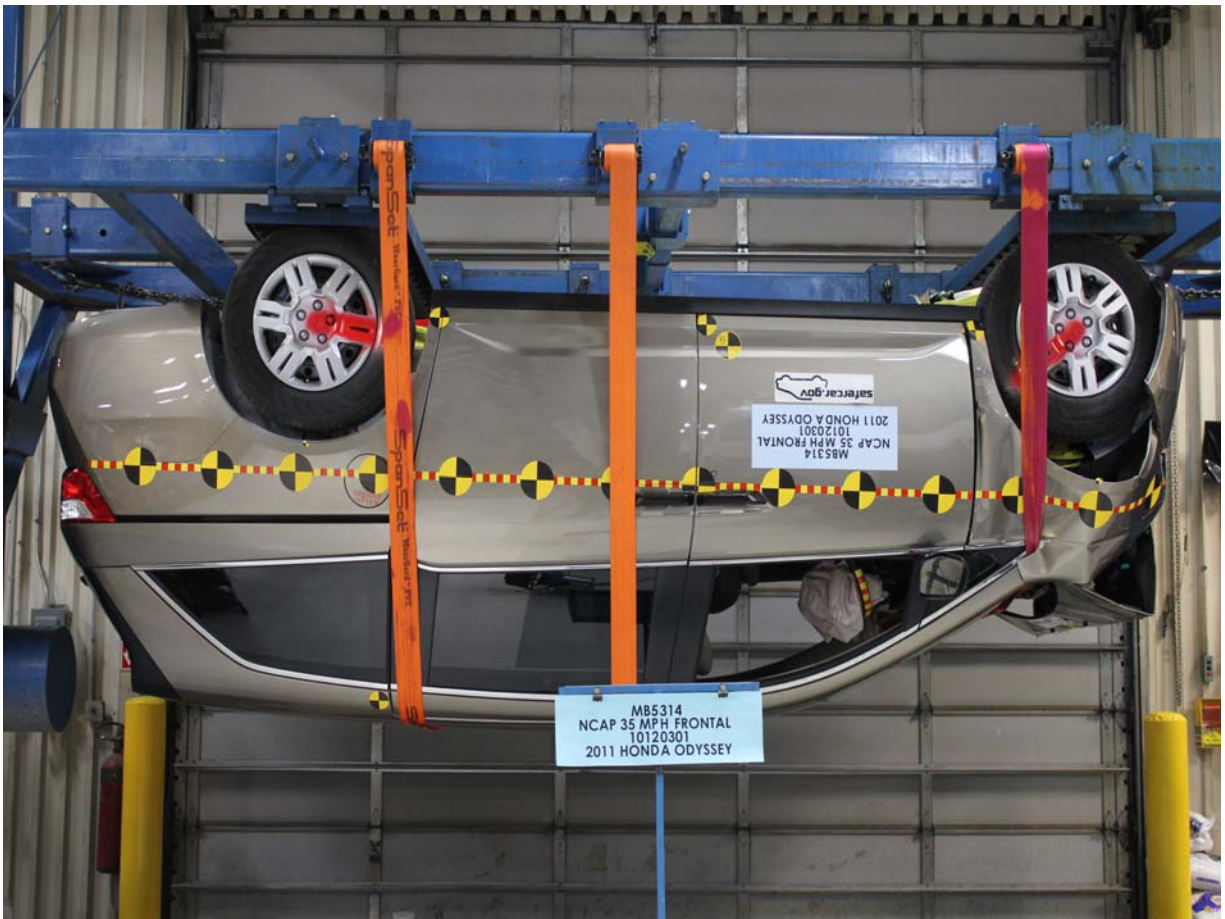
Vehicle at 180 Degrees on Static Rollover Device

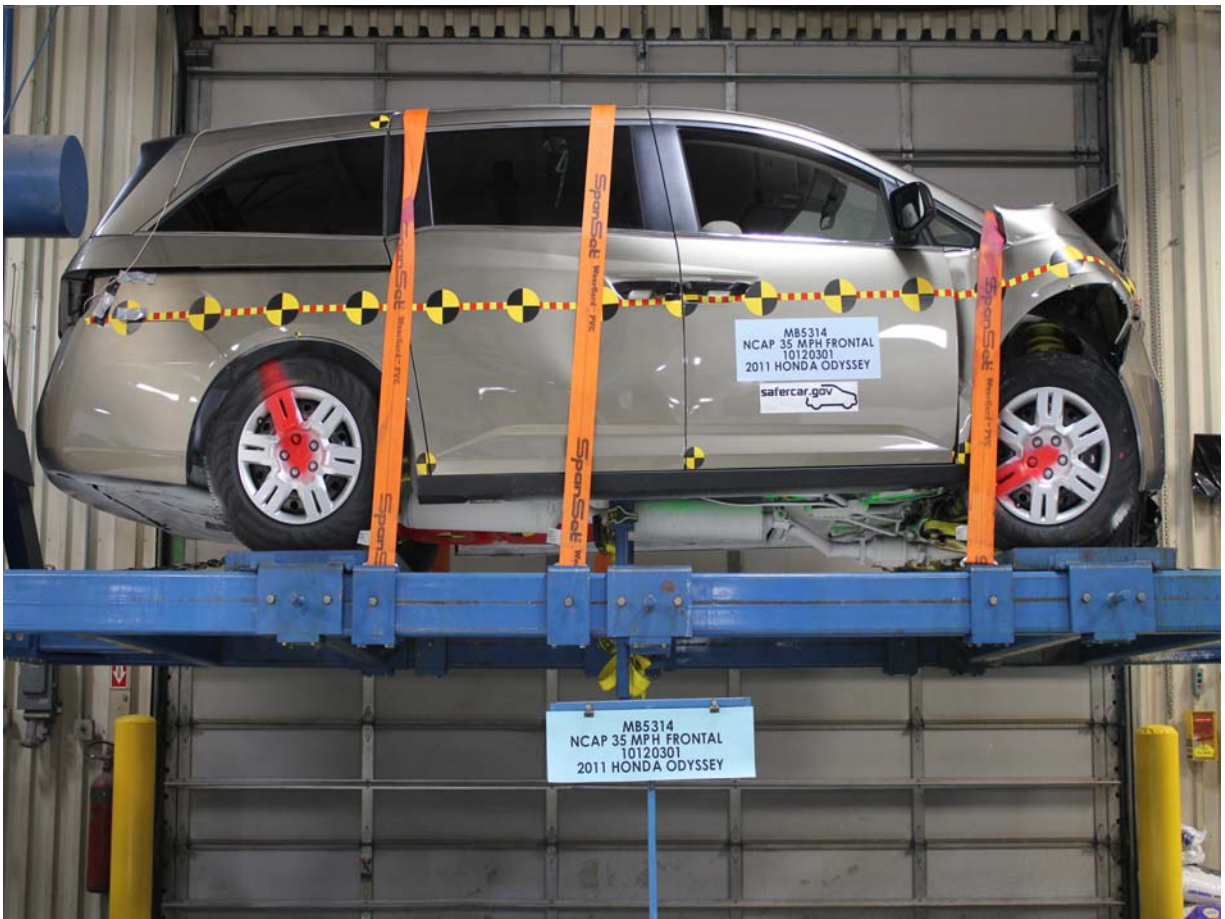
Vehicle at 360 Degrees on Static Rollover Device
