**REPORT NUMBER: NCAP-MGA-2011-050**

**NEW CAR ASSESSMENT PROGRAM (NCAP)  
Frontal Barrier Impact Test**

**DAIMLER AG STUTTGART  
2011 Mercedes-Benz C300 4-Dr Sedan  
NHTSA No.: MB0518**

**FINAL REPORT**

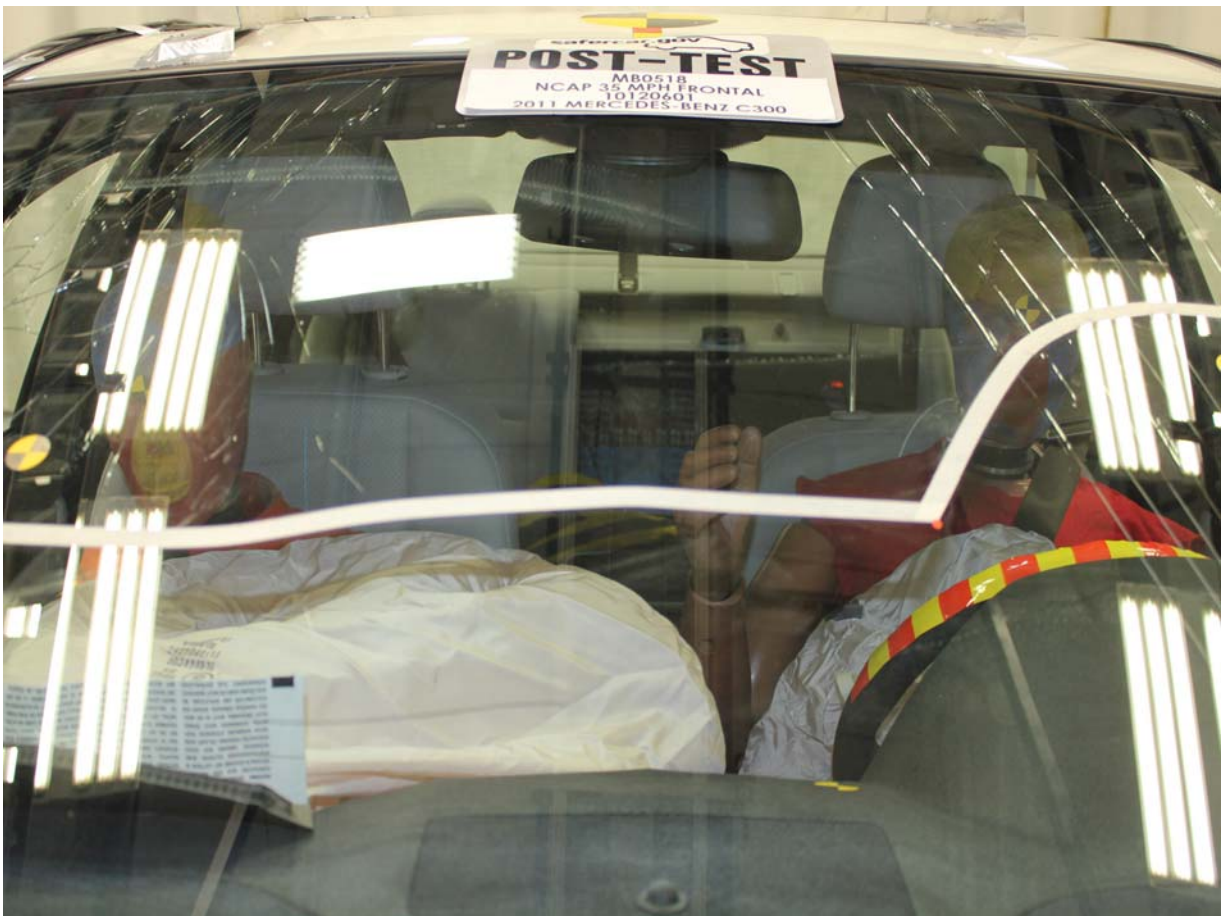
Post-Test Windshield View

There was 100 percent windshield retention and no intrusion into the protected zone of the windshield during the event. There was no Stoddard Solvent leakage after the event or during any phase of the static rollover.

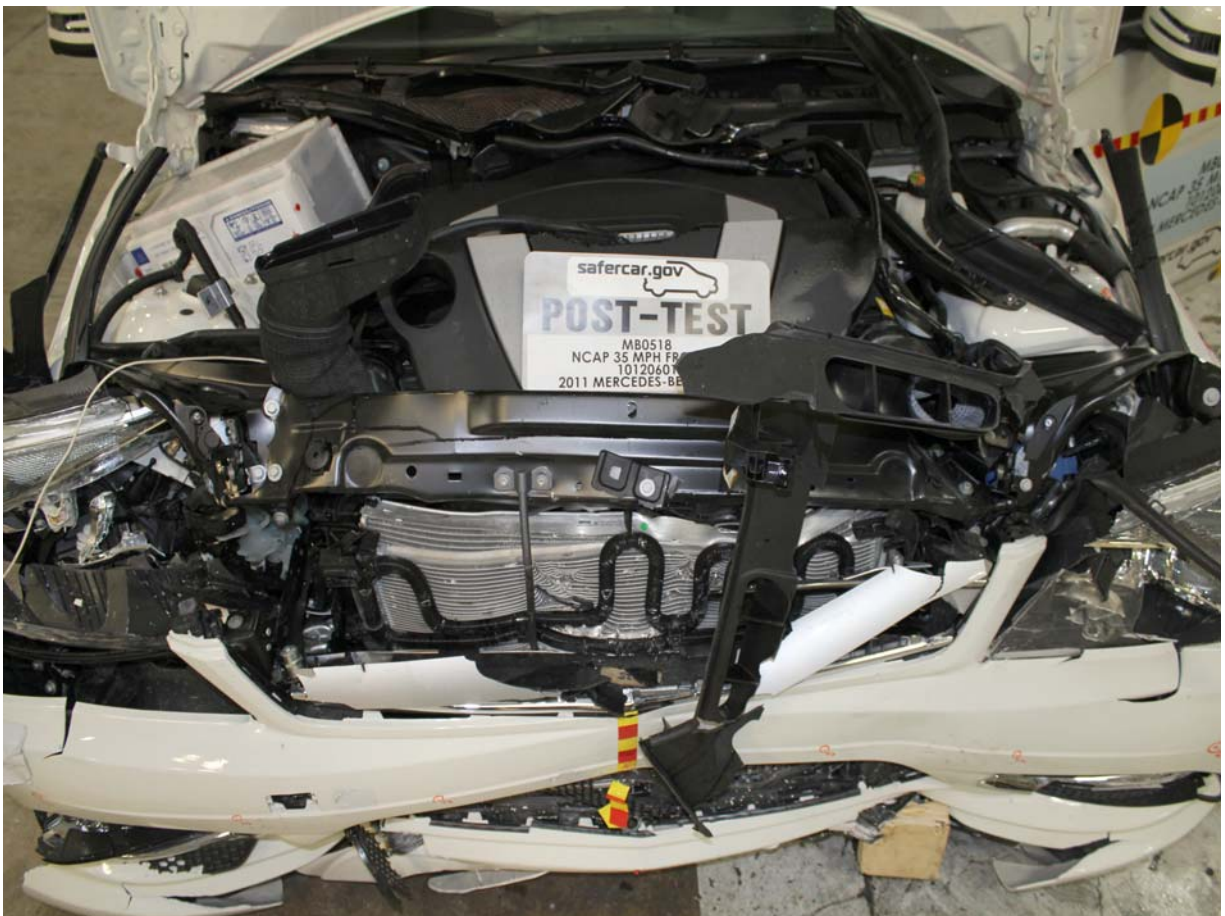
Post-Test Engine Compartment View

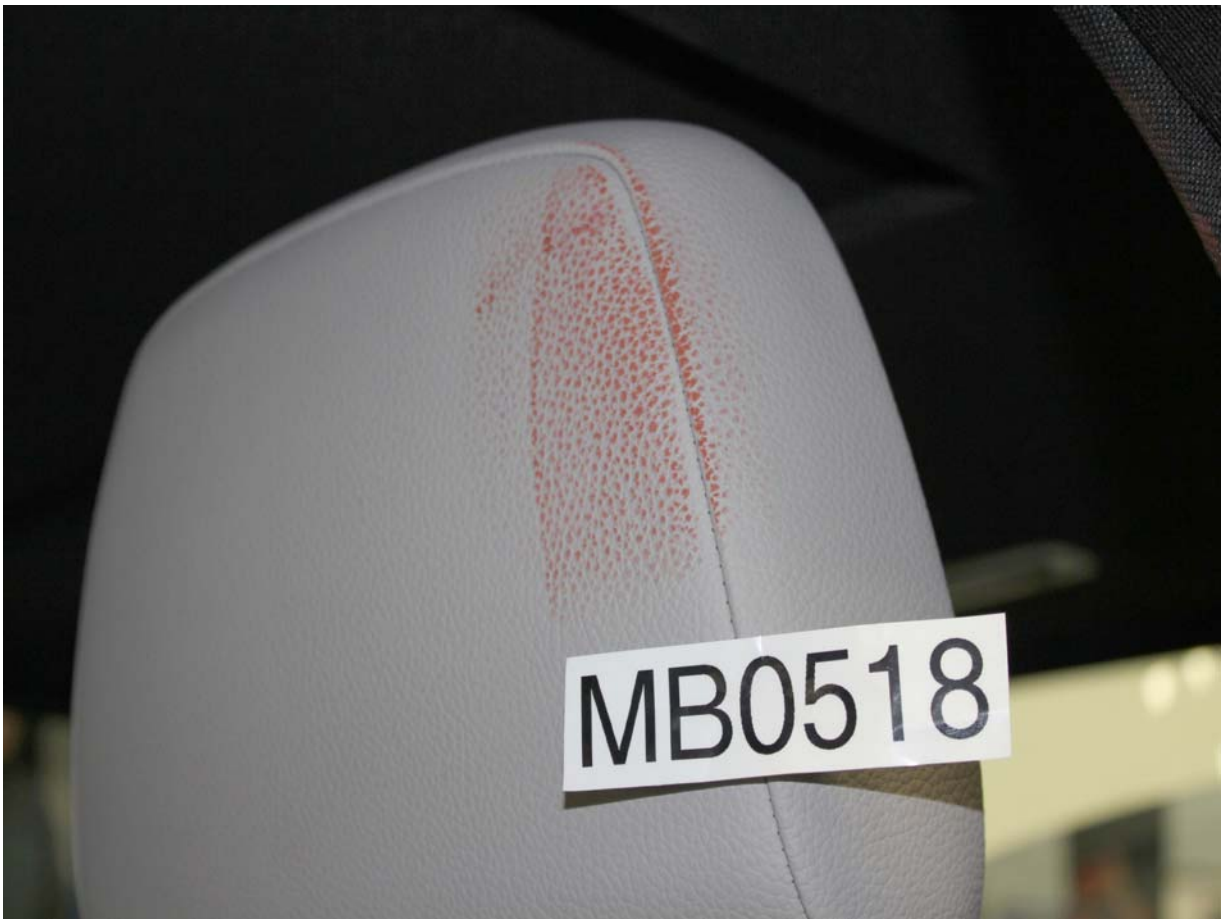
Post-Test Driver Dummy Contact with Headrest

The driver's head and chest contacted the airbag. The driver's head also contacted headrest and side header. The driver's knees contacted the knee airbag. The passenger's head and chest contacted the airbag. The passenger's head also contacted the headrest and side header. The passenger's knees contacted the glovebox.

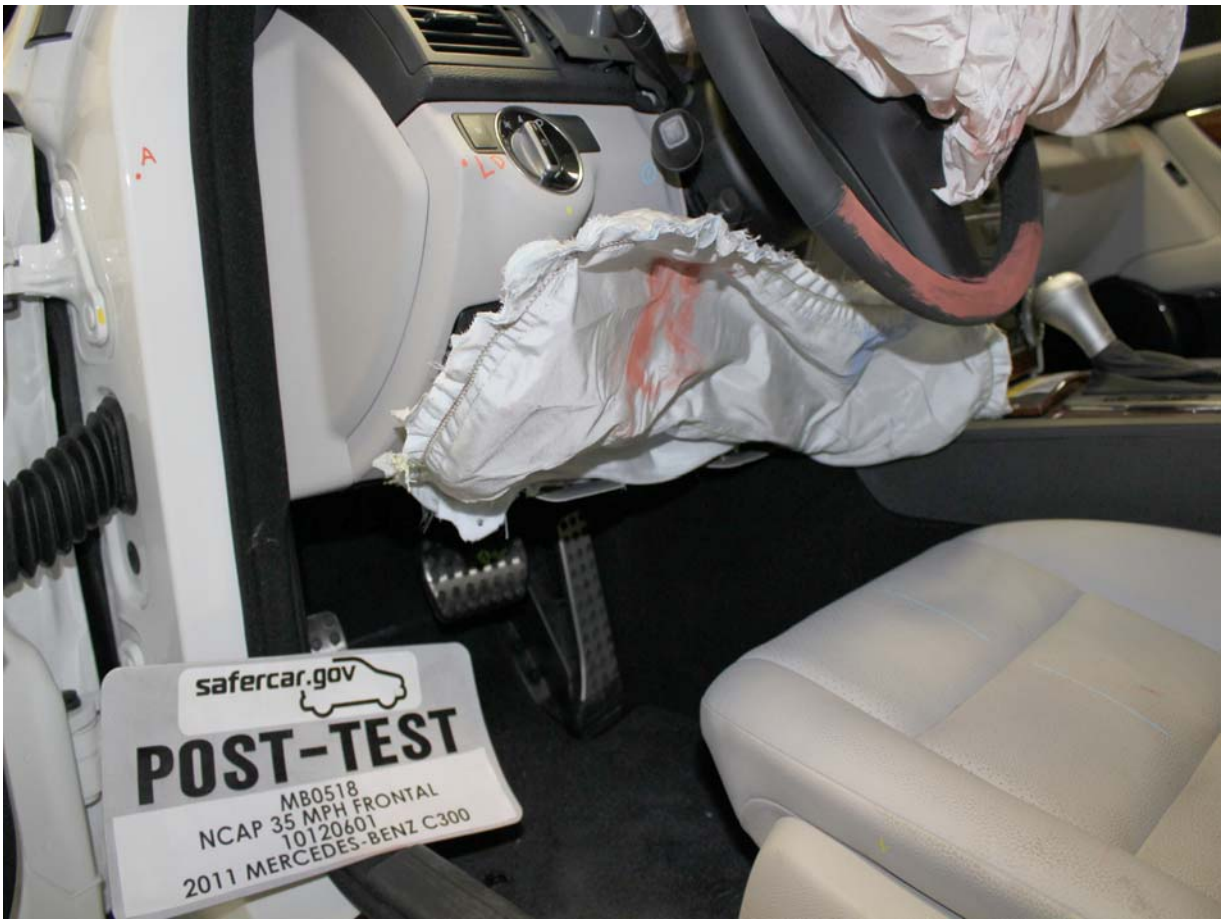
Post-Test Driver Dummy Contact with Knee Airbag

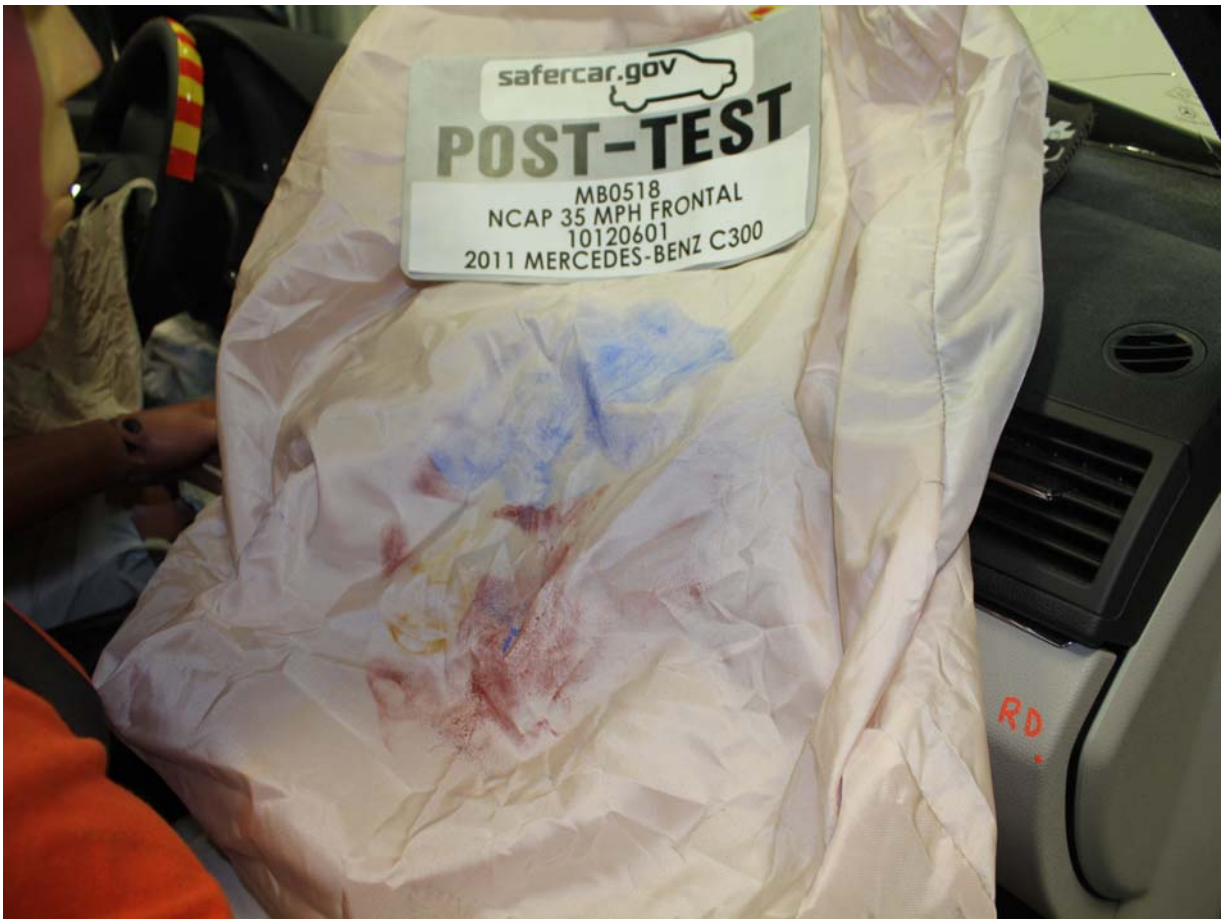
Post-Test Passenger Dummy Contact with Airbag

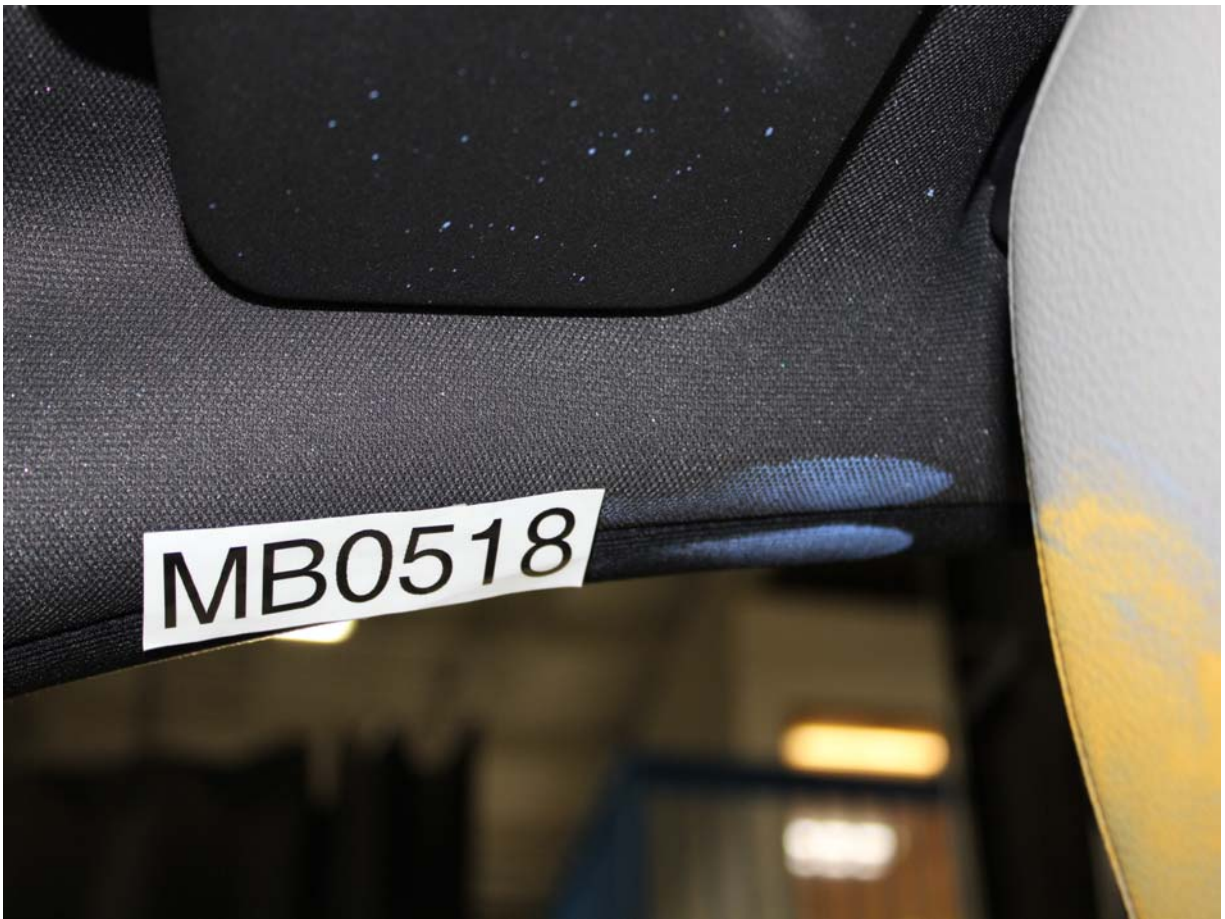
Post-Test Passenger Dummy Contact with Side Header

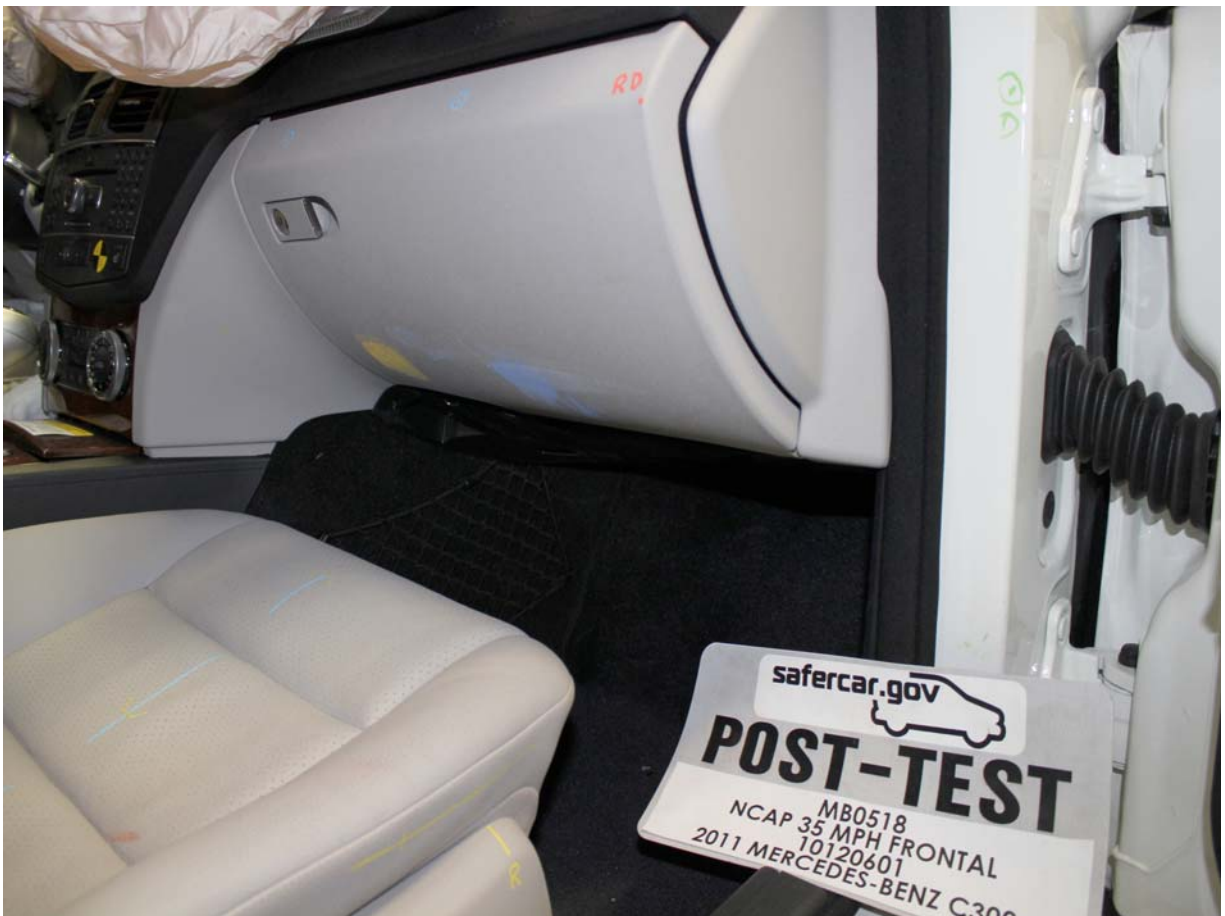
Post-Test Passenger Dummy Contact with Glovebox

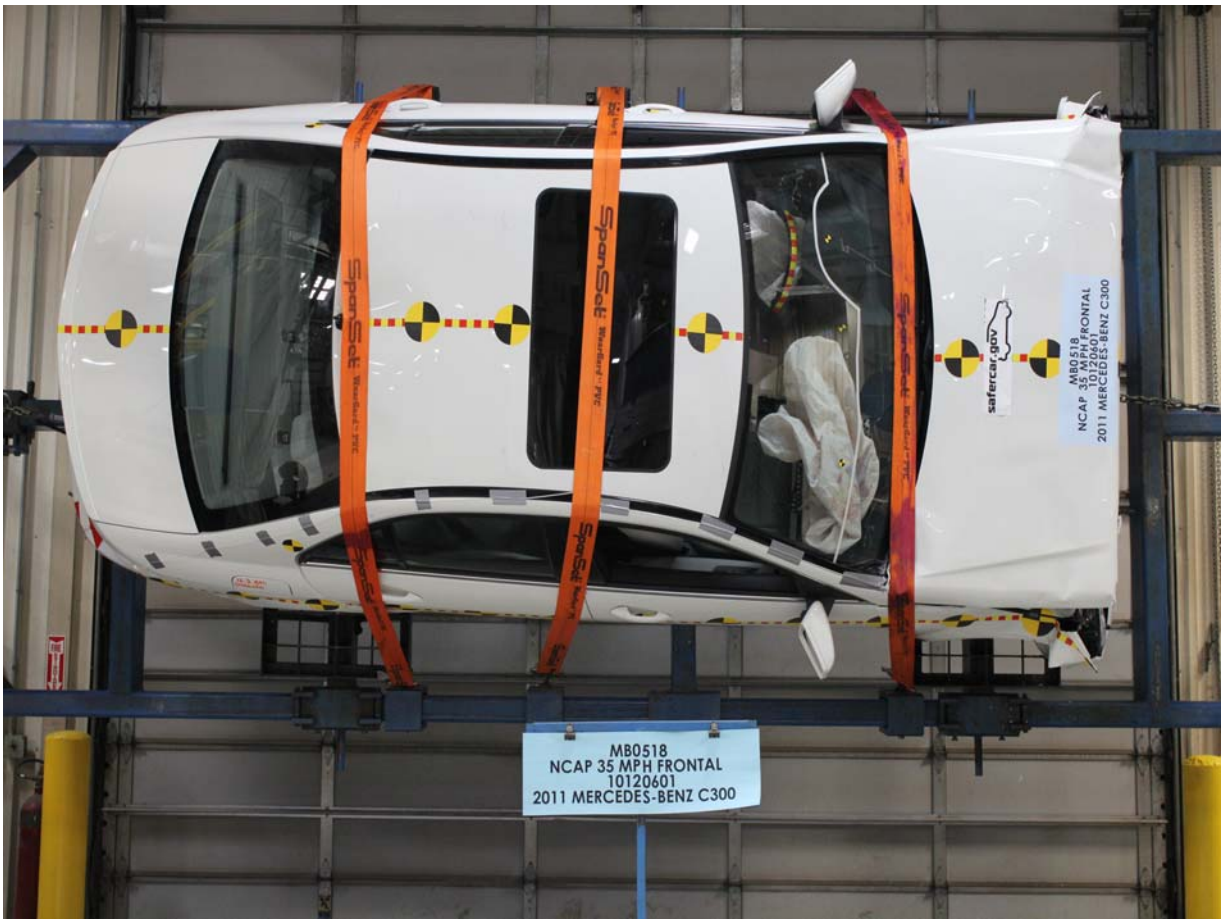
Vehicle at 90 Degrees on Static Rollover Device

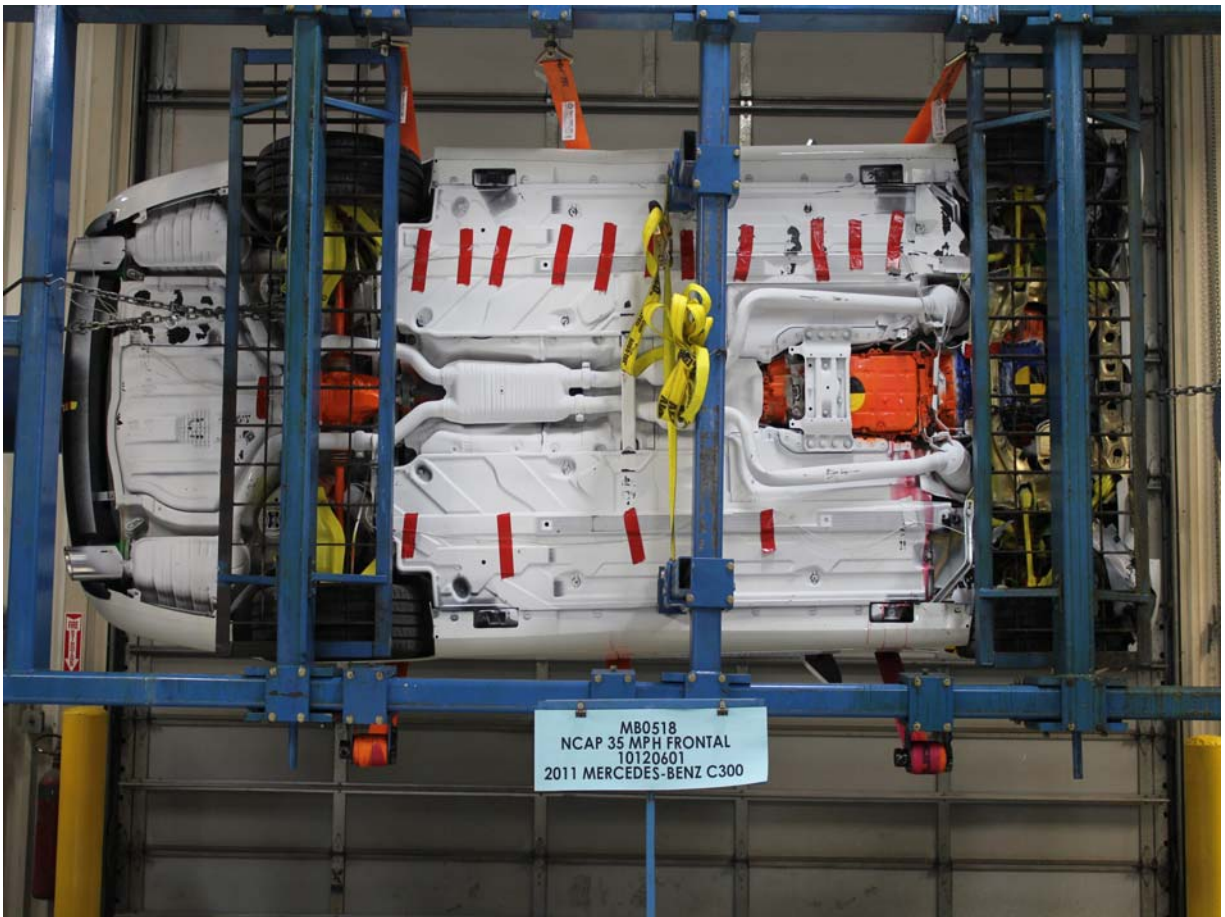
Vehicle at 270 Degrees on Static Rollover Device
