REPORT NUMBER: NCAP-KAR-11-046

**NEW CAR ASSESSMENT PROGRAM (NCAP)
FRONTAL BARRIER IMPACT TEST**

**TOYOTA MOTOR MANUFACTURING, INDIANA, INC.
2011 TOYOTA HIGHLANDER 4X4 5-DOOR MPV**

**PREPARED BY:
KARCO ENGINEERING, LLC.
9270 HOLLY ROAD
ADELANTO, CA 92301**

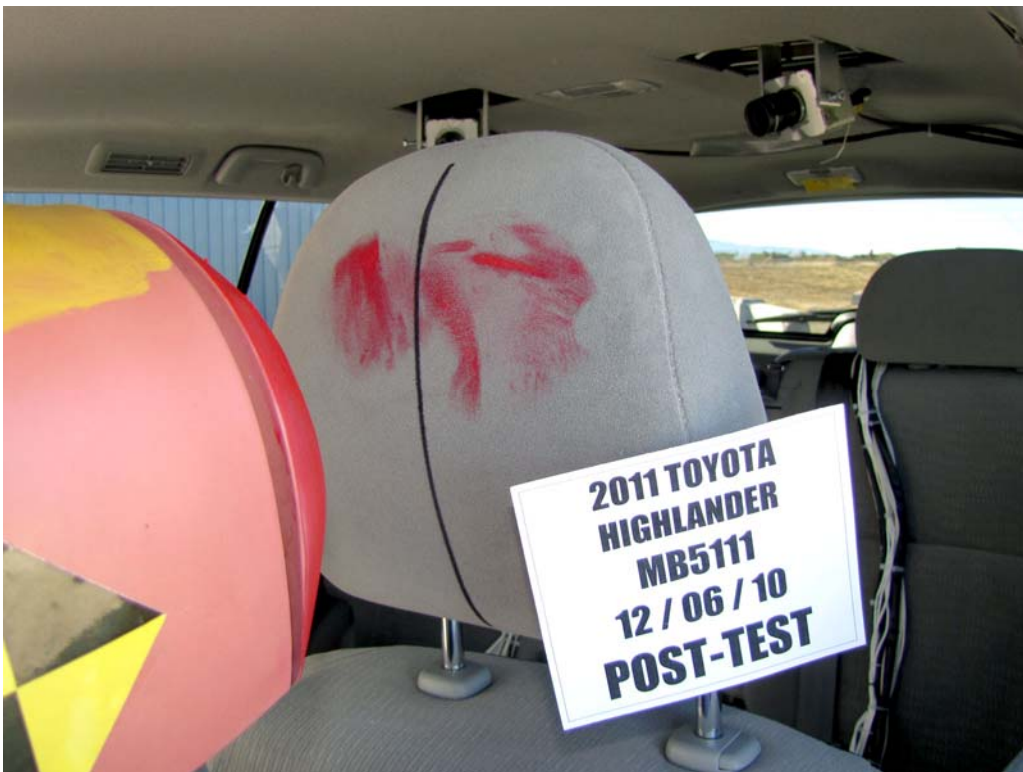
FIGURE 43a. Post-Test Driver Dummy Contact With Head Restraint

The driver's visible contact points were as follows: The driver ATD's head contacted the airbag and head restraint. The upper torso contacted the airbag. Both the left knee and right knee contacted the knee airbag.

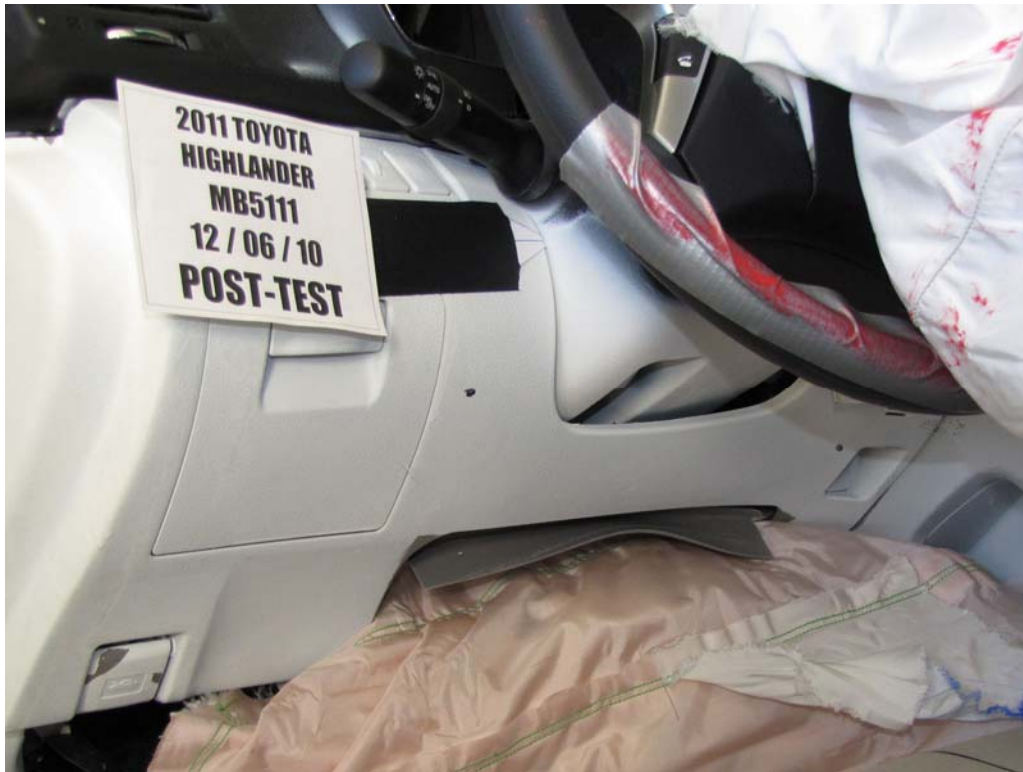
FIGURE 45. Post-Test View of Steering Column Shear Capsule

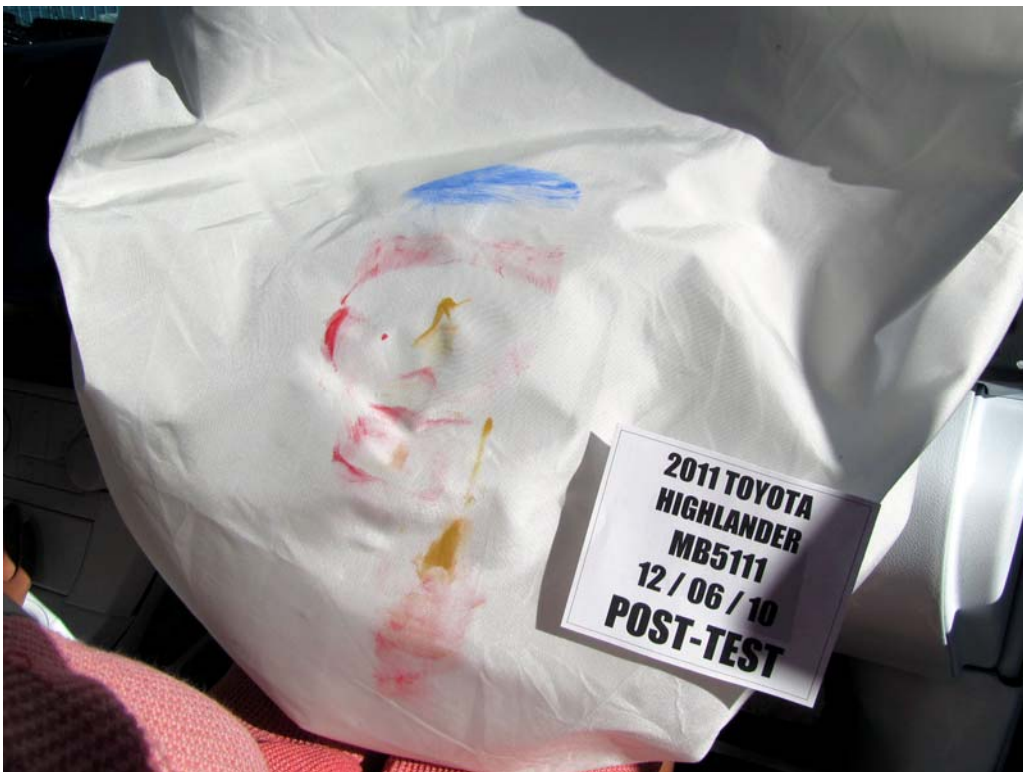
FIGURE 60. Post-Test Passenger Dummy Contact With Airbag

The passenger's visible contact points were as follows: The passenger ATD's head contacted the airbag and head restraint. The upper torso contacted the airbag. Both the left knee and right knee contacted the glovebox.

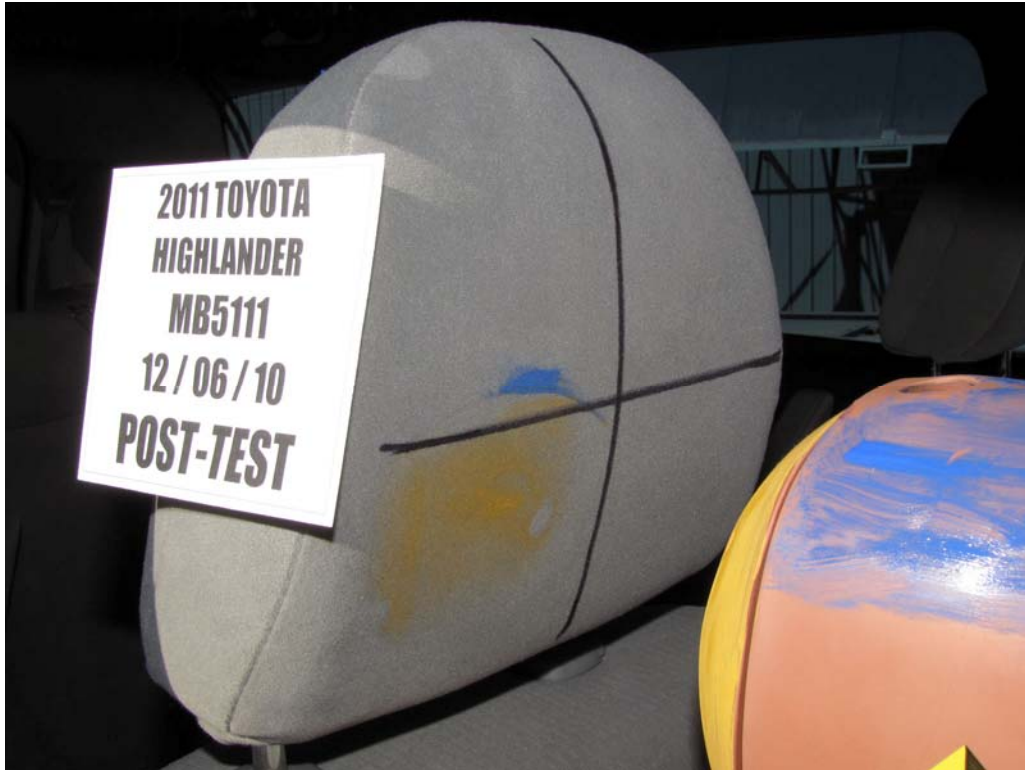
FIGURE 60a. Post-Test Passenger Dummy Contact With Head Restraint

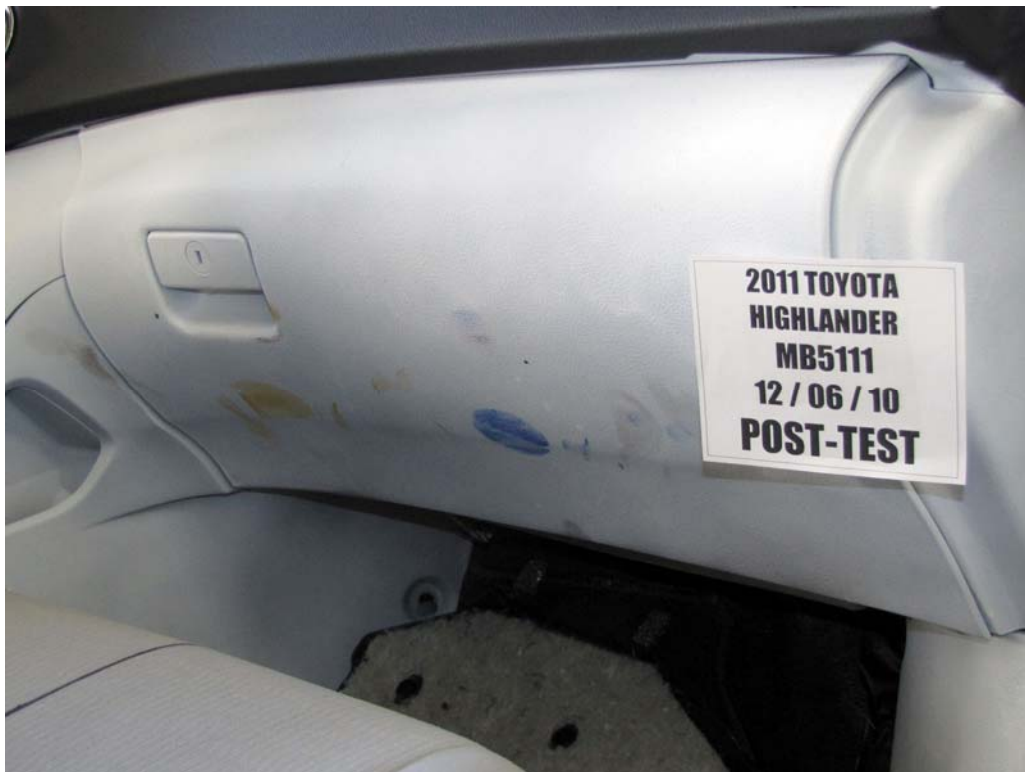
FIGURE 60b. Post-Test Passenger Dummy Contact With Glovebox
