**REPORT NUMBER: NCAP-CAL-11-030**

**NEW CAR ASSESSMENT PROGRAM (NCAP)  
FRONTAL BARRIER IMPACT TEST**

**Chrysler Group LLC  
2011 Dodge Caliber  
Five Door Hatchback**

**FINAL REPORT**

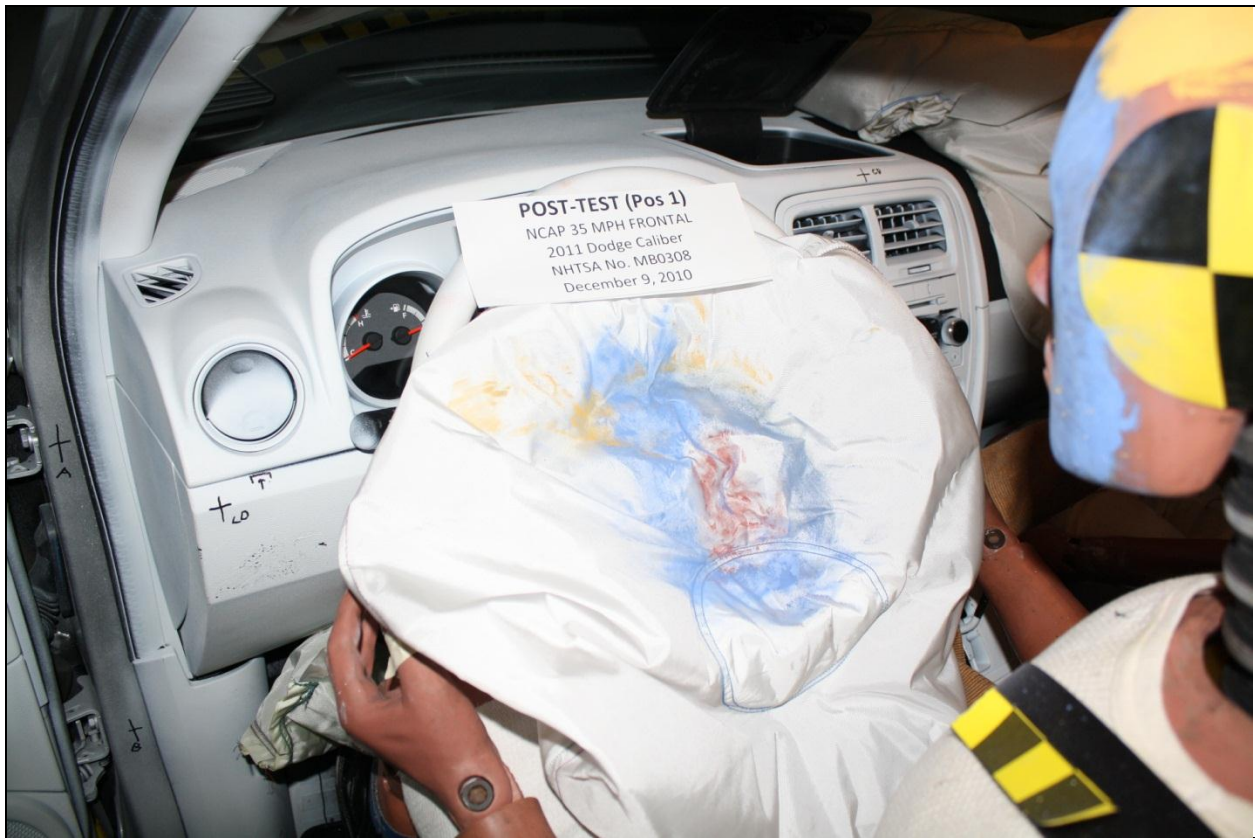
**Figure A-43: Post-Test Driver Dummy Contact with Airbag**

The driver's visible contact points were as follows: face and upper torso with frontal airbag with the back of head with the head restraint; both knees contacted the knee airbag. The passenger's visible contact points were as follows: face and upper torso with frontal airbag with the back of head with the head restraint; both knees contacted the lower glove box door.

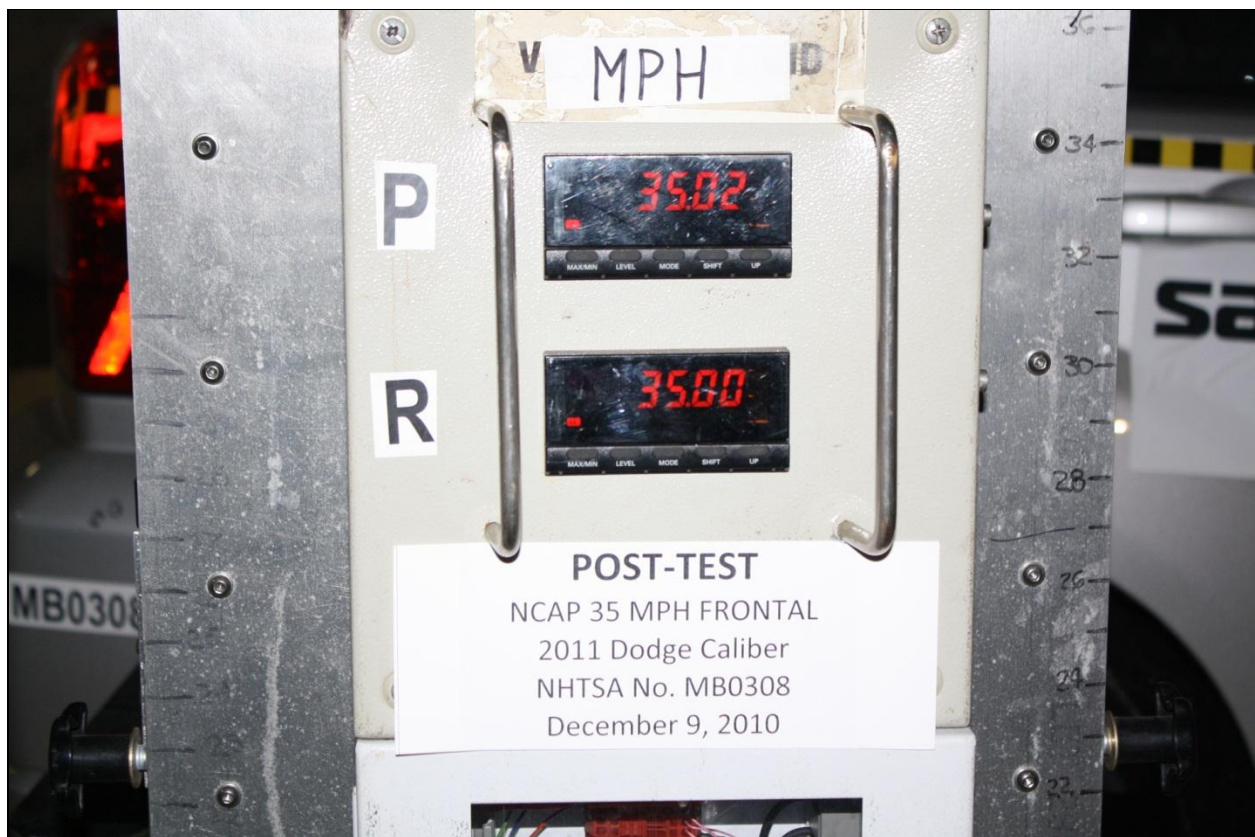
Figure A-63: Post-Test Speed Trap Read Out

A load cell barrier consisting of 36 load cells was impacted by a 2011 Dodge Caliber Five Door Hatchback at a velocity of 56.36 kph. The test was performed at Calspan on 12/9/2010. Pre- and post-test photographs of the vehicle and dummies can be found in Appendix A.
