**REPORT NUMBER: SNCAP-CAL-11-030**

**NEW CAR ASSESSMENT PROGRAM (NCAP)  
Moving Deformable Barrier Side Impact Test**

**Chrysler Group LLC.  
2011 Dodge Caliber  
Five Door Hatchback**

**FINAL REPORT**

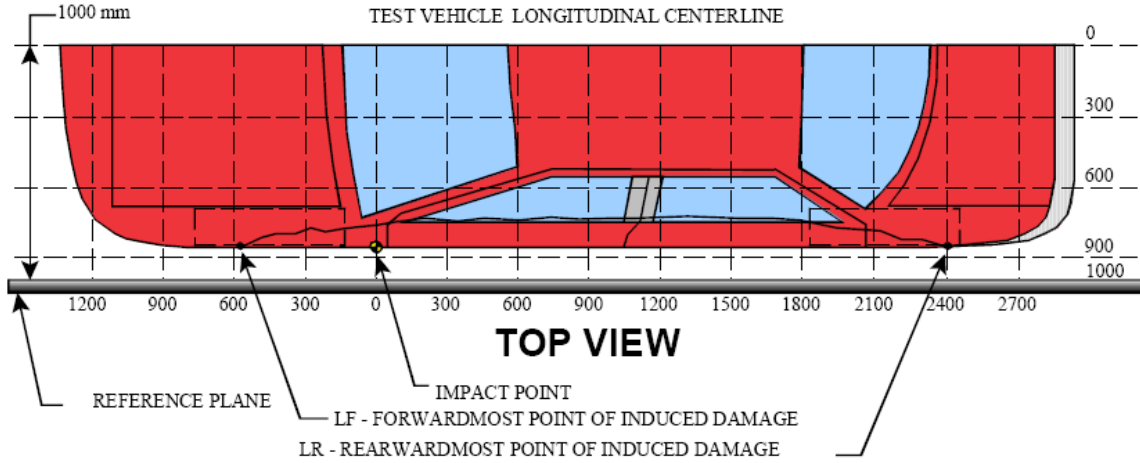
**DATA SHEET NO. 13  
VEHICLE DAMAGE PROFILE DISTANCES**

**DAMAGE PROFILE DISTANCES**

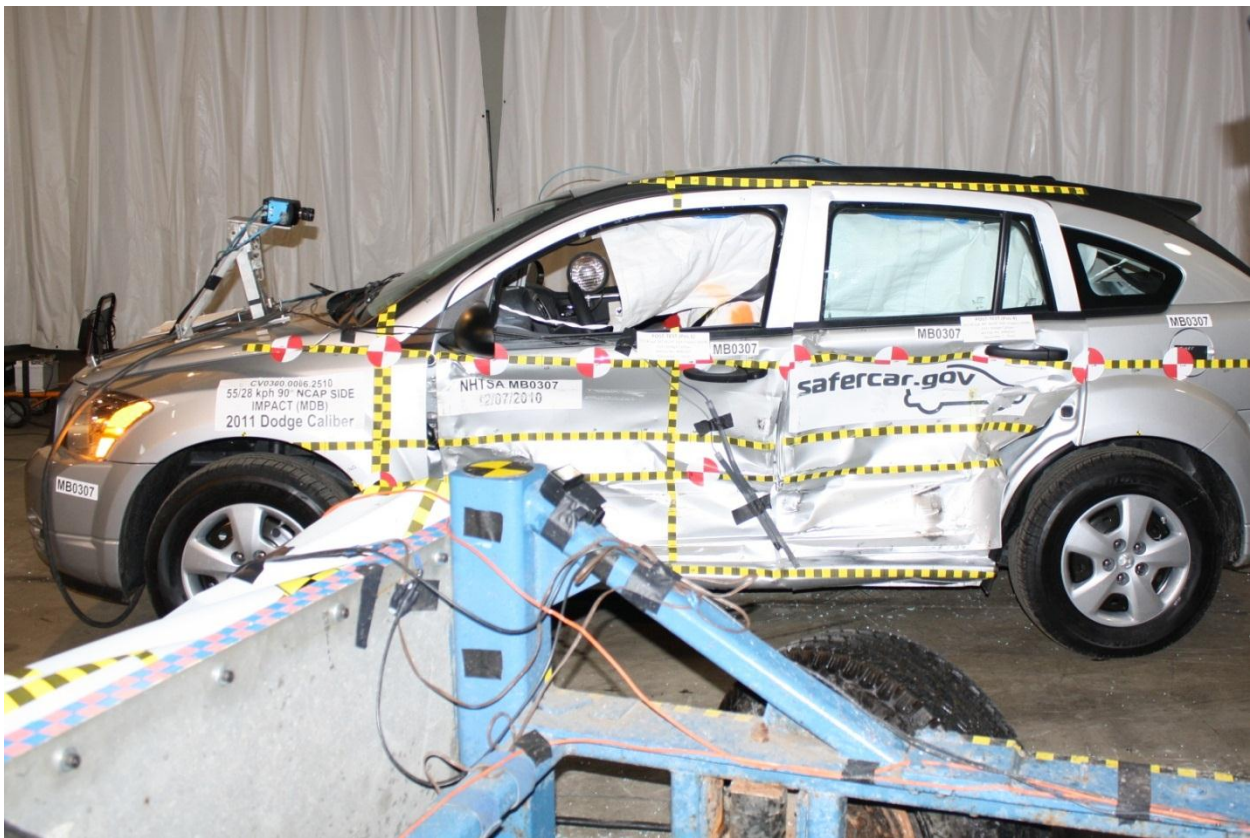
**Figure A-8: Post-Test Left Side View of Test Vehicle**

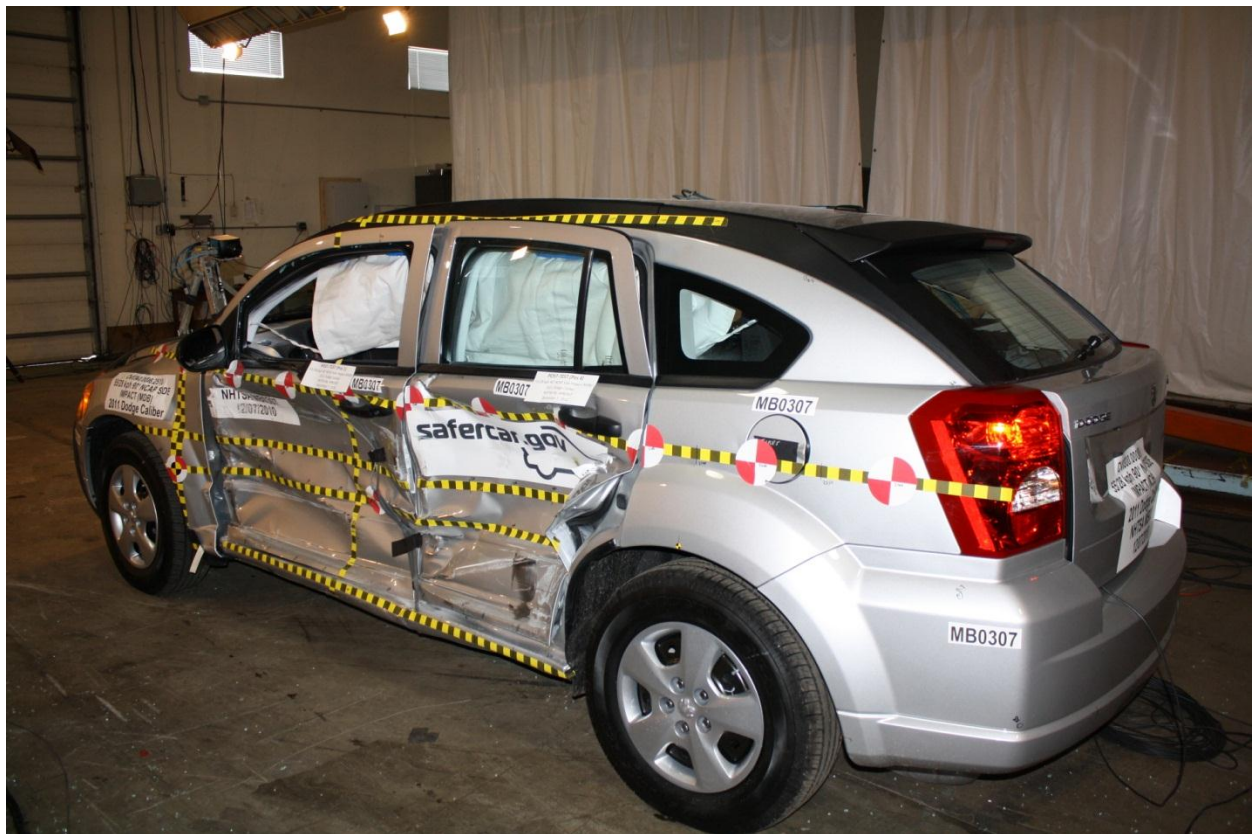
**Figure A-10: Post-Test Left Rear  $\frac{3}{4}$  View of Test Vehicle**

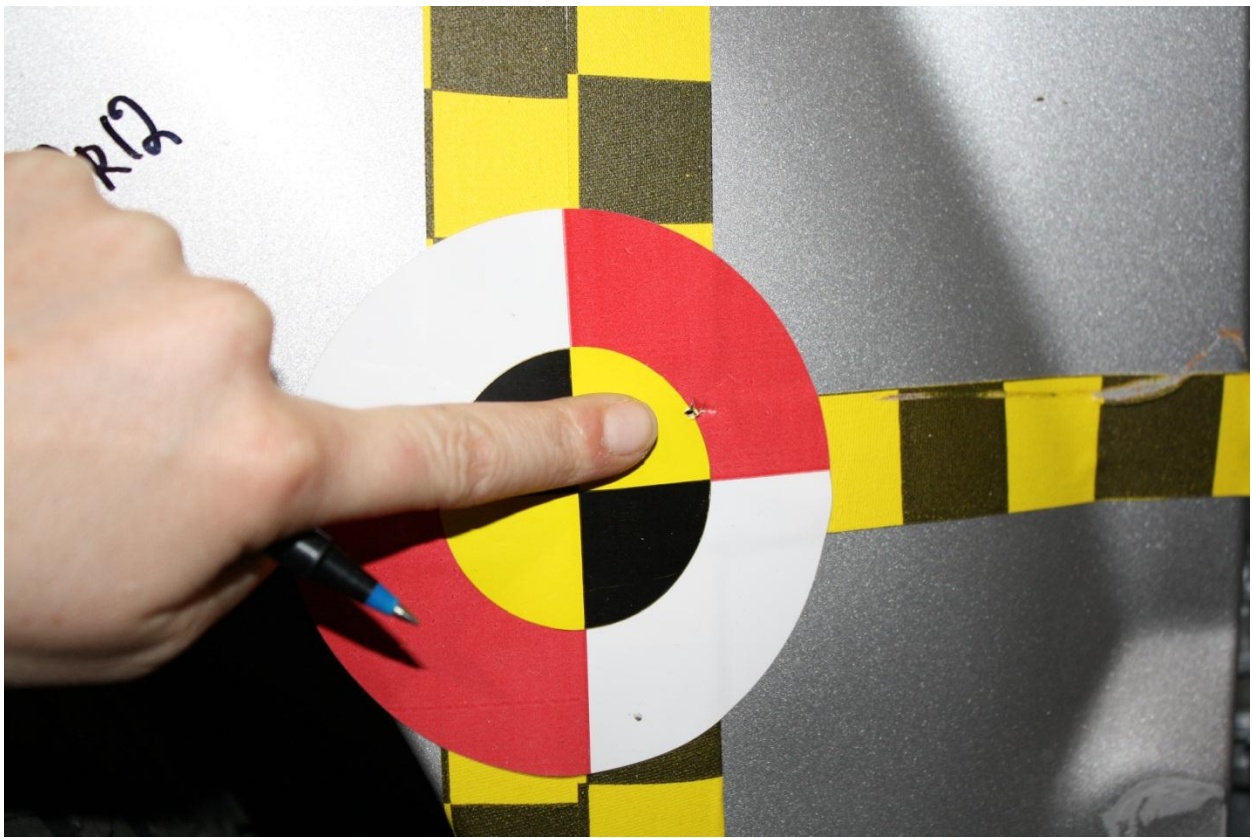
**Figure A-20: Post-Test Close-up View of Impact Point Target**

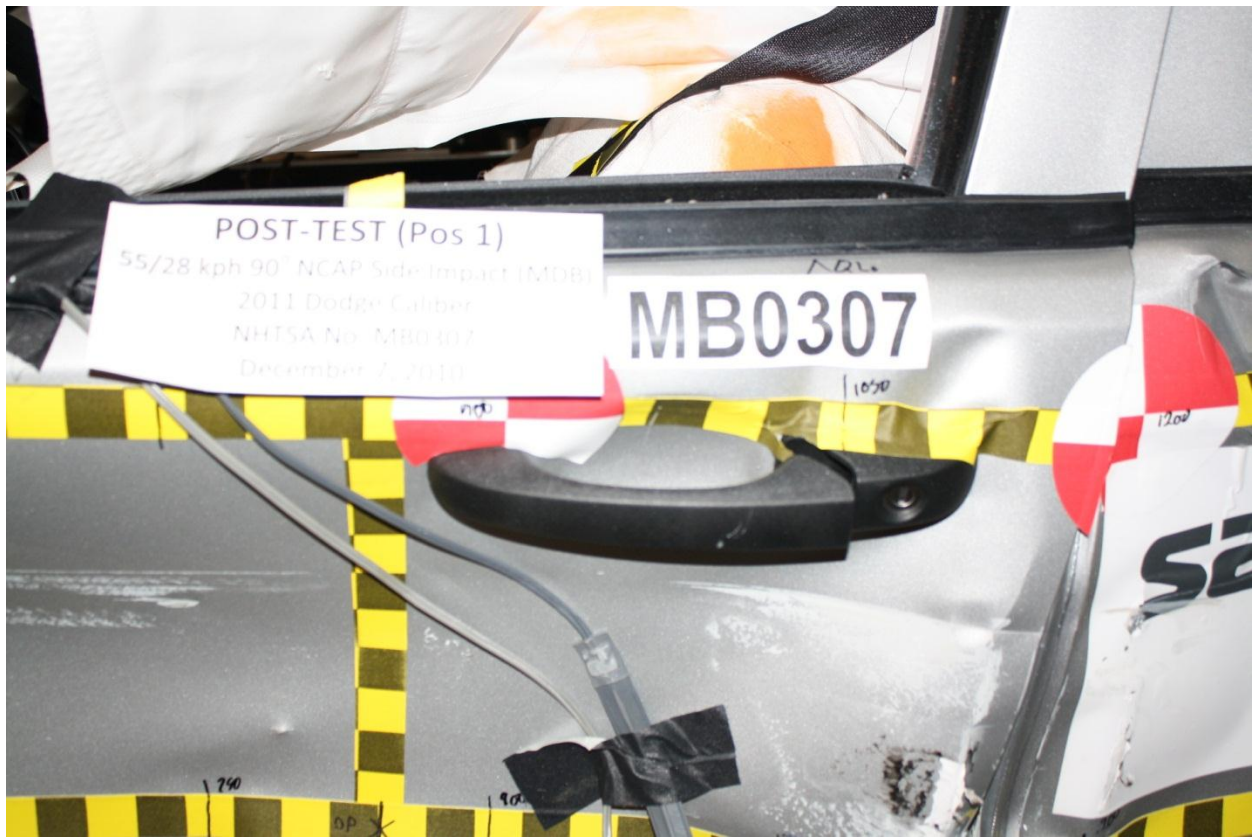
Figure A-22: Post-Test Left Front Door Latch Close-up

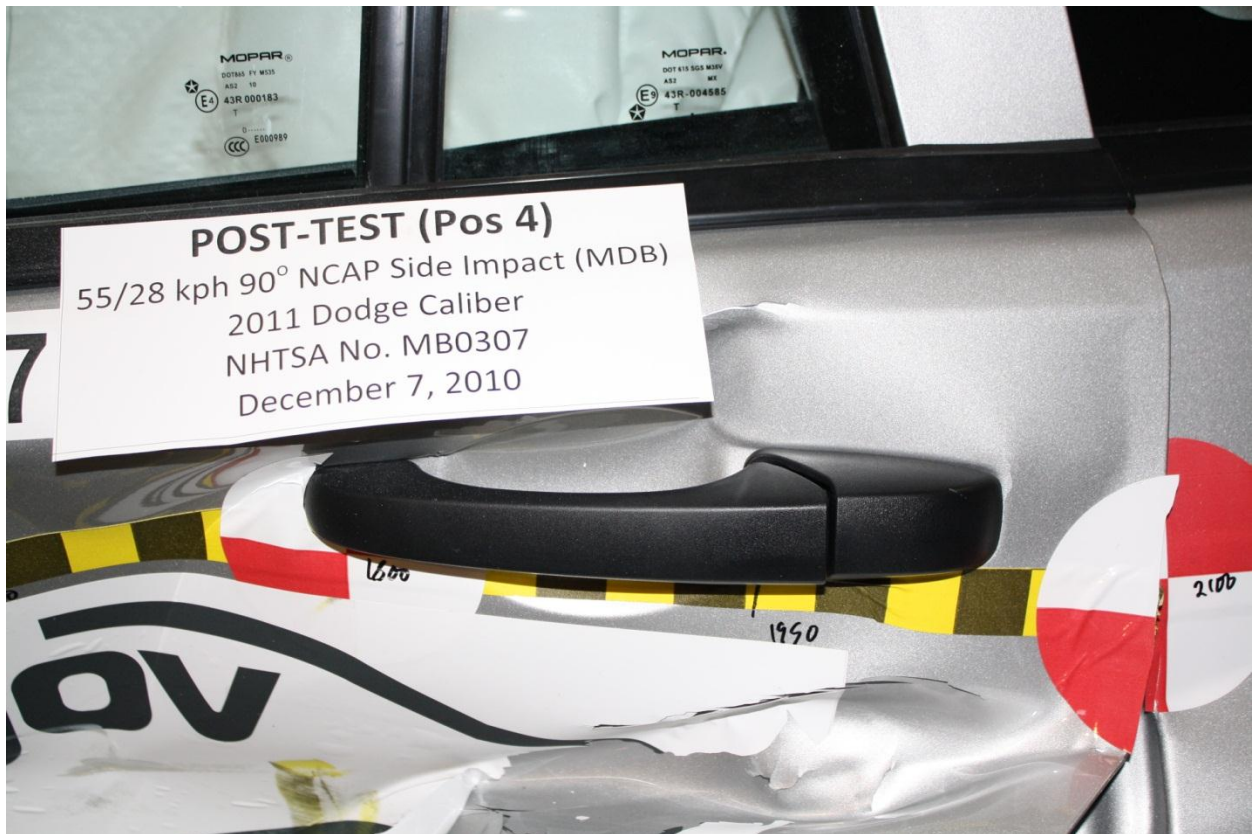
Figure A-24: Post-Test Left Rear Door Latch Close-up

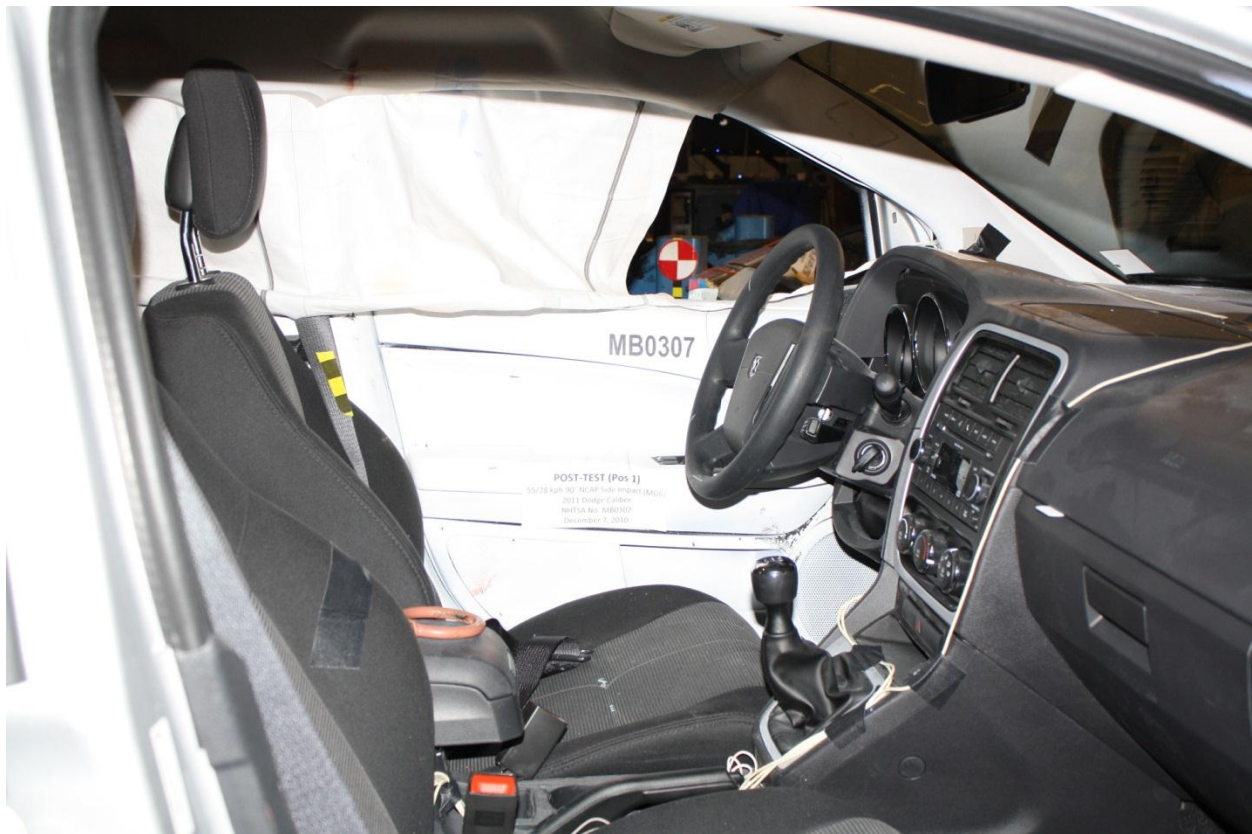
**Figure A-46: Post-test Driver Inner Door Panel View Showing Driver Dummy Contact Locations**

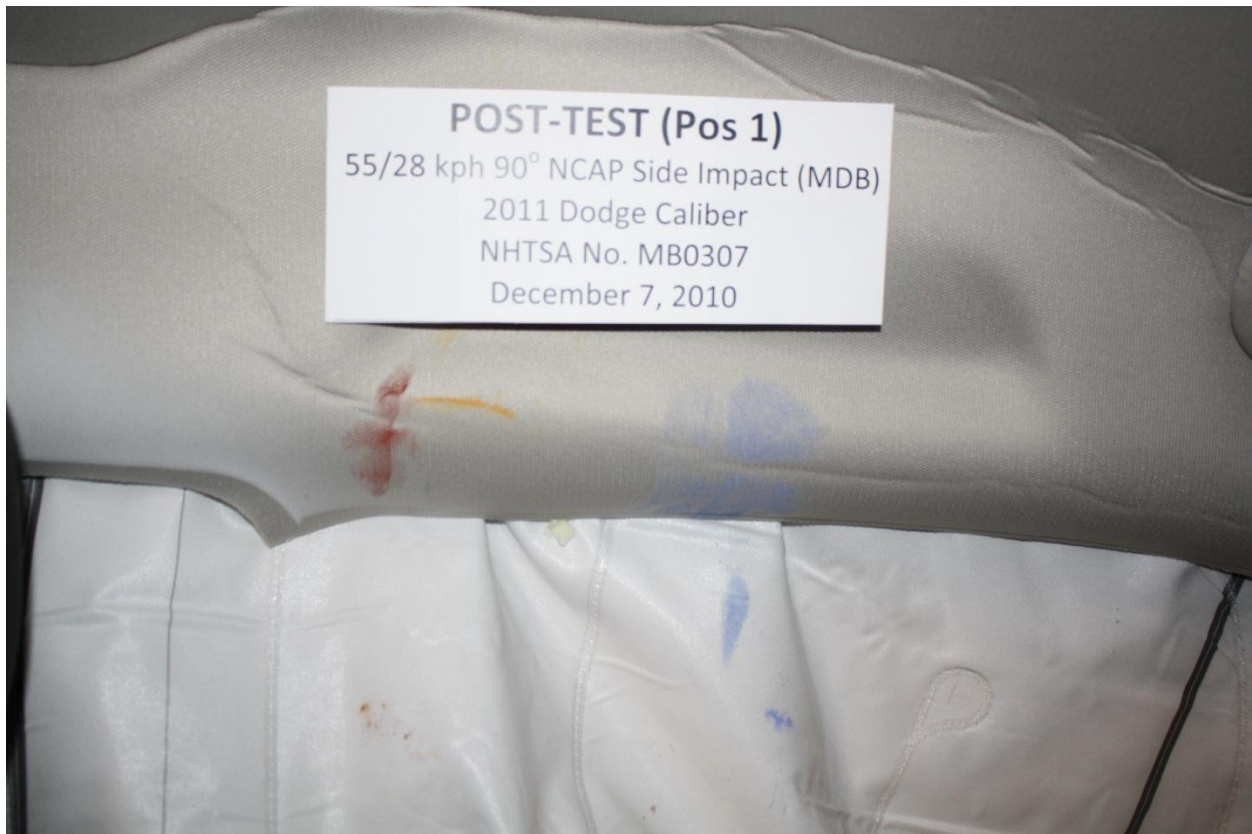
**Figure A-48: Post-test Driver Dummy Close-Up Head Contact with Side Airbag View**

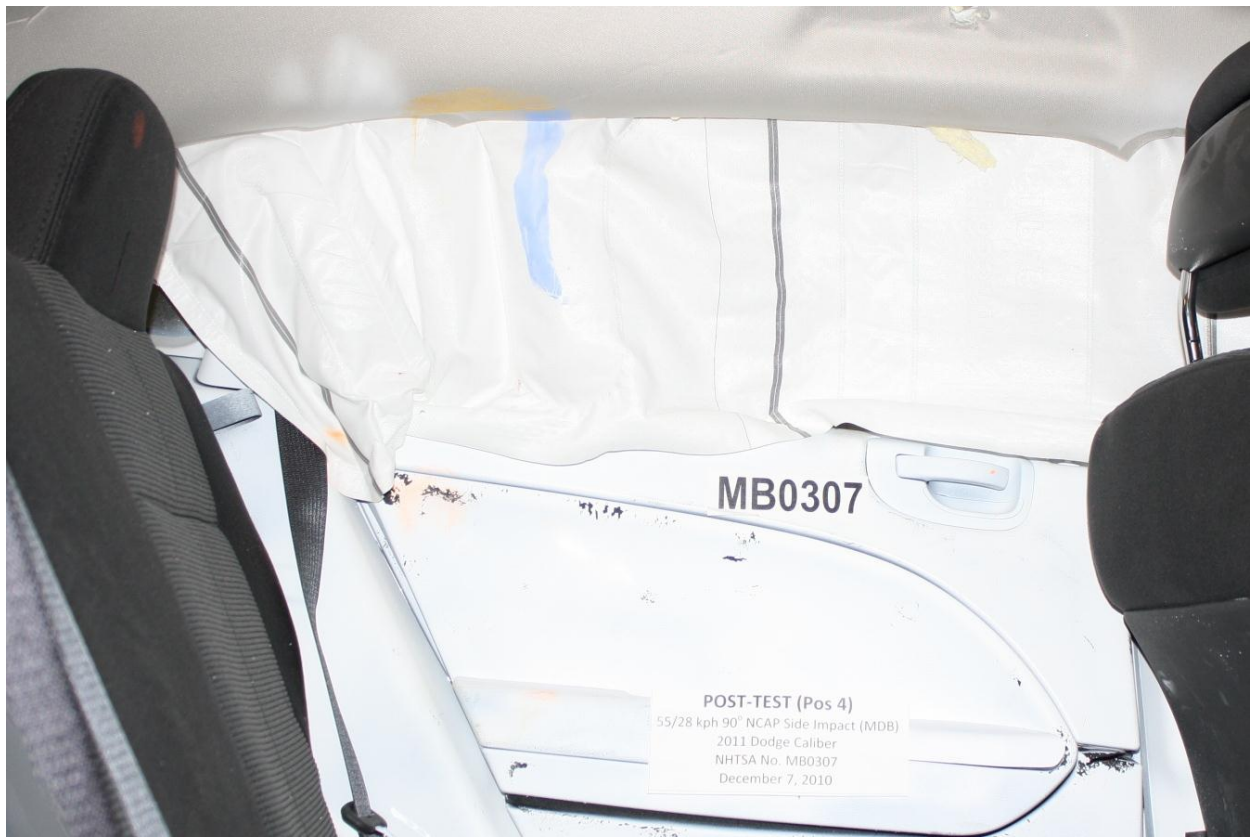
**Figure A-74: Post-test Rear Passenger Dummy Close-Up Head Contact with Side Airbag View**

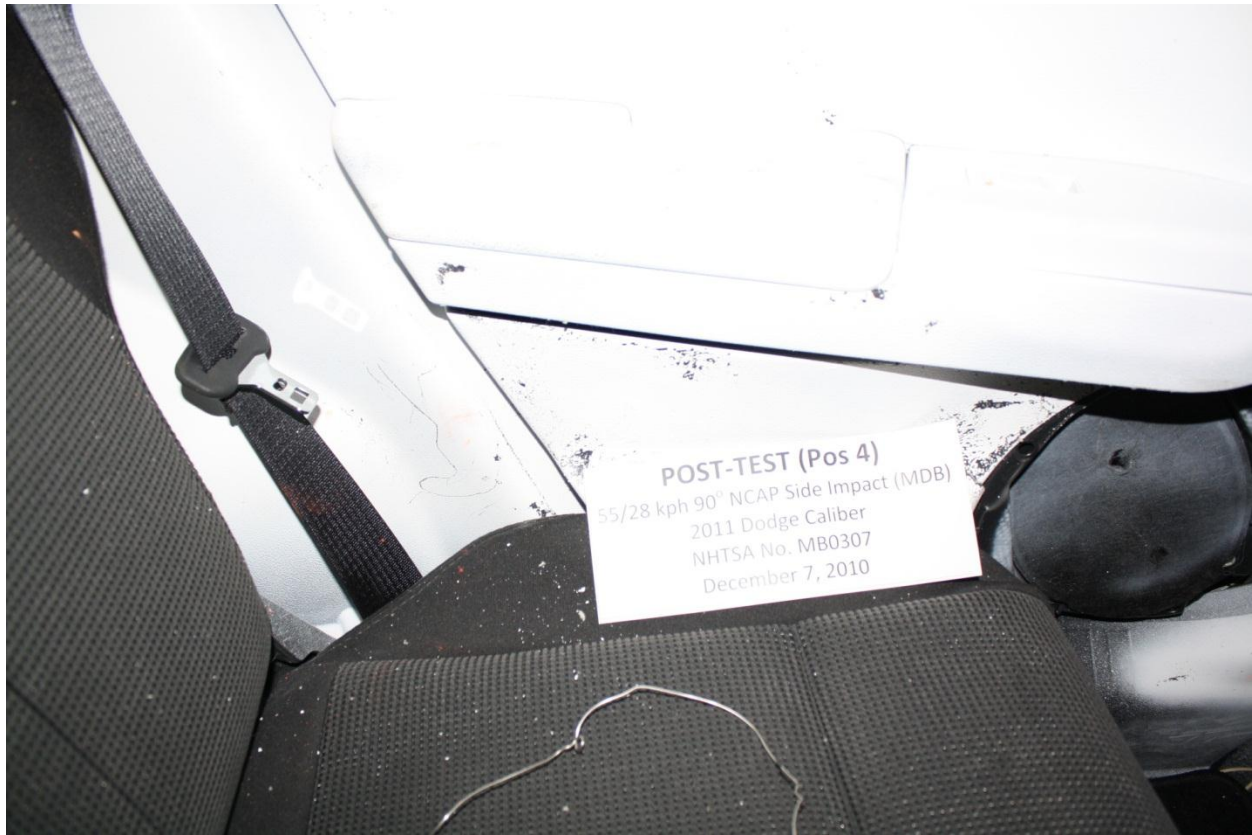
**Figure A-77: Post-Test Rear Passenger Dummy Close-Up Pelvis Contact View**

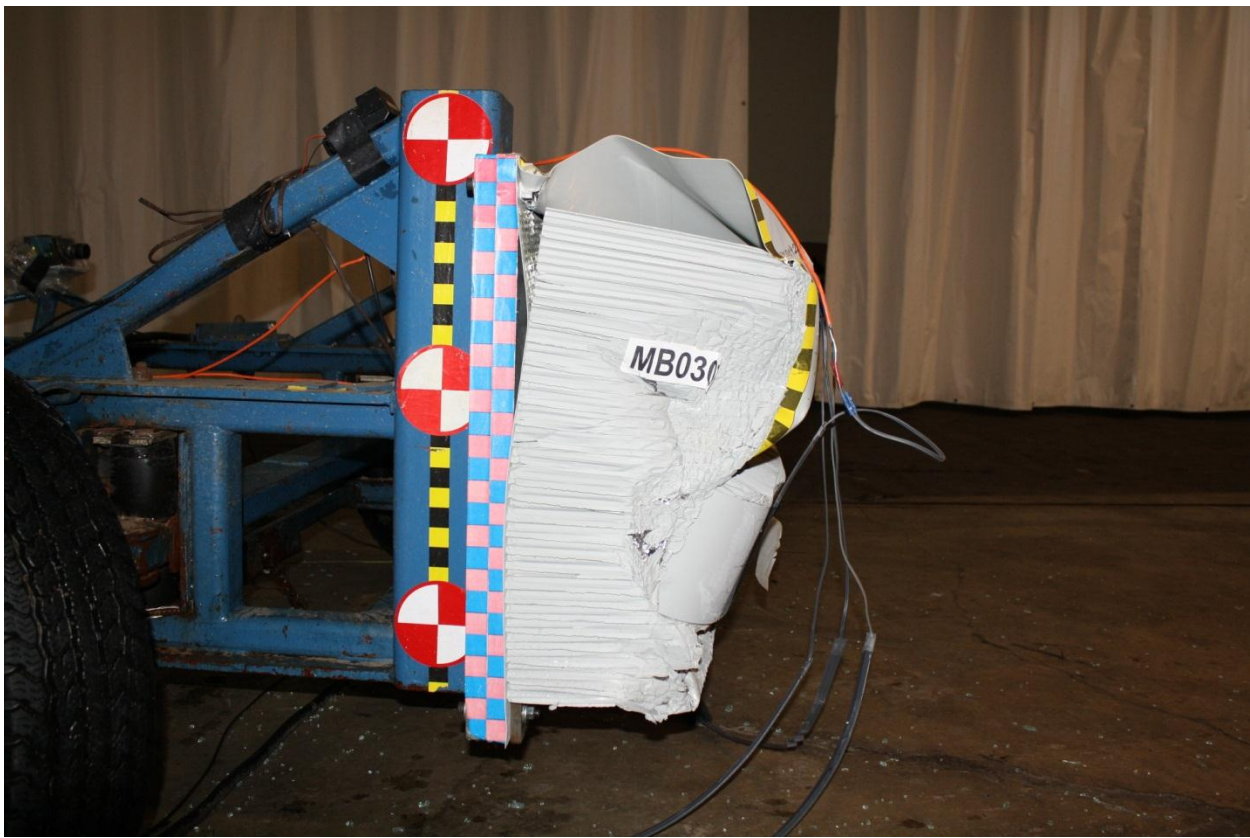
**Figure A-88: Post-Test Right Side View of MDB Impactor Face**

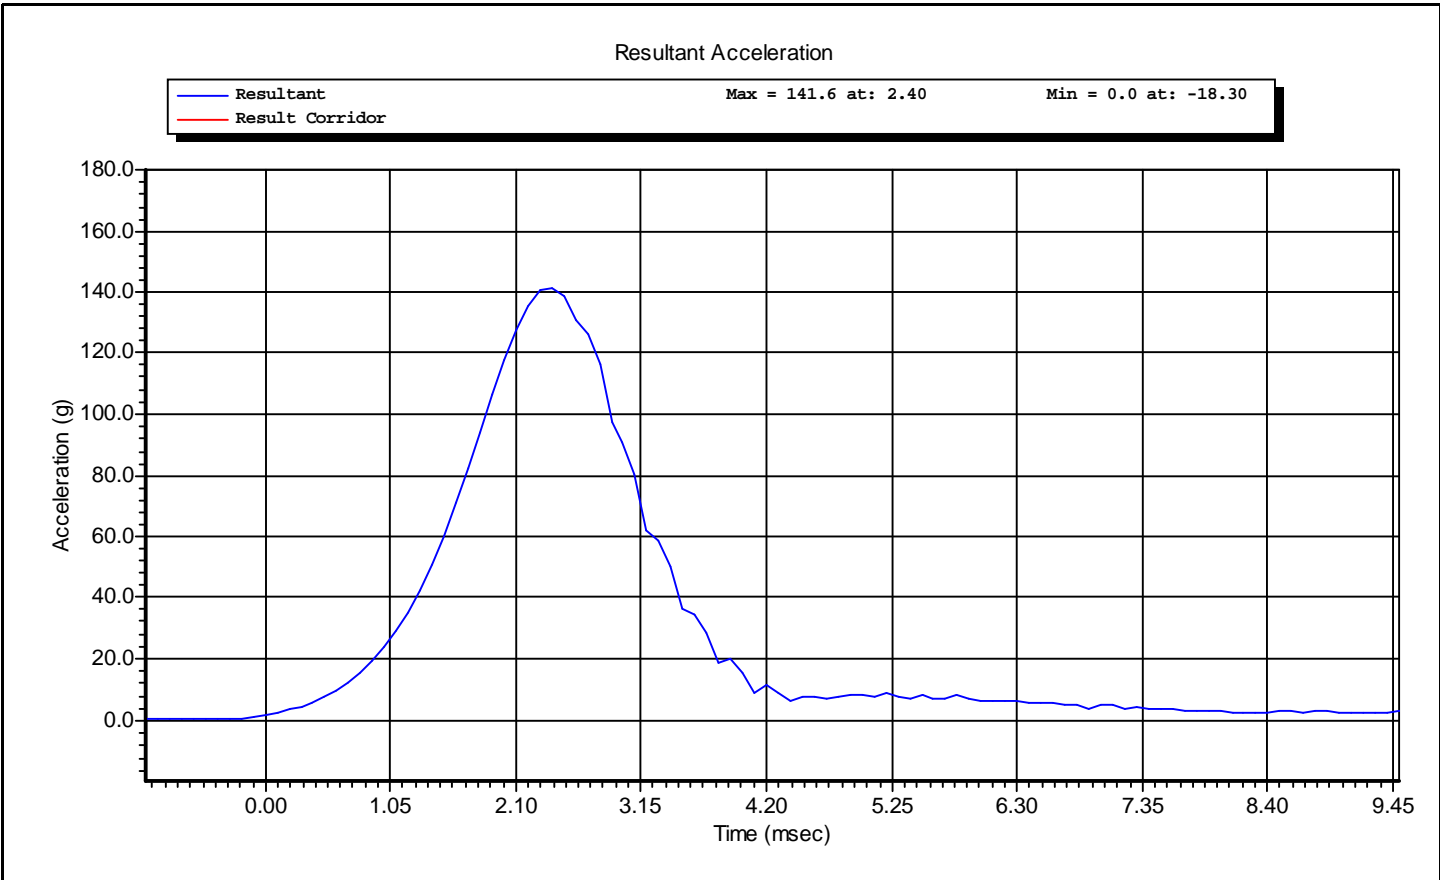
Test Name:	<b>Head Drop</b>	Revision:	<b>12/14/2006</b>
Sub Test Name:		Spec Type:	<b>NHTSA</b>
ATD Type:	<b>ES-2re</b>		
ATD Serial Number:	<b>F033</b>		
Test ID:	<b>Head Drop</b>	Test Date:	<b>11/29/2010</b>
Test Number:	<b>1</b>	Test Time:	<b>10:43:48 AM</b>

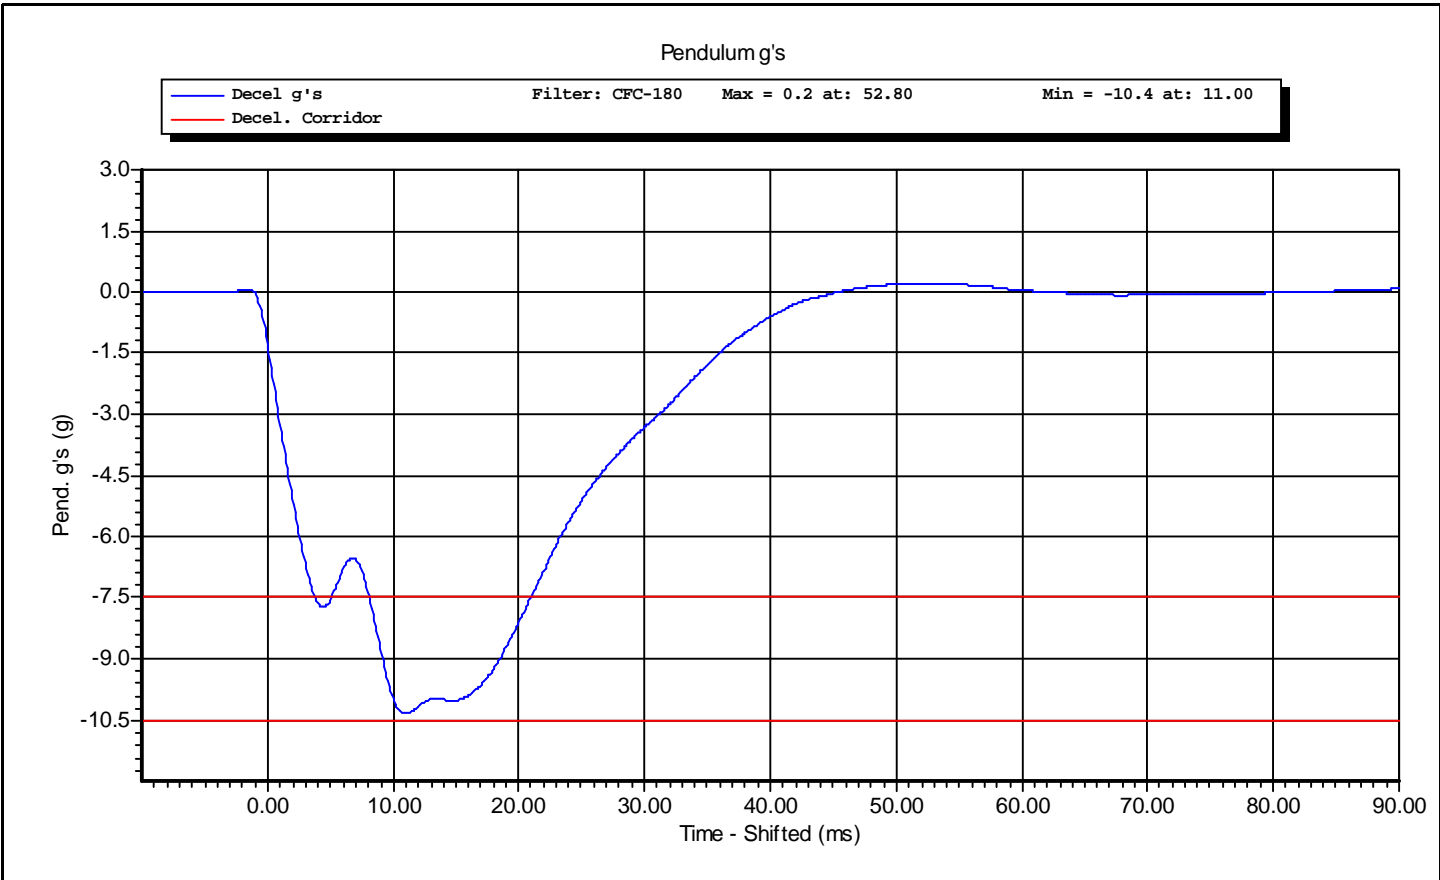
Test ID: **Shoulder**

Test Name:	<b>Shoulder Impact</b>	Revision:	<b>12/14/2006</b>
Sub Test Name:		Spec Type:	<b>NHTSA</b>
ATD Type:	<b>ES-2re</b>		
ATD Serial Number:	<b>F033</b>		
Test ID:	<b>Shoulder</b>	Test Date:	<b>11/30/2010</b>
Test Number:	<b>1</b>	Test Time:	<b>11:42:33 AM</b>
