**REPORT NUMBER: NCAP-MGA-2011-054**

**NEW CAR ASSESSMENT PROGRAM (NCAP)  
Frontal Barrier Impact Test**

**VOLKSWAGEN DE MEXICO S.A. DE C.V.  
2011 Volkswagen Jetta S 4-Dr Sedan  
NHTSA No.: MB5805**

**FINAL REPORT**

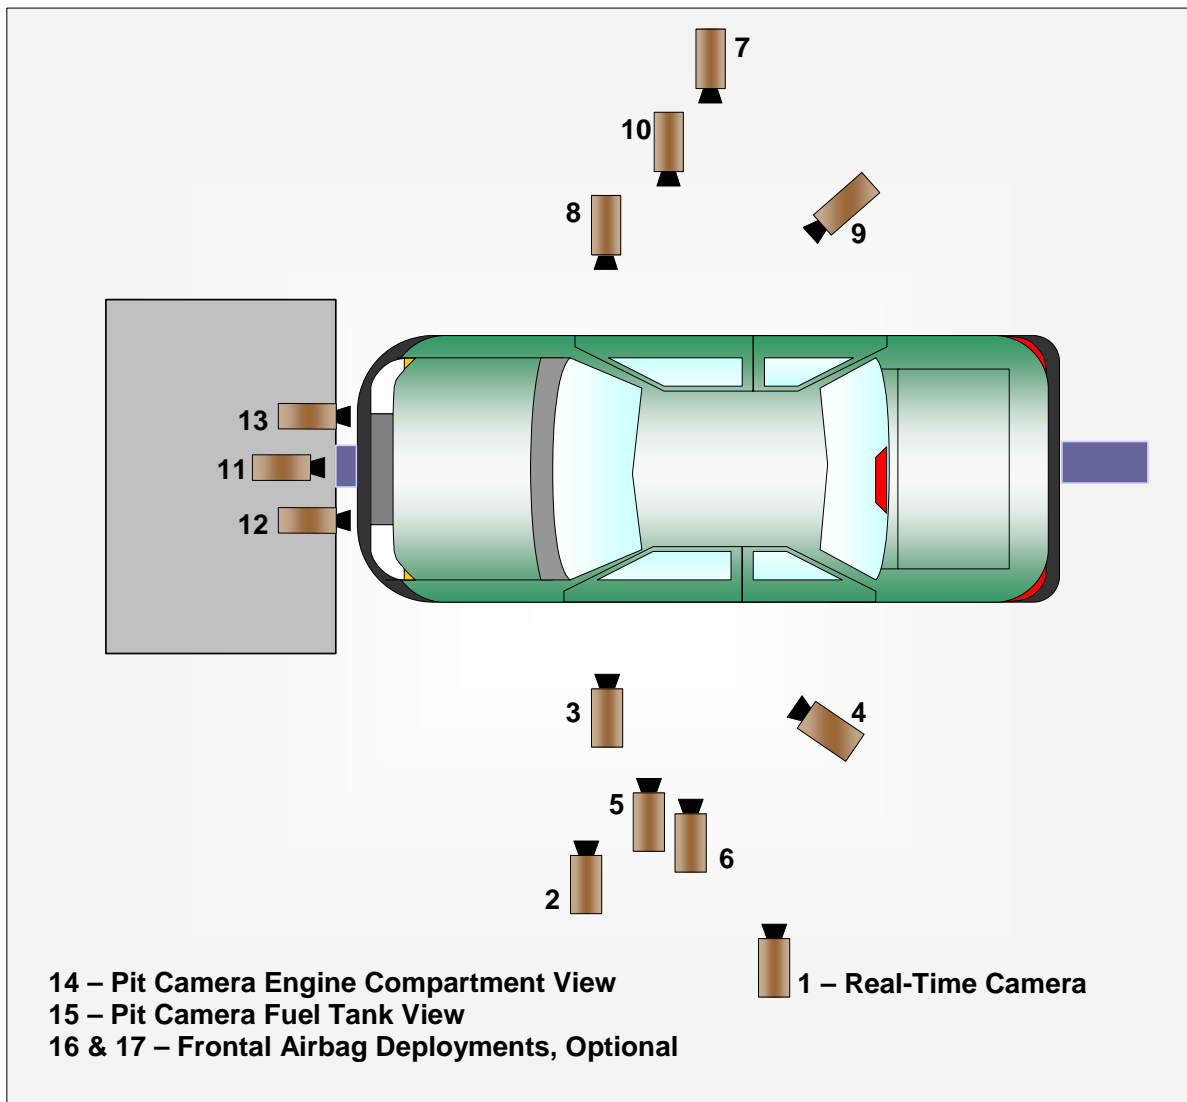
CAMERA POSITIONS FOR FRONTAL IMPACTS

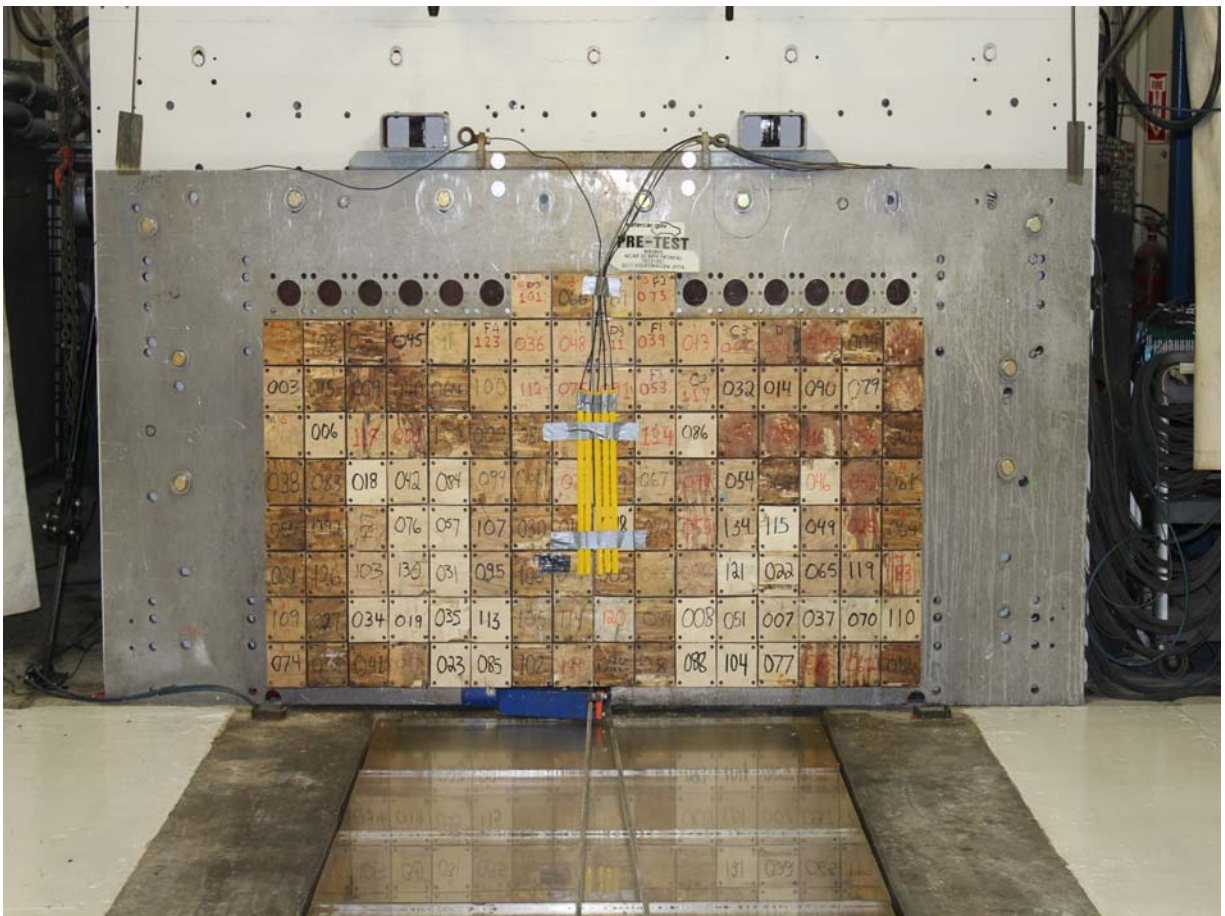
Load Cell Wall

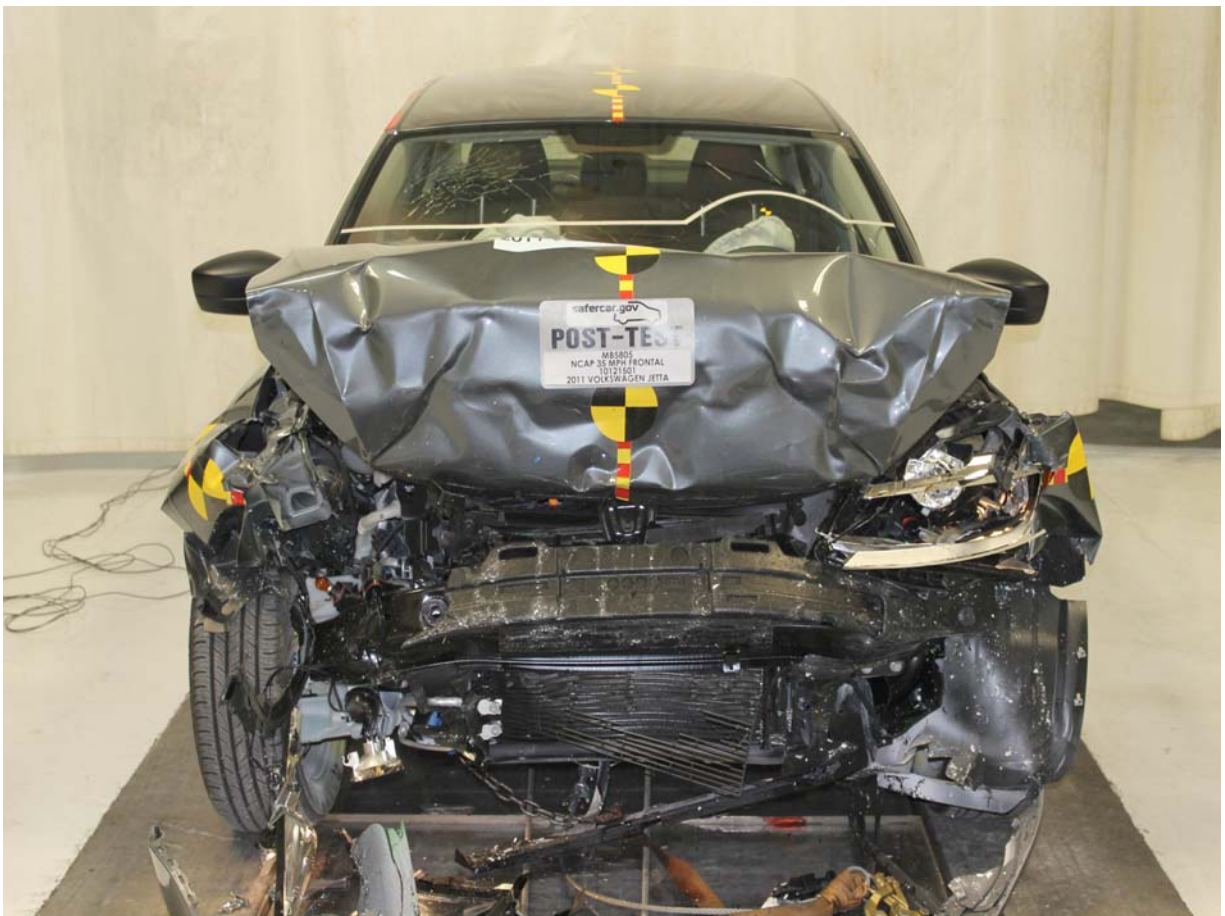
Post-Test Front View

The maximum static crush of the vehicle was 441 mm and both the driver and passenger side doors remained closed during the impact event and were operable after the impact.

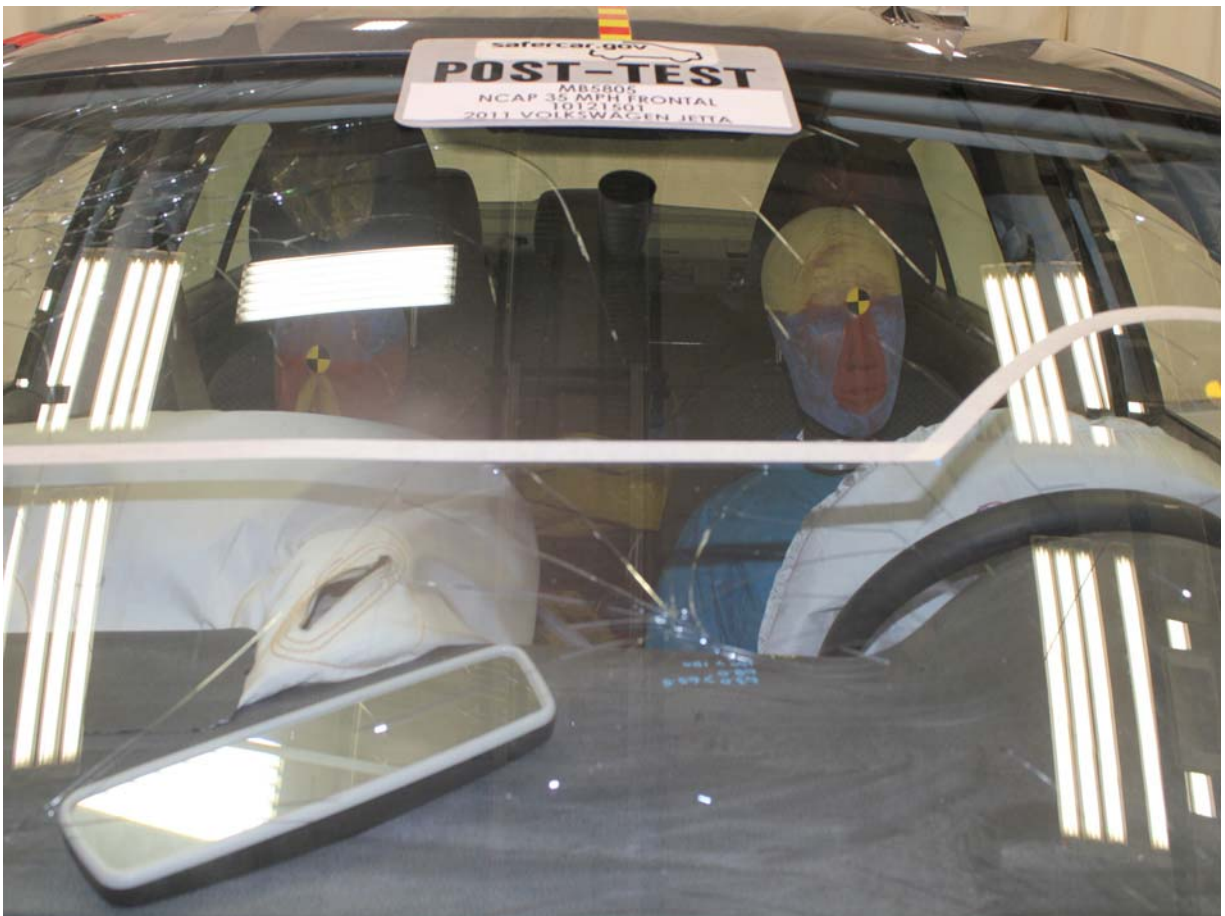
Post-Test Windshield View

There was 100 percent windshield retention and no intrusion into the protected zone of the windshield during the event. There was no Stoddard Solvent leakage after the event or during any phase of the static rollover.

| Critical Areas of Performance | Observations and Conclusions |
|---|---|
| Windshield Damage | Cracked |

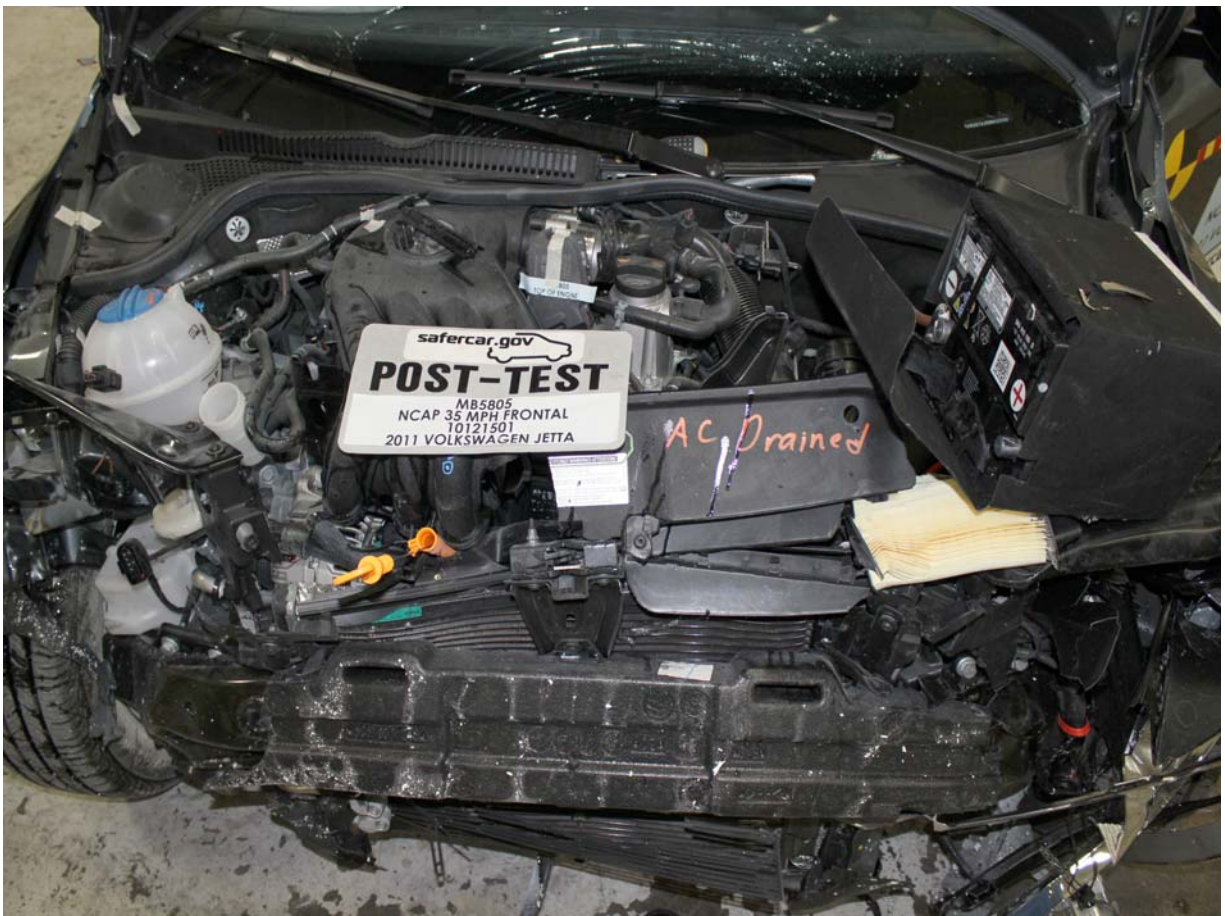
Post-Test Engine Compartment View

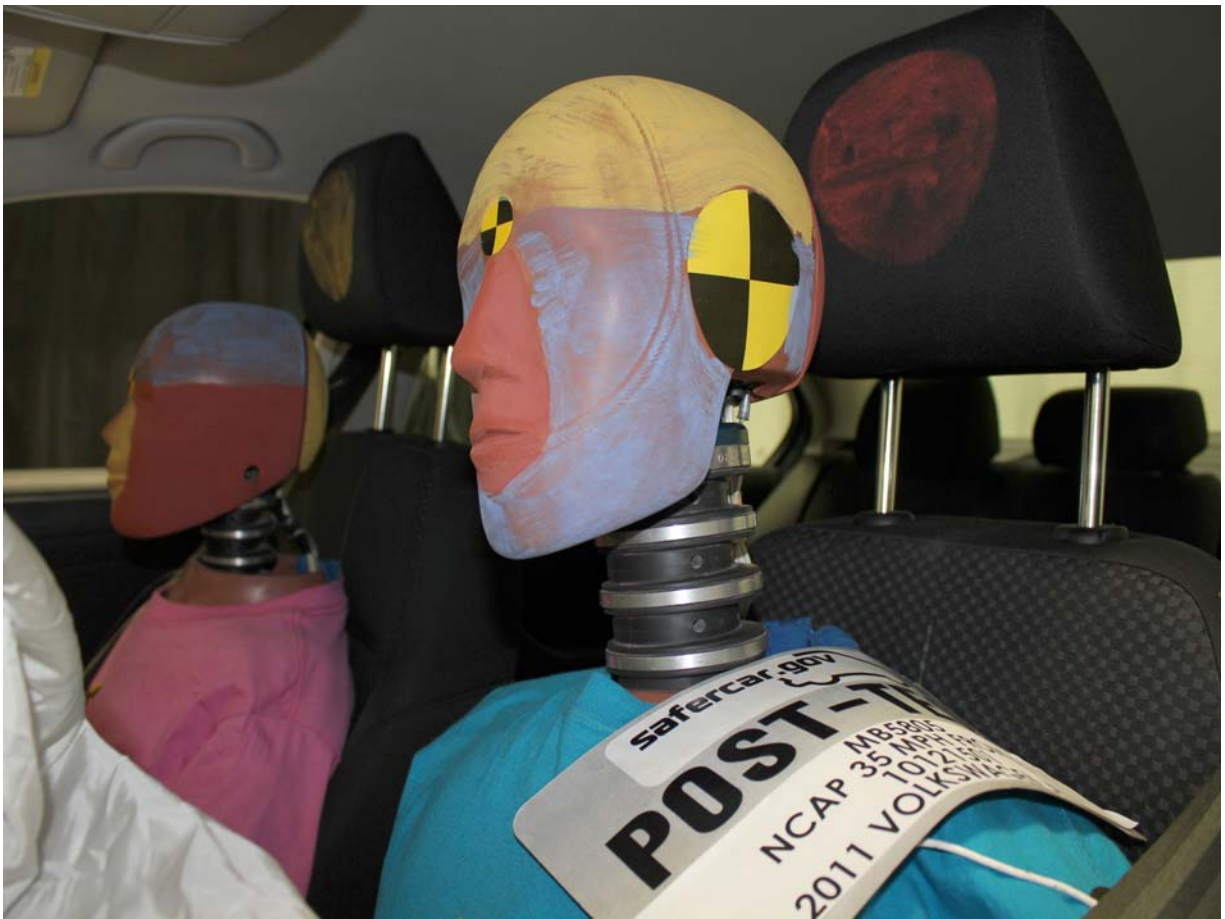
Post-Test Driver Dummy Contact with Headrest

The driver's head and chest contacted the airbag. The driver's head also contacted the headrest. The driver's knees contacted the knee bolster. The passenger's head and chest contacted the airbag. The passenger's head also contacted the headrest. The passenger's knees contacted the glovebox.

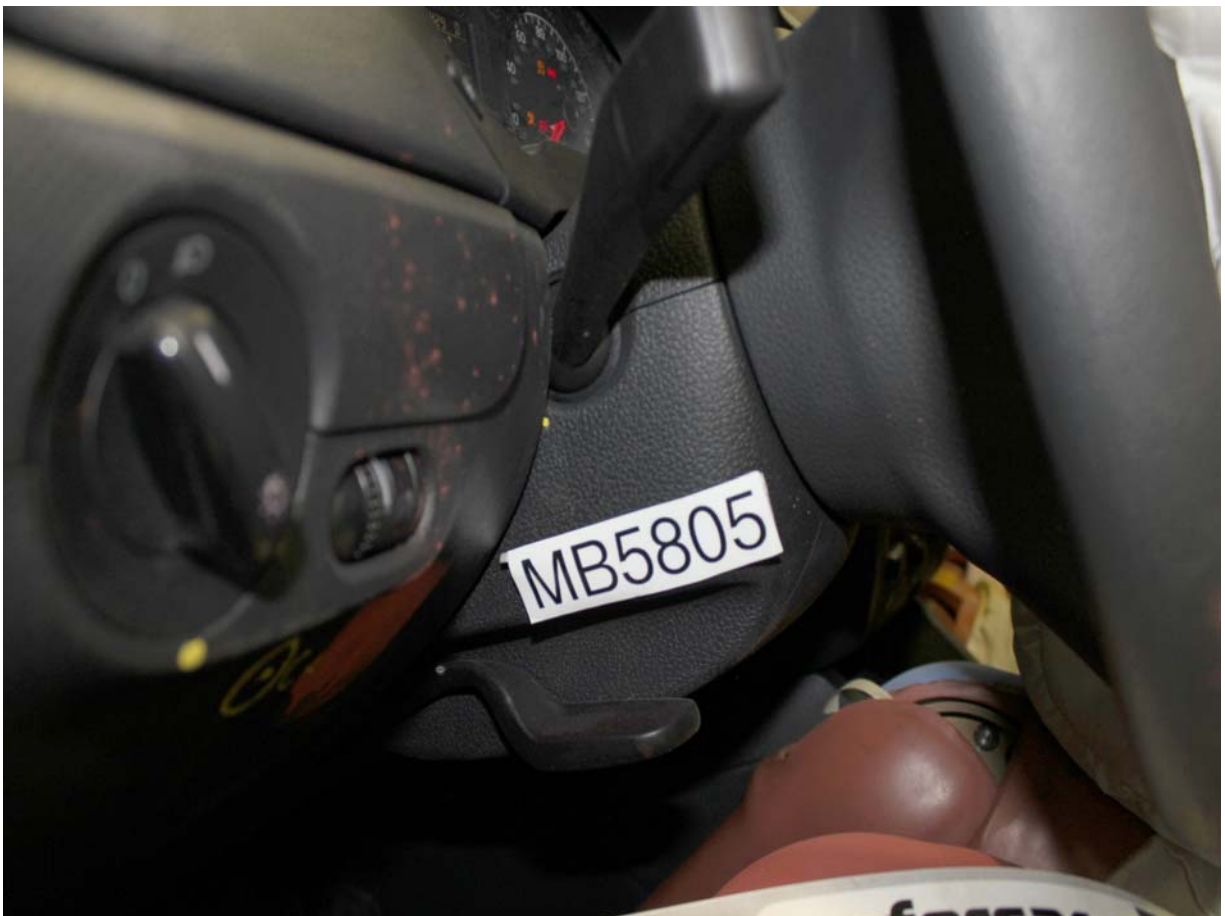
Post-Test View of Steering Column Shear Capsule

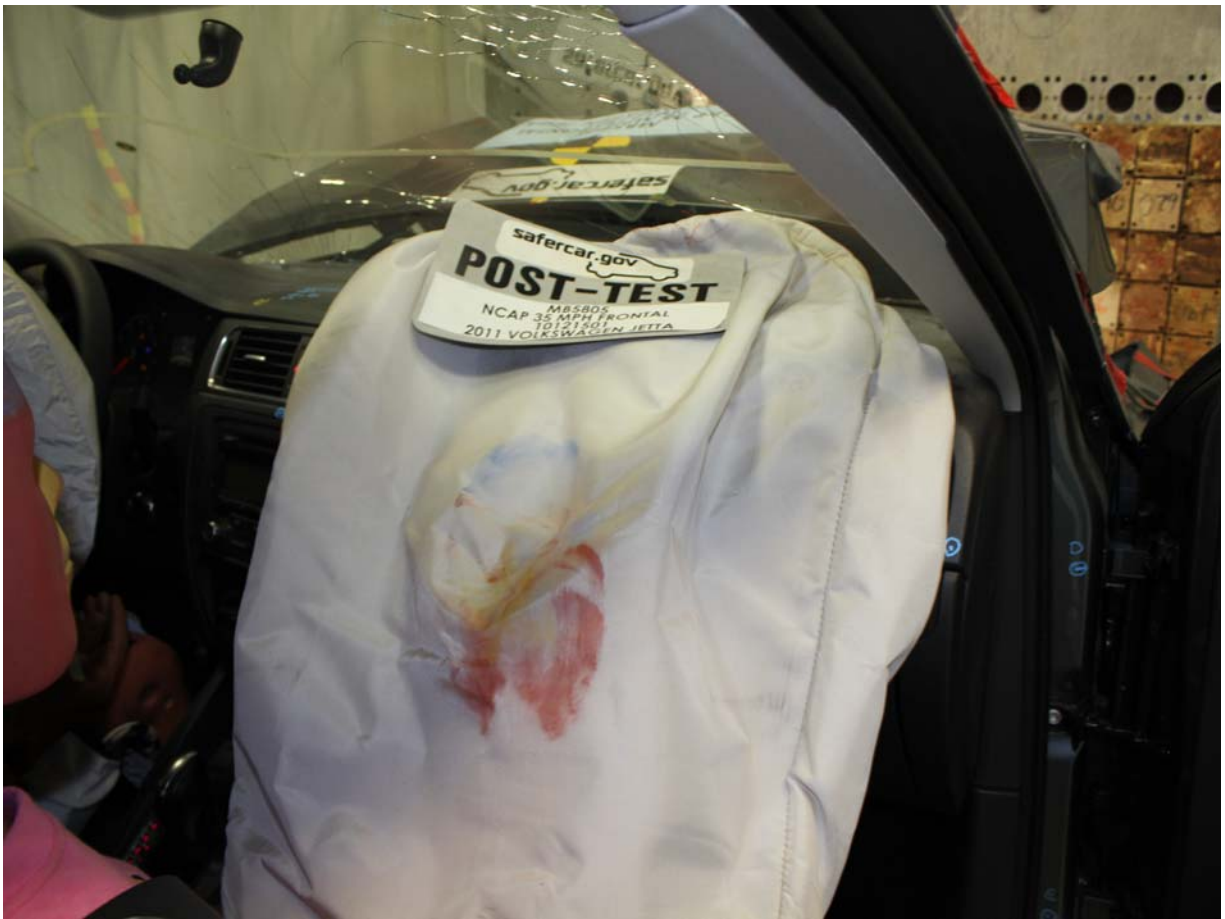
Post-Test Passenger Dummy Contact with Airbag

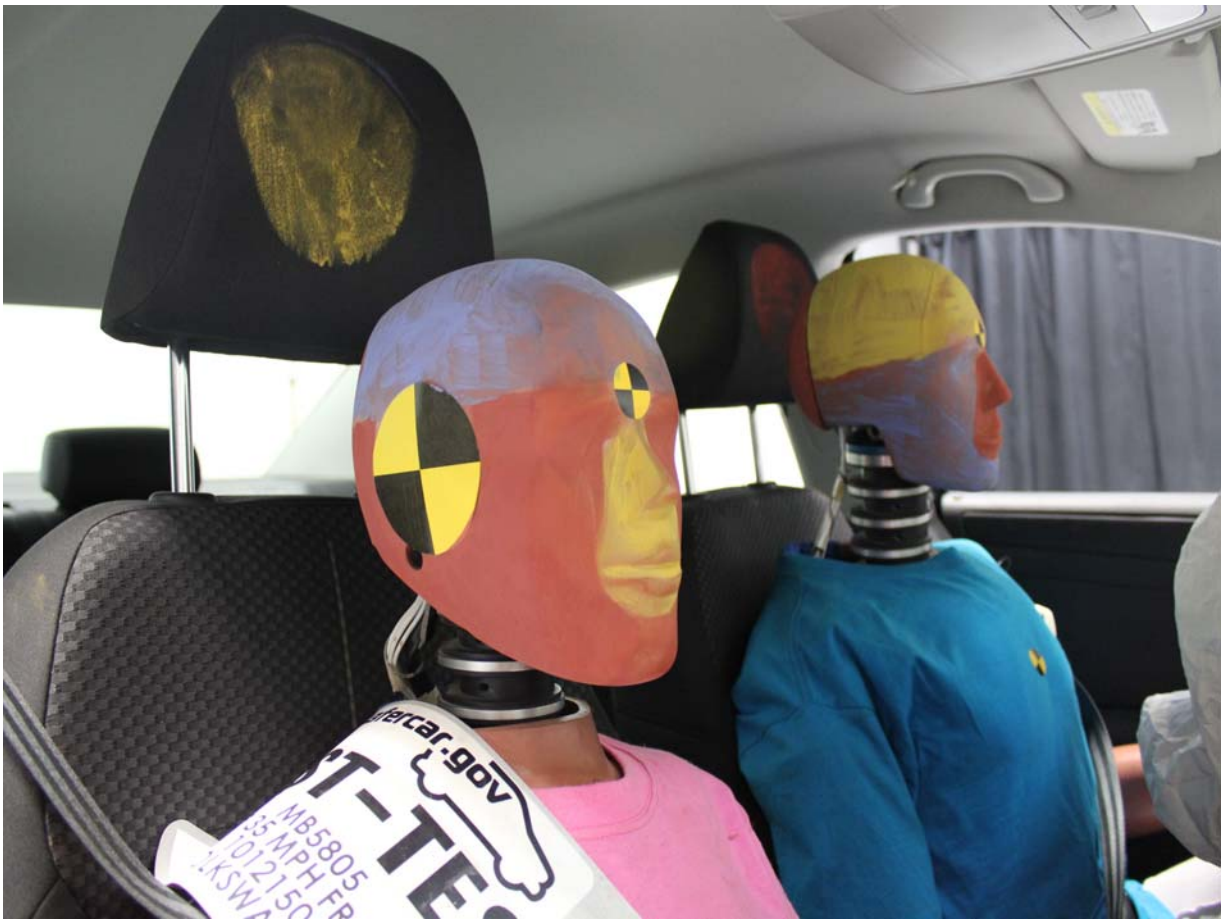
Post-Test Passenger Dummy Contact with Headrest

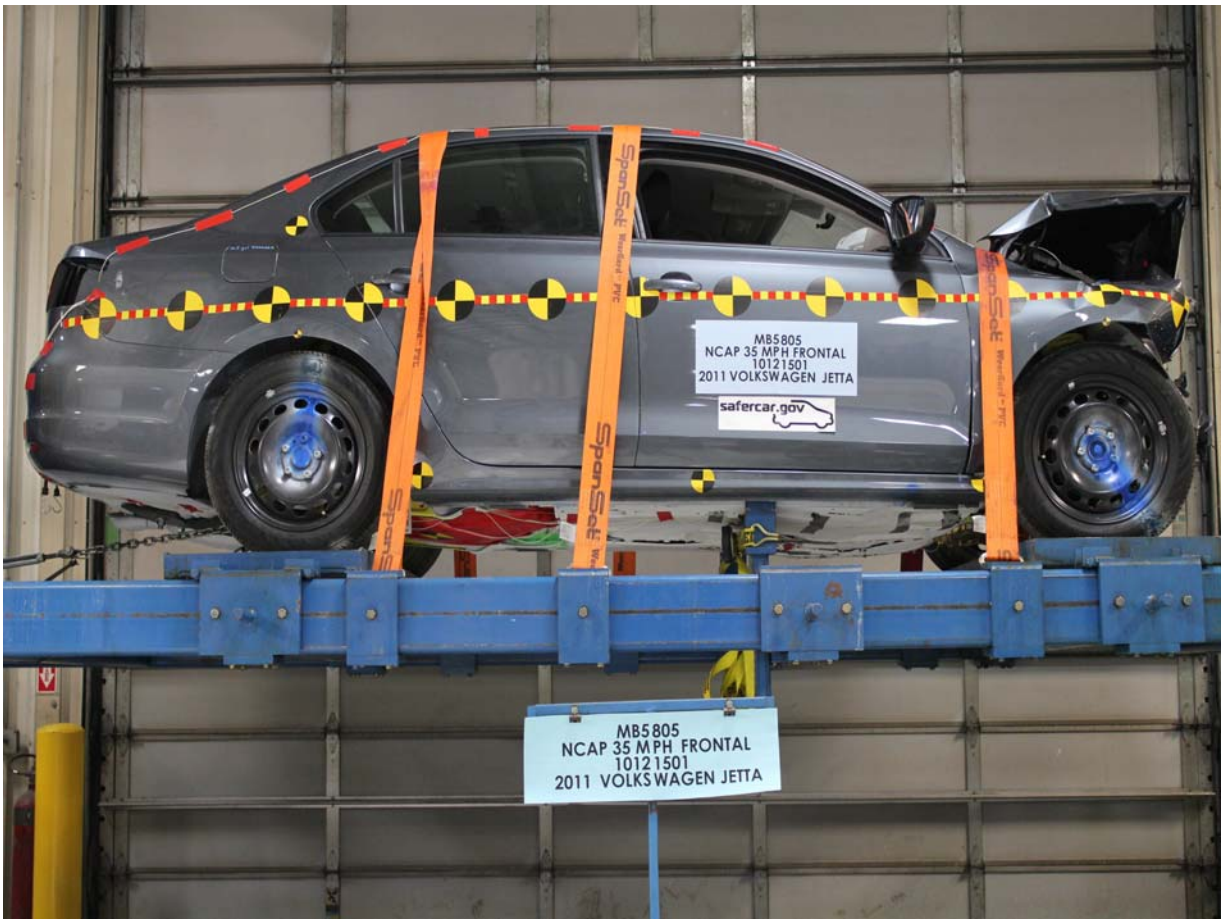
Vehicle at 0 Degrees on Static Rollover Device

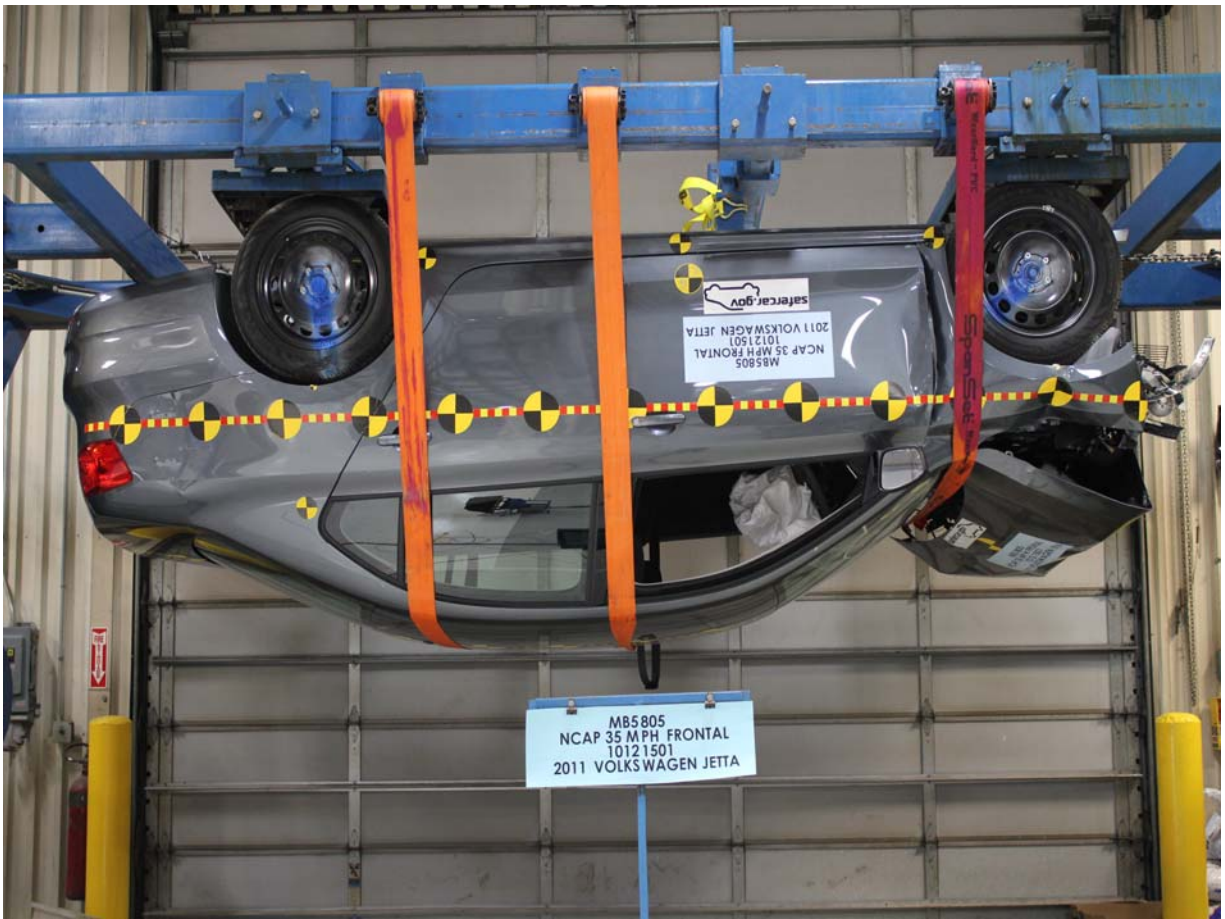
Vehicle at 180 Degrees on Static Rollover Device

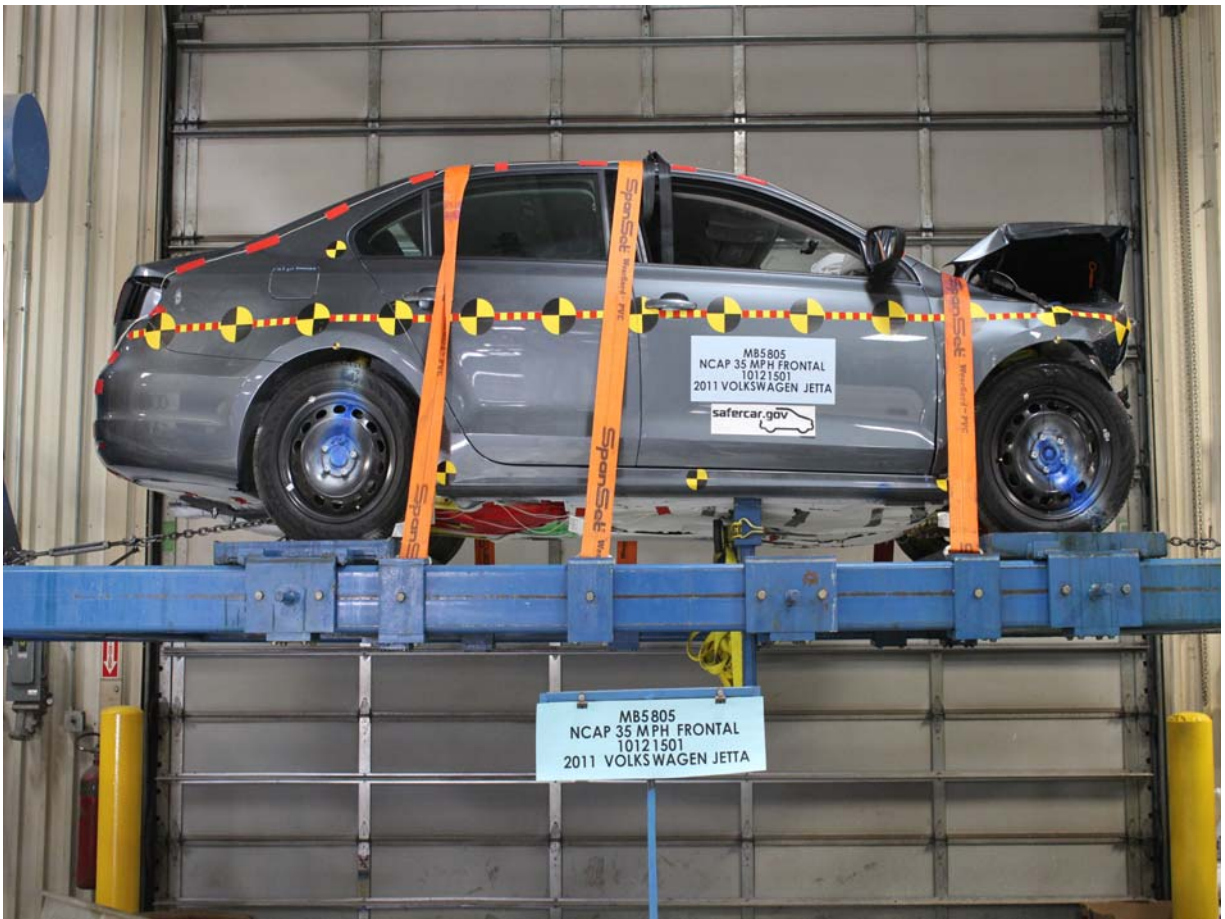
Vehicle at 360 Degrees on Static Rollover Device

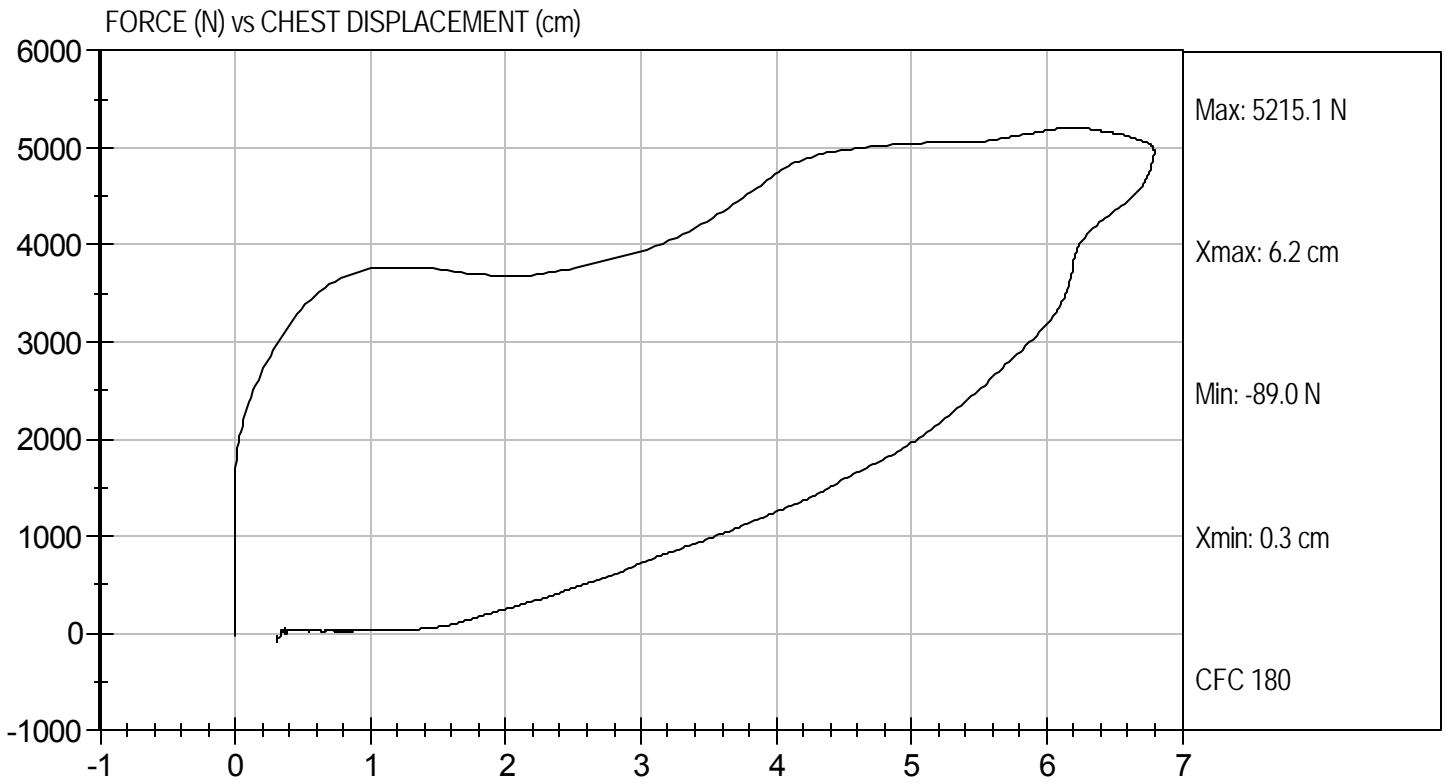
Test Desc: Thorax Impact  
Component ID: D104384

Test Date: 12/13/10  
Velocity: 22.22 ft/s, 6.77 m/s

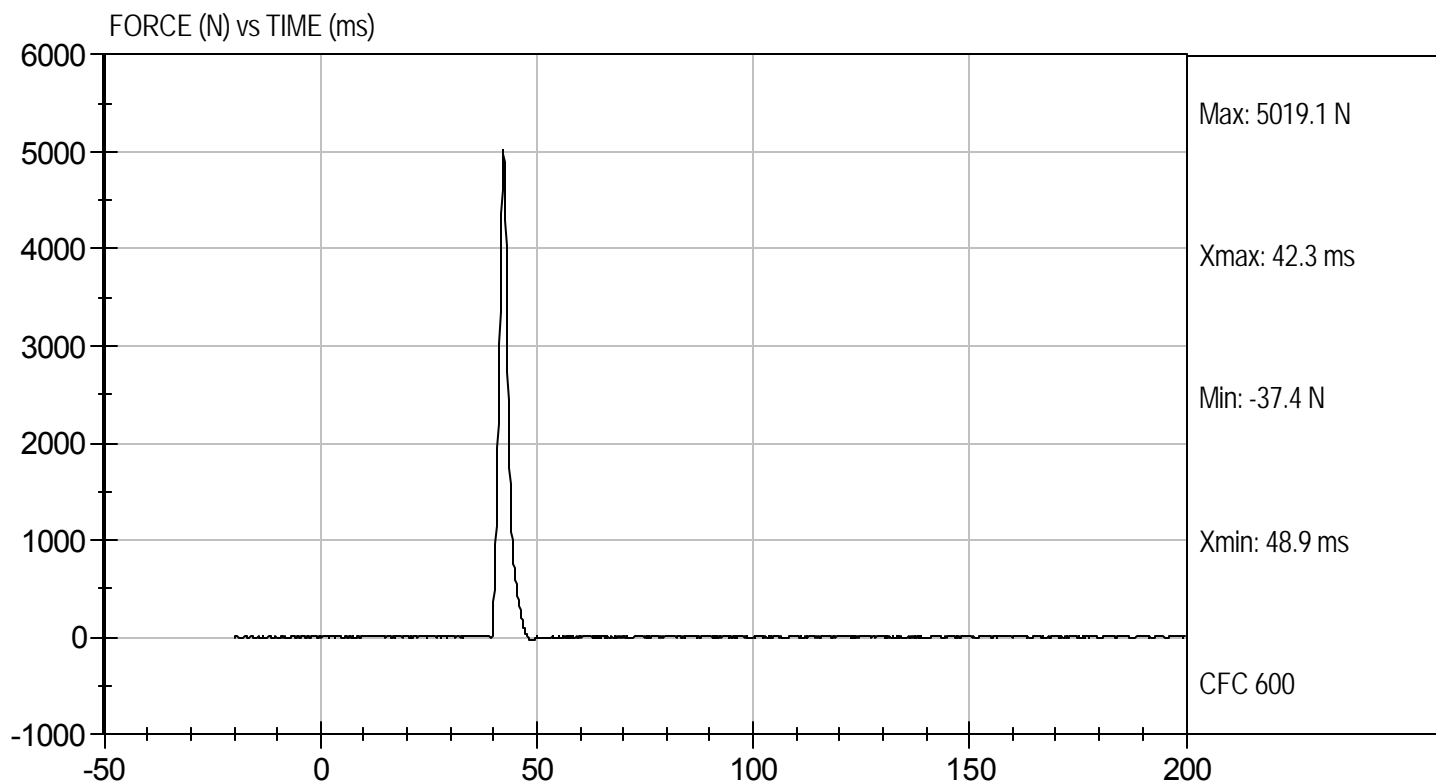
Test Desc: Right Knee  
Component ID: D104385

Test Date: 12/13/10  
Velocity: 6.86 ft/s, 2.09 m/s

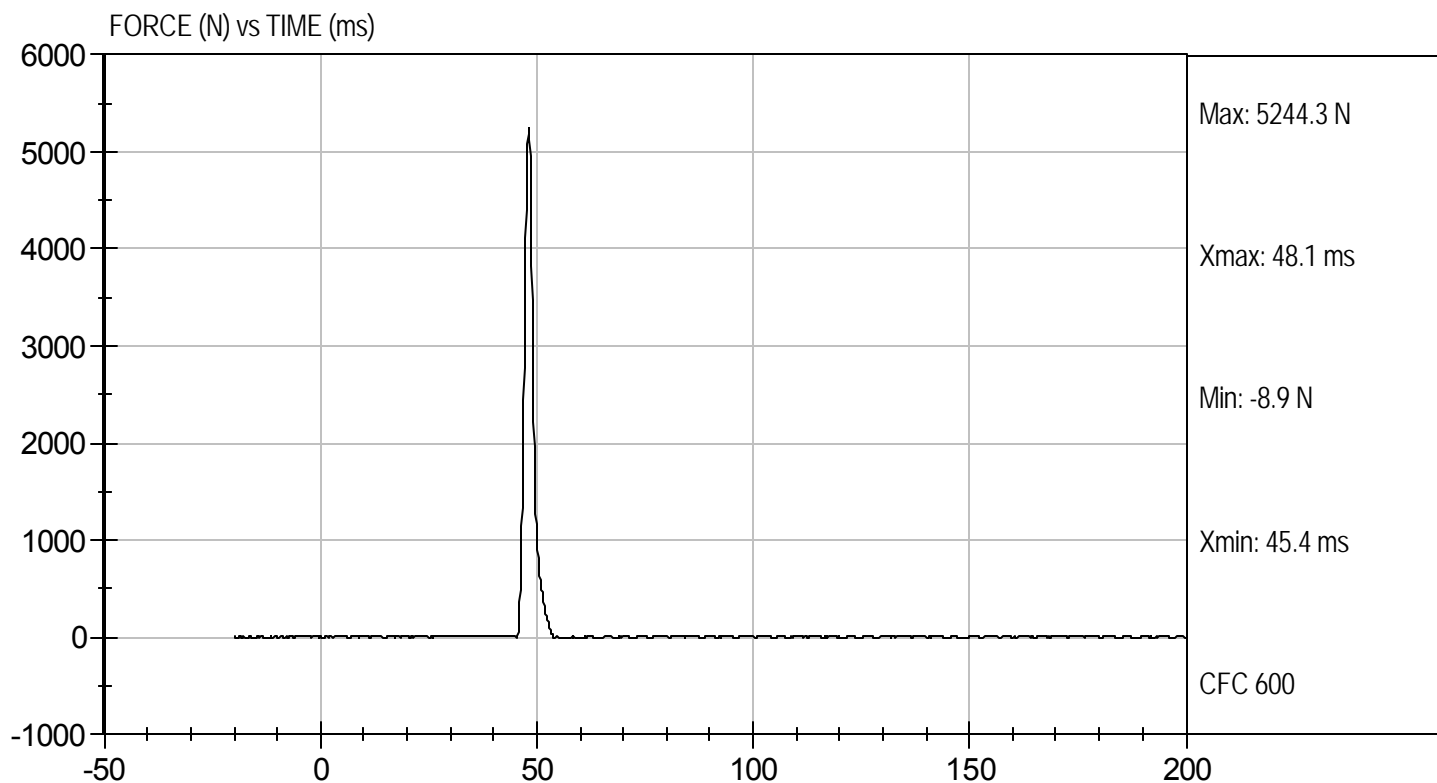
Test Desc: Left Knee  
Component ID: D104386

Test Date: 12/13/10  
Velocity: 6.86 ft/s, 2.09 m/s

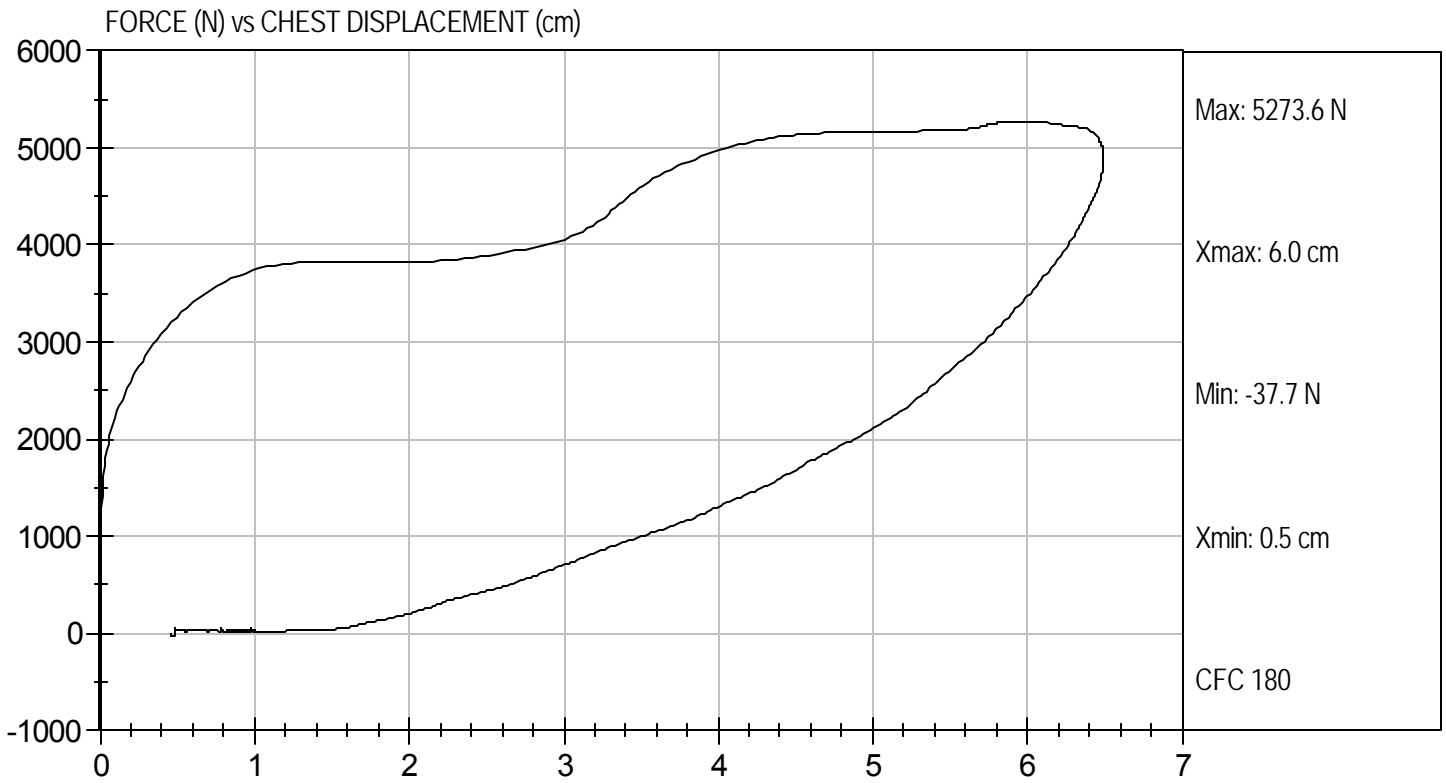
Test Desc: Thorax Impact  
Component ID: D104444

Test Date: 12/16/10  
Velocity: 21.64 ft/s, 6.60 m/s

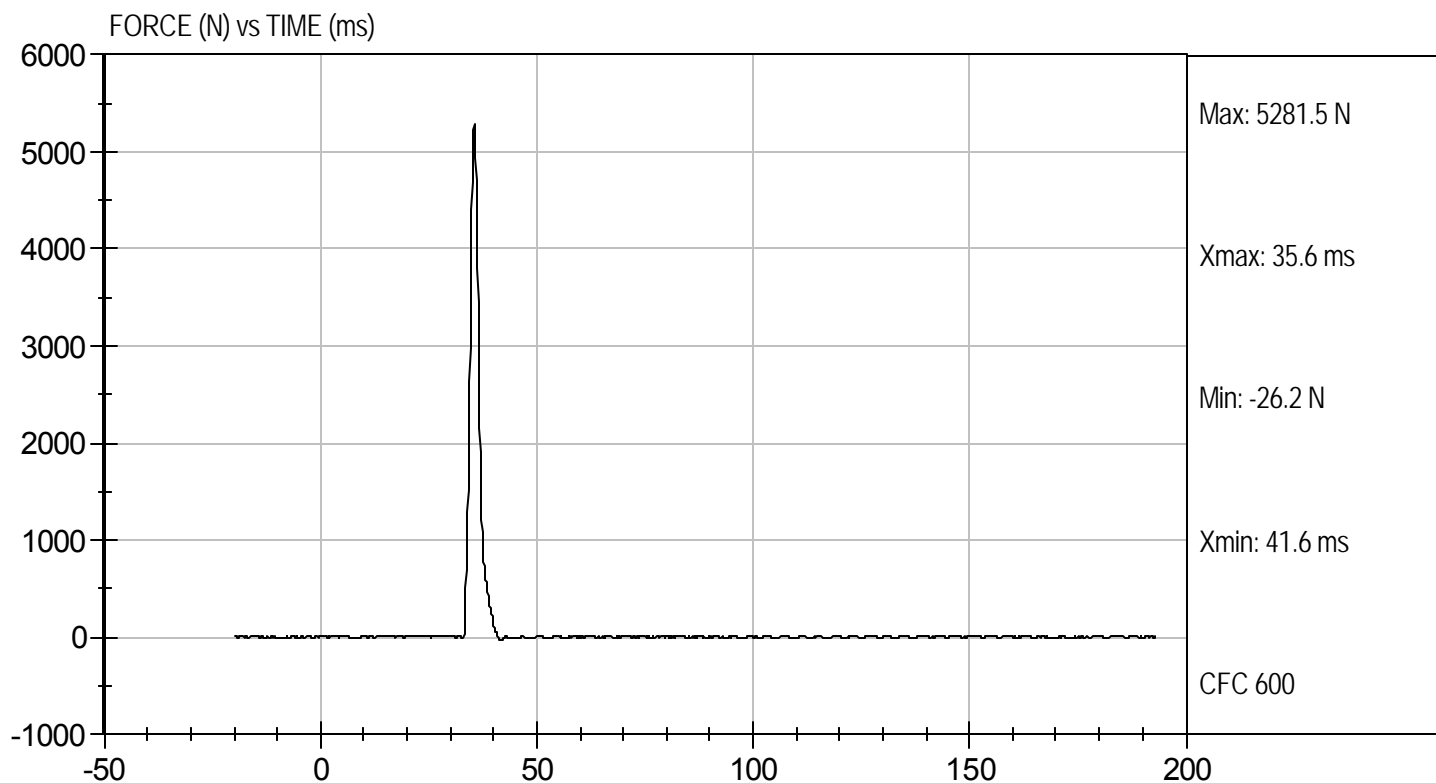
Test Desc: Right Knee  
Component ID: D104445

Test Date: 12/15/10  
Velocity: 6.94 ft/s, 2.12 m/s

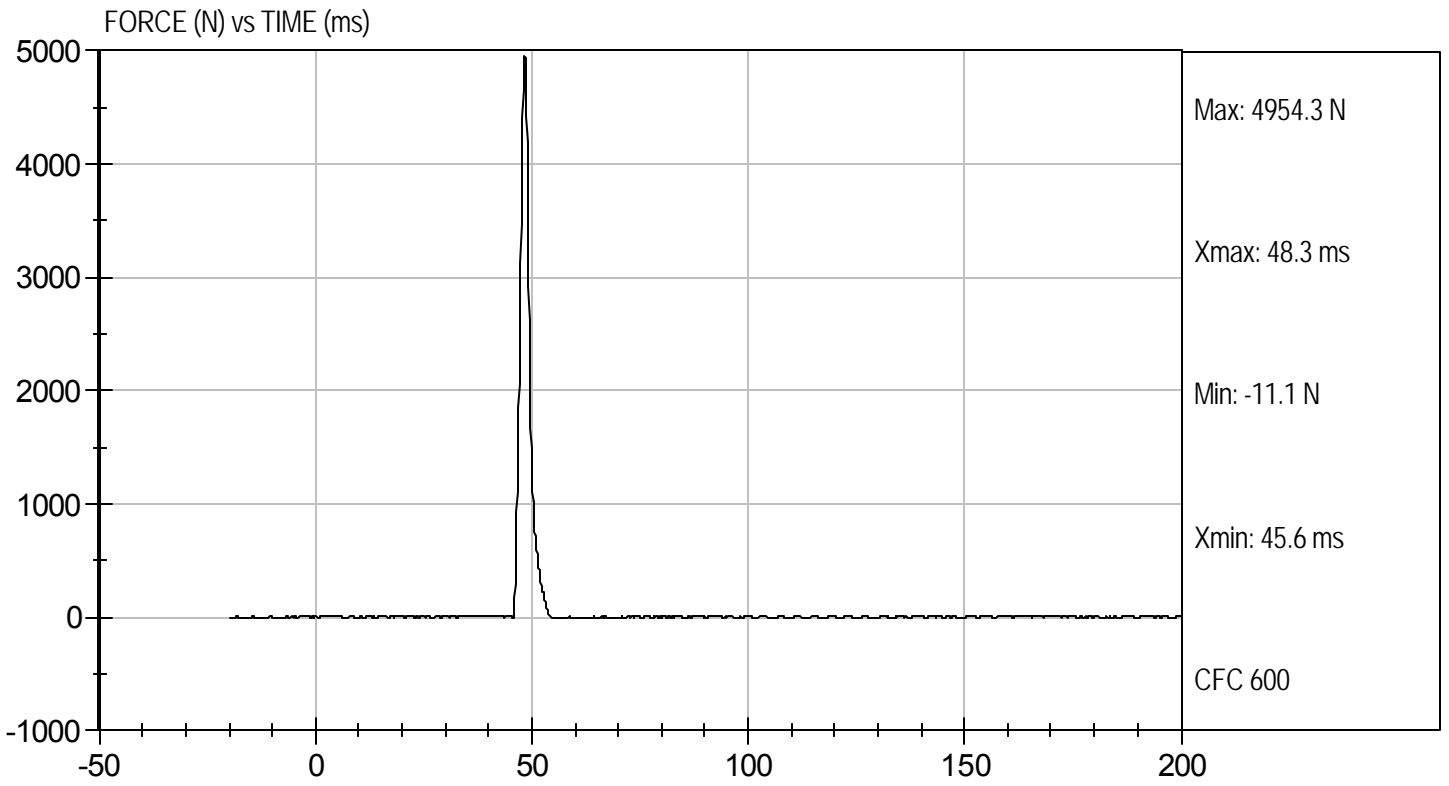
Test Desc: Left Knee  
Component ID: D104446

Test Date: 12/15/10  
Velocity: 6.86 ft/s, 2.09 m/s
