**REPORT NUMBER: SPNCAP-MGA-2011-055**

**NEW CAR ASSESSMENT PROGRAM (NCAP)  
Side Impact Pole Test**

**FUJI HEAVY INDUSTRIES LTD.  
2011 Subaru Forester  
NHTSA No.: MB5503**

**FINAL REPORT**

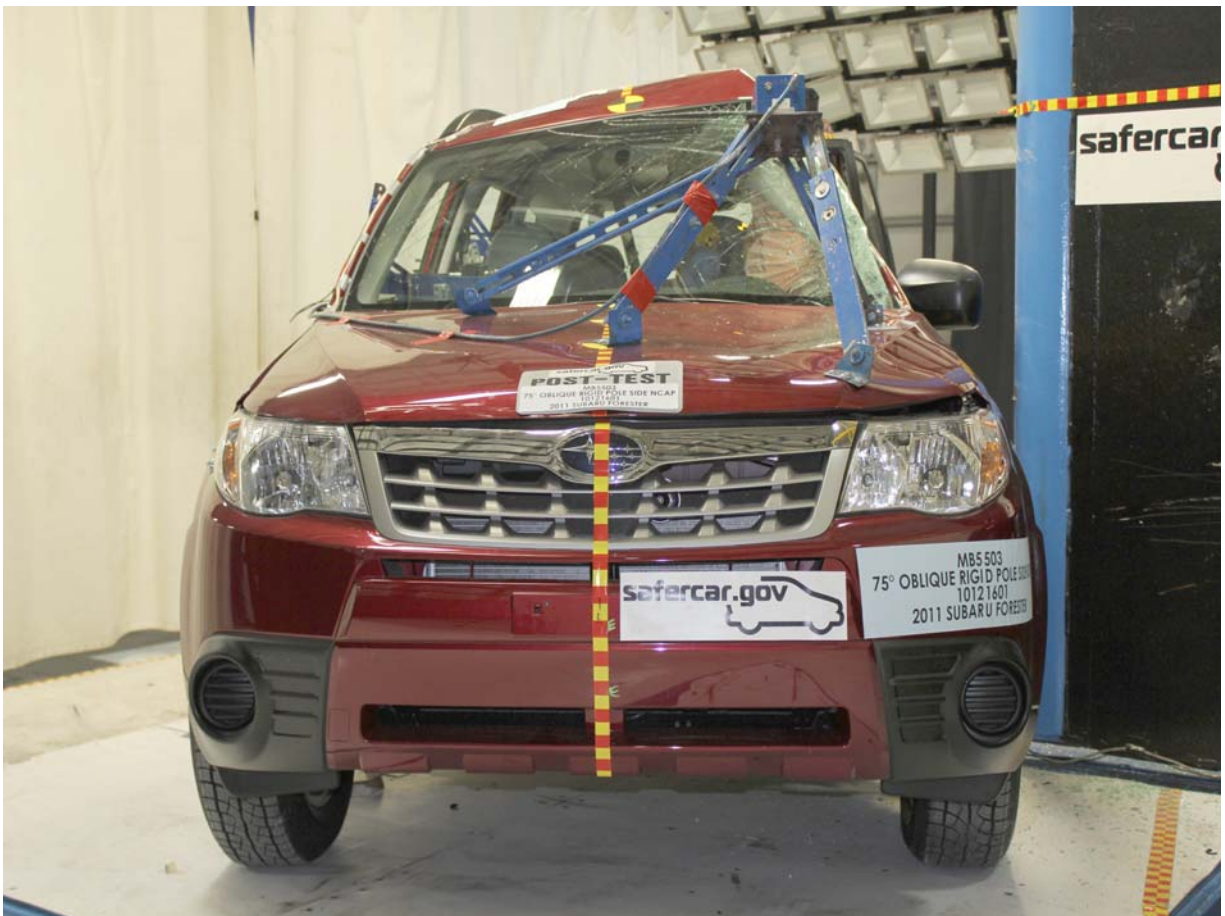
Post-Test Frontal View of Test Vehicle

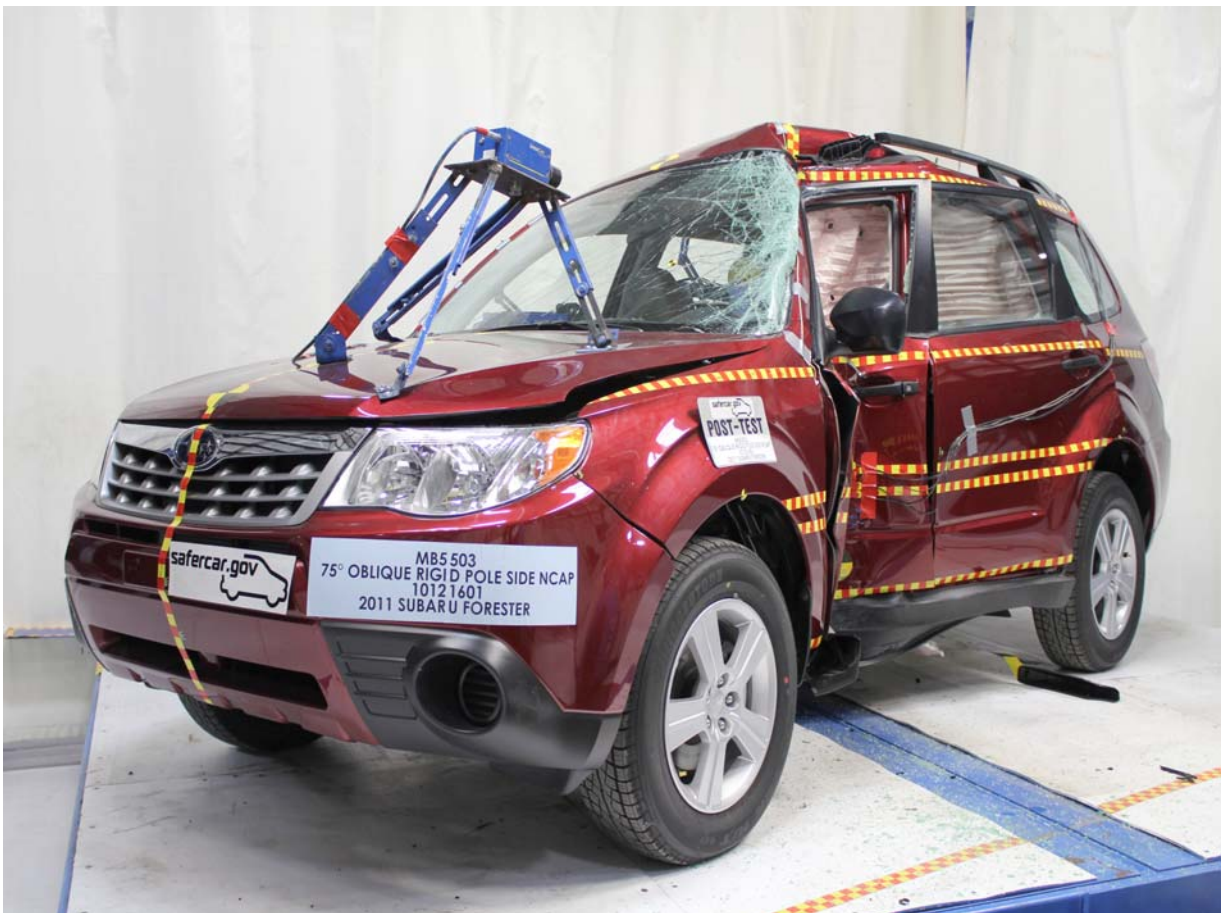
Post-Test Left Front  $\frac{3}{4}$  View of Test Vehicle

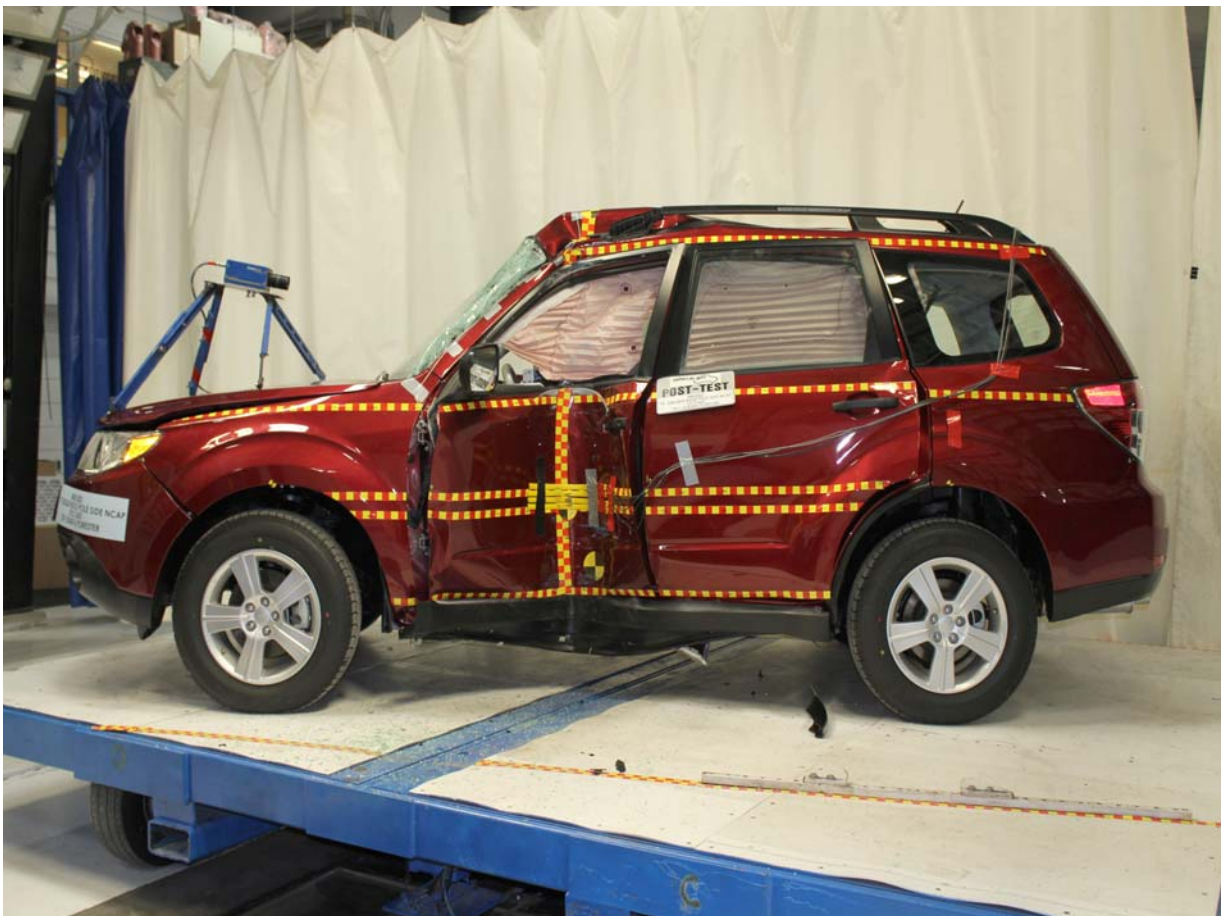
Post-Test Left Side View of Test Vehicle

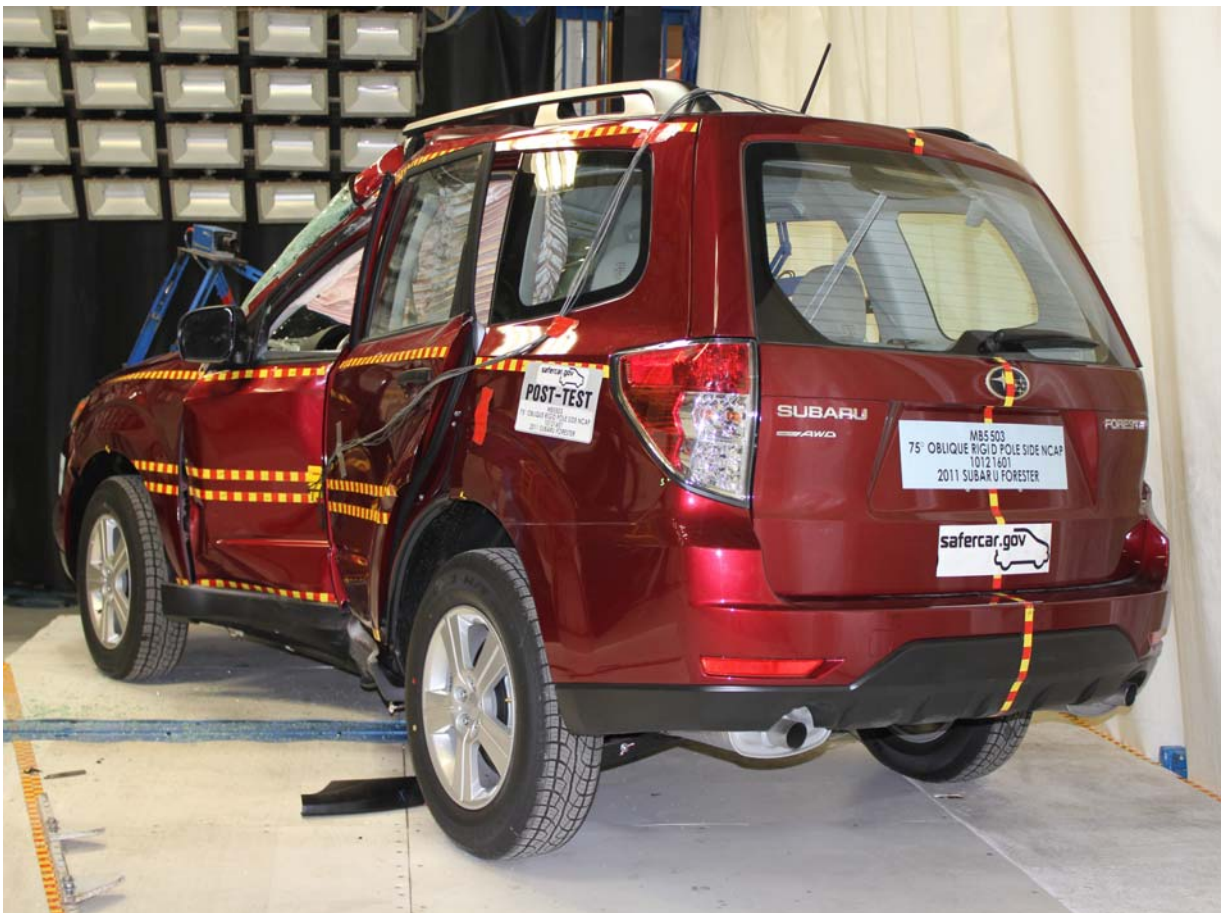
Post-Test Left Rear  $\frac{3}{4}$  View of Test Vehicle

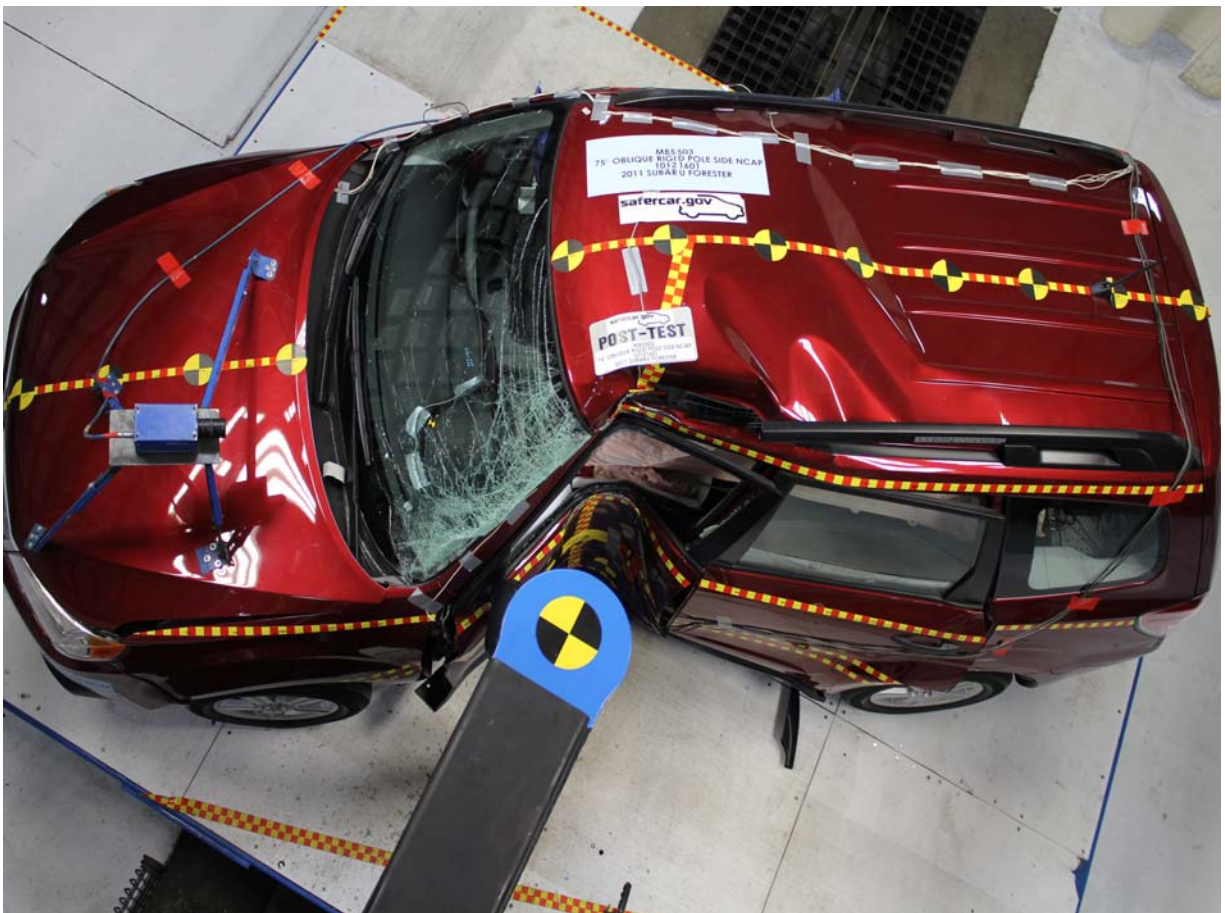
Post-Test Overhead View of Test Vehicle and Pole

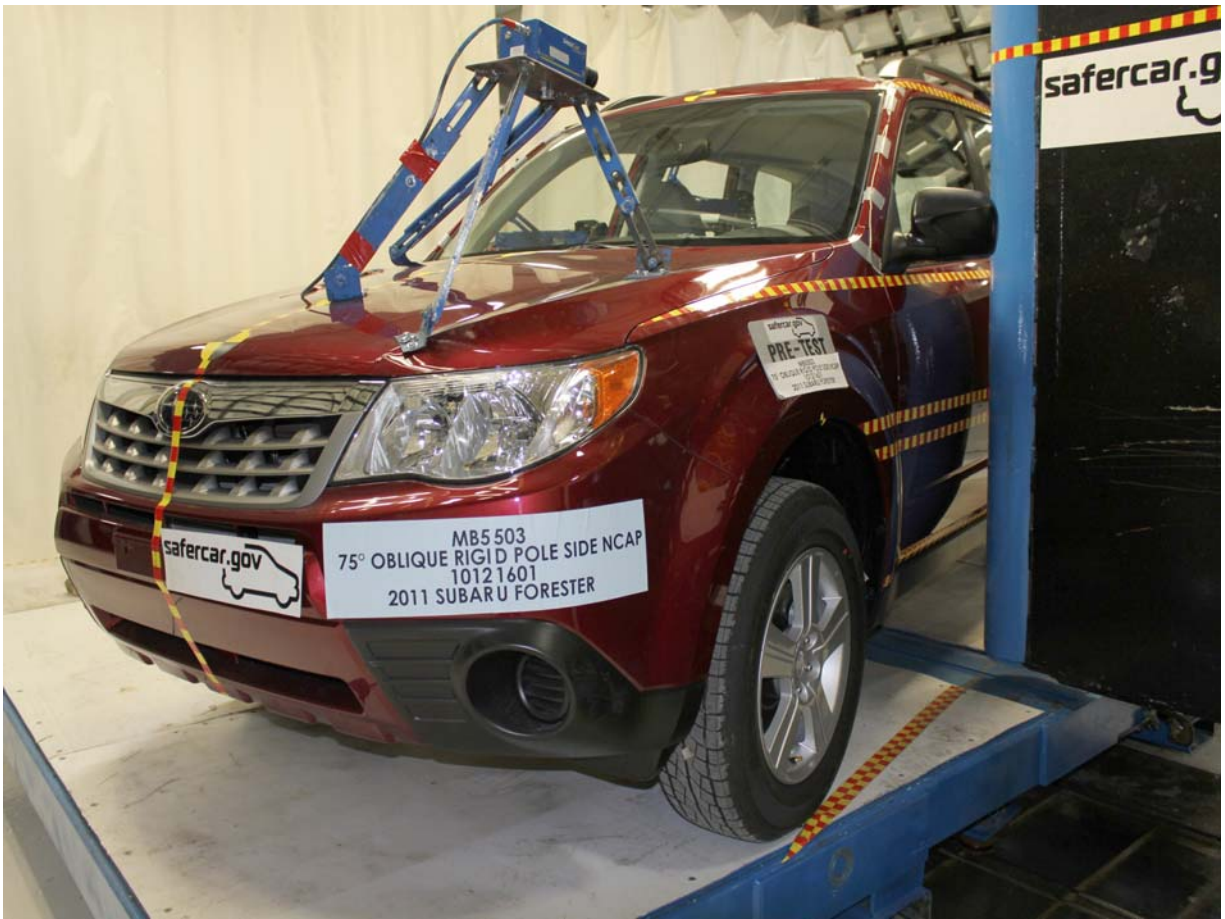
Pre-Test Left Side View of Pole Positioned Against Side of Vehicle

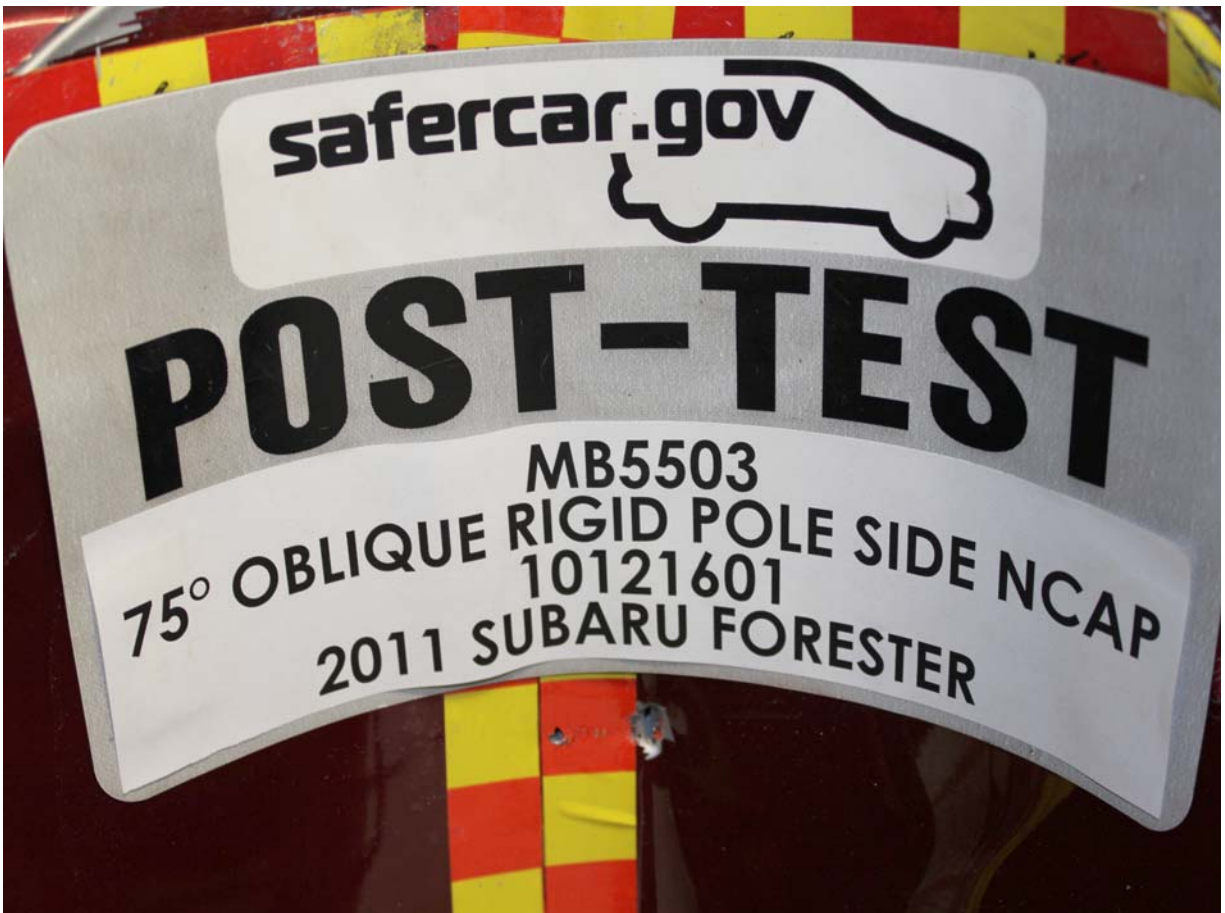
Post-Test Close-Up View of Impact Point Target Showing Impact Location

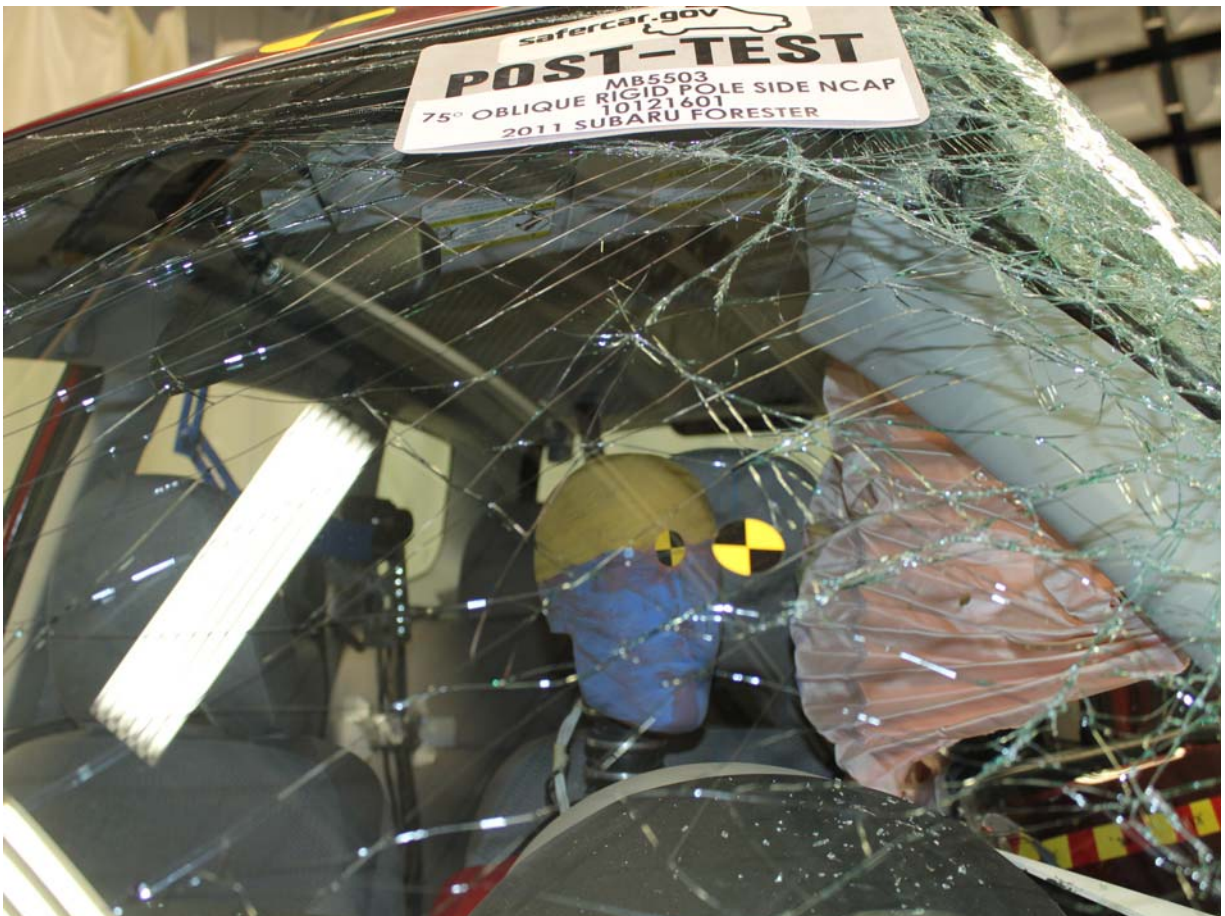
Post-Test Front Close-Up View of Dummy (through front window)

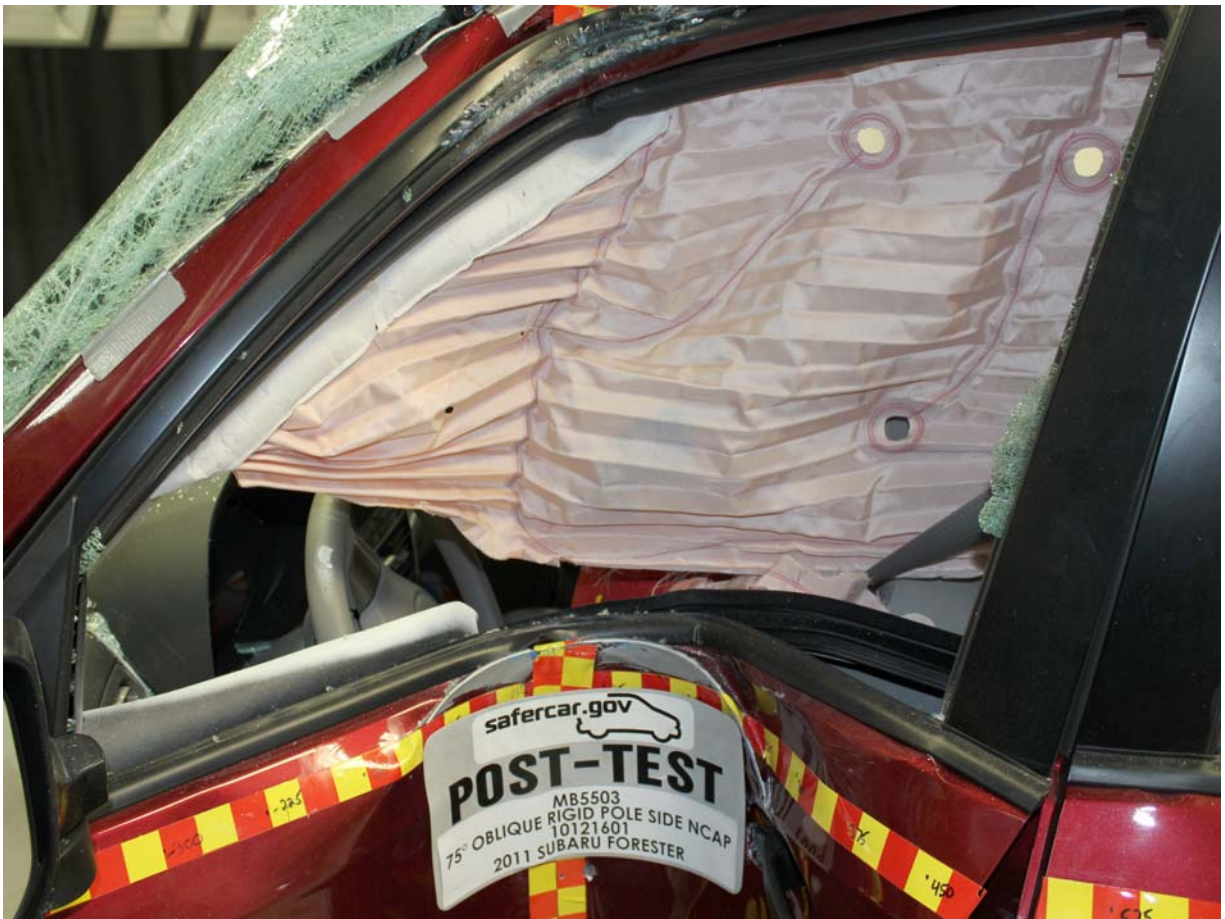
Post-Test Left Side View of Dummy Shoulder and Door Top View

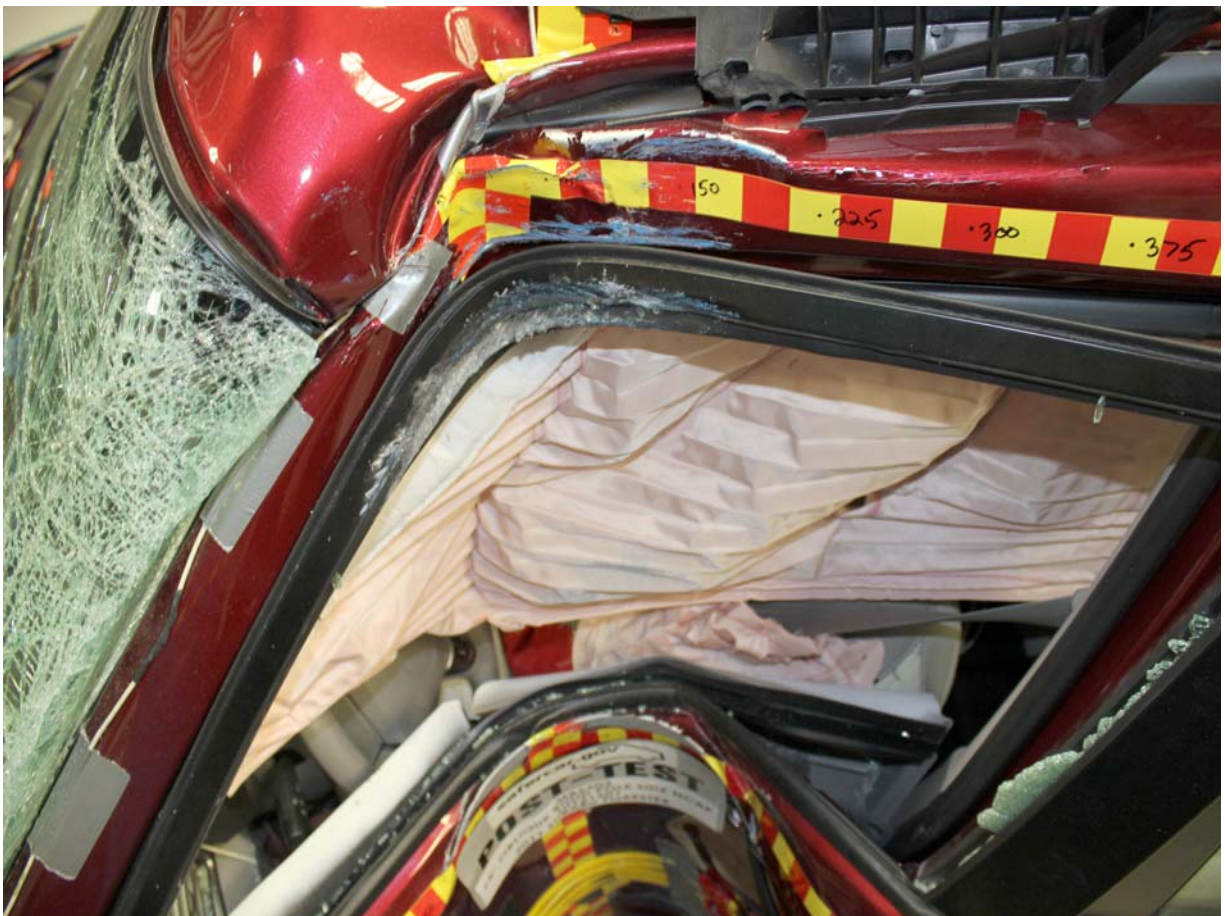
Post-Test Dummy and Door Clearance View

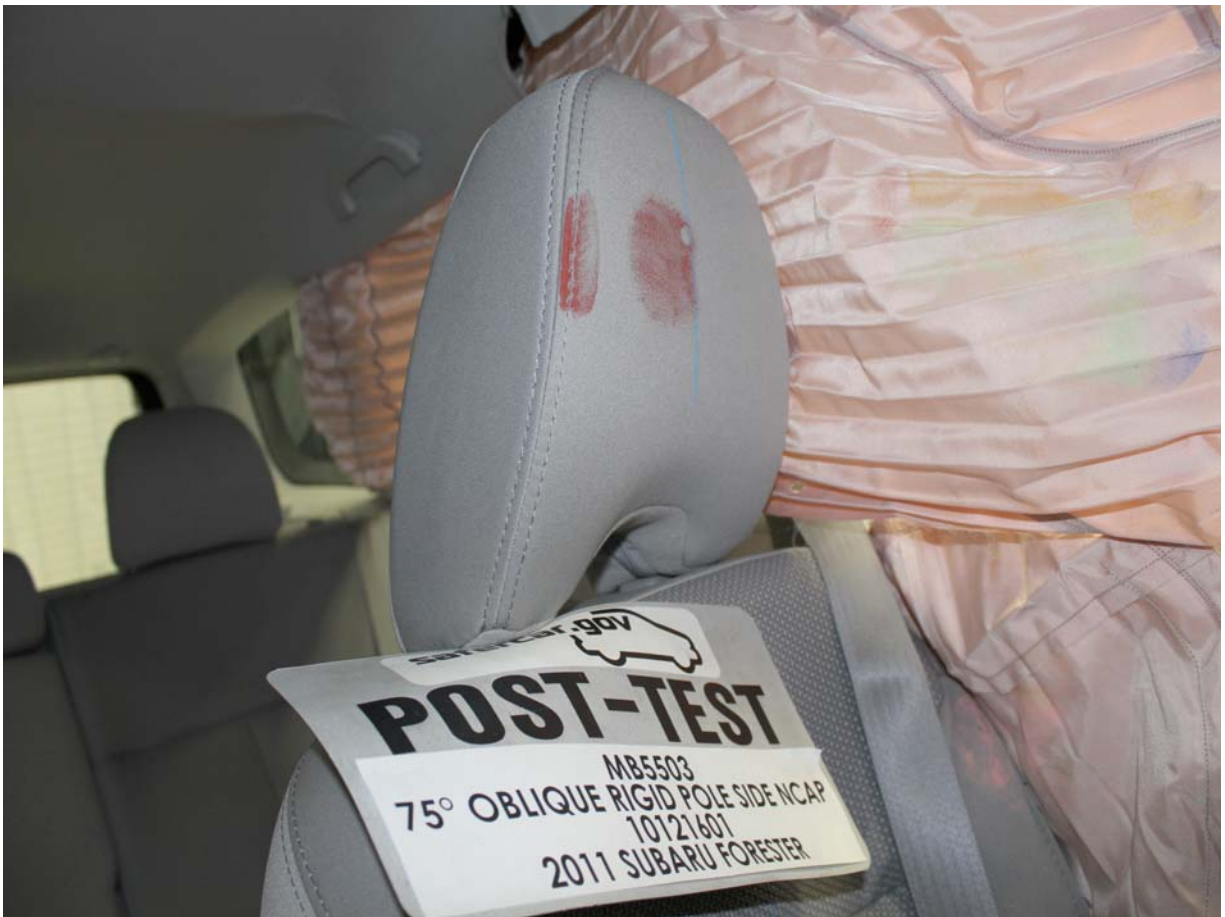
Post-Test Dummy Close-Up Head Contact with Vehicle Interior View

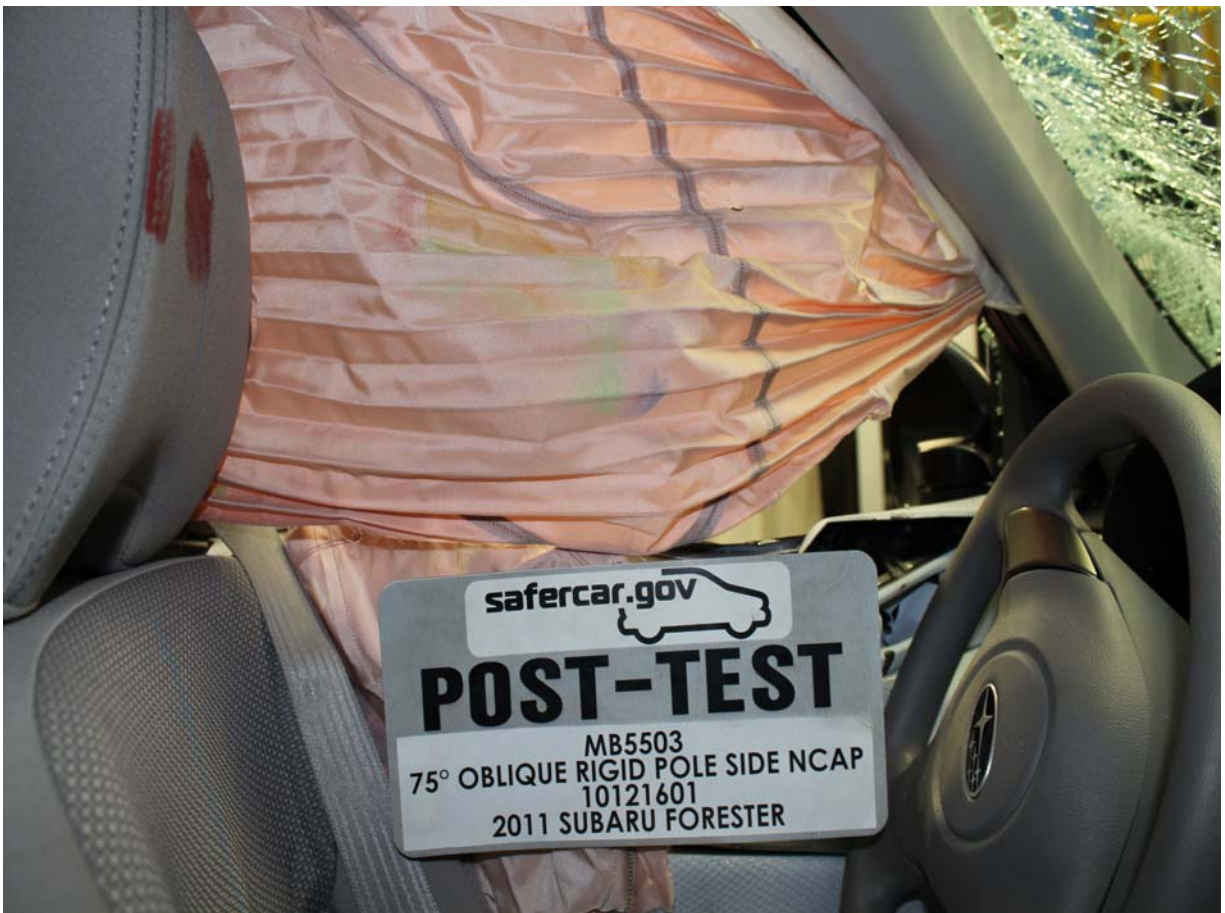
Post-Test Dummy Close-Up Head Contact with Side Airbag View

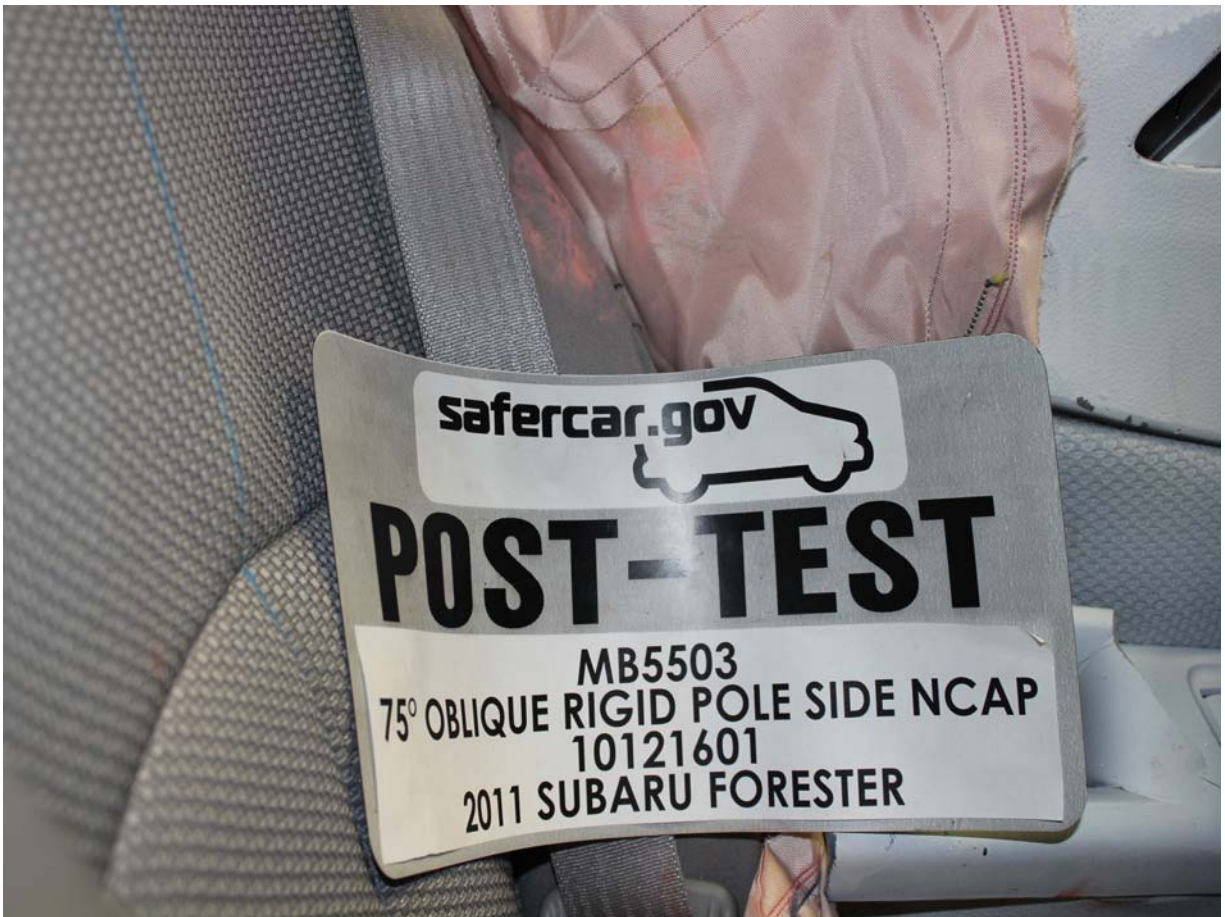
Post-Test Dummy Close-Up Torso Contact with Vehicle Interior View

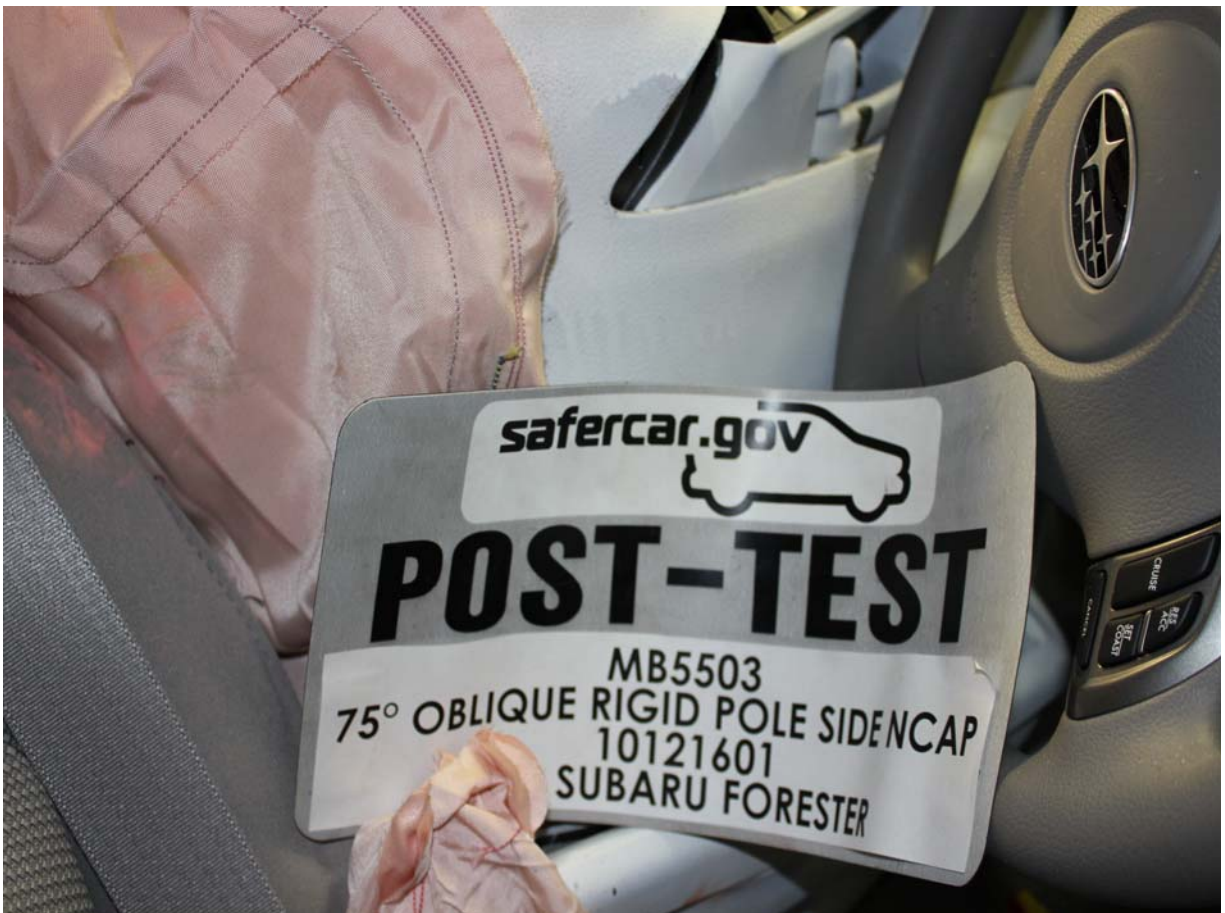
Post-Test Dummy Close-Up Torso Contact with Side Airbag View

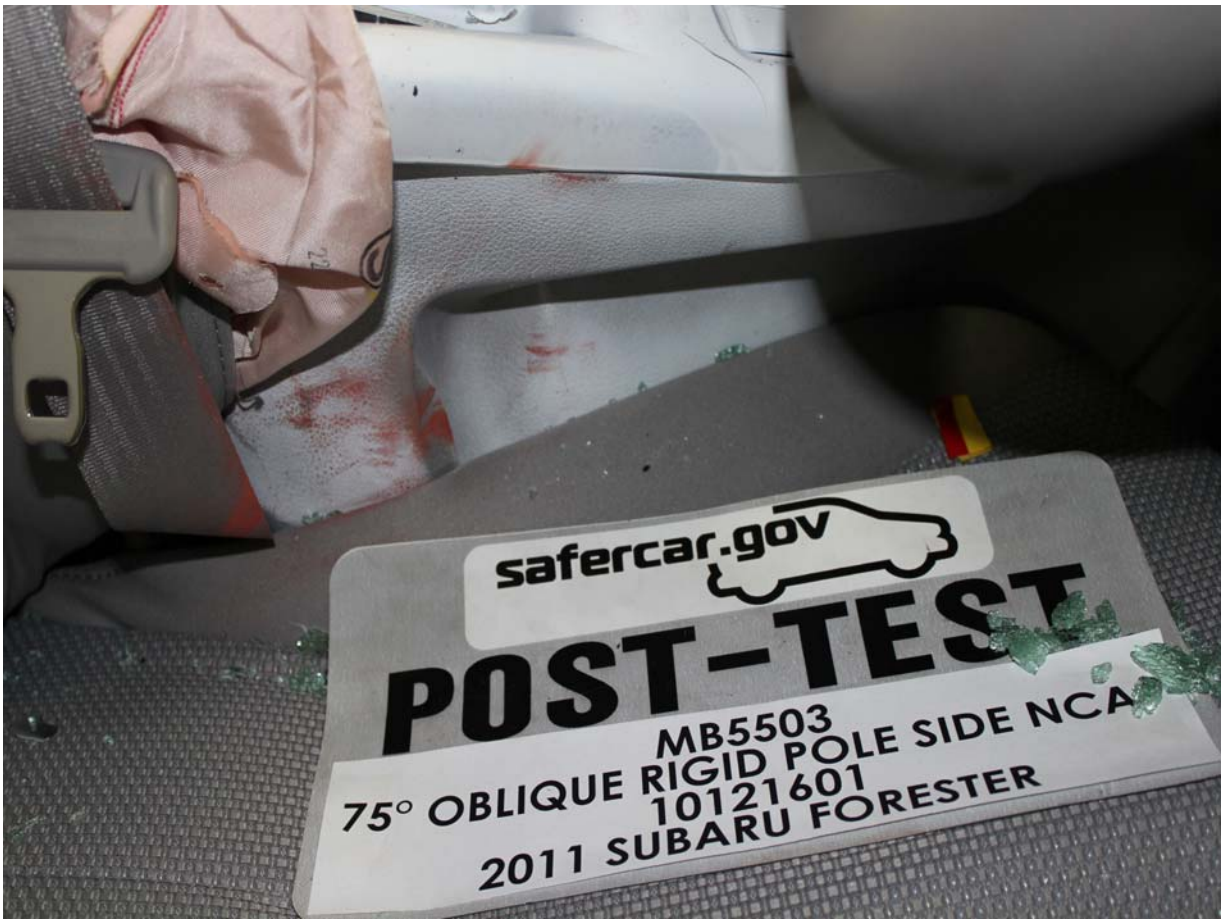
Post-Test Dummy Close-Up Pelvis Contact with Vehicle Interior View

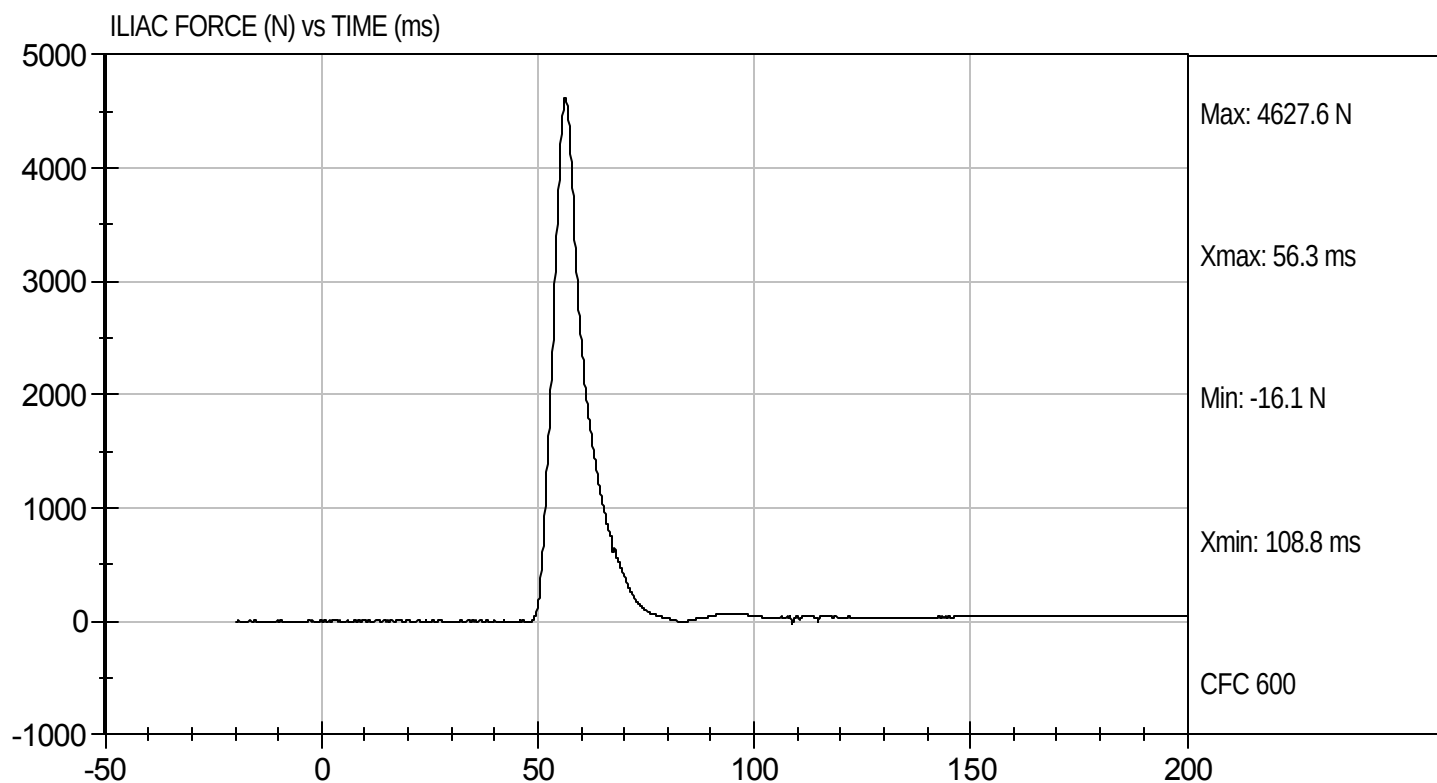
Test Desc: Iliac Impact  
Component ID: D104498

Test Date: 12/17/10  
Velocity: 14.36 ft/s, 4.38 m/s
