**REPORT NUMBER: SINCAP-MGA-2011-056**

**NEW CAR ASSESSMENT PROGRAM (NCAP)  
Moving Deformable Barrier Side Impact Test**

**FUJI HEAVY INDUSTRIES LTD.  
2011 Subaru Forester  
NHTSA No.: MB5504**

**MGA RESEARCH CORPORATION  
5000 Warren Road  
Burlington, WI 53105**

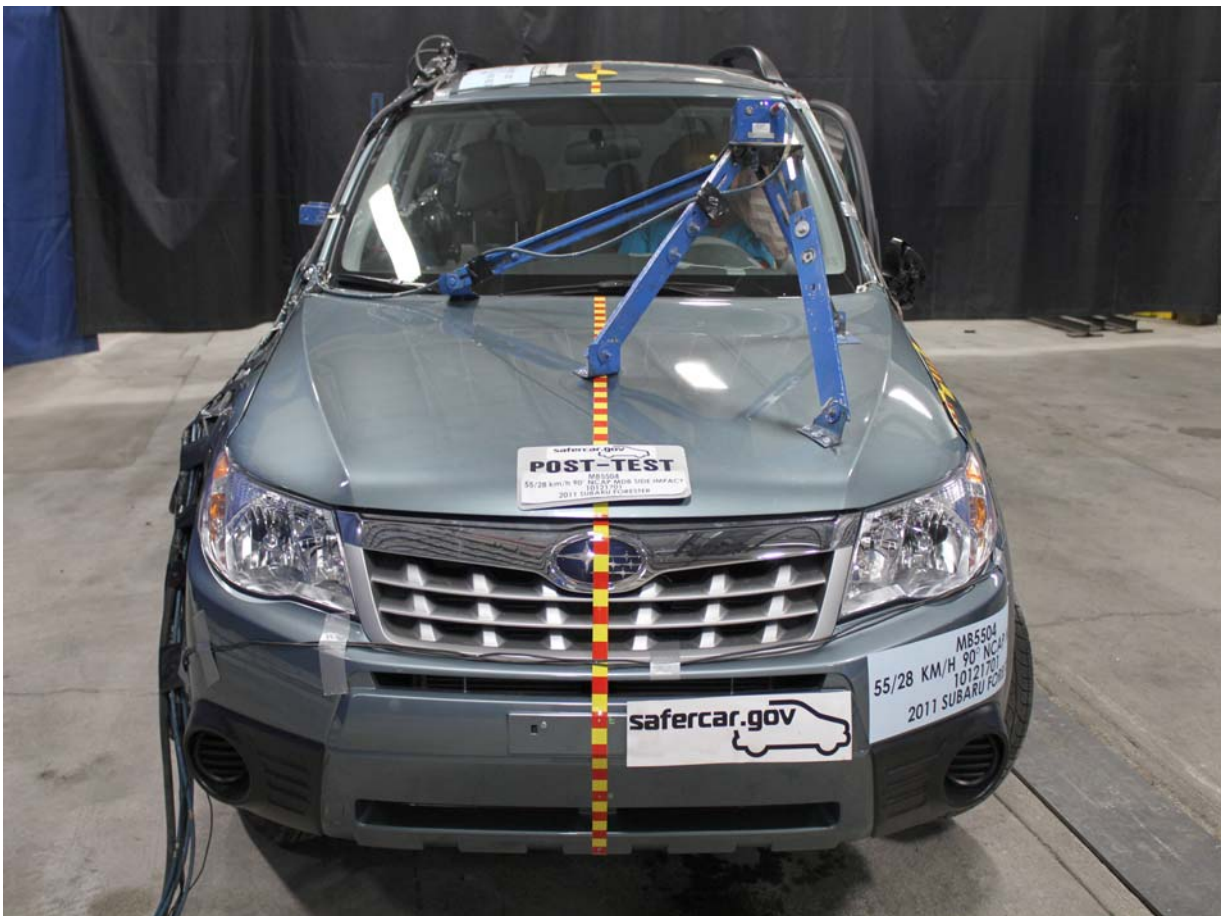
Post-Test Frontal View of Test Vehicle

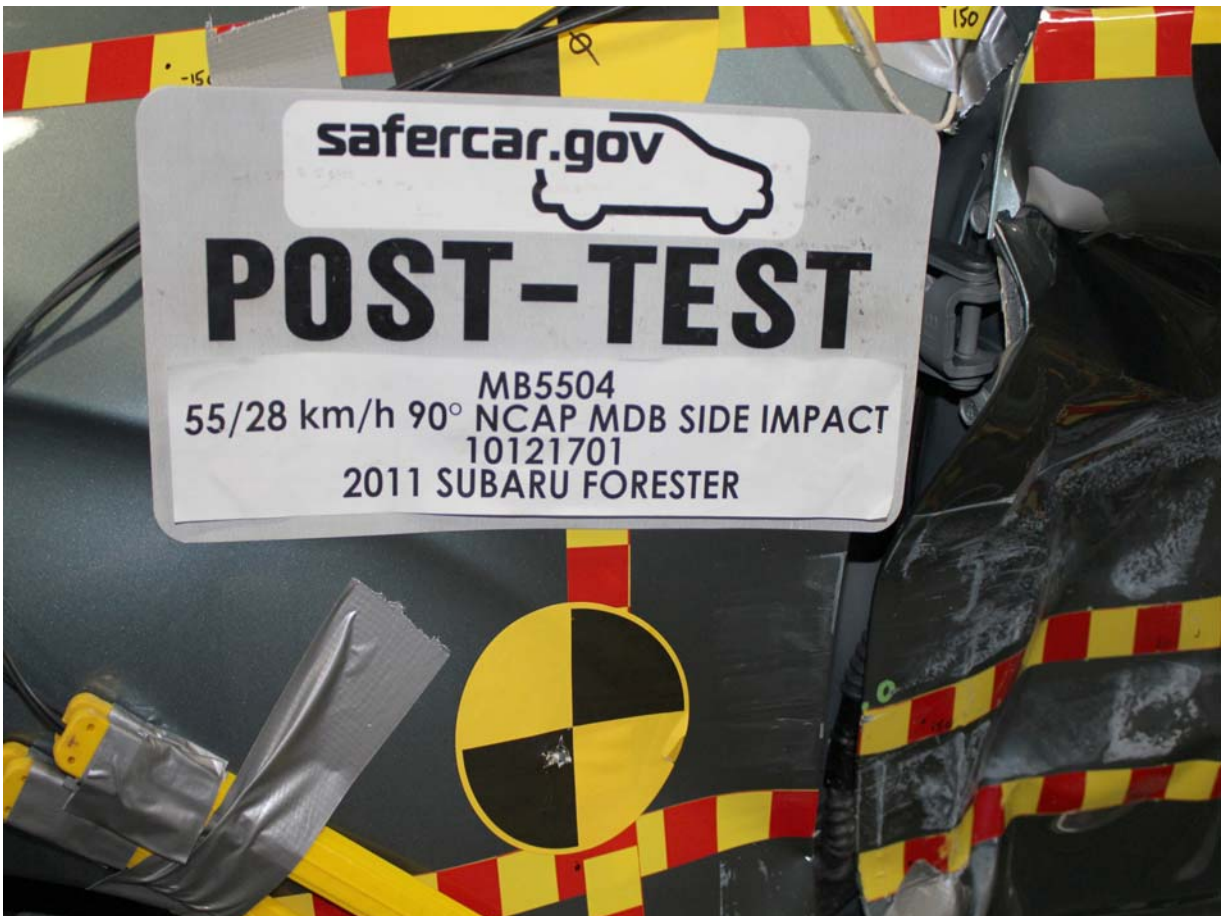
Post-Test Close-Up View of Impact Point Target

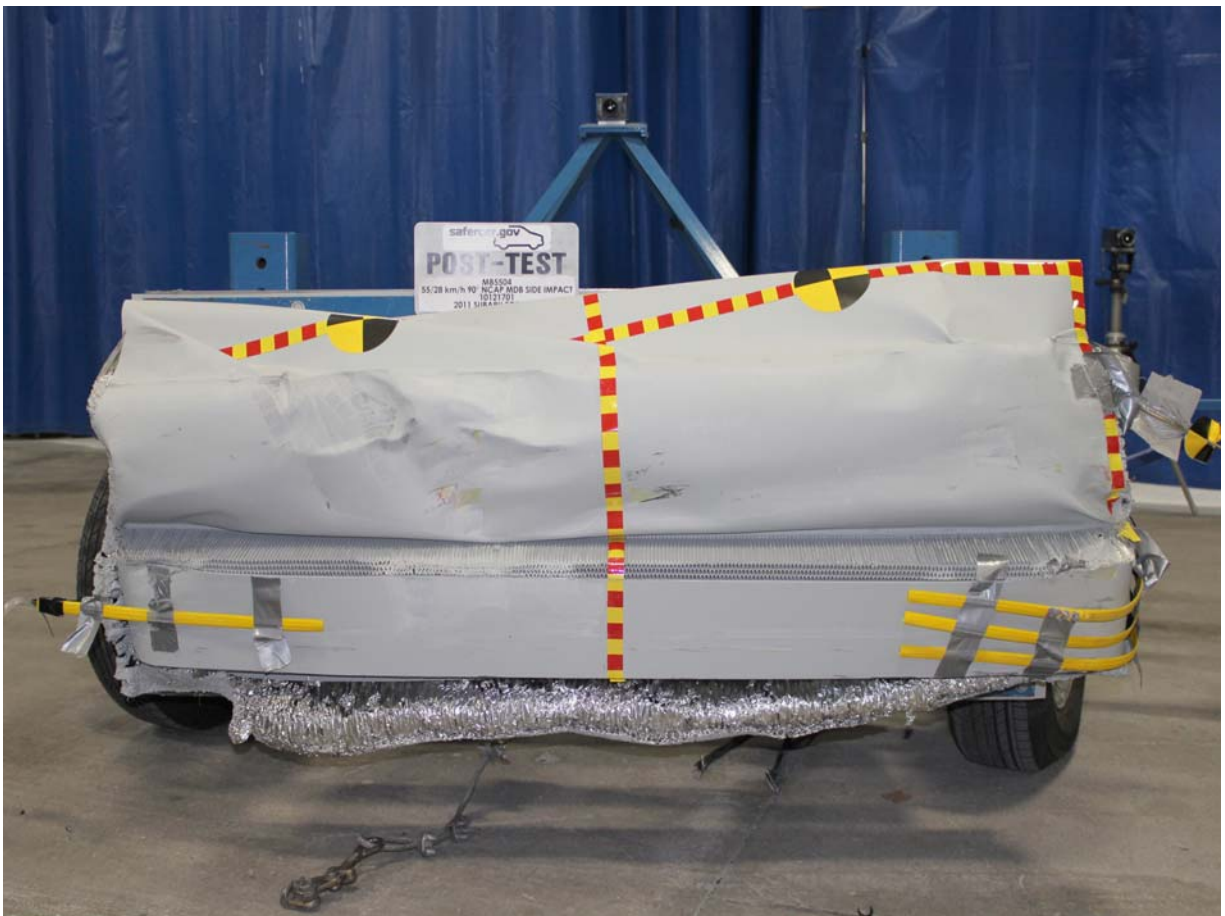
Post-Test Front View of MDB Impactor Face

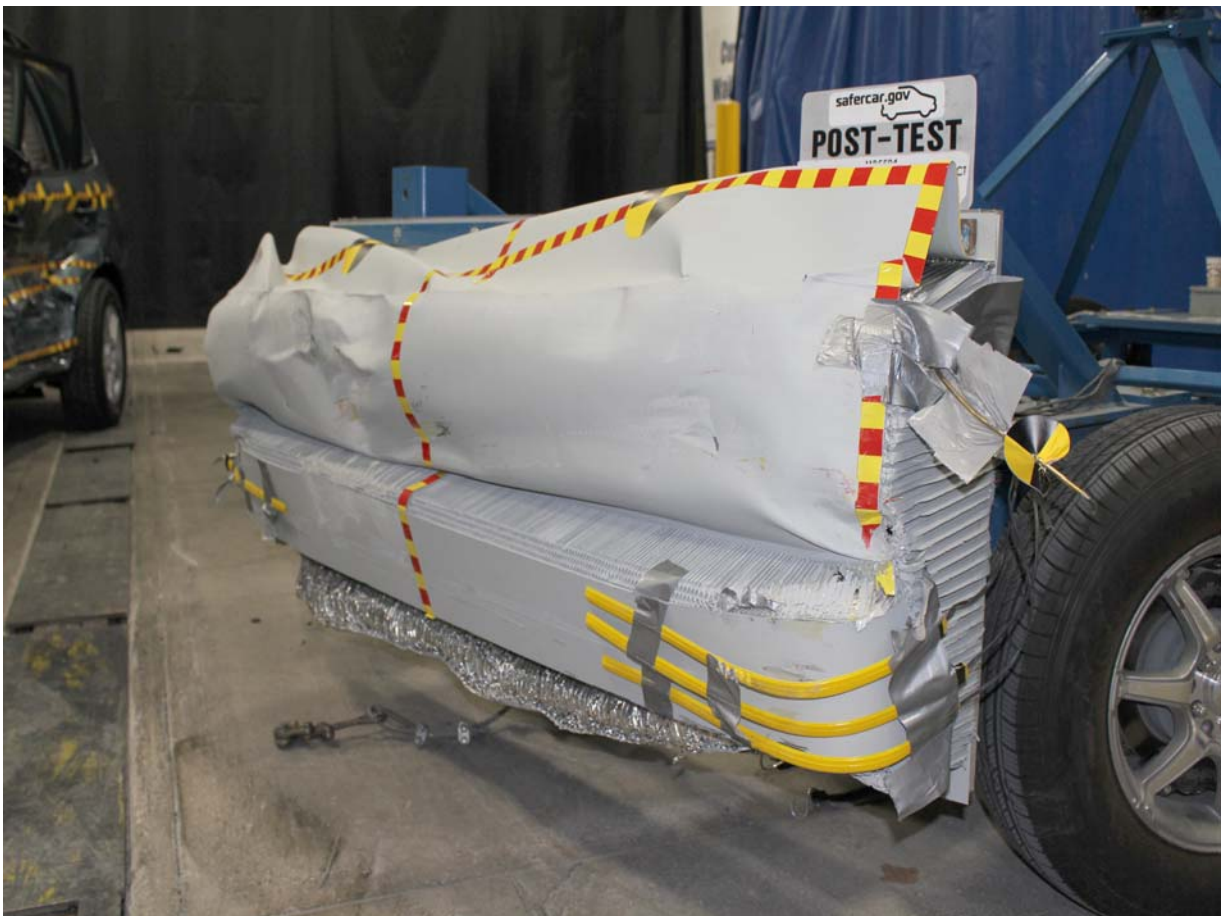
Post-Test Left Side View of MDB Impactor Face

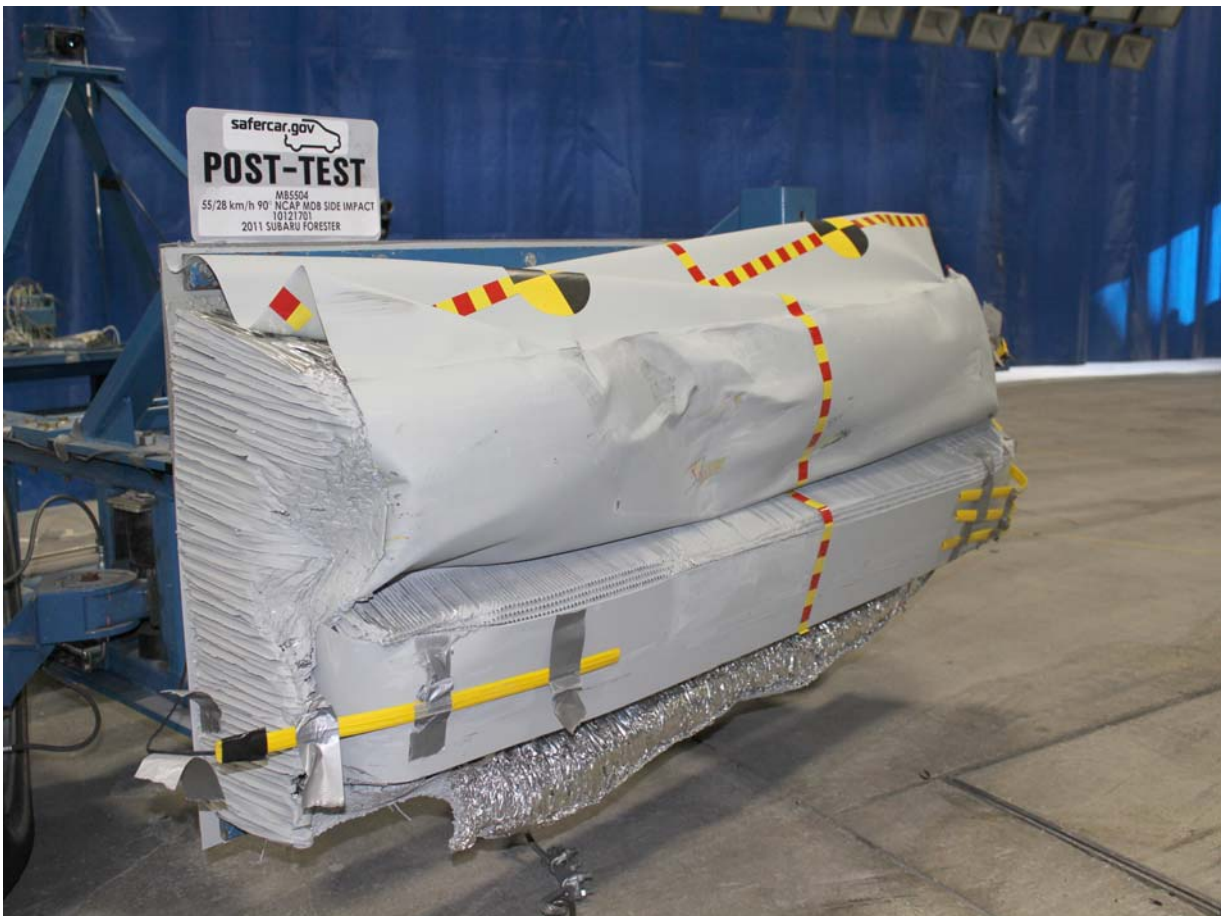
Post-Test Right Side View of MDB Impactor Face

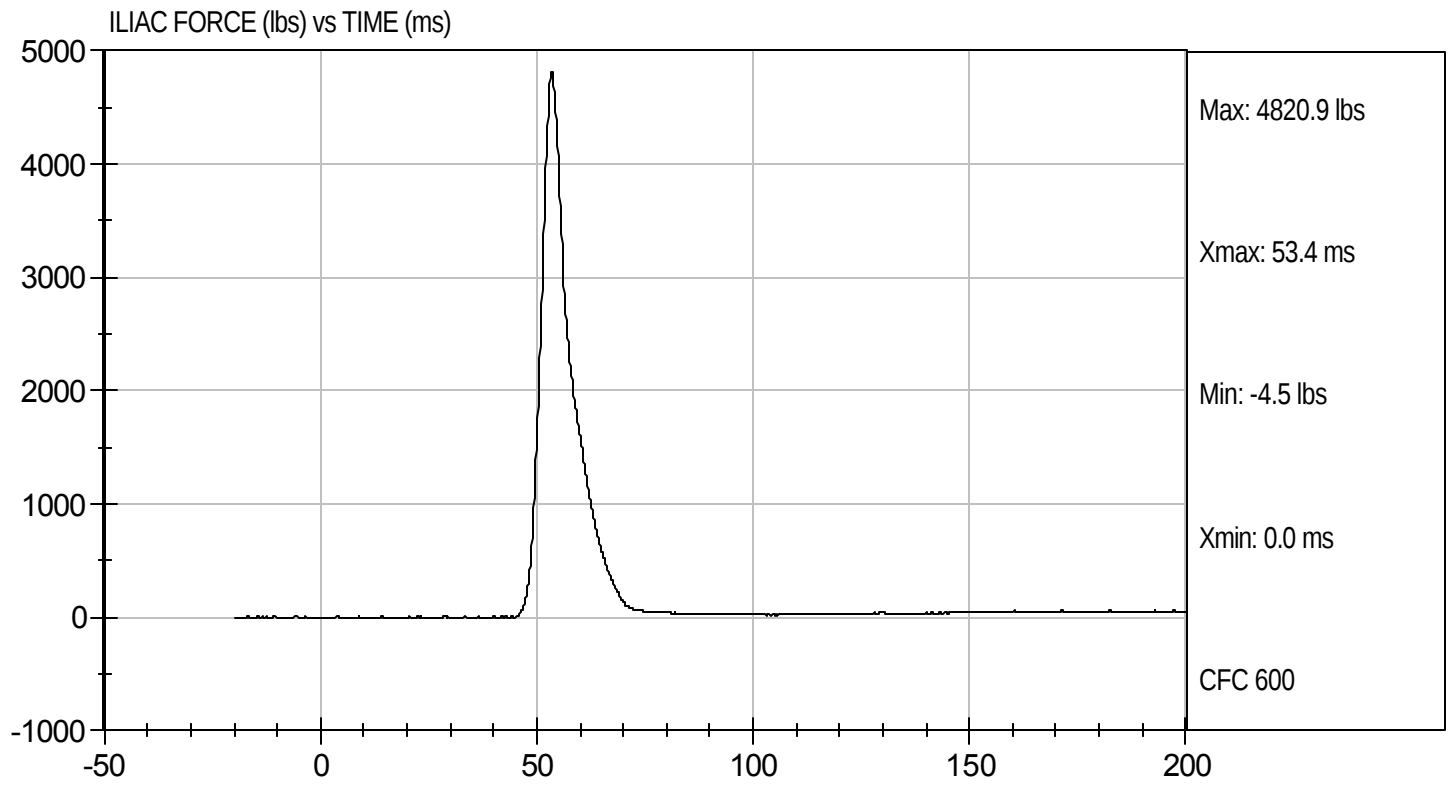
Test Desc: Iliac Impact  
Component ID: D104508

Test Date: 12/20/10  
Velocity: 14.25 ft/s, 4.34 m/s
