**REPORT NUMBER: NCAP-MGA-2011-058**

**NEW CAR ASSESSMENT PROGRAM (NCAP)  
Frontal Barrier Impact Test**

**KIA MOTORS CORPORATION  
2011 Kia Forte LX 4-Dr Sedan  
NHTSA No.: MB0511**

**FINAL REPORT**

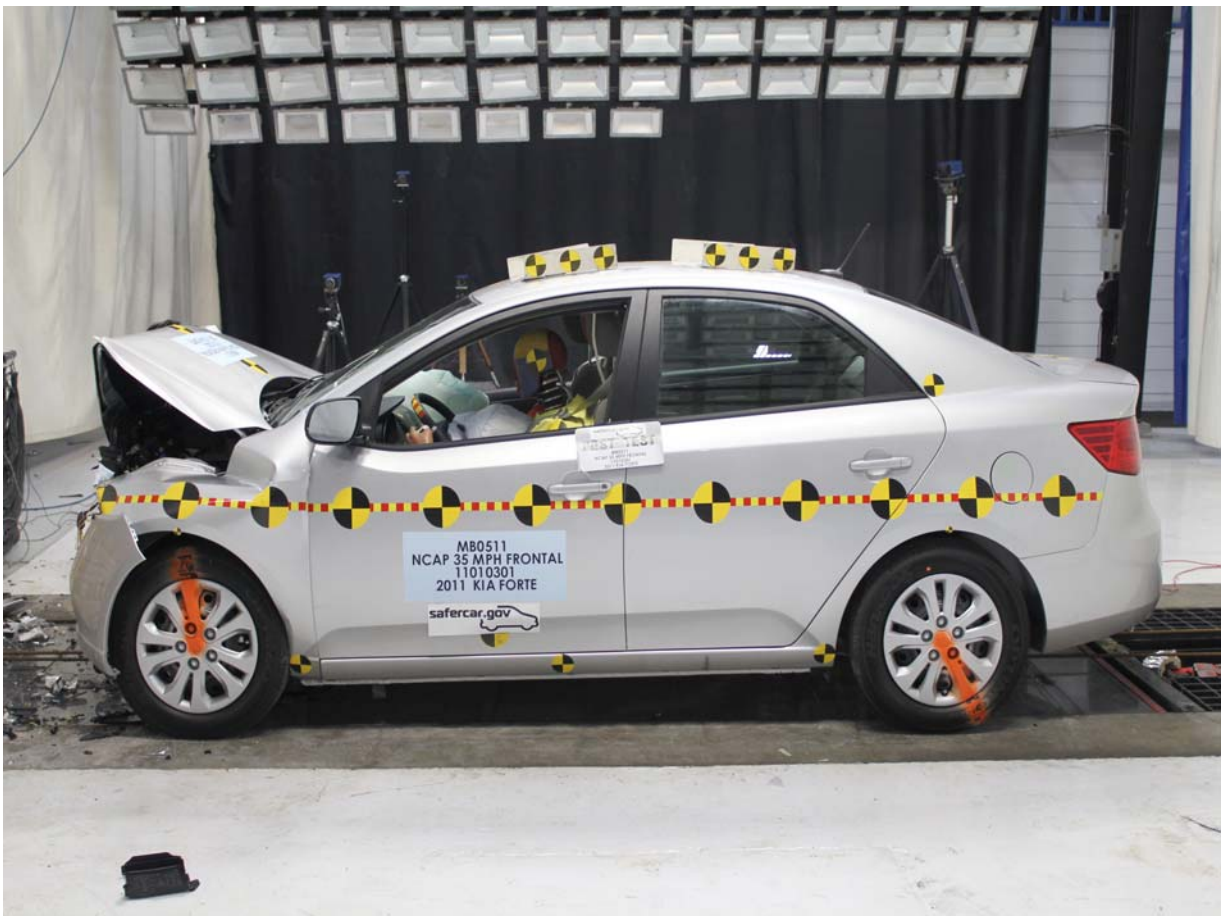
Post-Test Left Side View

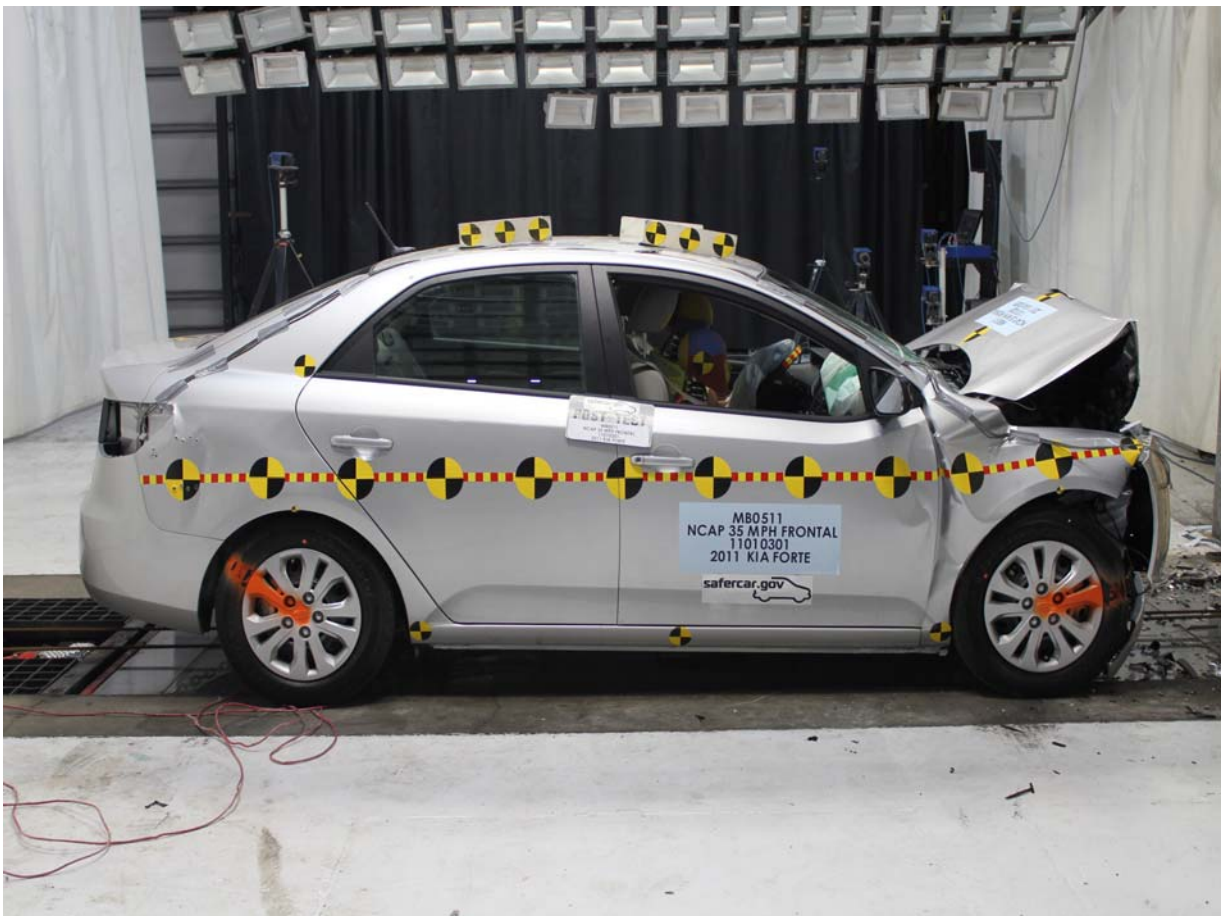
Post-Test Right Side View

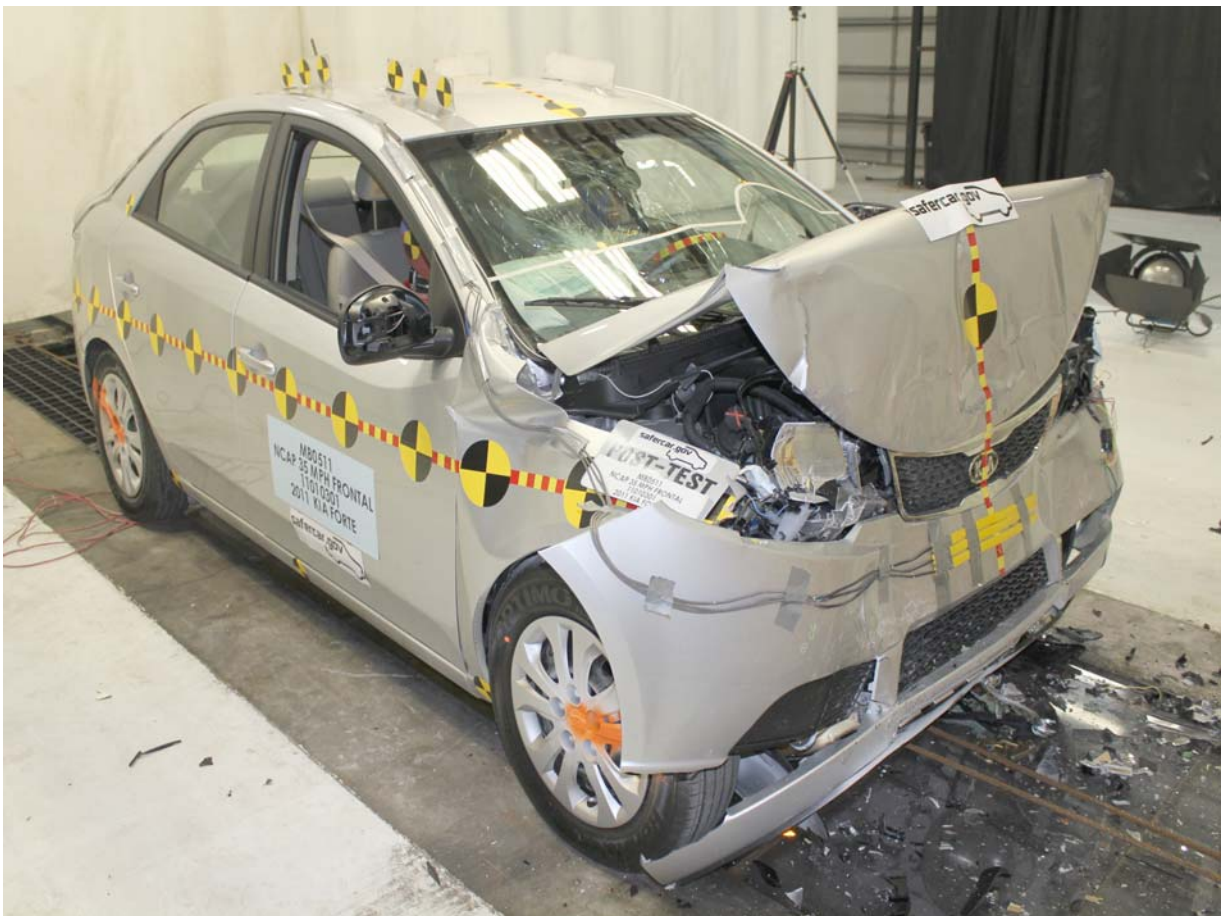
Post-Test Right Front Three-Quarter View

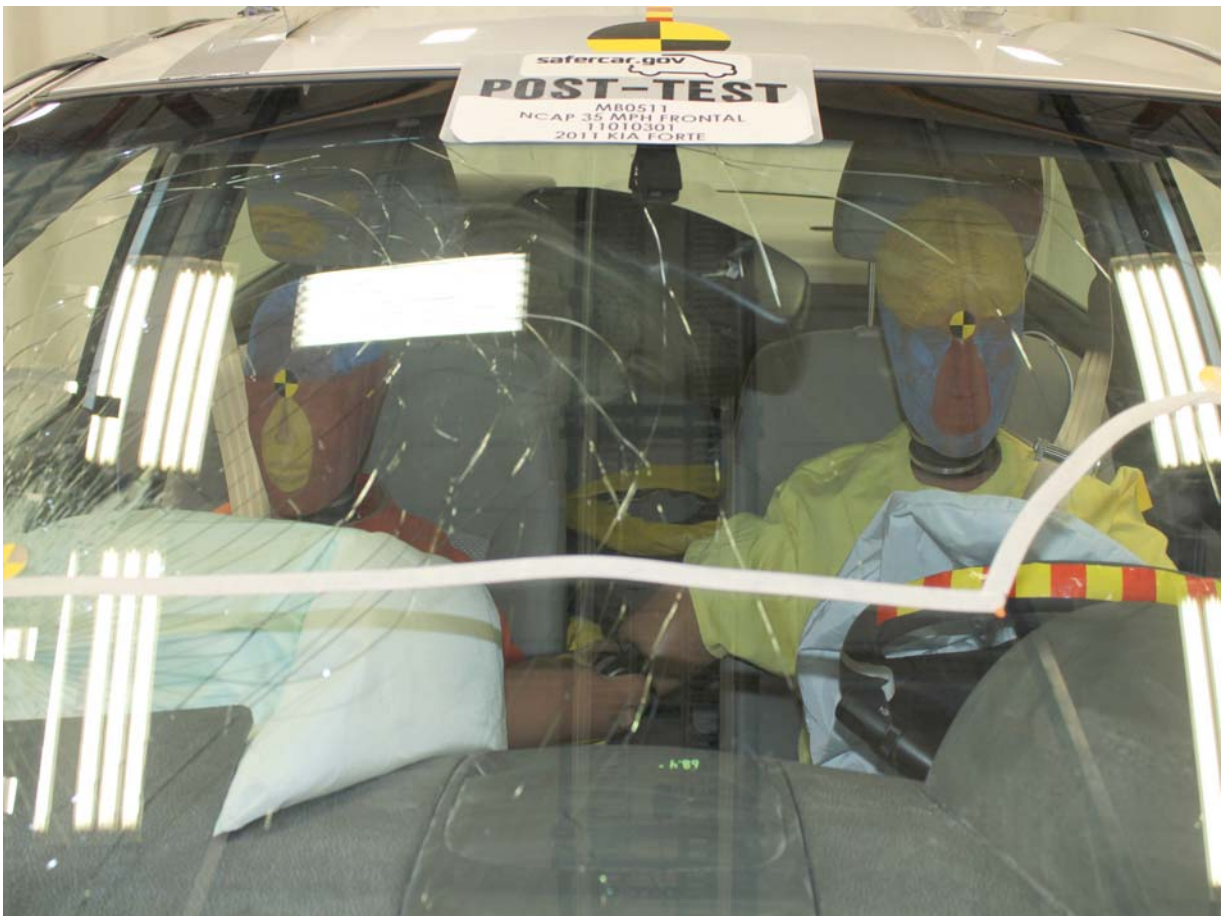
Post-Test Windshield View

There was 100 percent windshield retention and no intrusion into the protected zone of the windshield during the event. There was no Stoddard Solvent leakage after the event or during any phase of the static rollover.

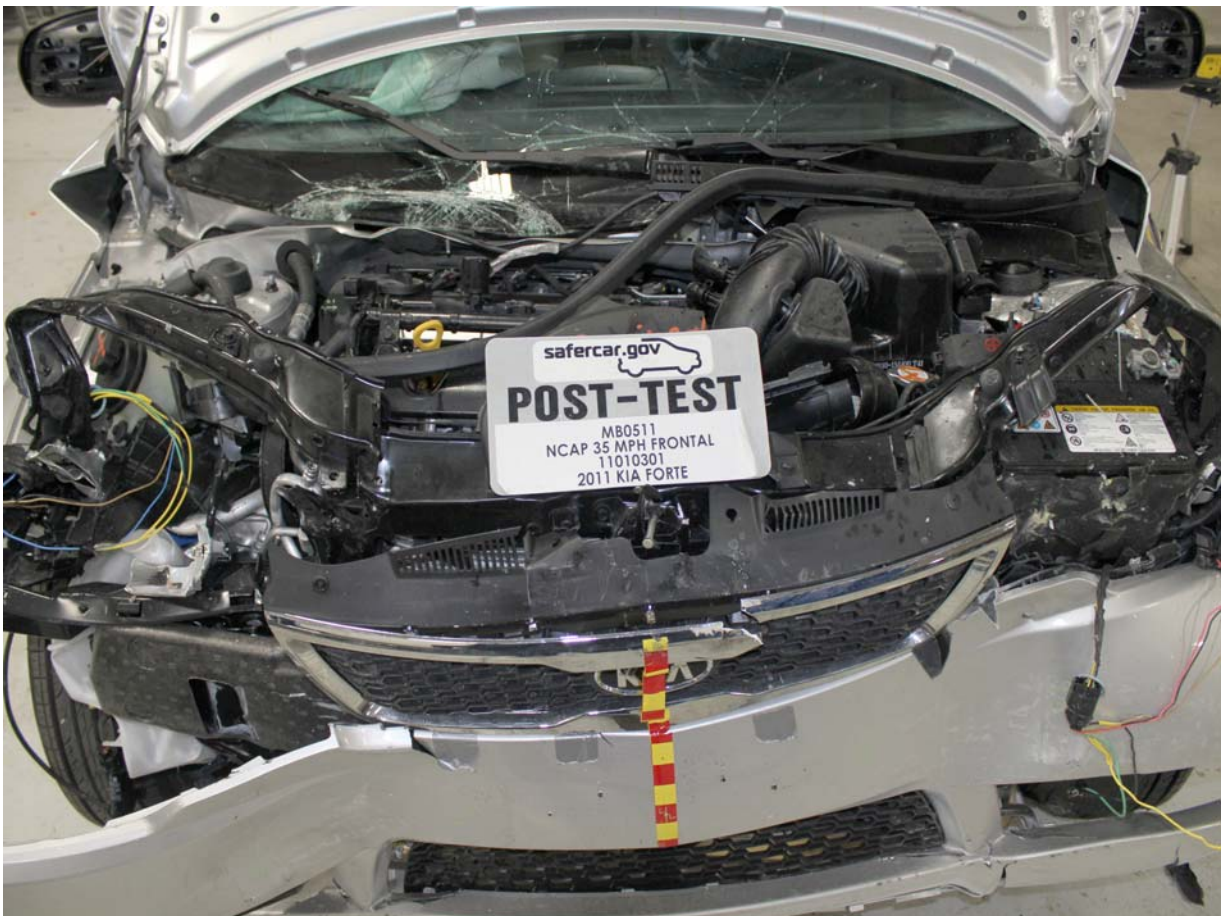
Post-Test Engine Compartment View

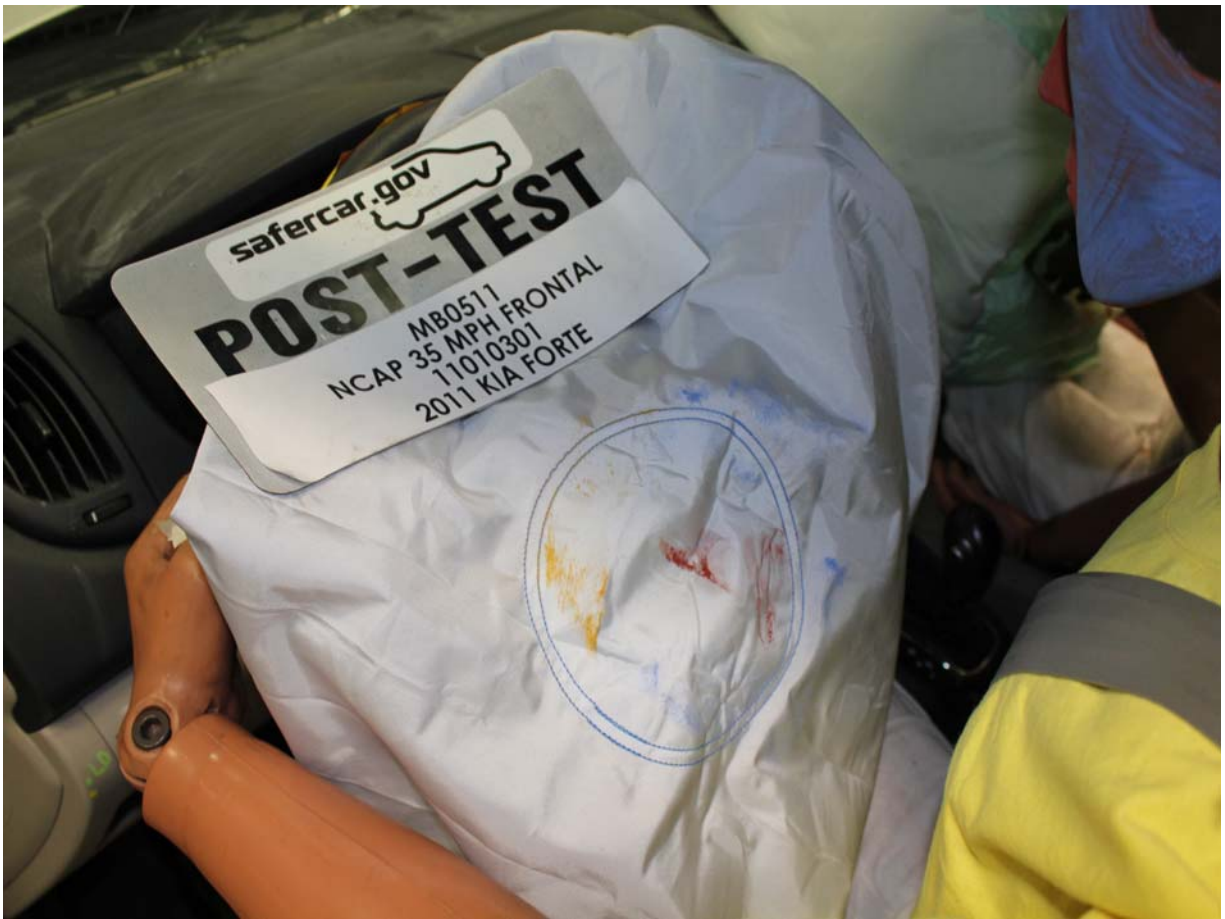
Post-Test Driver Dummy Contact with Airbag

The driver's head and chest contacted the airbag. The driver's head also contacted the headrest. The driver's knees contacted the knee bolster. The passenger's head and chest contacted the airbag. The passenger's head also contacted the headrest. The passenger's knees contacted the glovebox.

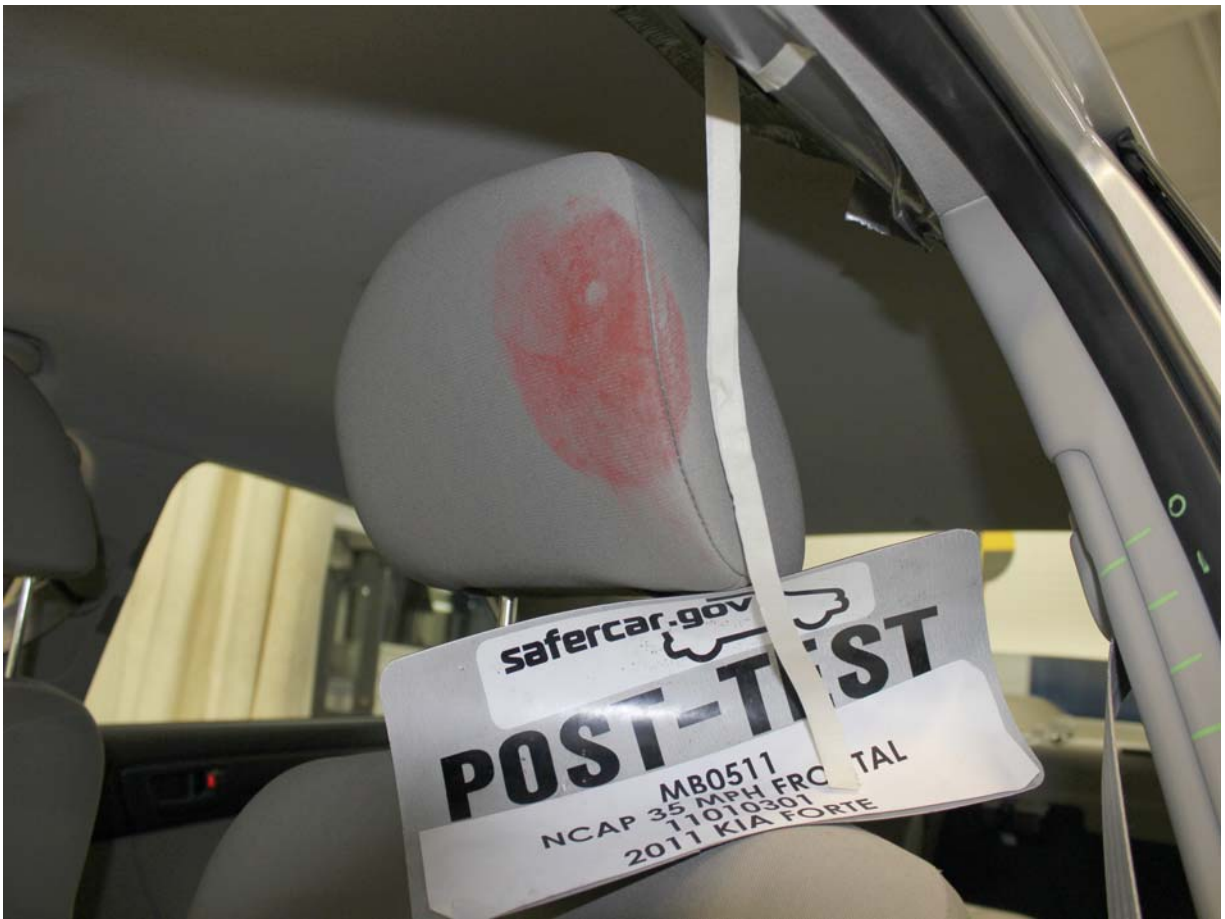
Post-Test Driver Dummy Contact with Headrest

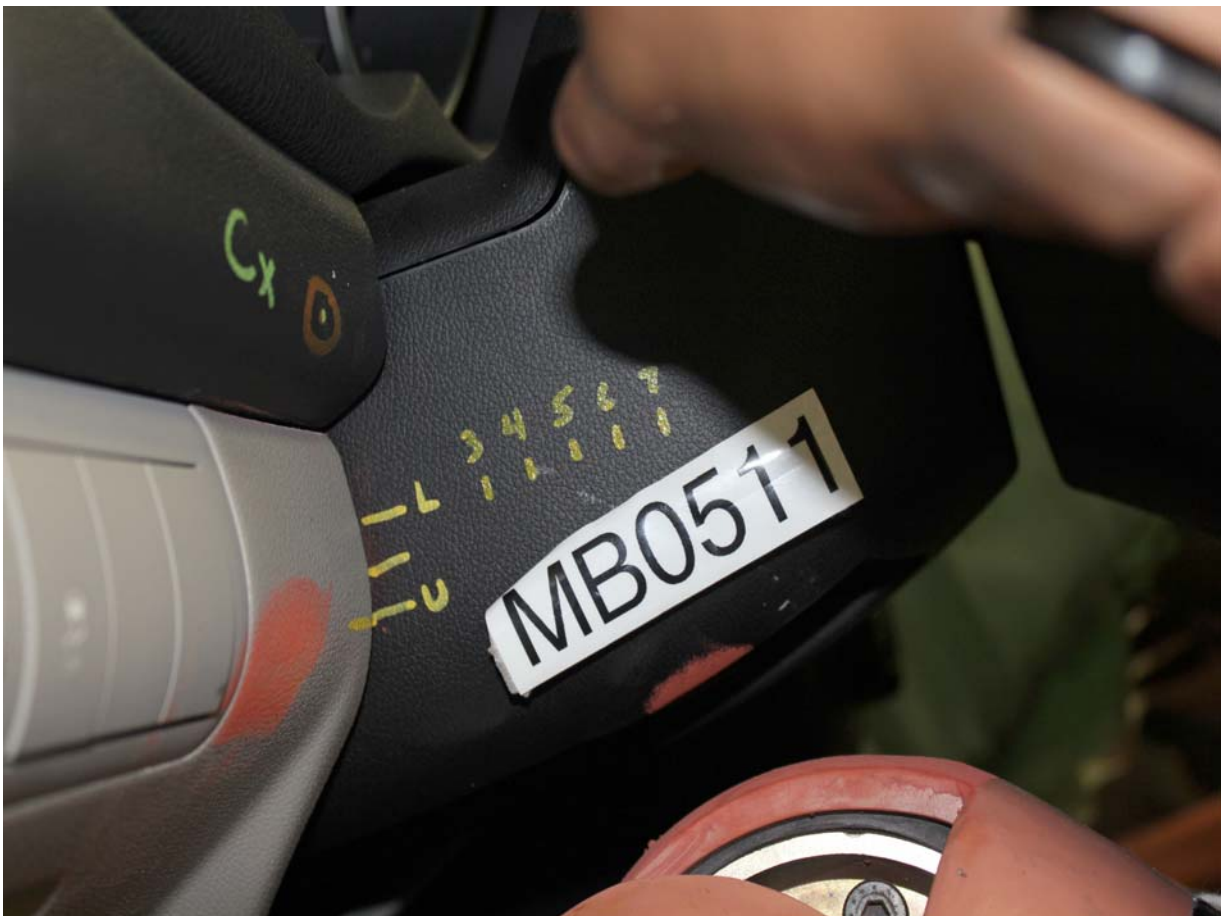
Post-Test View of Steering Column Shear Capsule

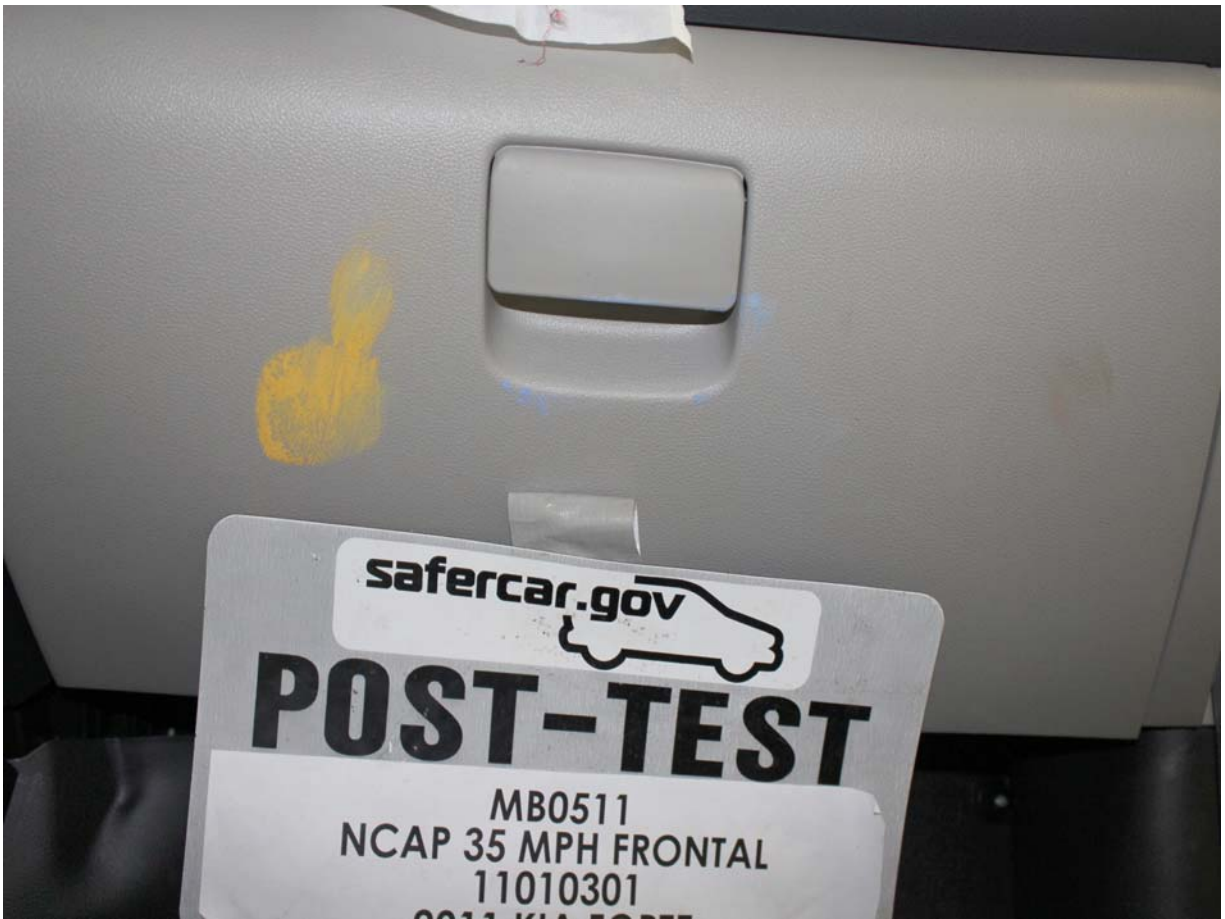
Post-Test Passenger Dummy Contact with Knee Bolster

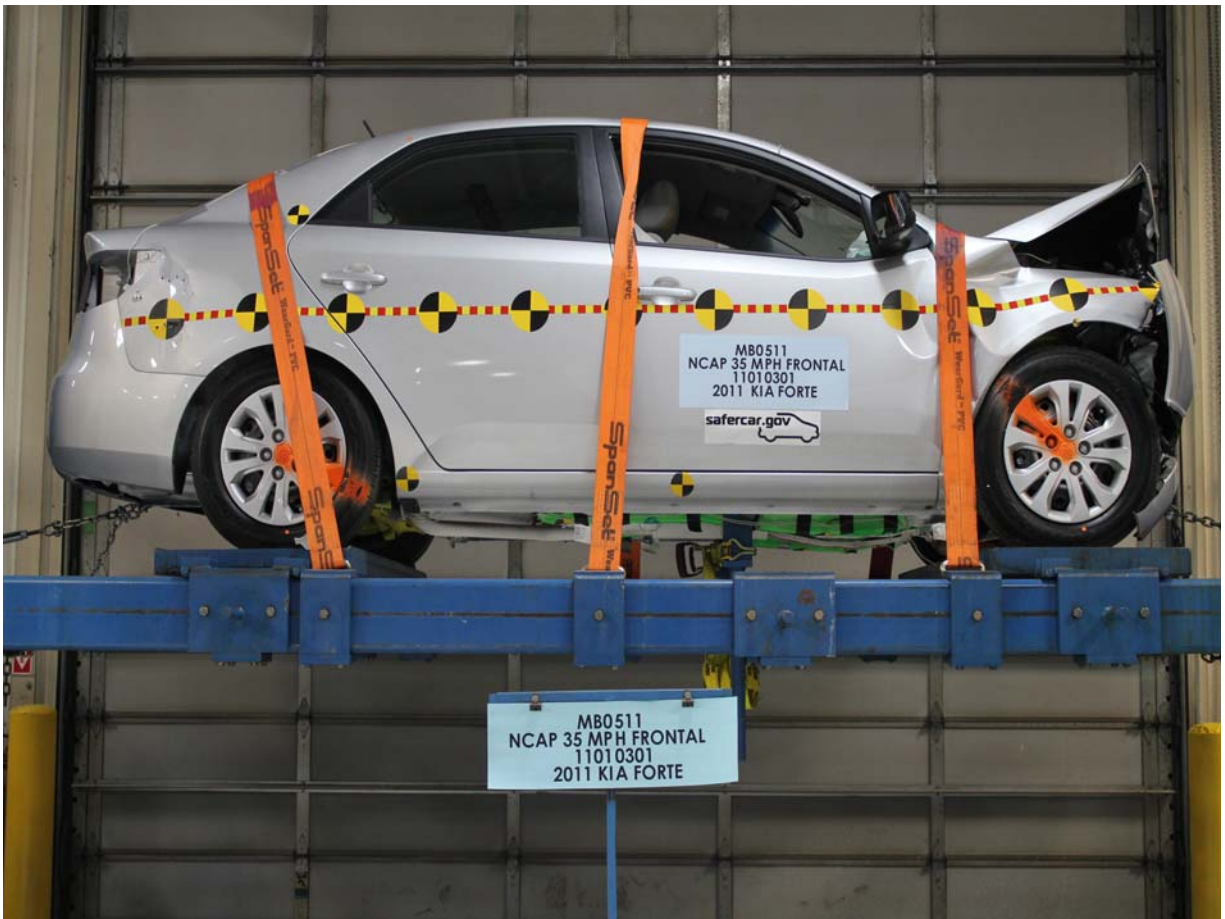
Vehicle at 0 Degrees on Static Rollover Device

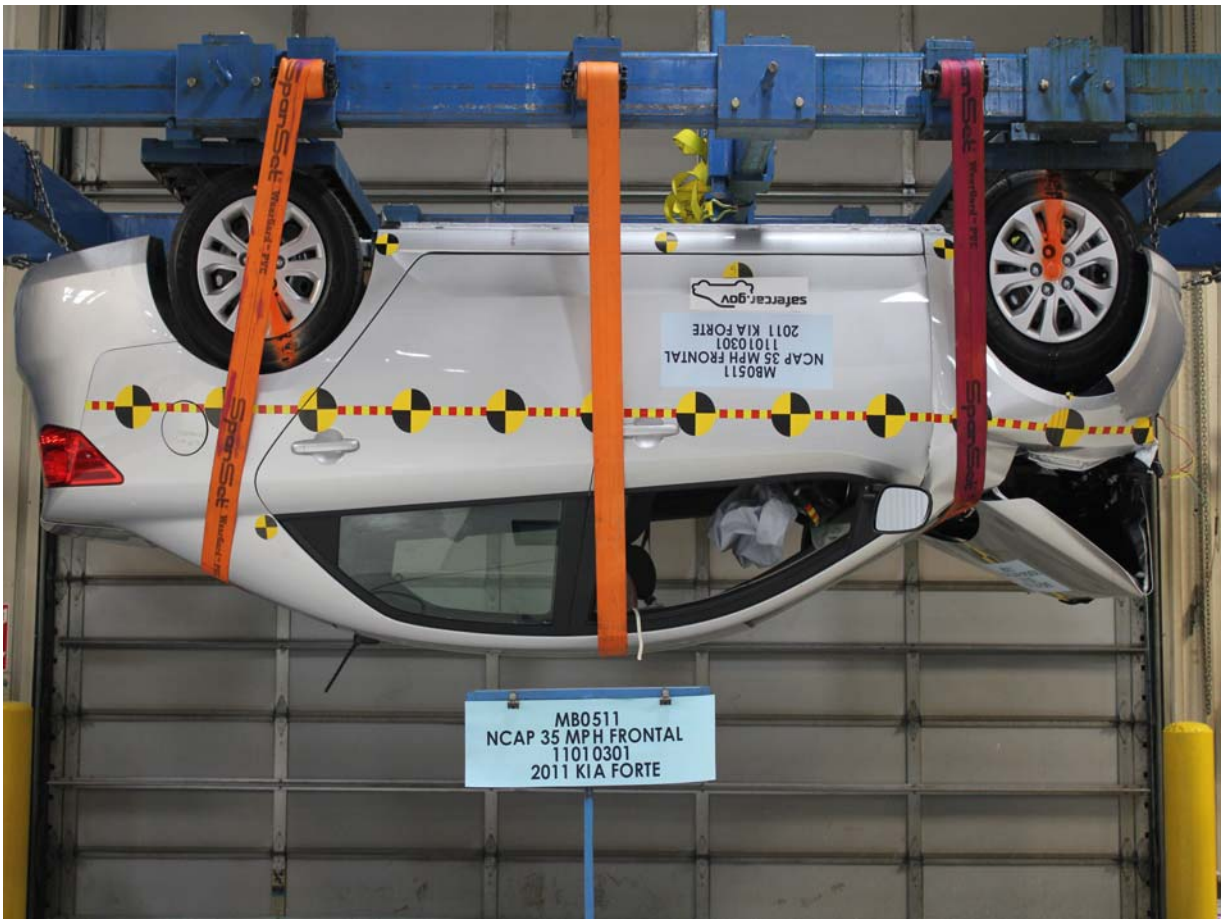
Vehicle at 180 Degrees on Static Rollover Device

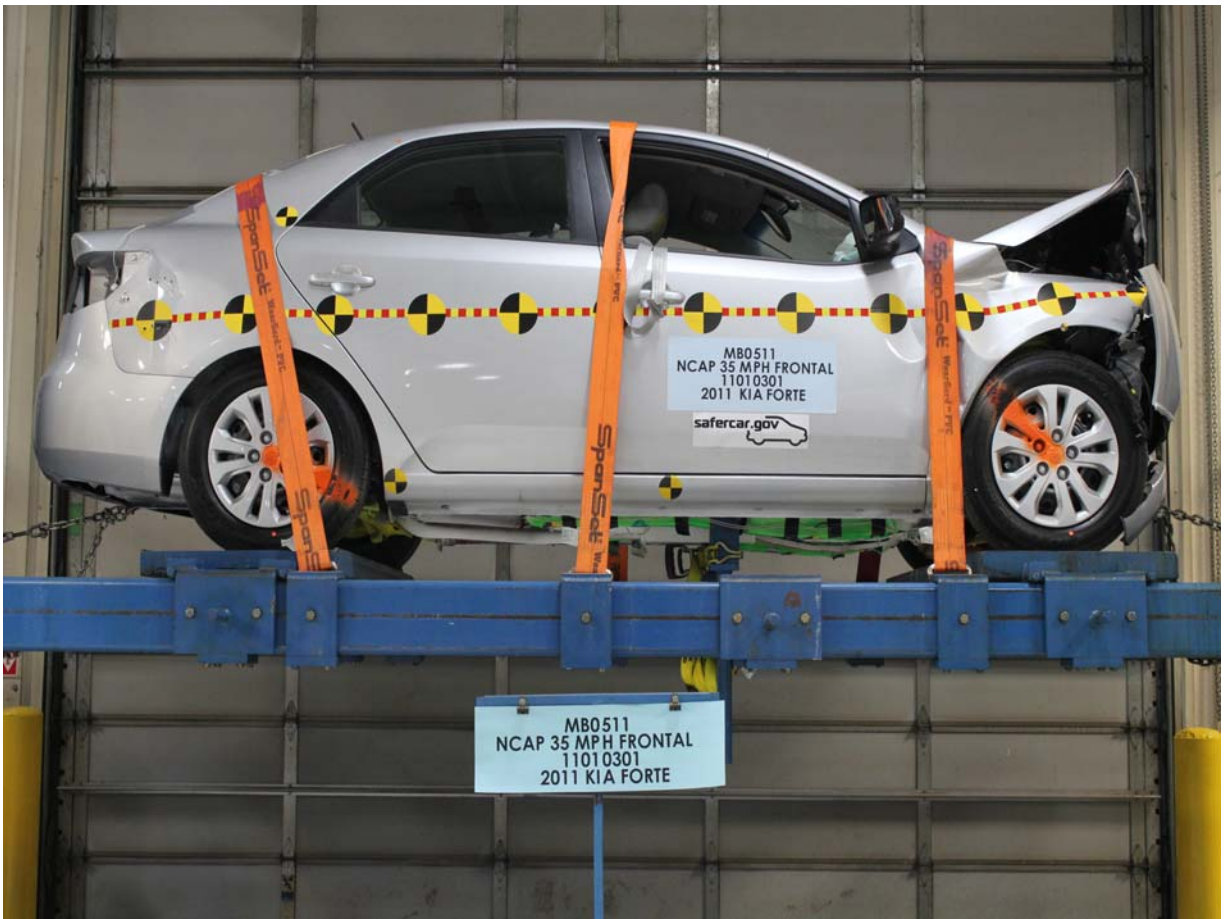
Vehicle at 360 Degrees on Static Rollover Device
