**REPORT NUMBER: NCAP-MGA-2011-060**

**NEW CAR ASSESSMENT PROGRAM (NCAP)  
Frontal Barrier Impact Test**

**HYUNDAI MOTOR MANUFACTURING ALABAMA, LLC  
2011 Hyundai Sonata GLS 4-Dr Sedan  
NHTSA No.: UB0501**

**FINAL REPORT**

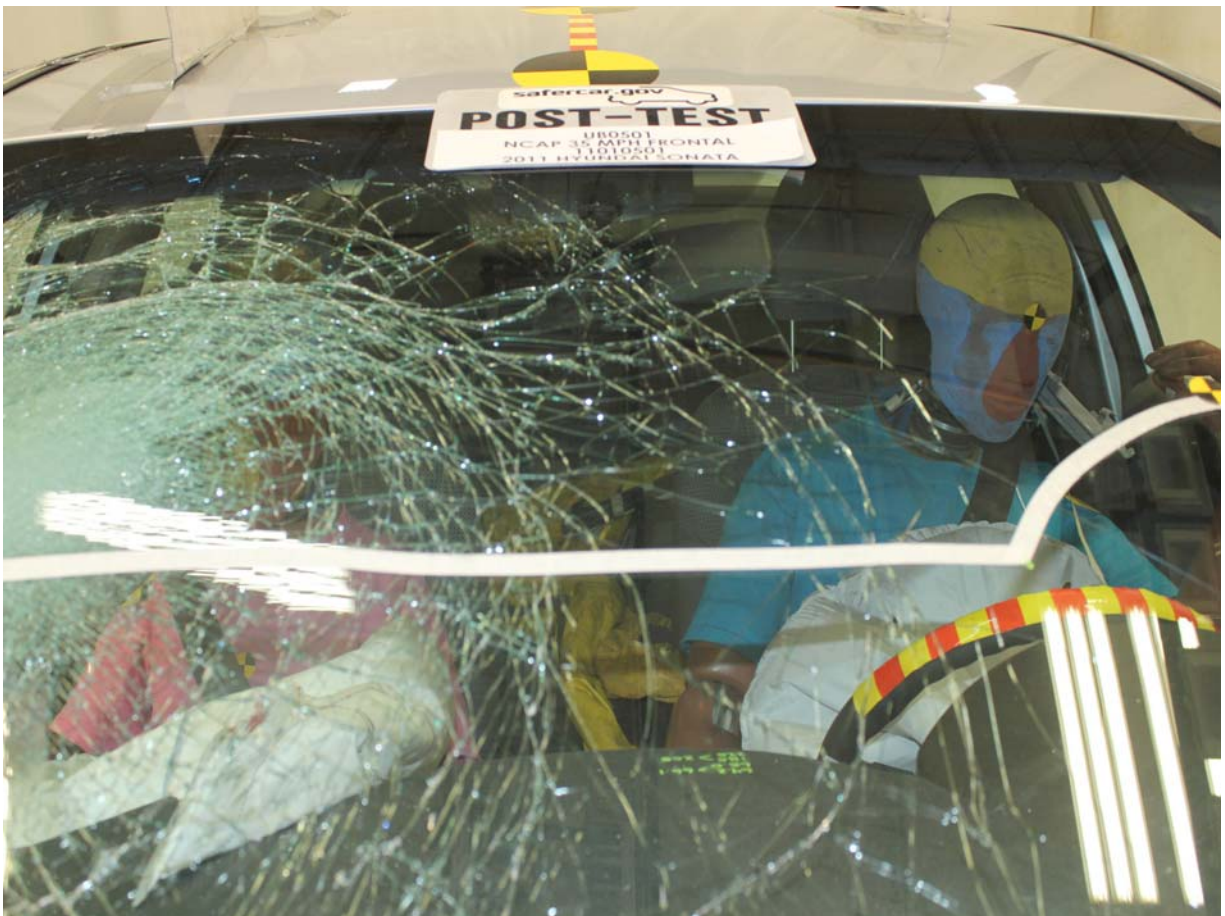
Post-Test Windshield View

There was 100 percent windshield retention and no intrusion into the protected zone of the windshield during the event. There was no Stoddard Solvent leakage after the event or during any phase of the static rollover.

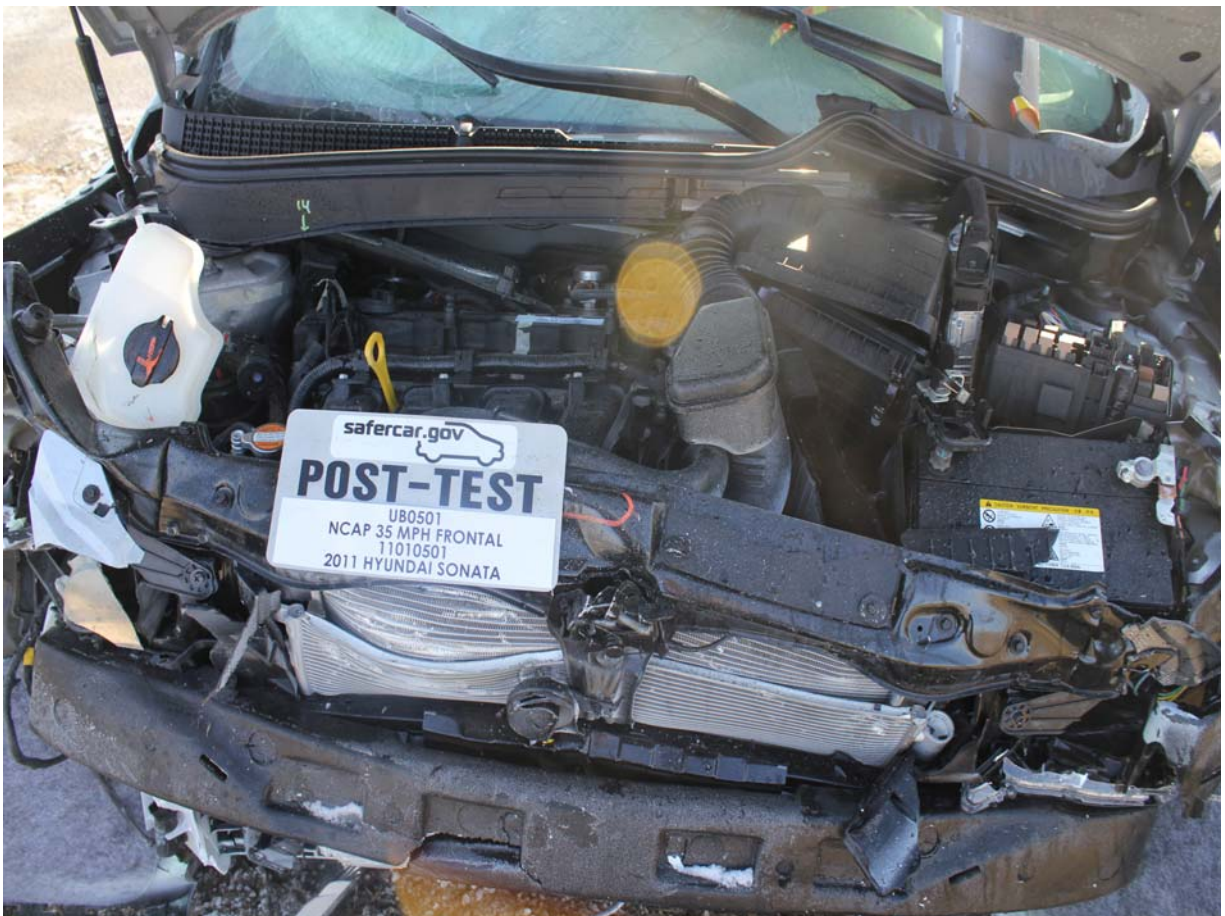
Post-Test Engine Compartment View

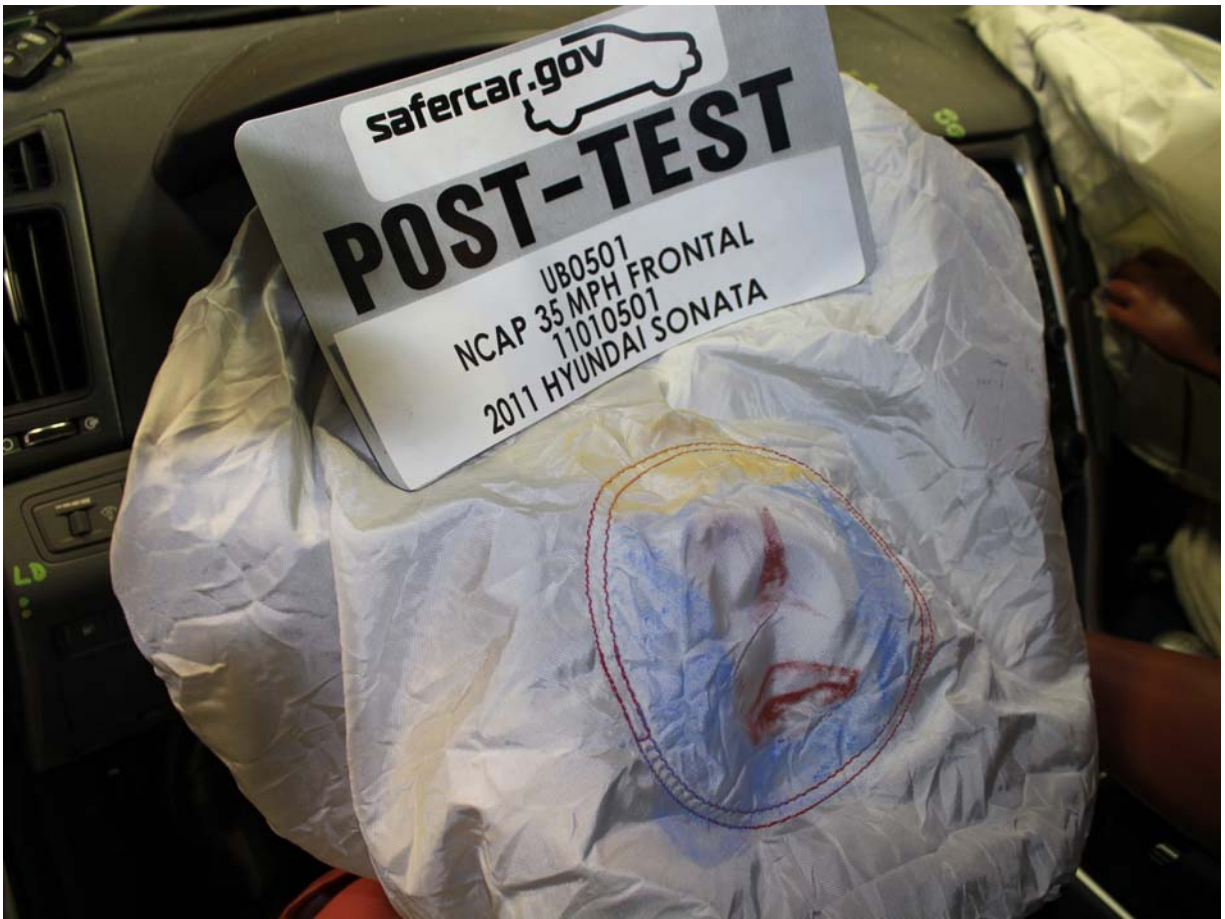
Post-Test Driver Dummy Contact with Airbag

The driver's head and chest contacted the airbag. The driver's head also contacted the headrest. The driver's knees contacted the knee bolster. The passenger's head and chest contacted the airbag. The passenger's head also contacted the headrest. The passenger's knees contacted the glovebox.

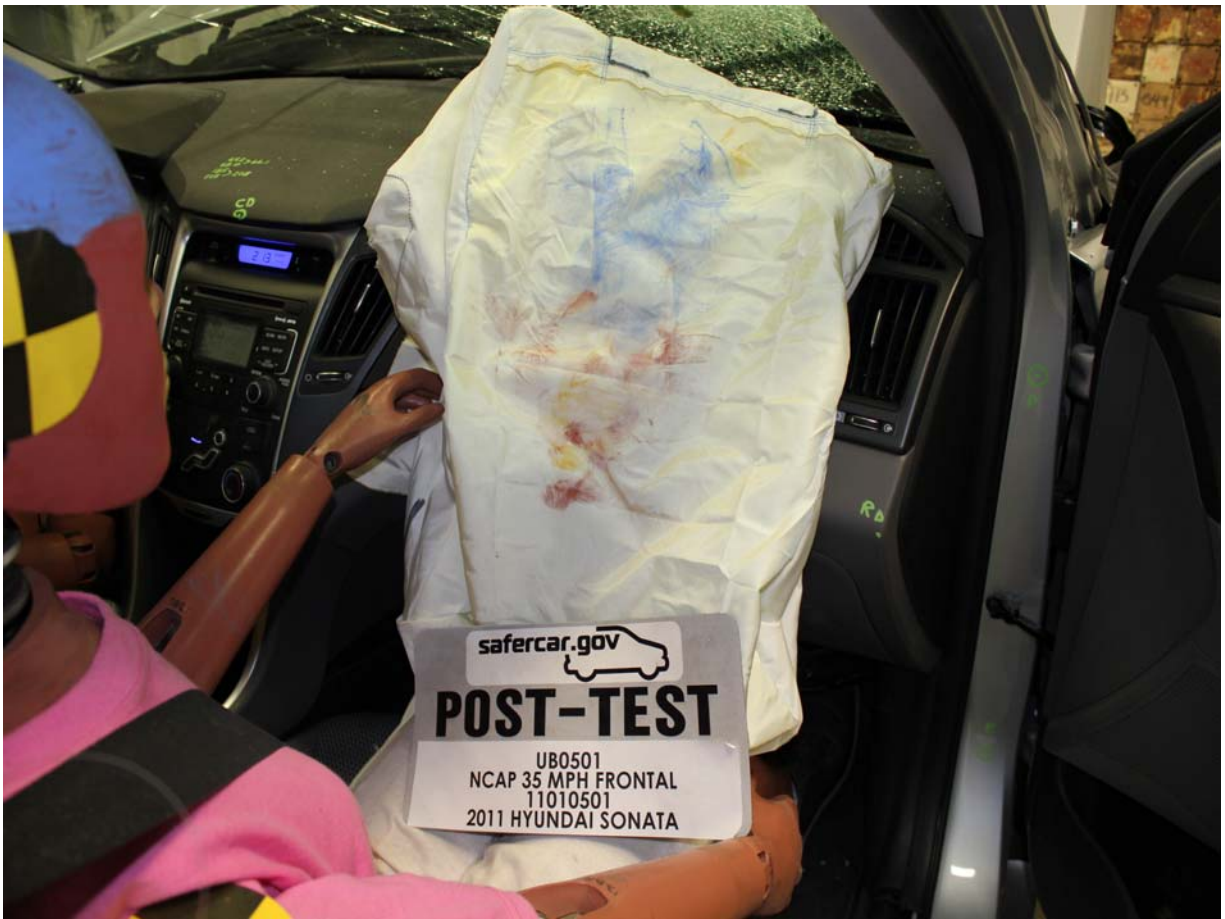
Post-Test Passenger Dummy Contact with Airbag

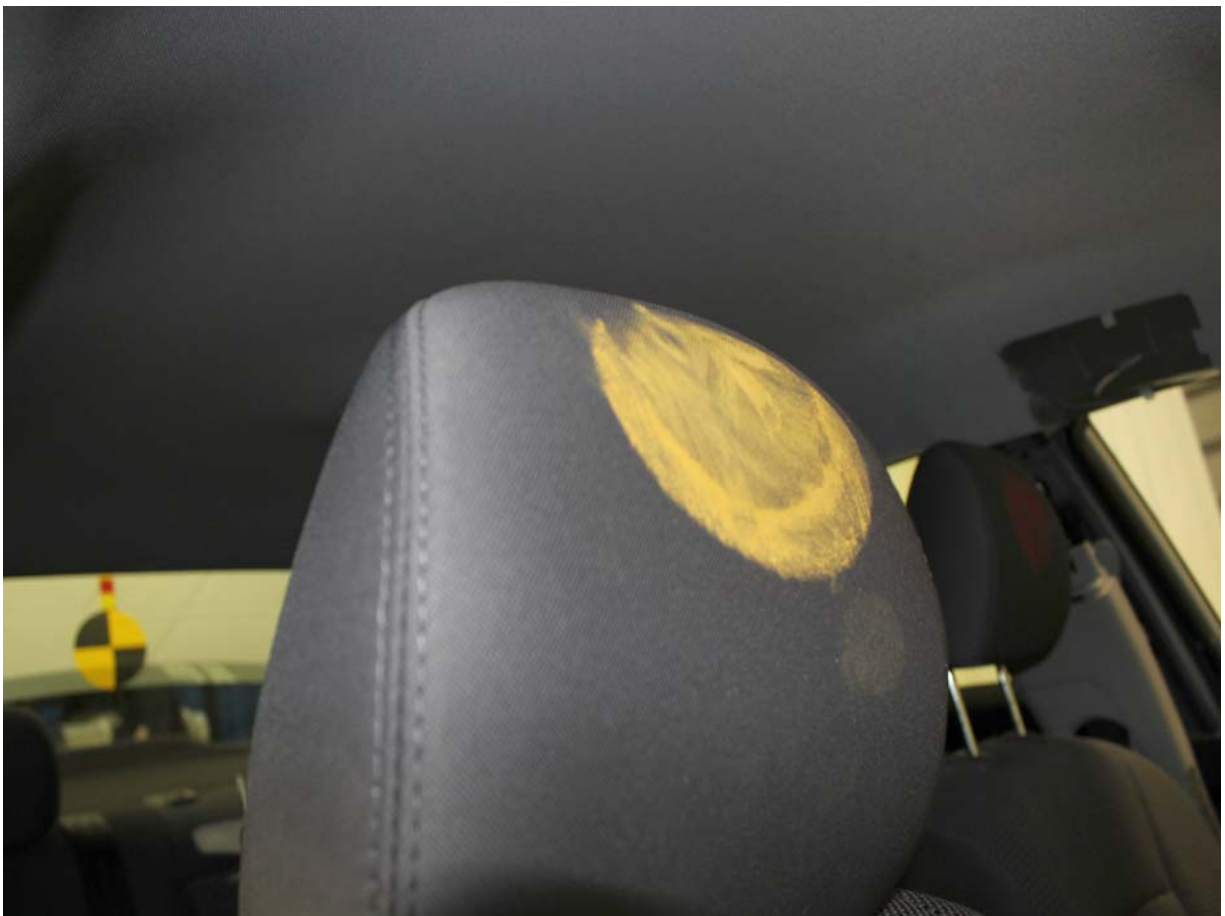
Post-Test Passenger Dummy Contact with Headrest

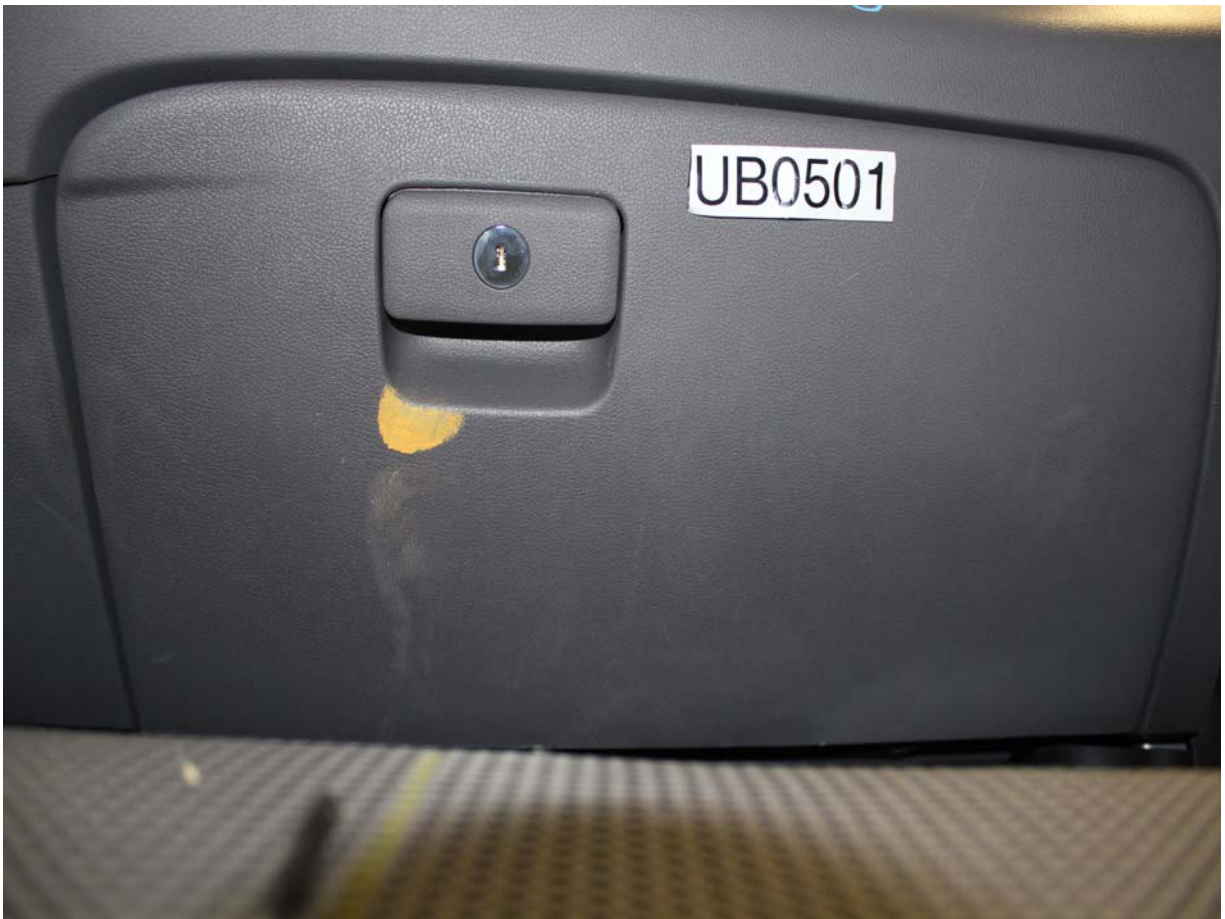
Post-Test Passenger Dummy Contact with Glovebox
