**REPORT NUMBER: SNCAP-MCW-11-004**

**NEW CAR ASSESSMENT PROGRAM (NCAP)  
MOVING DEFORMABLE BARRIER SIDE IMPACT TEST**

**KIA MOTORS  
2011 KIA FORTE 4-DOOR SEDAN  
NHTSA NUMBER: MB 0510**

**REPORT DATE: JANUARY 13, 2011  
FINAL REPORT**

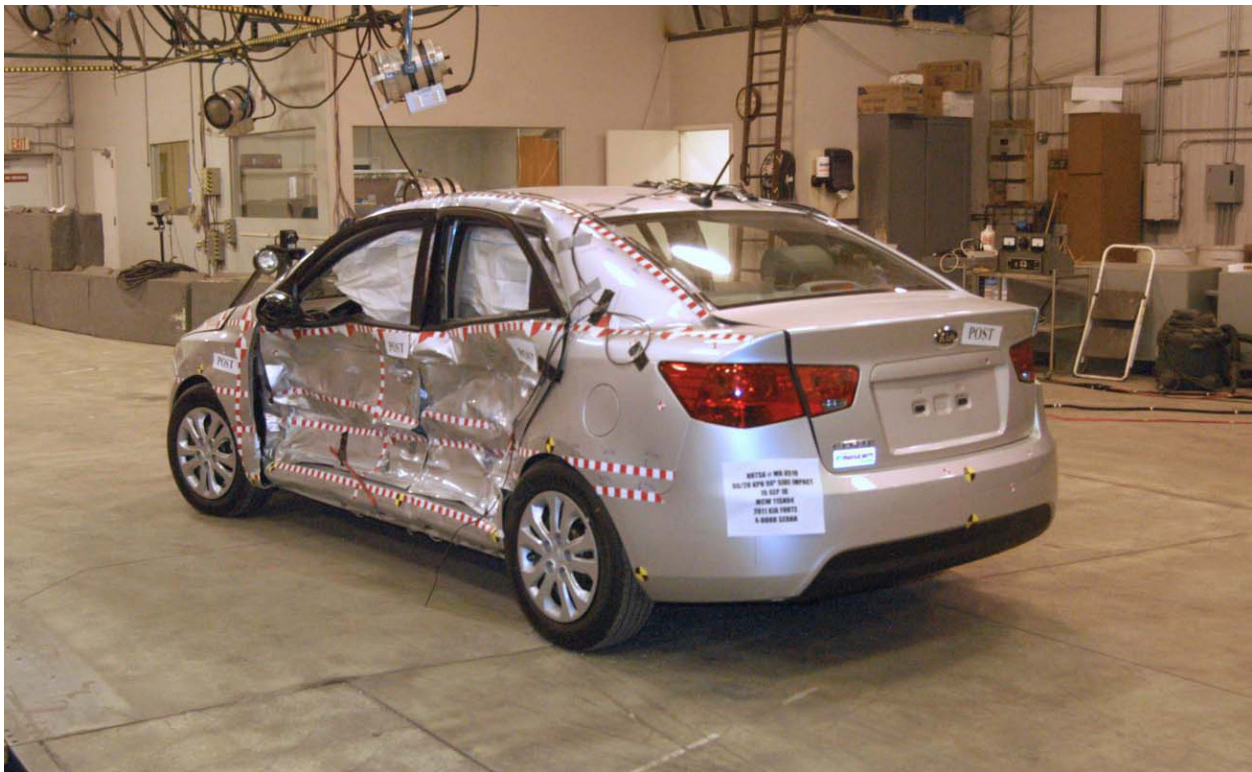
Figure A-10: Post-test Left Rear Three-Quarter View of Impact Zone

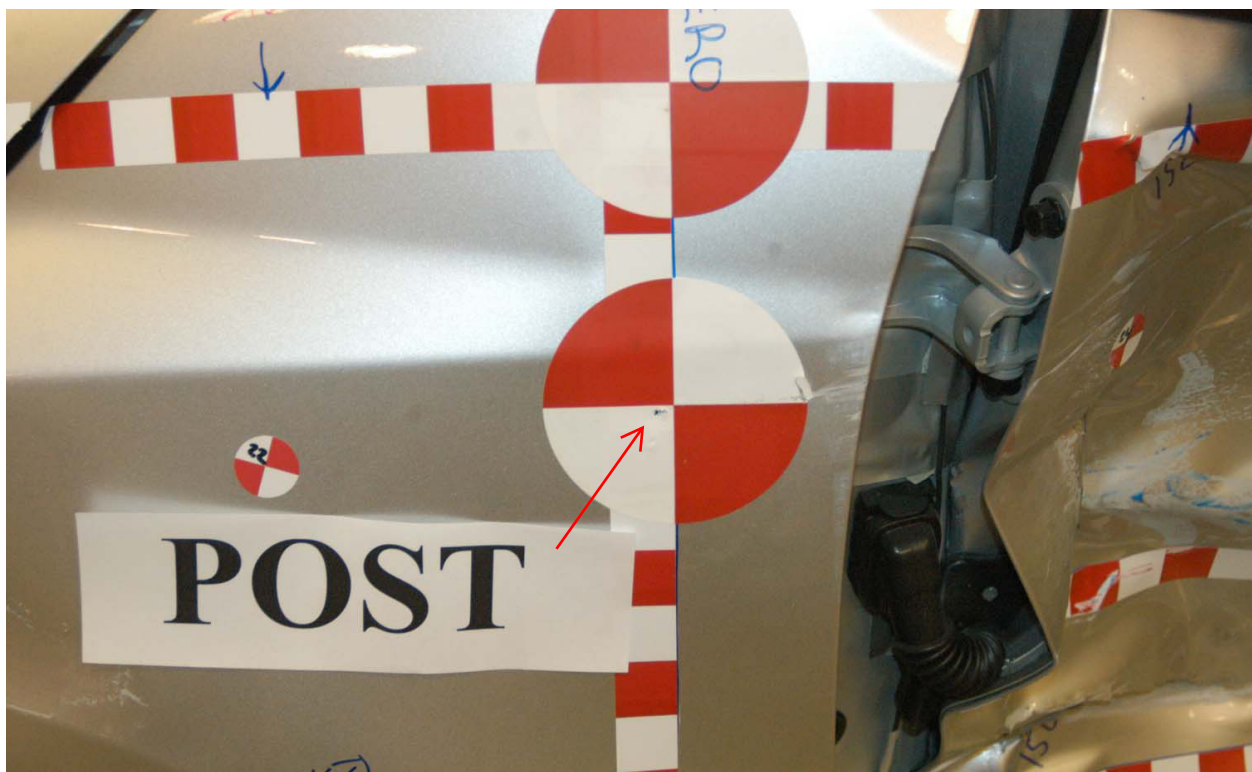
Figure A-20: Post-Test Close-Up View of Impact Point Target

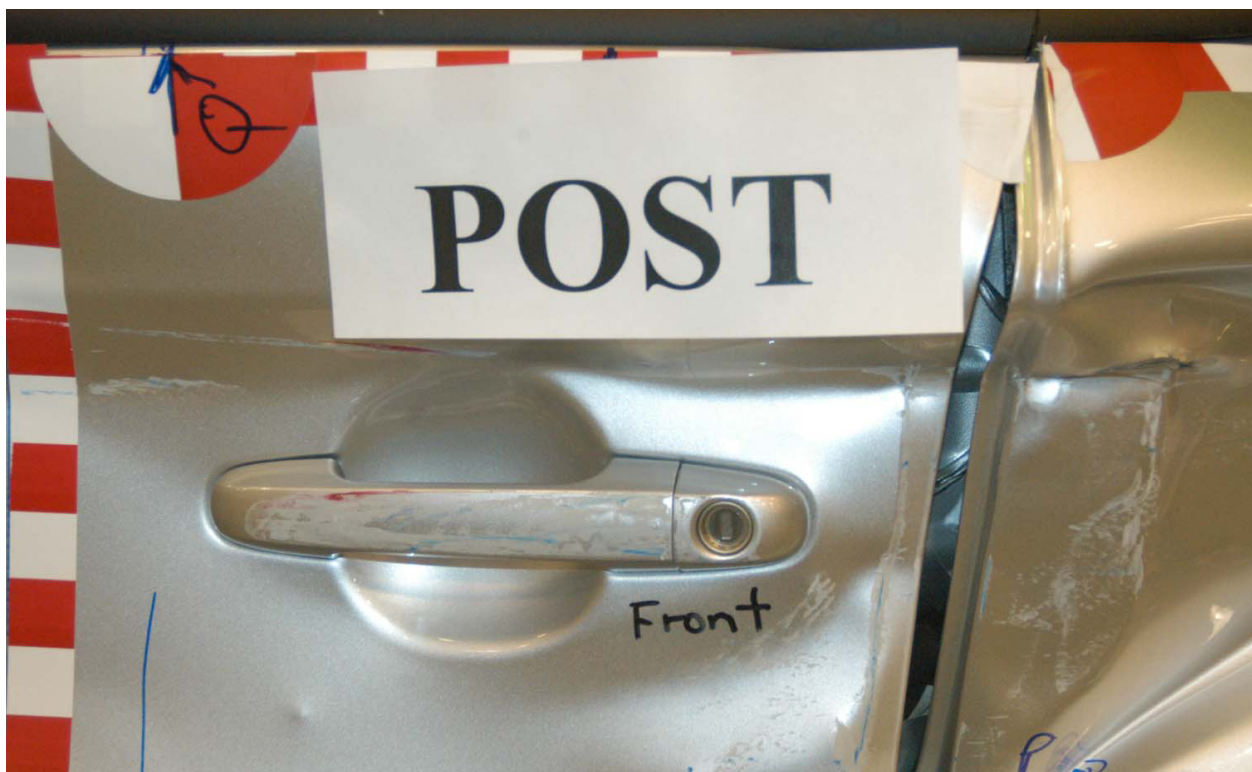
Figure A-22: Post-Test Left Front Door Latch Close-Up

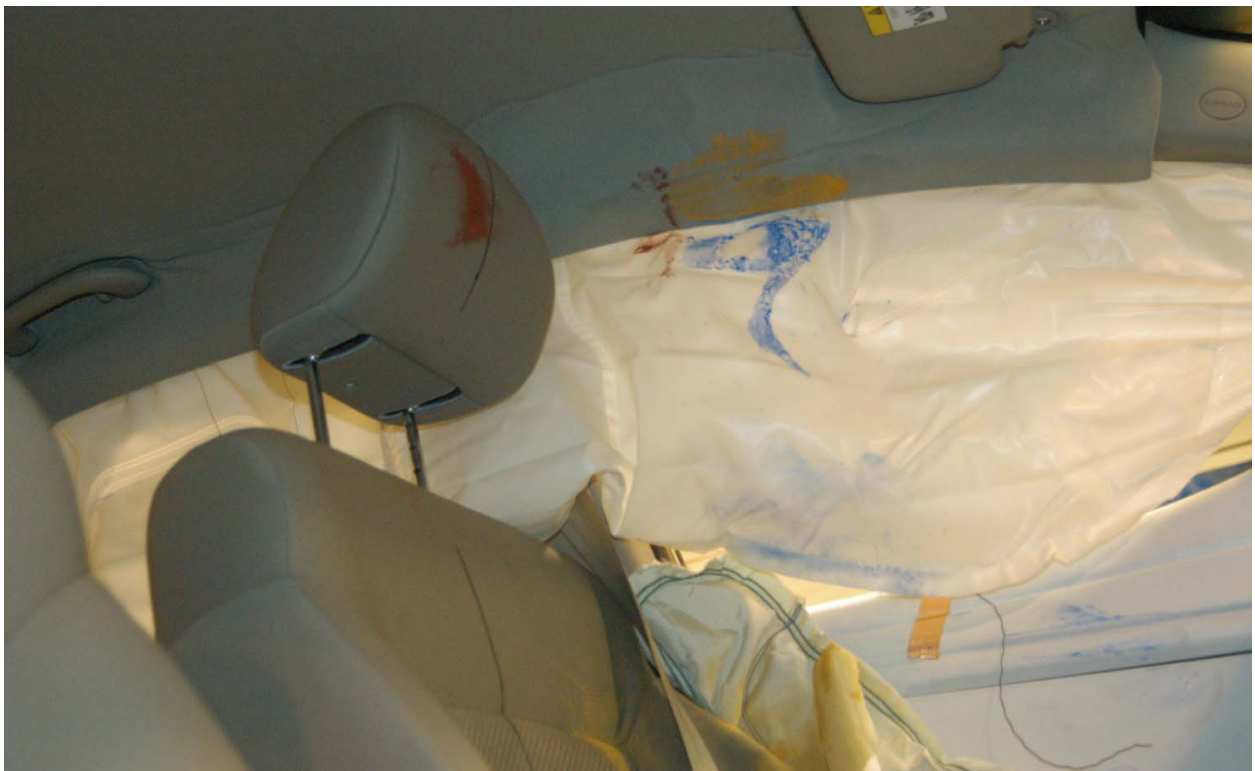
Figure A-48: Post-Test Driver Dummy Close-Up Head Contact with Side Air Bag View

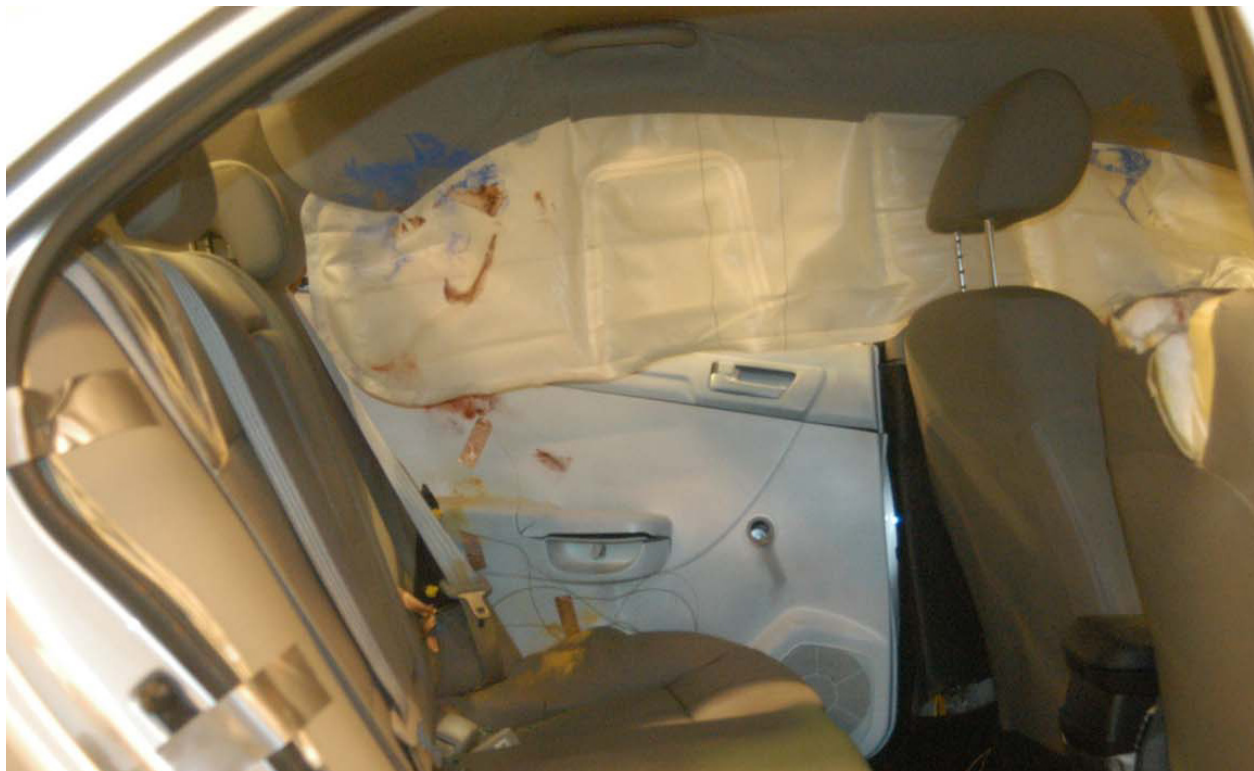
Figure A-72: Post-Test Rear Passenger Inner Door Panel View Showing Rear Passenger Dummy Contact Locations
