**REPORT NUMBER: NCAP-KAR-11-052**

**NEW CAR ASSESSMENT PROGRAM (NCAP)  
FRONTAL BARRIER IMPACT TEST**

**TOYOTA MOTOR MANUFACTURING, TEXAS, INC.  
2011 TOYOTA TUNDRA DOUBLE CAB 4X4 4-DOOR TRUCK**

**FINAL REPORT**

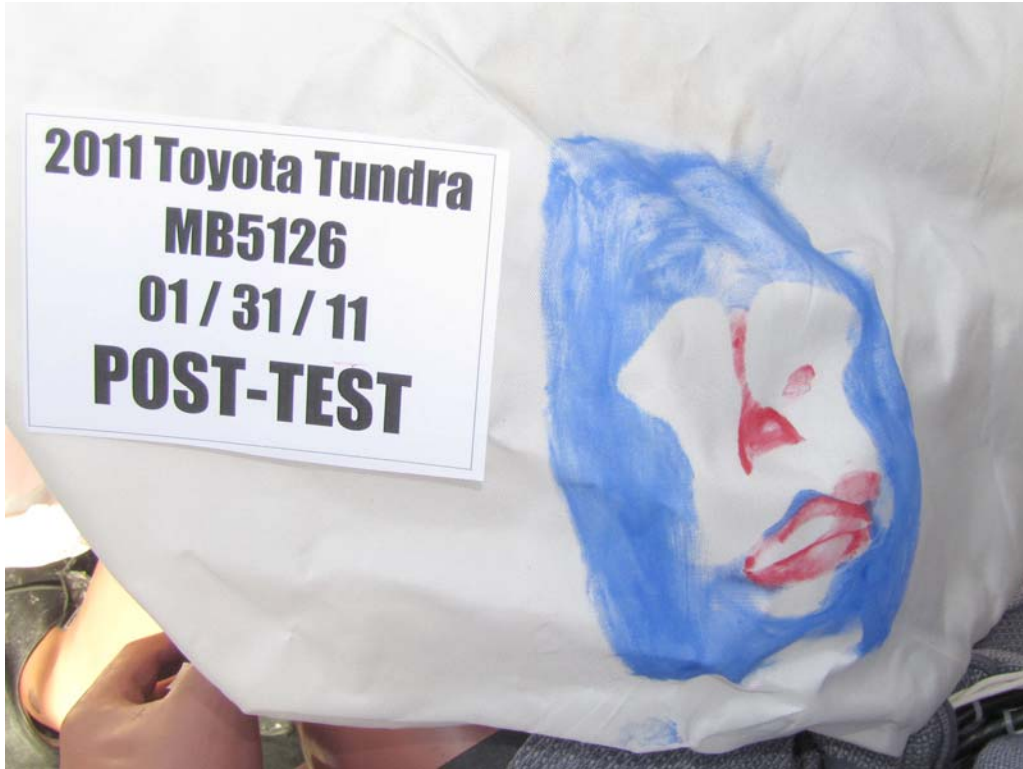
FIGURE 43. Post-Test Driver Dummy Contact With Airbag

The driver's visible contact points were as follows: The driver ATD's head contacted the airbag and headrest. The upper torso contacted the airbag. The left knee contacted the knee airbag and steering column. The right knee contacted the knee airbag.

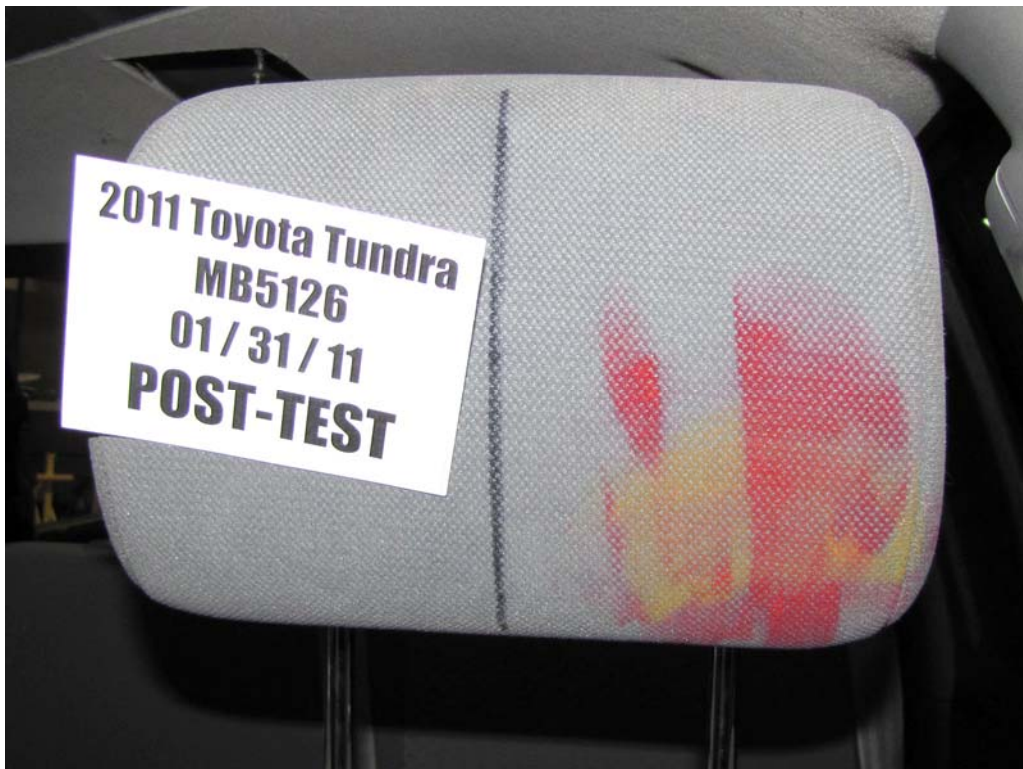
FIGURE 43a. Post-Test Driver Dummy Contact With Head Restraint

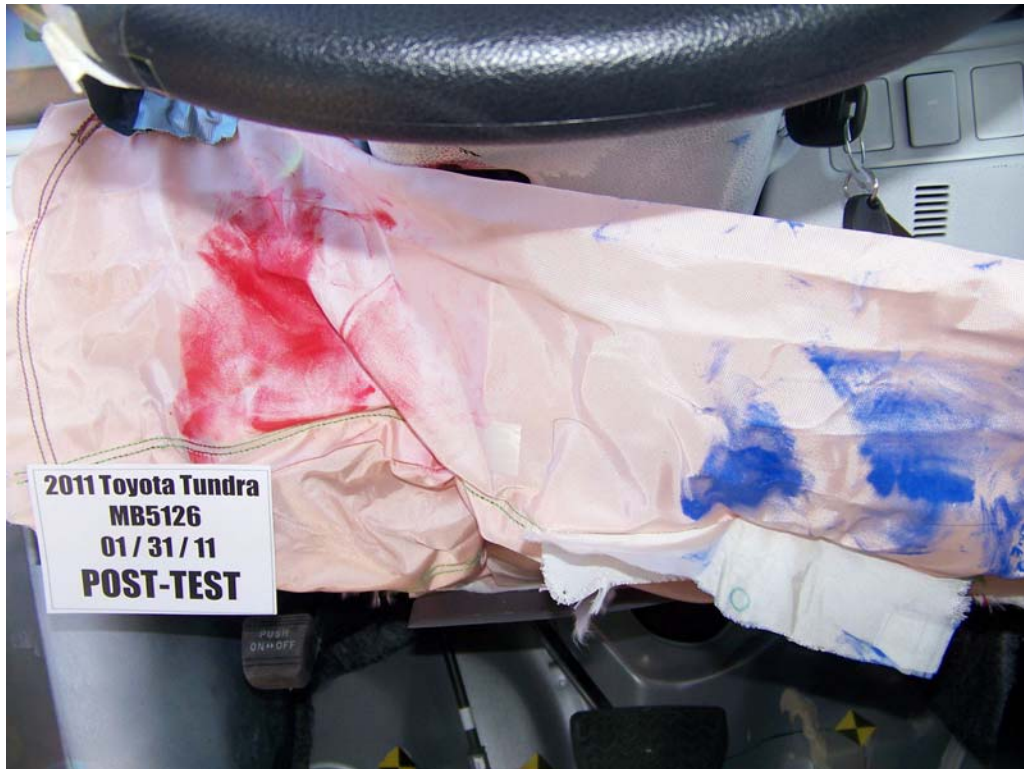
FIGURE 43b. Post-Test Driver Dummy Contact With Knee Airbag

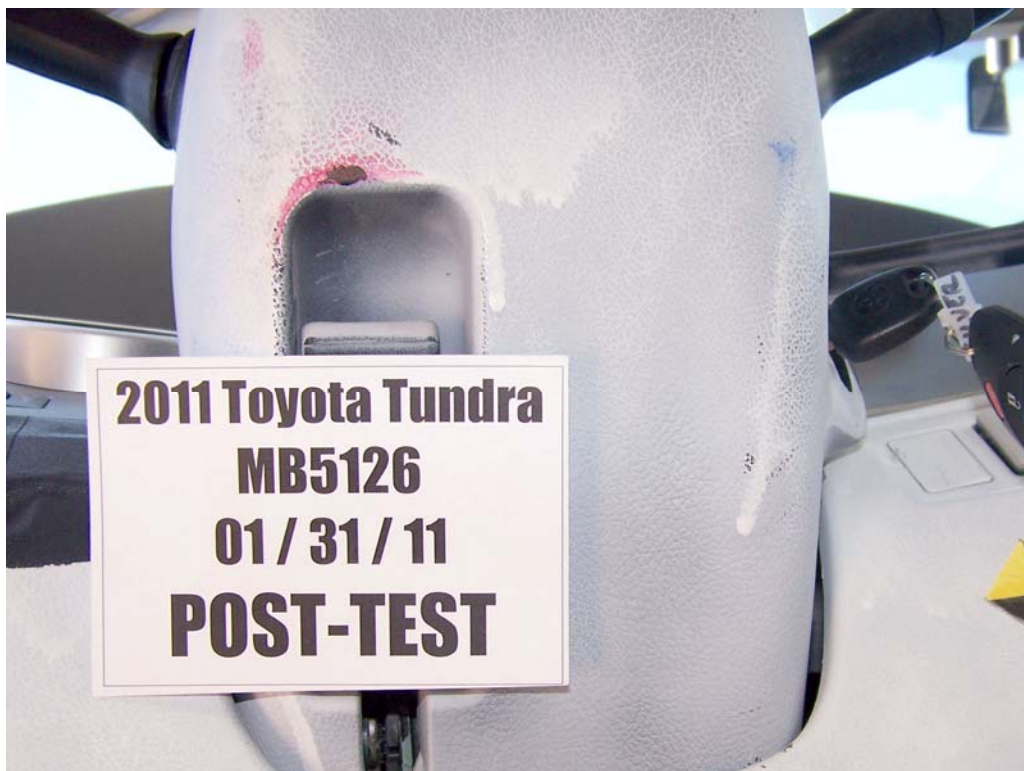
FIGURE 43c. Post-Test Driver Dummy Contact With Steering Column

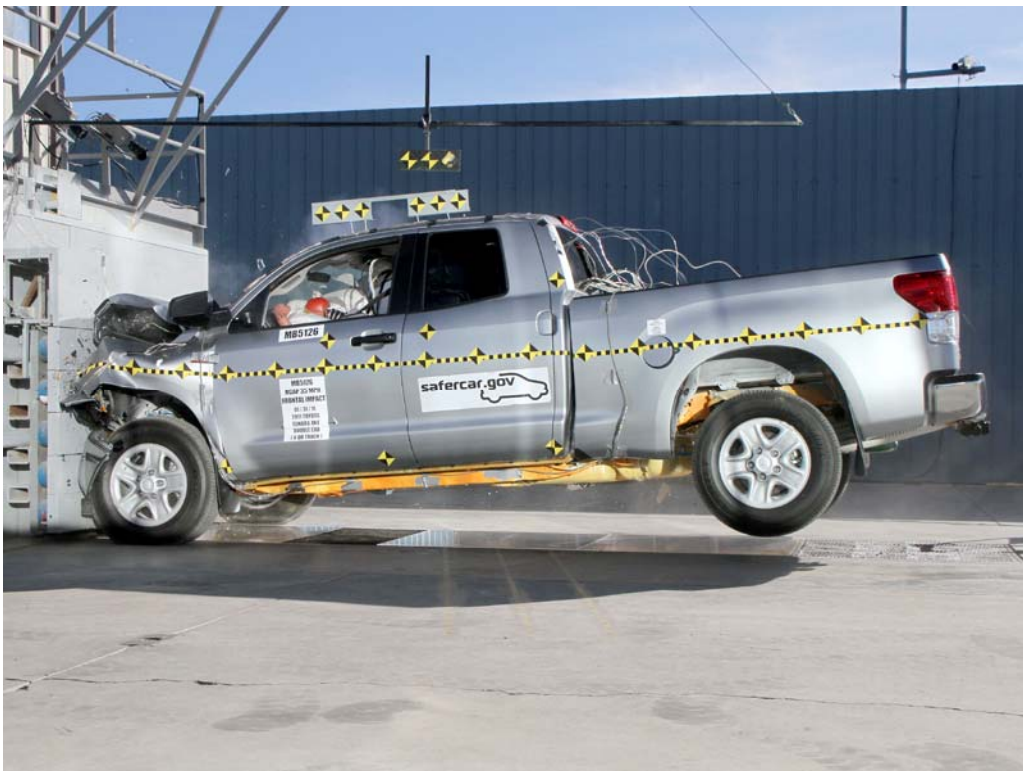
FIGURE 69. Impact Event
