**REPORT NUMBER: SPNCAP-KAR-11-054**

**NEW CAR ASSESSMENT PROGRAM (NCAP)  
SIDE IMPACT POLE TEST**

**TOYOTA MOTOR MANUFACTURING, TEXAS, INC.  
2011 TOYOTA TUNDRA 4X2 DOUBLE CAB 4-DOOR TRUCK**

**FINAL REPORT**

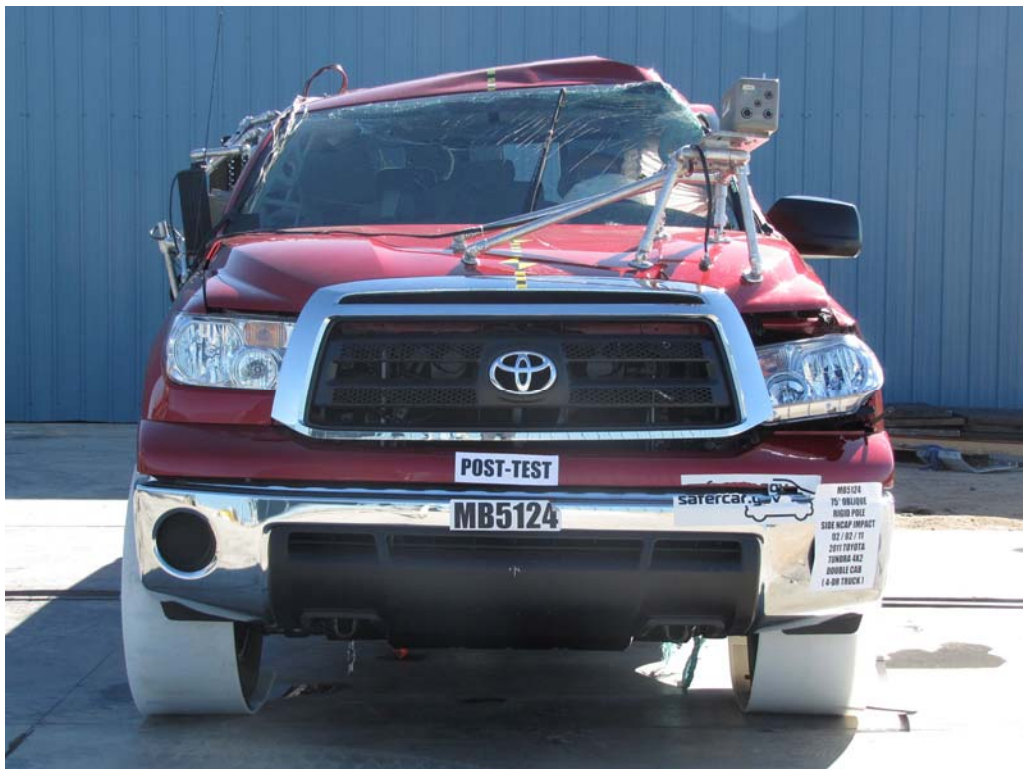
FIGURE 4. Post-Test Frontal View of Test Vehicle

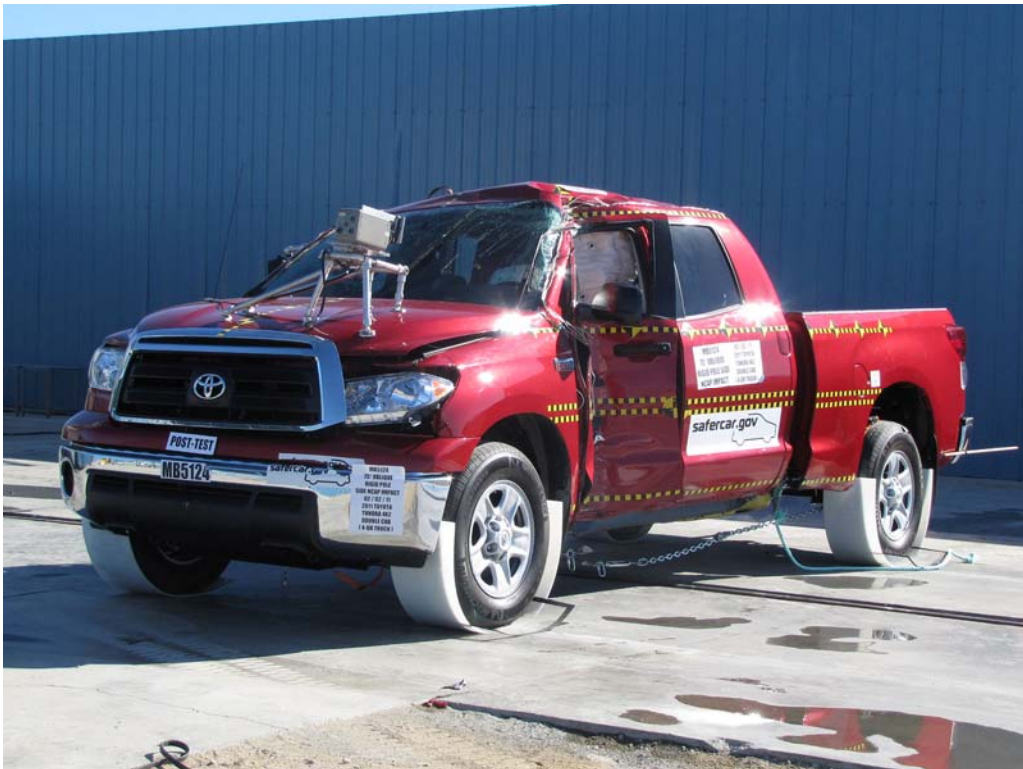
FIGURE 6. Post-Test Left Front Three-Quarter View of Test Vehicle

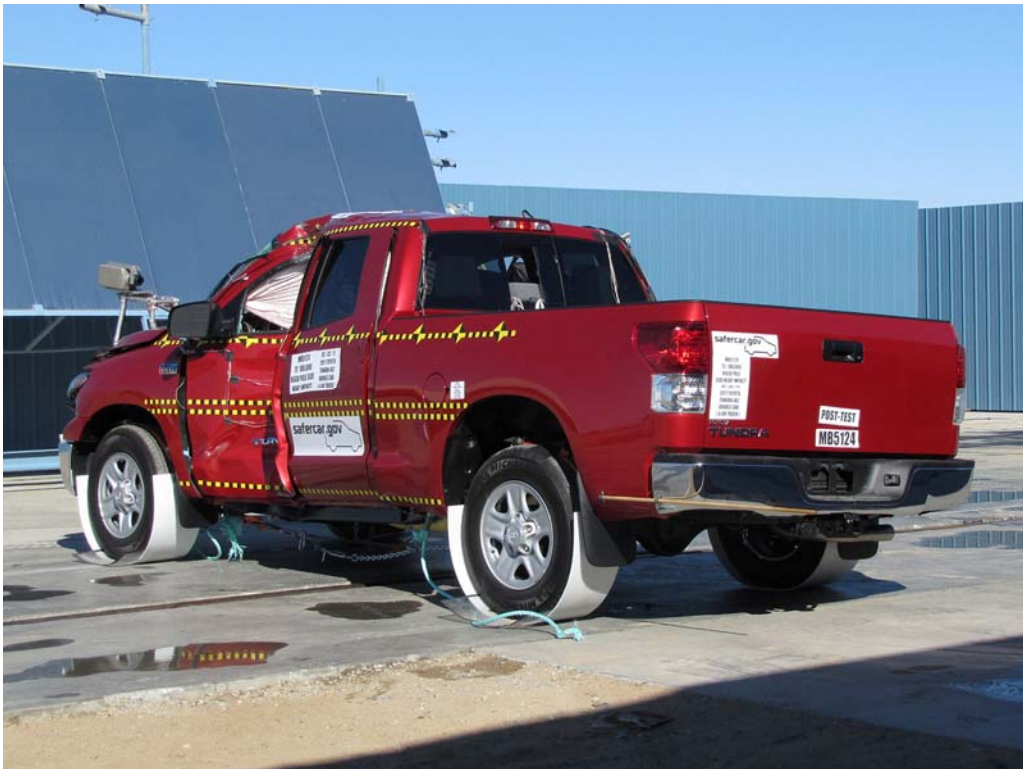
FIGURE 10. Post-Test Left Rear Three-Quarter View of Test Vehicle

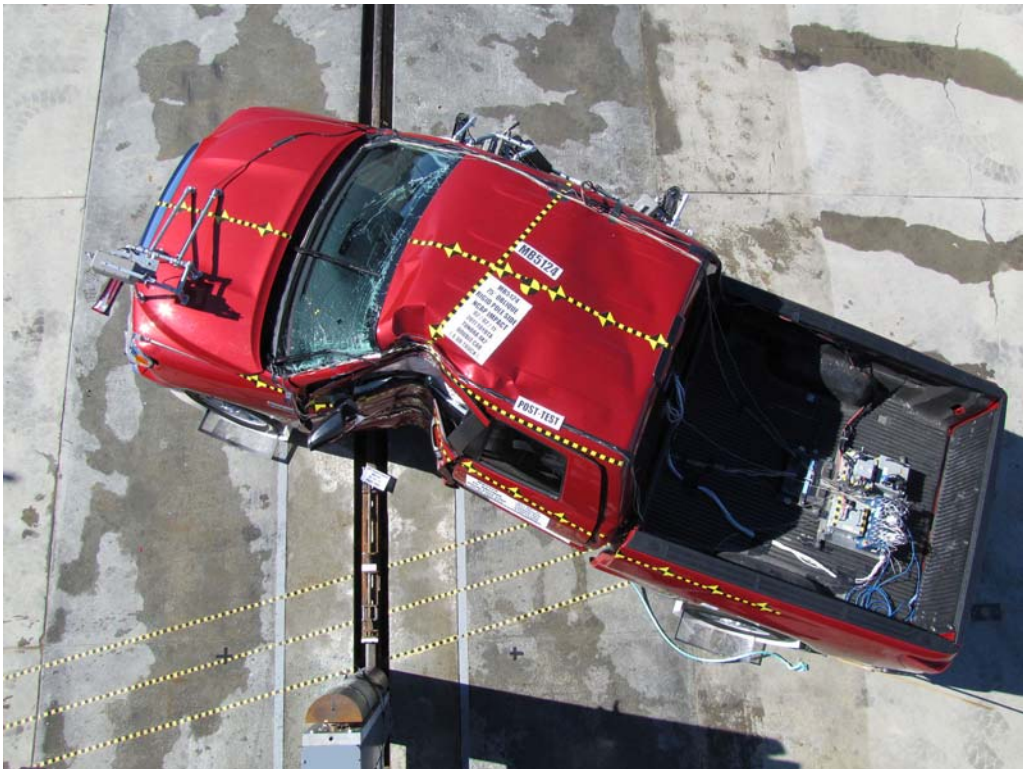
FIGURE 16. Post-Test Overhead View of Test Vehicle and Pole

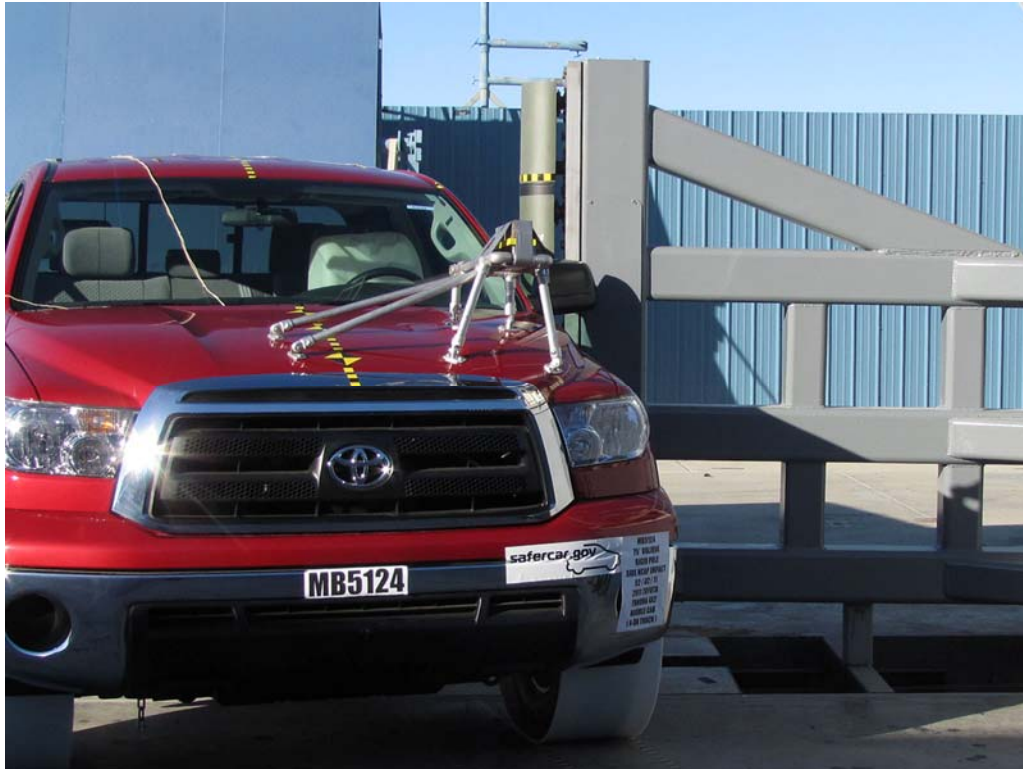
FIGURE 17. Pre-Test Left Side View of Pole  
Positioned Against Side of Vehicle at Impact Point

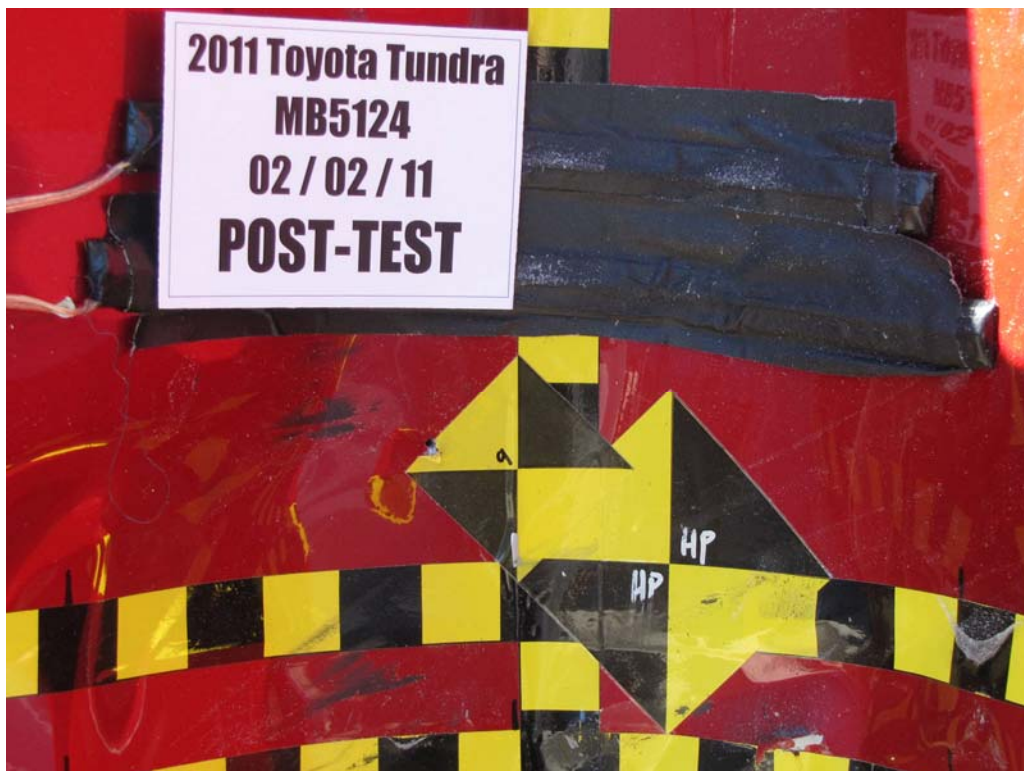
FIGURE 20. Post-Test Close-Up View of Impact Point Target Showing Impact Location

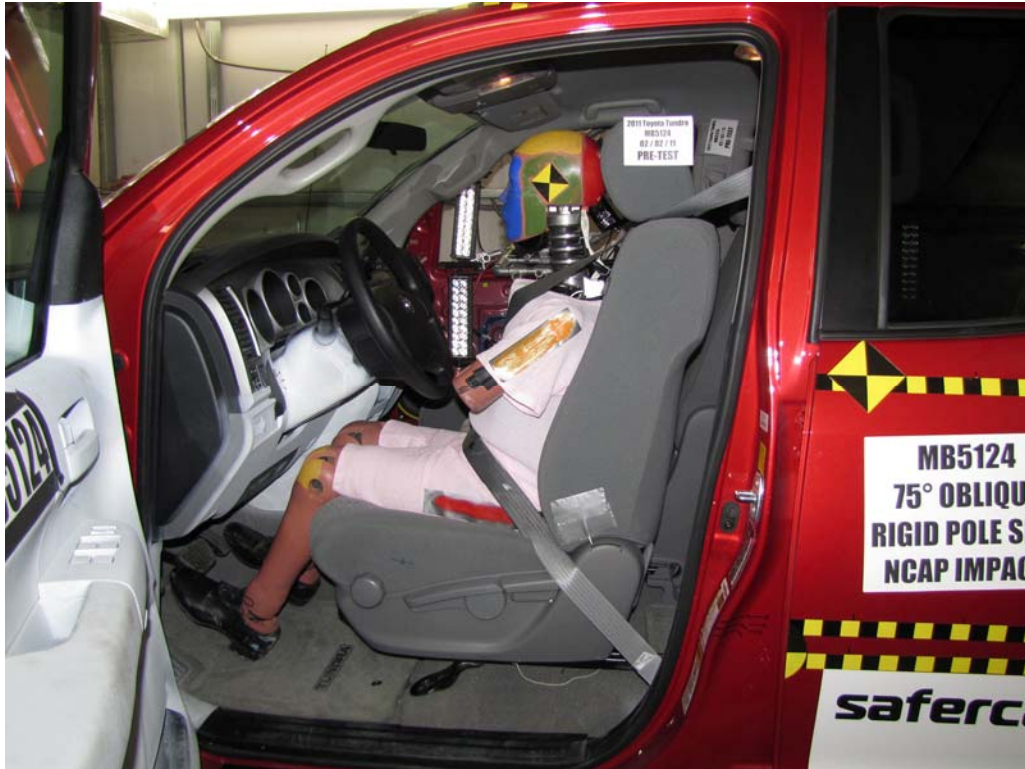
FIGURE 23. Pre-Test Left Side View of Dummy Showing Belt, Chalking, and Contact Switches

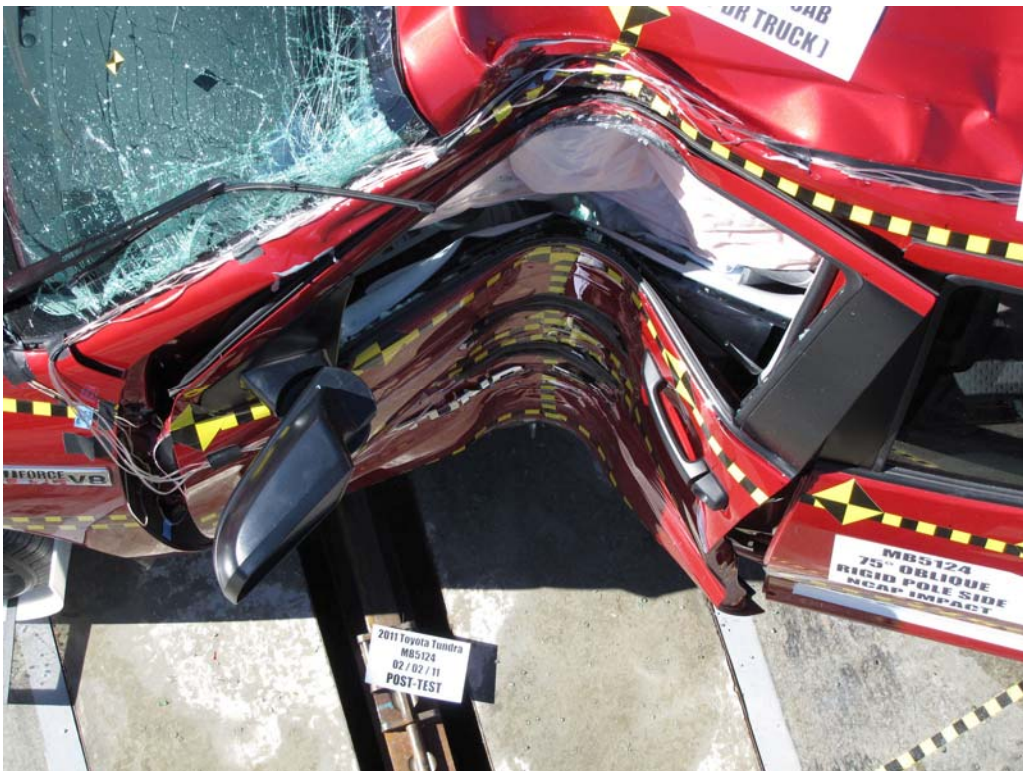
FIGURE 40. Post-Test Driver Dummy and Door Clearance

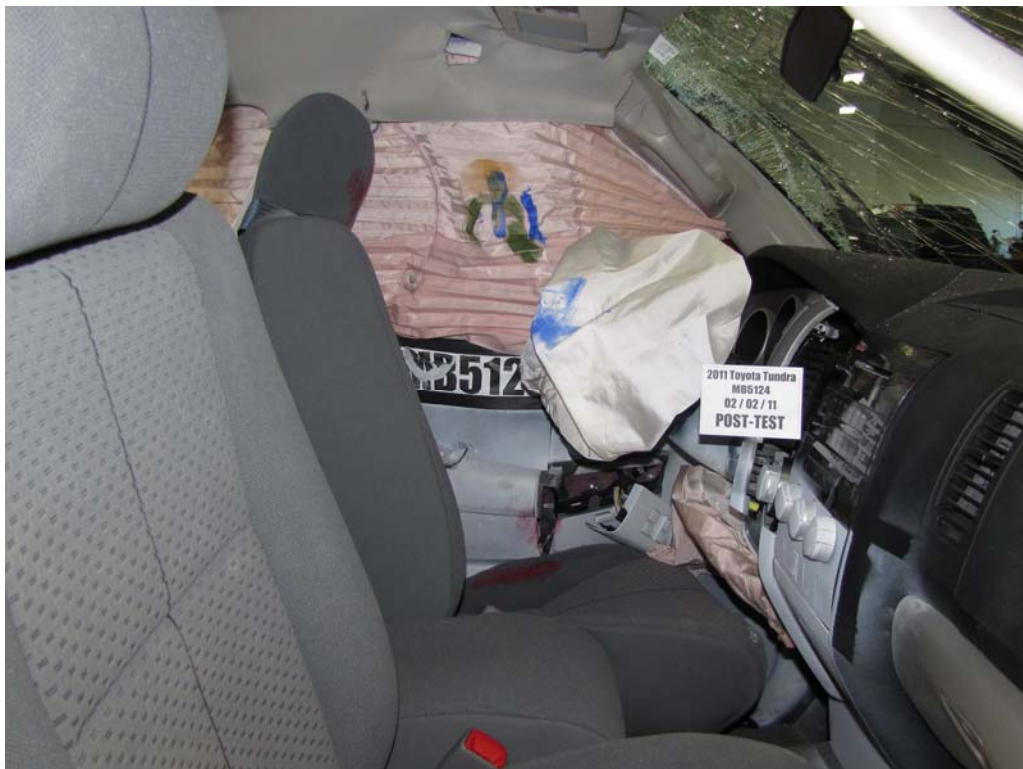
FIGURE 44. Post-Test Inner Driver Door Panel View  
Showing Dummy Contact Locations

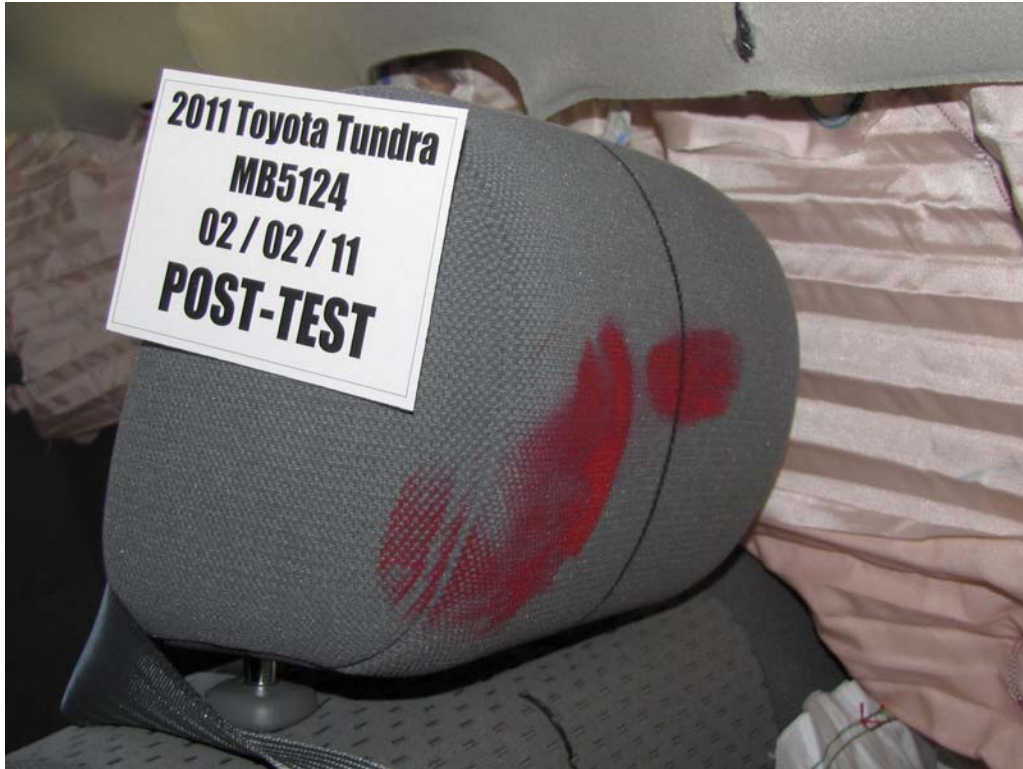
FIGURE 45. Post-Test Dummy Close-Up Head Contact with Vehicle Interior View

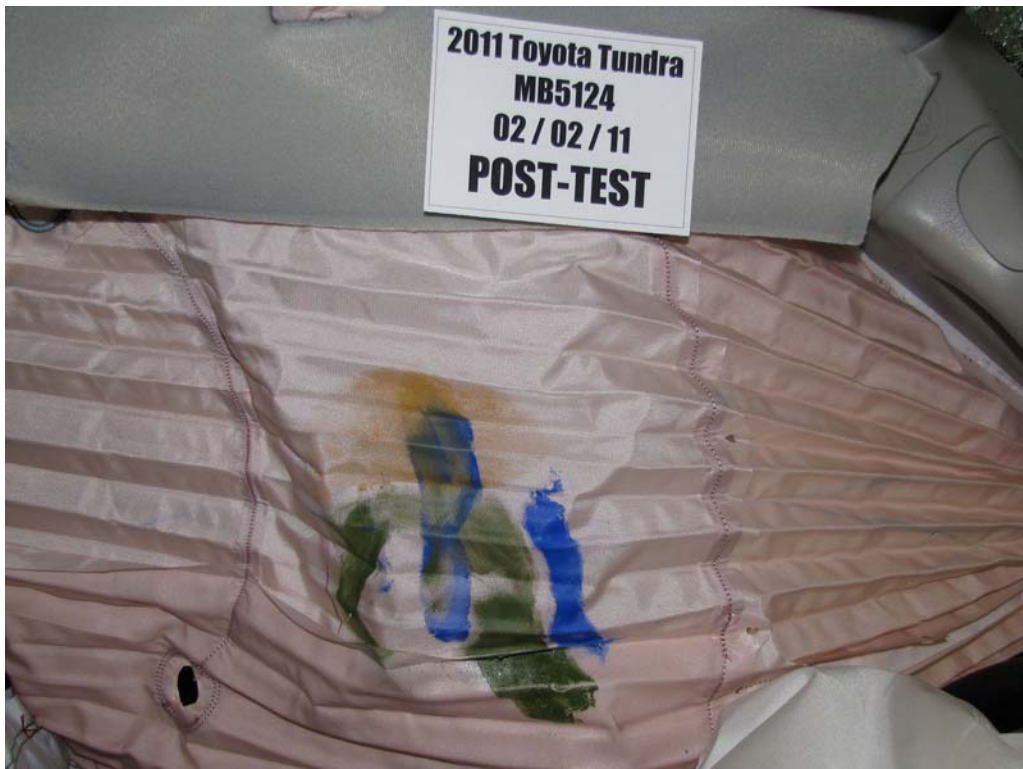
FIGURE 46. Post-Test Dummy Close-Up Head Contact with Side Airbag View

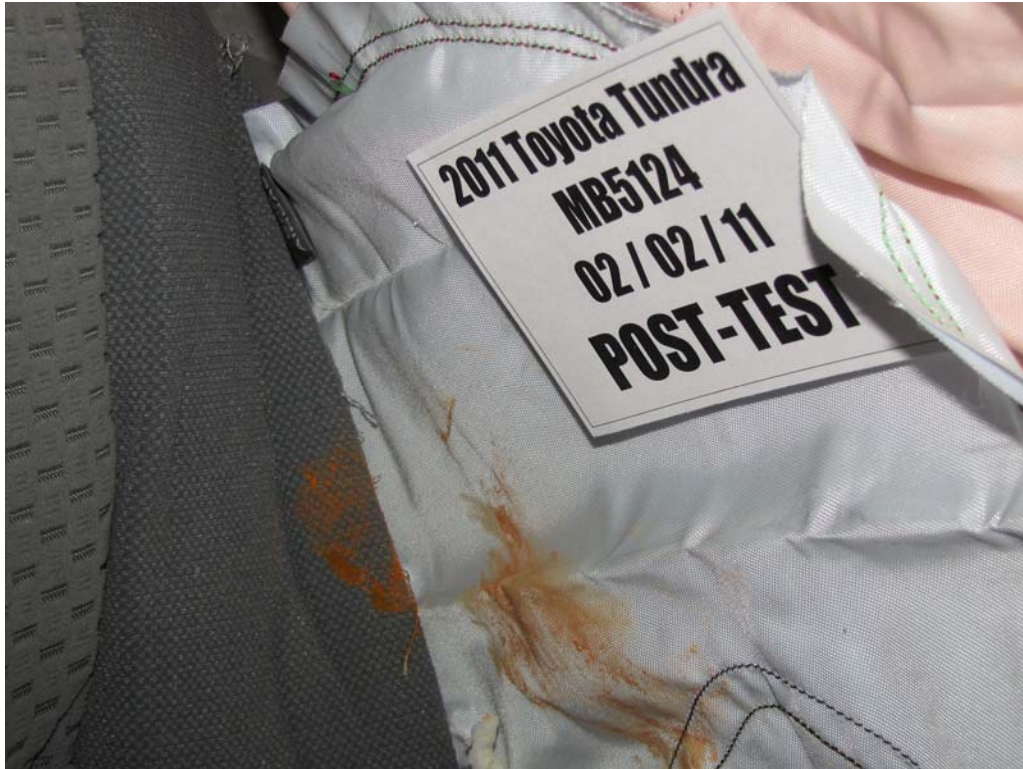
FIGURE 47. Post-Test Dummy Close-Up Torso Contact with Vehicle Interior View

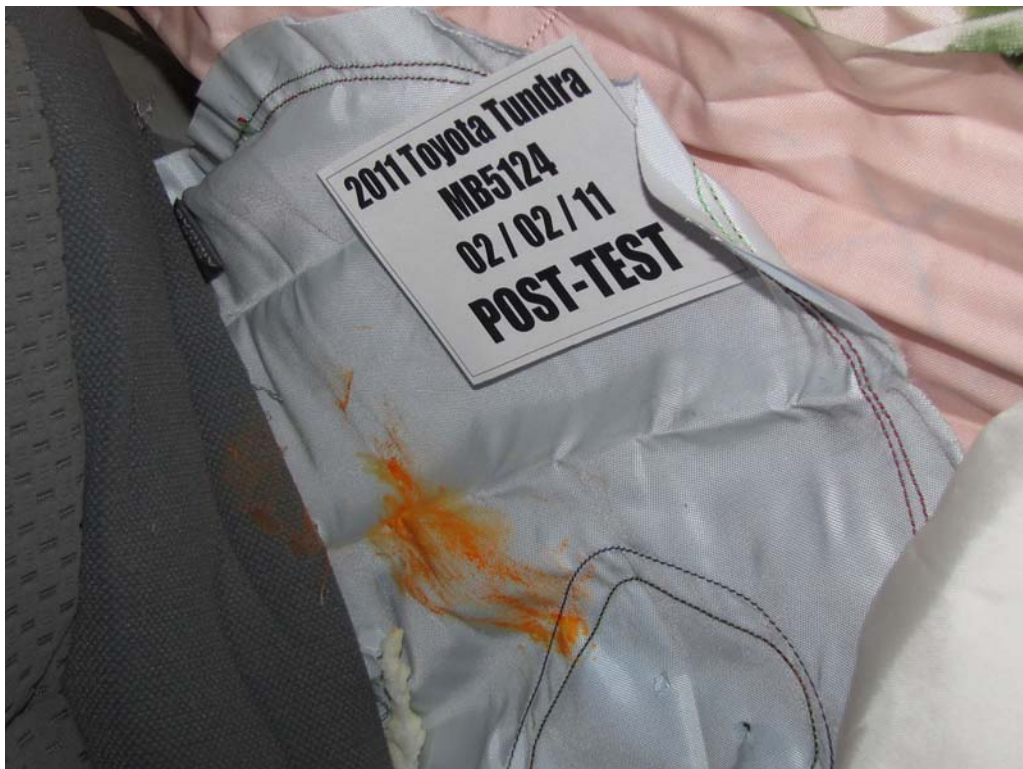
FIGURE 48. Post-Test Dummy Close-Up Torso Contact with Side Airbag View

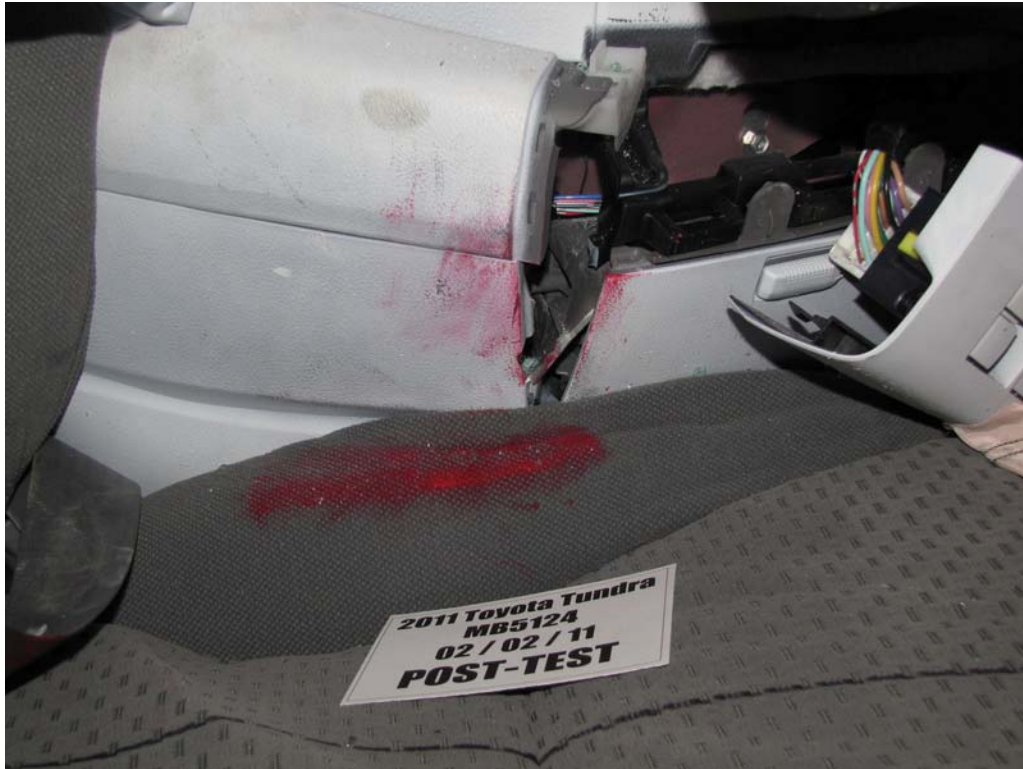
FIGURE 49. Post-Test Dummy Close-Up Pelvis Contact with Vehicle Interior View

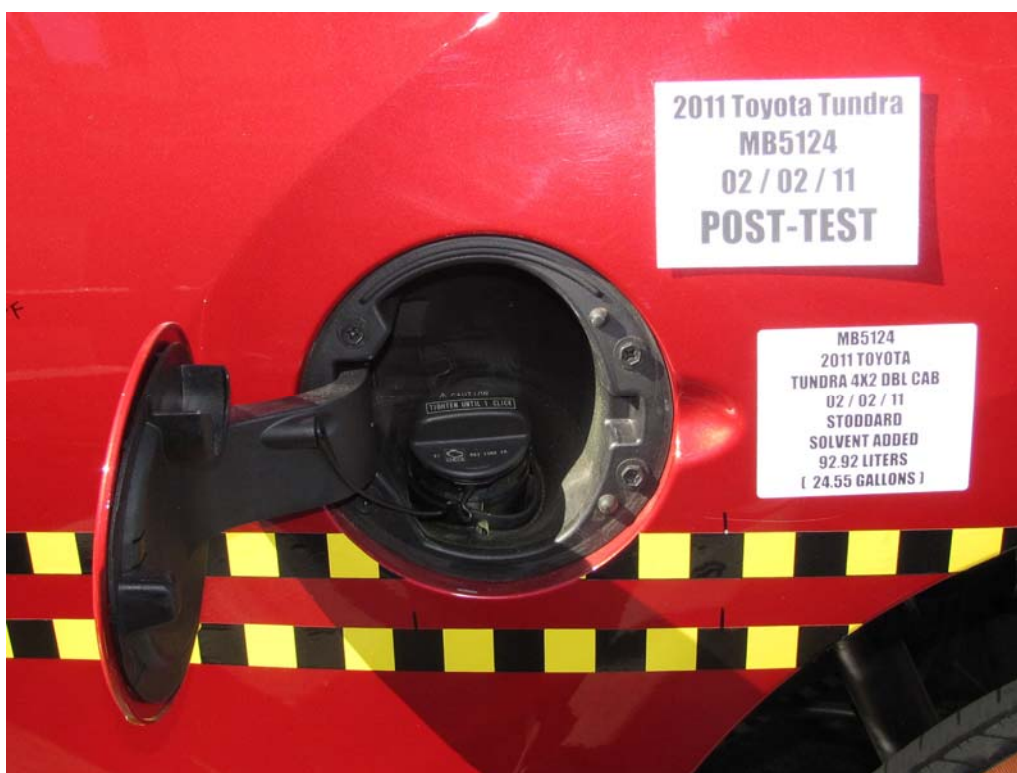
FIGURE 52. Post-Test View of Fuel Filler Cap or Fuel Filler Neck

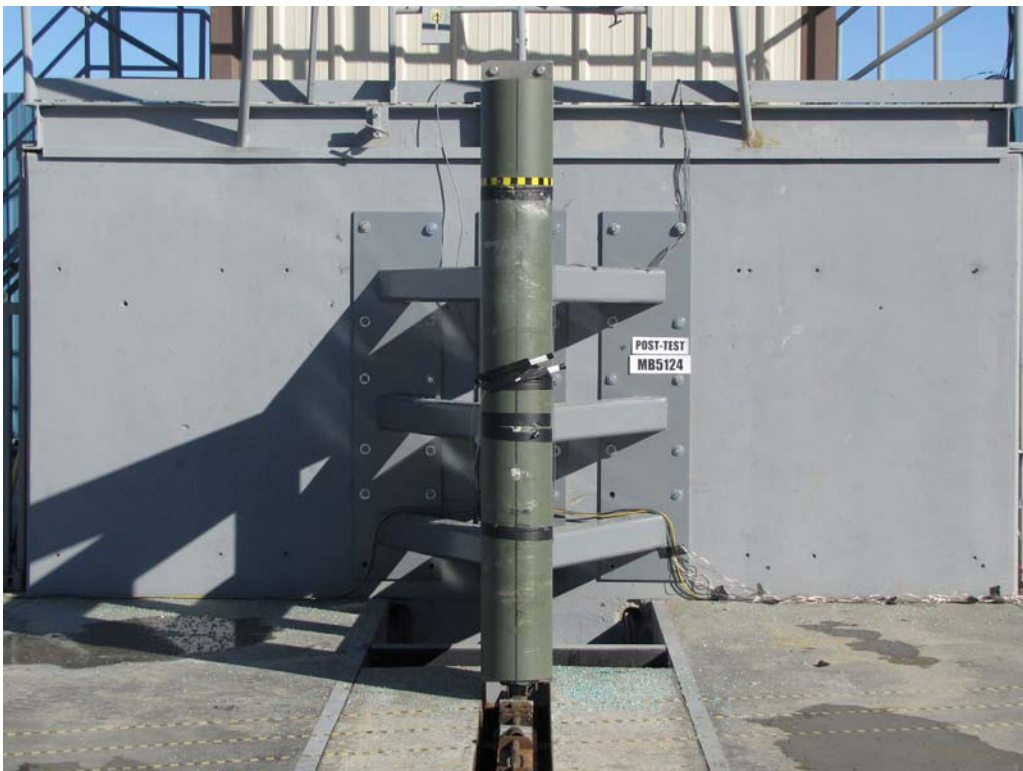
FIGURE 56. Post-Test Pole Barrier Front View

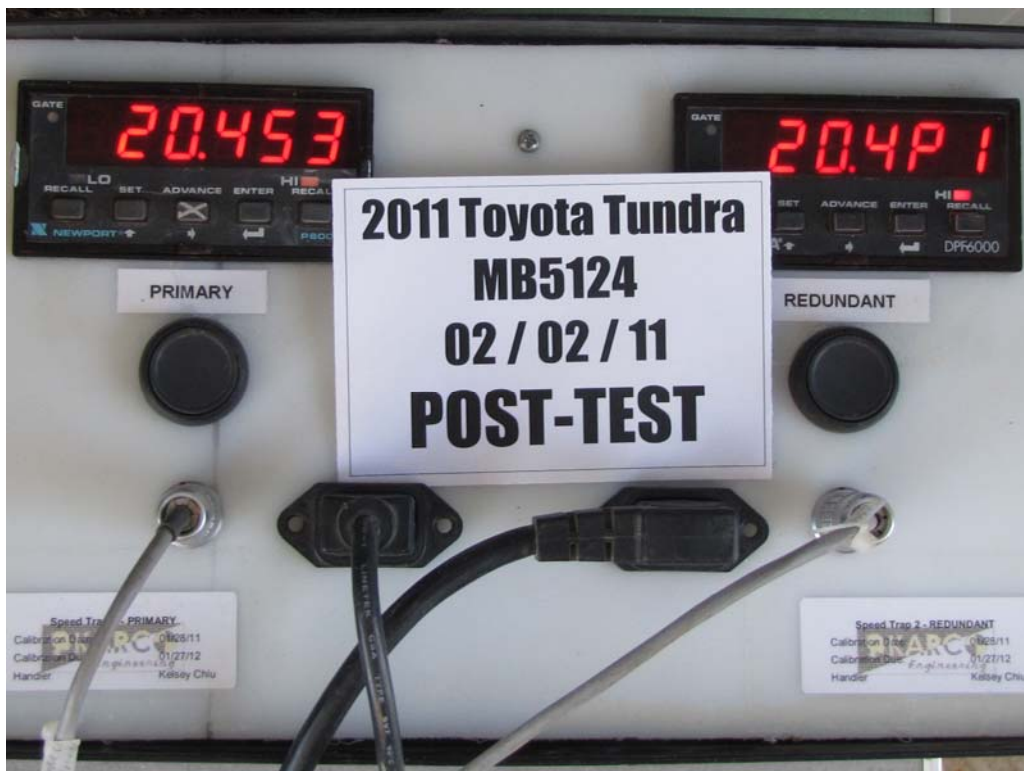
FIGURE 60. Post-Test Primary and Redundant Speed Trap Read-Out

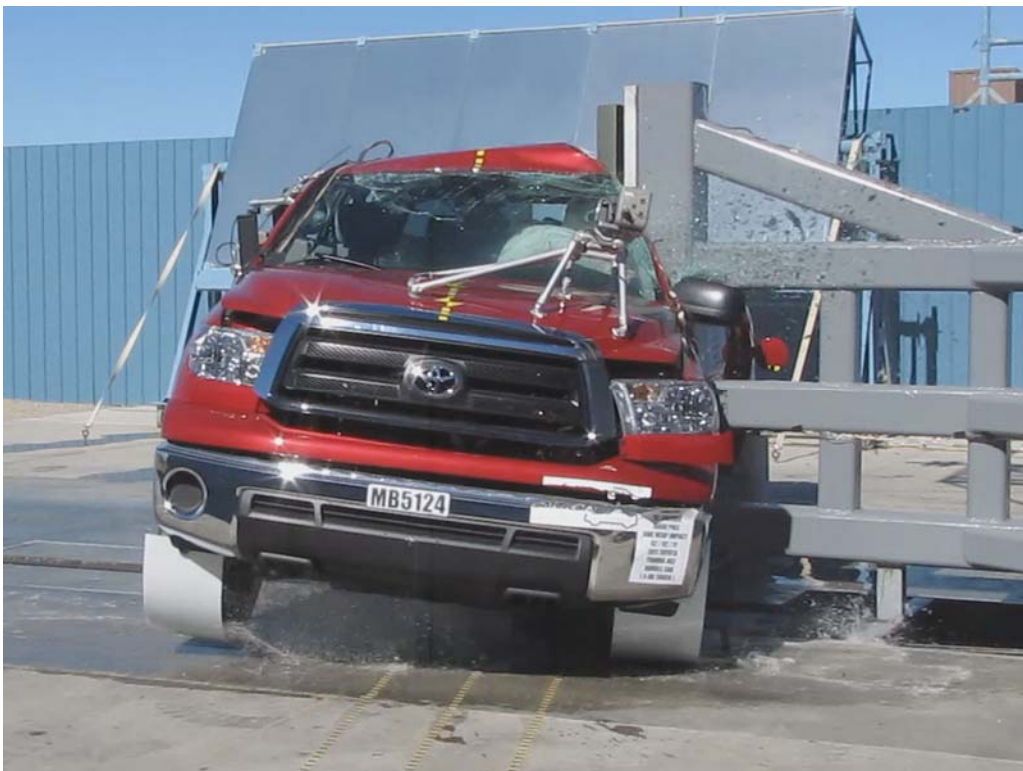
FIGURE 66. Impact Event
