**REPORT NUMBER: SNCAP-MCW-11-005**

**NEW CAR ASSESSMENT PROGRAM (NCAP)  
MOVING DEFORMABLE BARRIER SIDE IMPACT TEST**

**KIA MOTORS  
2011 KIA OPTIMA 4-DOOR SEDAN  
NHTSA NUMBER: MB 0513**

**REPORT DATE: FEBRUARY 10, 2011  
FINAL REPORT**

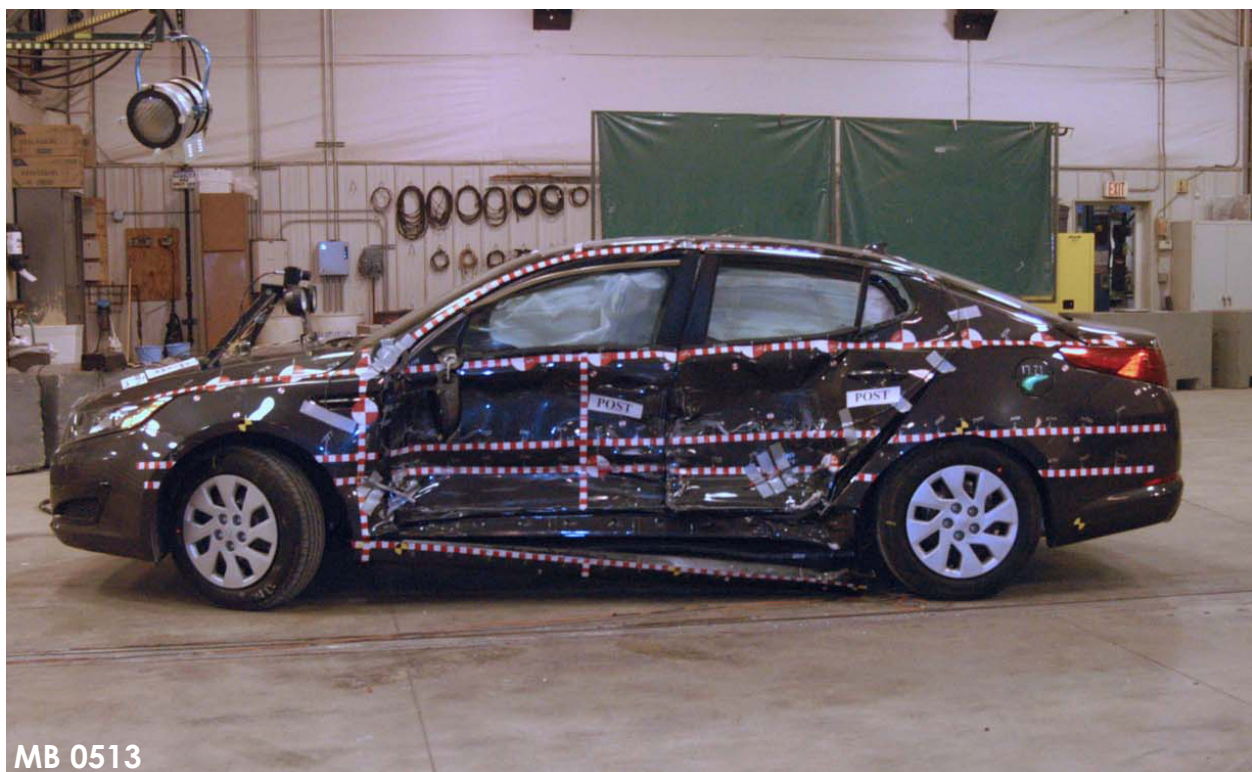
Figure A-8: Post-Test Left Side View of Test Vehicle

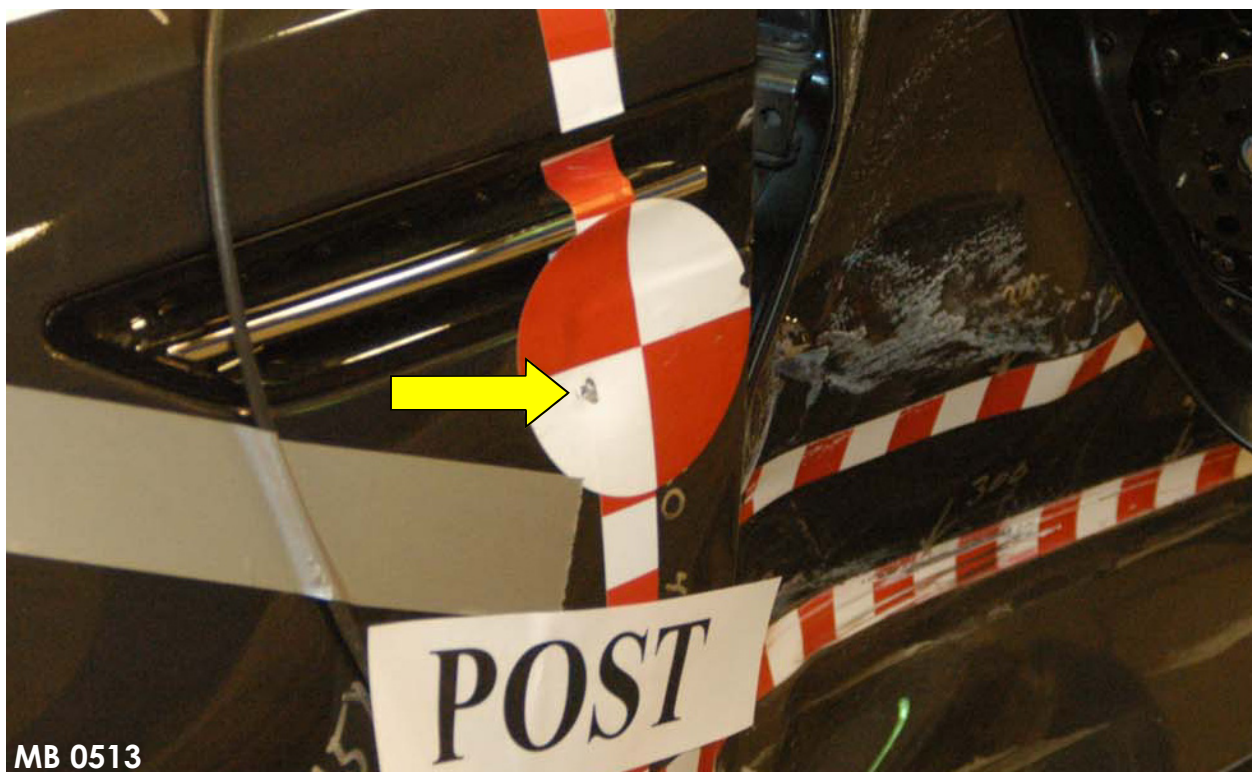
Figure A-20: Post-Test Close-Up View of Impact Point Target

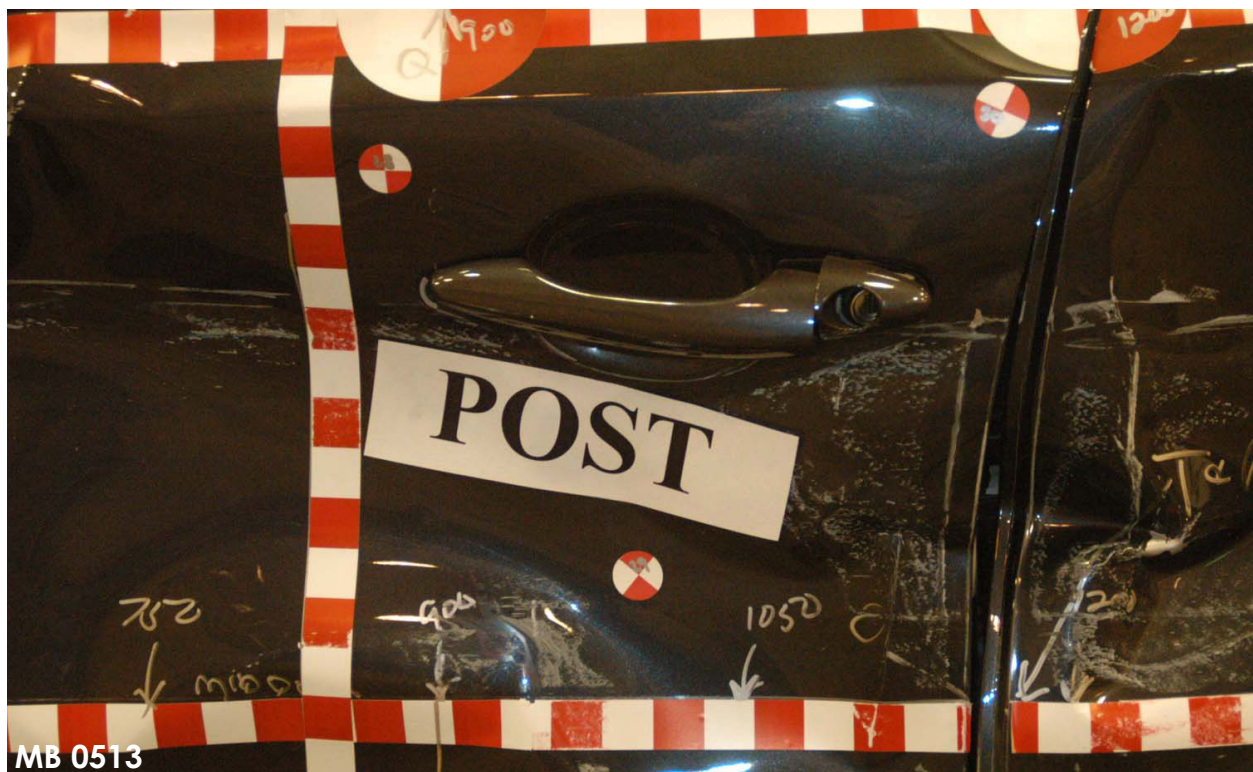
Figure A-22: Post-Test Left Front Door Latch Close-Up

| <b>1. Report No.</b><br>SNCAP-MCW-11-005 | <b>2. Government Accession No.</b> | <b>3. Recipient's Catalog No.</b> | | | | | | | | | | | | | | | | | | | | | | | | | | | | | | | | | | | | |
|---|---|---|---|---|---|---|---|---|---|---|---|---|---|---|---|---|---|---|---|---|---|---|--|---|---|---|---|---|---|---|---|---|---|---|---|---|---|---|
| The doors on the struck side of the vehicle did not separate from the body at the hinges or latches and the opposite doors did not open during the side impact event. | | | | | | | | | | | | | | | | | | | | | | | | | | | | | | | | | | | | | | |

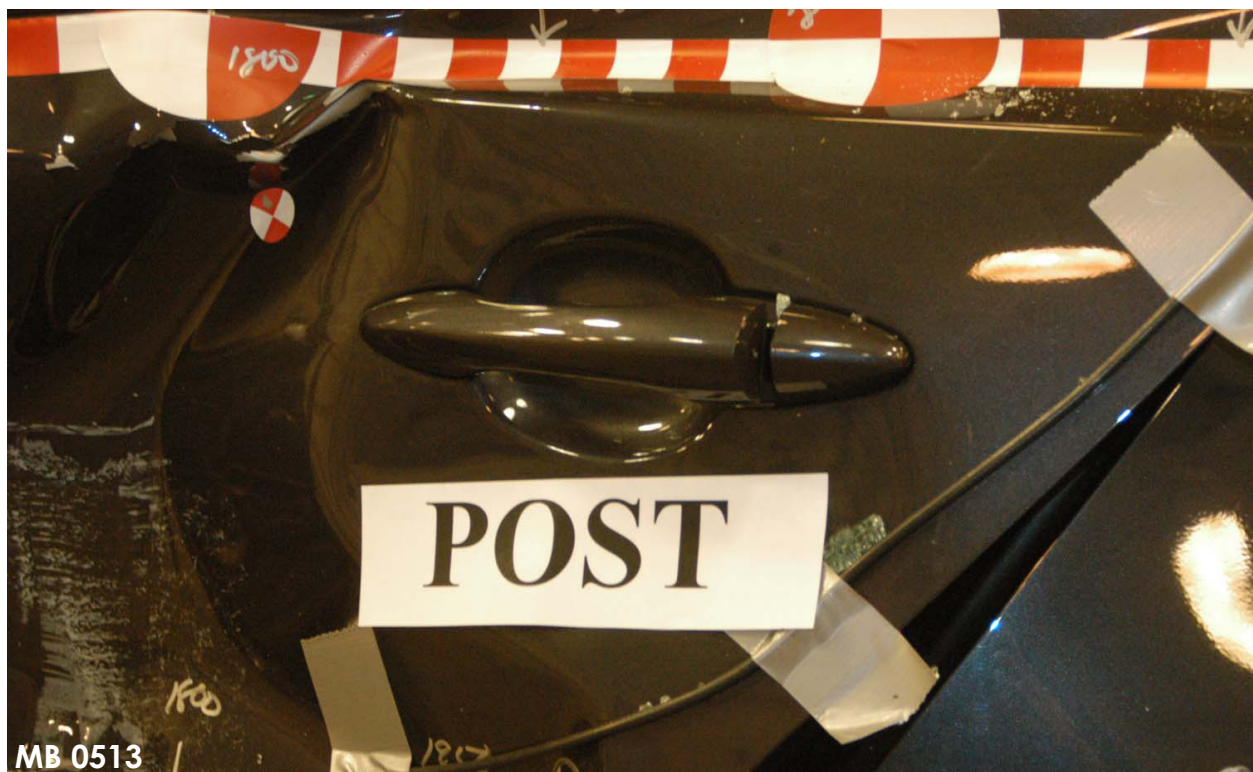
Figure A-24: Post-Test Left Rear Door Latch Close-Up

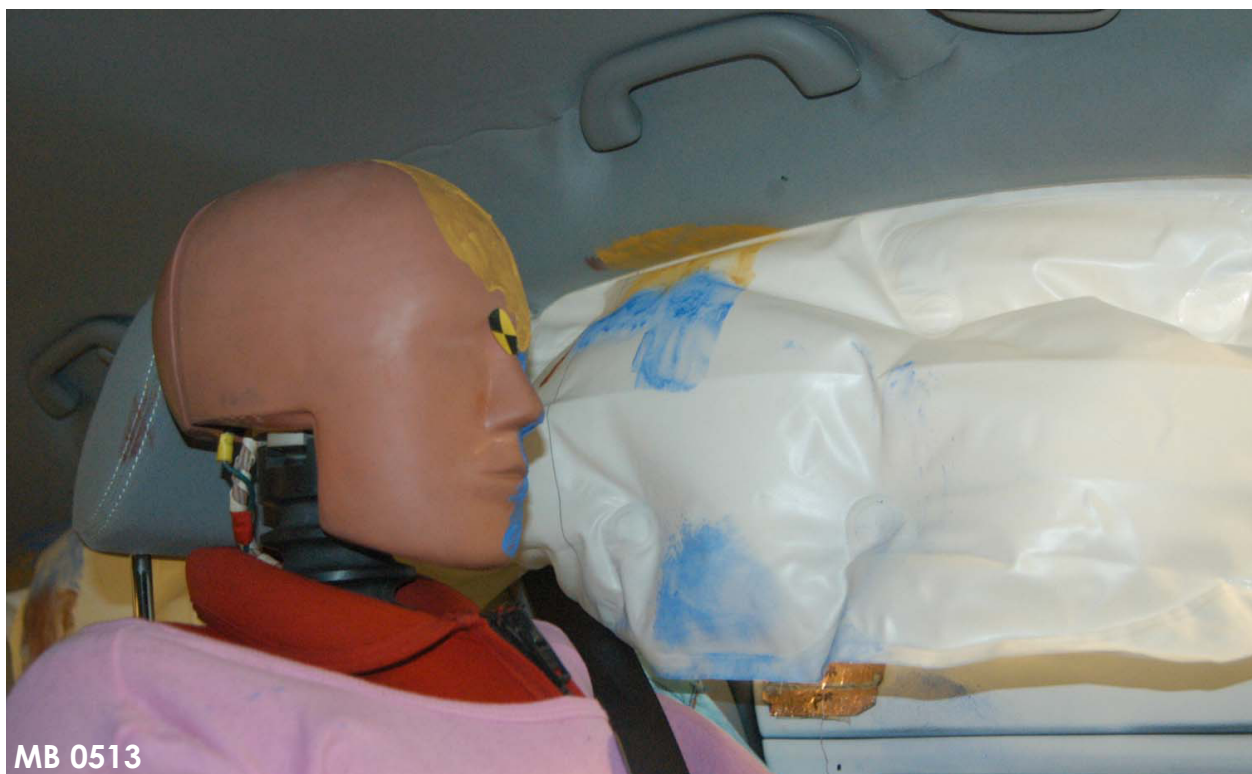
Figure A-48: Post-Test Driver Dummy Close-Up Head Contact with Side Air Bag View

| SUPPLEMENTAL RESTRAINT SYSTEM INFORMATION | | | | |
|---|---|---|---|---|
| Side Airbag 1 (Curtain Side Airbag) | Yes – Side header | Deployed properly | Yes – Side header | Deployed properly |

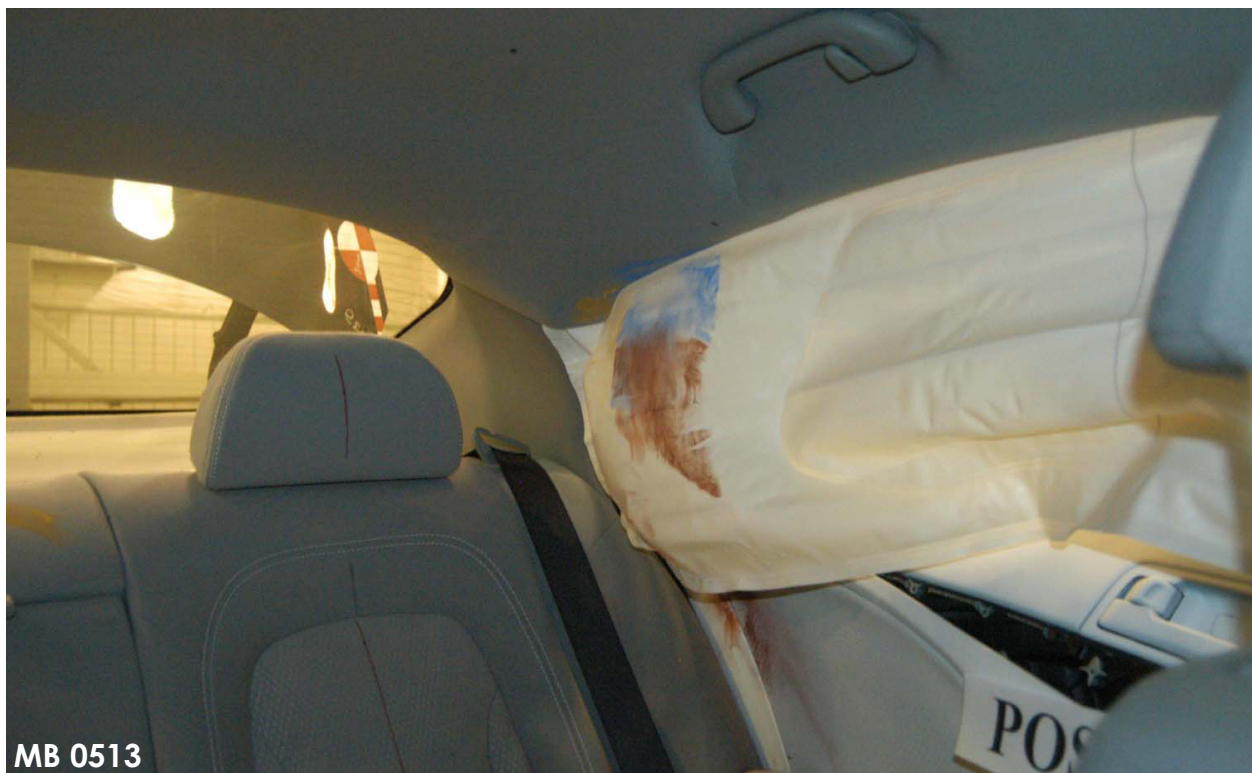
Figure A-74: Post-Test Rear Passenger Dummy Close-Up Head Contact with Side Airbag View

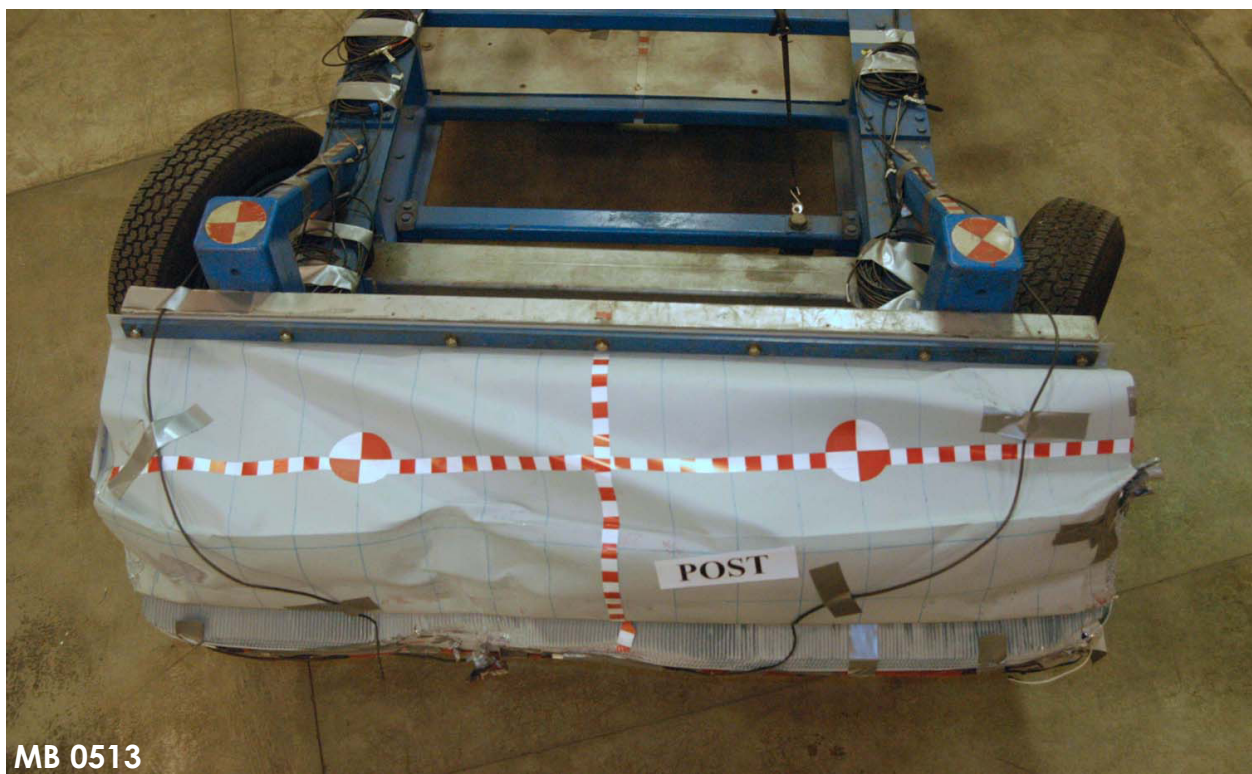
Figure A-84: Post-Test Top View of MDB Impactor Face

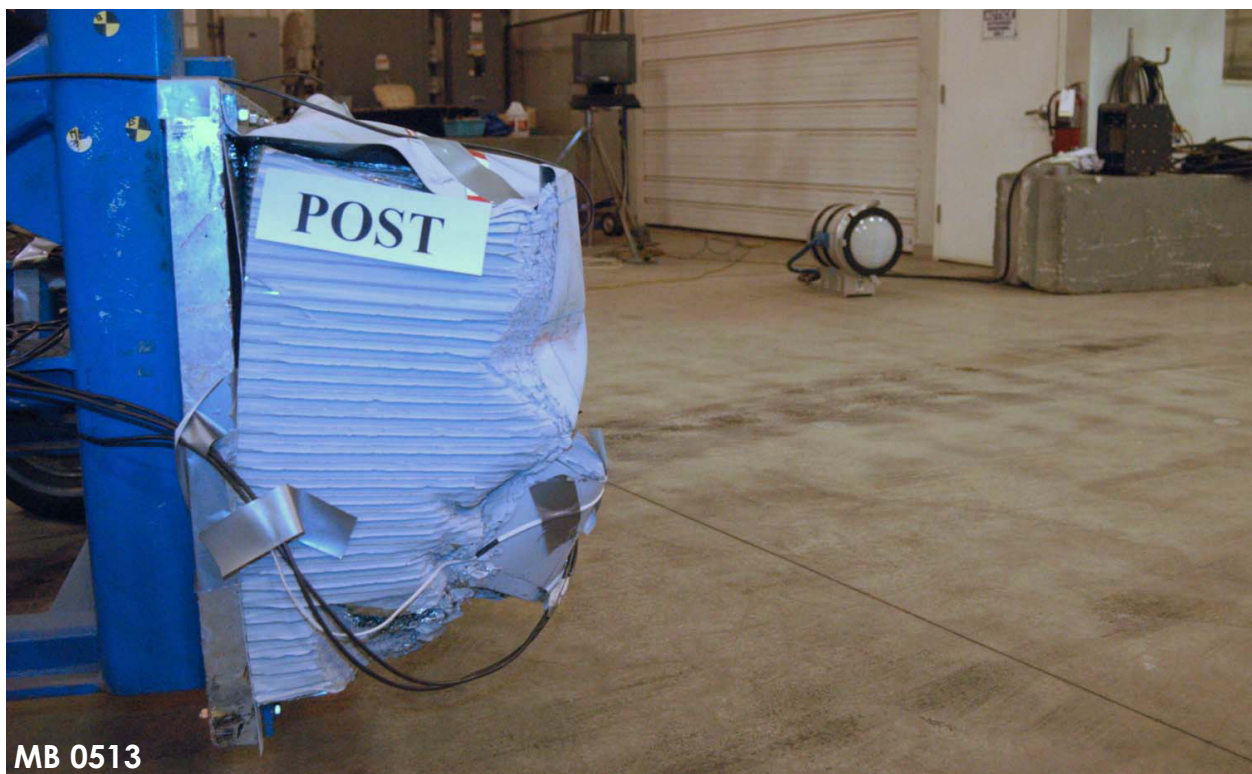
Figure A-88: Post-Test Right Side View of MDB Impactor Face
