**REPORT NUMBER: SPNCAP-MGA-2011-064**

**NEW CAR ASSESSMENT PROGRAM (NCAP)  
Side Impact Pole Test**

**TOYOTA MOTOR MANUFACTURING, CANADA, INC.  
2011 Toyota Corolla 4-Dr Sedan  
NHTSA No.: MB5106**

**FINAL REPORT**

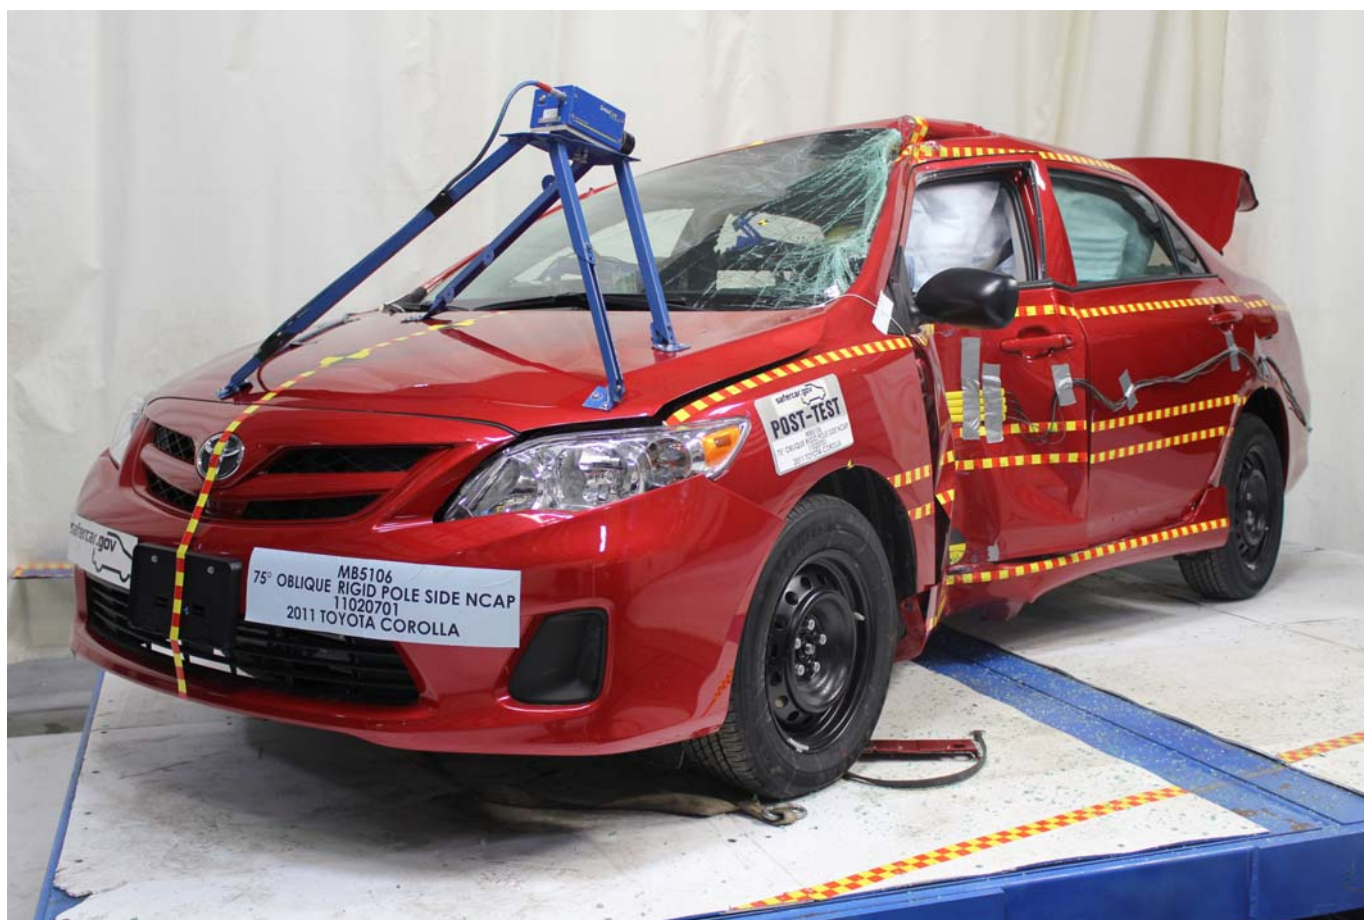
Post-Test Left Front  $\frac{3}{4}$  View of Test Vehicle

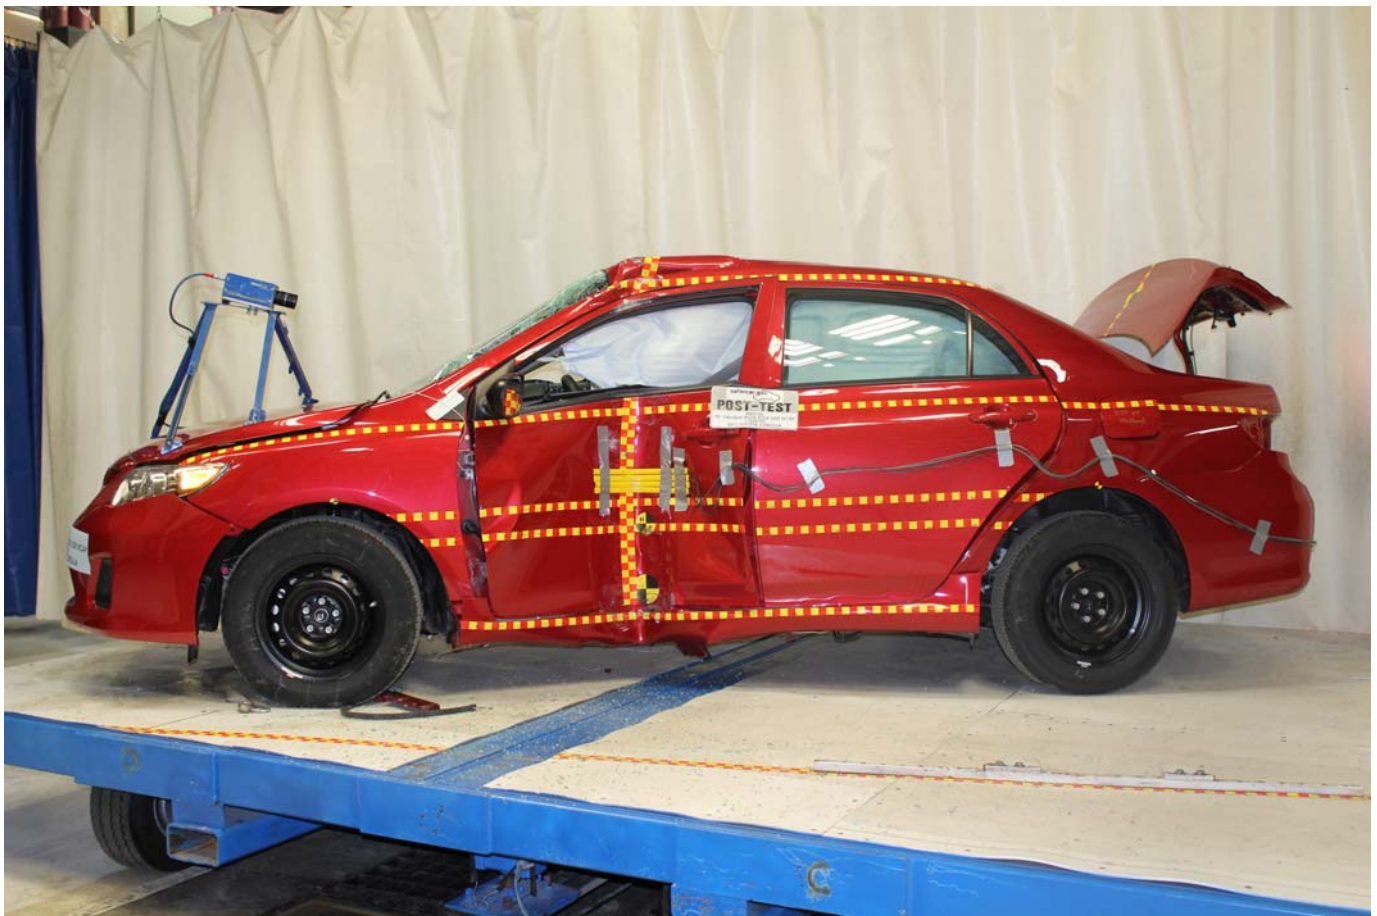
Post-Test Left Side View of Test Vehicle

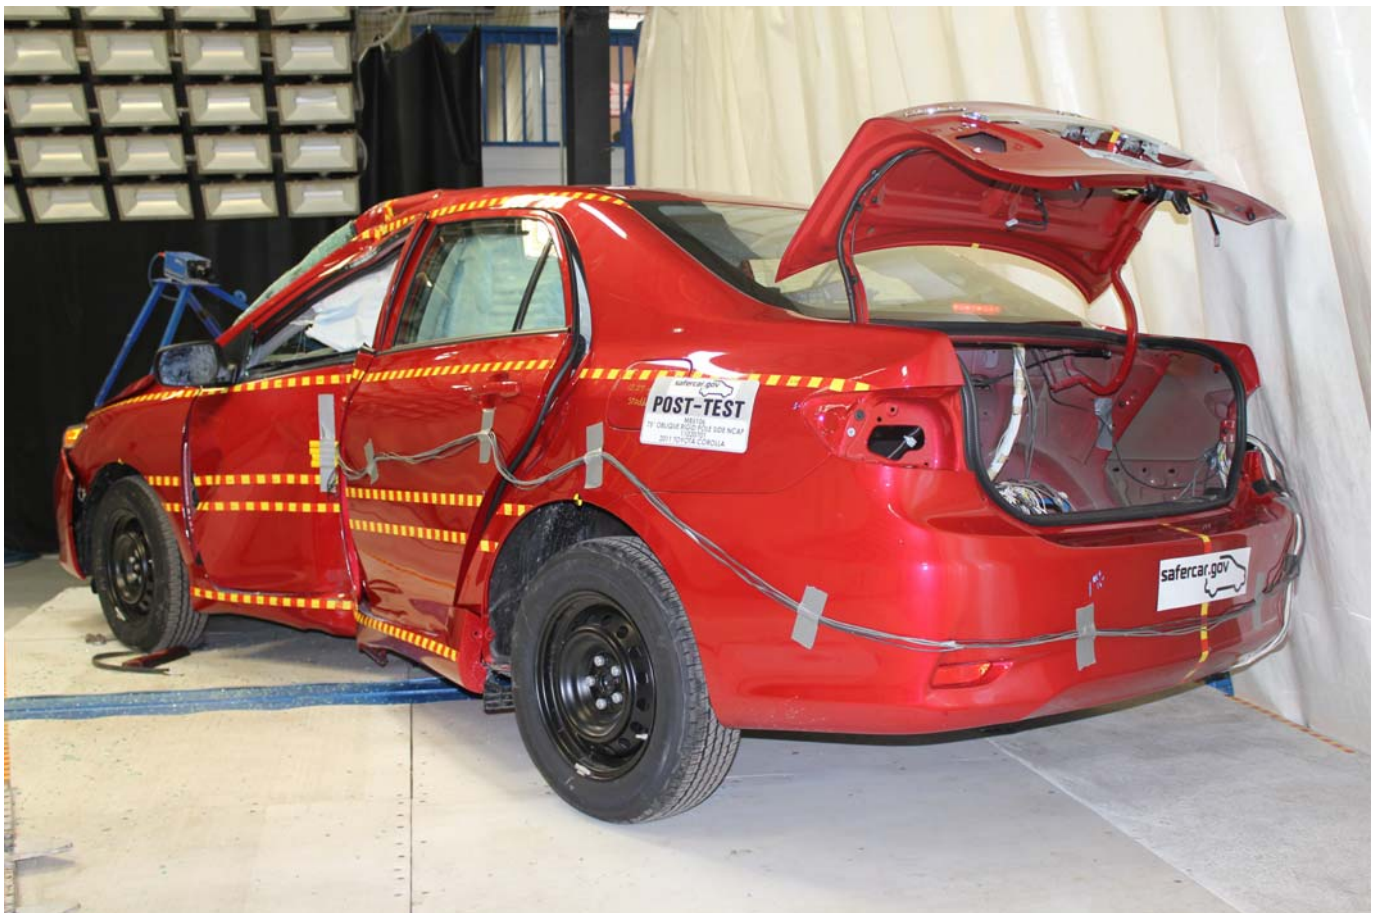
Post-Test Left Rear  $\frac{3}{4}$  View of Test Vehicle

The trunk lid opened during the event.

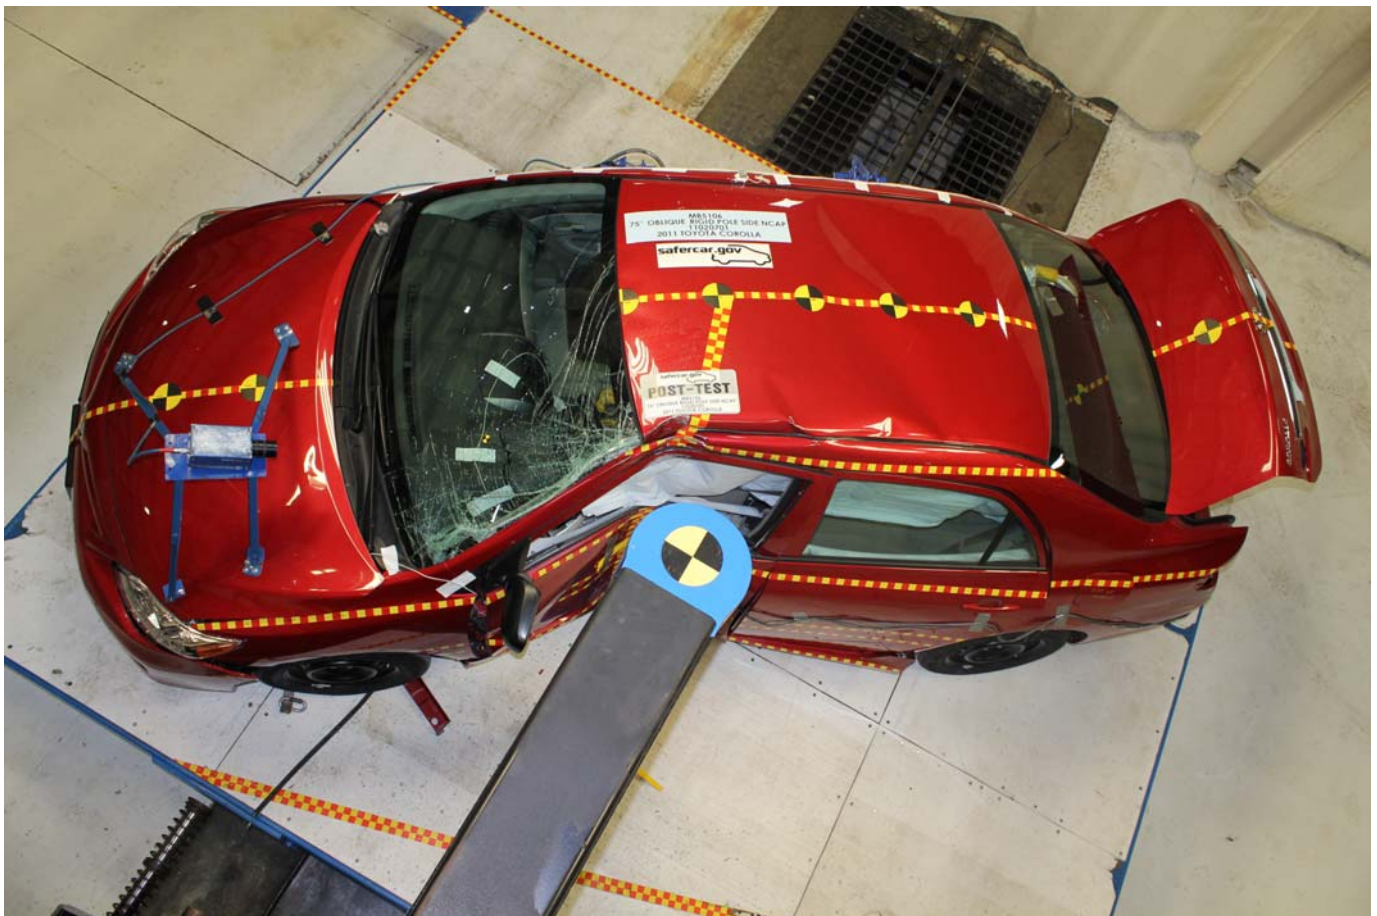
Post-Test Overhead View of Test Vehicle and Pole

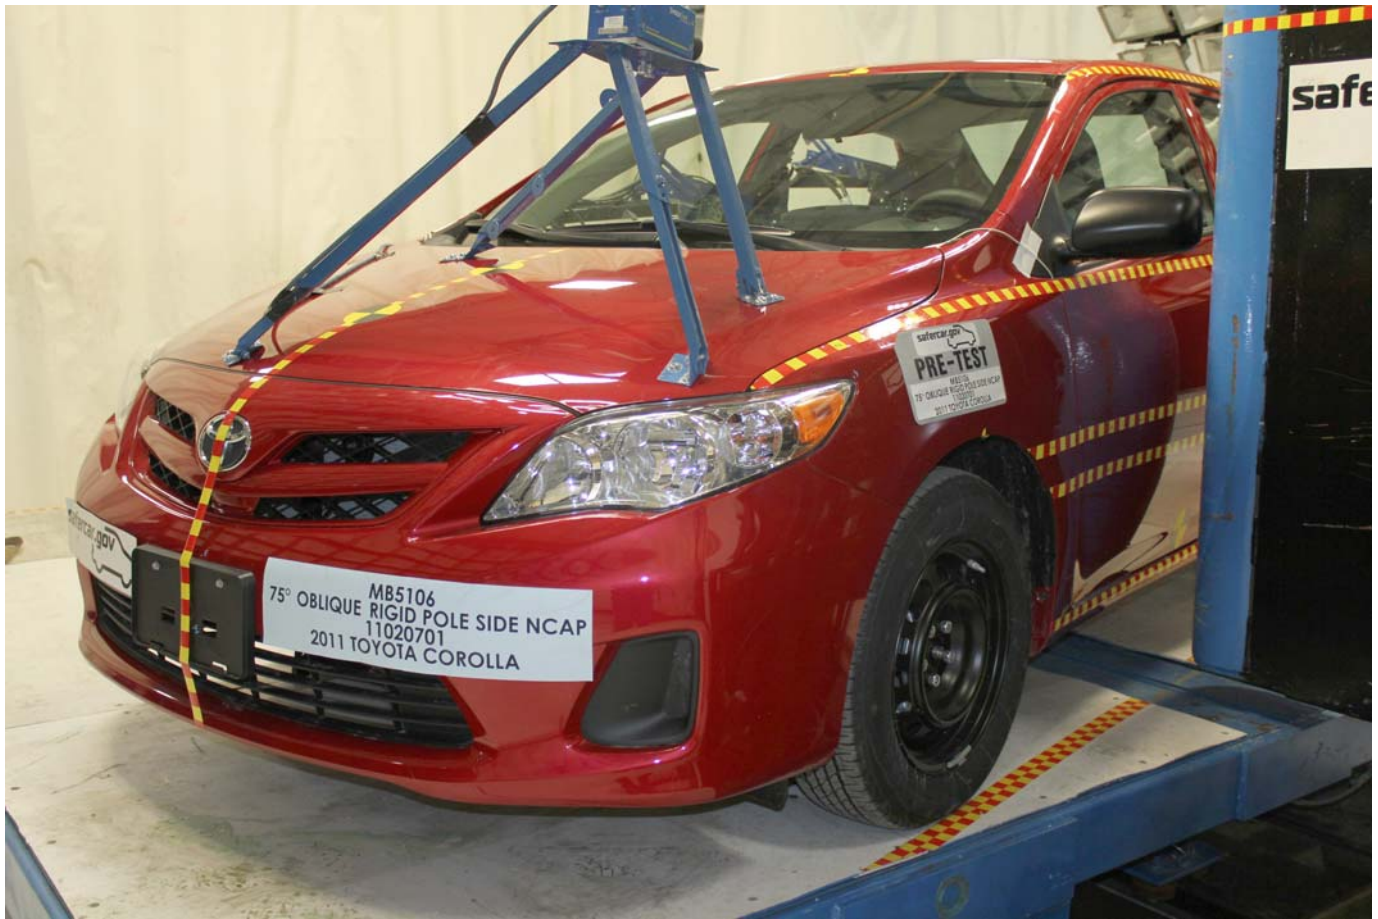
Pre-Test Left Side View of Pole Positioned Against Side of Vehicle

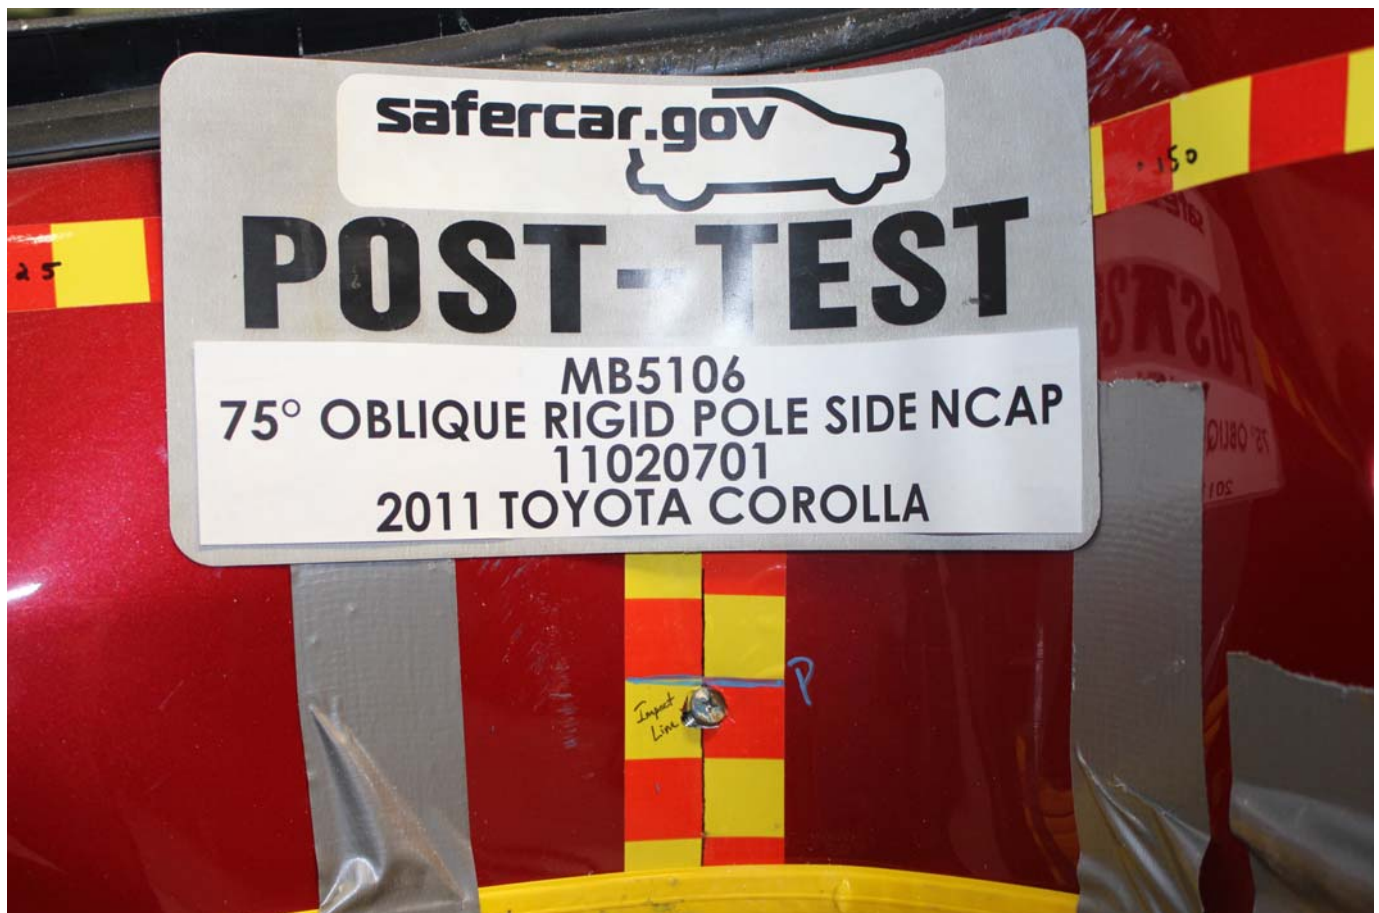
Post-Test Close-Up View of Impact Point Target Showing Impact Location

| Measurement Parameter | Units | Value |
|---|---|---|
| Actual Impact Point (Aft of Front Axle) | mm | 1017 |
| Impact Point Difference (- forward / + rearward) | mm | 3 |

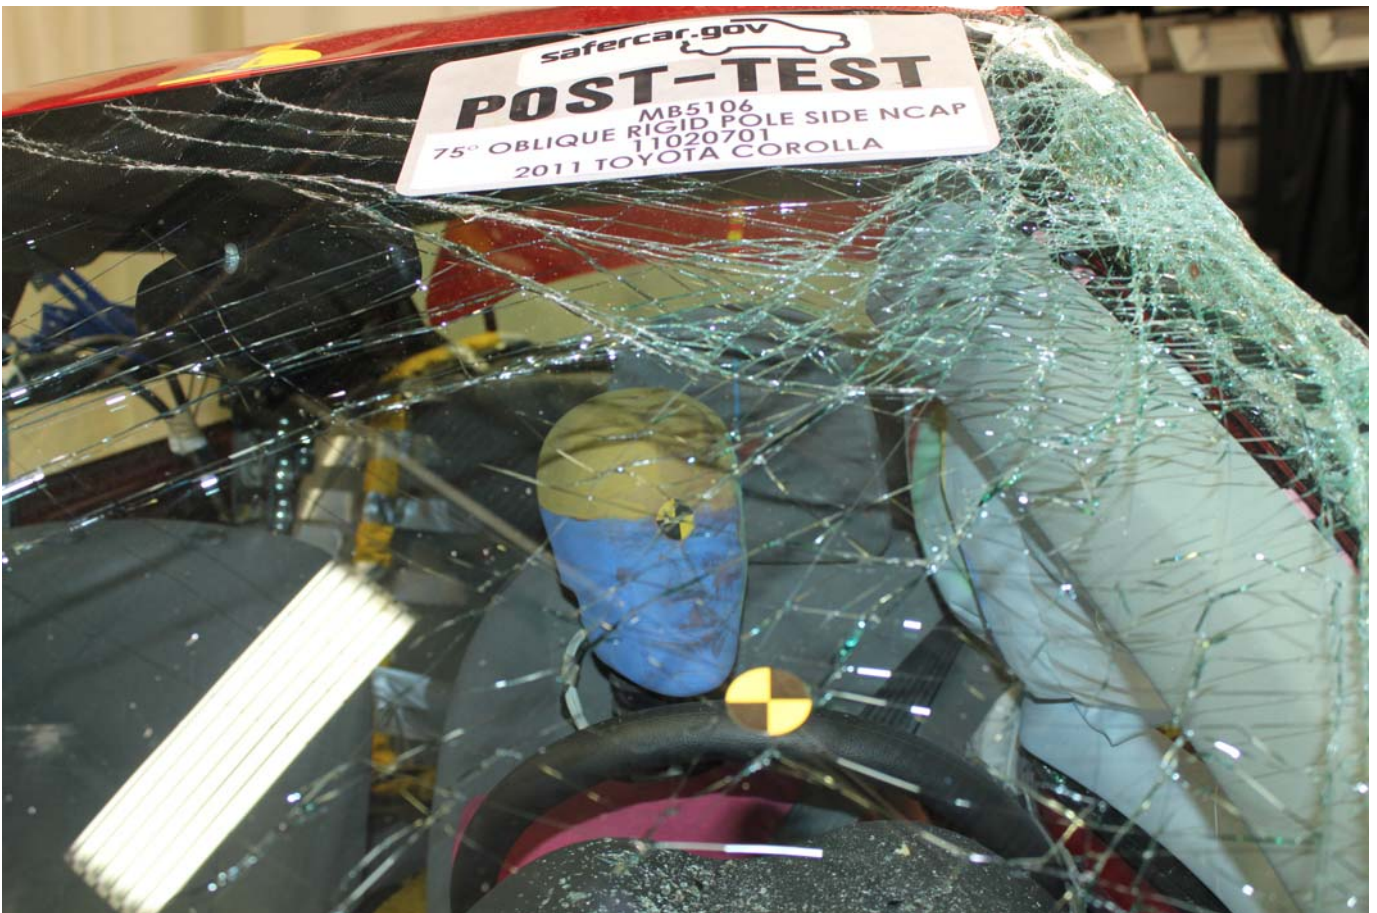
Post-Test Front Close-Up View of Dummy (through front window)

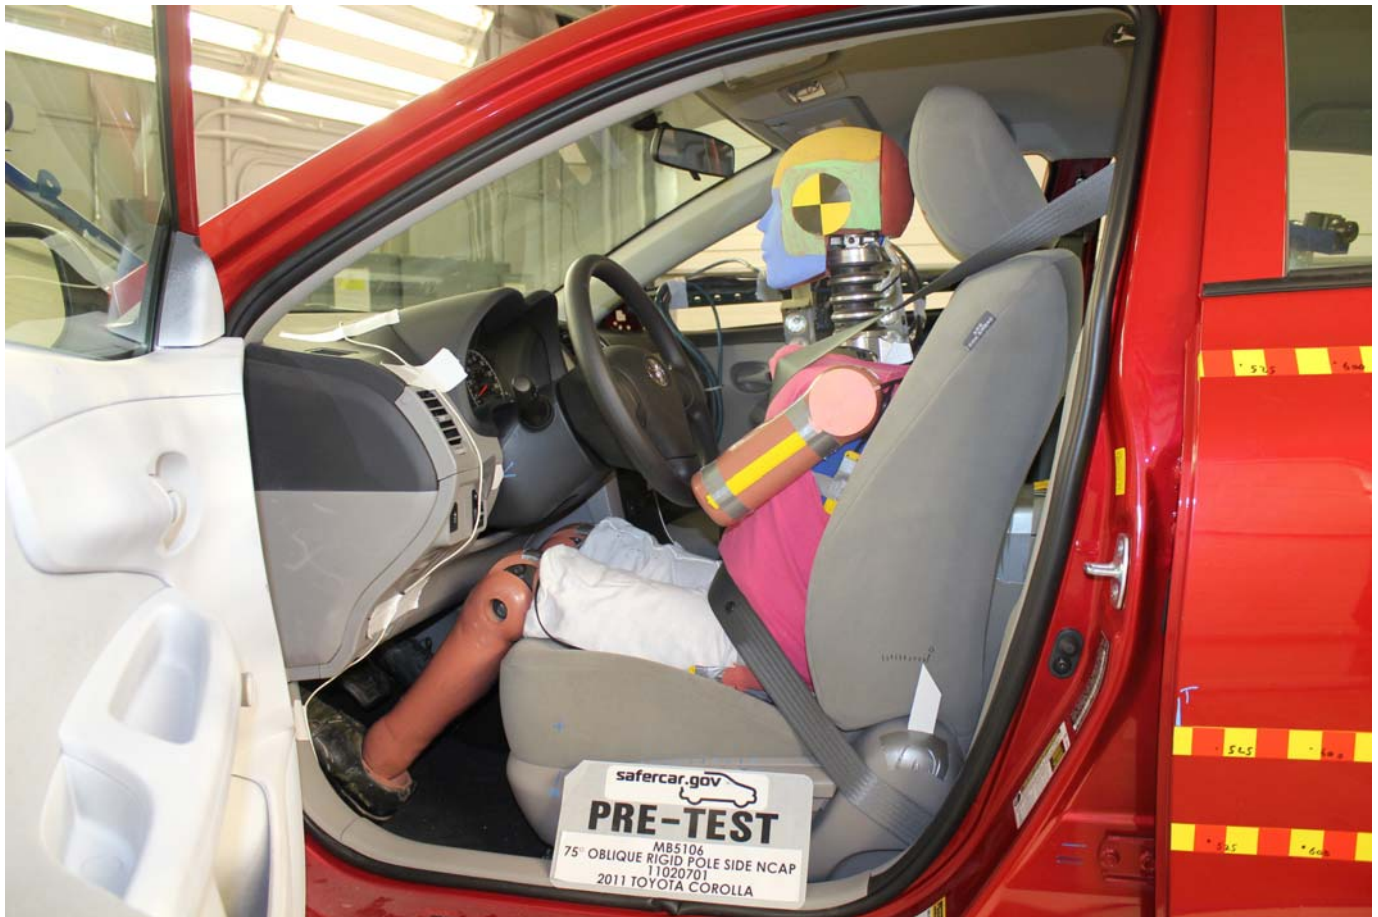
Pre-Test Left Side View of Dummy Showing Belts, Chalking, and Contact Switches (Door Open)

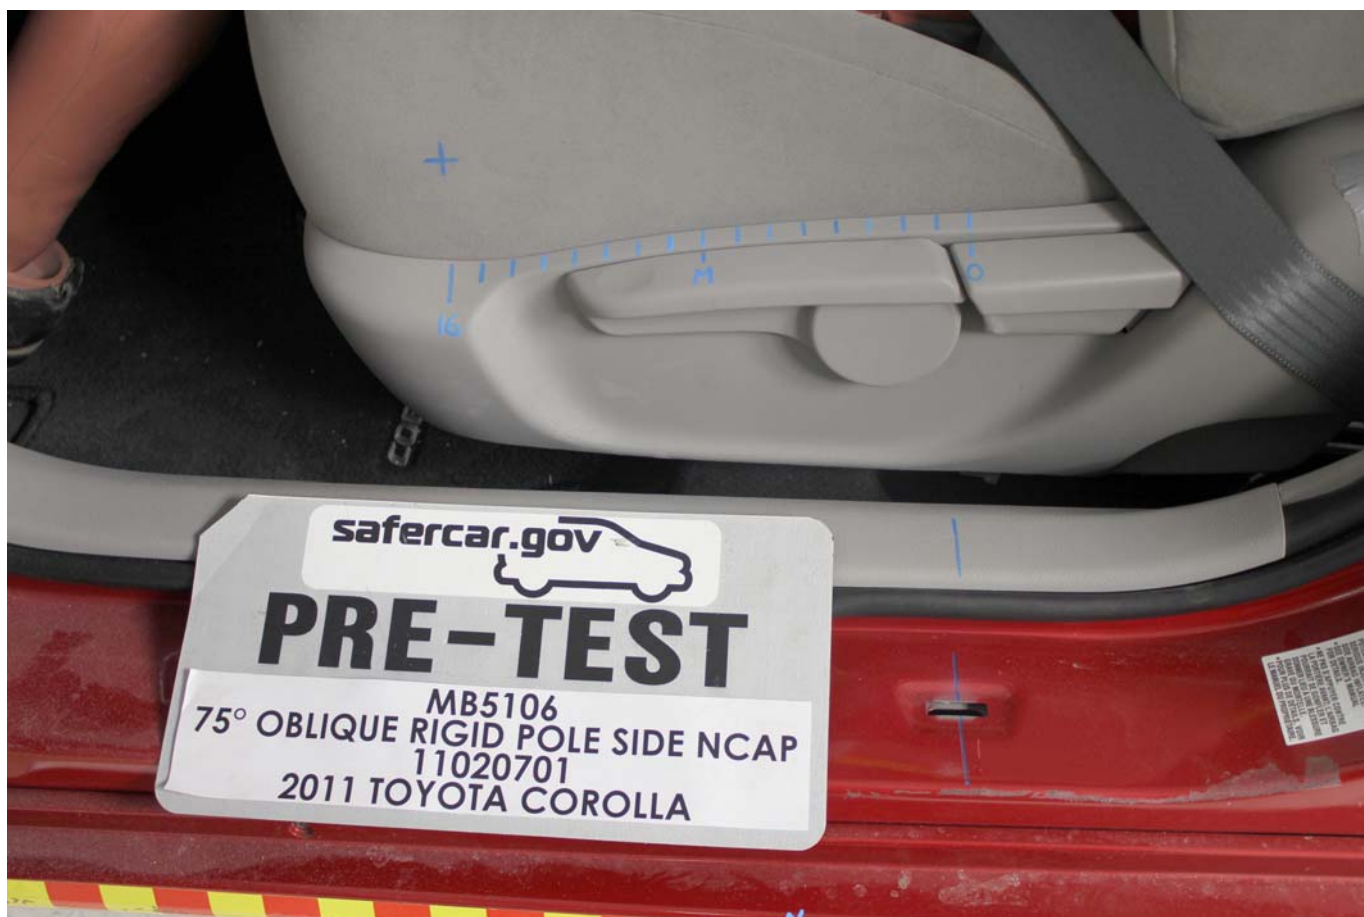
Pre-Test Close-Up Left Side View of Driver Seat Track Showing Test Position

| SEAT FORE/AFT POSITIONING | Total Fore/Aft Travel | Placed in Detent # or Position |
|---|---|---|
| Driver Seat | 17 detents (1 <sup>st</sup> as 0) | 0 (forward-most as 0) |

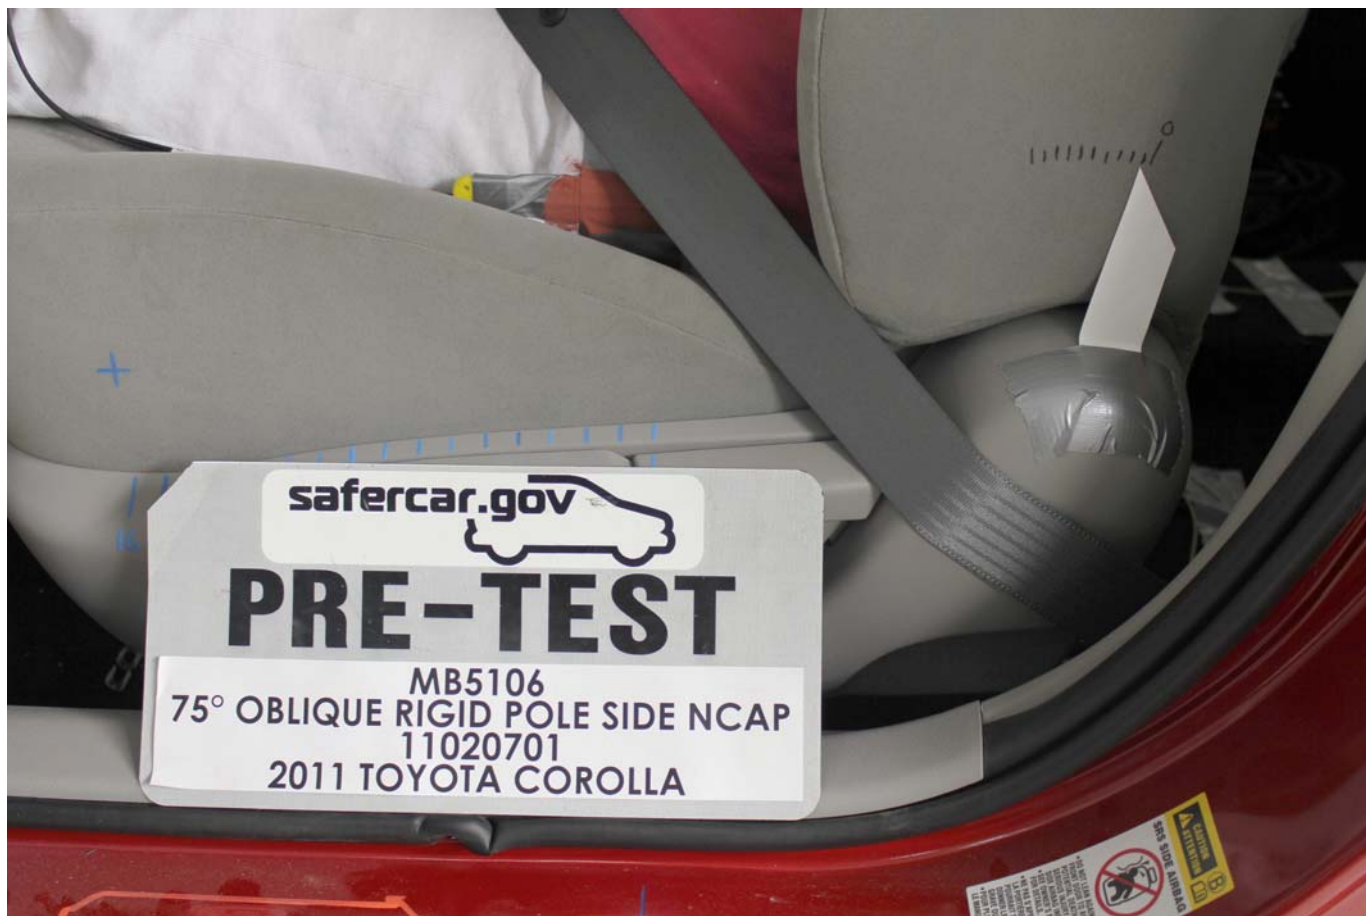
Pre-Test Close-Up Left Side View of Driver Seat Back Showing Test Position

| SEAT BACK ANGLE | Degrees | Detents |
|---|---|---|
| Driver Seat Back Angle with Seated Dummy | -4.6 | 1 <sup>st</sup> detent (first locking as 0) |

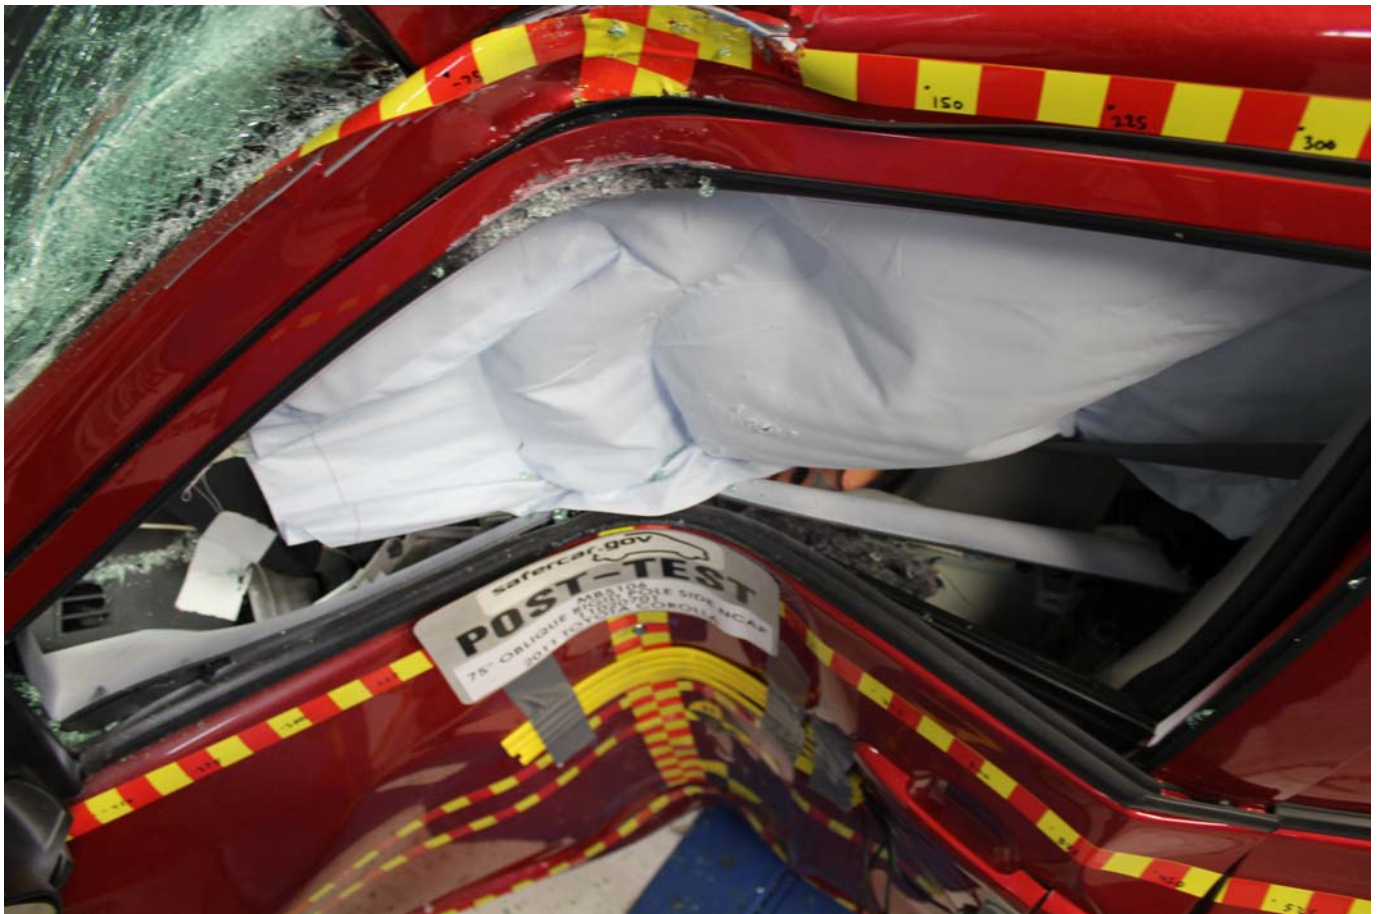
Post-Test Dummy and Door Clearance View

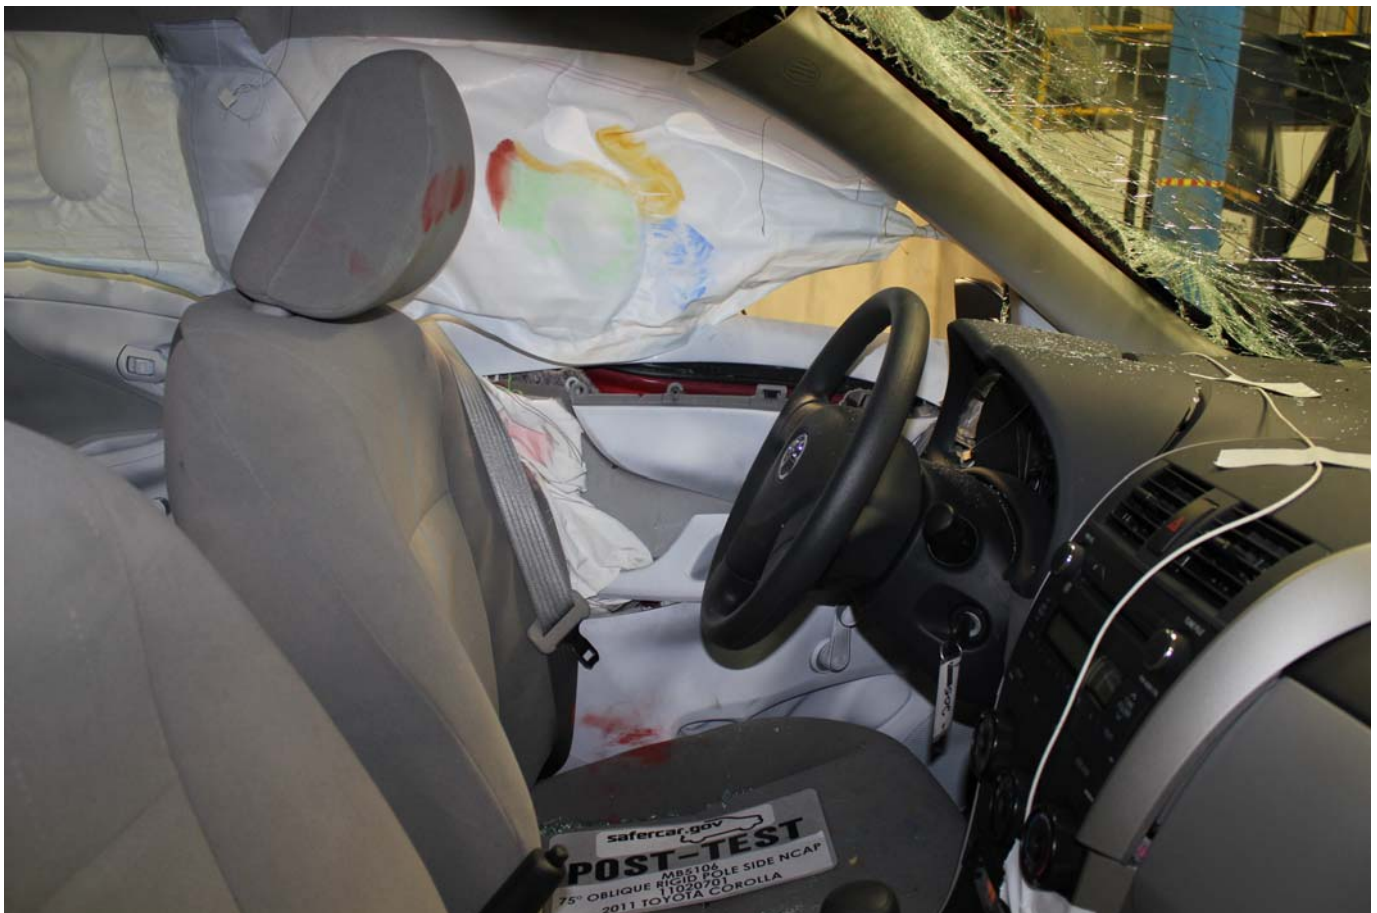
Post-Test Inner Driver Door Panel View Showing Dummy Contact Location

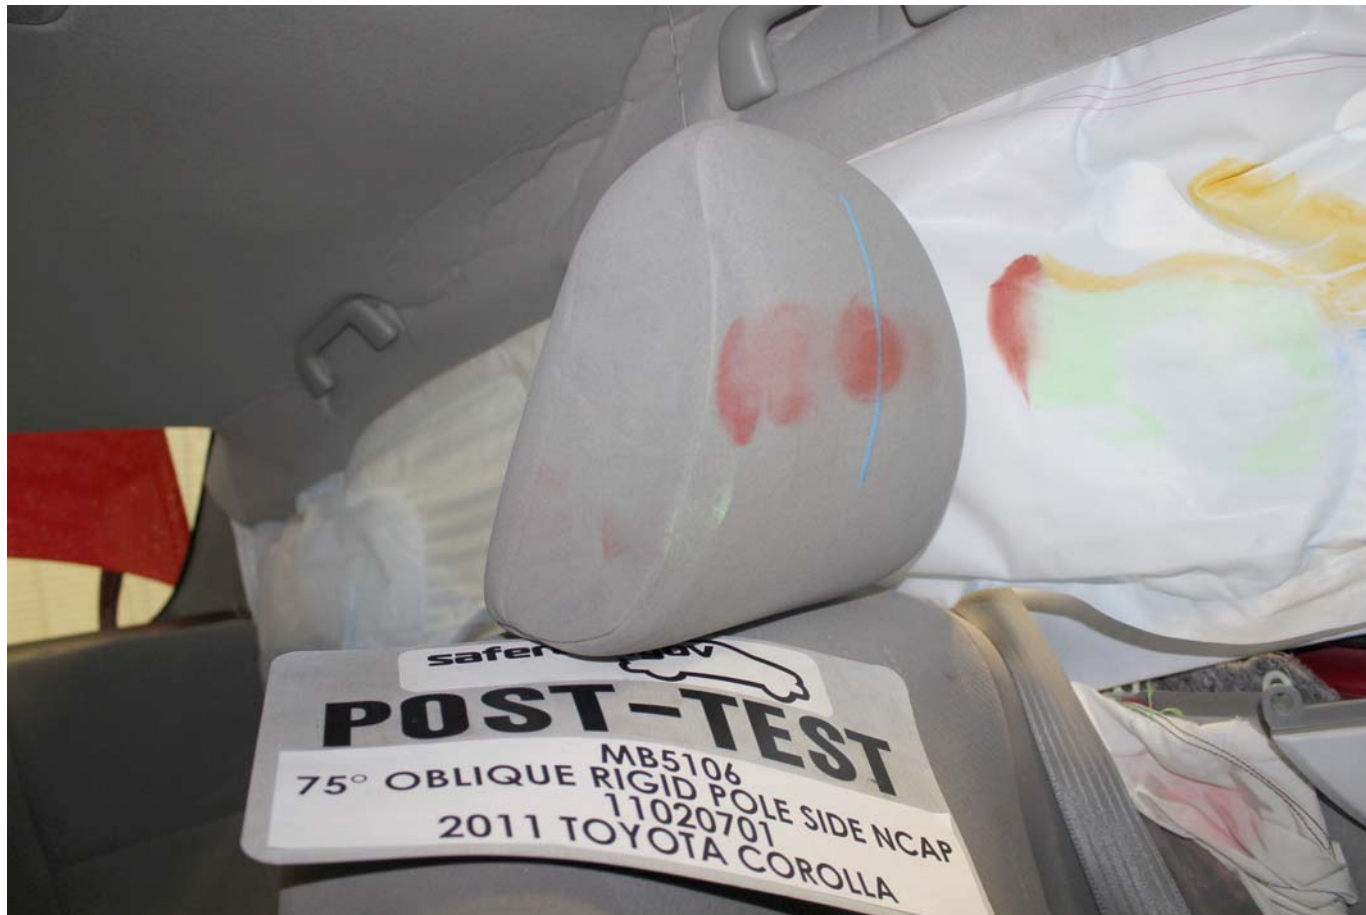
Post-Test Dummy Close-Up Head Contact with Vehicle Interior View

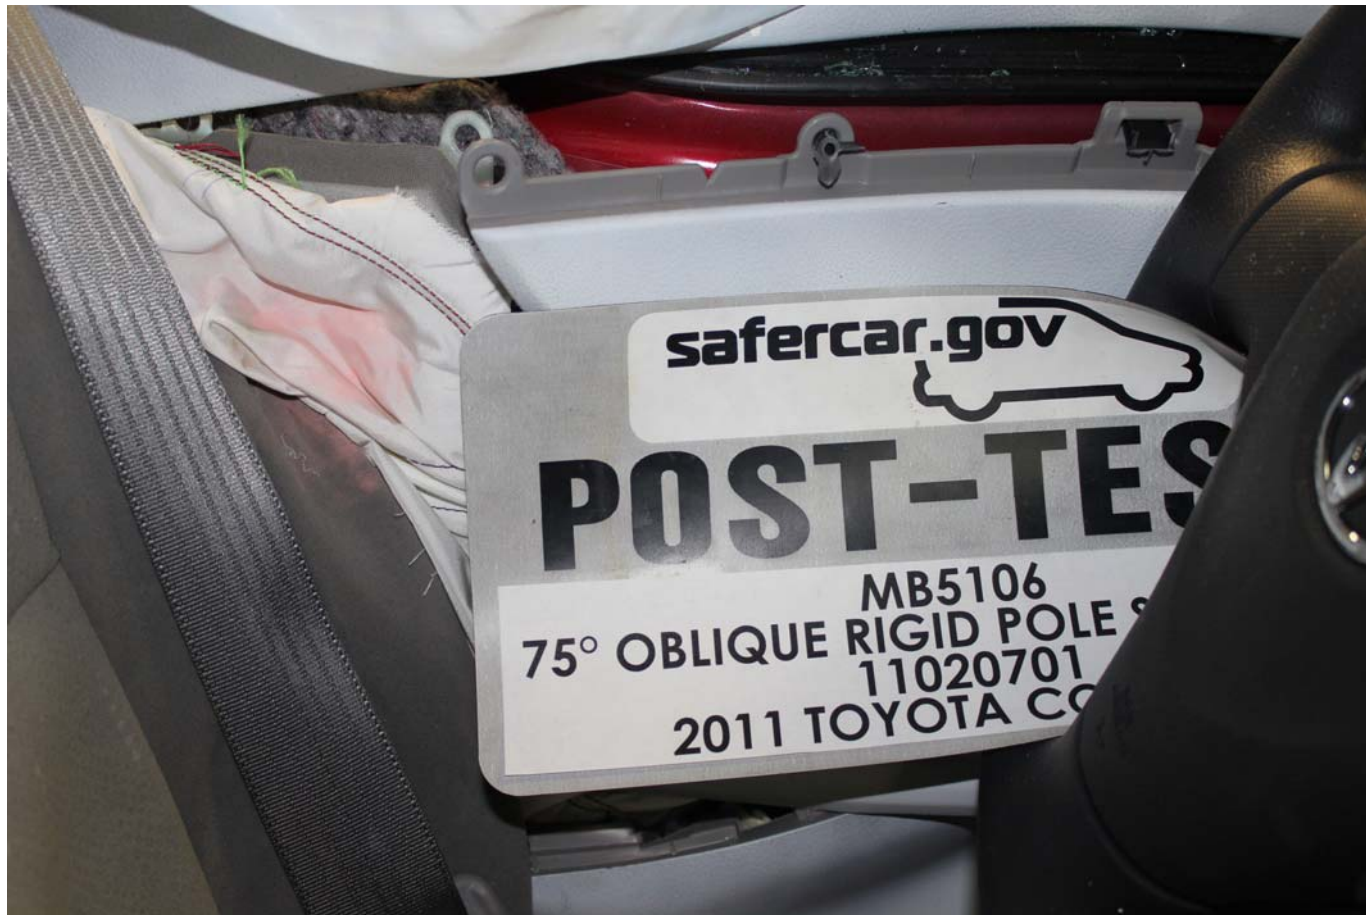
Post-Test Dummy Close-Up Torso Contact with Vehicle Interior View

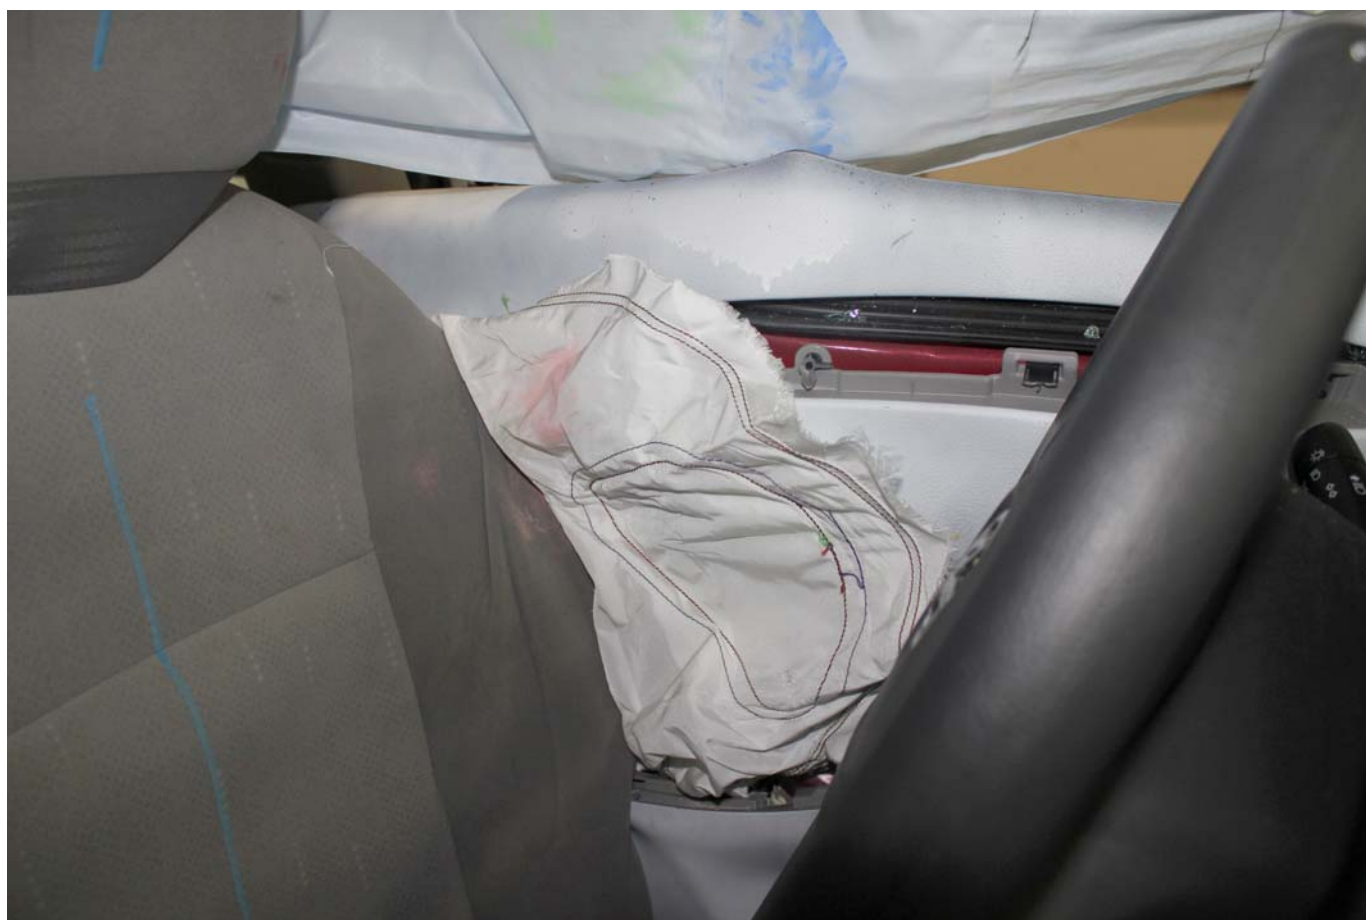
Post-Test Dummy Close-Up Torso Contact with Side Airbag View

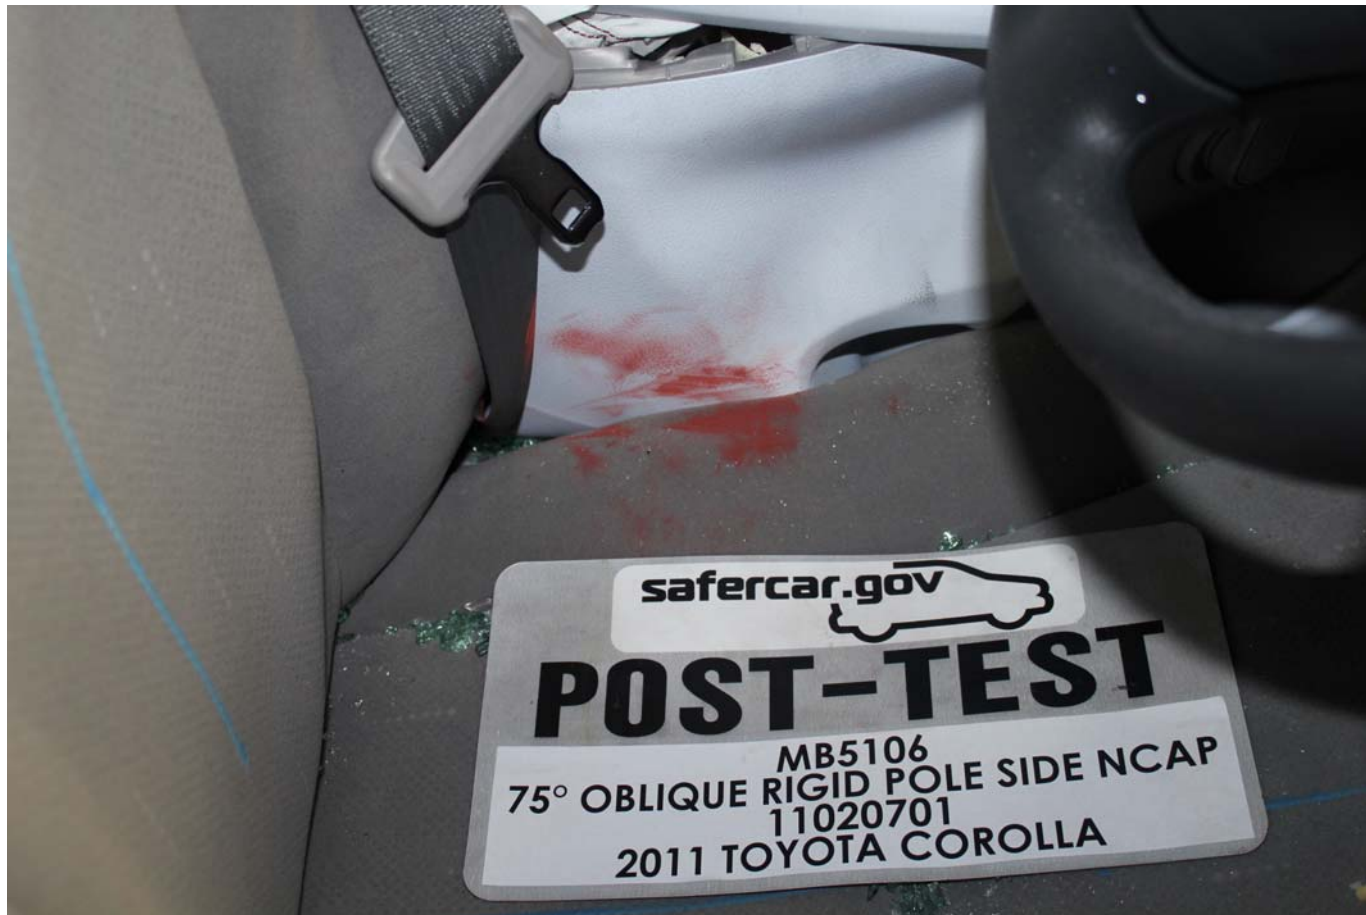
Post-Test Dummy Close-Up Pelvis Contact with Vehicle Interior View

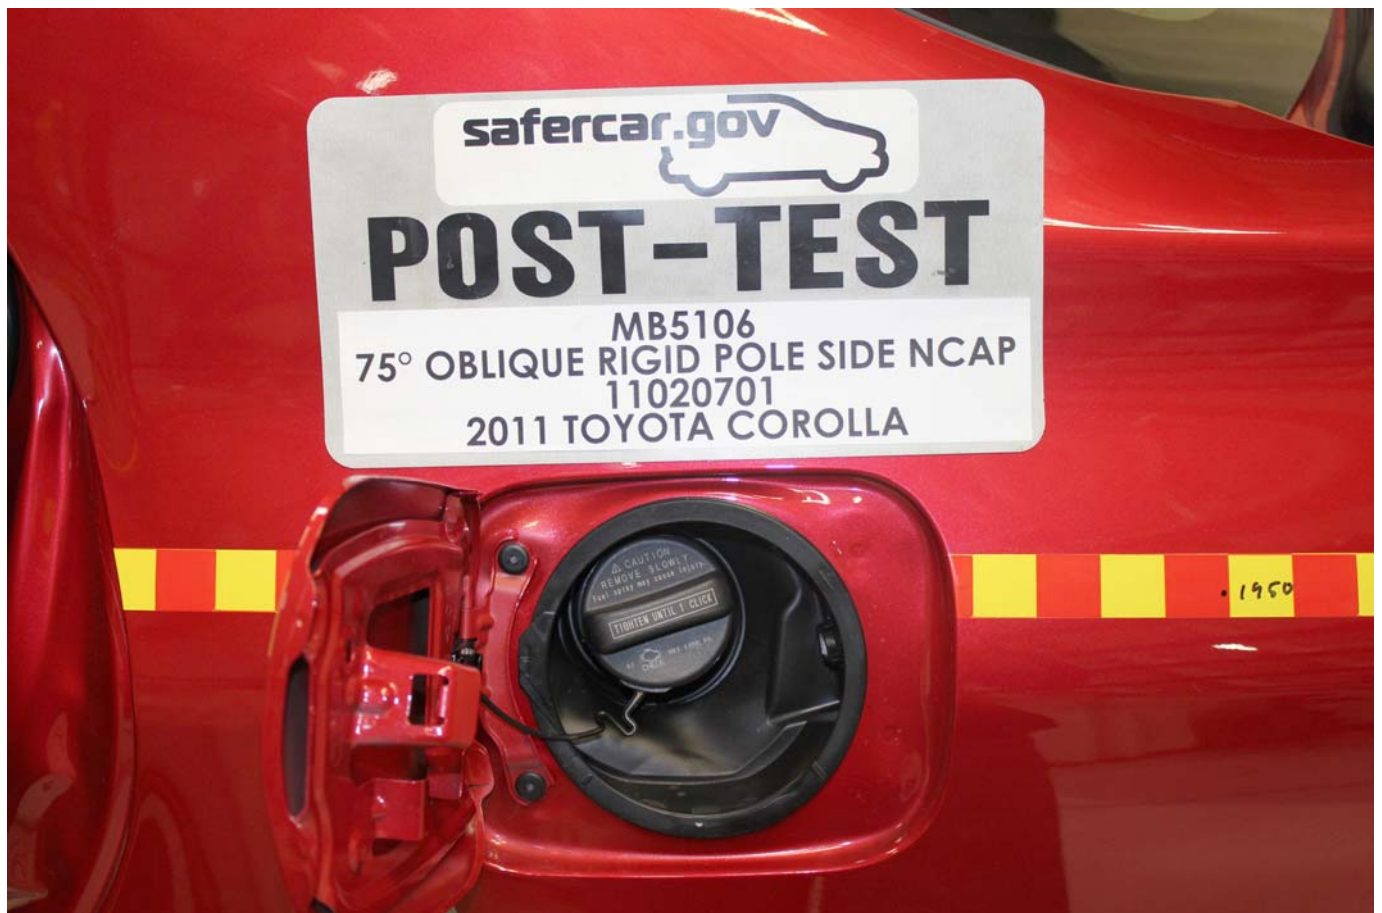
Post-Test View of Fuel Filler Cap or Fuel Filler Neck

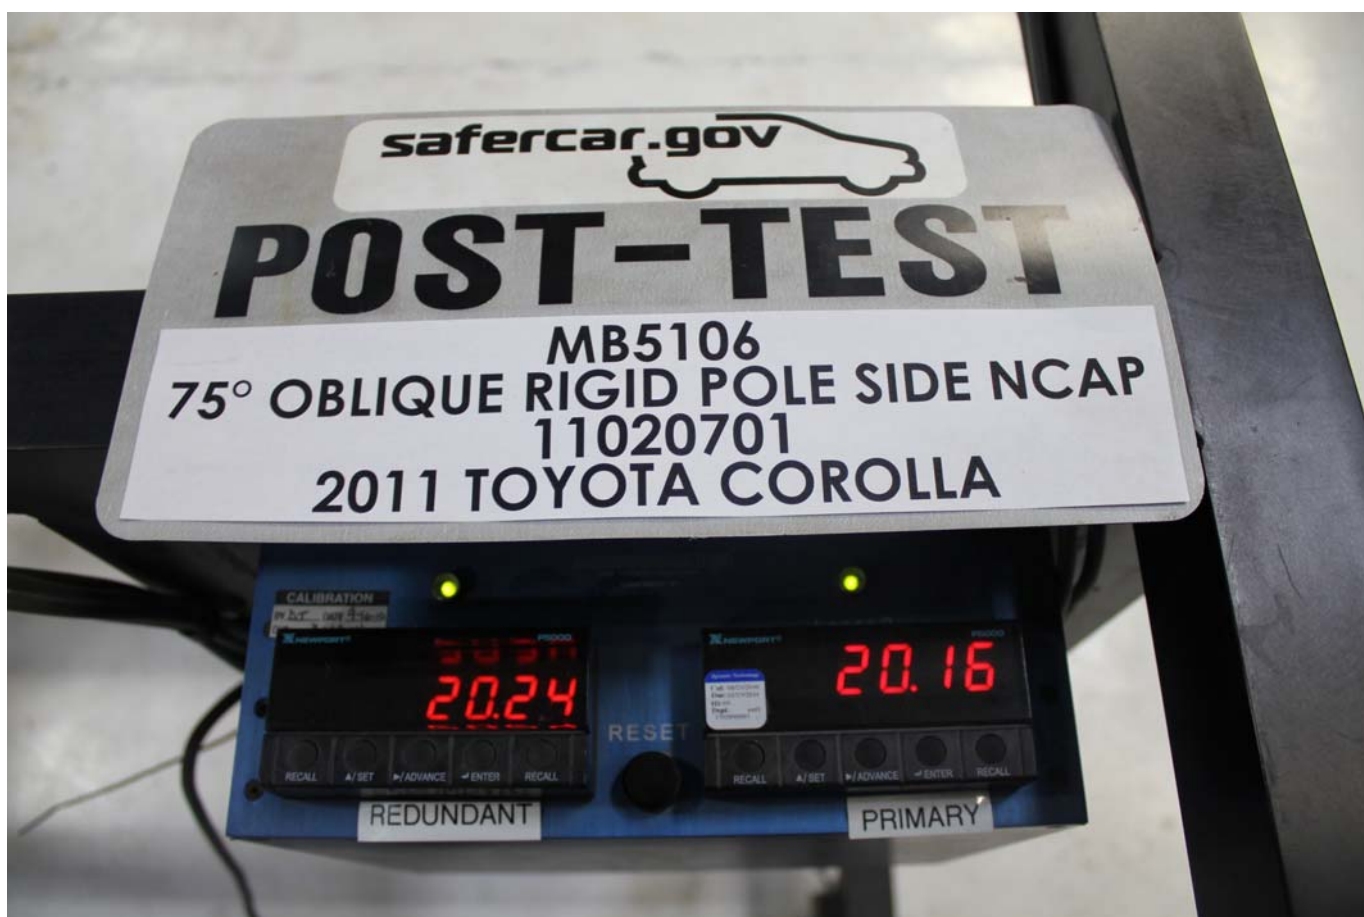
Post-Test Primary and Redundant Speed Trap Read-Out
