**REPORT NUMBER: SPNCAP-MGA-2011-064**

**NEW CAR ASSESSMENT PROGRAM (NCAP)  
Side Impact Pole Test**

**TOYOTA MOTOR MANUFACTURING, CANADA, INC.  
2011 Toyota Corolla 4-Dr Sedan  
NHTSA No.: MB5106**

**FINAL REPORT**

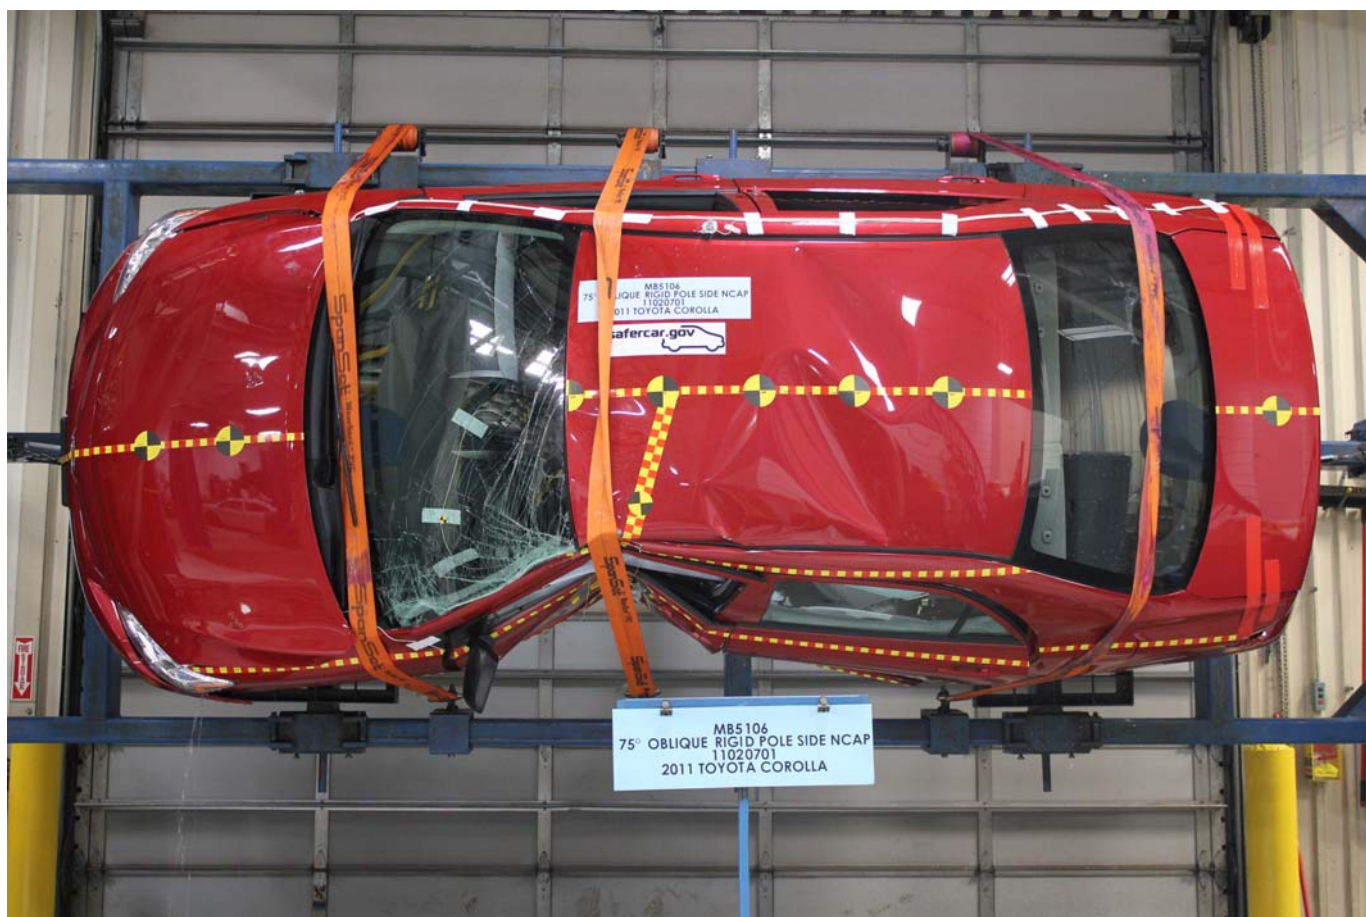
FMVSS No. 301/305 Rollover 90 Degrees

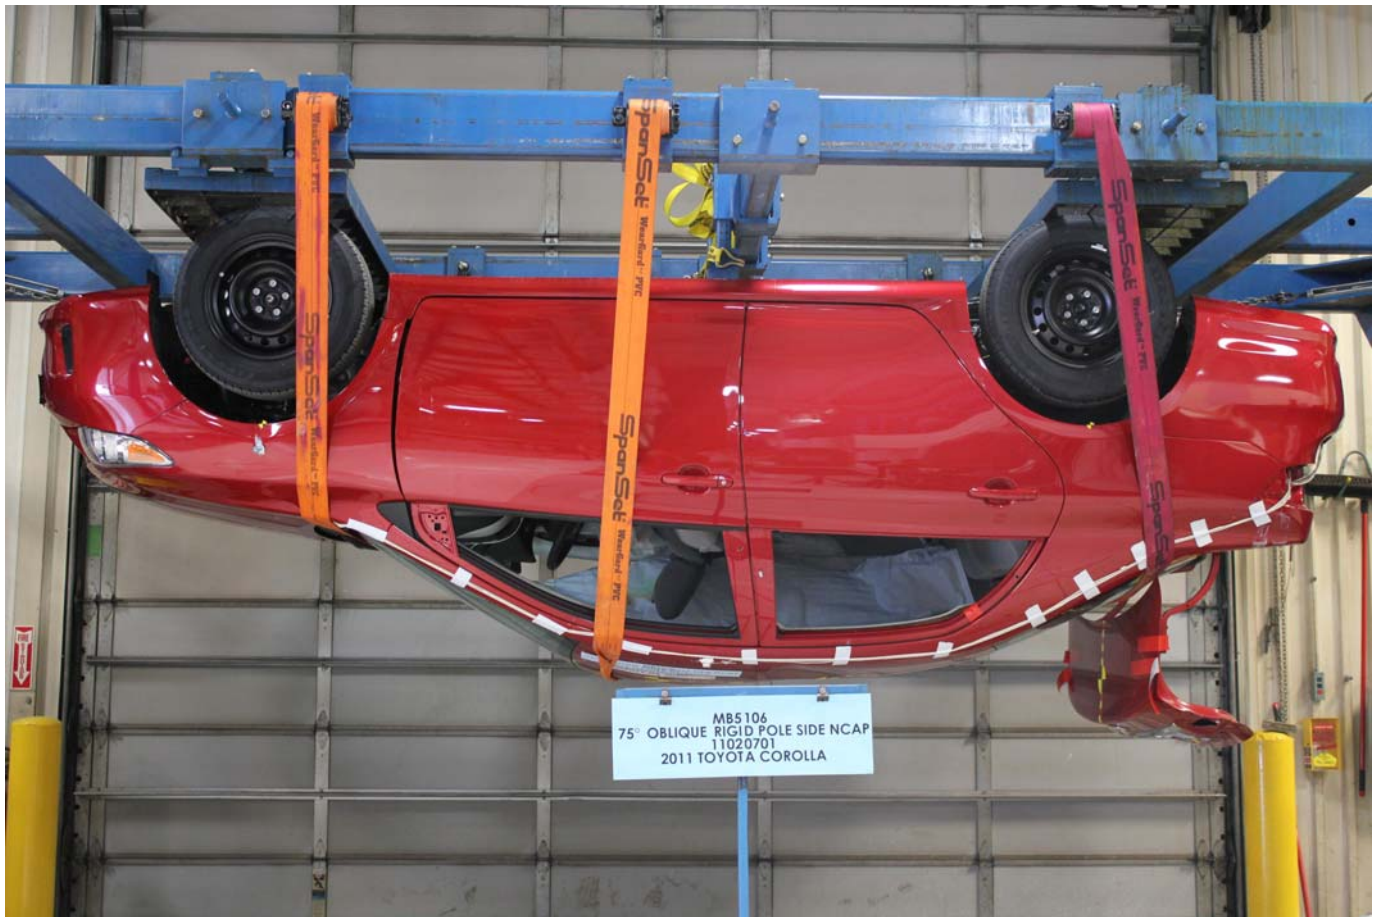
FMVSS No. 301/305 Rollover 180 Degrees

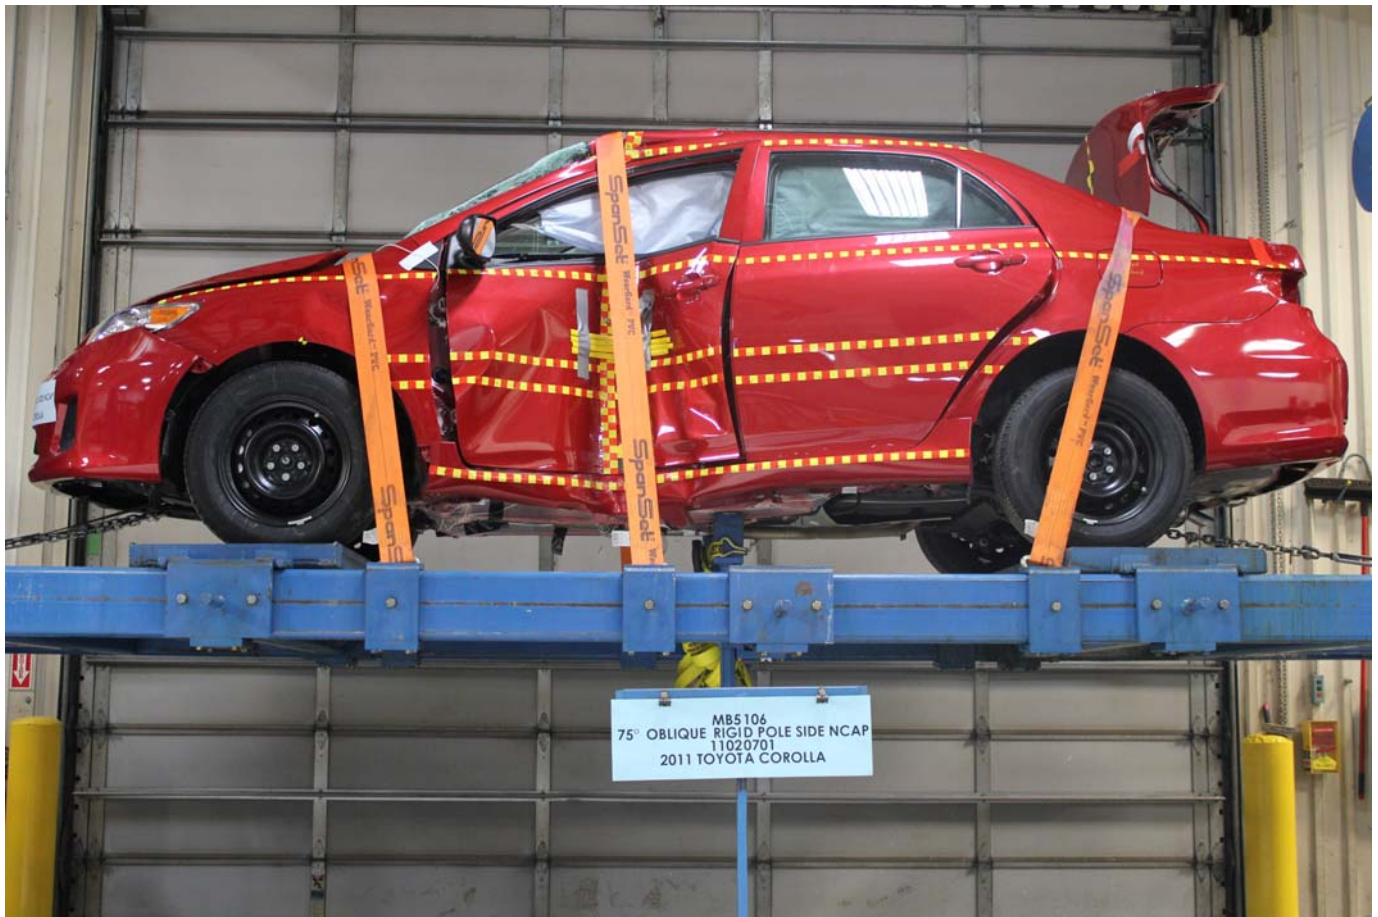
FMVSS No. 301/305 Rollover 360 Degrees
