**REPORT NUMBER: SPNCAP-MGA-2011-067**

**NEW CAR ASSESSMENT PROGRAM (NCAP)  
Side Impact Pole Test**

**TOYOTA MOTOR CORPORATION  
2011 Toyota Prius 5-Dr Liftback  
NHTSA No.: MB5112**

**MGA RESEARCH CORPORATION  
5000 Warren Road  
Burlington, WI 53105**

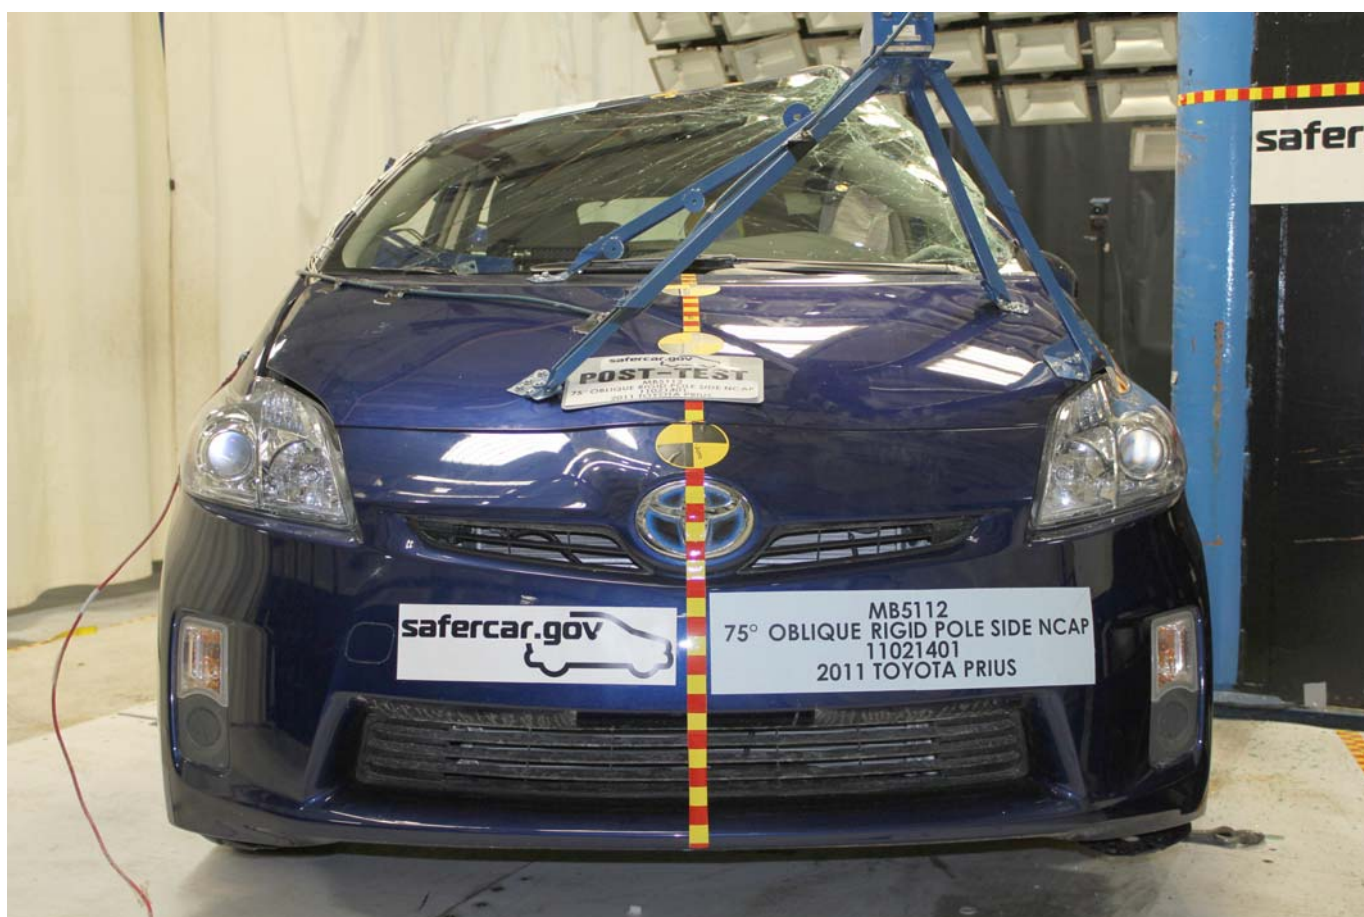
Post-Test Frontal View of Test Vehicle

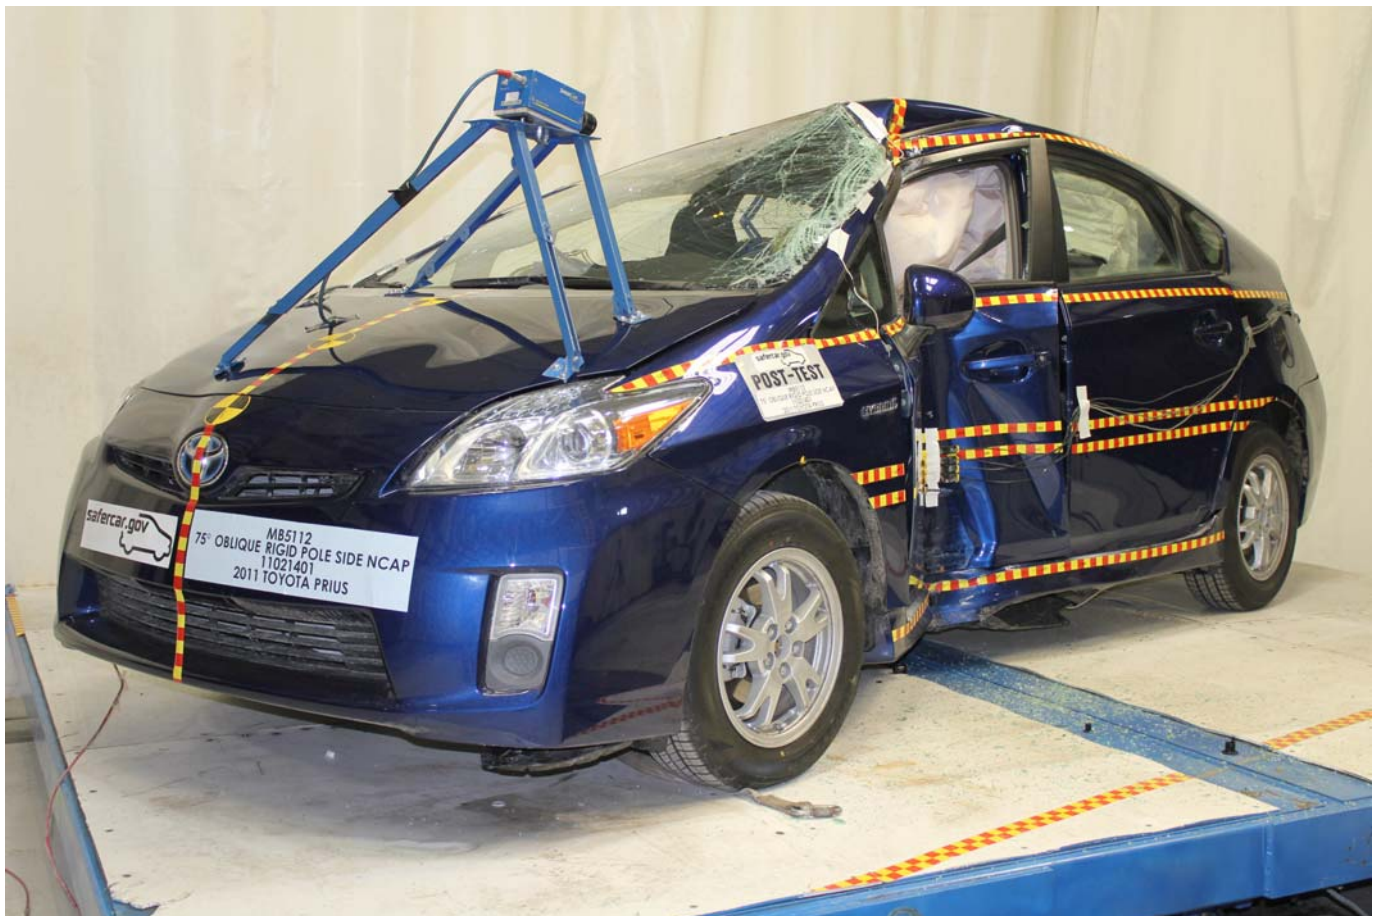
Post-Test Left Front  $\frac{3}{4}$  View of Test Vehicle

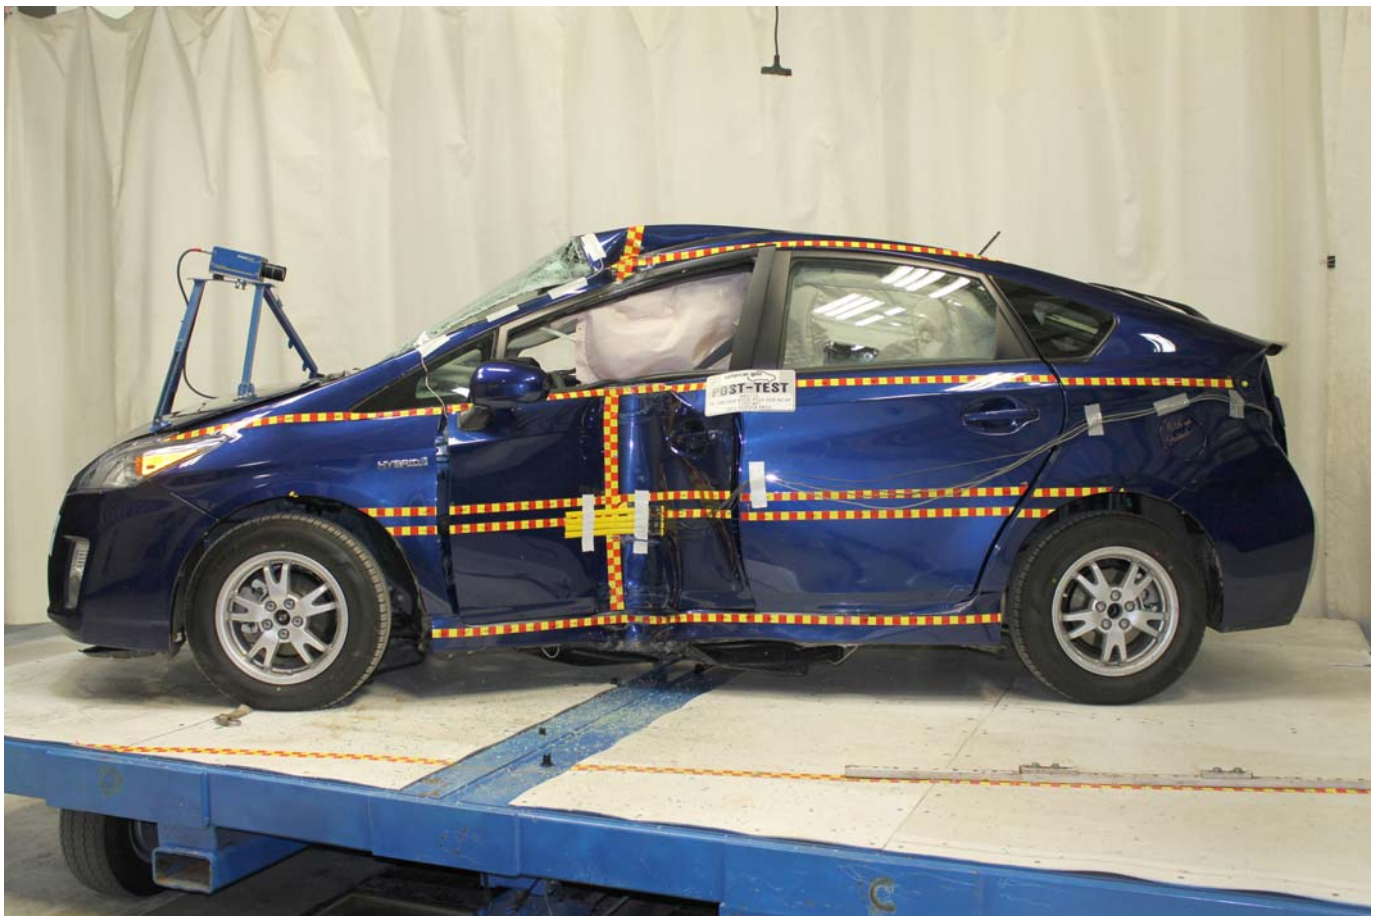
Post-Test Left Side View of Test Vehicle

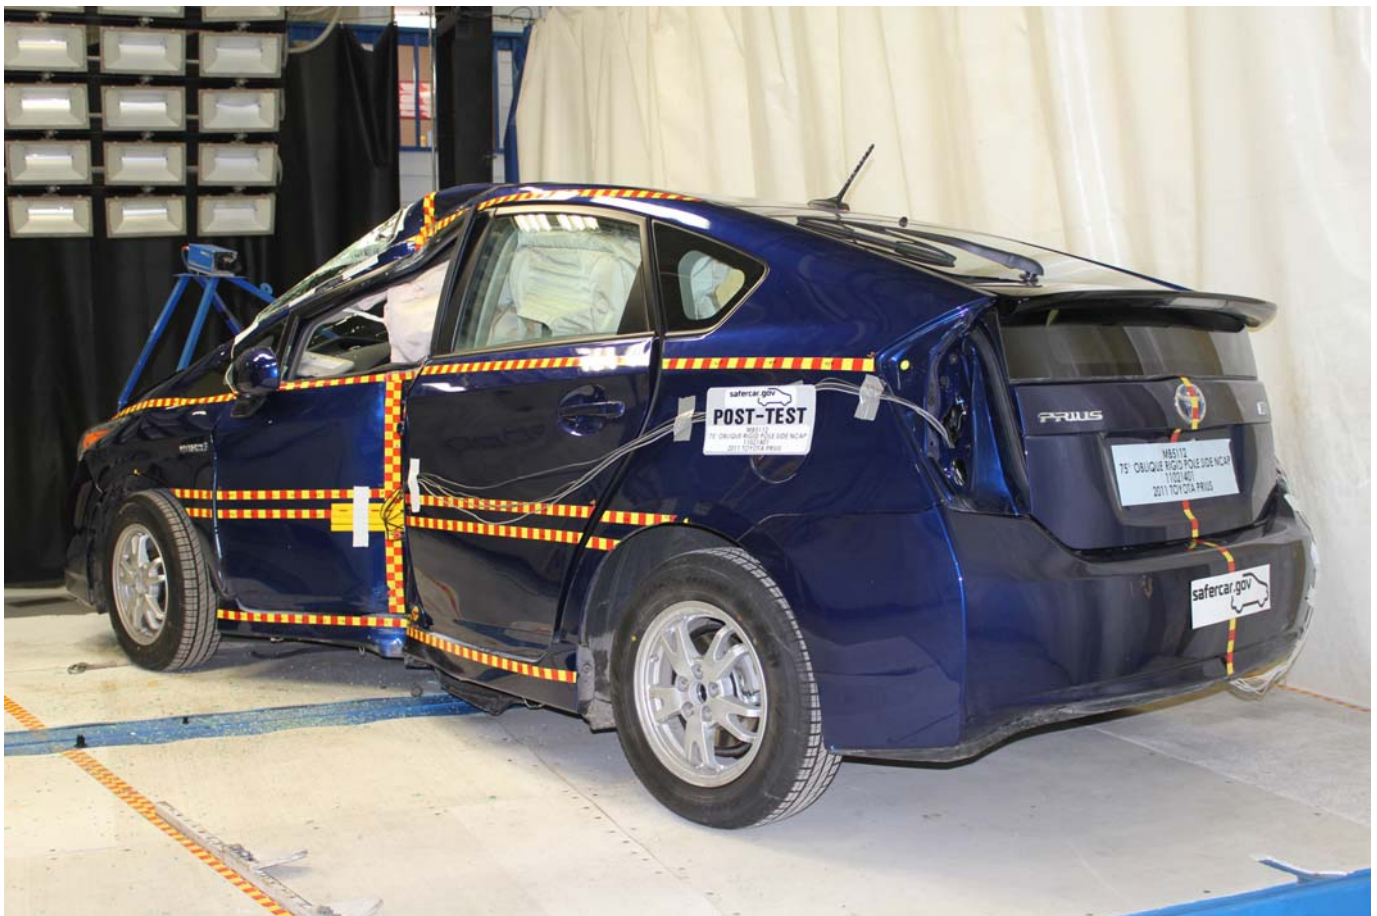
Post-Test Left Rear  $\frac{3}{4}$  View of Test Vehicle

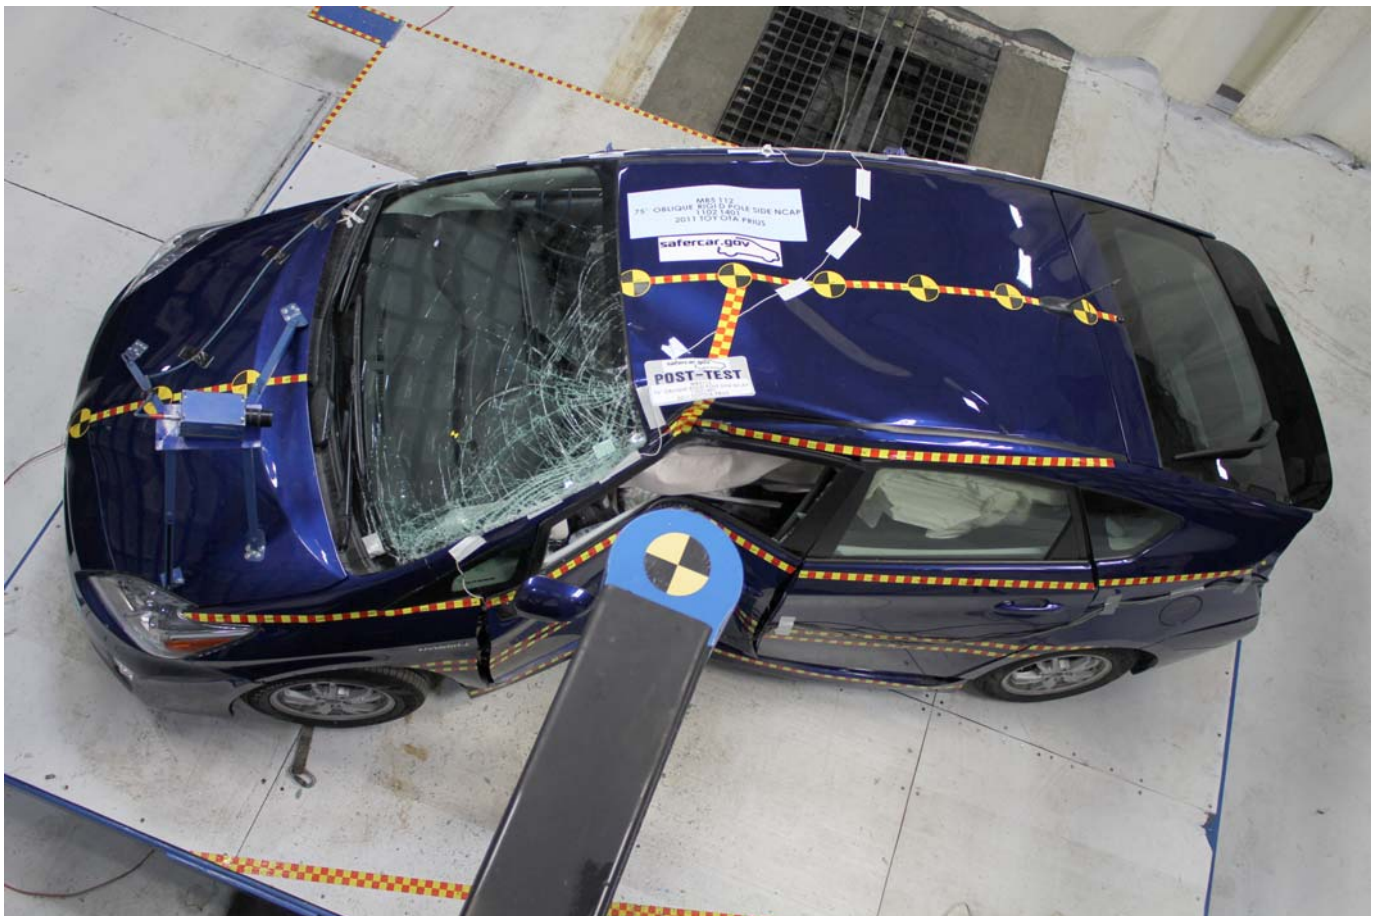
Post-Test Overhead View of Test Vehicle and Pole

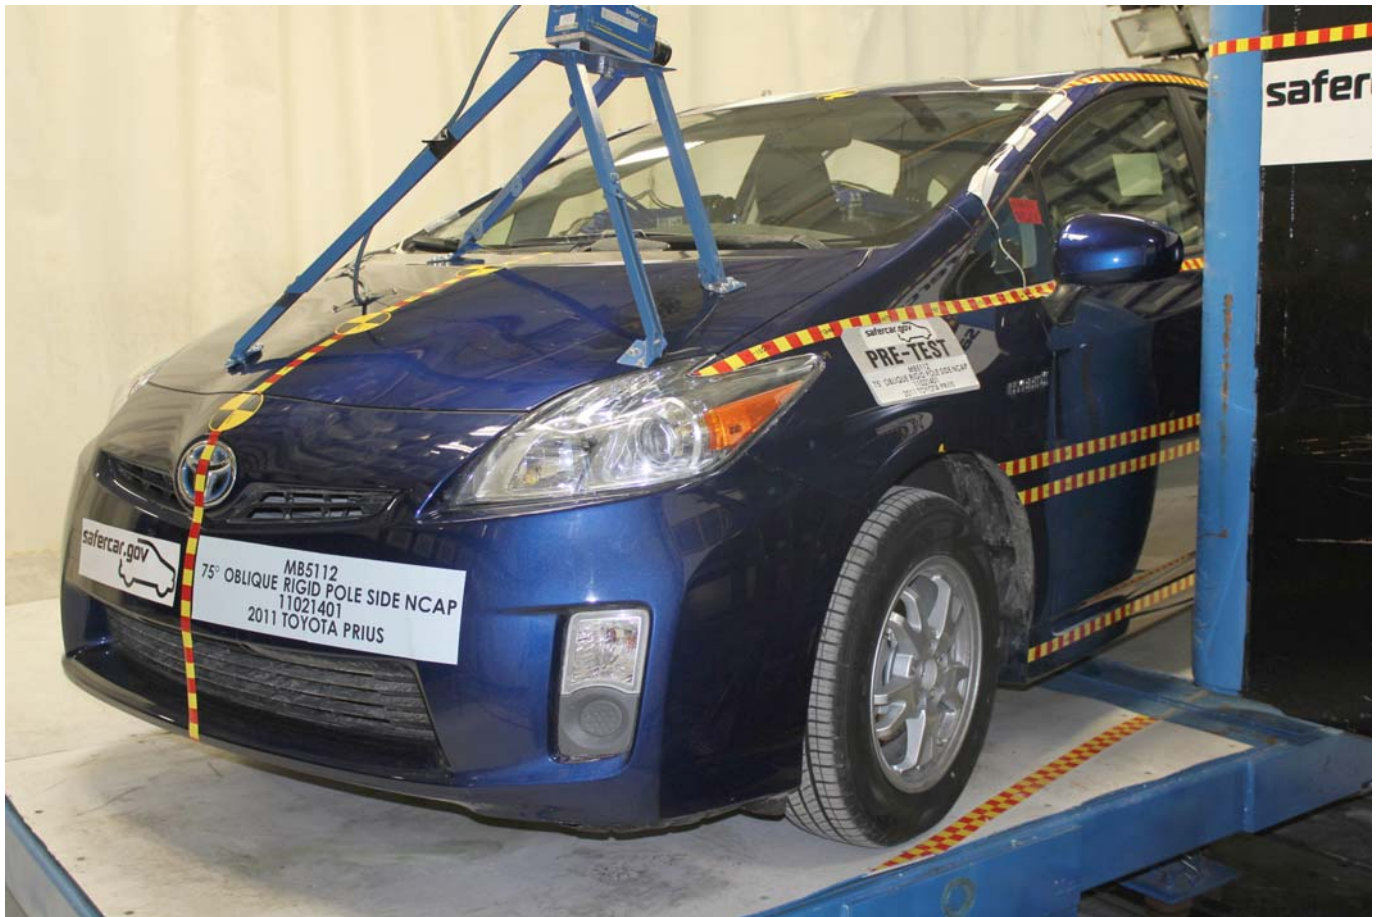
Pre-Test Left Side View of Pole Positioned Against Side of Vehicle

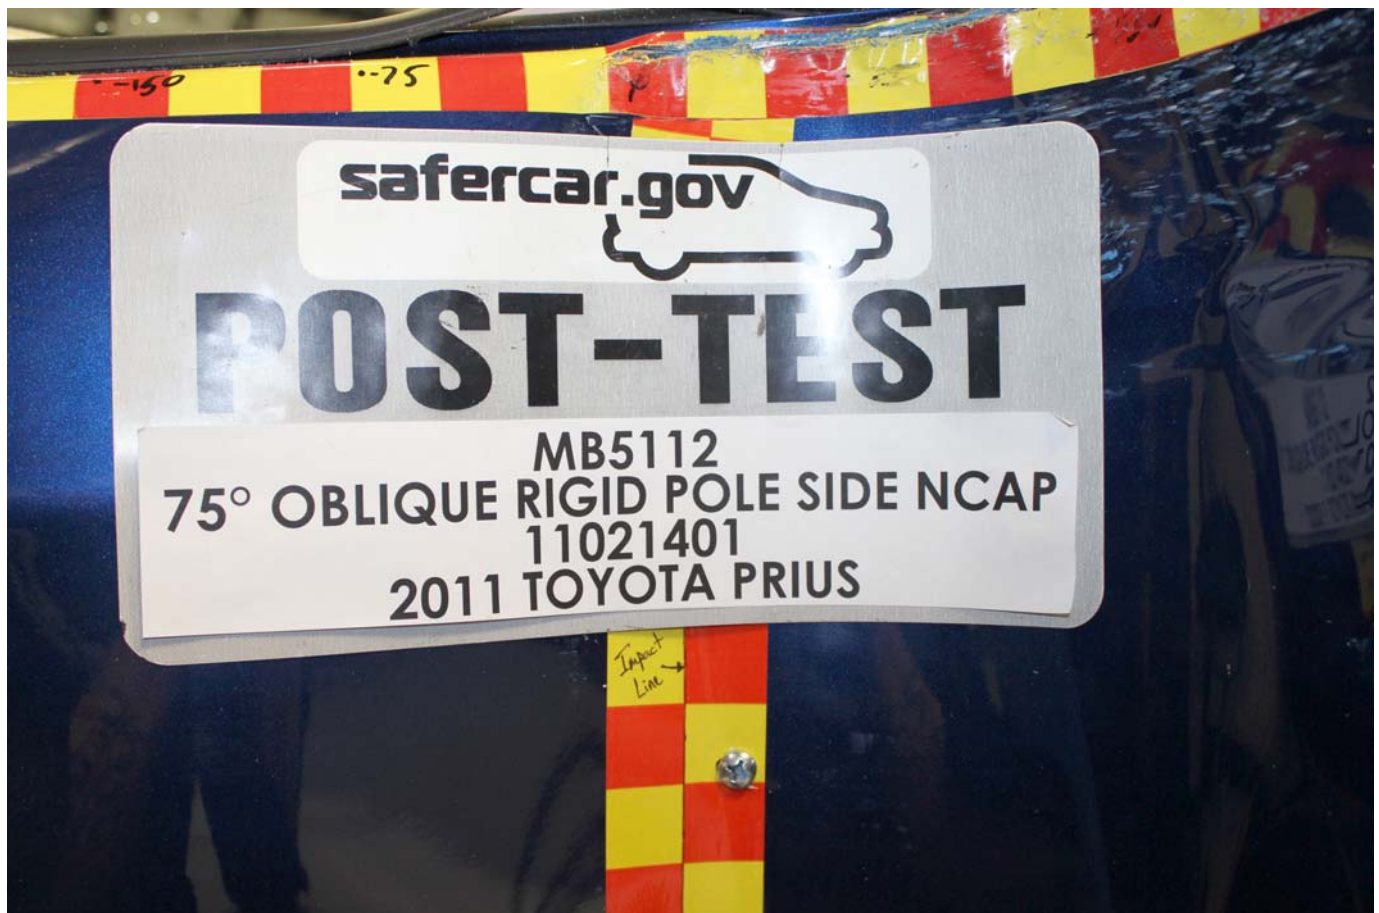
Post-Test Close-Up View of Impact Point Target Showing Impact Location

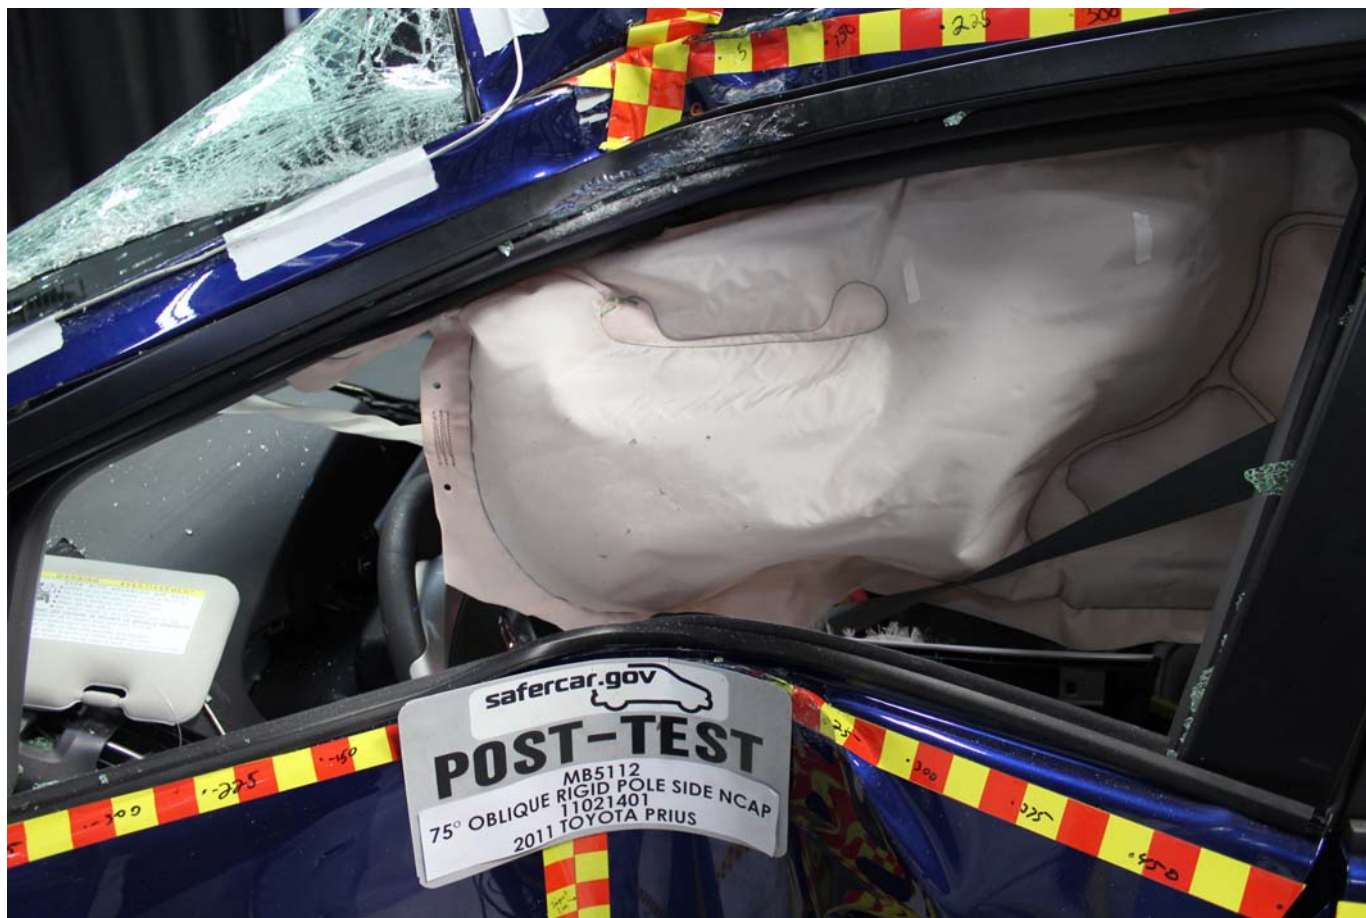
Post-Test Left Side View of Dummy Shoulder and Door Top View

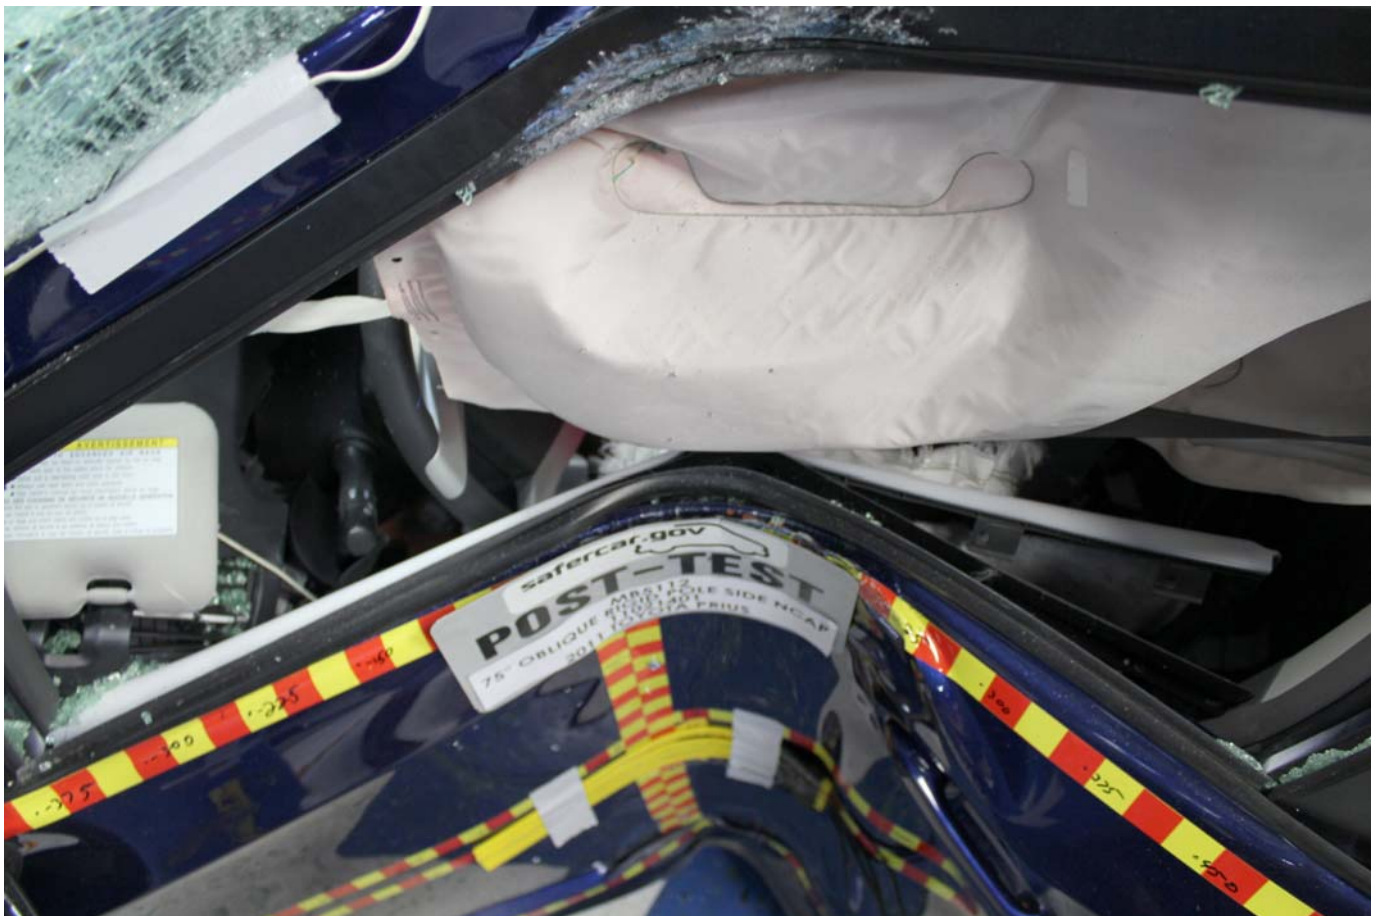
Post-Test Dummy and Door Clearance View

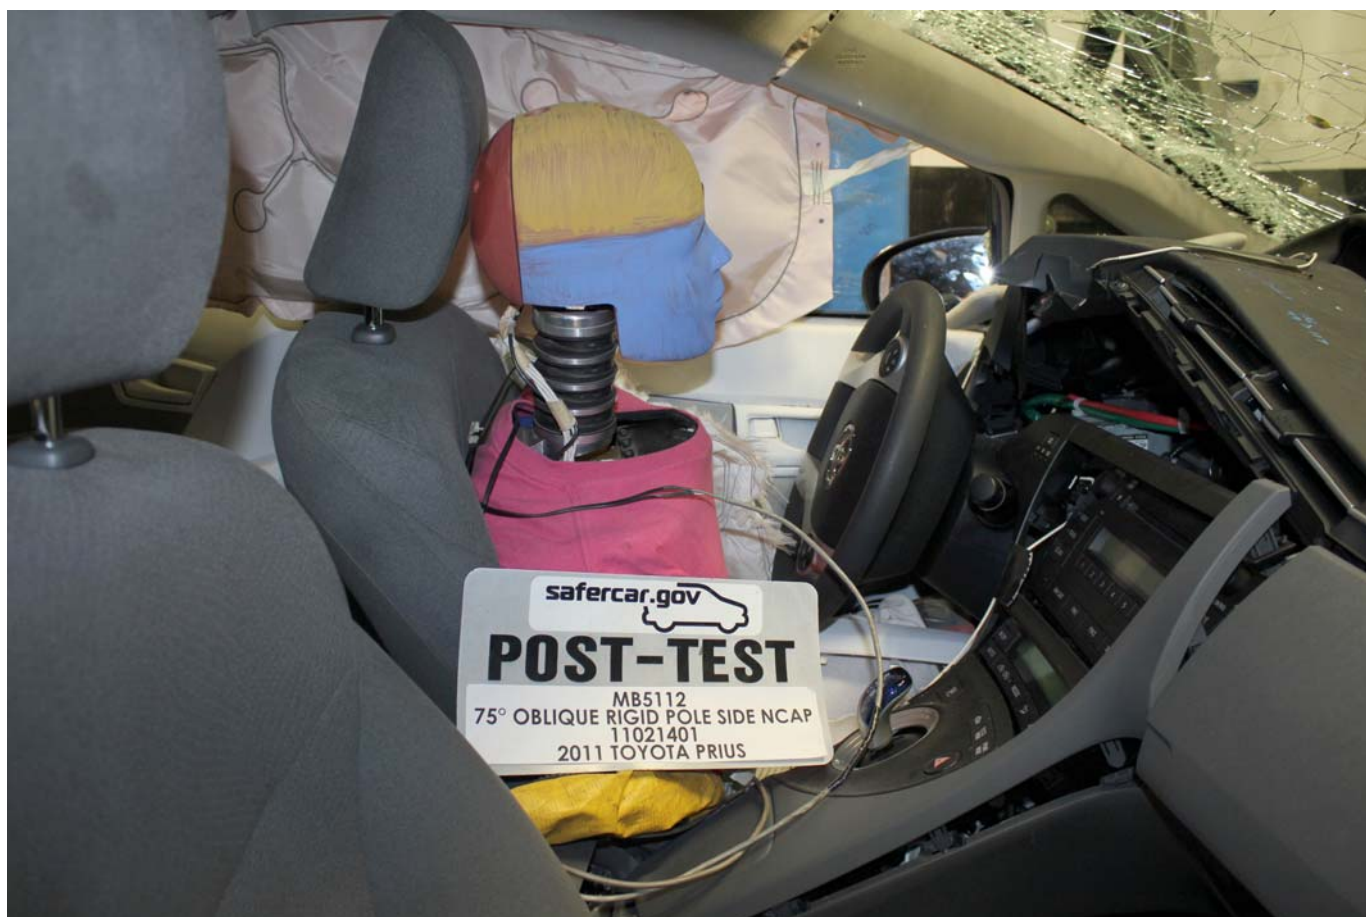
Post-Test Right Side View of Dummy and Front Seat Occupant Compartment

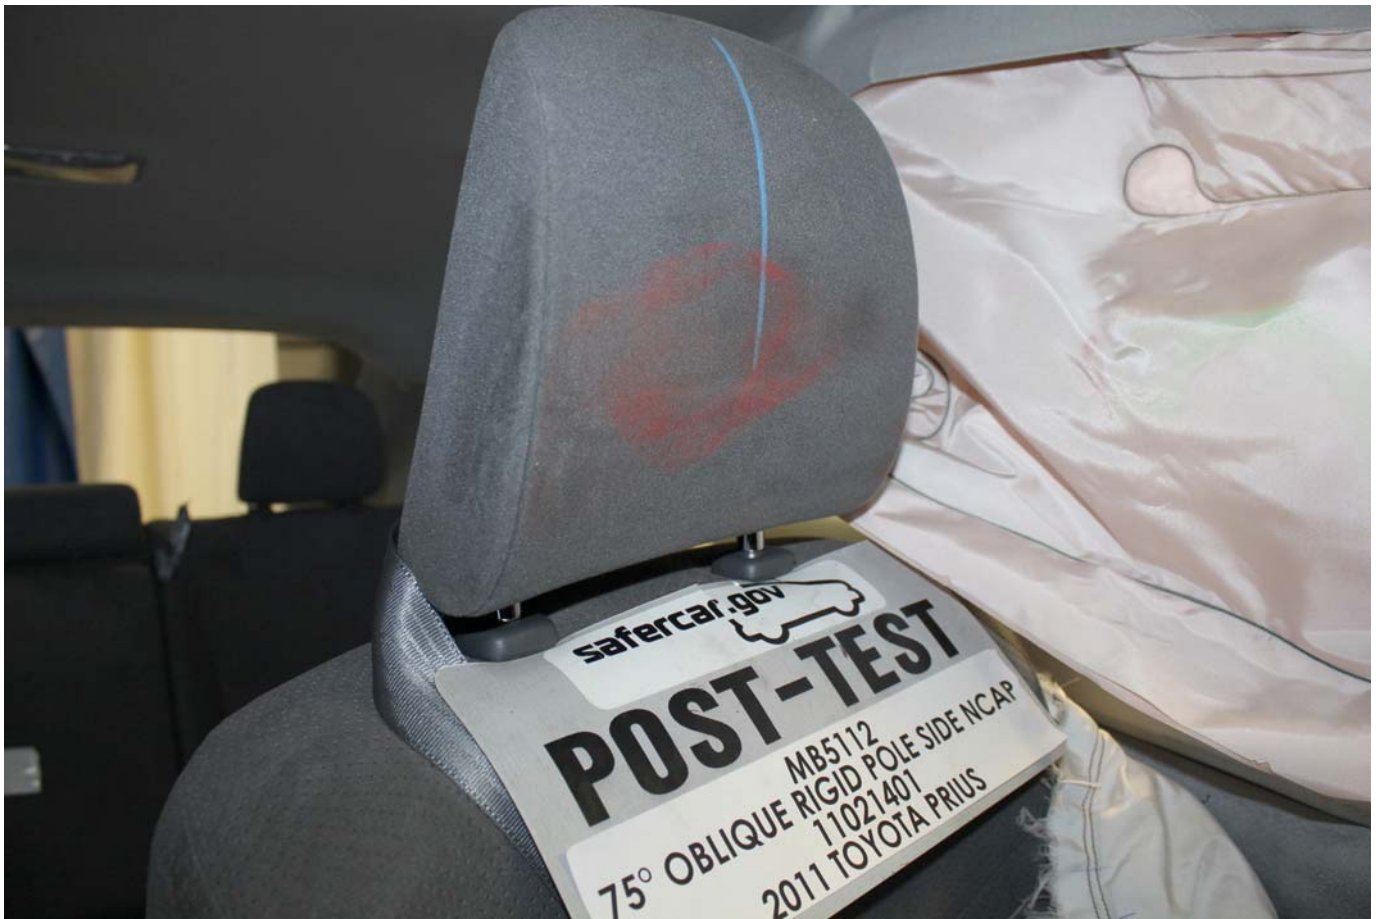
Post-Test Dummy Close-Up Head Contact with Vehicle Interior View

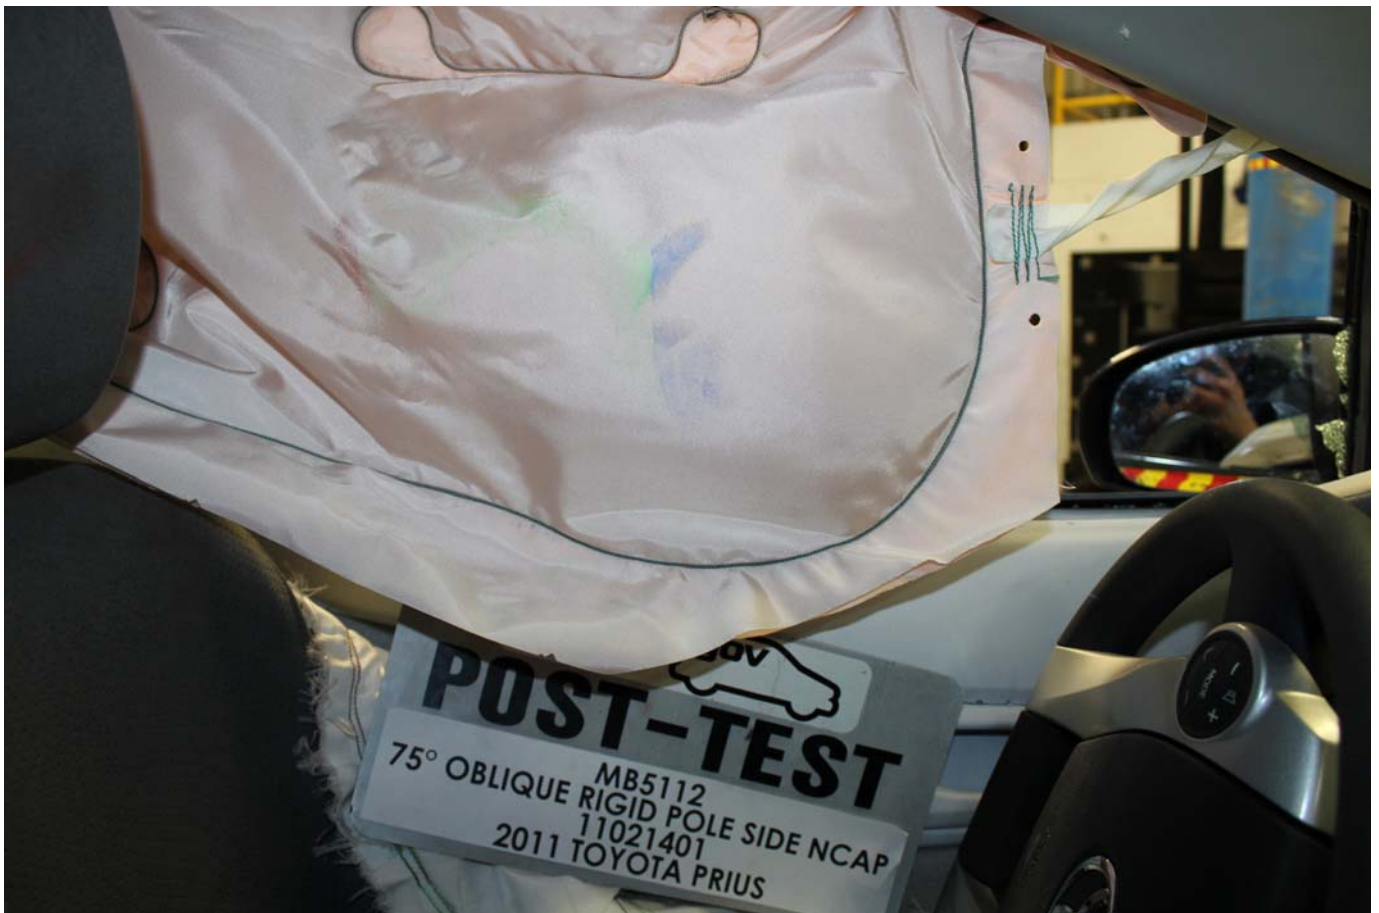
Post-Test Dummy Close-Up Head Contact with Side Airbag View

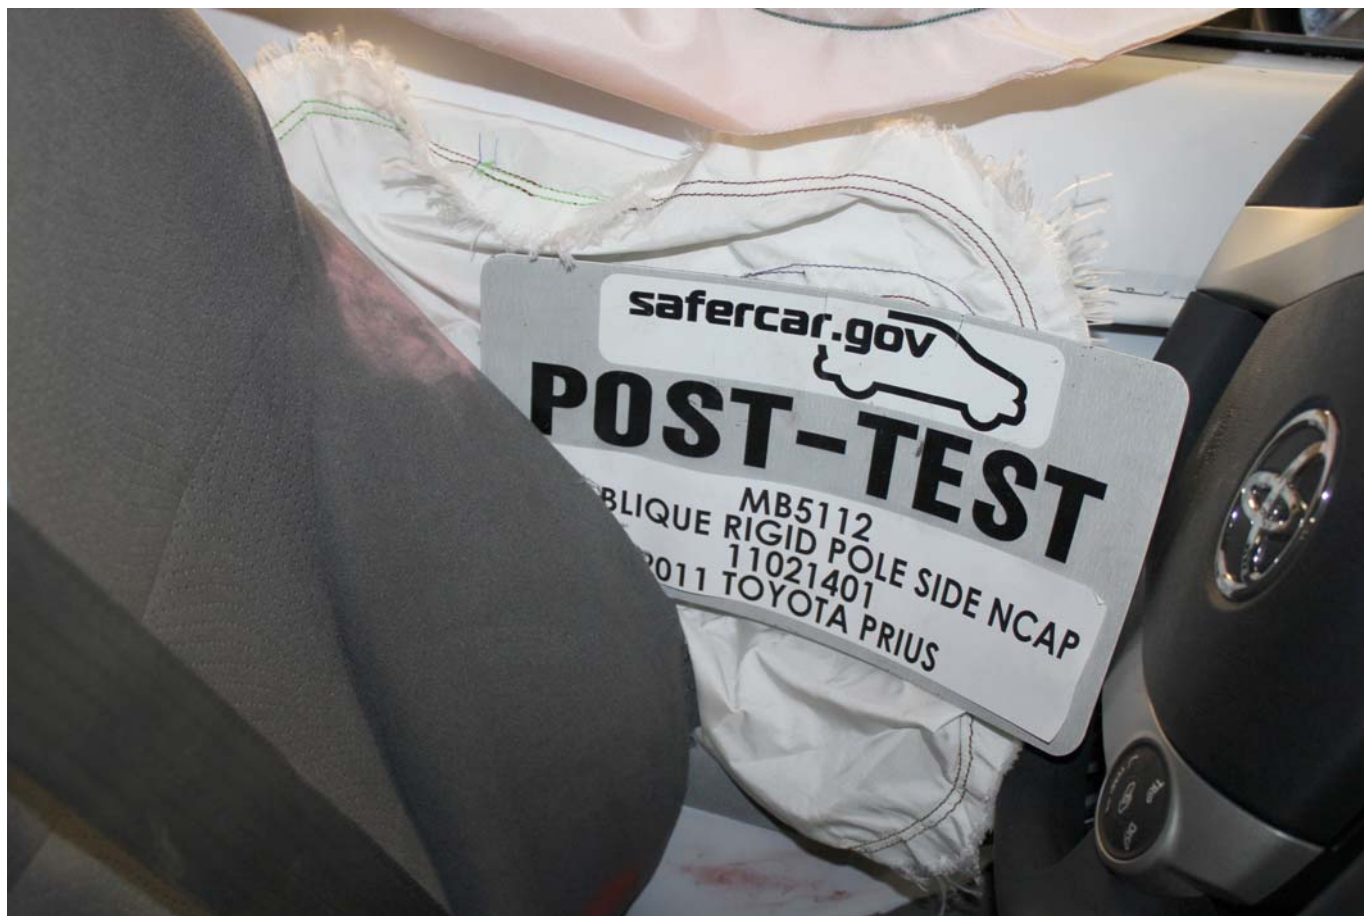
Post-Test Dummy Close-Up Torso Contact with Vehicle Interior View

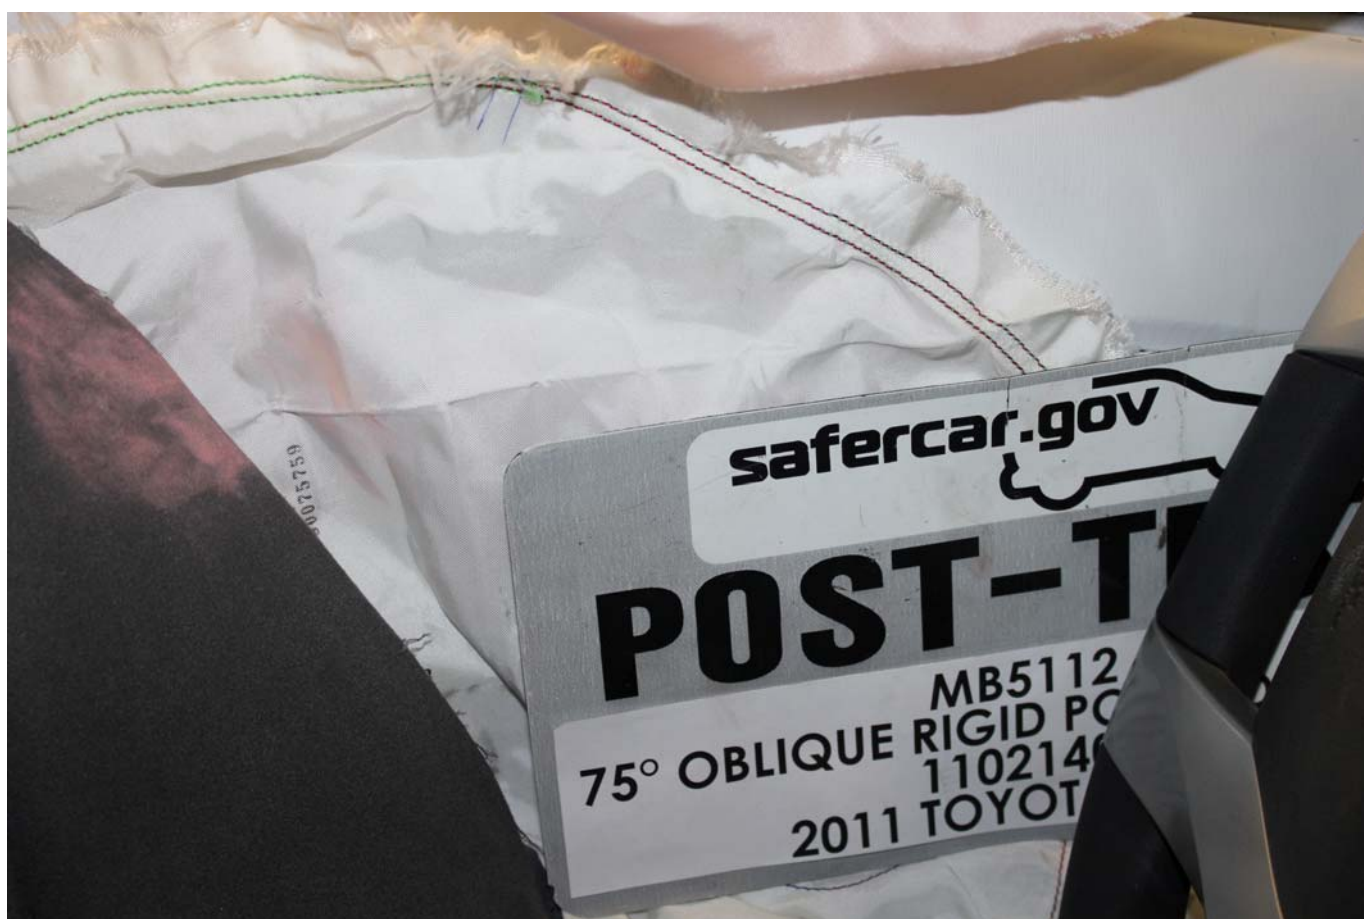
Post-Test Dummy Close-Up Torso Contact with Side Airbag View

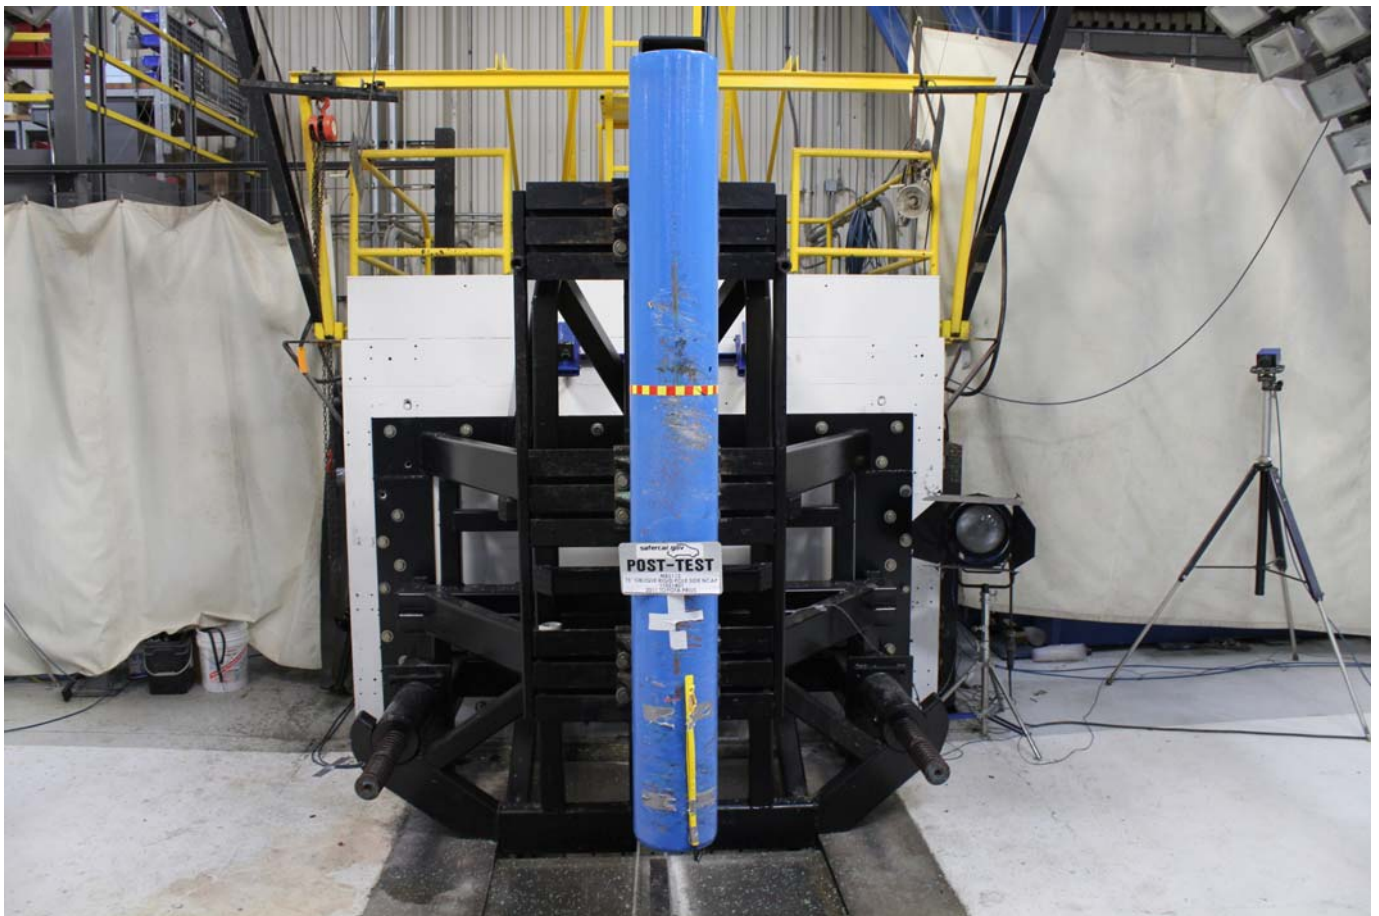
Post-Test Pole Barrier Front View

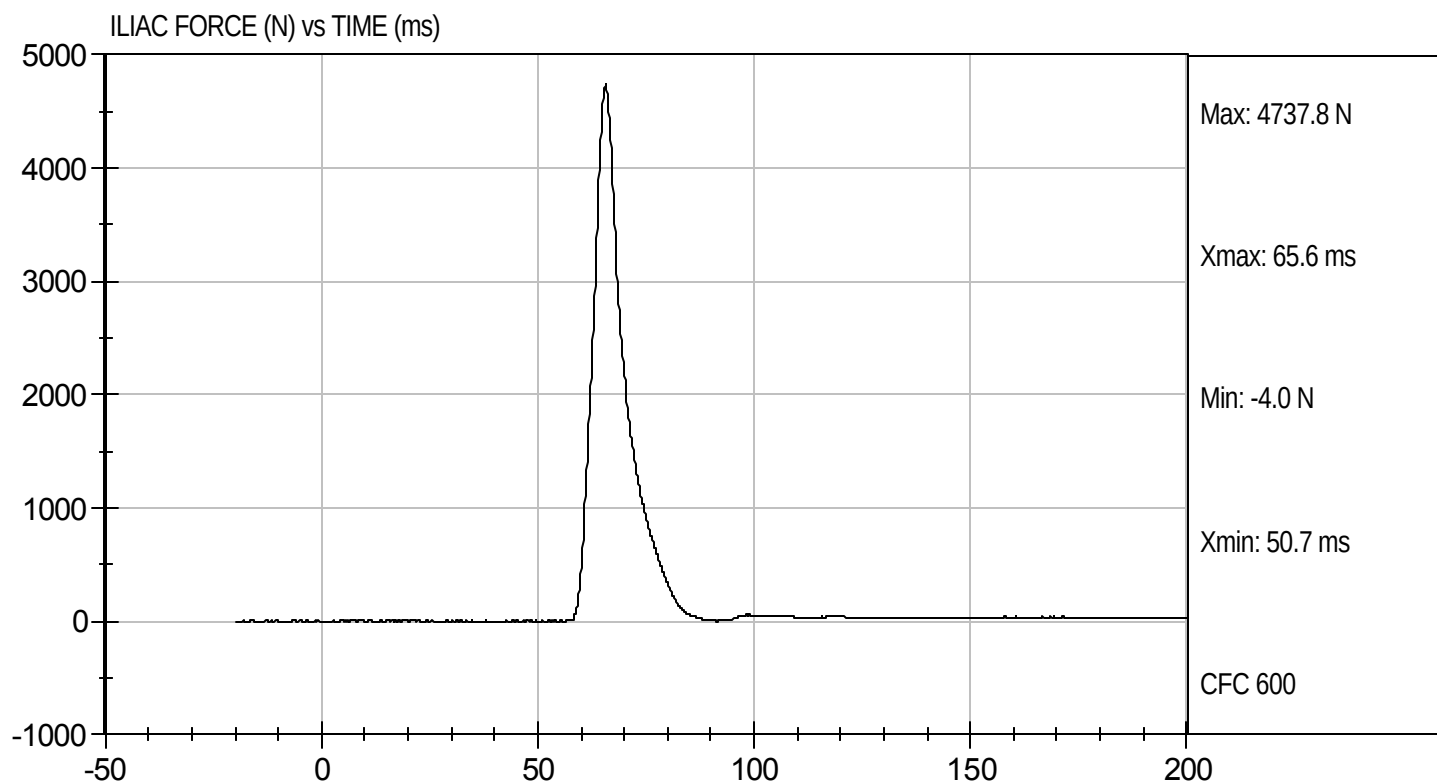
Test Desc: Iliac Impact  
Component ID: D11528

Test Date: 2/15/11  
Velocity: 14.36 ft/s, 4.38 m/s
