**REPORT NUMBER: SINCAP-MGA-2011-068**

**NEW CAR ASSESSMENT PROGRAM (NCAP)  
Moving Deformable Barrier Side Impact Test**

**TOYOTA MOTOR CORPORATION  
2011 Toyota Prius 5-Dr Liftback  
NHTSA No.: MB5113**

**FINAL REPORT**

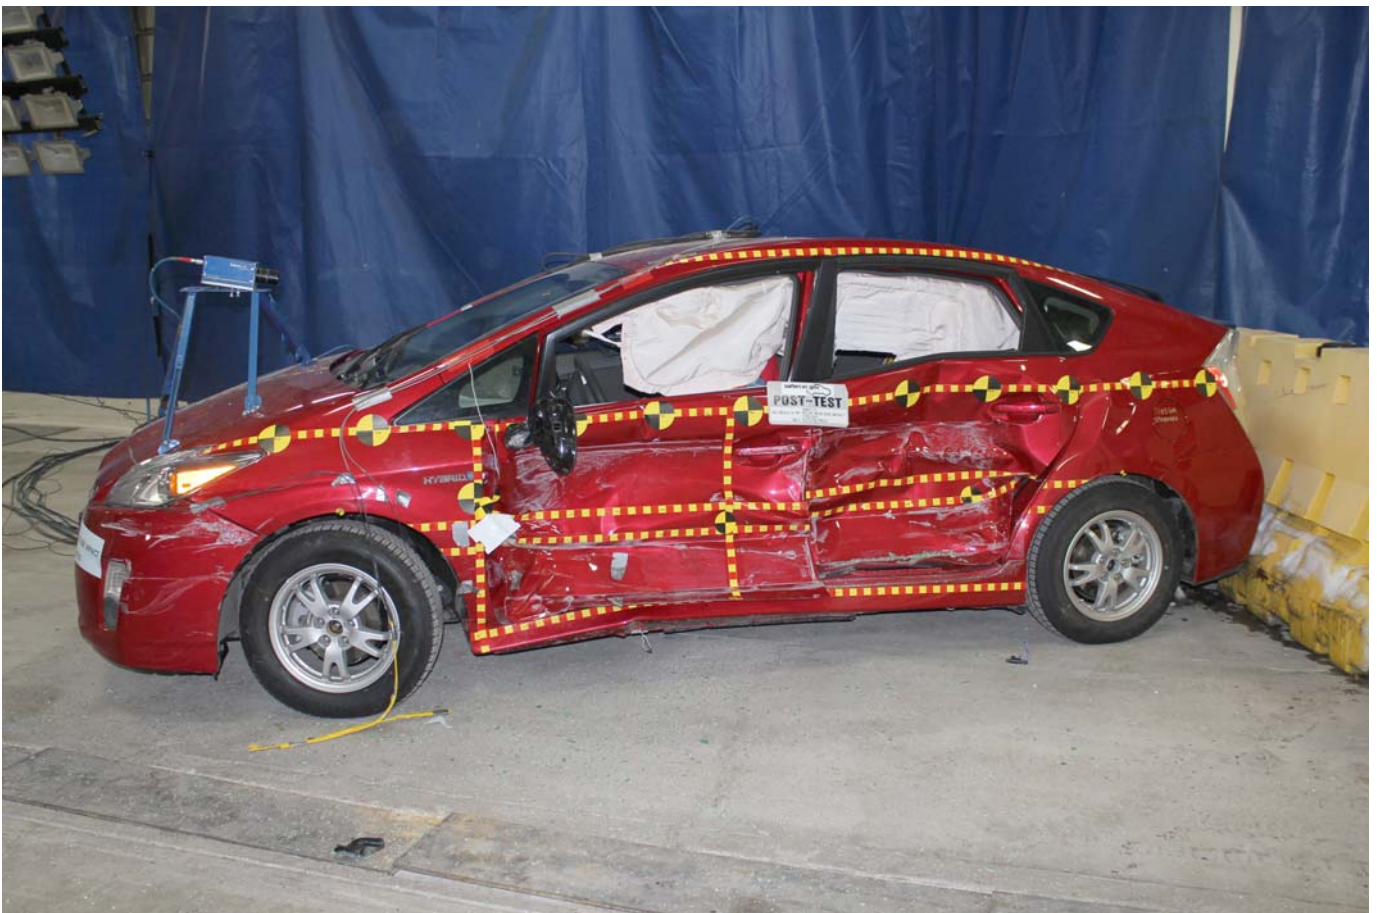
Post-Test Left Side View of Test Vehicle

| Critical Areas of Performance | Observations and Conclusions |
|---|---|
| Window Damage | Left Front and Left Rear Broke |

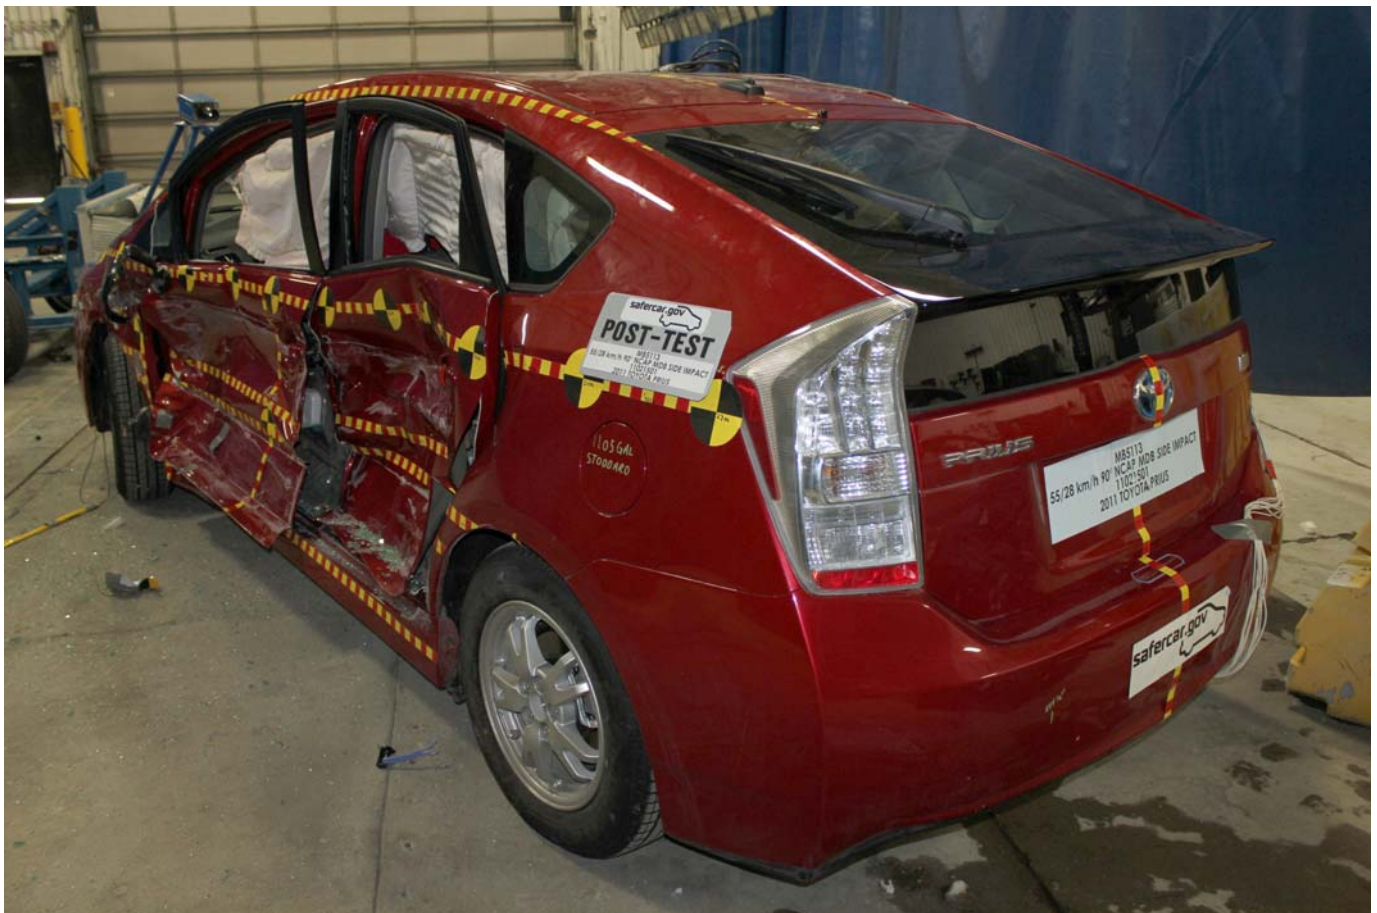
Post-Test Left Three-Quarter Rear View of Test Vehicle

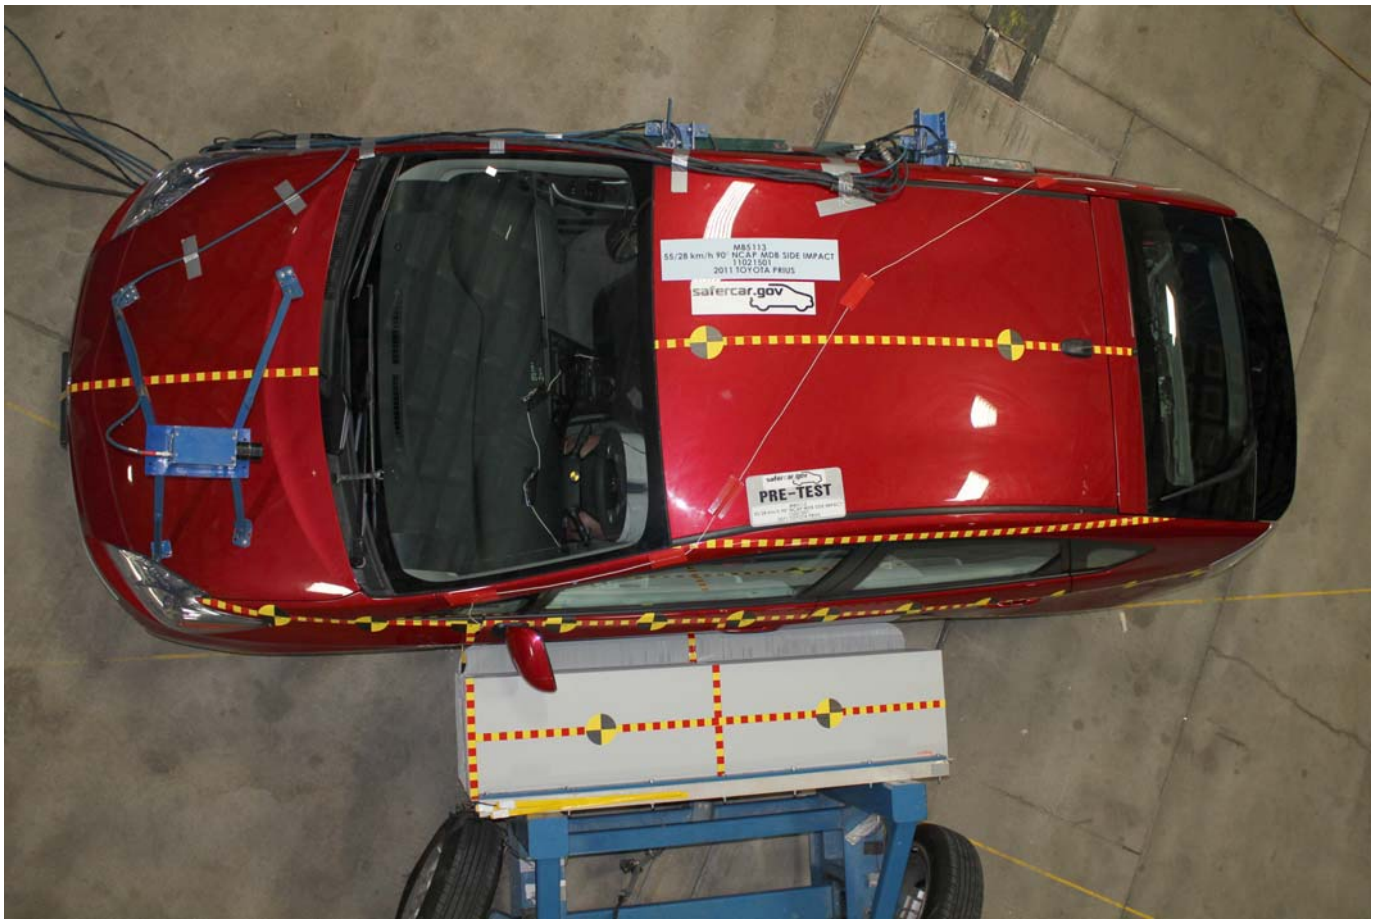
Pre-Test Overhead View of Test Vehicle with MDB Positioned Against Side of Test Vehicle

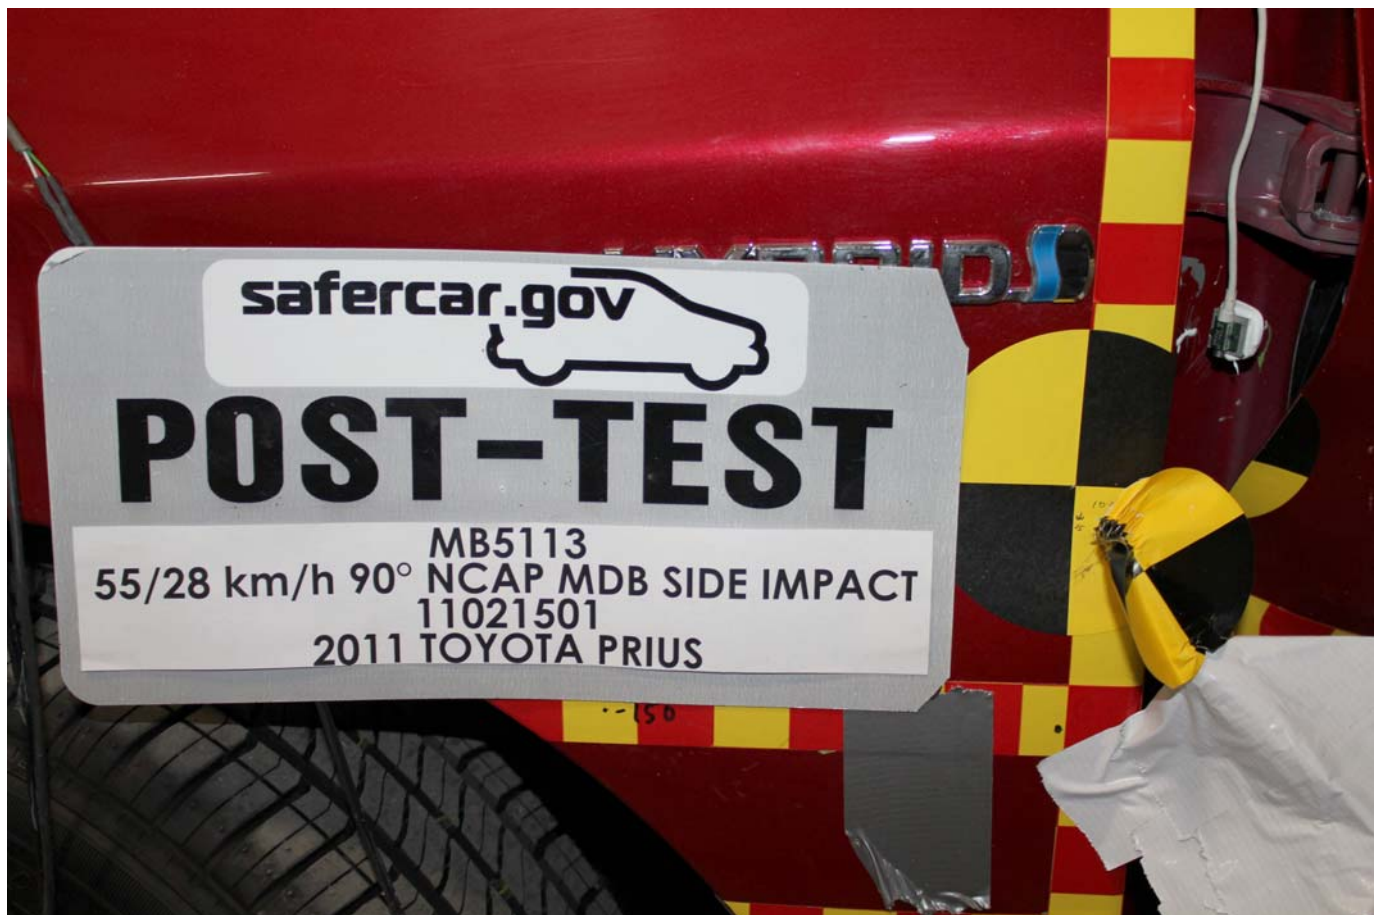
Post-Test Close-Up View of Impact Point Target

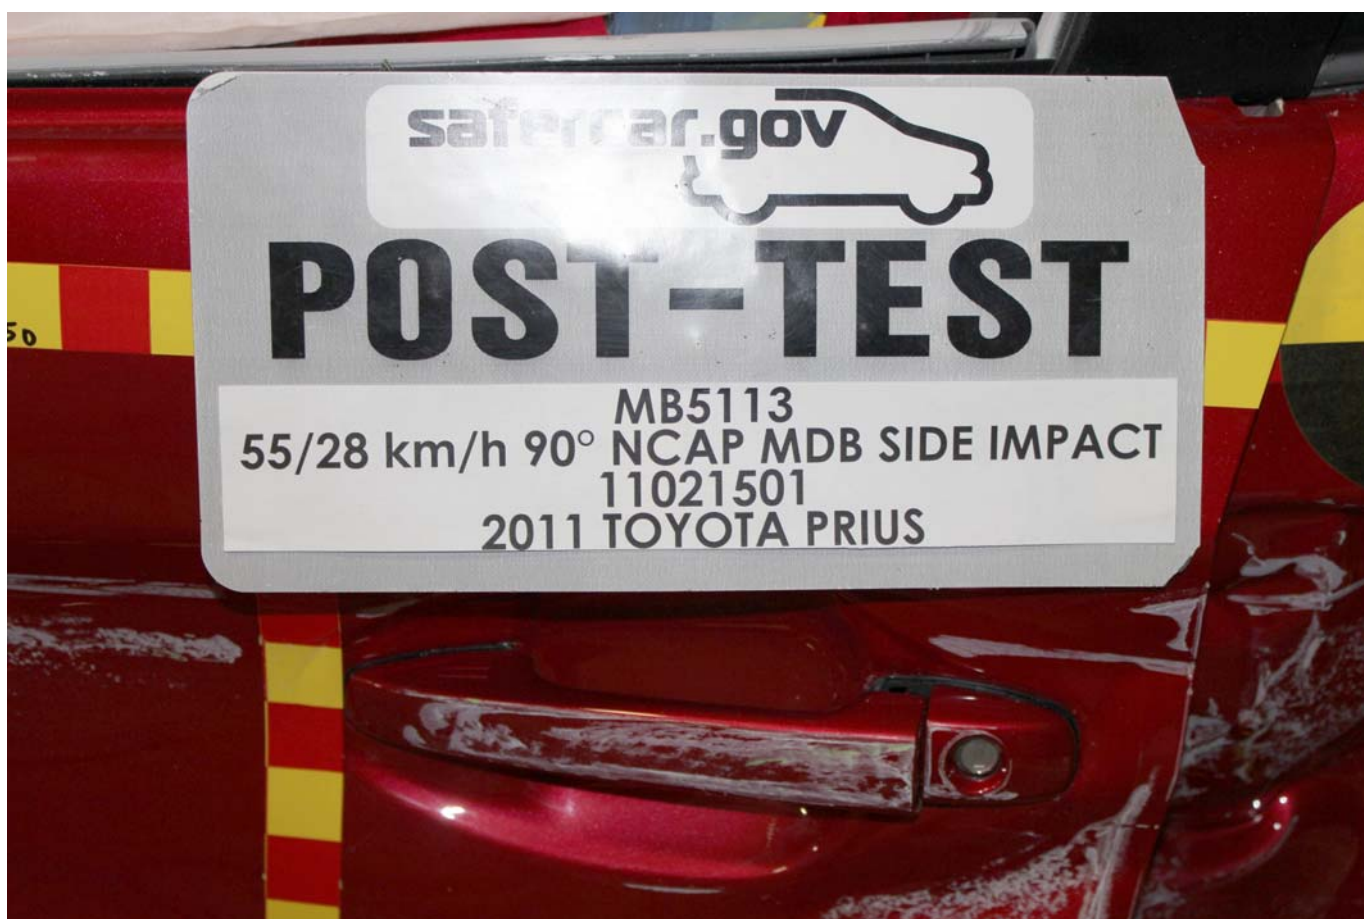
Post-Test Left Front Door Latch Close-Up

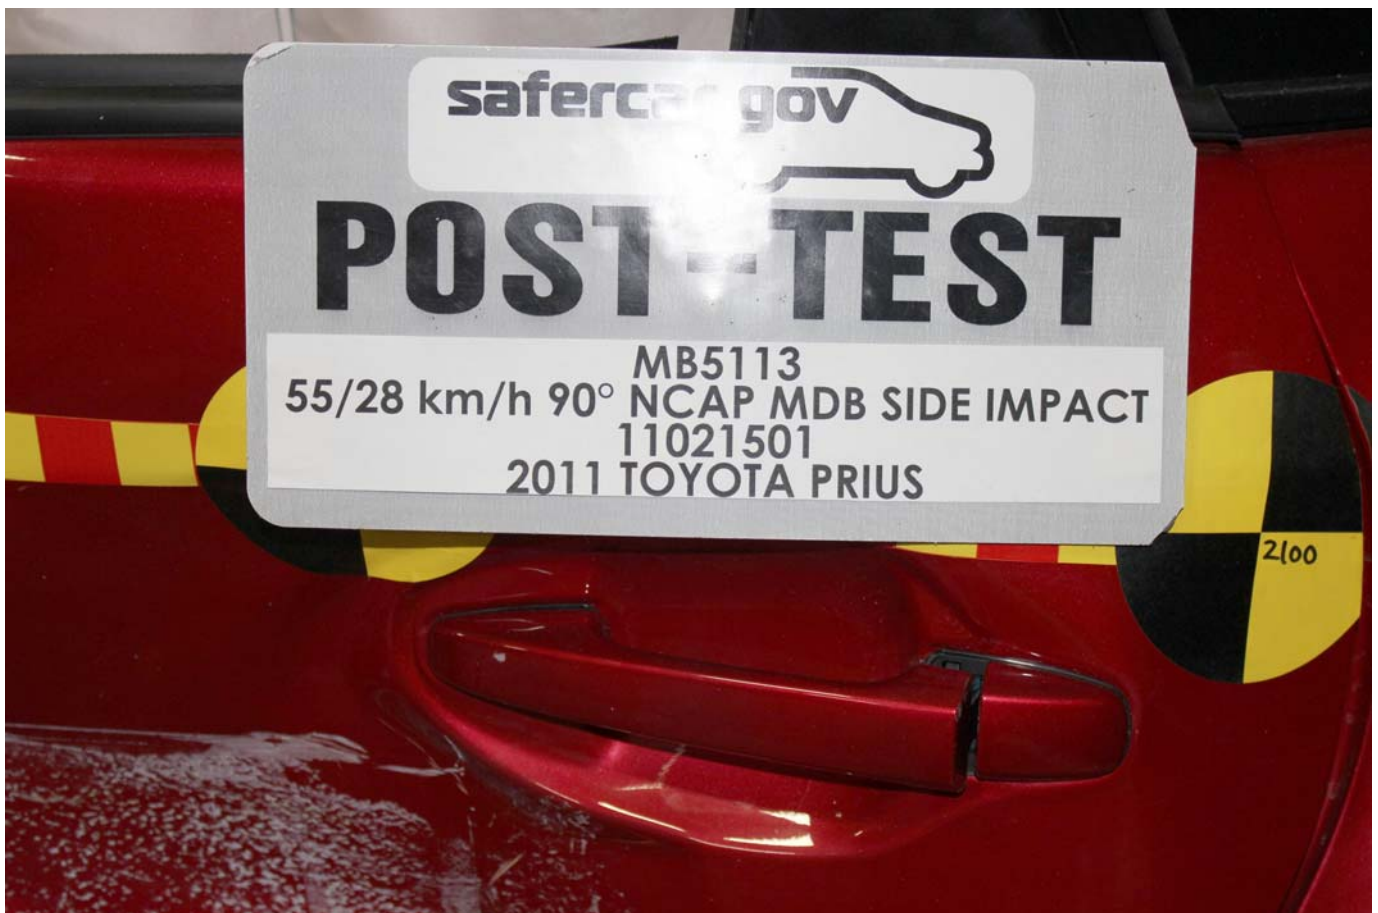
Post-Test Left Rear Door Latch Close-Up

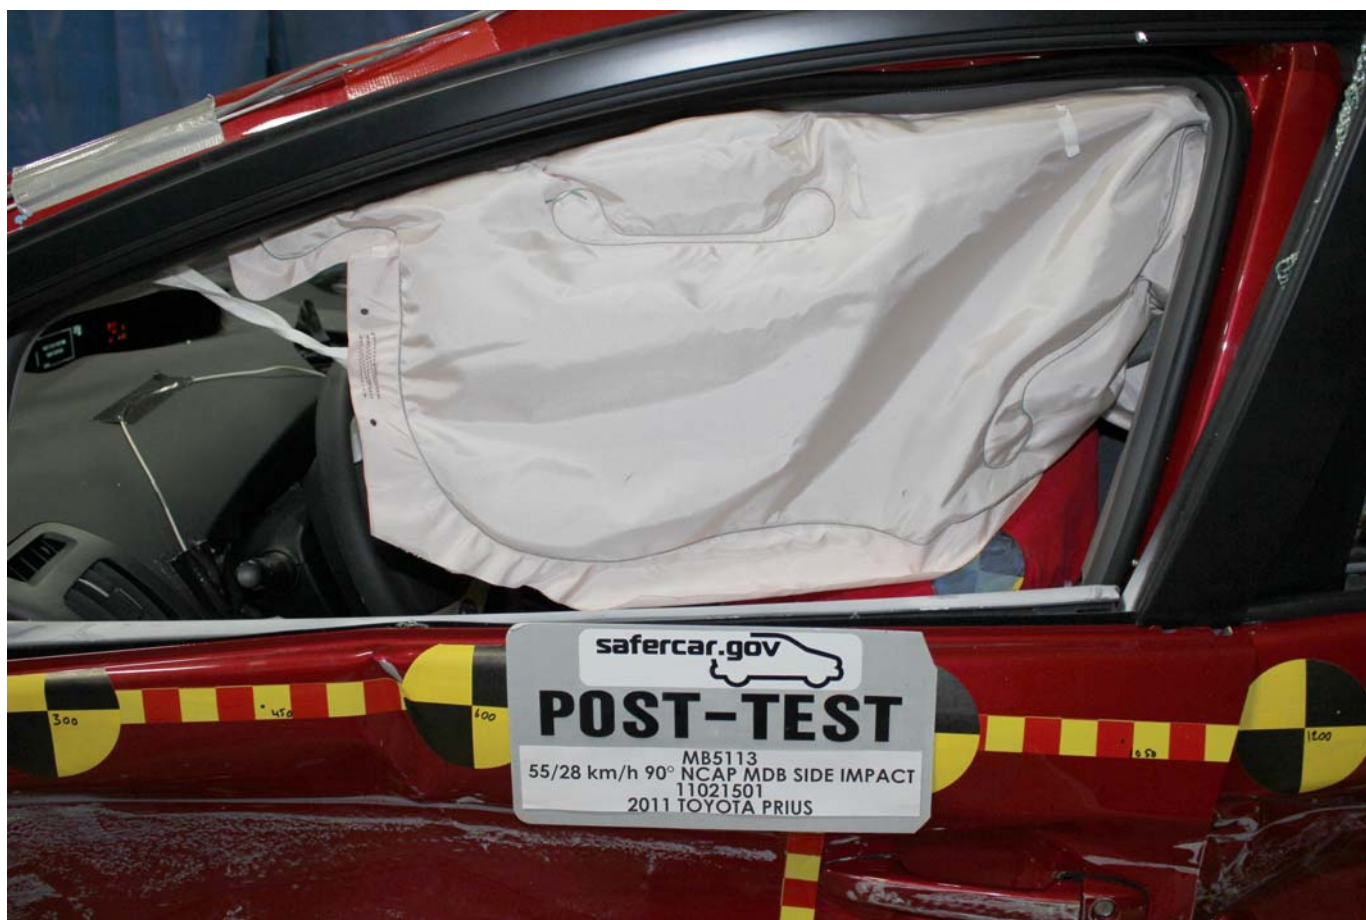
Post-Test Left Side View of Driver Dummy Shoulder and Door Top View

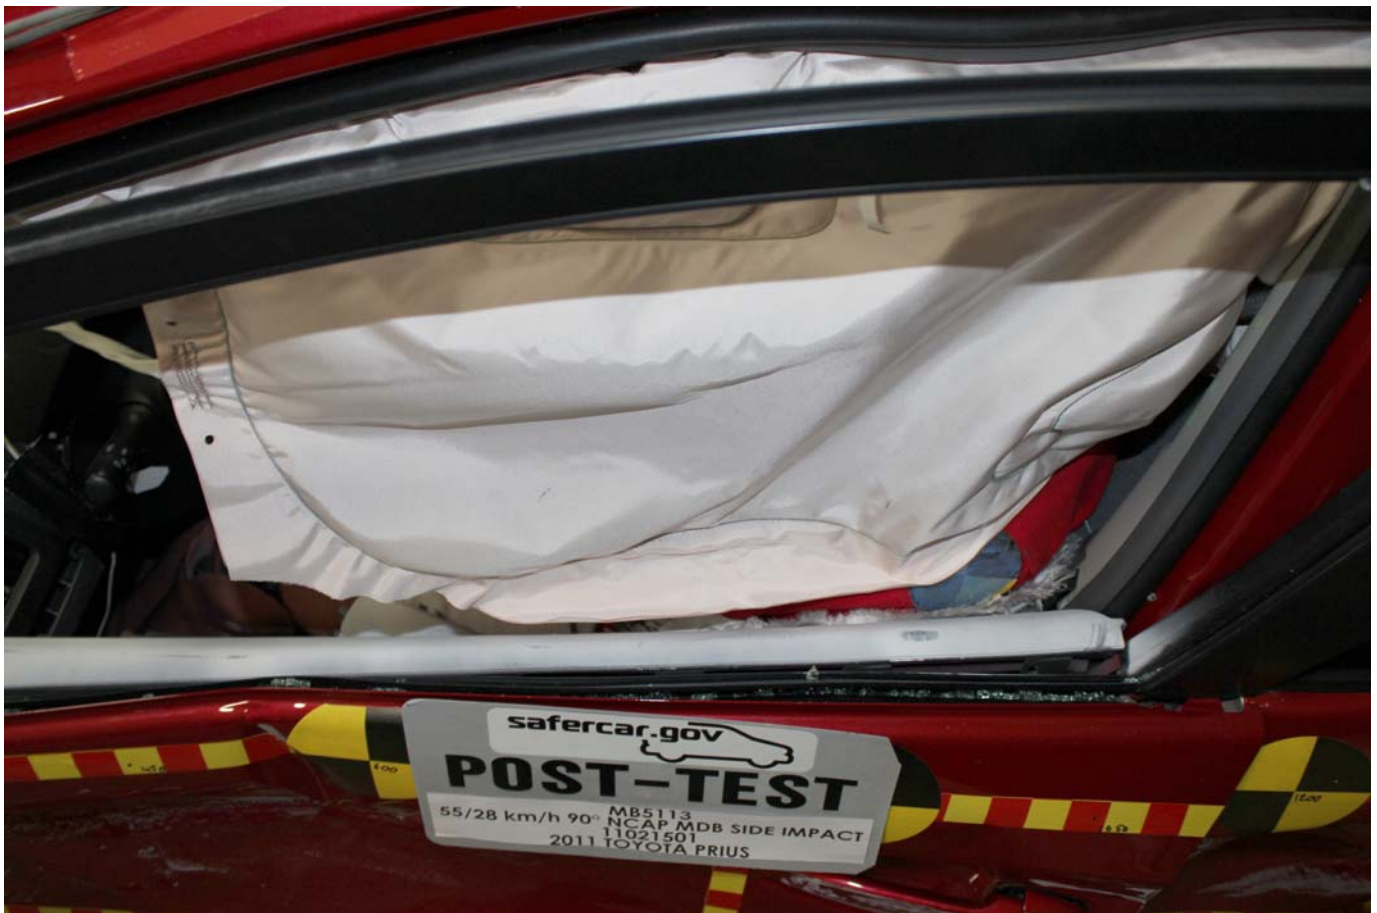
Post-Test Driver Dummy and Door Clearance View

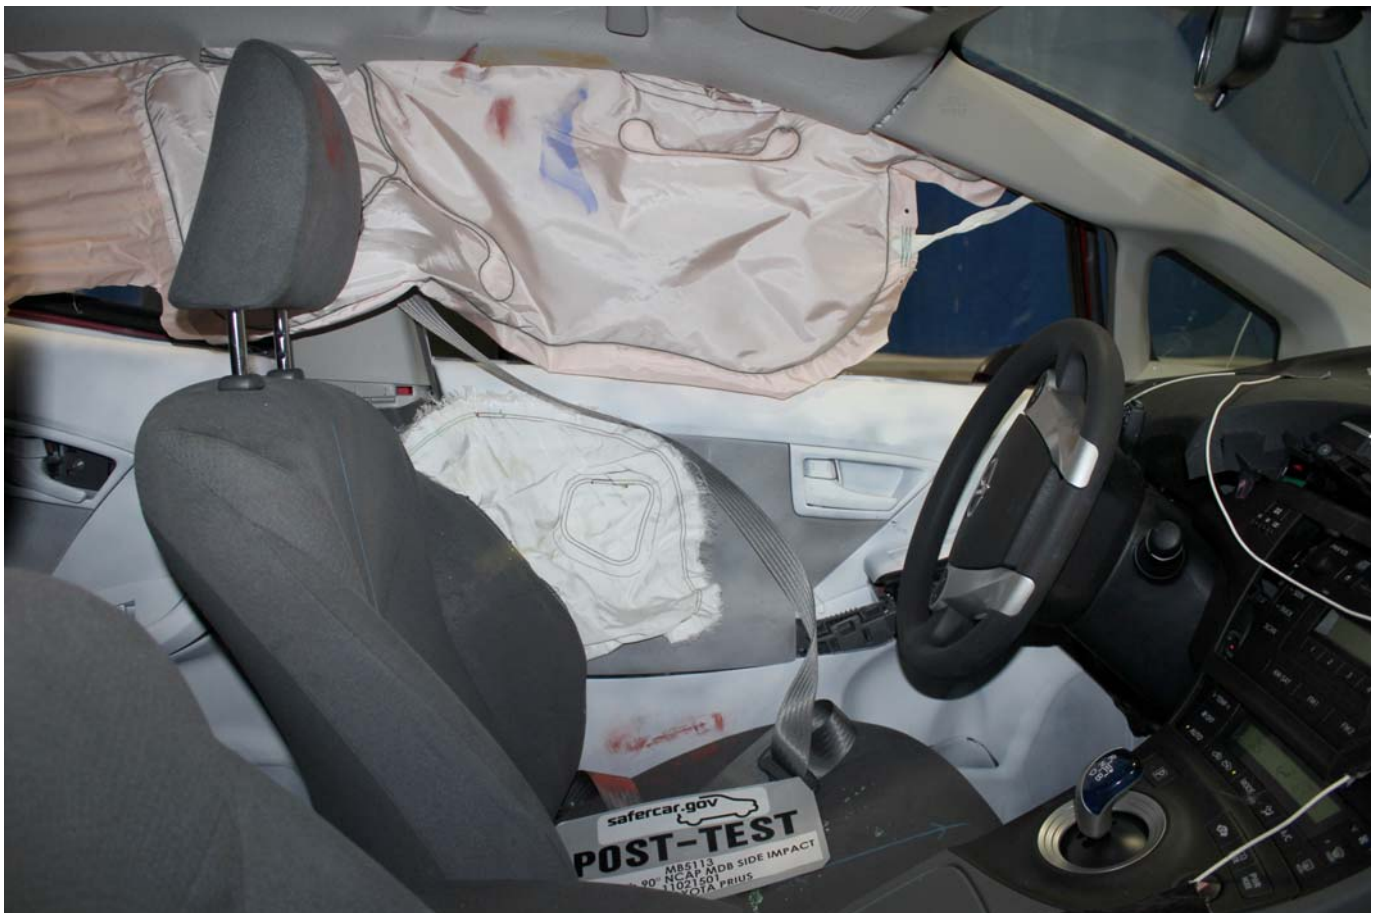
Post-Test Driver Inner Door Panel View Showing Driver Dummy Contact Locations

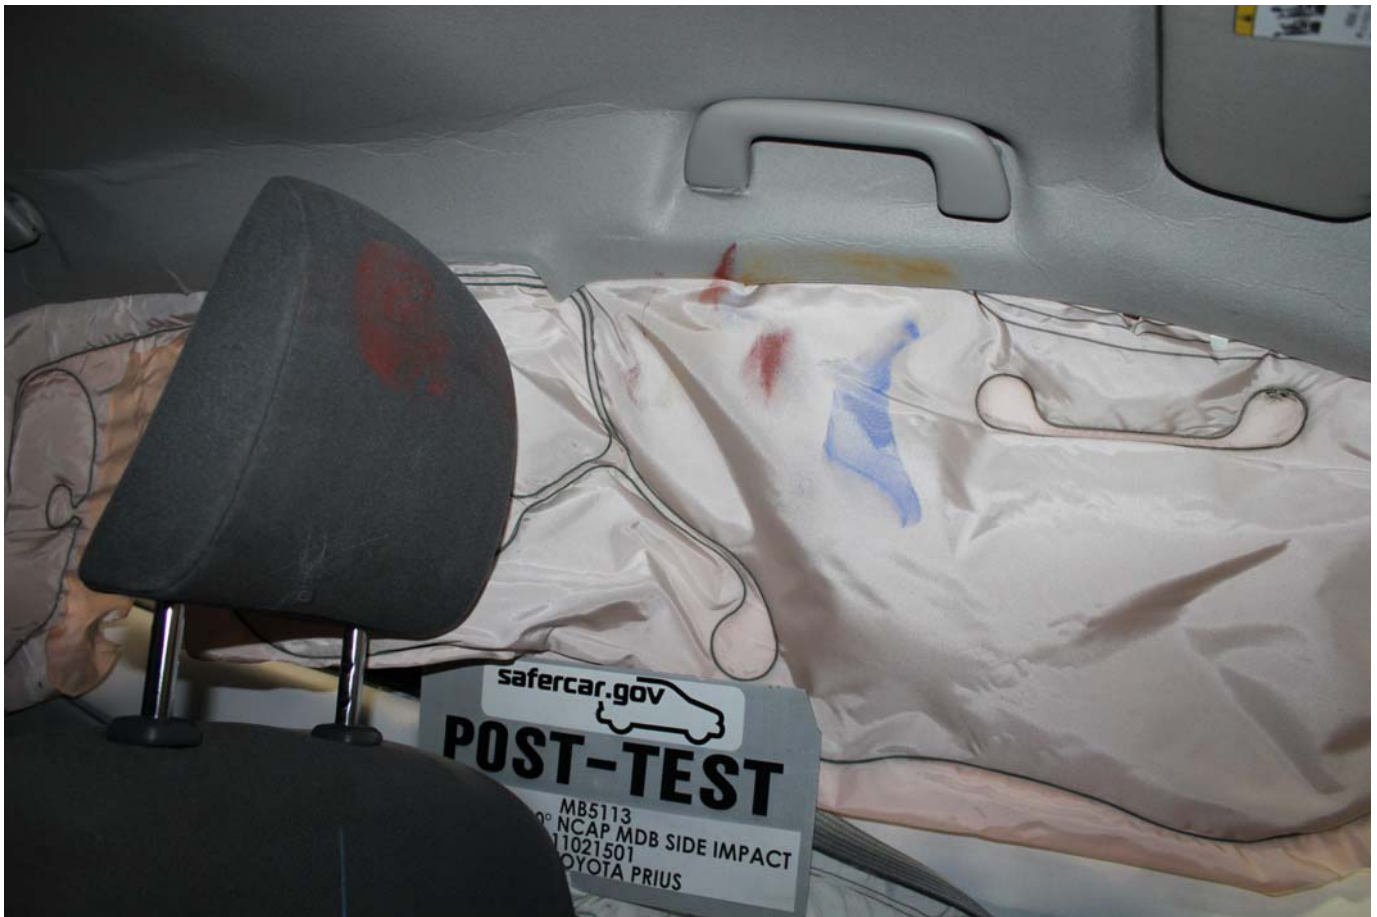
Post-Test Driver Dummy Close-up Head Contact with Vehicle Interior View

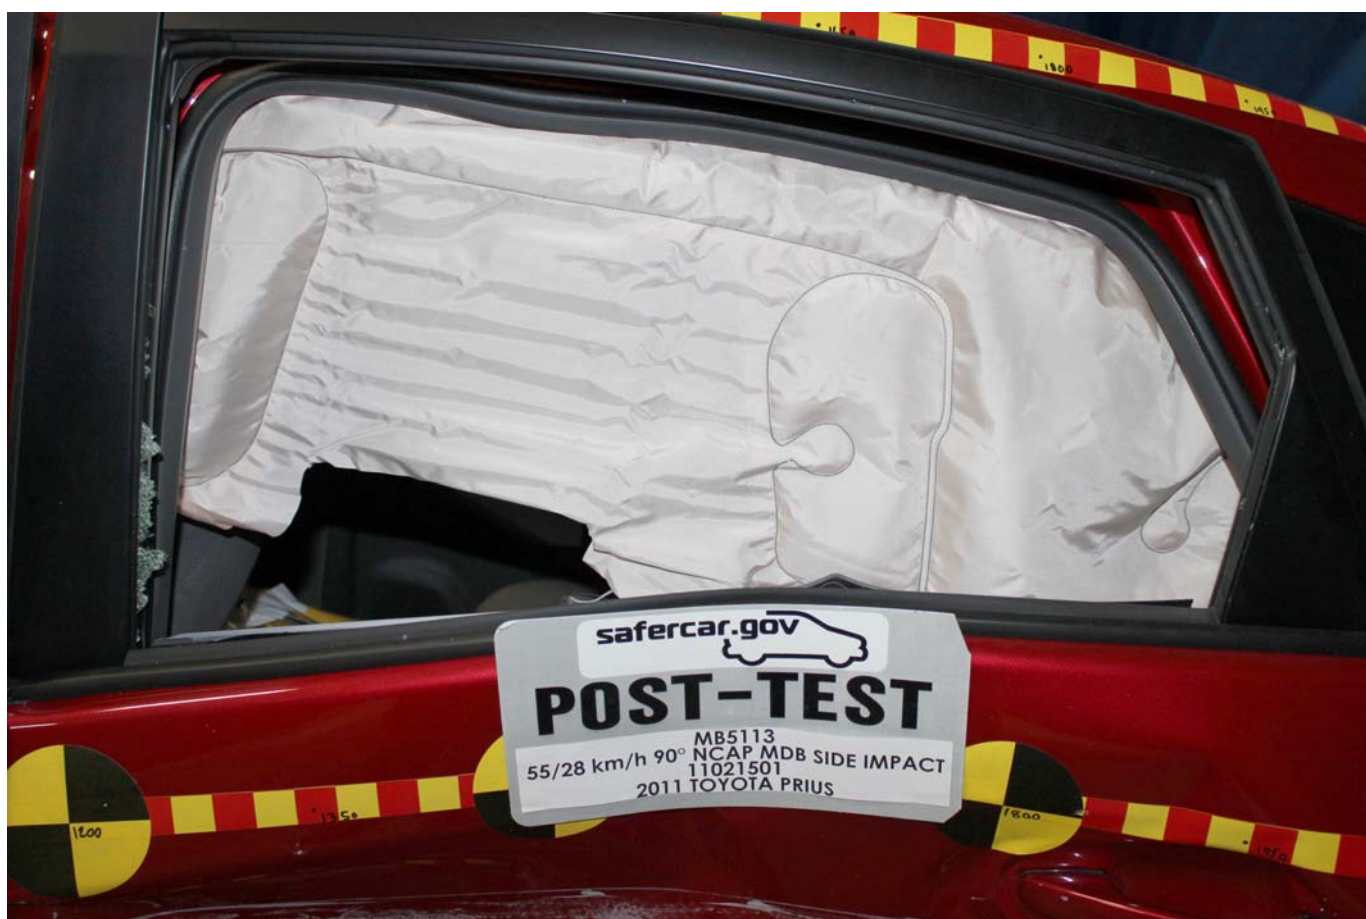
Post-Test Left Side View of Rear Passenger Dummy Shoulder and Door Top View

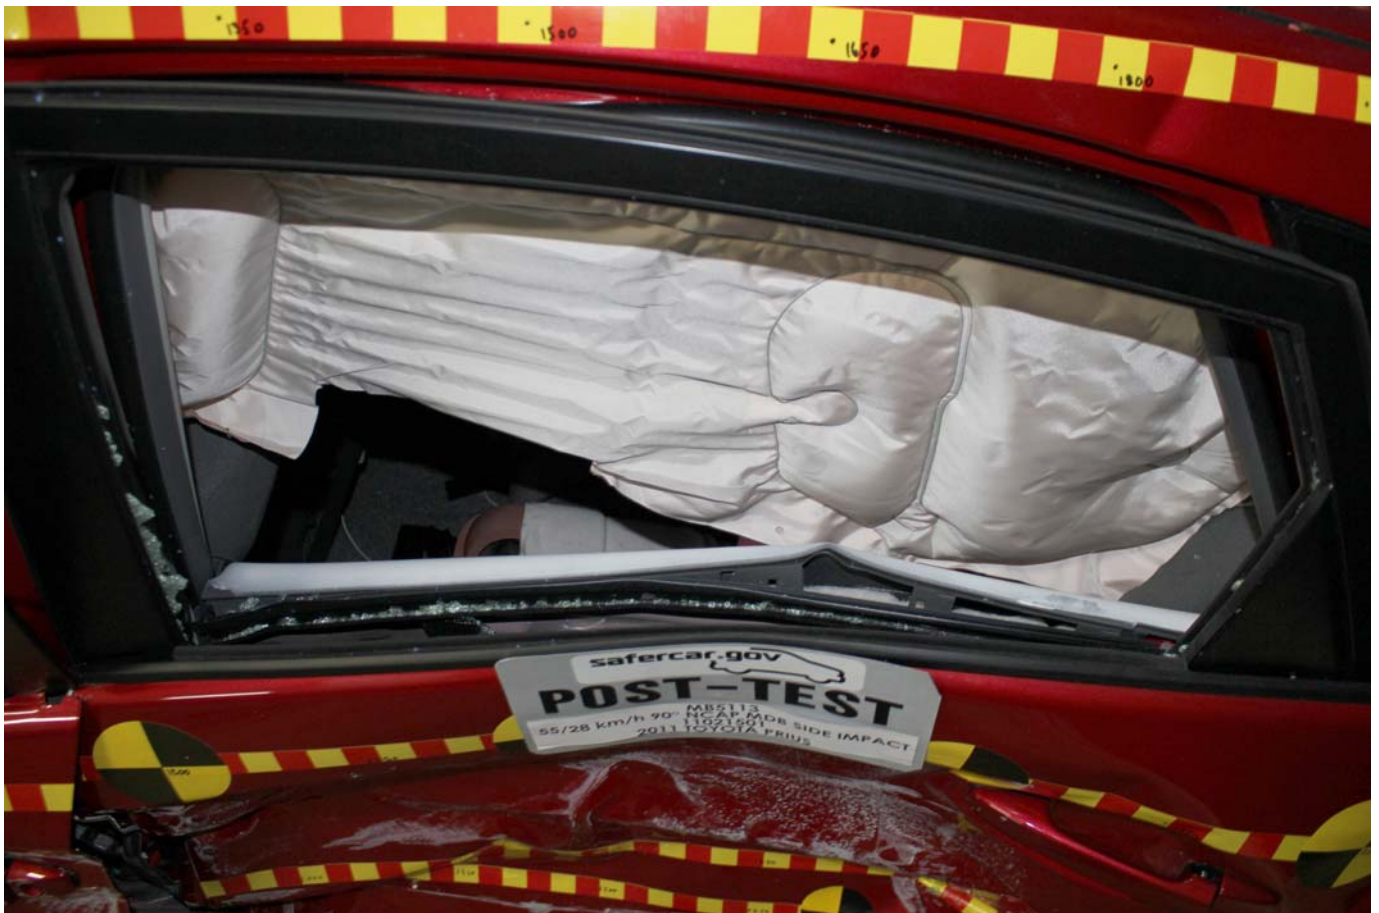
Post-Test Rear Passenger Dummy and Door Clearance View

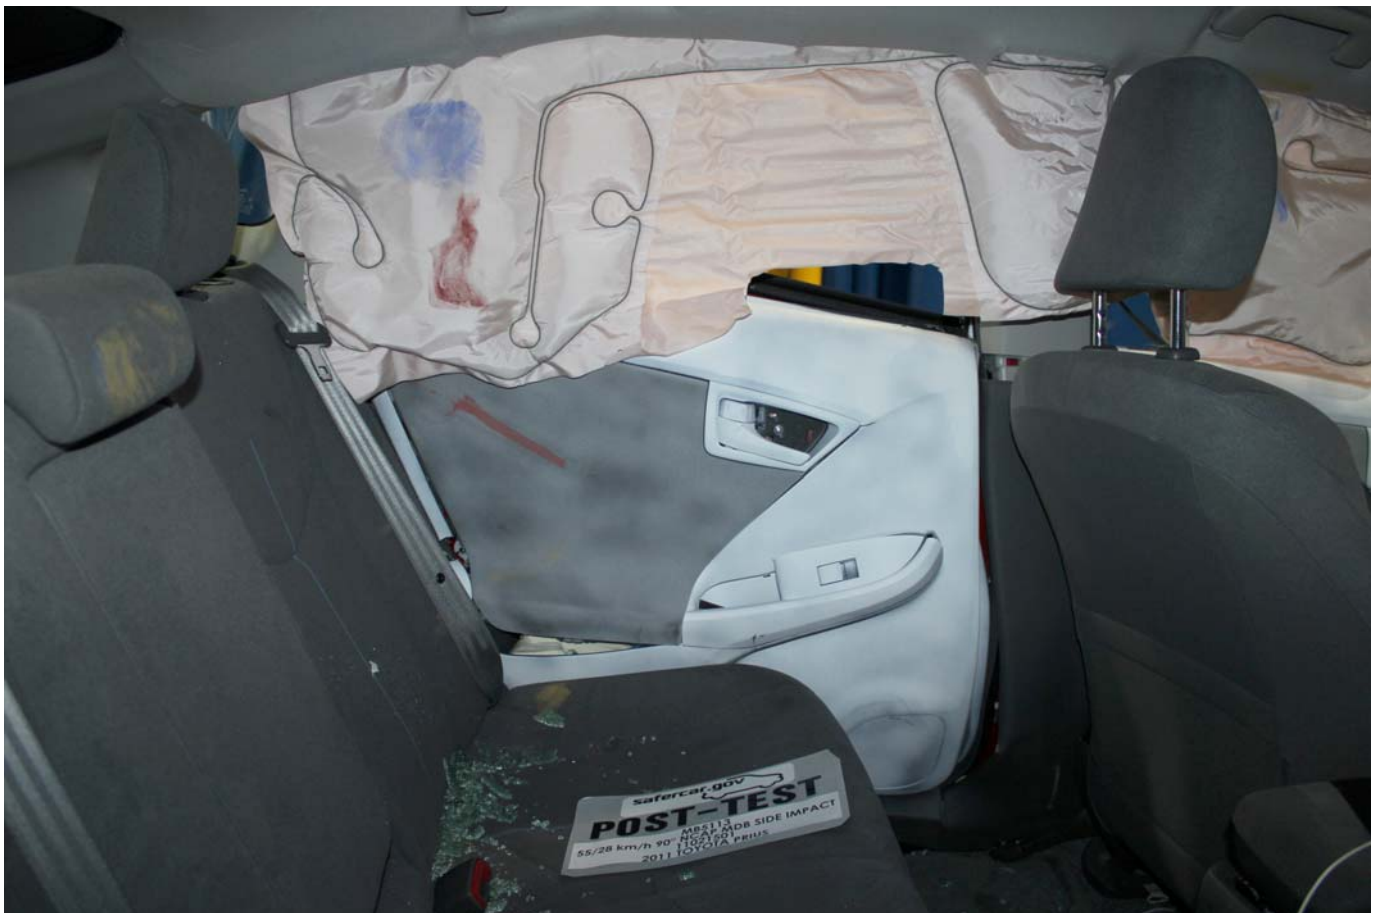
Post-Test Rear Passenger Inner Door Panel View Showing Dummy Contact Locations

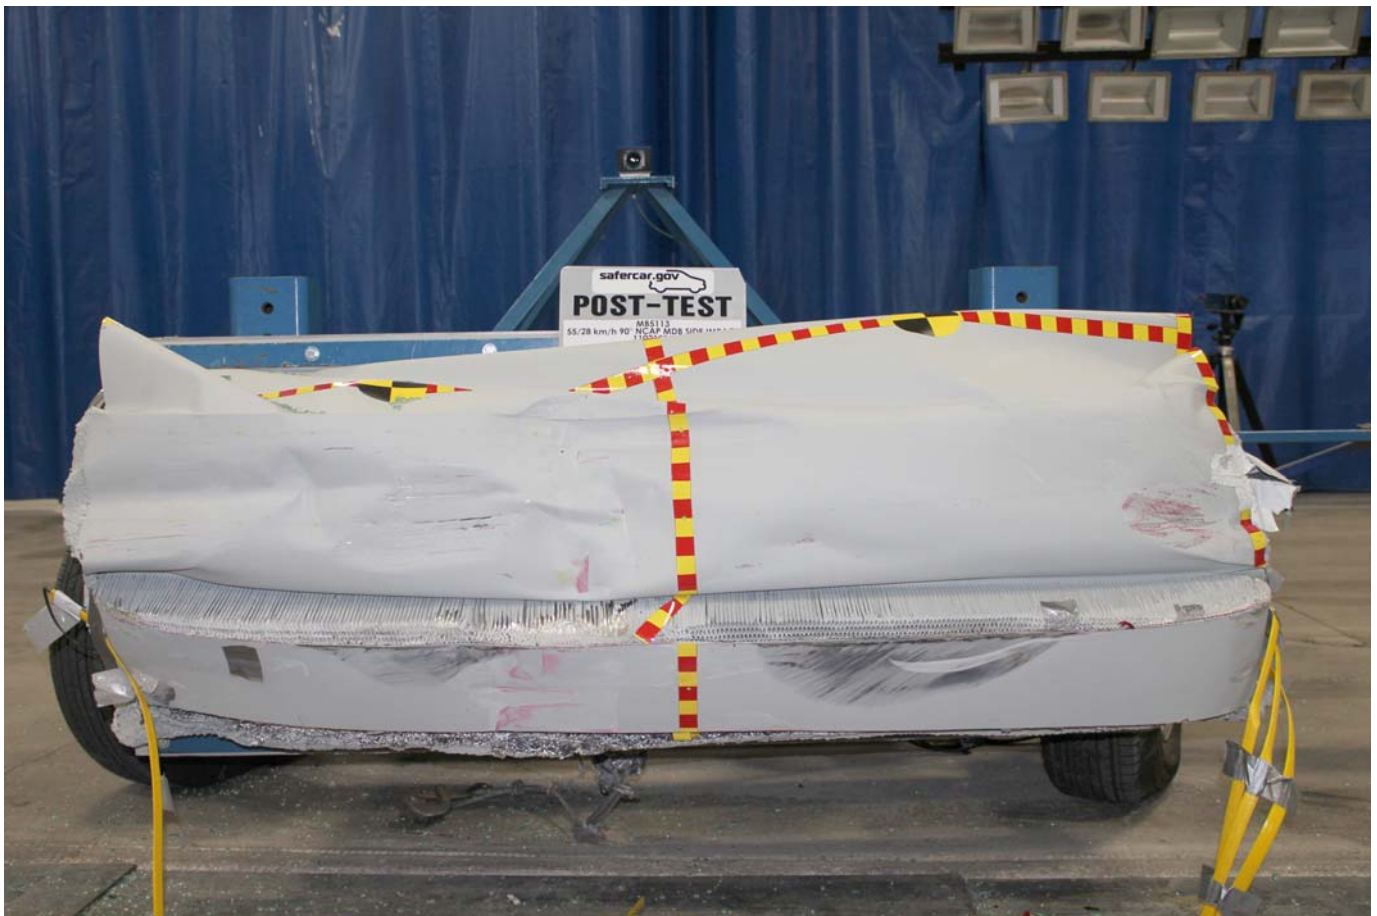
Post-Test Front View of MDB Impactor Face

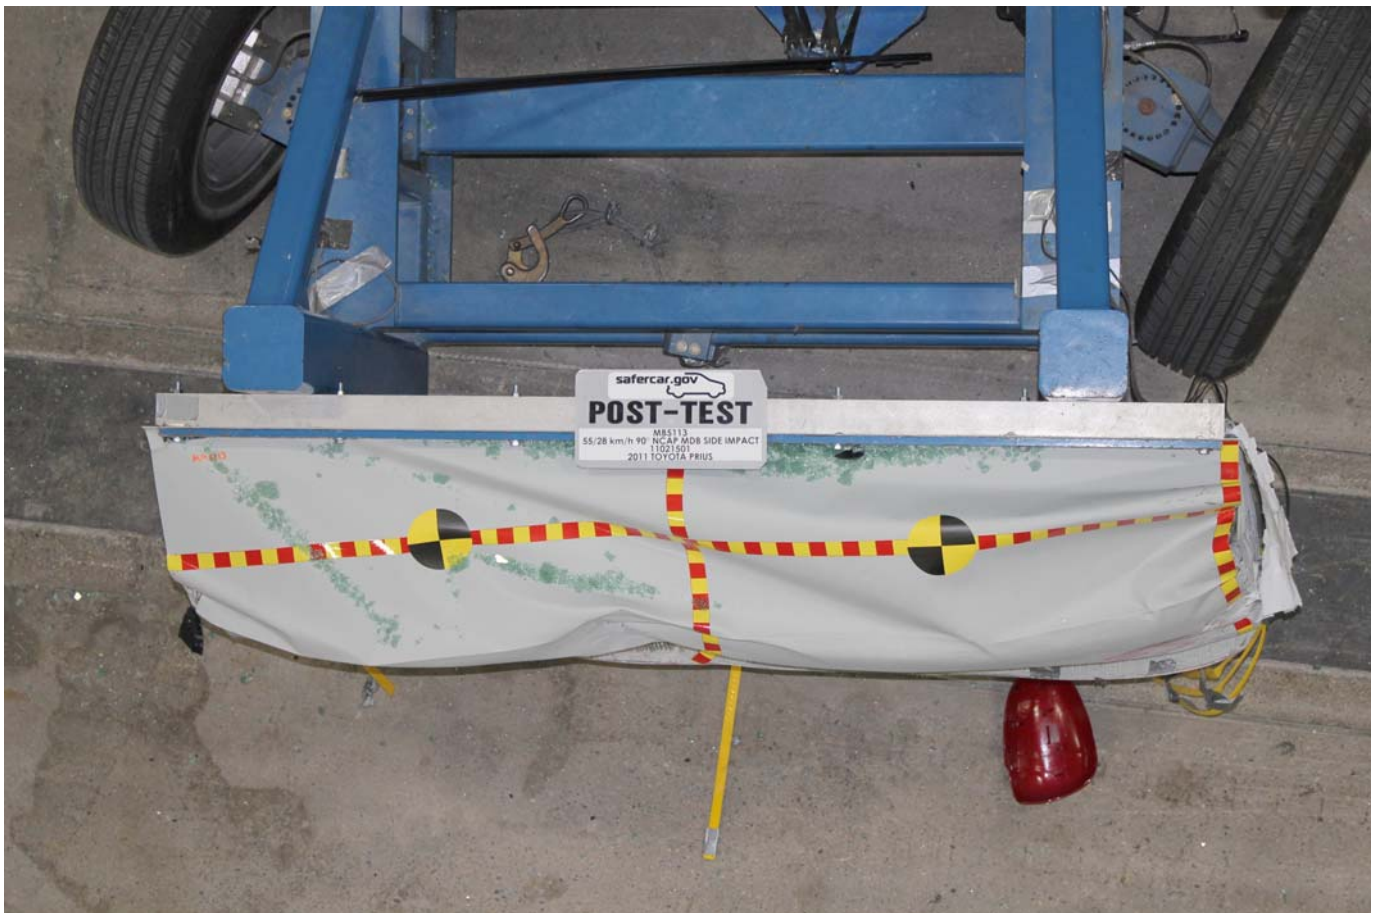
Post-Test Top View of MDB Impactor Face

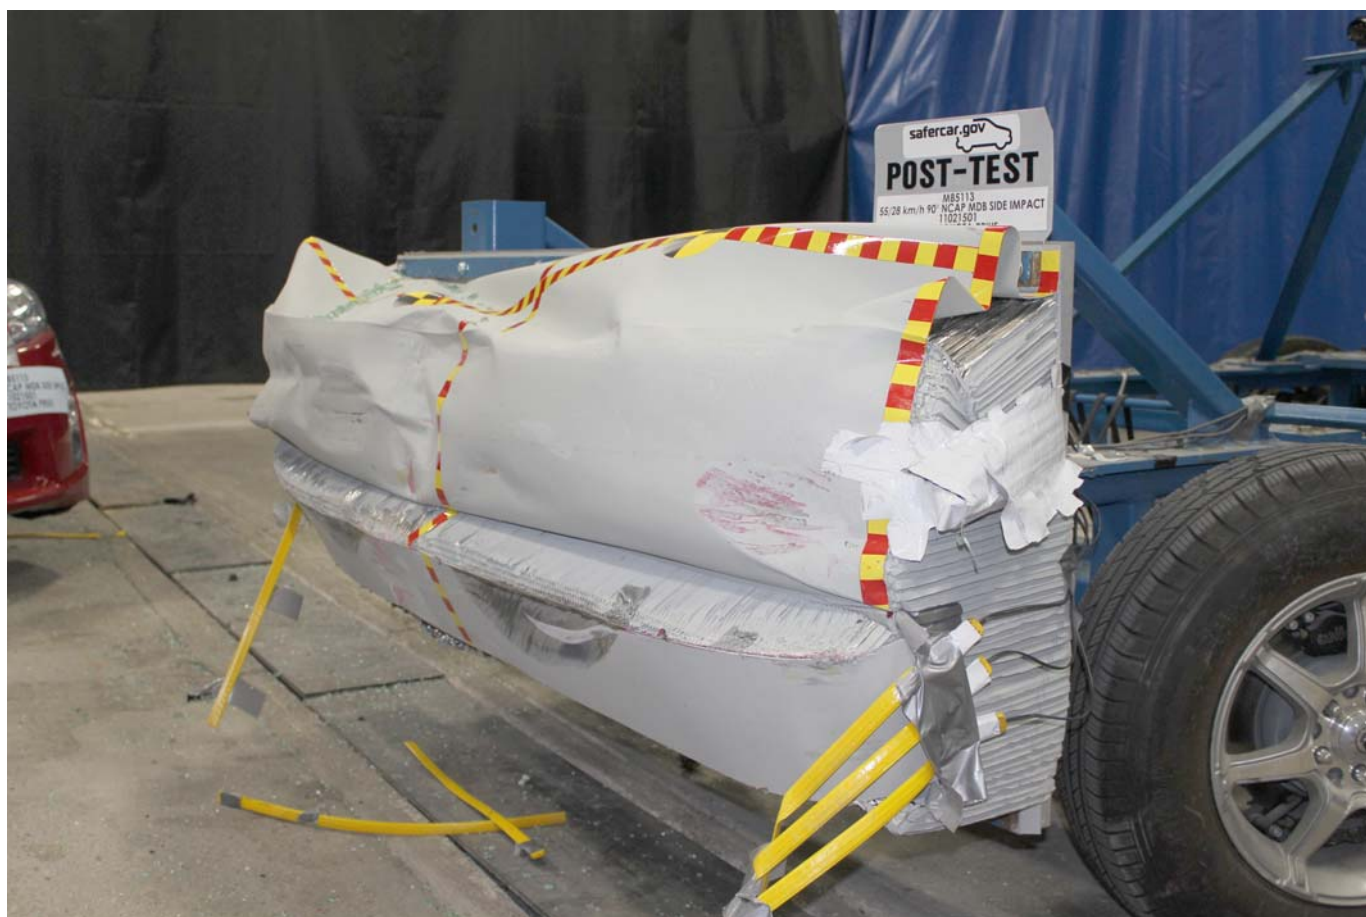
Post-Test Left Side View of MDB Impactor Face

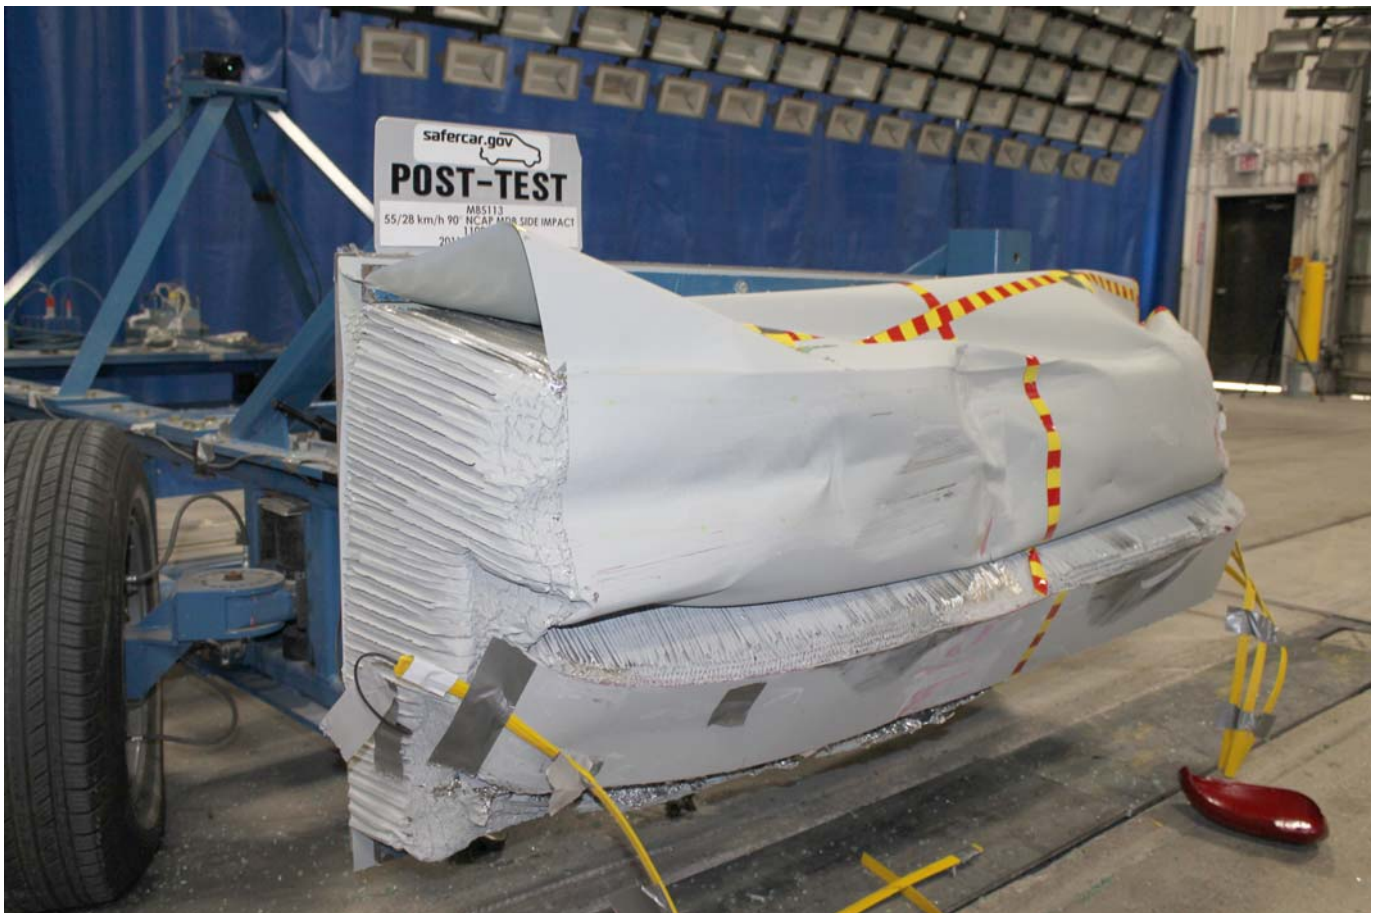
Post-Test Right Side View of MDB Impactor Face

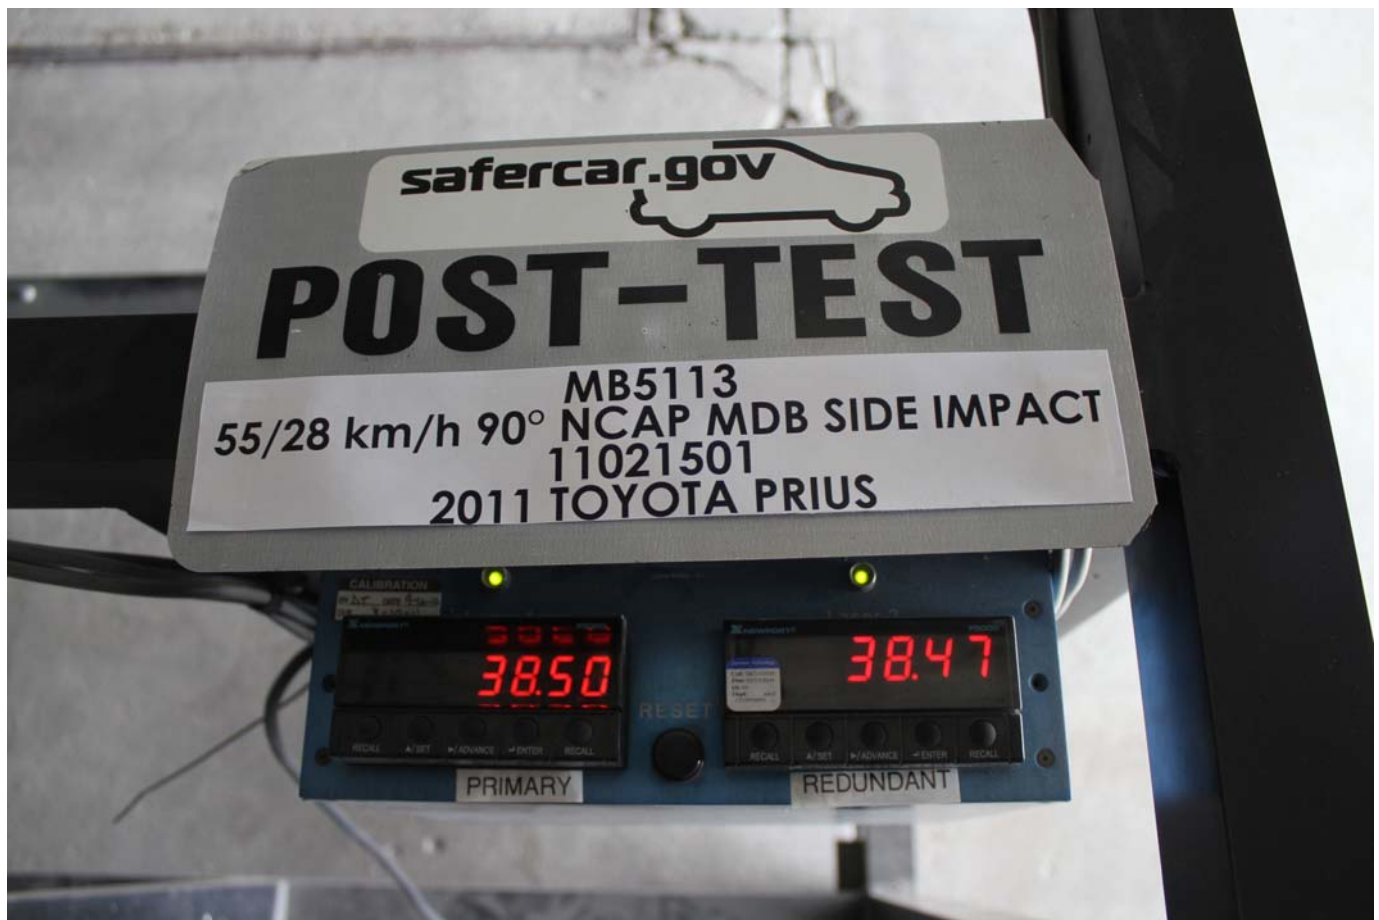
Post-Test Primary and Redundant Speed Trap Read-Out
