REPORT NUMBER: NCAP-CAL-11-034

**NEW CAR ASSESSMENT PROGRAM (NCAP)
FRONTAL BARRIER IMPACT TEST**

**Ford Motor Company
2011 Ford Ranger SuperCab
Extended Cab Pickup**

NHTSA NUMBER: MB0220

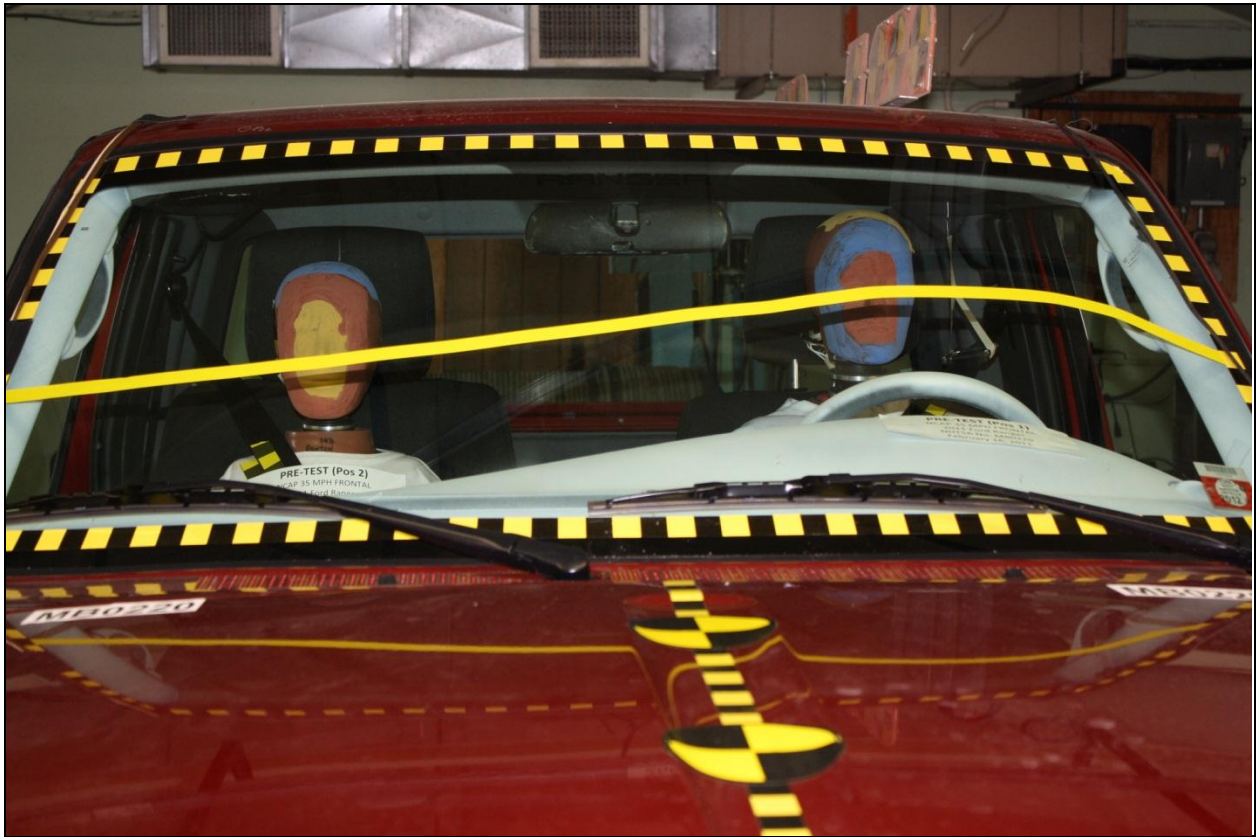
Figure A-17: Pre-Test Windshield View

There was 100 percent windshield retention and no intrusion into the protected zone of the windshield during the event. There was no Stoddard solvent leakage after the event or during any phase of the static rollover.

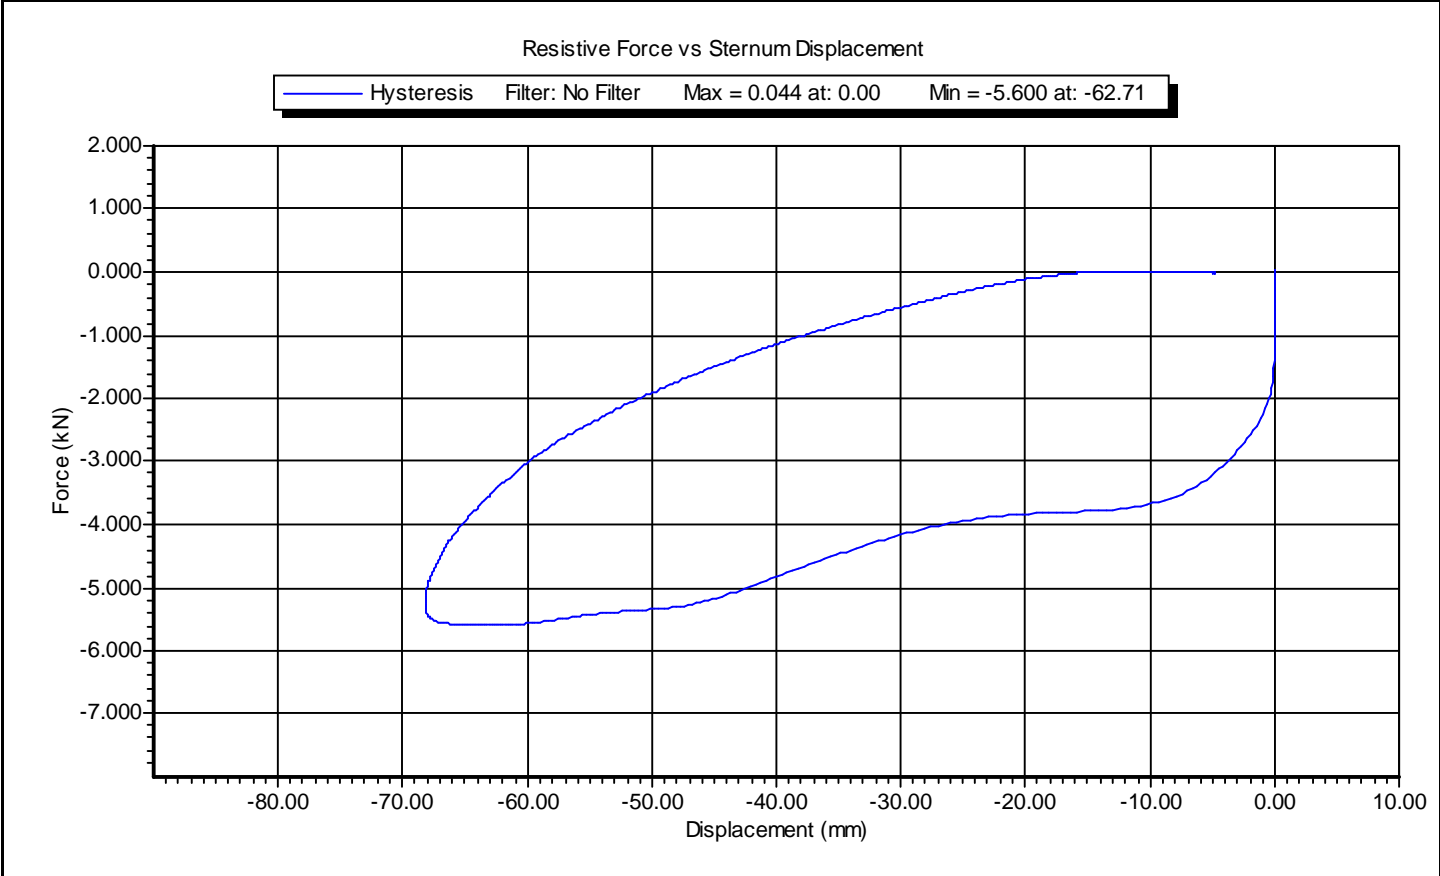
Test Parameters	Test Specifications	Test Results
Temperature	20.6 -- 22.2	22.1 deg C P
Humidity	10.0 -- 70.0	20.0 %RH P
Velocity	6.59 -- 6.83	6.71 m/s P
Resistive Force	-5.894 -- -5.160	-5.600 kN P
Sternum Displacement	-72.6 -- -63.5	-68.2 mm P
Hysteresis	69 -- 85	73 % P

Test Name:	Thorax Impact	Revision:	10/1/2001
Sub Test Name:		Spec Type:	NHTSA
ATD Type:	Hybrid III 50'th		
ATD Serial Number:	061		
Test ID:	Thorax	Test Date:	1/20/2011
Test Number:	1	Test Time:	3:05:11 PM
