REPORT NUMBER: NCAP-KAR-11-059

**NEW CAR ASSESSMENT PROGRAM (NCAP)
FRONTAL BARRIER IMPACT TEST**

**FORD MOTOR CO.
2011 FORD F-150 XLT 4X4 SUPERCREW 4-DOOR TRUCK**

FINAL REPORT

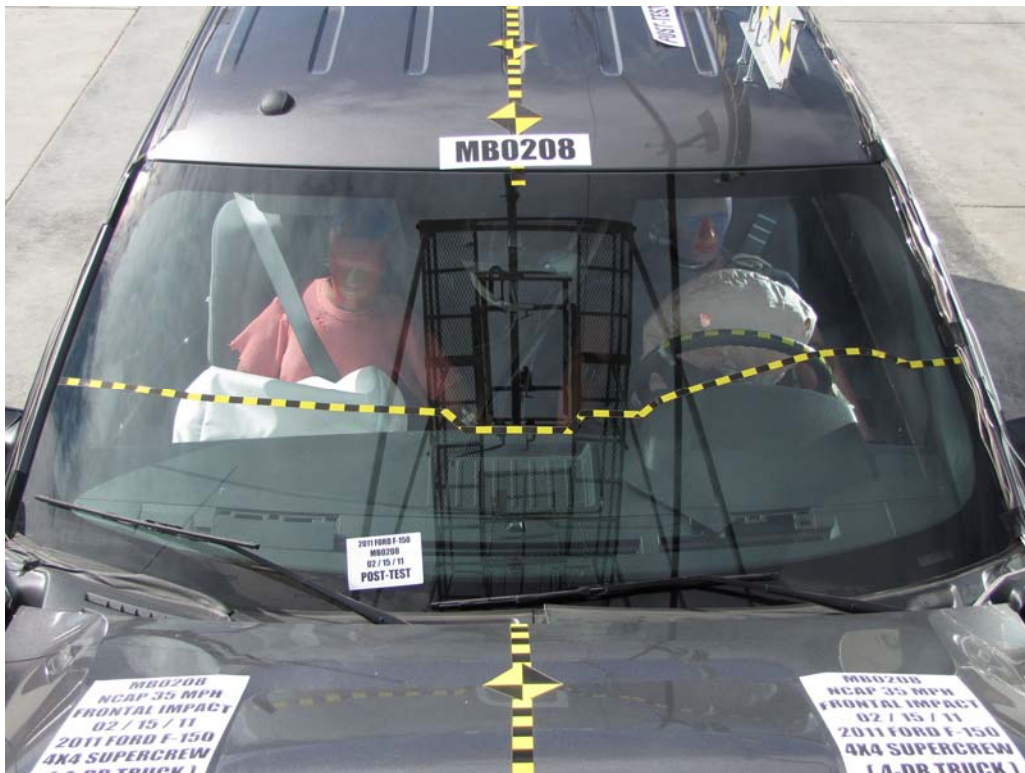
FIGURE 18. Post-Test Windshield View

There was 100.0% windshield retention and no intrusion into the protected zone of the windshield during the event. There was no Stoddard solvent leakage after the event or during any phase of the static rollover.

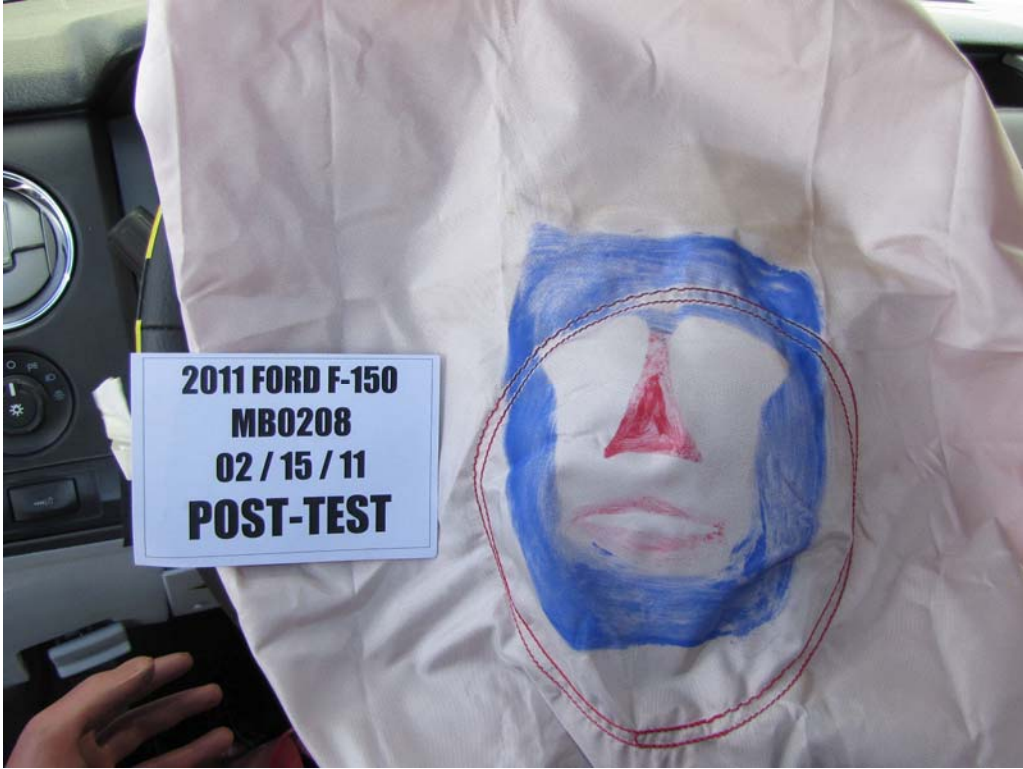
FIGURE 43a. Post-Test Driver Dummy Contact With Head Restraint

The driver's visible contact points were as follows: The driver ATD's head contacted the airbag and the head restraint. The upper torso contacted the airbag. The left knee contacted the knee bolster. The right knee contacted the knee bolster and the steering column.

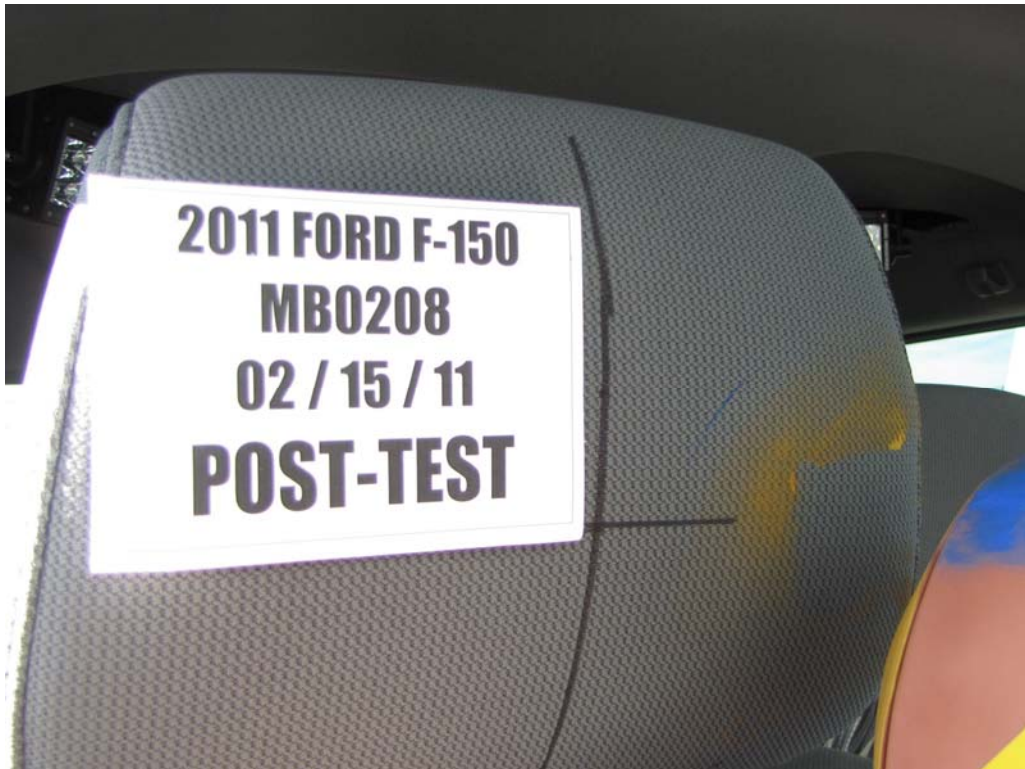
FIGURE 60a. Post-Test Passenger Dummy Contact With Head Restraint

The passenger's visible contact points were as follows: The passenger ATD's head contacted the airbag and the head restraint. The upper torso contacted the airbag. Both the left and right knees contacted the glovebox.

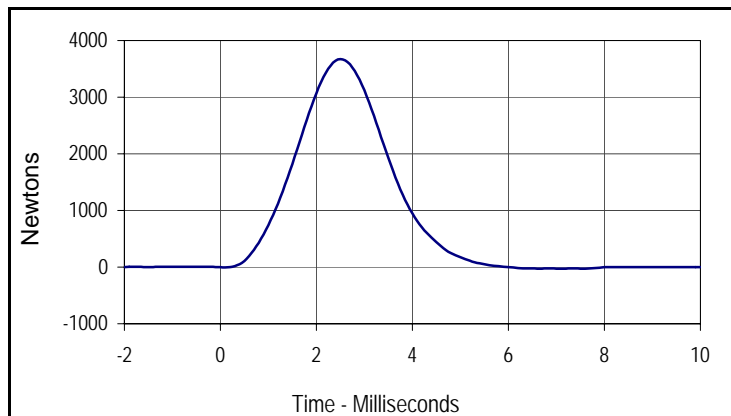
| Curve Description | | | |
|---|---|---|---|
| Max | Time | Min | Time |
| 3734.8 | 2.3 | -36.2 | 7.9 |

| Curve Description | | | |
| Right Knee Probe Force | | | |
