**REPORT NUMBER: NCAP-MGA-2011-071**

**NEW CAR ASSESSMENT PROGRAM (NCAP)  
Frontal Barrier Impact Test**

**TOYOTA MOTOR CORPORATION  
2011 Scion tC 3-Dr Liftback  
NHTSA No.: YB5103**

**MGA RESEARCH CORPORATION  
5000 Warren Road  
Burlington, WI 53105**

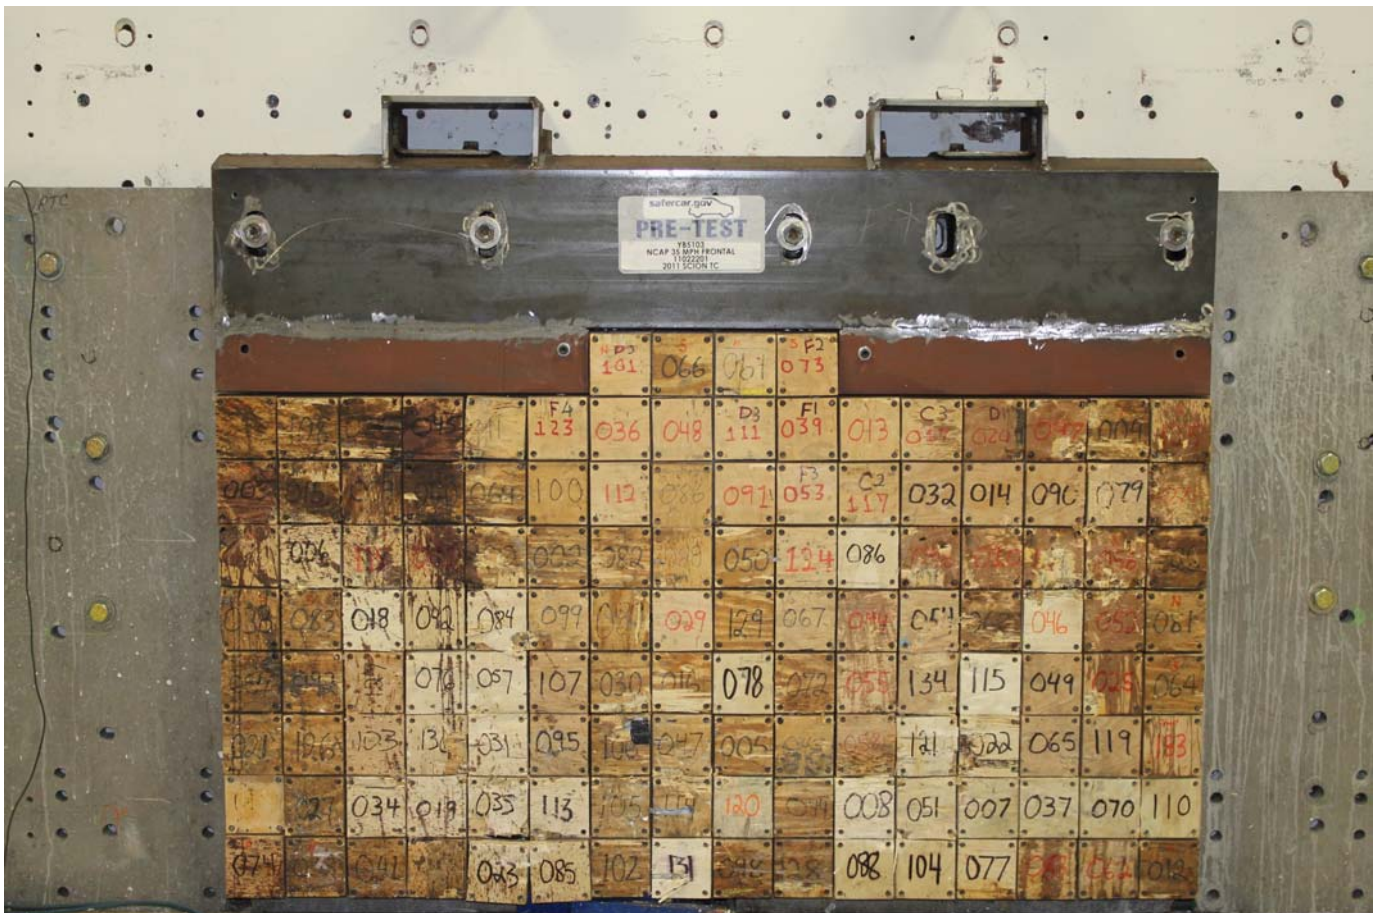
Load Cell Wall

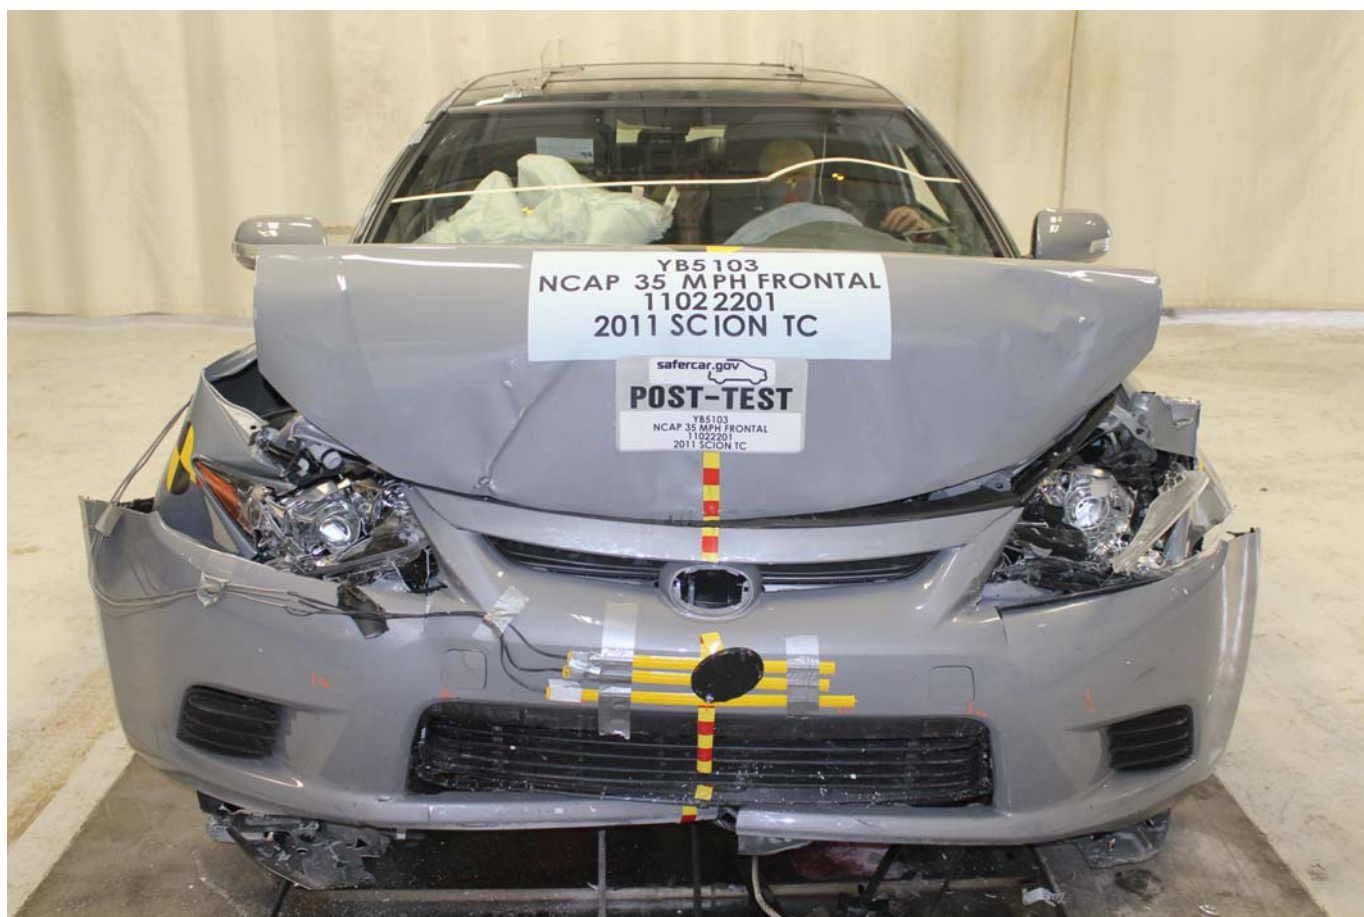
Post-Test Front View

The maximum static crush of the vehicle was 364 mm and both the driver and passenger side doors remained closed during the impact event and were operable after the impact.

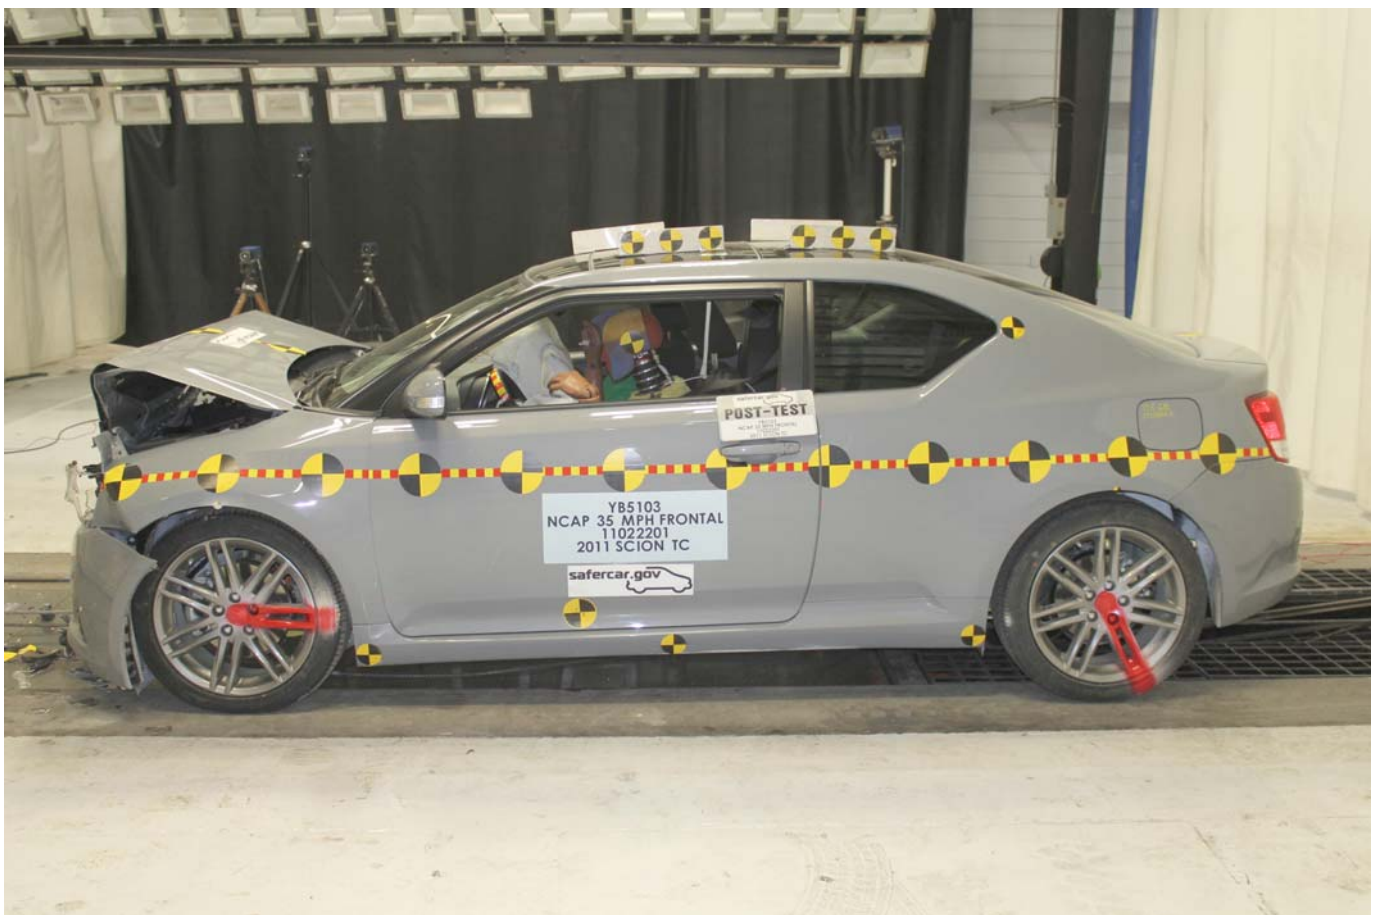
Post-Test Left Side View

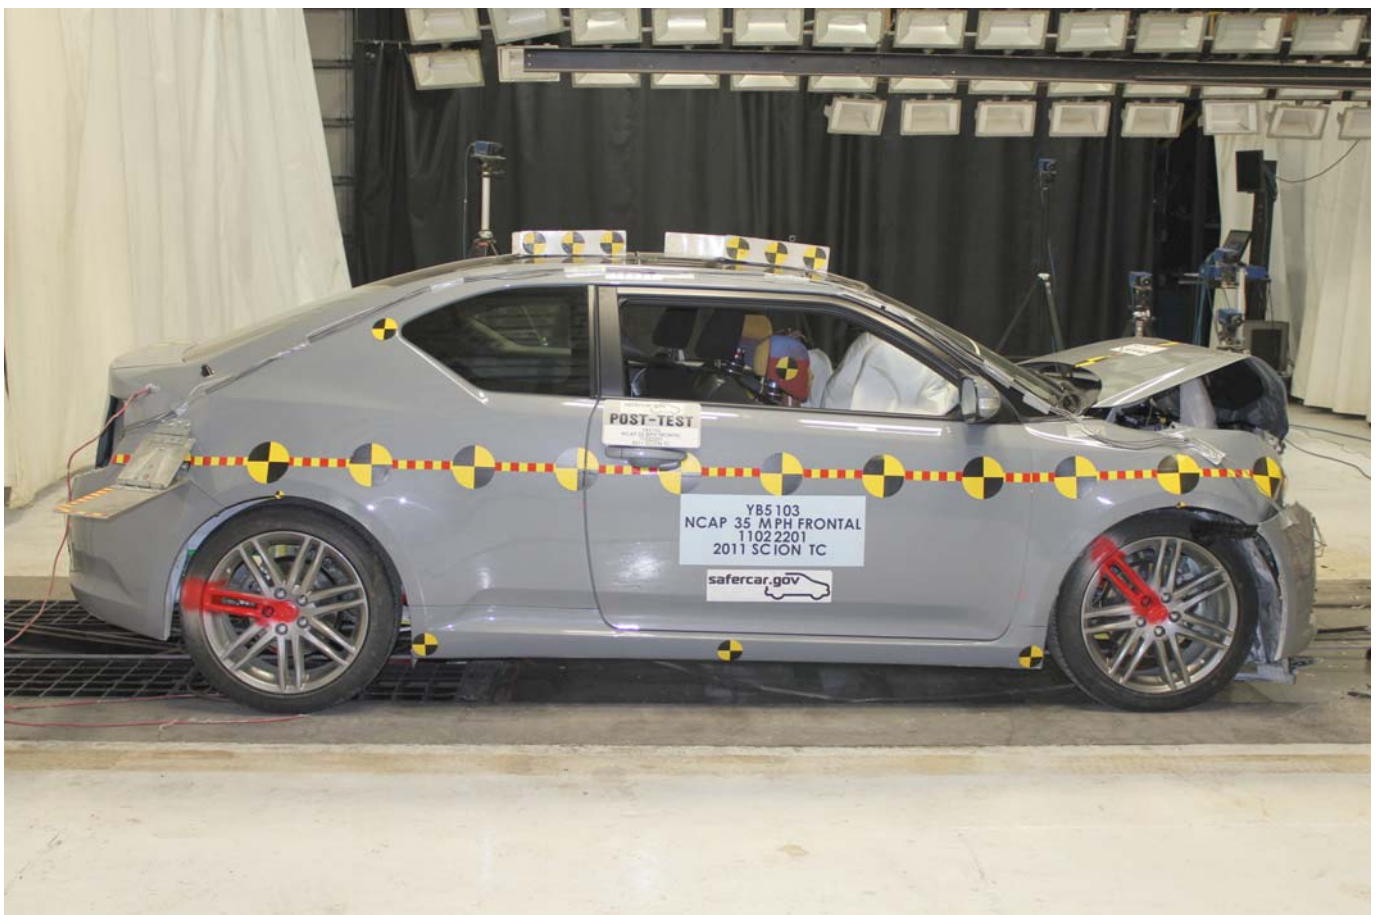
Post-Test Right Side View

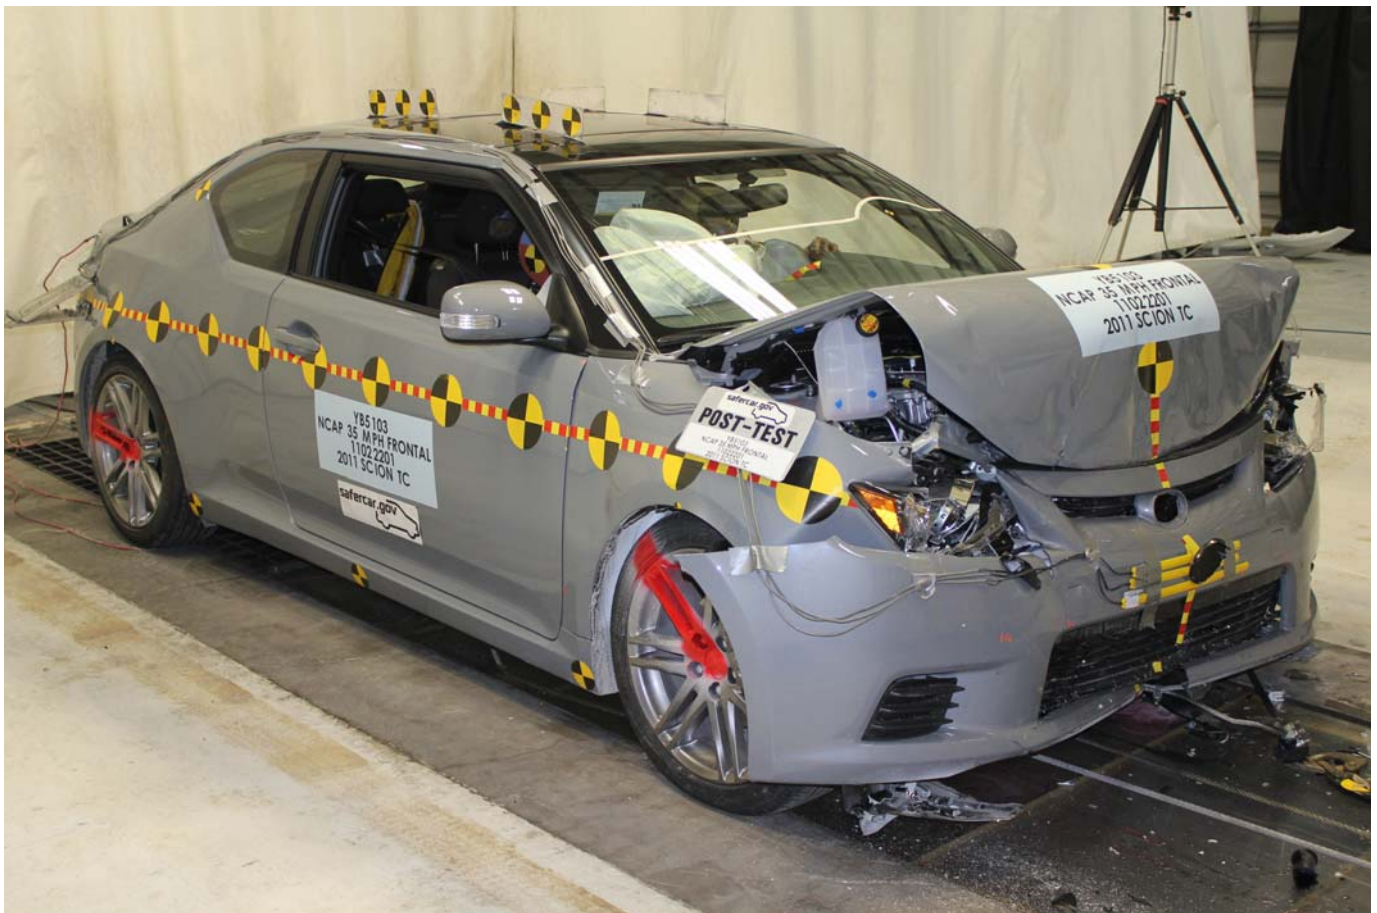
Post-Test Right Front Three-Quarter View

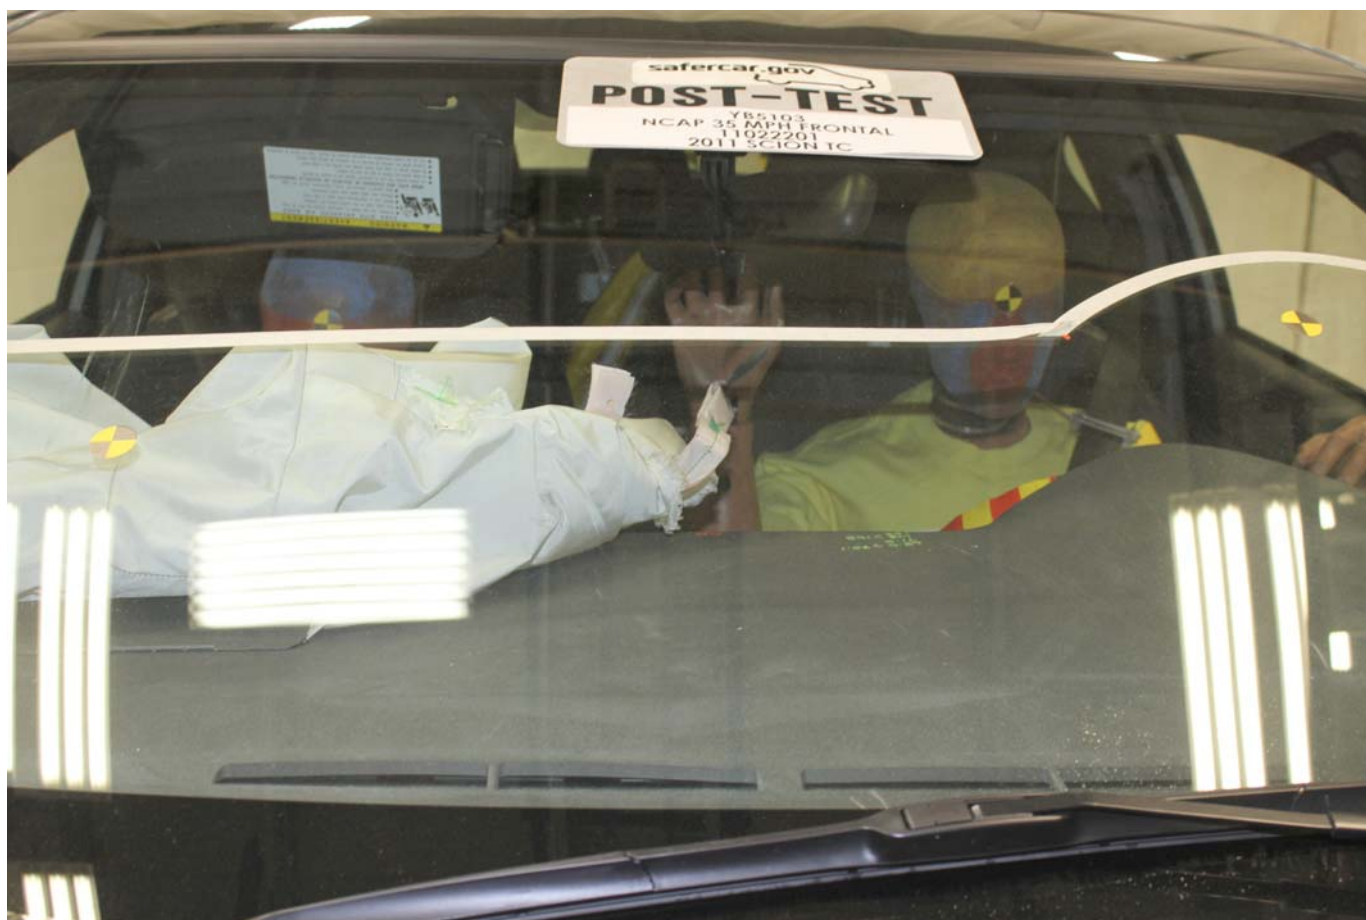
Post-Test Windshield View

There was 100 percent windshield retention and no intrusion into the protected zone of the windshield during the event. There was no Stoddard Solvent leakage after the event or during any phase of the static rollover.

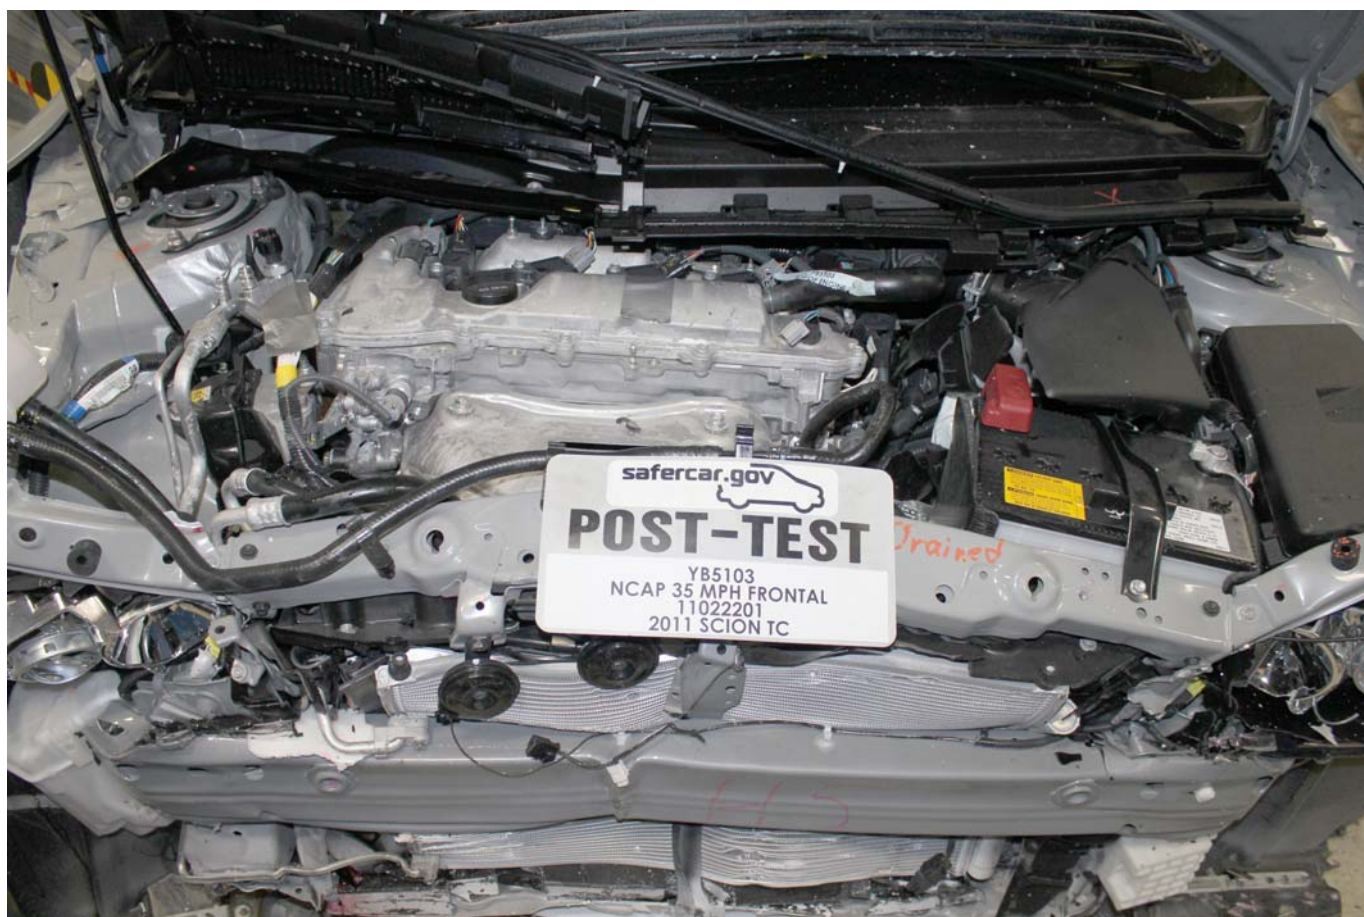
Post-Test Engine Compartment View

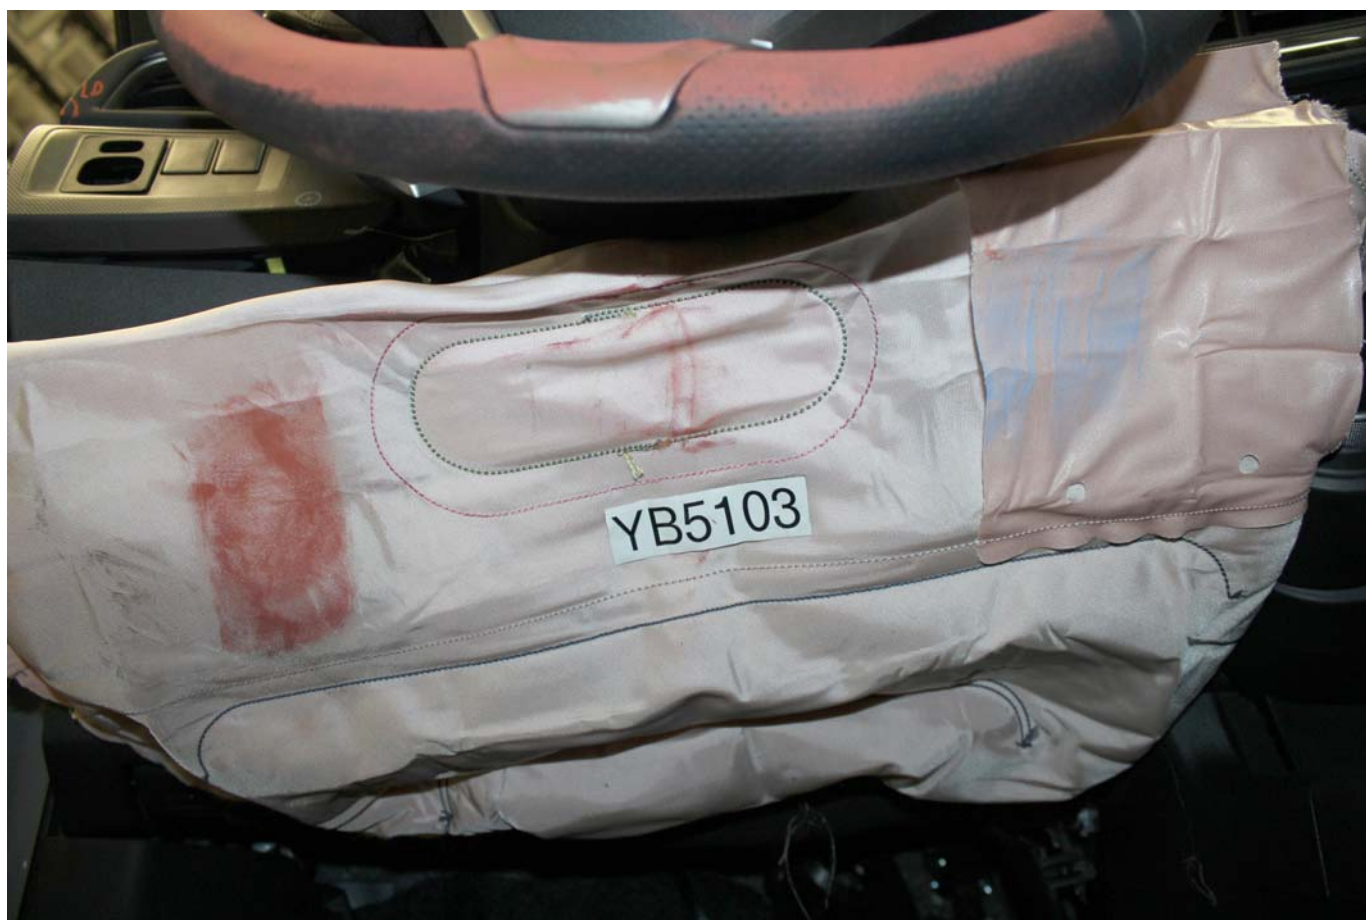
Post-Test Driver Dummy Contact with Knee Airbag

The driver's head and chest contacted the airbag. The driver's head also contacted the headrest. The driver's knees contacted the knee airbag. The passenger's head and chest contacted the airbag. The passenger's head also contacted the headrest. The passenger's knees contacted the knee airbag.

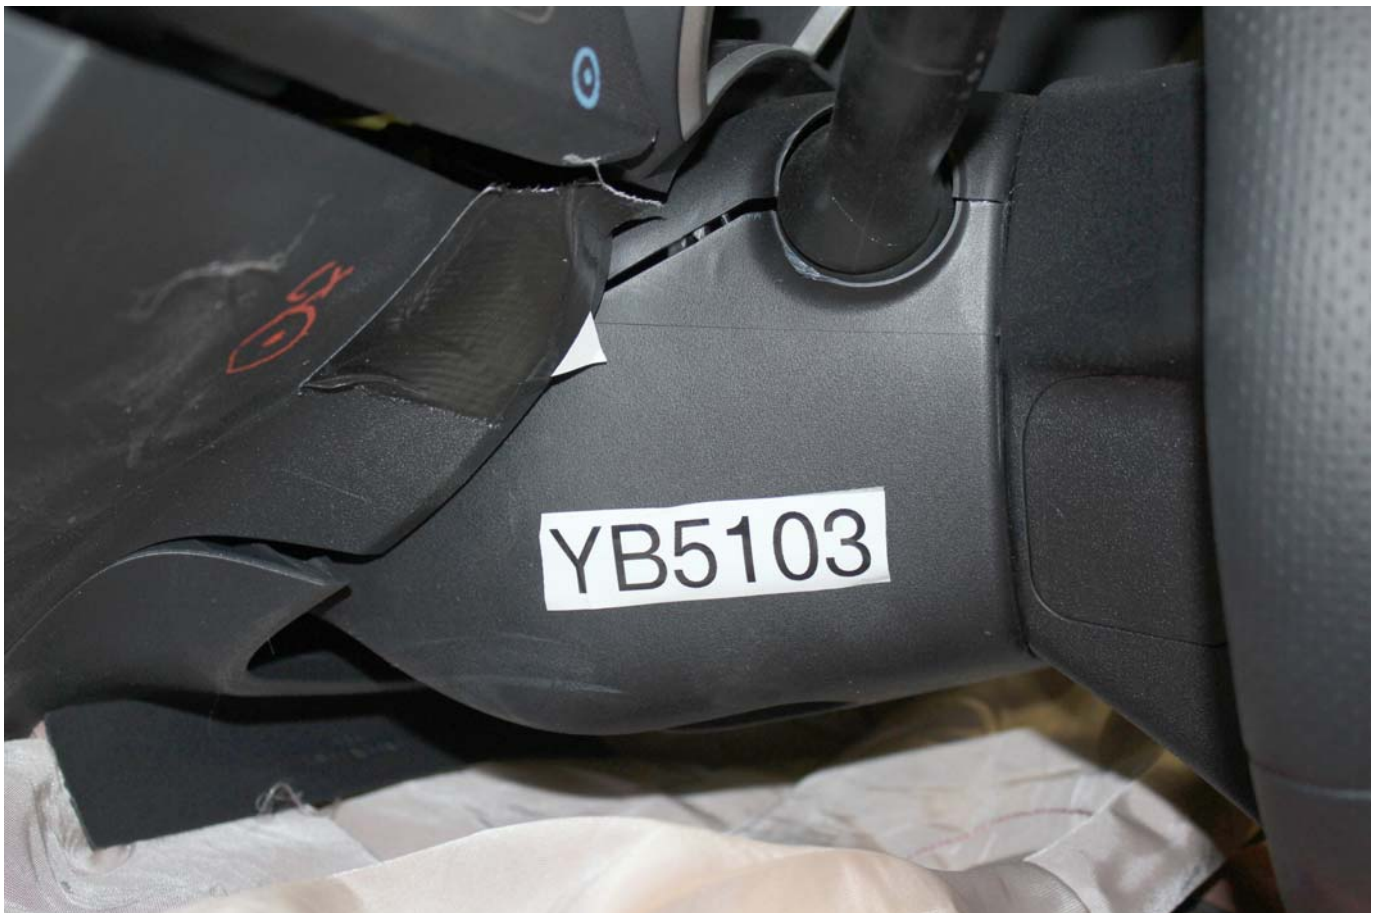
Post-Test View of Steering Column Shear Capsule

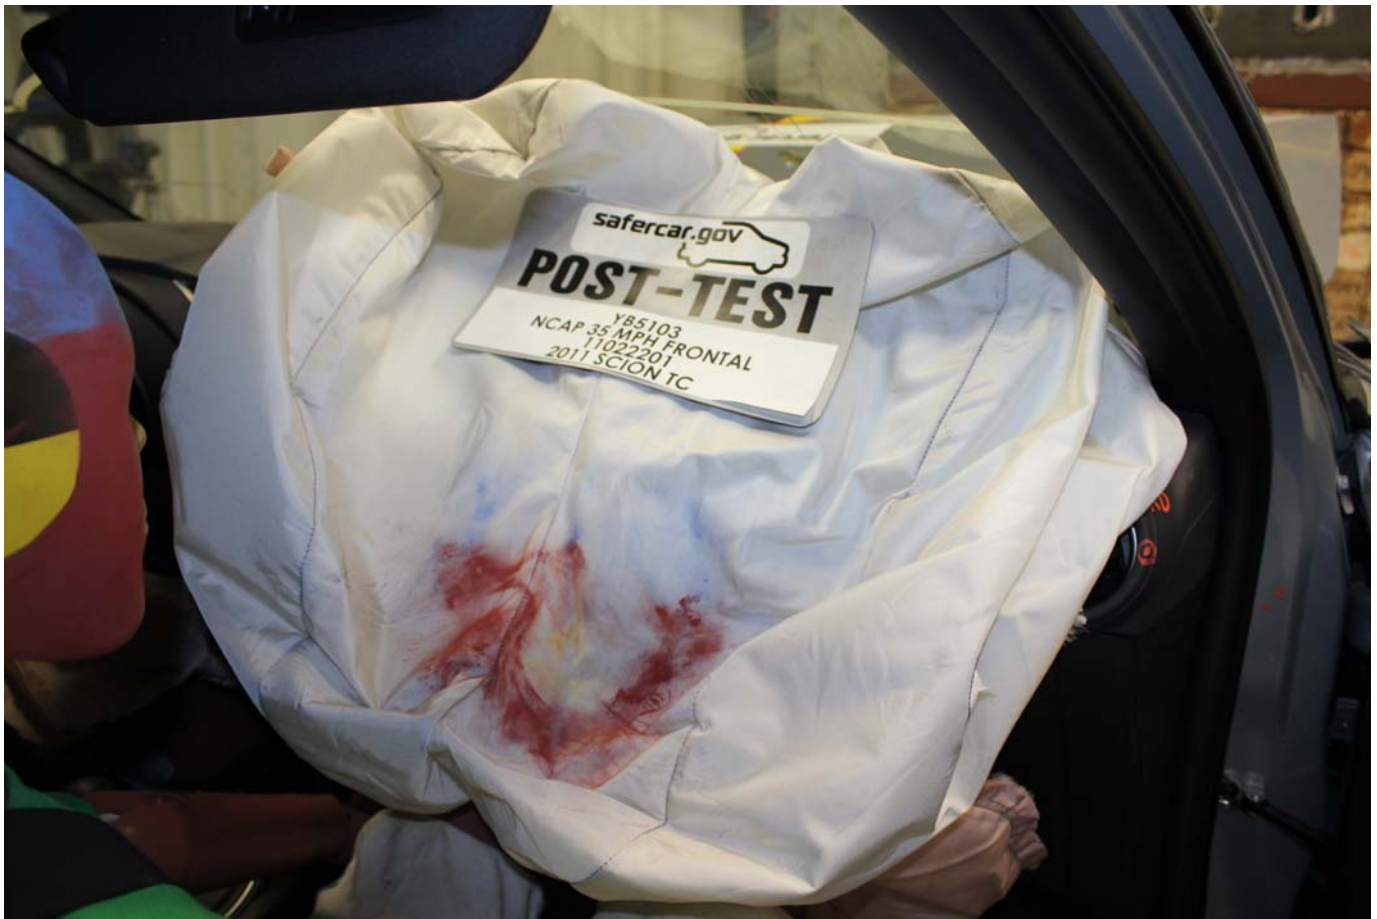
Post-Test Passenger Dummy Contact with Airbag

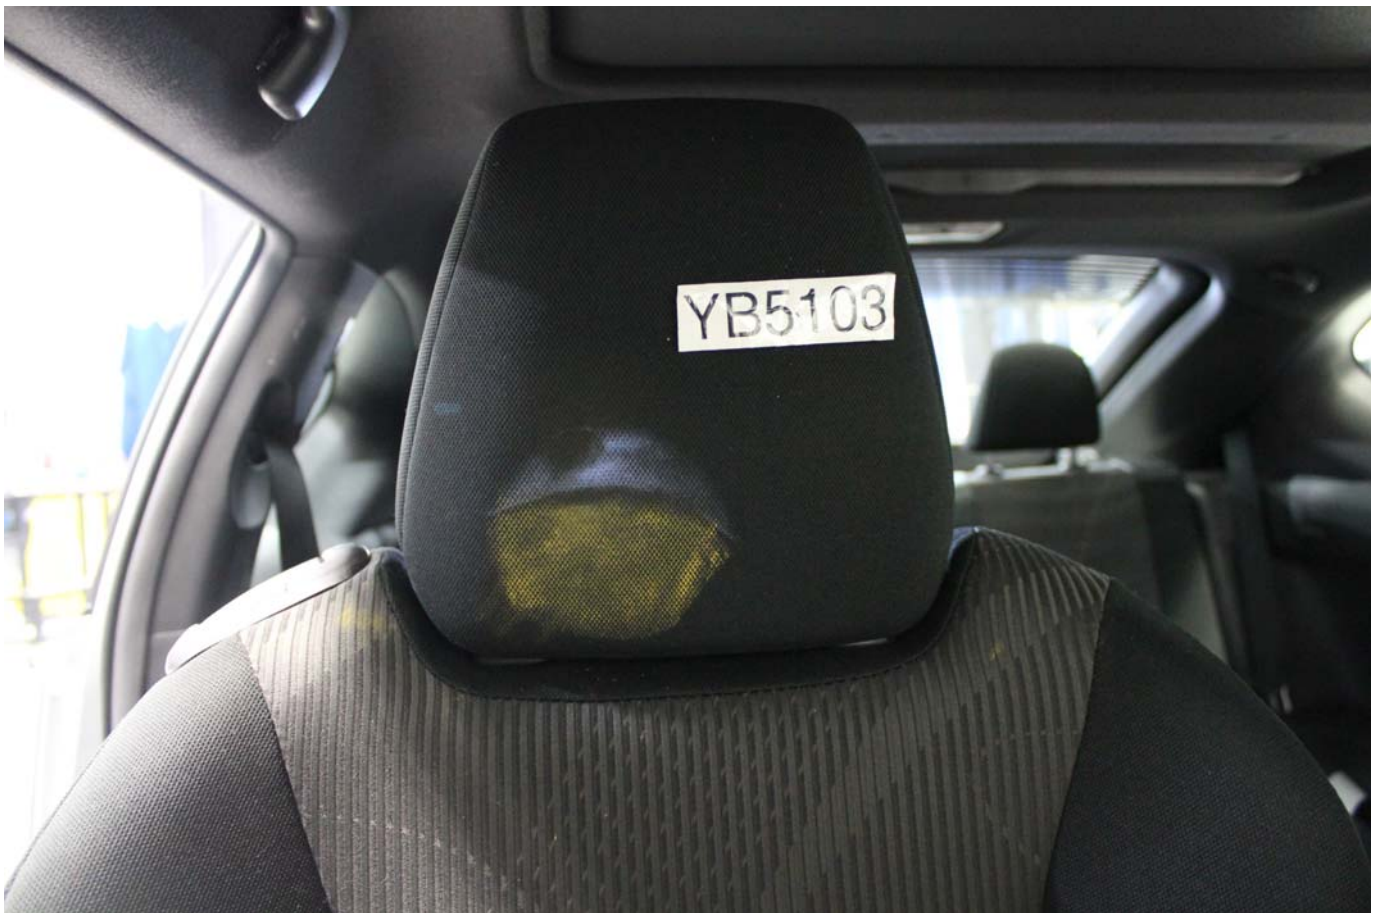
Post-Test Passenger Dummy Contact with Headrest

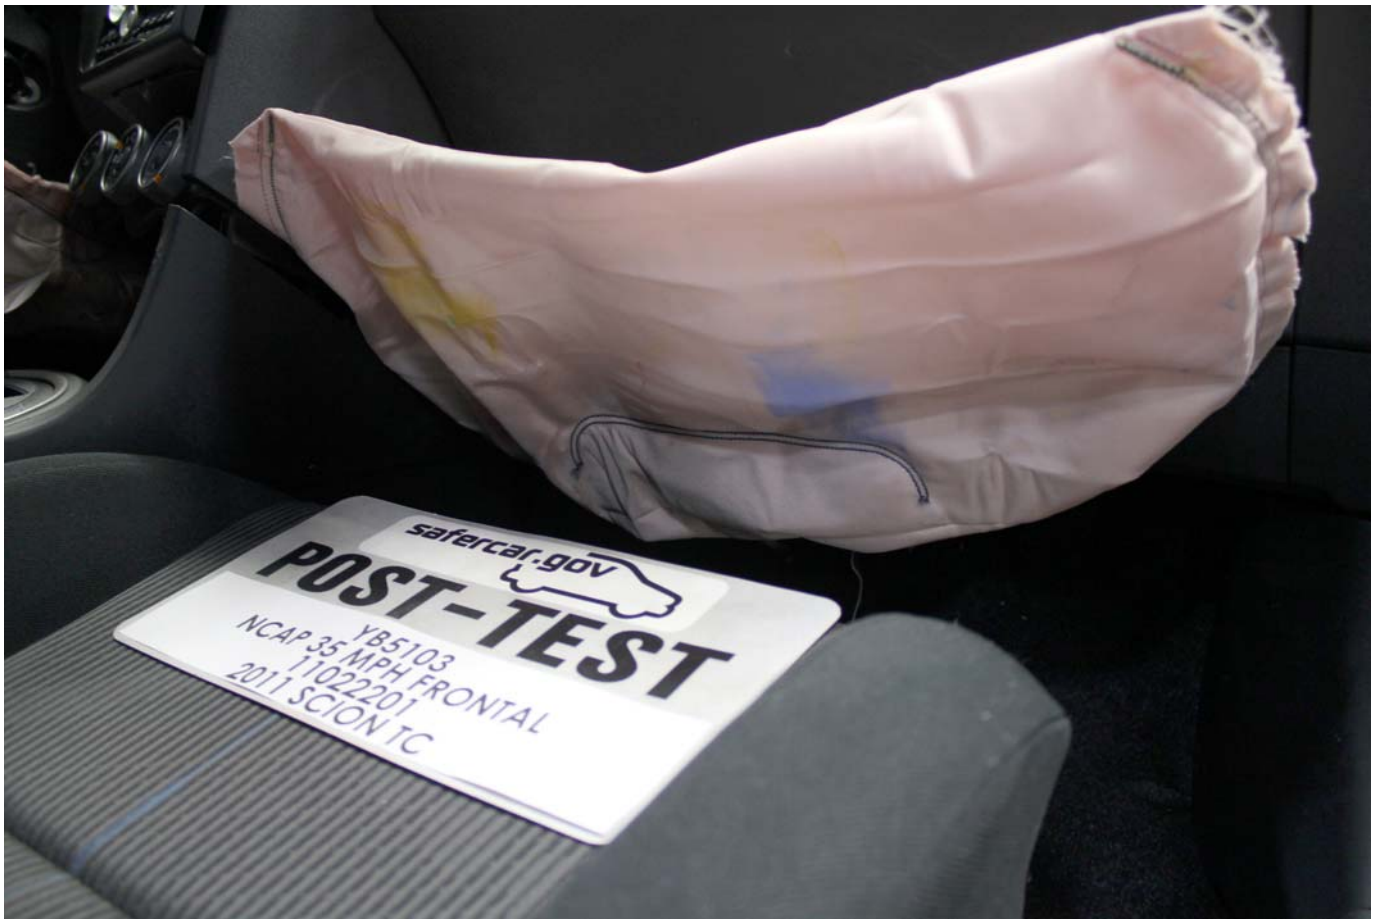
Post-Test Passenger Dummy Contact with Knee Airbag

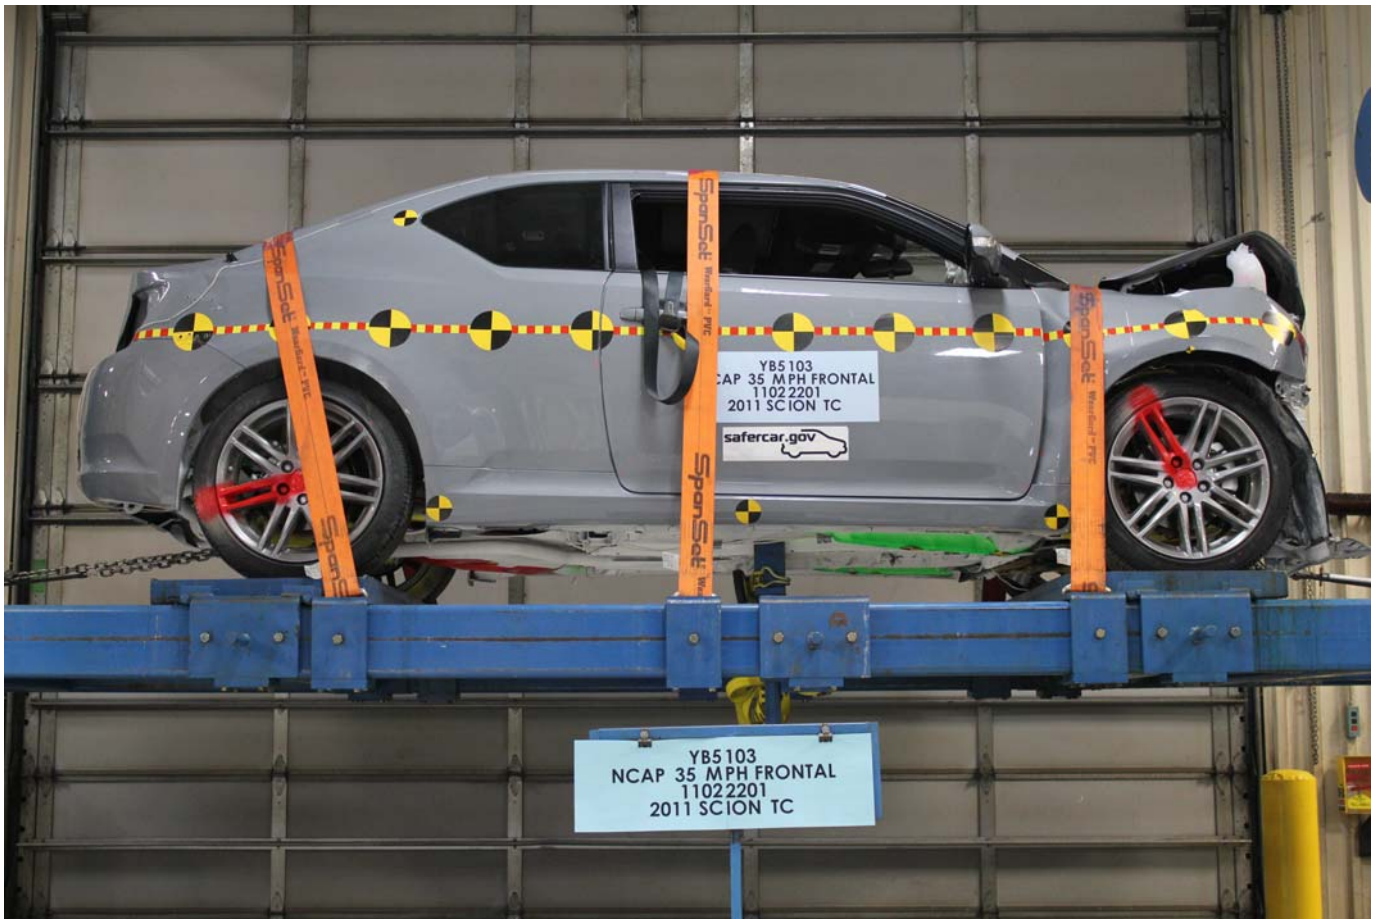
Vehicle at 360 Degrees on Static Rollover Device
