**REPORT NUMBER: SINCAP-MGA-2011-072**

**NEW CAR ASSESSMENT PROGRAM (NCAP)  
Moving Deformable Barrier Side Impact Test**

**TOYOTA MOTOR CORPORATION  
2011 Scion tC 3-Dr Liftback  
NHTSA No.: YB5102**

**FINAL REPORT**

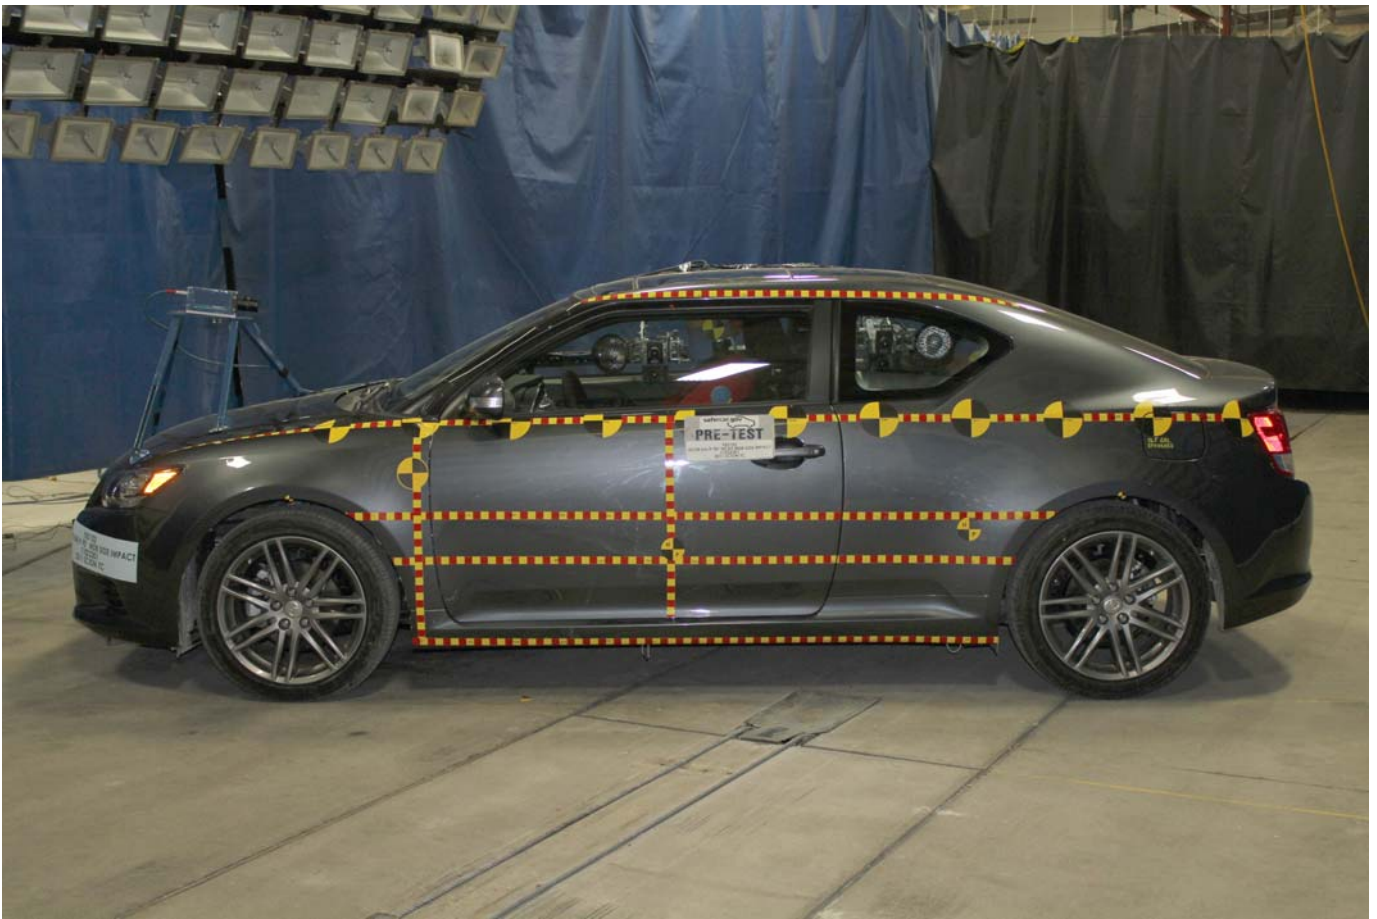
Pre-Test Left Side View of Test Vehicle

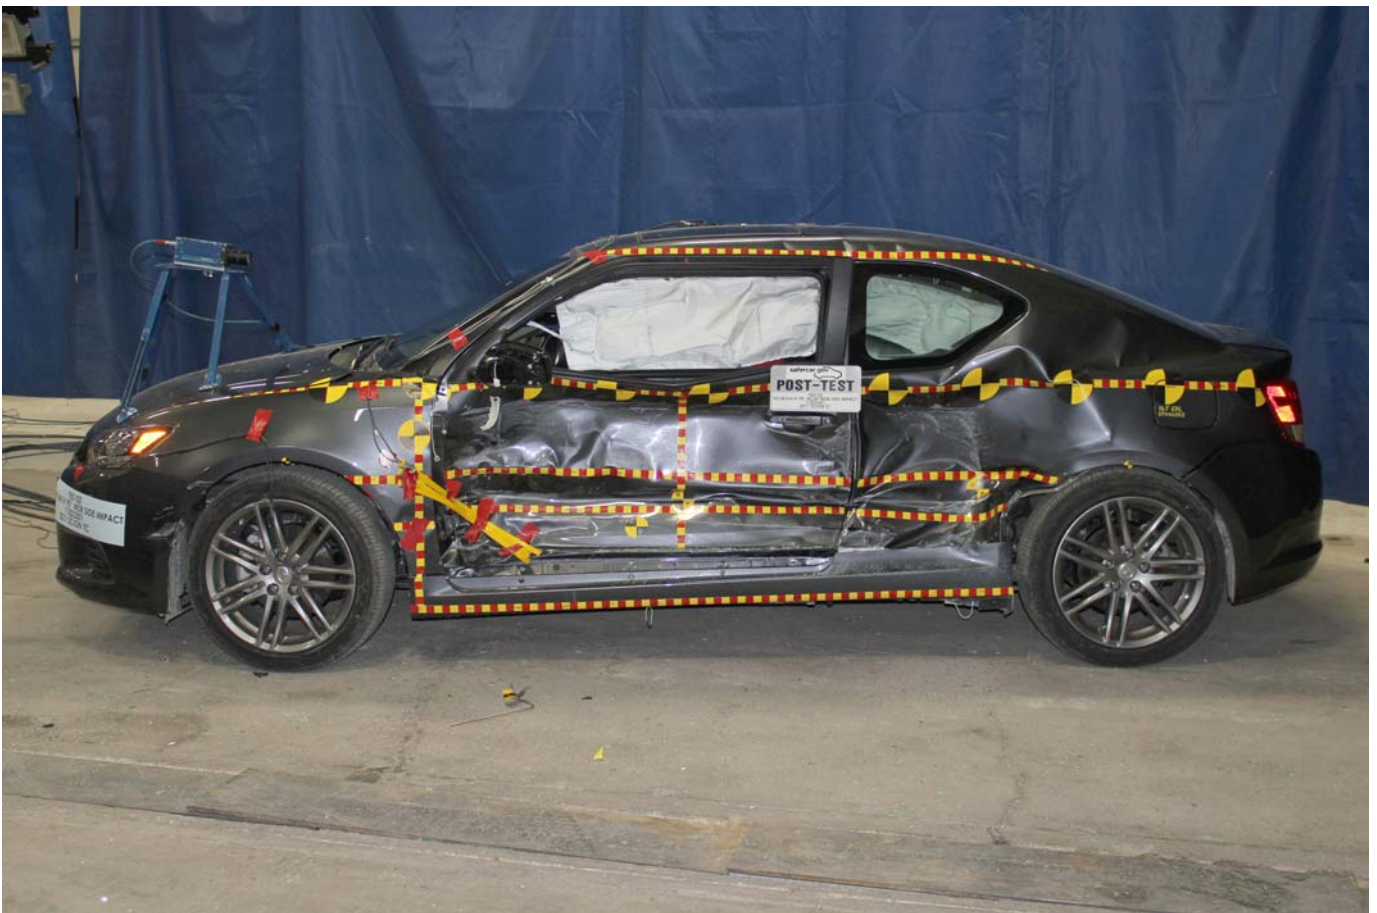
Post-Test Left Side View of Test Vehicle

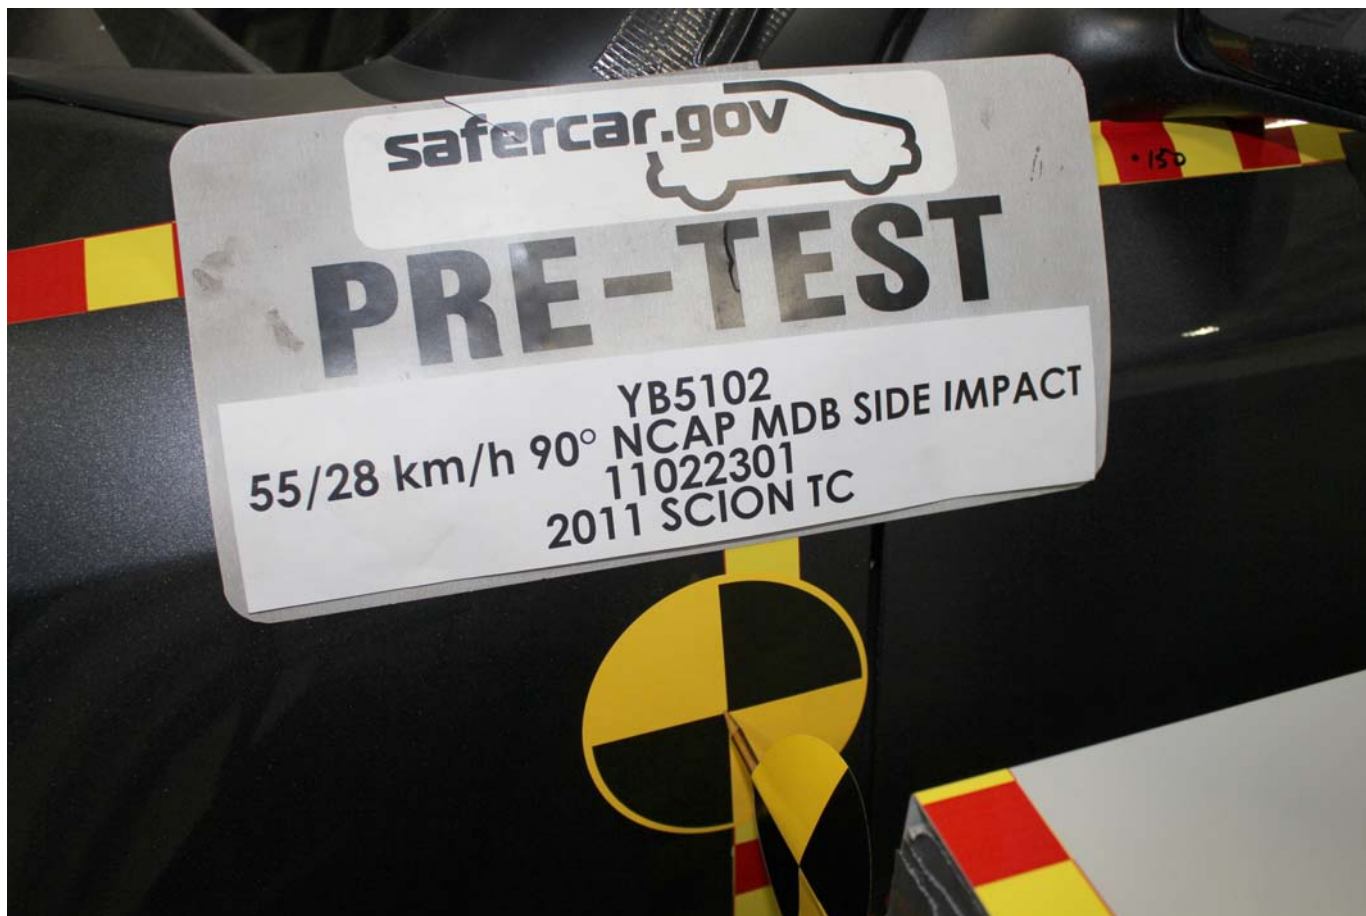
Pre-Test Close-Up View of Impact Point Target

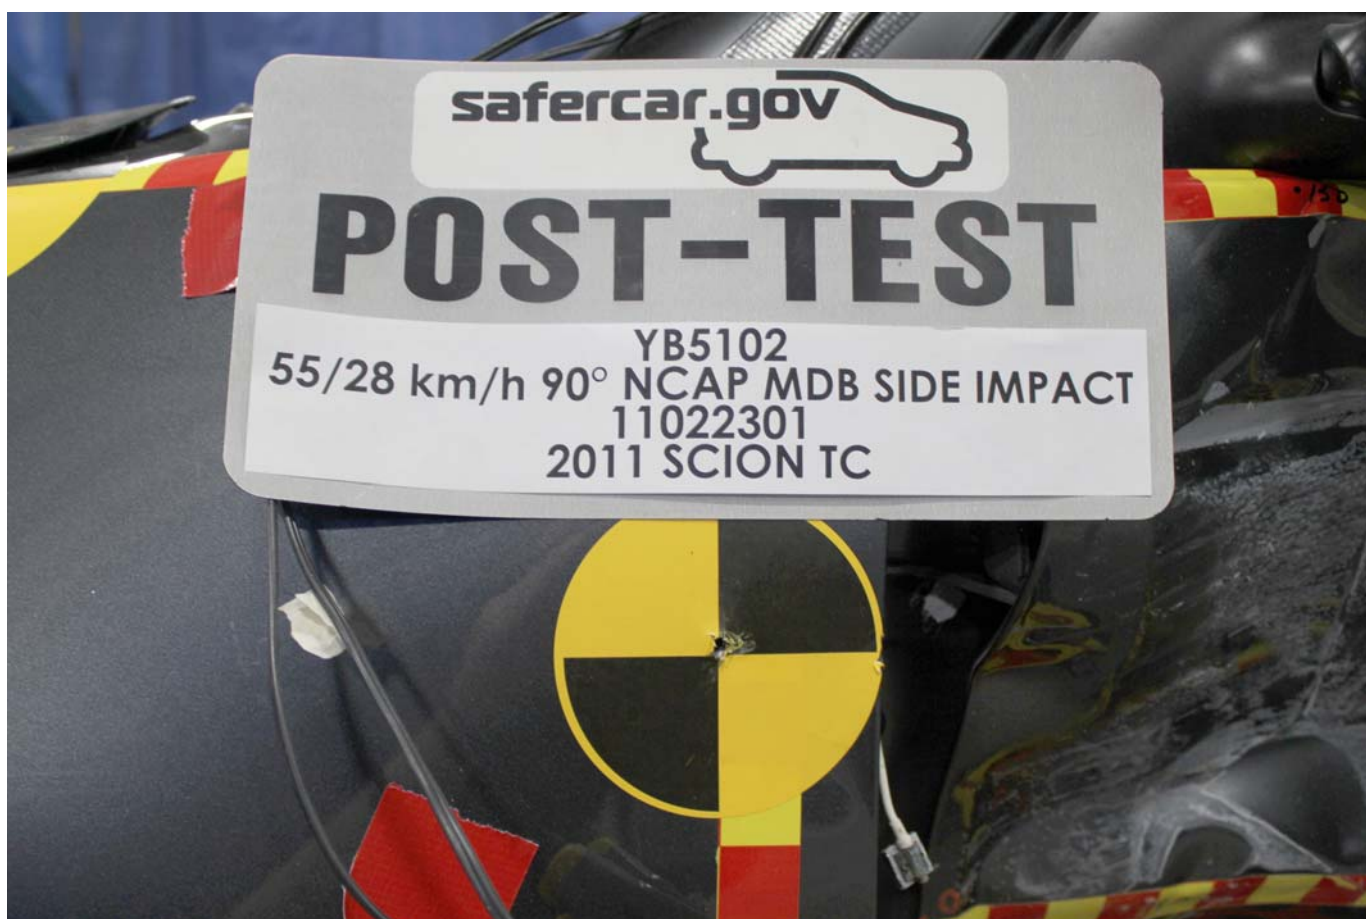
Post-Test Close-Up View of Impact Point Target

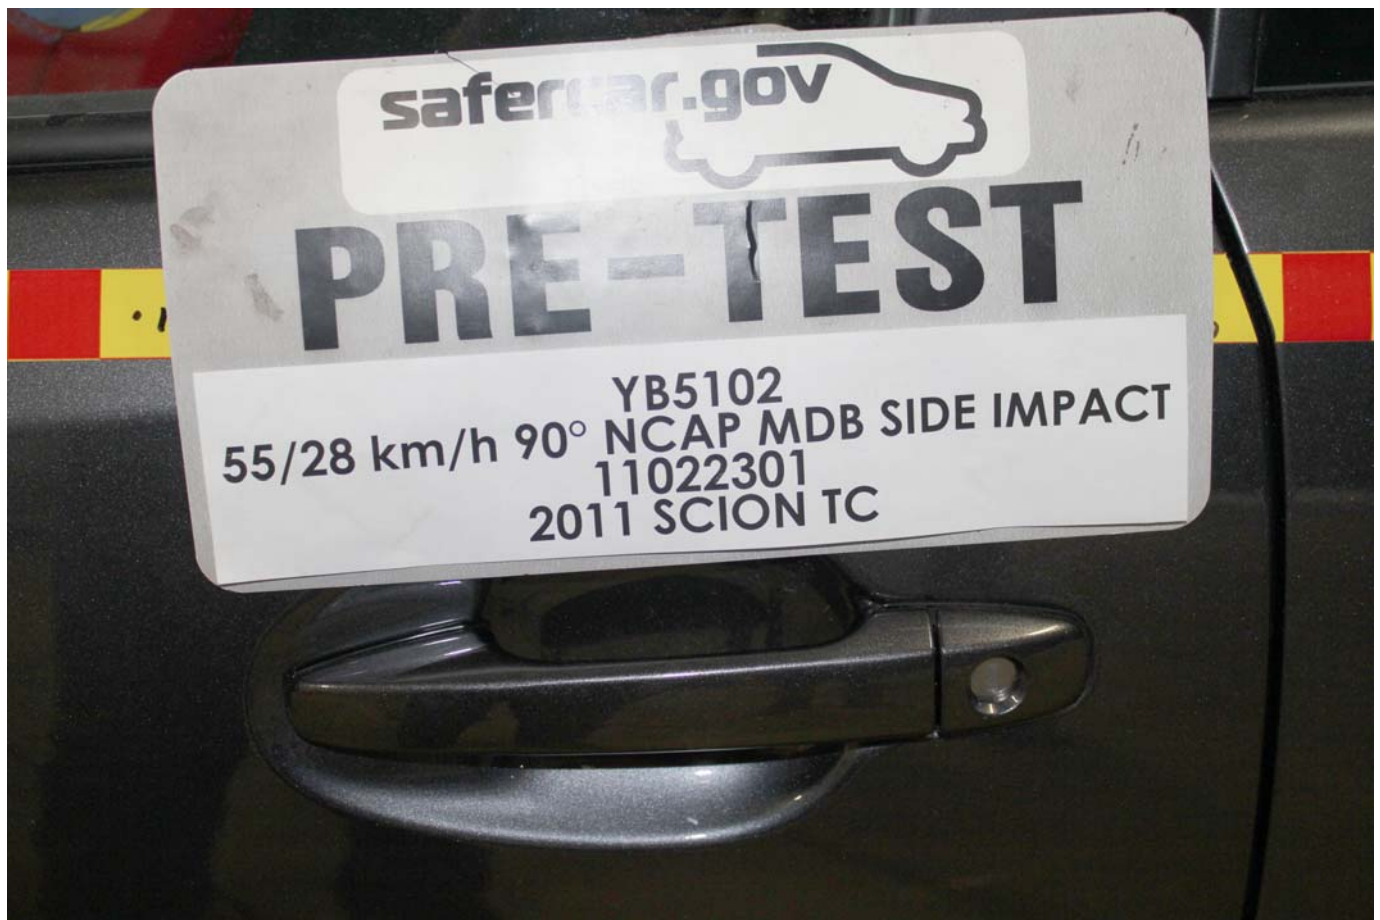
Pre-Test Left Front Door Latch Close-Up

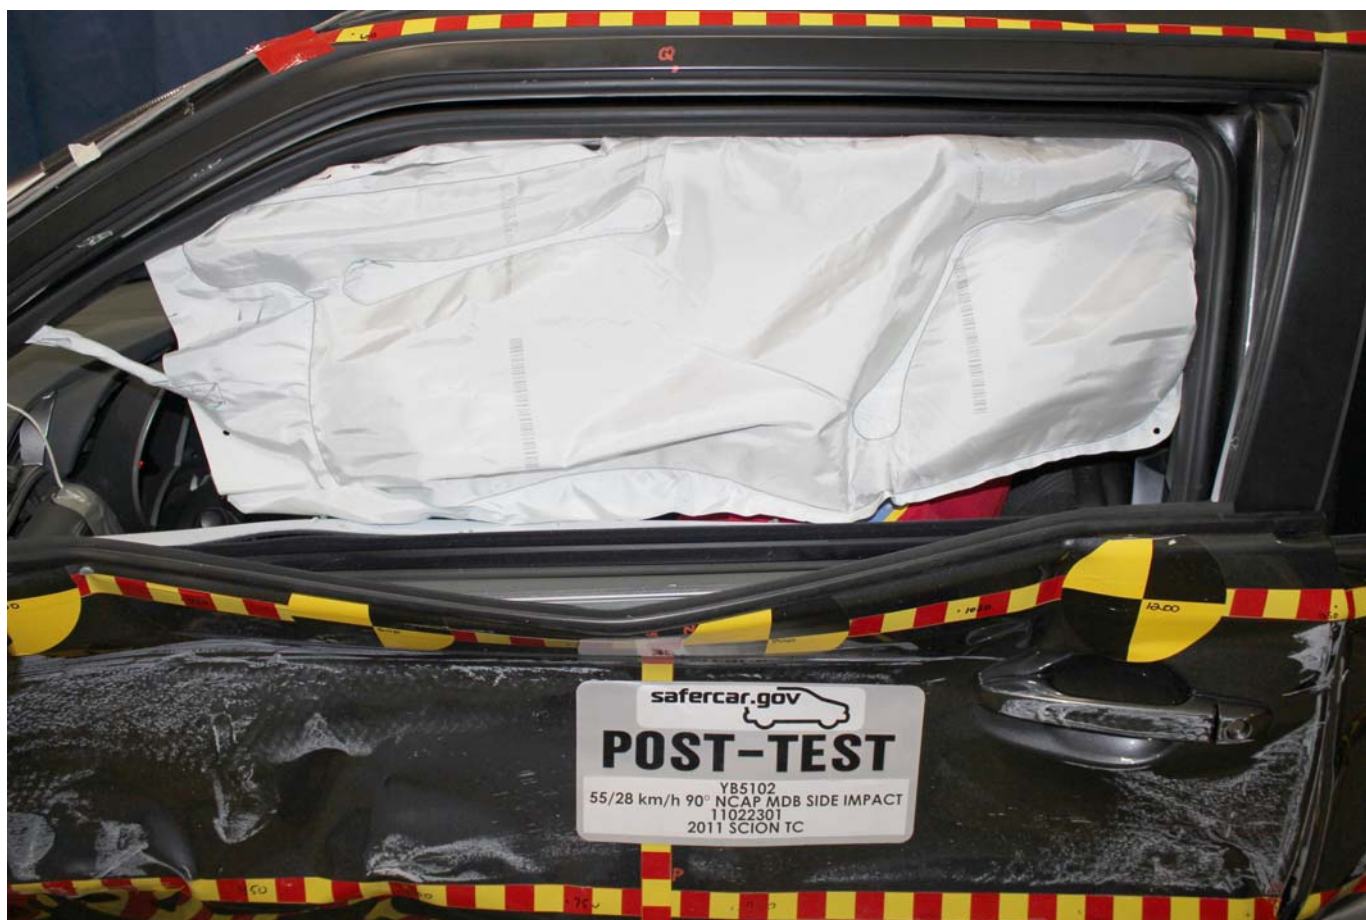
Post-Test Left Side View of Driver Dummy Shoulder and Door Top View

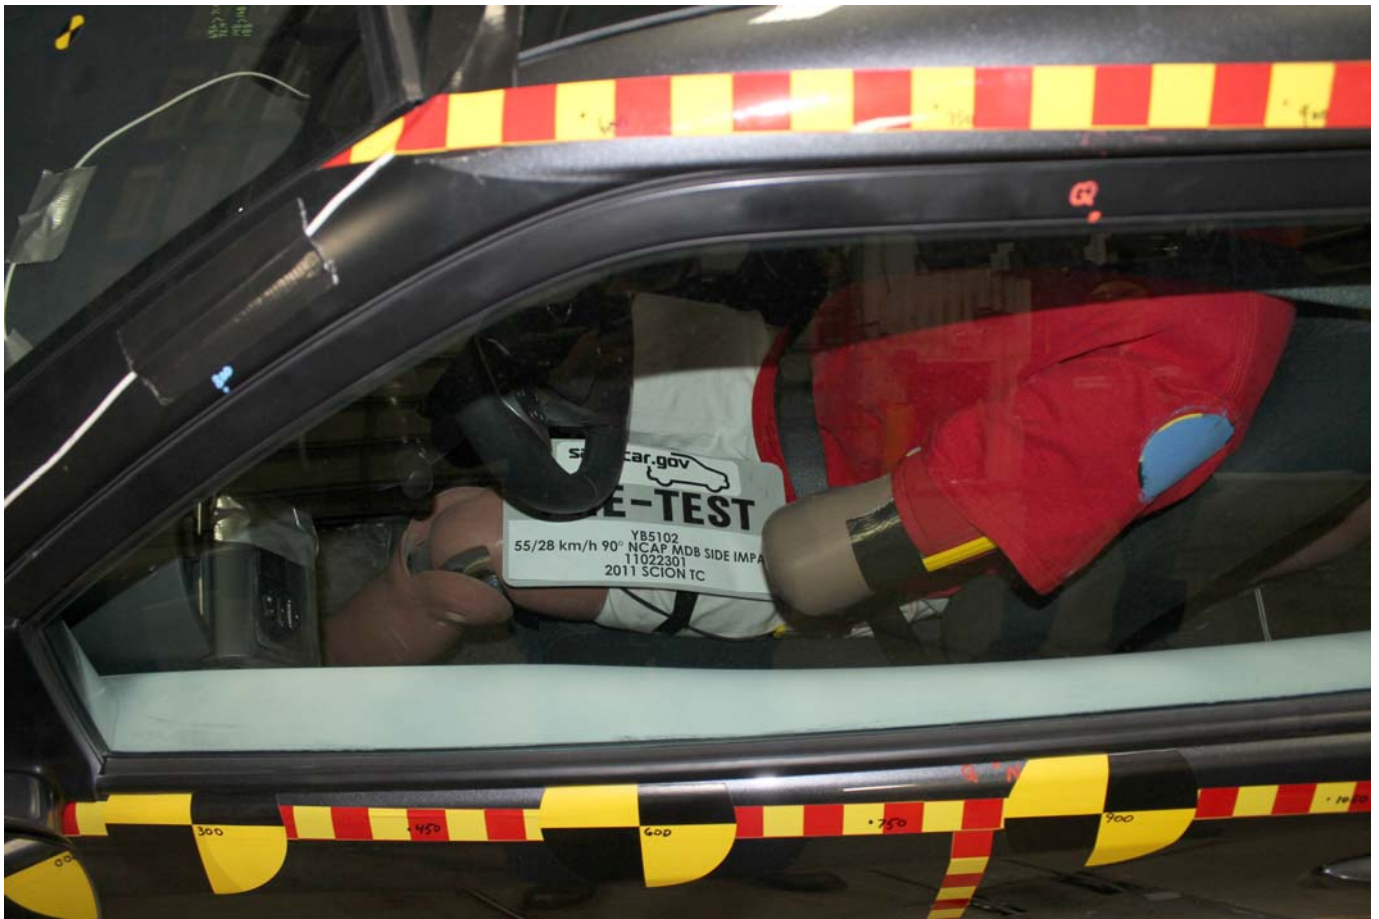
Pre-Test Driver Dummy and Door Clearance View

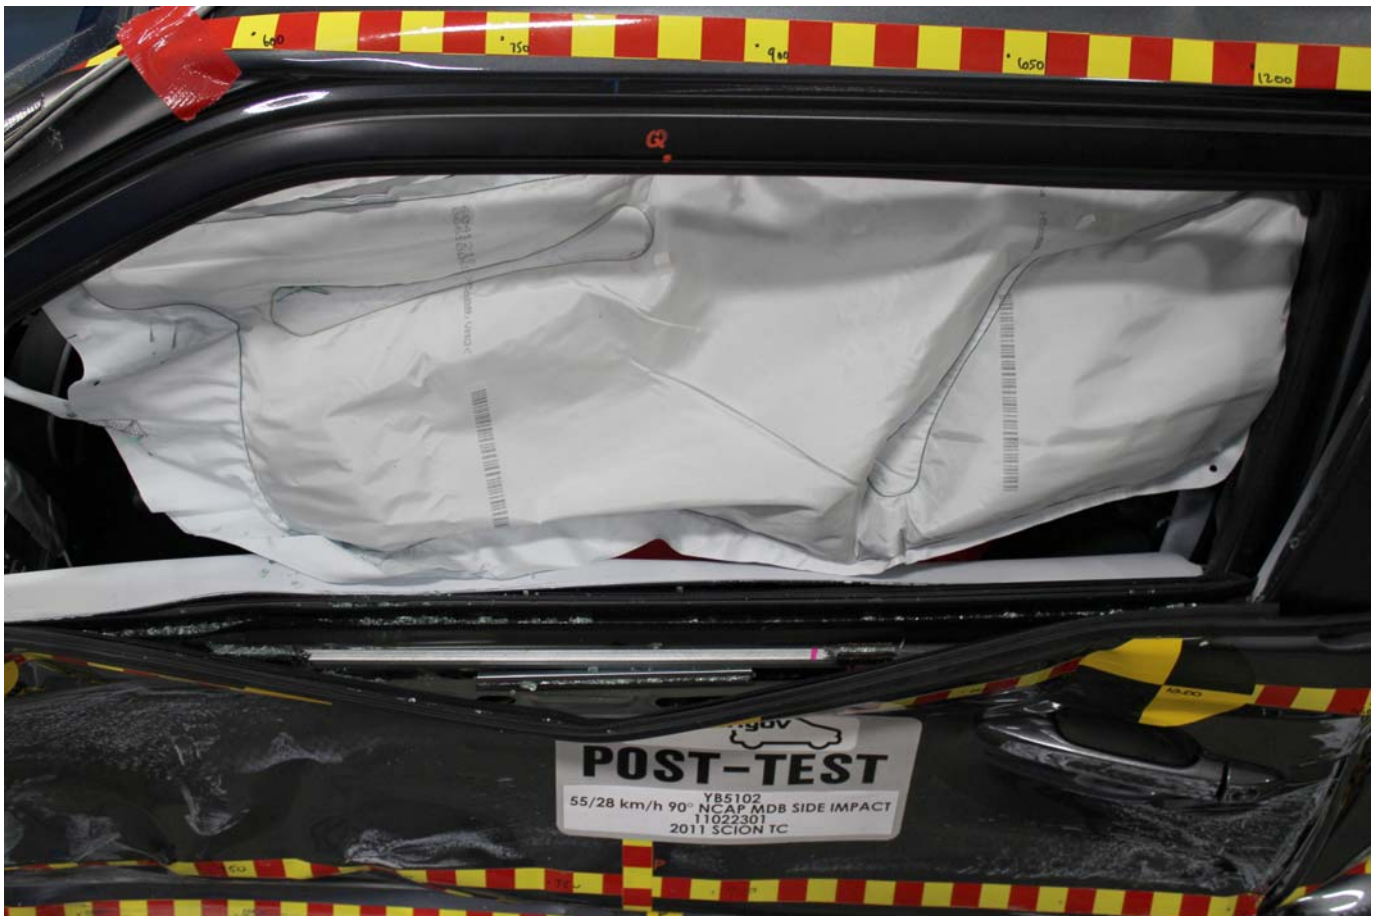
Post-Test Driver Dummy and Door Clearance View

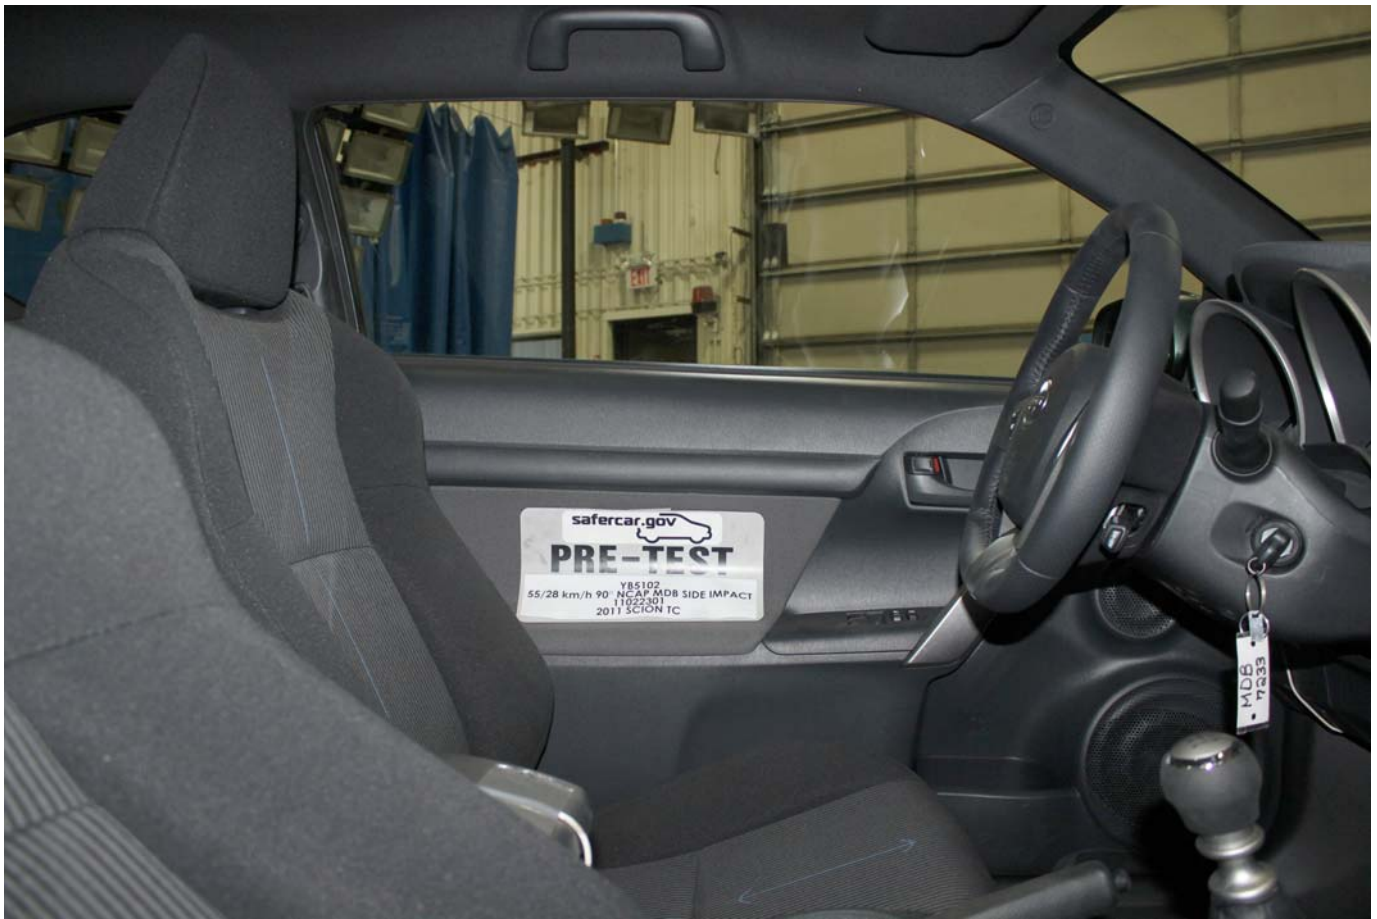
Pre-Test Driver Inner Door Panel View

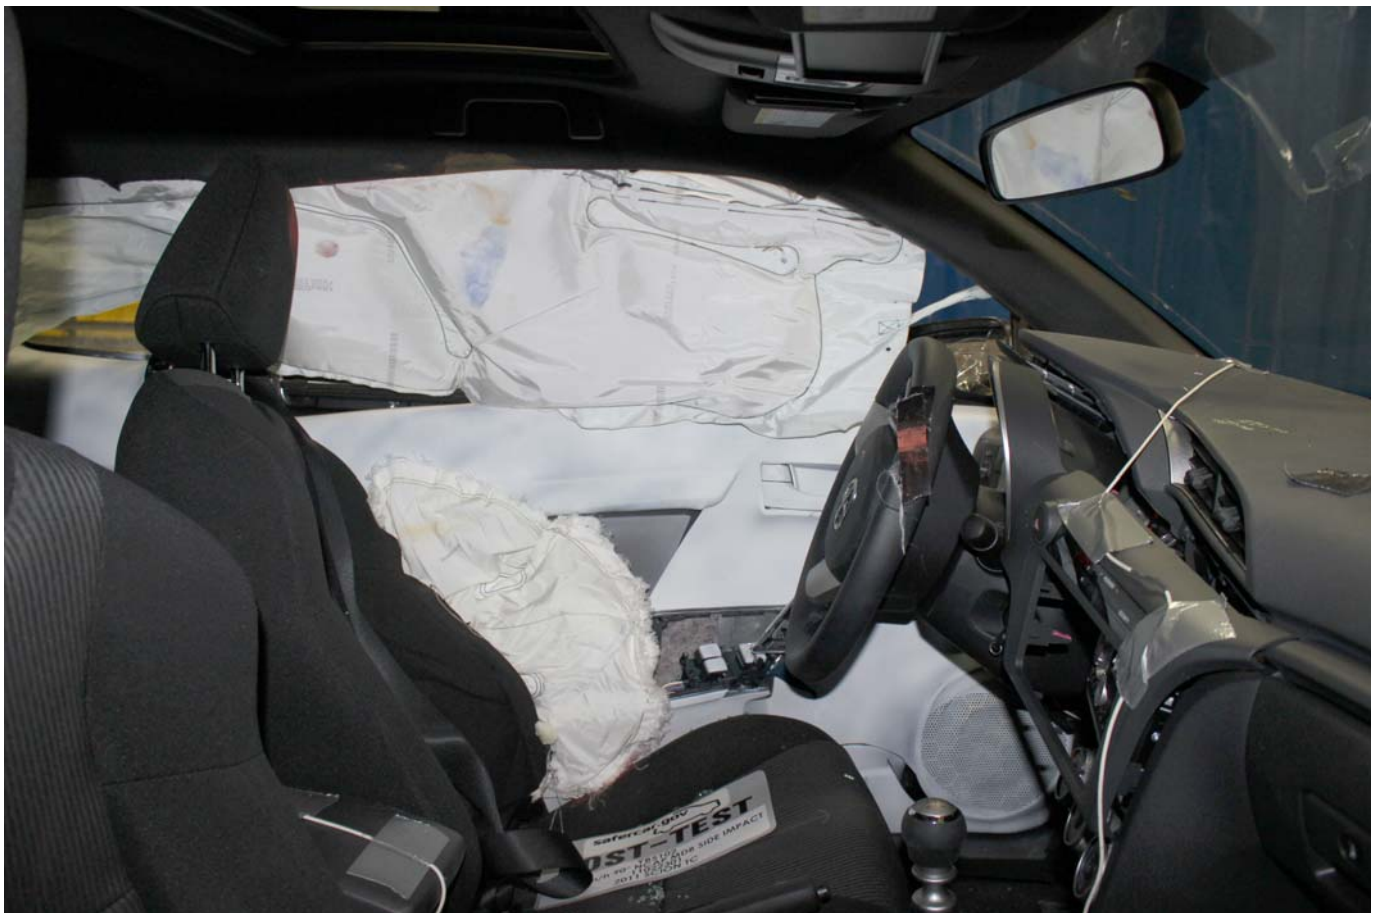
Post-Test Driver Inner Door Panel View Showing Driver Dummy Contact Locations

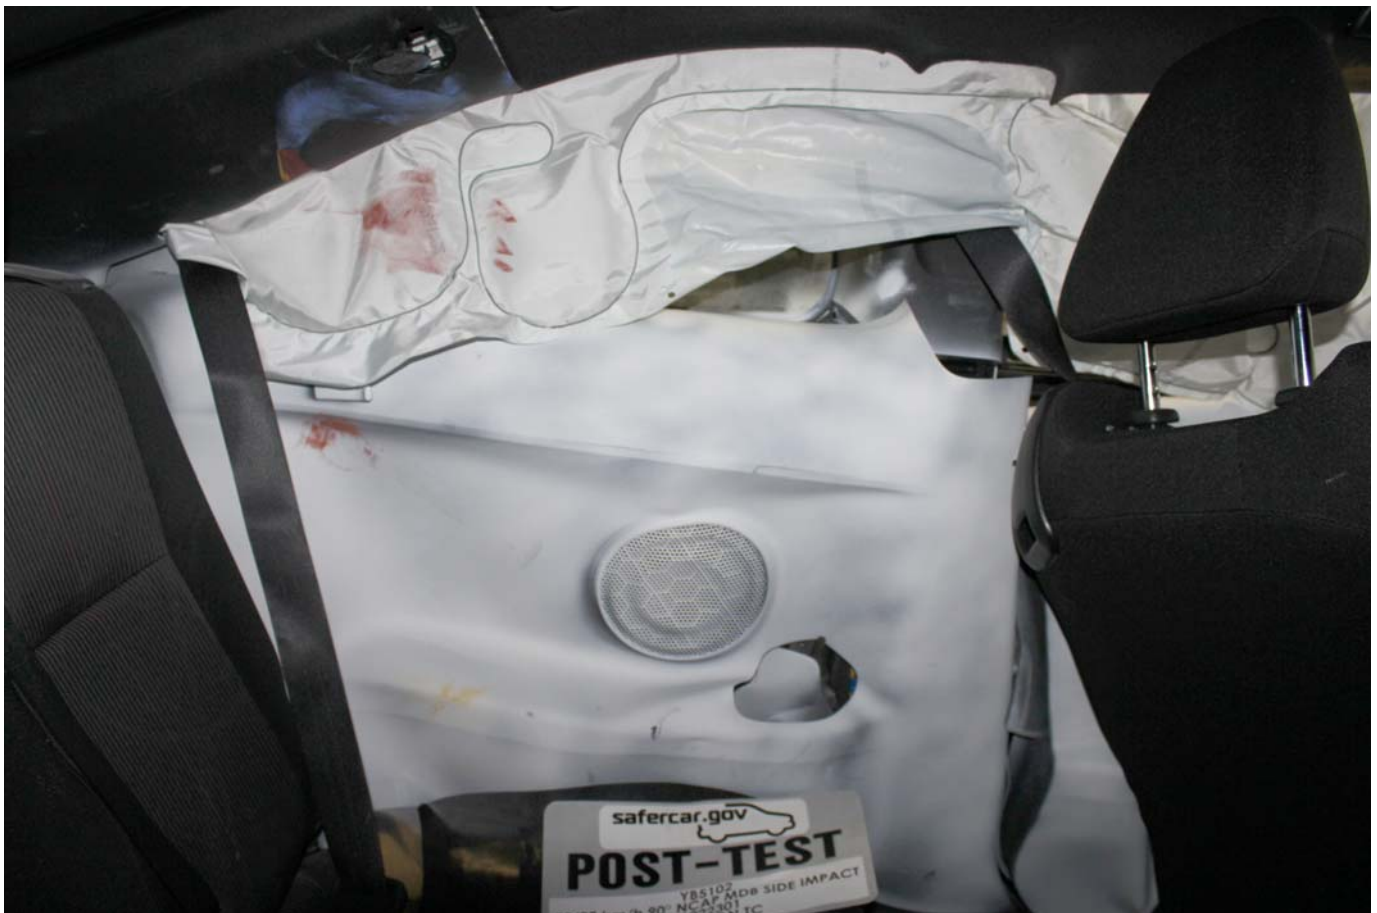
Post-Test Rear Passenger Inner Door Panel View Showing Dummy Contact Locations

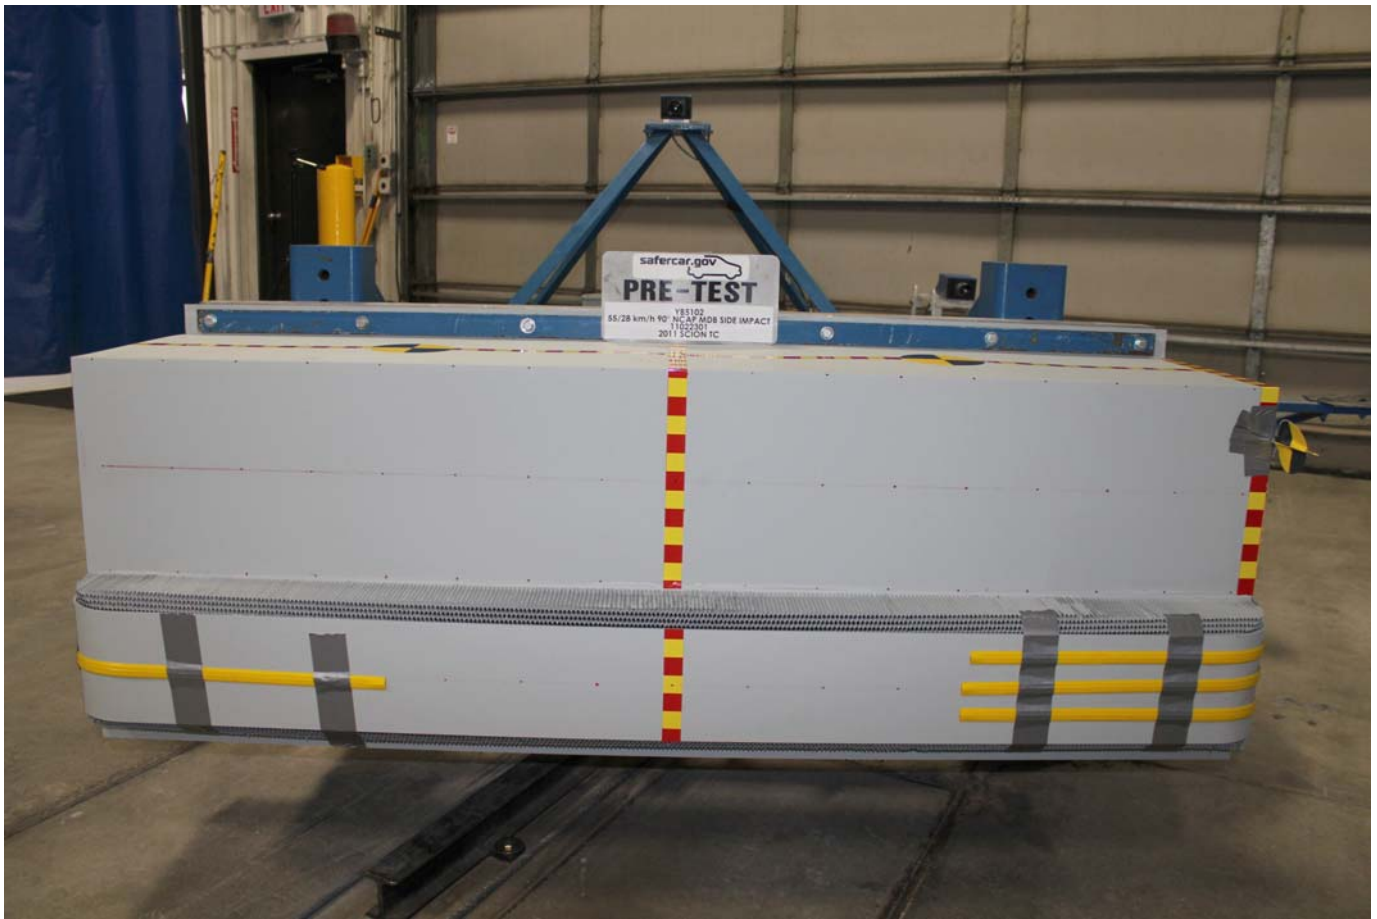
Pre-Test Front View of MDB Impactor Face

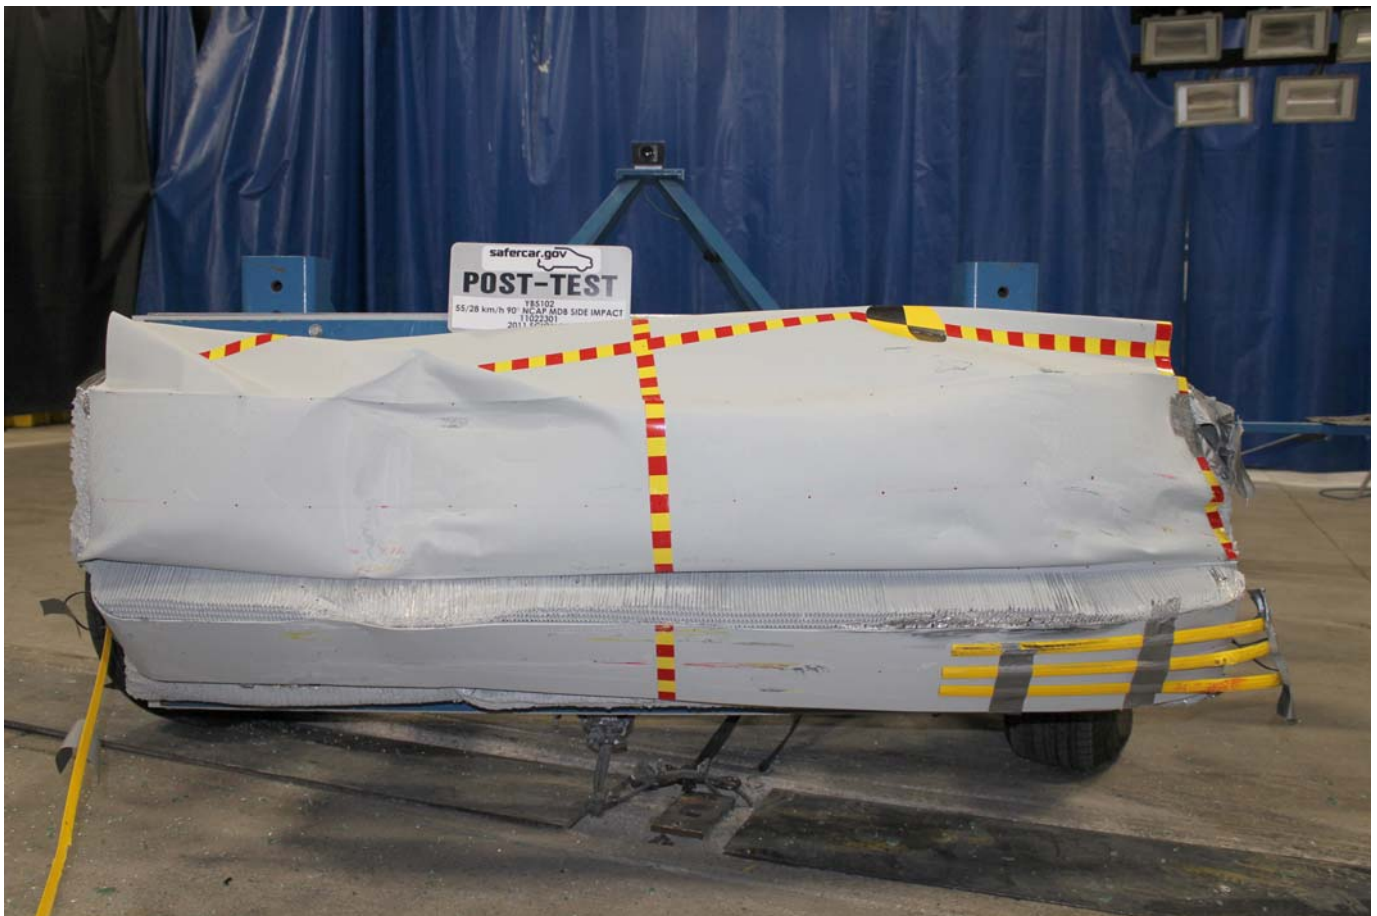
Post-Test Front View of MDB Impactor Face

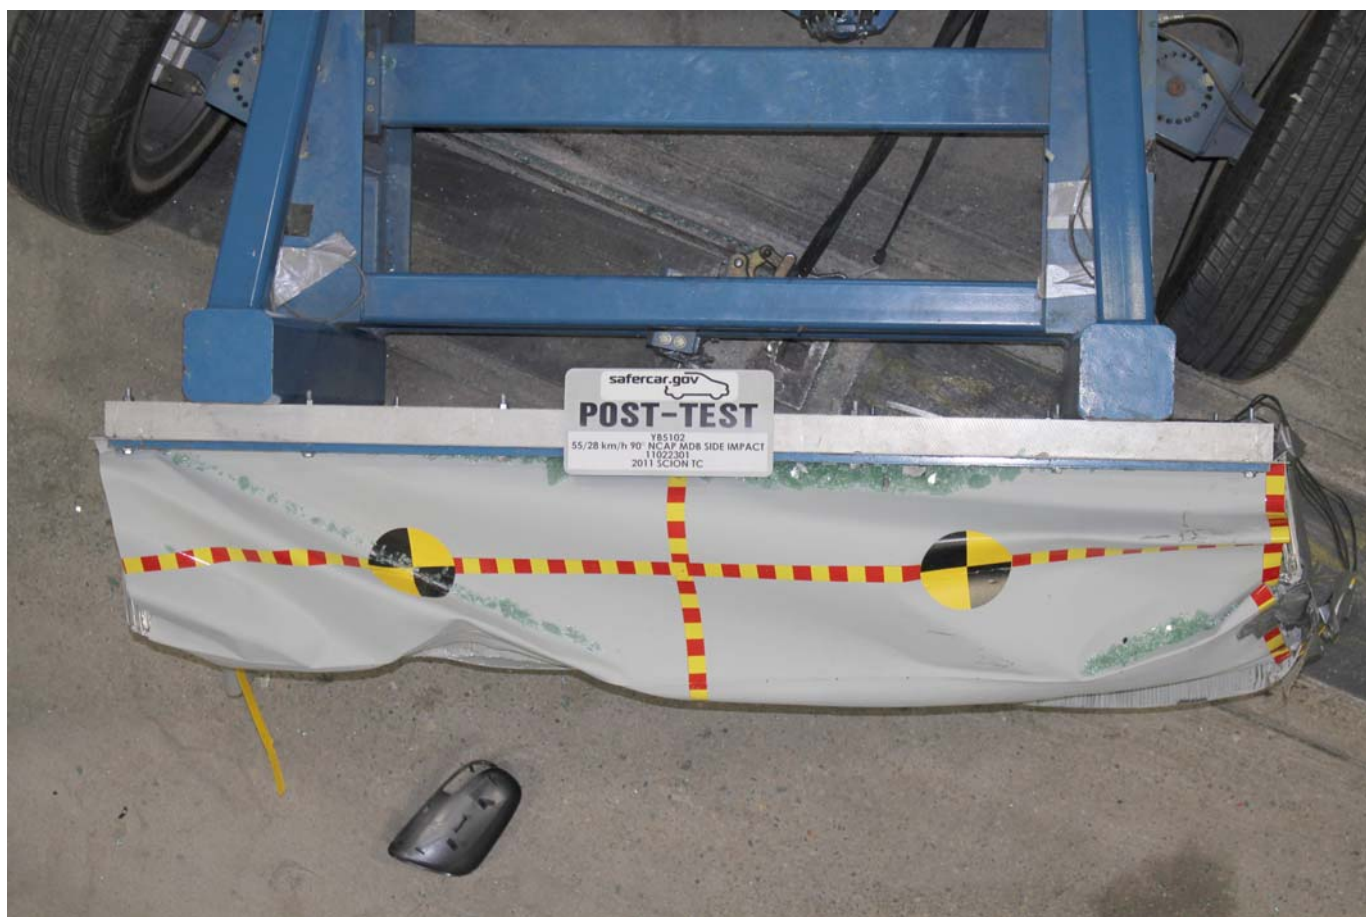
Post-Test Top View of MDB Impactor Face

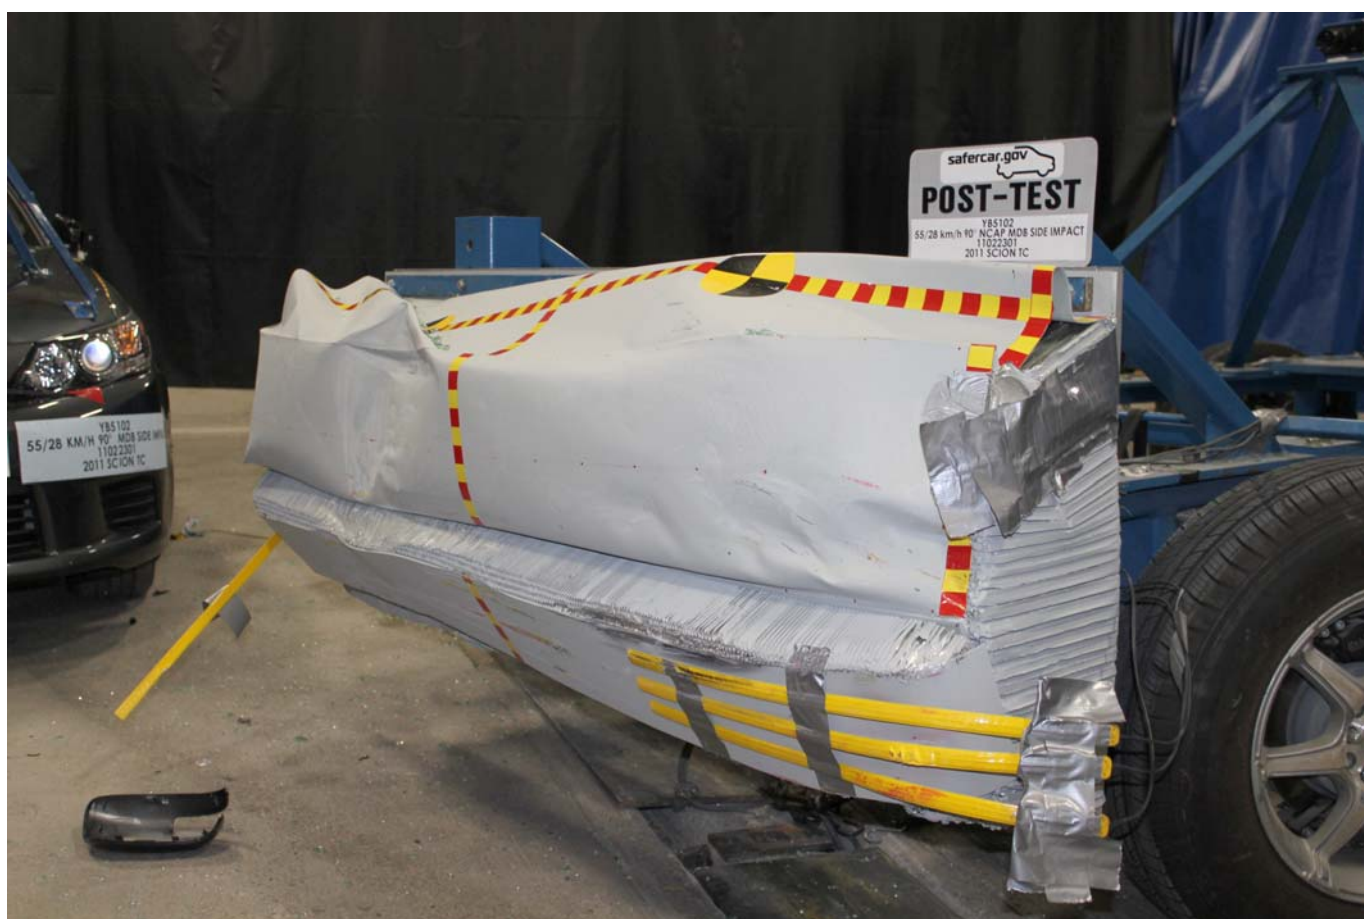
Post-Test Left Side View of MDB Impactor Face

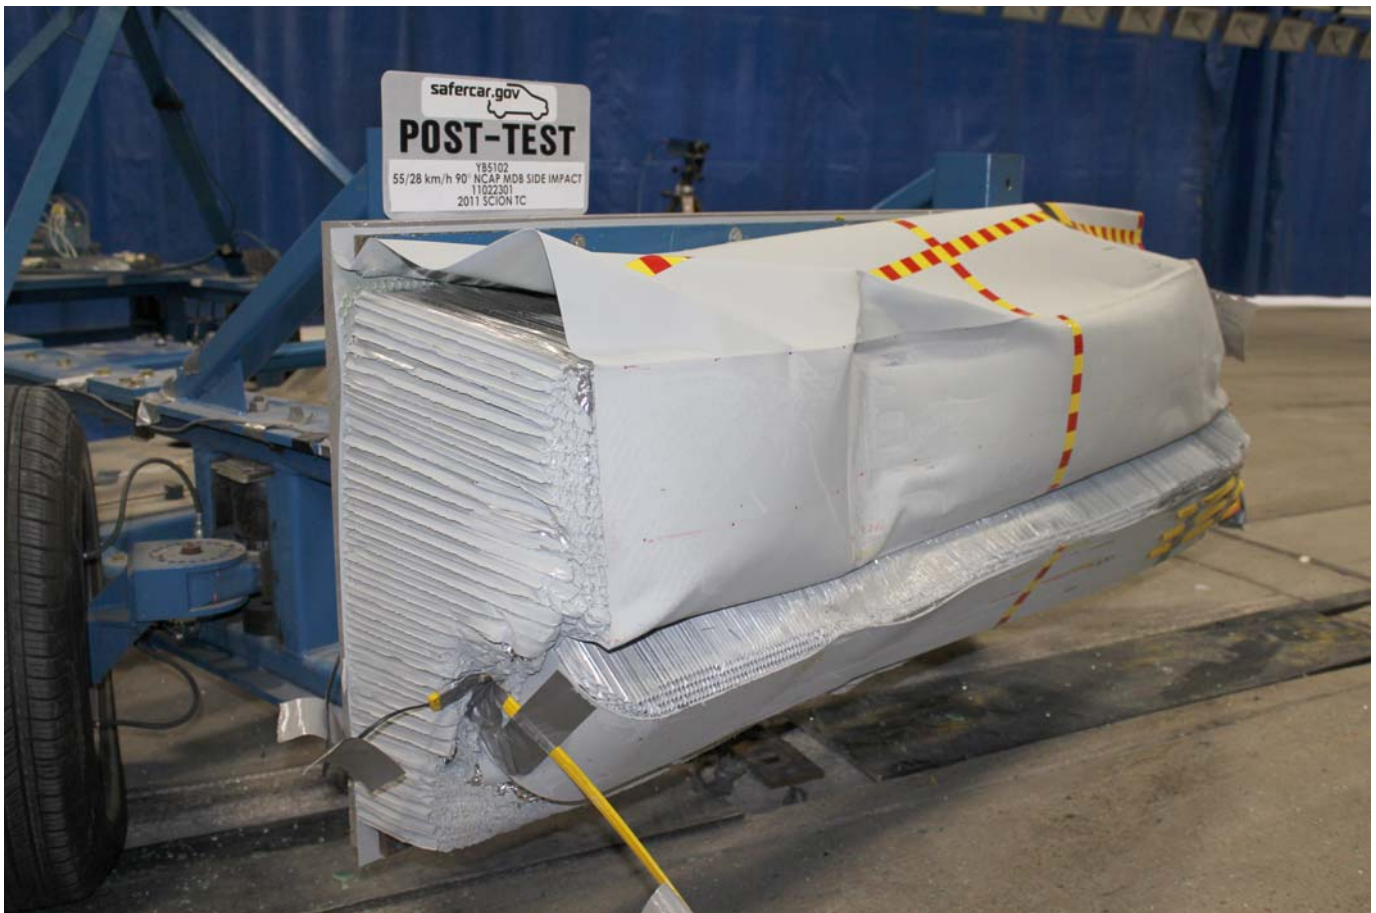
Post-Test Right Side View of MDB Impactor Face
