**REPORT NUMBER: SPNCAP-MGA-2011-074**

**NEW CAR ASSESSMENT PROGRAM (NCAP)  
Side Impact Pole Test**

**GENERAL MOTORS LLC  
2011 Buick Lucerne CX 4-Dr Sedan  
NHTSA No.: GB0100**

**FINAL REPORT**

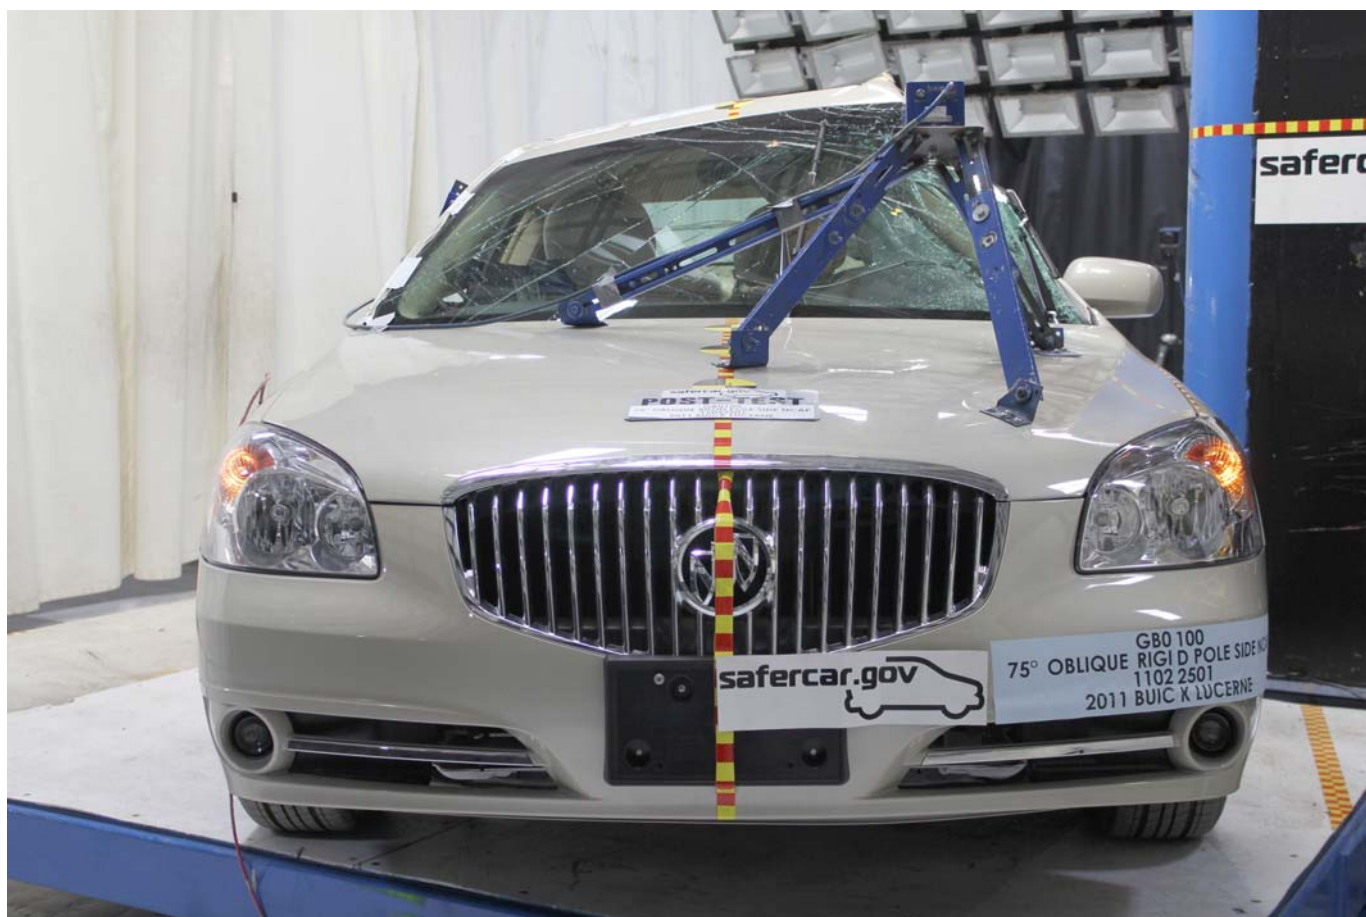
Post-Test Frontal View of Test Vehicle

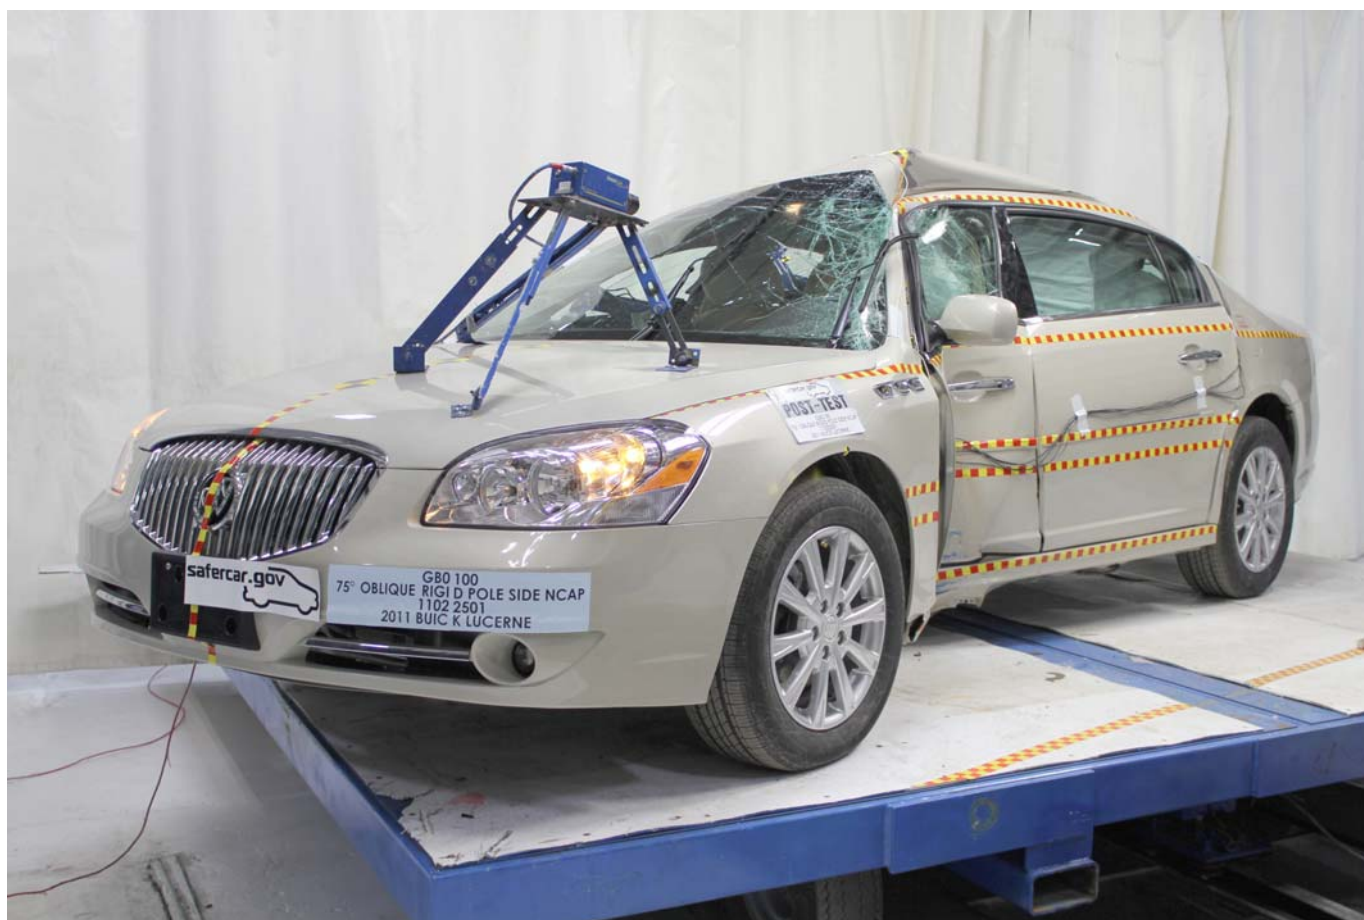
Post-Test Left Front  $\frac{3}{4}$  View of Test Vehicle

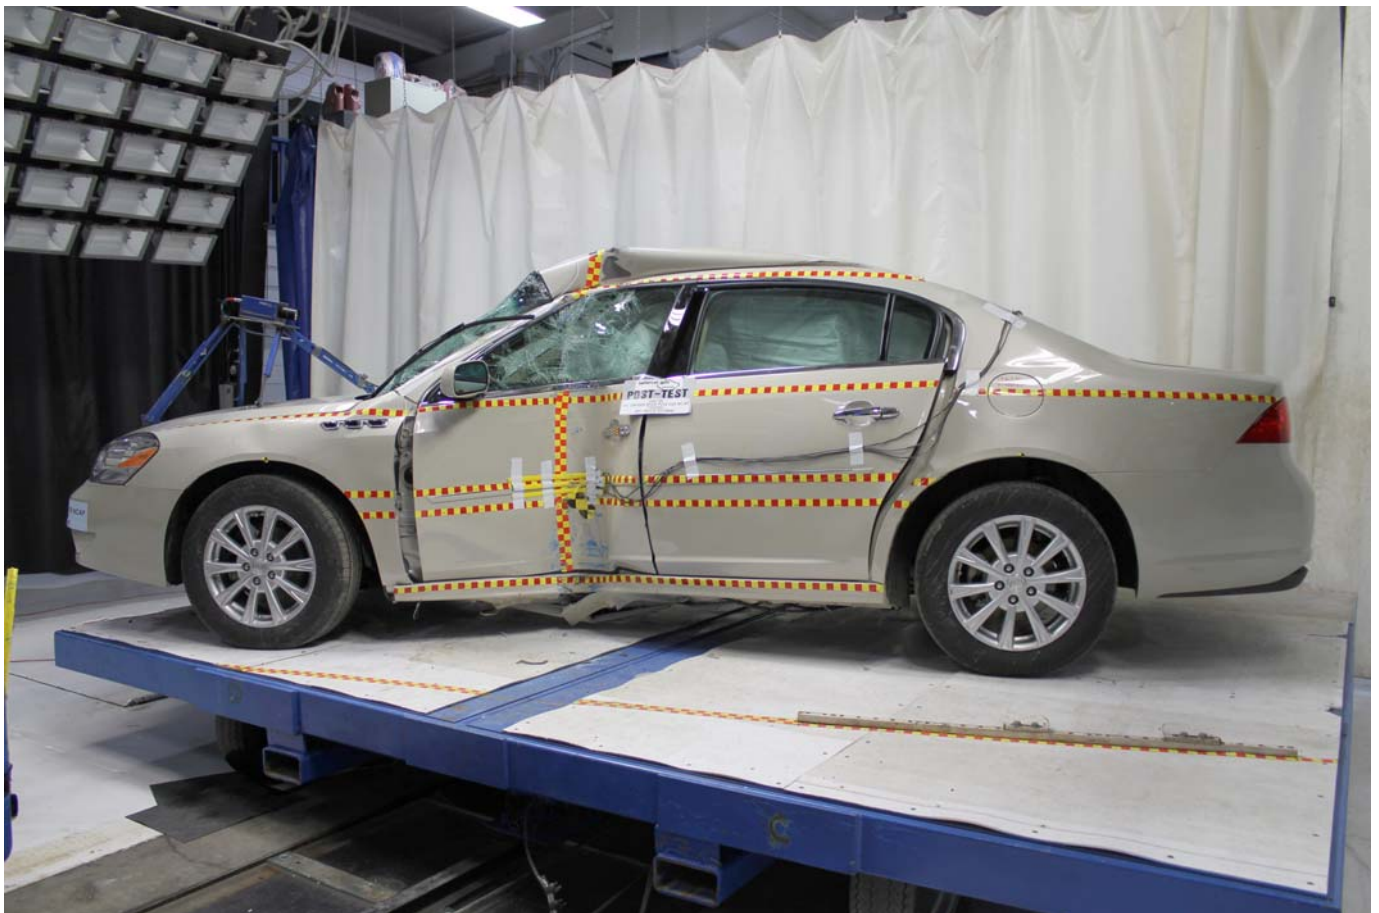
Post-Test Left Side View of Test Vehicle

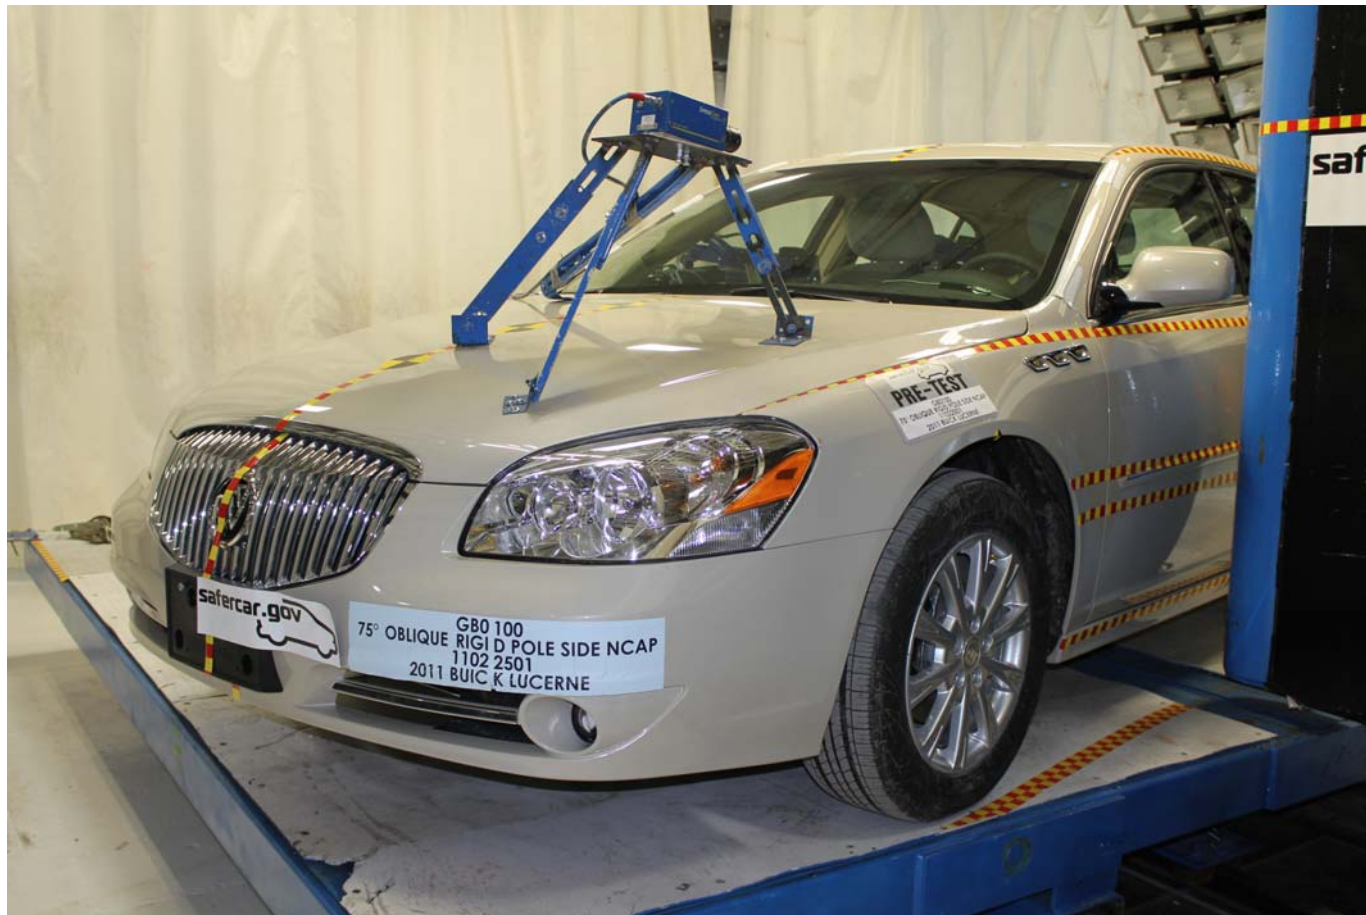
Pre-Test Left Side View of Pole Positioned Against Side of Vehicle

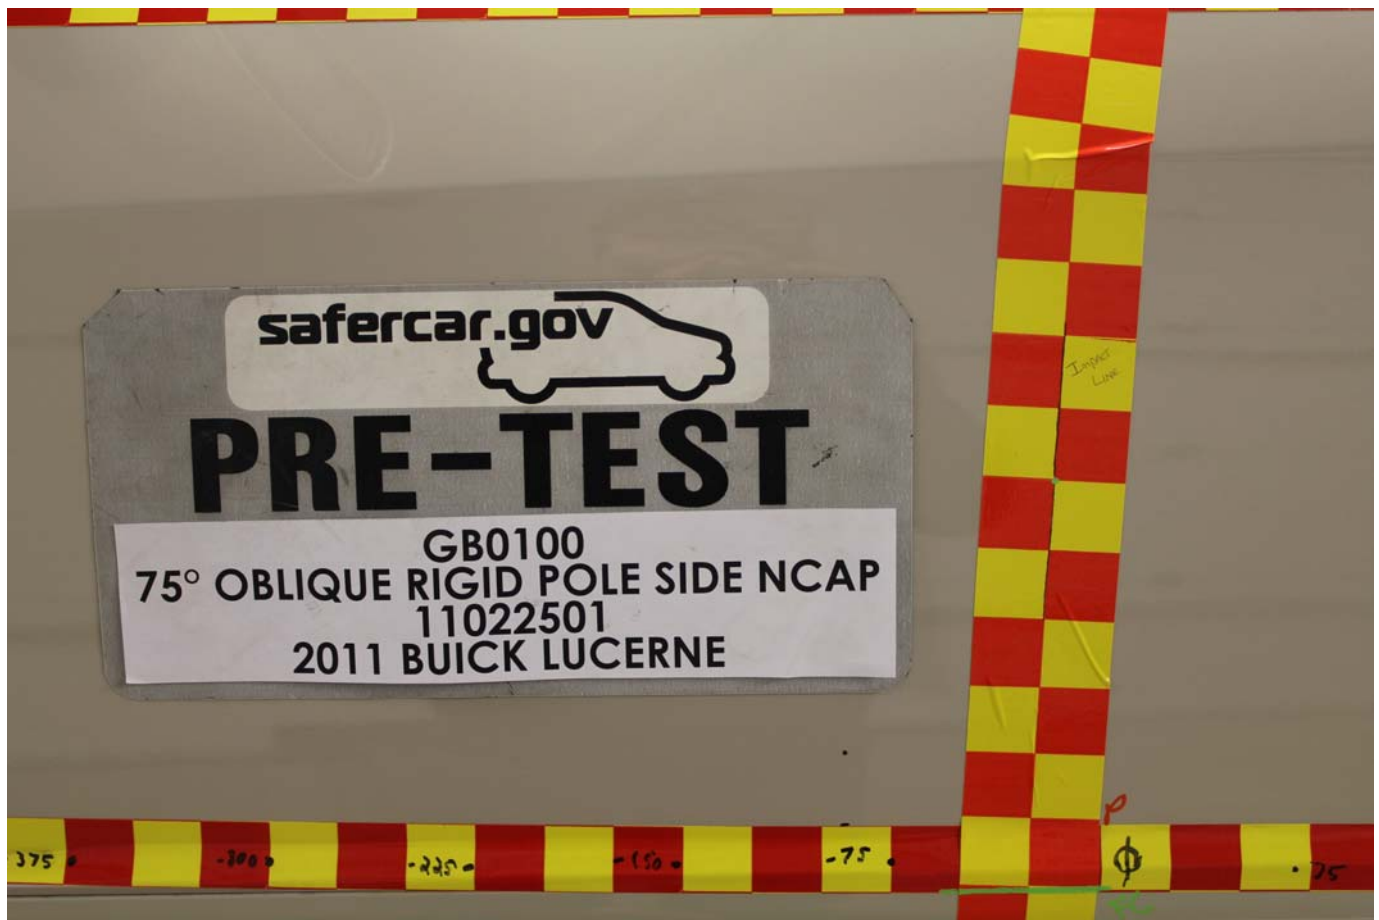
Pre-Test Close-Up View of Impact Point Target

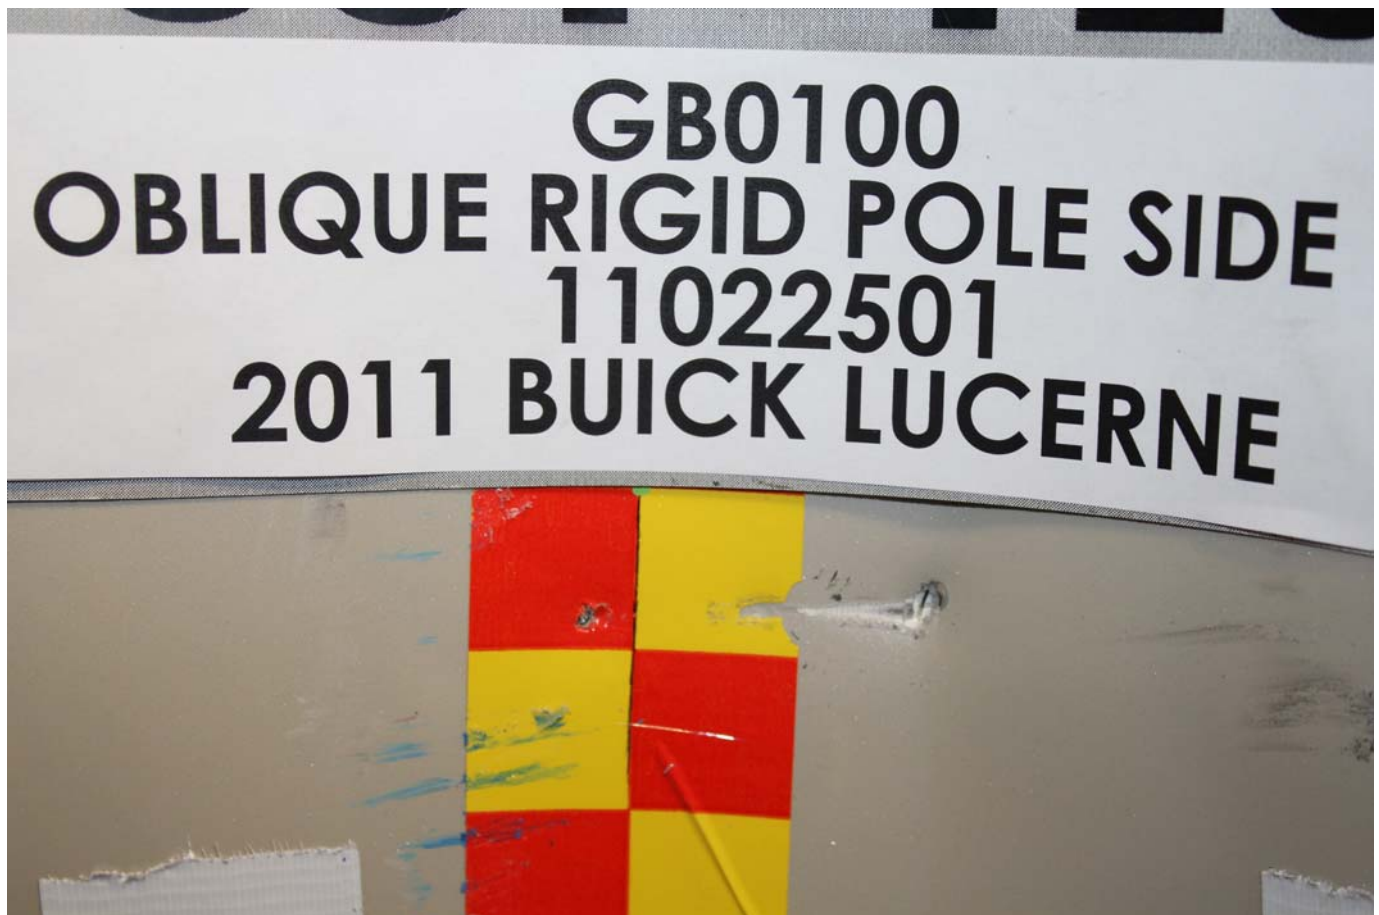
Post-Test Close-Up View of Impact Point Target Showing Impact Location

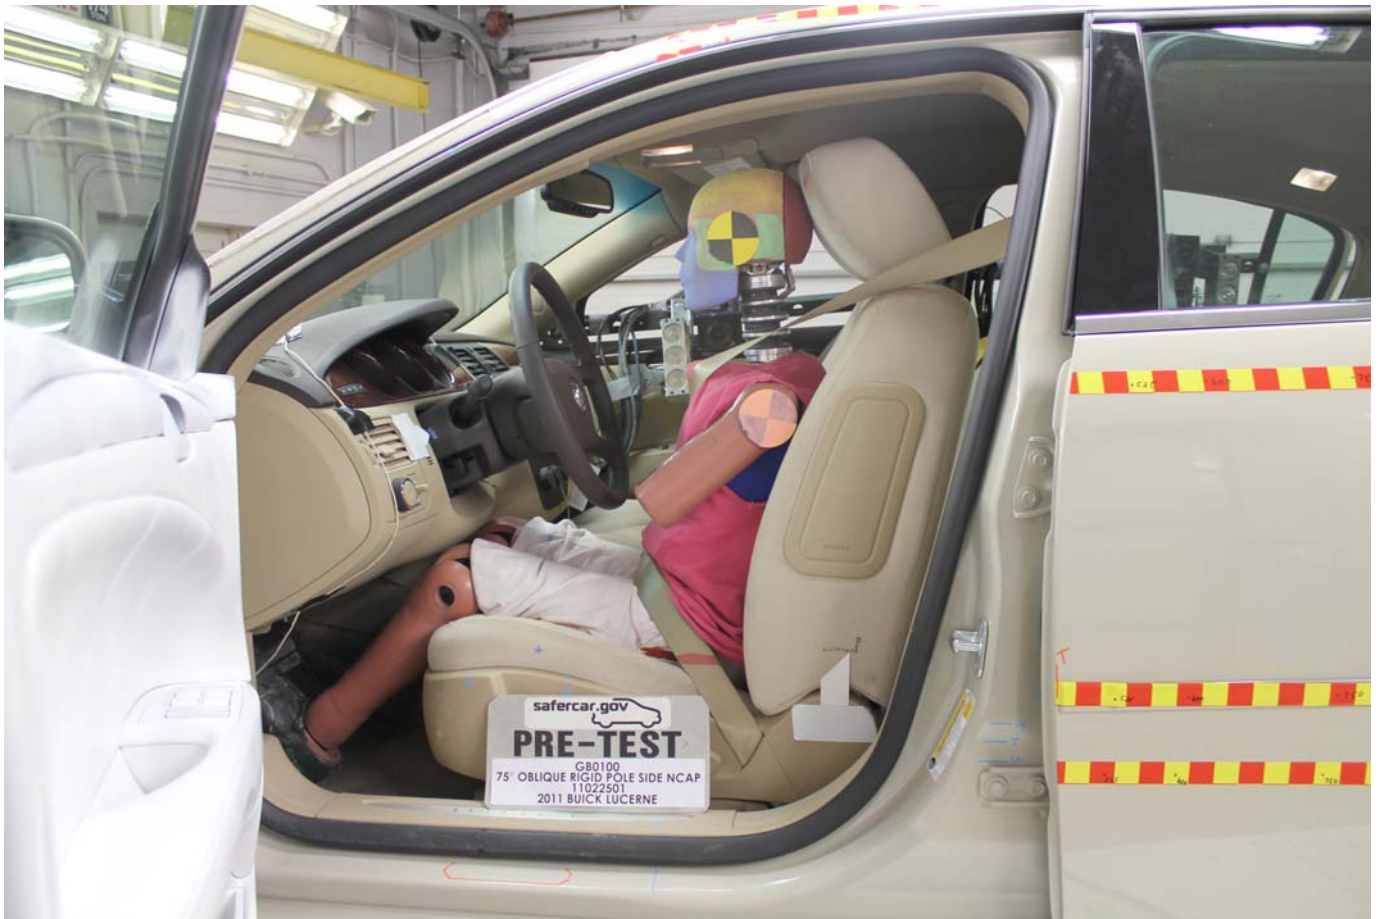
Pre-Test Left Side View of Dummy Showing Belts, Chalking, and Contact Switches (Door Open)

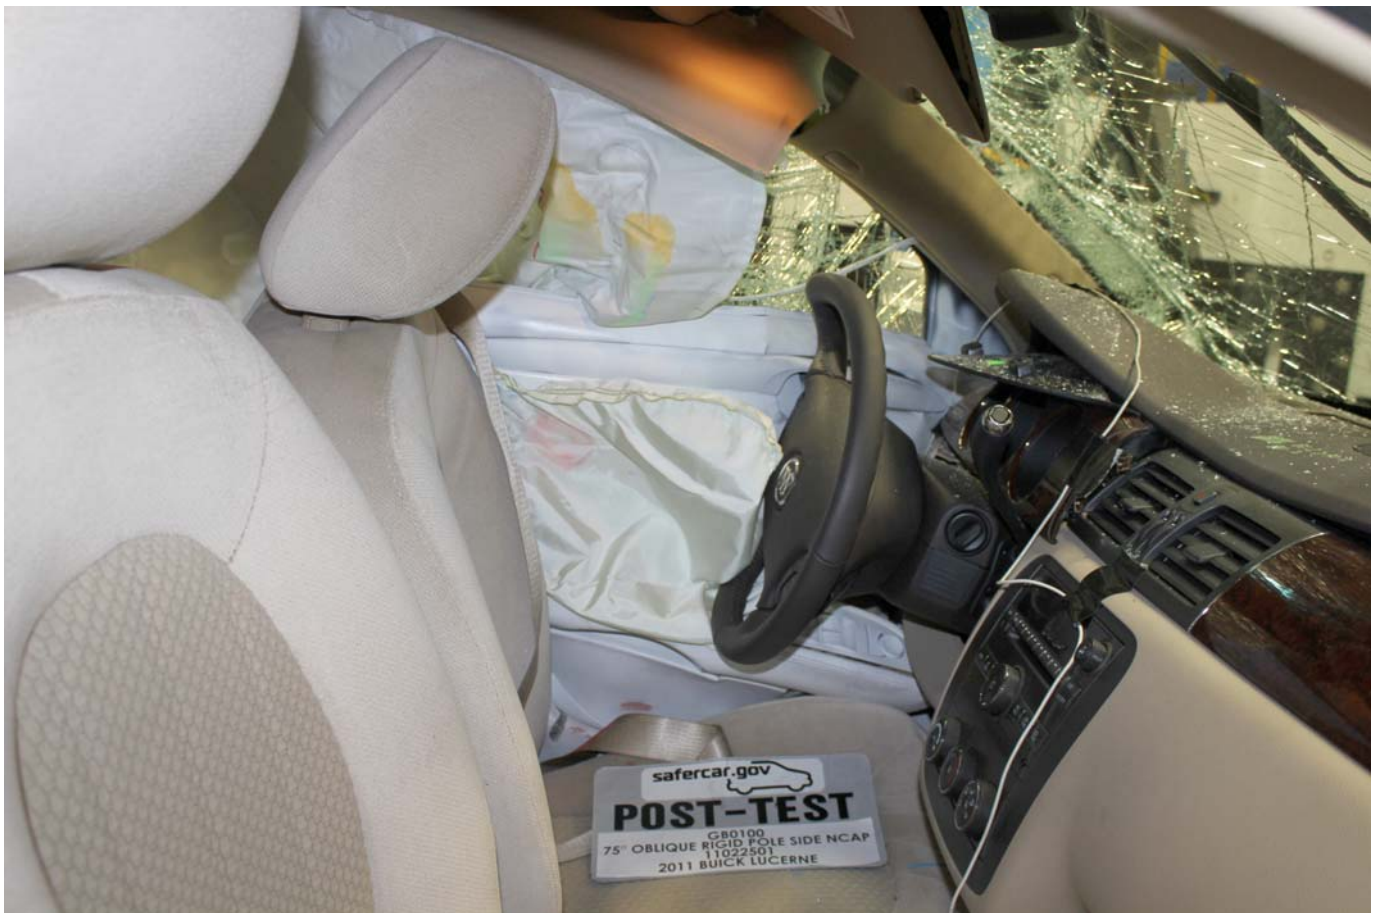
Post-Test Inner Driver Door Panel View Showing Dummy Contact Location

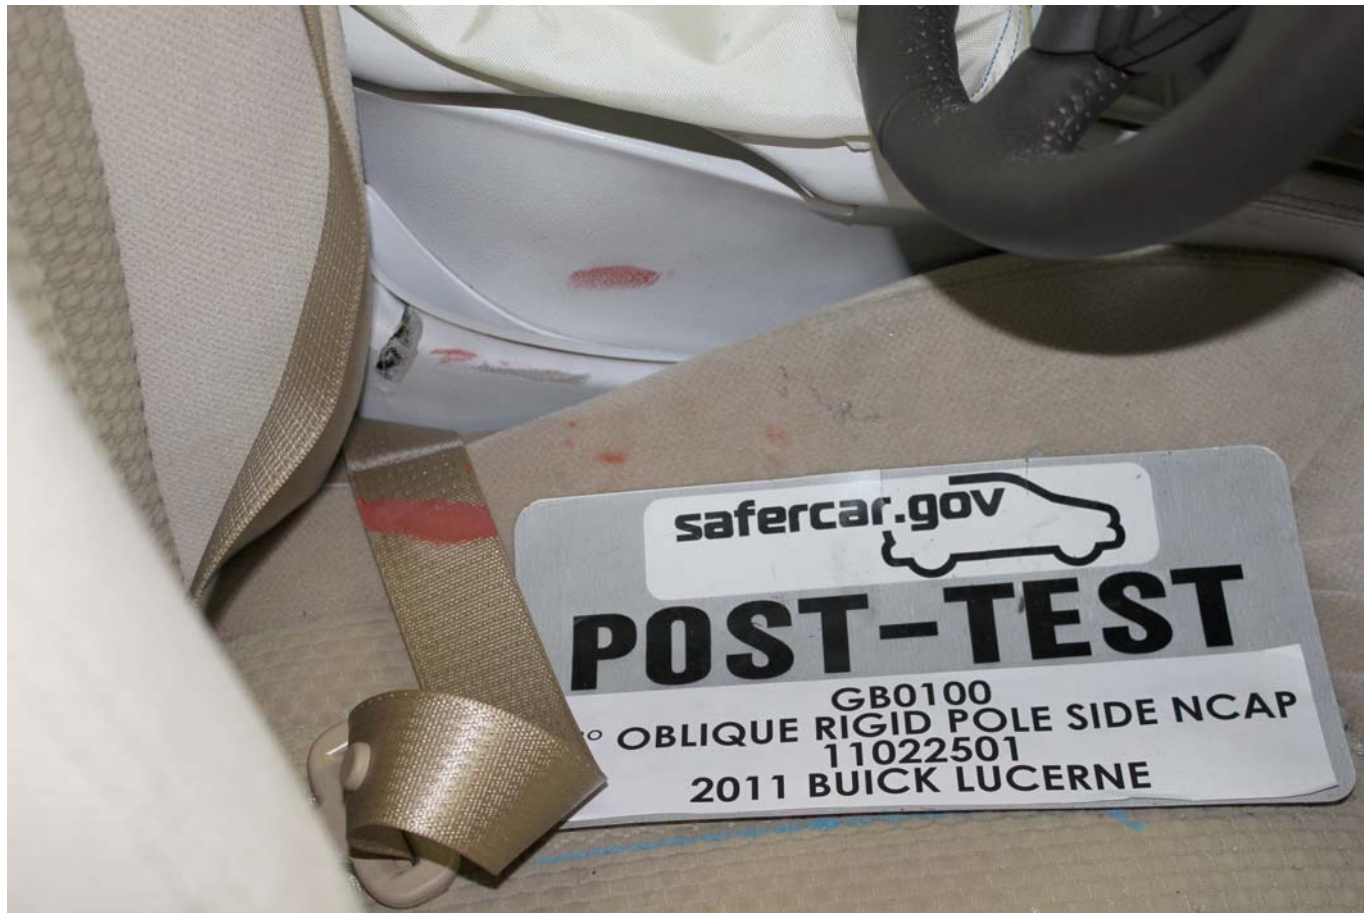
Post-Test Dummy Close-Up Pelvis Contact with Vehicle Interior View

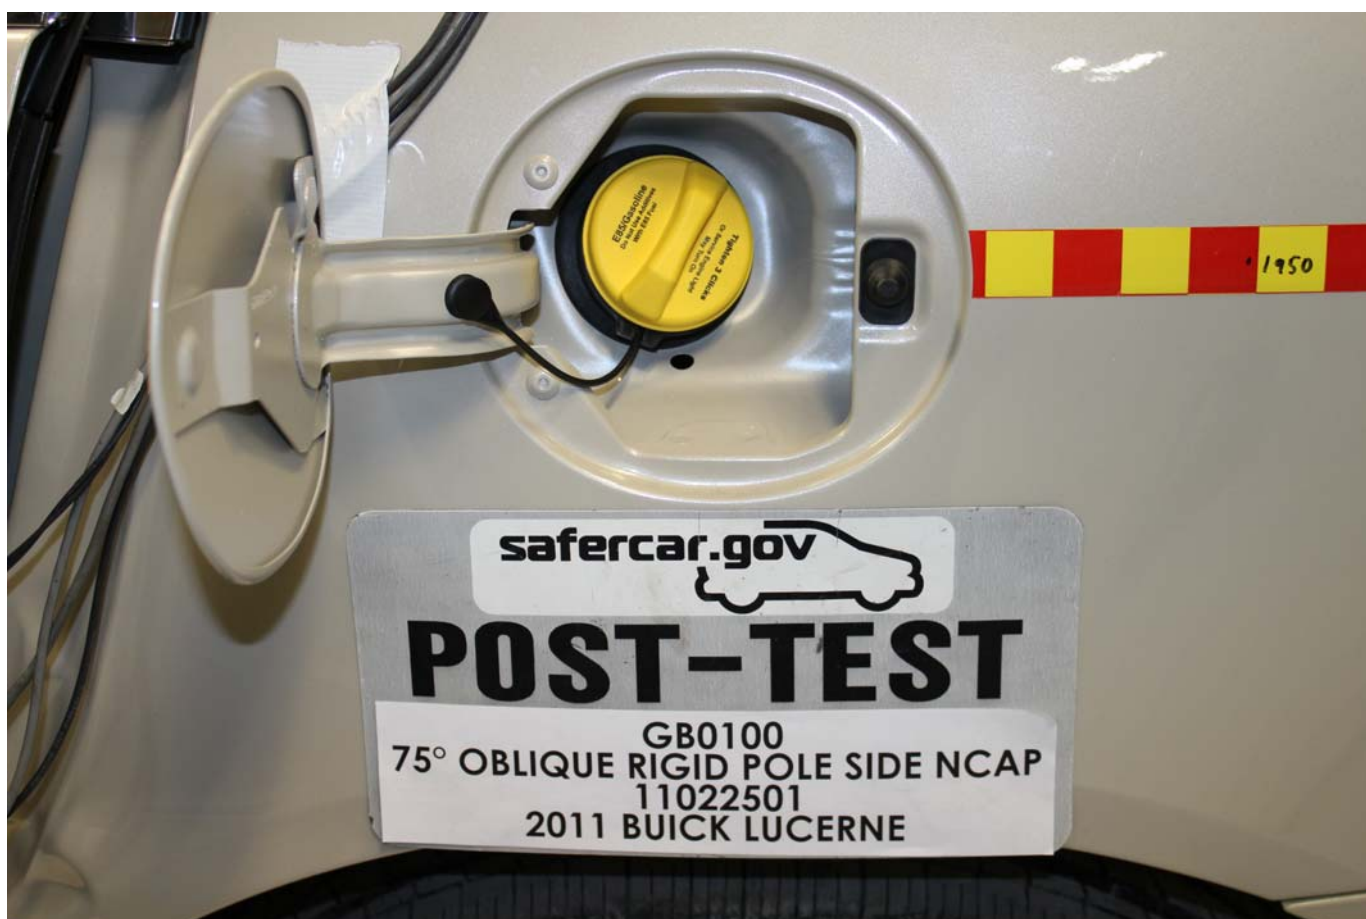
Post-Test View of Fuel Filler Cap or Fuel Filler Neck

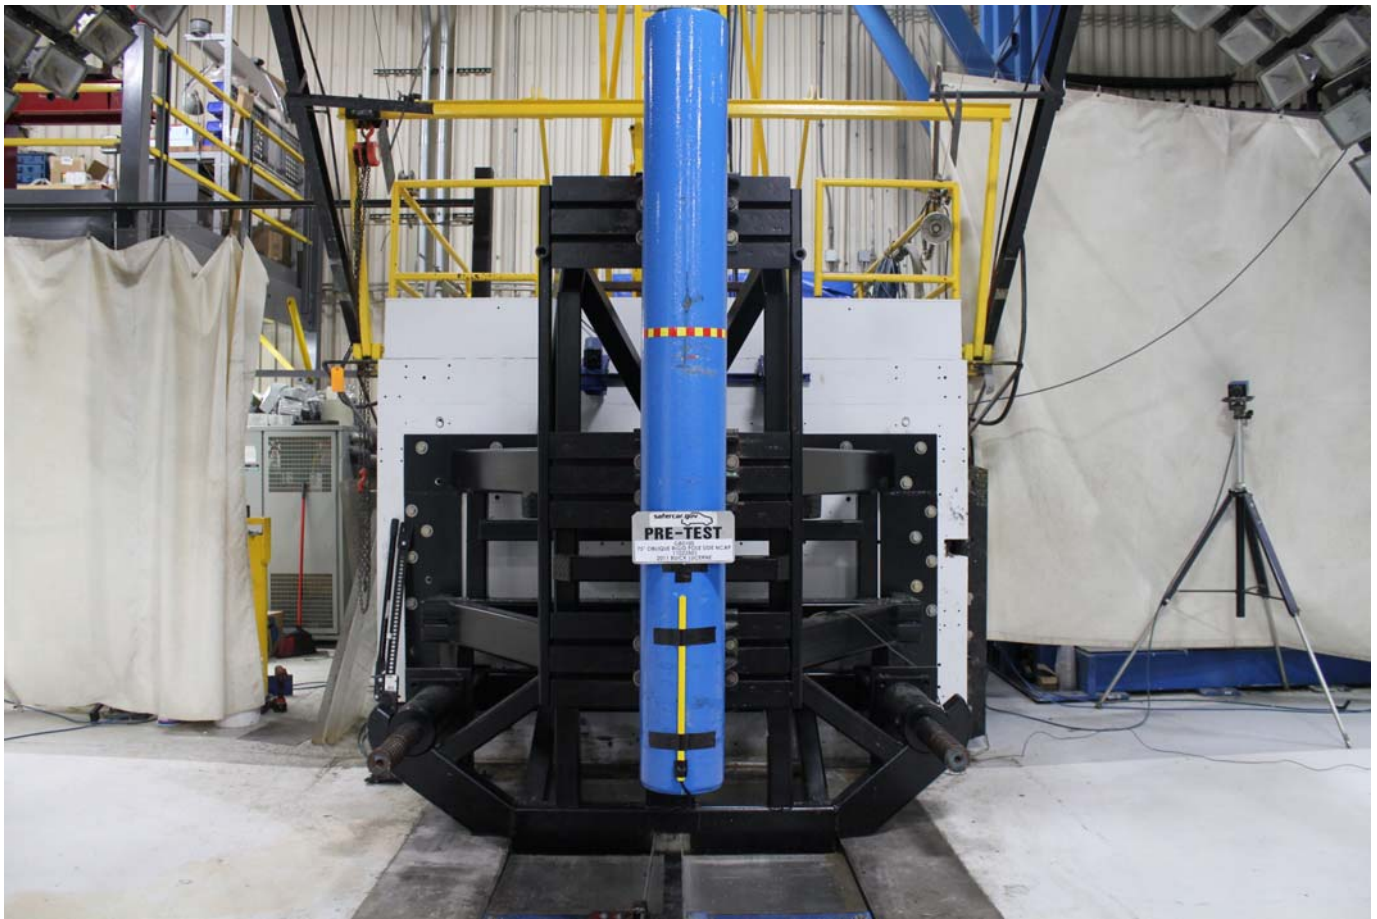
Pre-Test Pole Barrier Front View

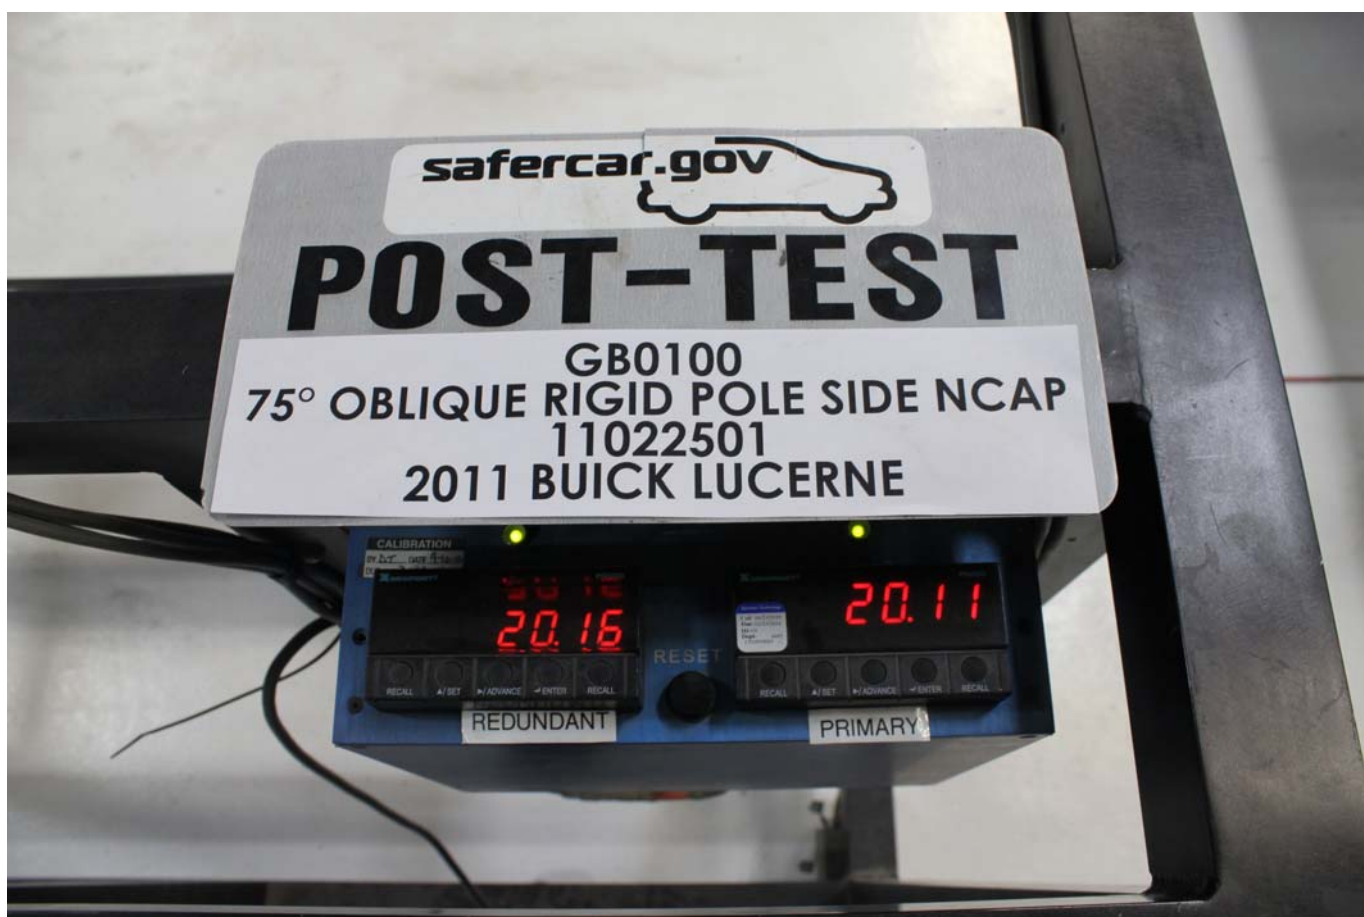
Post-Test Primary and Redundant Speed Trap Read-Out

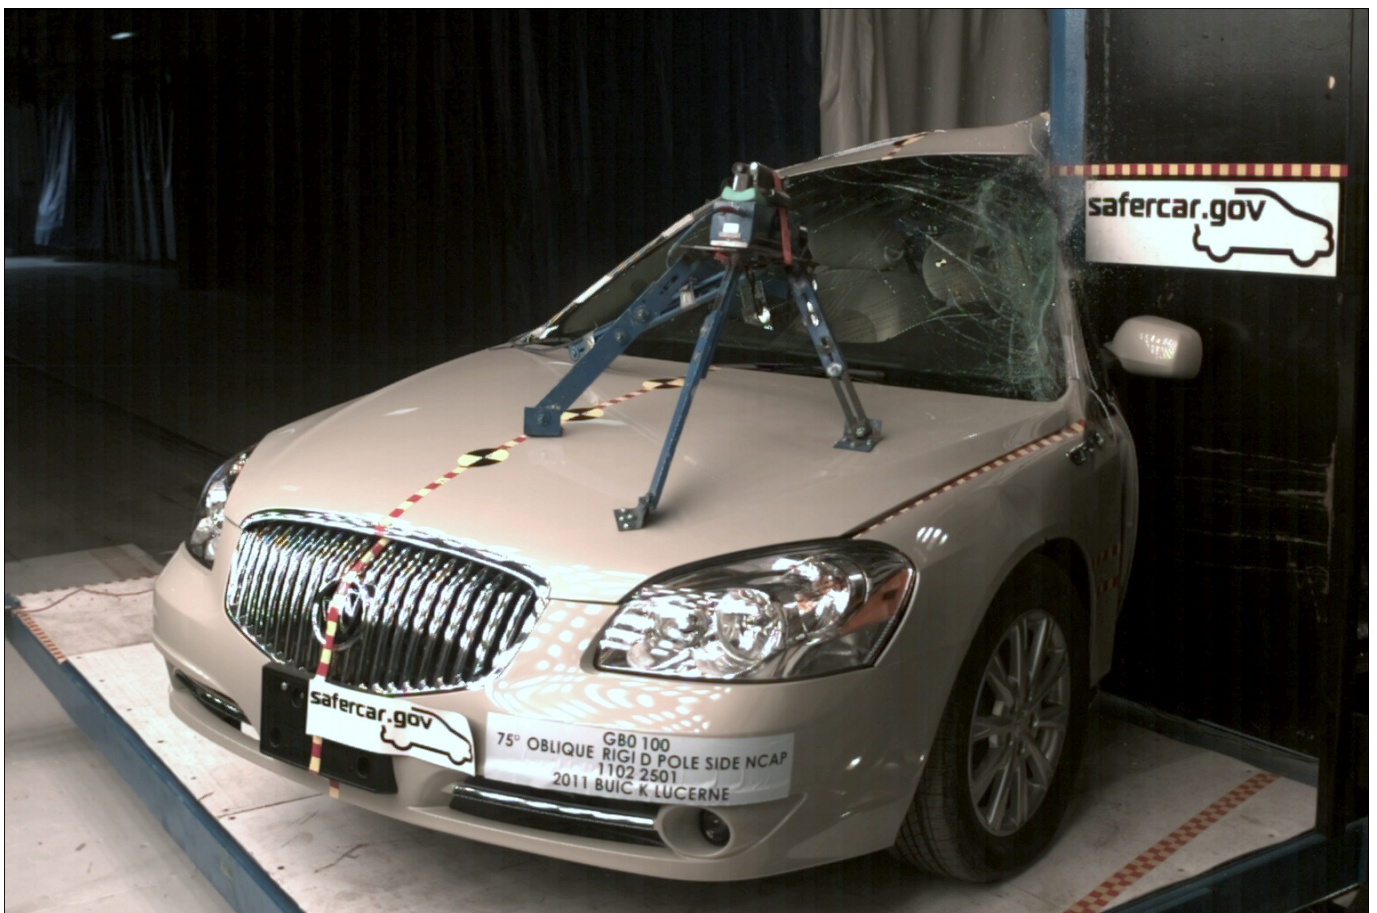
Impact Event

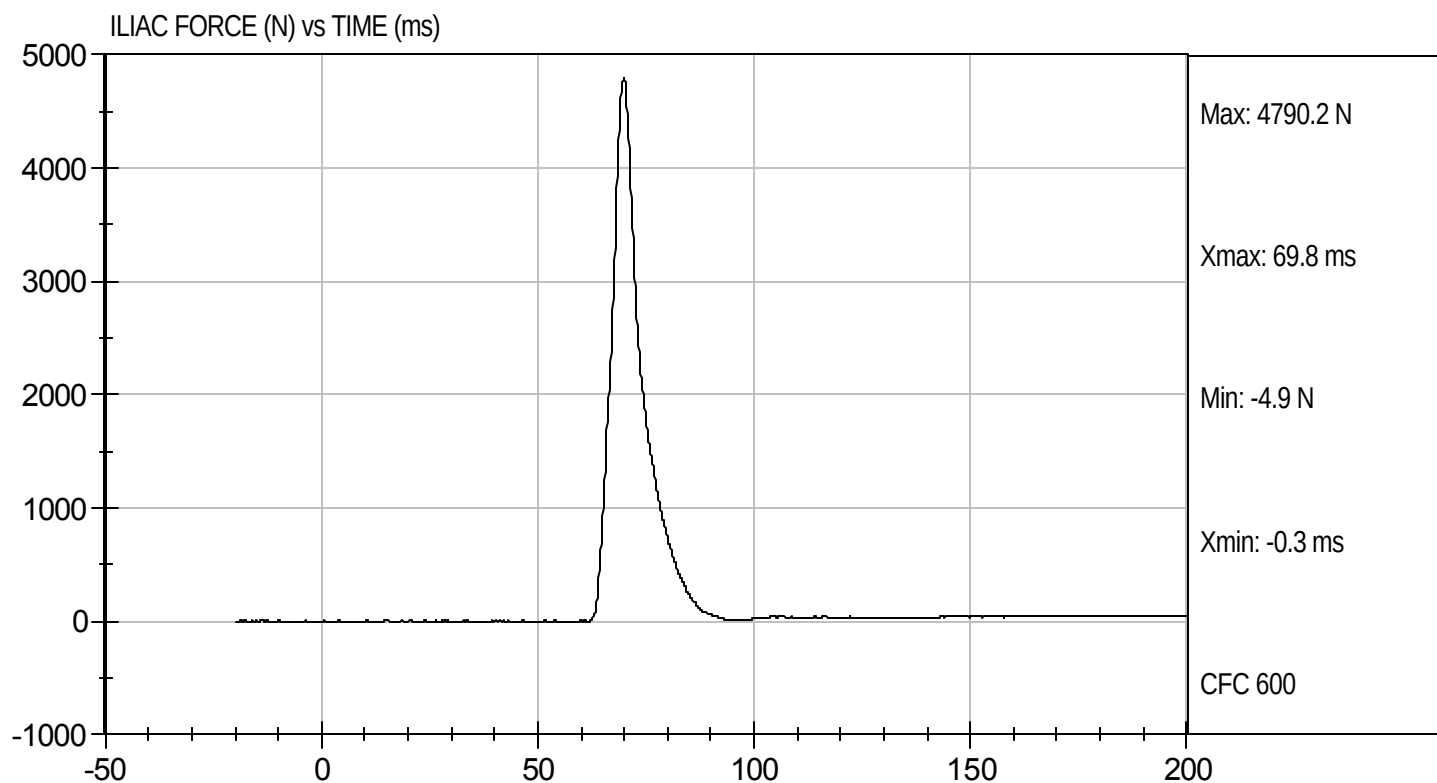
Test Desc: Iliac Impact  
Component ID: D11738

Test Date: 2/25/11  
Velocity: 14.37 ft/s, 4.38 m/s
