**REPORT NUMBER: NCAP-MGA-2011-077**

**NEW CAR ASSESSMENT PROGRAM (NCAP)  
Frontal Barrier Impact Test**

**GENERAL MOTORS LLC  
2011 Buick Lacrosse CXL 4-Dr Sedan  
NHTSA No.: GB0104**

**FINAL REPORT**

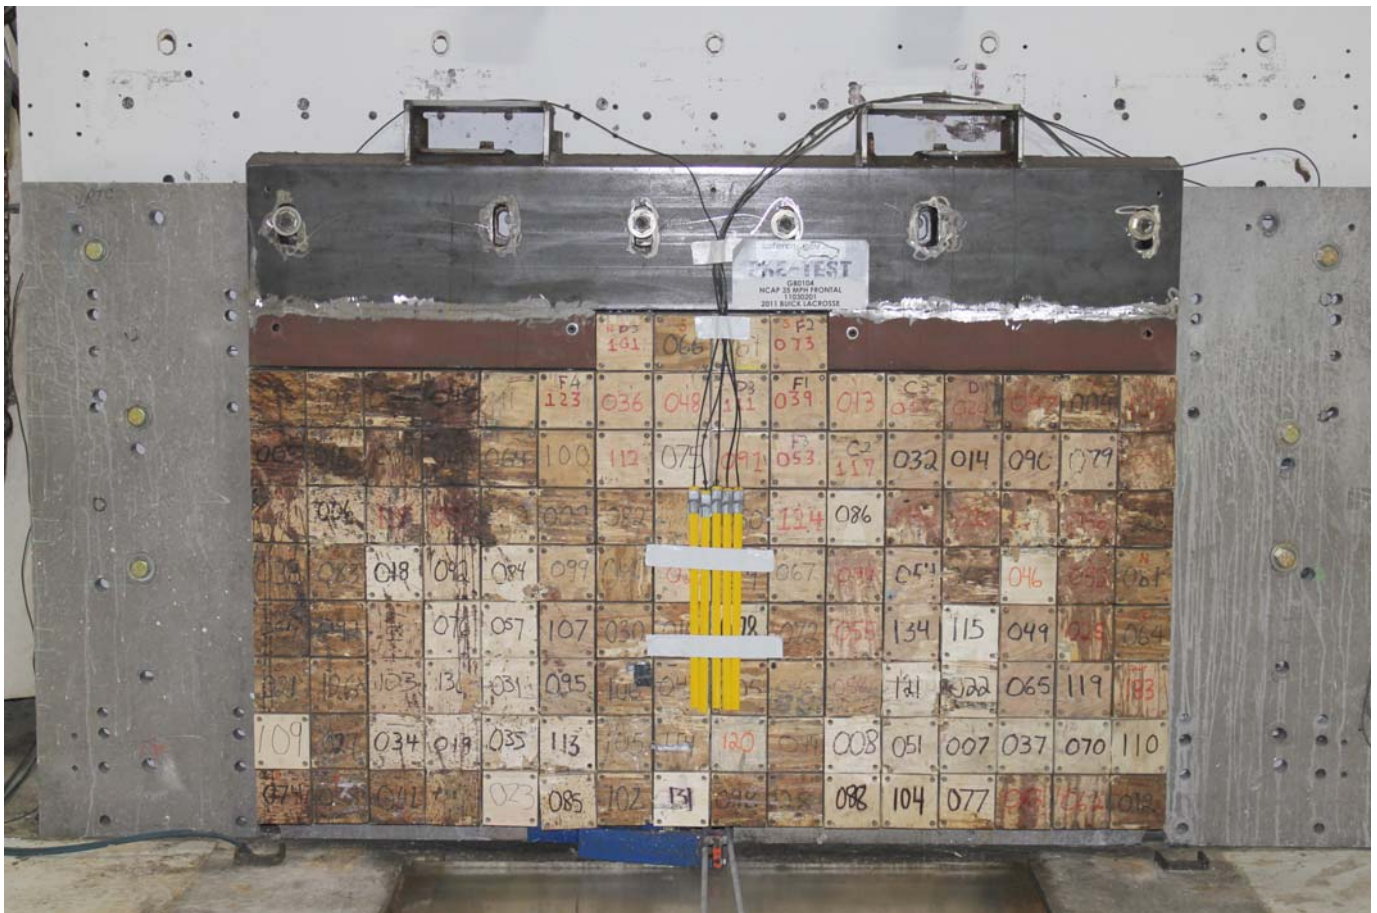
Load Cell Wall

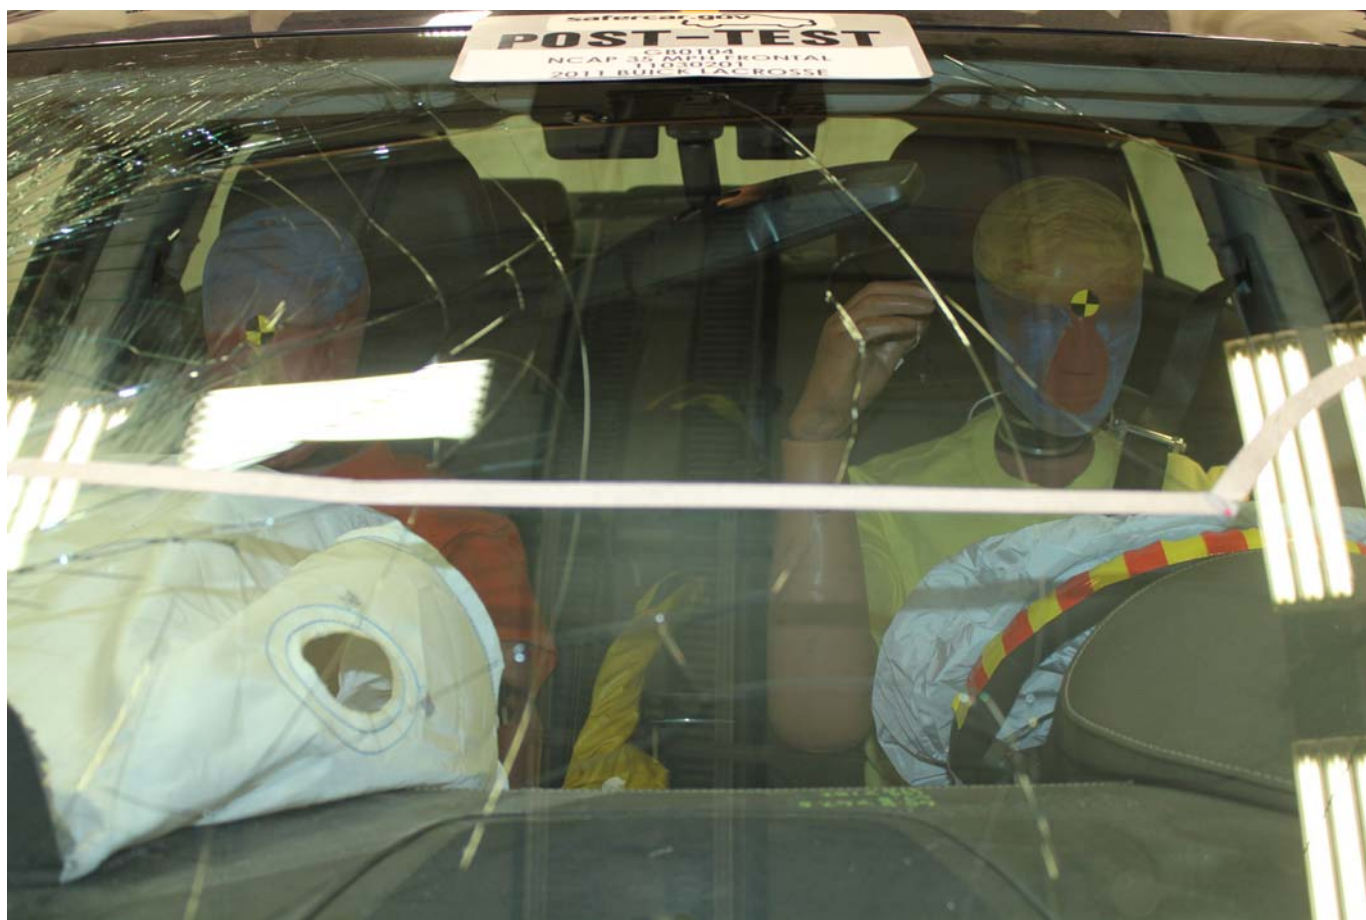
Post-Test Windshield View

There was 100 percent windshield retention and no intrusion into the protected zone of the windshield during the event. There was no Stoddard Solvent leakage after the event or during any phase of the static rollover.

| Critical Areas of Performance | Observations and Conclusions |
|---|---|
| Windshield Damage | Cracked |

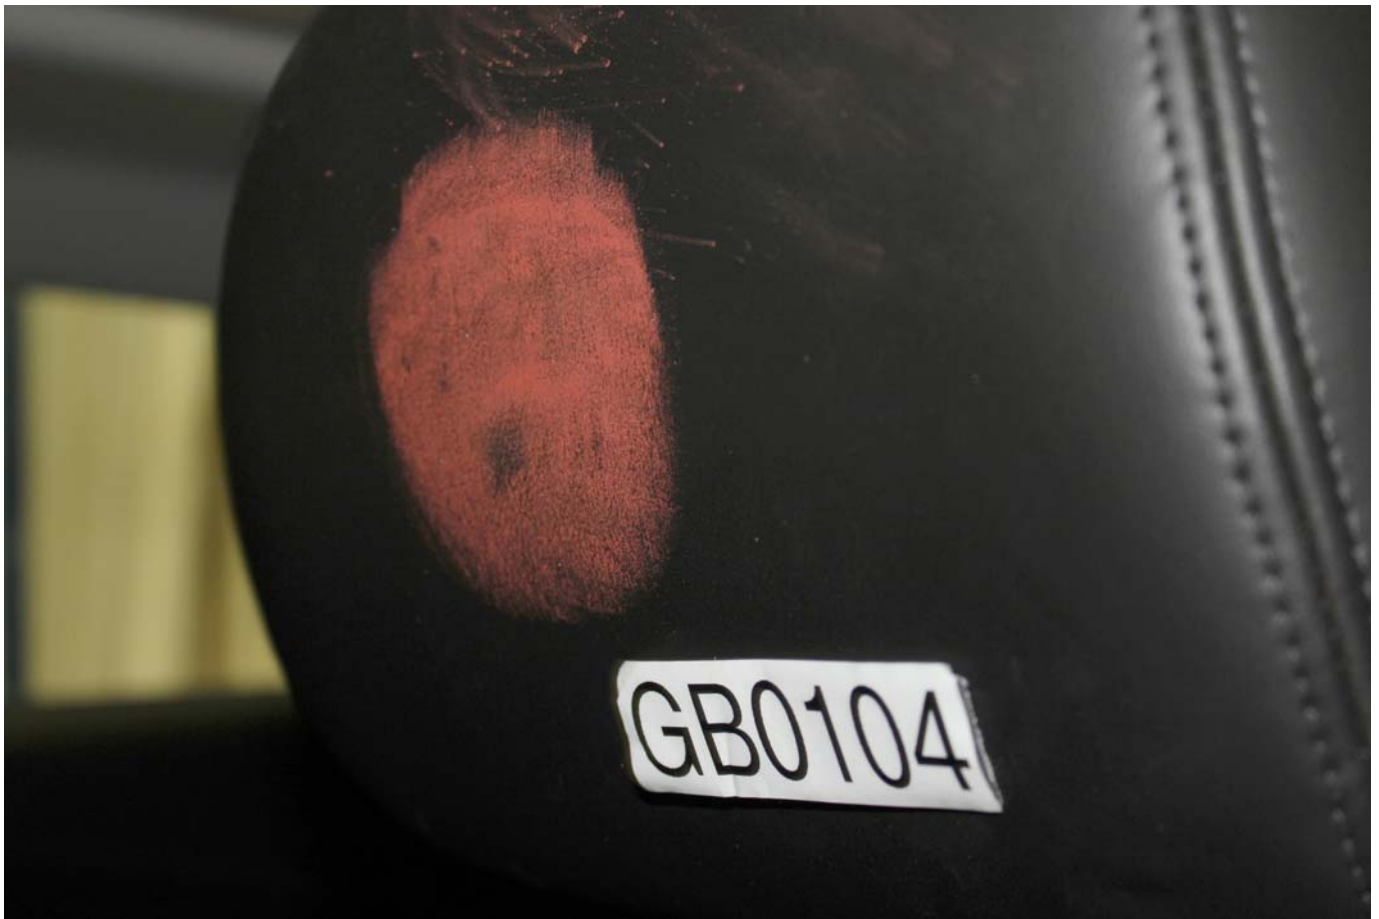
Post-Test Driver Dummy Contact with Headrest

The driver's head and chest contacted the airbag. The driver's head also contacted the headrest. The driver's knees contacted the knee bolster. The passenger's head and chest contacted the airbag. The passenger's head also contacted the headrest. The passenger's knees contacted the glovebox.

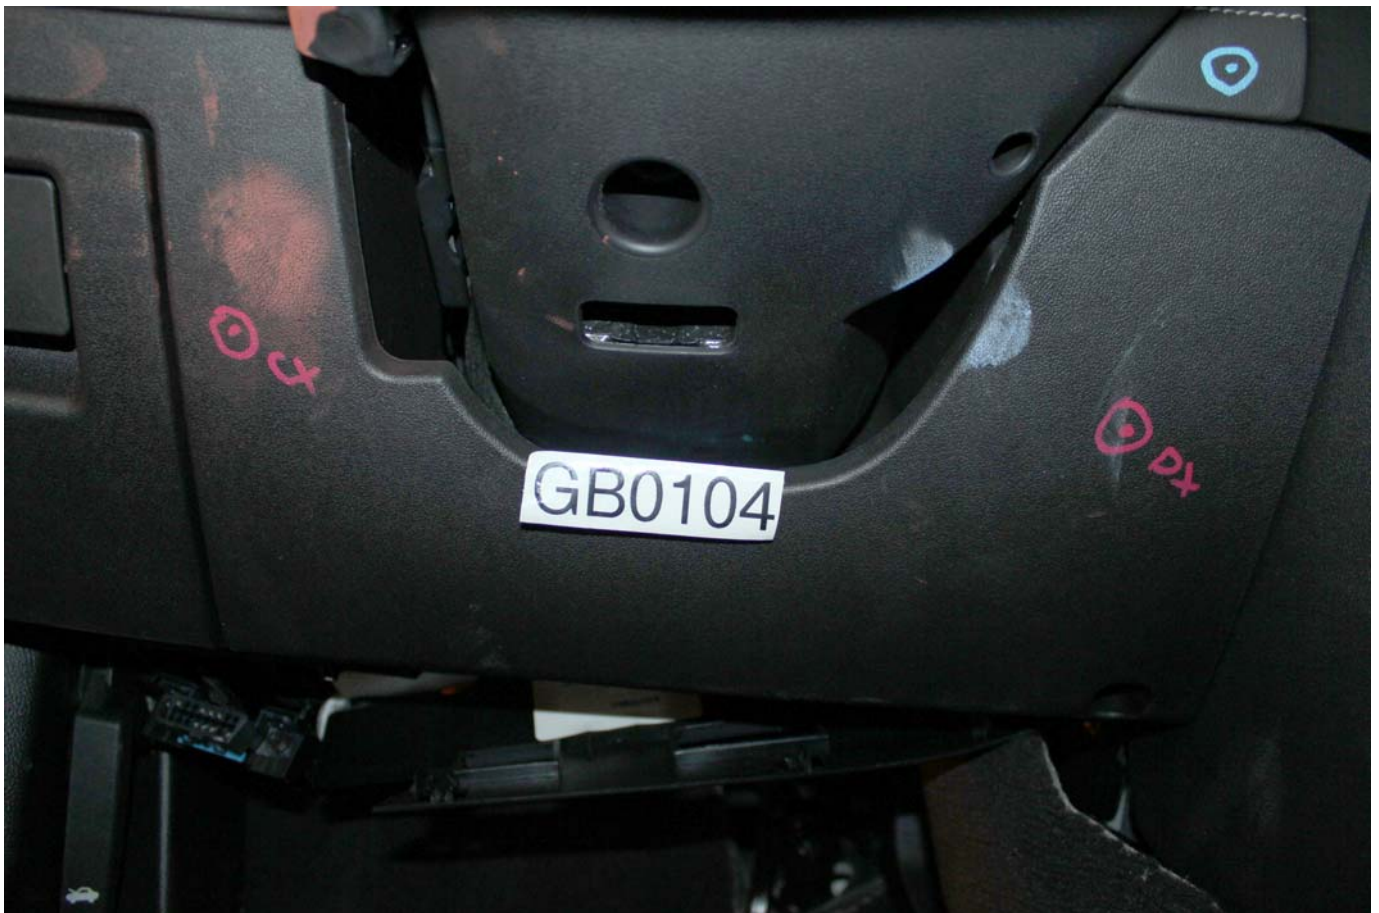
Post-Test Driver Dummy Contact with Knee Bolster

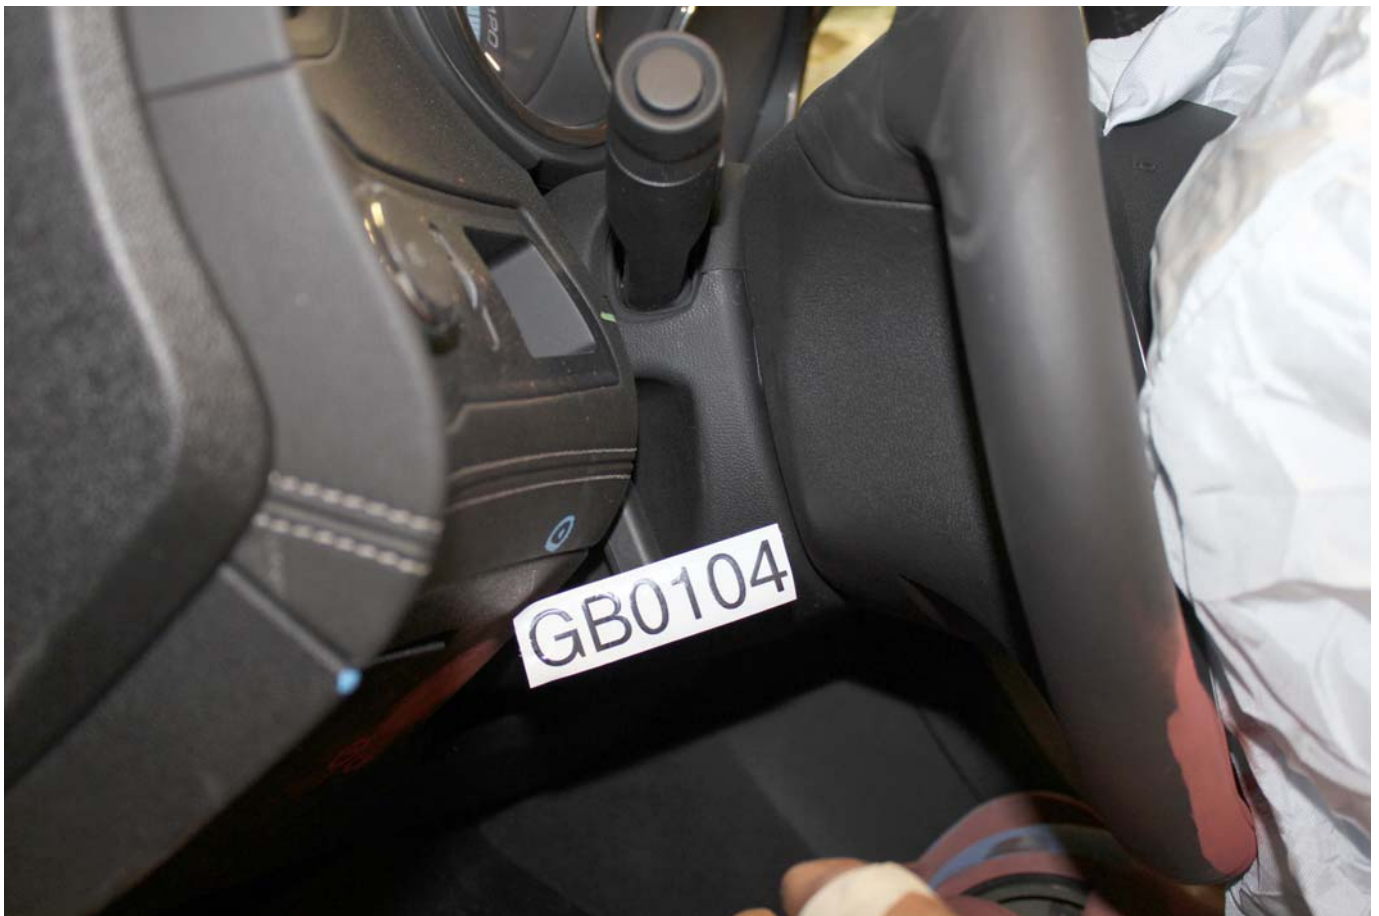
Post-Test View of Steering Column Shear Capsule

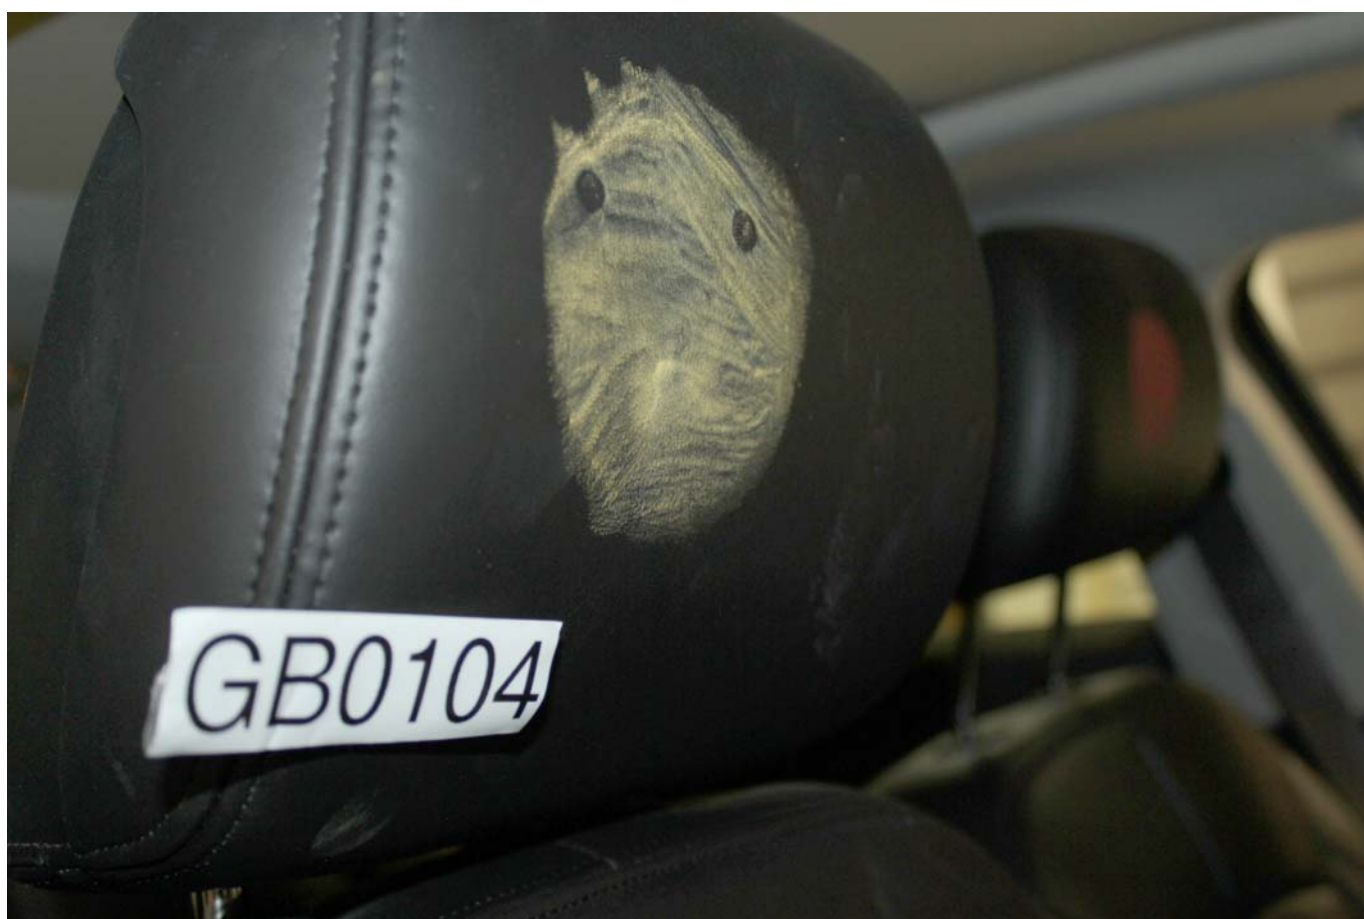
Post-Test Passenger Dummy Contact with Headrest

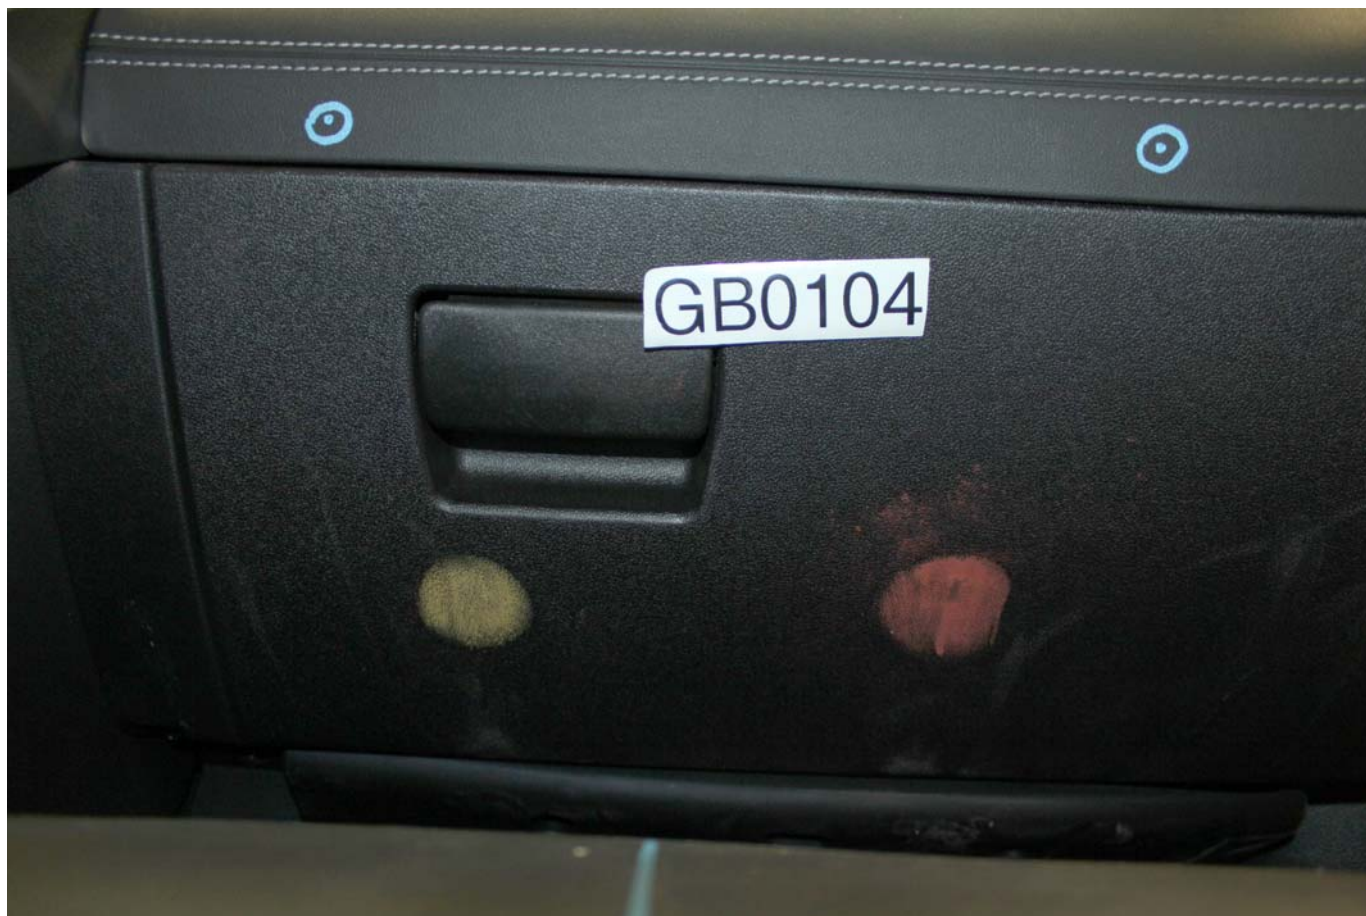
Post-Test Passenger Dummy Contact with Glovebox

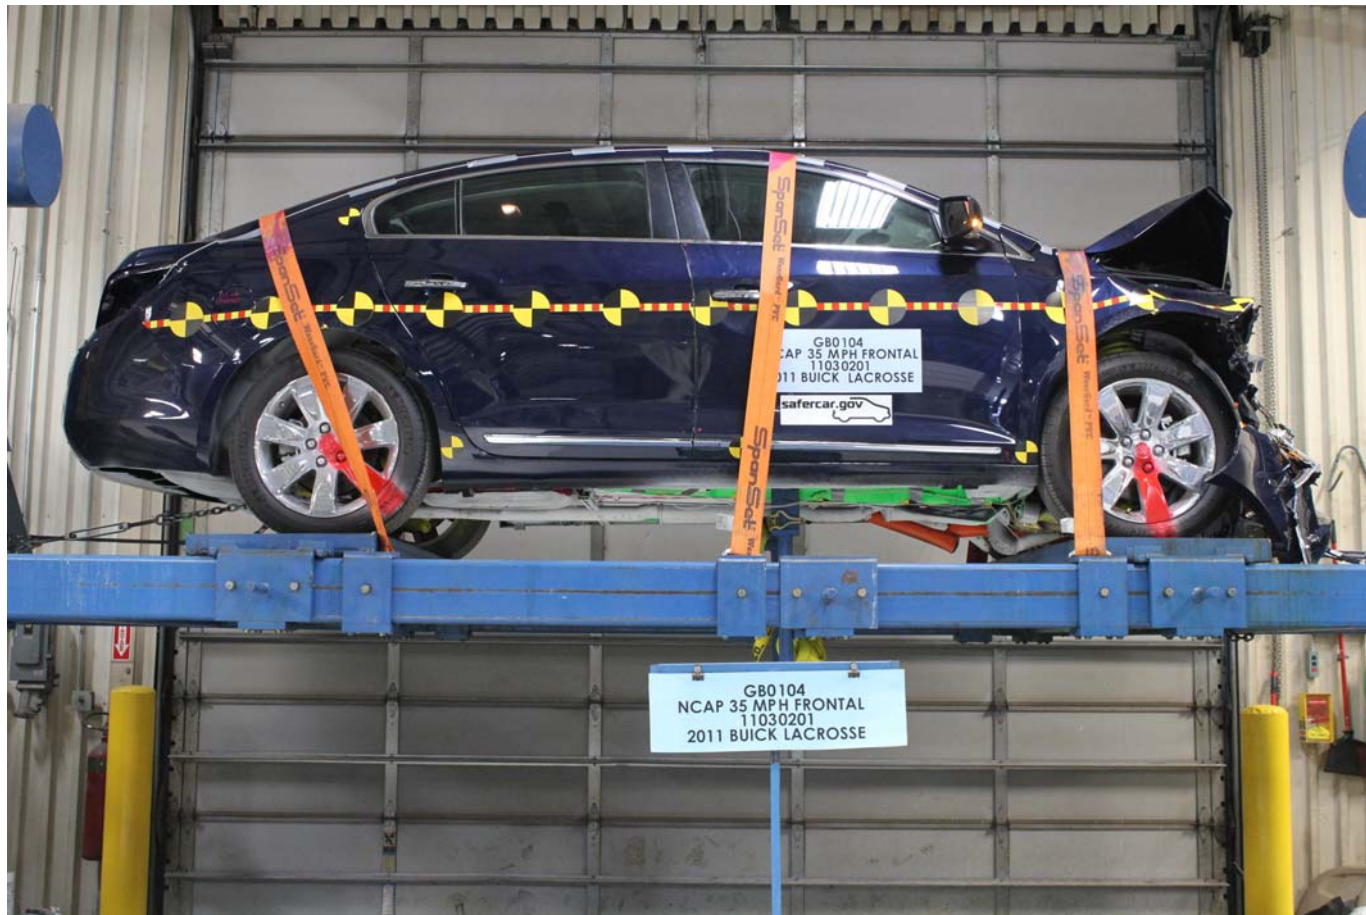
Vehicle at 0 Degrees on Static Rollover Device

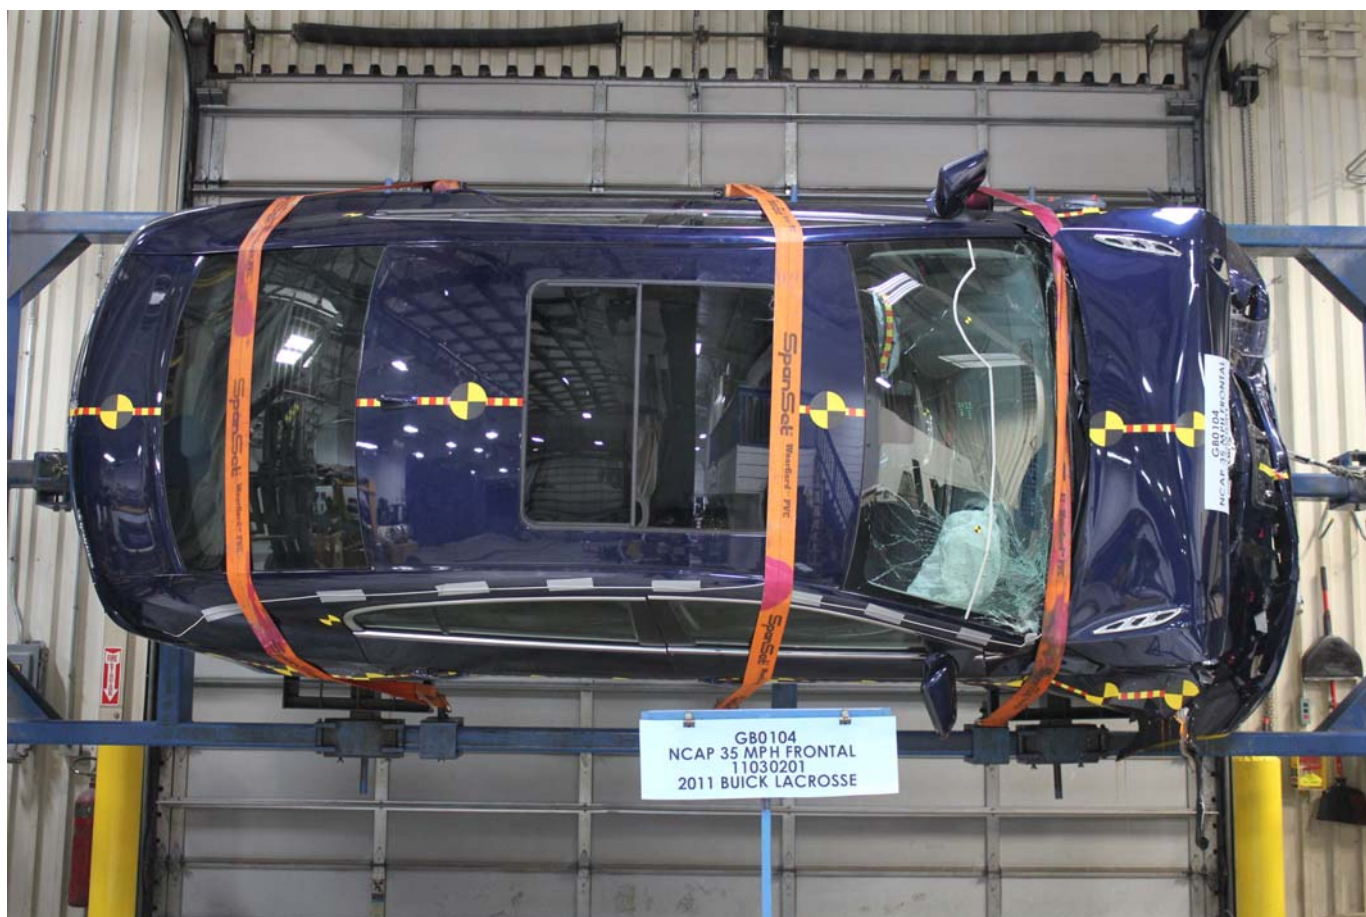
Vehicle at 90 Degrees on Static Rollover Device
