REPORT NUMBER: SINCAP-MGA-2011-079

**NEW CAR ASSESSMENT PROGRAM (NCAP)
Moving Deformable Barrier Side Impact Test**

**GENERAL MOTORS LLC
2011 Chevrolet Volt 5-Dr Hatchback
NHTSA No.: MB0126**

**MGA RESEARCH CORPORATION
5000 Warren Road
Burlington, WI 53105**

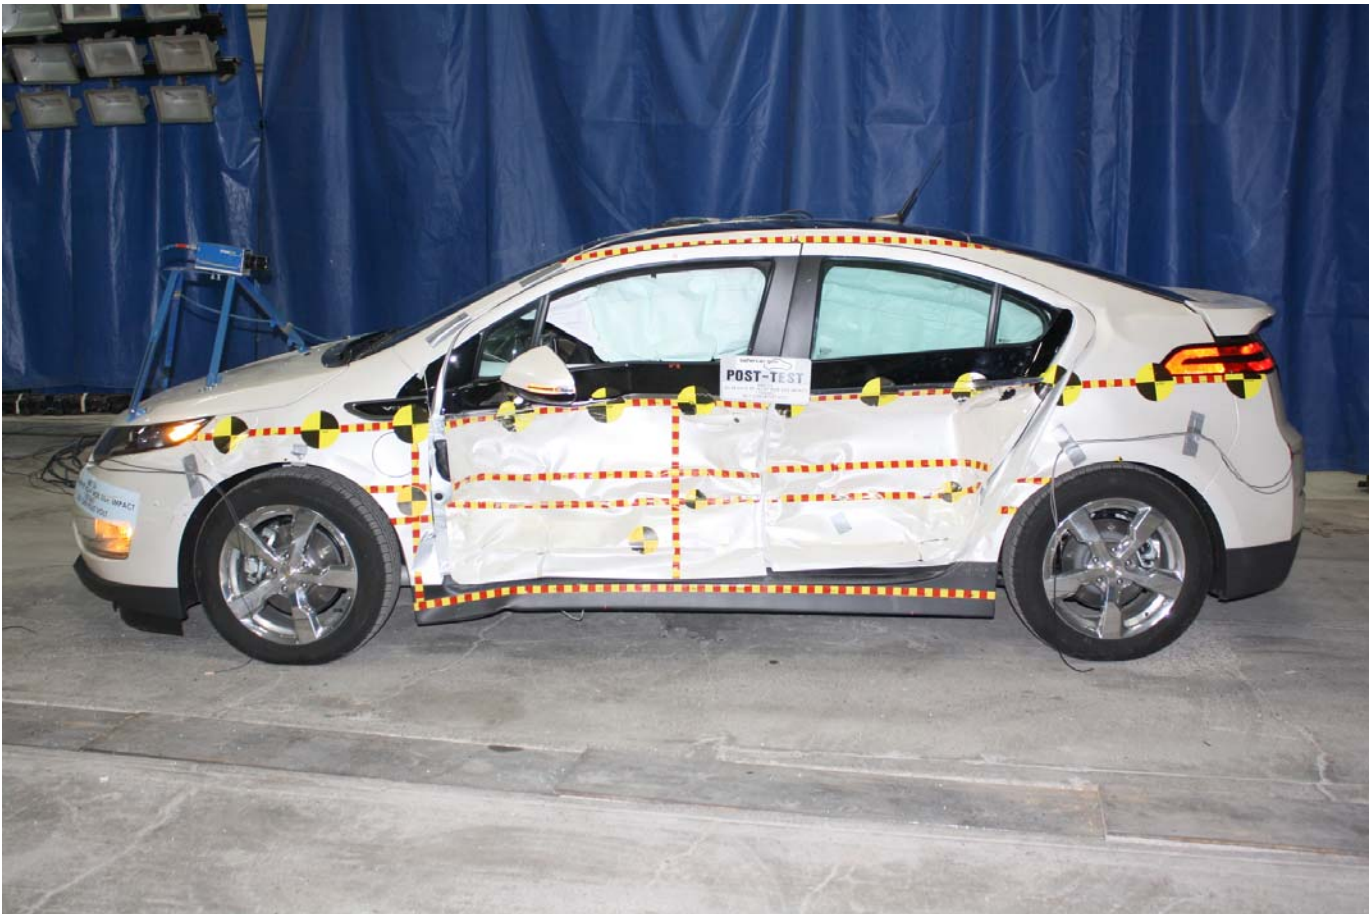
Post-Test Left Side View of Test Vehicle

Description	Front	Rear
Left Side Doors	Remained closed and jammed shut	Remained closed and jammed shut
Right Side Doors	Remained closed and operational	Remained closed and operational
Hatch and Other Doors		Remained closed and operational
Seat Movement	0	0
Seat Back Failure	None	None

Critical Areas of Performance	Observations and Conclusions
Pillar Performance	No Separation
Sill Separation	None
Windshield Damage	None
Window Damage	Left Front Broke
Other Notable Effects	None

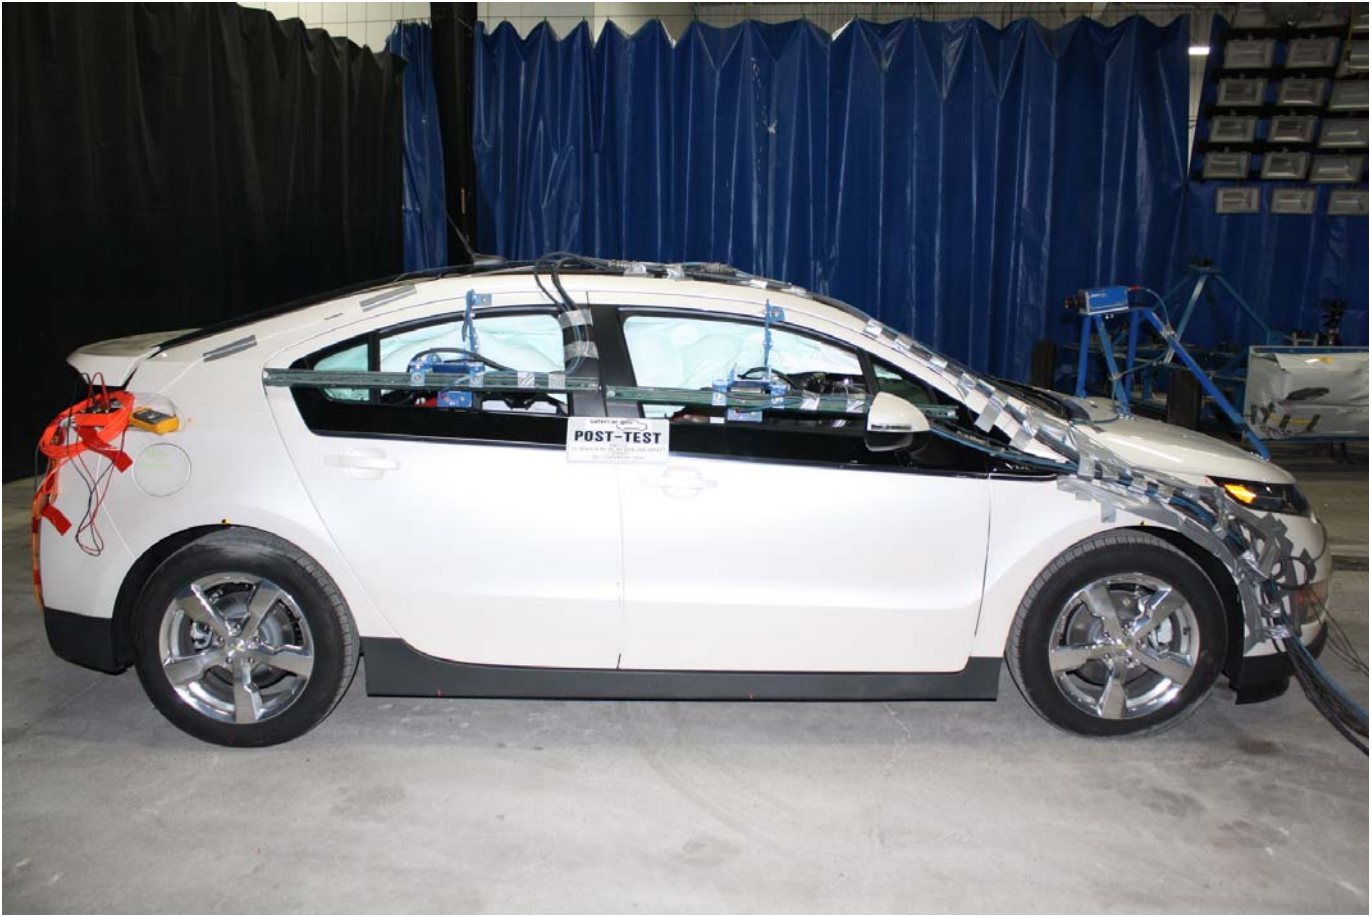
Post-Test Right Side View of Test Vehicle

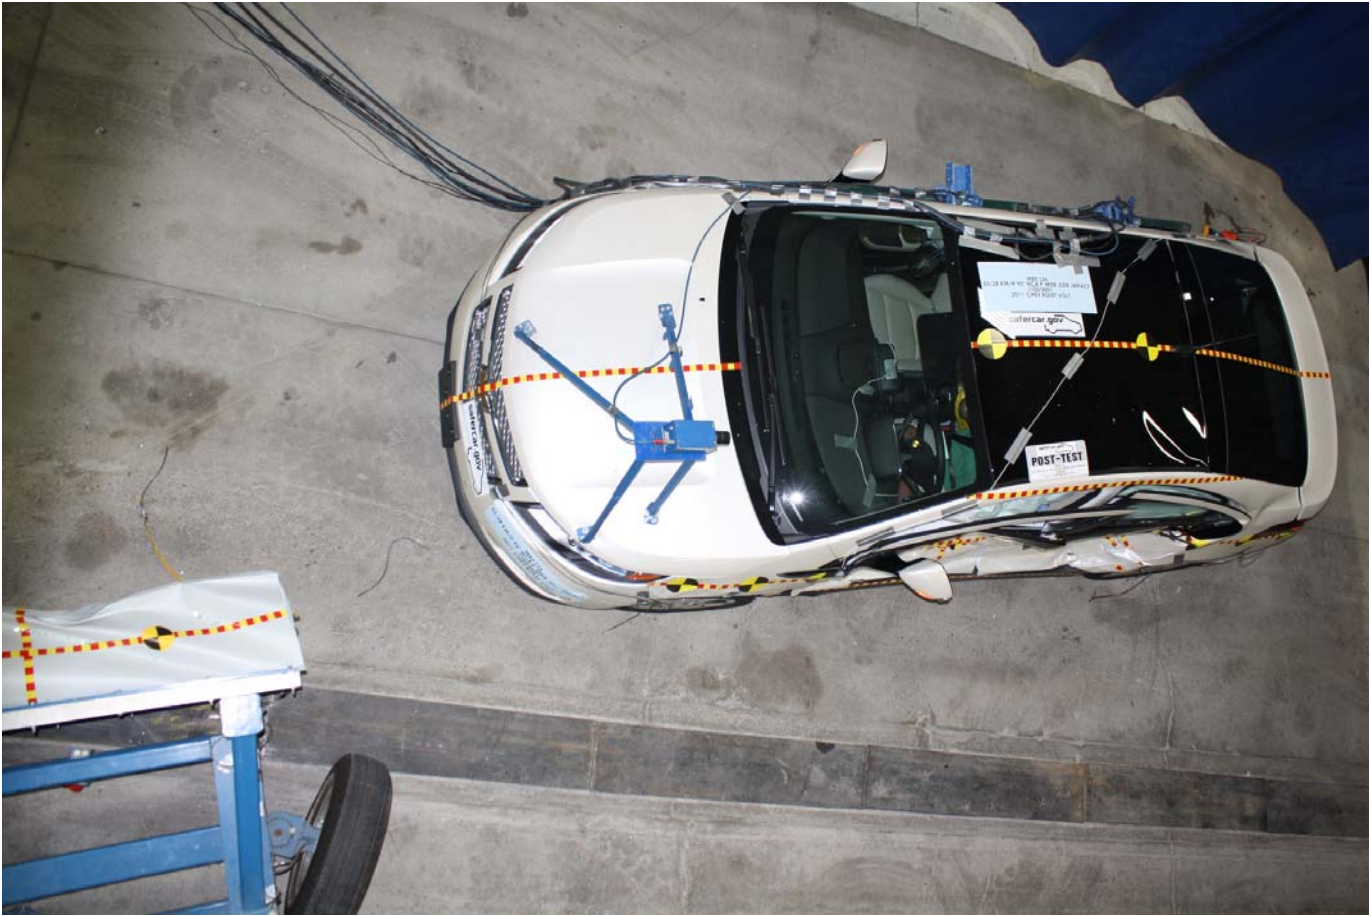
Post-Test Overhead View of Test Vehicle and MDB

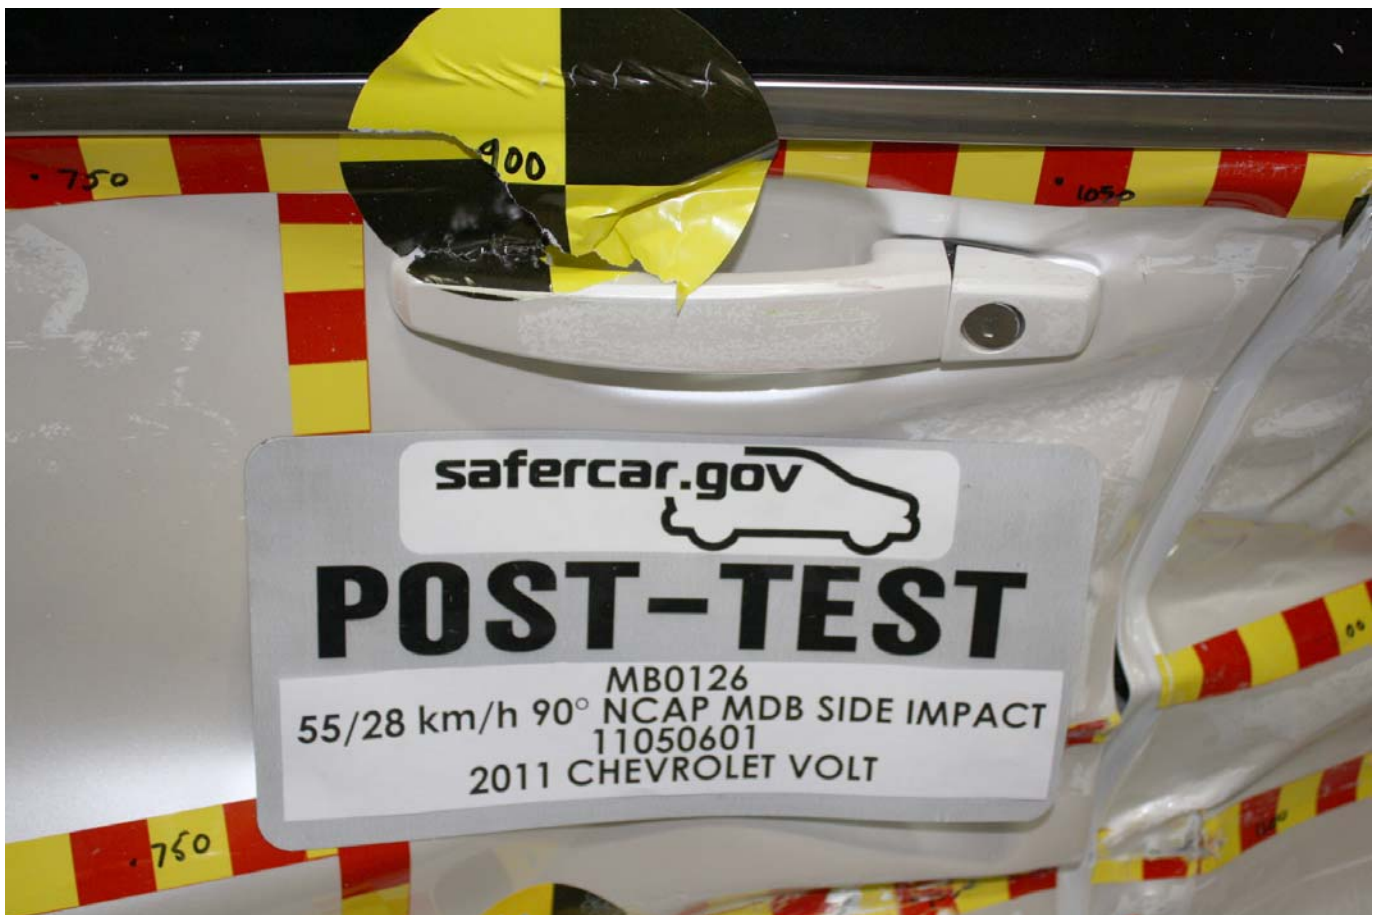
Post-Test Left Front Door Latch Close-Up

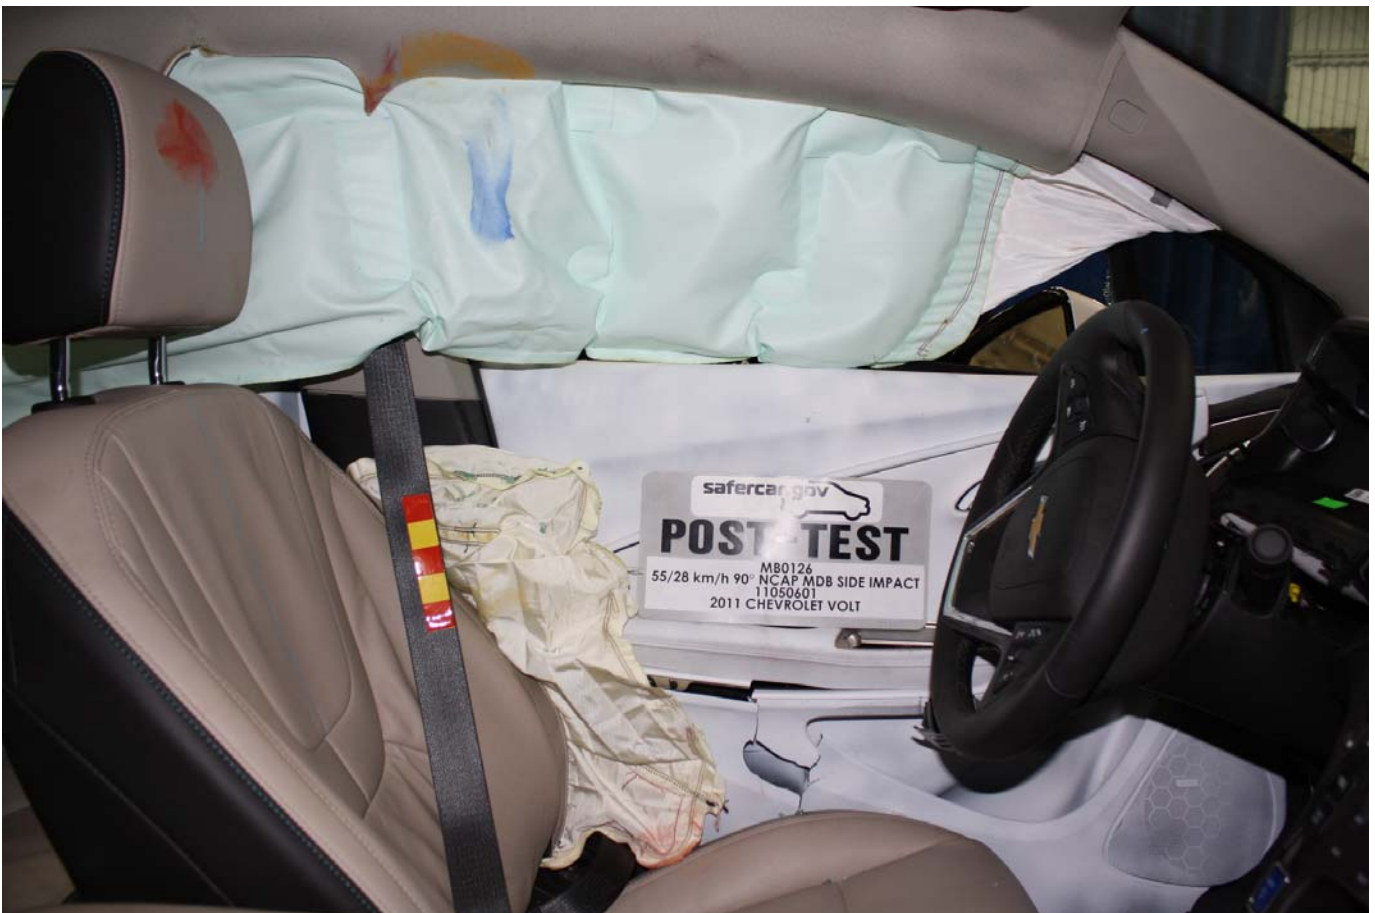
Post-Test Driver Inner Door Panel View Showing Driver Dummy Contact Locations

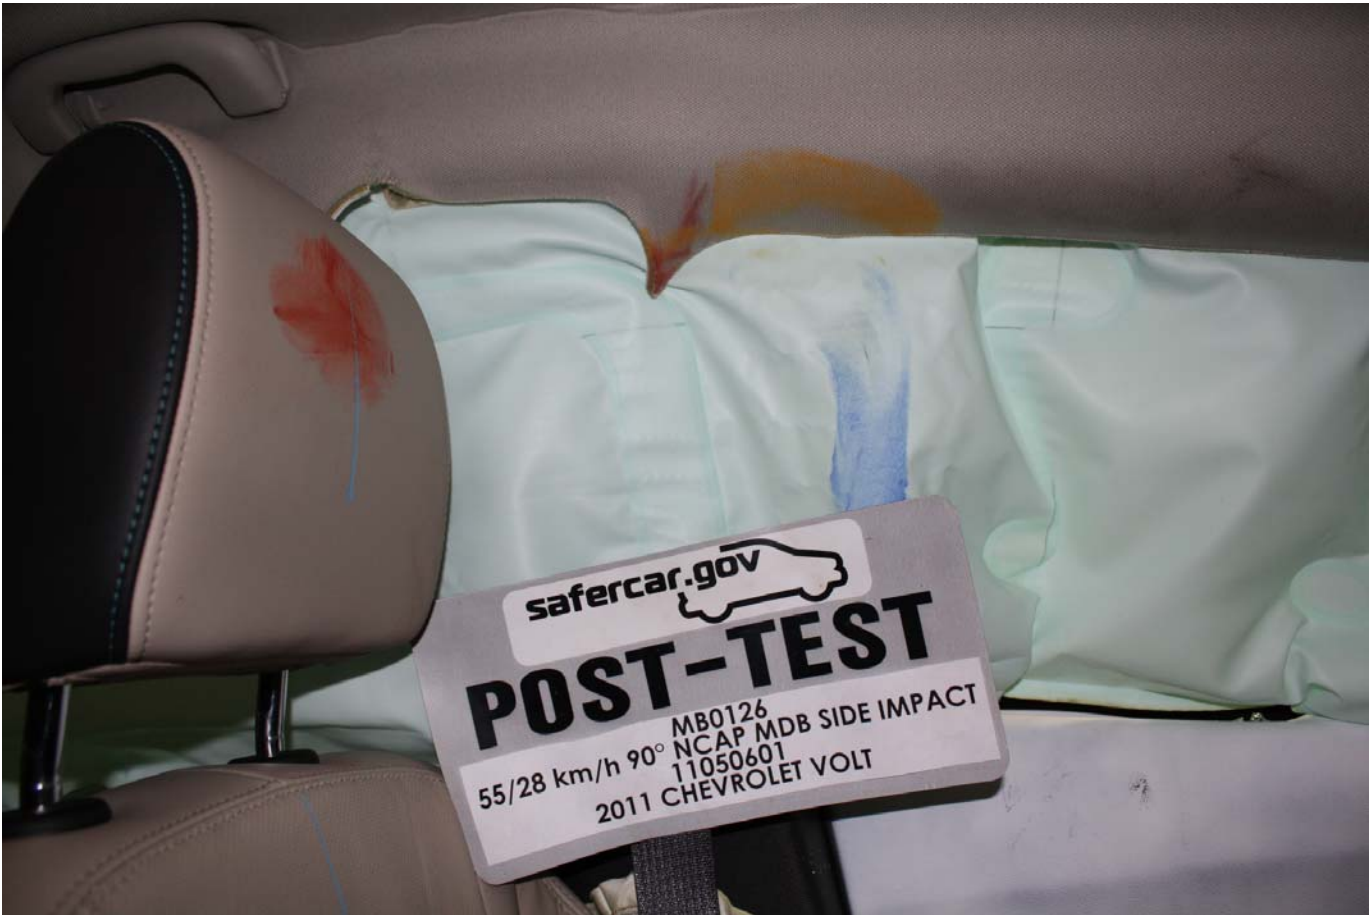
Post-Test Driver Dummy Close-up Head Contact with Vehicle Interior View

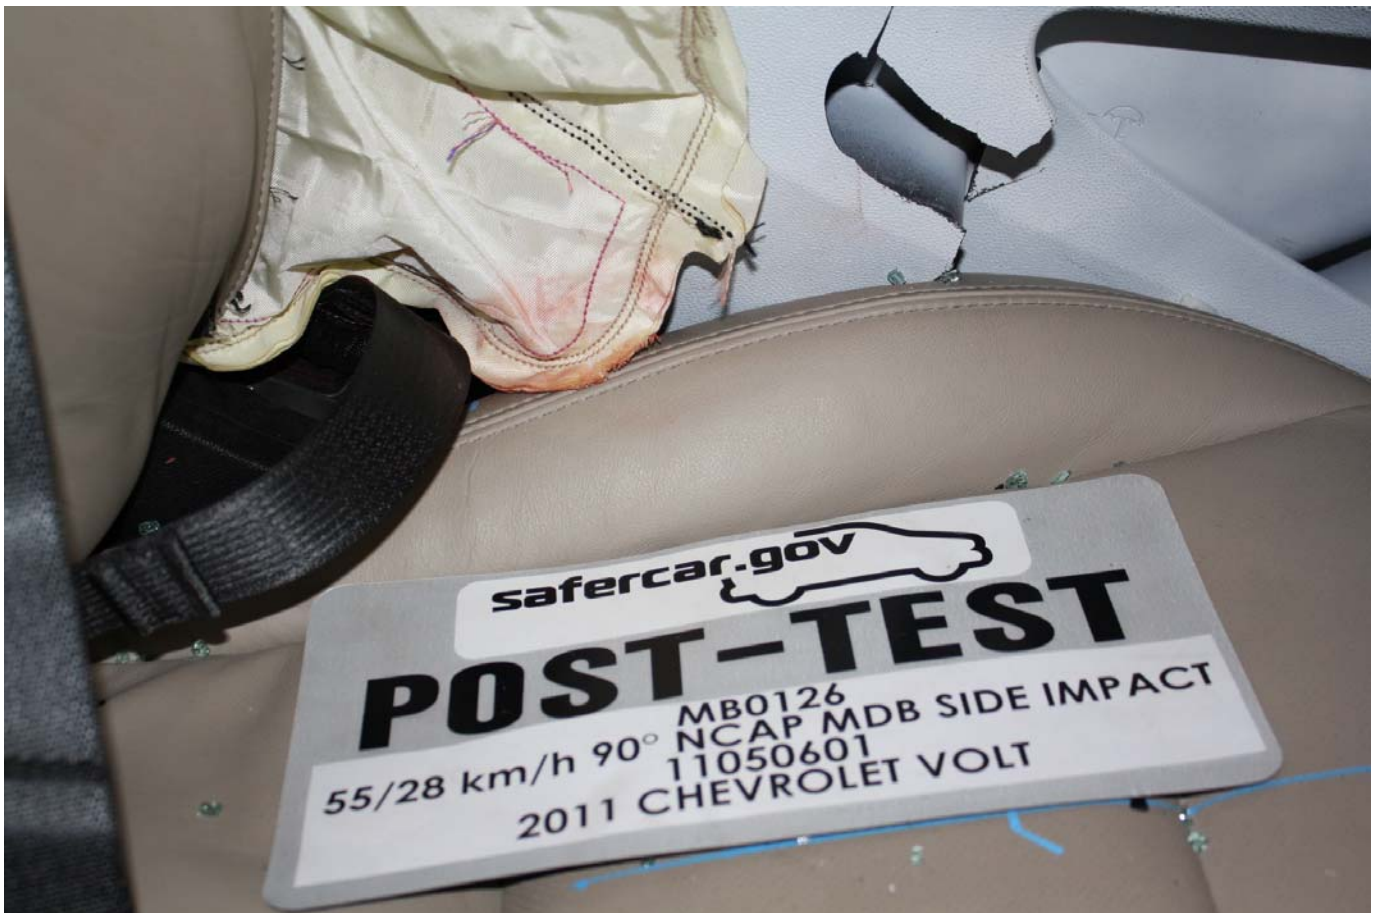
Post-Test Driver Dummy Close-up Pelvis Contact with Side Airbag View

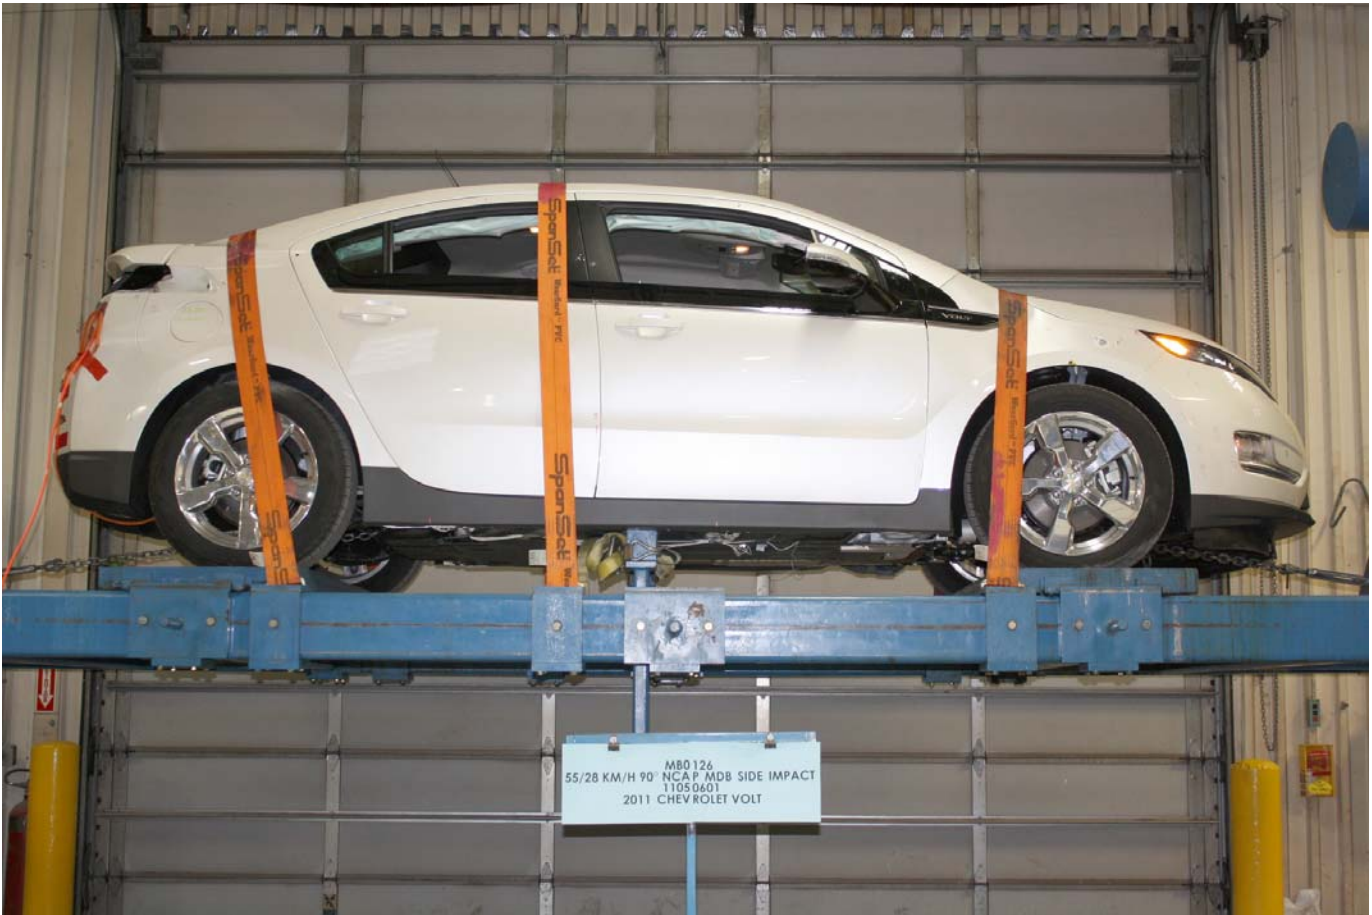
FMVSS No. 301/305 Rollover 0 Degrees

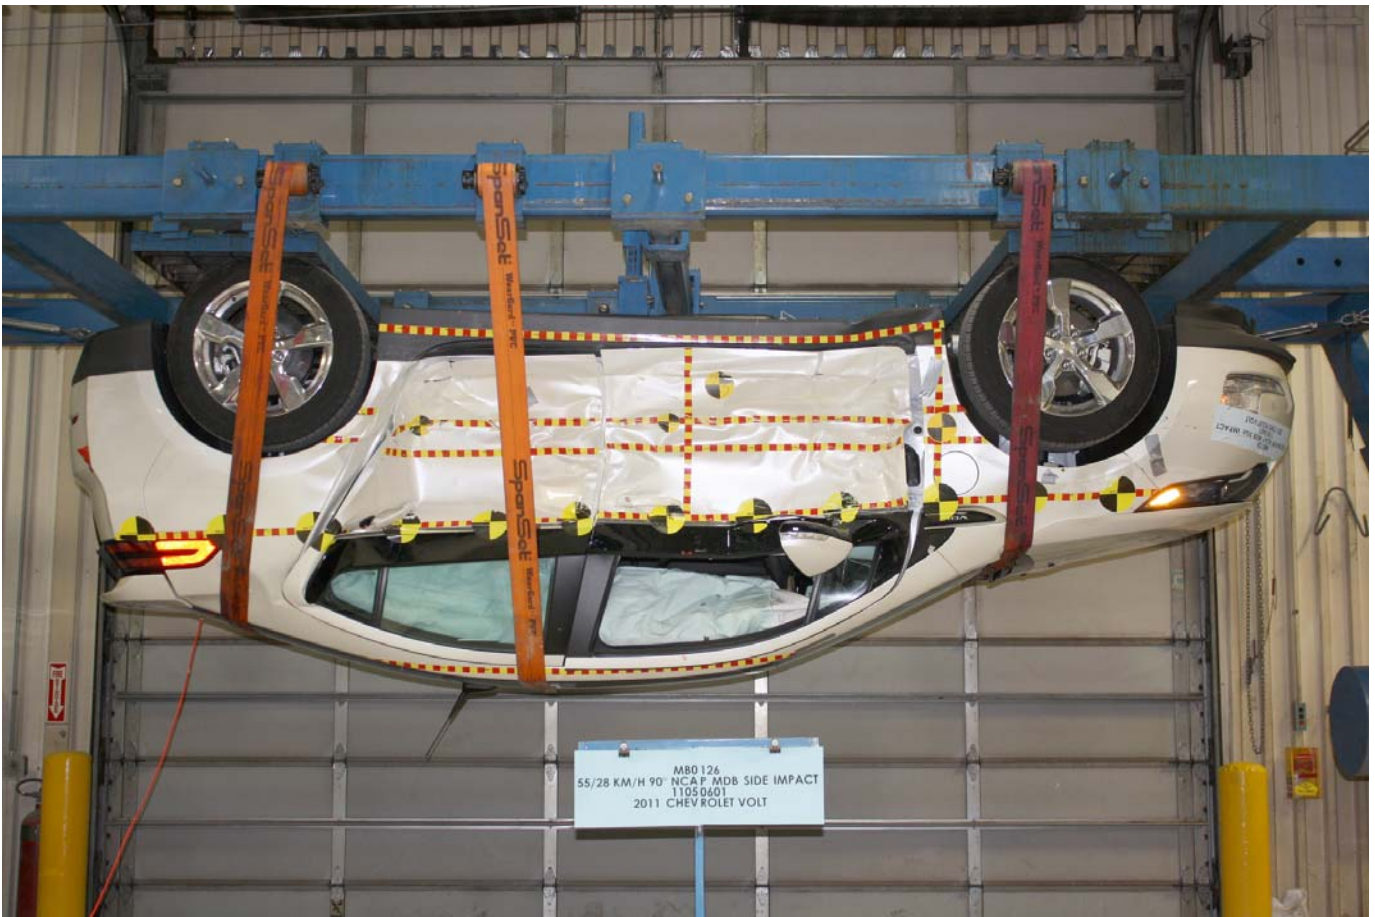
FMVSS No. 301/305 Rollover 180 Degrees

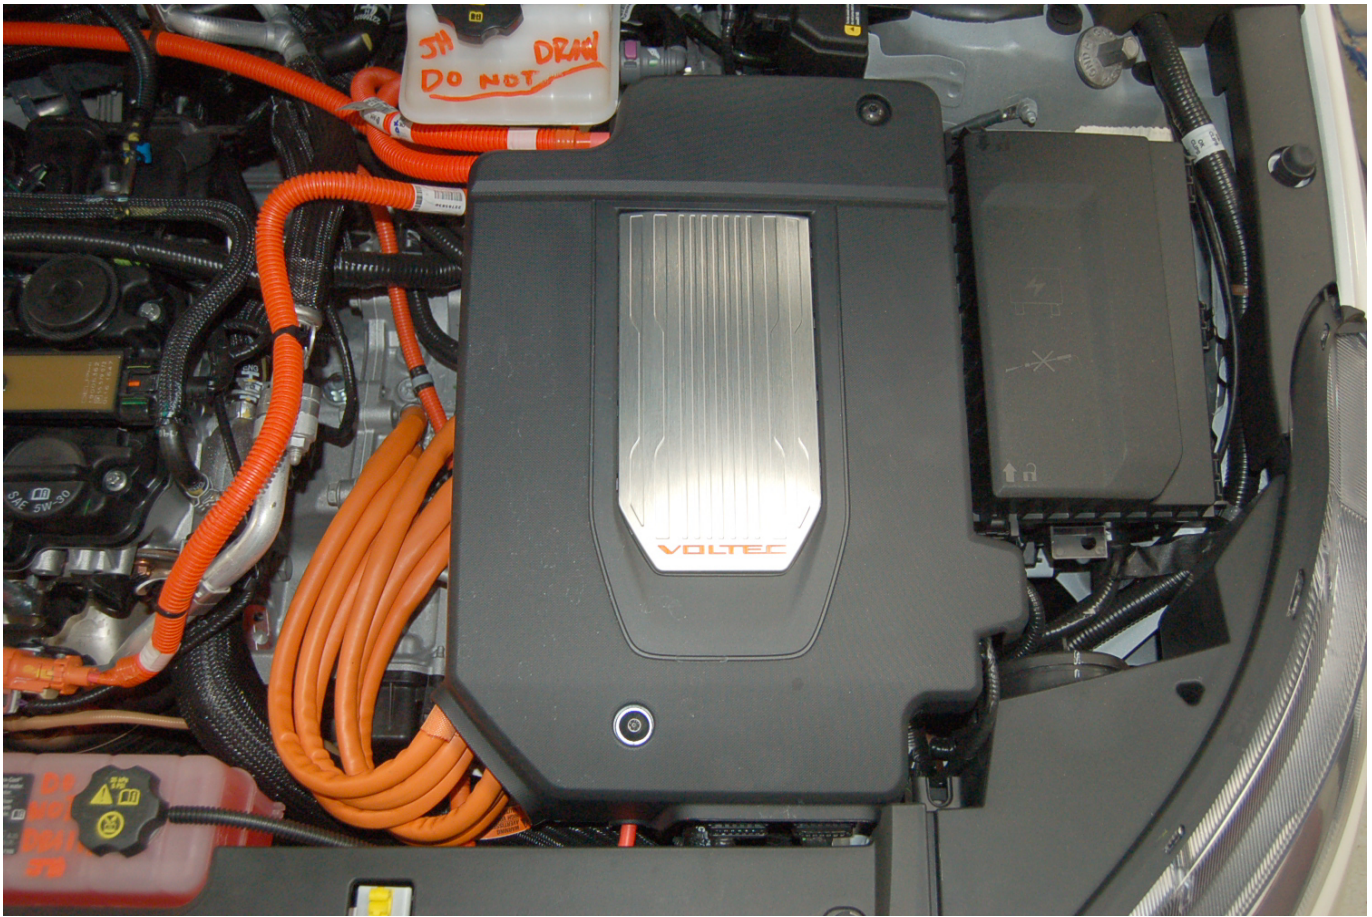
View of Electric Propulsion Drive

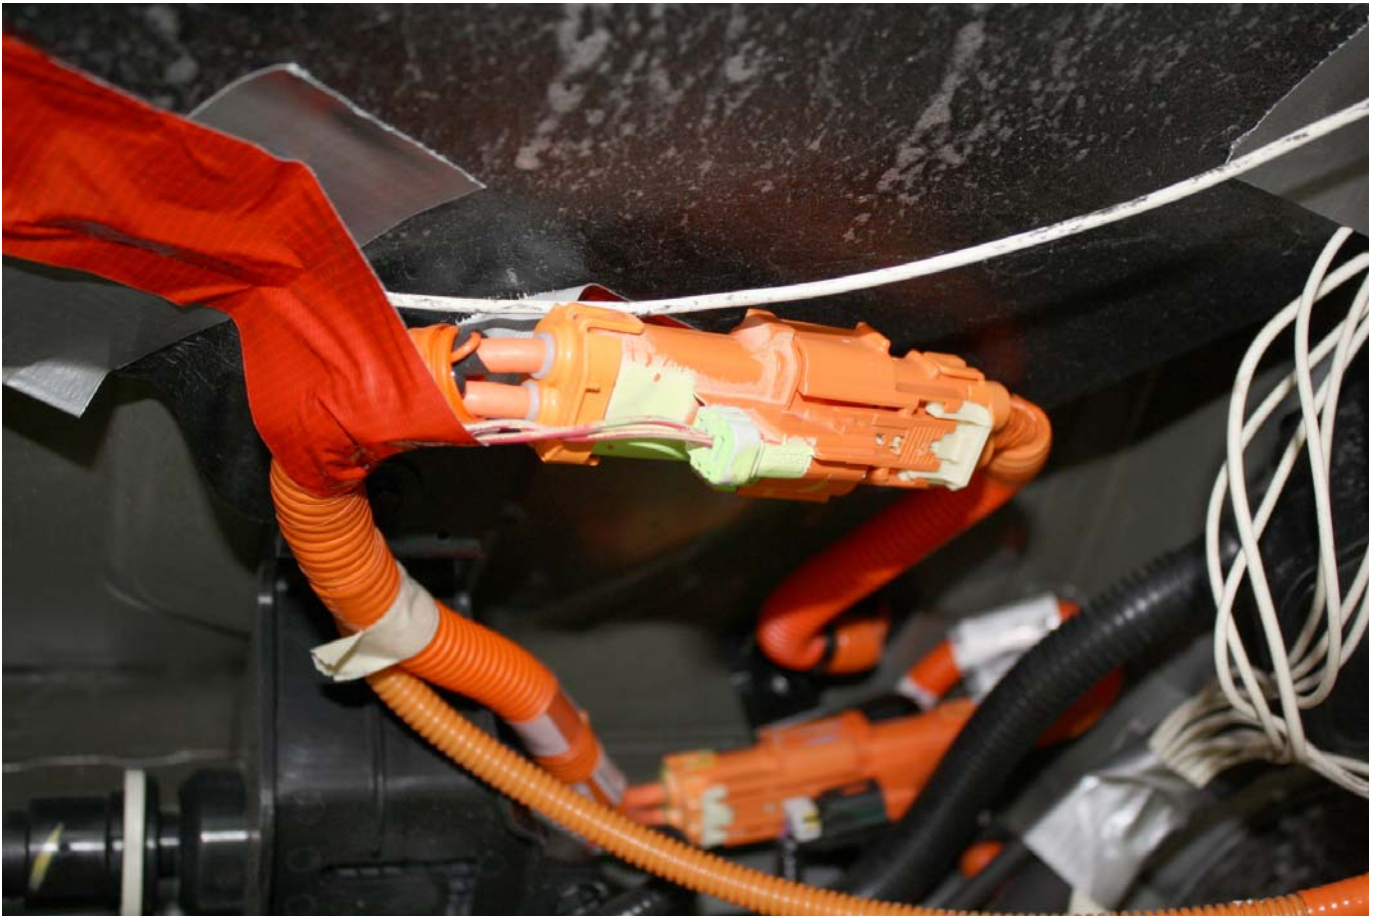
Close-Up of High Voltage Leads Attached
