**REPORT NUMBER: NCAP-MGA-2011-080**

**NEW CAR ASSESSMENT PROGRAM (NCAP)  
Frontal Barrier Impact Test**

**GENERAL MOTORS LLC  
2011 Chevrolet Volt 5-Dr Hatchback  
NHTSA No.: MB0127**

**FINAL REPORT**

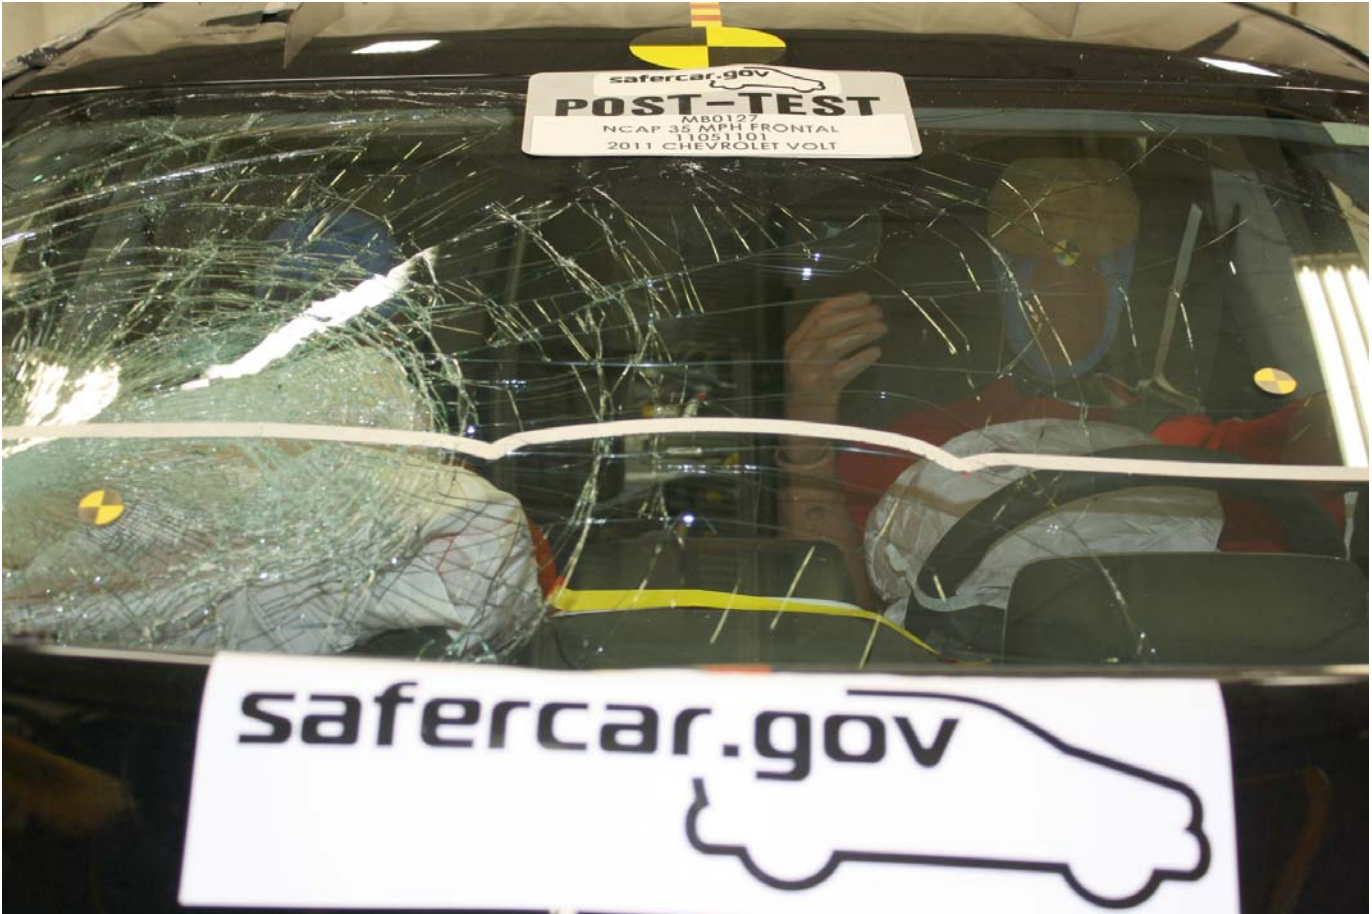
Post-Test Windshield View

Critical Areas of Performance	Observations and Conclusions
Windshield Damage	Cracked
Window Damage	None
Other Notable Effects	None

There was 100 percent windshield retention and no intrusion into the protected zone of the windshield during the event. There was no Stoddard Solvent leakage after the event or during any phase of the static rollover.

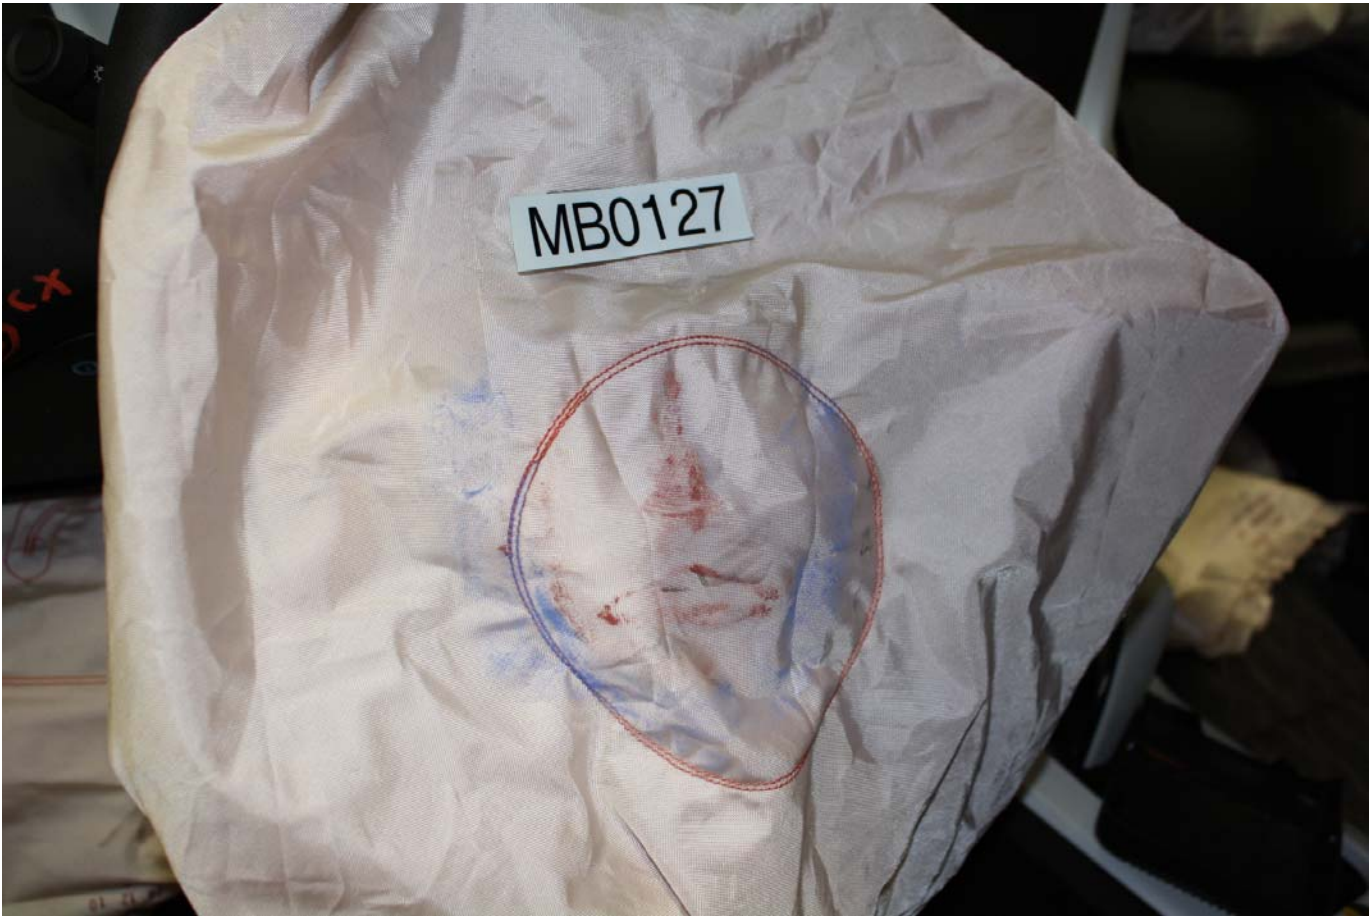
Post-Test Driver Dummy Contact with Airbag

The driver's head and chest contacted the airbag. The driver's head also contacted the headrest. The driver's knees contacted the knee airbag. The passenger's head and chest contacted the airbag. The passenger's head also contacted the headrest. The passenger's knees contacted the knee airbag.

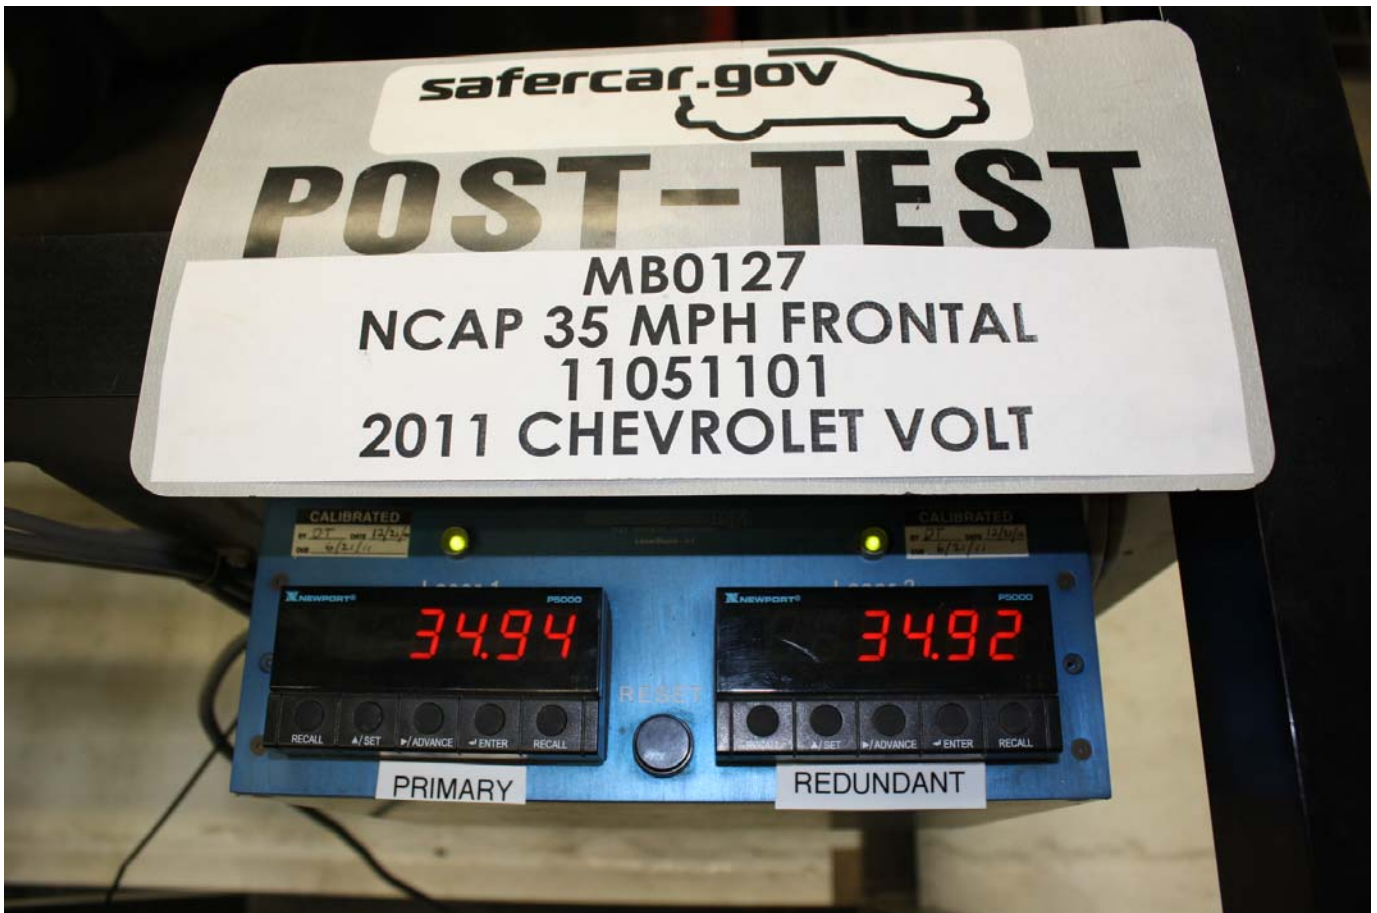
Post-Test Speed Trap Read-Out

A rigid barrier was impacted by a 2011 Chevrolet Volt 5-Dr Hatchback at a velocity of 56.2 kph. The test was performed at MGA Research Corporation on May 11, 2011. Pre-and post-test photographs of the vehicle and dummies can be found in Appendix A.
