**REPORT NUMBER: SPNCAP-MGA-2011-081**

**NEW CAR ASSESSMENT PROGRAM (NCAP)  
Side Impact Pole Test**

**GENERAL MOTORS LLC  
2011 Chevrolet Volt 5-Dr Hatchback  
NHTSA No.: MB0125**

**FINAL REPORT**

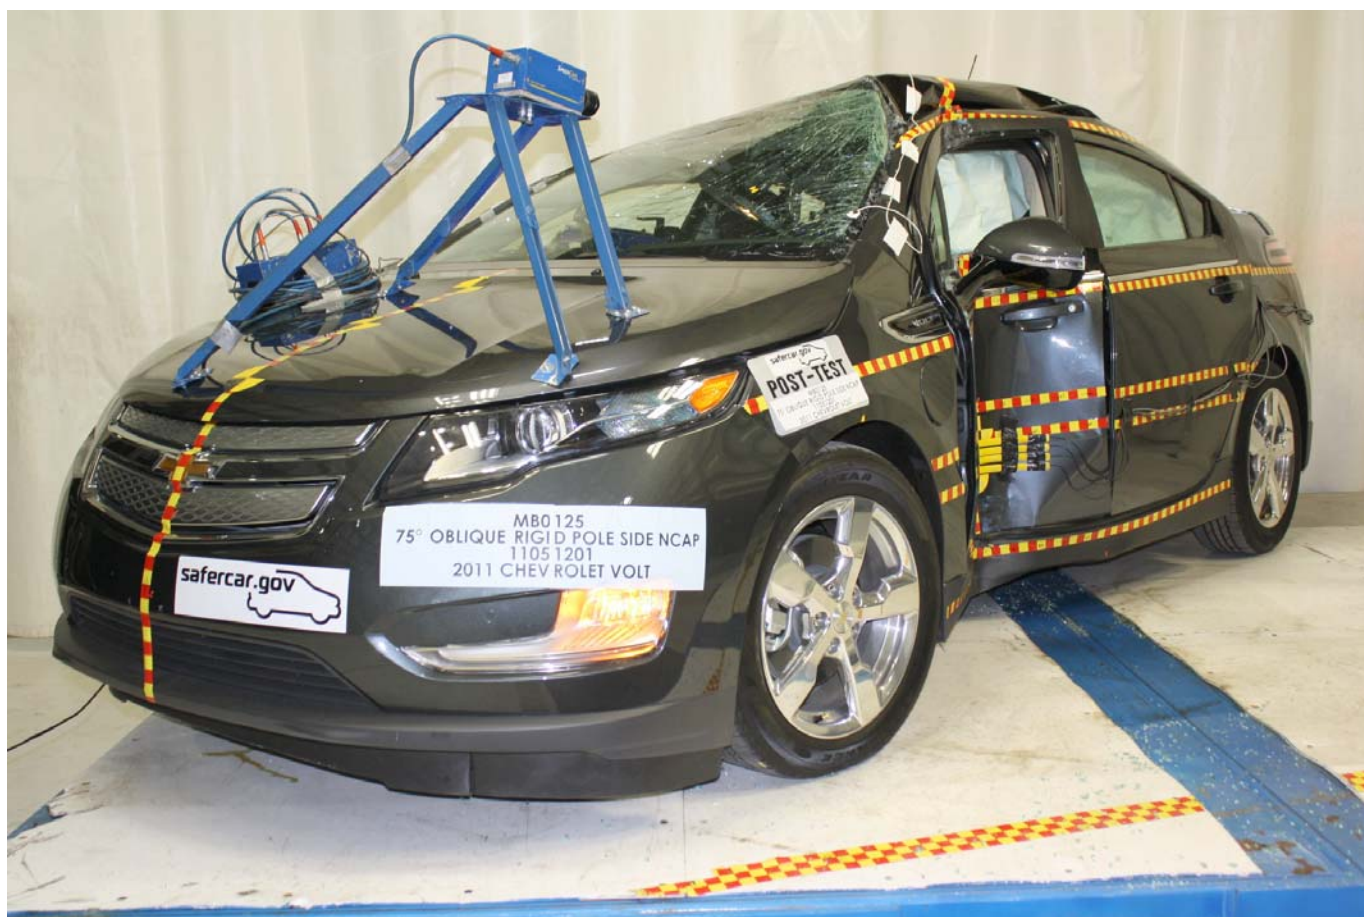
Post-Test Left Front  $\frac{3}{4}$  View of Test Vehicle

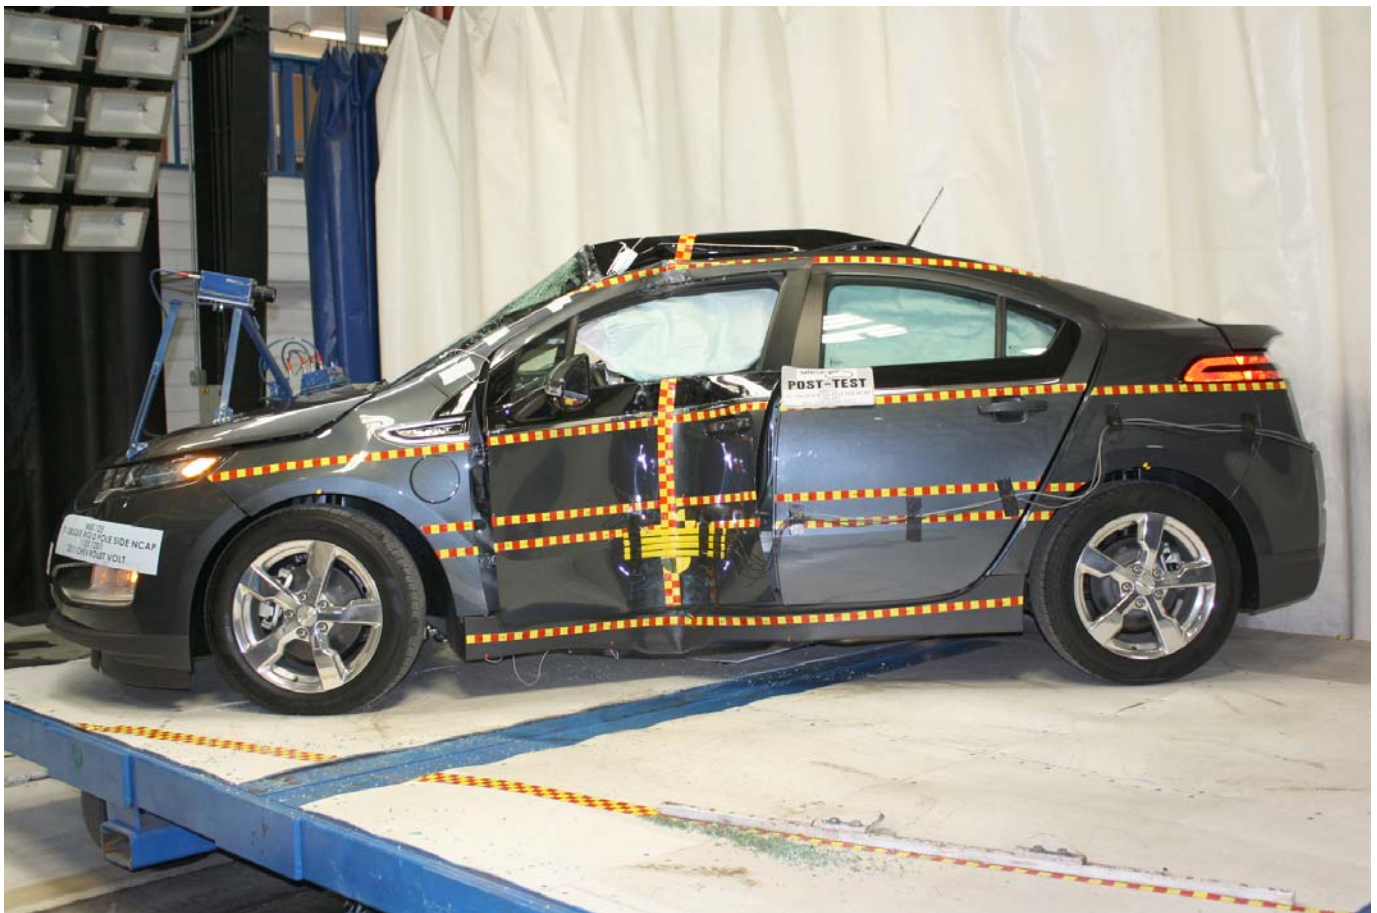
Post-Test Left Side View of Test Vehicle

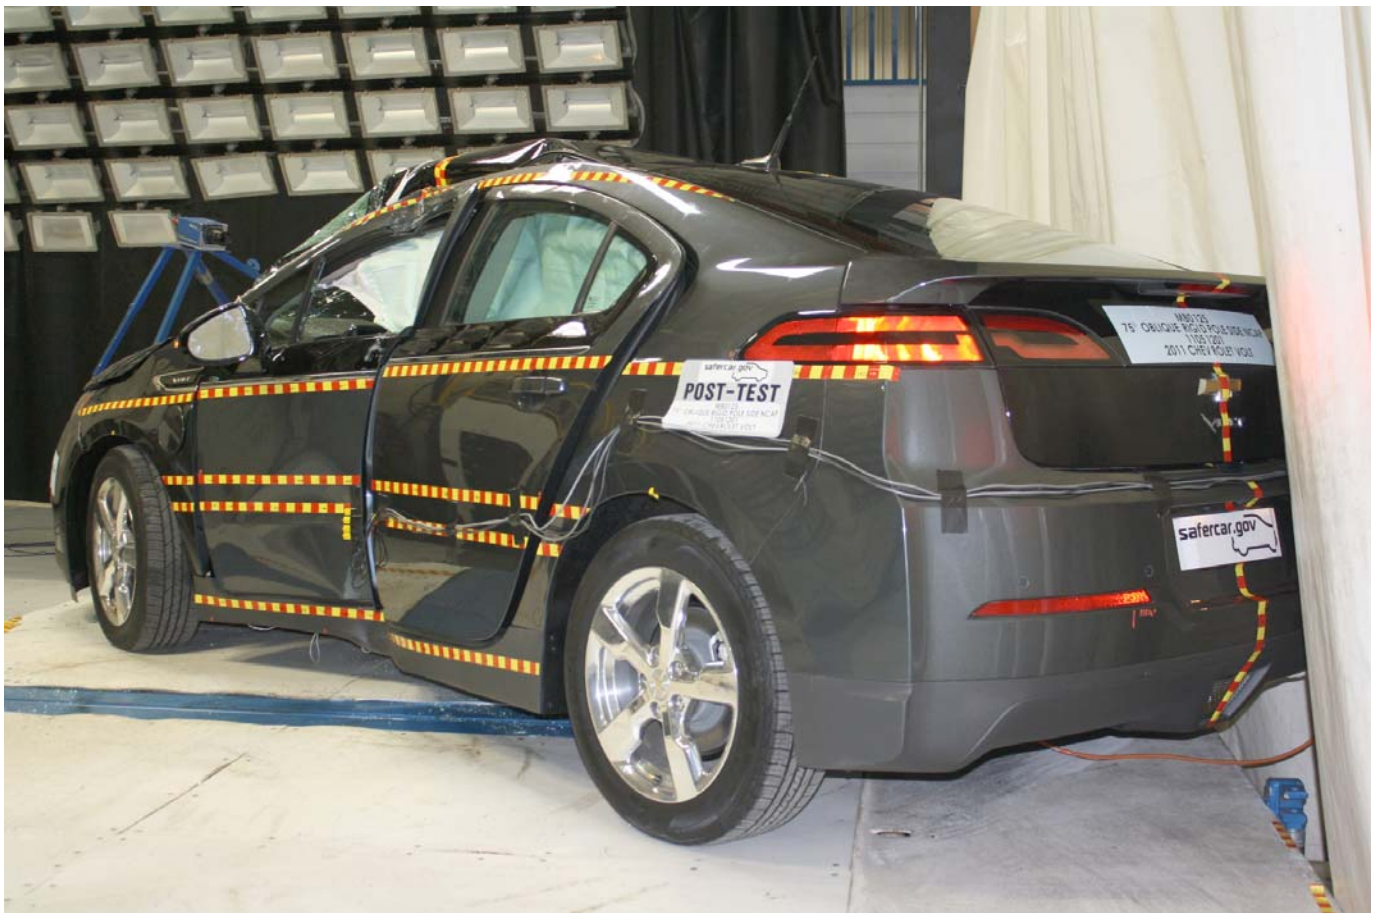
Post-Test Left Rear  $\frac{3}{4}$  View of Test Vehicle

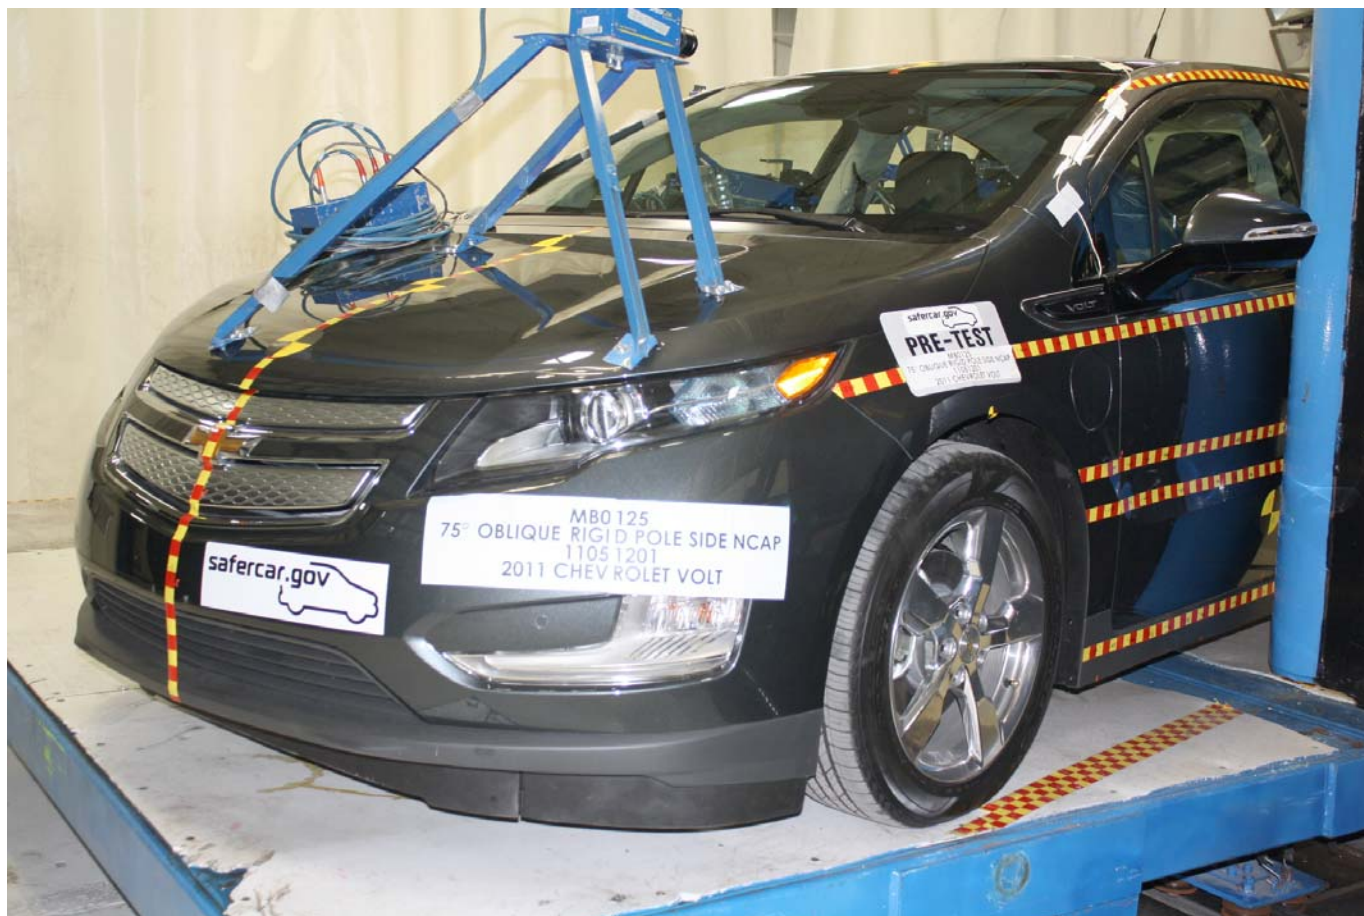
Pre-Test Left Side View of Pole Positioned Against Side of Vehicle at Ideal Impact Point

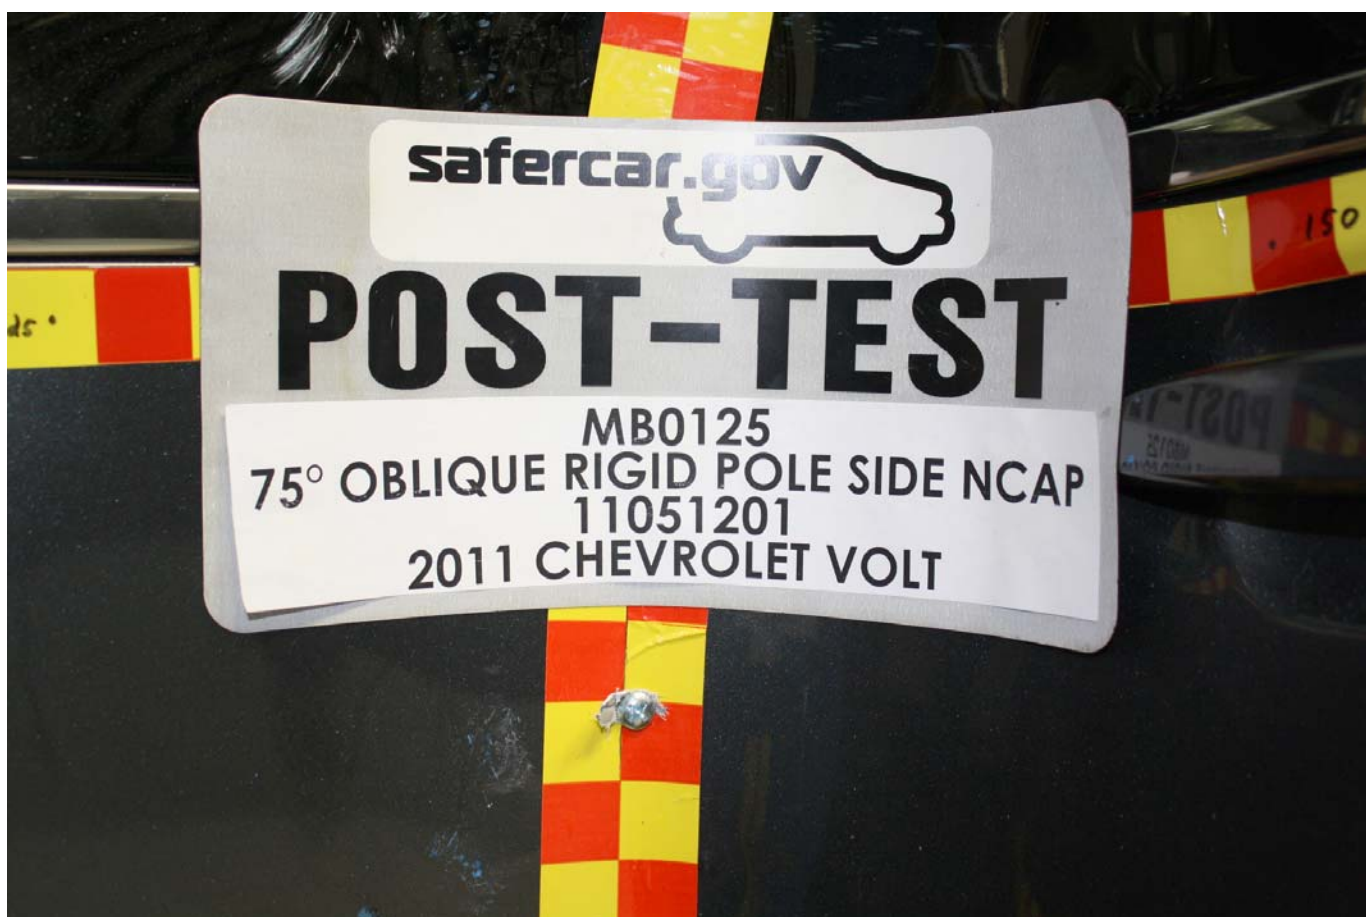
Post-Test Close-Up View of Impact Point Target Showing Impact Location

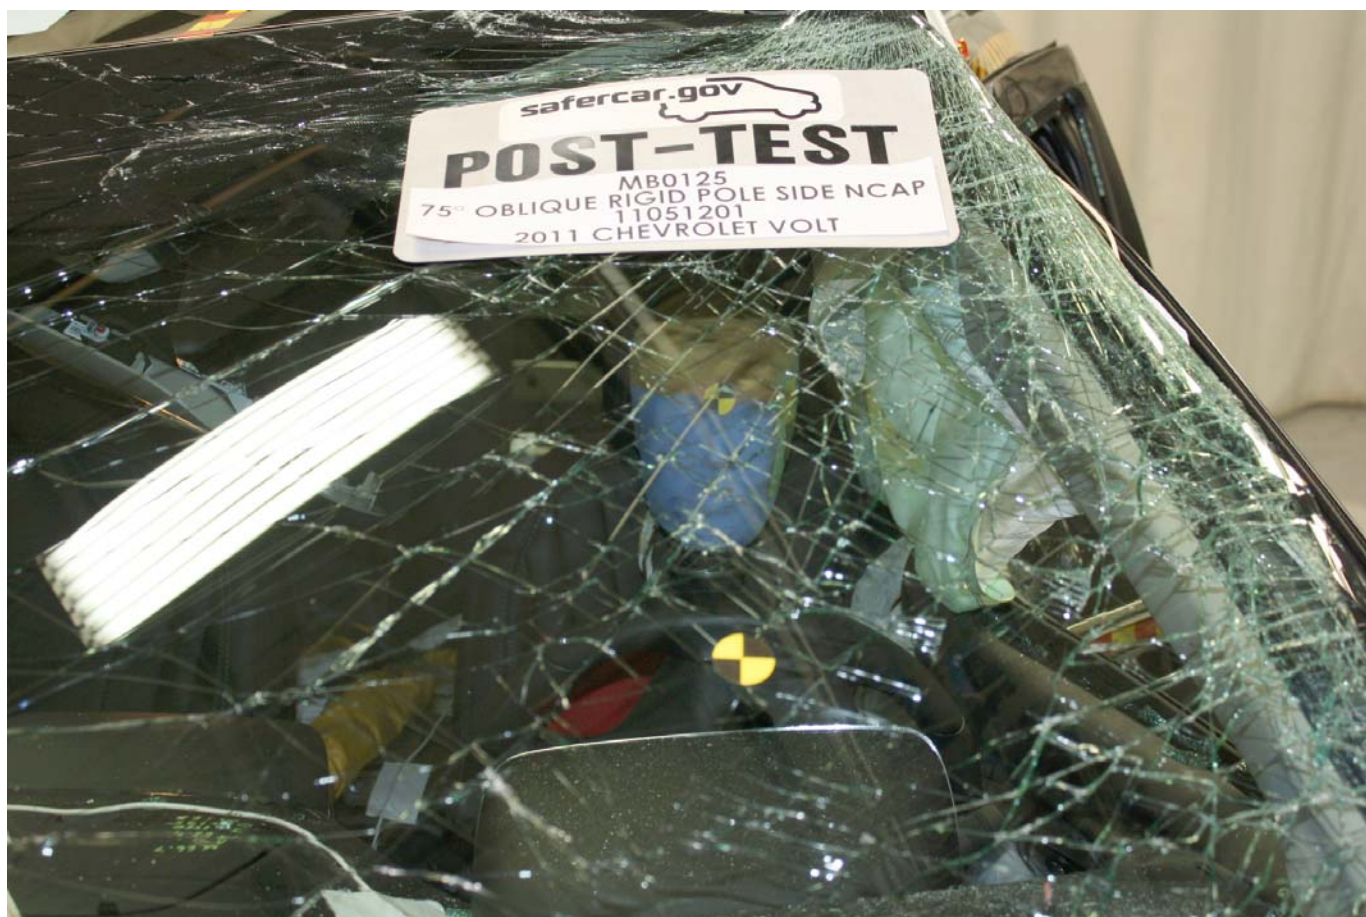
Post-Test Front Close-Up View of Dummy

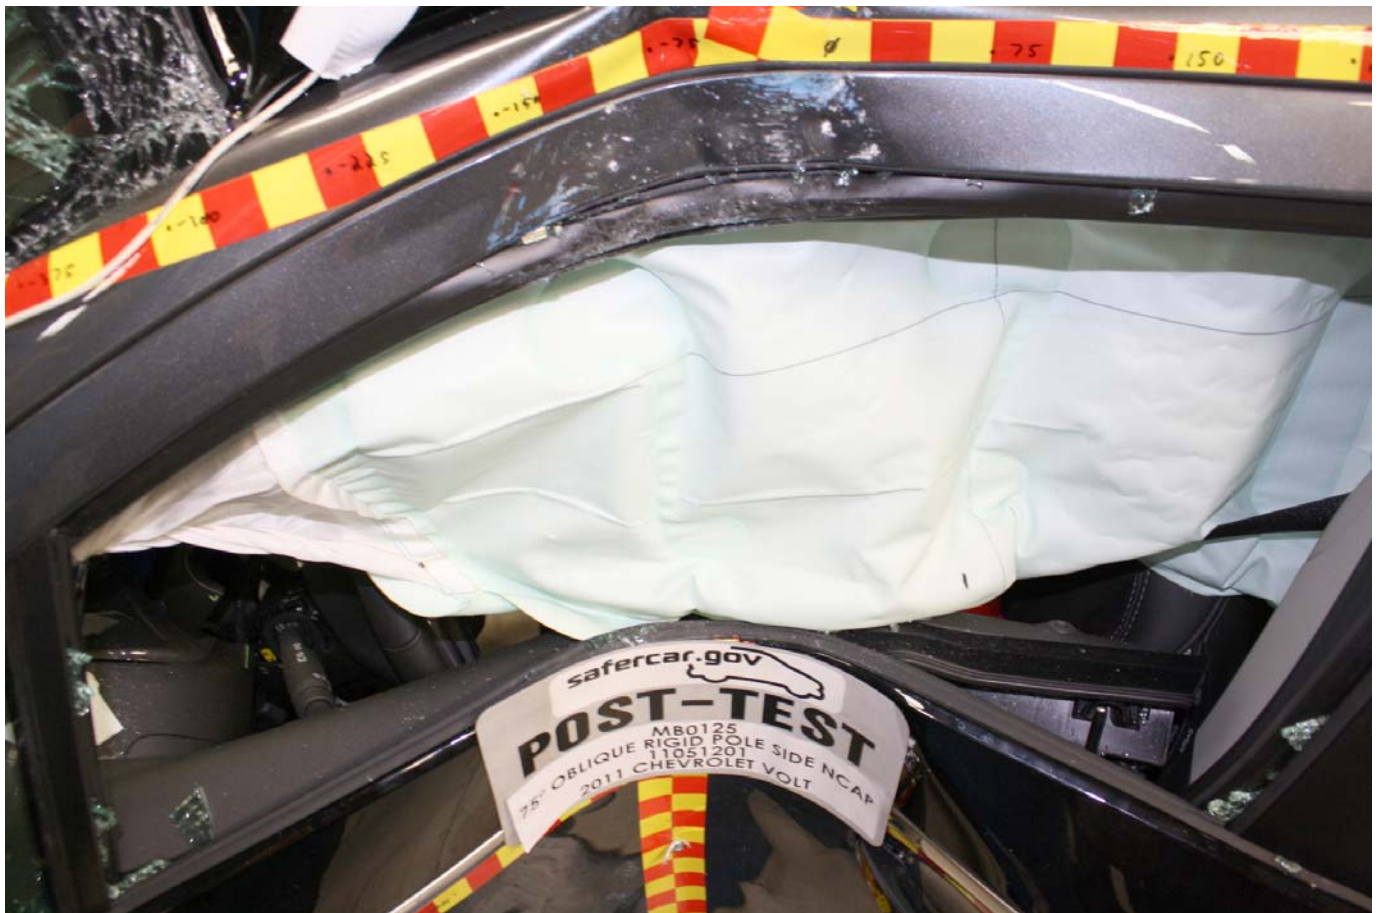
Post-Test Dummy and Door Clearance View

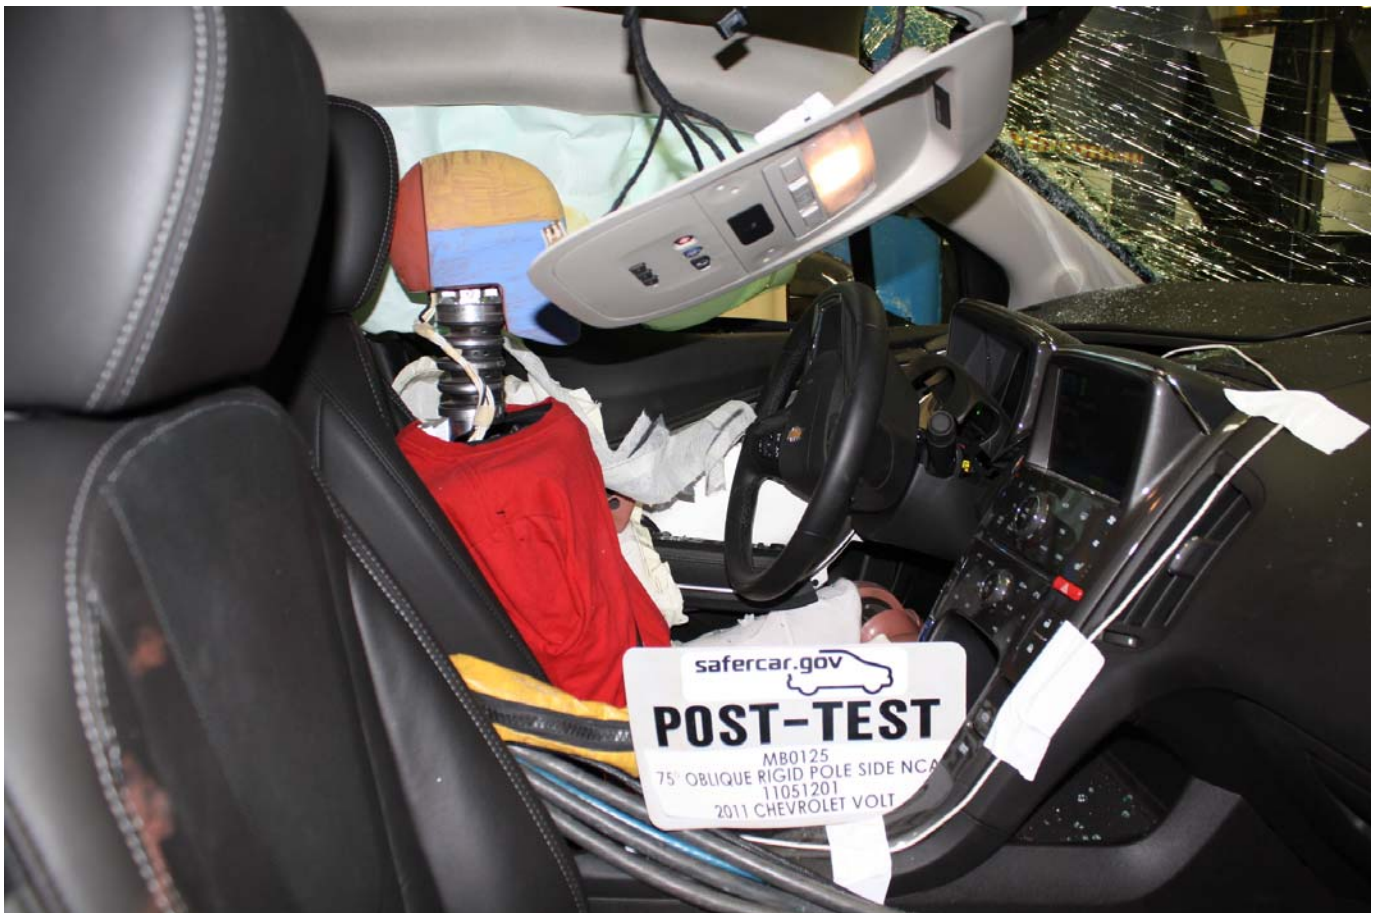
Post-Test Right Side View of Dummy and Front Seat Occupant Compartment

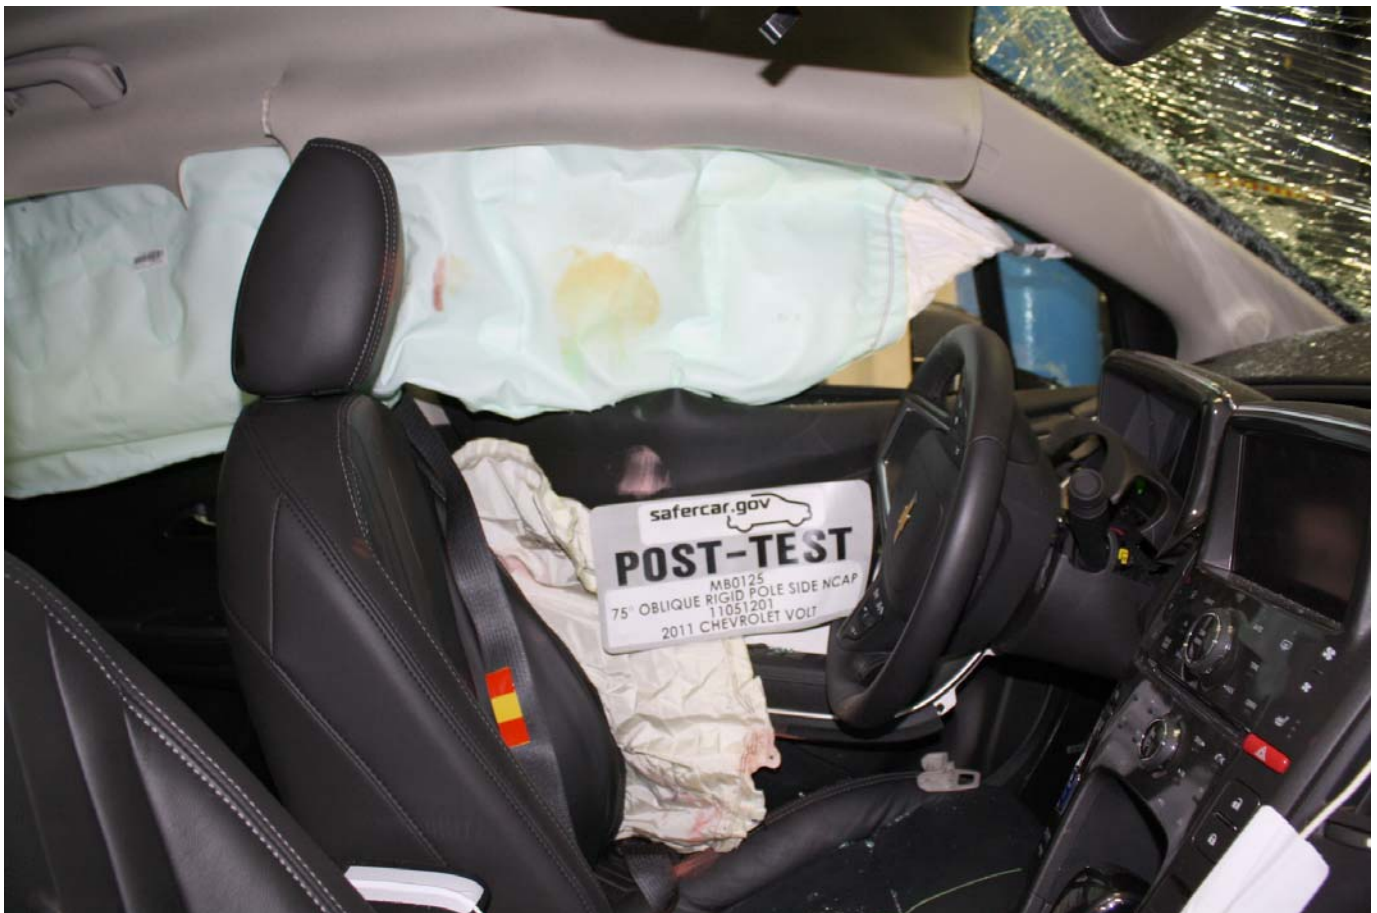
Post-Test Inner Driver Door Panel View Showing Dummy Contact Location

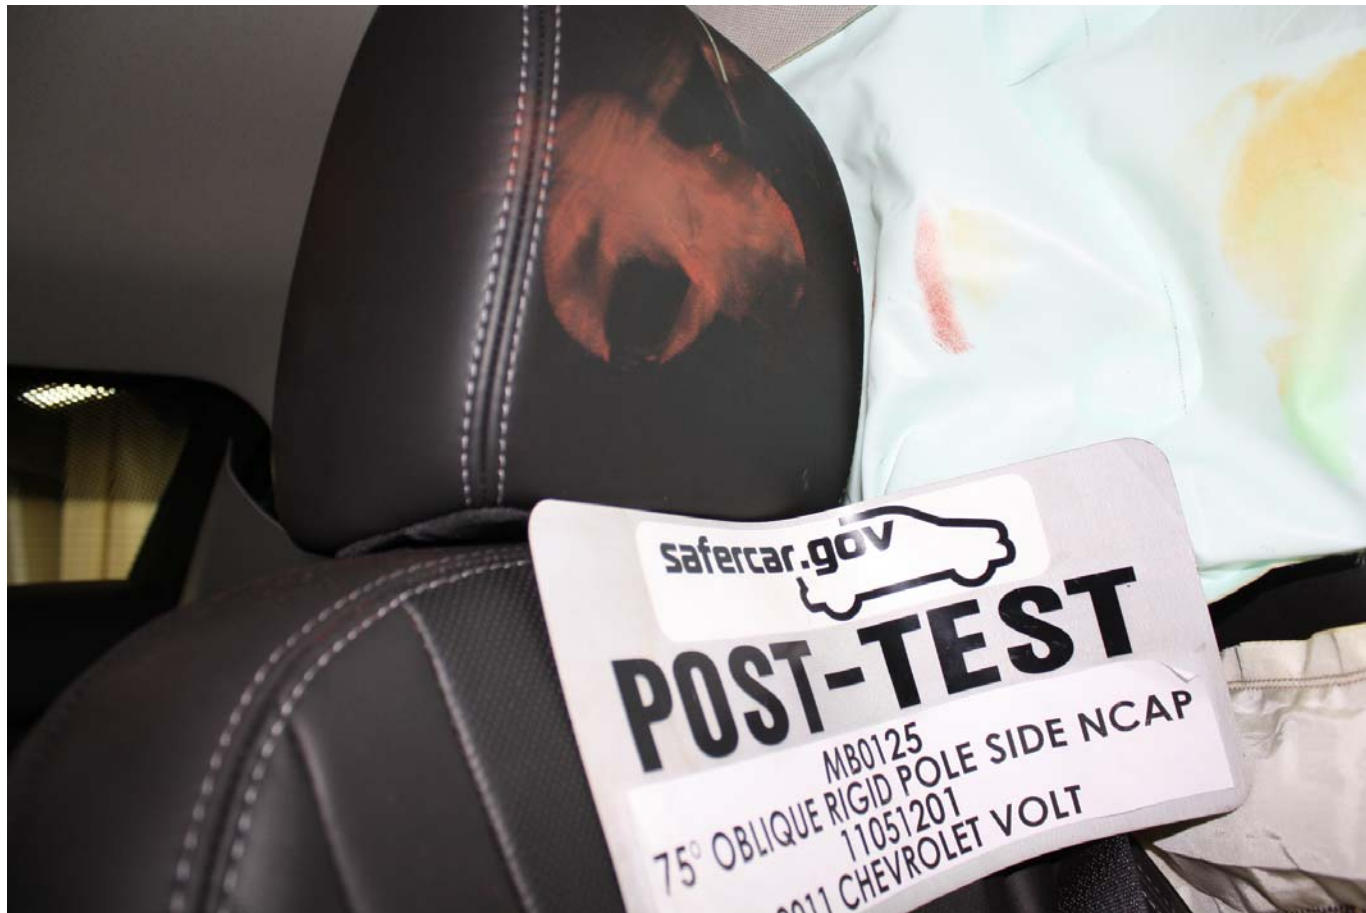
Post-Test Dummy Close-Up Head Contact with Vehicle Interior View

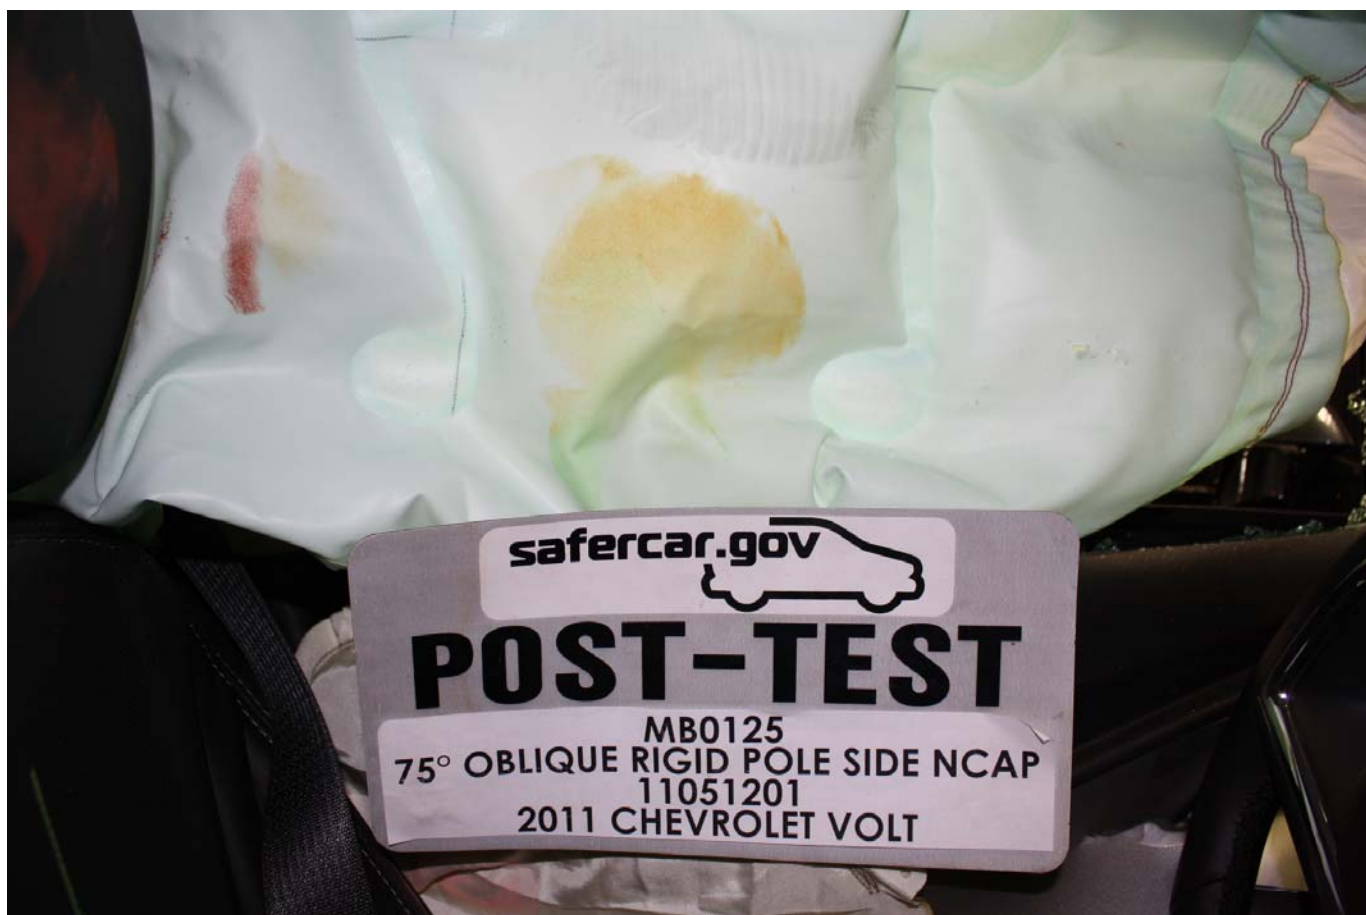
Post-Test Dummy Close-Up Head Contact with Side Airbag View

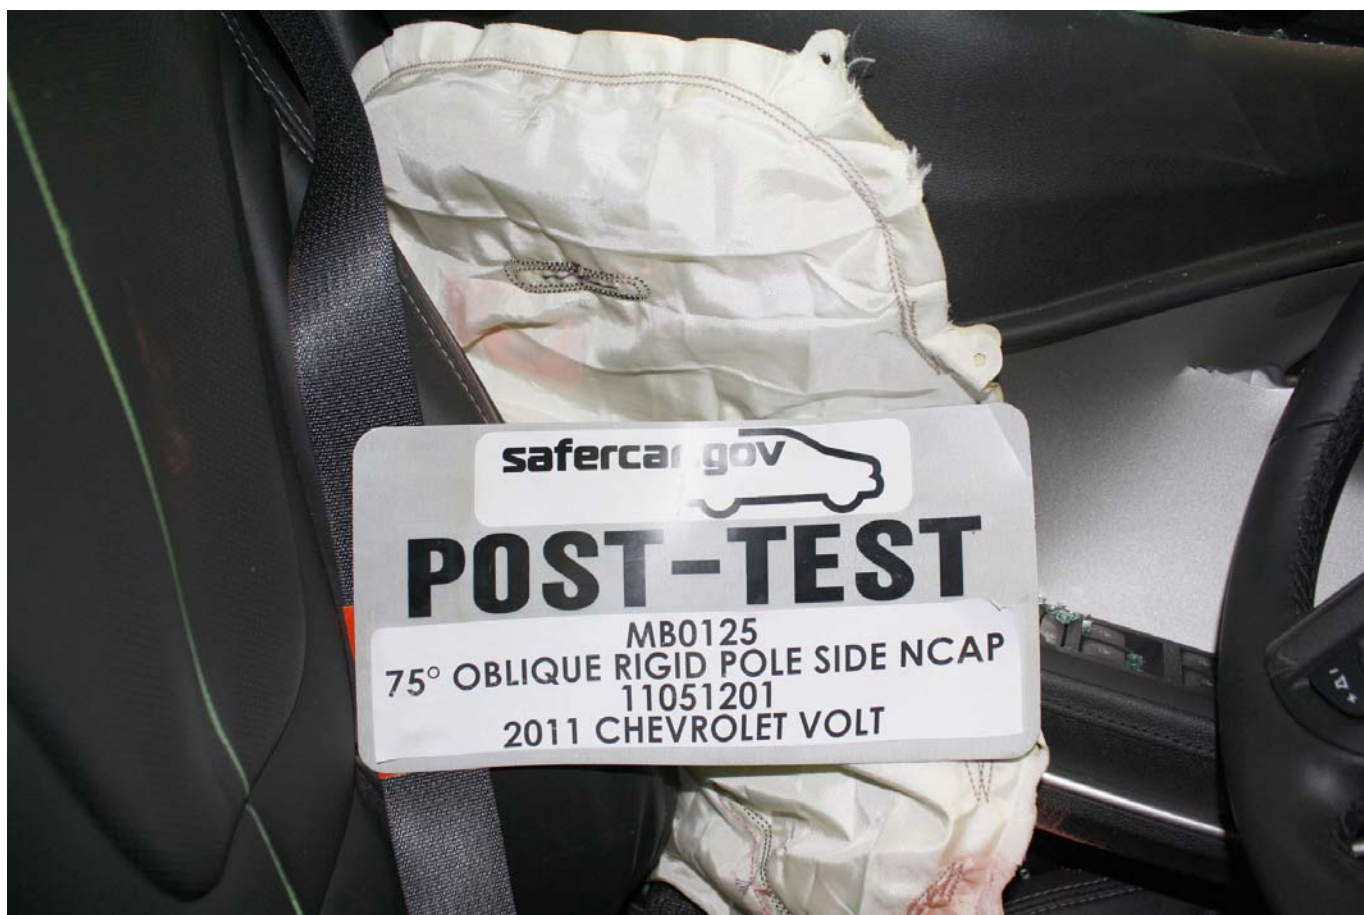
Post-Test Dummy Close-Up Torso Contact with Side Airbag View

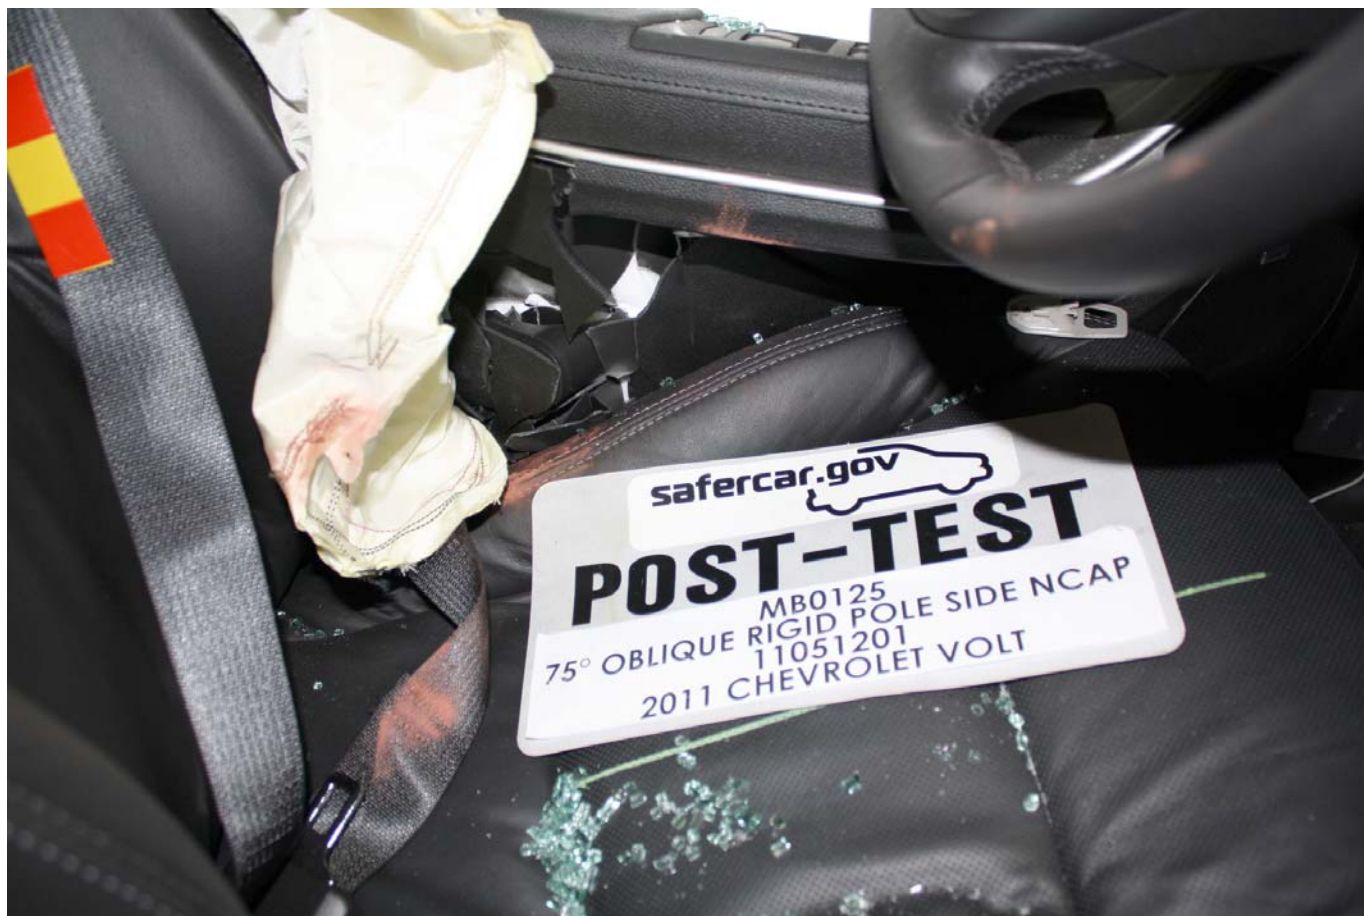
Post-Test Dummy Close-Up Pelvis Contact with Vehicle Interior View

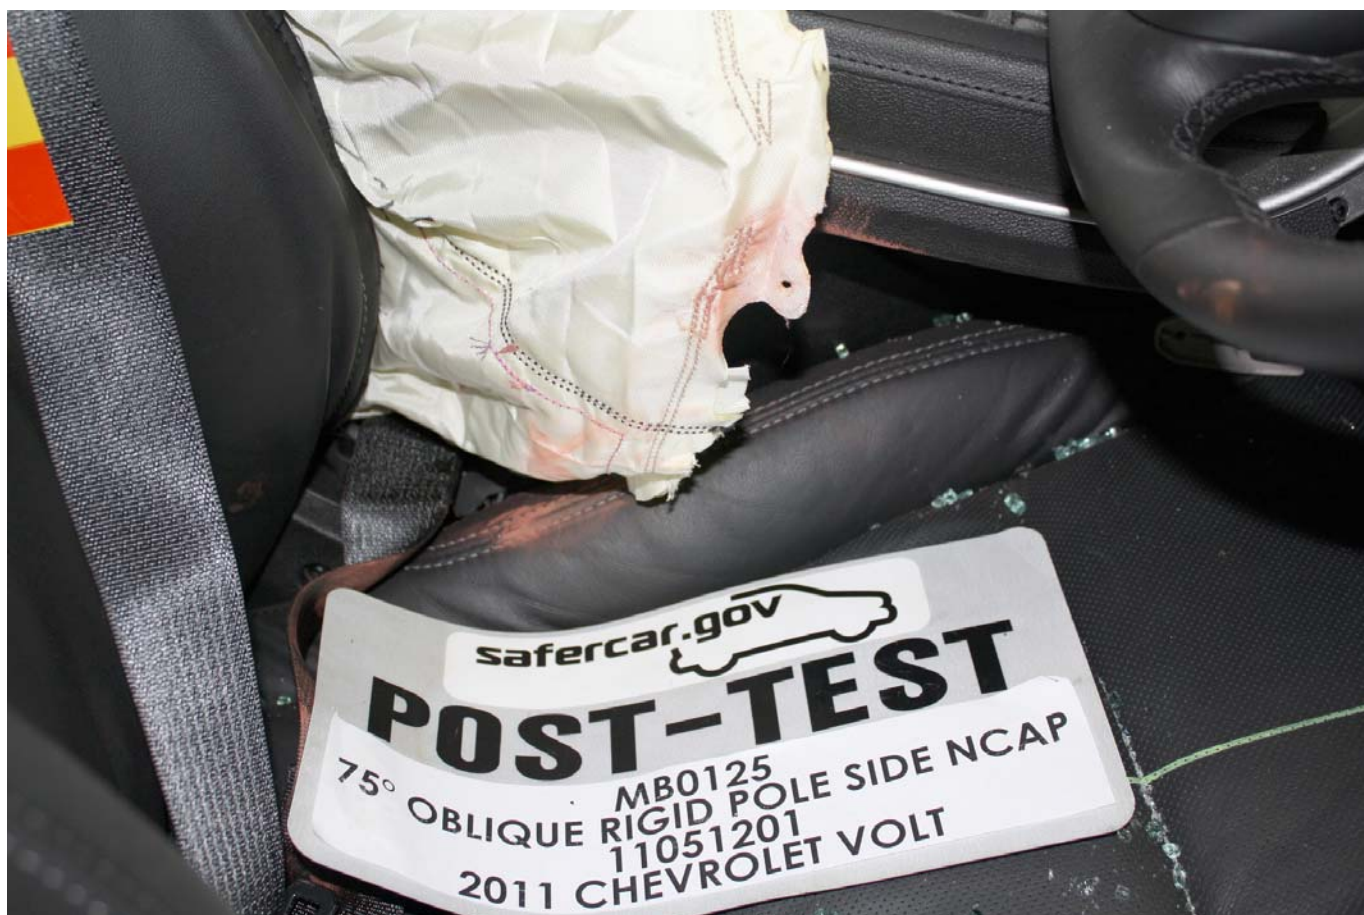
Post-Test Dummy Close-Up Pelvis Contact with Side Airbag View

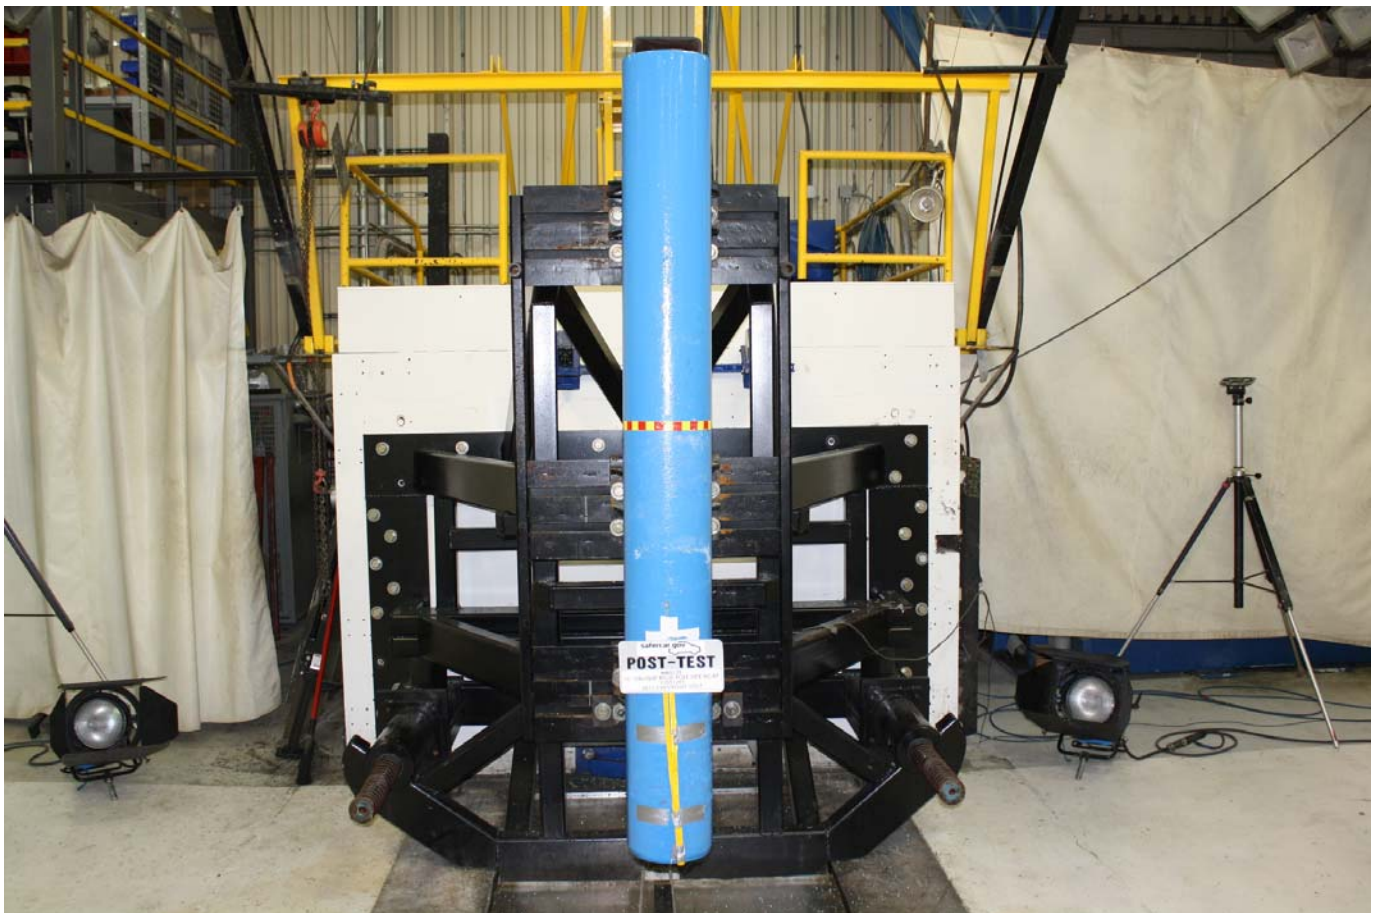
Post-Test Pole Barrier Front View

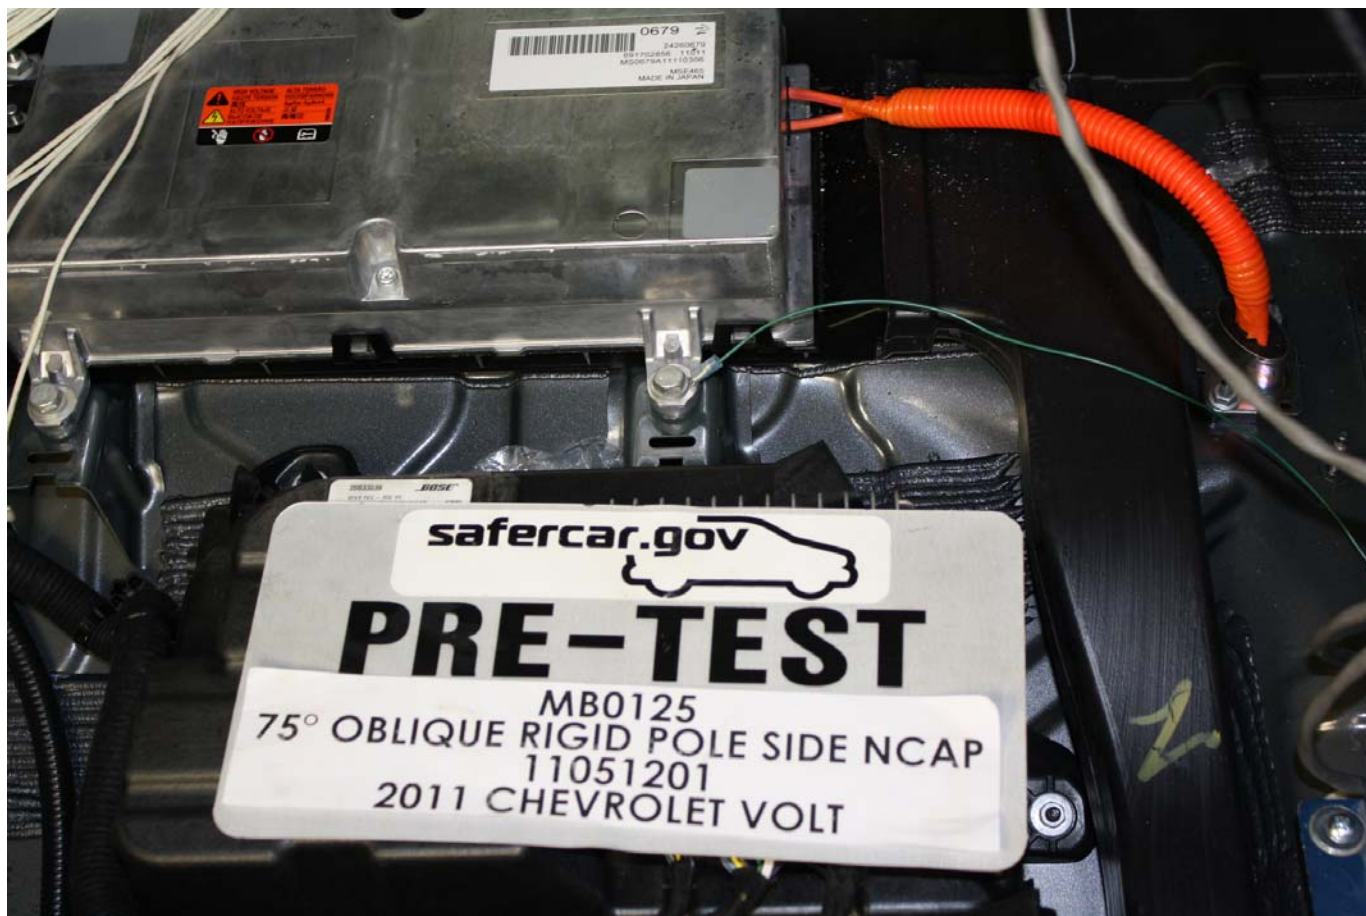
Close-Up of Ground Lead Attached

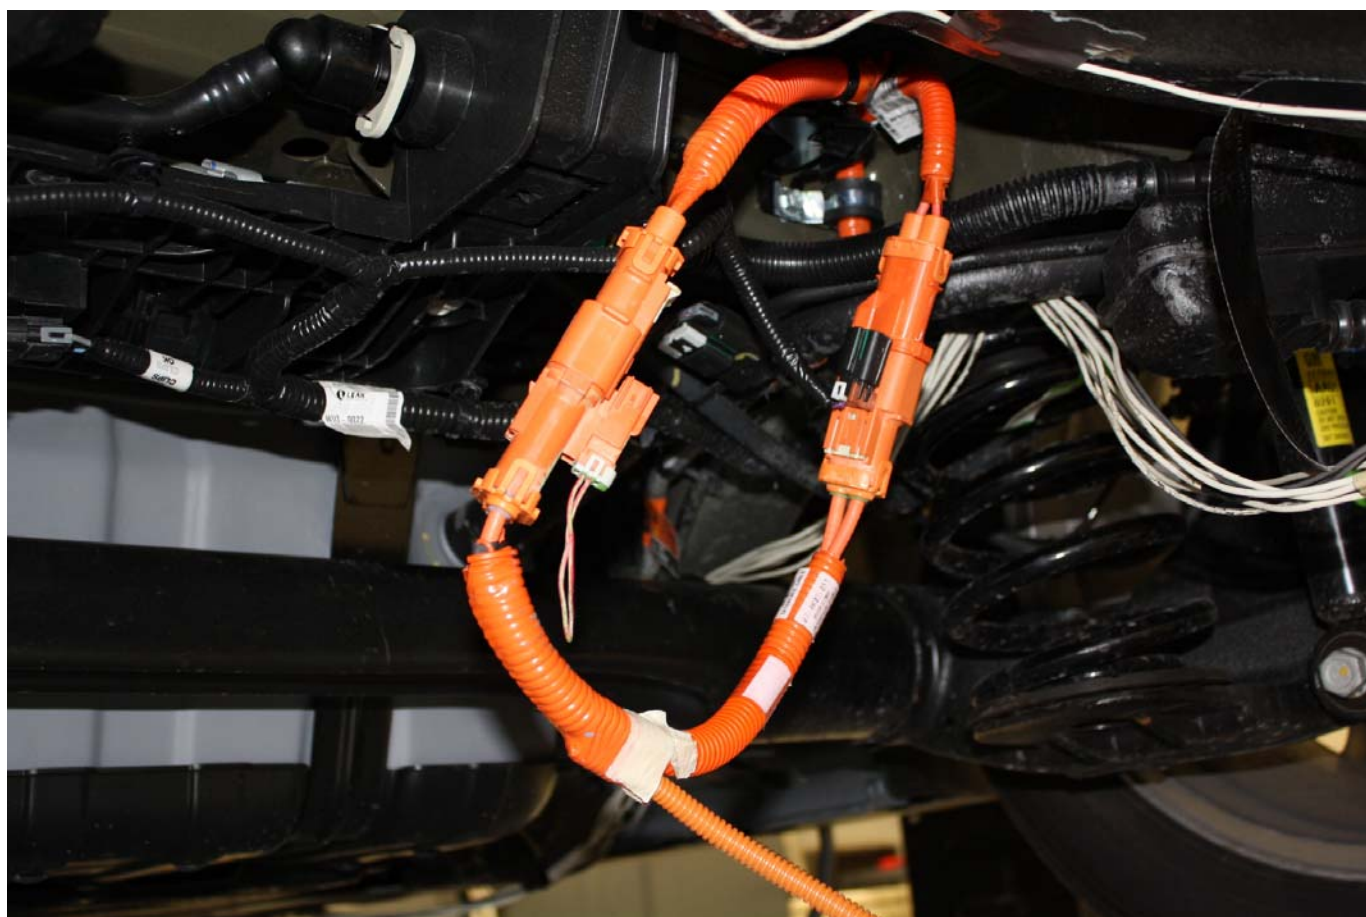
Close-Up of High Voltage Leads Attached
