**REPORT NUMBER: TWG-MGA-2011-008**

**SIDE AIRBAG OUT-OF-POSITION INJURY  
TECHNICAL WORKING GROUP**

**VOLKSWAGEN DE MEXICO S.A. DE C.V.  
2011 VOLKSWAGEN JETTA S  
NHTSA NUMBER: MB5805TWG2**

**FINAL REPORT**

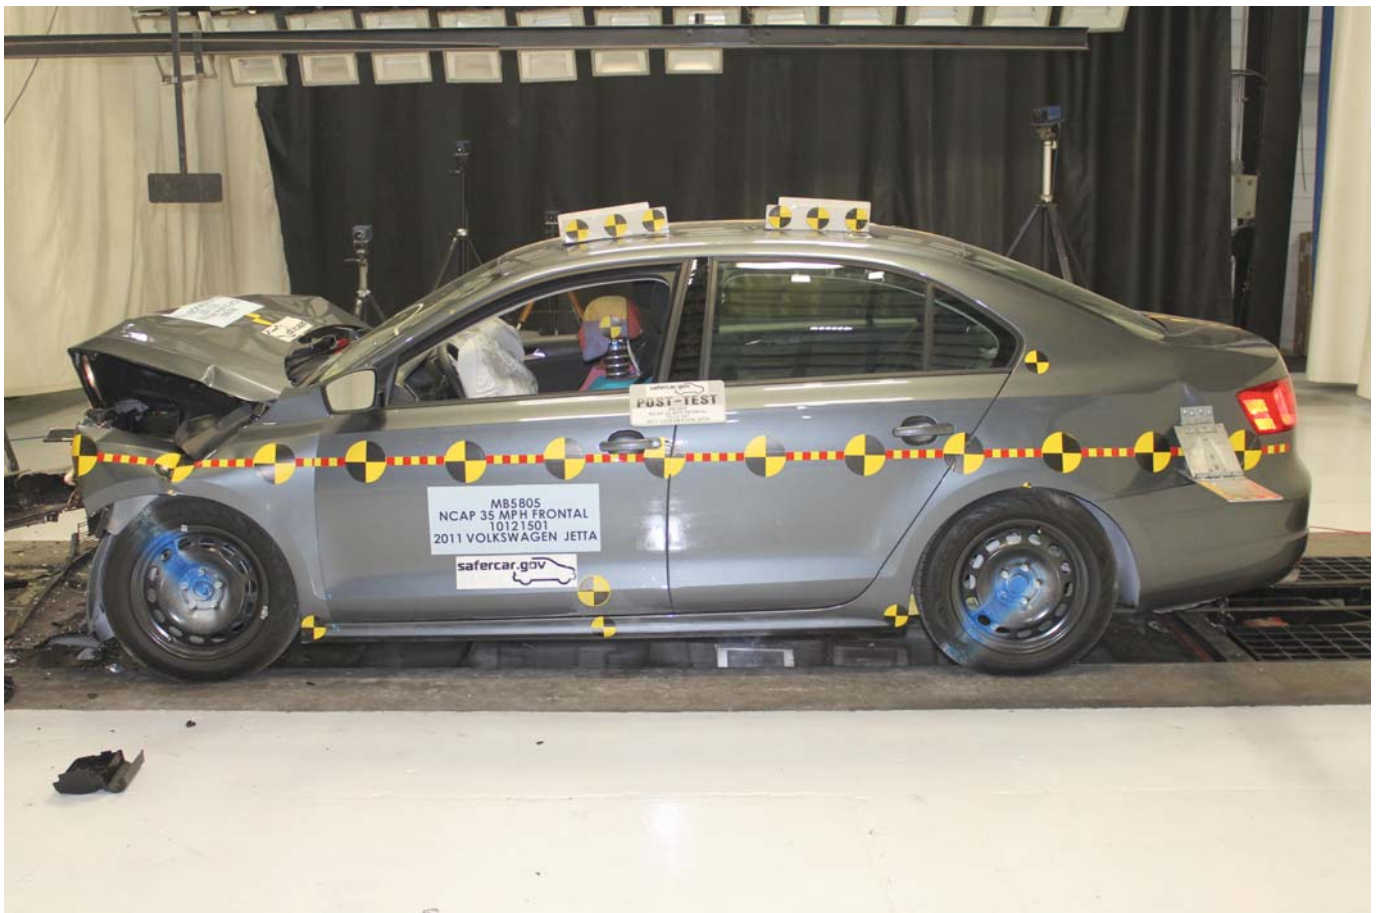
Post-Test Vehicle Left Side View

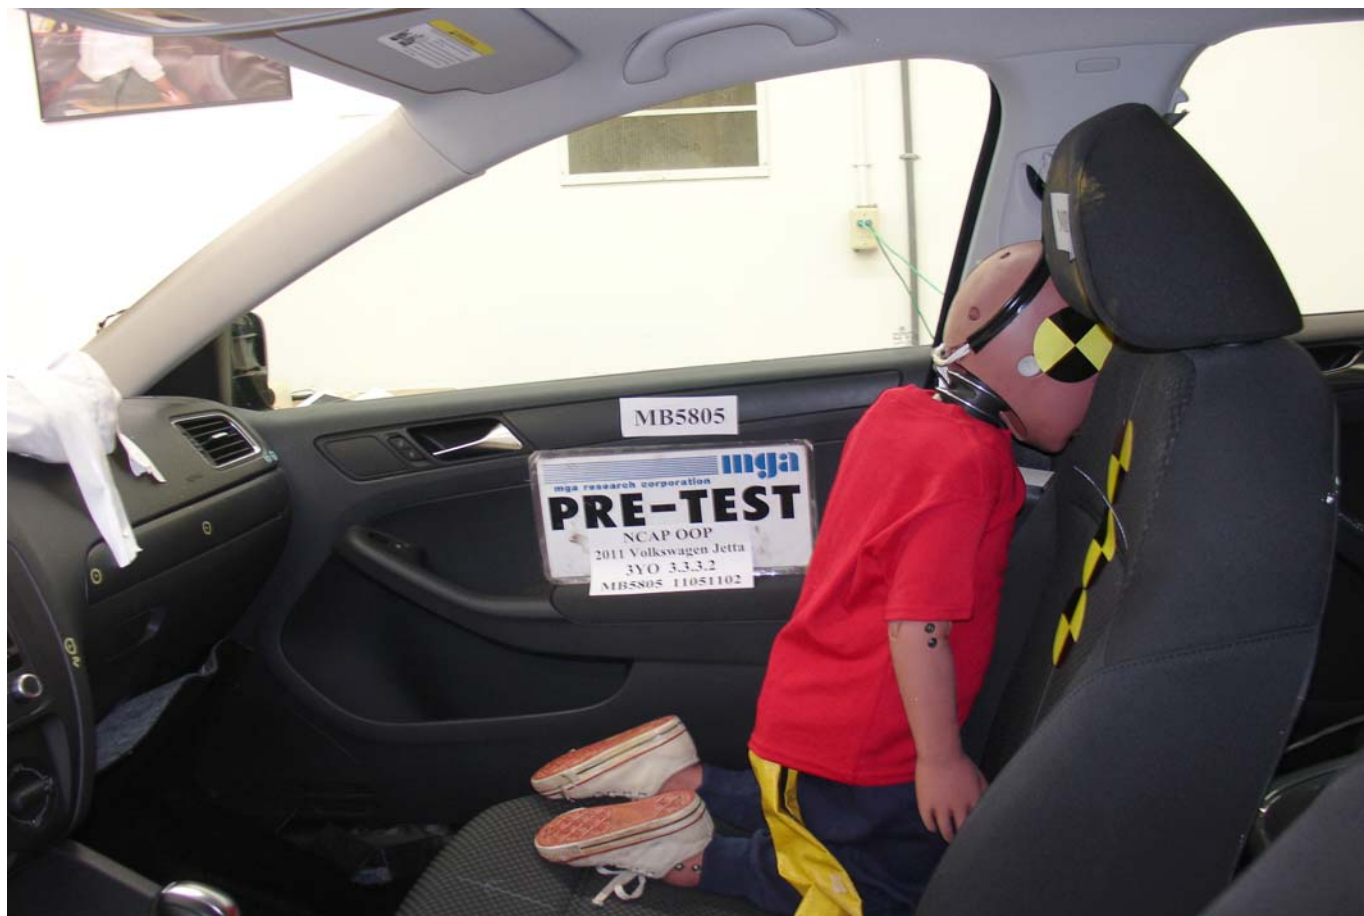
Pre-Test 3-Year-Old Child Dummy Left Side View

The Hybrid III 3-Year-Old child dummy was placed in the right front passenger seat along the outboard edge of the seat cushion, kneeling and facing rearward. The vertical centerline of the dummy's sternum was aligned as close as possible with the leading edge of the seat back bolster. The sternum contacted with seat. The dummy's head was placed in between the seat bolster and pillar/side trim to maximize contact between the sternum and seatback. The head remained in its neutral orientation. The outboard leg was positioned at the outboard edge of the seat cushion and parallel to the seat centerline and remained on the cushion. The outboard knee and lower leg was slid toward the seat back/seat cushion junction until the top edge of the upper rib was aligned horizontally with the top edge of the airbag module. The inboard leg was aligned parallel to the centerline of the seat cushion. The inboard knee and lower leg was slid toward the seat bight until a line drawn through both shoulder bolts was perpendicular to the vehicle centerline. The inboard arm was rotated towards the seat back until the thumb contacts the seat back. The outboard arm and hand was rotated to hang down as close to vertical as possible.

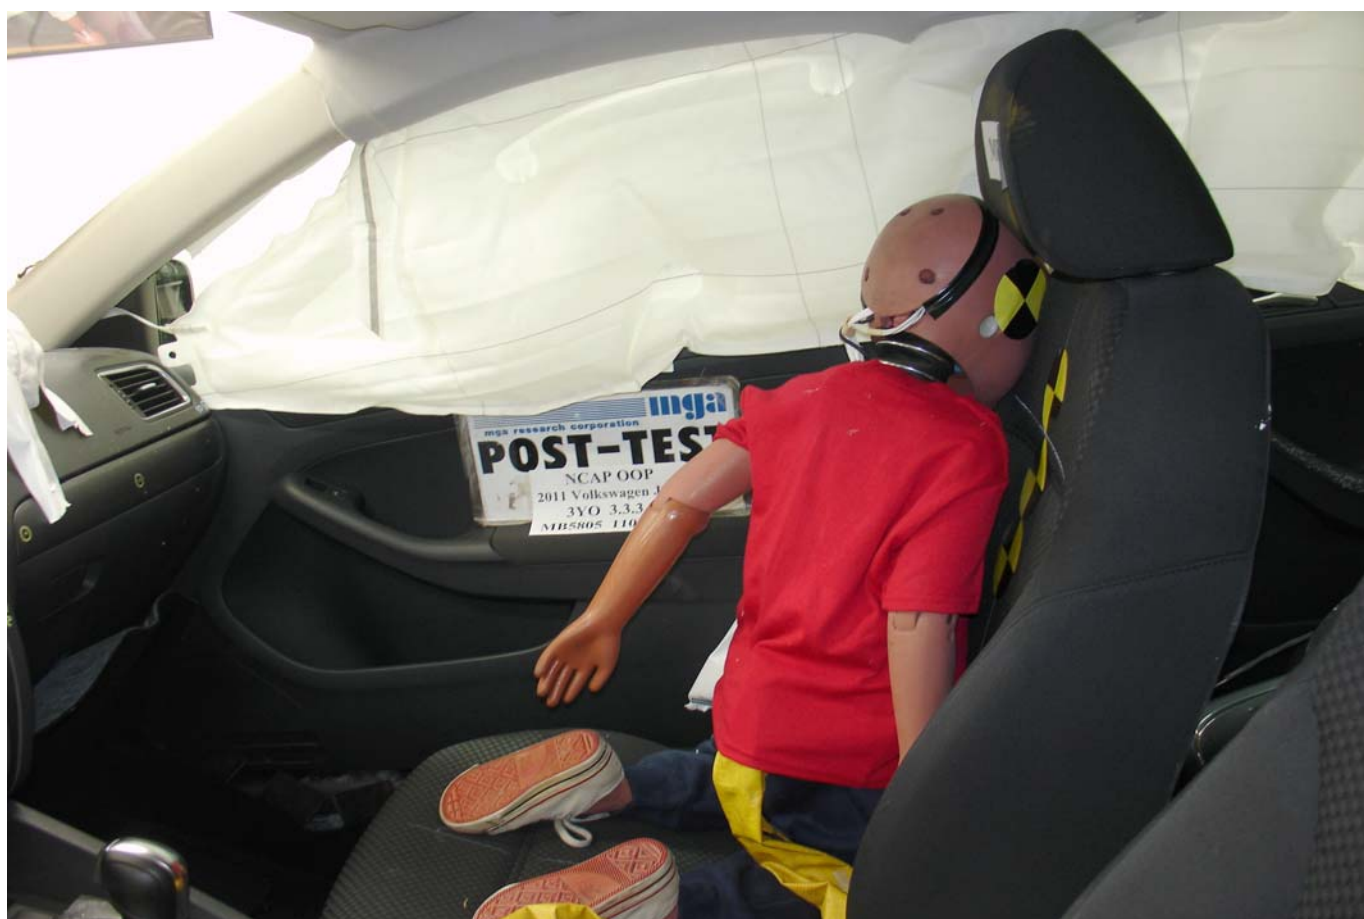
Post-Test 3-Year-Old Child Dummy Left Side View

- Curtain airbag to left side of head
- Torso/Pelvis airbag to left shoulder and torso

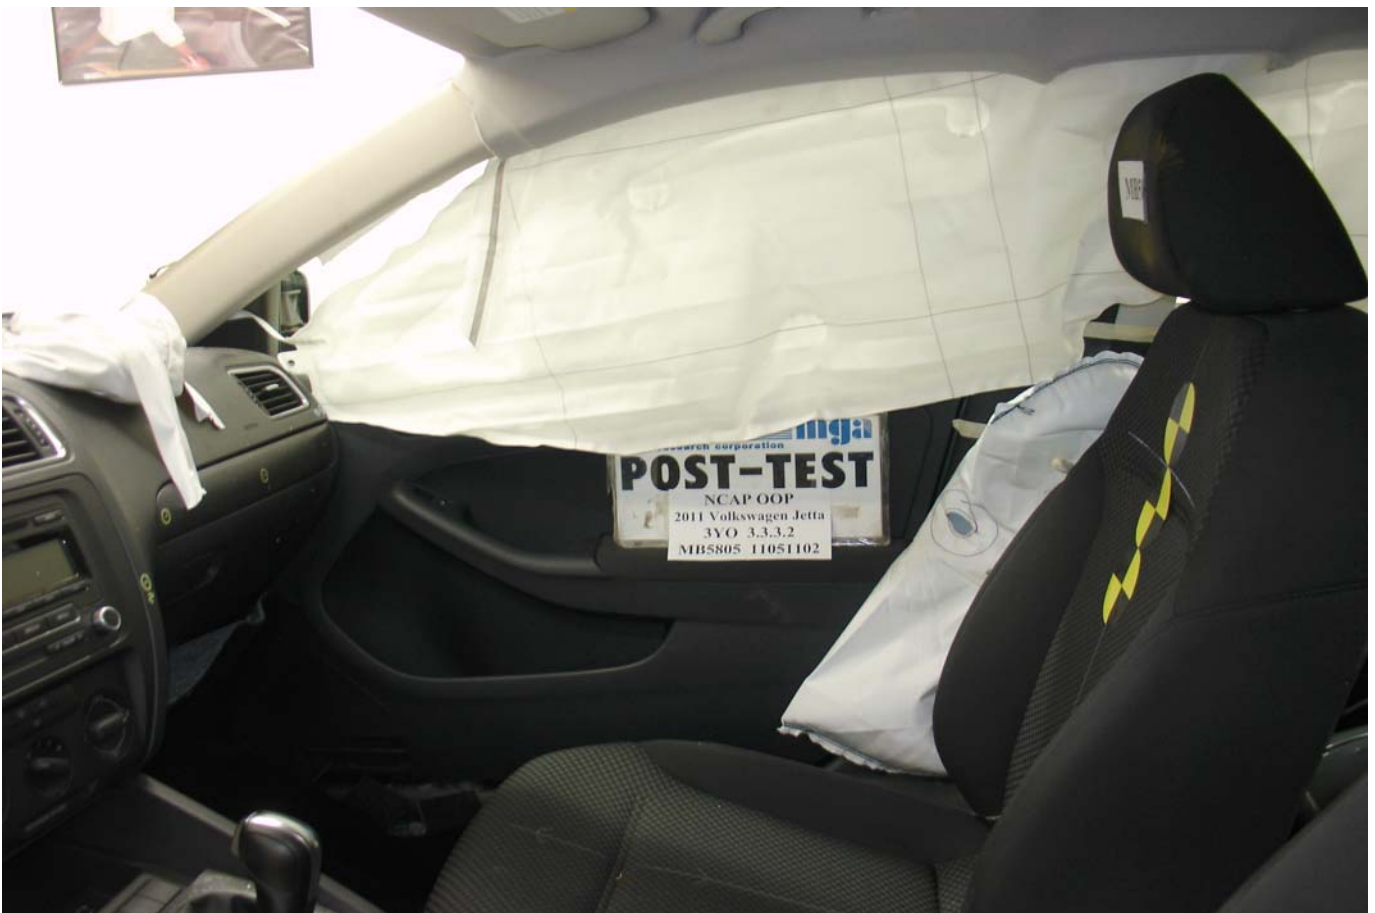
Post-Test Curtain and Torso Airbag Left Side View

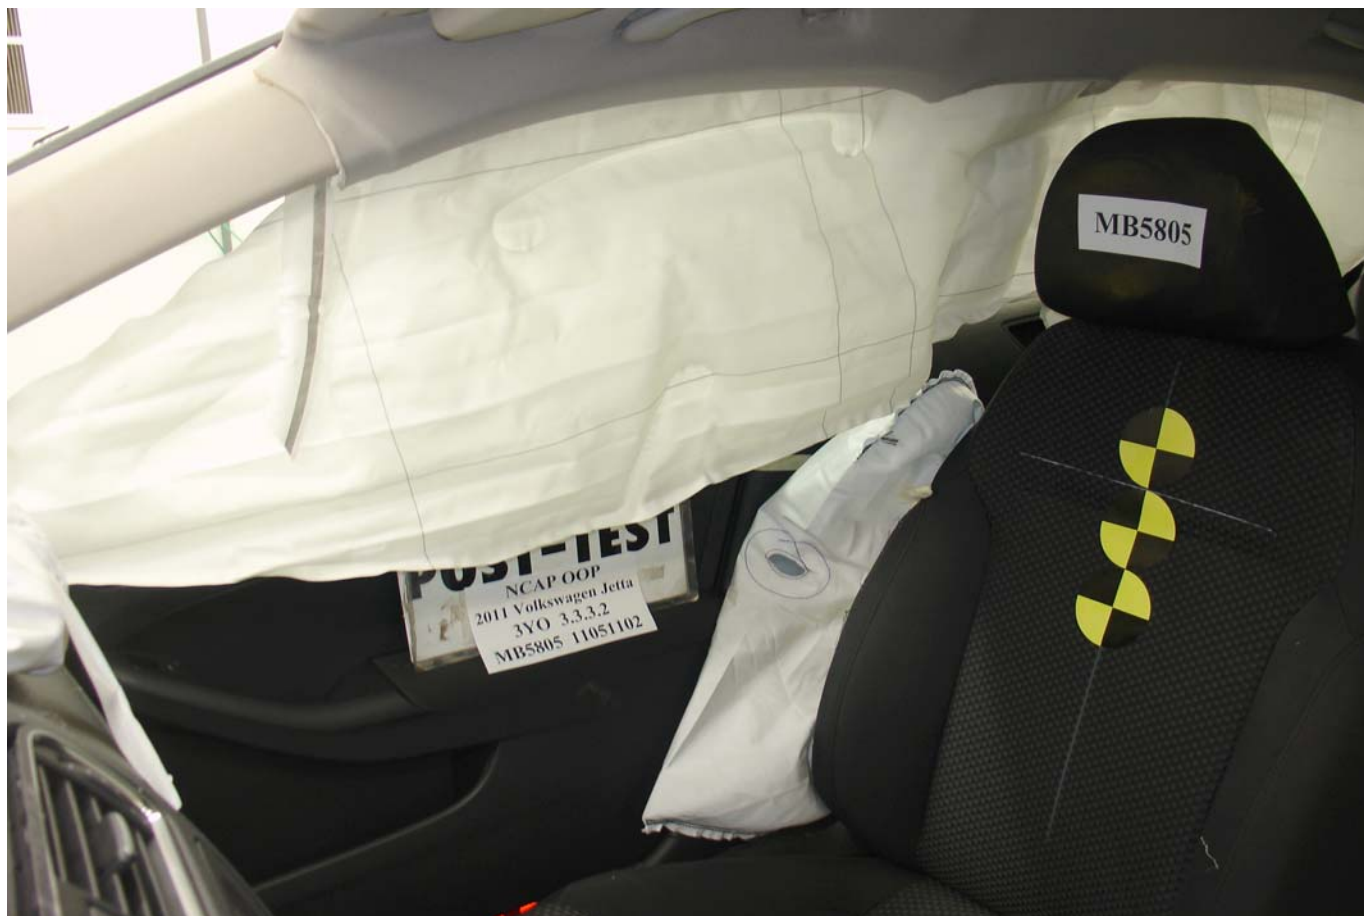
Post-Test Curtain and Torso Airbag Left ¾ Front View

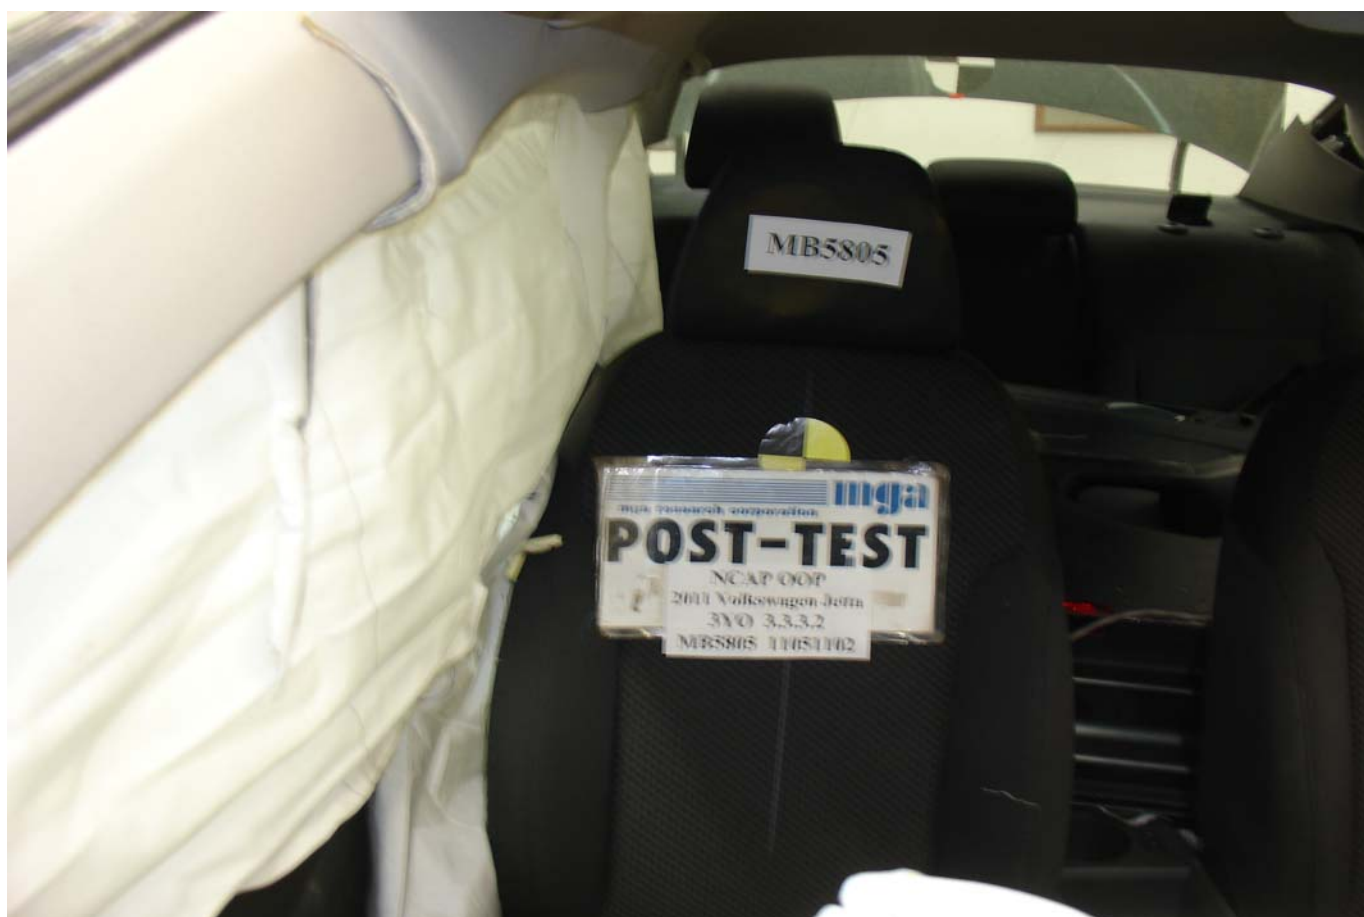
Post-Test Curtain and Torso Airbag Front View

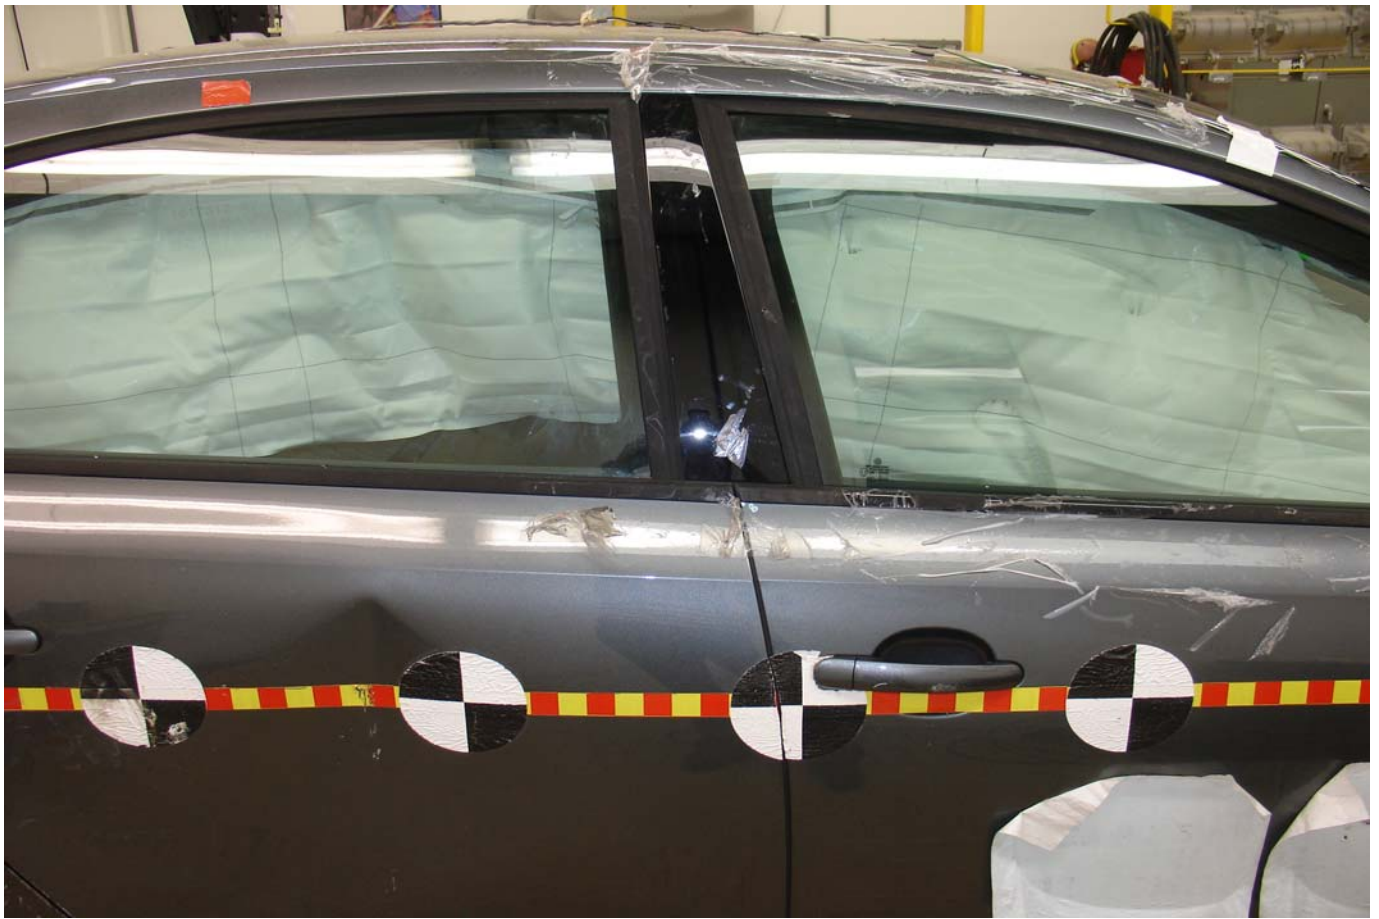
Post-Test Curtain Airbag Right Side View

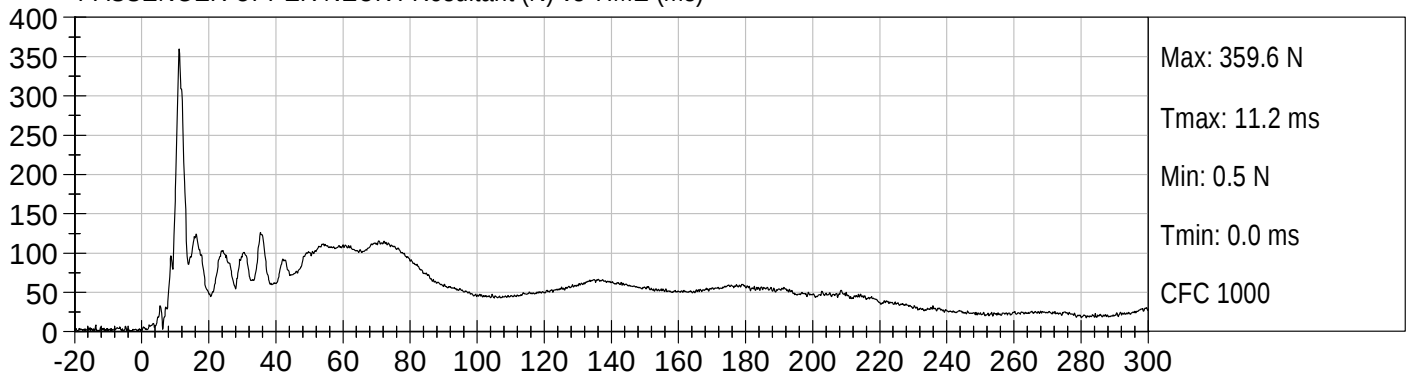
PASSENGER UPPER NECK FResultant (N) vs TIME (ms)

| DESCRIPTION | UNIT | MAXIMUM VALUE | | | |
|---|---|---|---|---|---|
| Upper Neck F Resultant | N | 359.6 | 11.2 | | |
