**REPORT NUMBER: TWG-MGA-2011-010**

**SIDE AIRBAG OUT-OF-POSITION INJURY  
TECHNICAL WORKING GROUP**

**NISSAN MOTOR COMPANY, LTD.  
2011 INFINITI M37X  
NHTSA NUMBER: MB5205TWG2**

**FINAL REPORT**

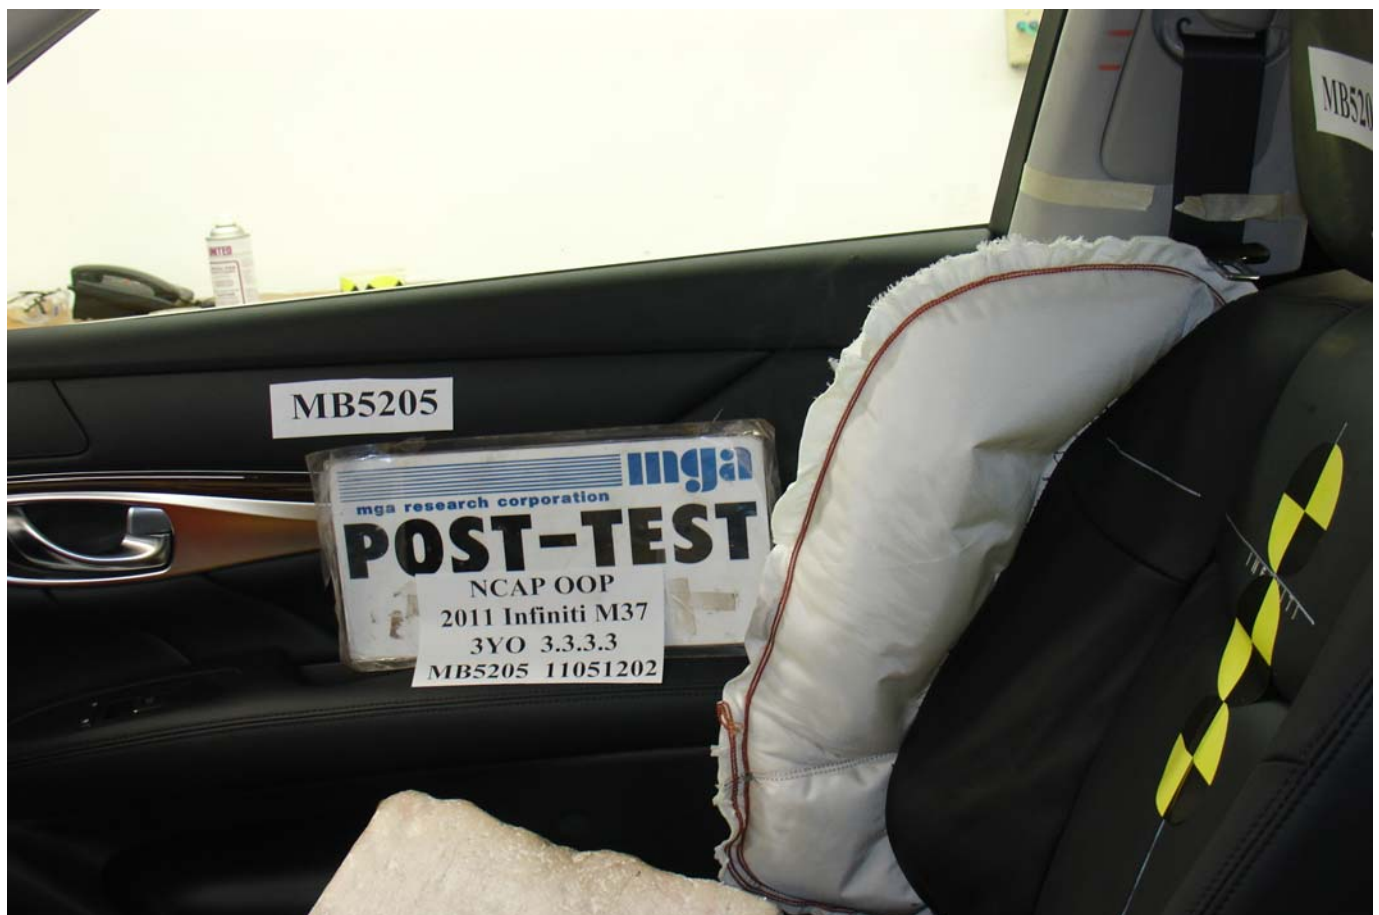
Post-Test 3-Year-Old Child Dummy Left Side Closeup View

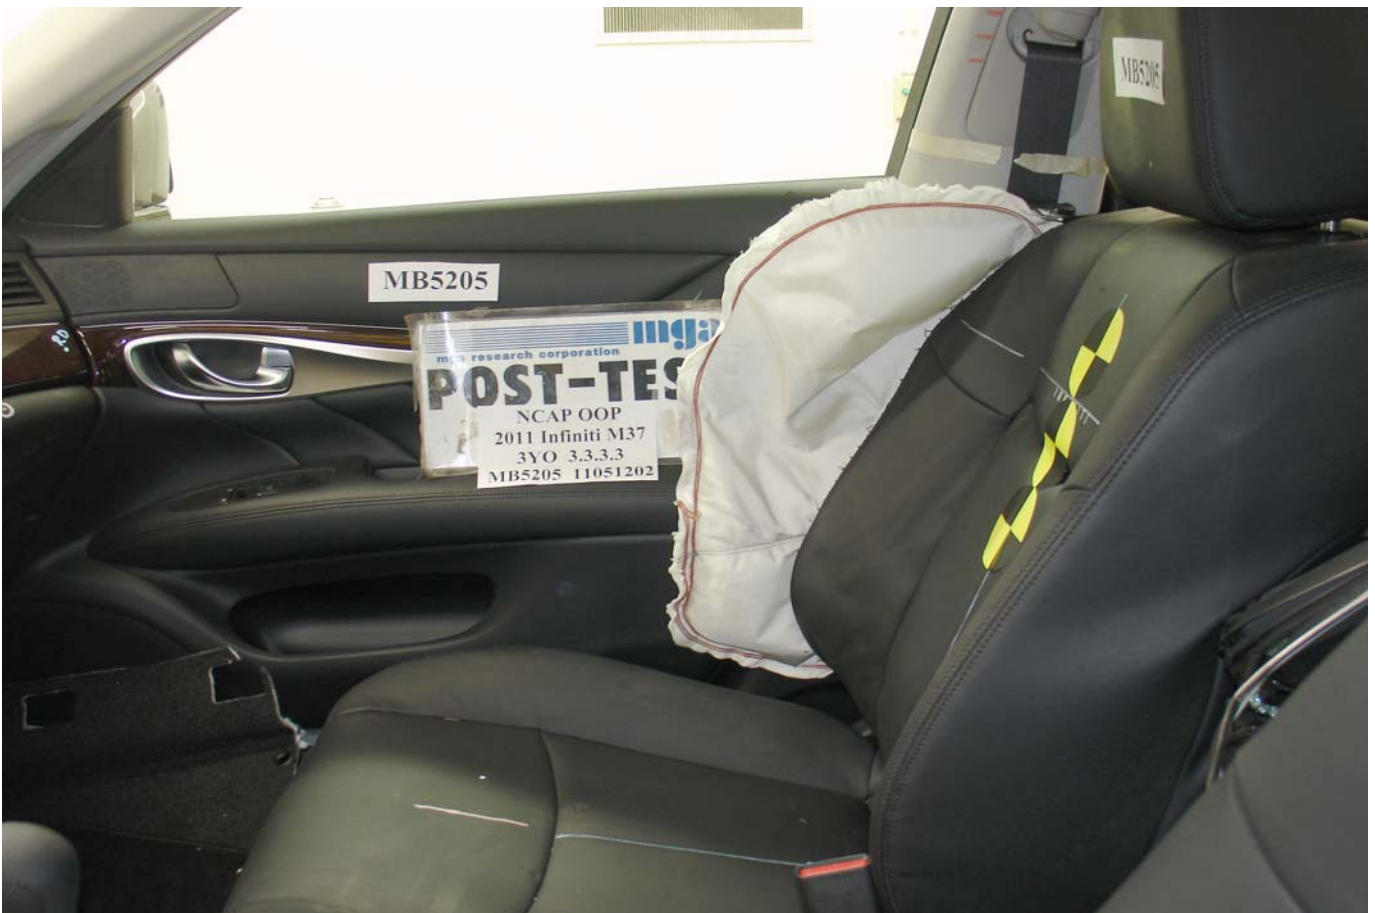
Post-Test Curtain and Torso Airbag Left Side View

- Torso/Pelvis airbag to left side of head

| Visible Dummy Contact Points | |
|---|---|
| Head Contact | Torso/Pelvis bag to left side of head |
