**REPORT NUMBER: SNCAP-KAR-11-061**

**NEW CAR ASSESSMENT PROGRAM (NCAP)  
MOVING DEFORMABLE BARRIER SIDE IMPACT TEST**

**NISSAN MOTOR CO., LTD.  
2011 NISSAN LEAF SL 5-DOOR HATCHBACK**

**NHTSA No: MB5219**

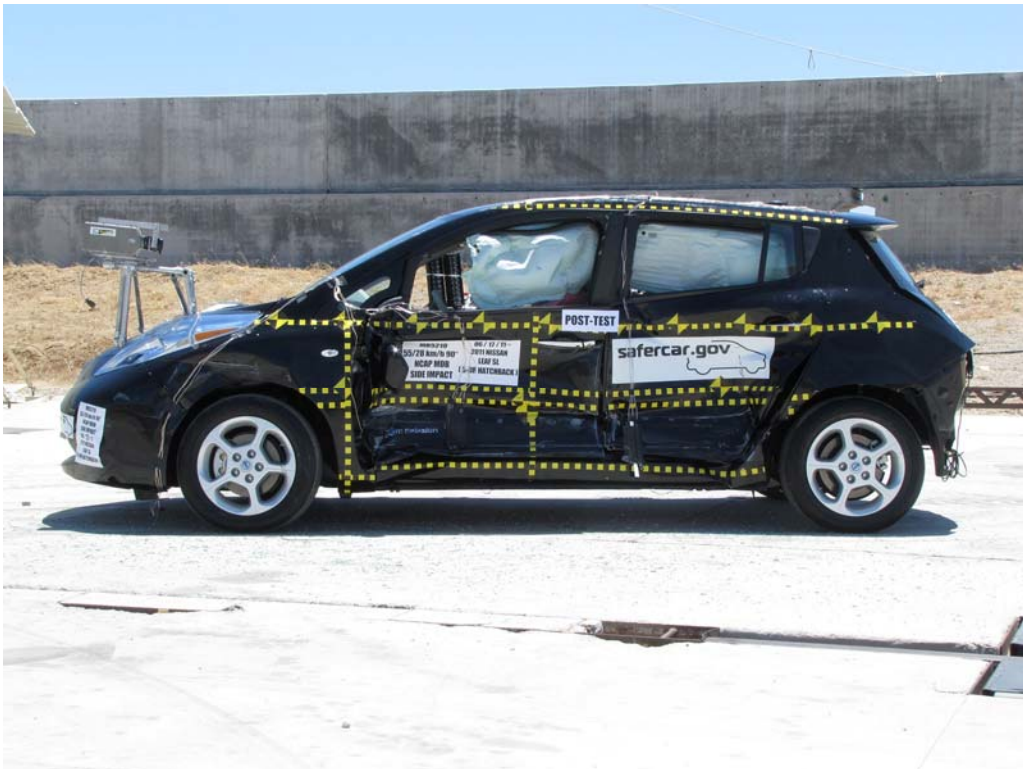
FIGURE 8. Post-Test Left Side View of Test Vehicle

The two doors on the struck side of the vehicle did not separate from the body at the hinges or latches, and the opposite doors did not open during the side impact event.

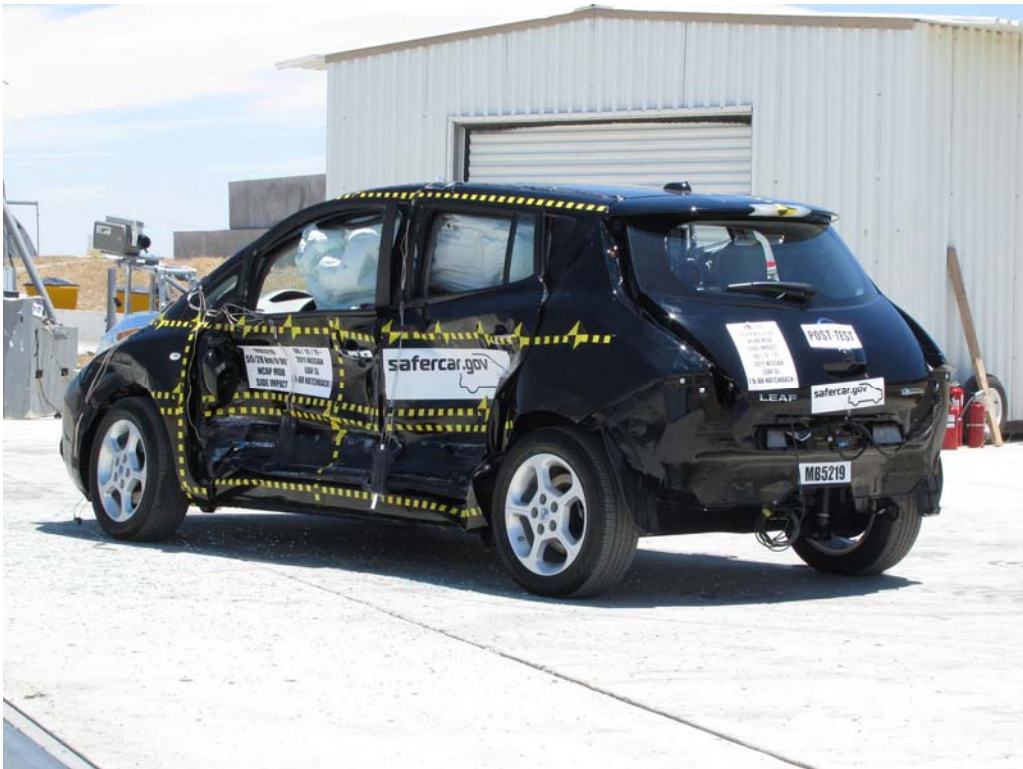
FIGURE 10. Post-Test Left Rear Three-Quarter View of Impact Zone

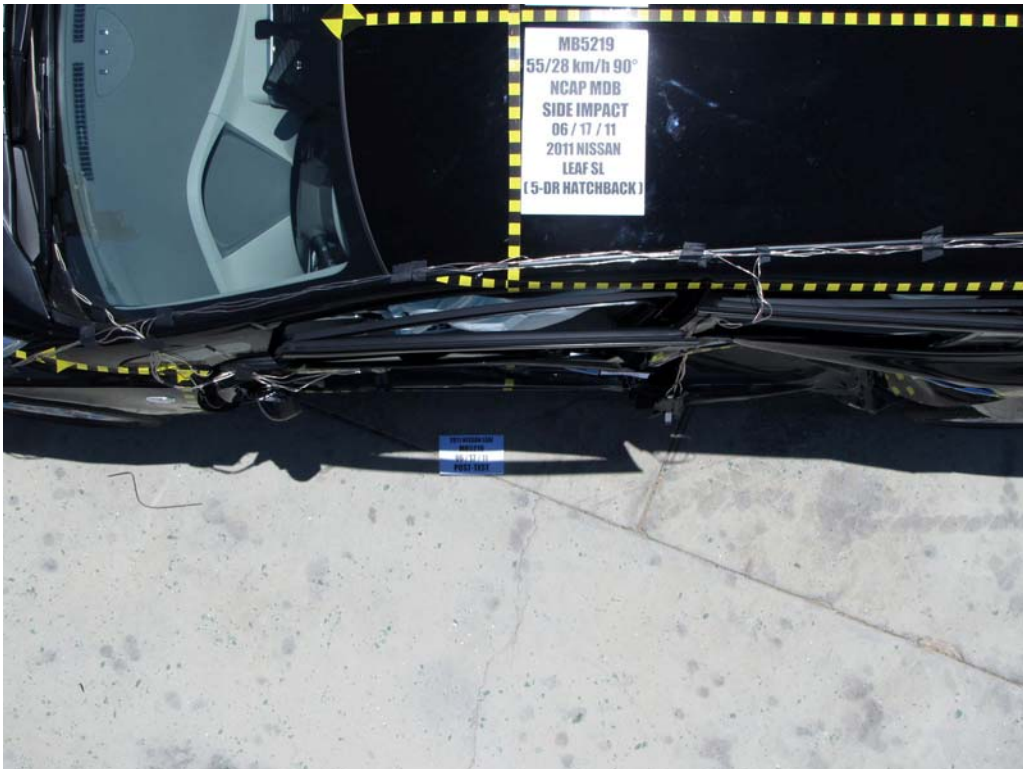
FIGURE 16. Post-Test Overhead View of Test Vehicle and MDB

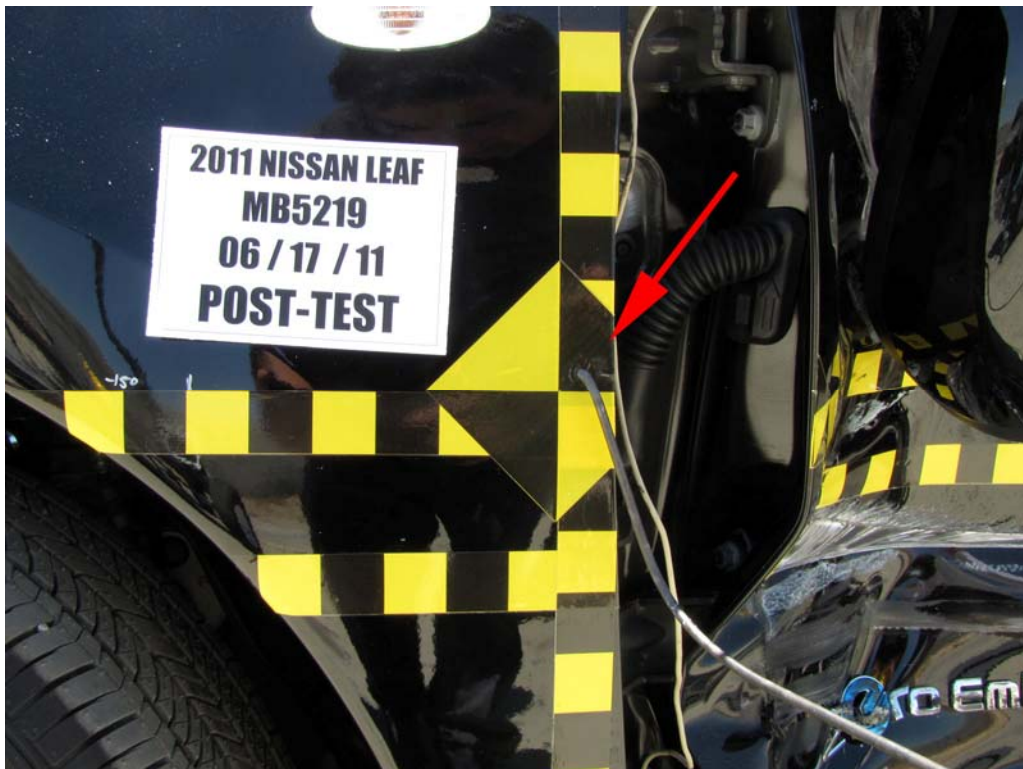
FIGURE 20. Post-Test Close-Up View of Impact Point Target  
Showing Impact Point Location

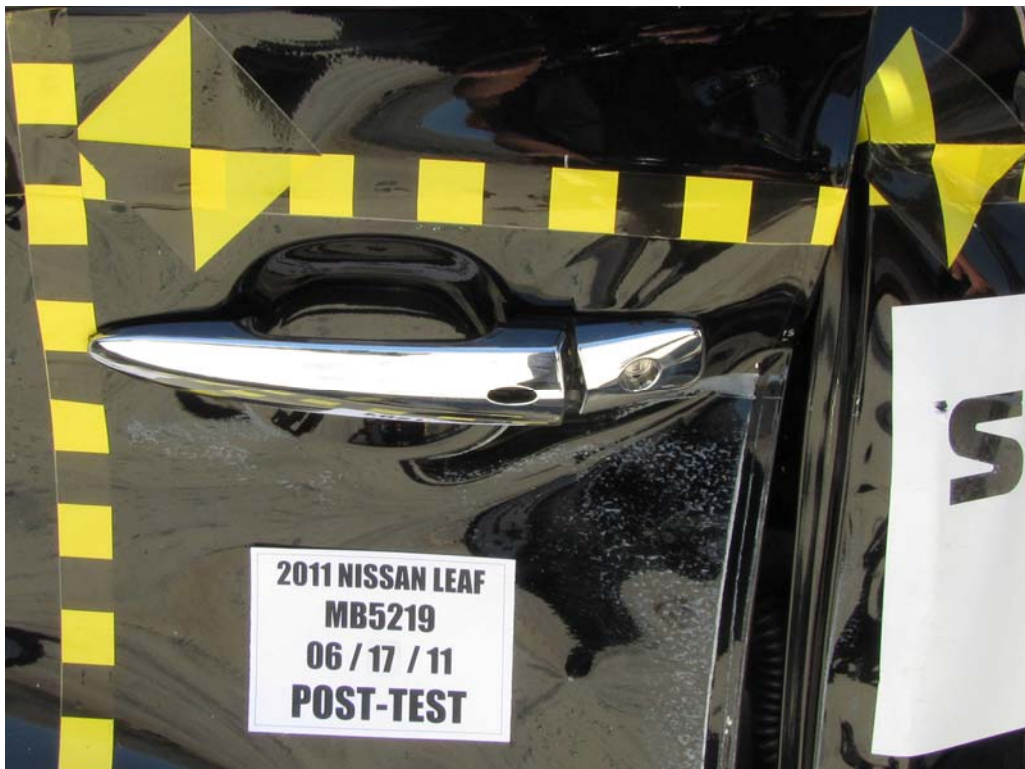
FIGURE 22. Post-Test Left Front Door Latch Close-Up

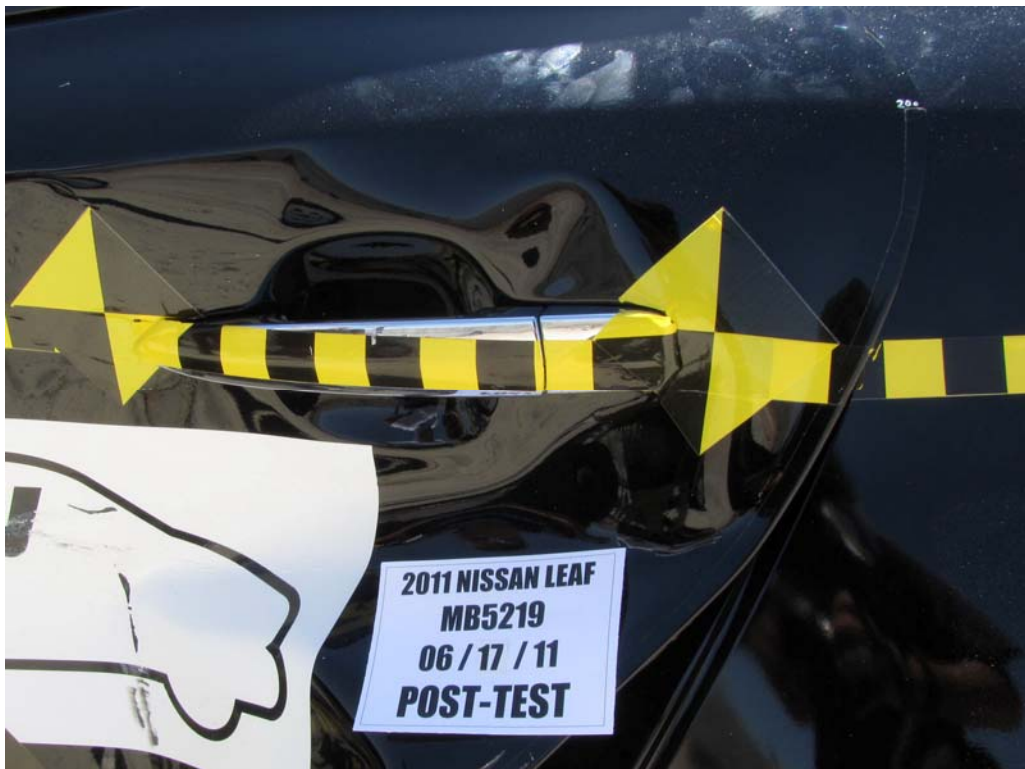
FIGURE 24. Post-Test Left Rear Door Latch Close-Up

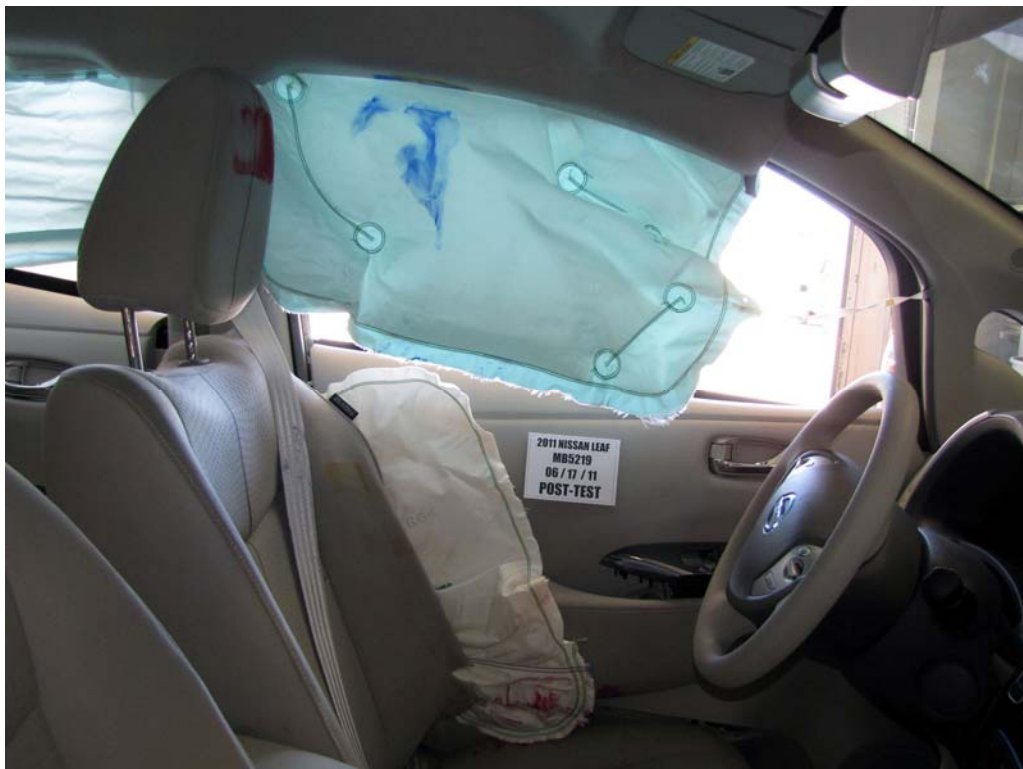
FIGURE 46. Post-Test Driver Dummy Inner Door Panel View  
Showing Driver Dummy Contact Locations

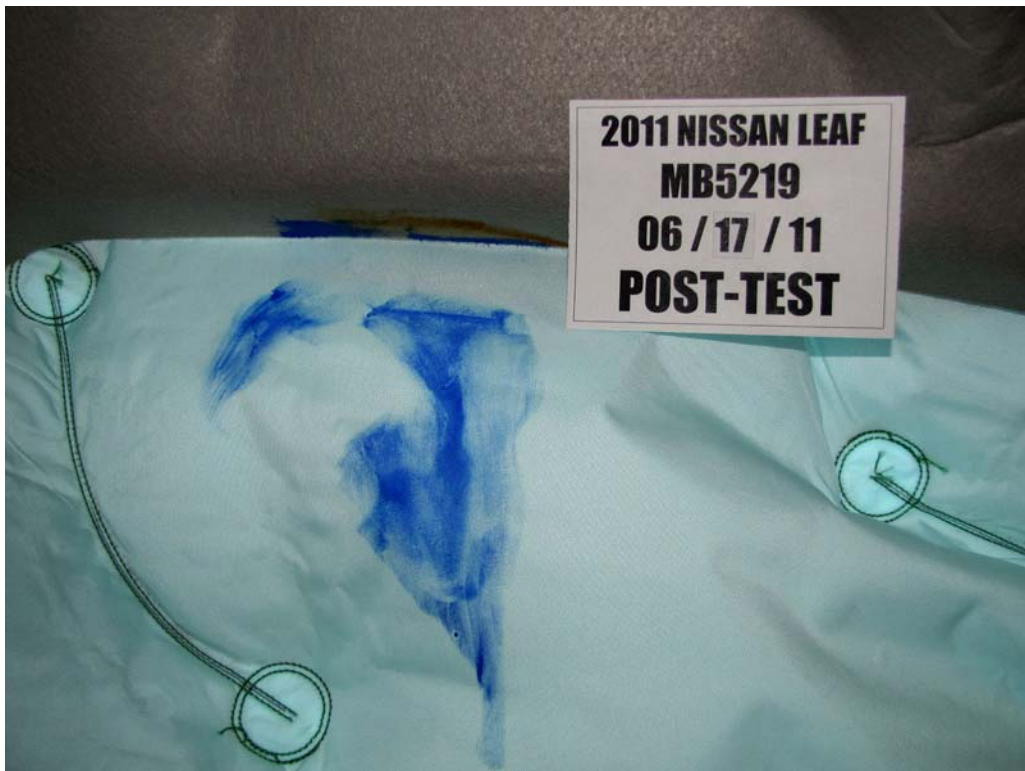
FIGURE 48. Post-Test Driver Dummy Close-Up Head Contact with Side Airbag View

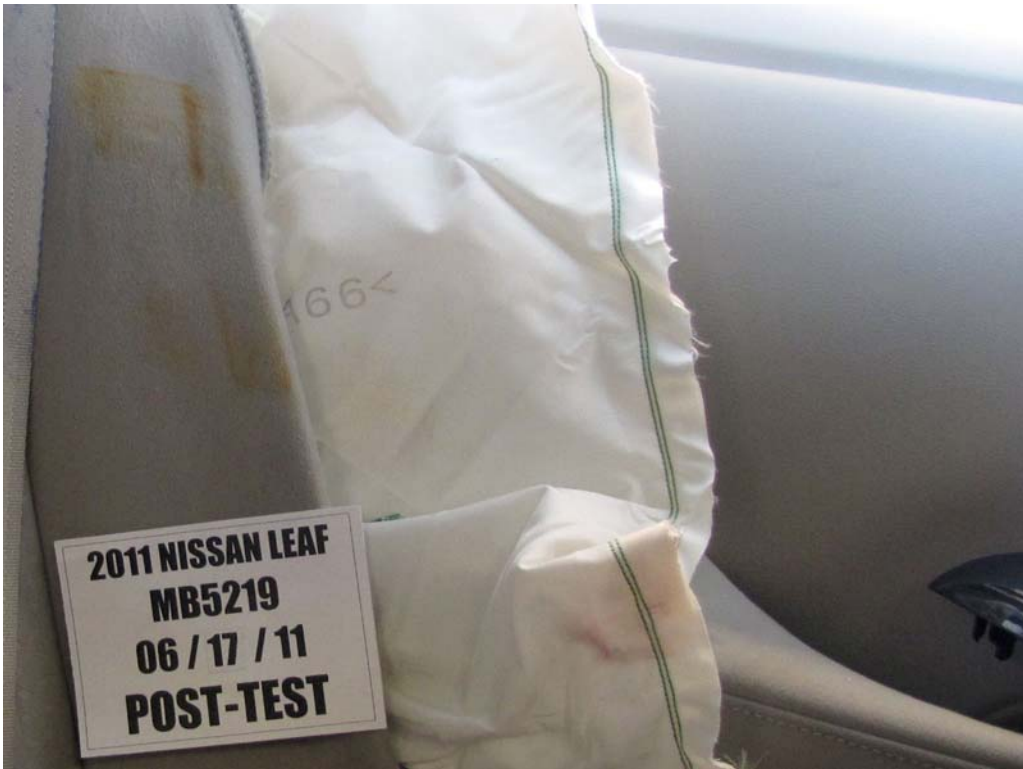
FIGURE 50. Post-Test Driver Dummy Close-Up Torso Contact with Side Airbag View

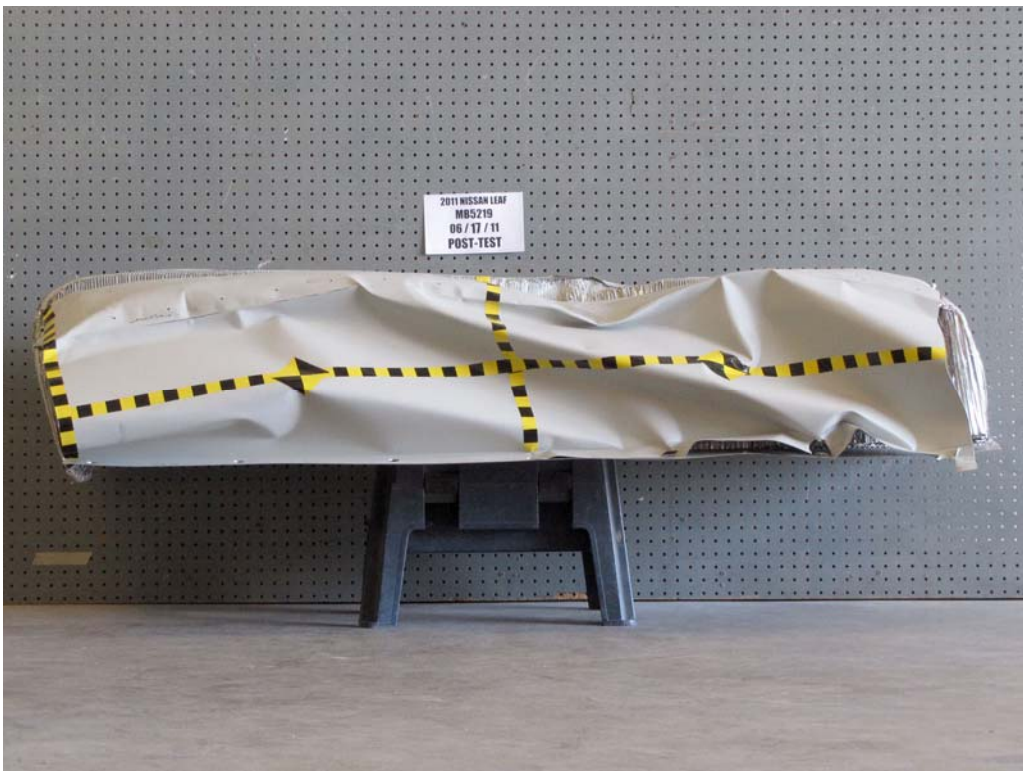
FIGURE 84. Post-Test Top View of MDB Impactor Face

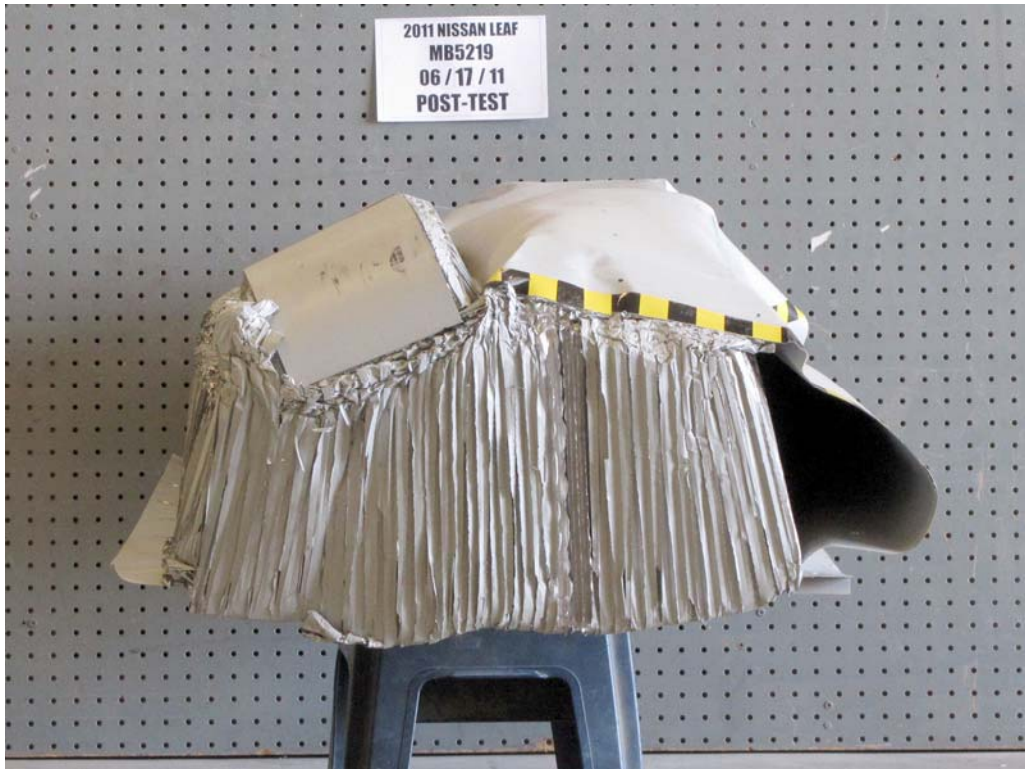
FIGURE 86. Post-Test Left Side View of MDB Impactor Face

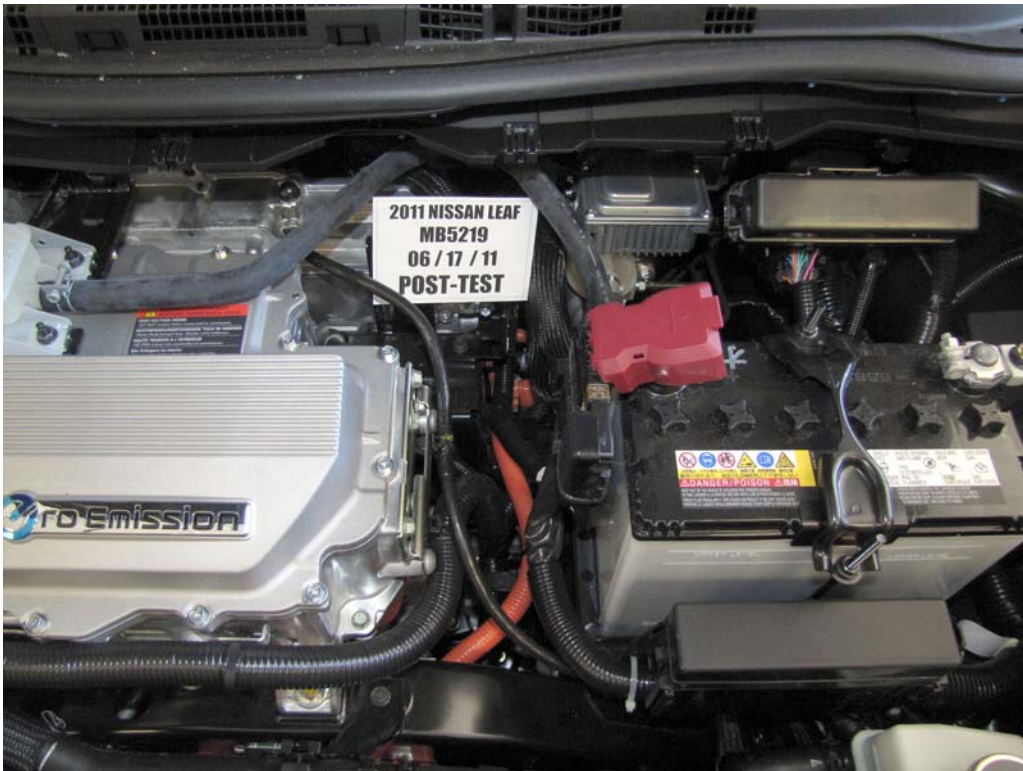
FIGURE 108. Post-Test Electric Drive Motor

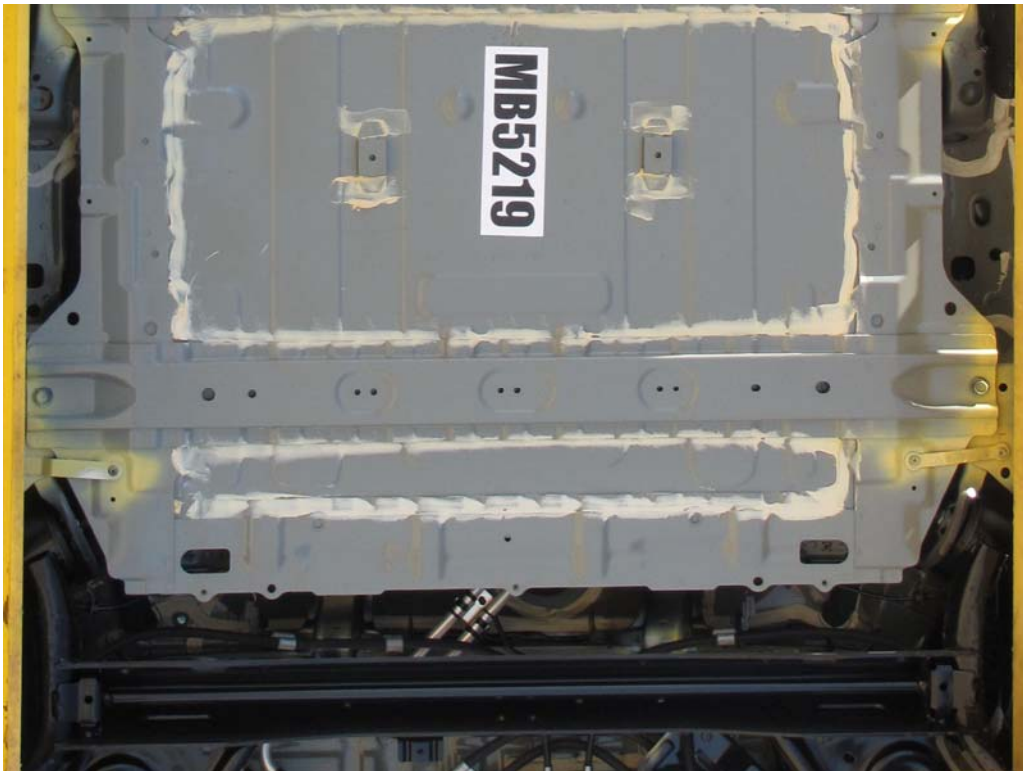
FIGURE 122. Post-Test Battery Mounting Hardware
