**REPORT NUMBER: SPNCAP-MGA-2011-082**

**NEW CAR ASSESSMENT PROGRAM (NCAP)  
Side Impact Pole Test**

**HONDA OF CANADA MFG.  
2011 Acura ZDX SUV  
NHTSA No.: HB5303**

**FINAL REPORT**

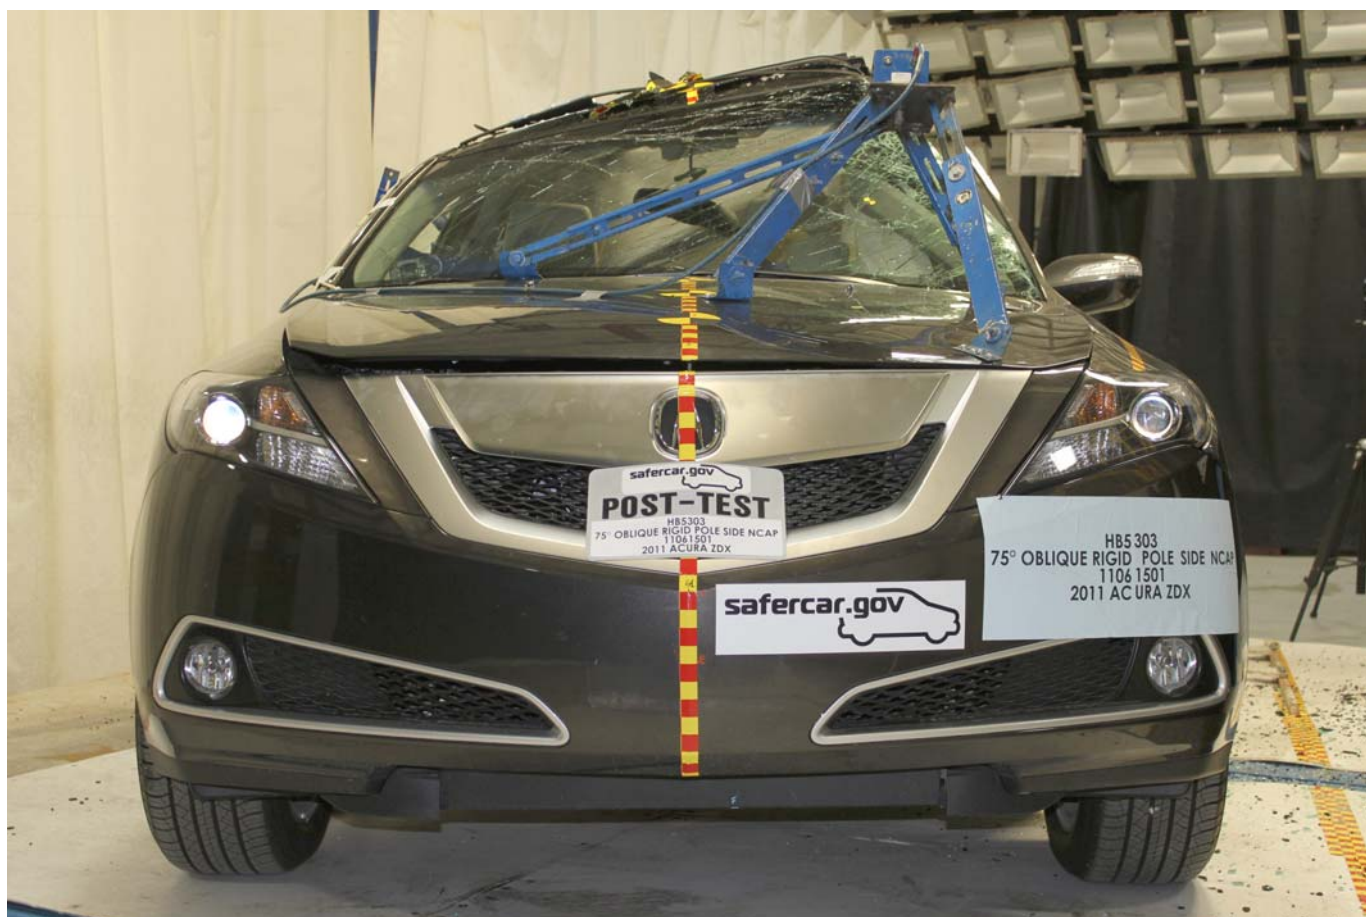
Post-Test Frontal View of Test Vehicle

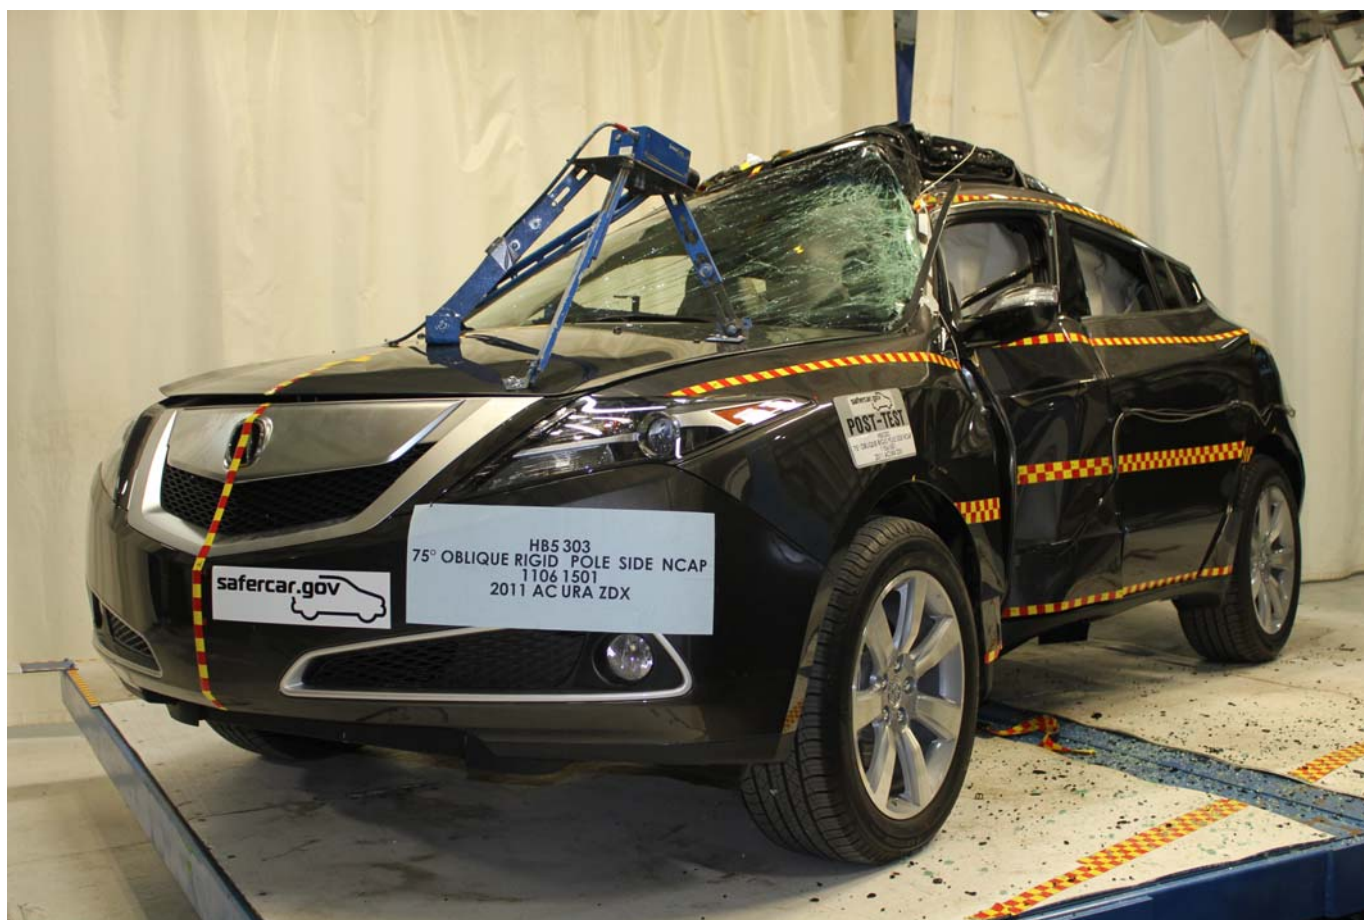
Post-Test Left Front  $\frac{3}{4}$  View of Test Vehicle

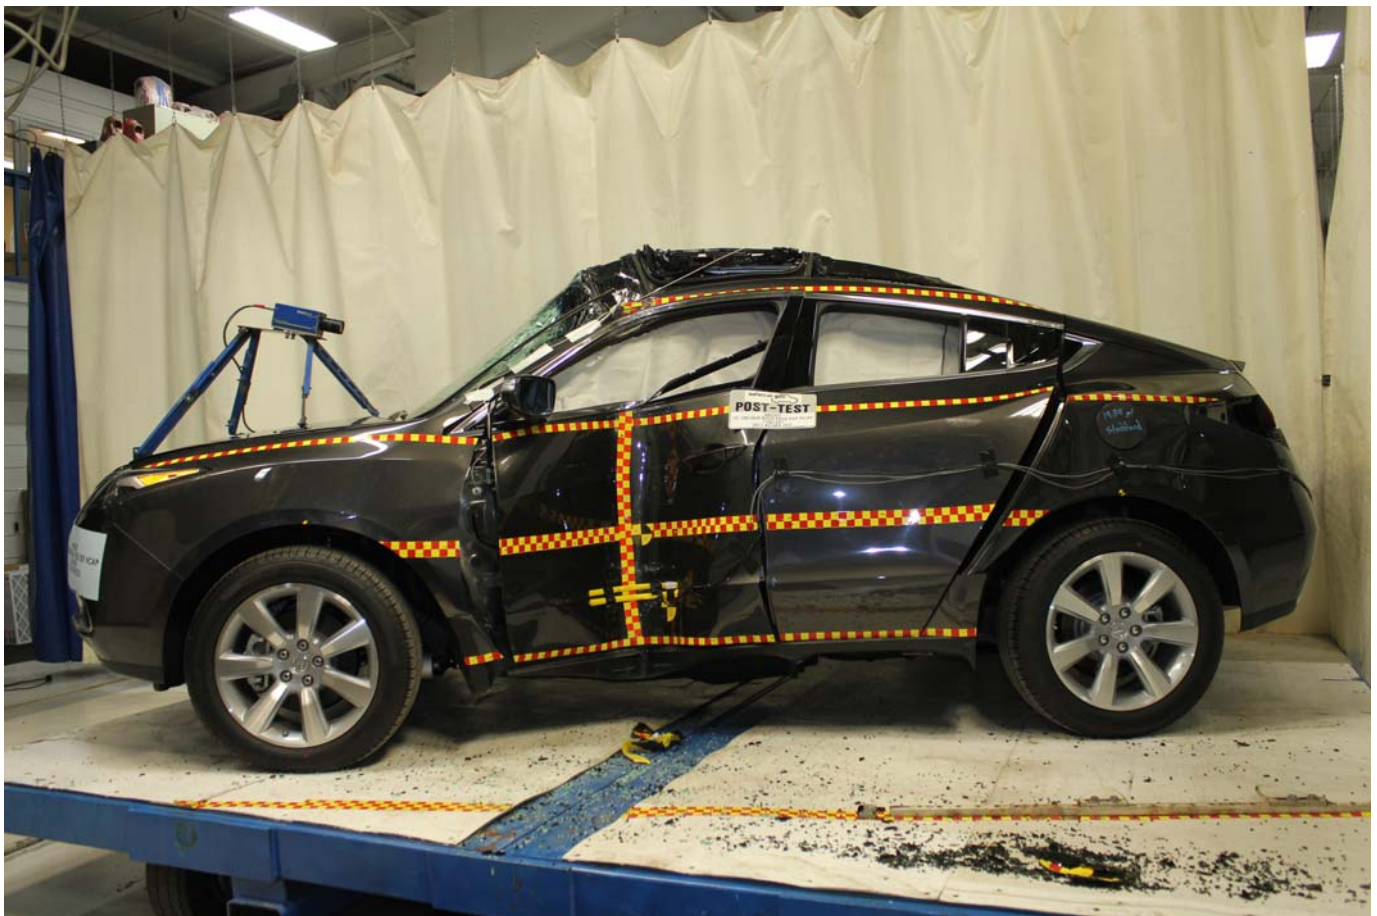
Post-Test Left Side View of Test Vehicle

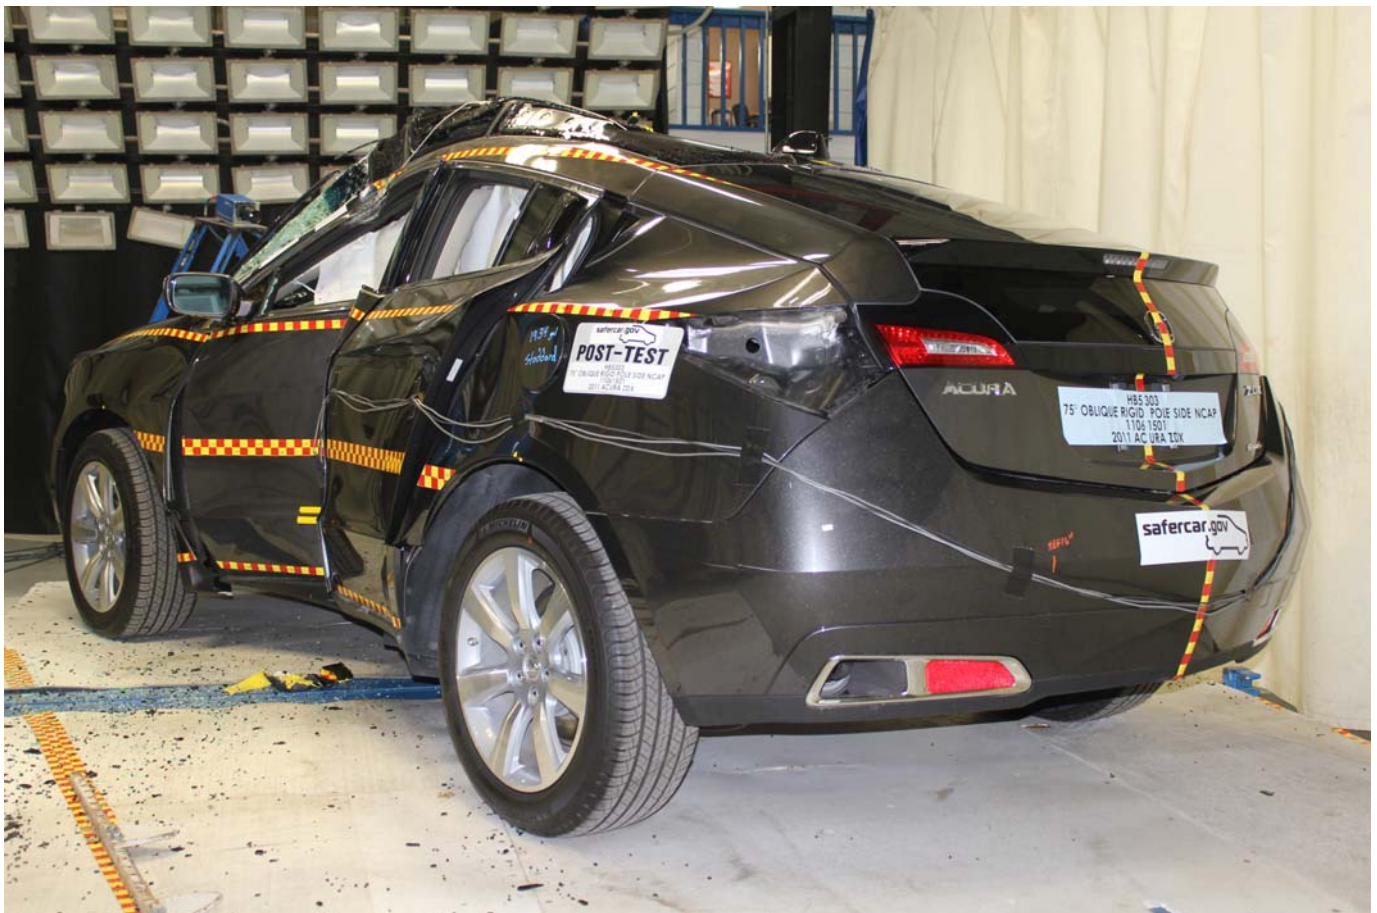
Post-Test Left Rear  $\frac{3}{4}$  View of Test Vehicle

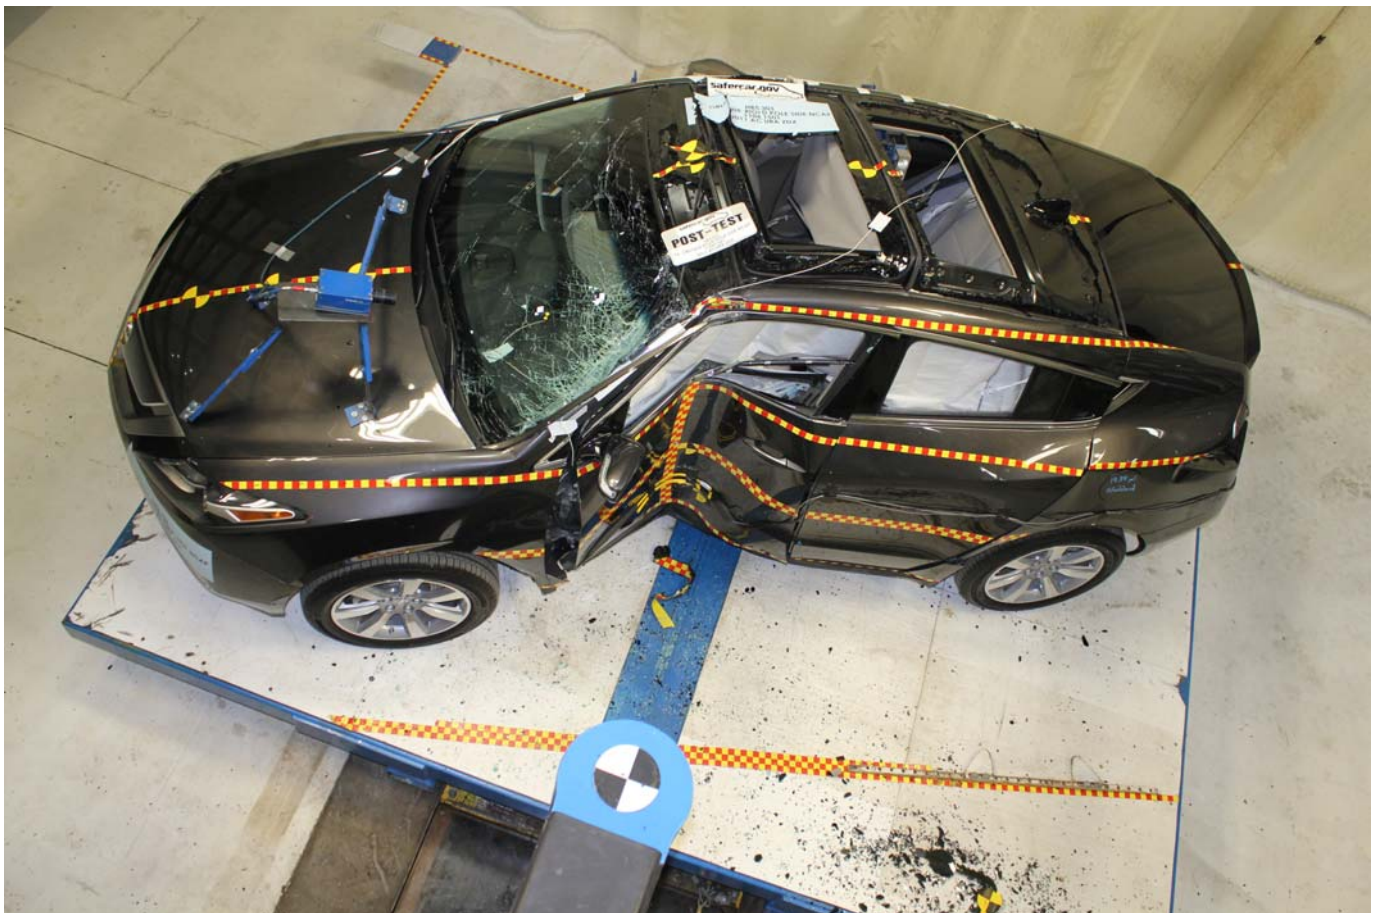
Post-Test Overhead View of Test Vehicle and Pole

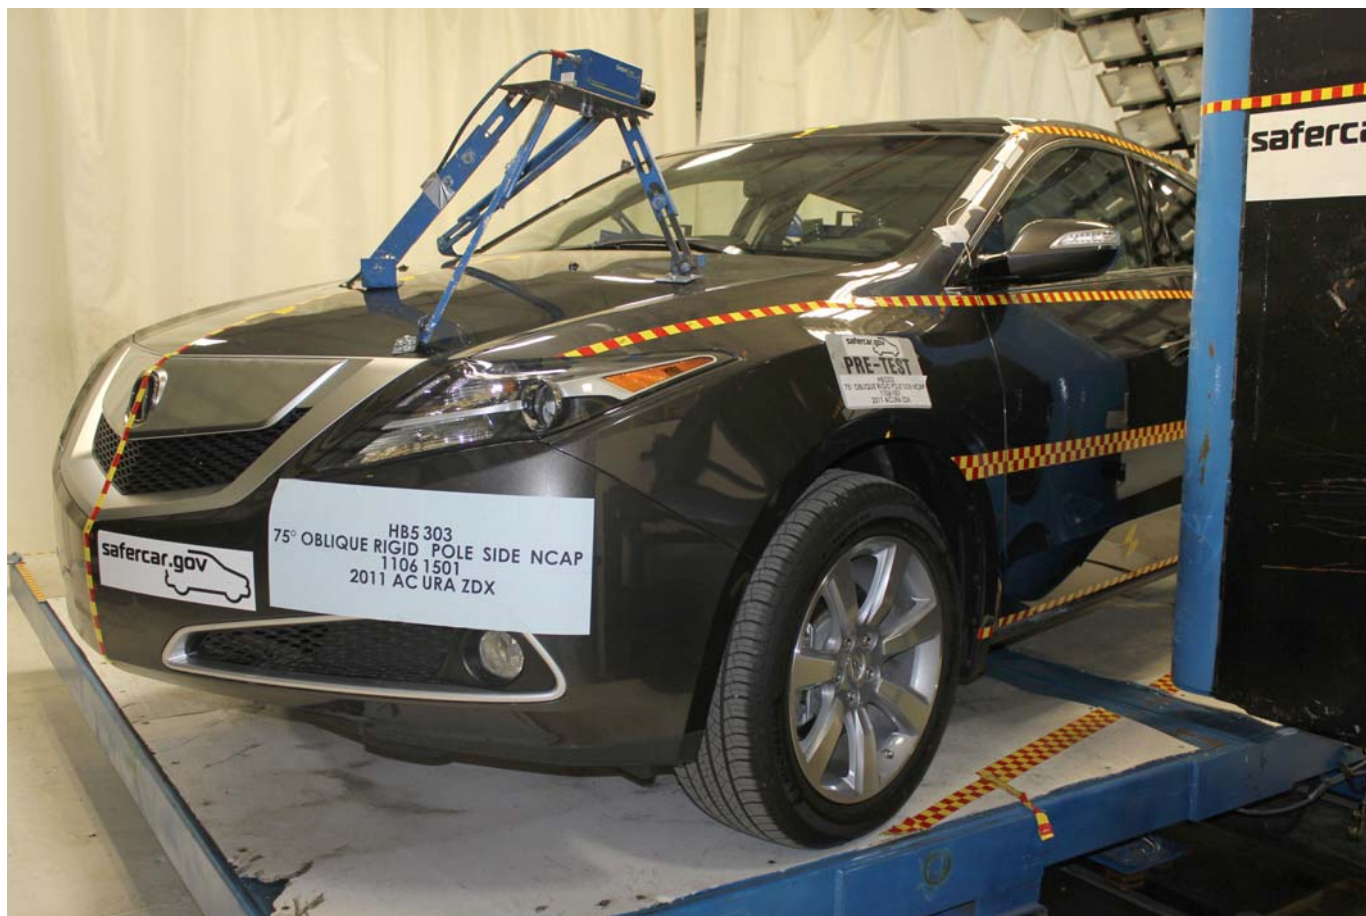
Pre-Test Left Side View of Pole Positioned Against Side of Vehicle

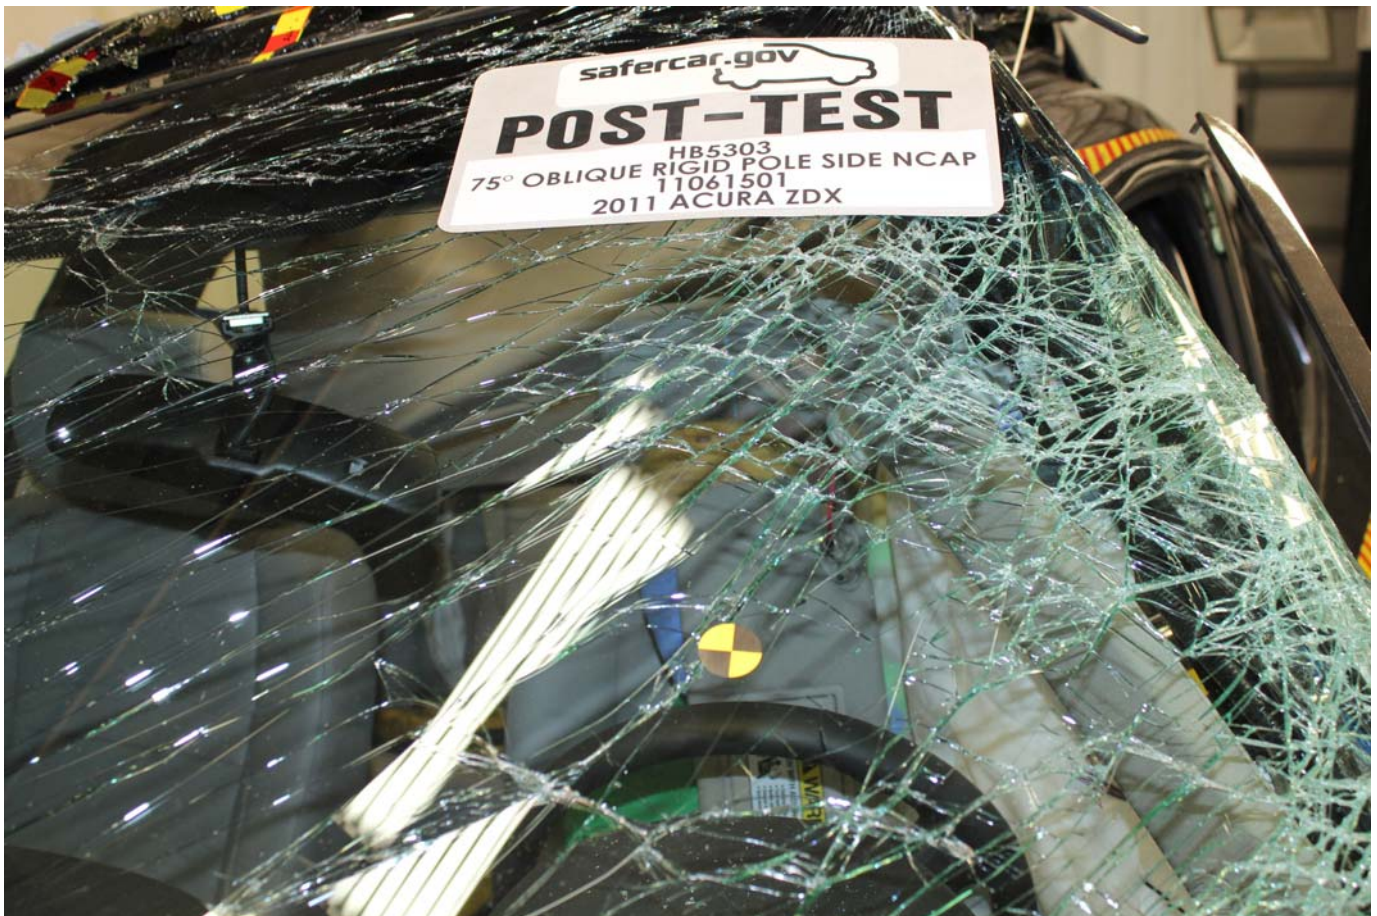
Post-Test Front Close-Up View of Dummy (through front window)

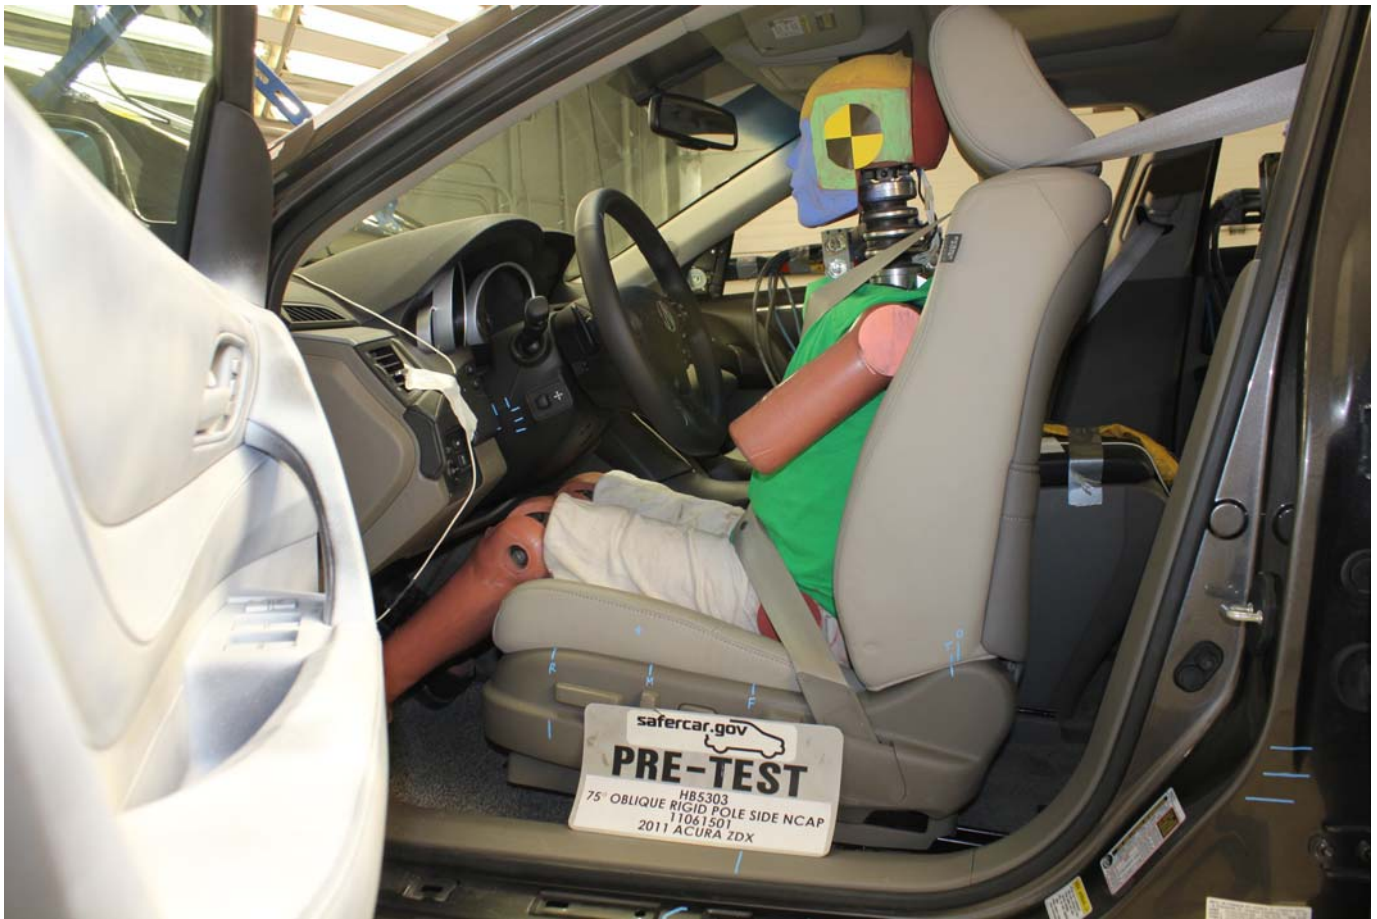
Pre-Test Left Side View of Dummy Showing Belts, Chalking, and Contact Switches (Door Open)

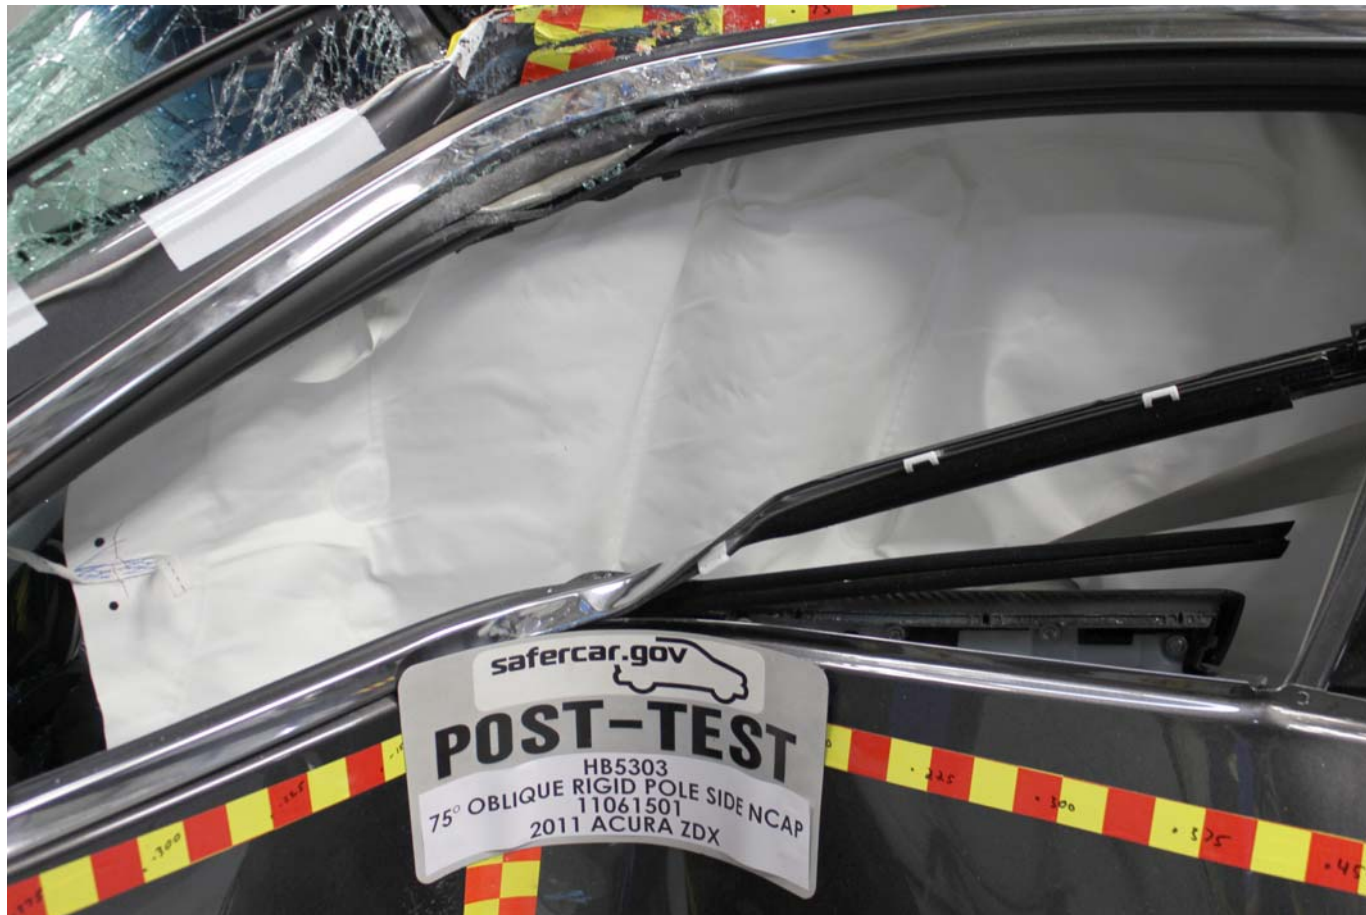
Post-Test Left Side View of Dummy Shoulder and Door Top View

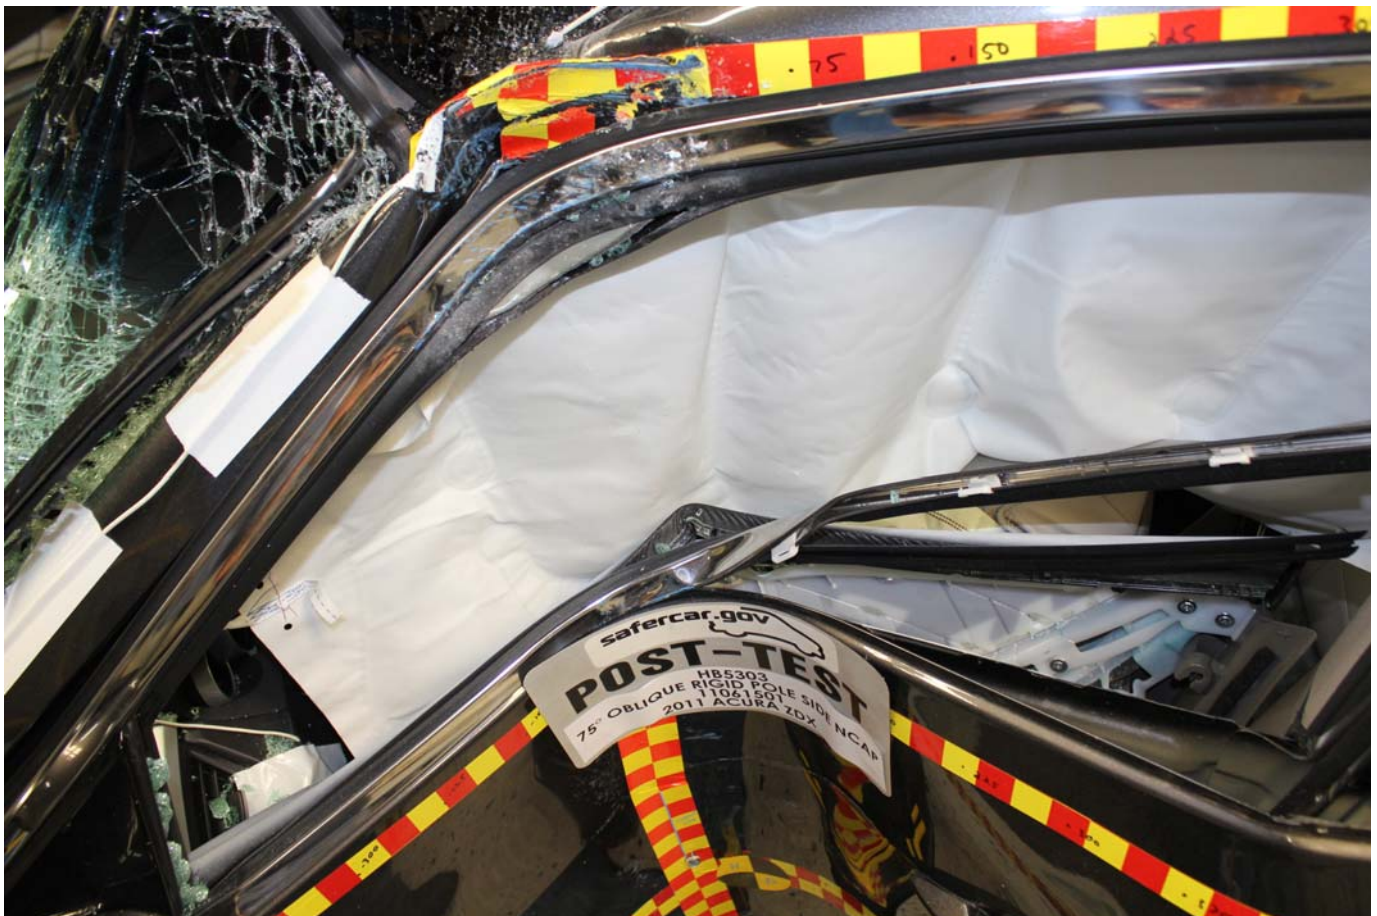
Post-Test Dummy and Door Clearance View

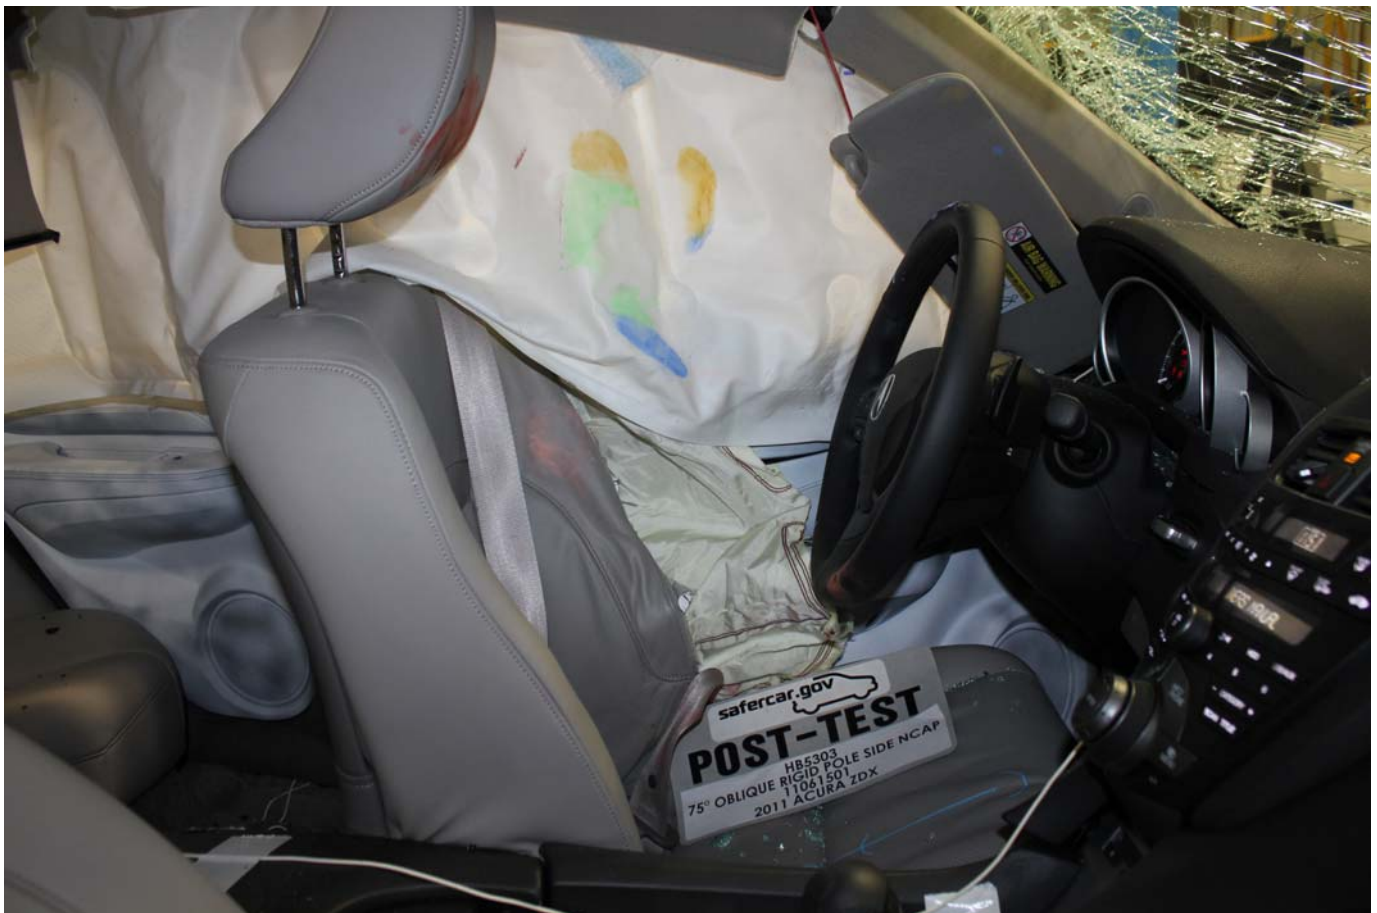
Post-Test Inner Driver Door Panel View Showing Dummy Contact Location

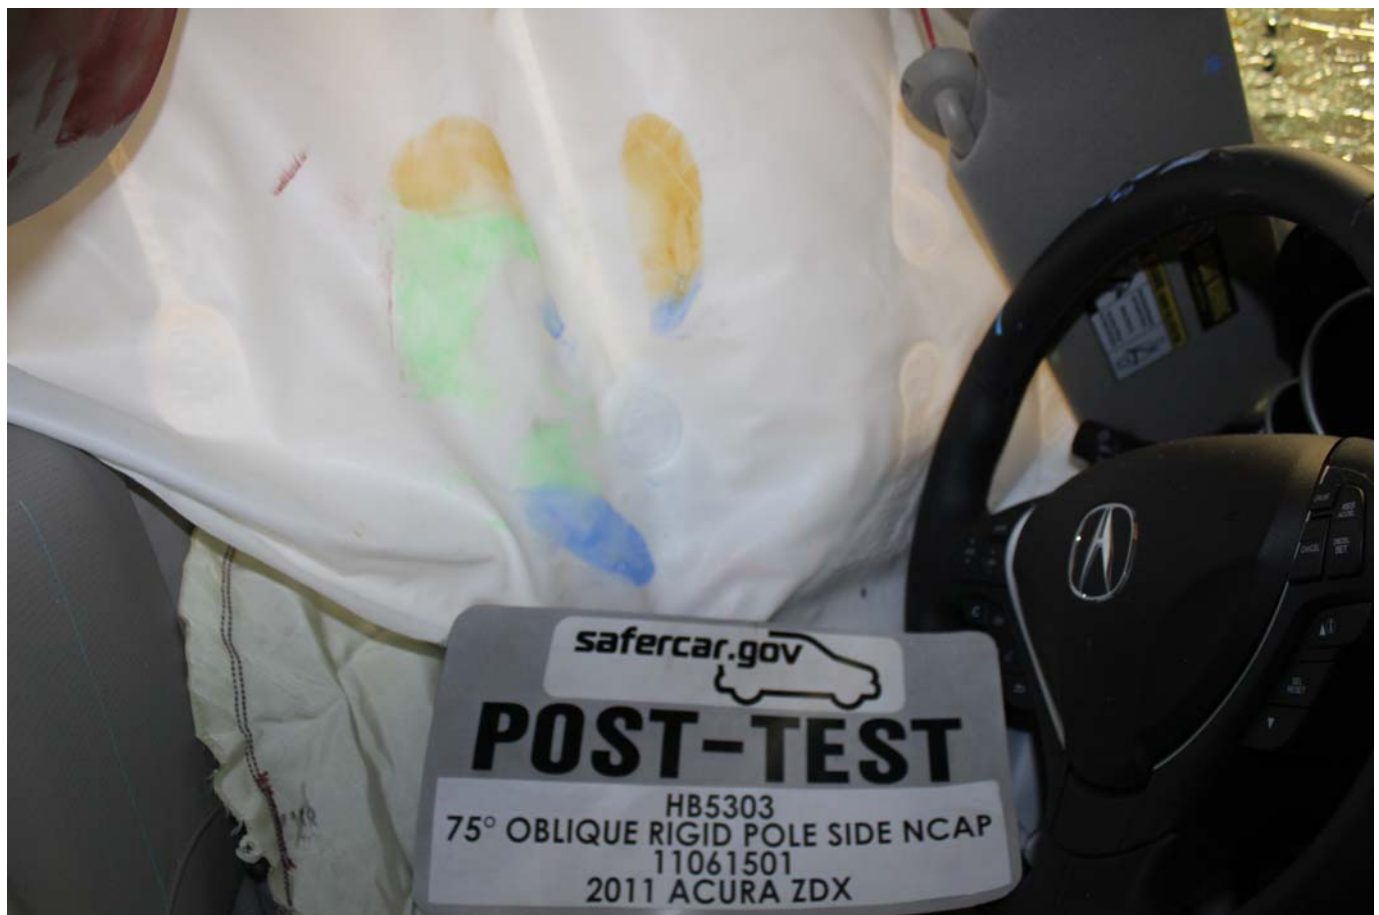
Post-Test Dummy Close-Up Head Contact with Side Airbag View

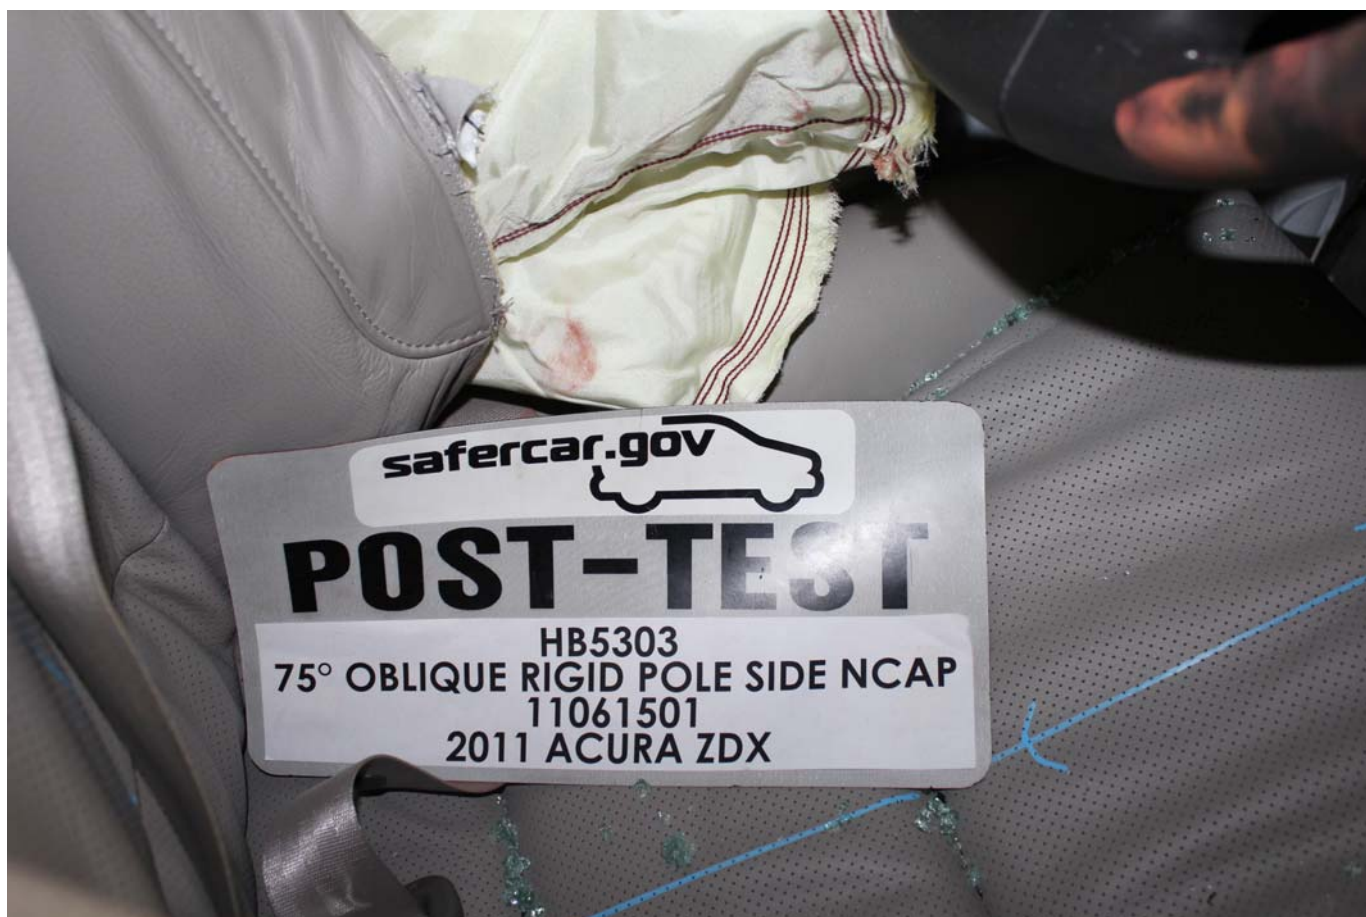
Post-Test Dummy Close-Up Pelvis Contact with Side Airbag View

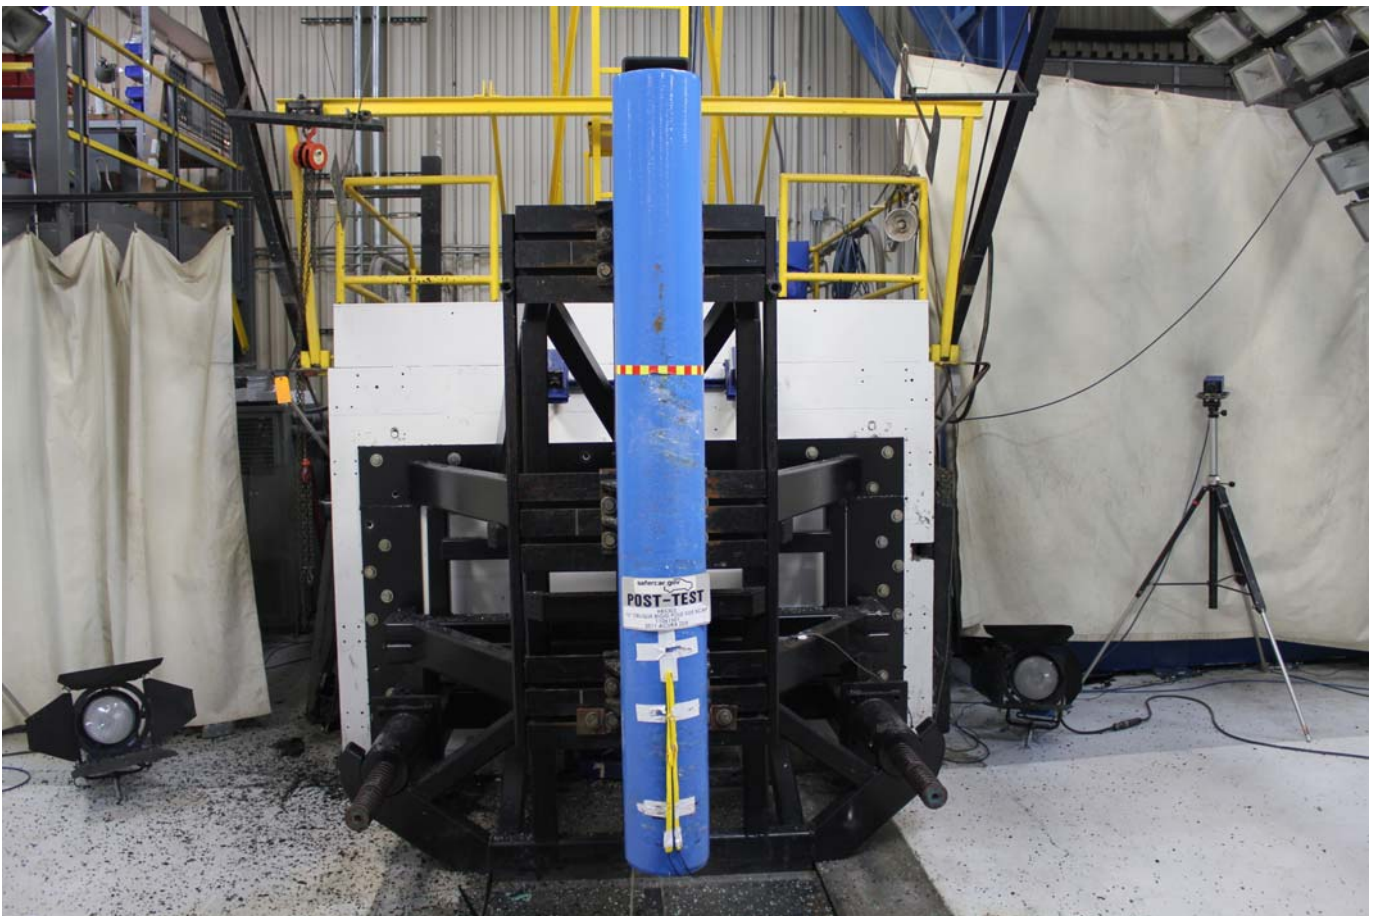
Post-Test Pole Barrier Front View

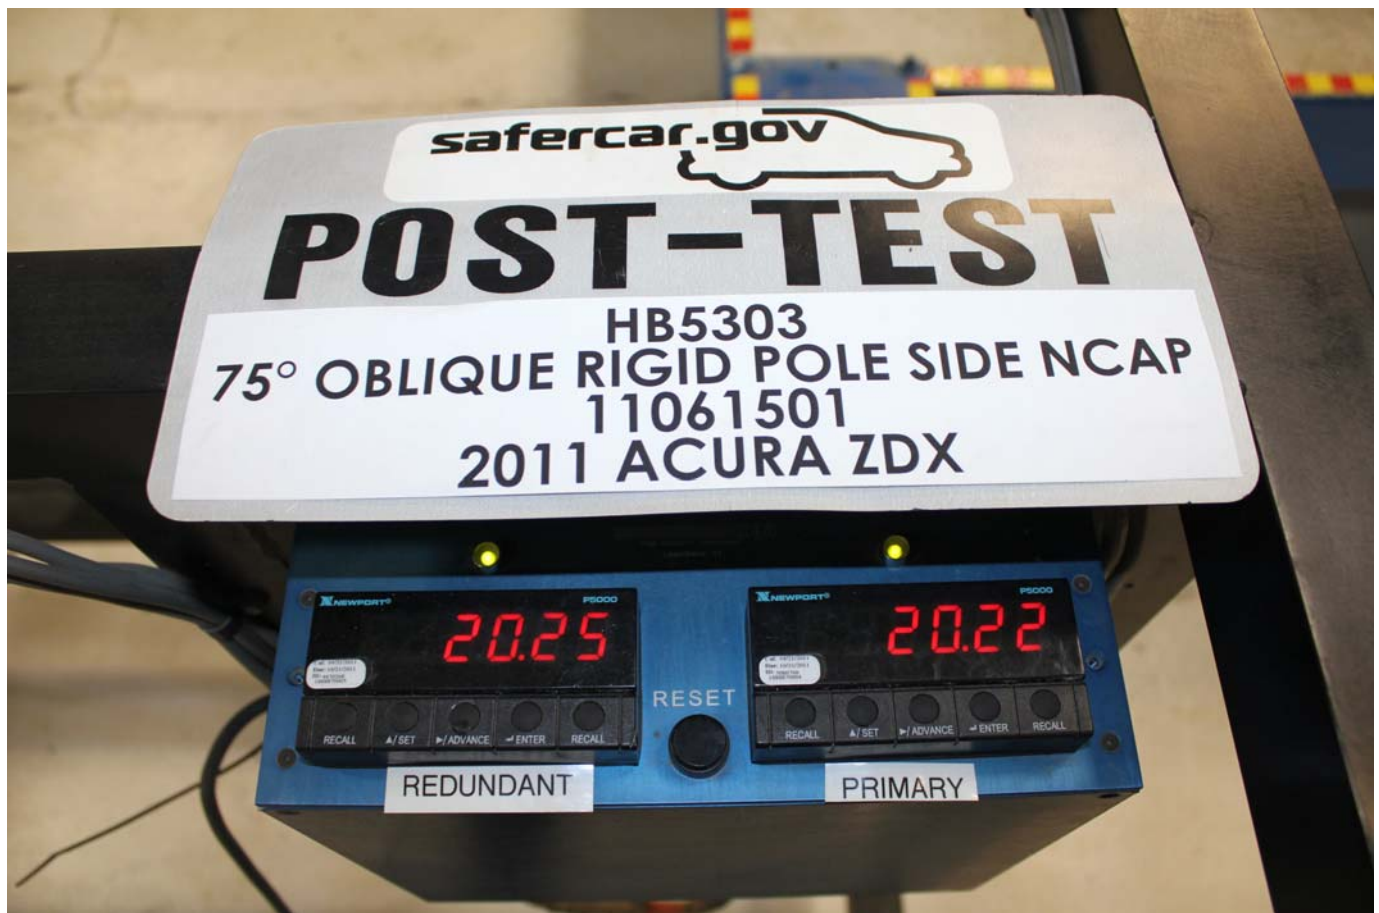
Post-Test Primary and Redundant Speed Trap Read-Out

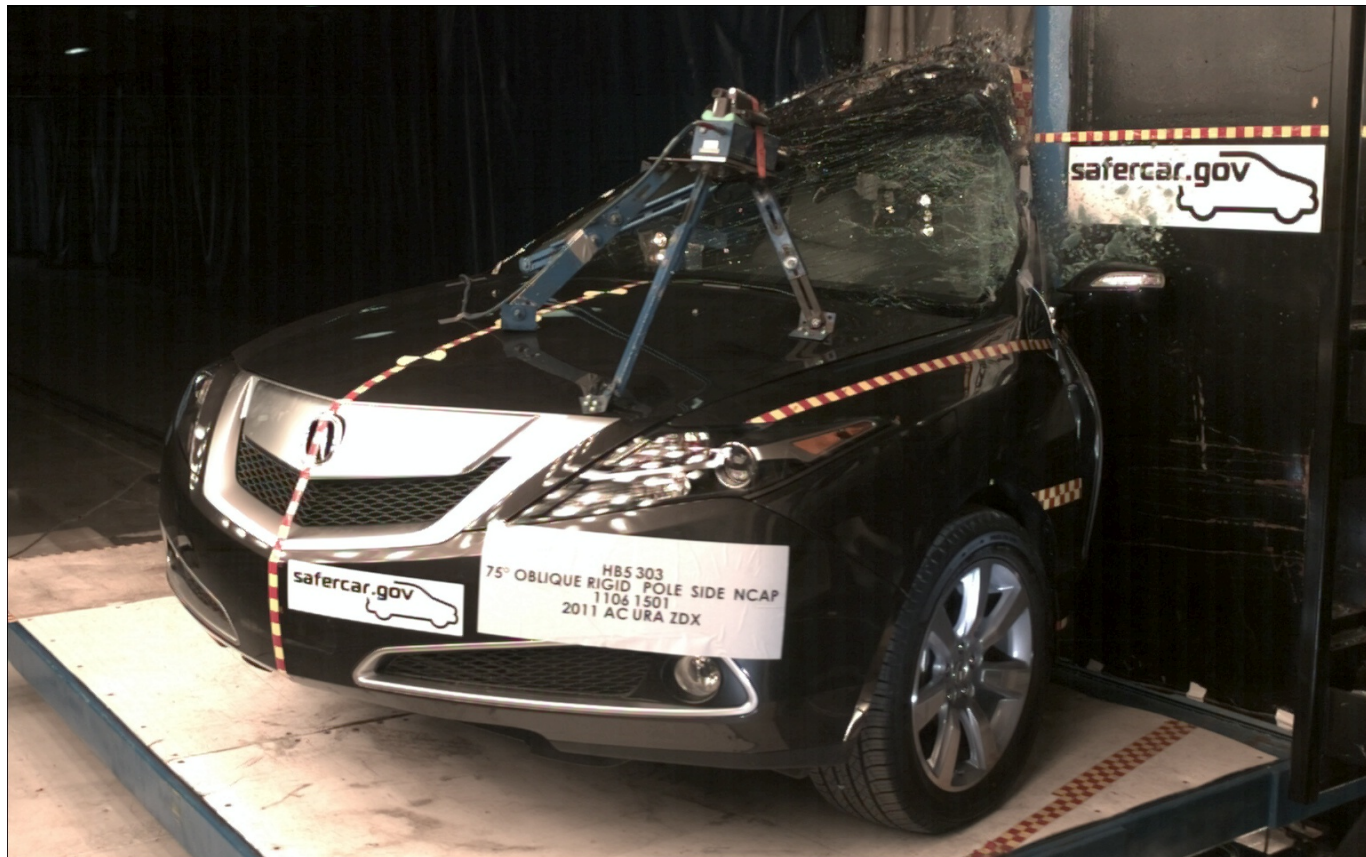
Impact Event

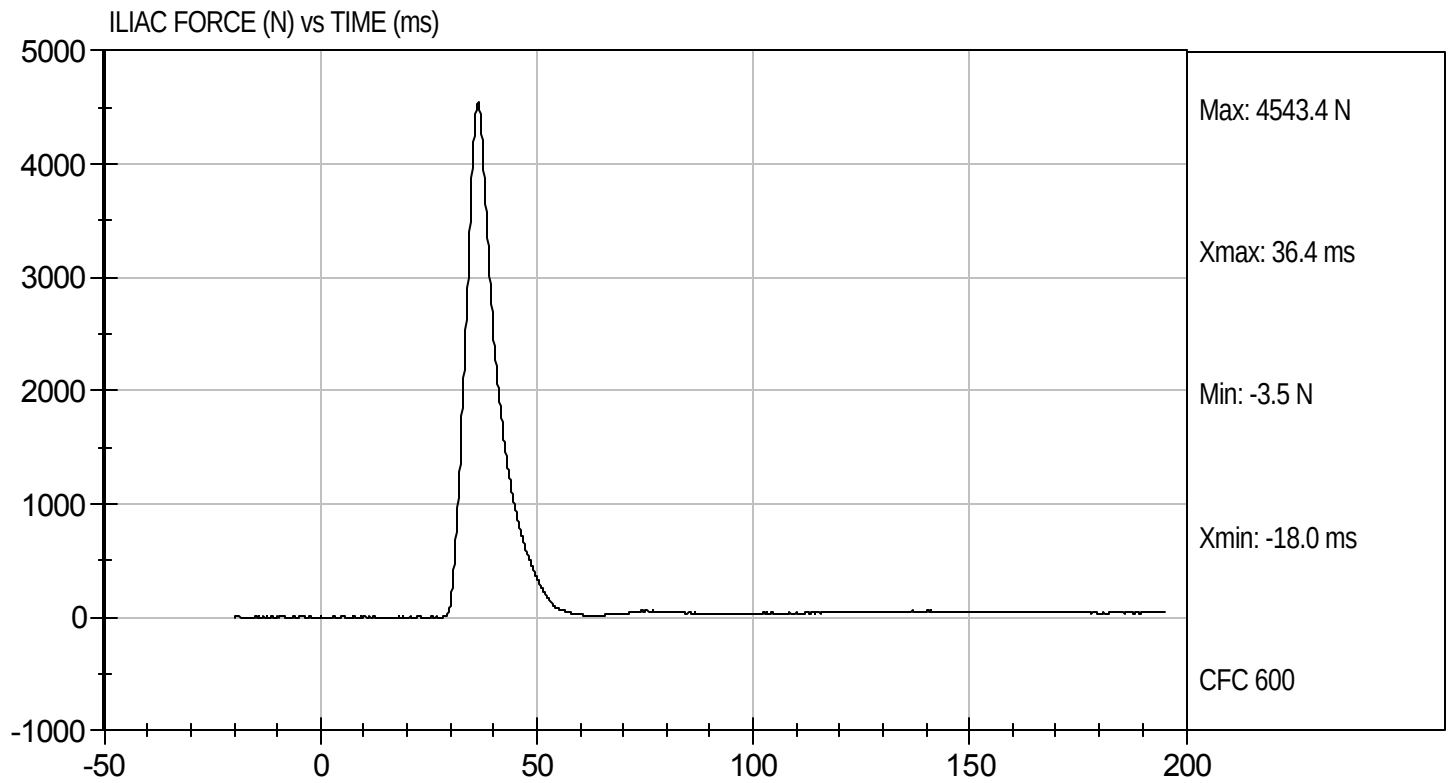
Test Desc: Iliac Impact  
Component ID: D112098

Test Date: 6/16/11  
Velocity: 14.36 ft/s, 4.38 m/s
