**REPORT NUMBER: SINCAP-MGA-2011-083**

**NEW CAR ASSESSMENT PROGRAM (NCAP)  
Moving Deformable Barrier Side Impact Test**

**HONDA OF CANADA MFG.  
2011 Acura ZDX SUV  
NHTSA No.: HB5304**

**FINAL REPORT**

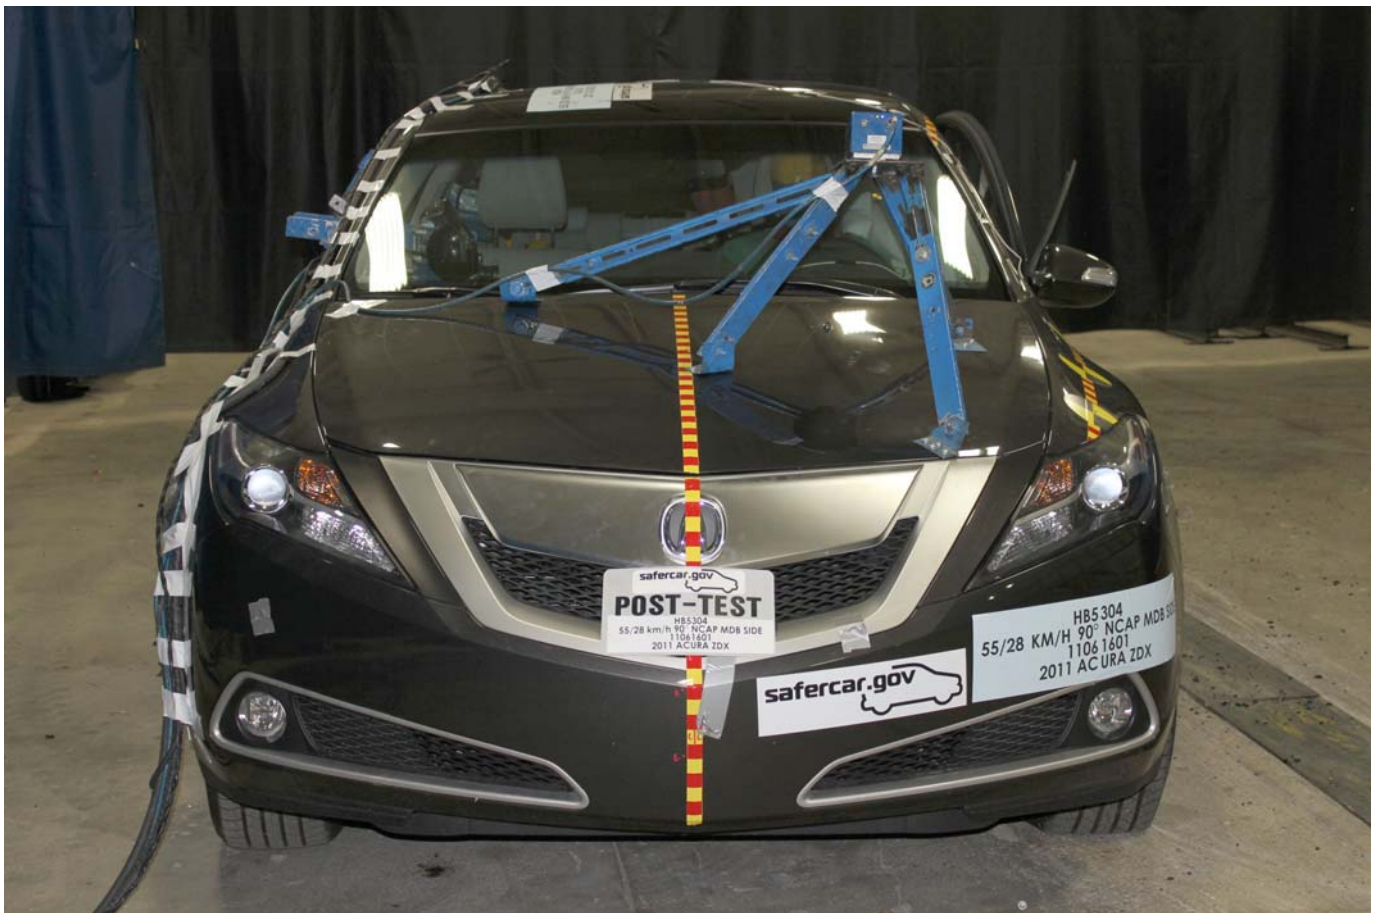
Post-Test Frontal View of Test Vehicle

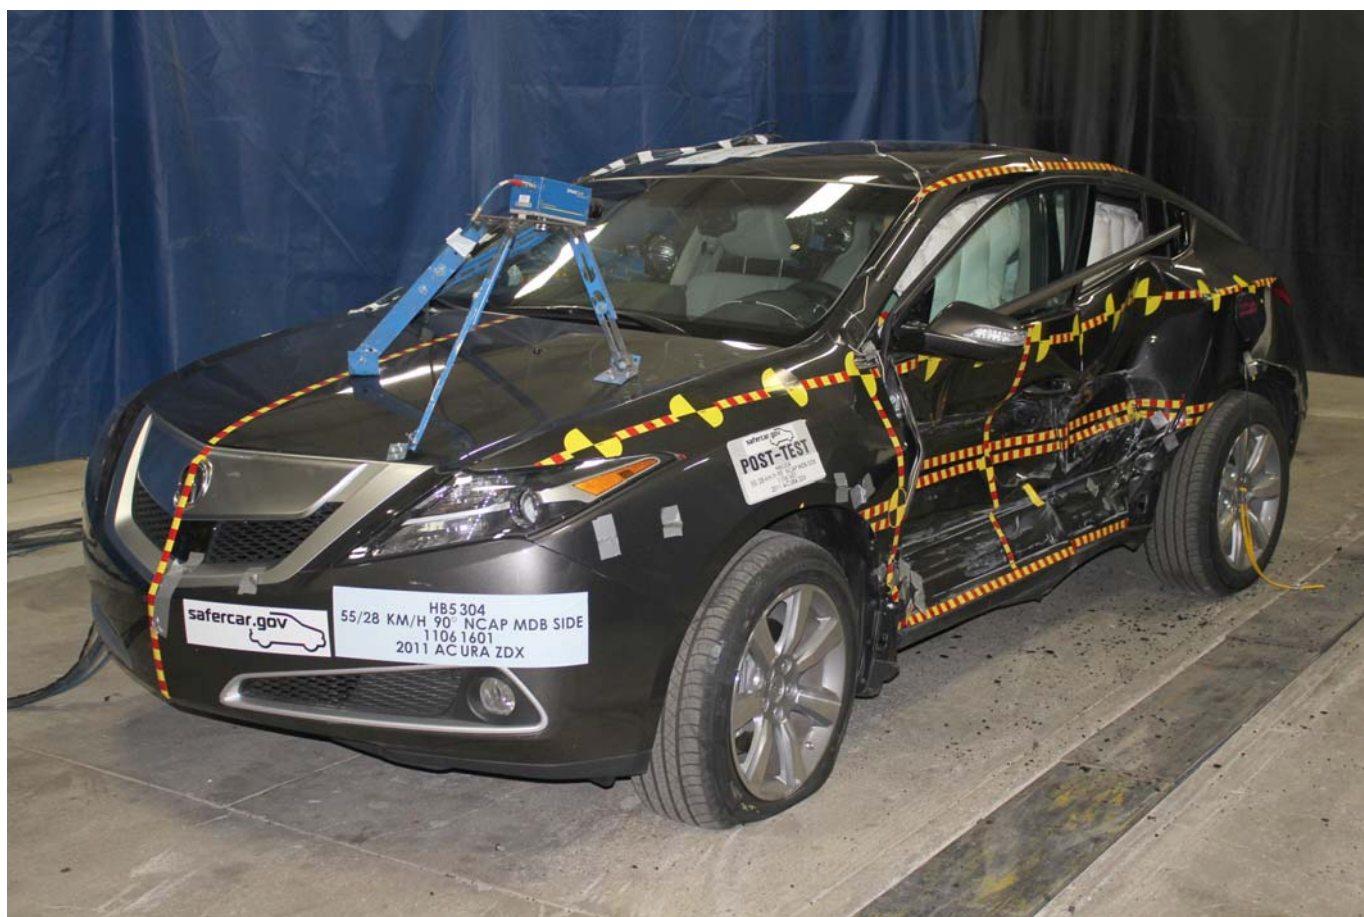
Post-Test Left Three-Quarter Front View of Test Vehicle

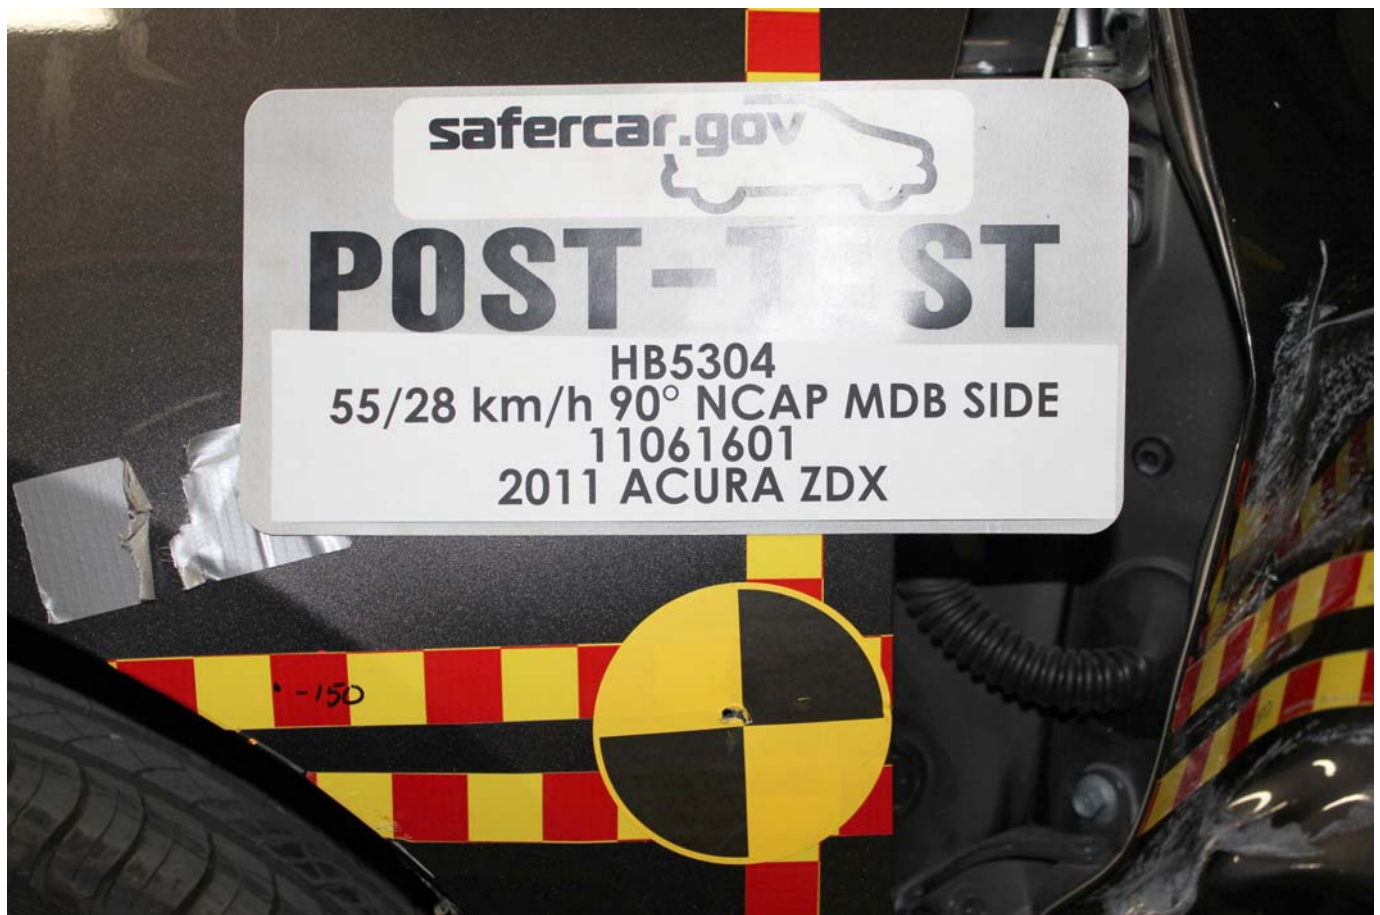
Post-Test Close-Up View of Impact Point Target

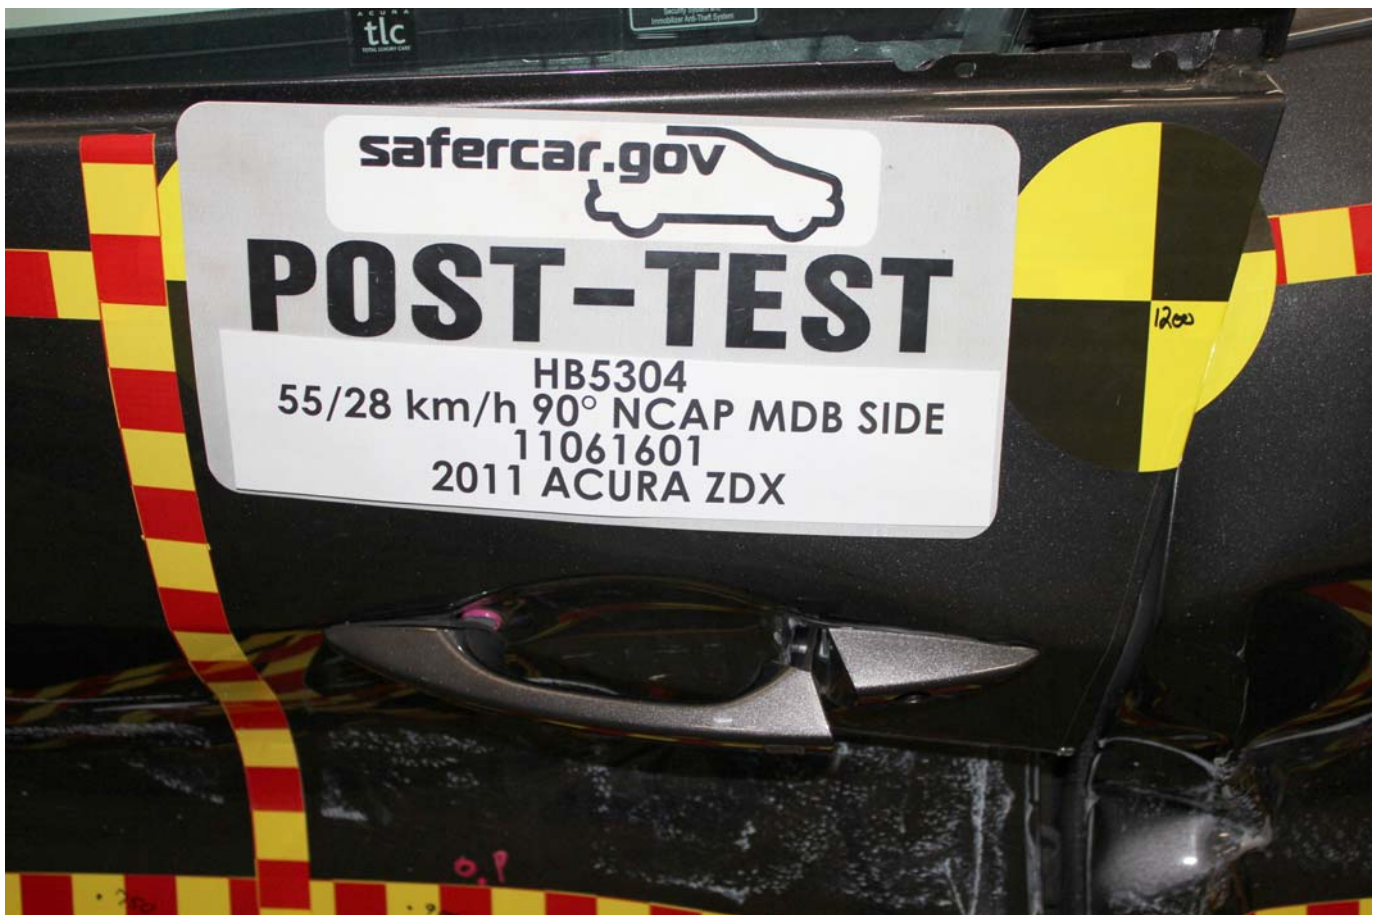
Post-Test Left Front Door Latch Close-Up

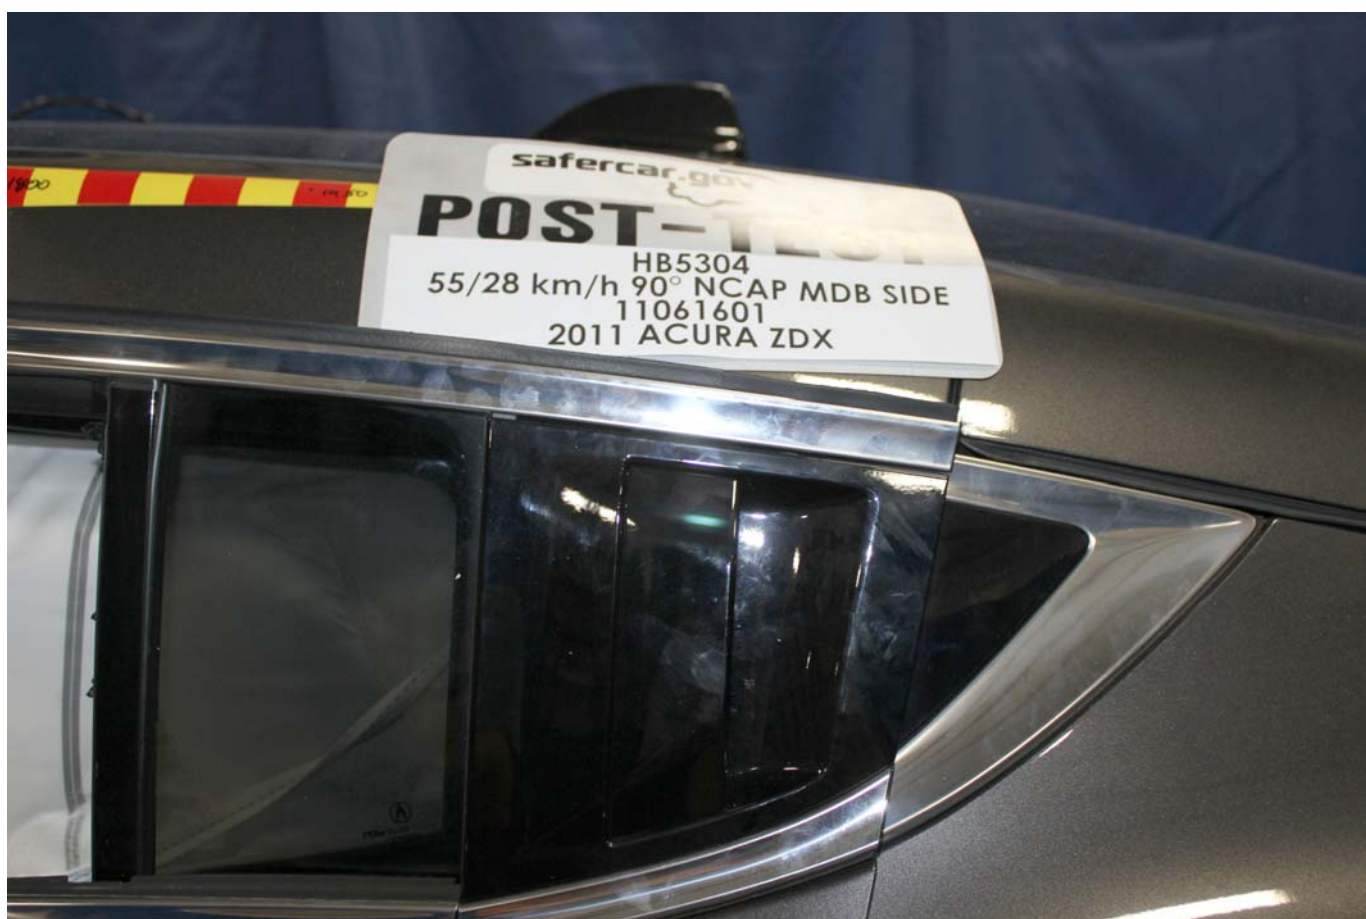
Post-Test Left Rear Door Latch Close-Up

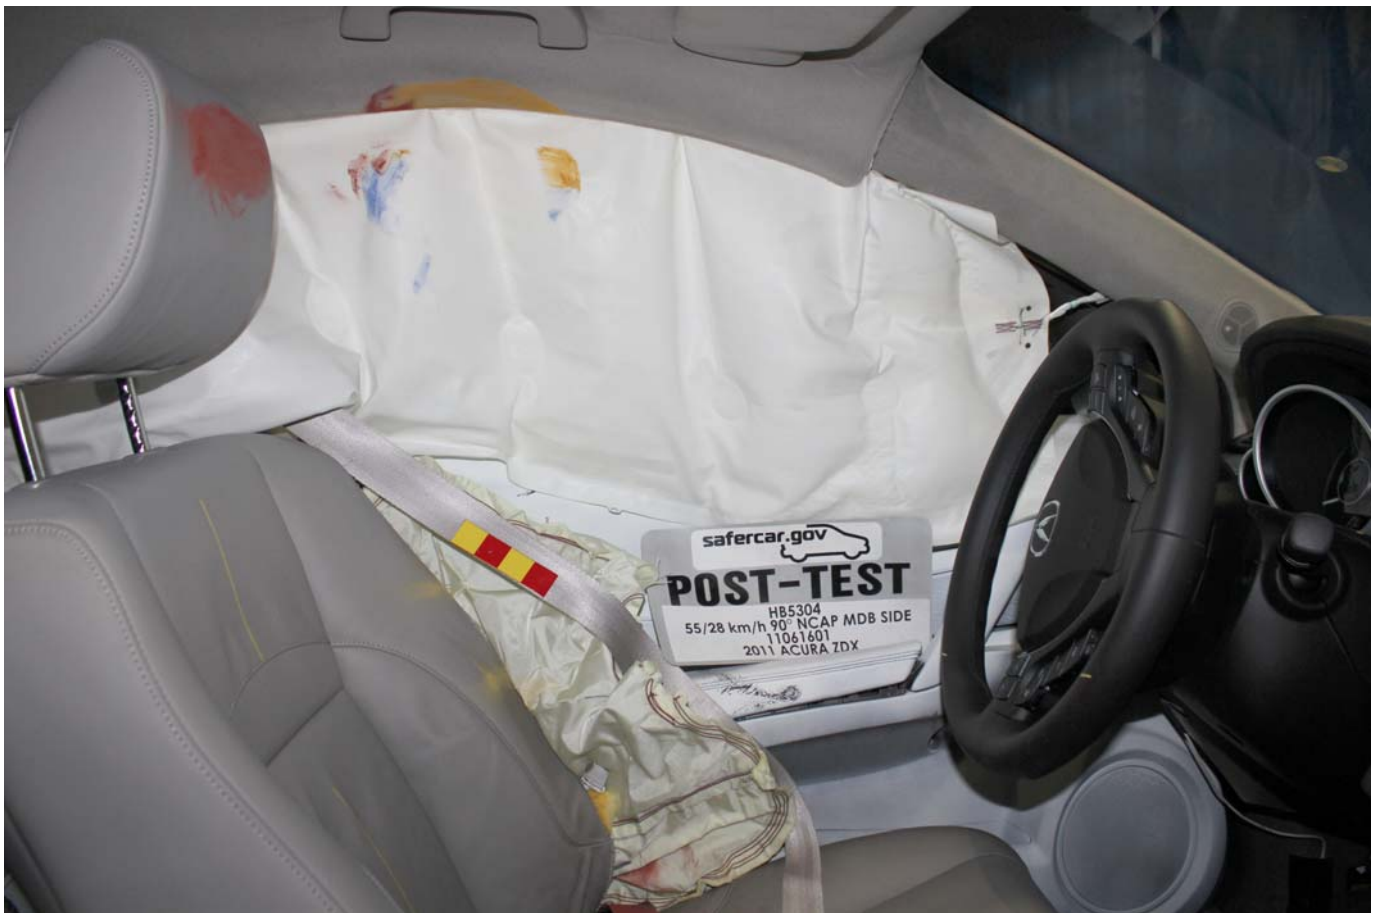
Post-Test Driver Inner Door Panel View Showing Driver Dummy Contact Locations

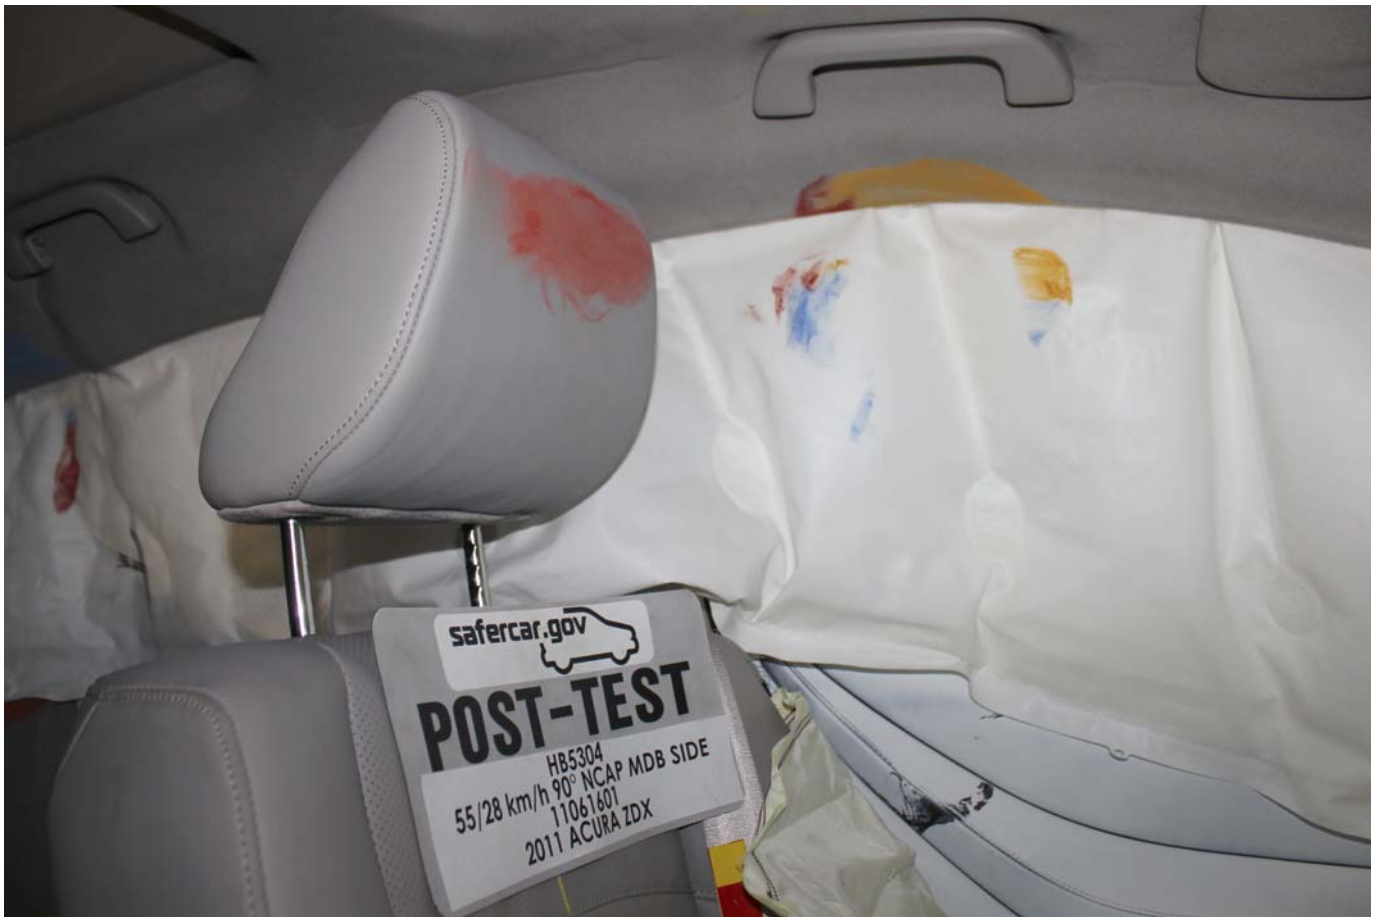
Post-Test Driver Dummy Close-up Head Contact with Vehicle Interior View

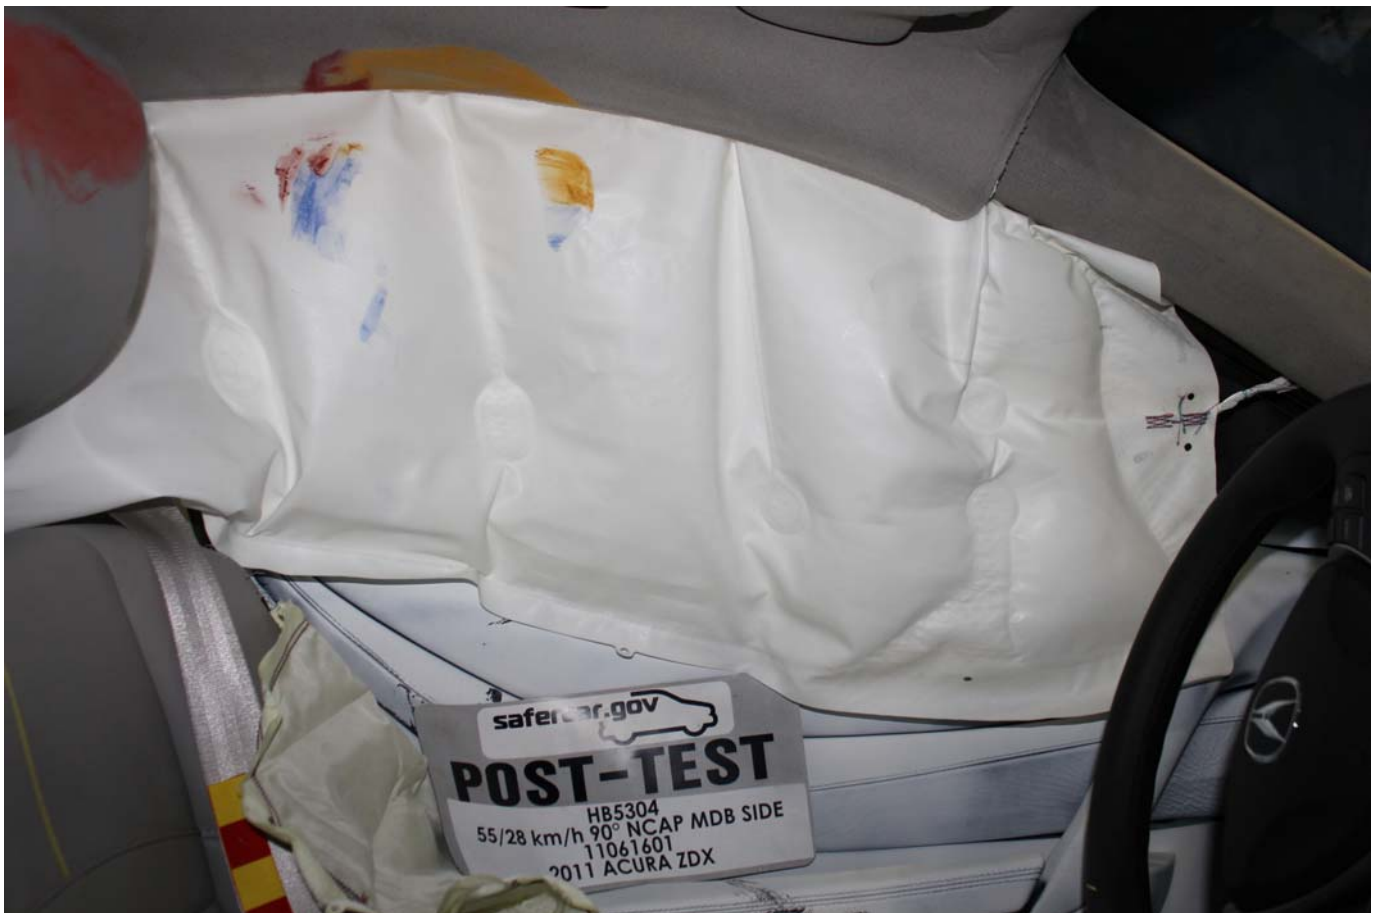
Post-Test Driver Dummy Close-up Head Contact with Side Airbag View

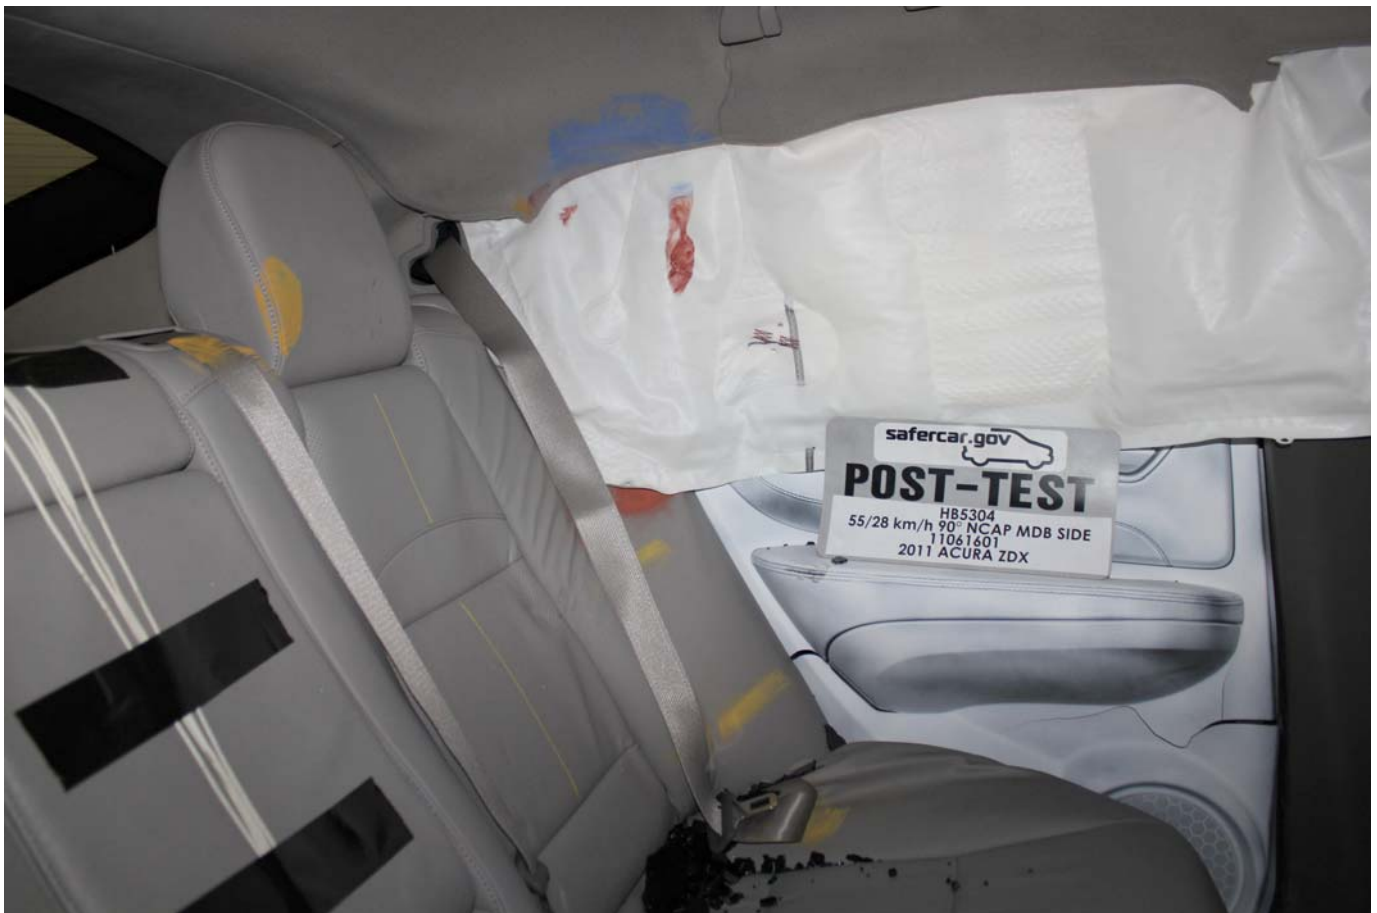
Post-Test Rear Passenger Inner Door Panel View Showing Dummy Contact Locations

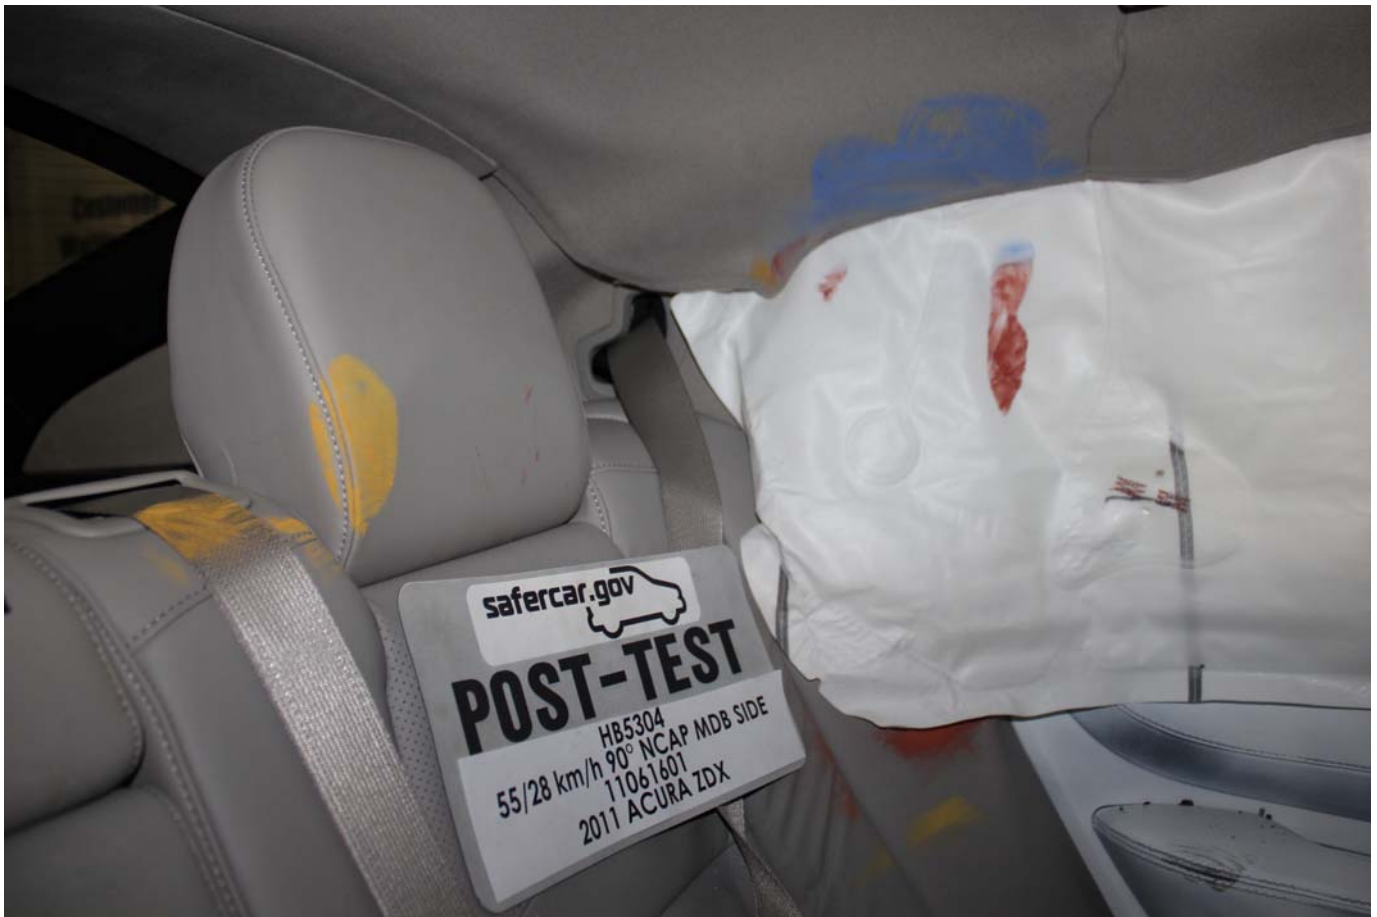
Post-Test Rear Passenger Dummy Close-up Head Contact with Vehicle Interior View

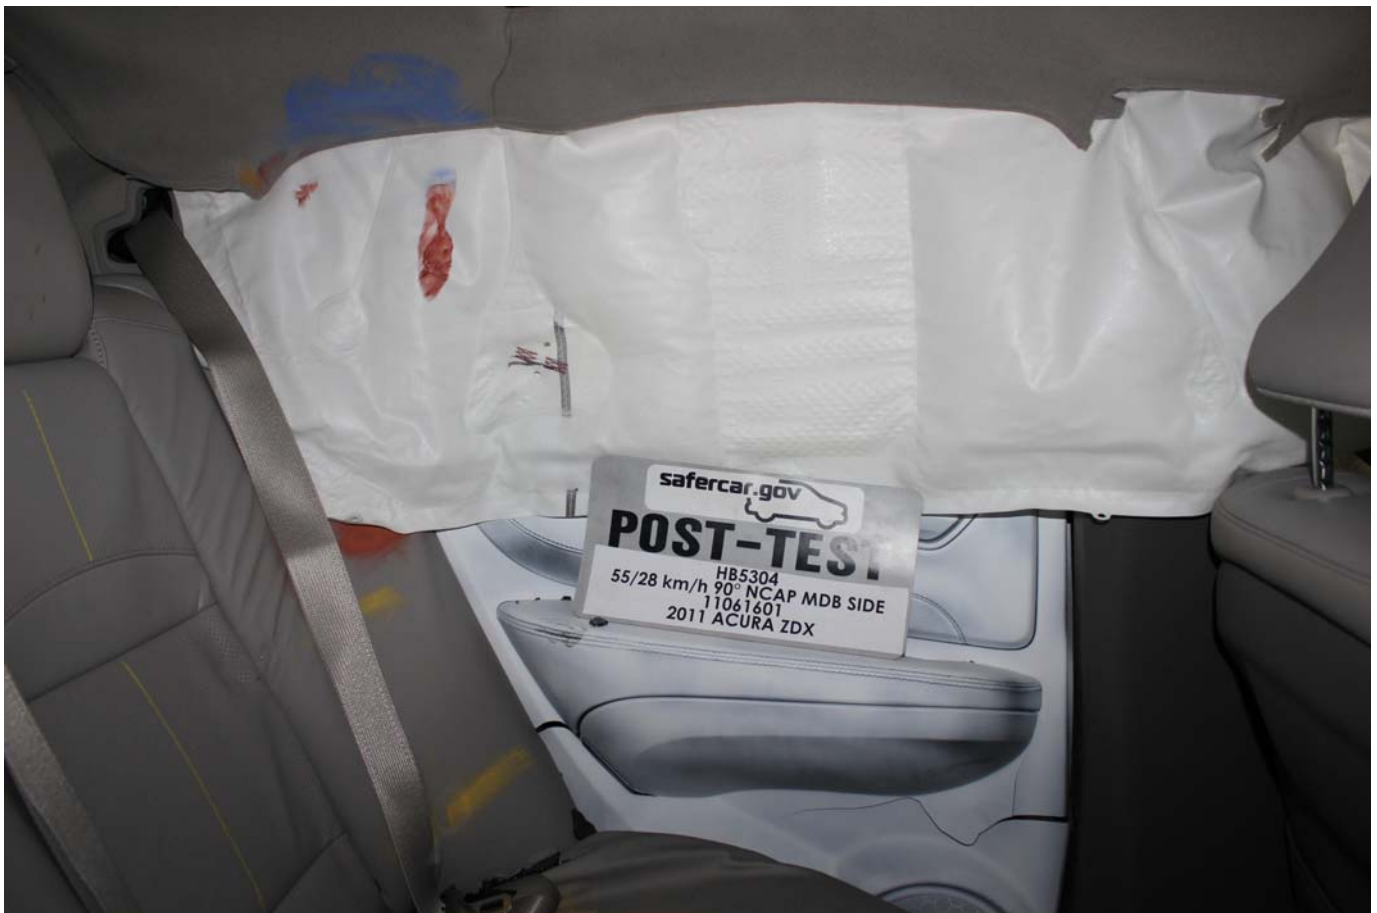
Post-Test Rear Passenger Dummy Close-up Head Contact with Side Airbag View

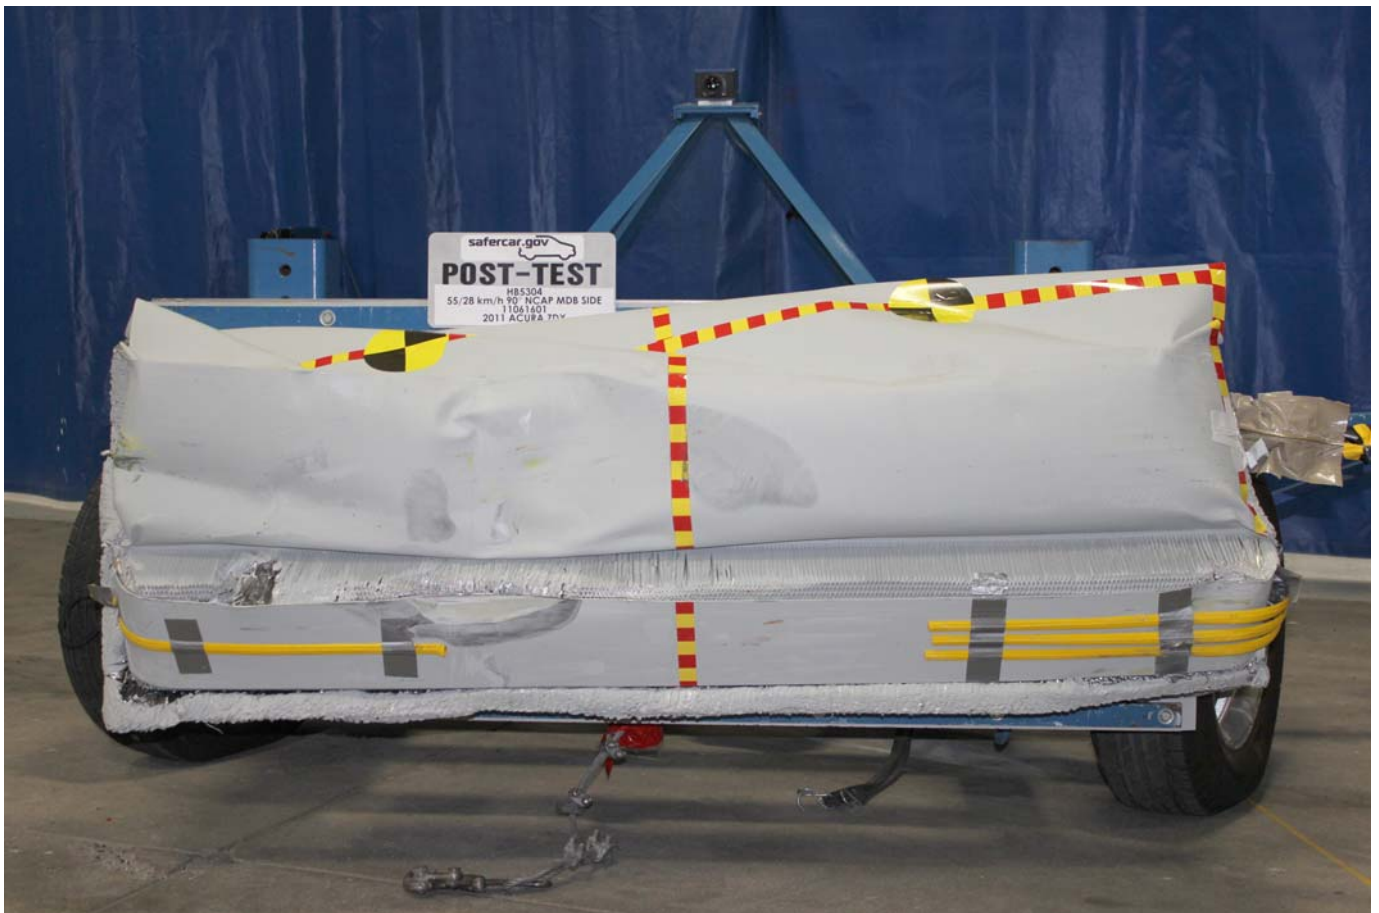
Post-Test Front View of MDB Impactor Face

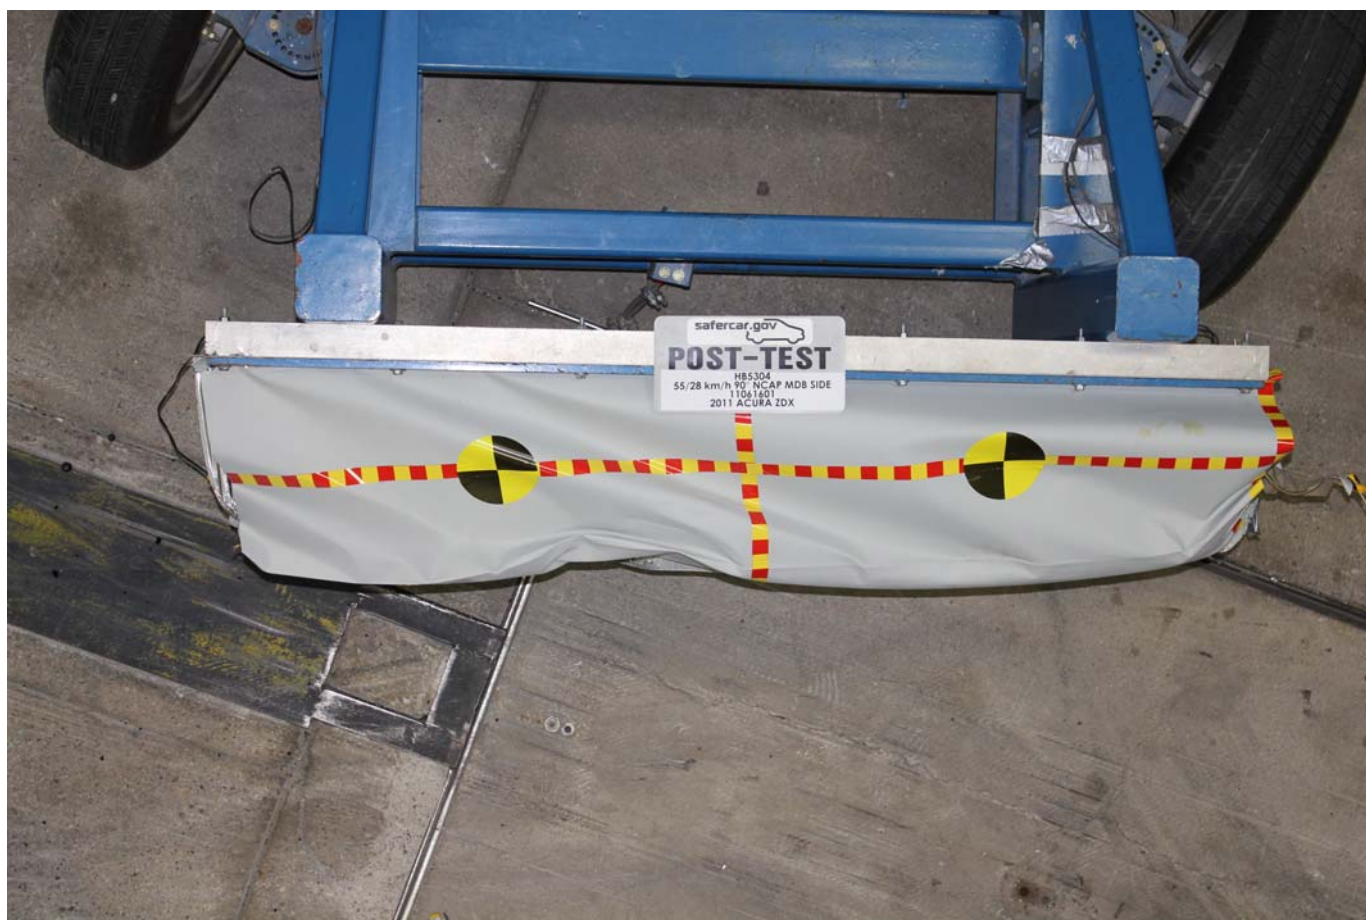
Post-Test Top View of MDB Impactor Face

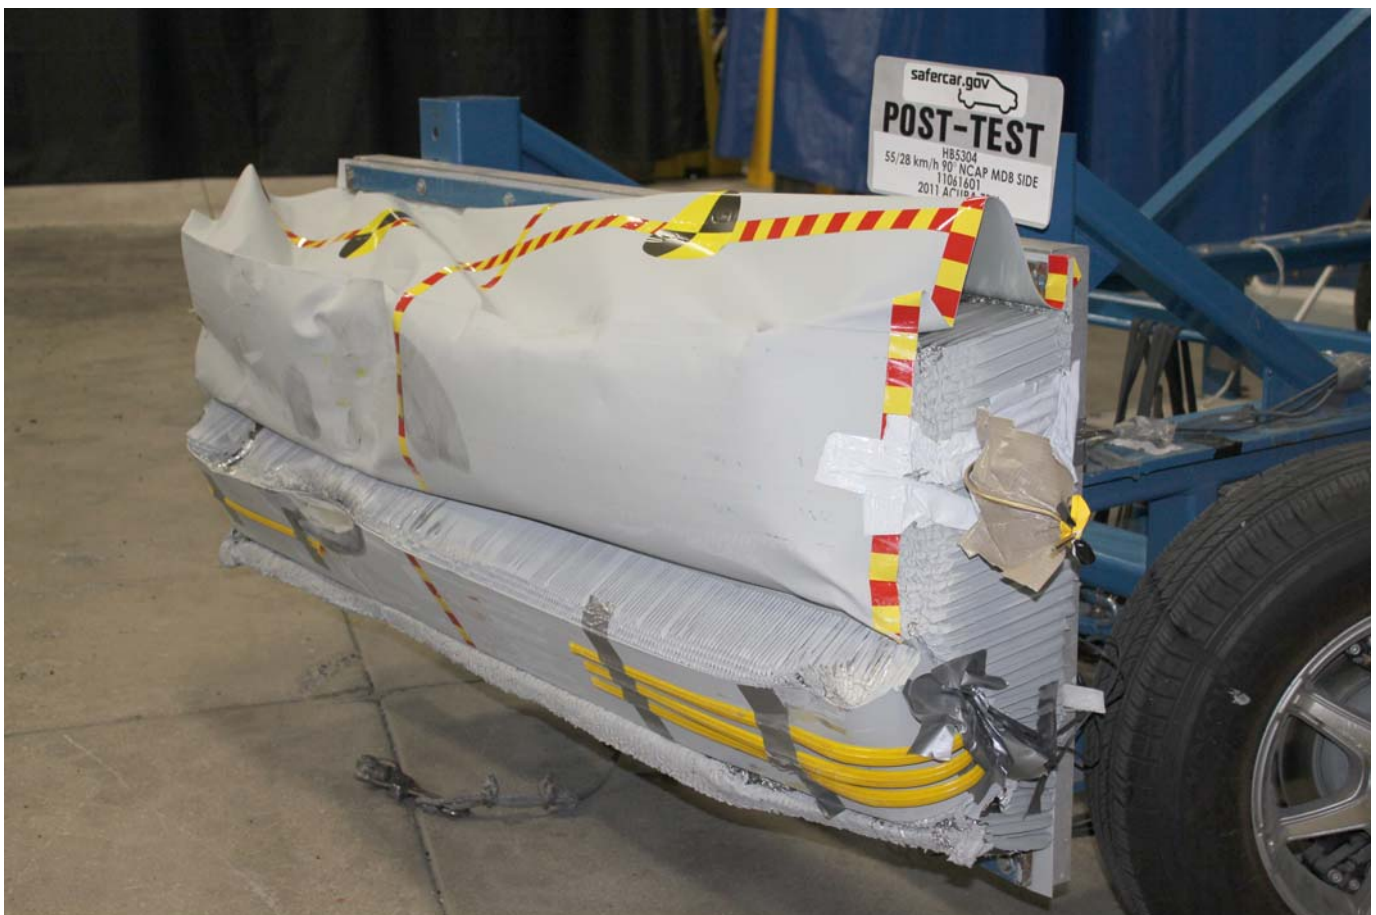
Post-Test Left Side View of MDB Impactor Face
