**REPORT NUMBER: SPNCAP-MGA-2011-085**

**NEW CAR ASSESSMENT PROGRAM (NCAP)  
Side Impact Pole Test**

**NISSAN MOTOR CO., LTD.  
2011 Nissan Leaf SL 5-Dr Hatchback  
NHTSA No.: MB5218**

**FINAL REPORT**

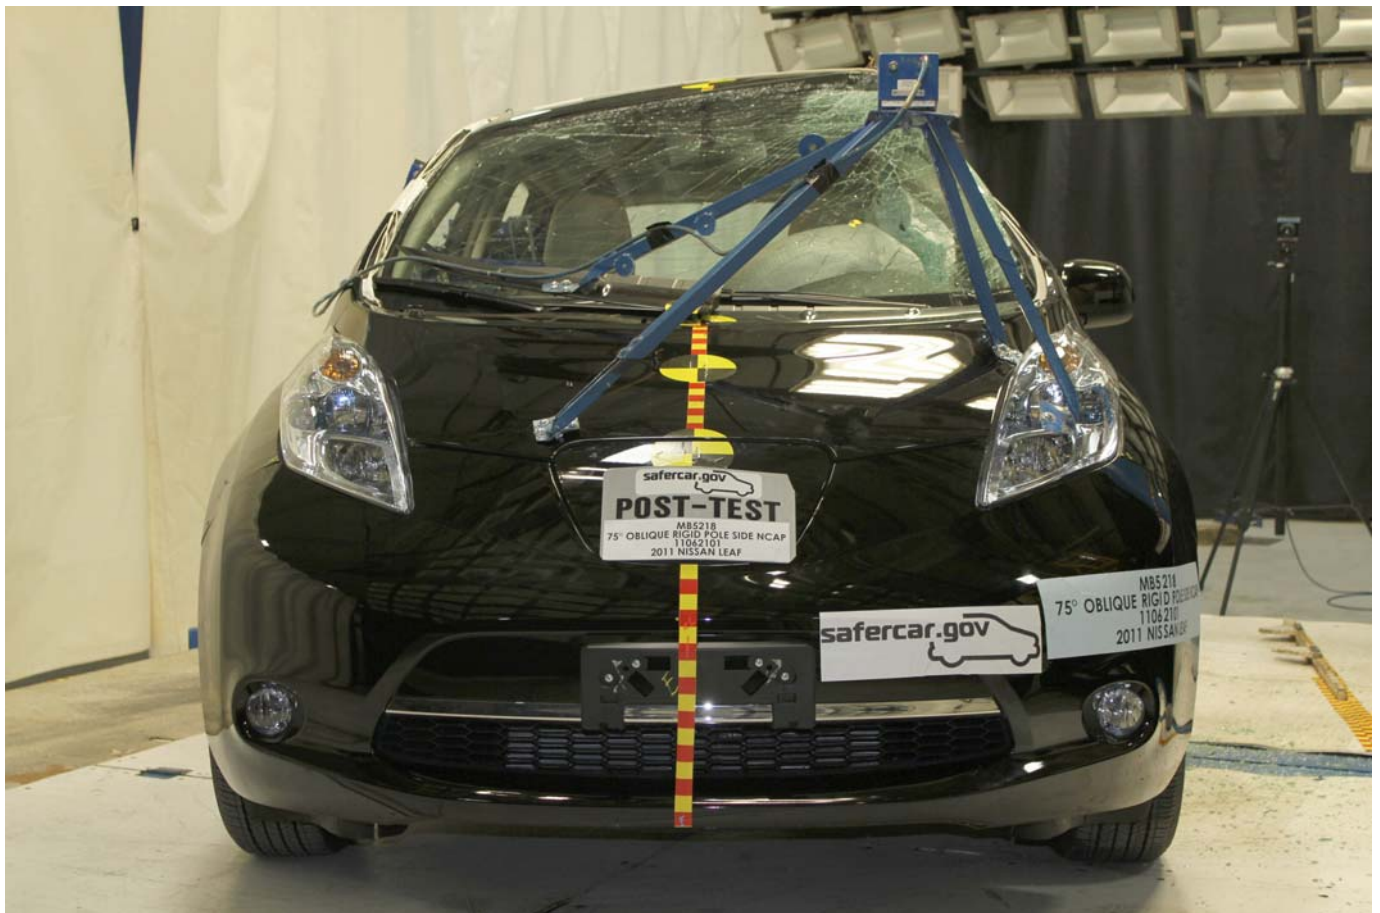
Post-Test Frontal View of Test Vehicle

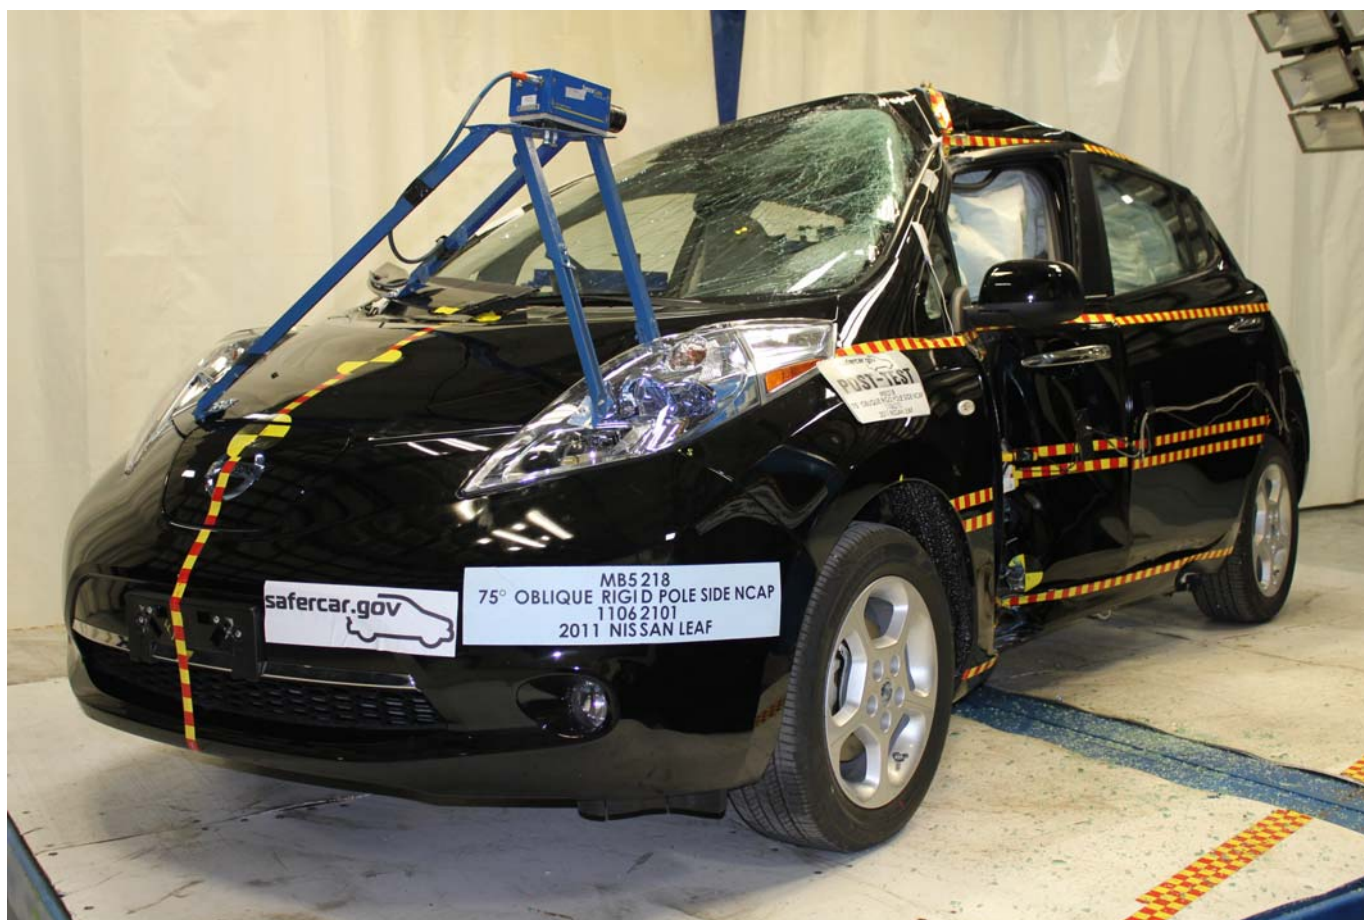
Post-Test Left Front  $\frac{3}{4}$  View of Test Vehicle

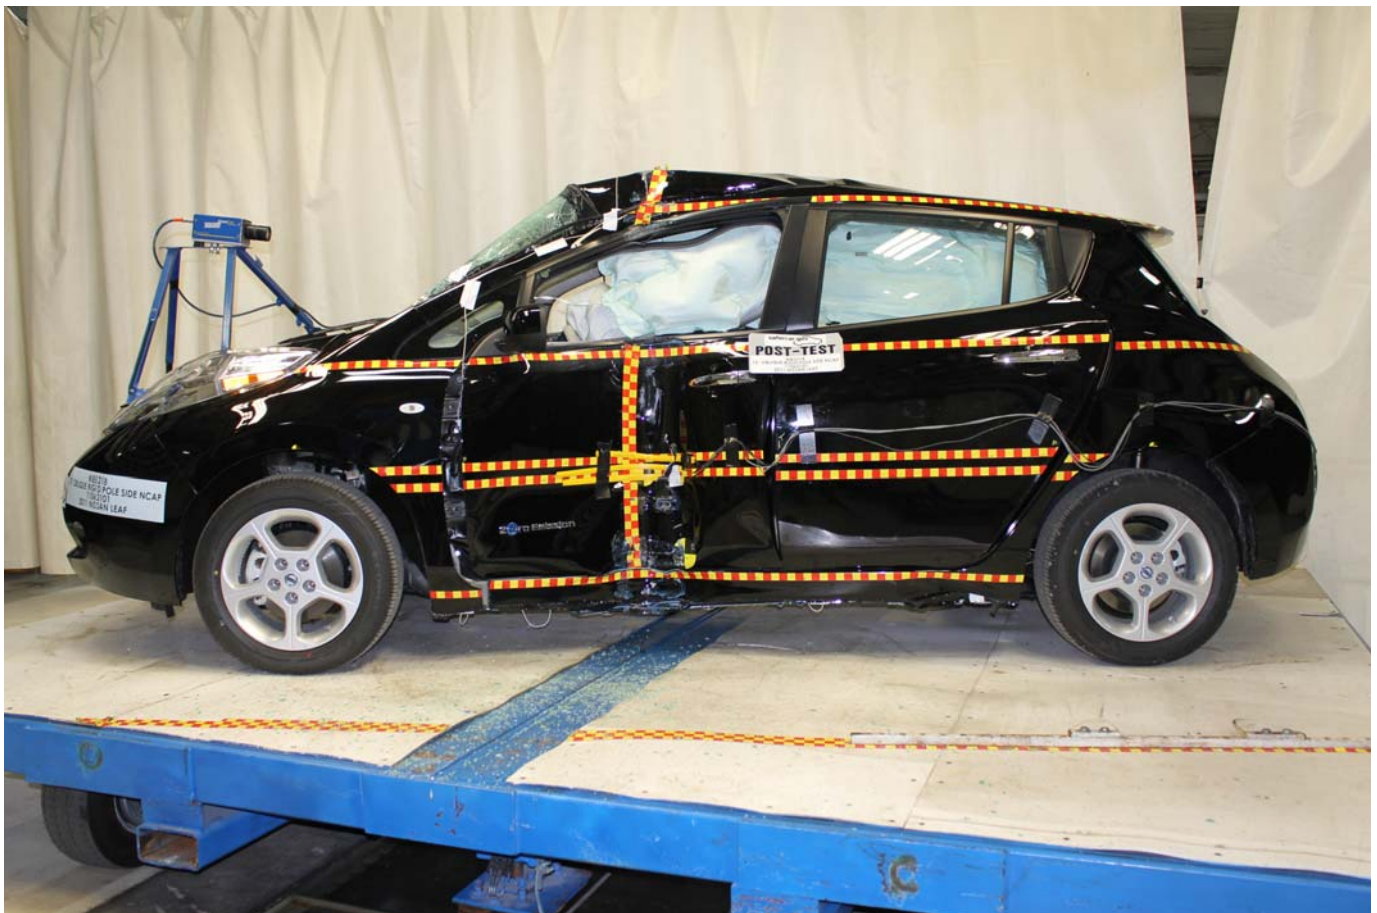
Post-Test Left Side View of Test Vehicle

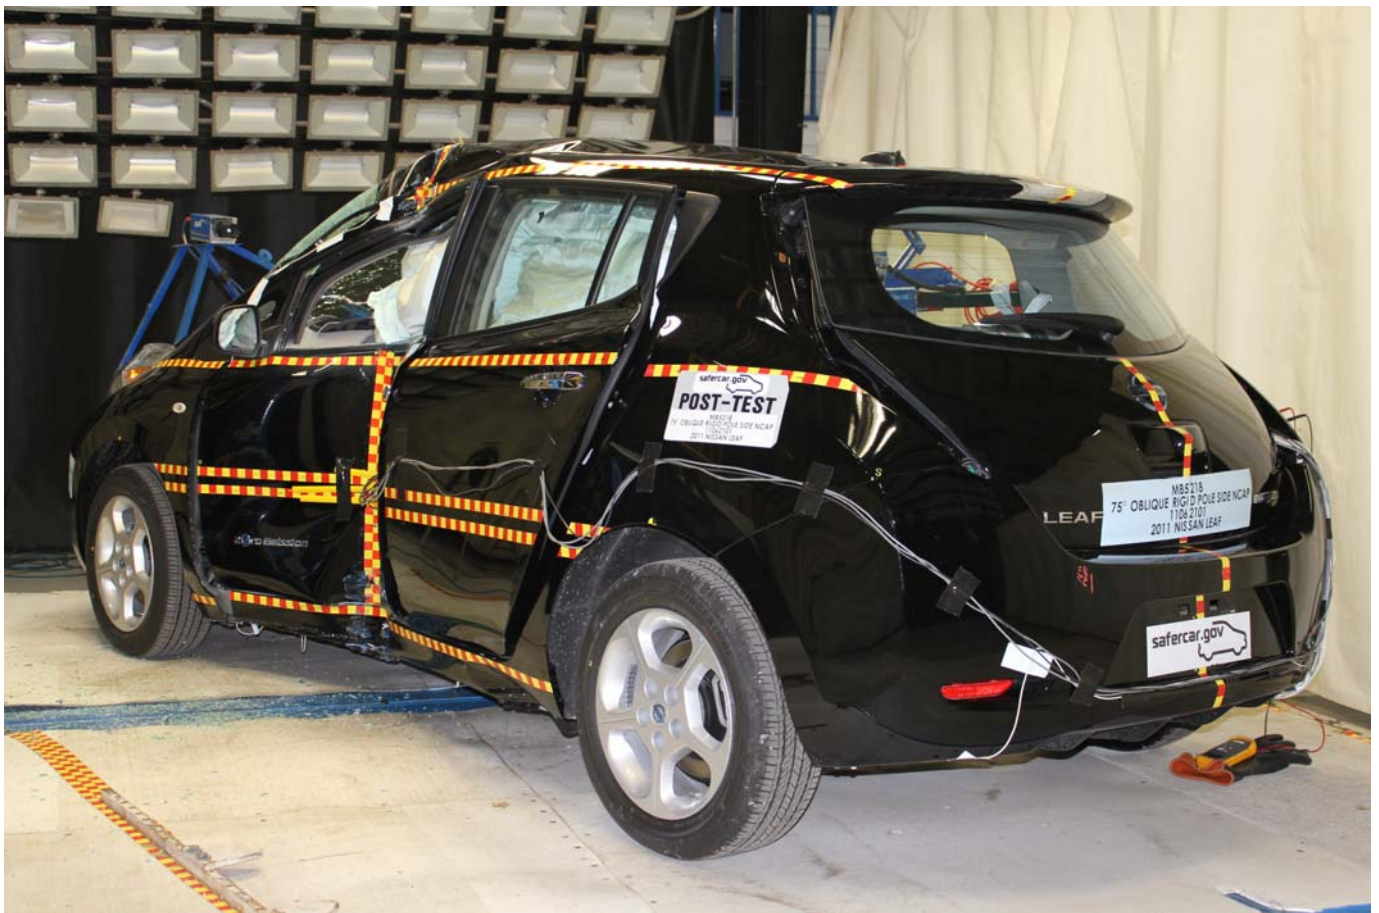
Post-Test Left Rear  $\frac{3}{4}$  View of Test Vehicle

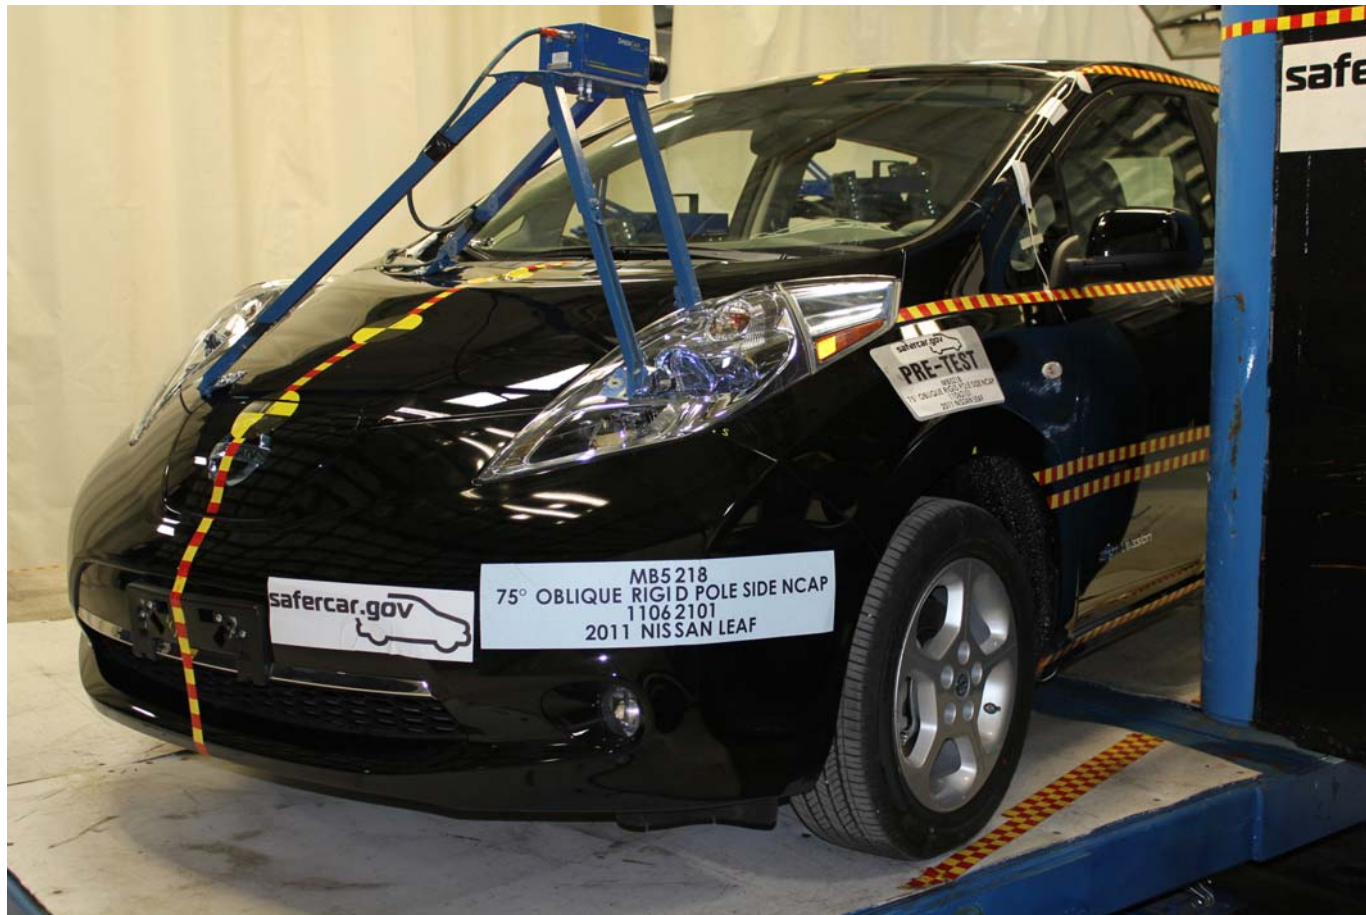
Pre-Test Left Side View of Pole Positioned Against Side of Vehicle at Ideal Impact Point

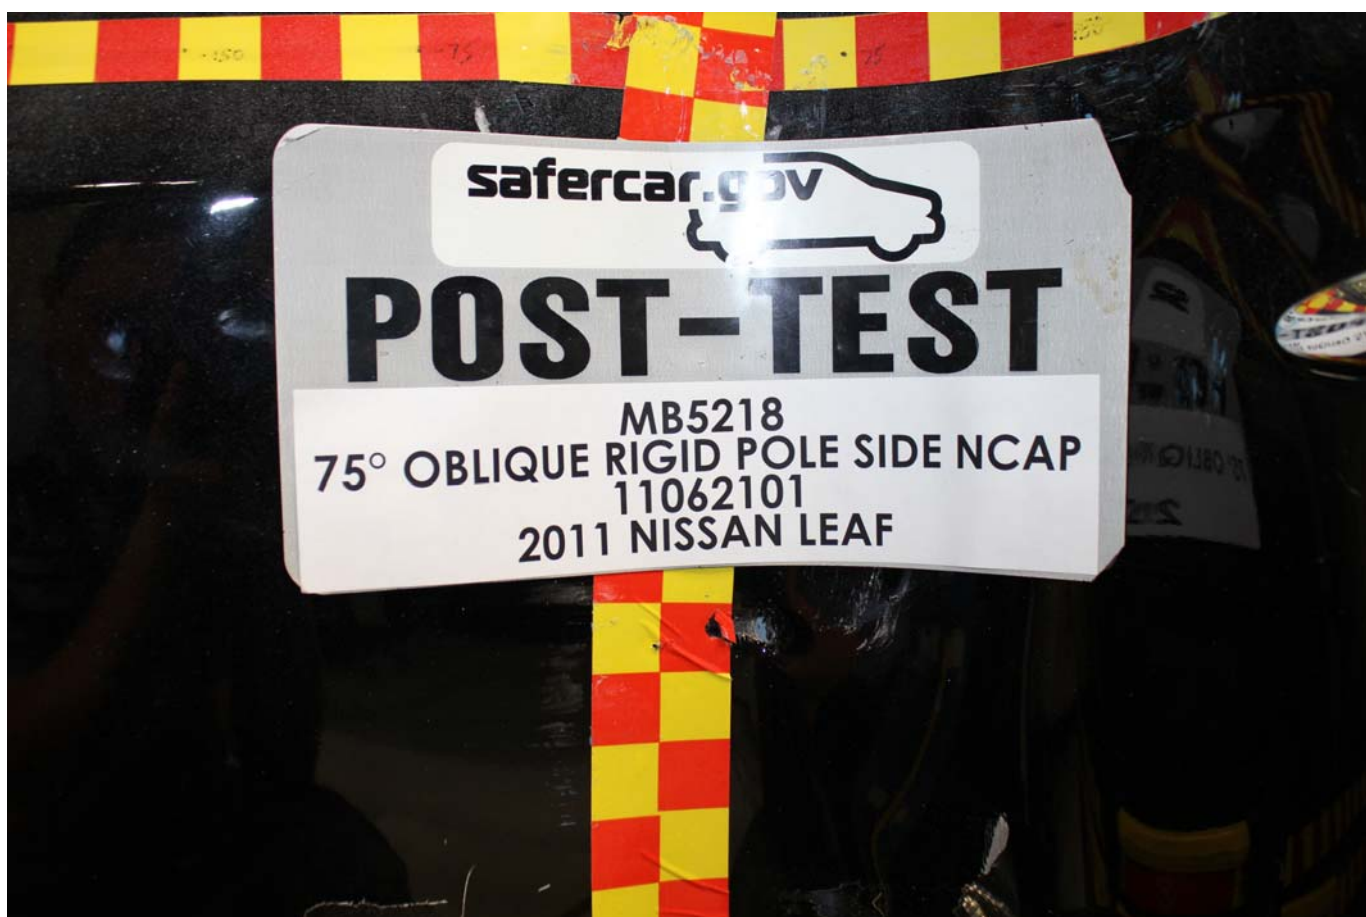
Post-Test Close-Up View of Impact Point Target Showing Impact Location

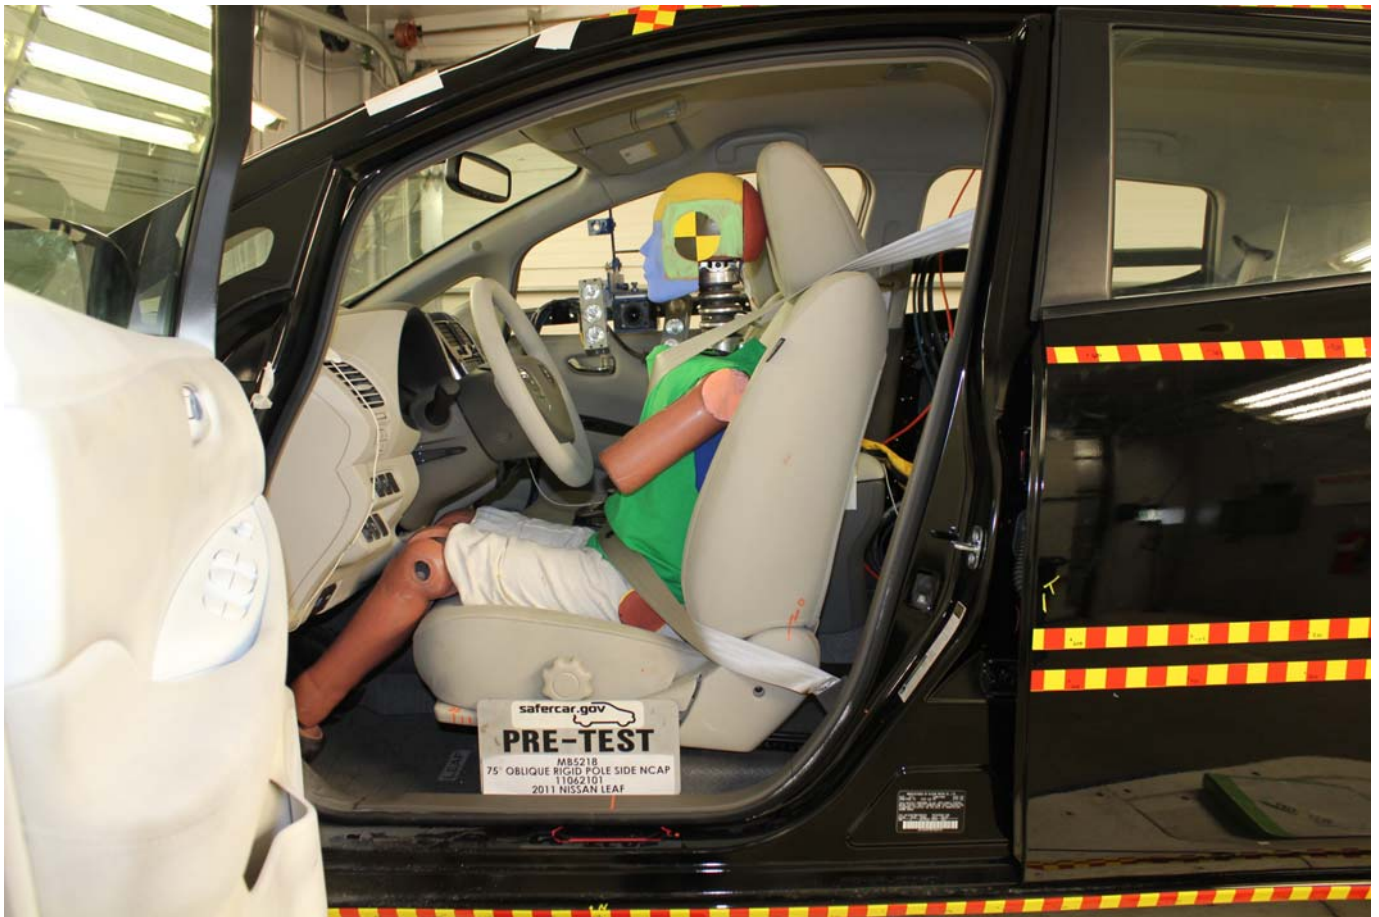
Pre-Test Left Side View of Dummy Showing Belts, Chalking, and Contact Switches (Door Open)

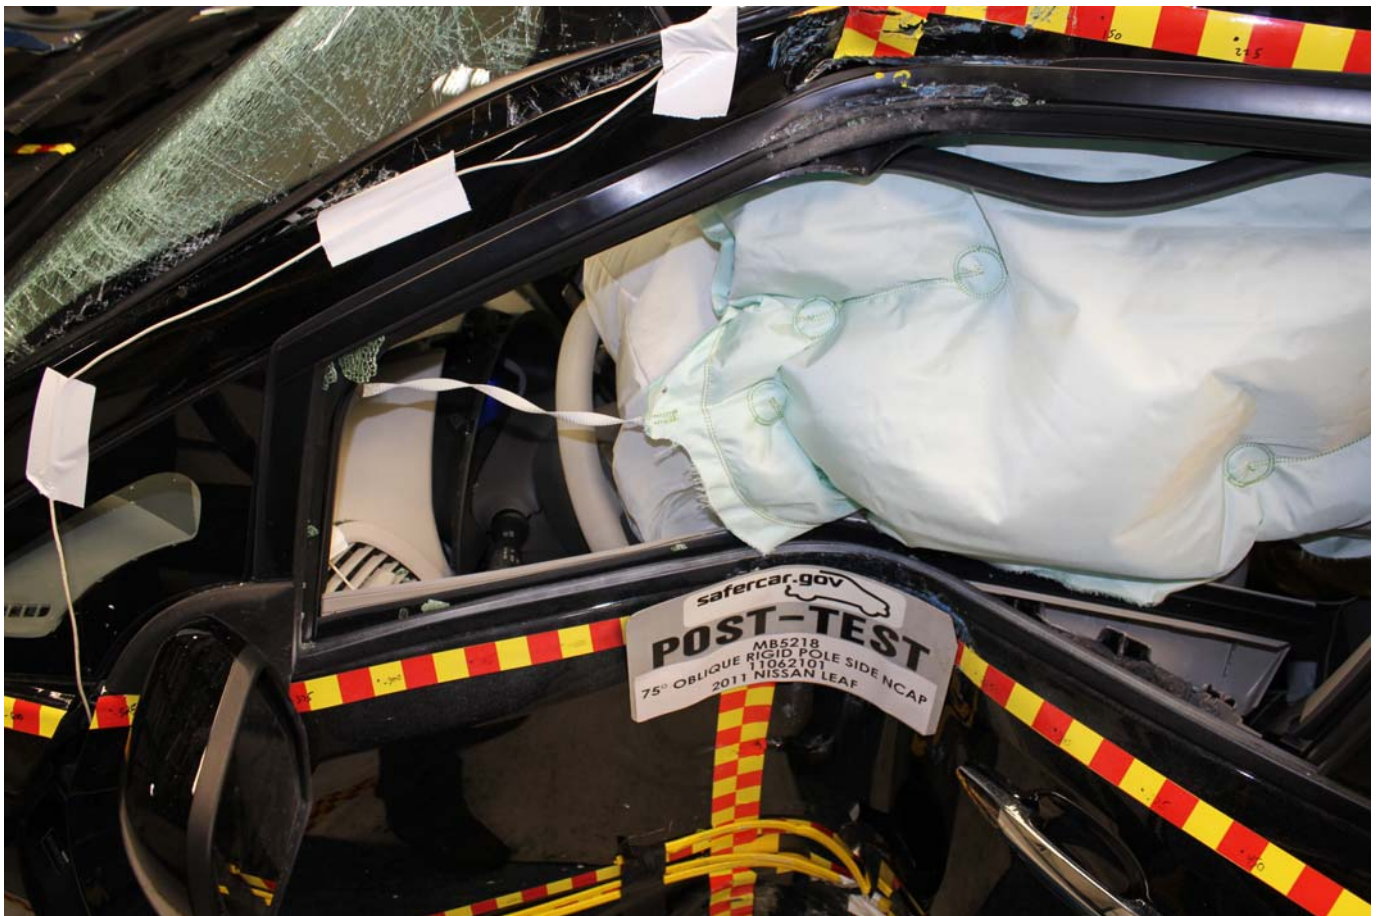
Post-Test Dummy and Door Clearance View

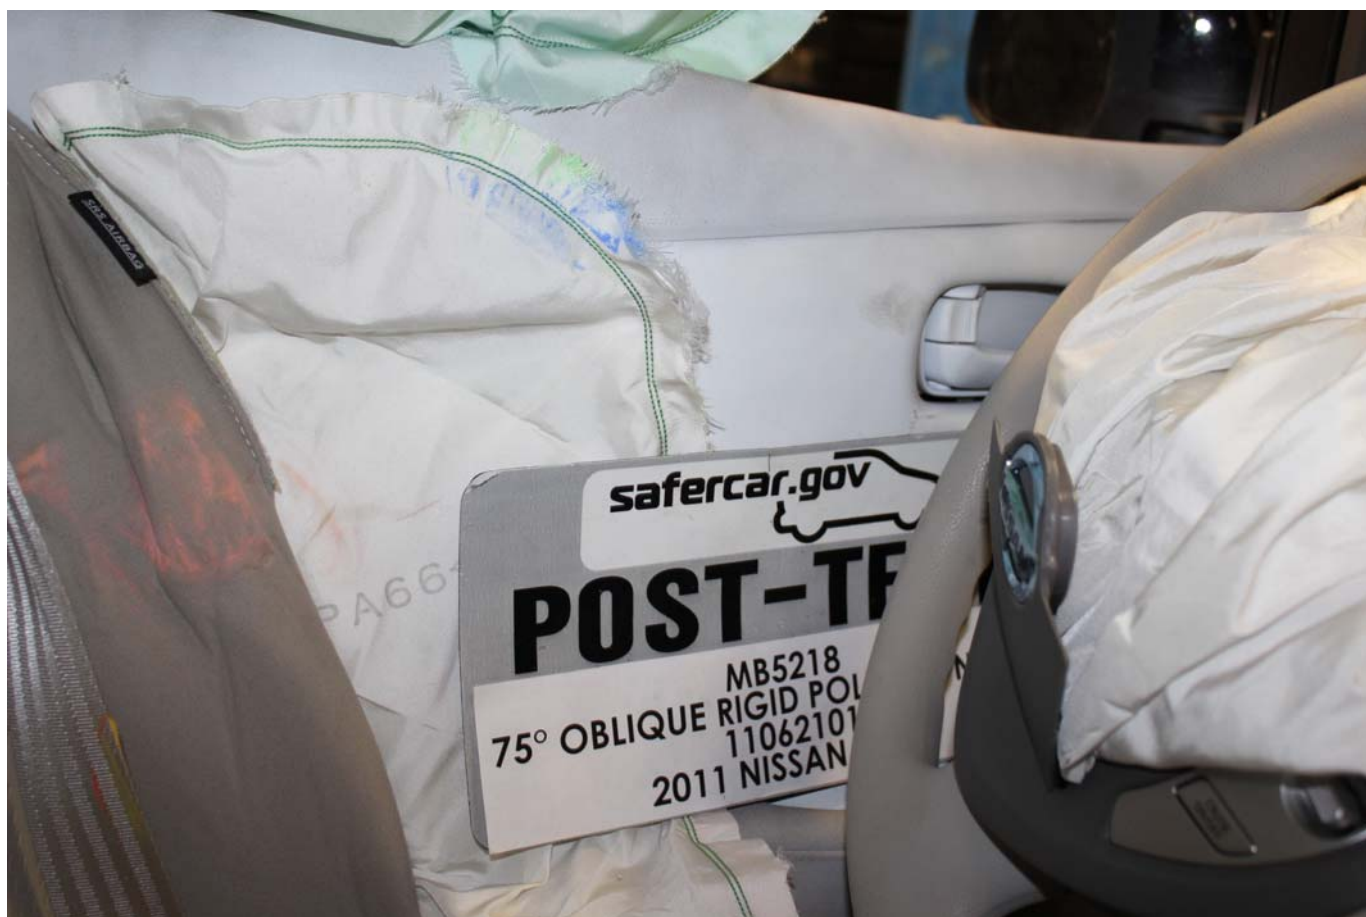
Post-Test Dummy Close-Up Torso Contact with Side Airbag View

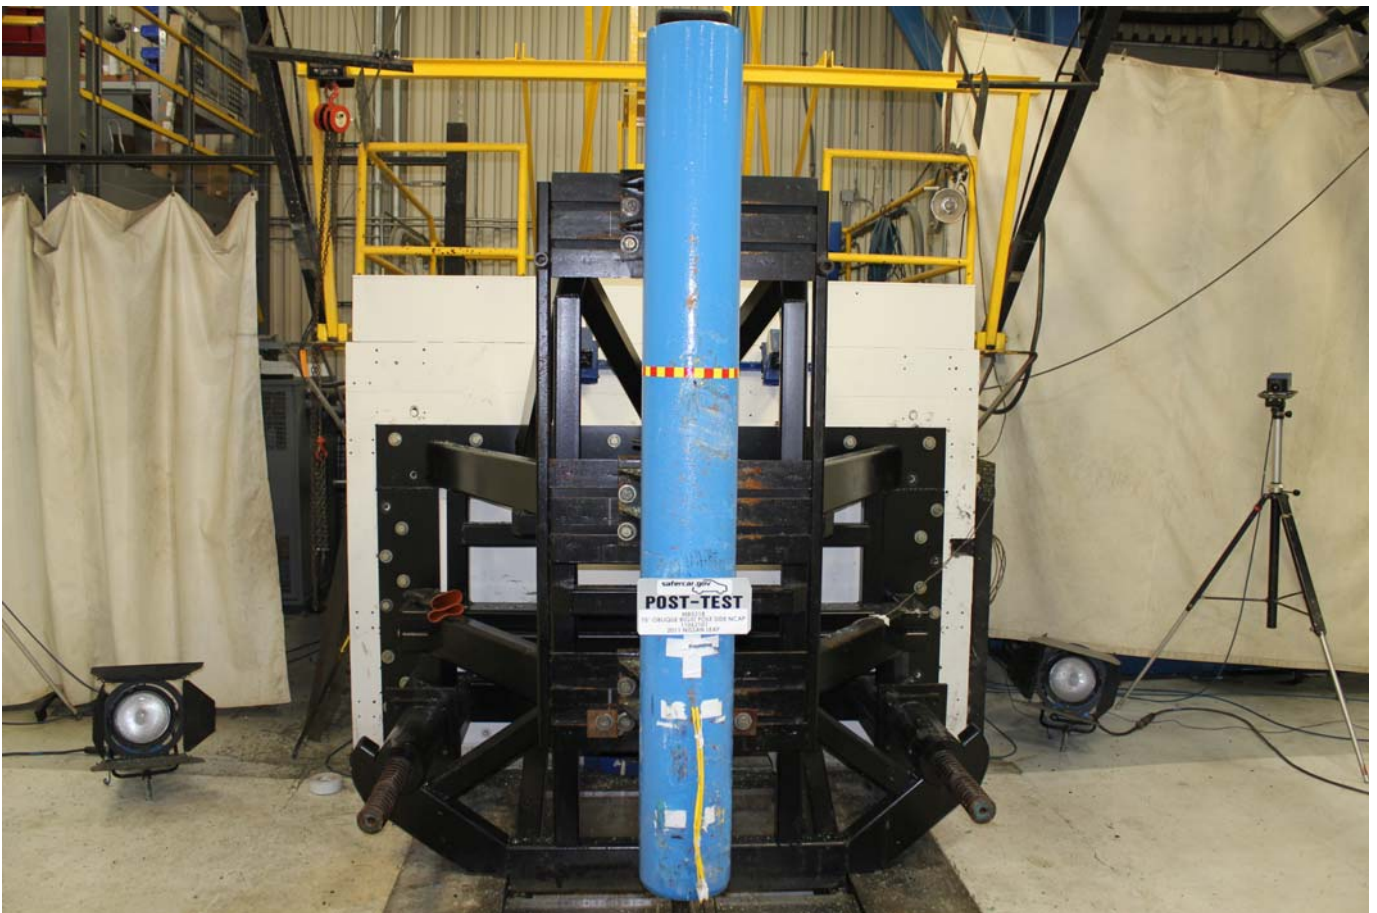
Post-Test Pole Barrier Front View

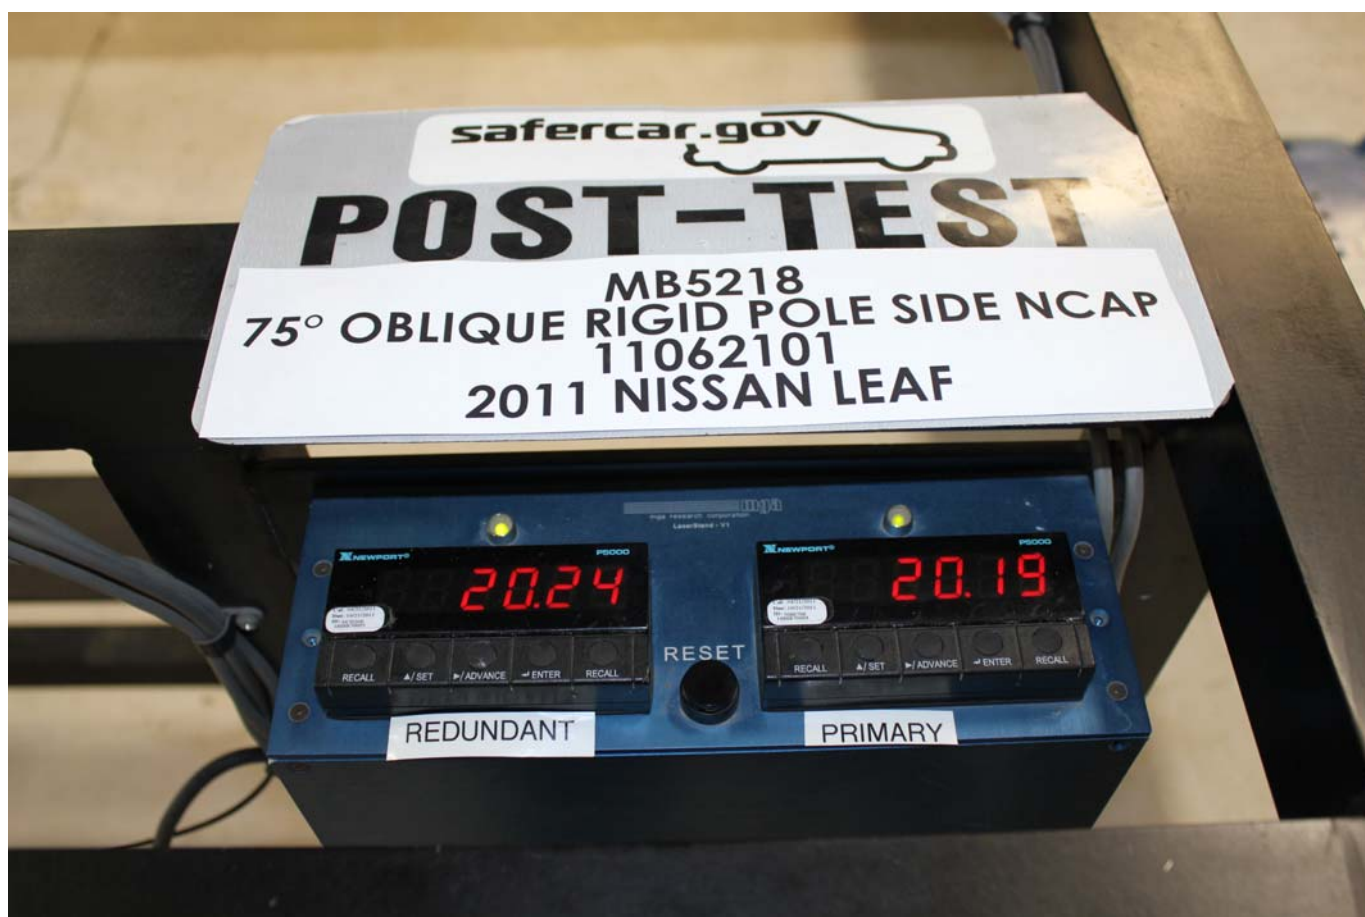
Post-Test Primary and Redundant Speed Trap Read-Out

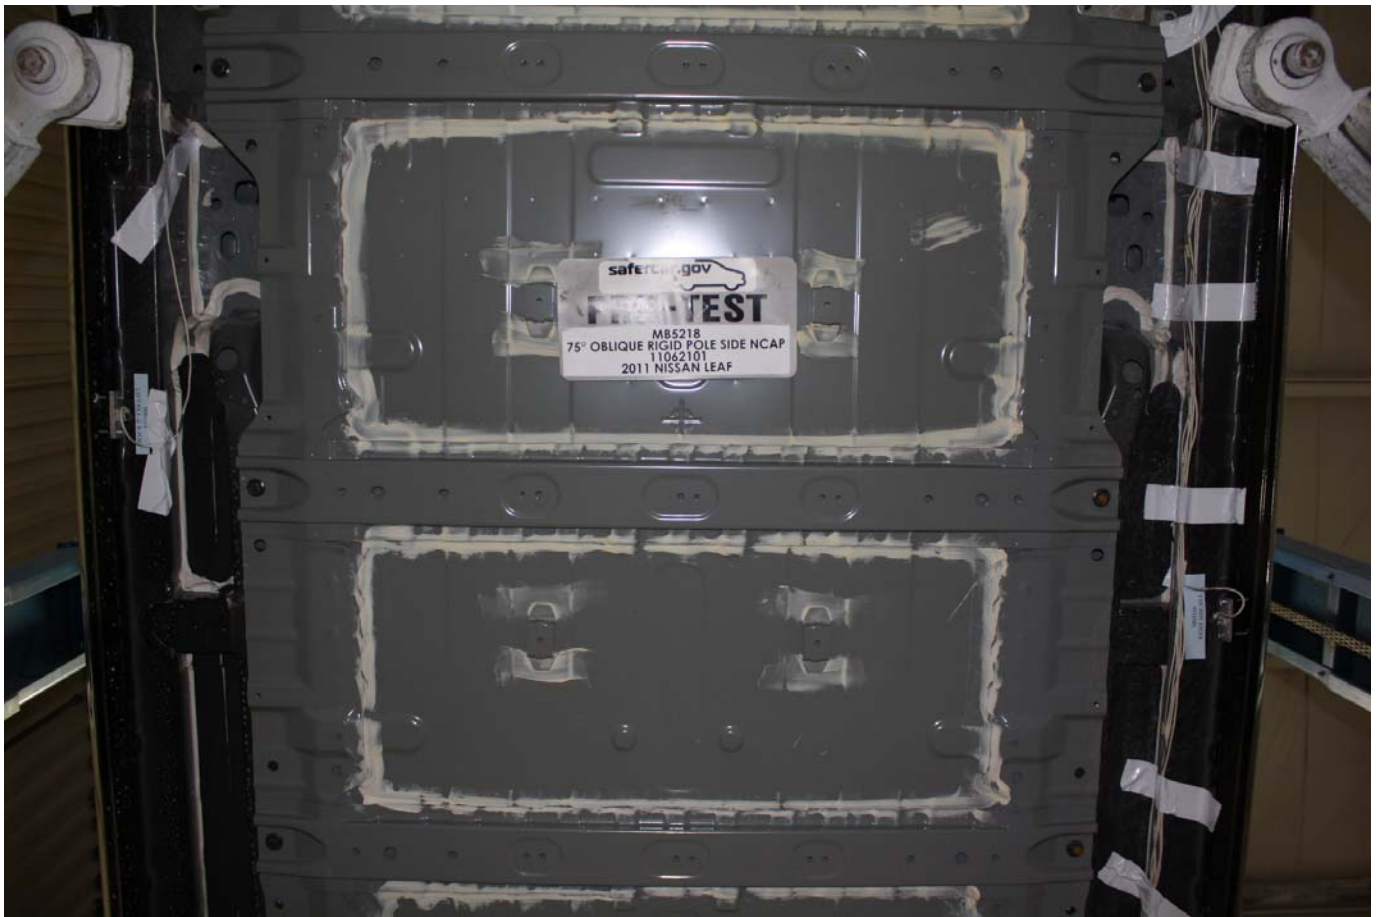
Pre-Test View of Propulsion Battery

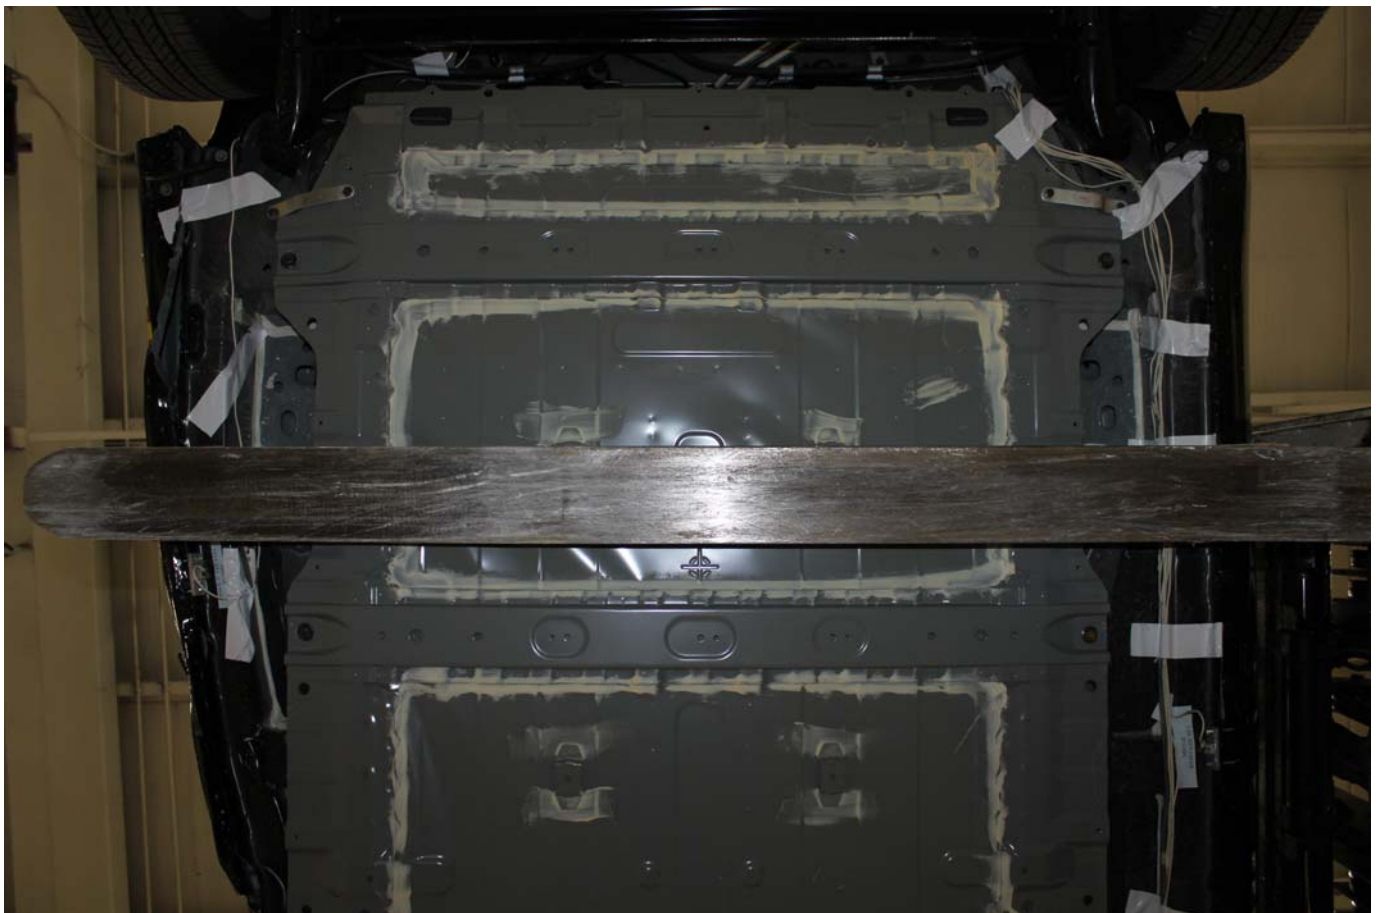
Post-Test View of Propulsion Battery

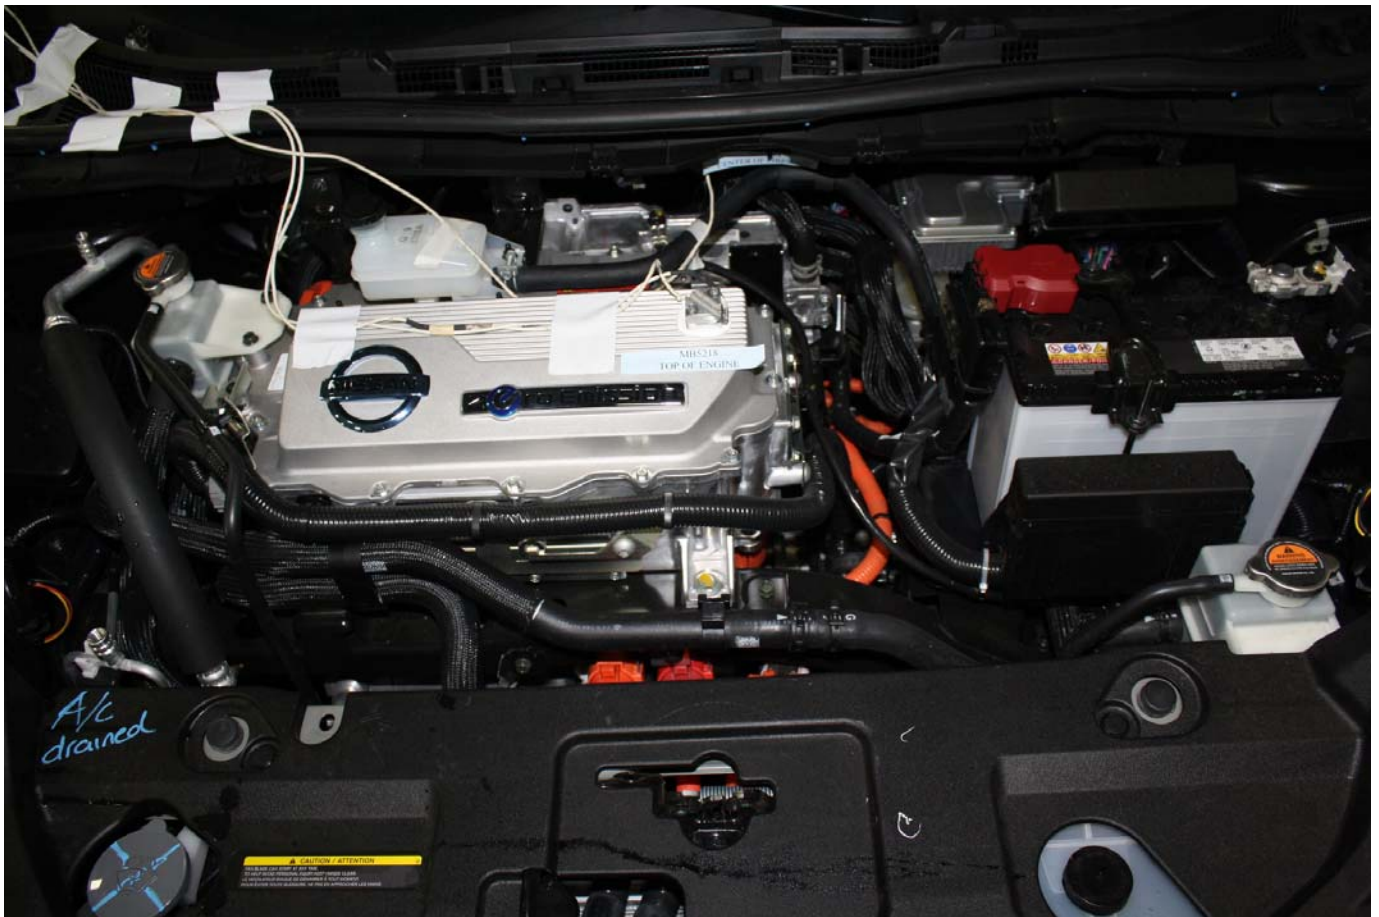
View of Electric Propulsion Drive
