**REPORT NUMBER: NCAP-KAR-11-062**

**NEW CAR ASSESSMENT PROGRAM (NCAP)  
FRONTAL BARRIER IMPACT TEST**

**NISSAN MOTOR CO., LTD.  
2011 NISSAN LEAF SL 5-DOOR HATCHBACK**

**FINAL REPORT**

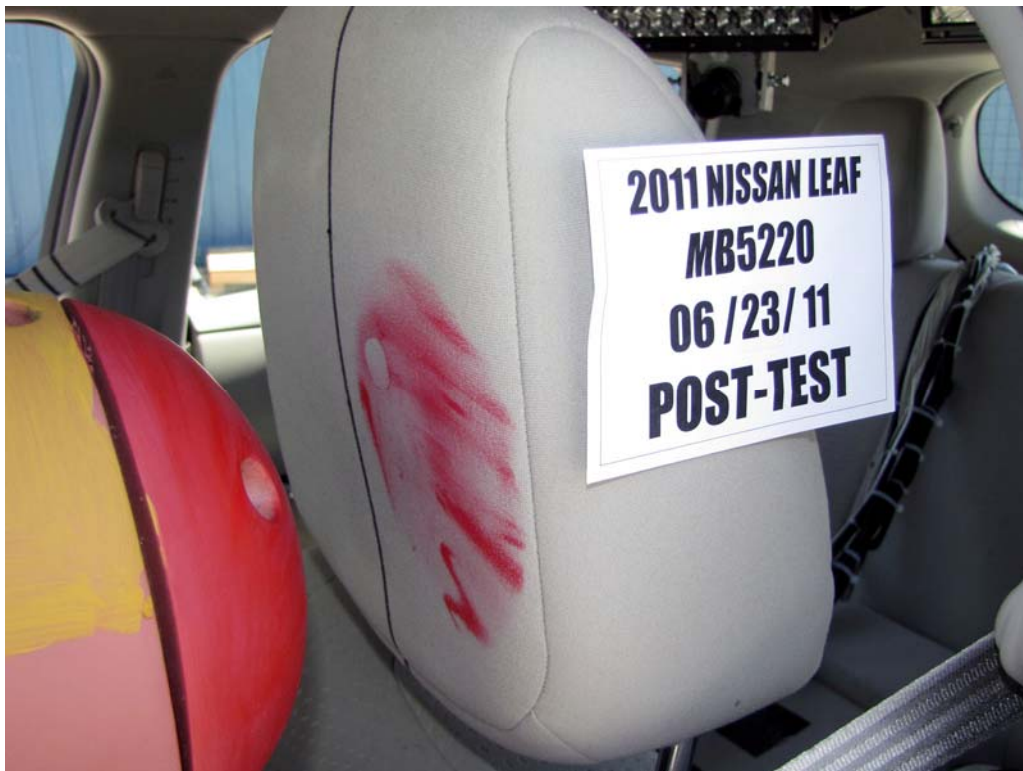
FIGURE 43a. Post-Test Driver Dummy Contact With Head Restraint

The driver's visible contact points were as follows: The driver ATD's head contacted the airbag and the head restraint. The upper torso contacted the airbag. Both the left and right knees contacted the knee bolster.

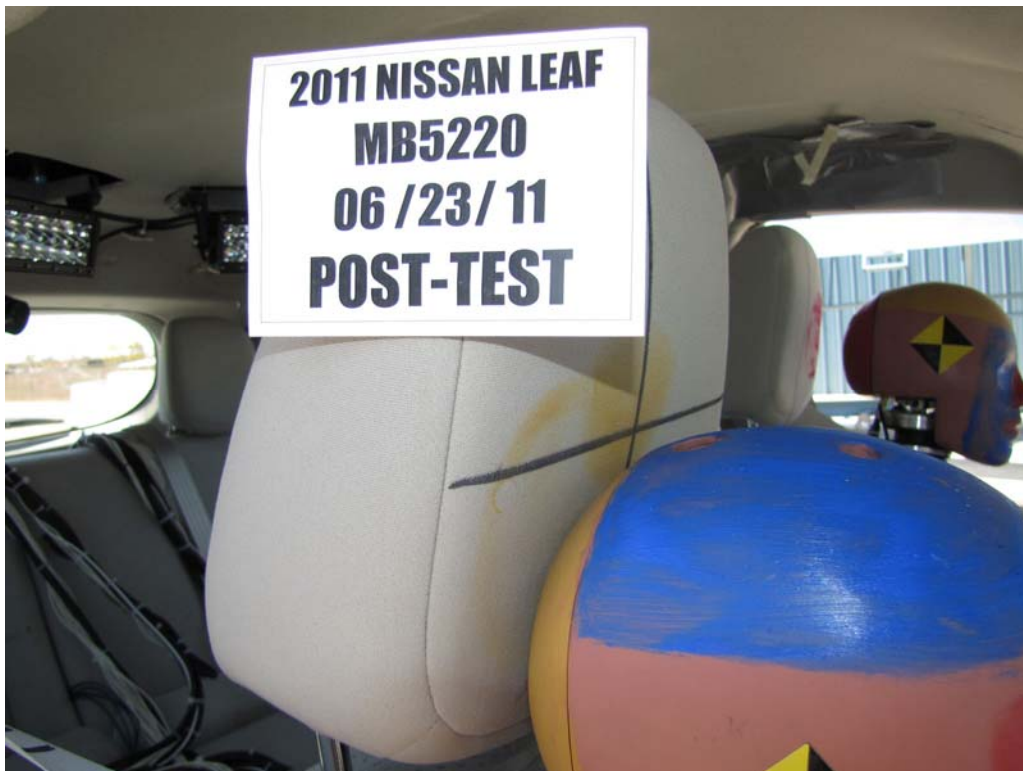
FIGURE 60a. Post-Test Passenger Dummy Contact With Head Restraint

The passenger's visible contact points were as follows: The passenger ATD's head contacted the airbag and the head restraint. The upper torso contacted the airbag. Both the left and right knees contacted the glovebox.
