**REPORT NUMBER: SPNCAP-MGA-2012-001**

**NEW CAR ASSESSMENT PROGRAM (NCAP)  
Side Impact Pole Test**

**KIA MOTORS MANUFACTURING GEORGIA, INC.  
2012 Kia Sorento LX SUV  
NHTSA No.: KC0502**

**FINAL REPORT**

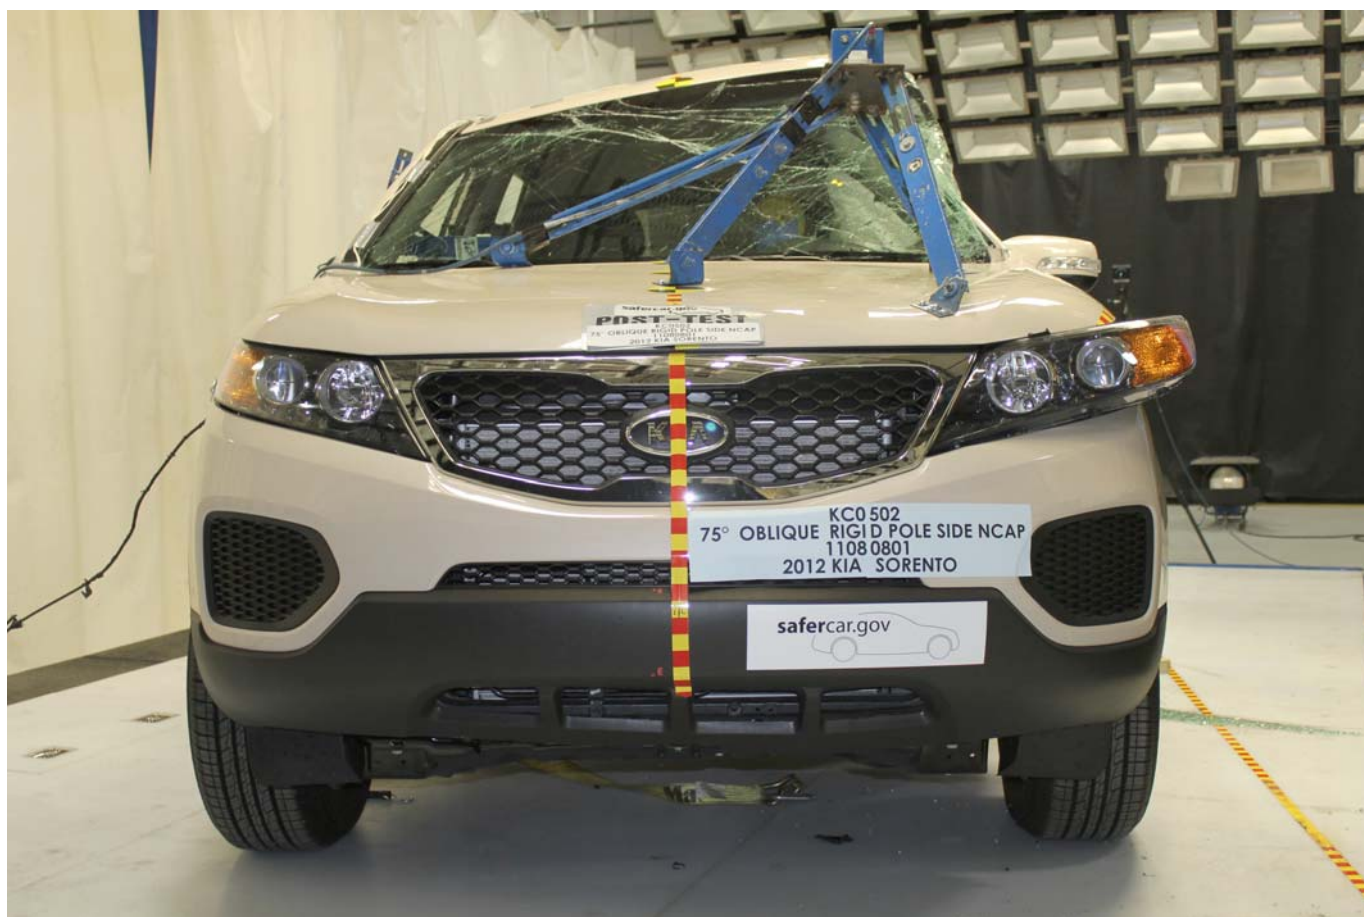
Post-Test Frontal View of Test Vehicle

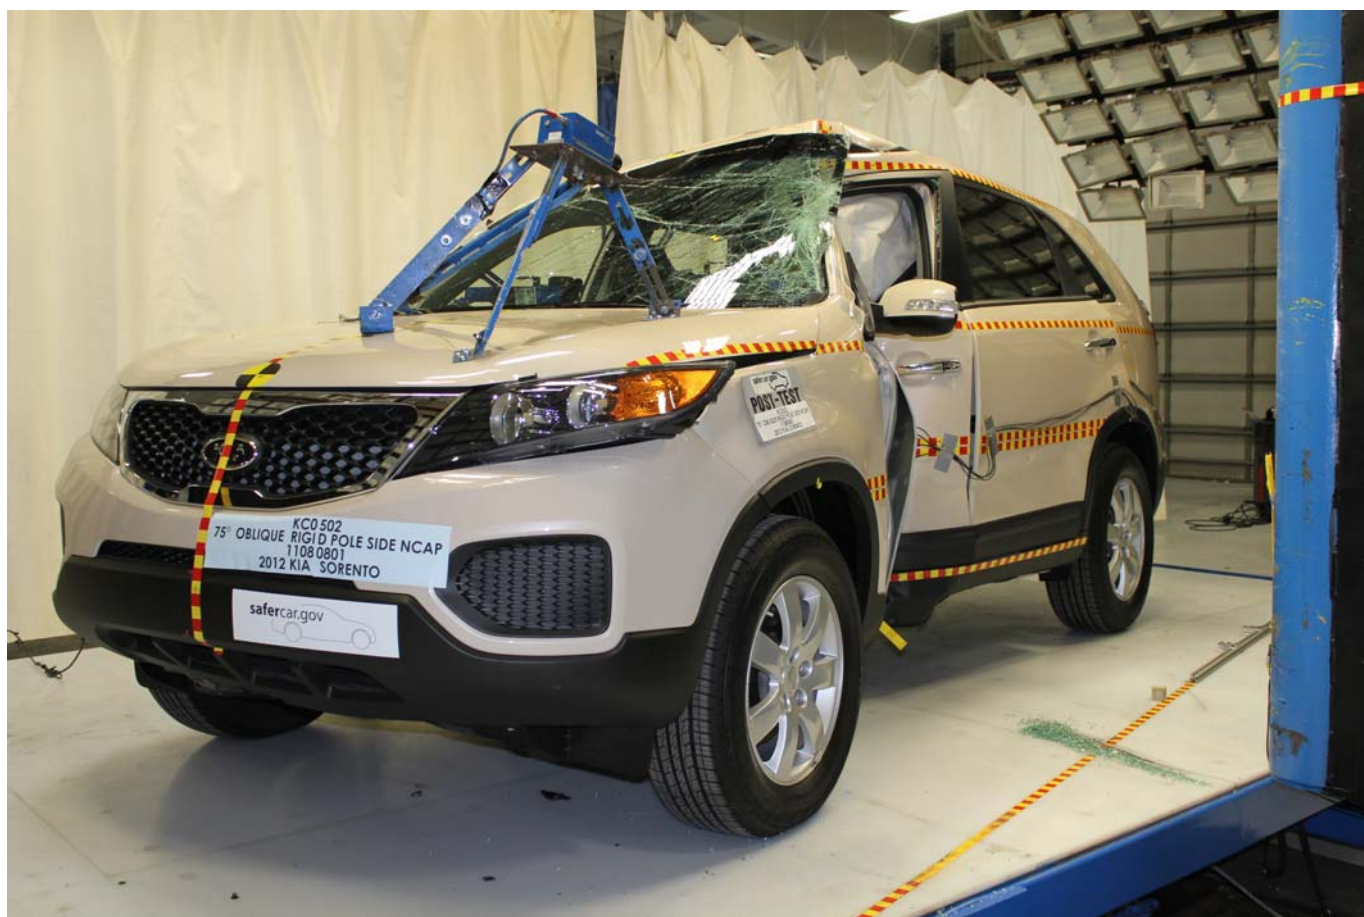
Post-Test Left Front  $\frac{3}{4}$  View of Test Vehicle

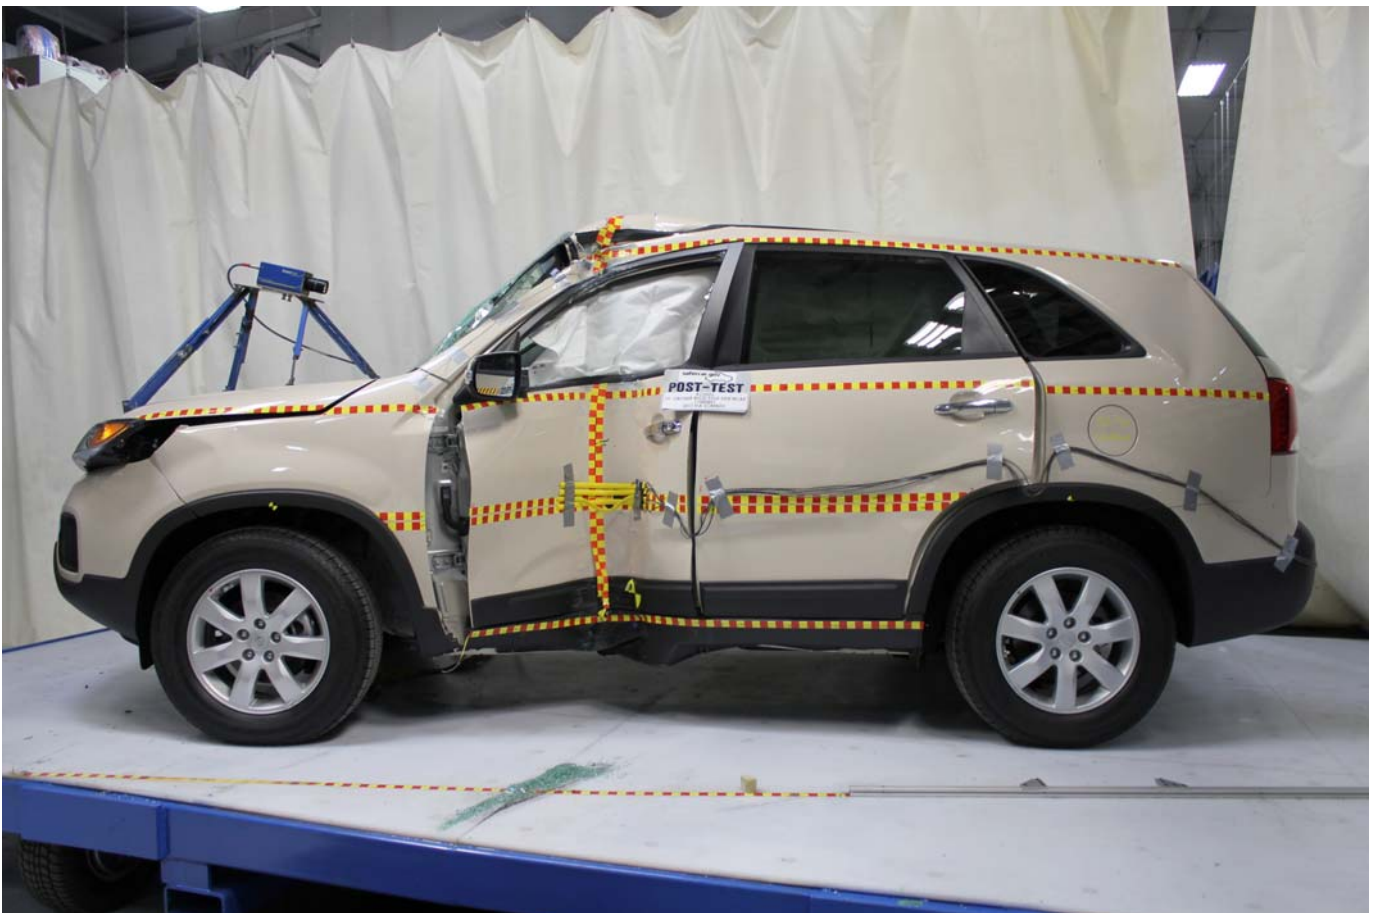
Post-Test Left Side View of Test Vehicle

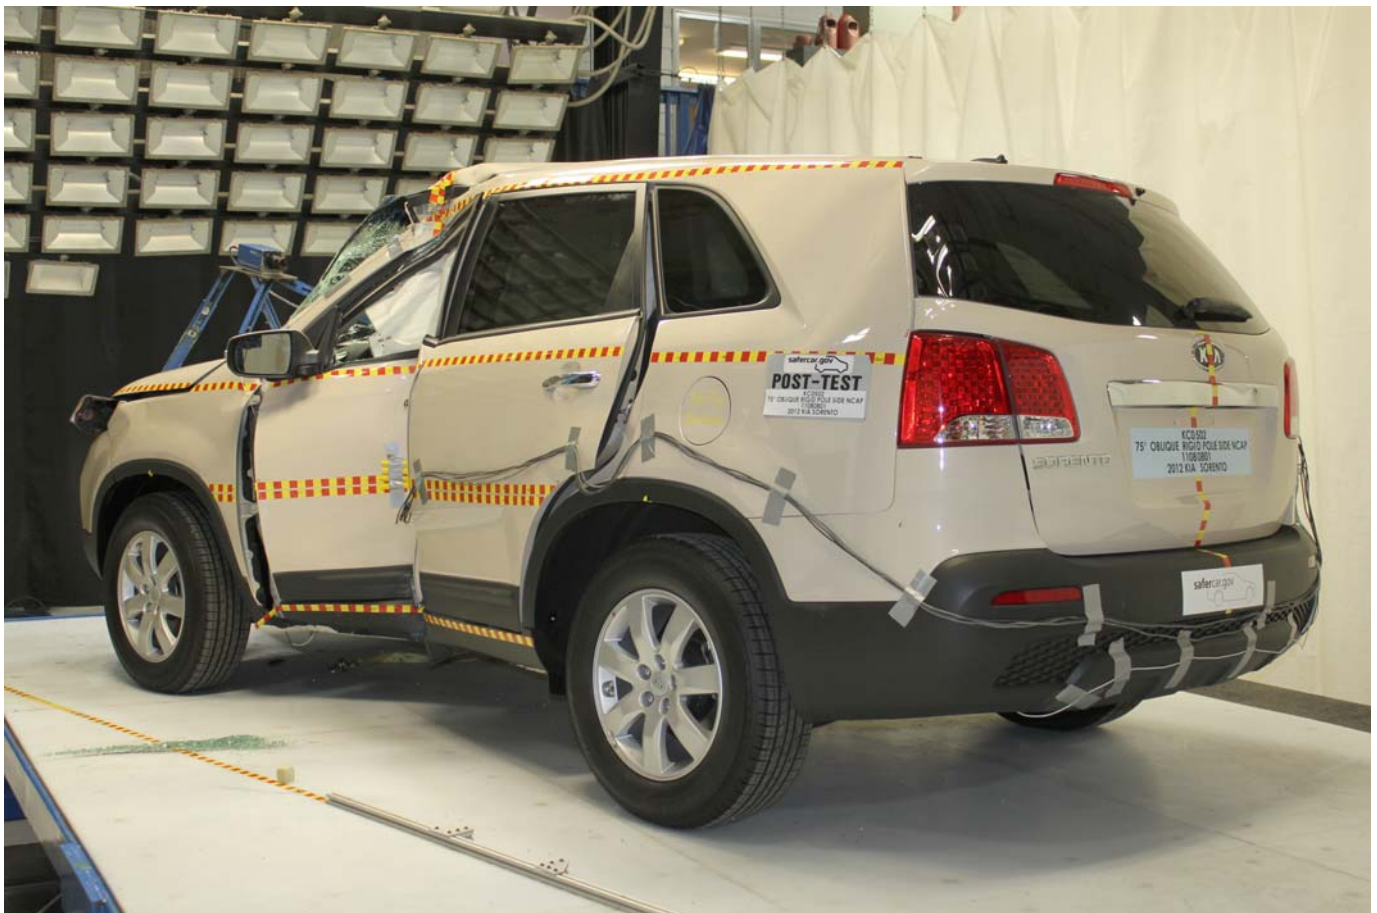
Post-Test Left Rear  $\frac{3}{4}$  View of Test Vehicle

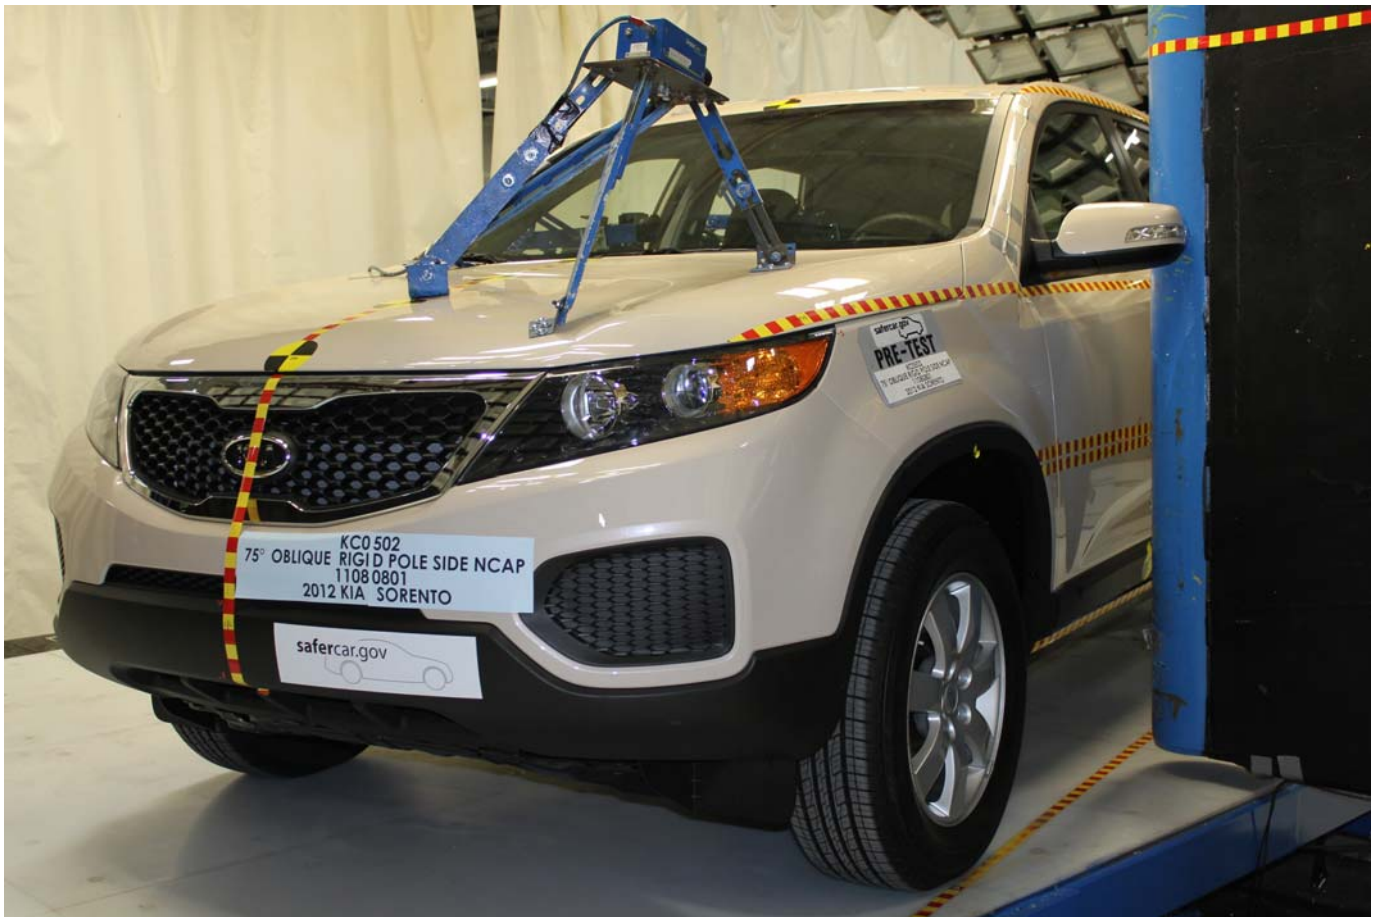
Pre-Test Left Side View of Pole Positioned Against Side of Vehicle

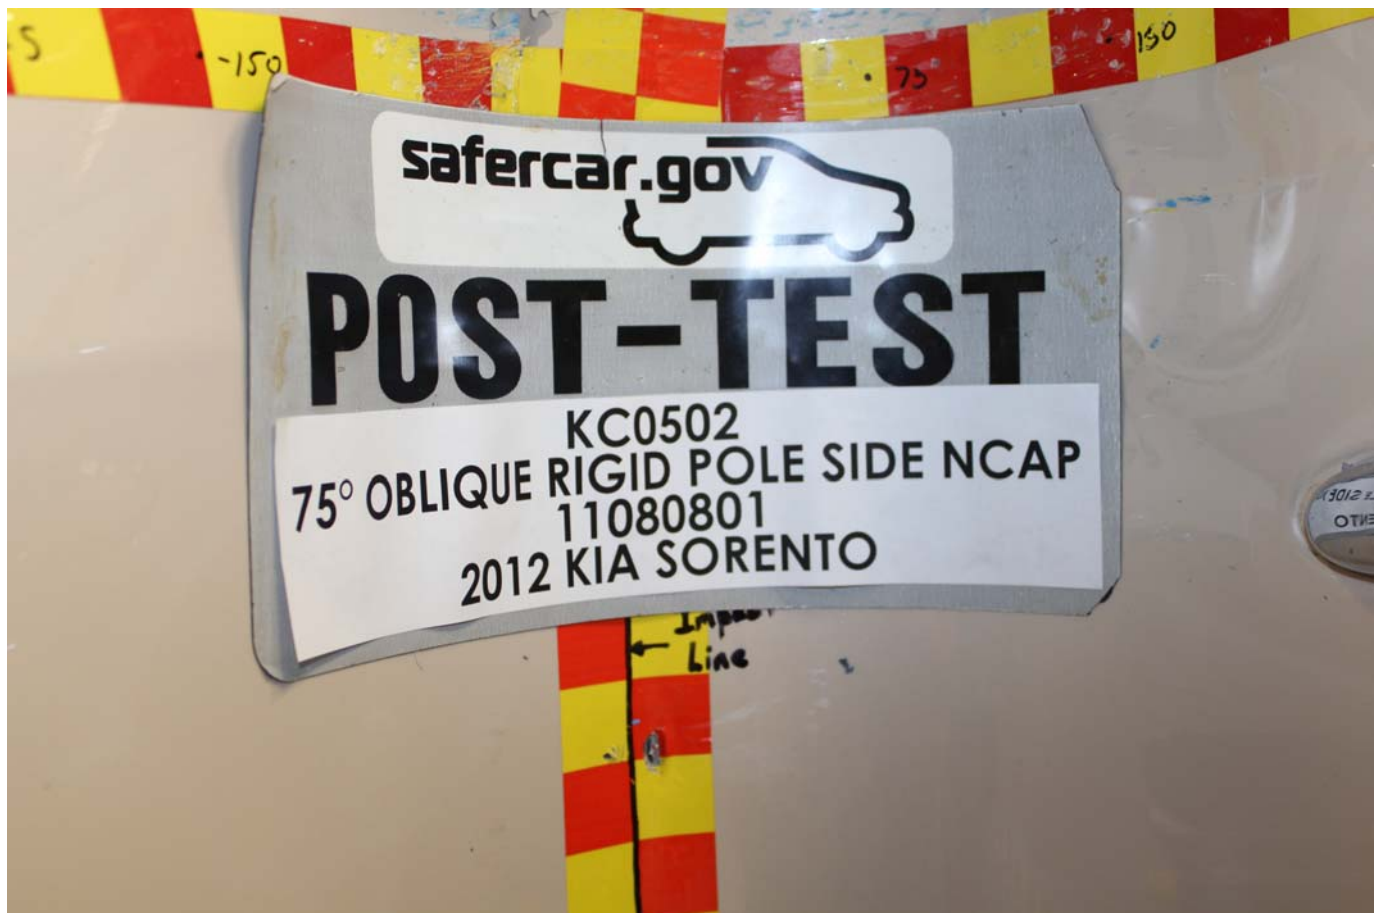
Post-Test Close-Up View of Impact Point Target Showing Impact Location

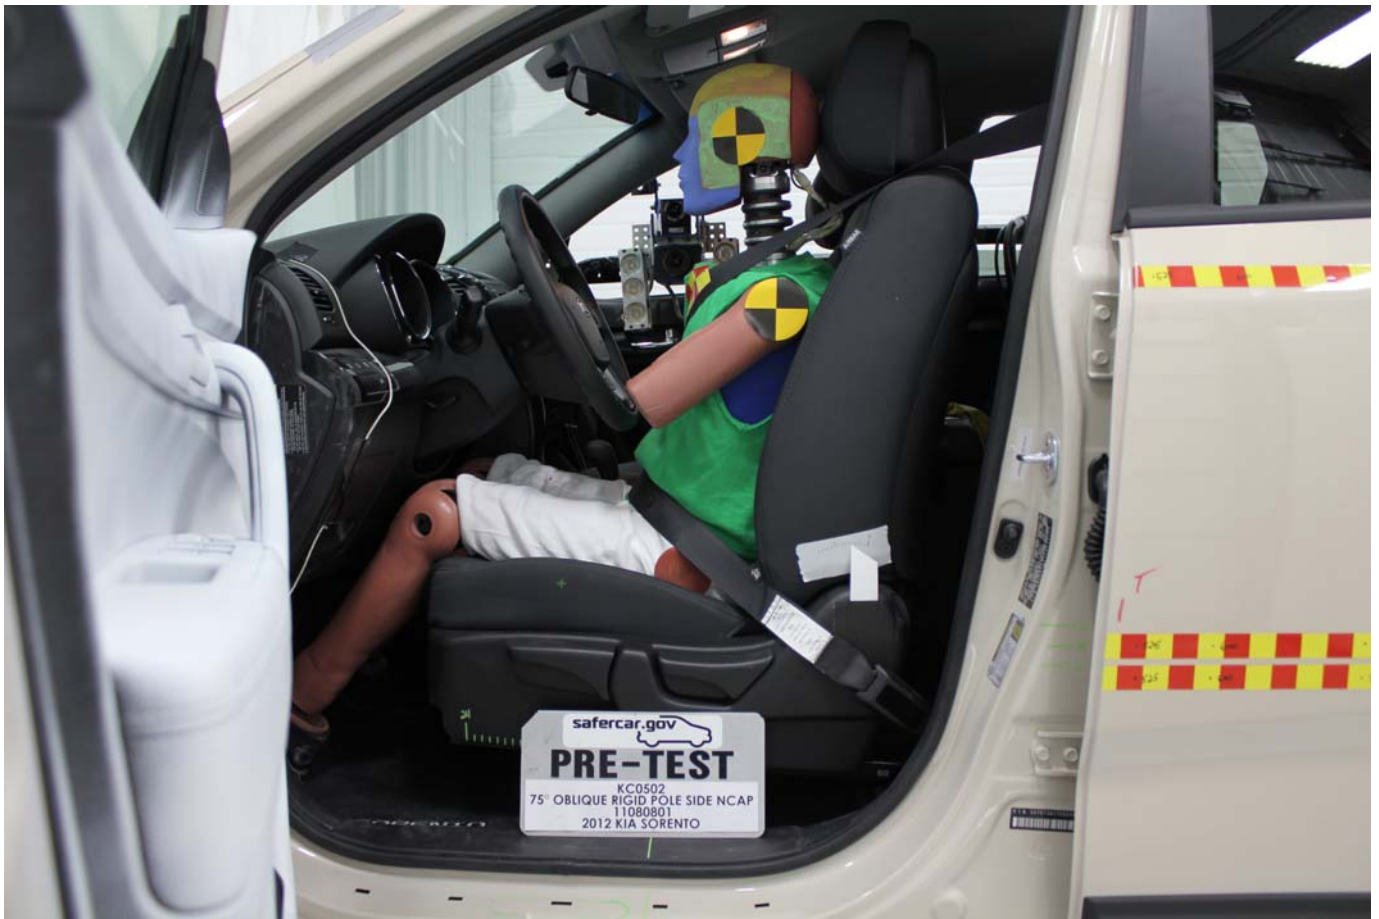
Pre-Test Left Side View of Dummy Showing Belts, Chalking, and Contact Switches (Door Open)

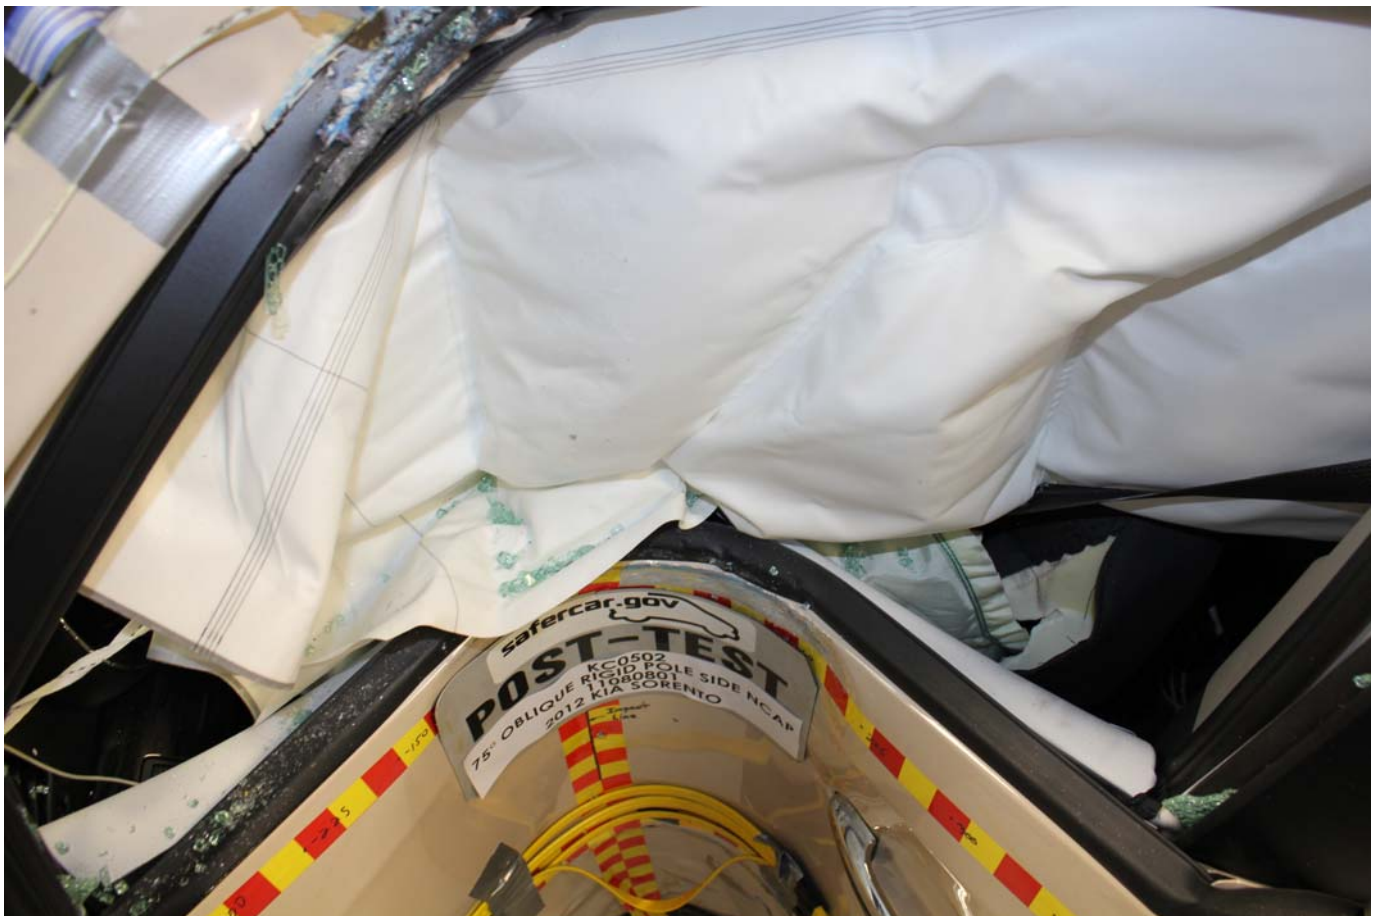
Post-Test Dummy and Door Clearance View

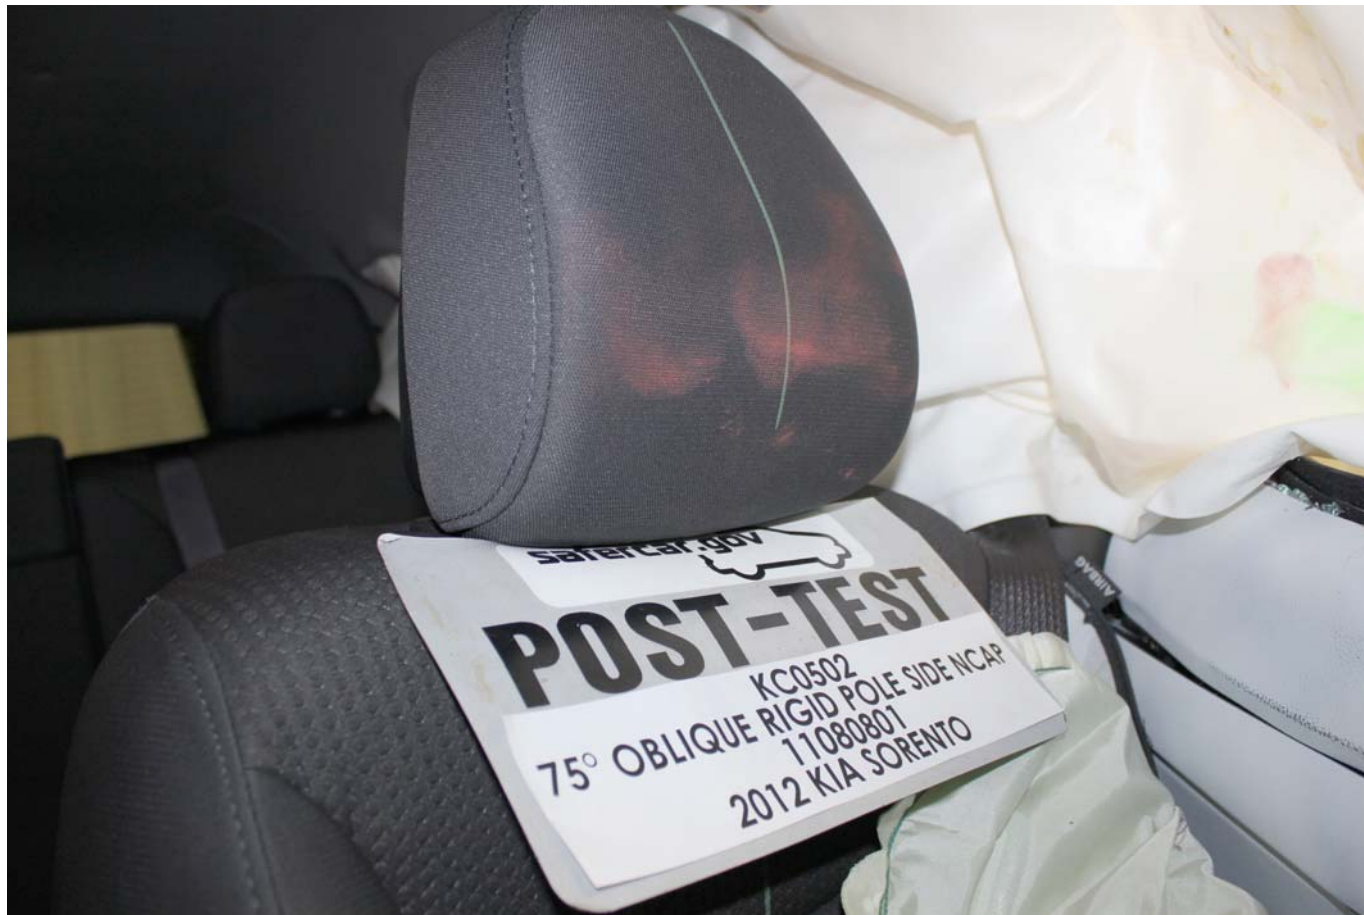
Post-Test Dummy Close-Up Head Contact with Vehicle Interior View

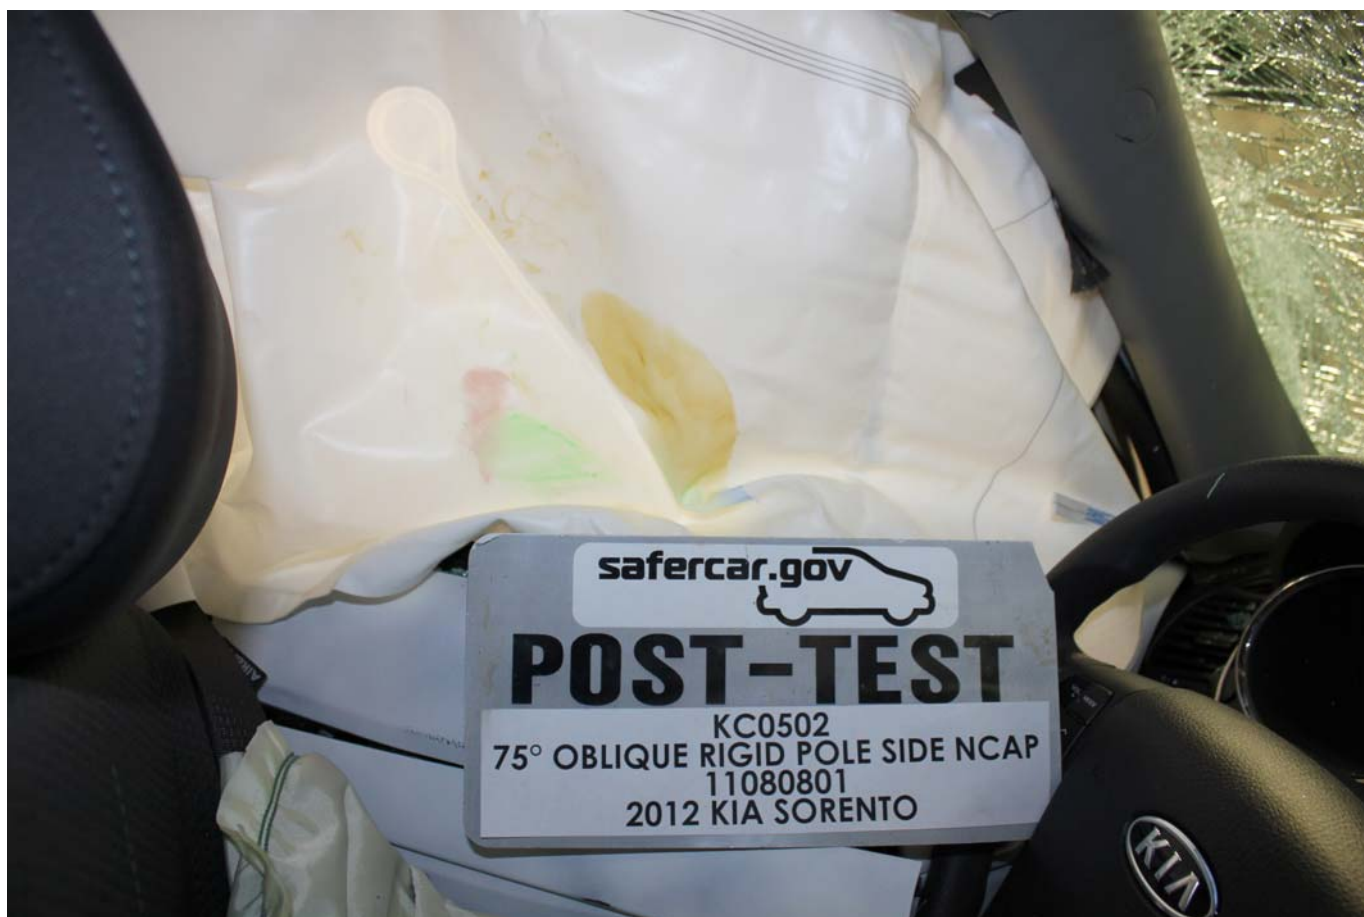
Post-Test Dummy Close-Up Head Contact with Side Airbag View

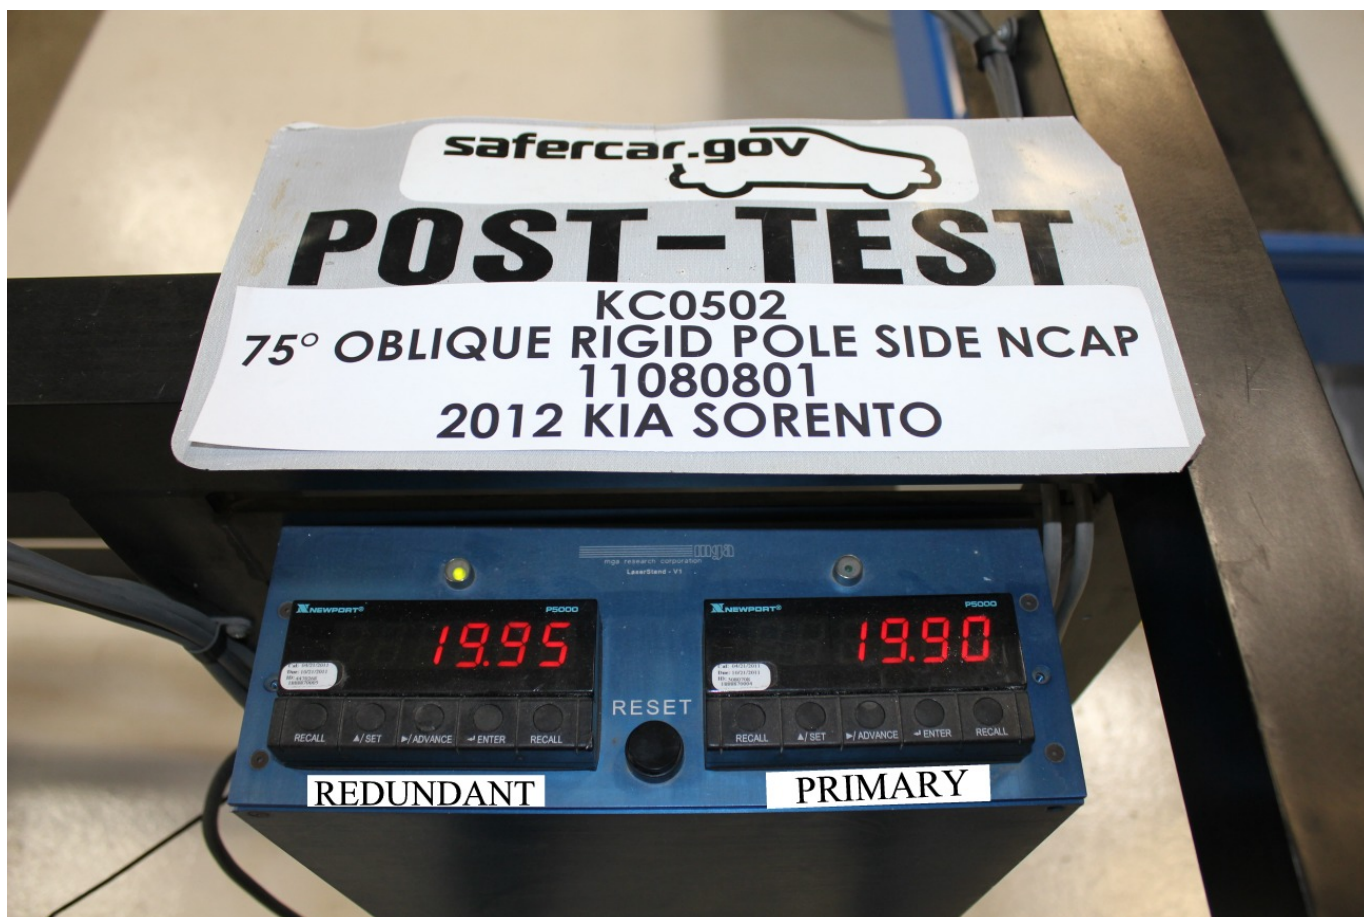
Post-Test Primary and Redundant Speed Trap Read-Out

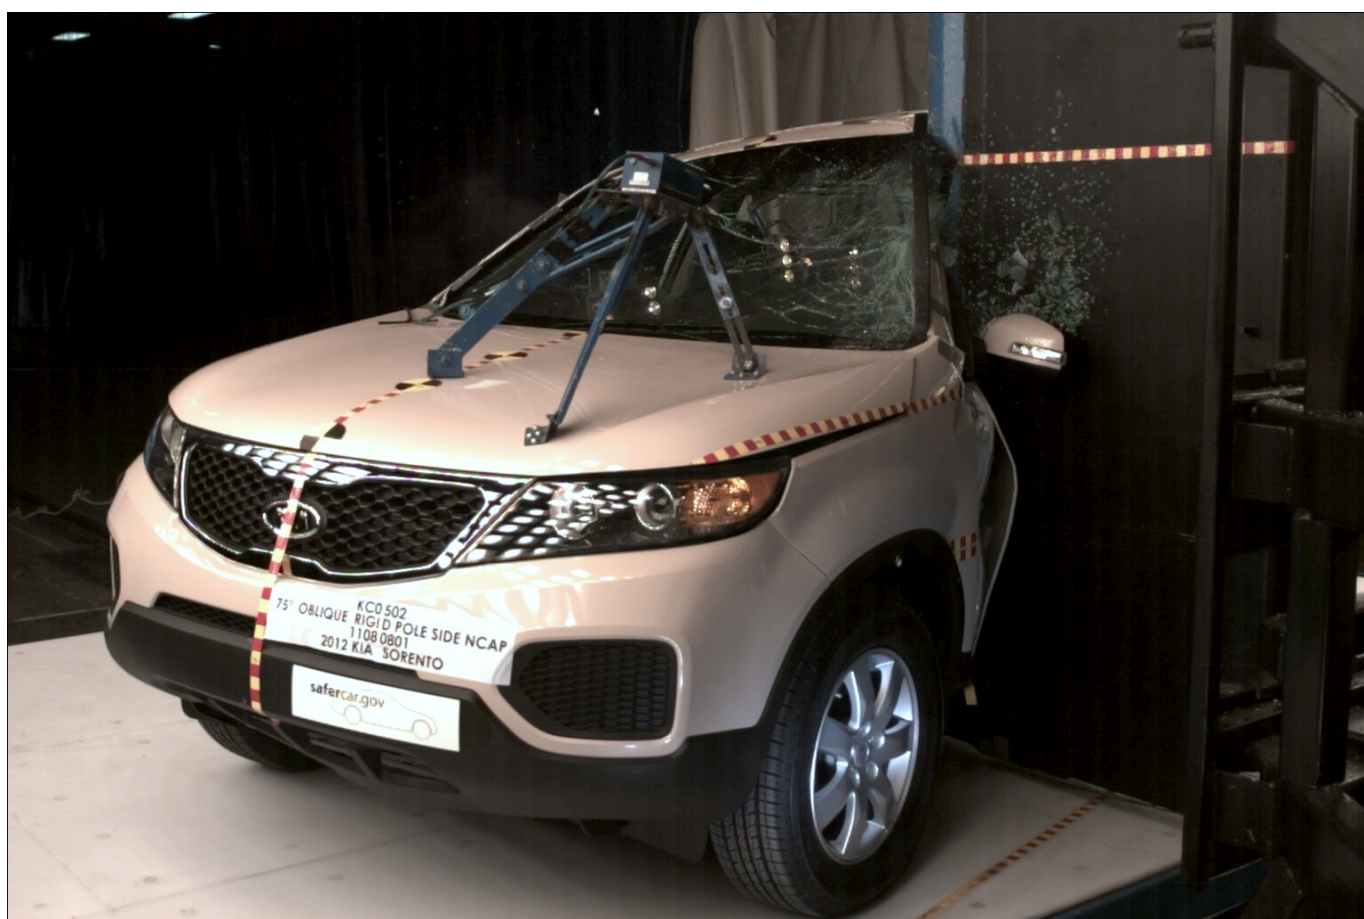
Impact Event

A rigid pole side impact test was conducted on a 2012 Kia Sorento LX SUV. The subject vehicle was towed into the rigid pole at an angle of 75° and a velocity of 32.0 km/h. The test was conducted by MGA Research Corporation in Burlington, Wisconsin, on August 8, 2011. Pre-test and post-test photographs of the test vehicle and side impact dummy (SID-IIs) are included in Appendix A of this report.

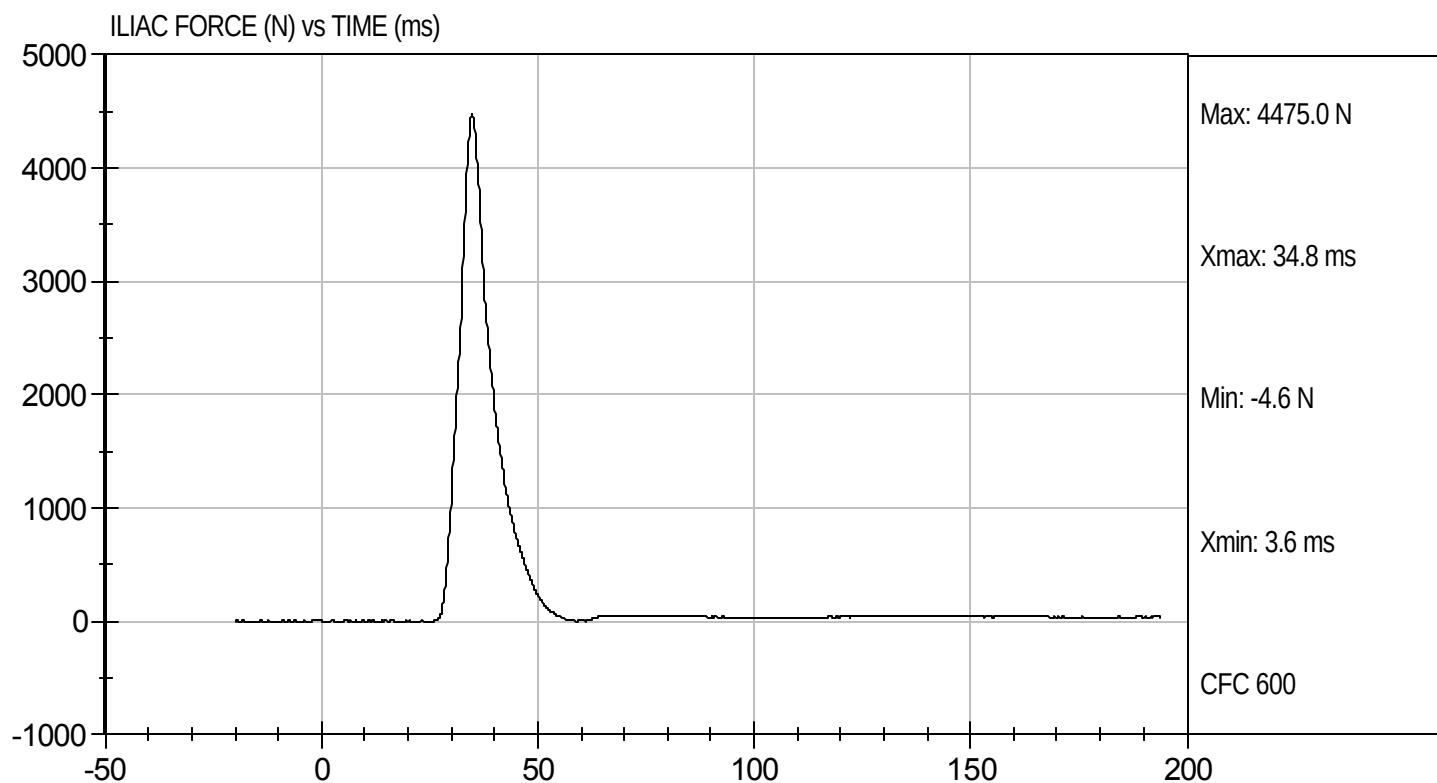
Test Desc: Iliac Impact  
Component ID: D112688

Test Date: 8/9/11  
Velocity: 14.25 ft/s, 4.34 m/s
