**REPORT NUMBER: SINCAP-MGA-2012-002**

**NEW CAR ASSESSMENT PROGRAM (NCAP)  
Moving Deformable Barrier Side Impact Test**

**KIA MOTORS MANUFACTURING GEORGIA, INC.  
2012 Kia Sorento LX SUV  
NHTSA No.: KC0501**

**MGA RESEARCH CORPORATION  
5000 Warren Road  
Burlington, WI 53105**

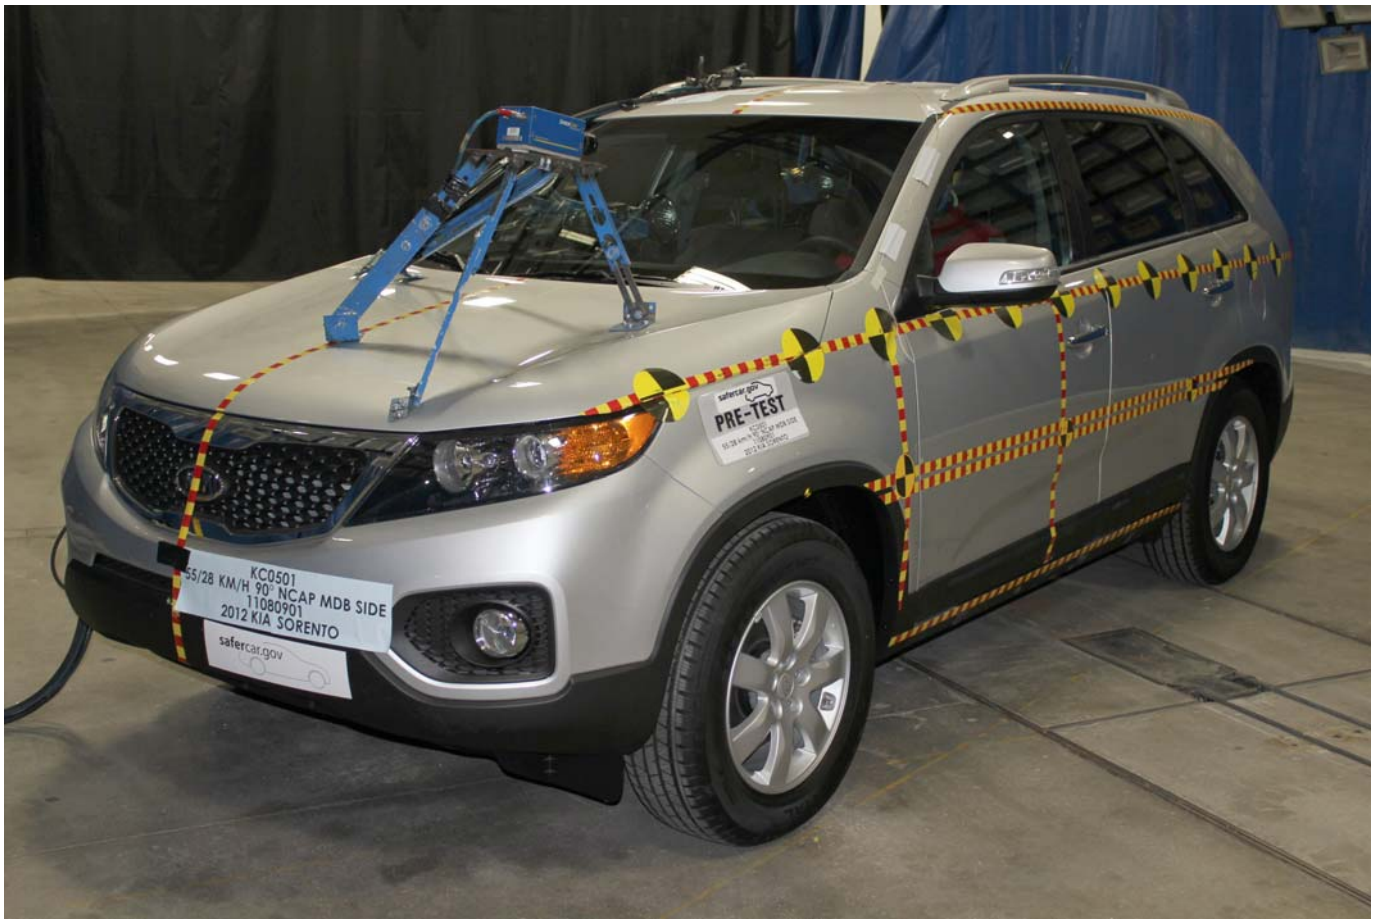
Post-Test Frontal View of Test Vehicle

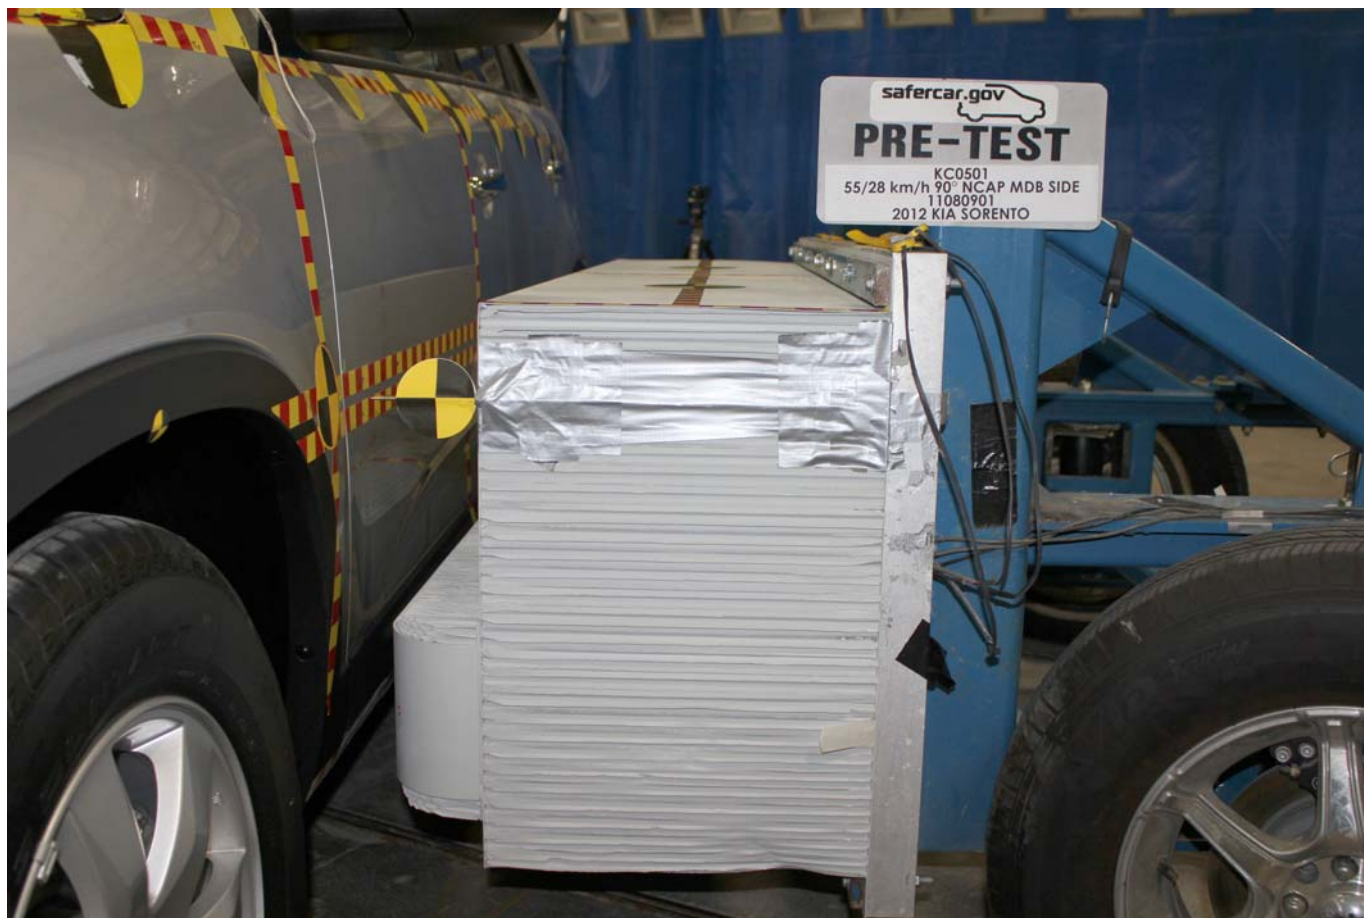
Post-Test Overhead View of Test Vehicle and MDB

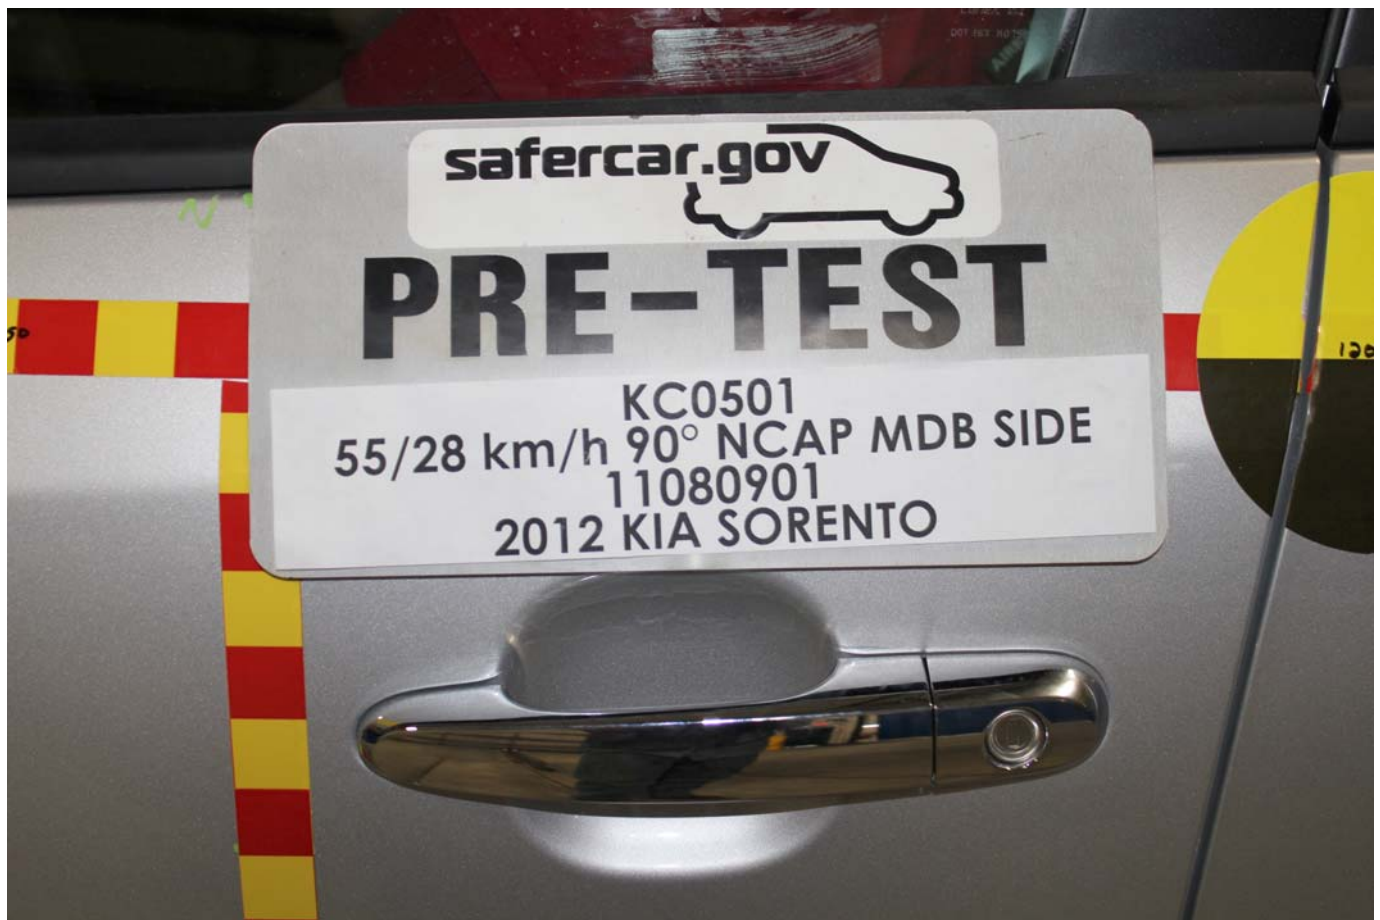
Post-Test Close-Up View of Impact Point Target

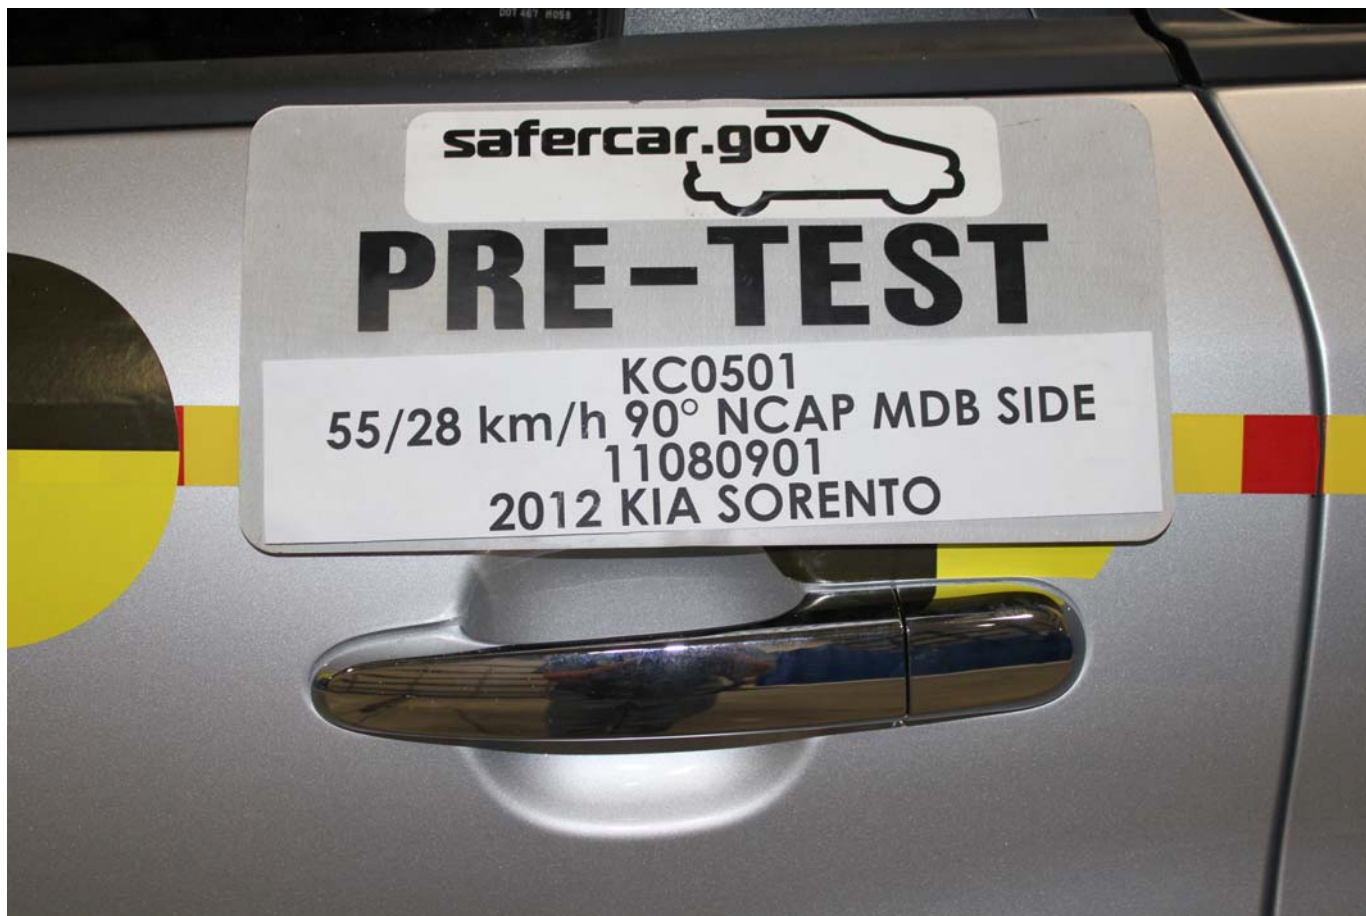
Post-Test Left Front Door Latch Close-Up

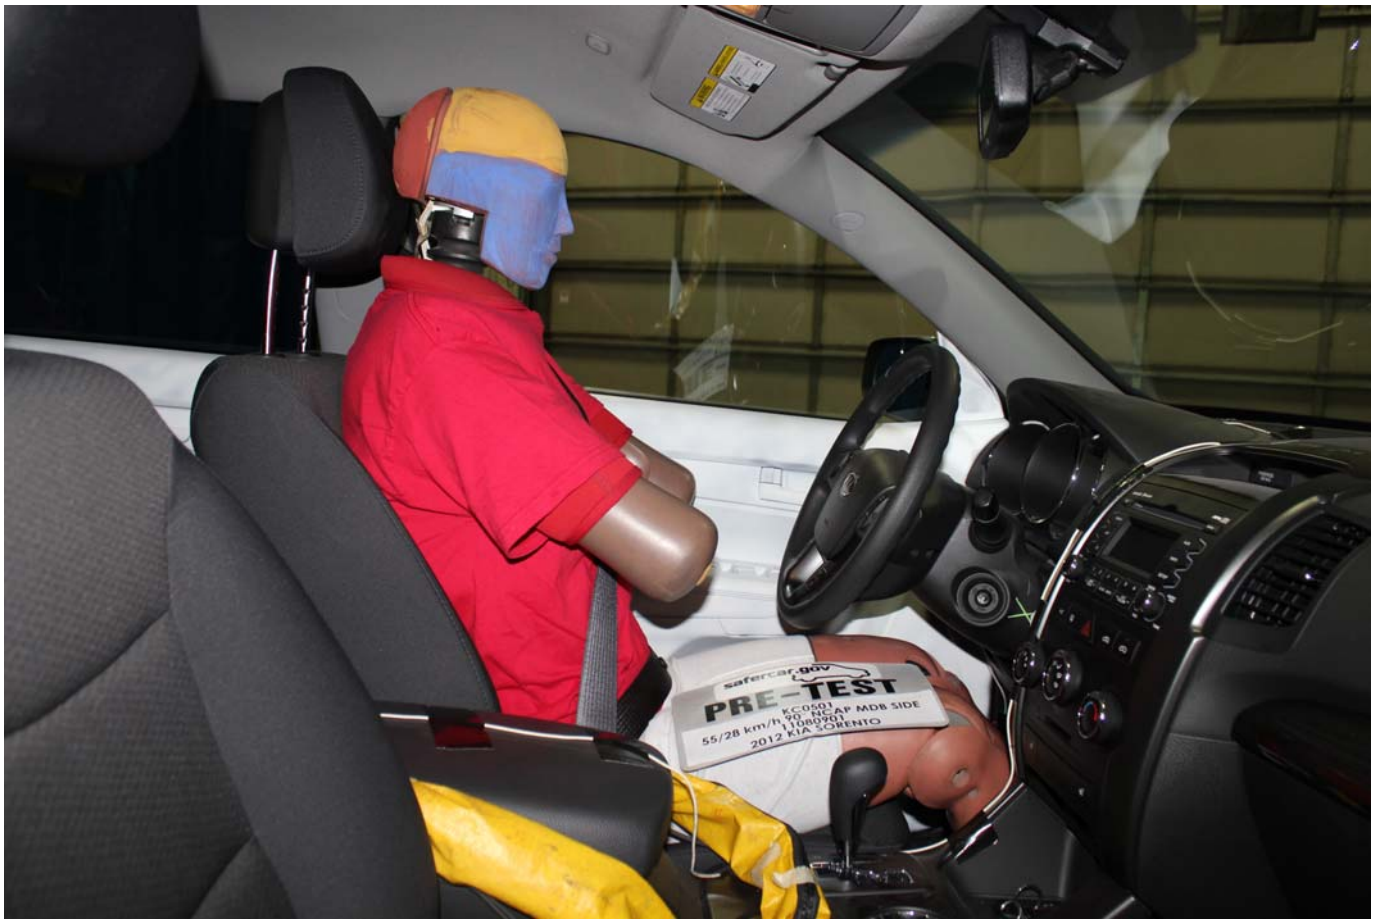
Post-Test Driver Dummy and Door Clearance View

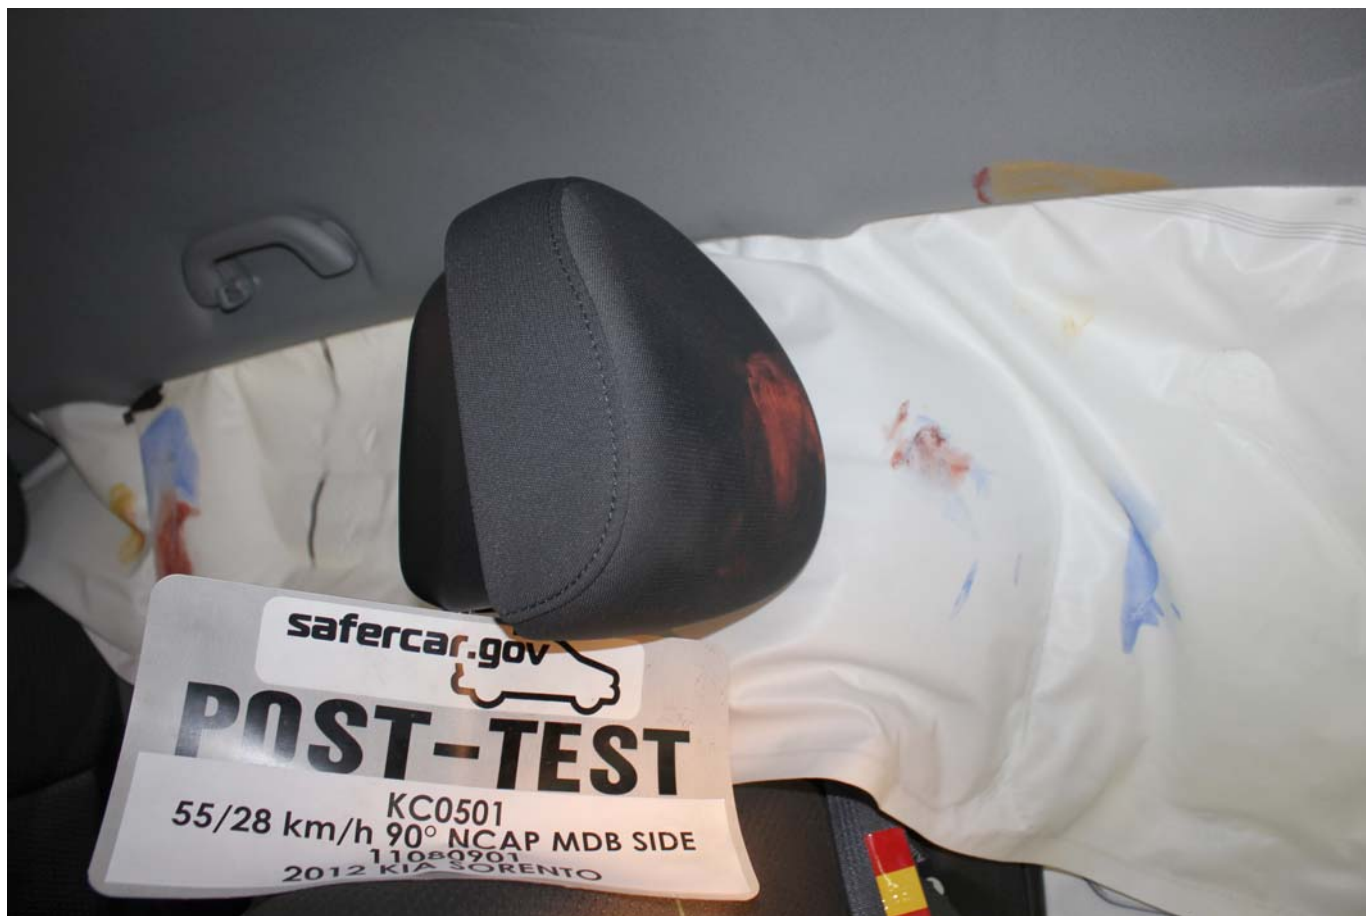
Post-Test Driver Inner Door Panel View Showing Driver Dummy Contact Locations

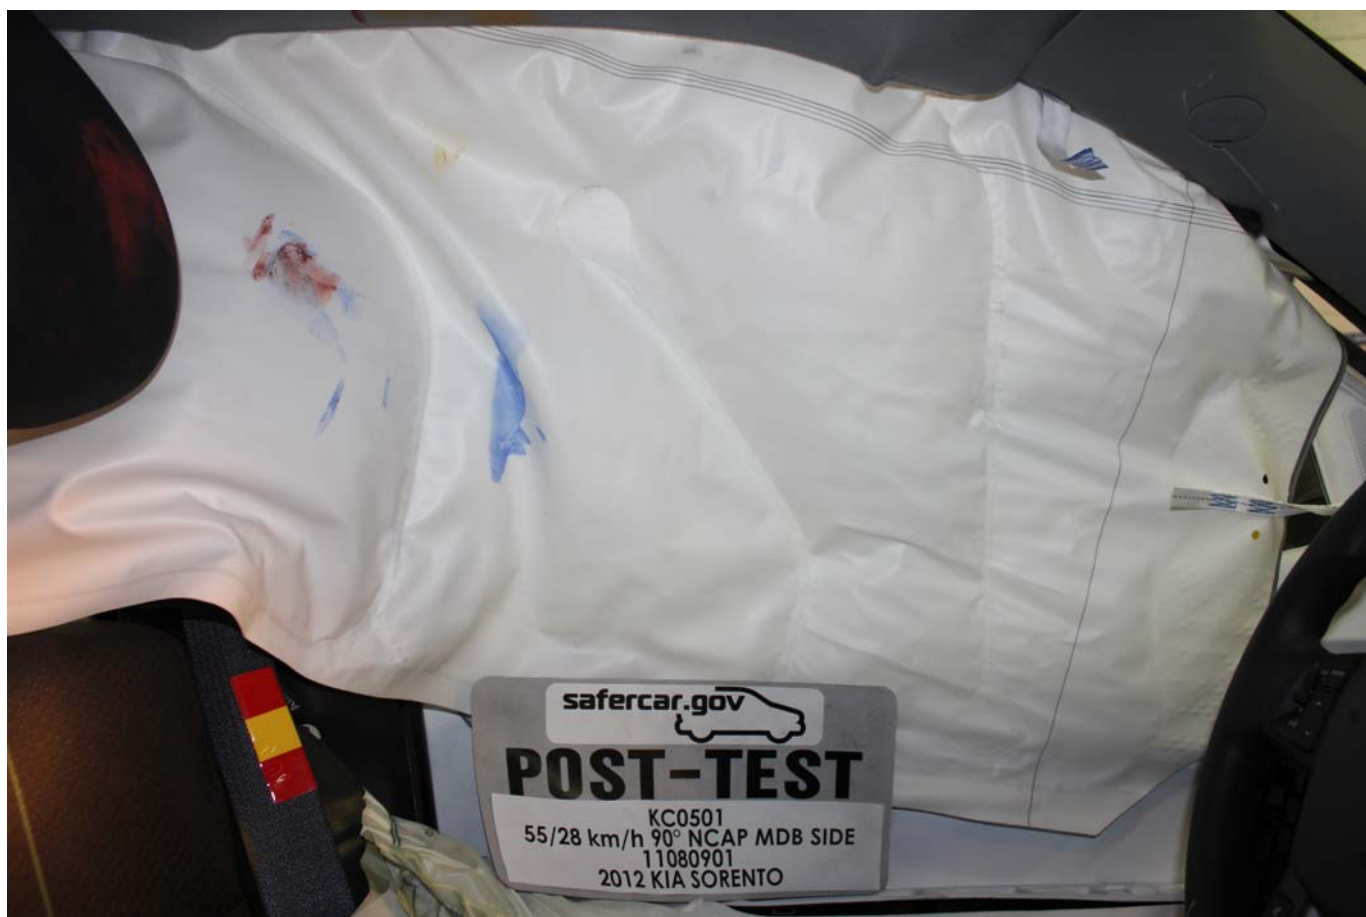
Post-Test Driver Dummy Close-up Head Contact with Vehicle Interior View

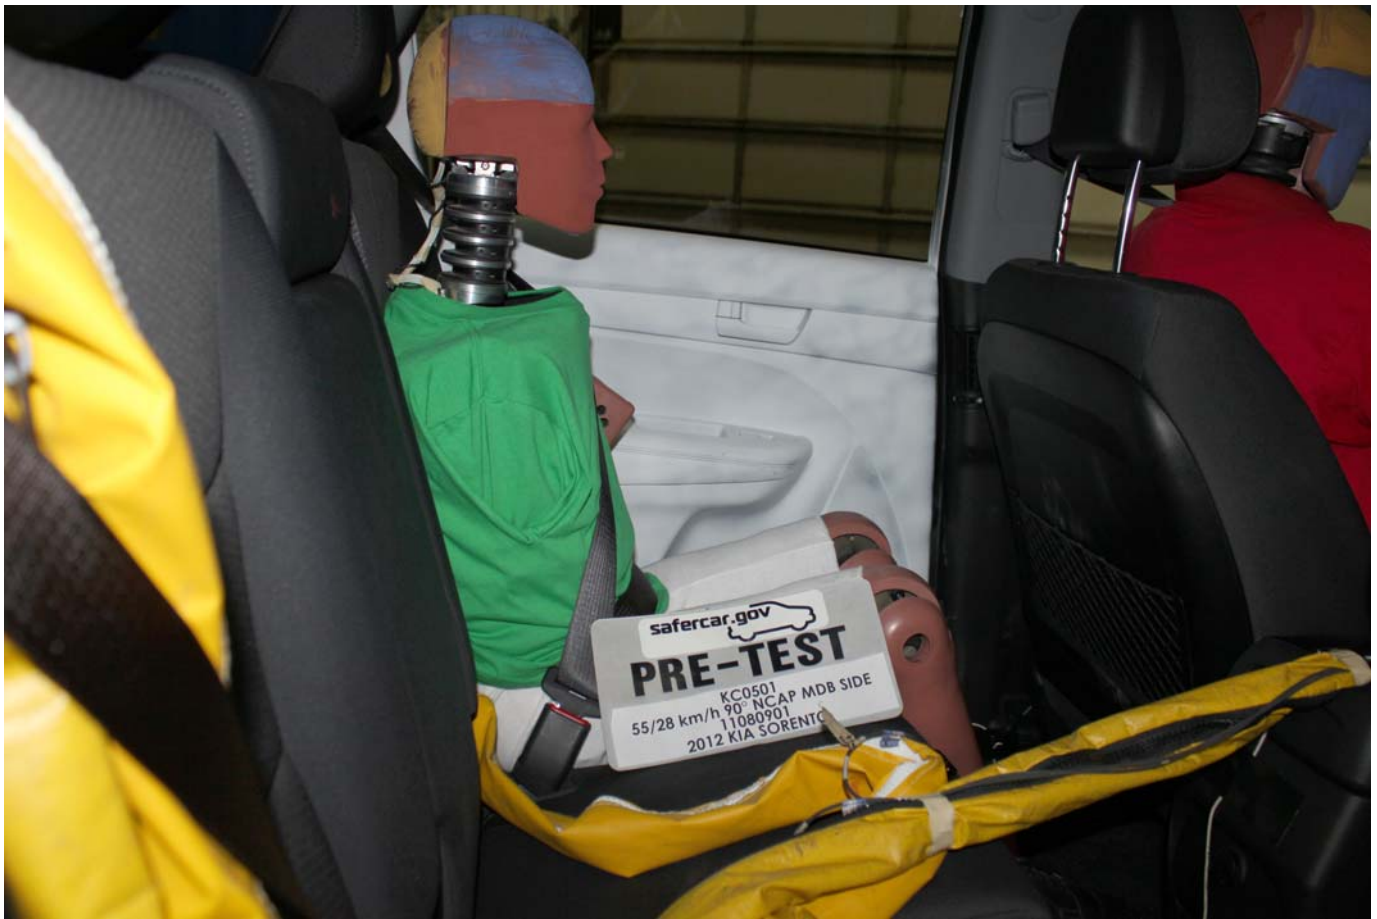
Post-Test Rear Passenger Dummy and Door Clearance View

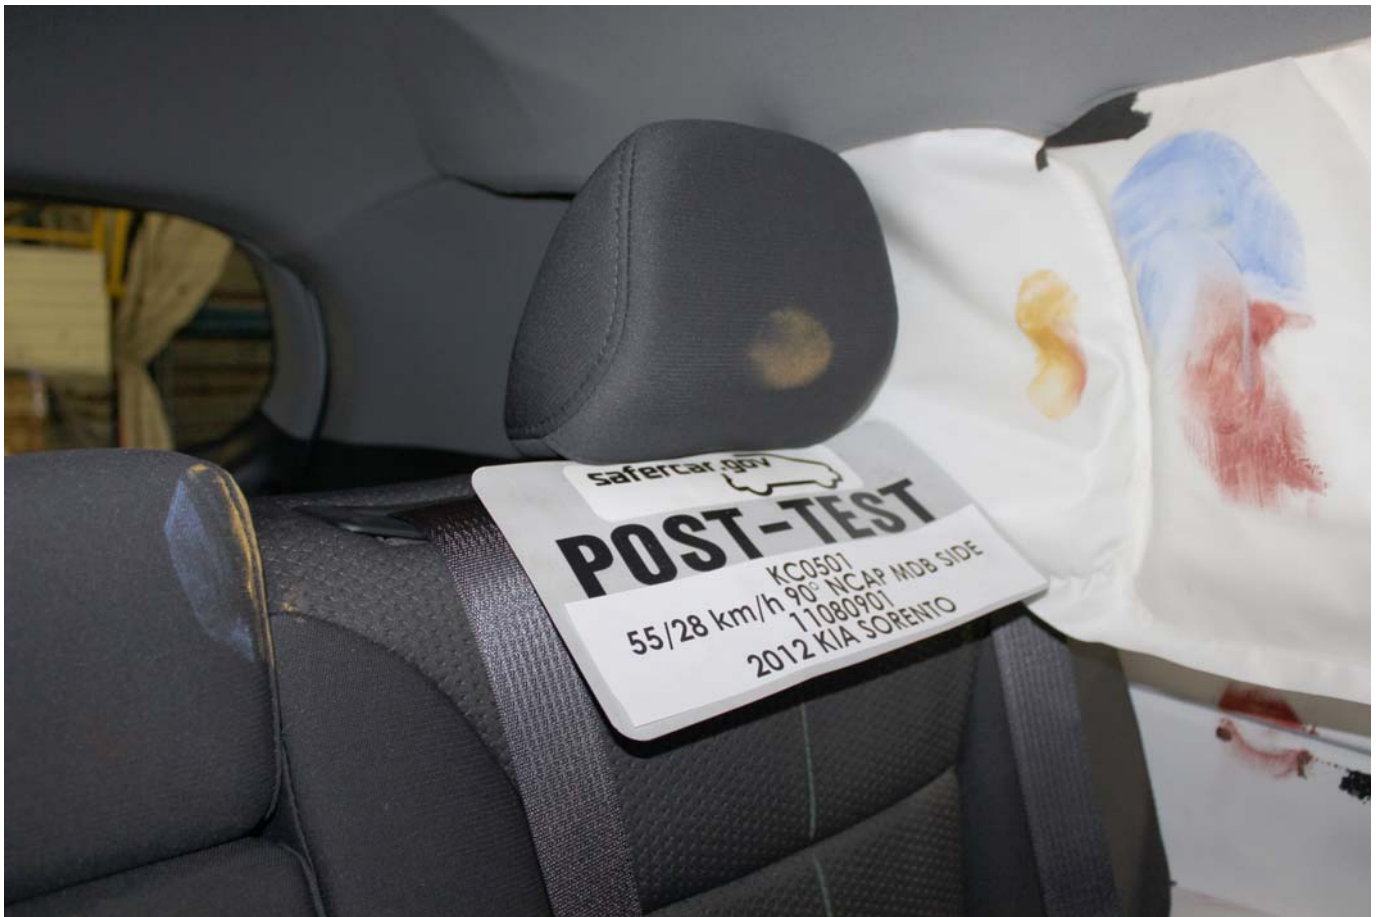
Post-Test Rear Passenger Inner Door Panel View Showing Dummy Contact Locations

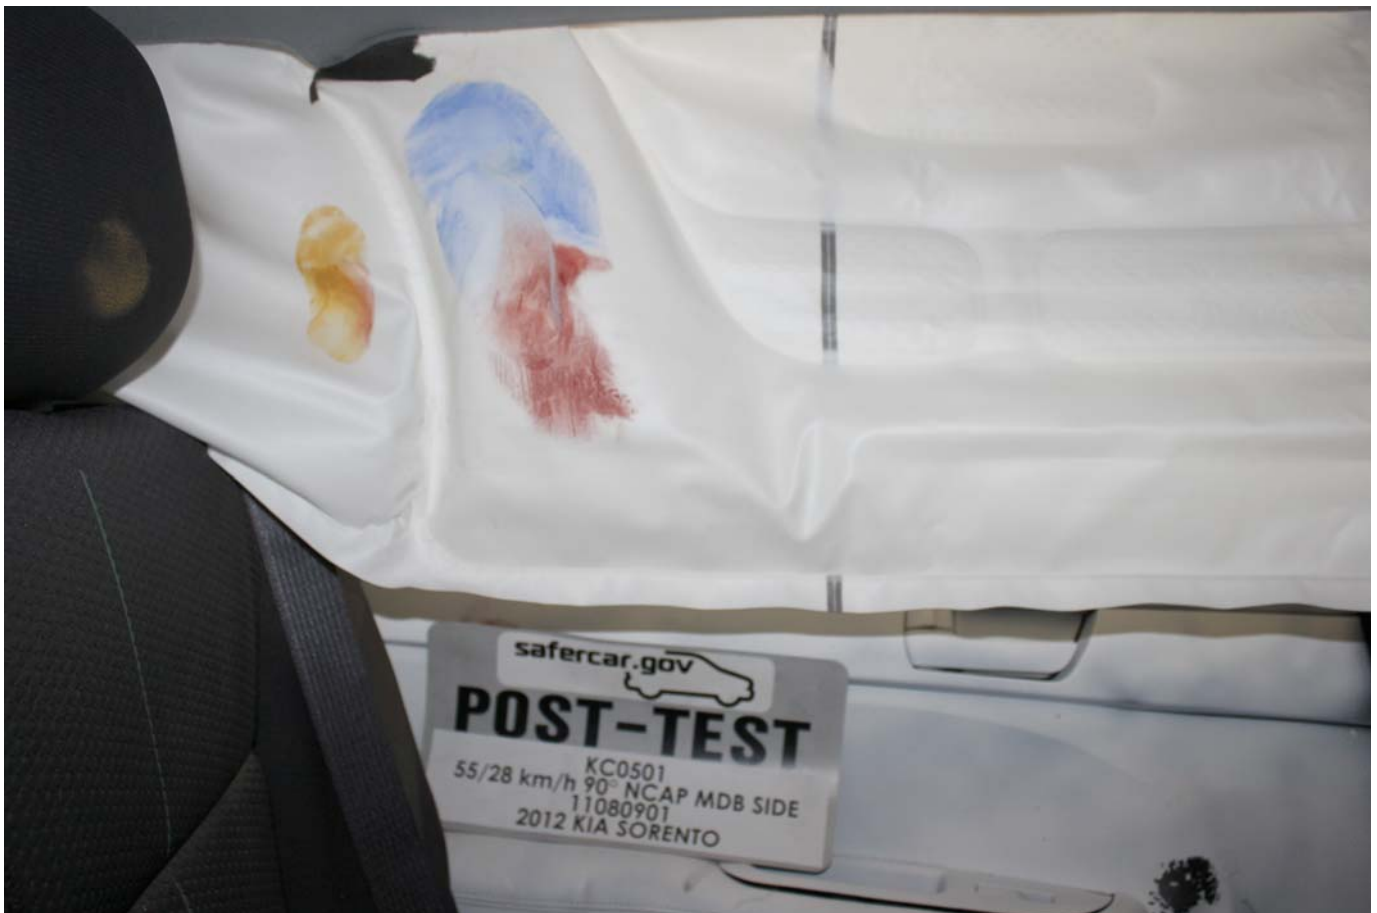
Post-Test Rear Passenger Dummy Close-up Head Contact with Vehicle Interior View
