REPORT NUMBER: TWG-MGA-2011-015

**SIDE AIRBAG OUT-OF-POSITION INJURY
TECHNICAL WORKING GROUP**

**DAIMLER AG STUTTGART
2011 MERCEDES-BENZ C300 4-DR SEDAN
NHTSA NO.: MB0501TWG2**

FINAL REPORT

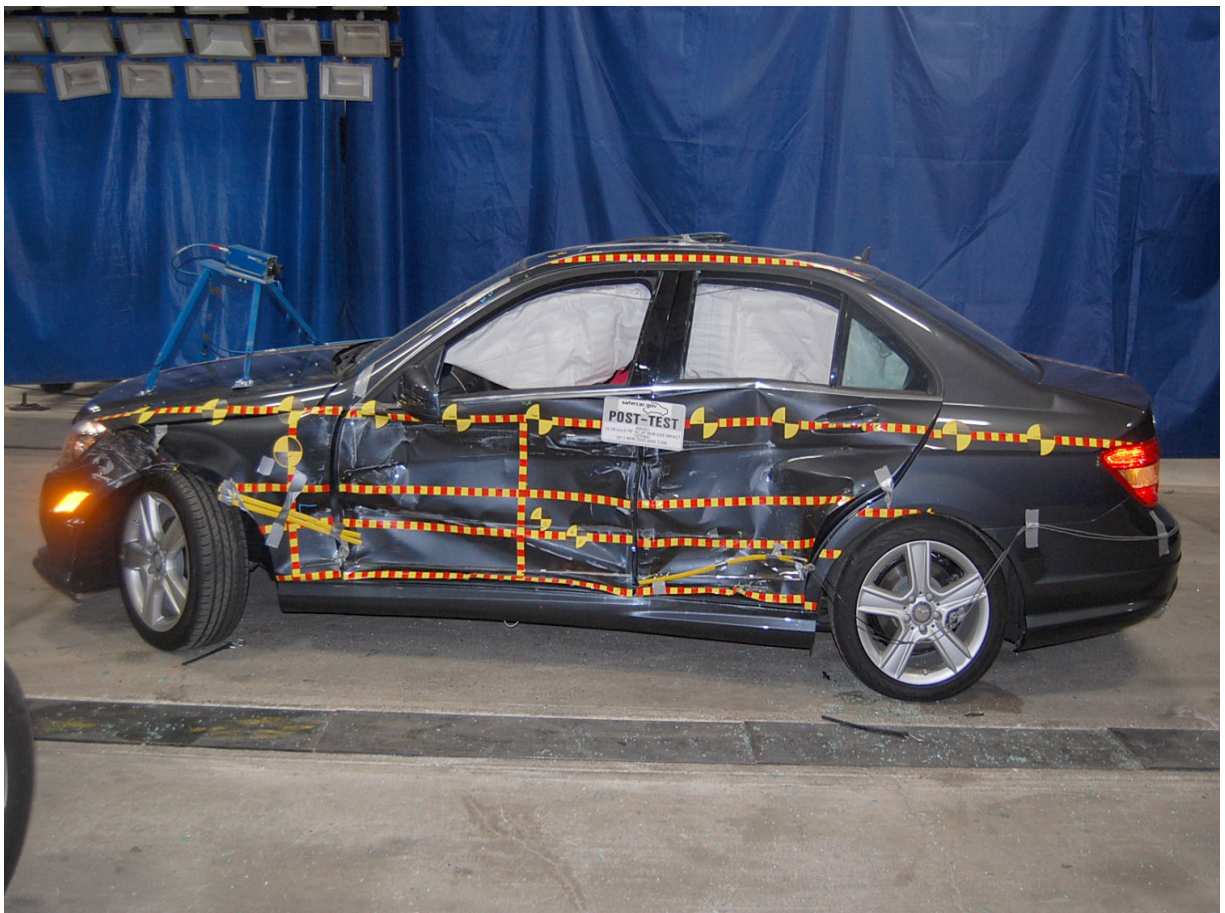
Post-Test Vehicle Left Side View

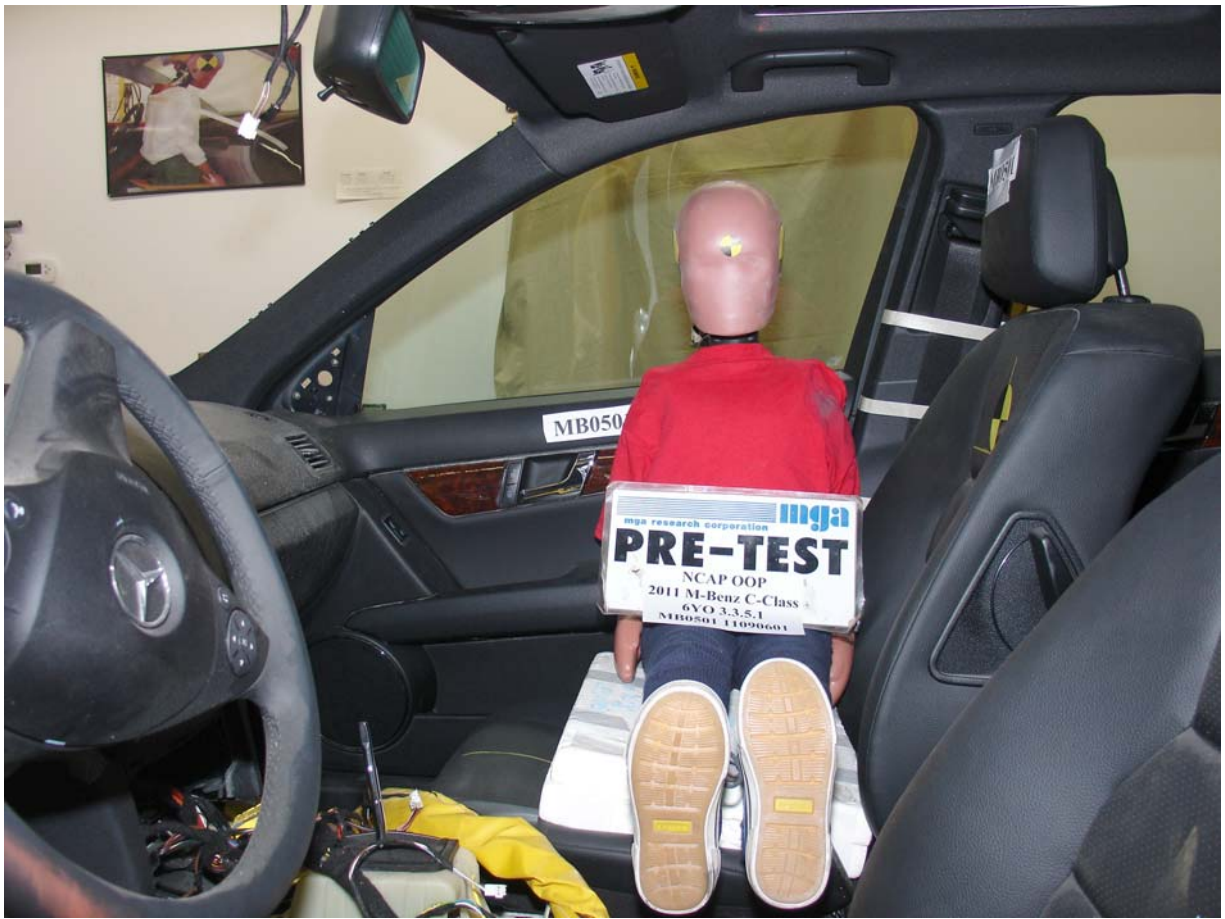
Pre-Test 6-Year-Old Child Dummy Left Side View

The Hybrid III 6-Year-Old child dummy was placed in the right front passenger seat along the outboard edge of the foam block, facing inboard with its legs extended and arms hanging at its sides. The seat track was positioned forward to minimize the cushion to head interaction. The dummy's pelvis was slid outboard until the dummy's back contacted the door trim panel or armrest and the center of gravity of the head was centered in the deployment trajectory of the airbag. The head remained in its neutral orientation. A vertical plane through the centerline of the dummy's shoulder bolts was parallel to the vehicle centerline. The dummy's arms were bent at the elbow until the fingertips contacted the foam block.

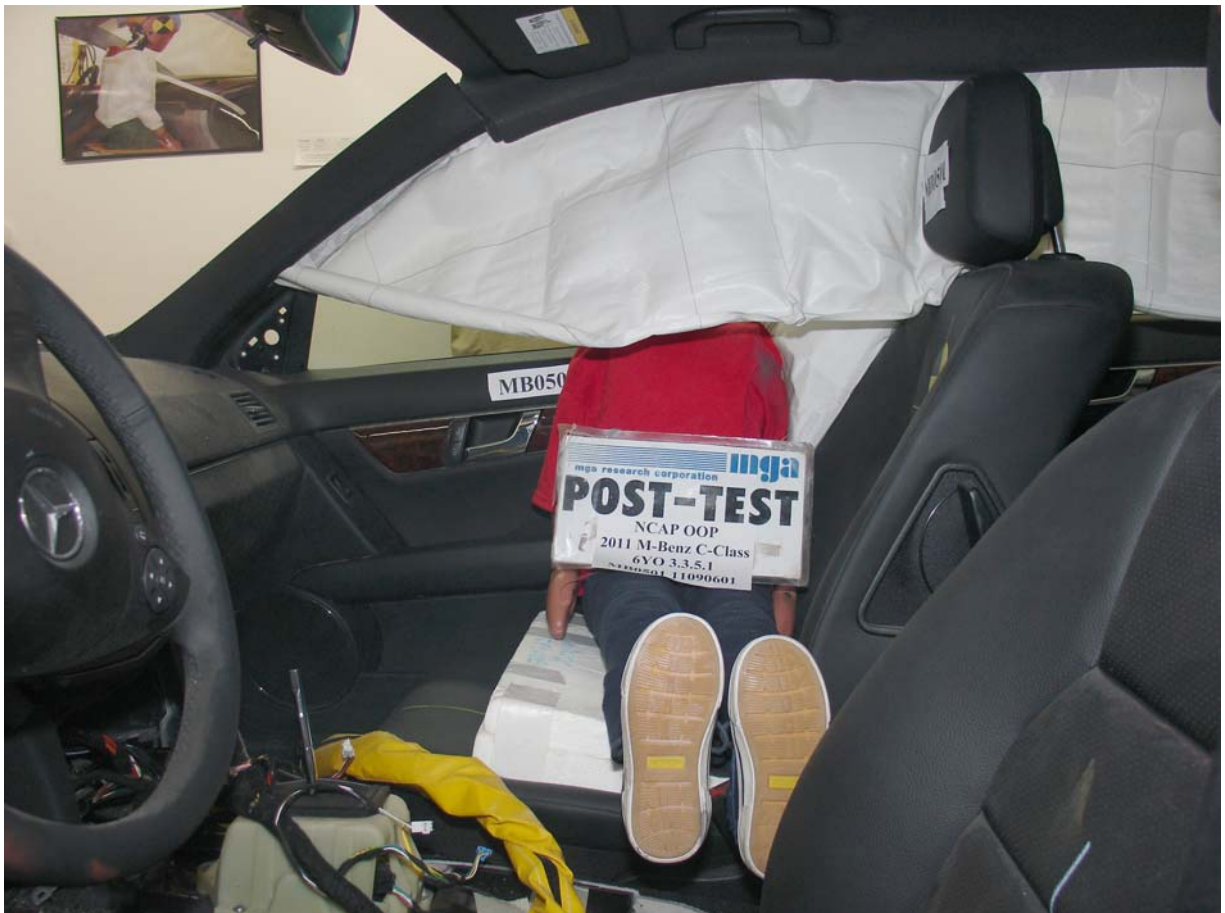
Post-Test 6-Year-Old Child Dummy Left Side View

- Curtain airbag to top and front of head
- Torso bag to left shoulder and left torso

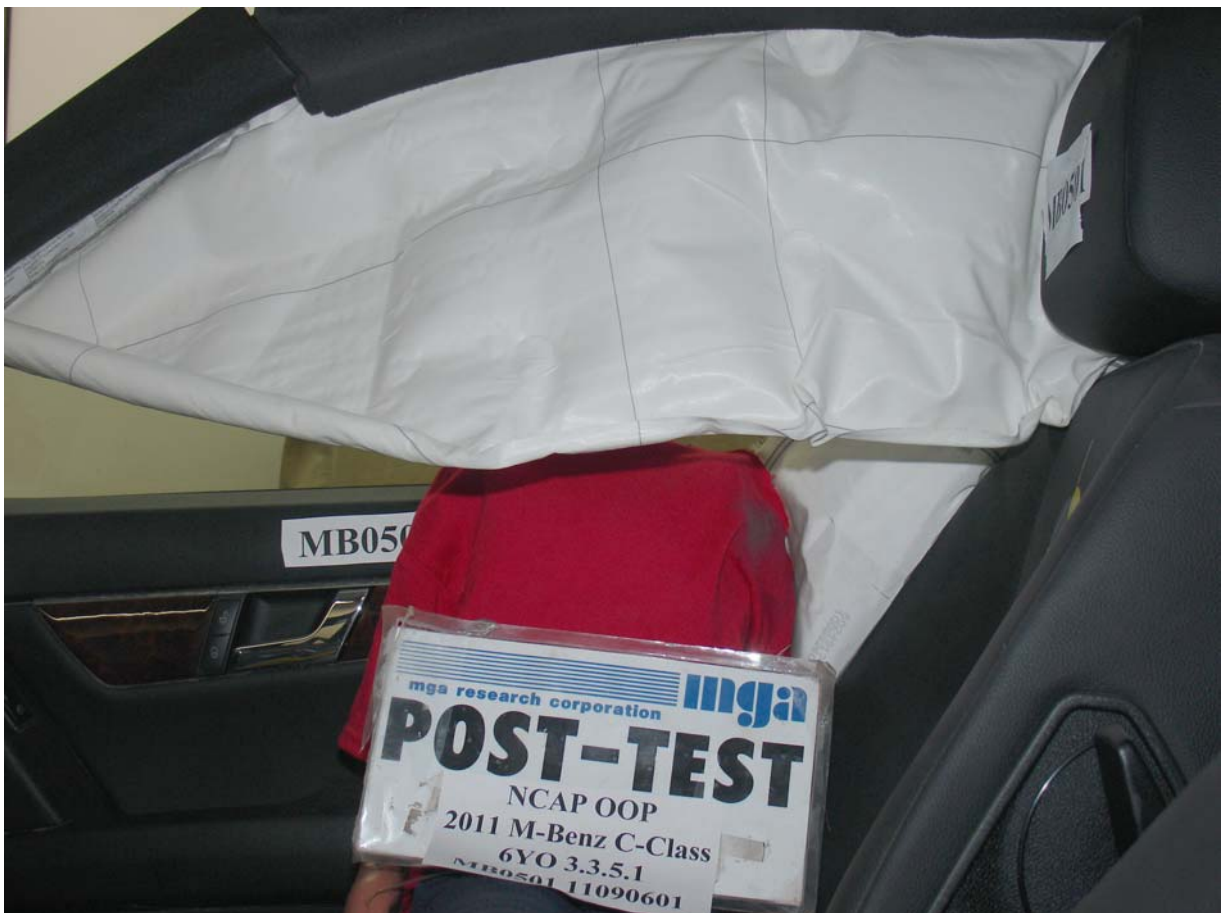
Post-Test 6-Year-Old Child Dummy Left Side Closeup View

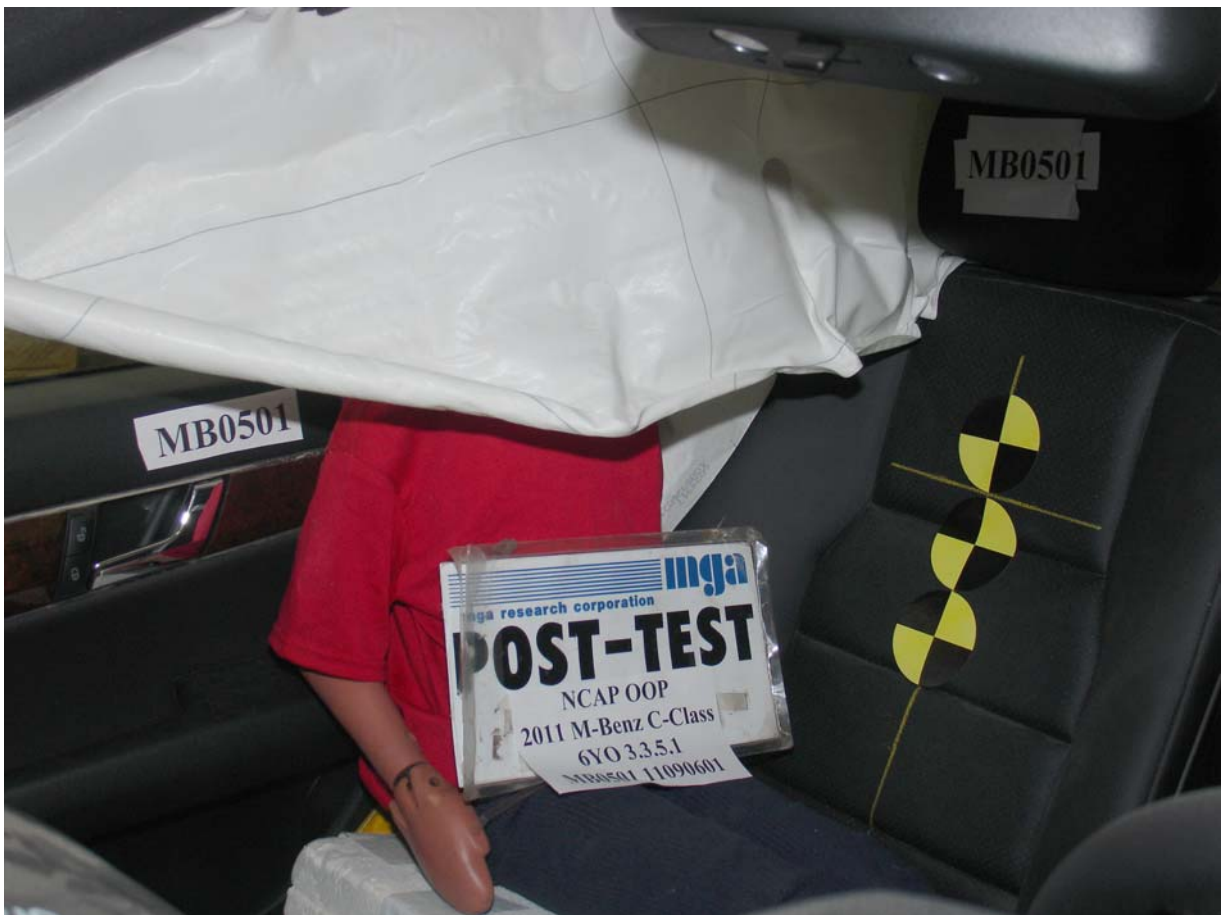
Post-Test 6-Year-Old Child Dummy Left $\frac{3}{4}$ Front View

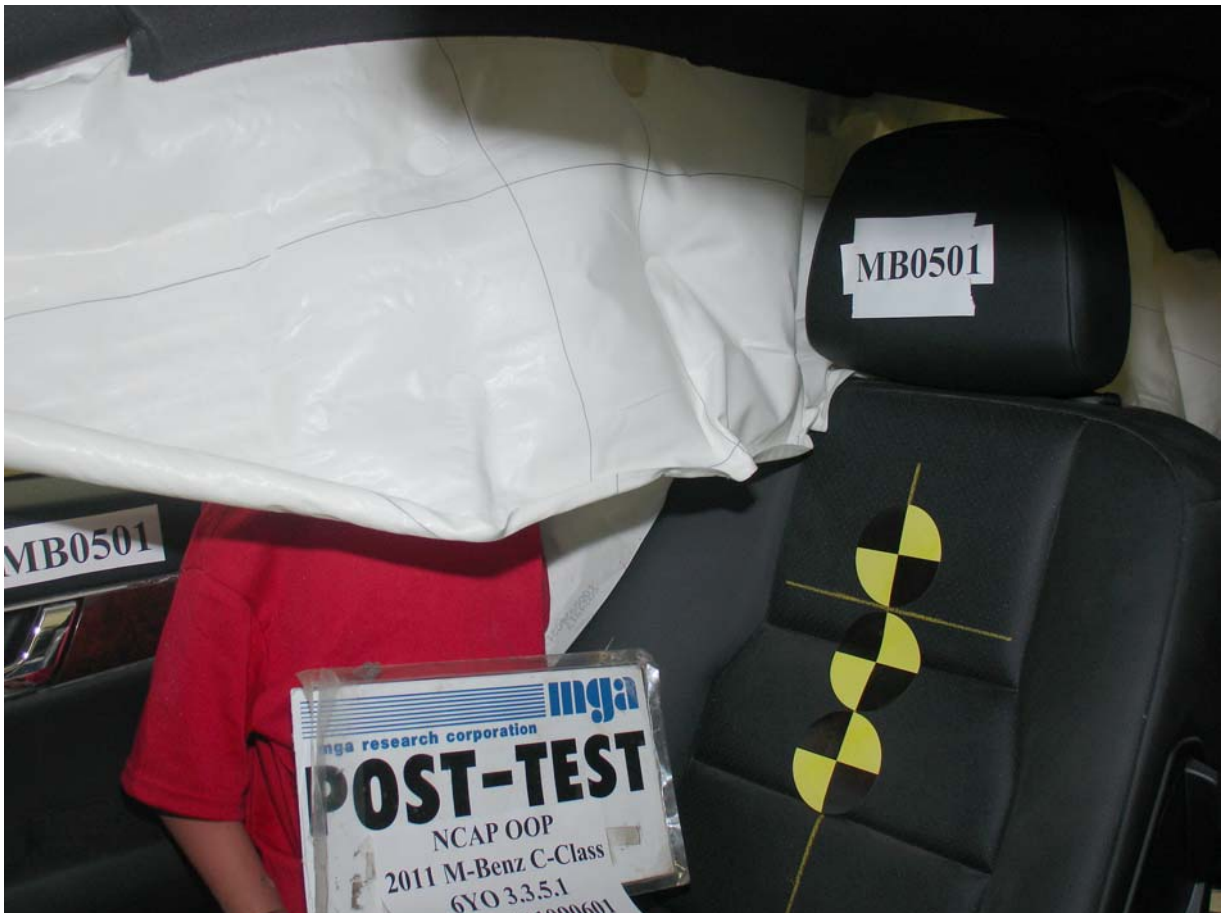
Post-Test 6-Year-Old Child Dummy Left $\frac{3}{4}$ Front Closeup View

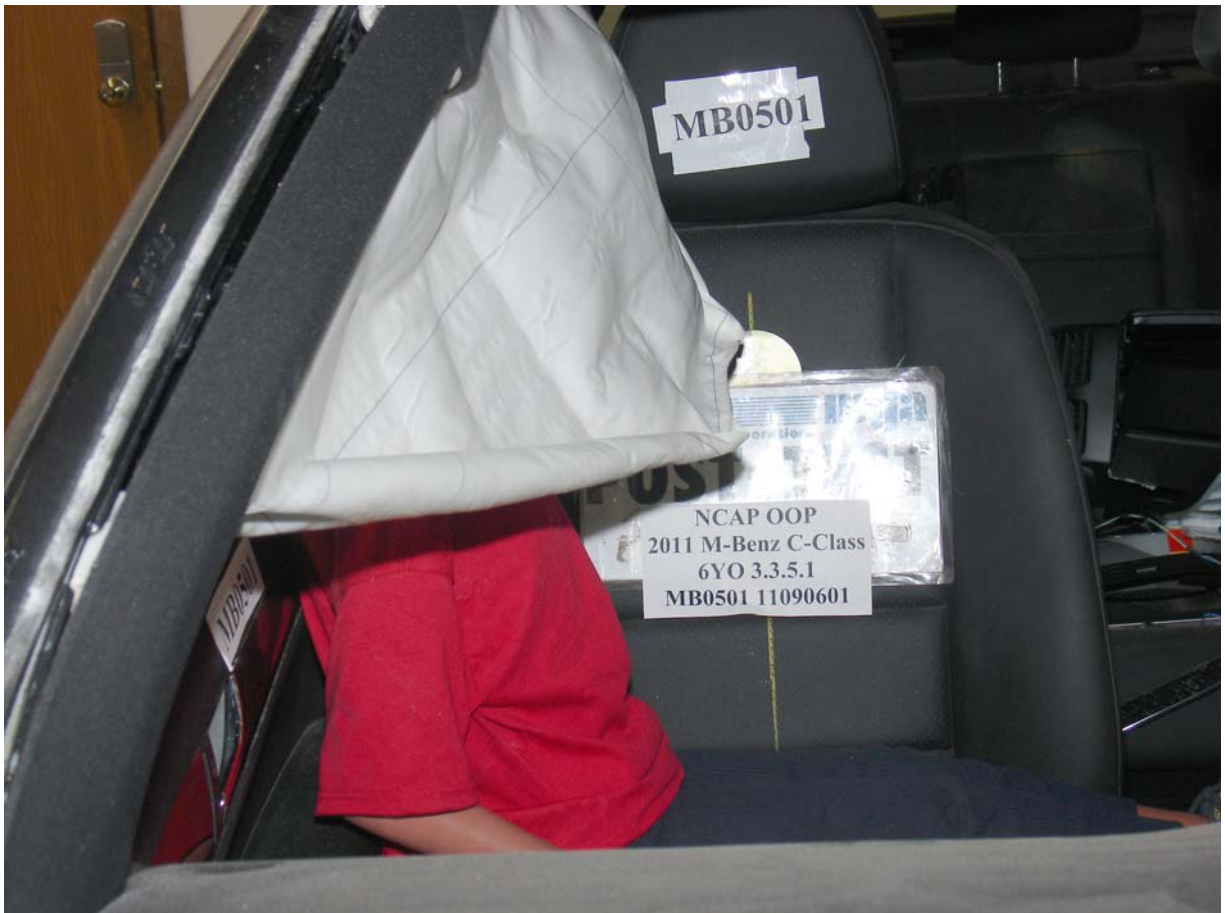
Post-Test 6-Year-Old Child Dummy Front View

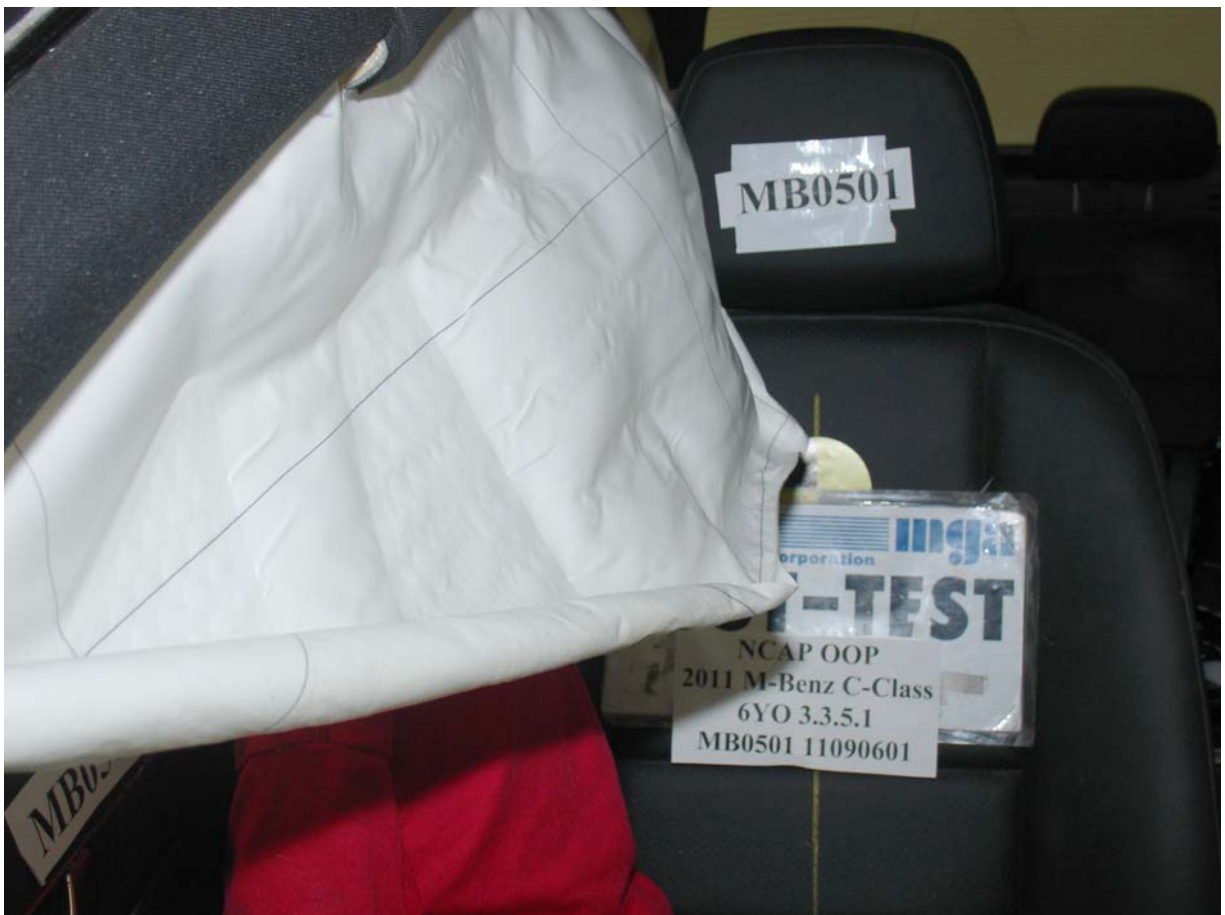
Post-Test 6-Year-Old Child Dummy Front Closeup View

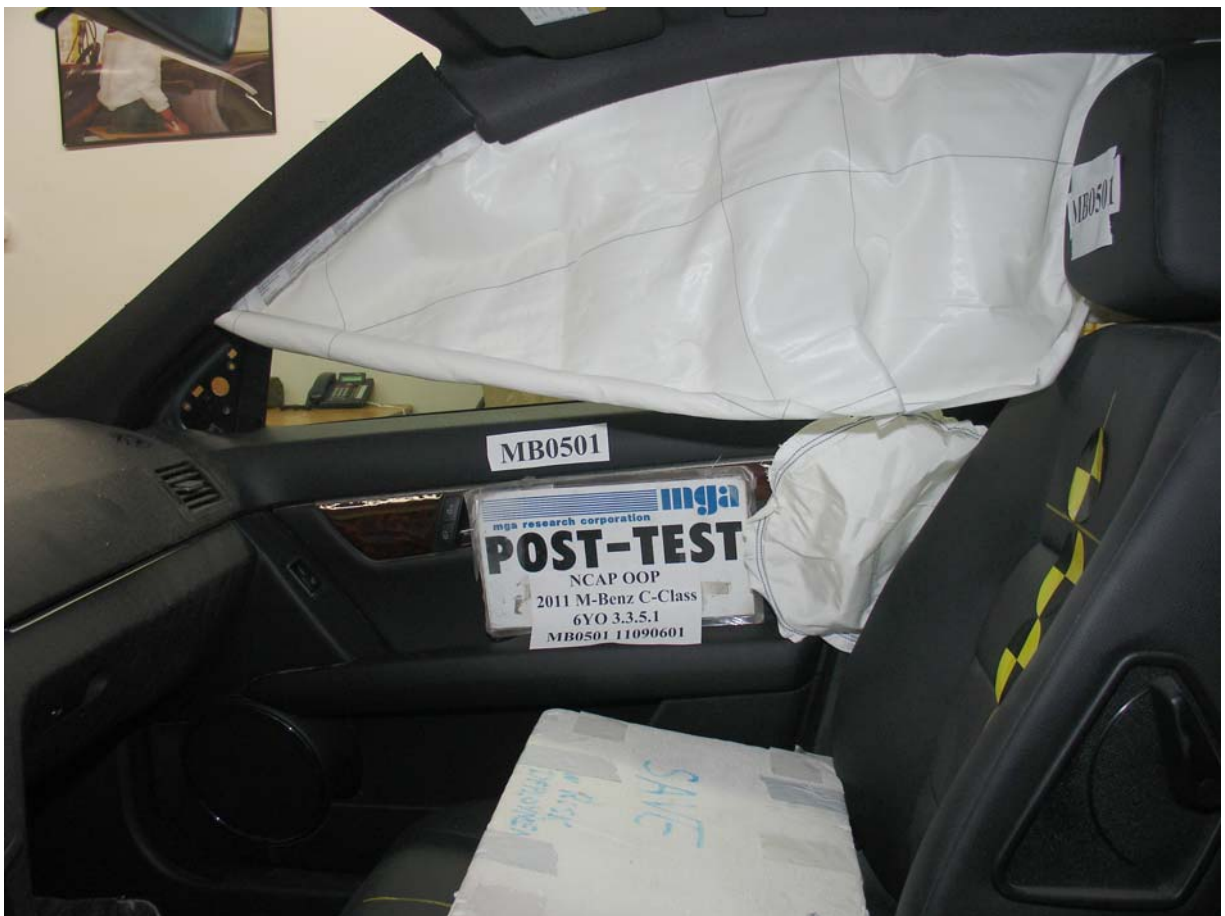
Post-Test Curtain Airbag Left Side View

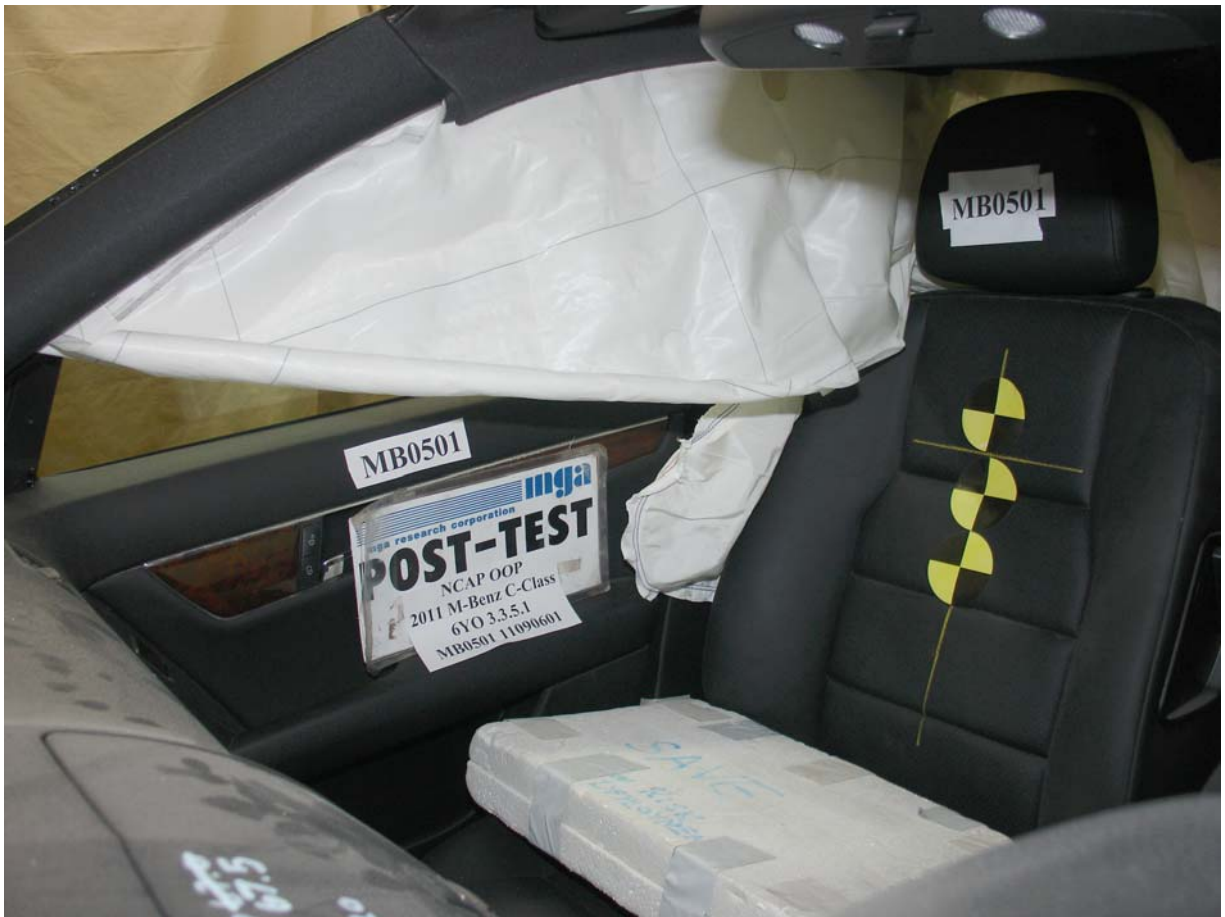
Post-Test Curtain Airbag Left 3/4 Front View

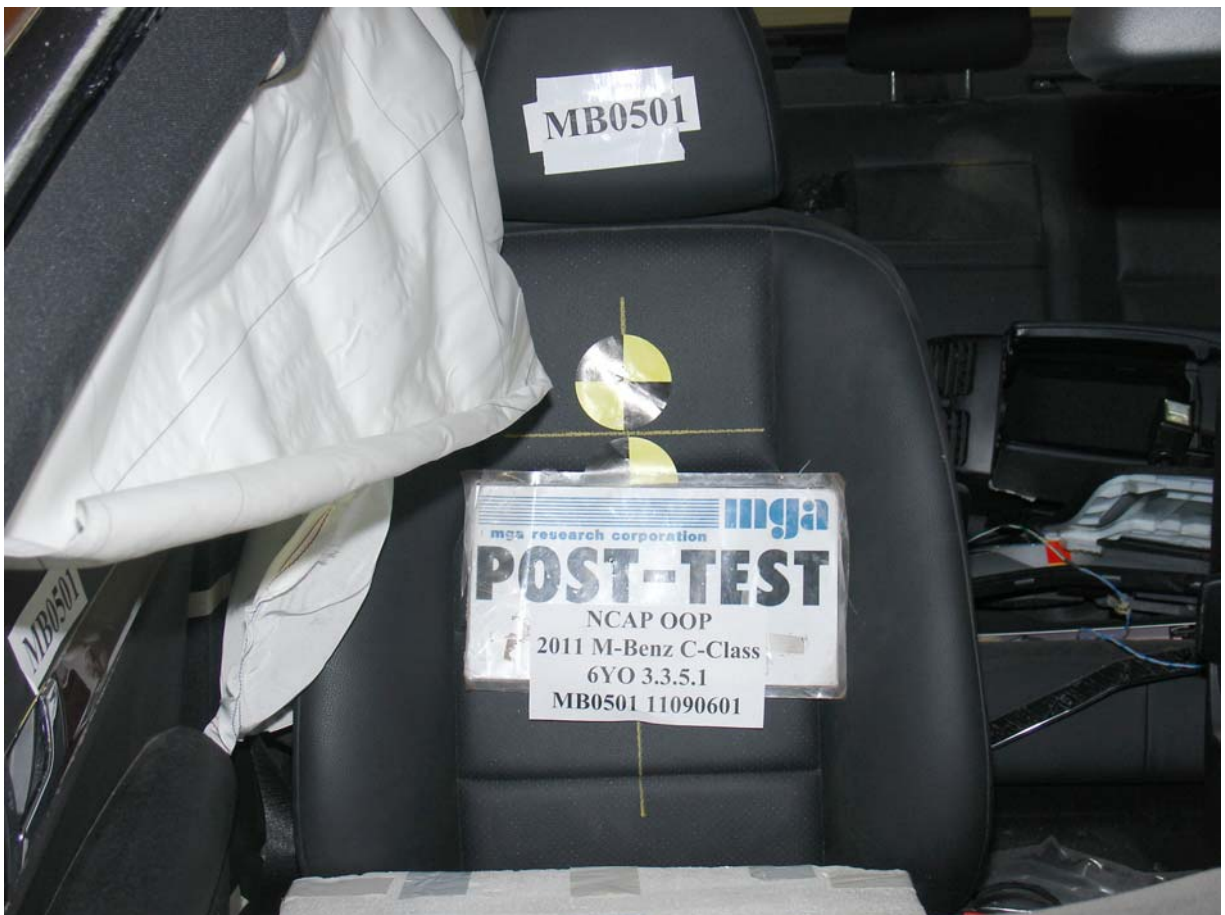
Post-Test Curtain Airbag Front View

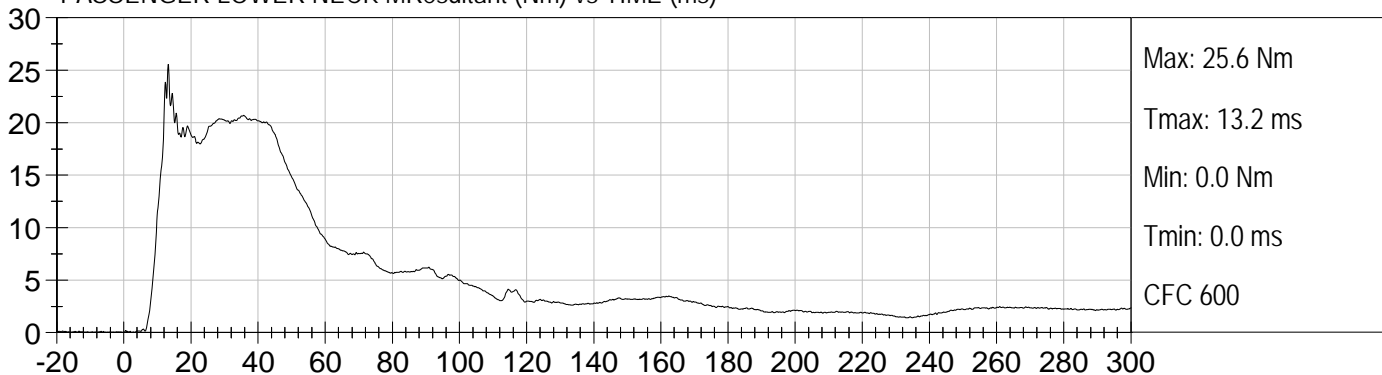
PASSENGER LOWER NECK MResultant (Nm) vs TIME (ms)
