**REPORT NUMBER: SPNCAP-MGA-2012-004**

**NEW CAR ASSESSMENT PROGRAM (NCAP)  
Side Impact Pole Test**

**CHRYSLER GROUP LLC  
2012 Chrysler Town & Country Minivan  
NHTSA No.: MC0302**

**FINAL REPORT**

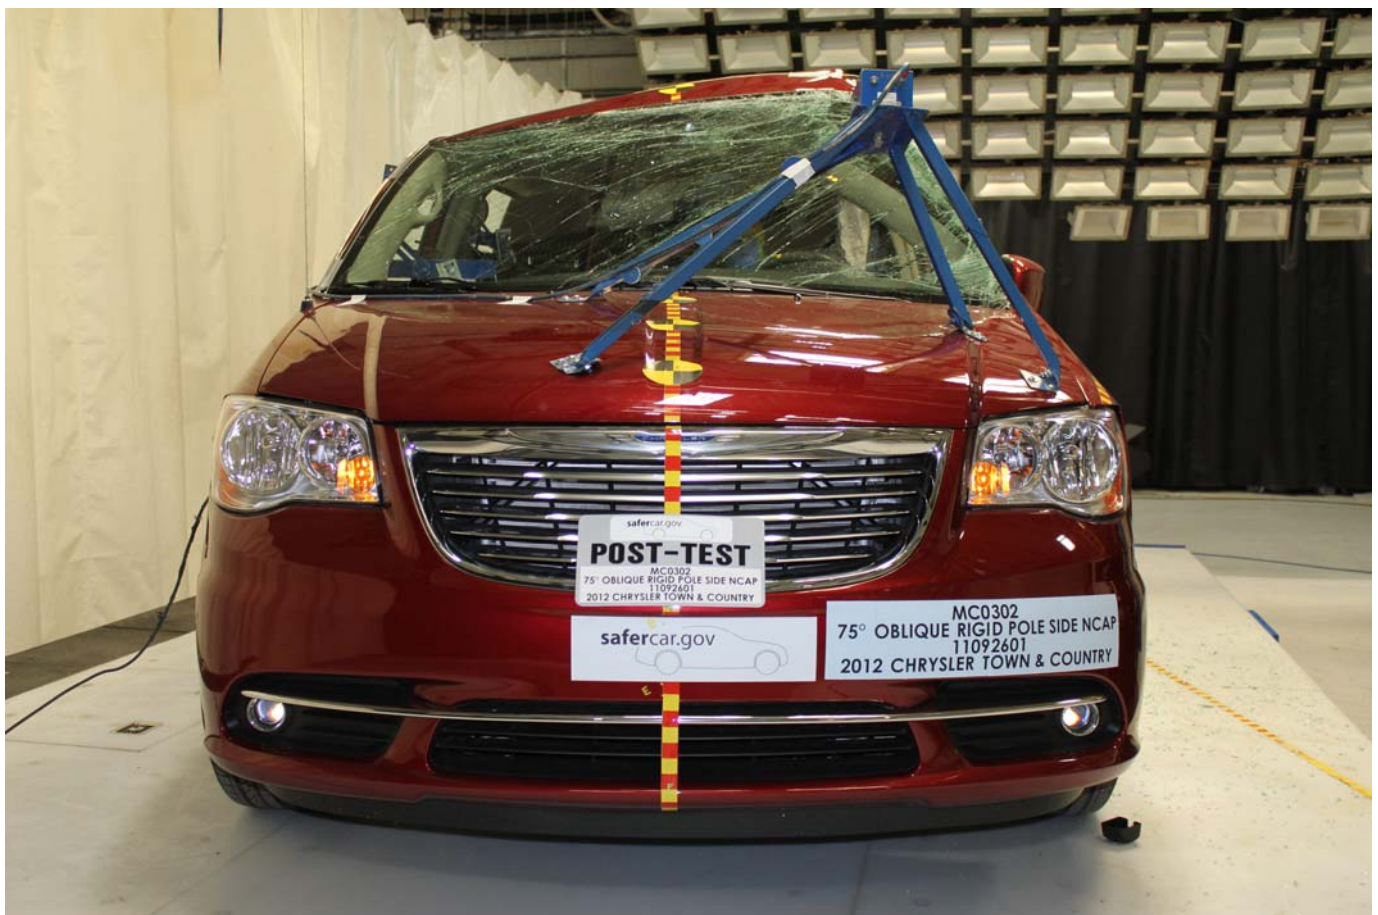
Post-Test Frontal View of Test Vehicle

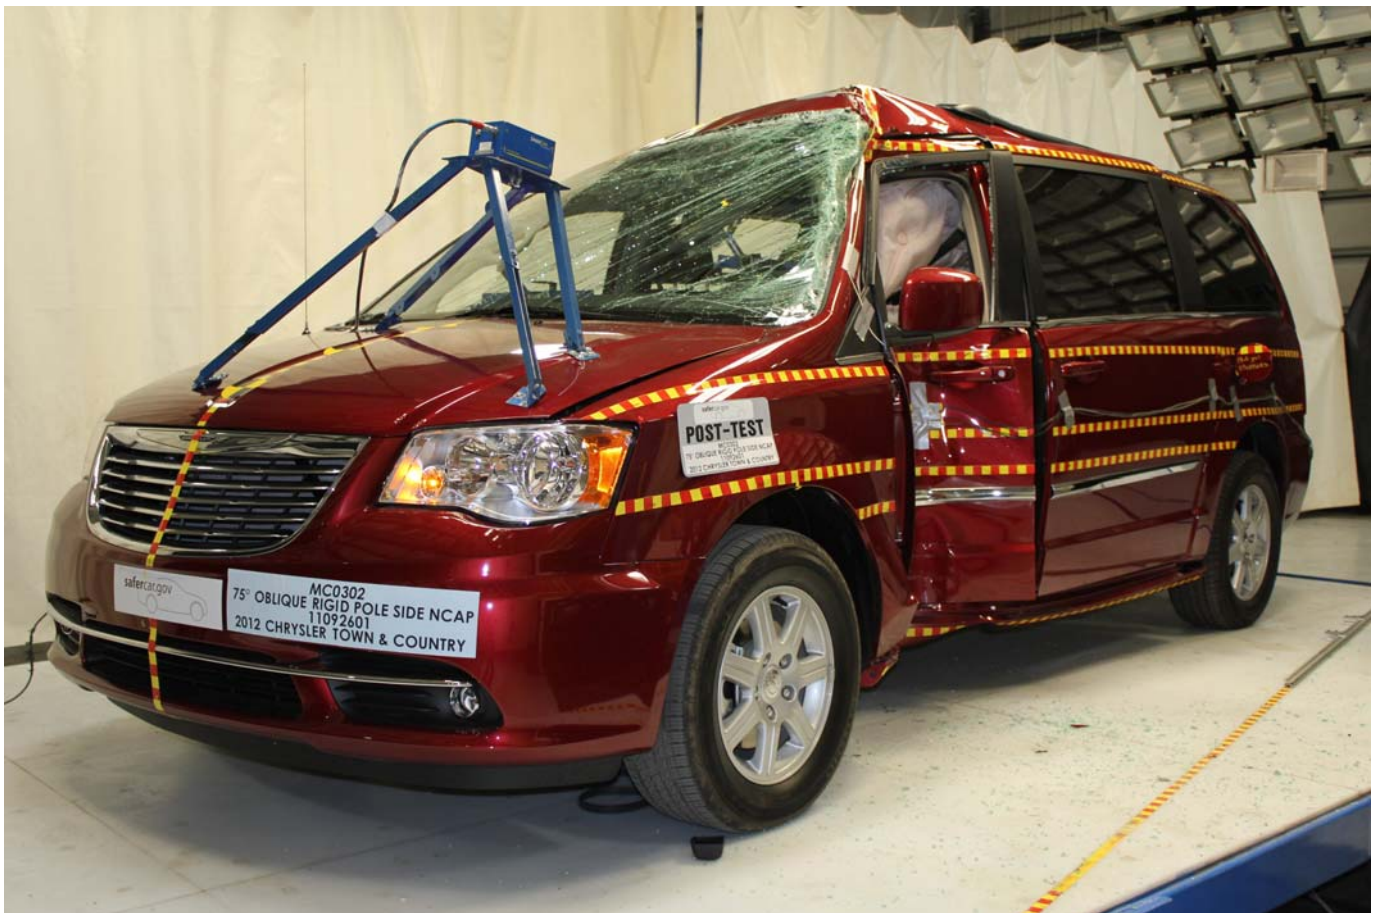
Post-Test Left Front  $\frac{3}{4}$  View of Test Vehicle

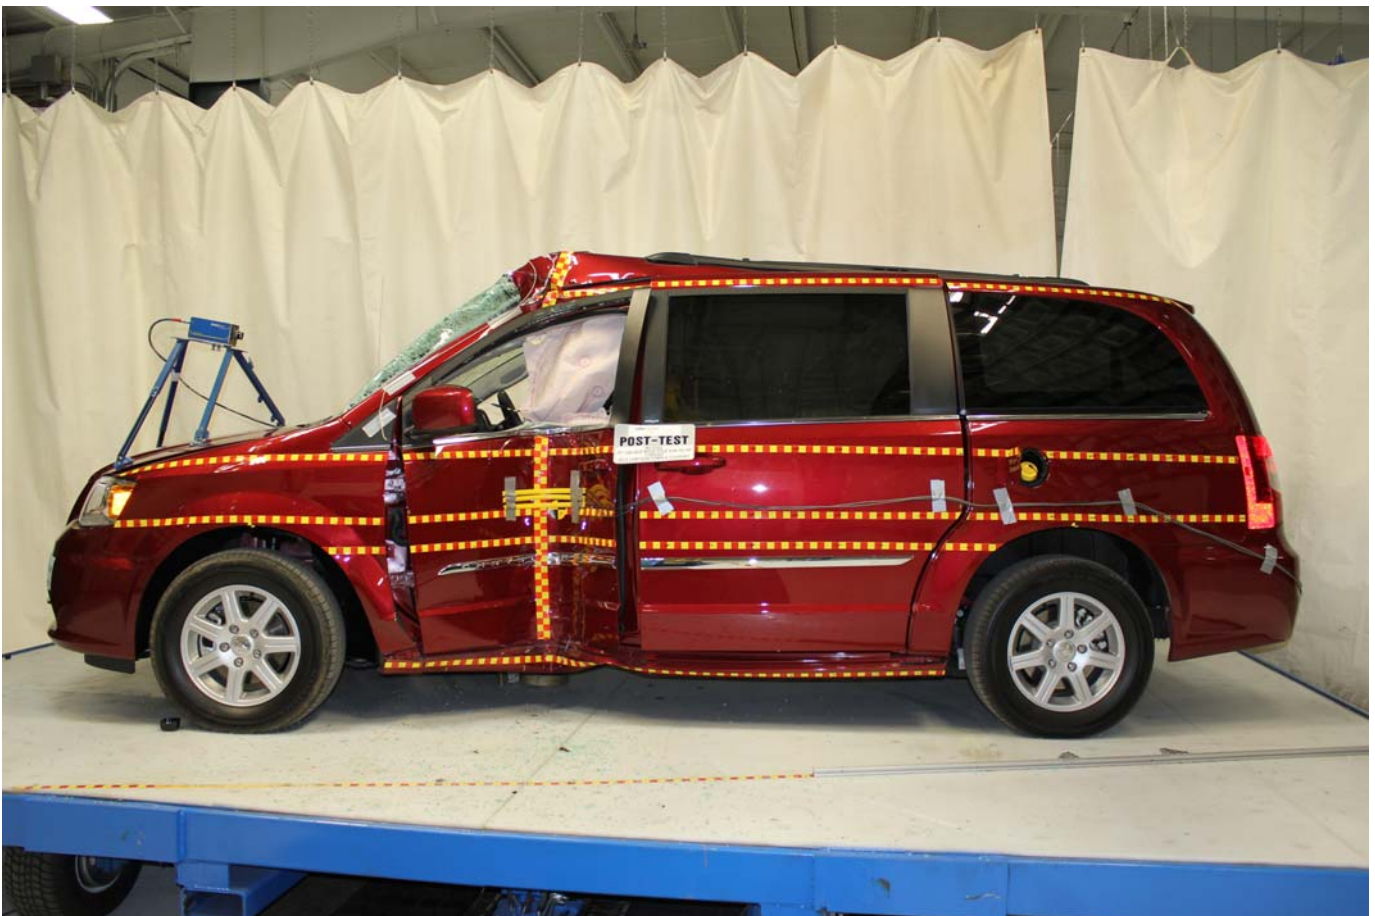
Post-Test Left Side View of Test Vehicle

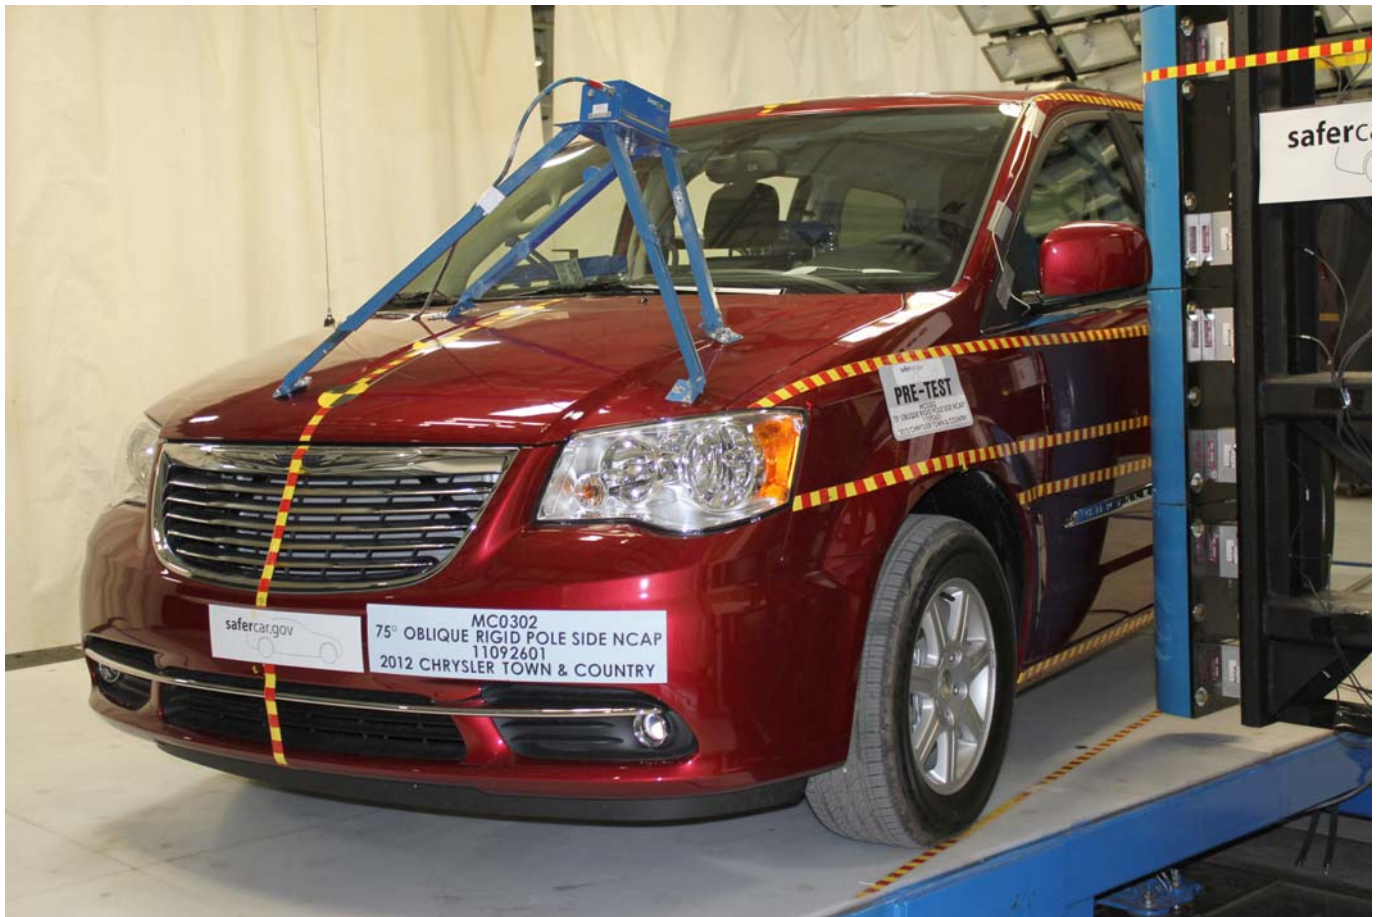
Pre-Test Left Side View of Pole Positioned Against Side of Vehicle

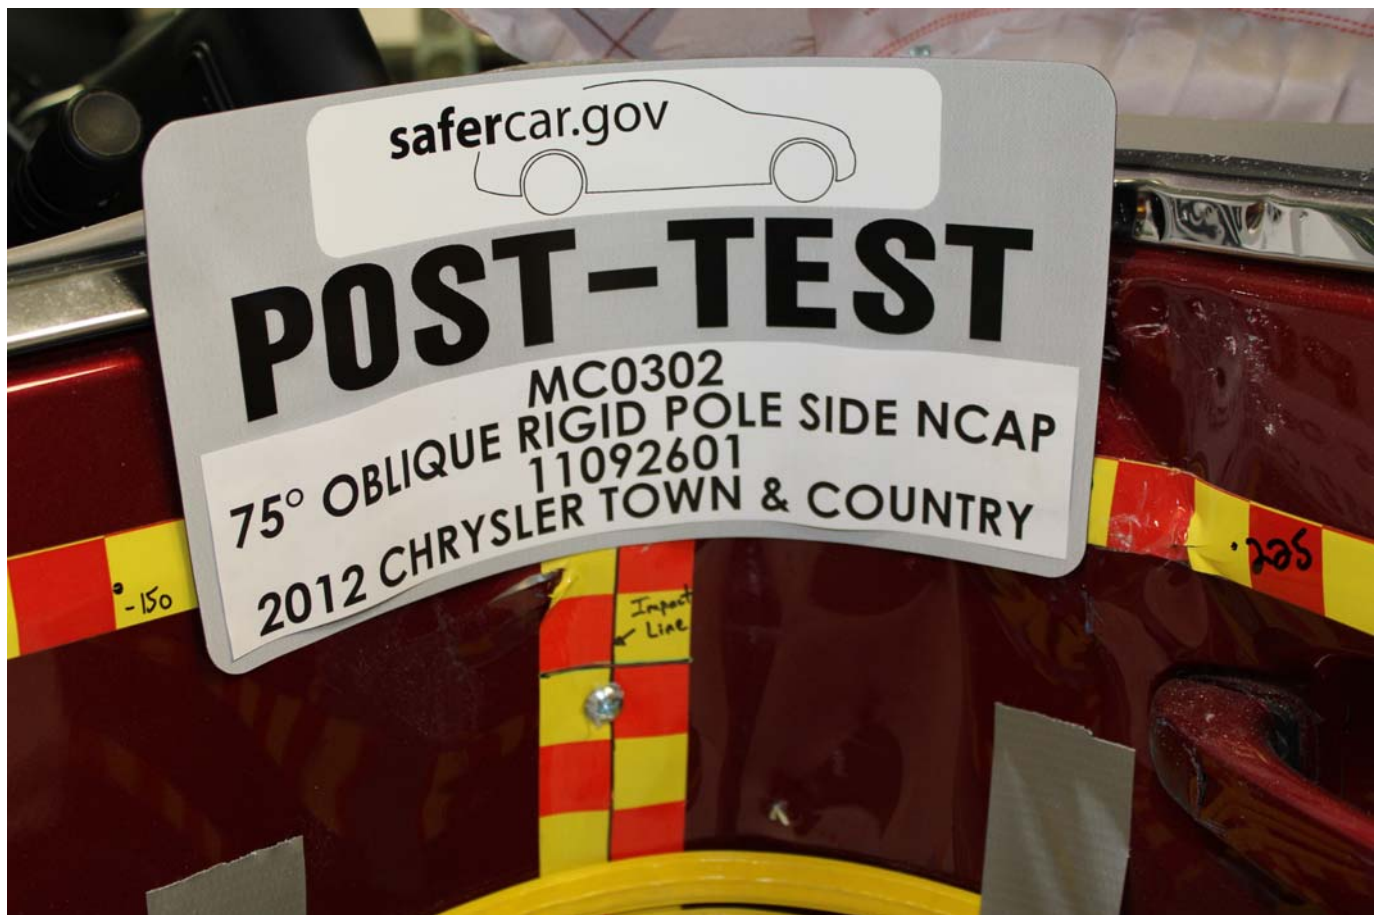
Post-Test Close-Up View of Impact Point Target Showing Impact Location

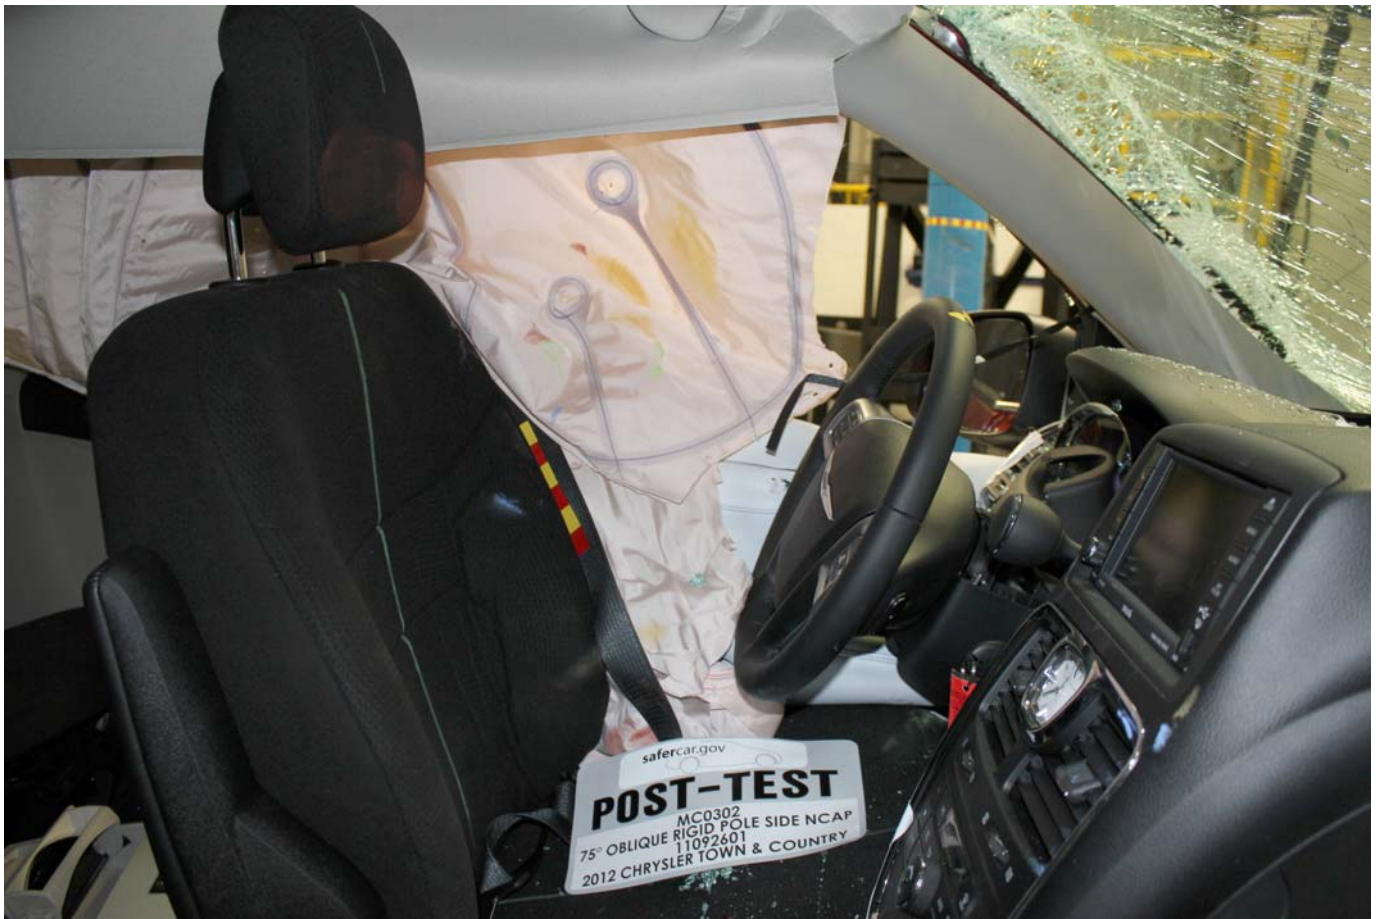
Post-Test Inner Door Panel View Showing Dummy Contact Location

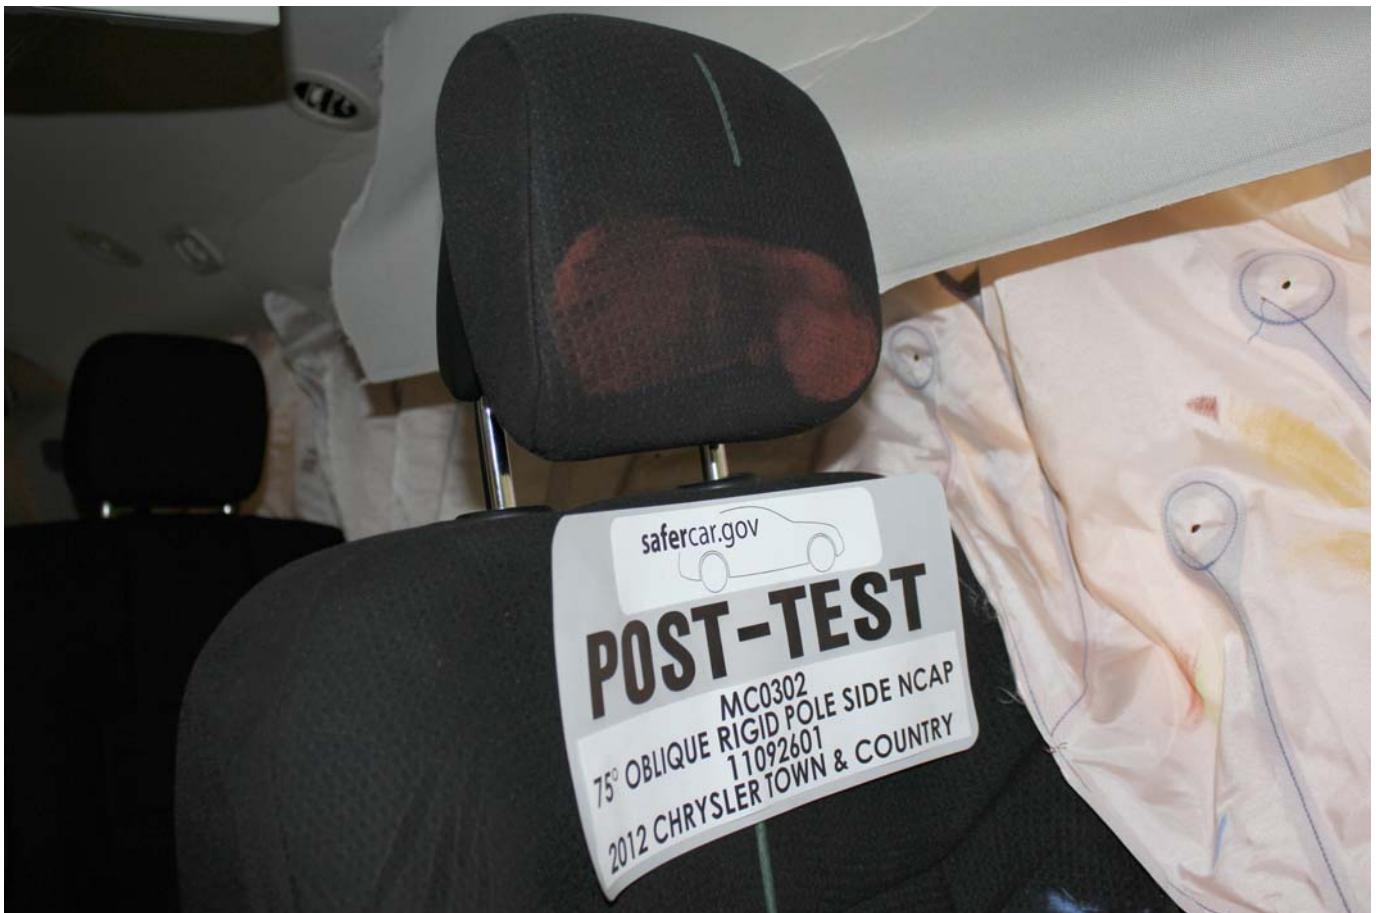
Post-Test Dummy Close-Up Head Contact with Vehicle Interior View

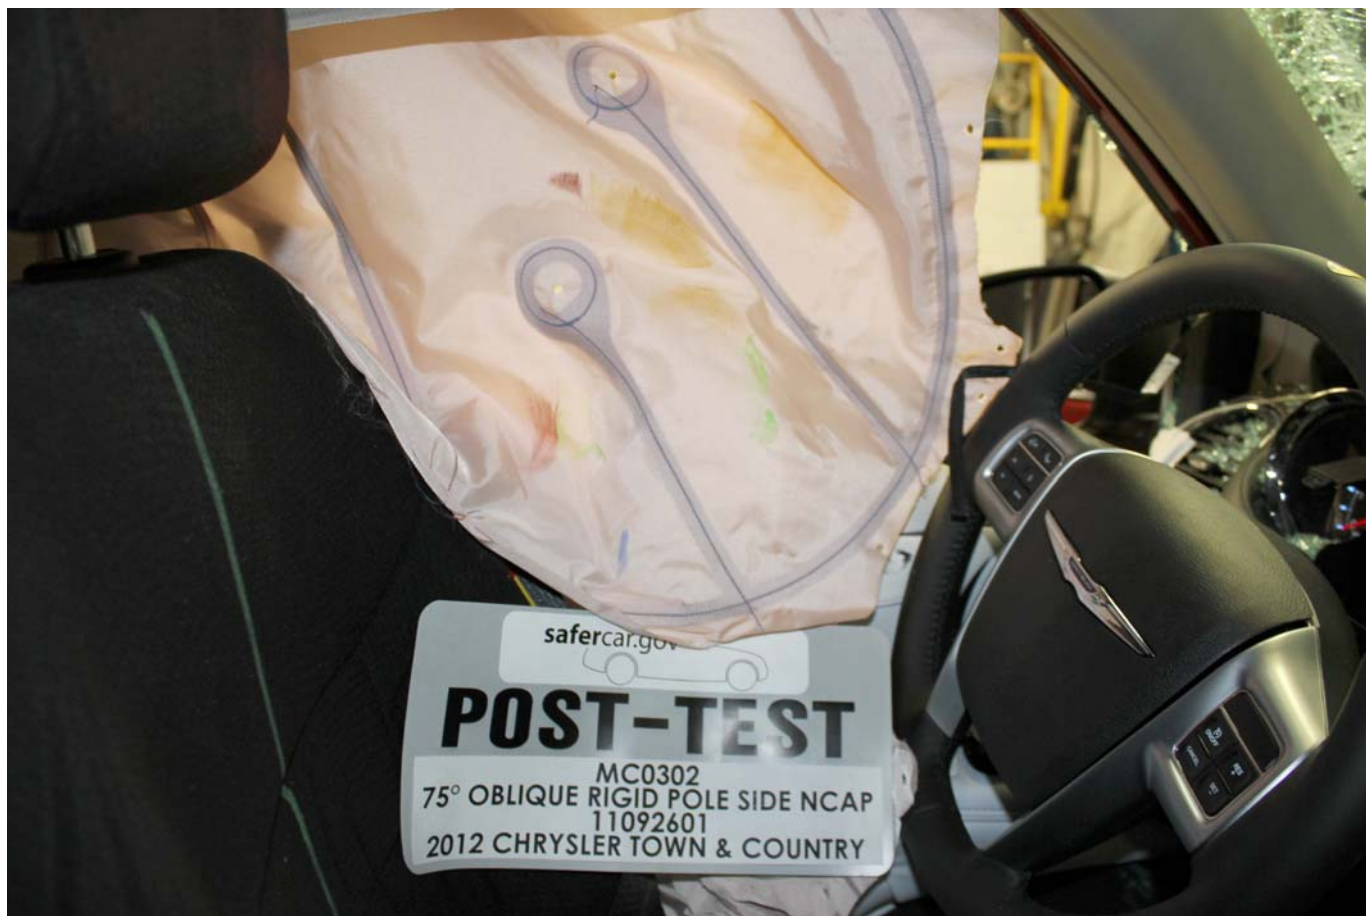
Post-Test Dummy Close-Up Head Contact with Side Air Bag View

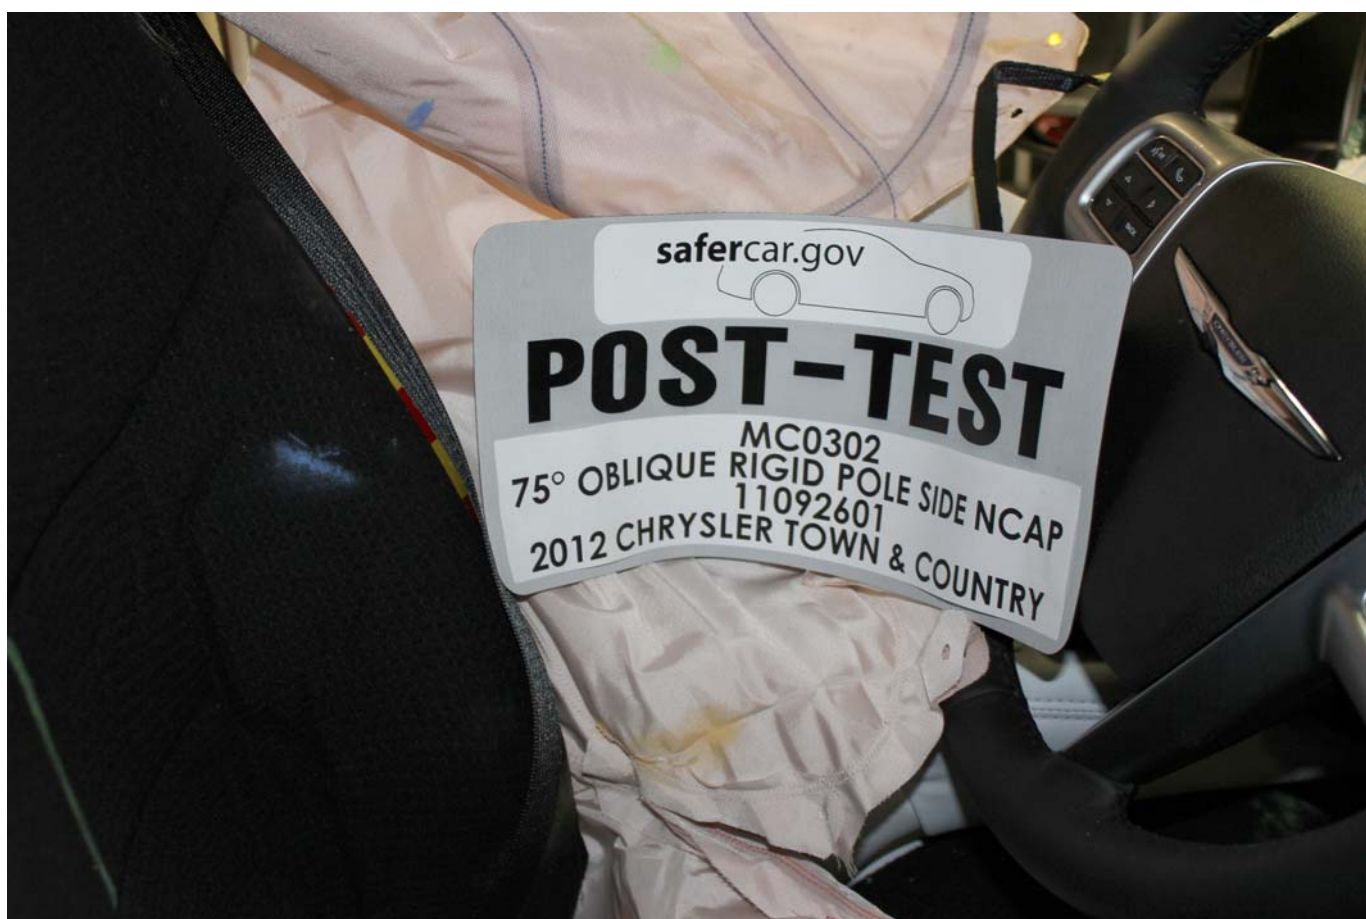
Post-Test Dummy Close-Up Torso Contact with Vehicle Interior View

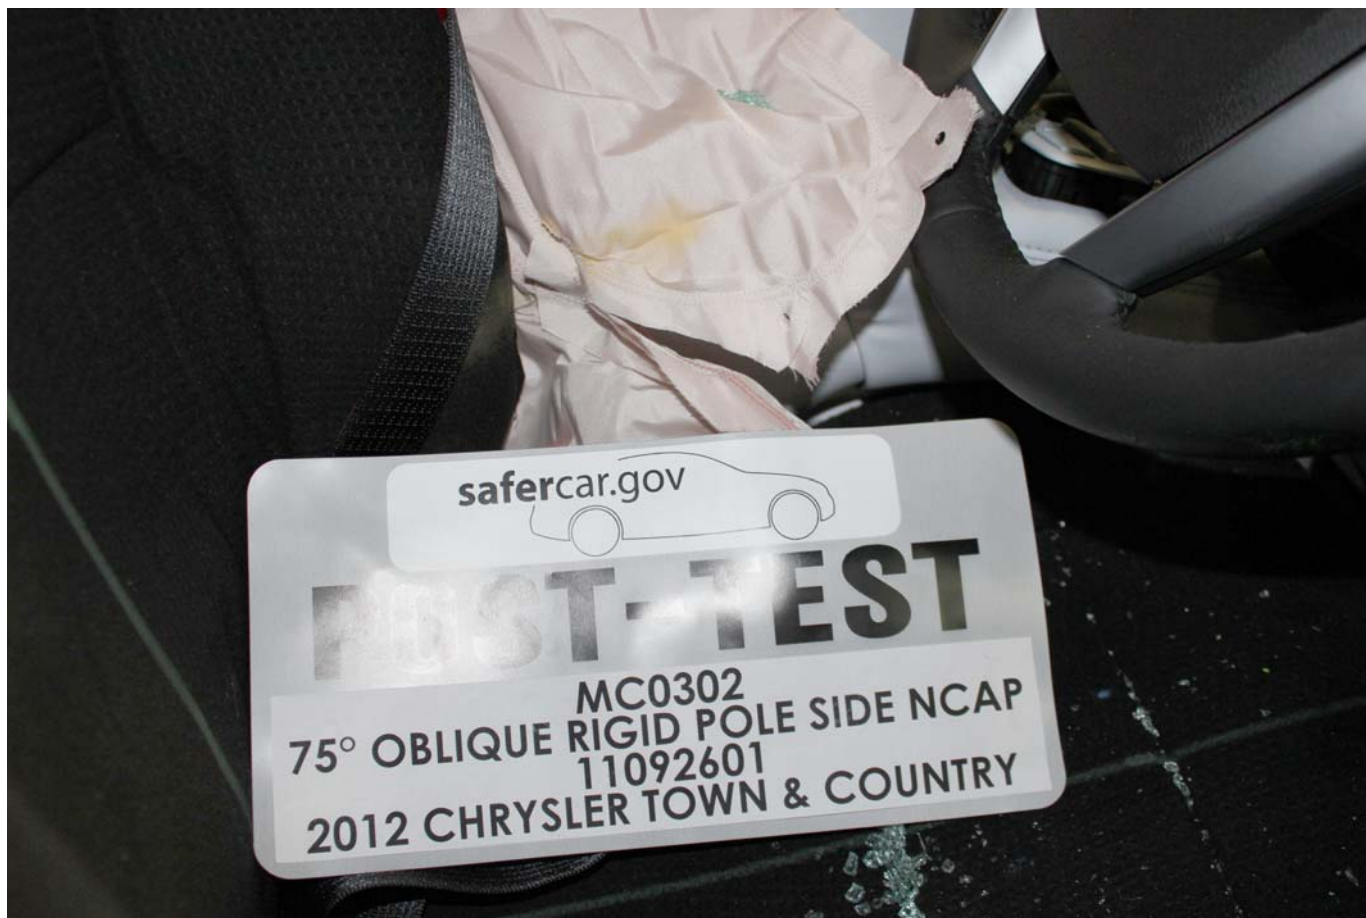
Post-Test Dummy Close-Up Torso Contact with Side Air Bag View

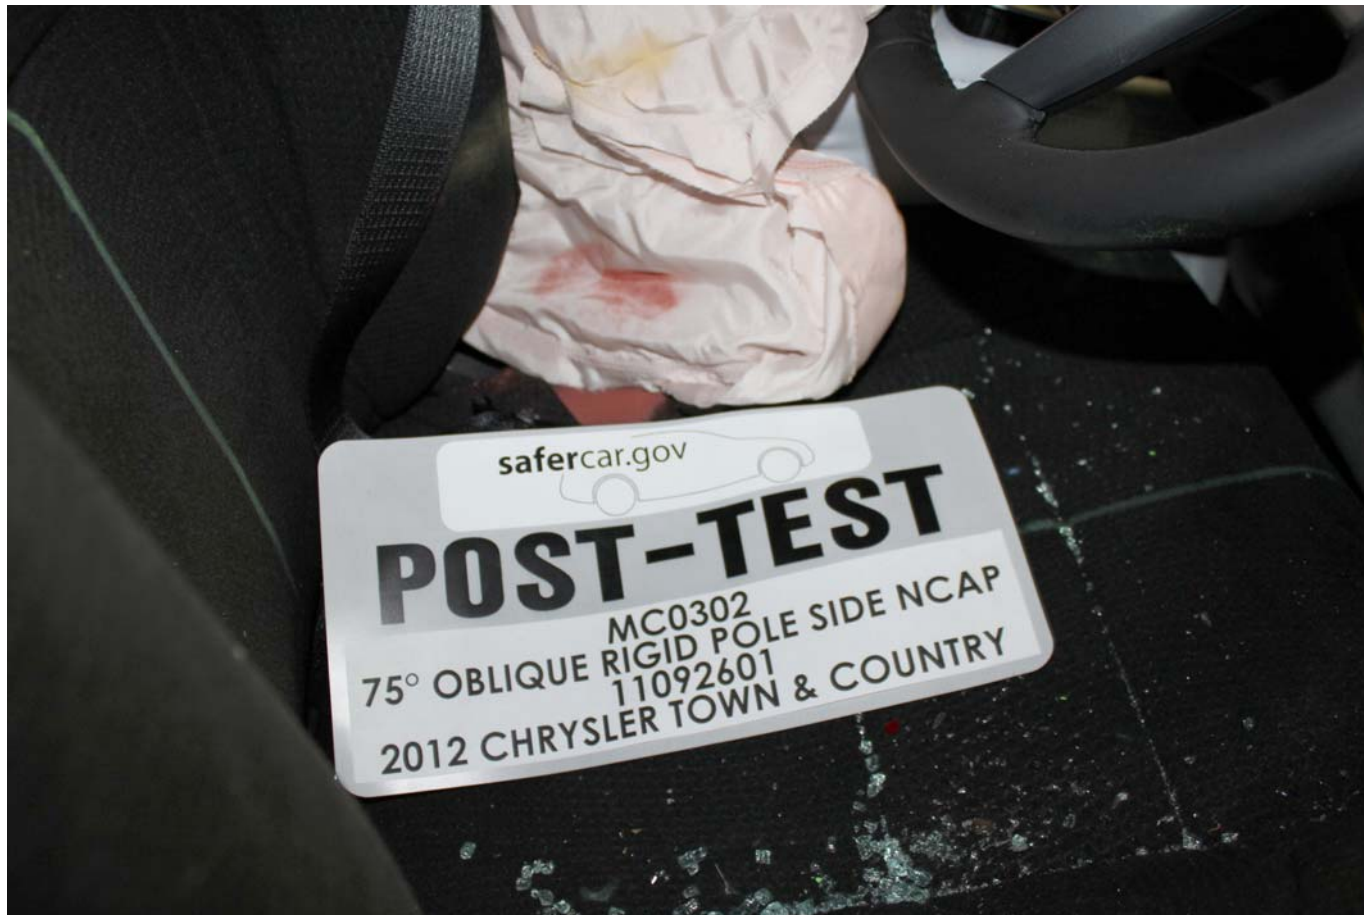
Post-Test Dummy Close-Up Pelvis Contact with Side Air Bag View

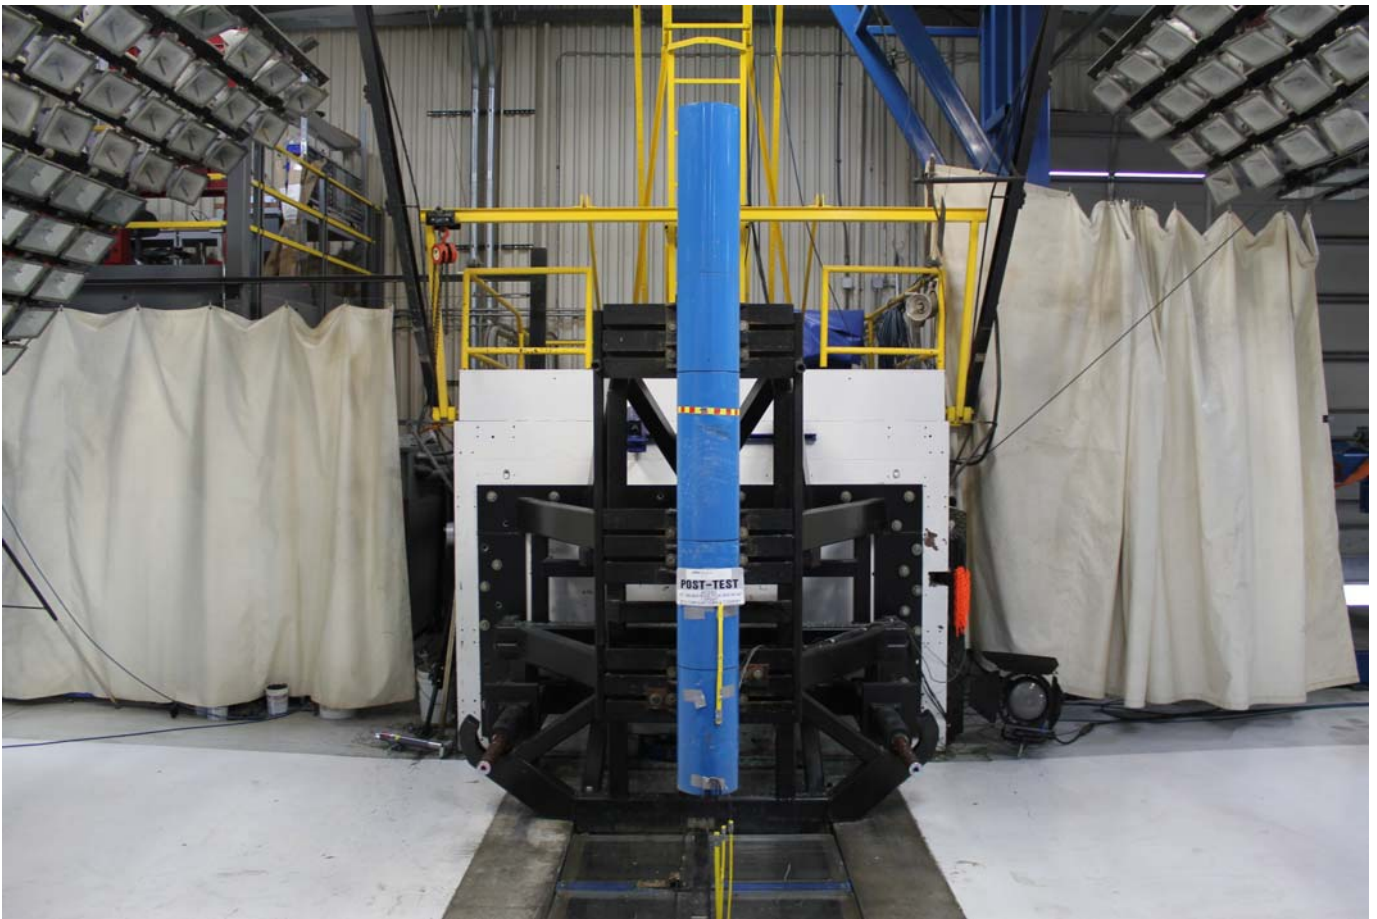
Post-Test Pole Barrier Front View
