**REPORT NUMBER: NCAP-MGA-2012-005**

**NEW CAR ASSESSMENT PROGRAM (NCAP)  
Frontal Barrier Impact Test**

**CHRYSLER GROUP LLC  
2012 Chrysler Town & Country Minivan  
NHTSA No.: MC0300**

**FINAL REPORT**

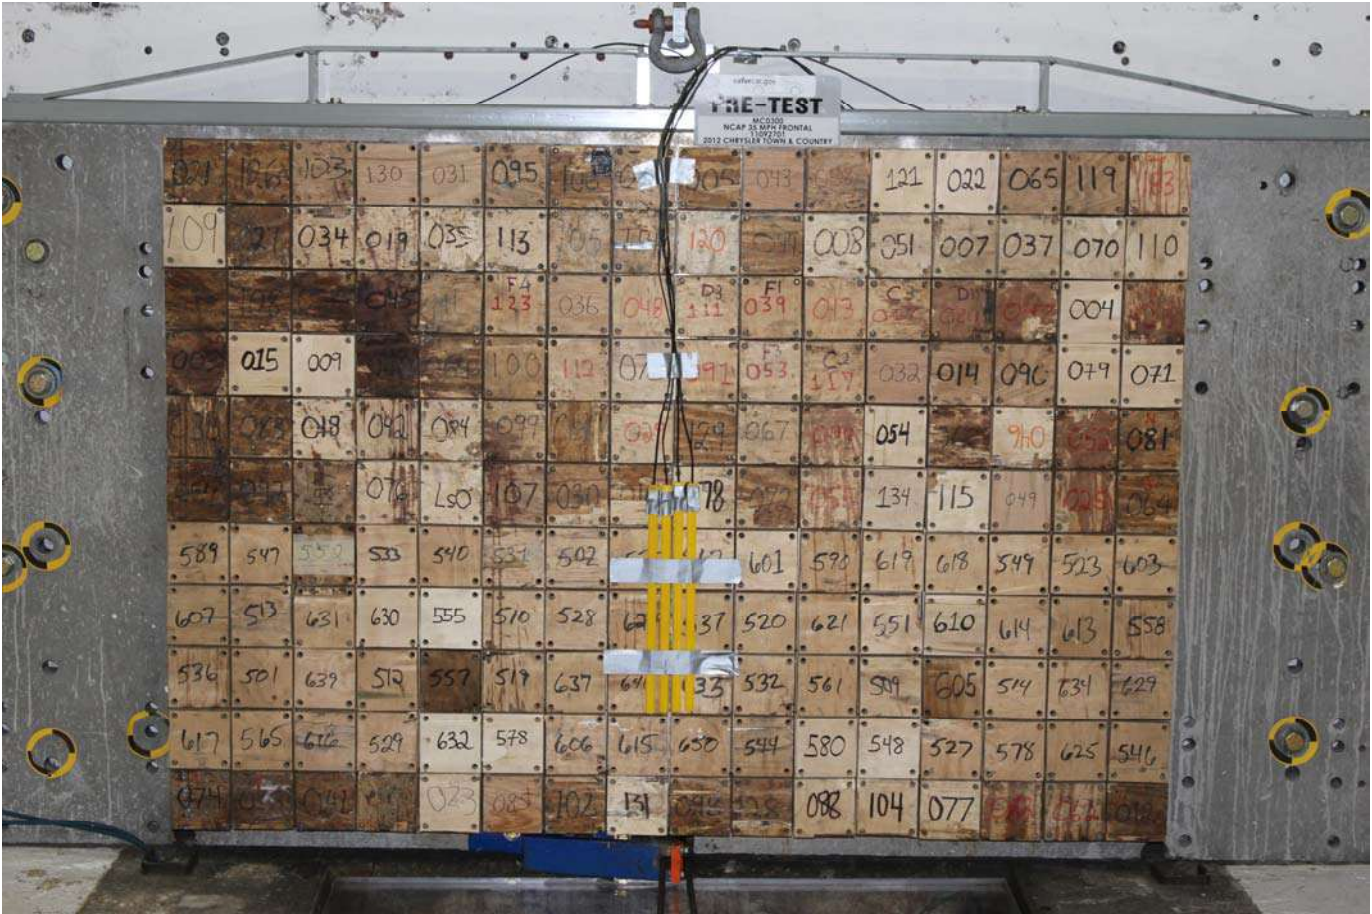
Load Cell Wall

A load cell barrier was impacted by a 2012 Chrysler Town & Country Minivan at a velocity of 56.4 kph. The test was performed at MGA Research Corporation on September 27, 2011. Pre- and post-test photographs of the vehicle and dummies can be found in Appendix A.

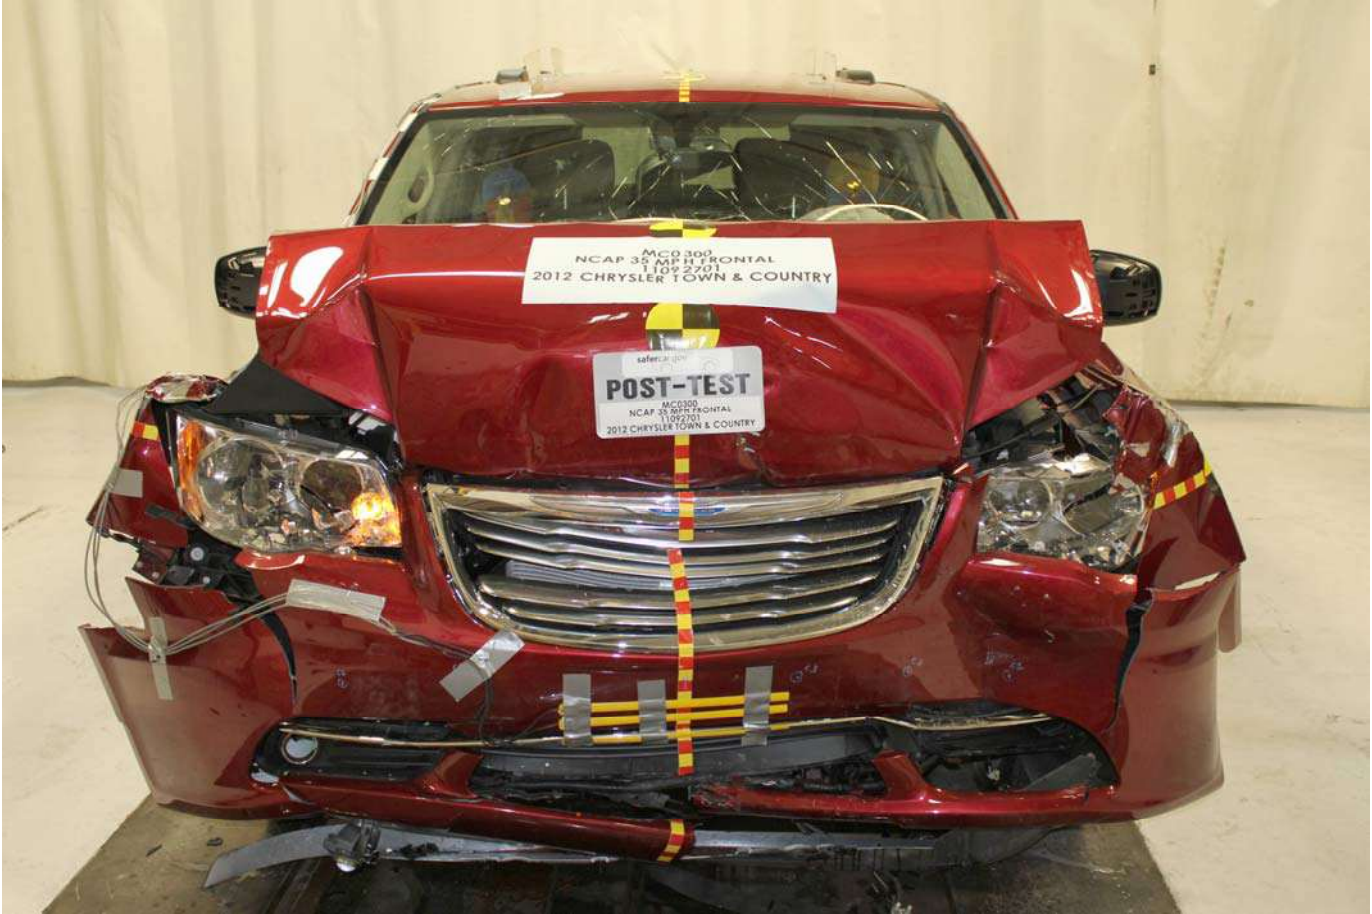
Post-Test Front View of Test Vehicle

The maximum static crush of the vehicle was 520 mm and both the driver and passenger side doors remained closed during the impact event and were operable after the impact.

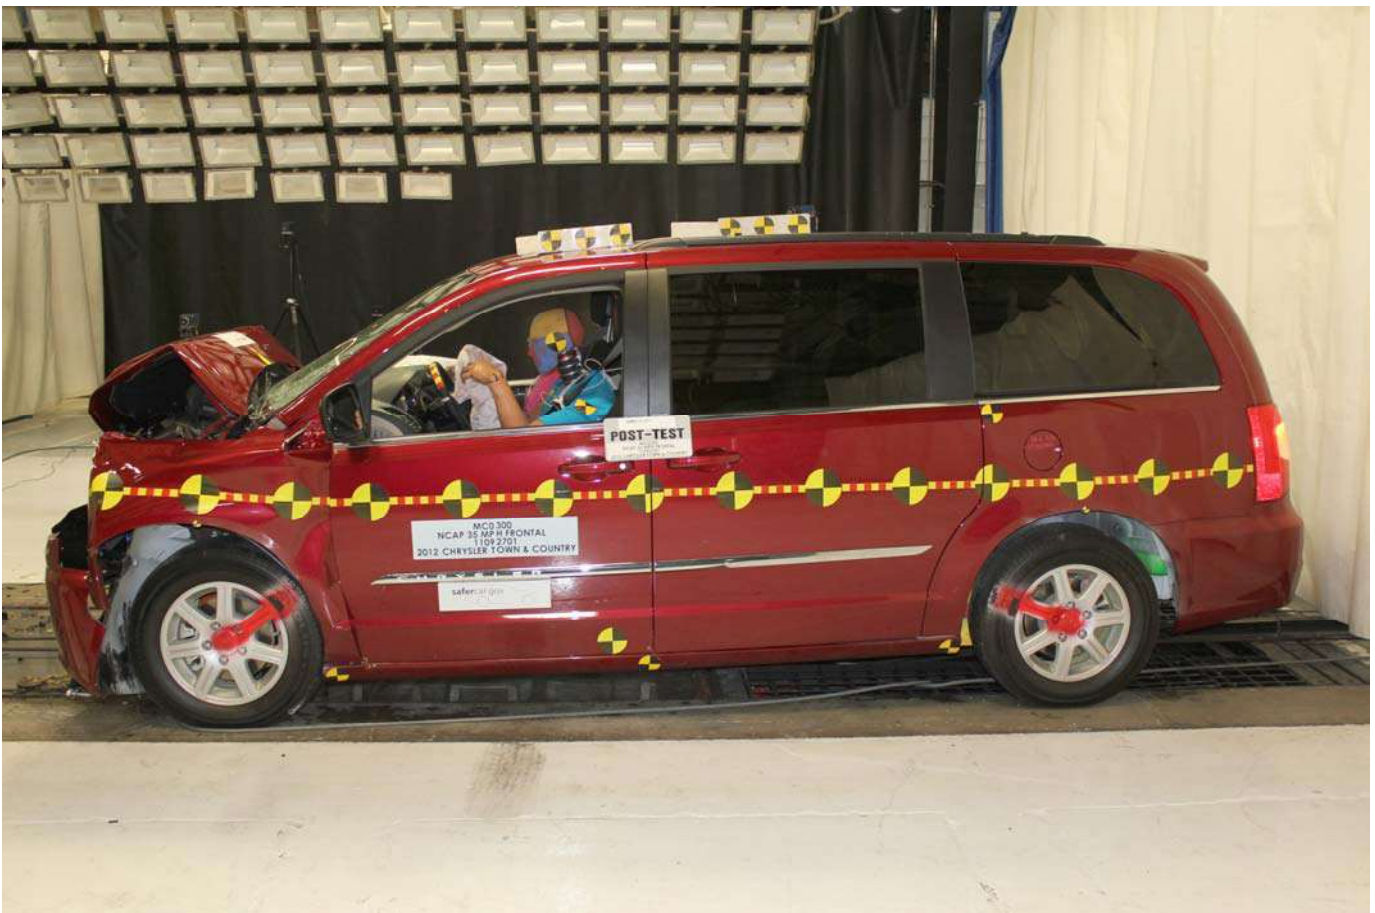
Post-Test Left View of Test Vehicle

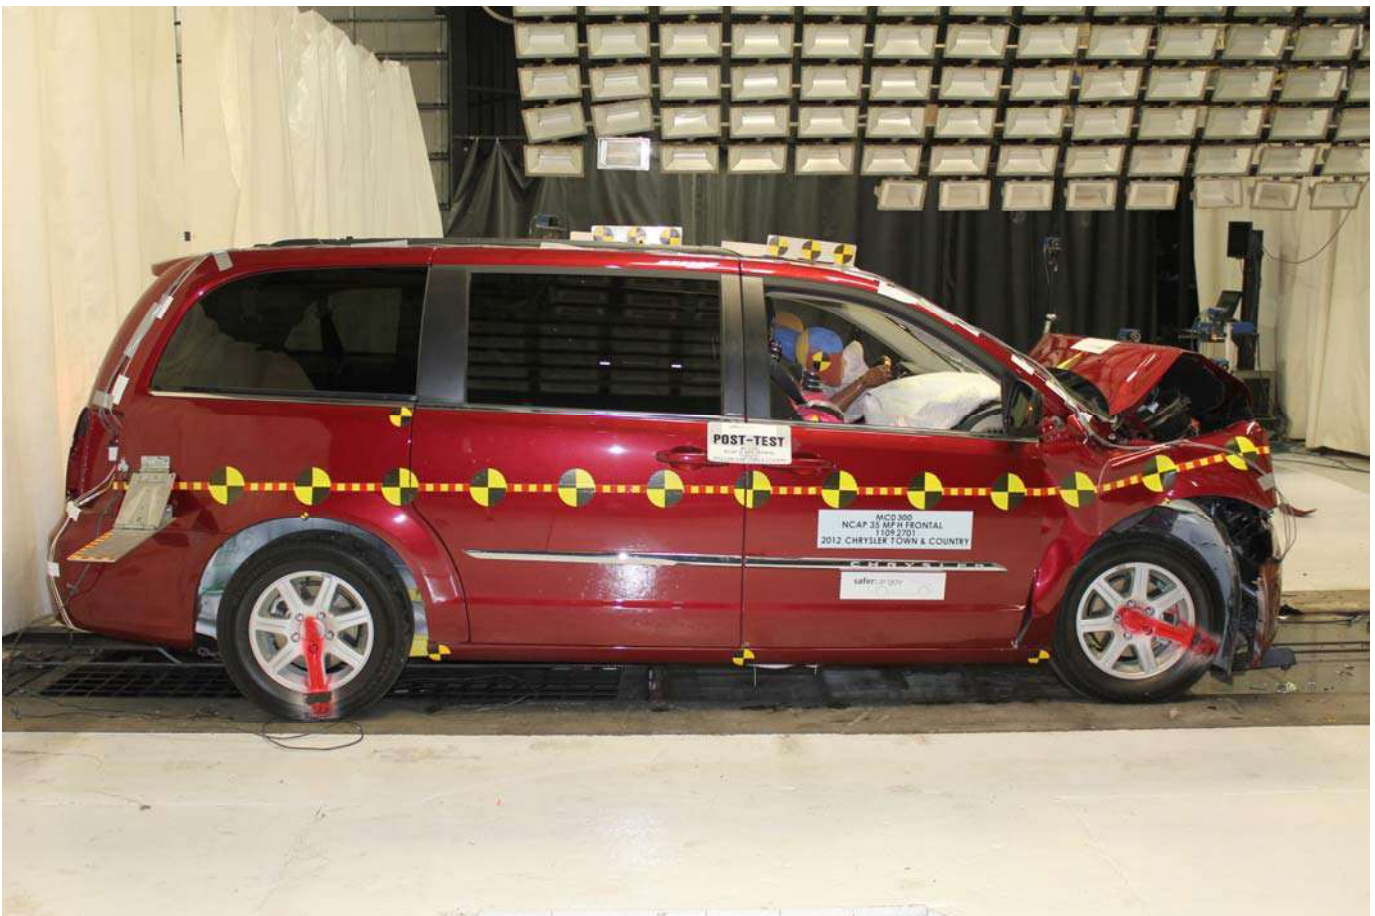
Post-Test Right View of Test Vehicle

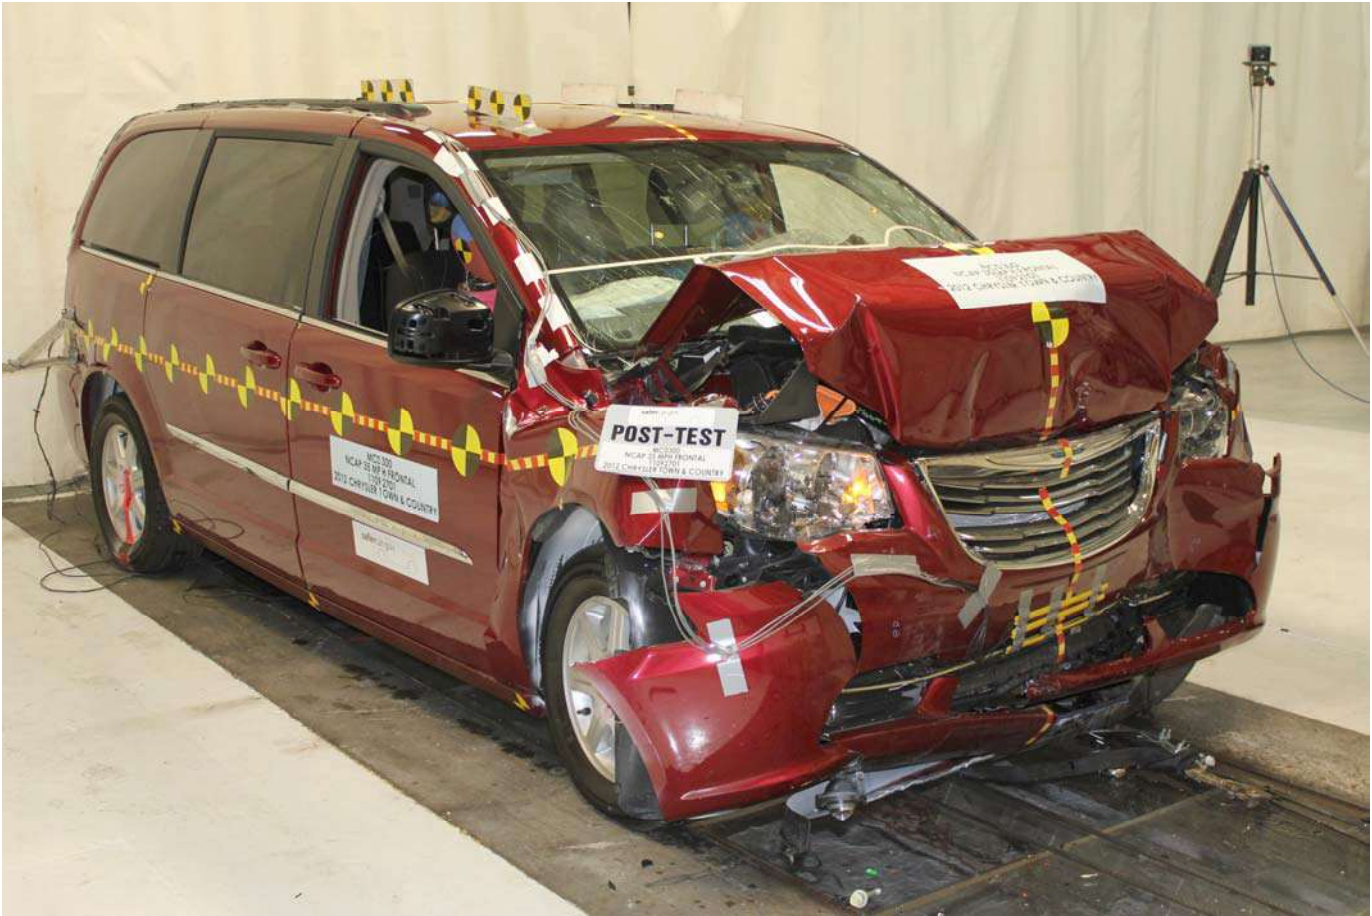
Post-Test Right Front Three-Quarter View

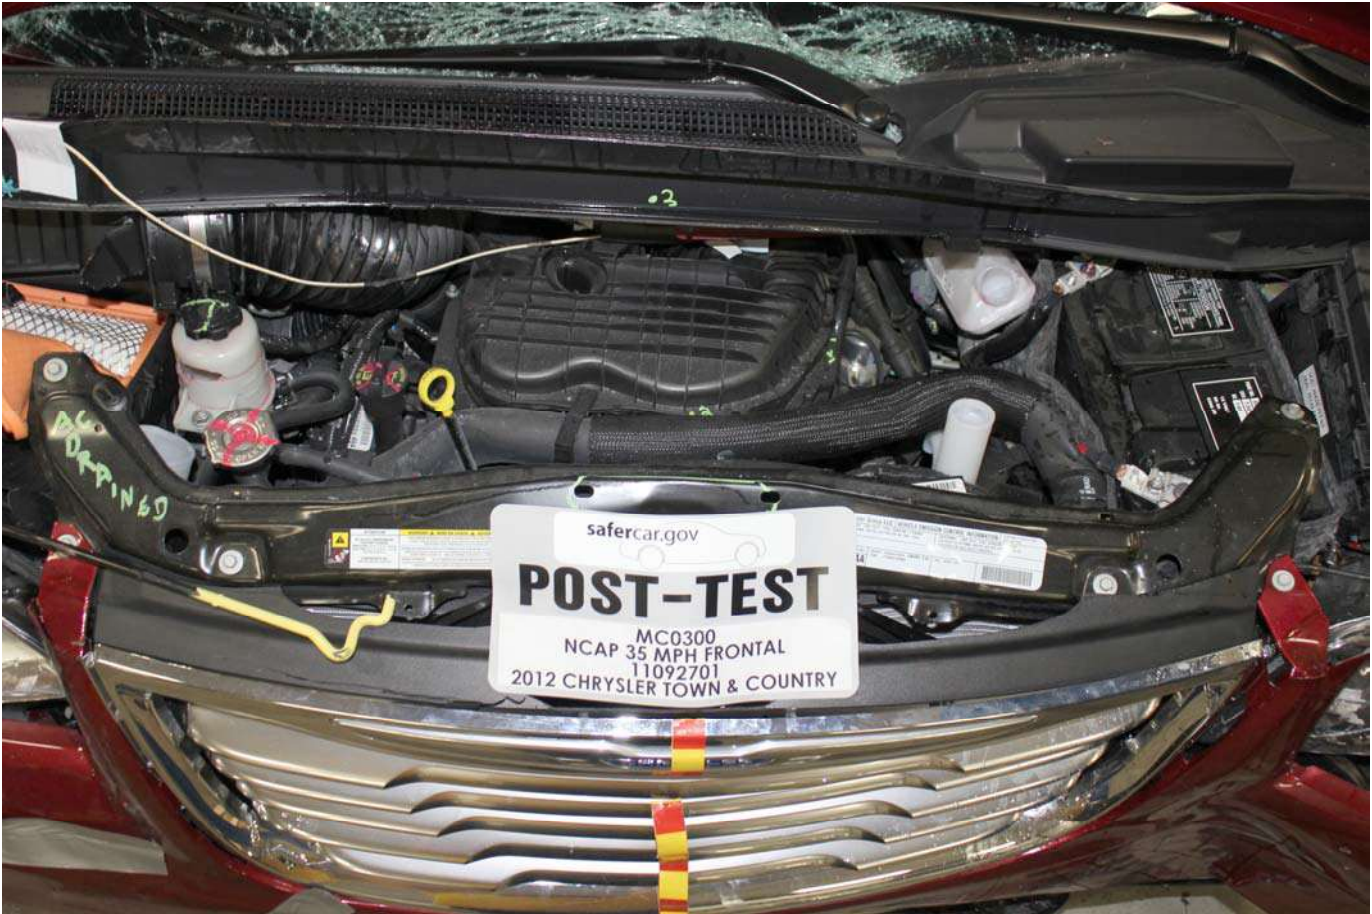
Post-Test Engine Compartment View

There was no valid data collected for:  
 Top of Engine X after 73 msec.  
 Bottom of Engine X after 45 msec.  
 Right Brake Caliper X after 60 msec.

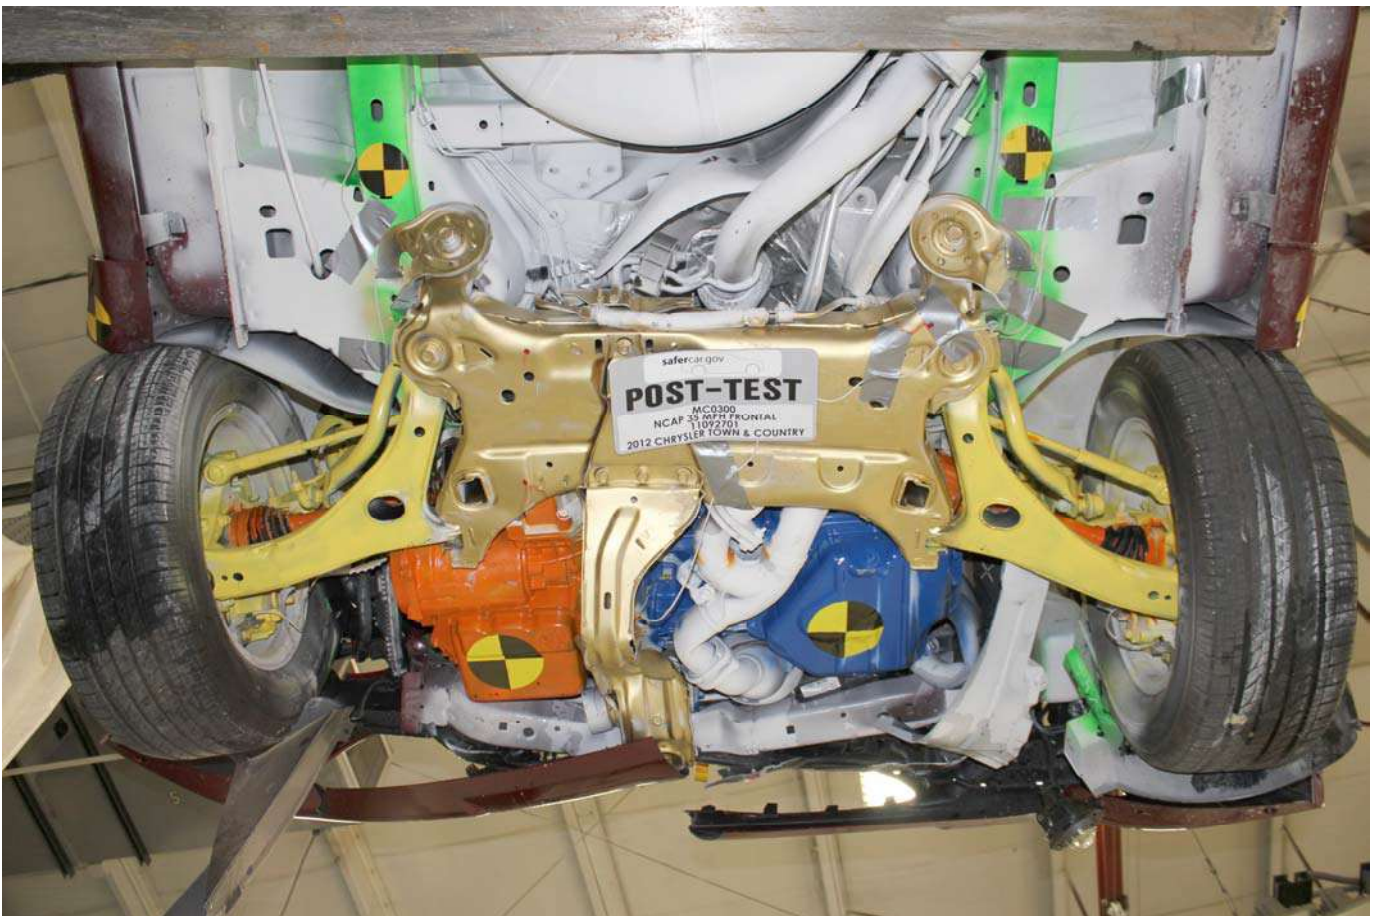
Post-Test Front Underbody View

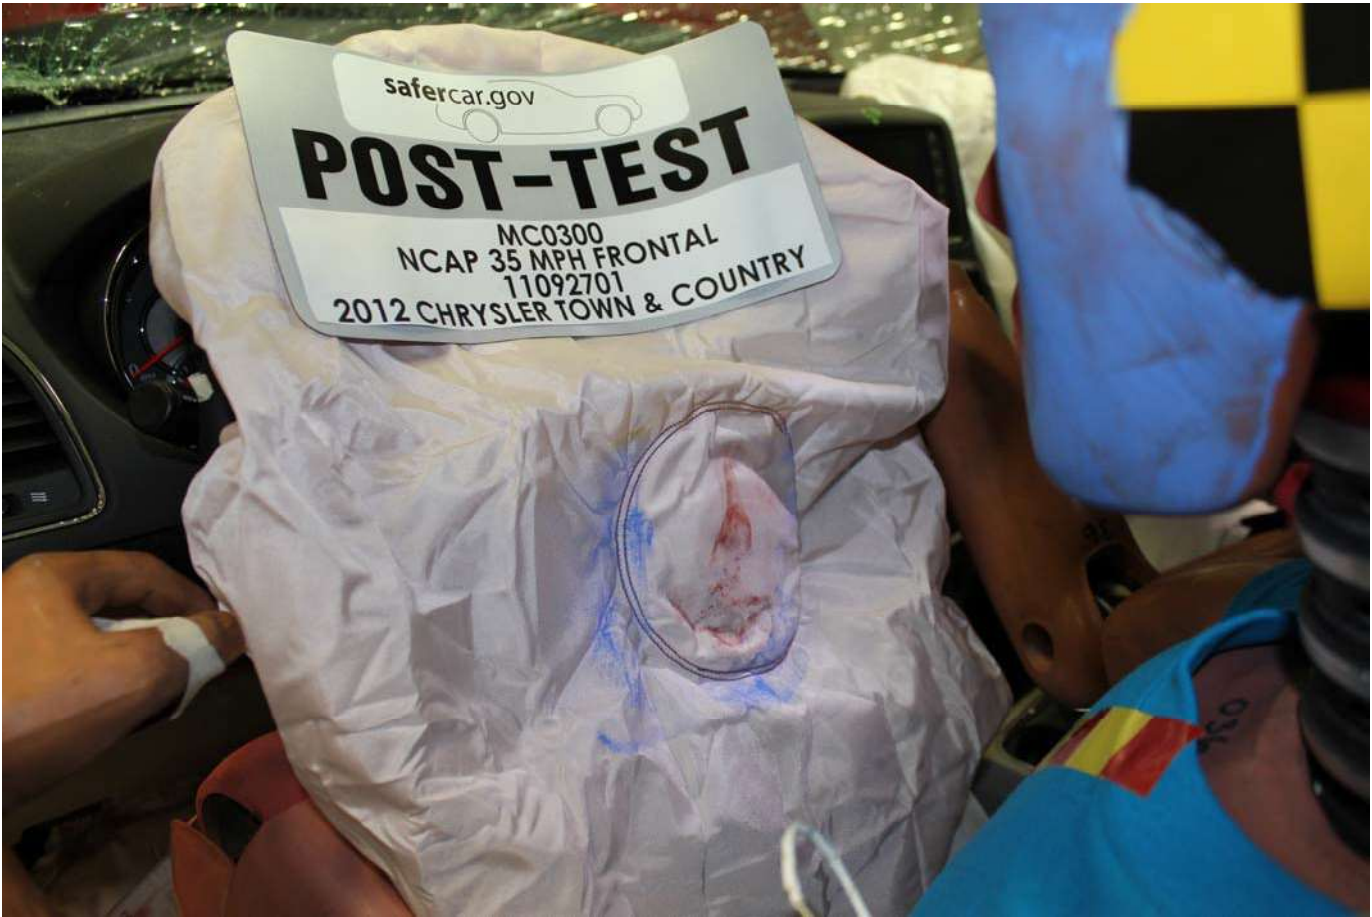
Post-Test Driver Dummy Contact with Airbag

The driver's visible contact points were as follows: The driver's head and chest contacted the airbag. The driver's head also contacted the headrest. The driver's knees contacted the knee bag and knee bolster. The passenger's visible contact points were as follows: The passenger's head and chest contacted the airbag. The passenger's head also contacted the headrest and seatbelt. The passenger's knees contacted the glovebox and dash panel.

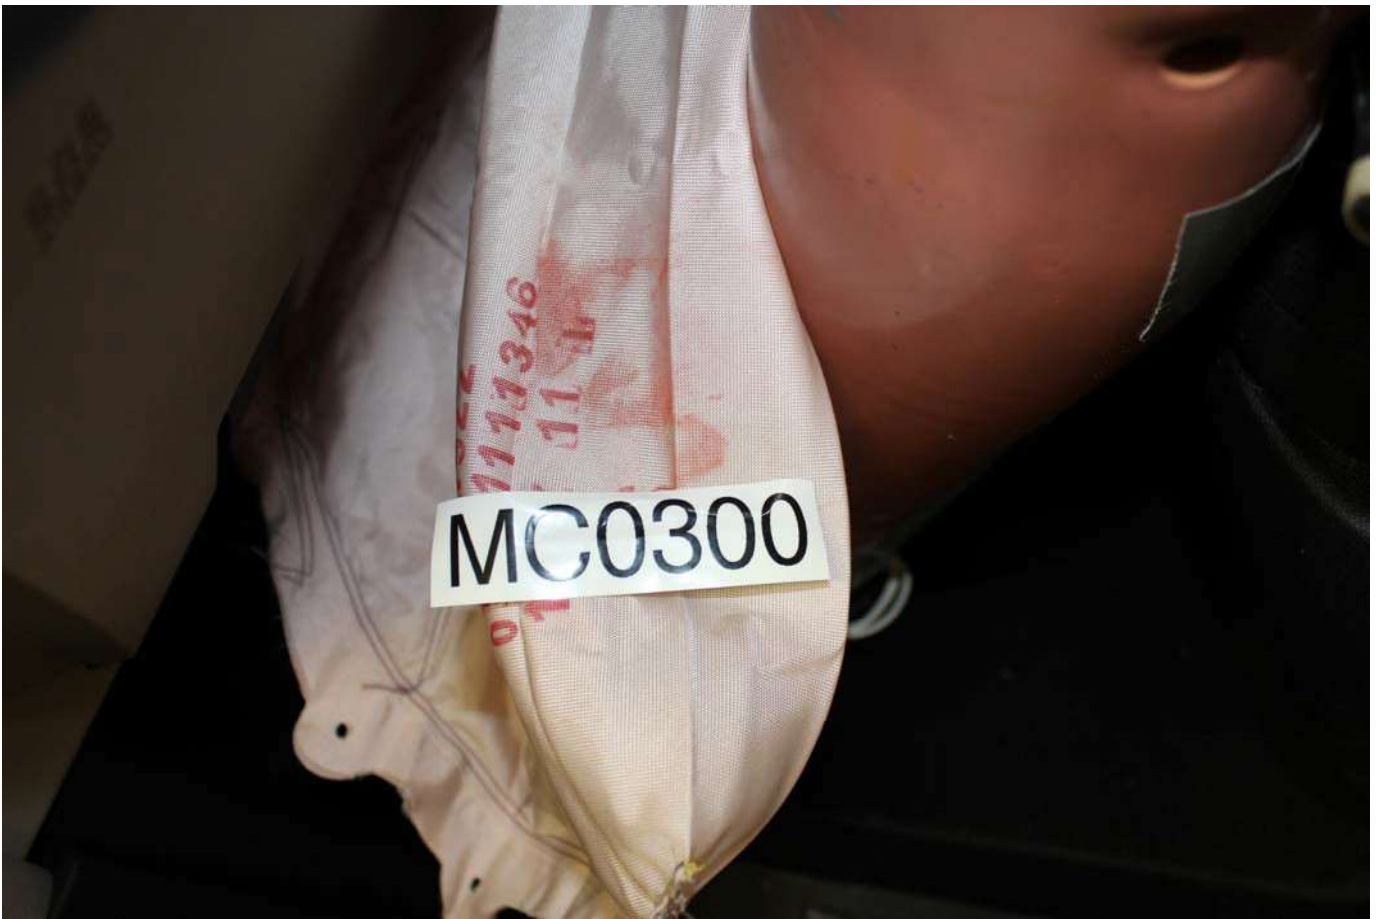
Post-Test Driver Dummy Contact with Knee Bag

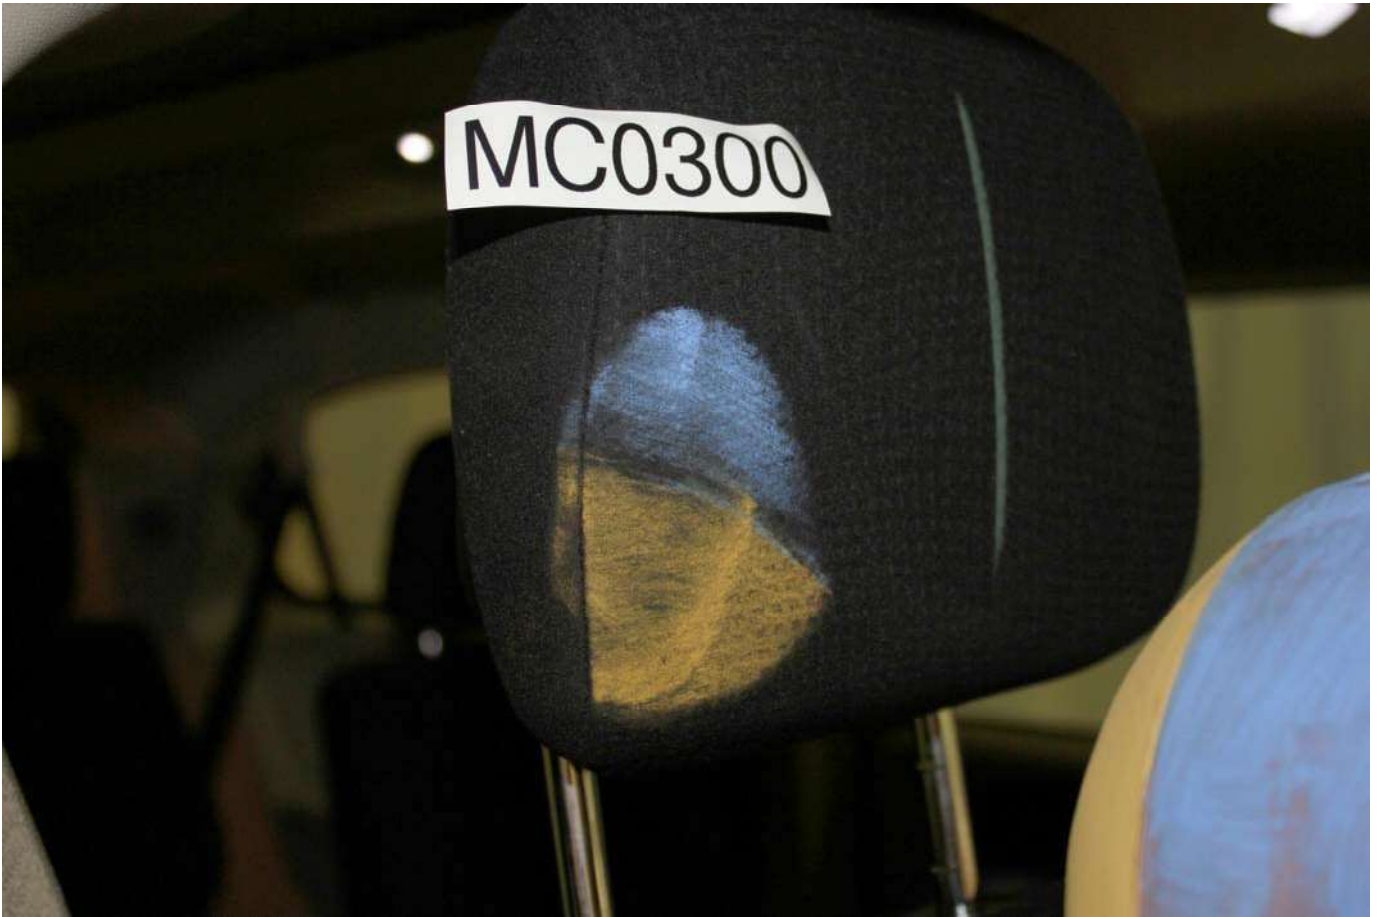
Post-Test Passenger Dummy Contact with Headrest

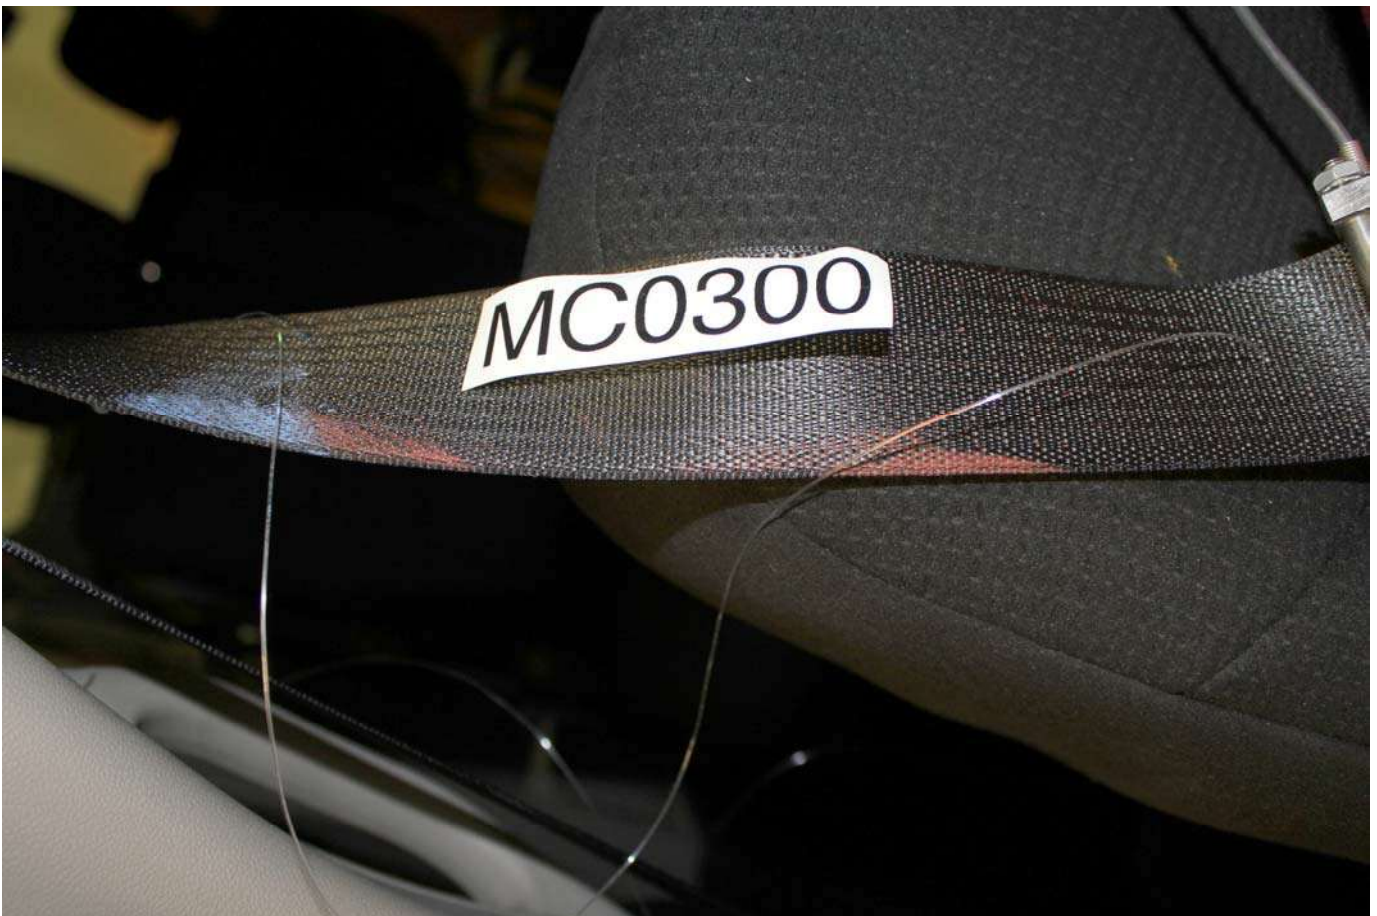
Post-Test Passenger Dummy Contact with Seatbelt

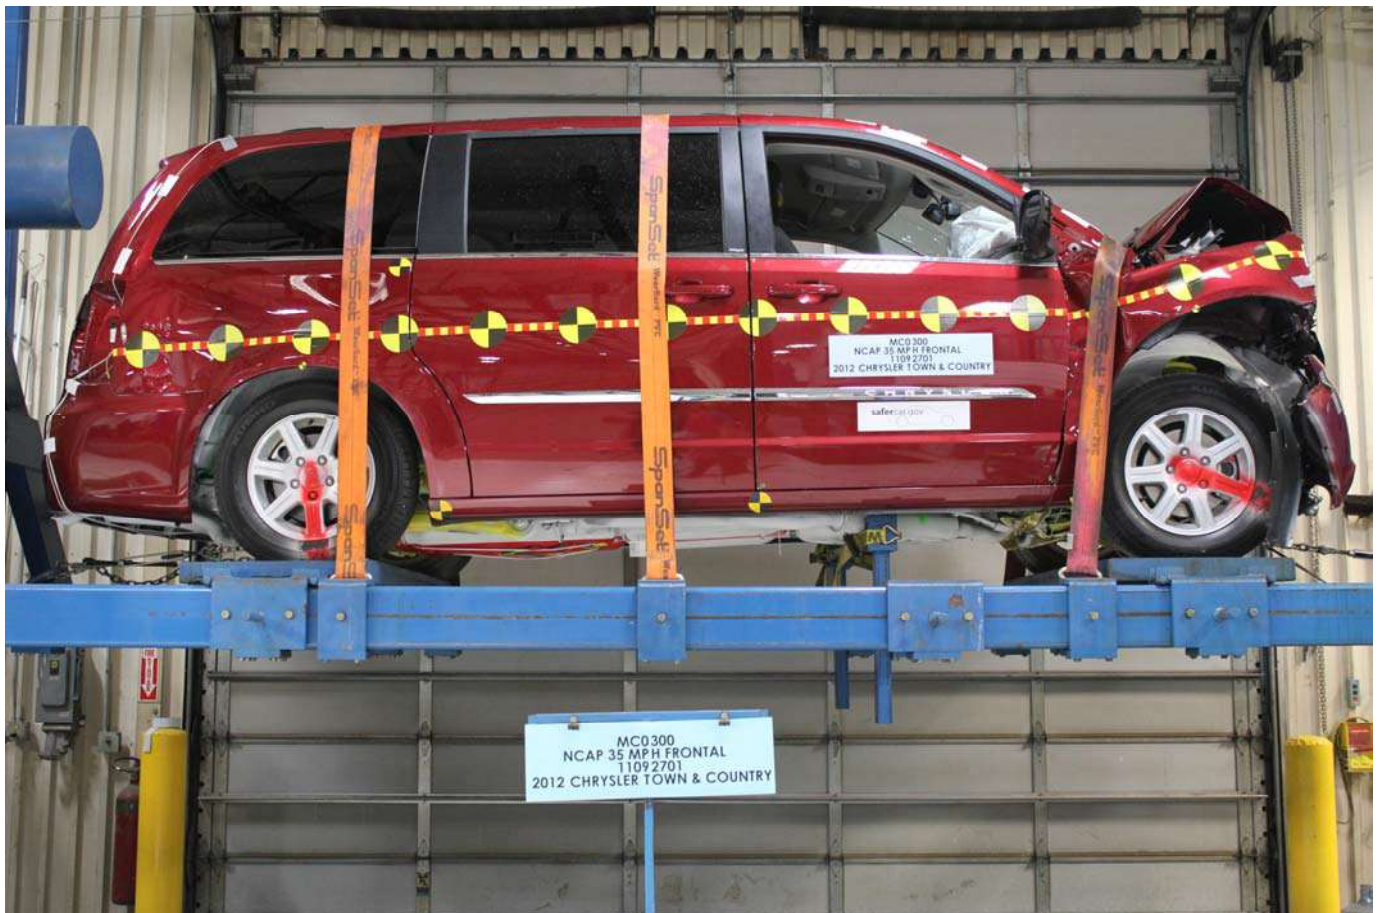
Vehicle at 0 Degrees on Static Rollover Device

There was 100 percent windshield retention and no intrusion into the protected zone of the windshield during the event. There was no Stoddard Solvent leakage after the event or during any phase of the static rollover.

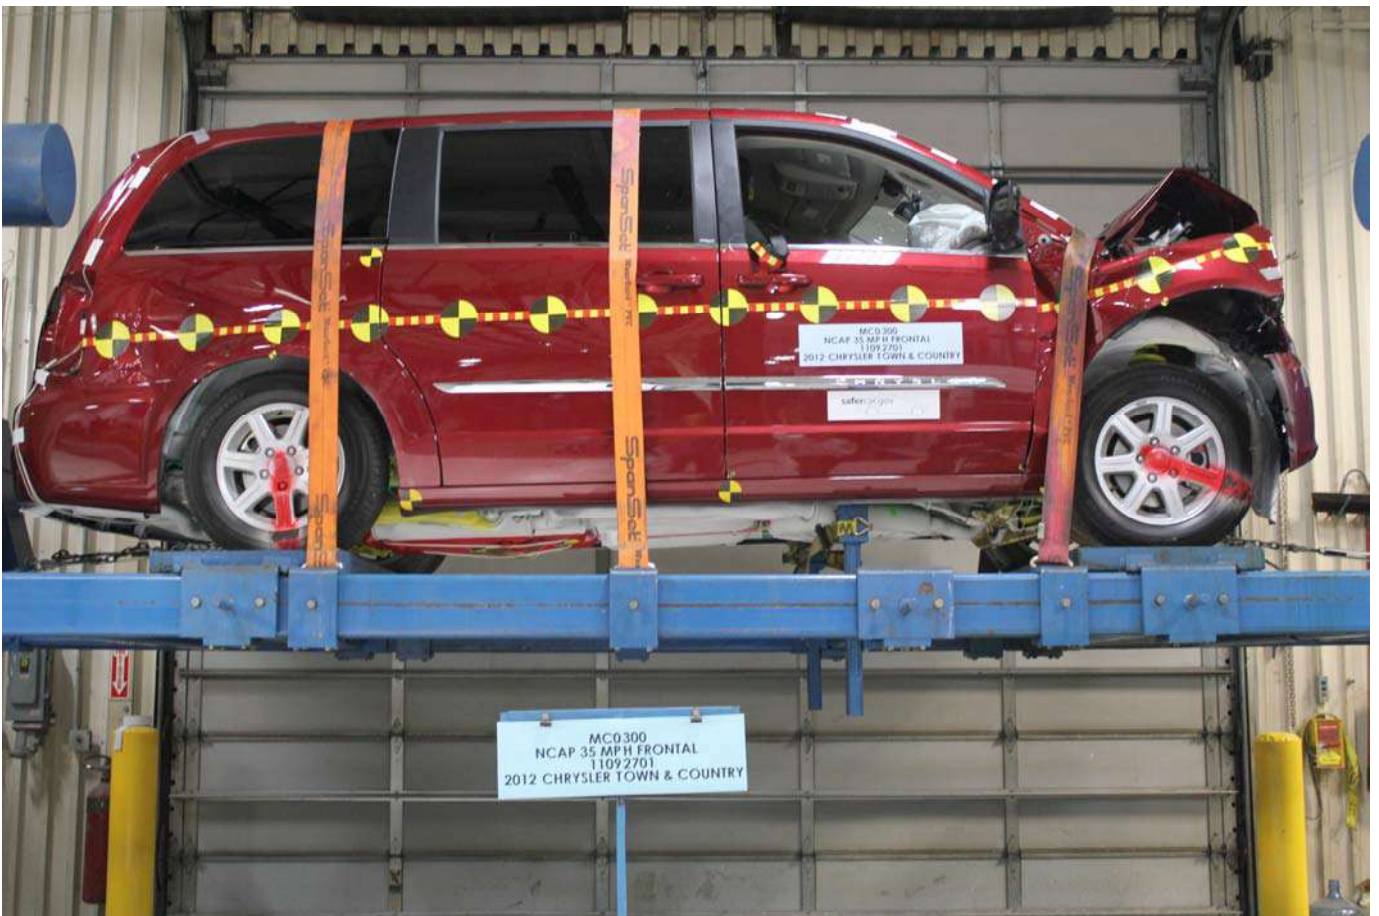
Vehicle at 360 Degrees on Static Rollover Device

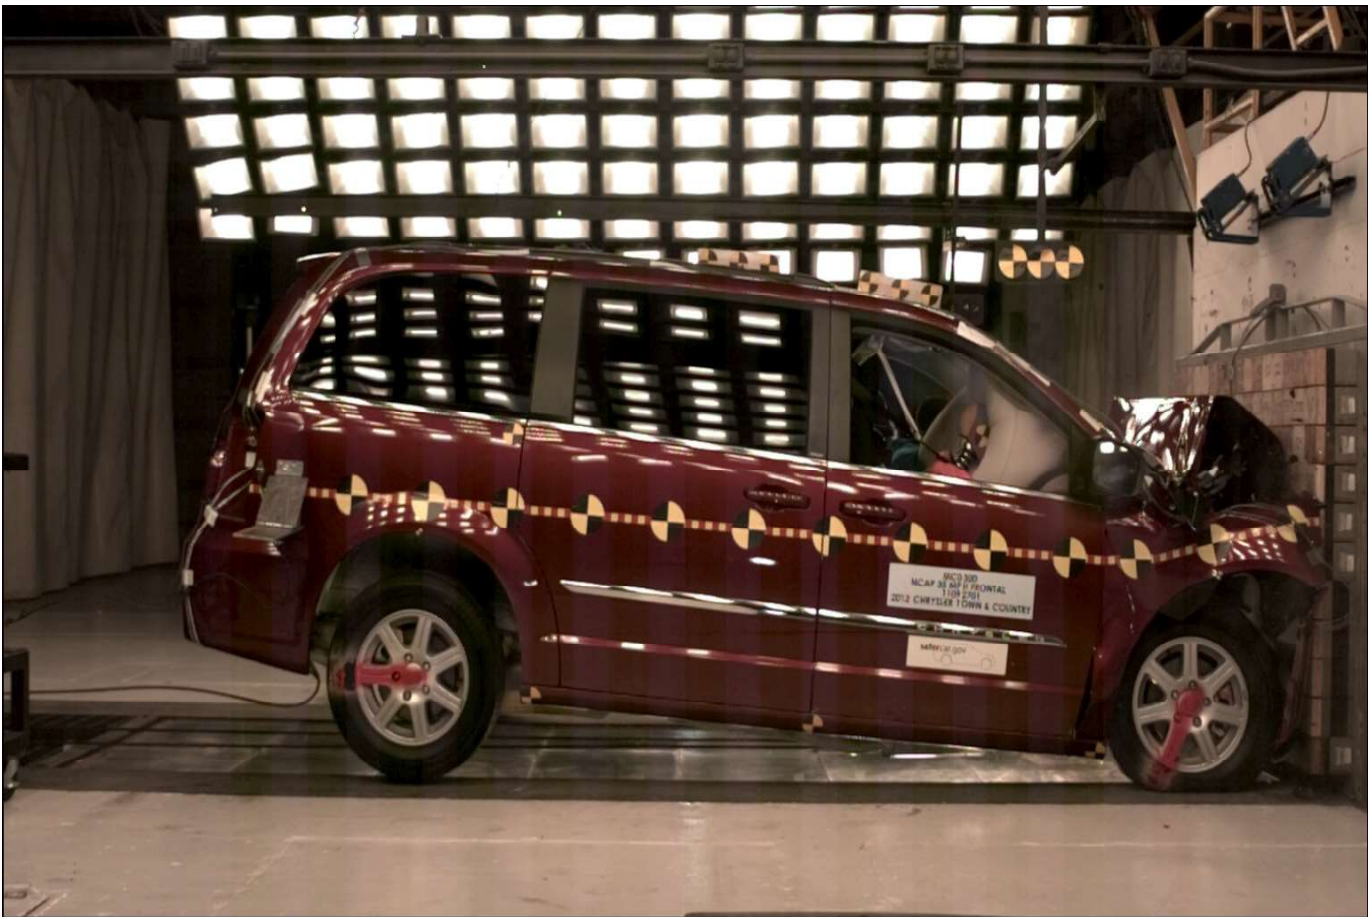
2012 Chrysler Town & Country Frontal Impact Event
