**REPORT NUMBER: NCAP-MGA-2012-007**

**NEW CAR ASSESSMENT PROGRAM (NCAP)  
Frontal Barrier Impact Test**

**CHRYSLER GROUP LLC  
2012 Dodge Avenger SXT 4-Dr Sedan  
NHTSA No.: MC0310**

**MGA RESEARCH CORPORATION  
5000 Warren Road  
Burlington, WI 53105**

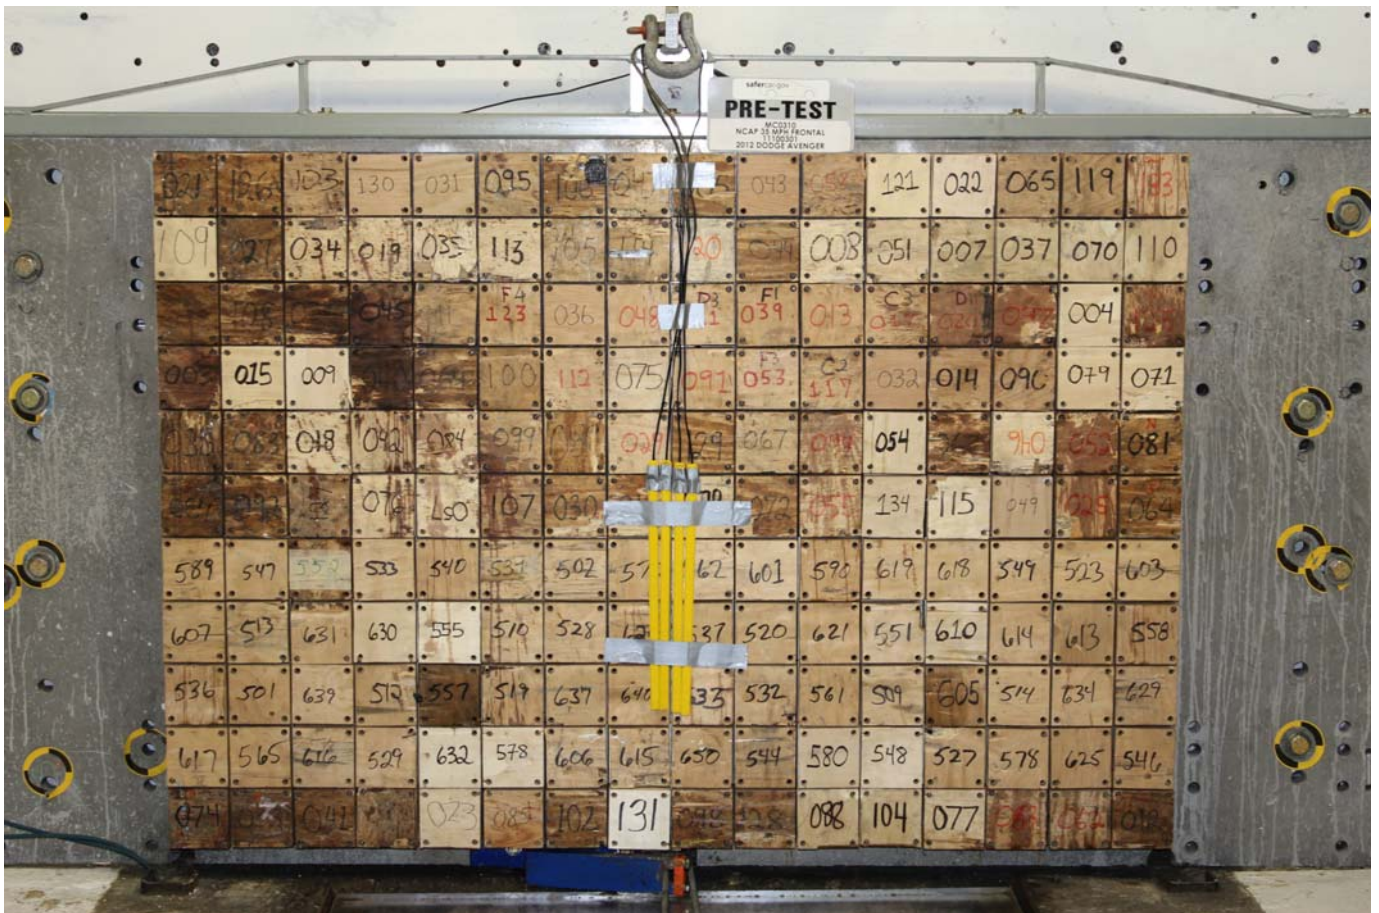
Load Cell Wall

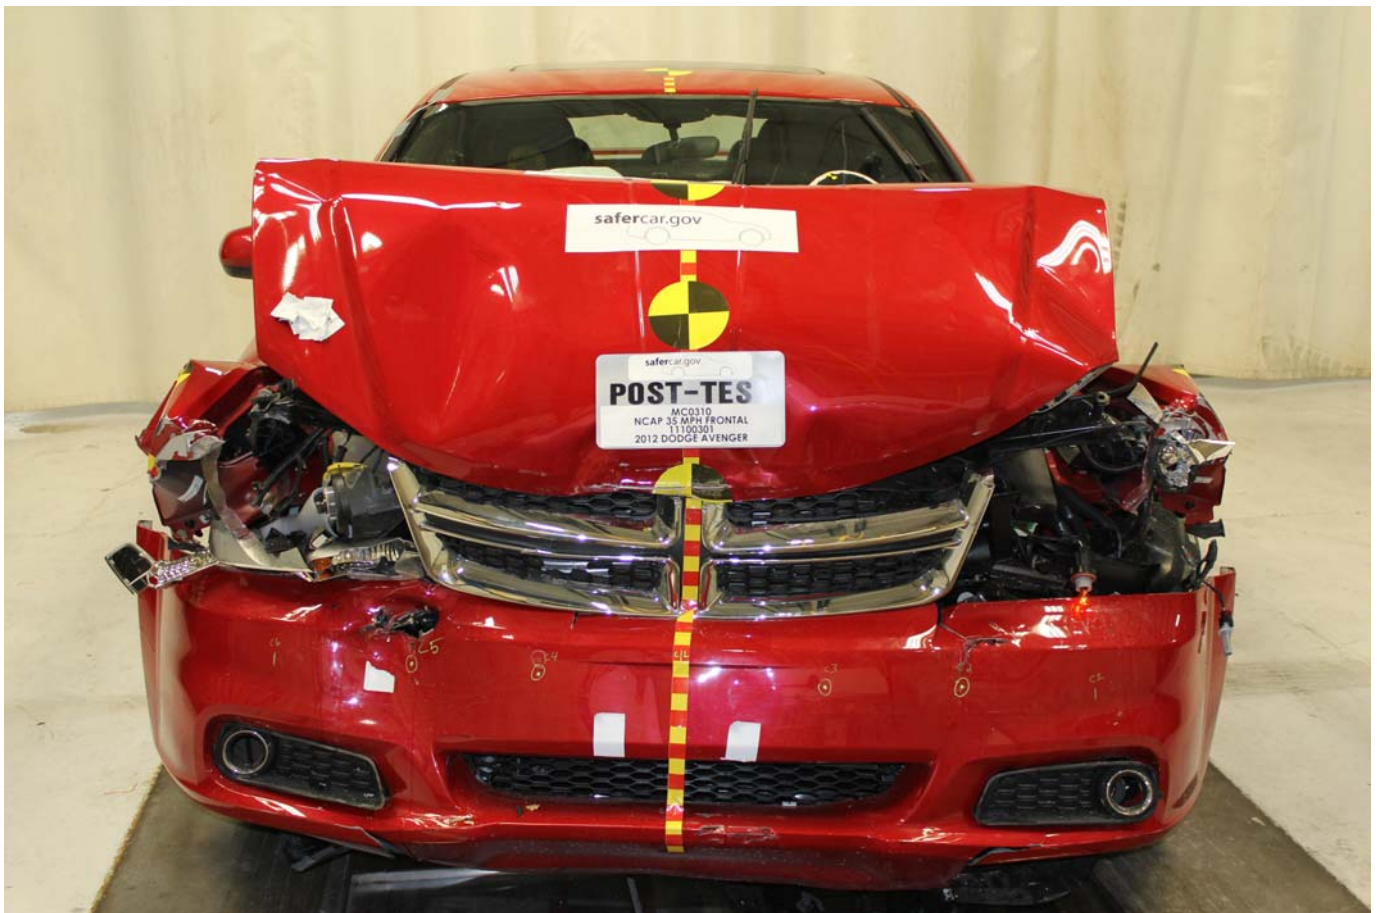
Post-Test Front View of Test Vehicle

The maximum static crush of the vehicle was 410 mm and both the driver and passenger side doors remained closed during the impact event and were operable after the impact.

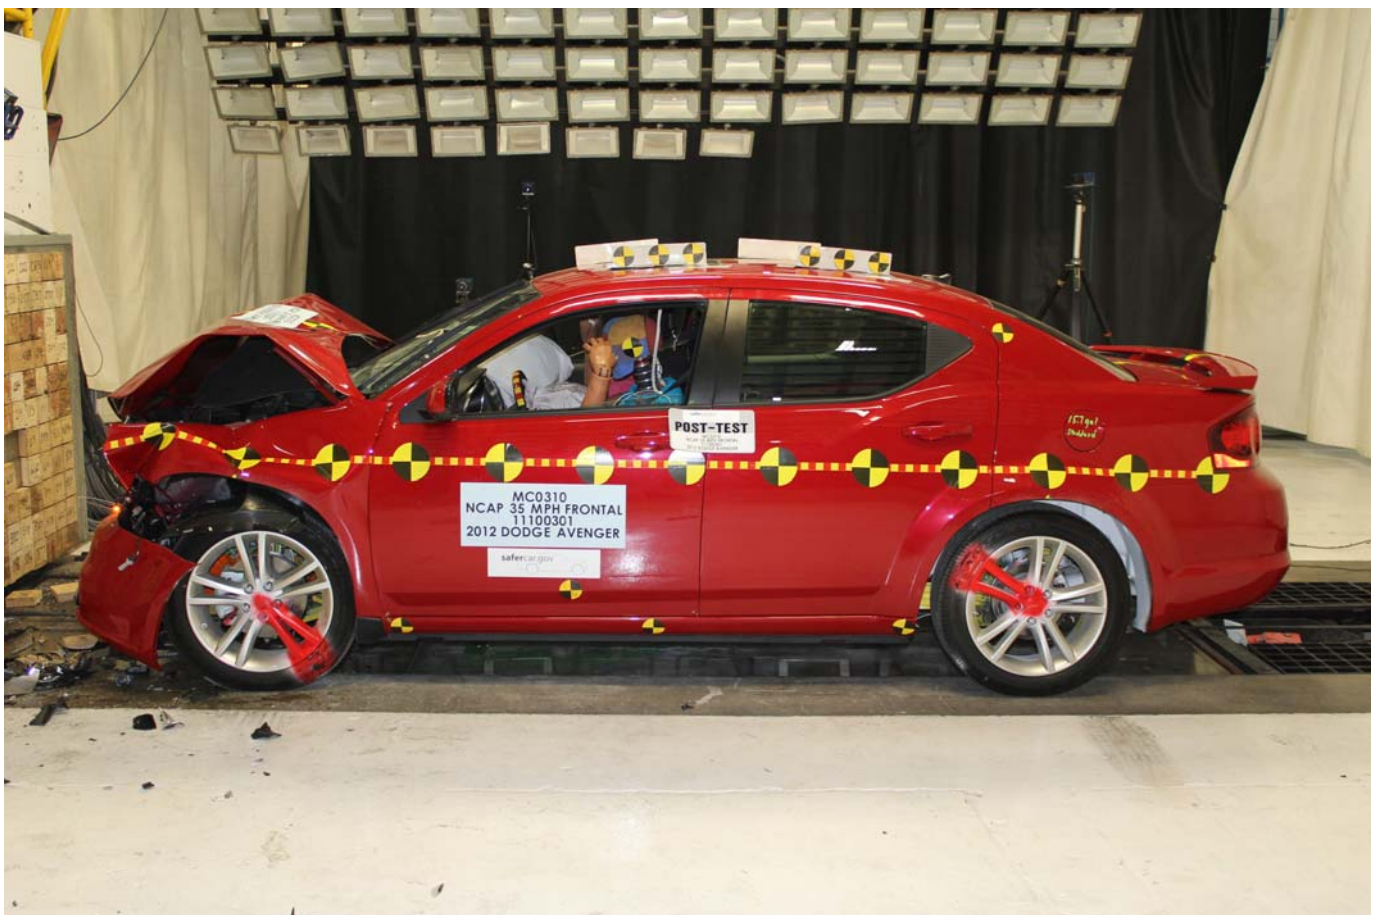
Post-Test Left View of Test Vehicle

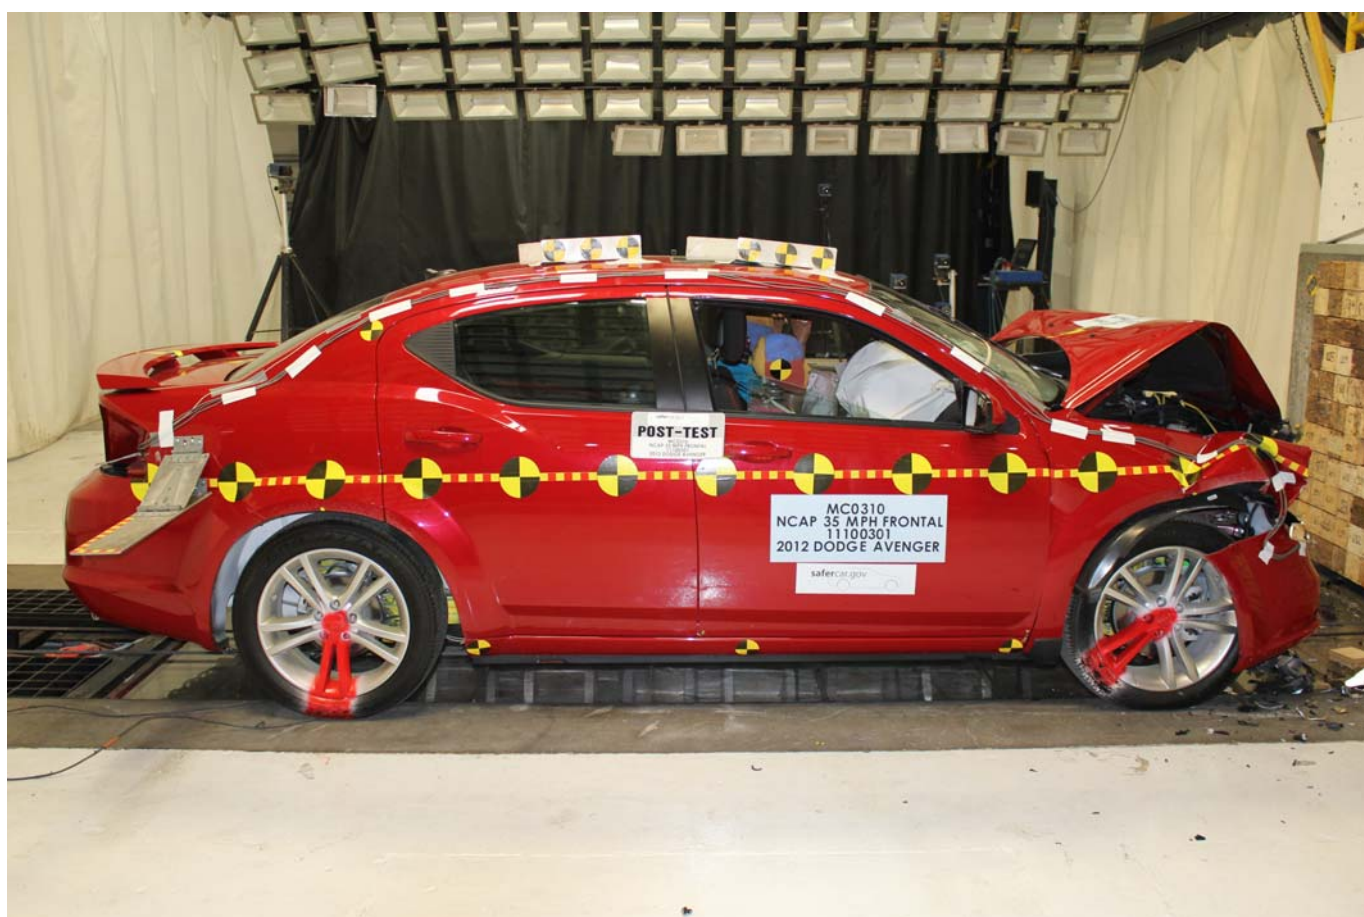
Post-Test Right View of Test Vehicle

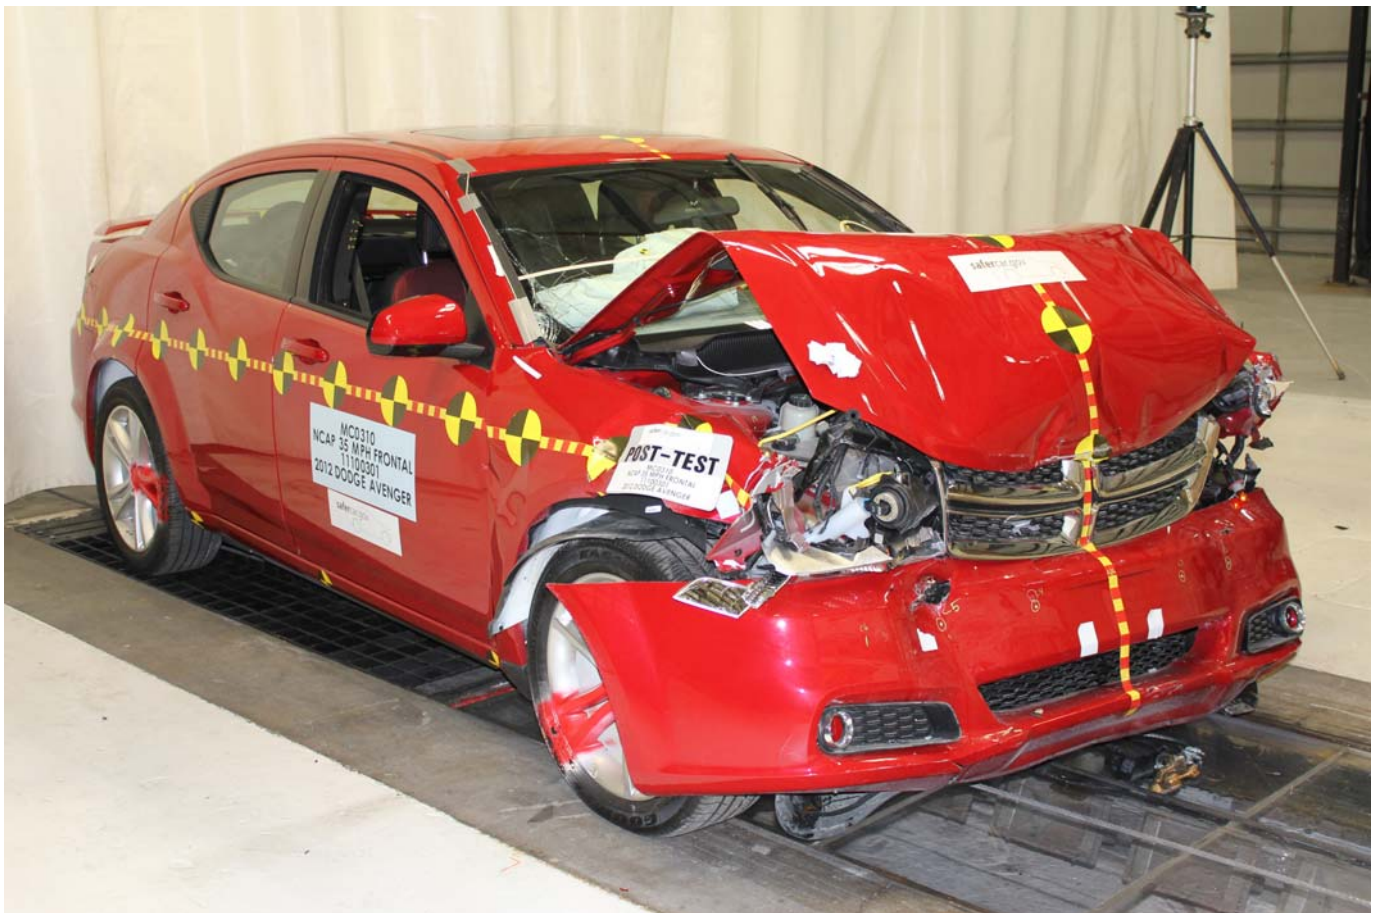
Post-Test Right Front Three-Quarter View

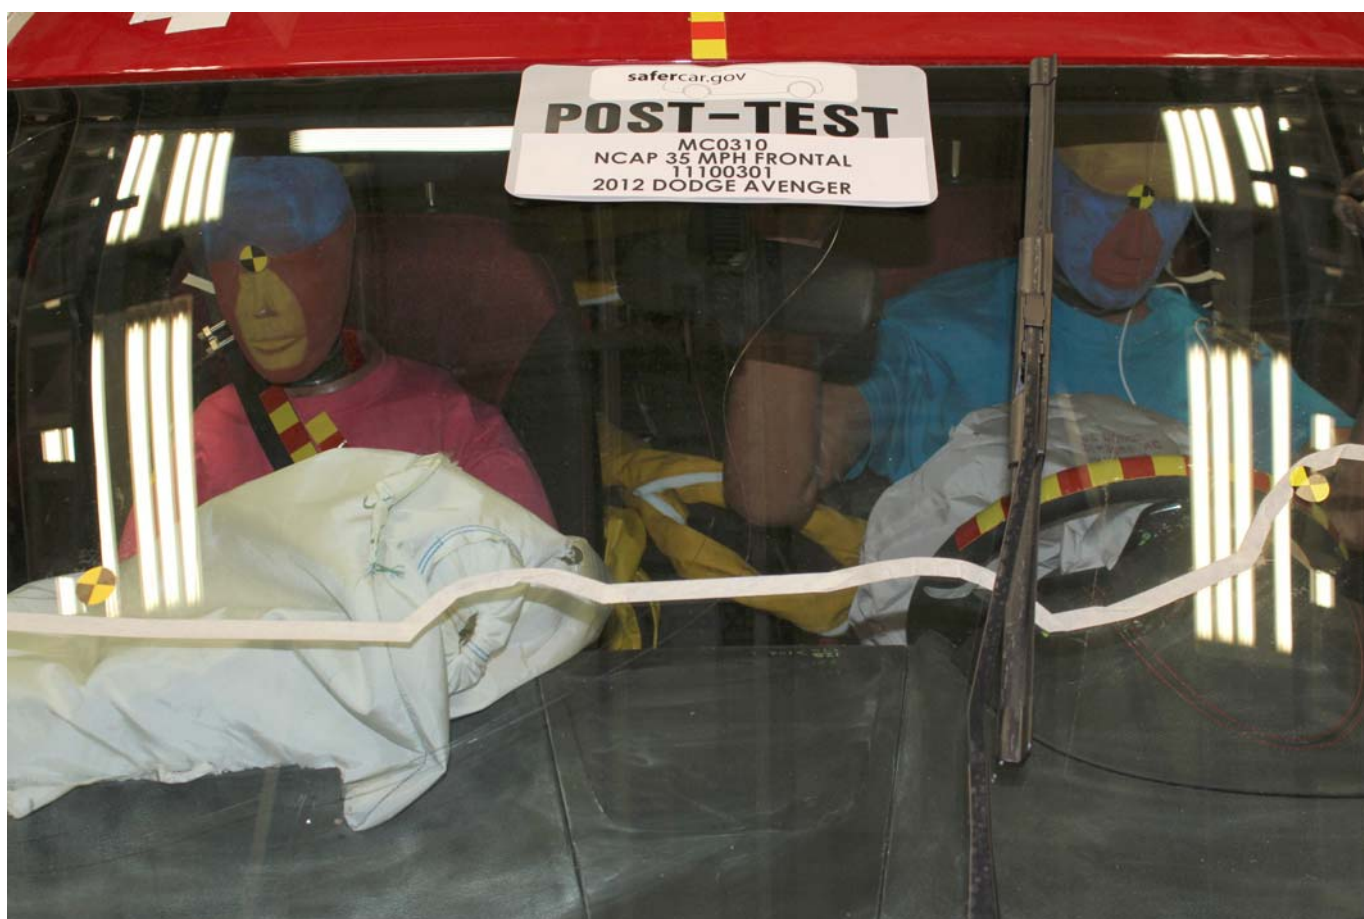
Post-Test Windshield View

There was 100 percent windshield retention and no intrusion into the protected zone of the windshield during the event. There was no Stoddard Solvent leakage after the event or during any phase of the static rollover.

| Critical Areas of Performance | Observations and Conclusions |
|---|---|
| Windshield Damage | Cracked |

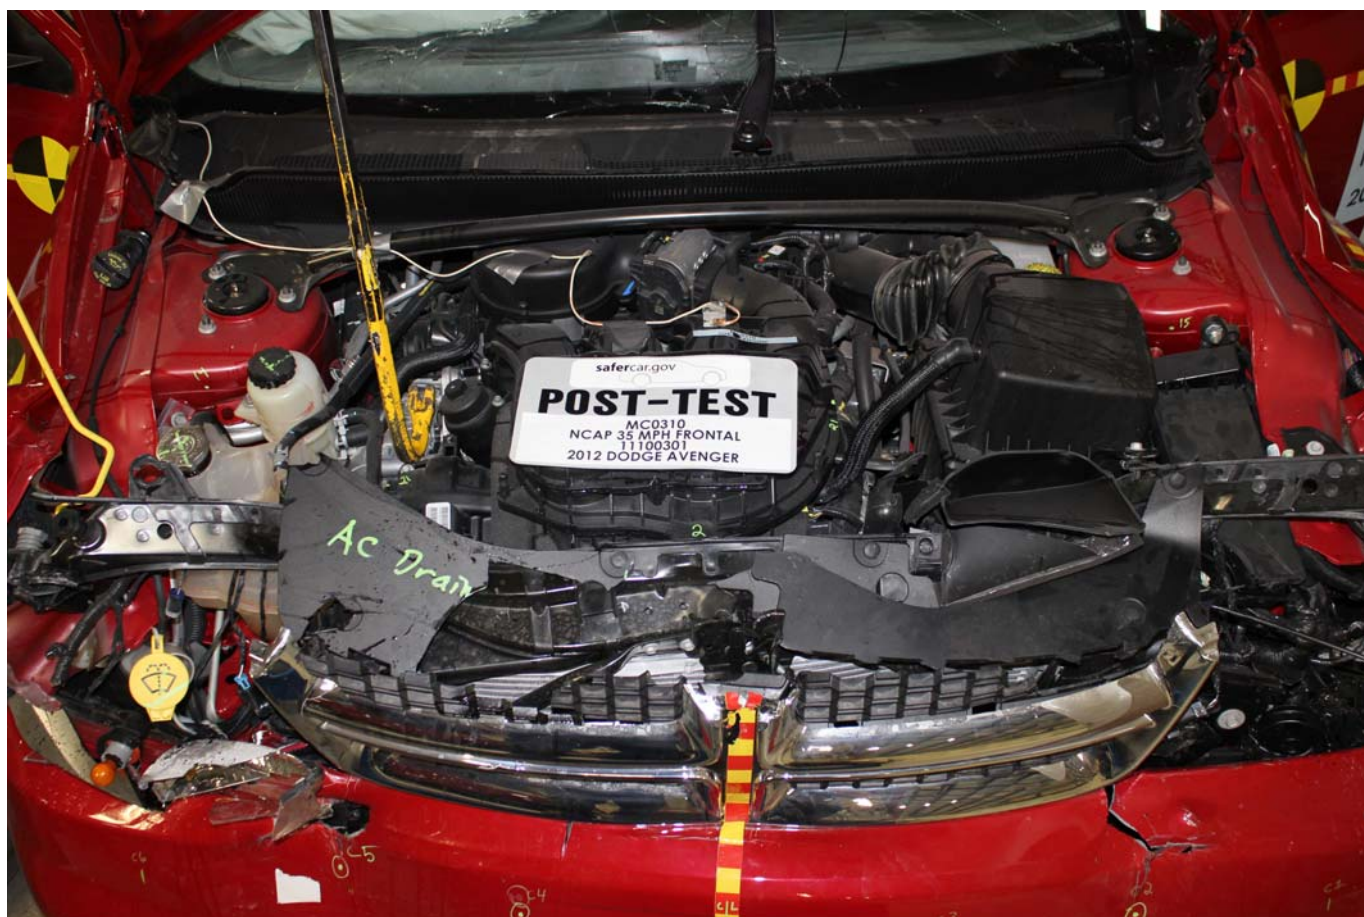
Post-Test Engine Compartment View

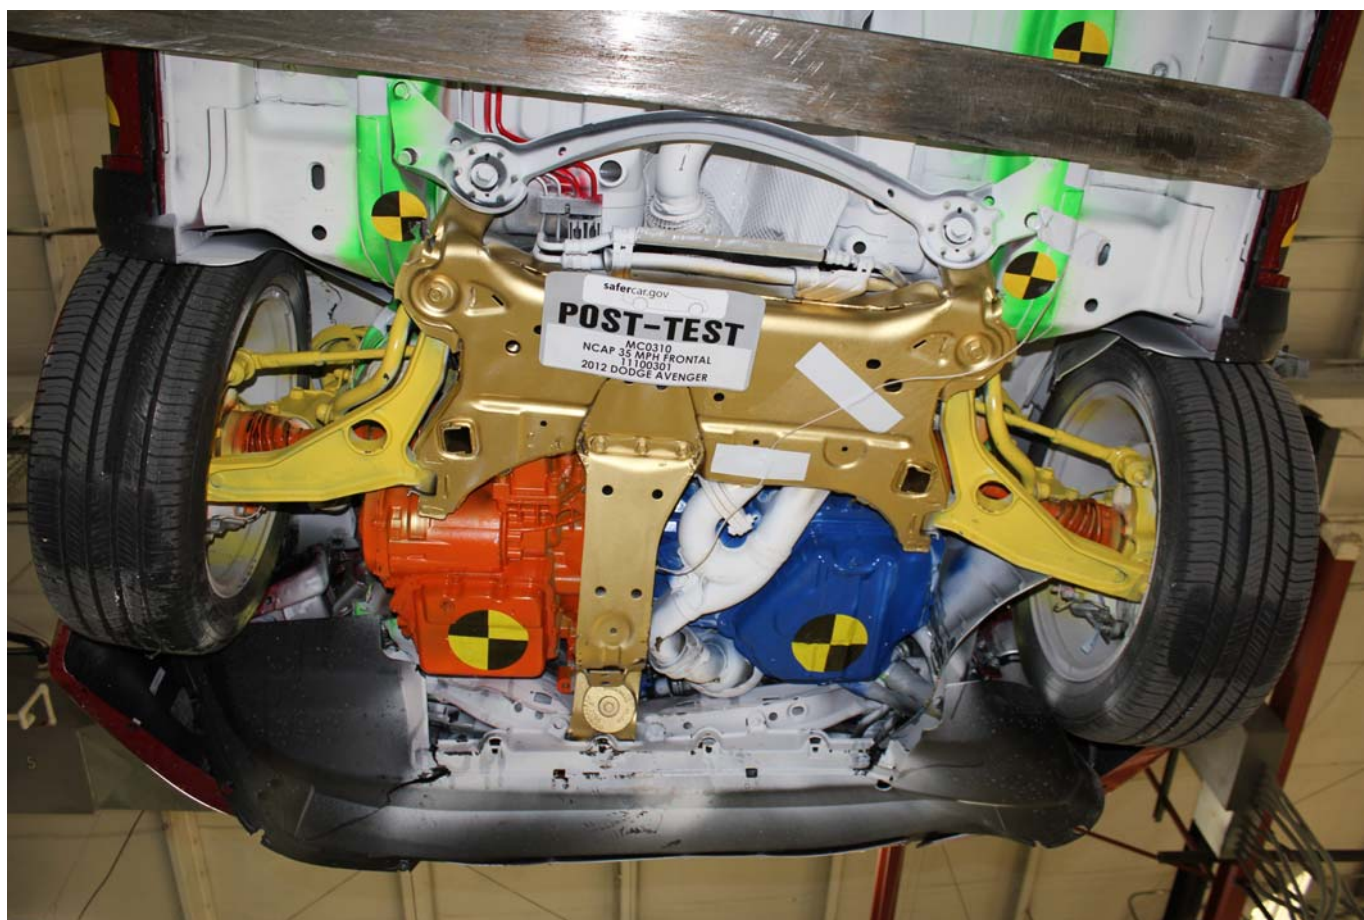
Post-Test Front Underbody View

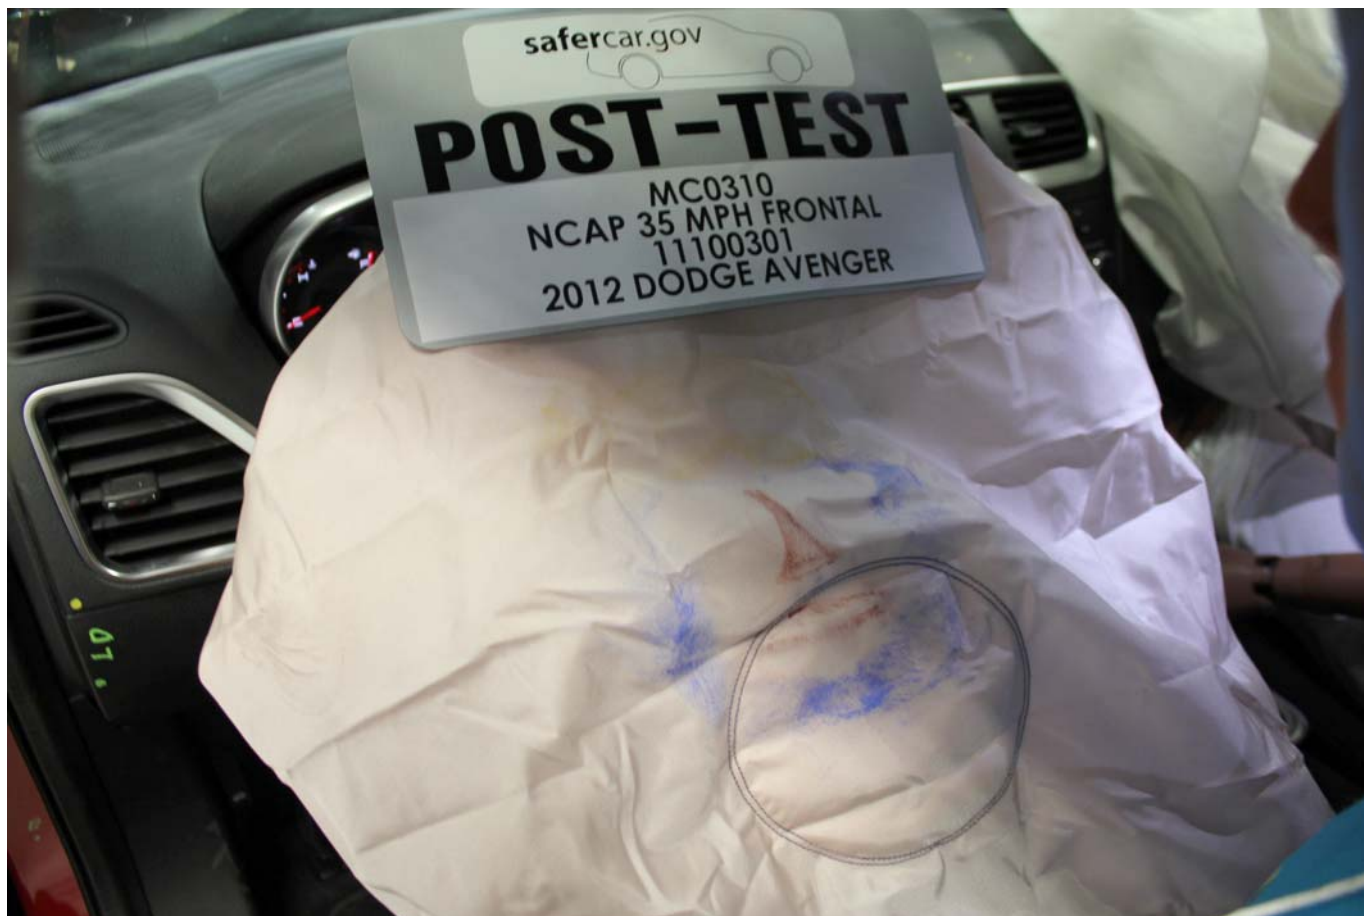
Post-Test Driver Dummy Contact with Airbag

The driver's visible contact points were as follows: The driver's head and chest contacted the airbag. The driver's head also contacted the headrest. The driver's knees contacted the knee bolster. The passenger's visible contact points were as follows: The passenger's head and chest contacted the airbag. The passenger's head also contacted the headrest. The passenger's knees contacted the glovebox.

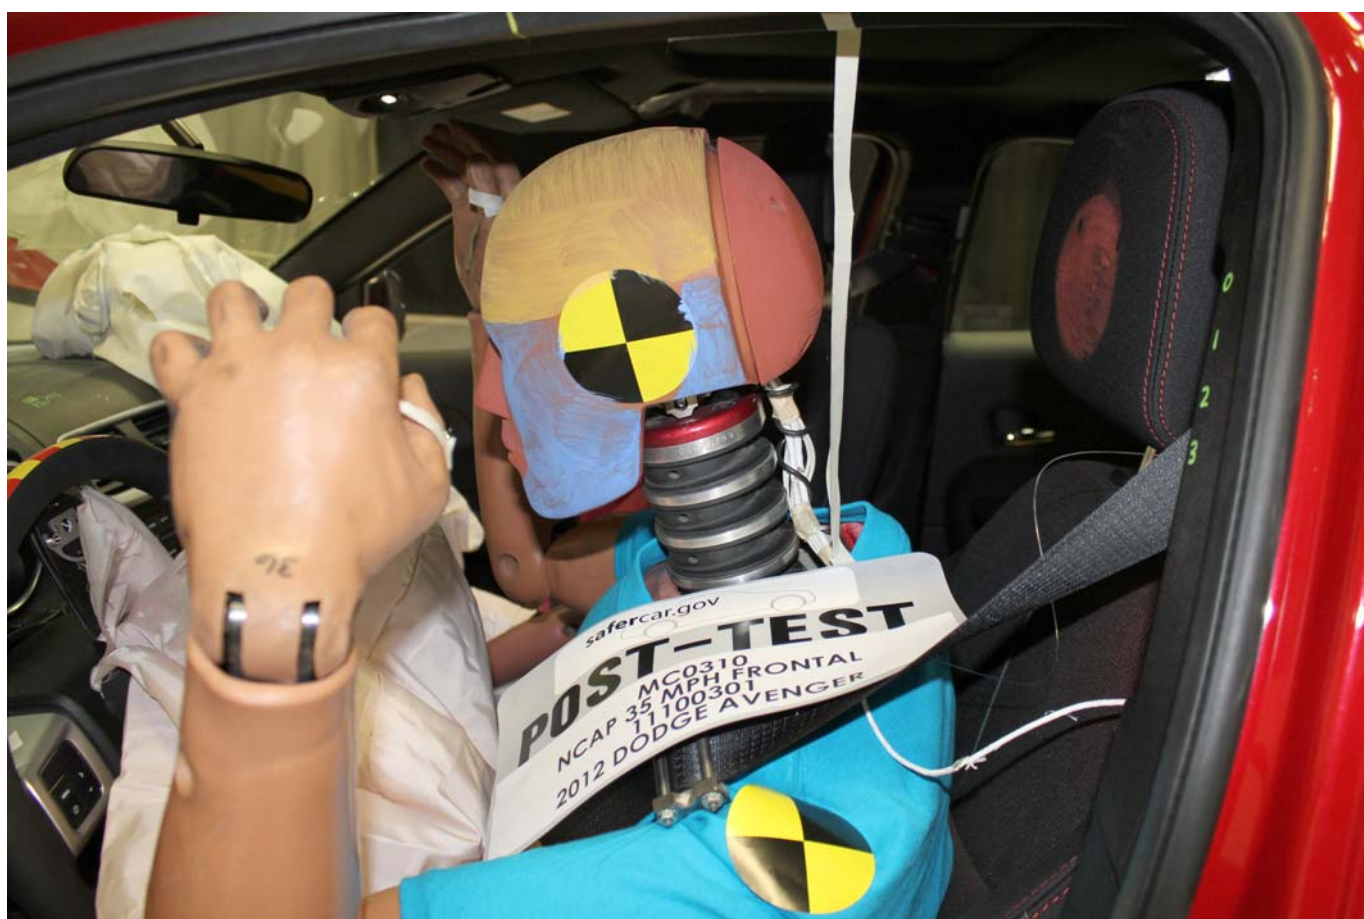
Post-Test Driver Dummy Contact with Headrest

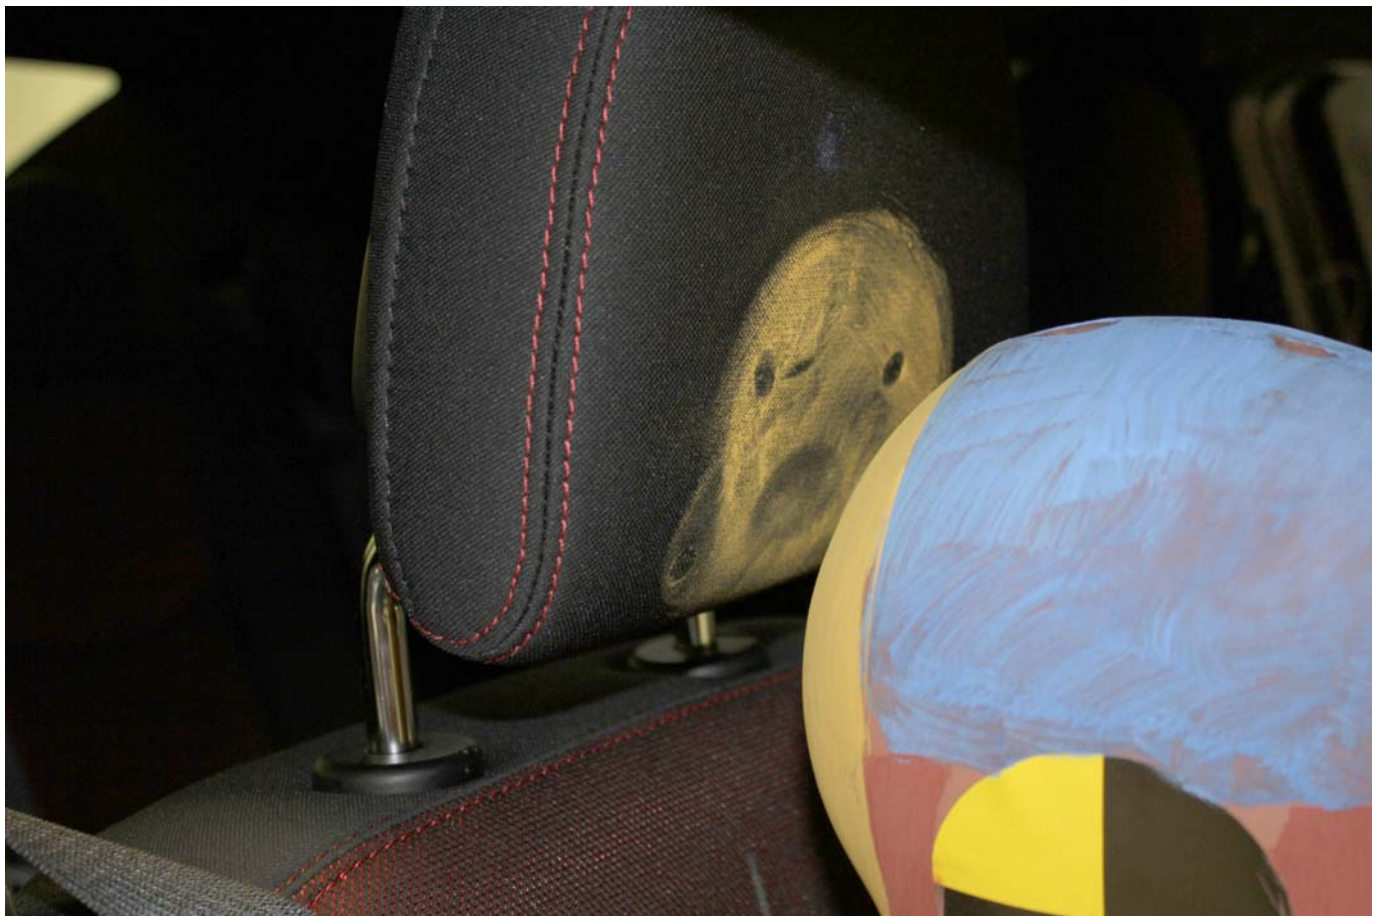
Post-Test Passenger Dummy Contact with Headrest

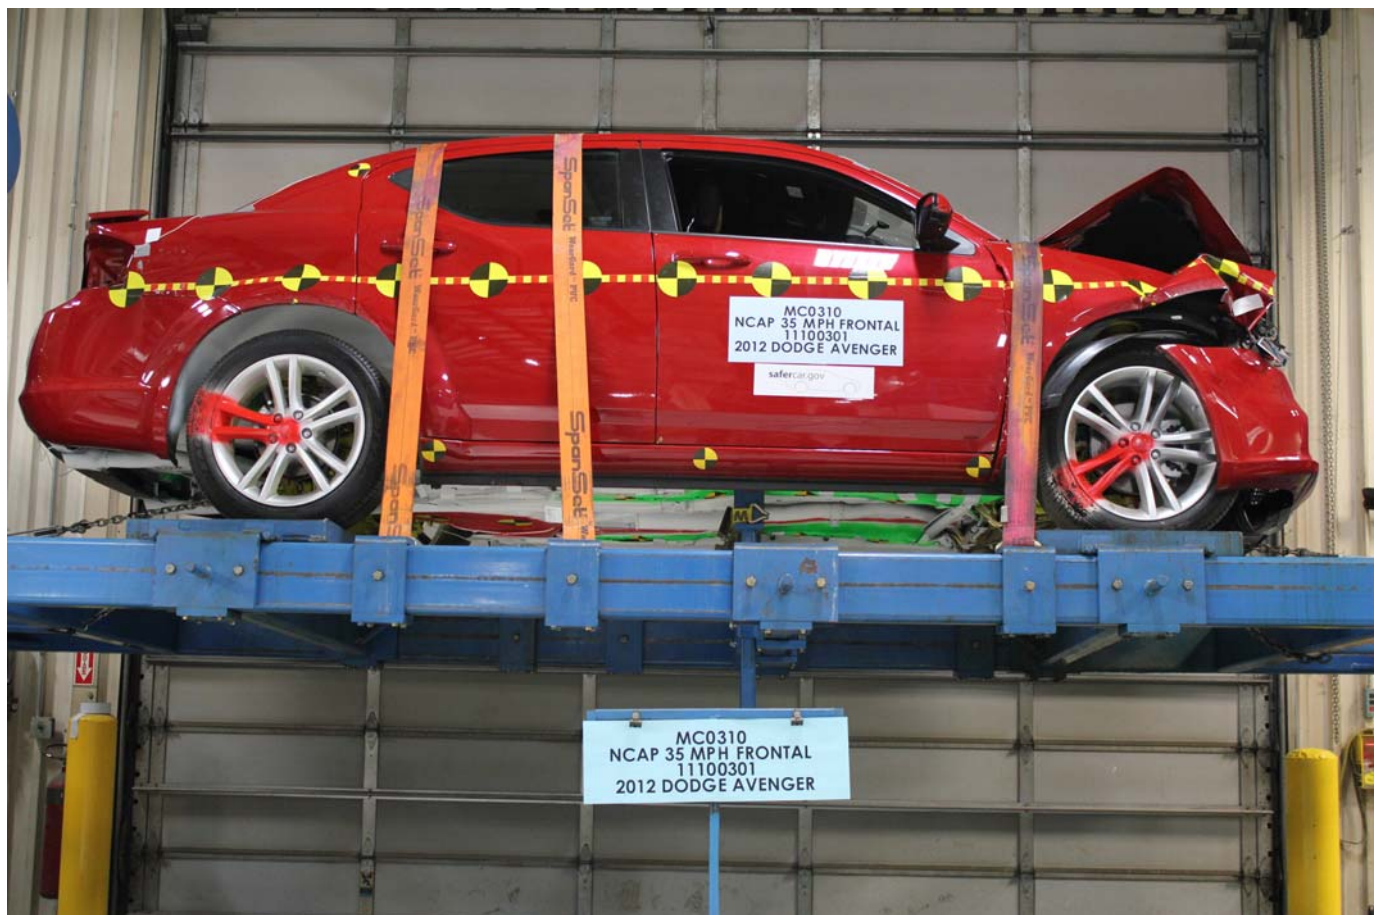
Vehicle at 0 Degrees on Static Rollover Device

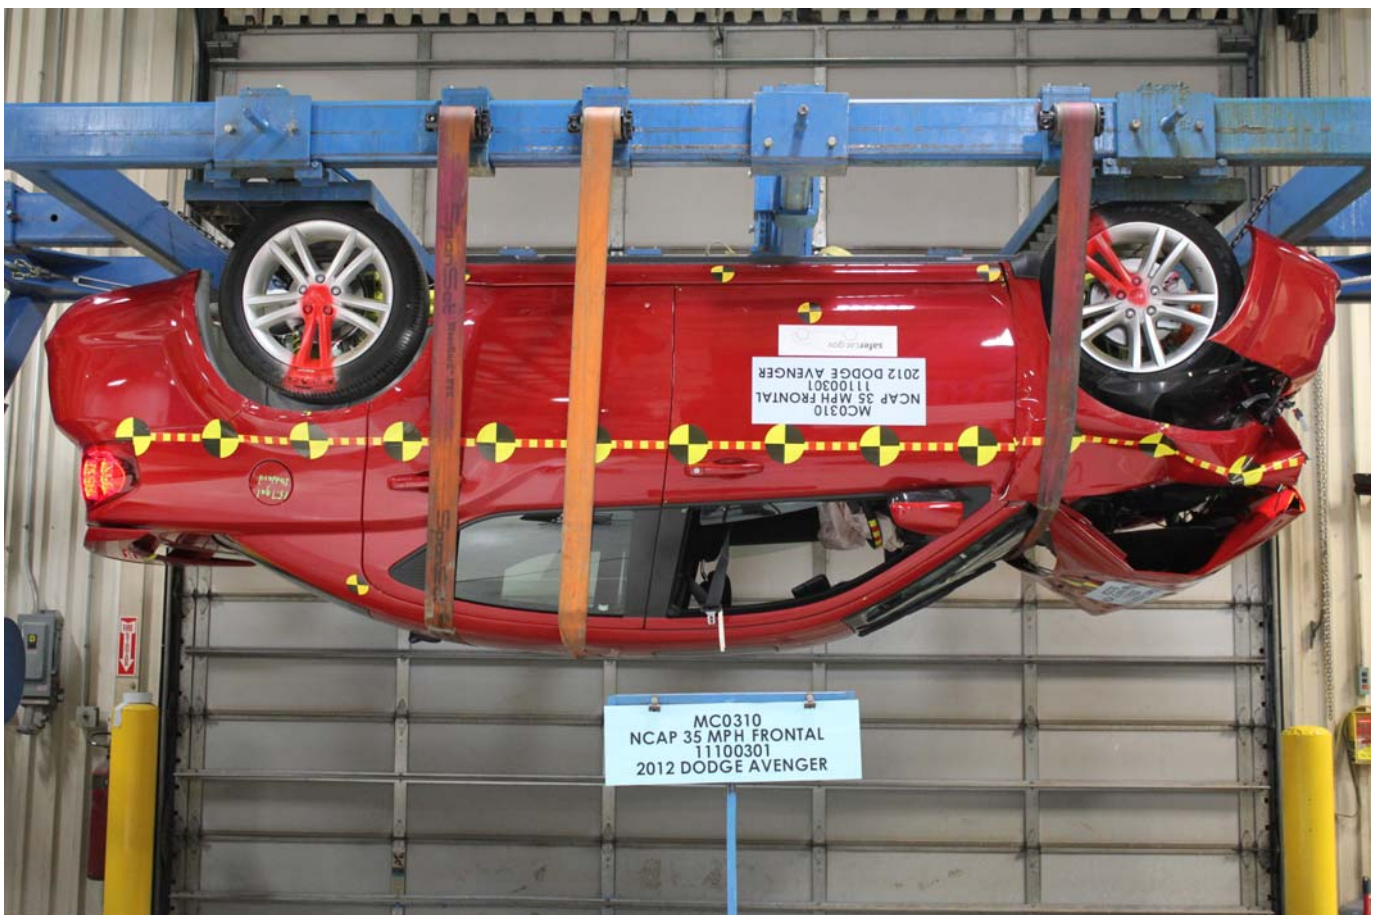
Vehicle at 180 Degrees on Static Rollover Device

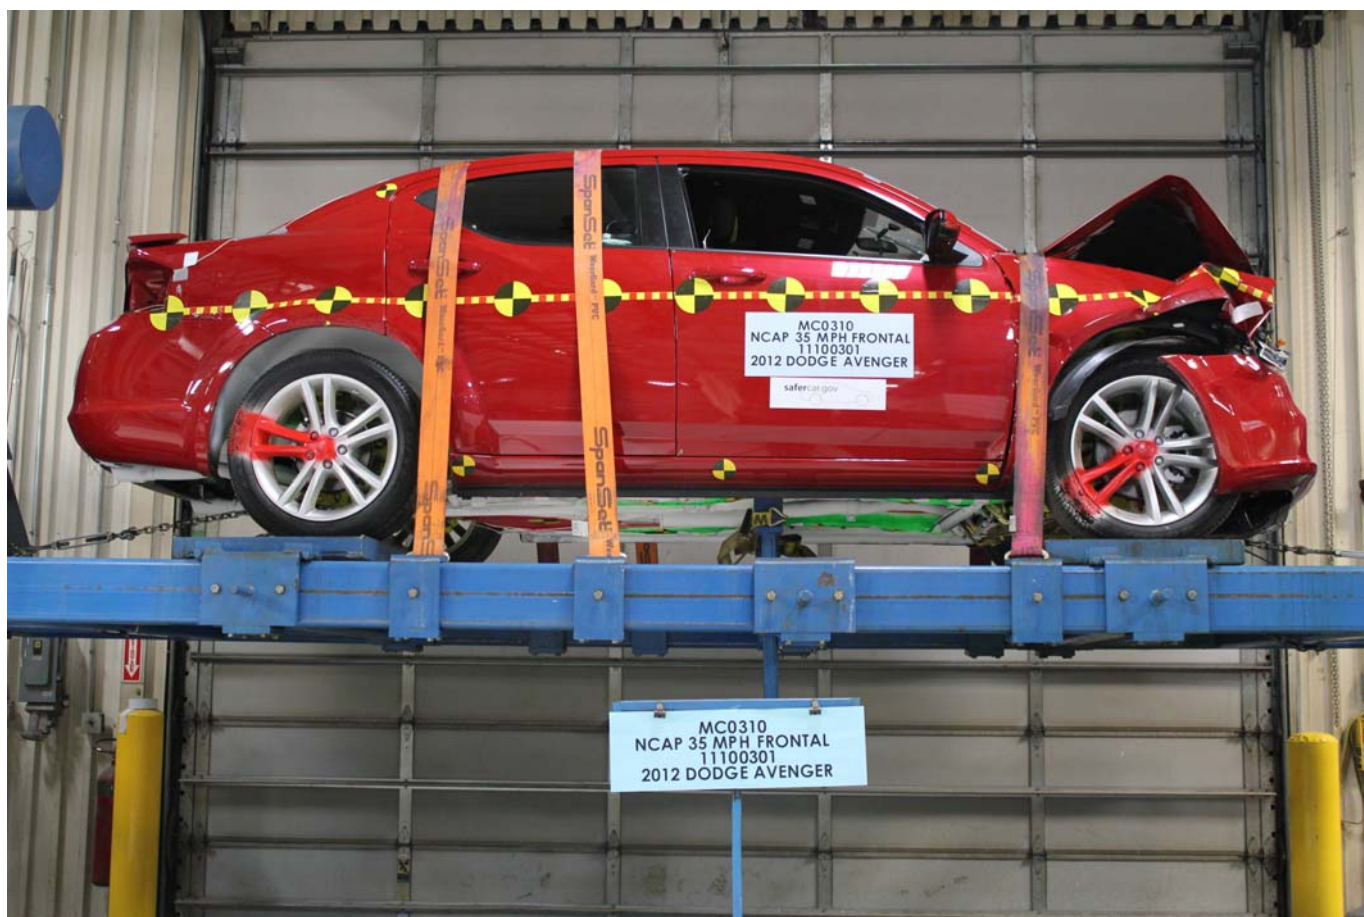
Vehicle at 360 Degrees on Static Rollover Device
